Historic Building Investigation

Black Friar Public House,
Blackfriars Road,
Salford

Report No:
SA/2017/55

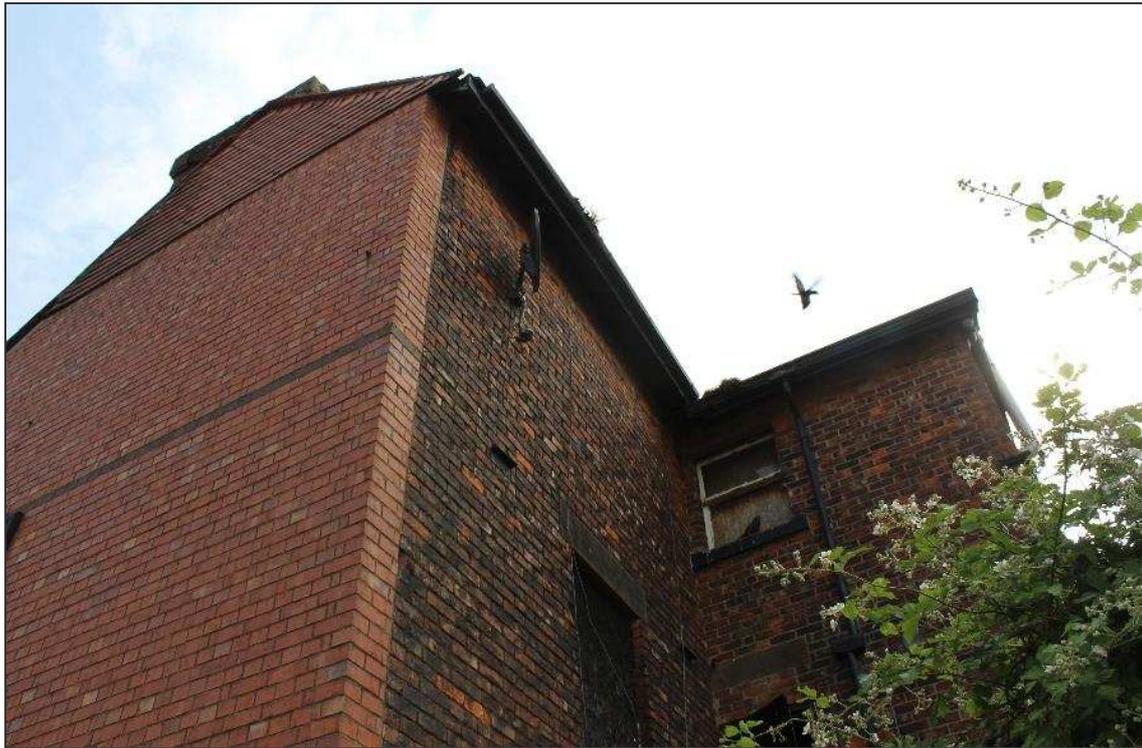
Plate 30: Detail photo of the western elevation abutting the southern elevation, denoting the rebuilding

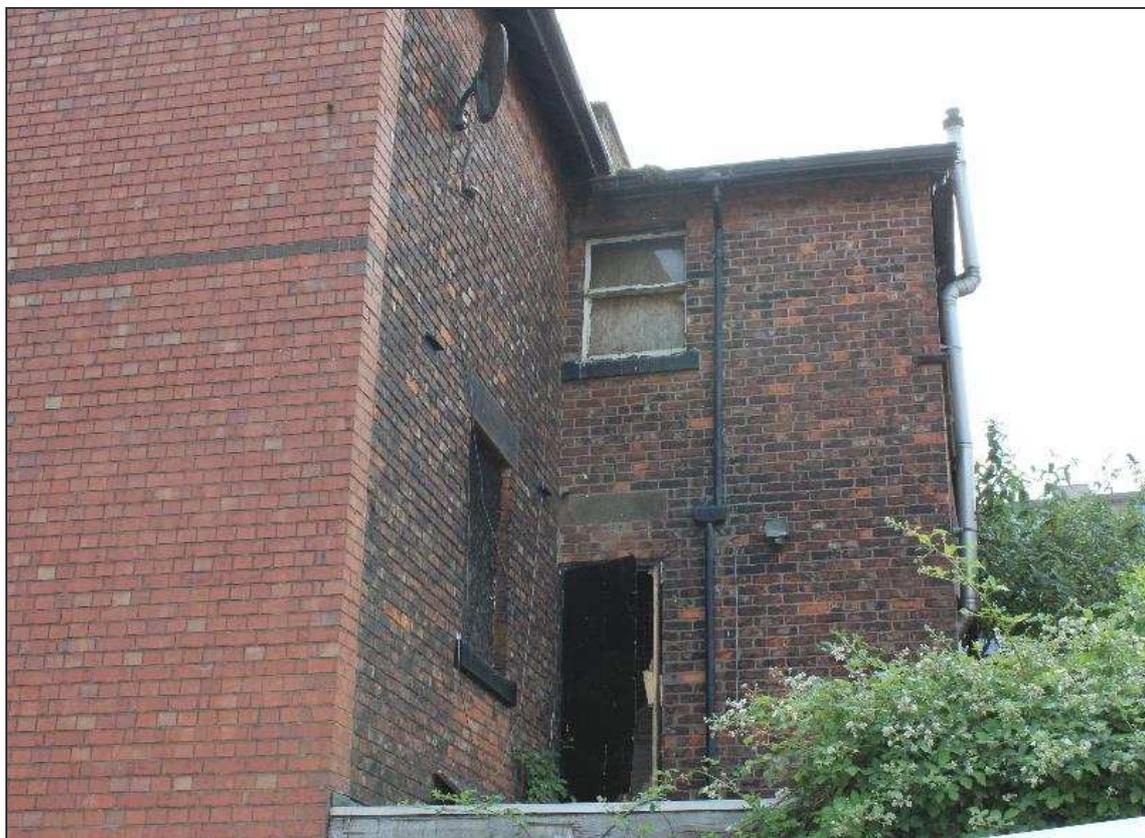
A doorway is situated to the northern end of the wall at first-floor level. It has square return reveals, which support a steel and brick lintel. The door had been later modernised to be a timber-framed fire door. This was inserted into an earlier, partially blocked-up window. The window has a sandstone lintel that has been dressed smooth. Its reveals could not be ascertained (Plate 31). A window located at the northern end of the wall at second-floor level has square return reveals with a sandstone lintel and a chamfered sandstone sill. The window is a two-light timber-framed sash window that has been boarded up due to damaged glass panes (Plate 31).

Plate 31: General view of the western wall of the L shape

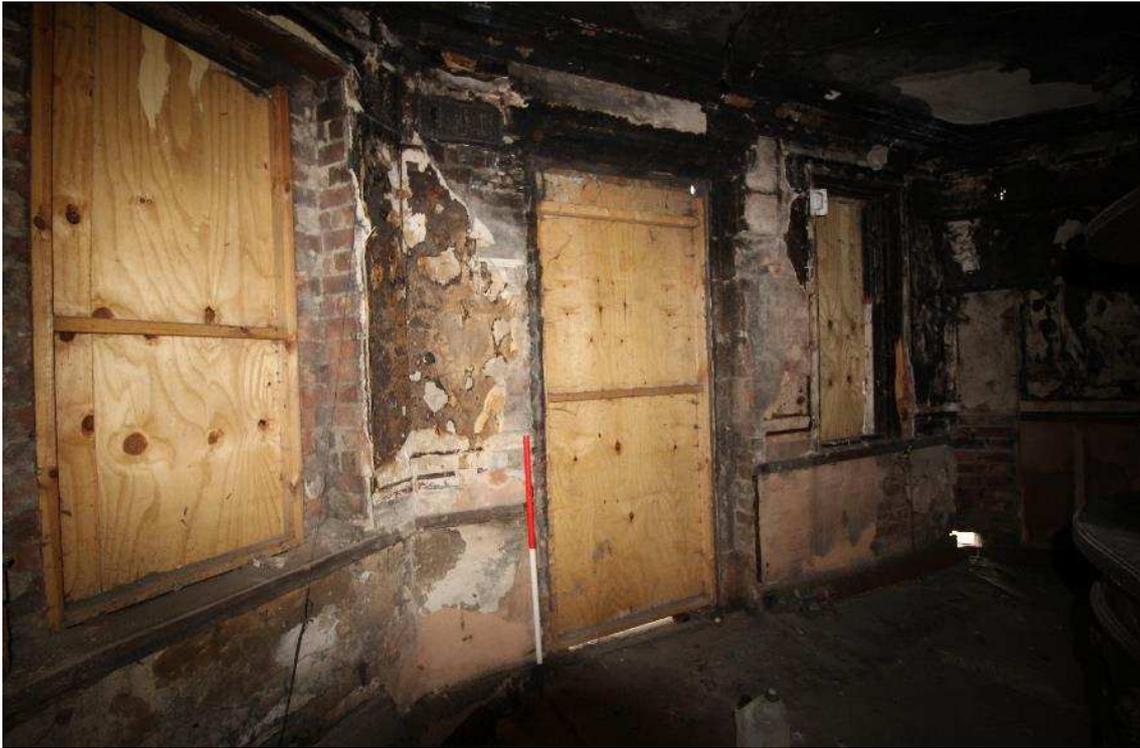
A second main entrance door is located at the north-western side of the north-eastern wall. The door and doorframe have been removed completely, presumably due to the fire (Plate 36). A window is situated 500mm south-east of the door. This window is rectangular in shape with brick reveals that support a sandstone lintel. The timber frame, as with the windows on the northern wall, had been badly fire damaged. The frame has moulded timber side and header casings. The window is supported by a 2” timber baton inserted into the wall and has been bedded using cement mortar. The wall below and above the window has been rendered in plaster, although due to water ingress the majority of the plaster has been removed, exposing the inner face of the external wall (Plate 37).

Plate 36: The north-eastern wall of the main room, detailing the second entrance doorway

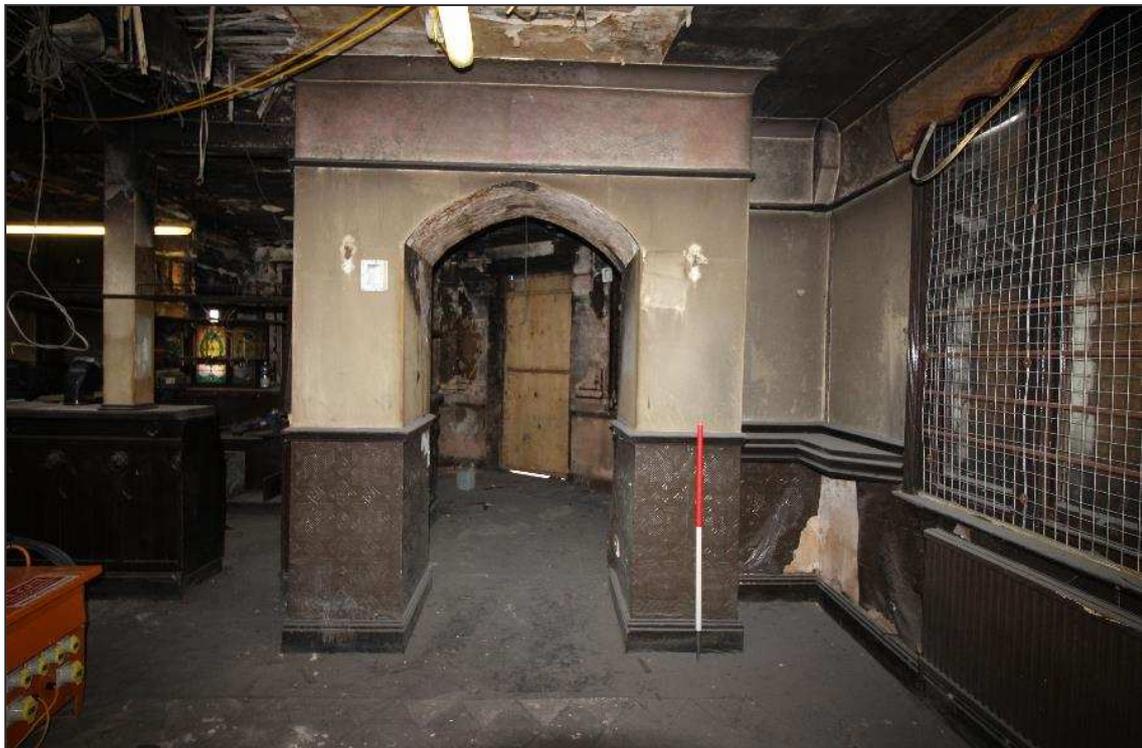
This room is separated from a second room by a non-load bearing decorative archway that incorporates a three-pointed arch at its southern end. It has been built using a timber frame that has been rendered using plaster. It has moulded skirting boards which have been nailed to the frame using headless nails. A dado rail that has been painted mahogany red separates the pier walls. The top half of the wall has plain white wallpaper, whilst the lower half has patterned wallpaper that has been painted a mahogany red. A half-round moulded picture rail is located directly above the crown of the arch. Above this is flowery patterned wallpaper that leads up to a plaster coving, both of which have been heavily fire damaged (Plate 40).

Plate 40: Arch between the main room and a second room

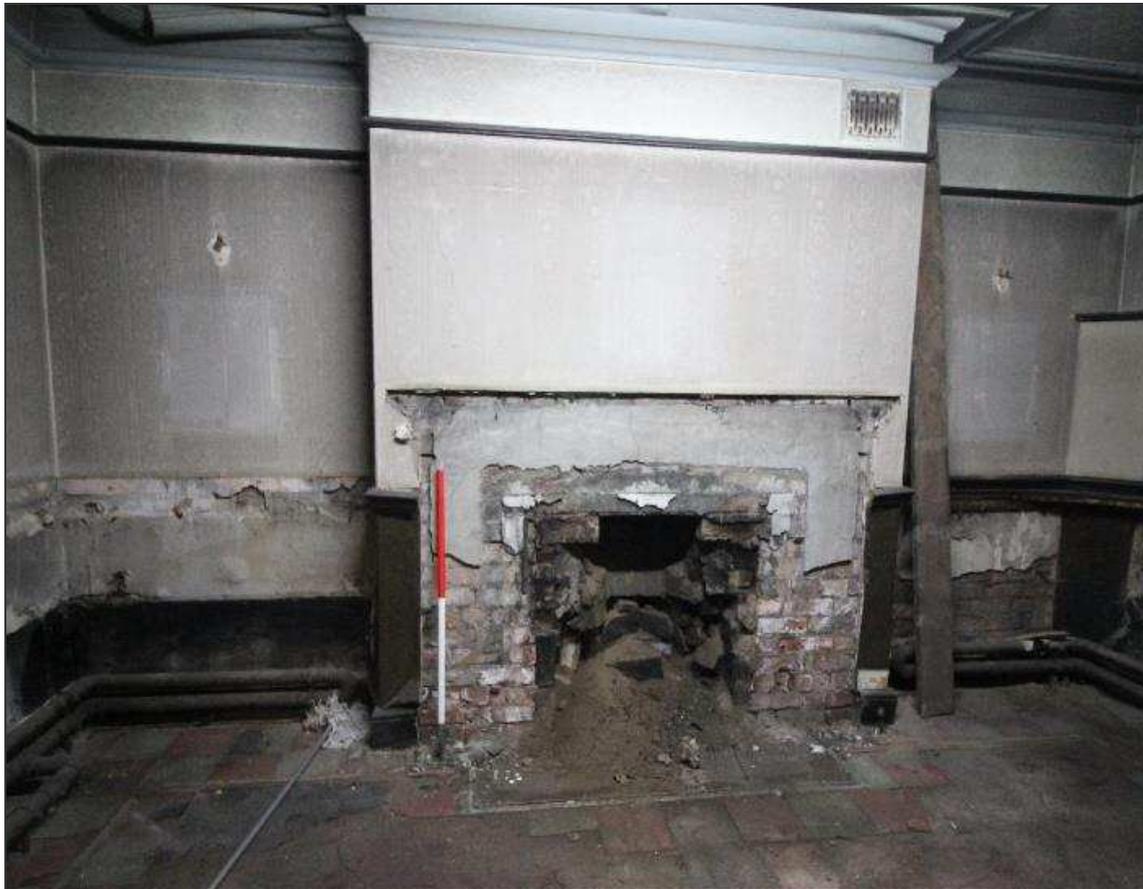
The western wall is dominated by a protruding chimney in its centre of the wall, together with its demolished fireplace. The fireplace has a stone hearth and firebrick back which was exposed after the removal of the surround that would have originally been of cast iron. The mantel had also been removed, but the remains of the 1 ½”thick timber mantle were observed 1.5m up from the floor (Plate 44).

Plate 44: Protruding chimney and the robbed out fireplace in the western wall

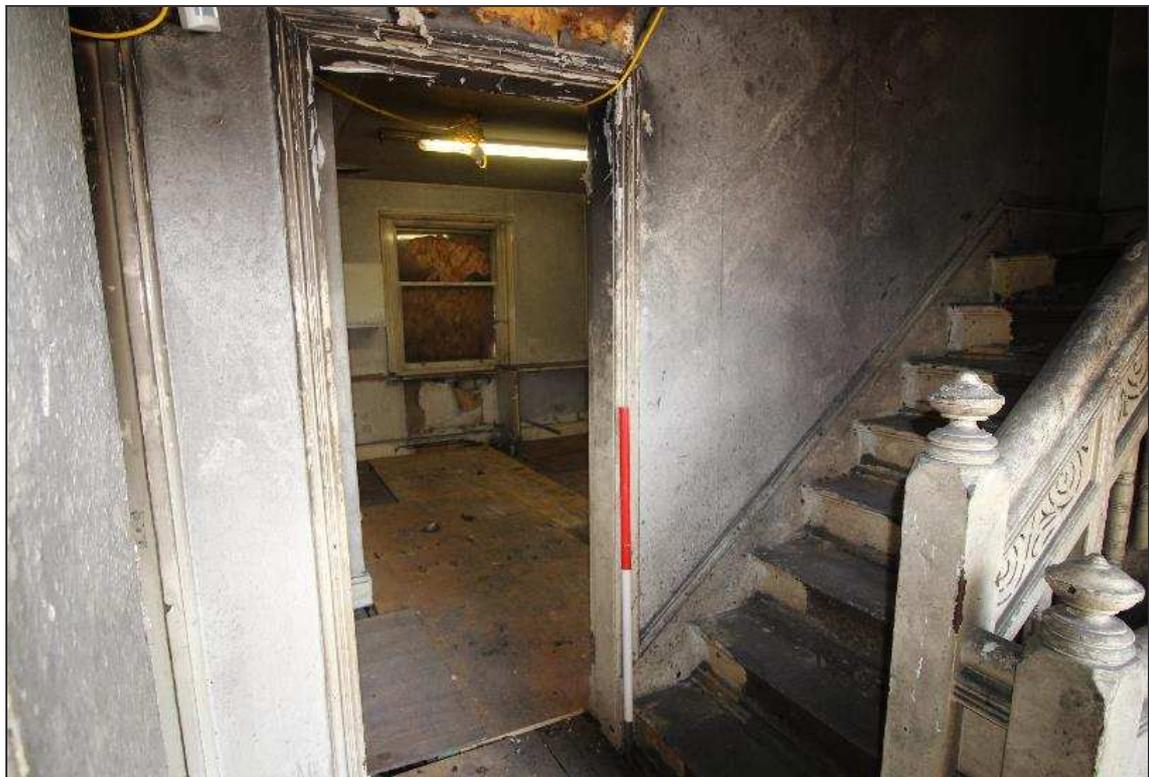
The first room lies at the eastern end of the hallway. The door frame has moulded timber sides and header casing and has a half upturned timber threshold. The door has been removed, and the frame has suffered extensive fire damage (Plate 52).

Plate 52: Doorway leading into the eastern room on the first floor

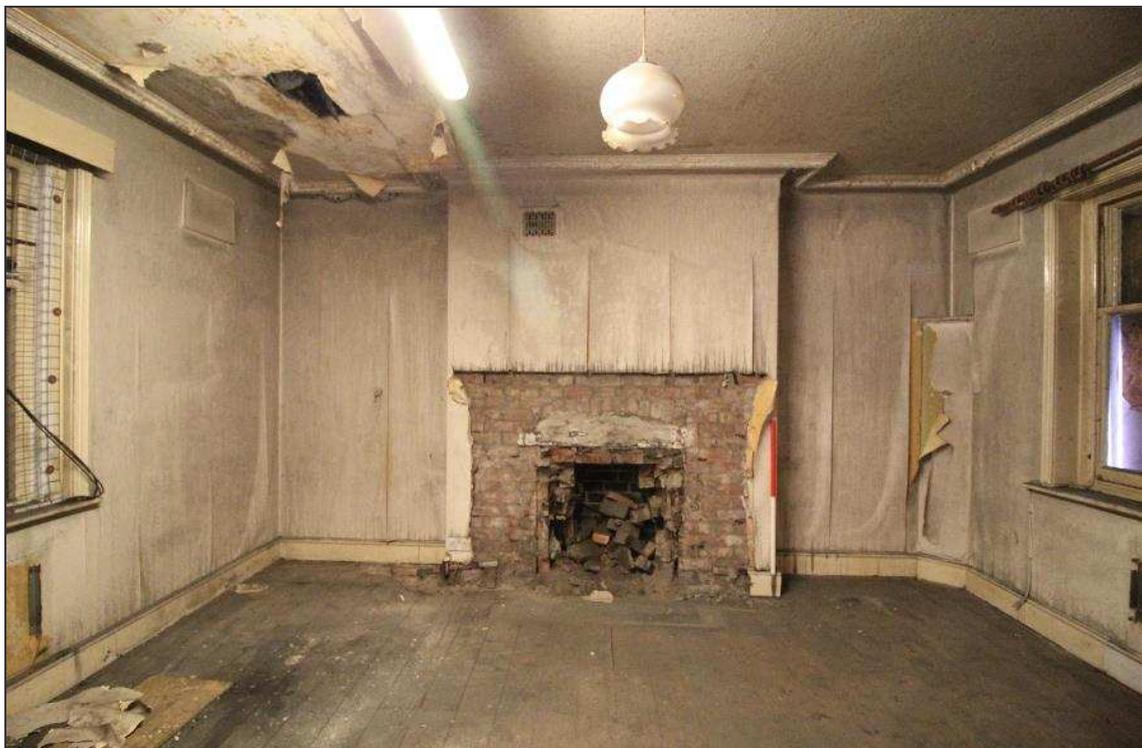
Plate 60: Chimney and robbed-out fireplace on the western elevation

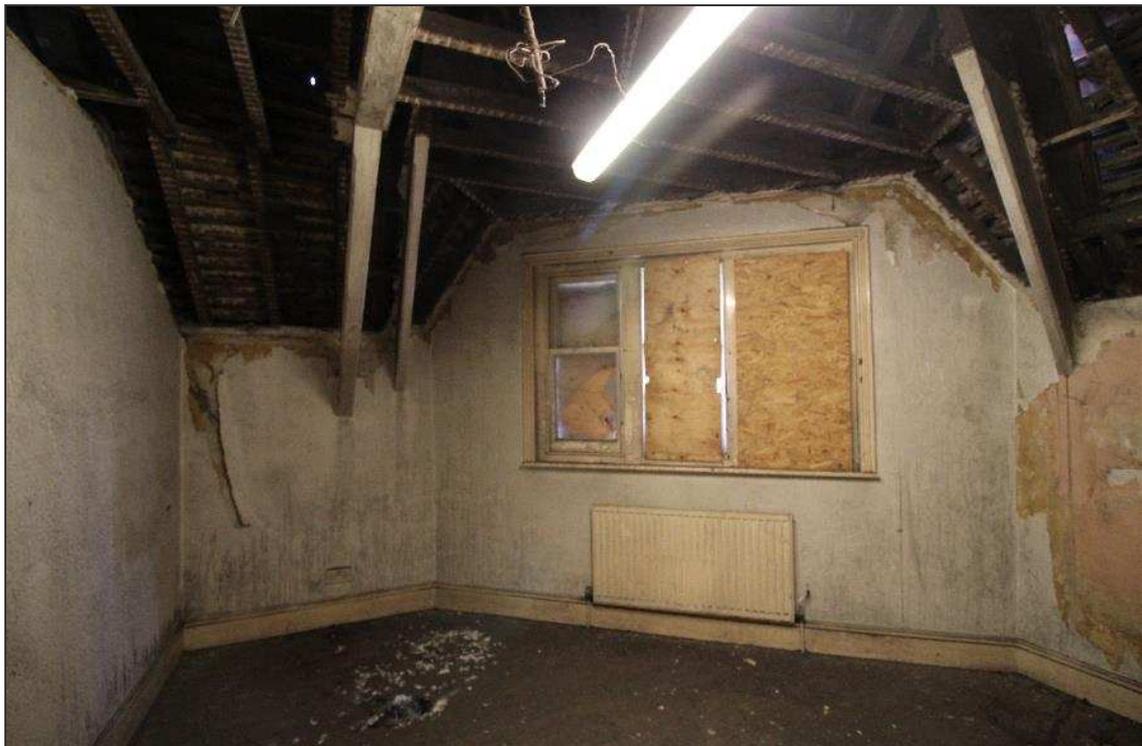
The eastern and northern walls had been painted white originally, but both had suffered smoke and fire damage. A timber-framed window is located on the north-eastern wall. It is a six-light sash window that has Victorian-style moulded side and header casing. The single-glazed window panes have been mainly destroyed or removed and boarded-up using plywood, except the bottom north-western pane that has been partially damaged by vandalism. The sill is 1” thick timber that has a half-round moulded edge and has been laid upon the inner course of the north-eastern elevation. Below the window is a modern double-panelled radiator that has been hung above the skirting board (Plate 70).

Plate 70: General view of the window in the north-eastern wall

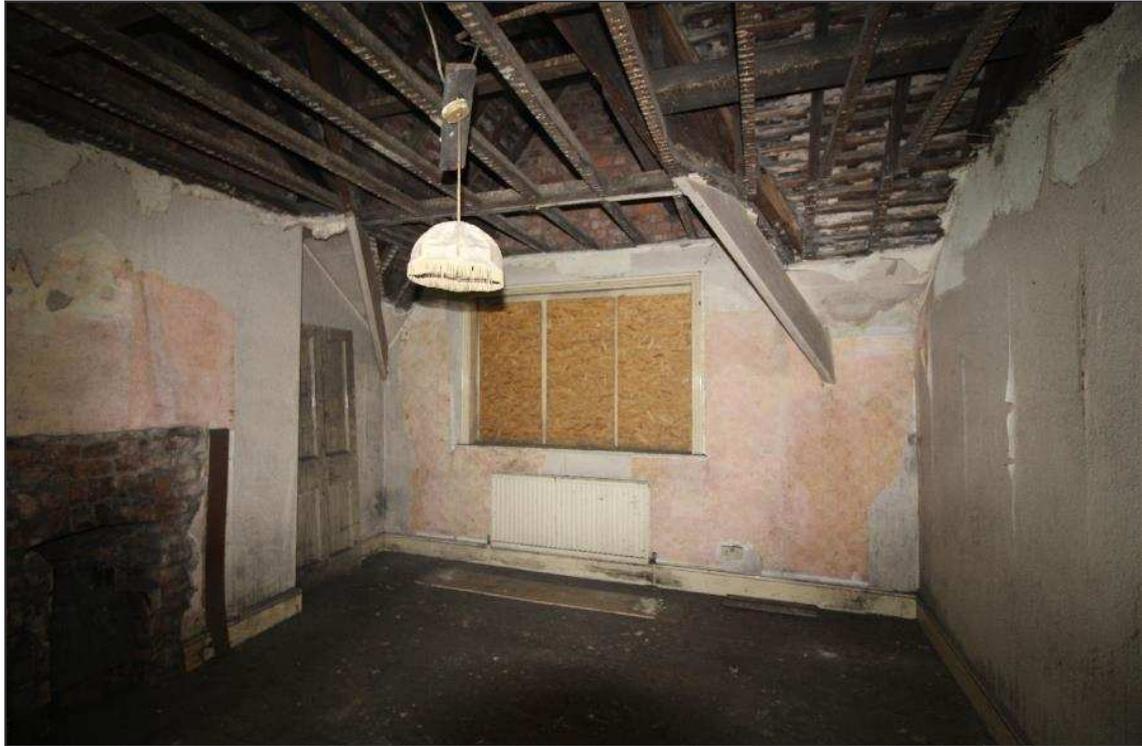
The northern wall has a six-light timber-framed window within it. As with the window in the second bedroom, it has a Victorian moulded style side and header case. The glass panes have been removed, and the lights boarded-up with plywood. Below the window is a double-panelled modern radiator that has been hung at skirting-board level. The wall has been papered with a light pink flowery design wallpaper that has sustained smoke and fire damage (Plate 71).

Plate 71: General view of the window in the northern wall of the third bedroom

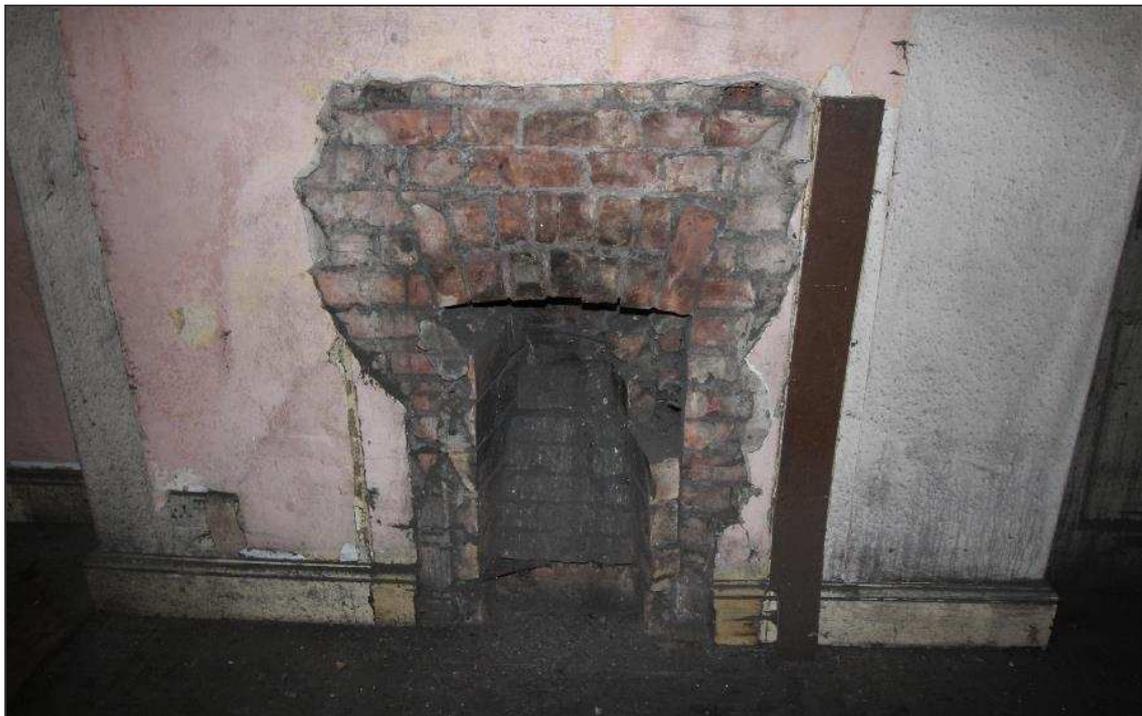
The western wall contains a chimney and its associated brick built fireplace. The chimney measures 2m wide and extends 460mm into the room. The fireplace surround has been removed completely, exposing the firebrick back and its segmental brick-arch head. The breast and the wall have been papered using a pink coloured flowery design wallpaper, that has suffered some smoke damage (Plate 72).

Plate 70: Detail view of the fireplace on the western wall of the third bedroom

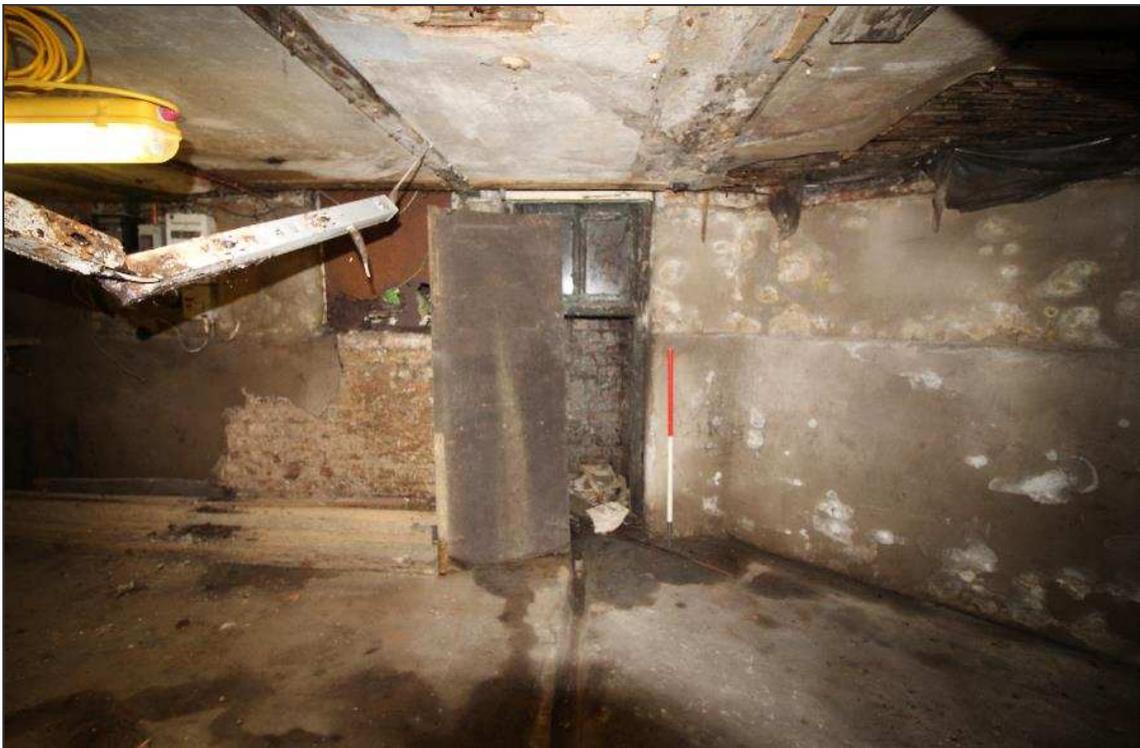
A second cellar light was observed at the eastern end of the wall. This window had most of the render removed around the sill and around the eastern reveal. This exposed that both had been built from brick, with bull-nose brick edges. The panes had been removed from the timber frame, and the aperture boarded-up subsequently using plywood (Plate 79).

A doorway into a small cupboard is situated 300mm to the east of the window. The doorway comprises bull-nose brick reveals that support a 200mm thick timber lintel. It has a timber doorframe with a fanlight at the top that has its glass panes removed and replaced with timber panels. The internal walls, ceiling and floor of the cupboard are built from hand-made brick that have been bonded using lime mortar. The door has been removed, although the pintels have been retained on the western jamb (Plate 79).

Plate 79: Blocked-up window and cupboard at the eastern end of the northern wall
