Rochdale Riverside Archaeological Evaluation

Introduction

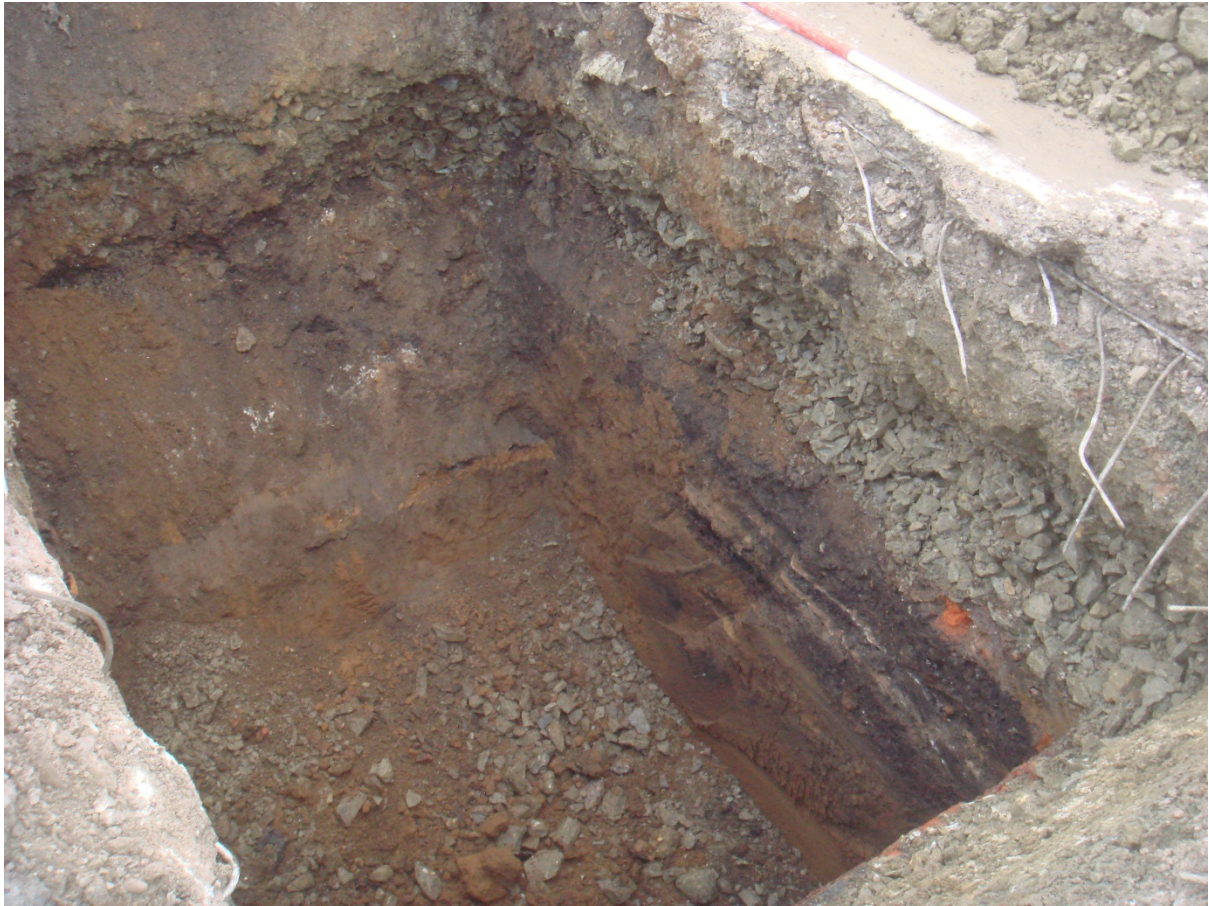
Trench 1a was excavated through the concrete car park surface and its stone bedding. Below this was 2m of compact stone levelling/infill with 0.5m of mixed compacted demolition rubble below. This overlay natural mid brown clay at 2.7m below the current ground level.

Depth of levelling material in trench 1a, natural sand at base, looking north

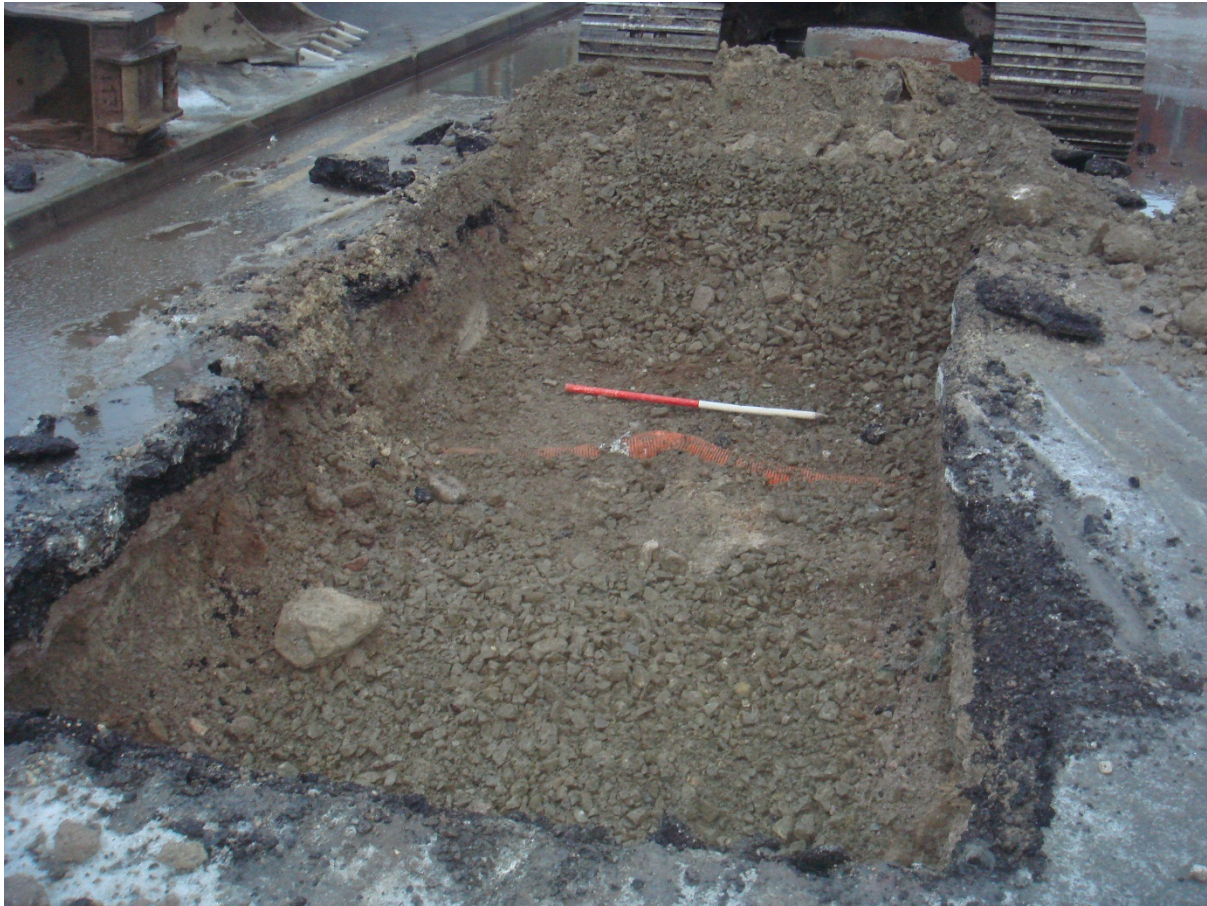
Trench 1b was excavated to a depth of 0.68m through tarmac and stone bedding and into compact stone levelling material. Within this material, at a depth of 0.68m, was an orange plastic duct running east/west with a live electricity cable within it. This was in line with the car park lighting columns.

Cable duct in trench 1b, looking northwest

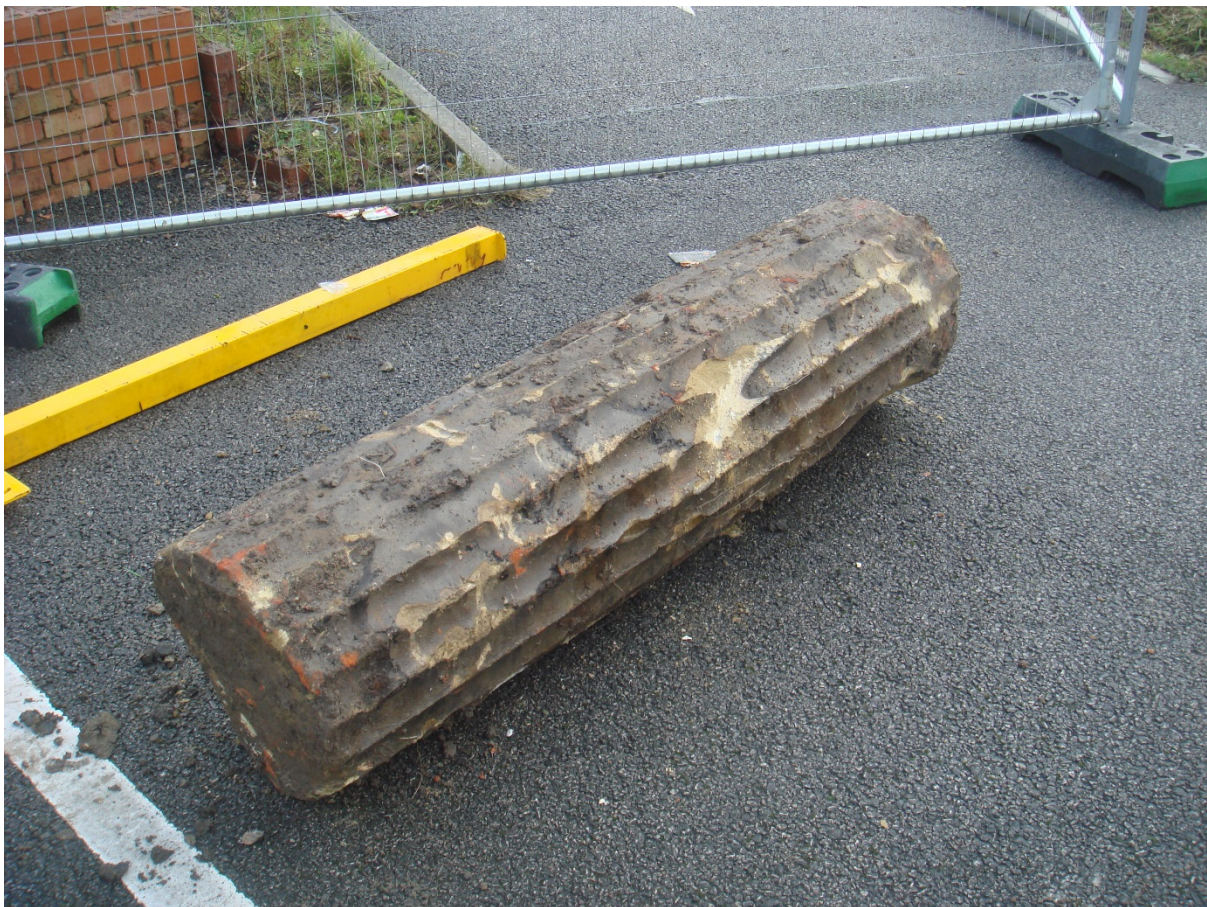
Below the tarmac three concrete piles with concrete ring beams were encountered at a depth of 0.98m to 1.01m. These ran across the trench, radiating from the curved front of the former health centre. Between these piles were rough concrete ducts, all giving strong live electrical signals on the CAT scan. At the east end of the trench 6.9m long section was clear of services and concrete and could be excavated deeper through mixed loose demolition rubble. The rubble contained fragments of architectural masonry including a fluted column.

Fluted column from demolition rubble in trench 8

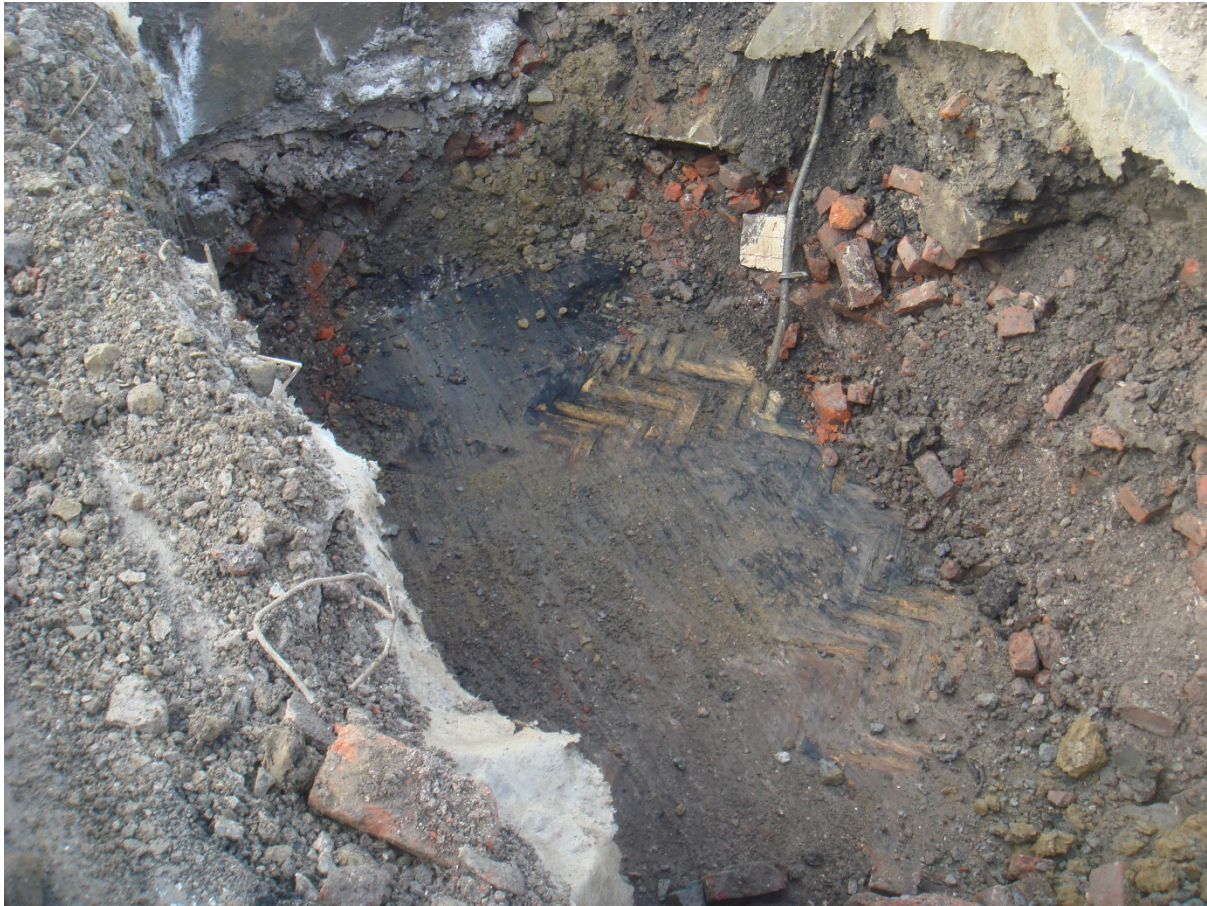
Below the rubble, at a depth of 2.2m and running below the concrete ring beams, was a wooden herringbone pattern parquet floor surface, probably from the former chapel.

Wooden parquet flooring at base of trench 8, looking southeast

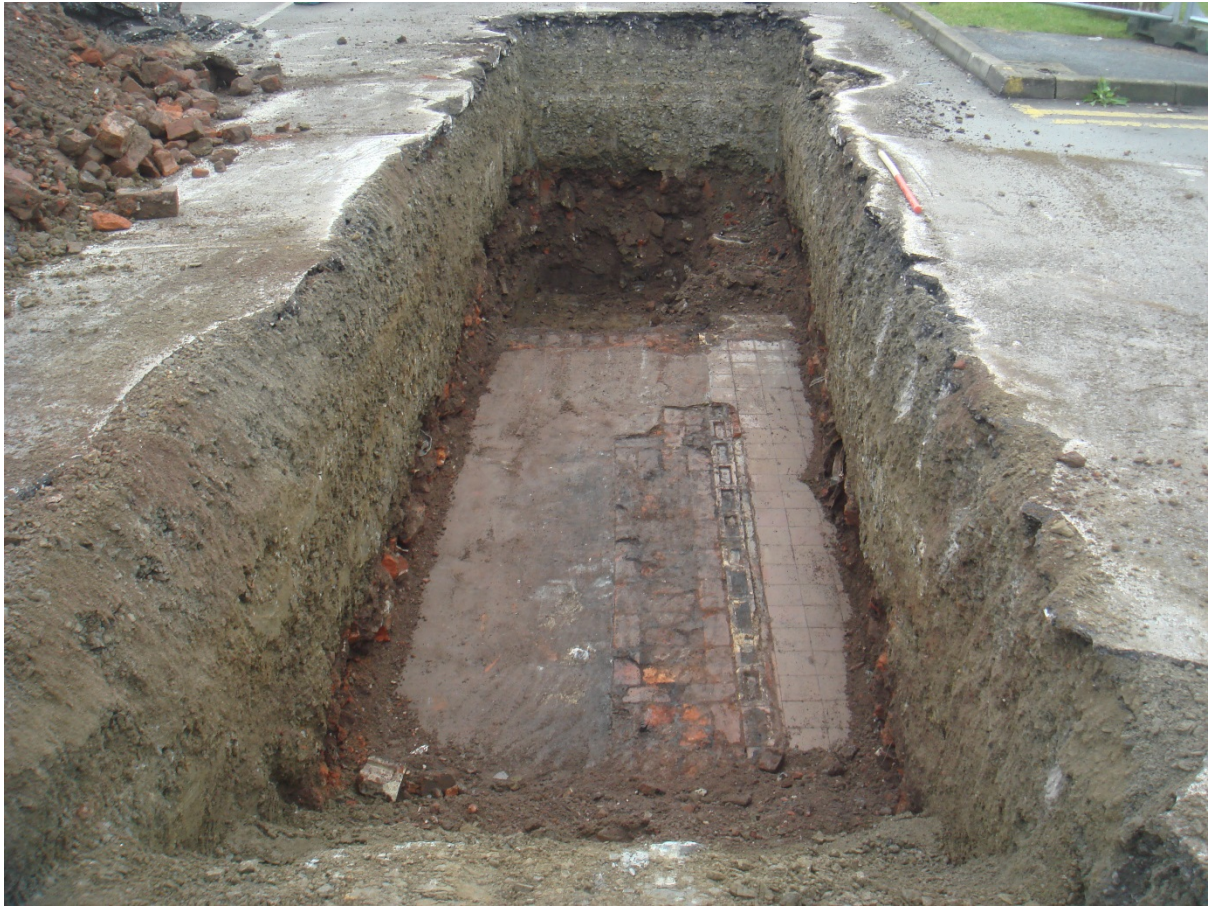
The northern 5.3m of the trench, below the tarmac, had been heavily disturbed and comprised mixed loose demolition rubble to a depth of 2.6m at which point natural clay was observed. At the immediate south side of this was a concrete duct which gave off a strong power signal with the CAT scanner. This concrete duct had cut through part of the floor of the former school which comprised very hard orangey red square tiles at the west side and a concrete floor surface at the east side. Between these was a 5 course wide brick wall. The central two courses appeared to be the original wall, of machine made brick with hard dark cement. The two courses running along the east side of this, also machine made brick with hard cement, appeared to have been roughly added at a later date. The western course was also later and comprised modern frogged and glazed bricks with a narrow concrete channel, presumably for drainage, running alongside it. At the south side of the floor surfaces was a four course wide east/west wall of machine made brick with hard black cement. At the south end of the trench, beyond the southernmost brick wall, was mixed loose demolition rubble to a depth of 2.1m at which point natural clay was observed.

Floor surface and walls in trench 9, looking south

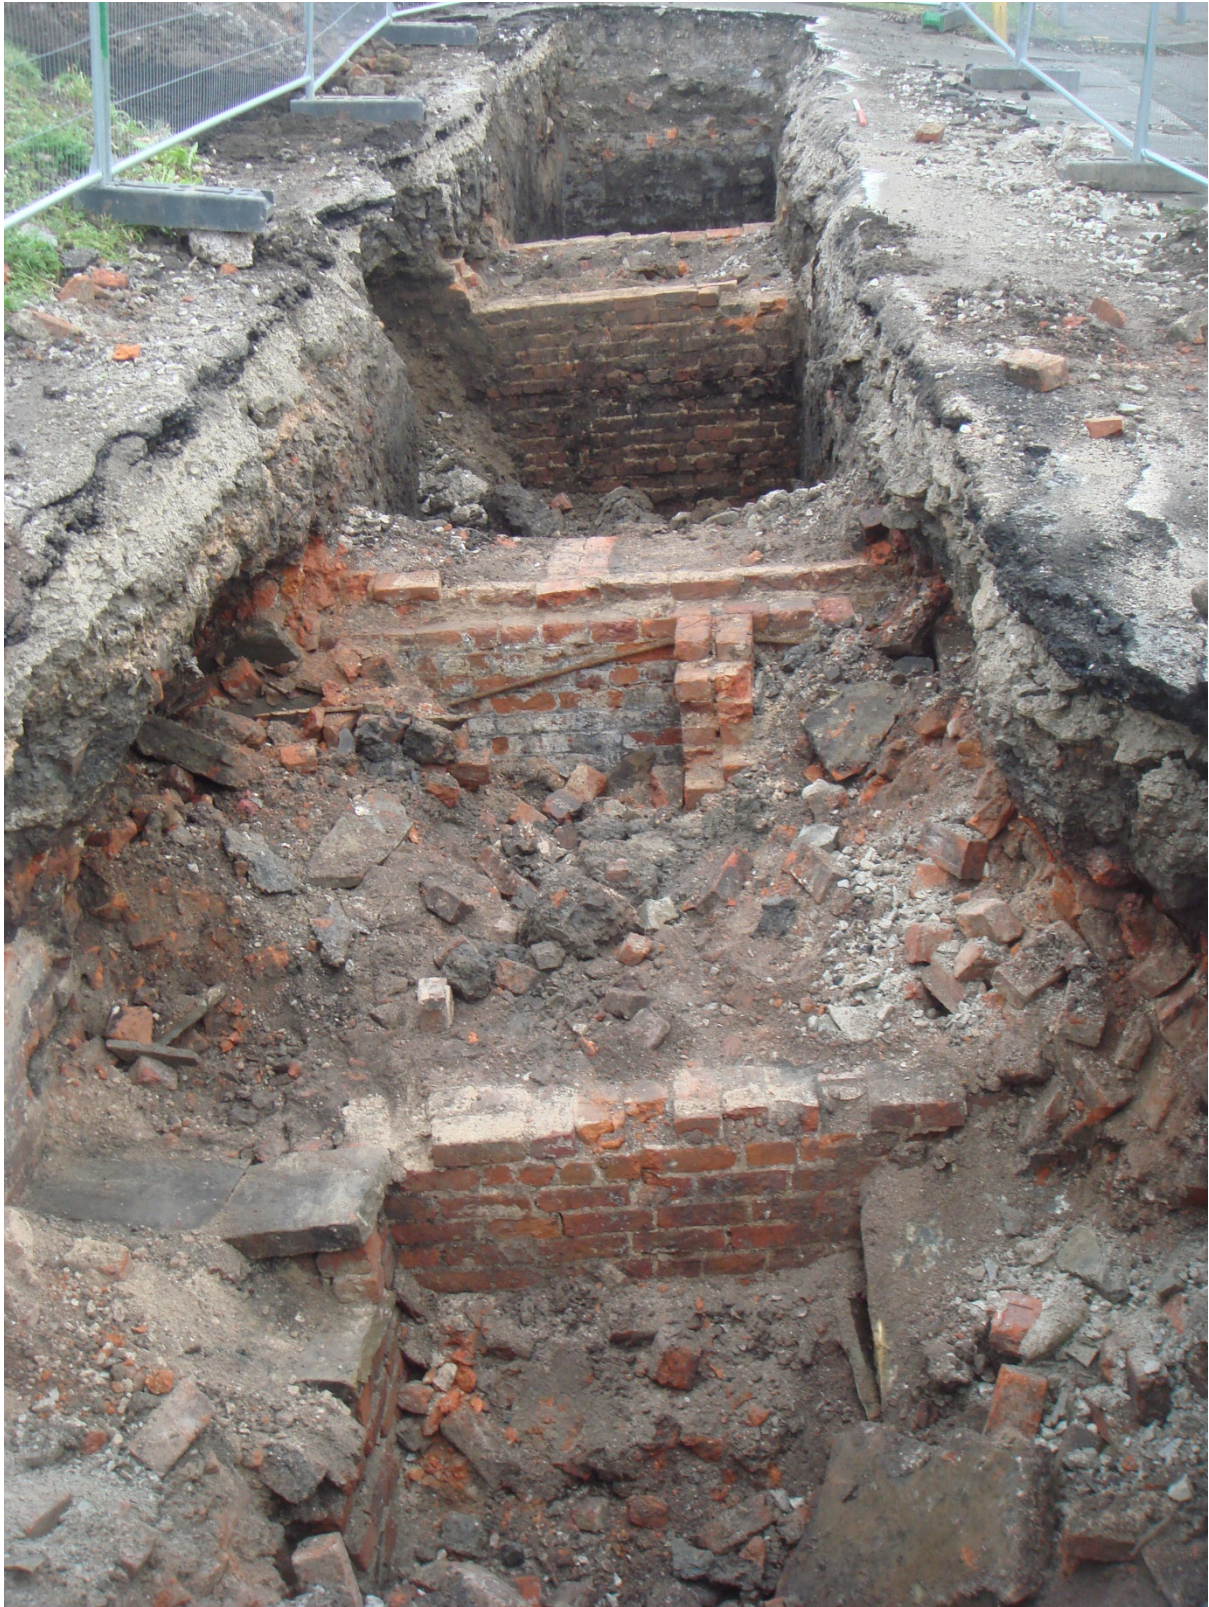
A series of handmade brick walls with lime mortar ran north/south across the trench forming the internal division walls between the cellars of the back-to back housing.

Walling of back-to-back house cellars in trench 10, looking east

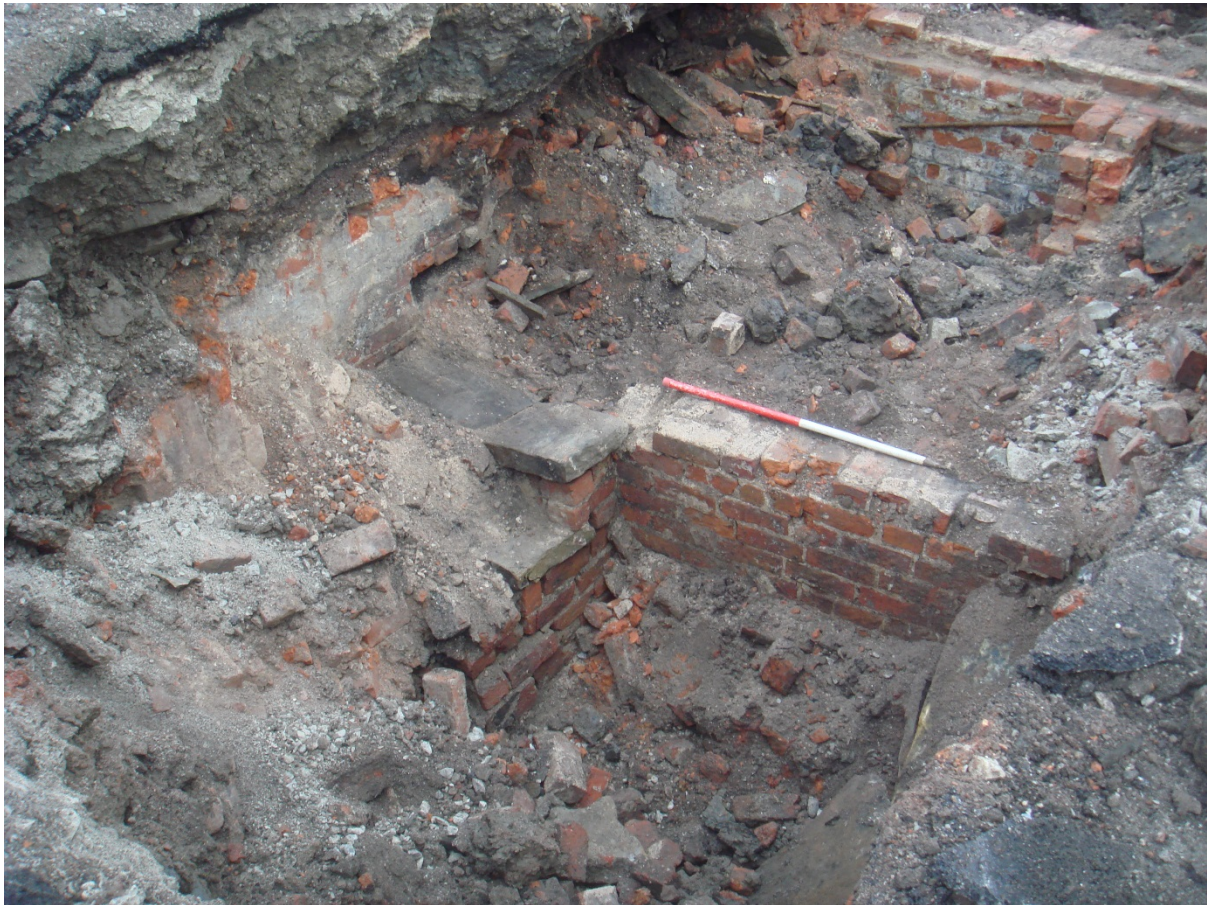
The dividing wall between the north and south sides of the range was also visible in the northern trench edge. Two sets of brick and stone stairs were uncovered leading down into the cellars. The narrowness of the structures within the trench meant that the cellars could not be emptied by machine without destroying the in situ walling but the presence of the intact stairs and of

mixed loose demolition rubble filling the cellars strongly suggested that the cellar floors and any internal features survive below.

Western cellar stairs in trench 10, wall dividing the north and south sides of the range visible at left, looking northeast

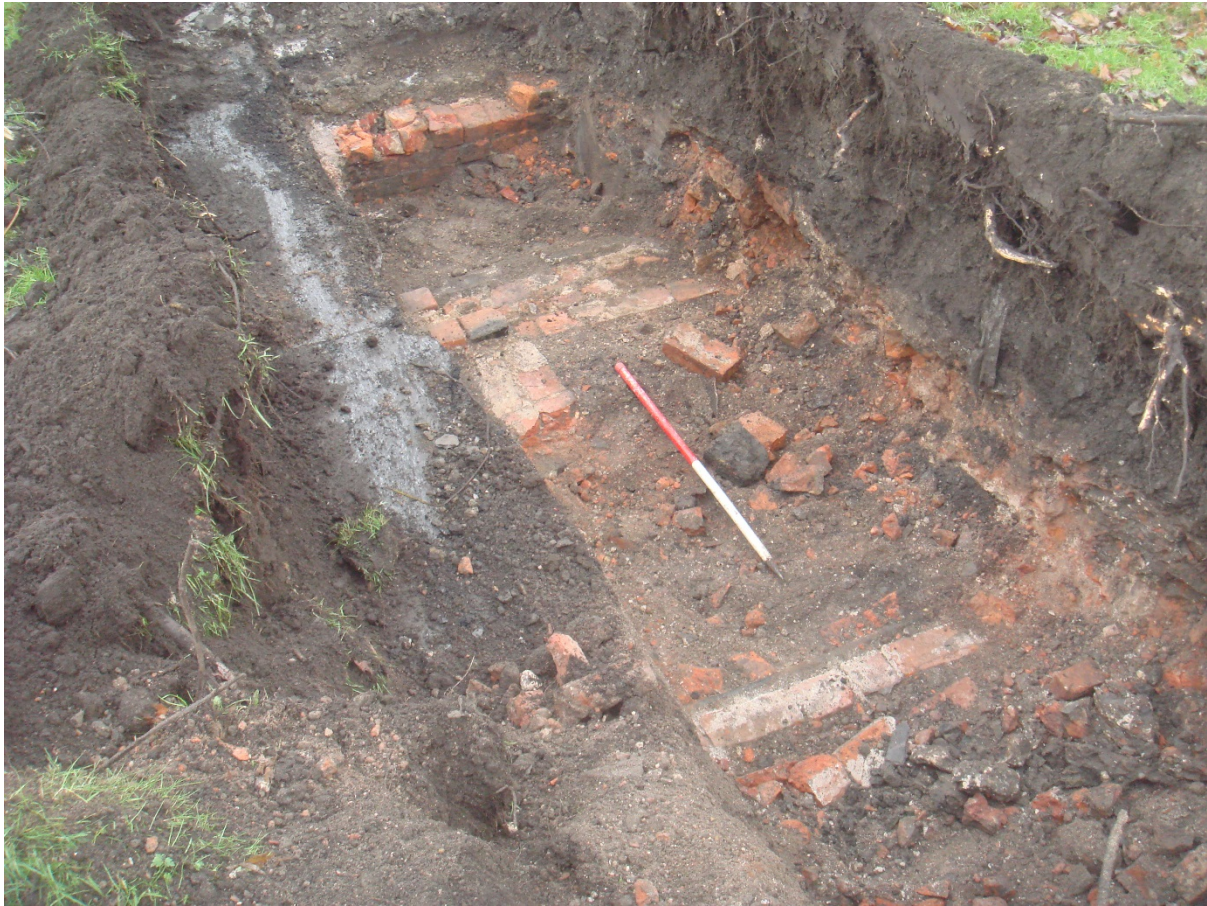
The western 17.6m of the trench could not be excavated to any depth due to the presence of a number of strong CAT scan signals and a very thick 6.5m wide tarmac surface of a former roadway. The eastern 6.4m of the trench was excavated to a depth of c. 0.7m and revealed three handmade brick walls with white lime mortar running across the trench. Between these walls was loose demolition rubble. These represented the internal dividing walls of the back-to-back houses.

Walling of back-to-back house cellars in trench 11, looking northwest

Although the western 17.6m of the trench could not be accessed due to ground conditions at the time of the evaluation it is unlikely that the tarmac road or the services present would be deep enough to remove the cellars and it is therefore likely that the cellars survive in situ below this.

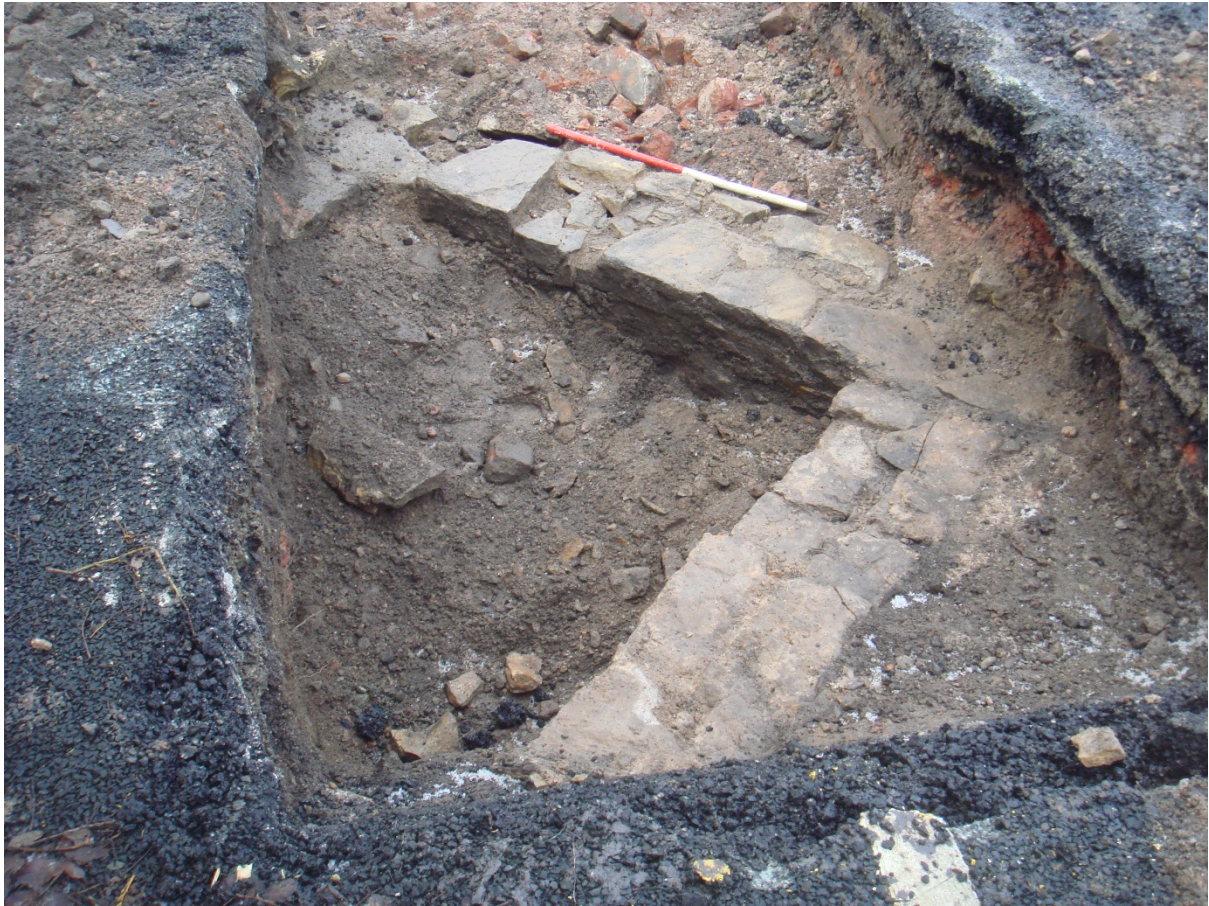
At the south end of the trench were a series of 0.4m wide stone walls forming a 2.3m wide room filled with loose demolition rubble. This ran northeast/southwest with the northwest, northeast and southeast walls visible within the trench.

Southern stone walled room in trench 12, looking north

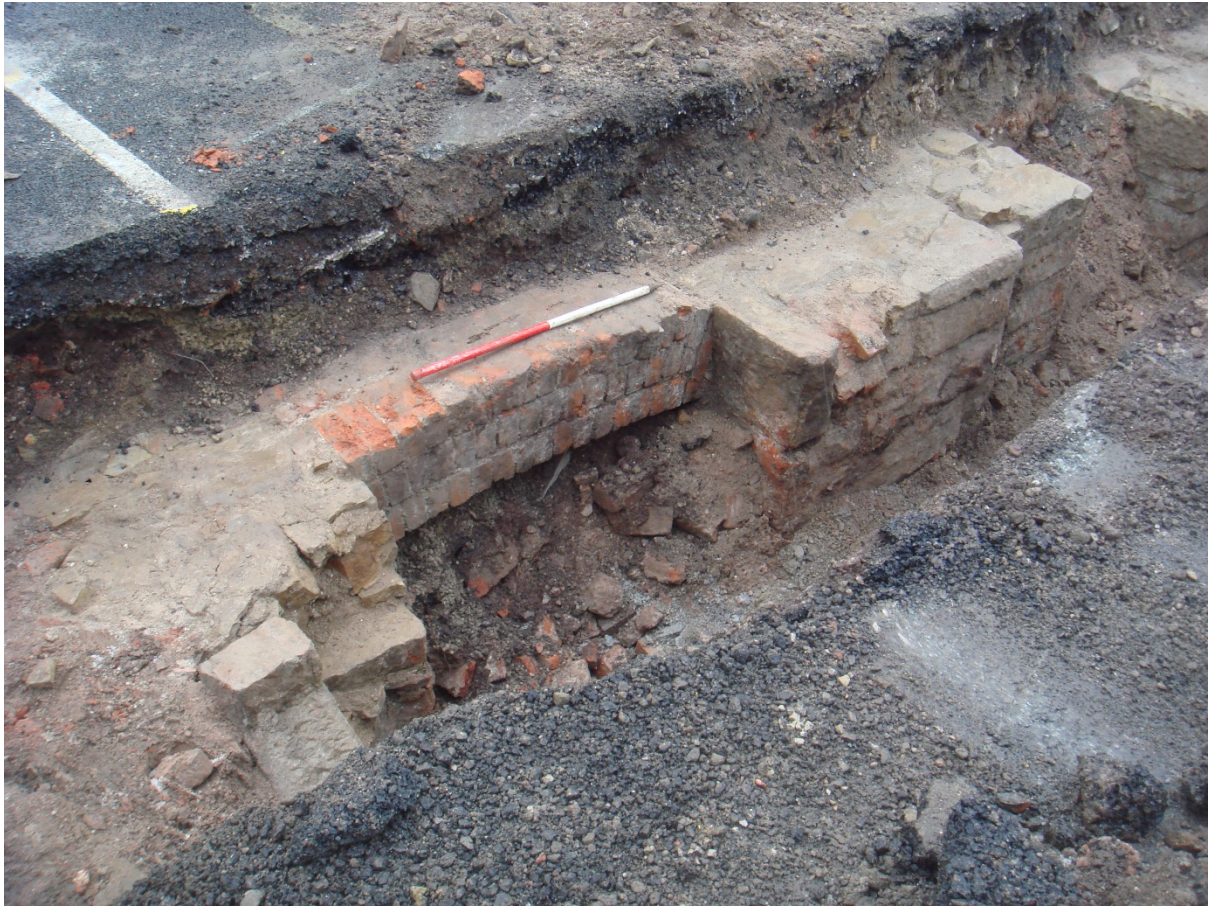
To the north of this were a series of stone structures. The northern and central structure were c 1.9m wide and stepped inwards on the east side. The northern structure stepped in at the south side of its edge and the central structure at the north side of its east edge, mirroring each other, with a 0.8m gap, possibly a basement corridor between the two. To the south of the central structure was a 0.84m wide stone structure. The 1.4m gap between the two was bridged by a four course wide handmade brick arch with lime mortar.

Stone structures and brick arch, looking northwest

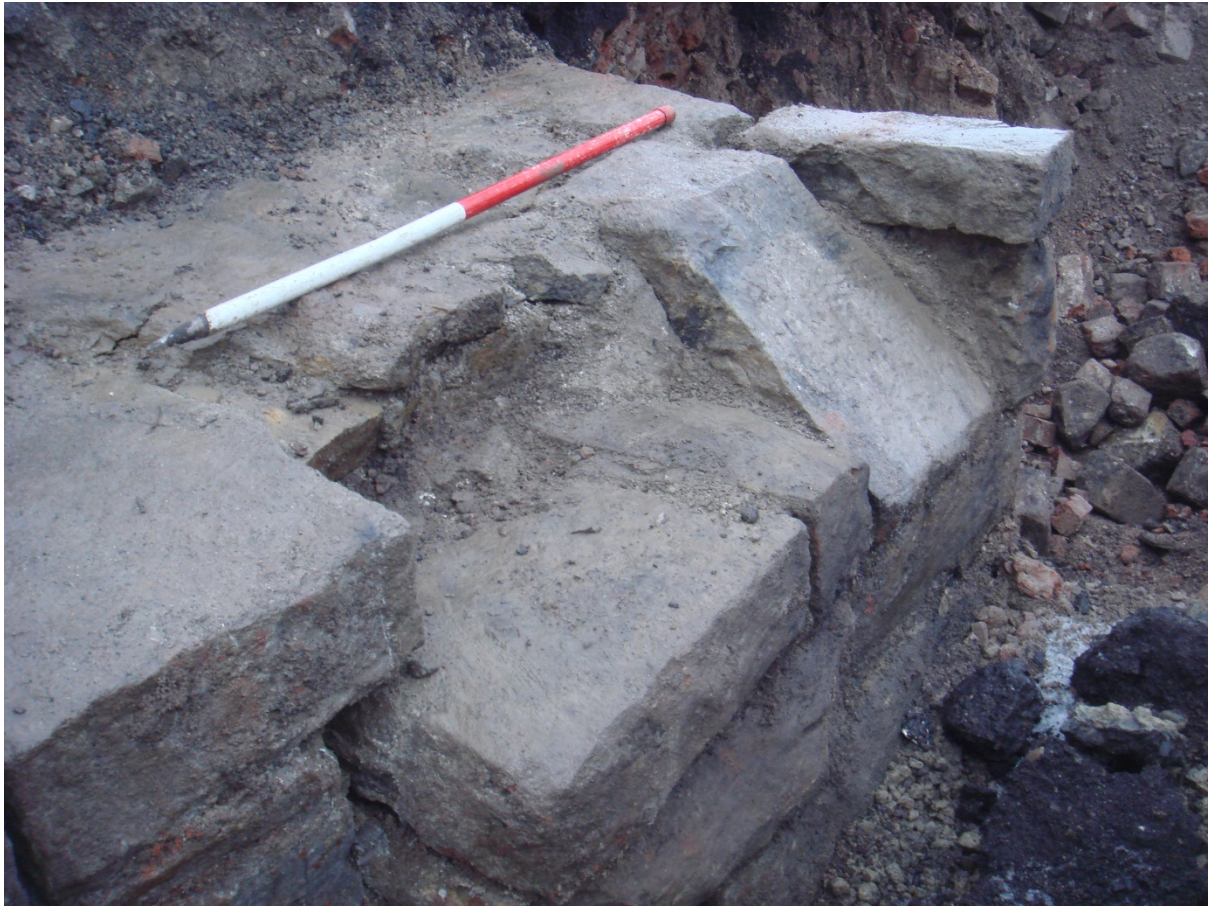
The south structure had a chamfered stone block at the south side of its east edge and the northern structure had a similar block at the north side of its east edge. These suggested that originally brick arches sprang from these chamfered blocks running east, possibly forming a north/south basement corridor.

Chamfered stone block, looking northwest

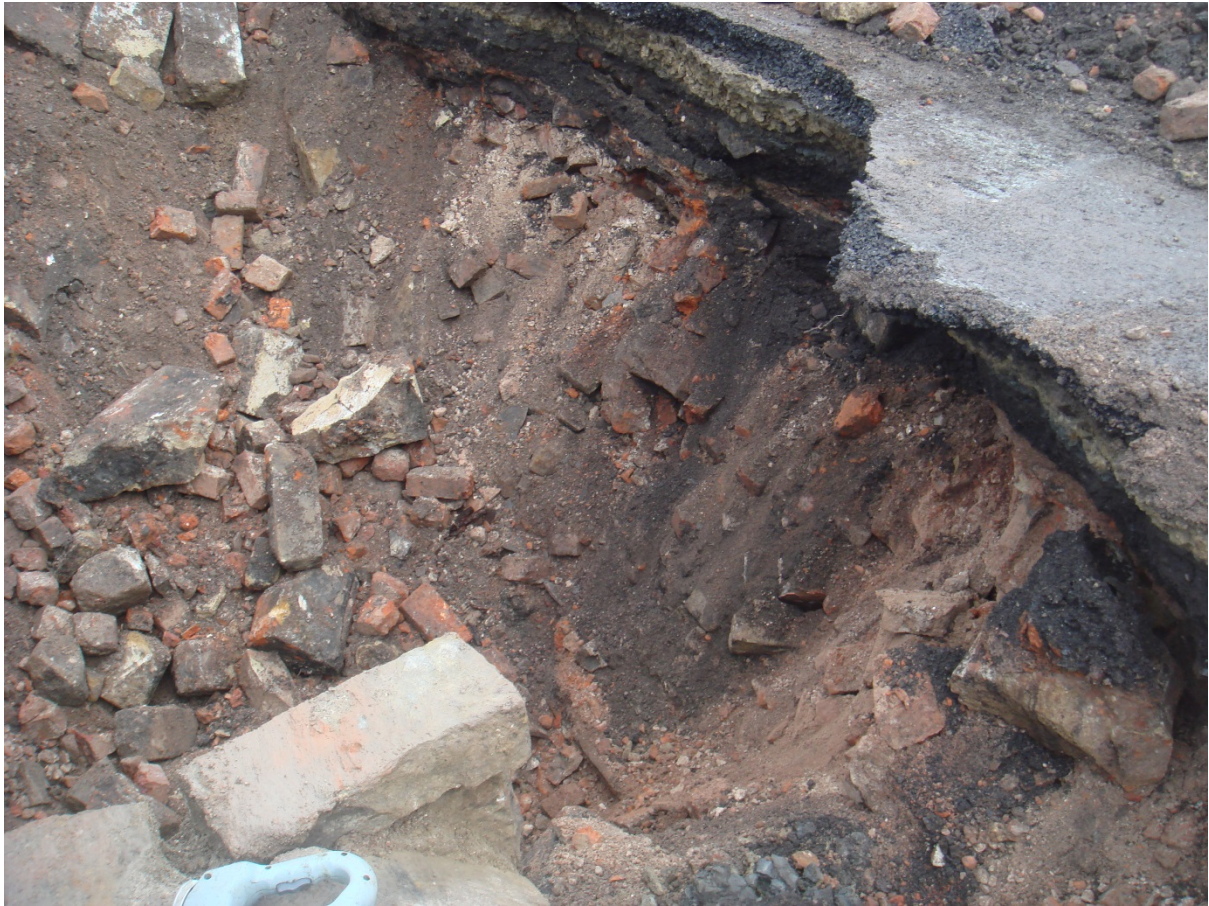
The area to the north of the northern structure appeared to expand into a large basement which was filled loose demolition rubble. This was not bottomed due to the presence of a large live electricity cable at 2.02m below the current ground level, which appeared to run north/south along the basement corridor, possibly having removed the former brick arches.

Rubble filled basement, live cable visible at bottom centre, looking northeast

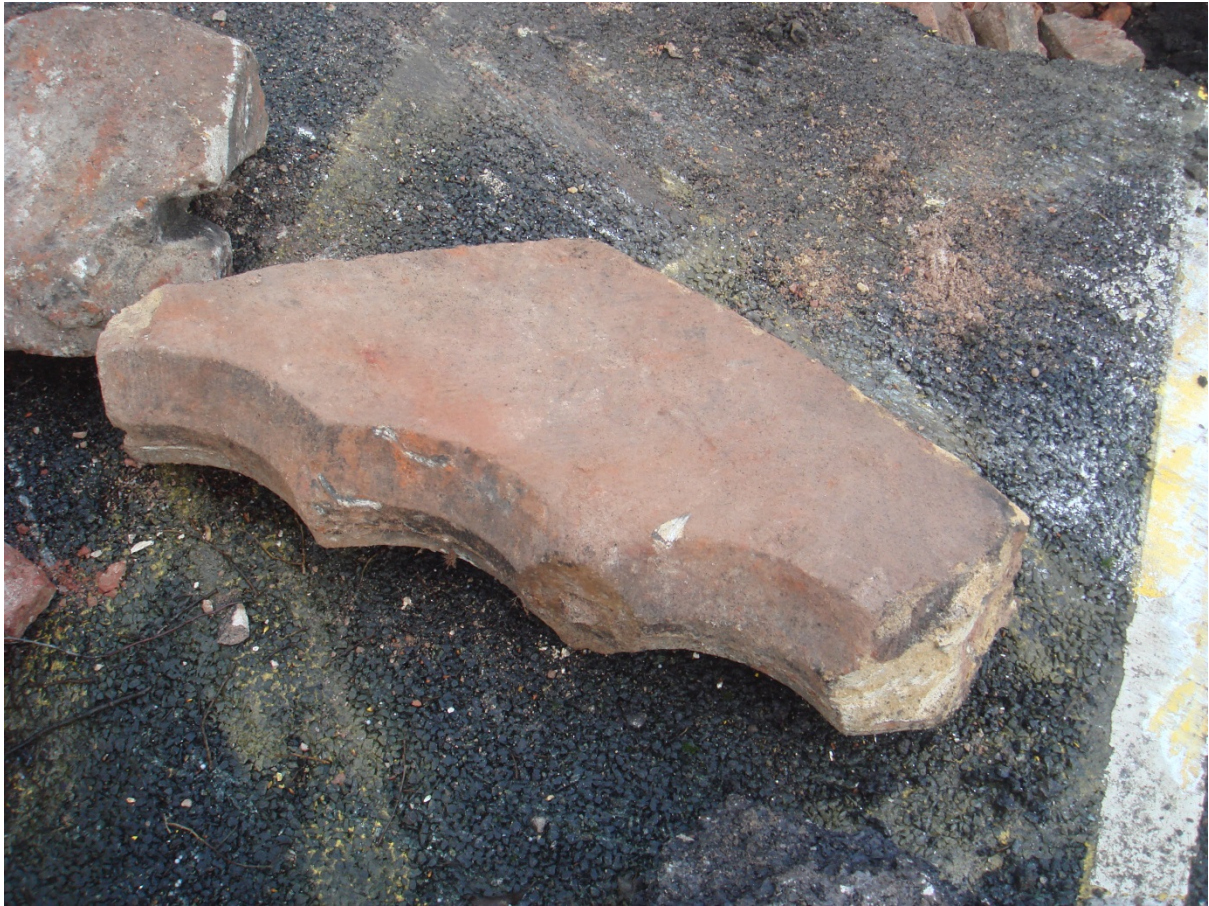
Within the demolition rubble were large pieces of ornate architectural masonry.

Example of the architectural masonry within the rubble fill of the basement, probably an upper moulding from a door or window arch

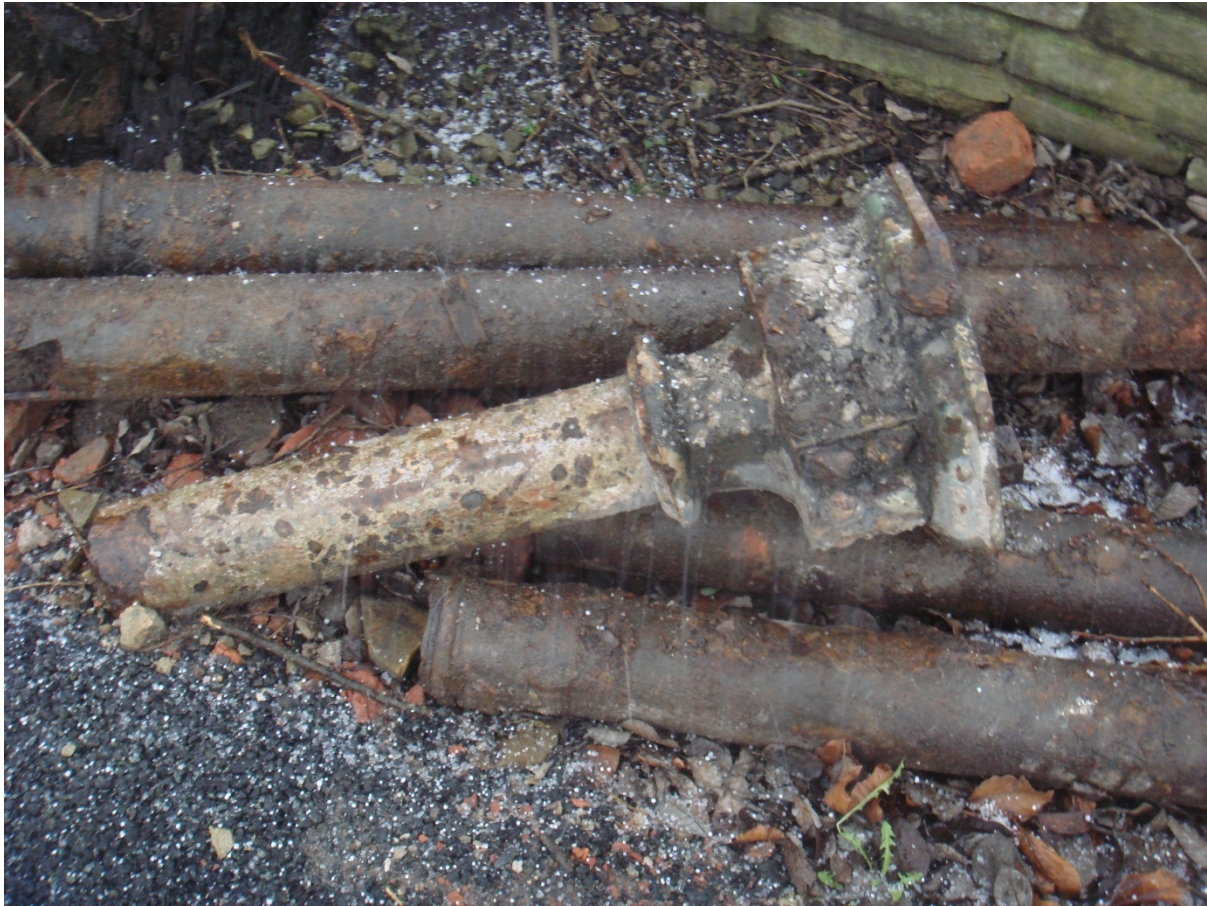
Beside the trench a geotechnical trial pit had been excavated and backfilled. Some cast iron had been removed during the excavation of this trench and had been deposited beside the trench. This comprised some piping and an ornate column base with floral decoration.

Ornamental cast iron column base and pipes from former trial pit
