## Archaeological Excavation

Dakota Manchester,  
Ducie Street,  
Piccadilly,  
Manchester

SA/2017/61

**Document Type:** Archaeological Excavation Report

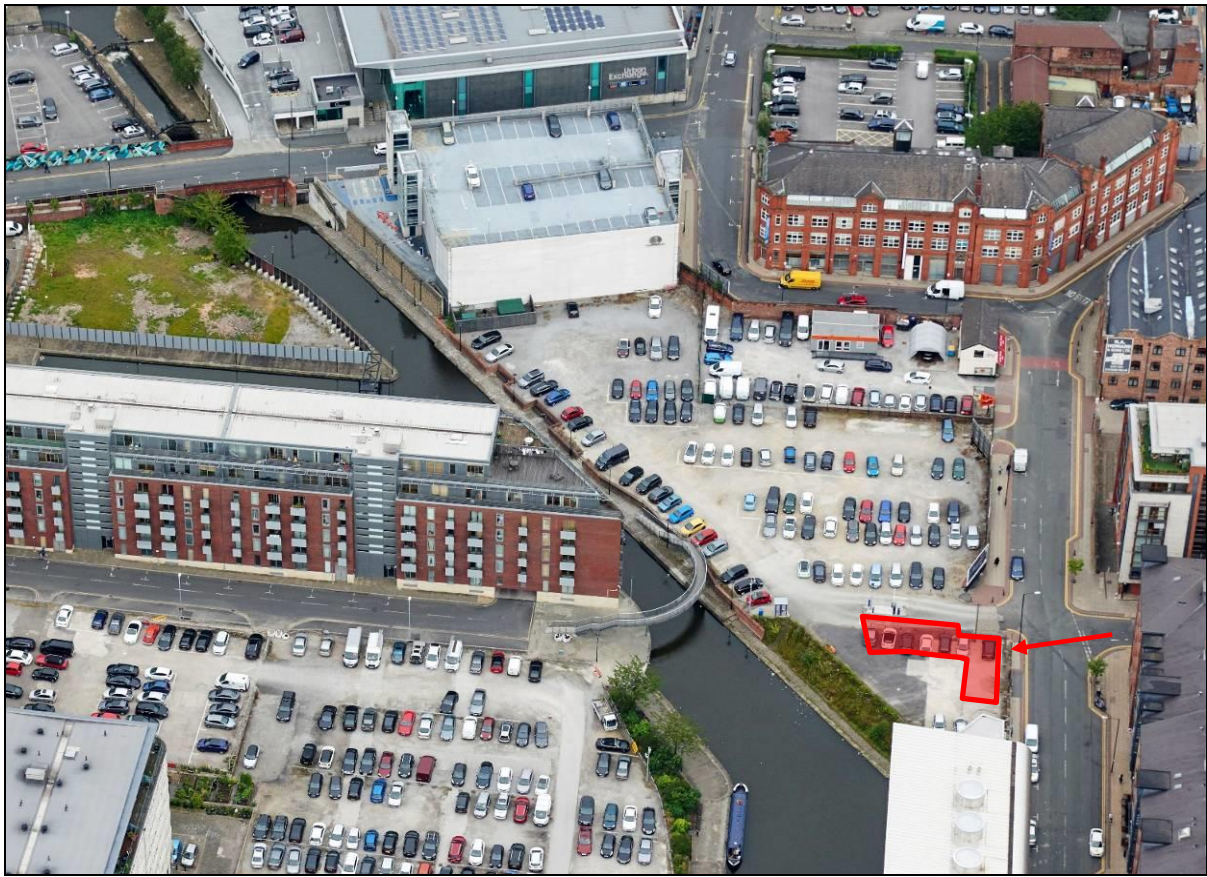
*Plate 1: Aerial view across the study area, marking the position of the excavation area*

The site of the proposed Dakota Manchester hotel (centred on NGR SJ 84843 98193) lies in the Piccadilly Basin area Manchester city centre (Fig 1). It is bounded to the west and north by the Rochdale Canal, to the east by a car park, and to the south by Ducie Street (Plate 1). The area of archaeological interest as identified in the evaluation trenching was limited to the footprint of two stable blocks dating to the early 19<sup>th</sup> century, situated in south-western part of the development site (Salford Archaeology 2017a).

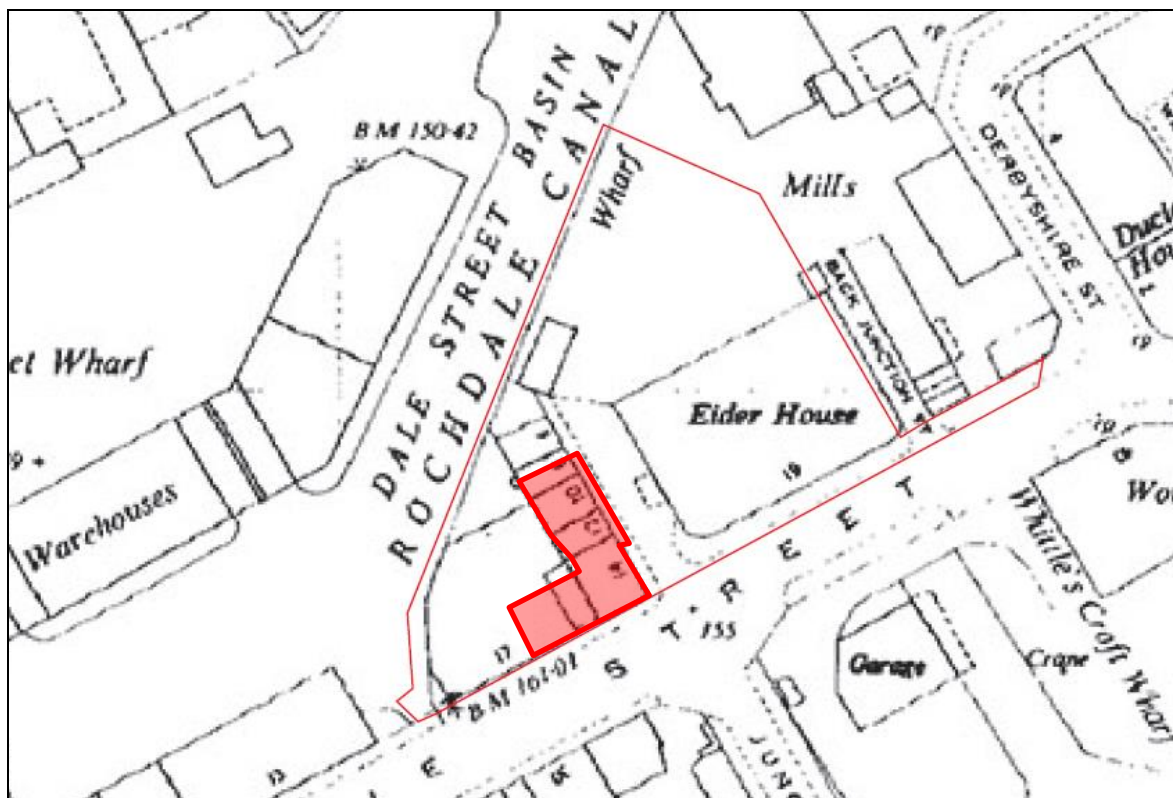
*Plate 4: Development area boundary superimposed on the Ordnance Survey map of 1965, showing the location of the excavation area*

The Ordnance Survey map of 1951 shows the former stables to have been divided into five units, suggesting that the building had been subject to considerable remodelling, or even a complete rebuild. The revised layout is also shown on the next edition of Ordnance Survey mapping, published in 1965, which identifies the properties as 6-16 Junction Street, with Thomas Hassall's drysaltery to the south marked as 17 Ducie Street (Plate 4).

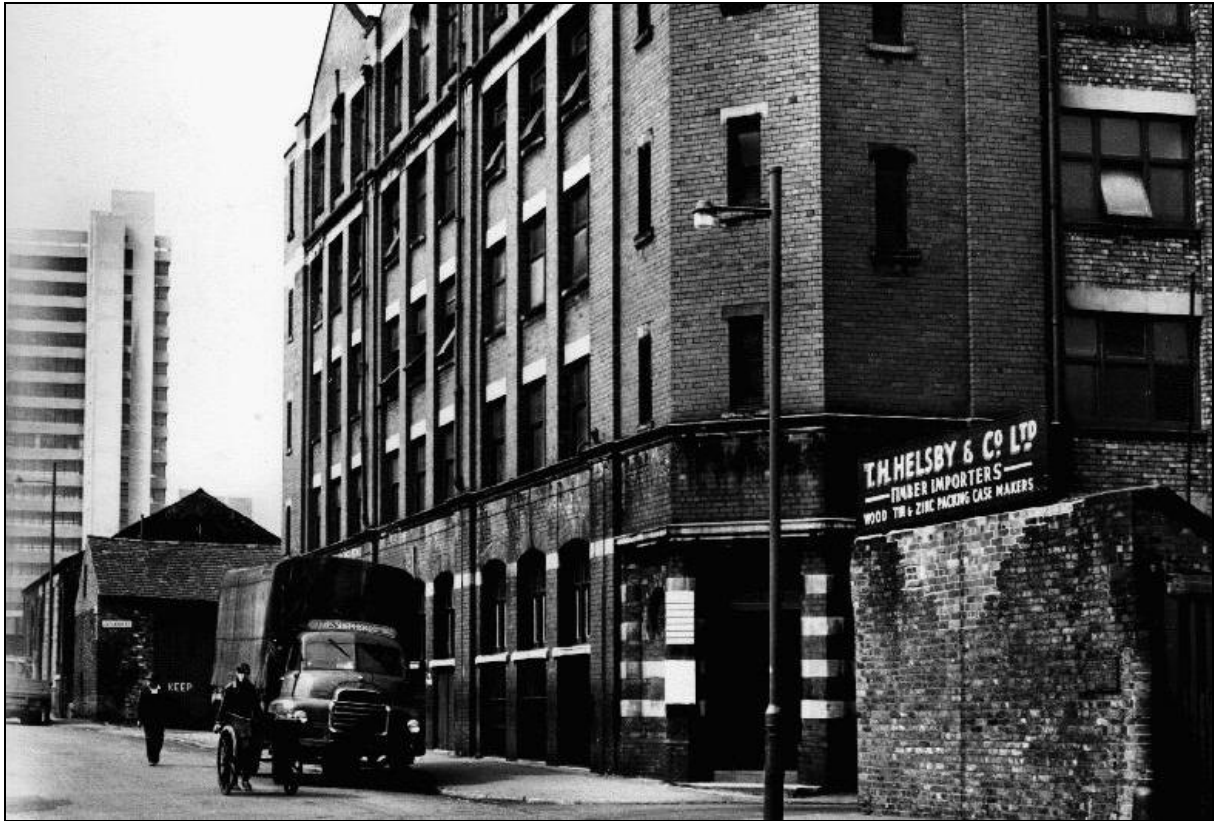
*Plate 5: The former stables just visible beyond Eider House*

Hassall's salt warehouse and the former stable on Junction Street (known as Jutland Street by the late 1960s) are shown on subsequent mapping, and feature in two photographs taken during the 1960s. These indicate that the salt warehouse was occupied by Clark & Partridge Ltd, who specialised in heating boilers and radiators. The building is shown as a tall, single-storey, brick-built structure, with large arched windows on the street front, inconsistent with an original use as a stables (Plates 5 and 6). The southern gable of the former stable appears to have been either re-pointed or rebuilt at first-floor level on Junction Street. Painted logos show that it was. All the buildings on the site were cleared after the 1980s, and the land has been used as a car park since.

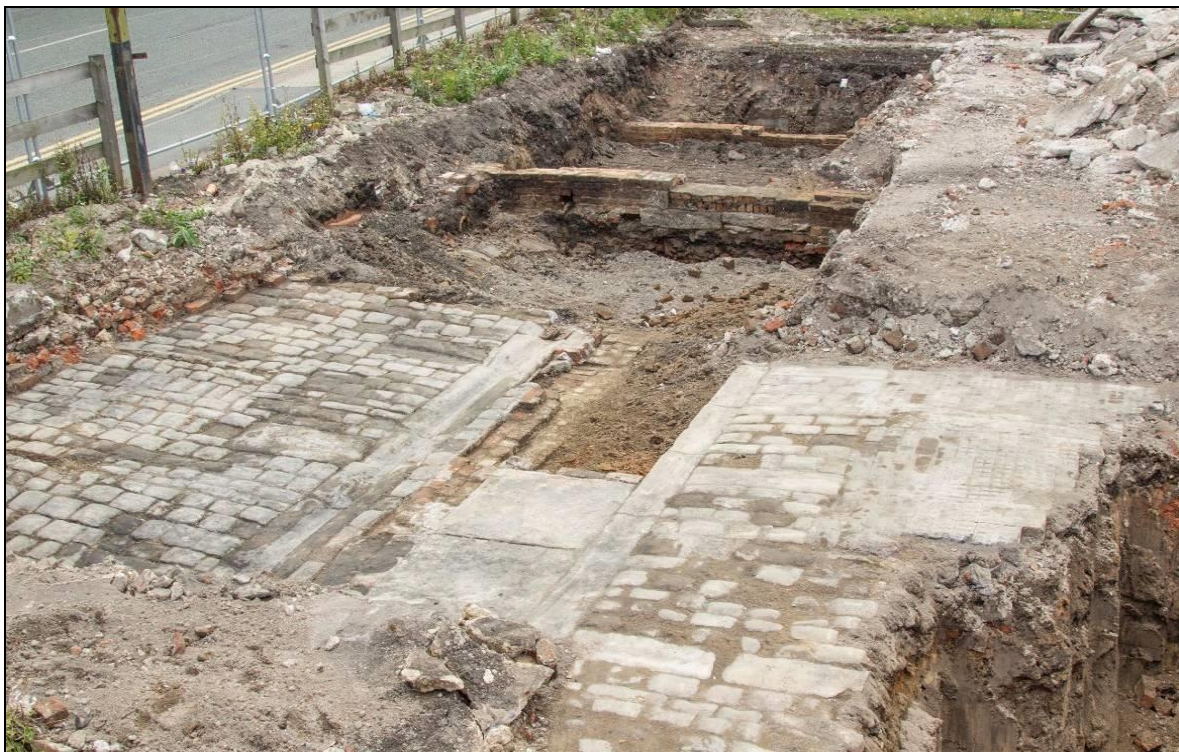
*Plate 7: General view of the stable block adjacent to Ducie Street, looking south*

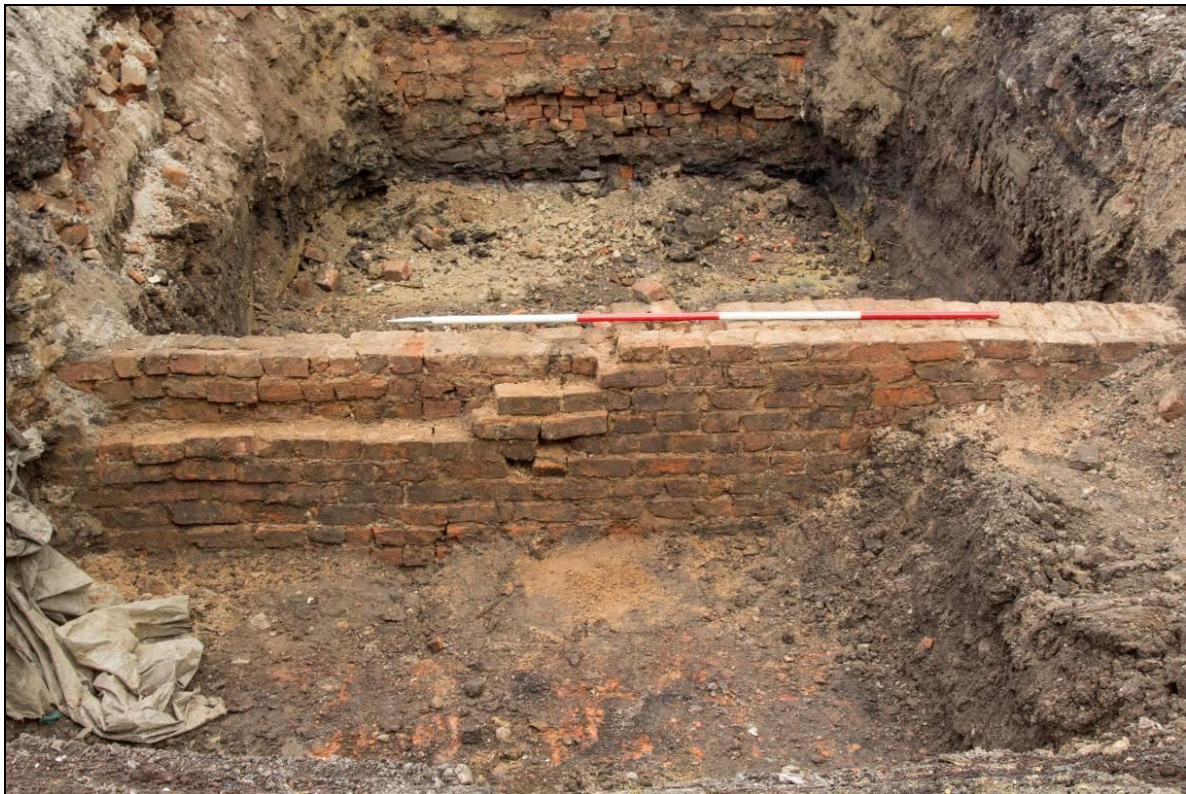
*Plate 8: Wall 1 of the building/stable block along Ducie Street, looking north-east*

Remains of the former building/stable block along Ducie Street were revealed at the south-eastern end of the L-shaped trench. The upper surviving course of the foundations of a north-west/south-east-aligned wall (*I*) were exposed at a distance of 3.70m from the south-western end of the trench, at a depth of *c* 1m below the modern concrete surface. The wall survived to a height 12 brick courses, and was three brick-courses wide (0.36m). The fabric comprised hand-made bricks (0.23 x 0.11 x 0.07m) bonded with sandy lime-based mortar, consistent with an early 19<sup>th</sup>-century construction date. The fairly substantial foundations of wall *I* implied that it had been an external wall, although its location was consistent with it having been an internal partition (Figs 4 and 5).

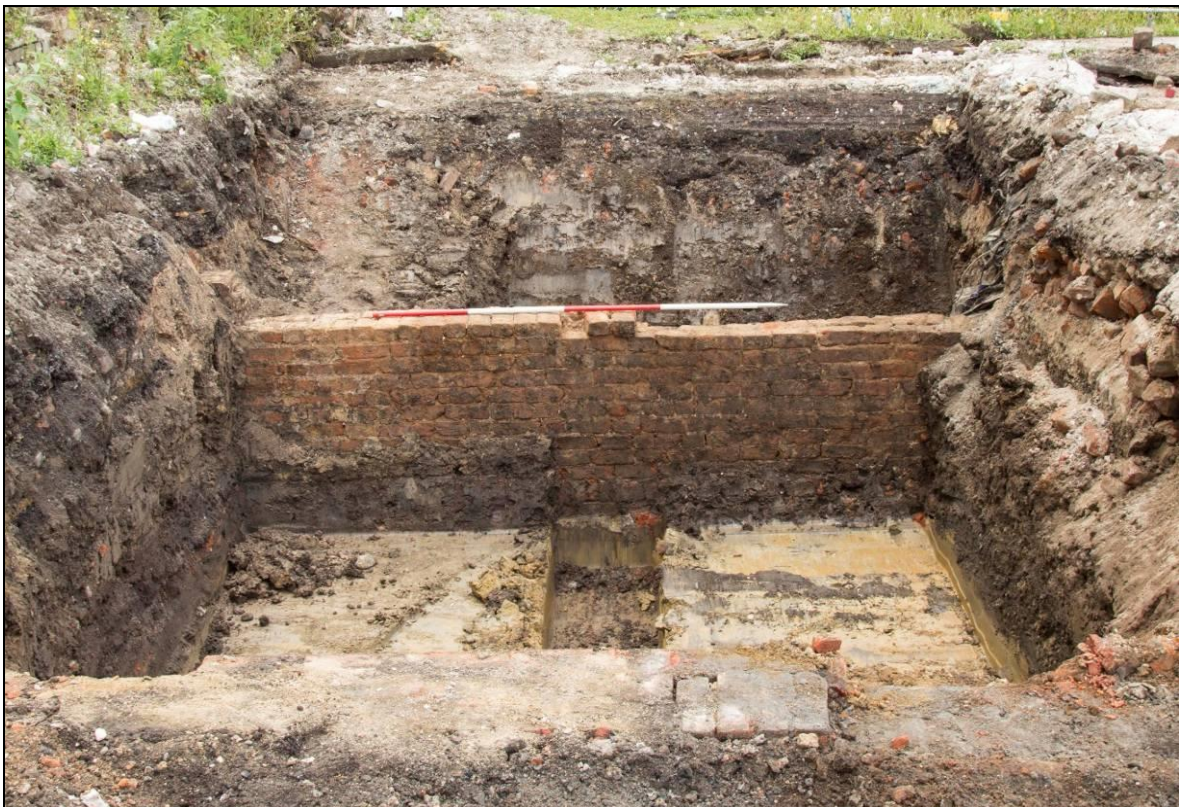
*Plate 9: The north-east-facing elevation of Wall 1, looking south-west*

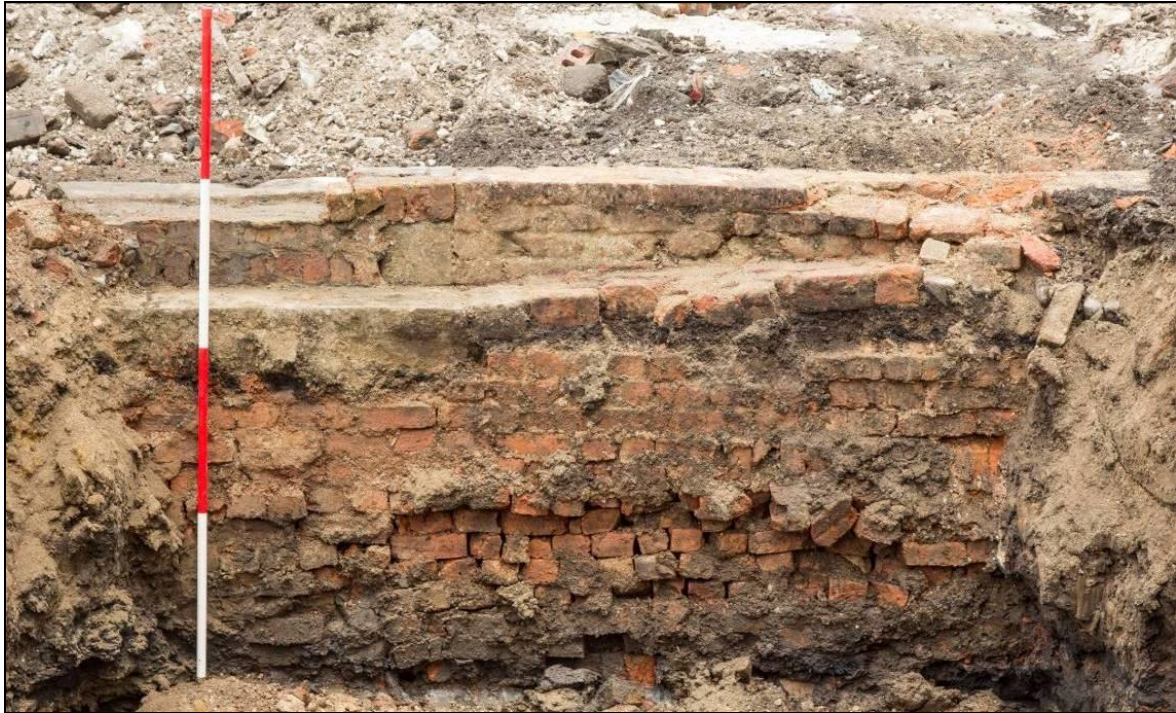
*Plate 10: The south-east-facing elevation of wall 2, looking north-west*

The foundations of a second brick-built wall (2) were exposed at a distance of 4.50m north-east of wall 1, running parallel across the trench. The bottom course of the wall lay at 2.30m beneath the modern surface, and had evidently been laid directly onto the natural clay.

The lower 1.30m of the wall comprised poorly coursed bricks with no visible mortar (Plates 10-12). The upper courses were laid regularly and incorporated a stepped course, which may have represented the position of the internal floor. Both excavated ends of the wall had been bonded with coarse, grey, sandy mortar and appeared to have two stopped-ends (Plate 11). Two large, rectangular, stone blocks, one deeper than the other, were identified in the central section of the wall (Plate 11), which appeared to have formed a doorway threshold. The doorway had been bricked-up subsequently, presumably during the 20<sup>th</sup> century, based on the cement-based mortar employed in the blocking (Plate 11). The position of the wall corresponds precisely with the north-eastern wall of the stable shown on the OS 1851 map (Fig 4), and had almost certainly been constructed in the early 19<sup>th</sup> century.

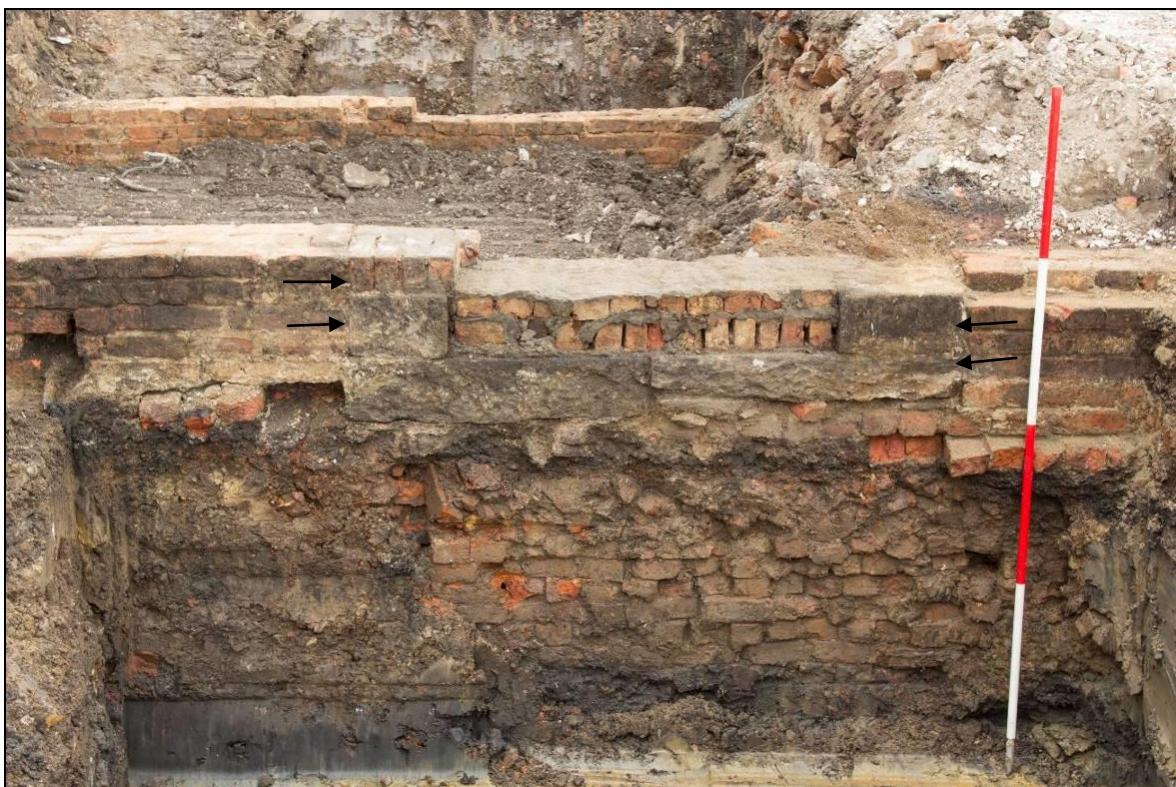
*Plate 11: The north-west facing elevation of wall 2, the black arrows show the stopped-ends*

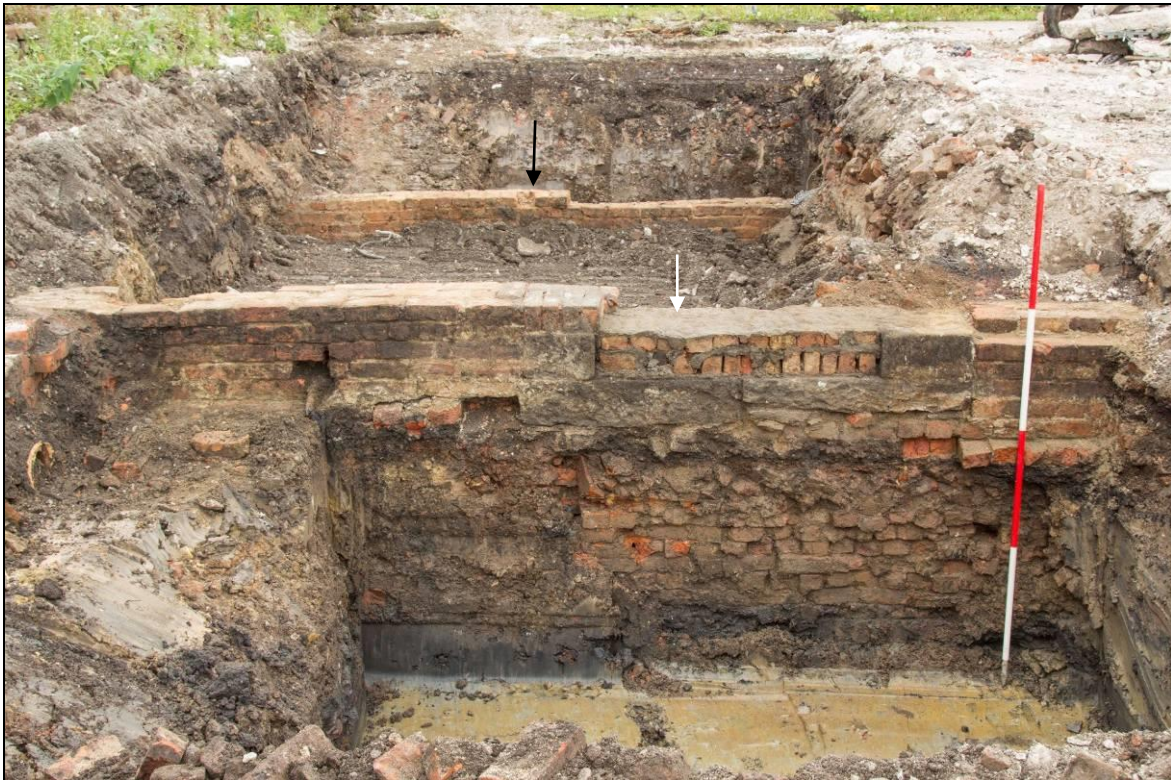
*Plate 12: Walls 1 (black arrow) and 2 (white arrow) of the building/stable block, looking south-west*

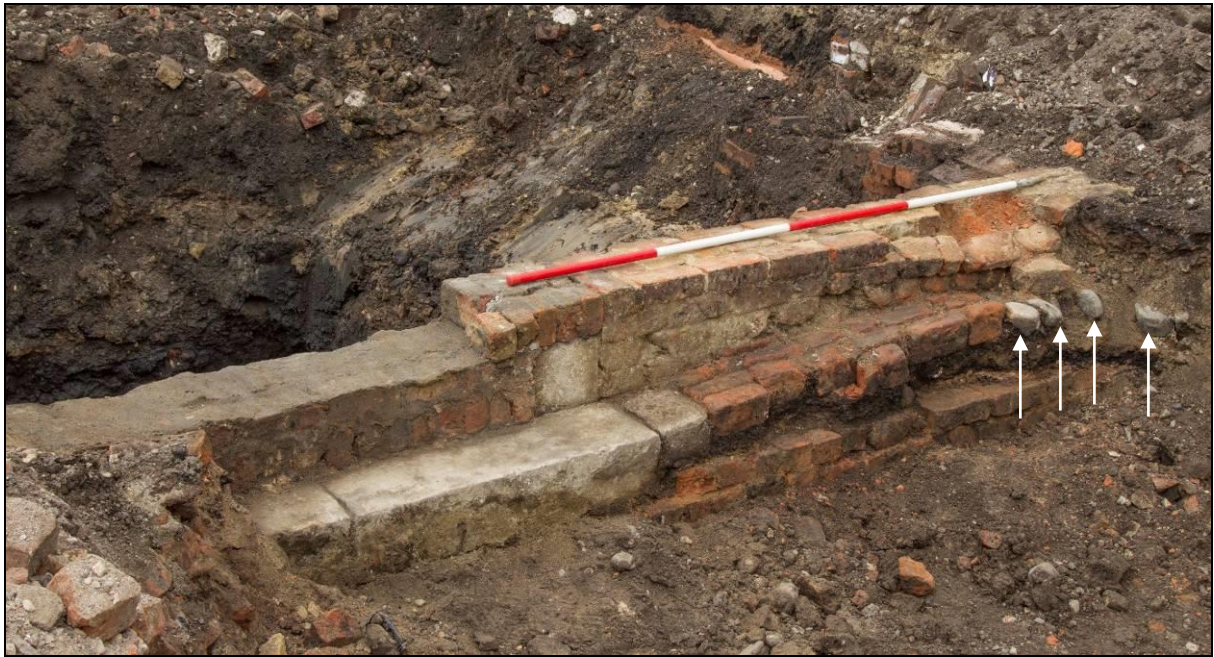
*Plate 13: The possible vestiges of an interior cobbled floor, looking east*

The only indication of a floor surface within the building was identified in the south-western side of wall 2, and in the west-facing section between walls 1 and 2, which appeared to have comprised large pebbles/cobbles (Plates 13-14). Given this location between the two walls, the cobbles presumably represented at least part of the internal floor, although this had been almost entirely removed when the building was demolished.

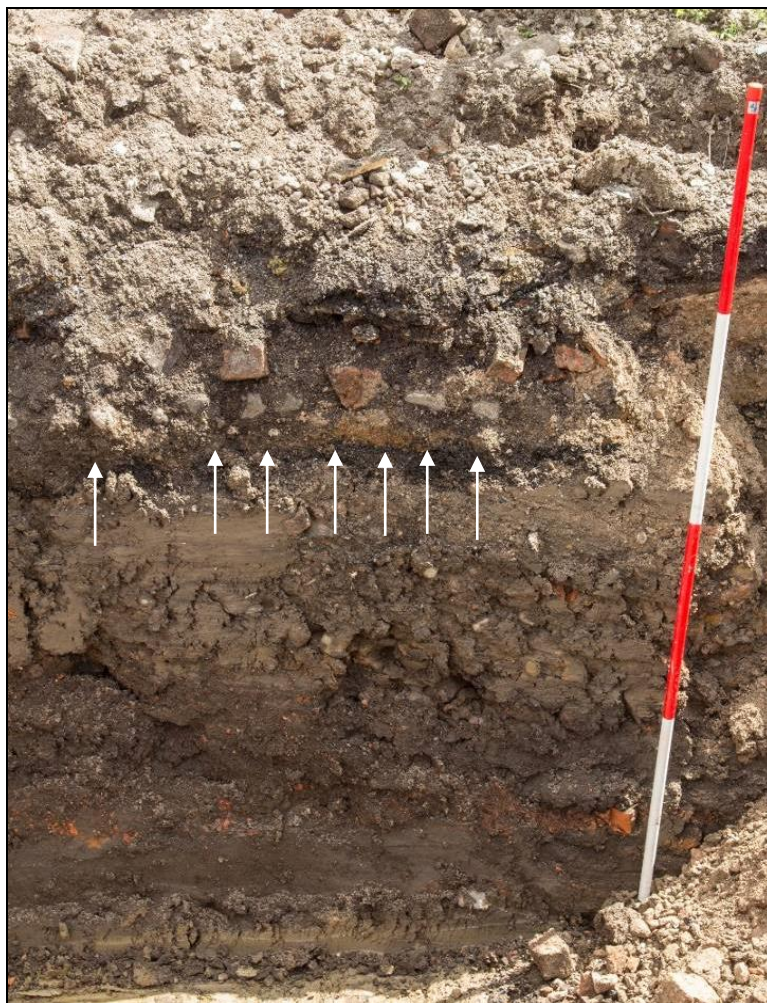
*Plate 14: Possible remains of a cobbled surface in the west-facing section between walls 1 and 2*

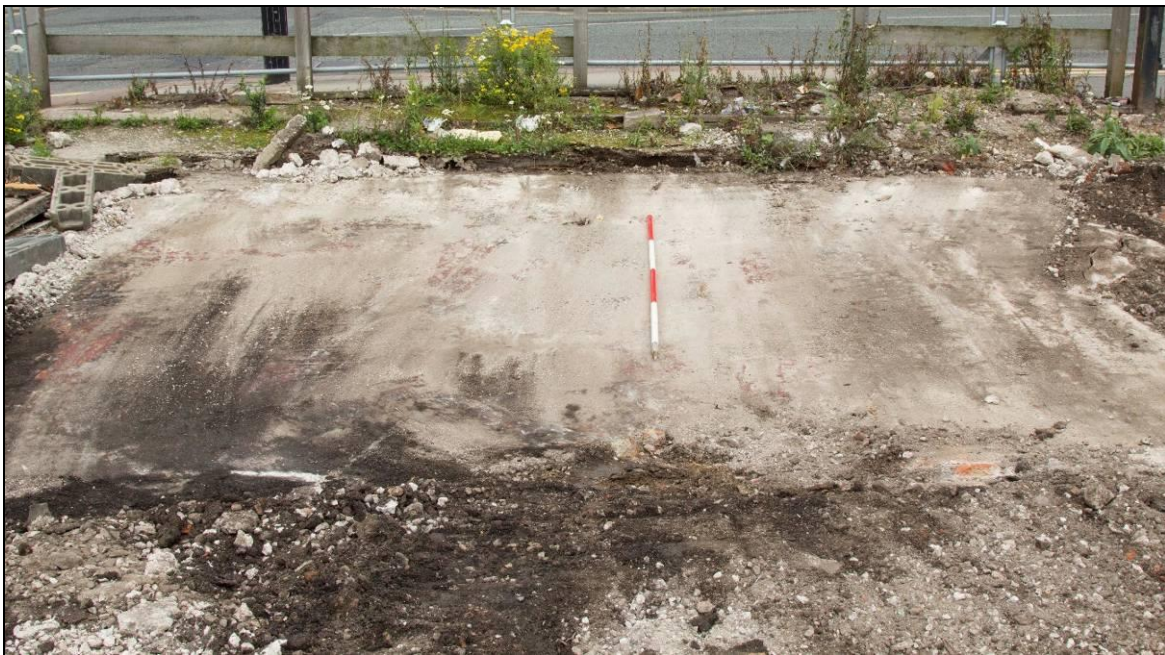
*Plate 15: Remains of a concrete surface at the southern end of the second stable block*

Situated to the north-east of the Ducie Street building lay the foundations of the second stable block, which had been built adjacent and parallel to Junction Street. These remains comprised several walls and surfaces, representing different compartments, or stalls, within the stables. The most recent surface in the southern part of the building, comprising a 20<sup>th</sup>-century concrete surface, was exposed immediately beneath the modern car-park surface, and almost certainly represented a late phase in the development of the building (Plate 15). This abutted wall 3, a two-brick course wide wall, comprising hand-made bricks bonded with sandy lime-based mortar typical of an early 19<sup>th</sup>-century construction date, that formed an internal partition towards the southern end of the stable block (Fig 4).

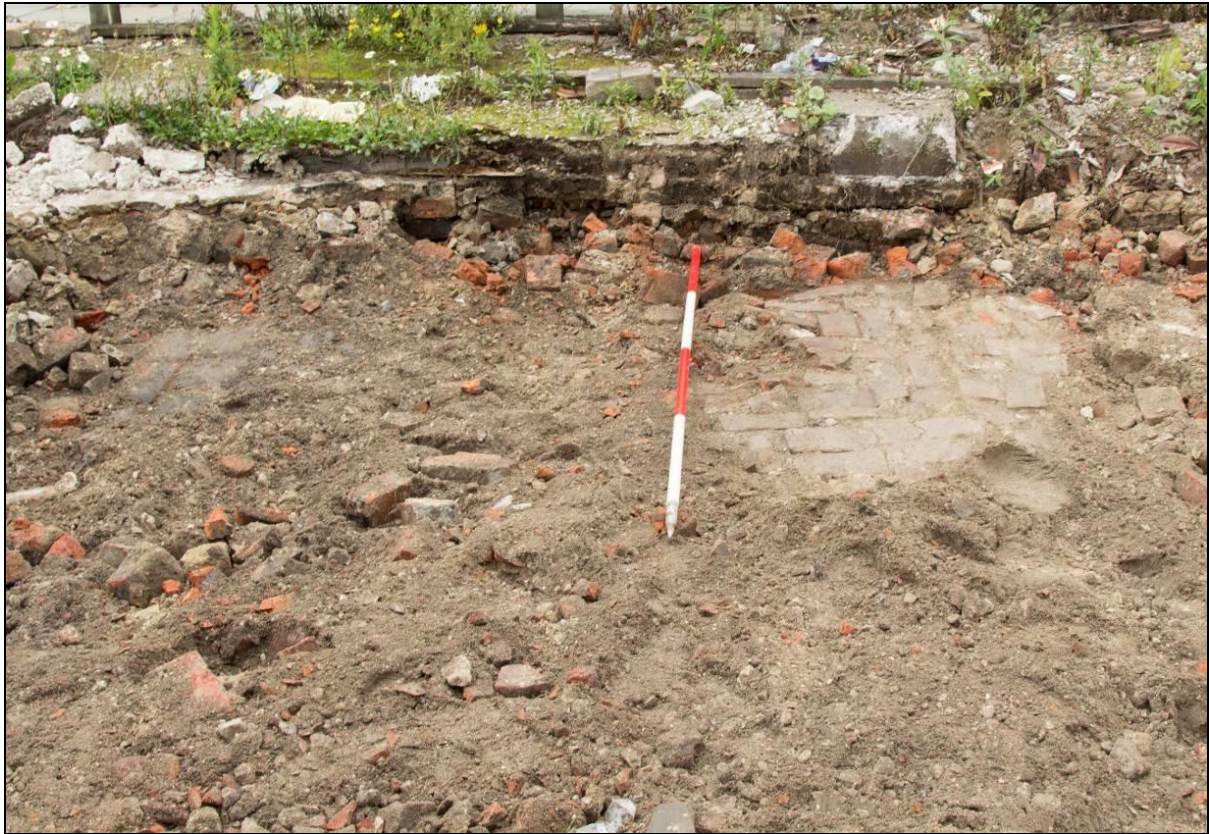
*Plate 16: The fragmentary remains of an earlier brick surface below the concrete floor, looking east*

Below the concrete surface were the fragmentary remains of an earlier brick floor, comprising hand-made bricks laid in no discernible pattern (Plate 16). This surface was removed, revealing a surface of large stone setts below. Fine cleaning of the stone sett surface revealed a pattern indicate of individual stalls separated by a wooden partition, each with a central drainage stone, which in turn led into a stone-carved channel that drained through a metal grid and into a ceramic drain pipe that was exposed on the southern side of wall 3. Three apparent stalls were uncovered (the northernmost only partially); the central stall measured 1.64m in width and the southernmost 1.71m, and both were 2.76m long. They were separated by a narrow slot between the cobbles measuring 0.11-0.13m by 1.45m and 1.65m in length, which contained the remains of decaying timber, indicative of wooden partitions between the stalls. Each of the stone drainage blocks measured 0.94 x 0.45m. The long drainage channel running across the ends of the stables was made up of varying lengths of stone block, concaved on the upper surface, 0.45m in width, which led into a square drain, 0.23m square (Plates 17-19).

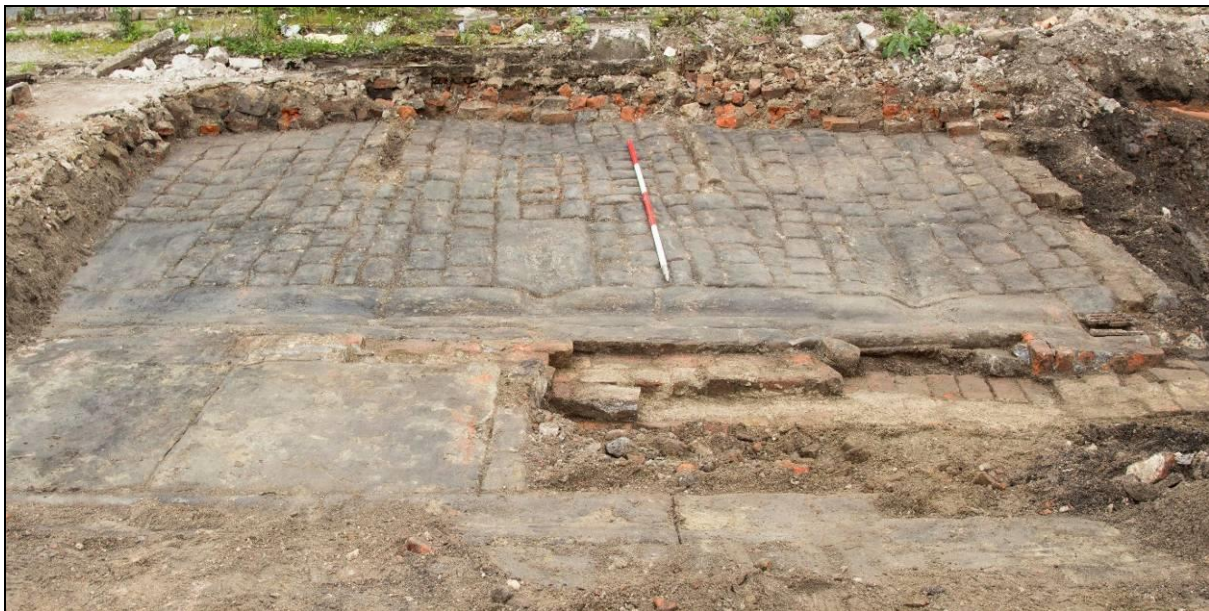
*Plate 17: The stone sett surface at the southern end of the stable block, and a flagstone path in the foreground, looking east*

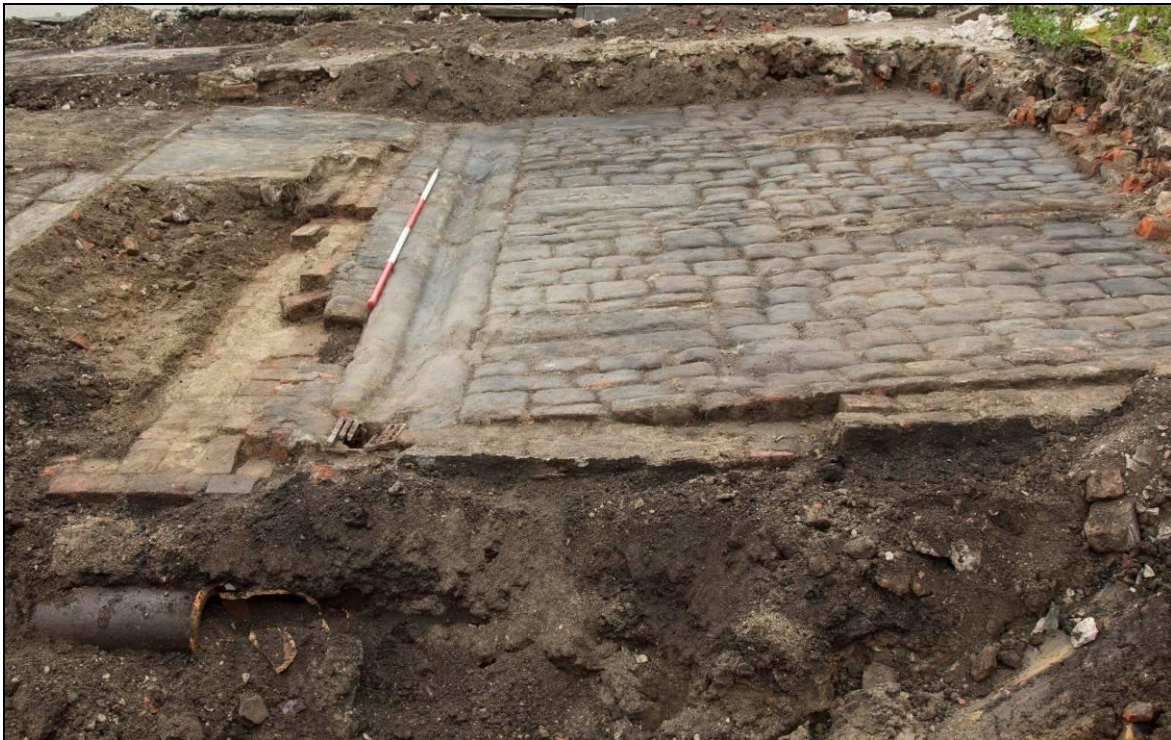
*Plate 18: The surface of stone setts with stables, drainage channel and ceramic drain pipe in the foreground, looking north-east*

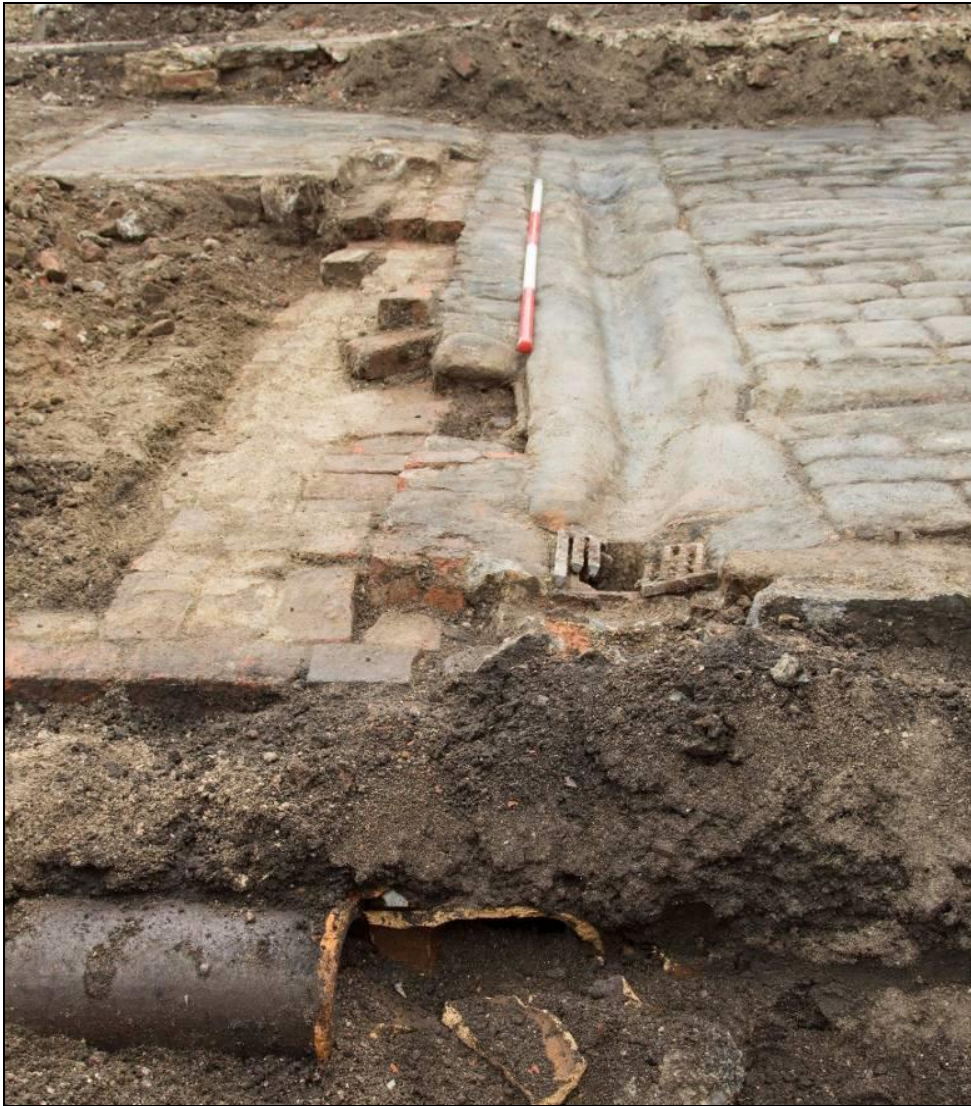
*Plate 19: Drainage system associated with the stables, looking north-east*

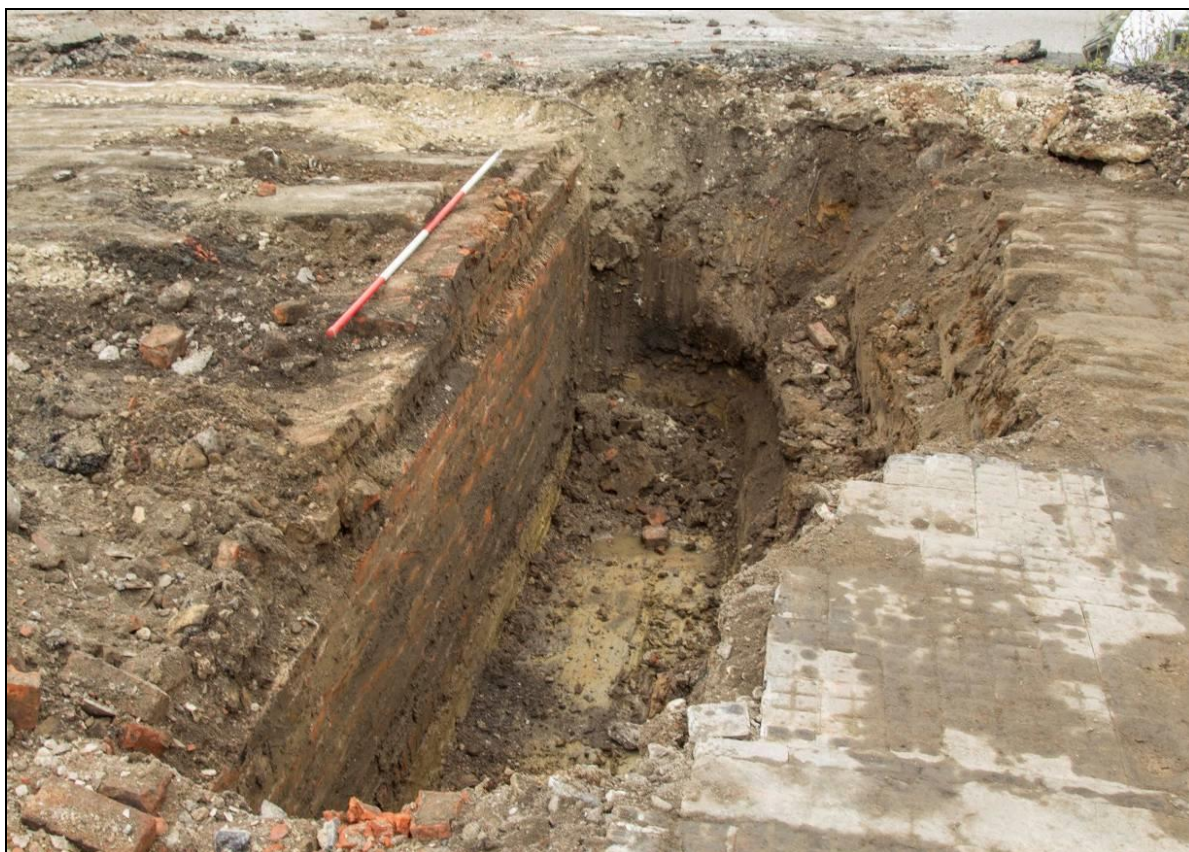
*Plate 20: Sondage excavated between the truncated floor and wall 5, looking north-east*

The stratigraphic sequence below the stone-sett floor was examined in a small sondage, and consisted of a layer of brick rubble overlaying disturbed natural clay with undisturbed natural geology reached at a depth of approximately 1.30m below the modern surface (Plates 20-21). Wall 5 lay on the western side of the sondage, aligned north-east/south-west, comprising two brick-courses in width bonded with lime mortar. The bottom course of the wall was reached at approximately 1.30m from the modern surface, sitting on natural clay with one foundation step below the top four courses. The component bricks in this course had been laid on edge (Plate 21).

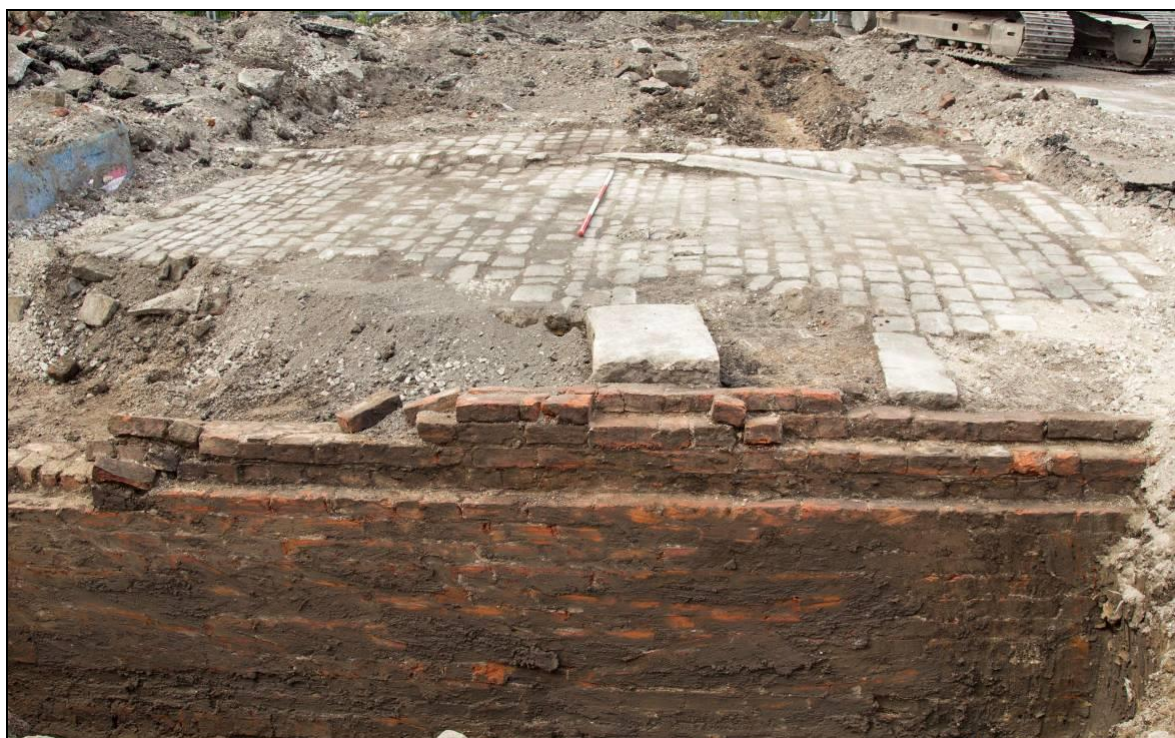
*Plate 21: Wall 5 and the stone-sett floor to the west, looking west*

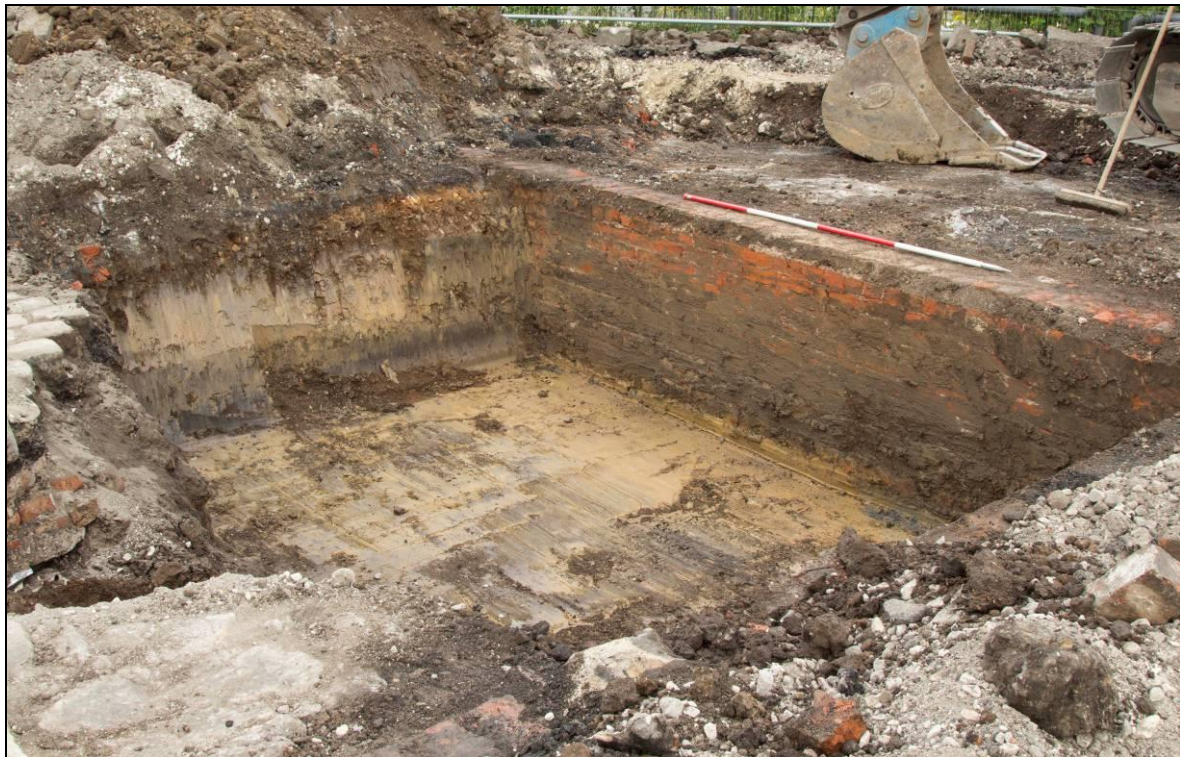
*Plate 22: The east-facing elevation of wall 7 showing natural clay below, looking south-west*

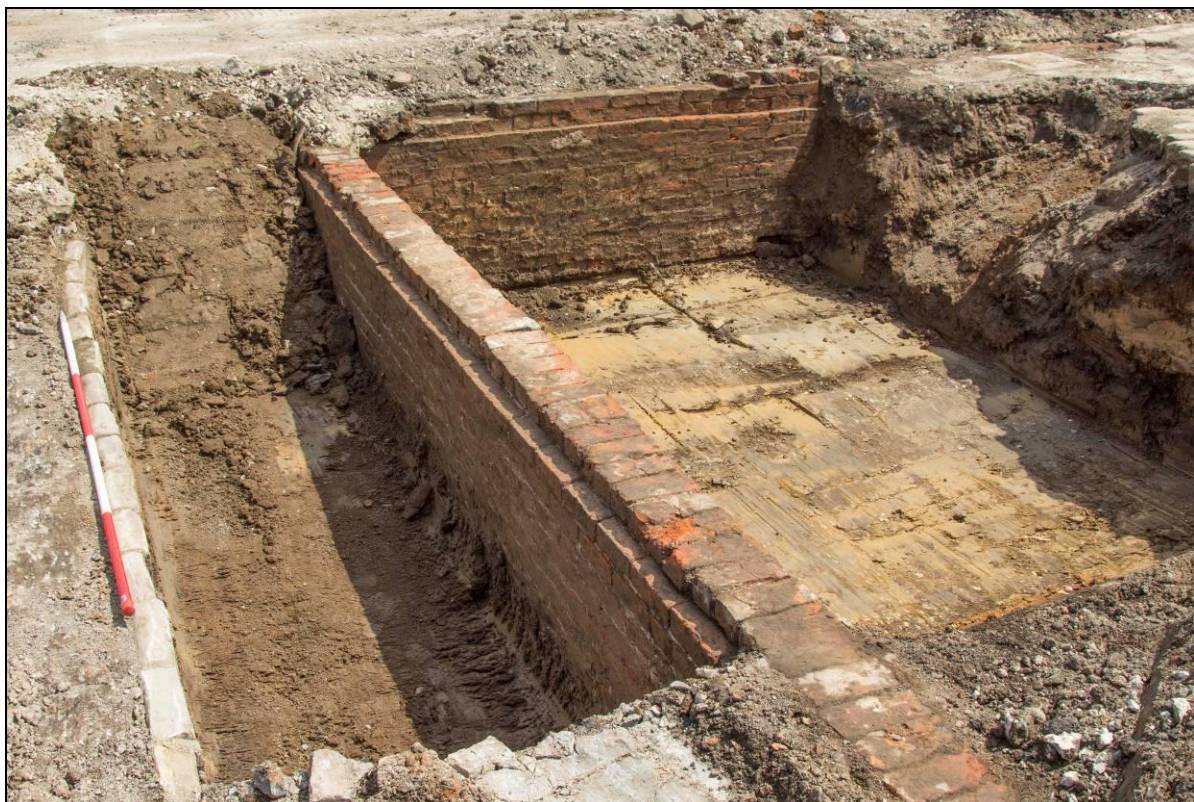
*Plate 23: Walls 6 and 7 at the western end of the trench, looking north-east*

Wall 6 was aligned north-west/south-east and would have formed the north-eastern wall of the former stable block. It survived to a height of 11 brick courses (1.18m), comprising two courses in width and bonded with lime-based mortar. Wall 7, running parallel to wall 5, was three brick courses wide and appeared to represent another partition within the stables. The bottom 11 courses formed the foundation, which had been laid directly onto the natural clay geology. The two upper surviving courses were reduced to two brick courses in width. Both walls had been constructed using hand-made brick and probably dated to the original phase of the building in the early 19<sup>th</sup> century (Plates 23 and 24).

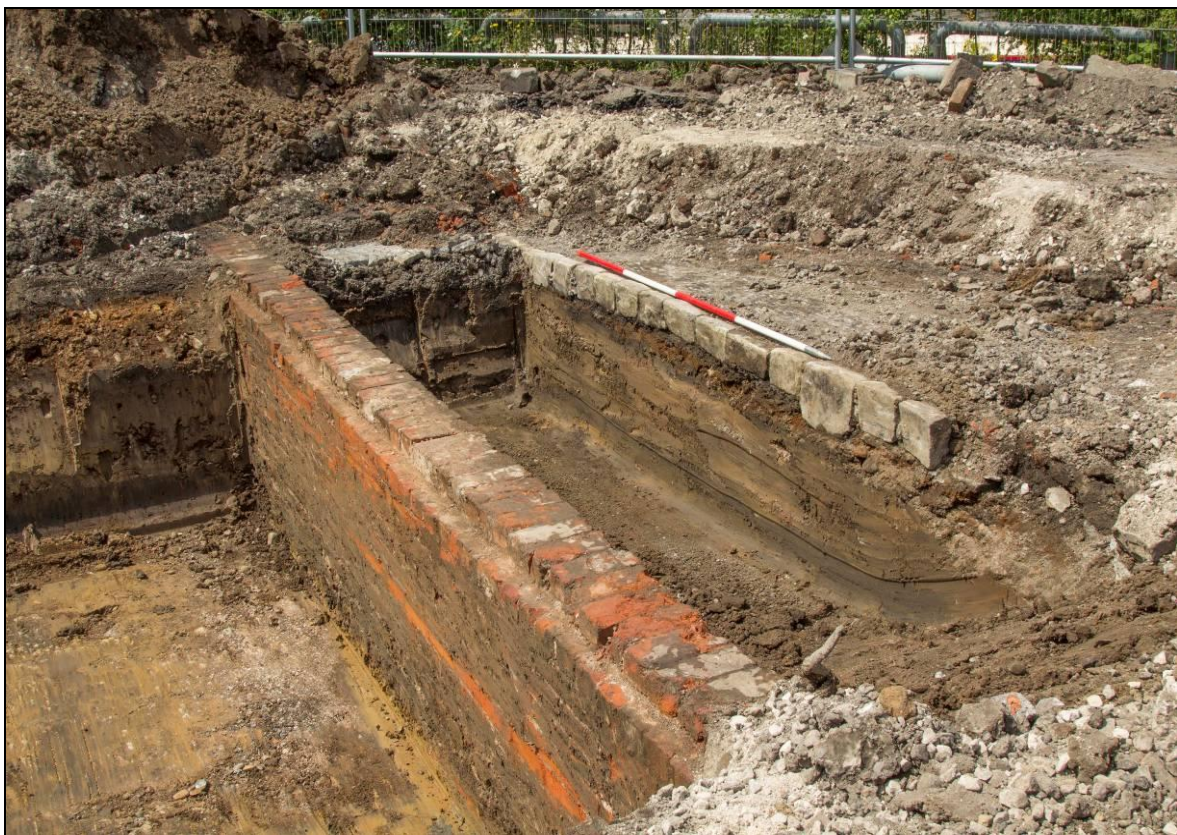
*Plate 24: A single row of stone setts found at the far western end of the trench, looking south-west*

At the northern end of the trench, 1.28m north of wall 7, was a narrow (0.09m), single row of stone setts laid on edge in a line parallel to wall 7. The setts, of varying sizes, had been set into a thin lens (0.04m) of cinder, overlying 0.07m of coarse red sand, below which lay redeposited clay excavated to a depth of 0.08m. Their exact function was unclear but the setts are most likely to have marked the edge of an internal path or separated two different types of flooring inside the room (Plates 24 and 25).

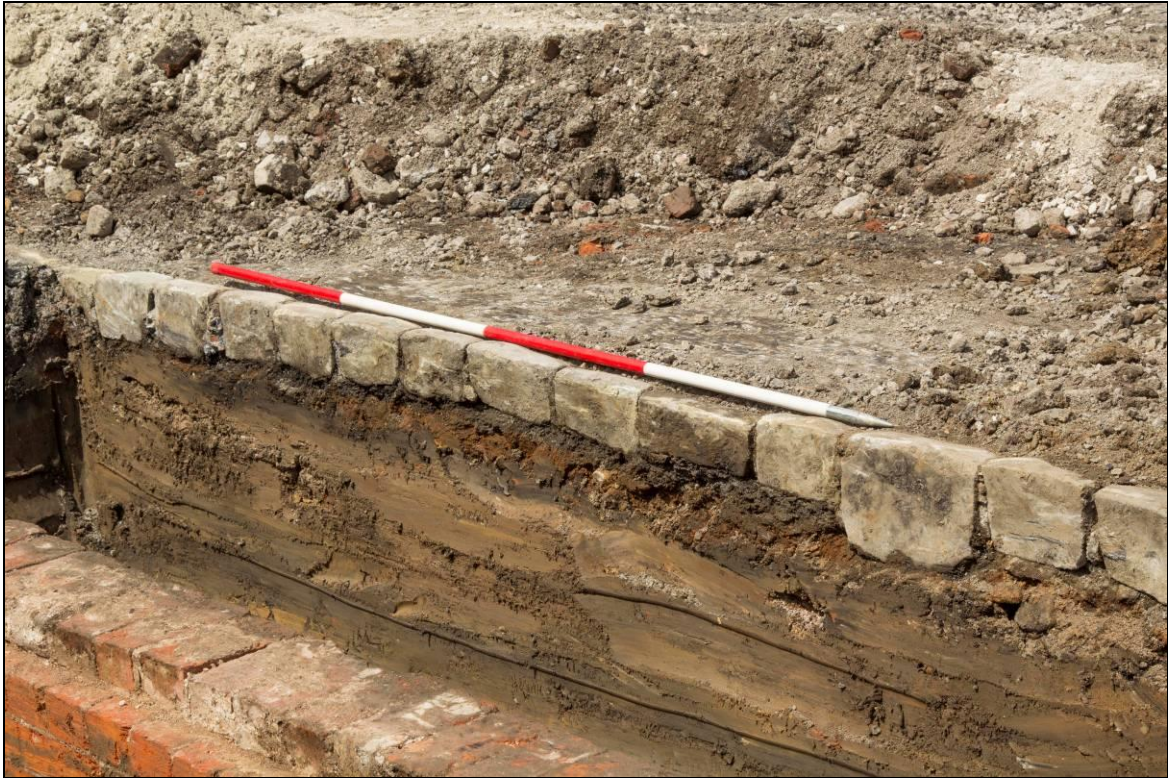
*Plate 25: Detail of the row of stone setts found at the far western end of the trench, looking south-west*
