## Archaeological Excavation

Dakota Manchester,  
Ducie Street,  
Piccadilly,  
Manchester

SA/2017/61

**Document Type:** Archaeological Excavation Report

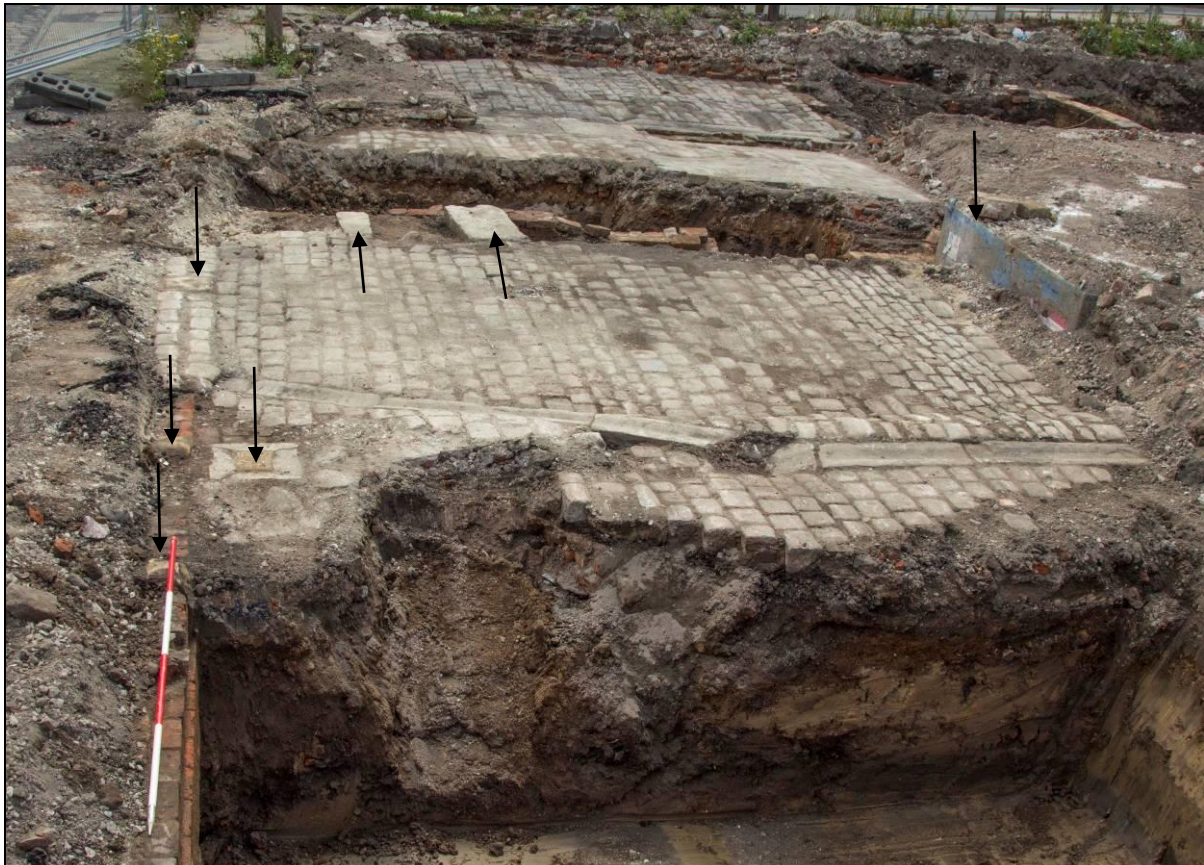
Plate 26: The black arrows show probable later additions to the flooring in the second room from the east

The building appears to have been sub-divided during the 20<sup>th</sup> century, and of some of the resultant compartments were in use as garages for motor vehicle repairs before demolition in the 1980s. Patches of oil found adhered to the floor surfaces in the rooms in the middle of the row, together with a few modern features, are consistent with the final use of the building as a garage. Plate 26 shows various features such as stone blocks and a metal tank, which appeared to have been later additions to the fabric of the building.
