Project: Coupland Street, Hulme, Manchester: Archaeological Evaluation

Report No: SA/2017/64

Document Type: Archaeological Evaluation Report

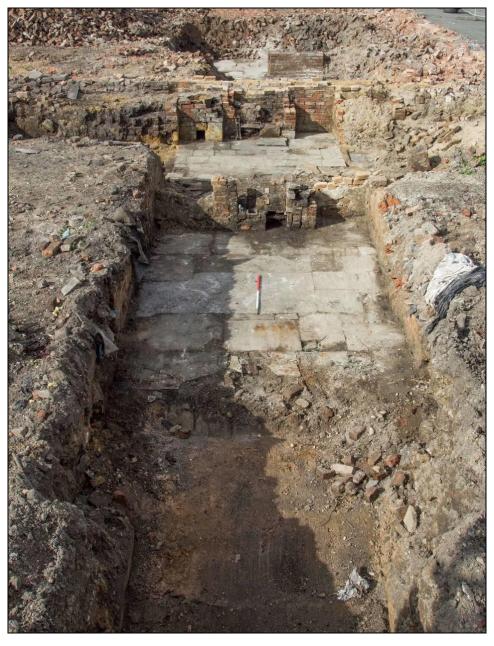
Plate 5: General view of Trench 1, looking west

Trench 1 was located along the northern side of the study area, south of Coupland Street, targeting the footprint of four early 19th-century houses (Nos 87-93 Coupland Street) thought to have contained cellars (Fig 2). Aligned east/west, the trench measured 28m long and was 2m wide at the ends but widened in the central section to 8m (Plate 5). Natural sand and gravels were reached at a depth of 1.60m at the eastern end of the trench, where the foundations of House 1 had been removed completely, with the resulting make-up of the trench comprising a mixture of re-deposited natural and demolition rubble (Plates 5-6).

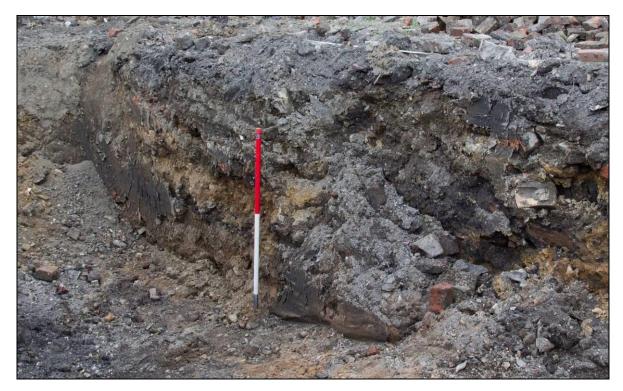
Plate 6: The north-facing section at the eastern end of the trench where the remains of the houses had been removed completely, looking south-east

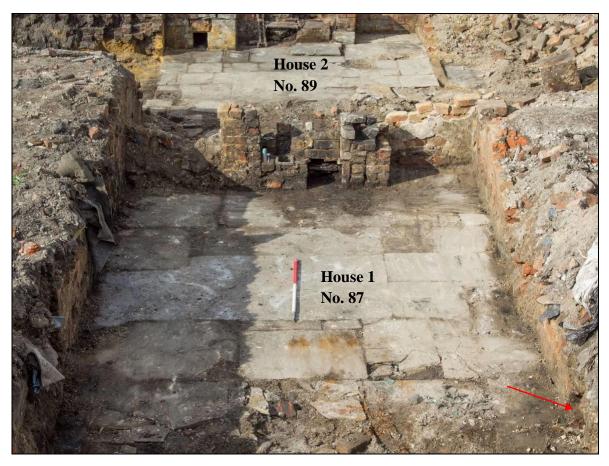
Plate 7: The excavated remains of House 1, looking west

The remains of the rear part of No 87 Coupland Street (House 1) were uncovered at the eastern end of the trench, and comprised the rear wall, a stone-flagged floor, the brick-built partition between the front and back rooms, and the western party wall and associated fireplace (Plate 7). The back room measured 3.38m (11ft) wide, and the stone-flagged floor survived *in-situ* for a length of 5.50m.

The four walls of the room were constructed using hand-made bricks (average dimensions 0.23 x 0.11 x 0.07m), bonded with sandy lime-based mortar, typical of the first half of the 19th century. The walls survived to a maximum height of 1m, whilst the fireplace survived to a height of 0.80m. The northern wall of the room had been in part reduced to floor level during demolition, and almost certainly represented the dividing wall between the front and back rooms of the house, with the front wall of the row of houses lying beneath the modern pavement to Coupland Street. The eastern wall of the room was missing, whilst the southern wall survived to the highest height and was likely to have formed the rear wall of the house. No evidence for access out into the rear yard area was apparent. The western wall, a singleskin, hand-made brick wall, incorporated a 1.57m wide fireplace (measured from the outer edges of the original supporting columns determined by the hand-made bricks and sandy mortar. The inner features, creating a range for cooking had been added later in the 19th century, identified by black ash mortar bonding (Plates 8-9). A small cache of complete and broken household chemical glass bottles were found at the truncated end of the northern wall (Plate 10), but no other artefacts were recovered from this house.

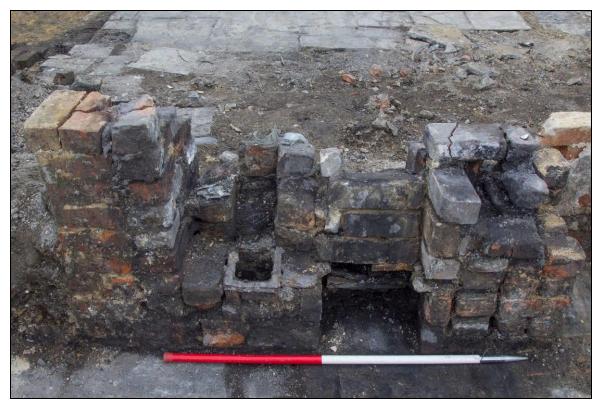
Plate 8: The fireplace in House 1 located on the western party wall, looking west

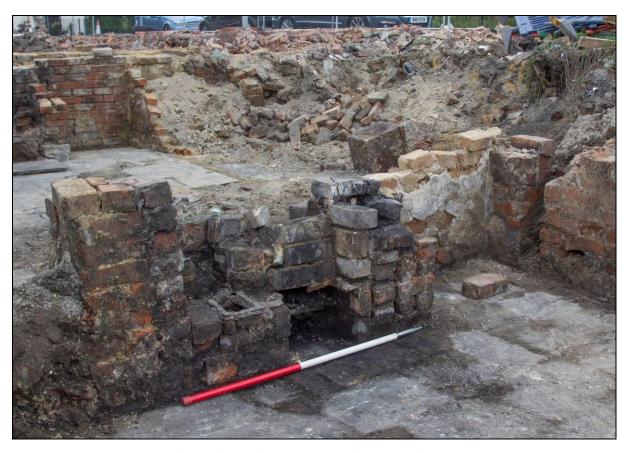
Plate 9: The fireplace in House 1, looking north-west

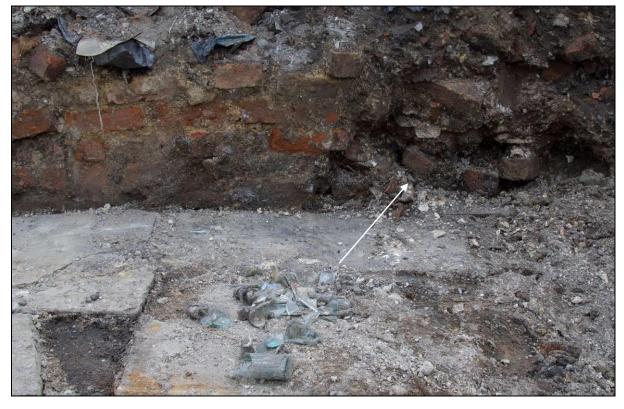
Plate 10: The location of a rubbish pit containing remains of complete and broken household chemical bottles, looking north

A rubbish pit found just above the level of the floor on the south-facing section (Plate 10) contained four complete poison bottles and a number other broken ones. The complete bottles were all identical being oval in shape, 18.5cm (7.28") in height by 6.5cm (2.55") and 4cm (1.57") in width. One side of the bottles had distinct vertical ridges produced whilst in the mould, a very common way of distinguishing poisonous contents to the user, a method developed during the Victorian period (1837-1901).

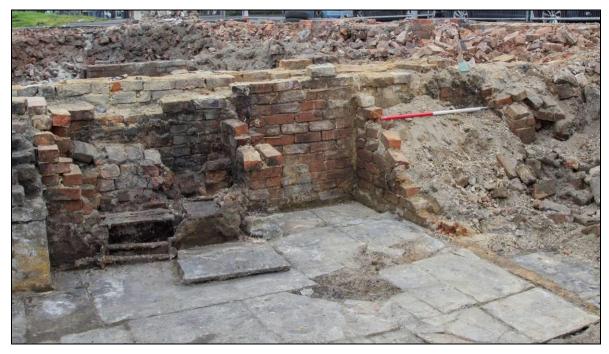
Plate 11: The back room of House 2 and part of the front room to the right of the photo, looking north-west

No 89 Coupland Street (House 2) lay to the west of House 1, joined by the single brickcourse party wall. The remains comprised a stone-flagged floor, the eastern half of which was missing and was rather wide, measuring 5.32m east/west internally. A single brick-course wall was aligned east/west across the floor at a distance of 3.31m from the inside surface of the southern, rear wall of the house (two brick-courses wide), which appeared to have separated the front and back rooms of the house. There had probably been a doorway, but no physical evidence survived in-situ. Part of the front room floor was also exposed, again comprising flagstones, and possibly the remains of the southern fireplace cheek on the western, front room wall (Plate 11). The floor incorporated a square ceramic drain in the floor along the southern side of the room, as frequently seen in housing of this period (Plates 15-16). The western wall of the room contained the fireplace and a later 'copper' (boiler). As with House 1, the two original fireplace cheeks remained extant, identified by the sandy limebased mortar, with a later range added within the interior, identified by the black ash mortar. Some of the ironwork grates survived *in-situ*, including the cast-iron oven (Plate 12).

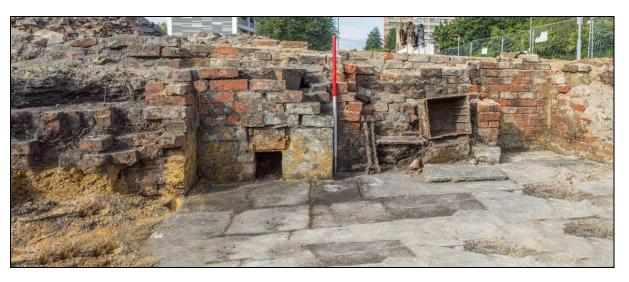
Plate 12: The copper and fireplace on the western wall of House 2 showing an attempt to re-position the castiron oven and yellow staining on the copper, looking west

The copper had been built against the southern side of the original fireplace, and still contained the cast-iron pot used for heating water for general household duties such as cooking and washing. The small, cast-iron, range door was till in-situ above the gap at the bottom of the brick structure where the ash waste from the coal fire would have been raked out. The yellow staining on the exterior of the bricks had been caused by unused coal stored there (Plates 12 and 14). The fireplace and copper survived to heights of between 0.80-0.90m. The total width of the copper was 0.91m north/south by 0.82m east/west. The total width of the fireplace was 1.54m, only 0.03m shorter than that of House 1. The distance between the northern fireplace cheek and the partition wall was 0.86m in the back room and 1.08m in the front room, which could suggests the front room was slightly larger than the back room.

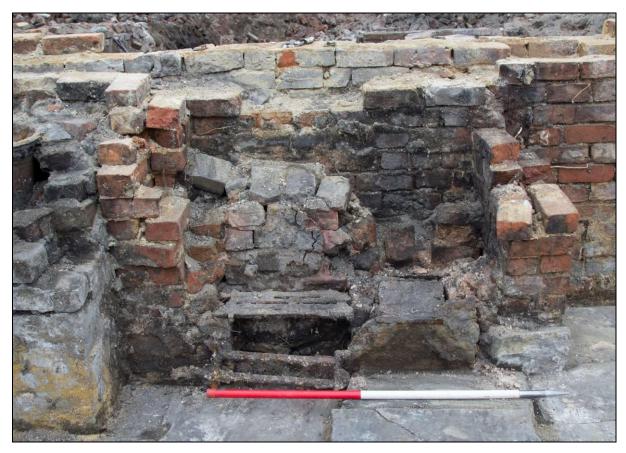
Plate 13: Detail of the fireplace and range on the western wall of House 2, looking west

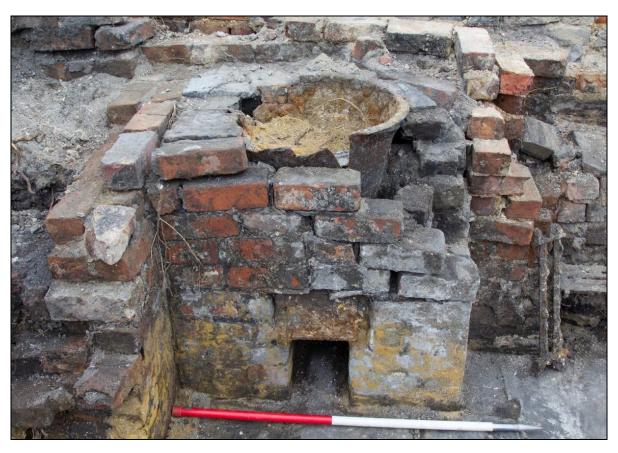
Plate 14: Detail of a copper (boiler) in House 2, looking west

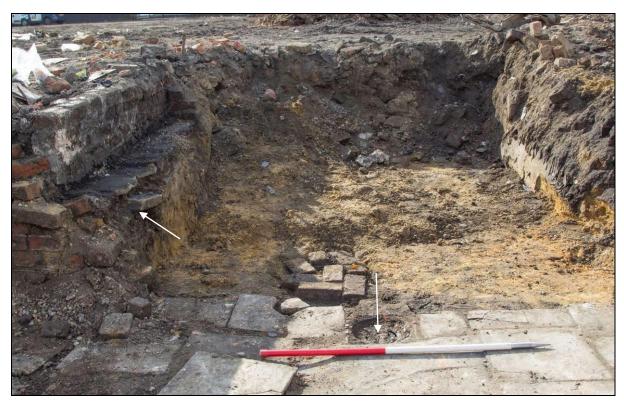
Plate 15: The ceramic drain in the floor of the back room and the rear yard at the back of House 2, the floor surface was probably where the stone flags can be seen in the west-facing section, looking south

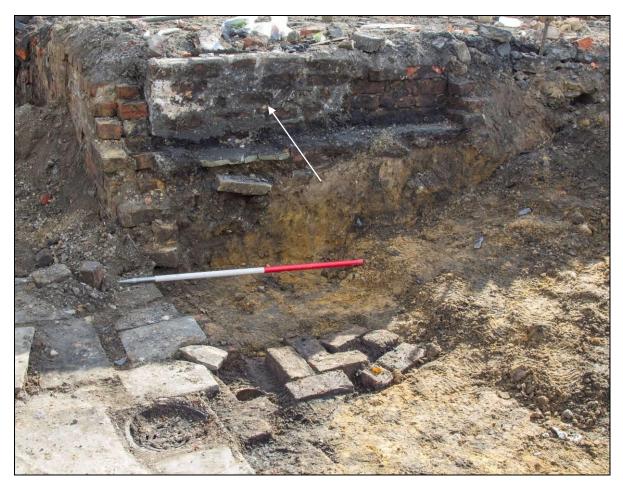
Plate 16: The rear yard wall bonded with black ash mortar suggests a later addition, looking south-east

Part of the yard to the rear of the house was also excavated, although the access stair was not. Part of a possible stone-flagged floor was visible, and a later garden wall bonded with black ash mortar, which appeared to have been constructed onto natural sand (Plates 14-15). On the western side of the rear yard there appeared to be the remains of a brick floor surface adjacent to a two brick-course wide wall bonded with black ash mortar.

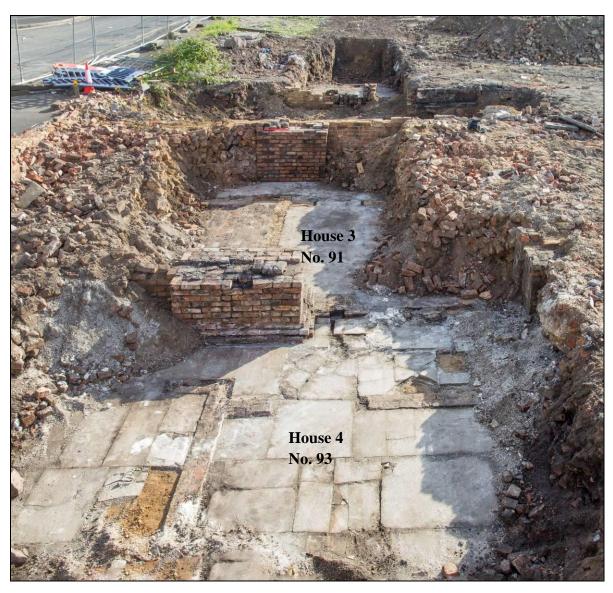
Plate 17: Houses 3 and 4, showing the footprint of the early houses at floor level and the extant remains of the later industrial units, looking east

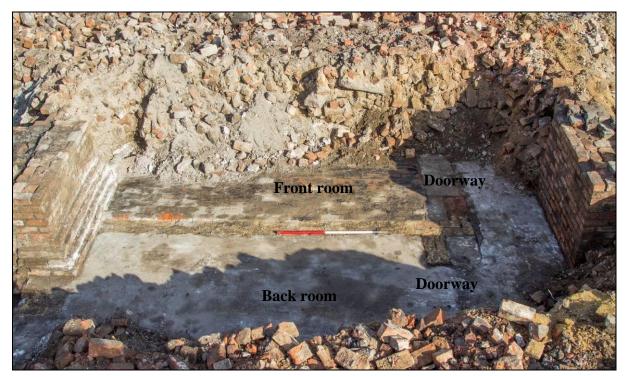
Plate 19: General view of House 3/ Corn & Provender Dealer showing the footprint of the house and the extant remains of the later phase, looking north

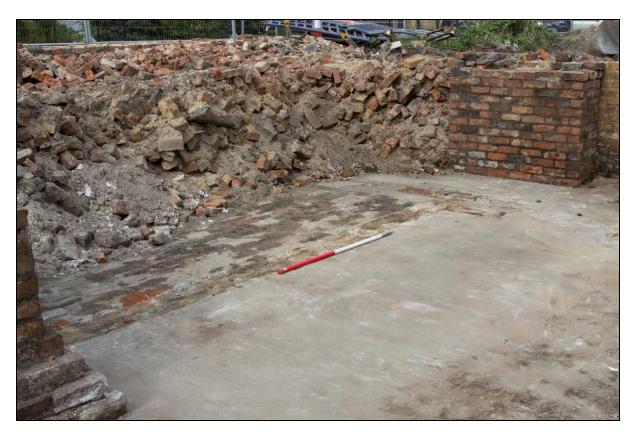
Plate 20: Remains of the dividing wall between the front and back rooms of House 3, with a later brick pillar in the top right corner, looking north-east

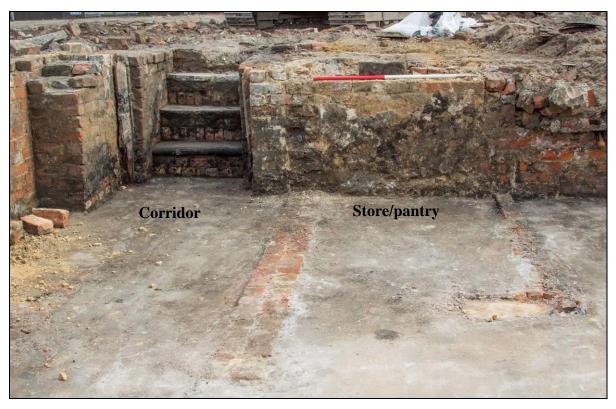
Plate 21: The original staircase of House 3, which led out to the rear yard area, looking south
The staircase abutted the rear wall of the house, and comprised hand-made bricks bonded with black ash mortar, which could suggest they were a slightly later addition to the house or

a later re-model. The timber door frame survived either side of the staircase. Three steps survived and part of a fourth comprising a stone tread resting on two brick-courses, as is often seen in houses of this date (Plate 21). To the west of the staircase in the outer yard, the vestiges of an L-shaped wall had probably been part of a small outhouse (Plate 22).

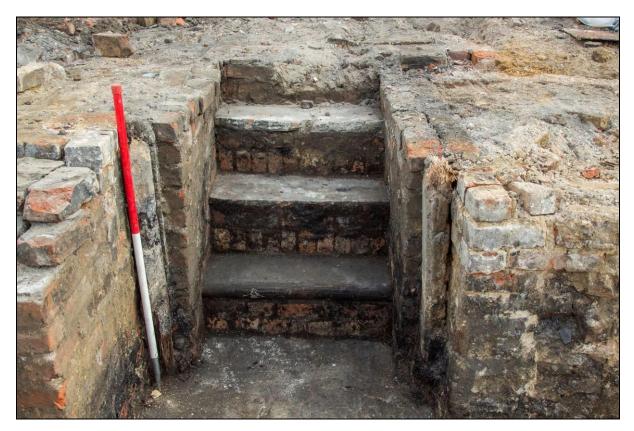
Plate 22: Detail of the rear staircase associated with House 3, looking south

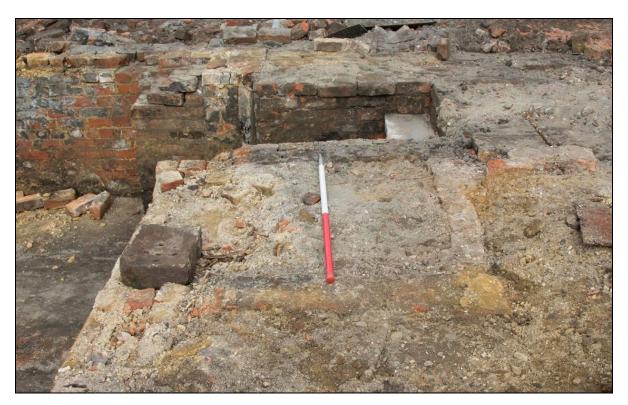
Plate 23: Possible outhouse in the rear yard area, next to the staircase, looking east

In House 3, a brick pier or fireplace base had been added against the eastern wall, which measured 1.50m long by 0.75m wide, surviving to a height of 1m. On the western side of the room was another brick pier with four foundation steps, which straddled Houses 3 and 4, measuring 1.80 x 1.20m (including foundation steps), and 0.90m in height. Two smaller brick piers with two foundation steps had been built either side of the House 3/4 party wall, which appeared to have been reduced to one brick-course wide by this point (Plate 23).

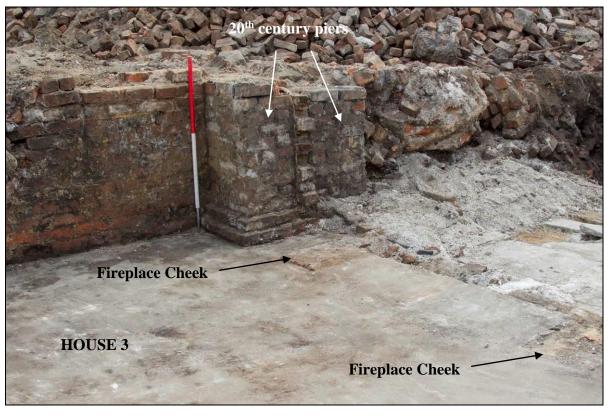
Plate 24: House 3/4 party wall visible in the floor (bottom right), the rear wall of House 3 (top right) and two later brick pillars either side of the party wall (centre), looking south-west

The scar of a large fireplace with an internal measurement of 1.40m was identified along the footprint of the western party wall. The remains of the flanking cheeks were visible in the floor (Plate 24).

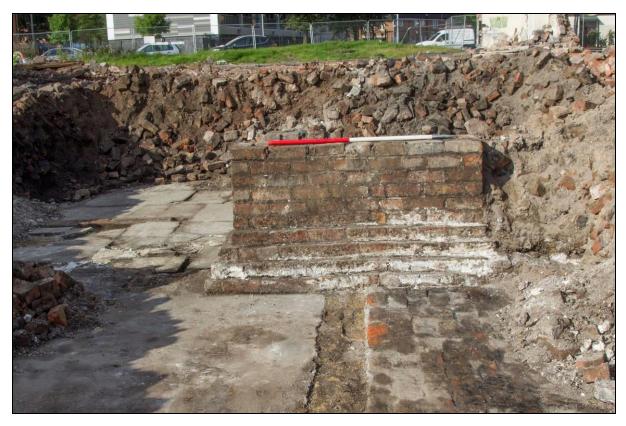
Plate 25: Brick pier contemporary with the 20th-century corn and provender shop phase constructed over the earlier house remains, looking west

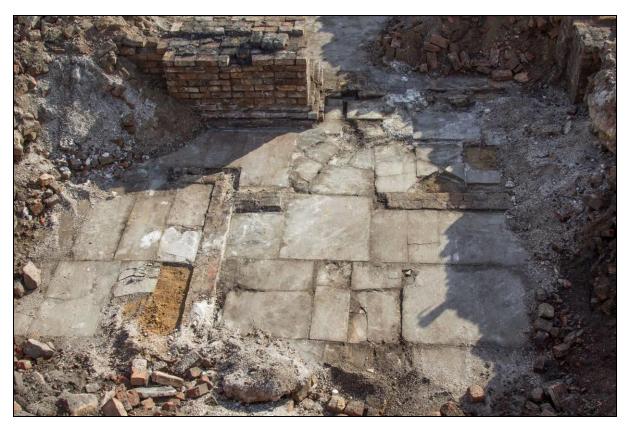
Plate 26: The remains of House 4 and later stanchion from above, looking east

House 4 (No 93 Coupland Street) lay to the west of House 3, and was the westernmost property exposed in the excavated trench. The internal layout of the house was very similar to that of House 3, although it had a stone-flagged floor throughout. There appeared to have been a corridor from the back door with doorway leading west into the back room, which did not appear to have a store/pantry. The corridor narrowed to the front room, again with a doorway leading west into the front room. All internal walls comprised two brick-courses in width of hand-made bricks bonded with sandy mortar. Natural sand appeared below the stone floor (Plates 26-27). The remains of the industrial warehouse period comprised the brick pier described in House 3.

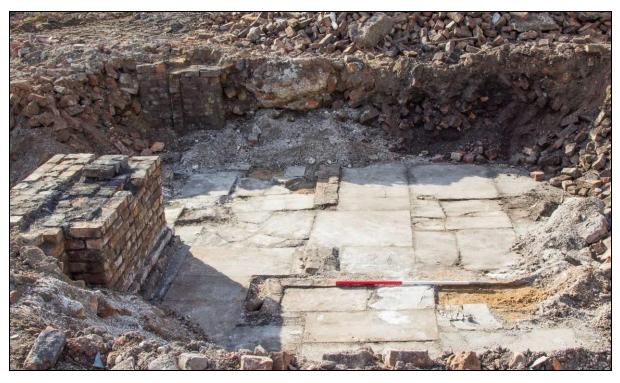
Plate 27: The footprint of House 4 visible in the floor, looking south

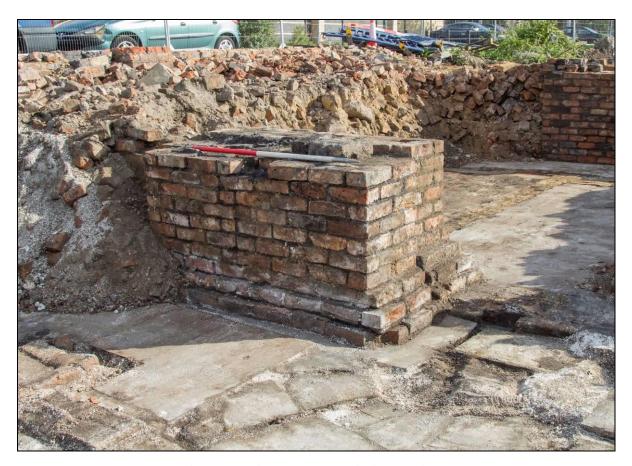
Plate 28: Brick pier in House 4, looking north-east

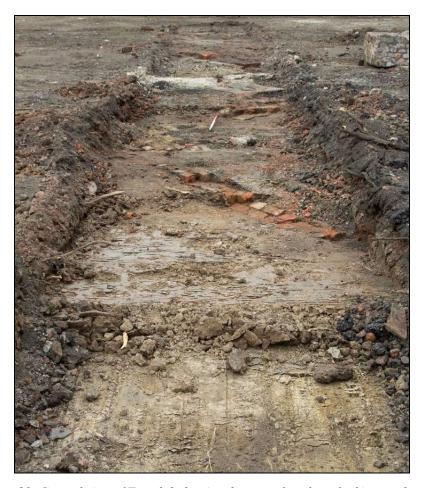
Plate 29: General view of Trench 2 showing the natural geology, looking south-west

The first 4m of the trench contained disturbed garden soil overlaying natural sand. The garden soils survived to about 0.10m in depth and contained frequent roots (Plates 29-30). At 4m was a two brick-course wide, hand-made brick wall bonded with sandy mortar, crossing the trench on a diagonal, aligned north/south. The wall appeared to return to the west, and was likely to have been the dividing wall between the private gardens of Houses 1 (No 89) and 2 (No 91). The wall also appeared to return again at 7.5m along the trench, to the south, at which point there was a ceramic drain pipe, probably associated with an outside privy (Plate 31).

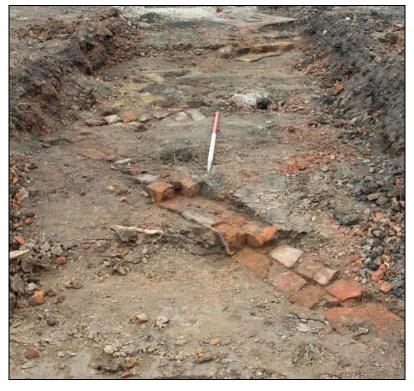
Plate 30: Probable garden wall dividing Houses 1 and 2 (Nos 89-91 Coupland Street), looking south-west

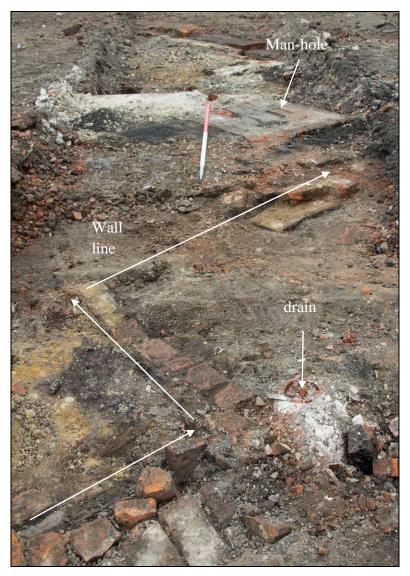
Plate 31: Probable remains of outhouse in the rear garden of houses fronting Burlington Street, looking southwest

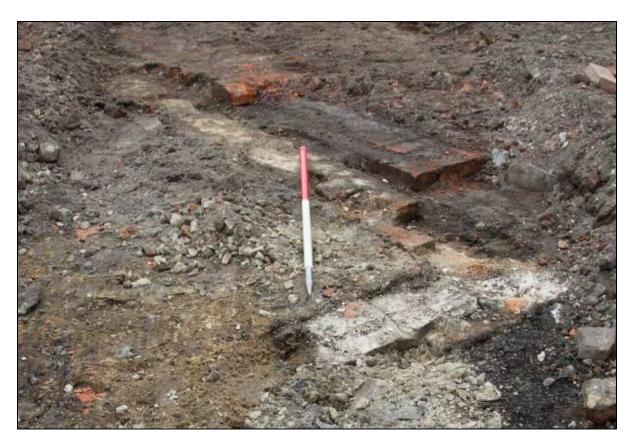
Plate 32: Remains of garden walls with a later wall behind, possibly the former school, looking south-west

The rest of the remains in the south-western end of the trench all pertained to the rear gardens of houses fronting Burlington Street, all of which had been subject to modern disturbance, and the foundations of the later school shown on the OS 25":1 mile map of 1948-50 (Plates 32-33).

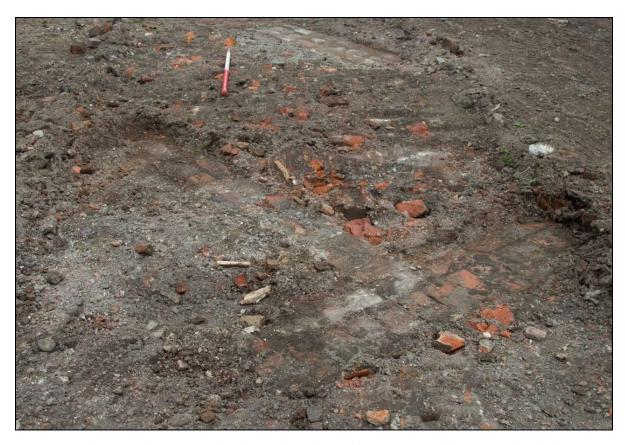
Plate 33: The far south-western end of the trench, with possible remains of walls associated with the former school, looking north-east

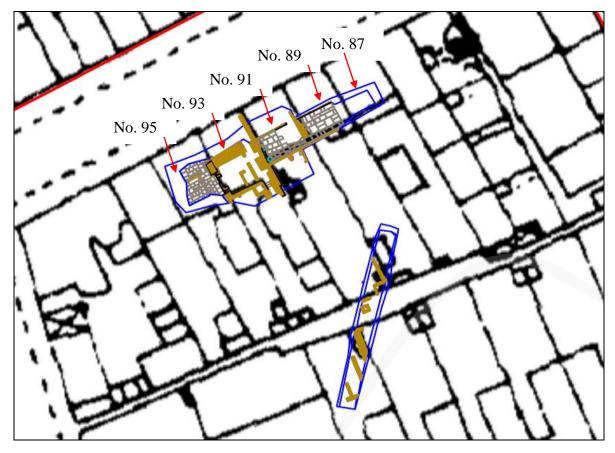
Plate 37: The excavation results overlaid onto an extract of the OS map of 1893

The position of the rear wall of Houses 1 and 2 (Nos 89 and No 91) corresponds precisely with that depicted on Ordnance Survey mapping of 1851 and 1893 (Plate 37), as can the rear wall and external steps to the slightly larger House 3 (No 93). The party walls between each of the houses are easily identified on the overlay, as are the remains of the far, southern end of the garden and possible small outbuilding in the corner (Plate 34).
