## **Archaeological Excavation**

Chapel Street,  
Plots E7 and E8,  
Salford

### **Technical Report:**

**Report No:** SA/2018/58

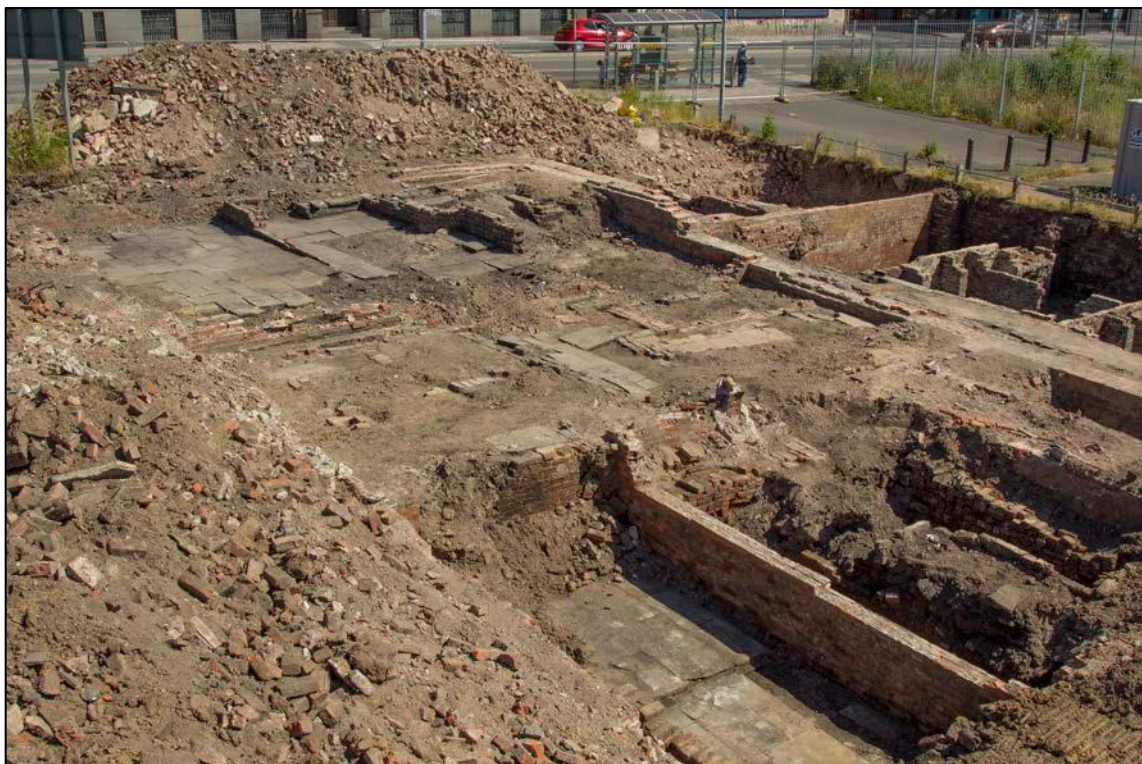
**Figure 4.** General view of Area 1 looking northeast.

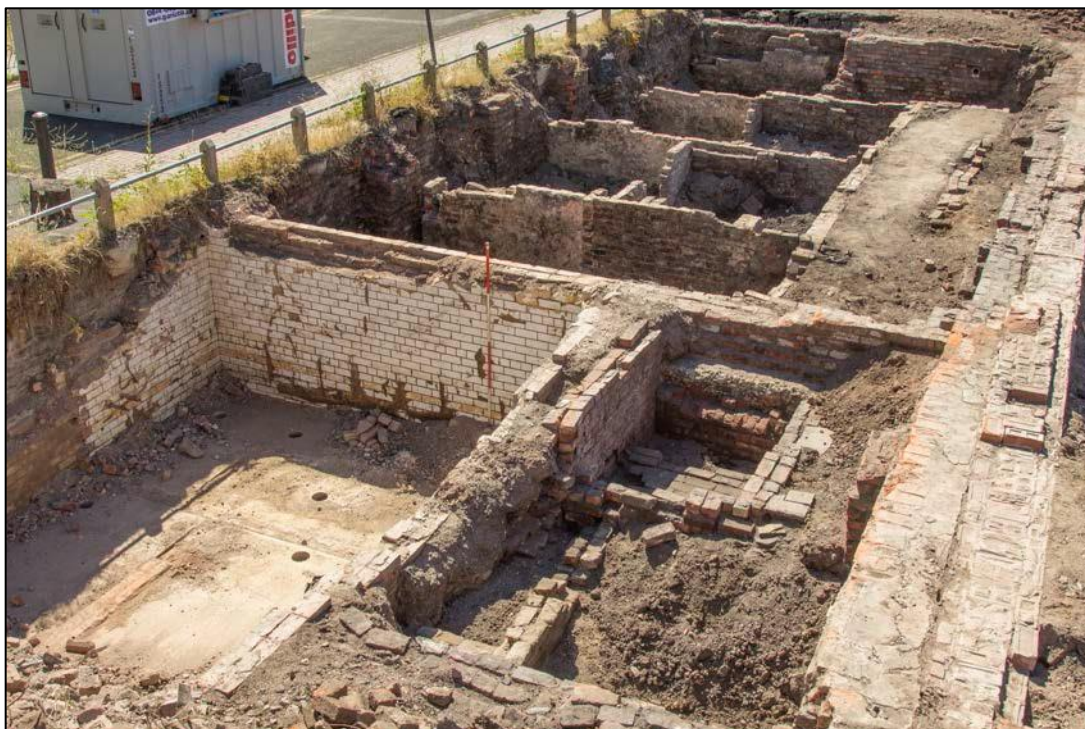
**Figure 5.** Cellars to the west of walls (017) and (044). Looking southeast.

eastern side. The western wall (044) was composed of machine made frogged bricks laid 4 courses wide with a white cement mortar 0.48m wide. A third wall (045) relating to the warehouse structure was uncovered running east-west along the northern edge of the area. This wall was also constructed from machine-made brick laid with a white mortar, three courses wide (0.47m).

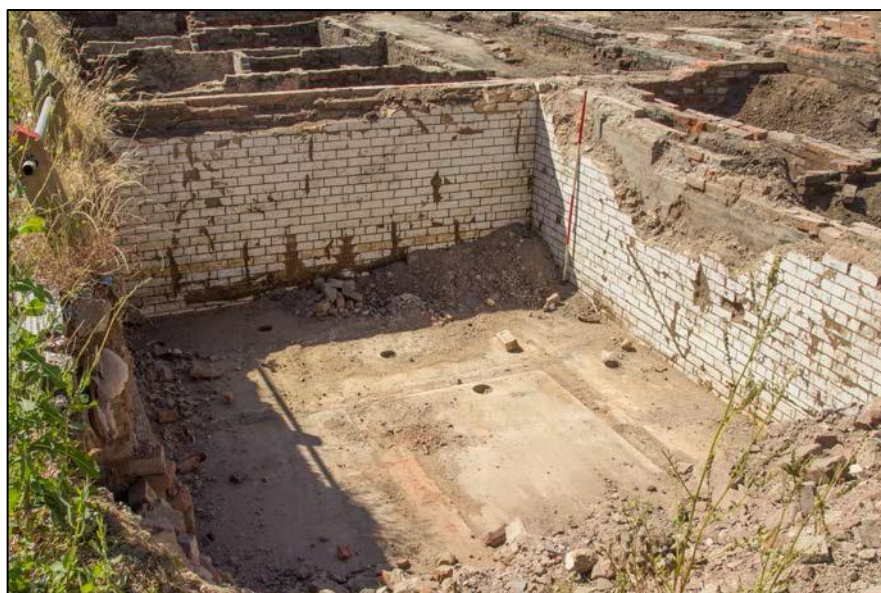
**Figure 6.** Bank Room 1, showing glazed brick walls, concrete floor and wall scars (010), (011) and (012). Looking southwest.

As corresponding scars on the walls were not identified, it is likely that these walls did not represent dividing walls within the room, rather they were associated with smaller scale features within the room.

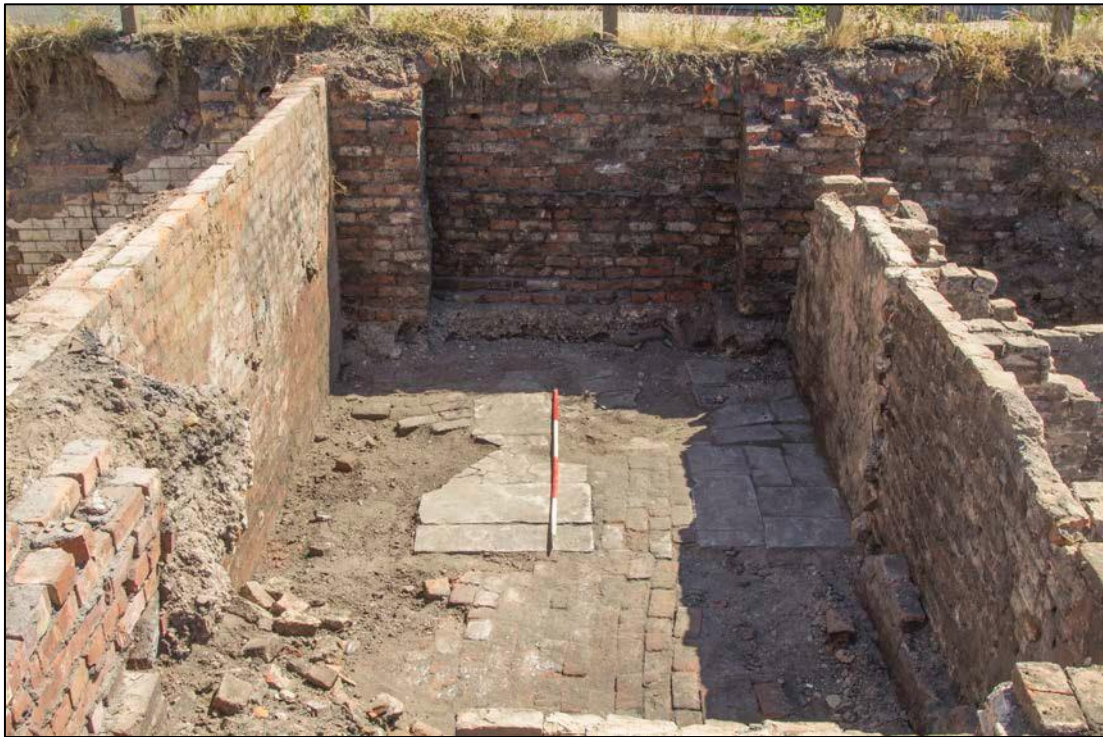
**Figure 10.** Room 1, showing floors (022) and (024) and walls (014), (018) and (020) to the left centre and right of the picture respectively. Looking east.

were identified on the southern face of the wall. The truncated remains of a cross wall with a central opening (023) was revealed, extending northwards from (014), with the portion to the north retaining evidence of plaster and paint. At the southern end of (020) a single course of handmade bricks was found to abut the wall which was interpreted as the base of a staircase. Wall (018) was 2 courses wide, bonded in an unspecified bond with a white lime mortar and also formed the western wall of Houses 1 & 2 to the south. The floor of this House was a mix of handmade bricks to the east (024) and stone flags (022) to the west with a drain in the south-eastern corner.

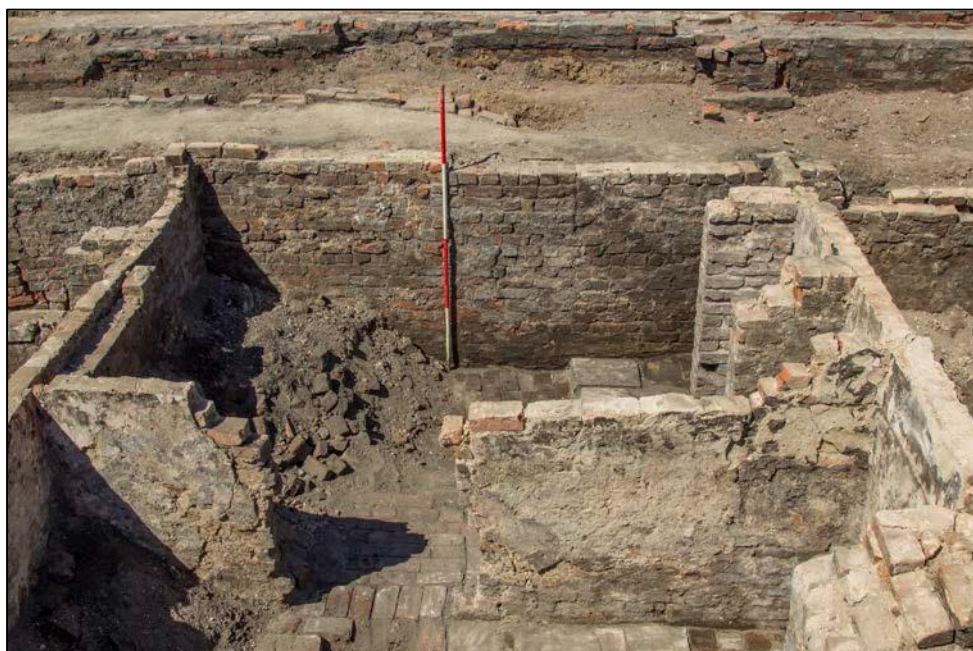
**Figure 11.** House 1 showing wall (26) in the foreground and western room and wall (018) in the background. Looking west.

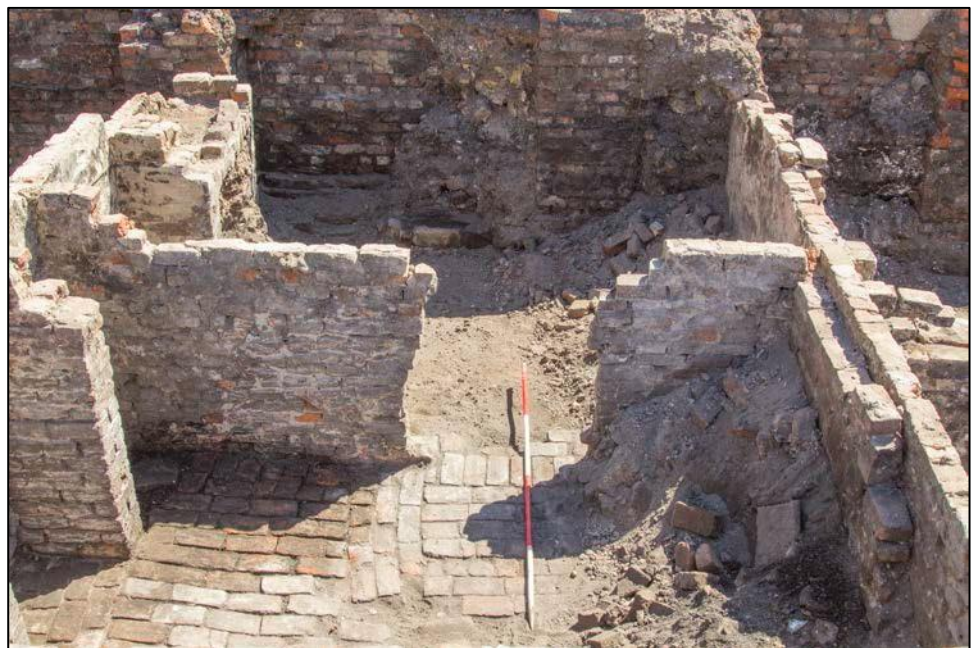
**Figure 12.**  
House 1  
showing wall  
(016) in the  
background  
and the eastern  
room. Looking  
east.

House 1 lay to the immediate south of House 4 and measured 3.66m x 5.50m. The house shared its northern wall with House 4 which, as mentioned above, possessed a fireplace complete with *in situ* lintel measuring 1.43m x 0.51m at the eastern end and two brick buttresses measuring 0.50m x 0.24m at the western end forming a second fireplace. To the east and west walls (016) and (018) identified in House 4, continued through this house with no change in their form or construction. The southern wall of the house, (028), was again a single course wall bonded with white lime mortar abutted by a second course of bricks to the west measuring 1.70m in length. The house was divided into two rooms to the east and west by a single course brick wall (026) with evidence of plaster on both faces. This wall contained a central doorway, 0.74m in width. A complete brick floor (27) was revealed to the west of this wall but the flooring to the east was a truncated mix of bricks and flags (025).

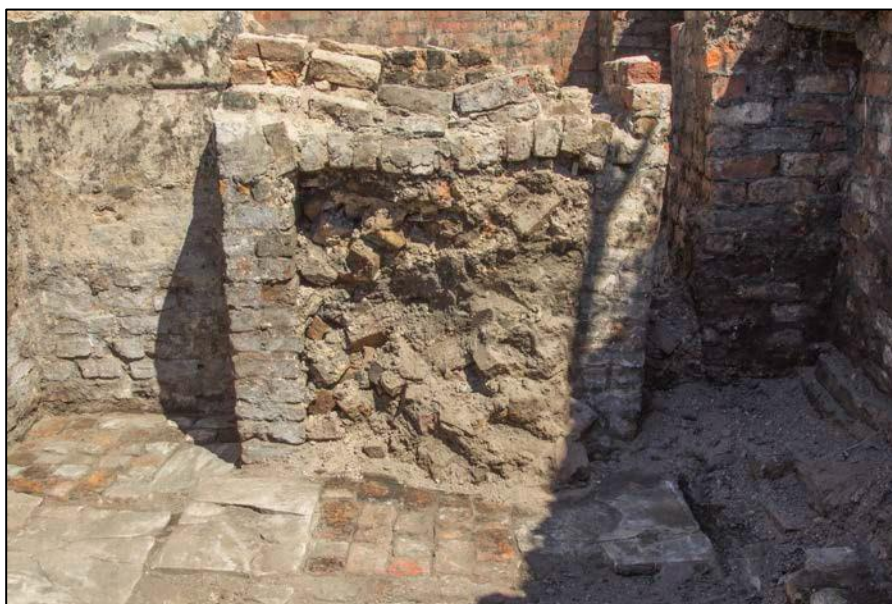
**Figure 13.**  
Fireplace in  
eastern room of  
House 1.  
Looking north.

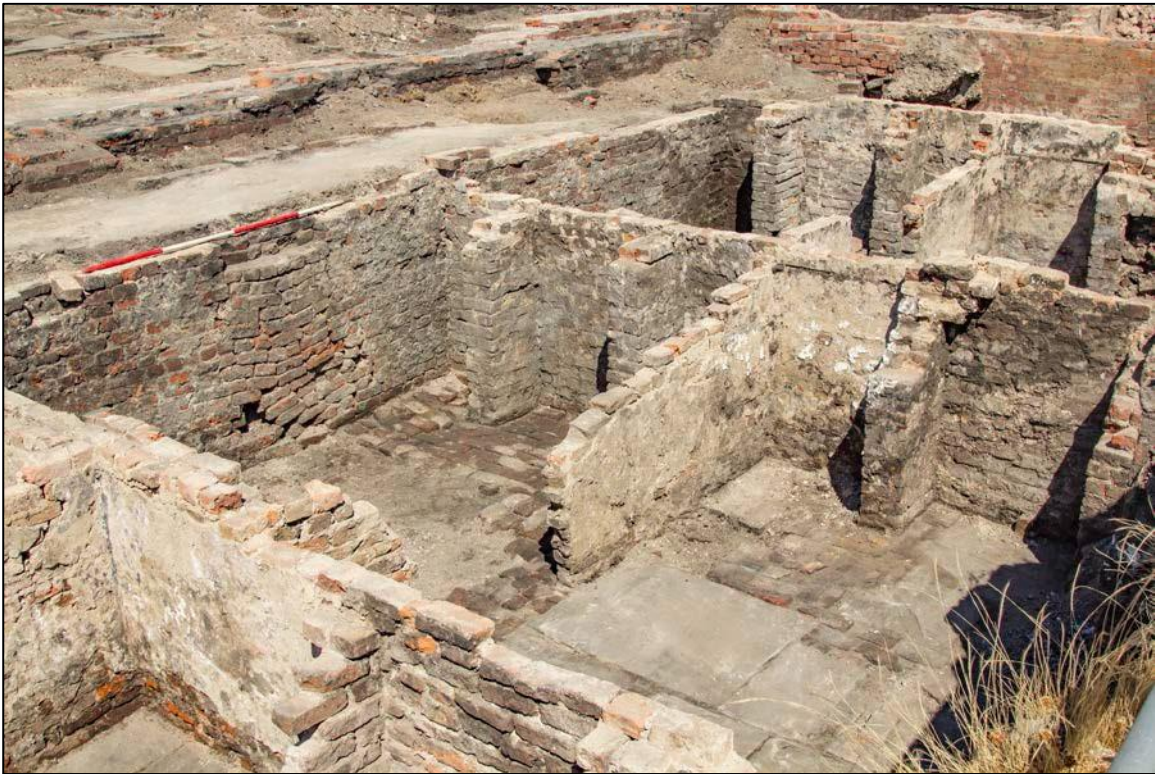
**Figure 14.** General view of House 2. Looking northwest.

House 2 was identical in construction and layout to House 1 with only minor differences in some of the internal features. The fireplace in the eastern room on the southern face of (028) was less well preserved and did not retain its brick lintel like that in House 1. In addition the central part of the brick floor in the western room (031), was either missing or broken, although the remaining bricks indicated its similarity to the floors in the houses either side. Finally, a row of bricks laid as headers in wall (018), measuring 0.78m, indicated the position of a cellar light on this side of the room.

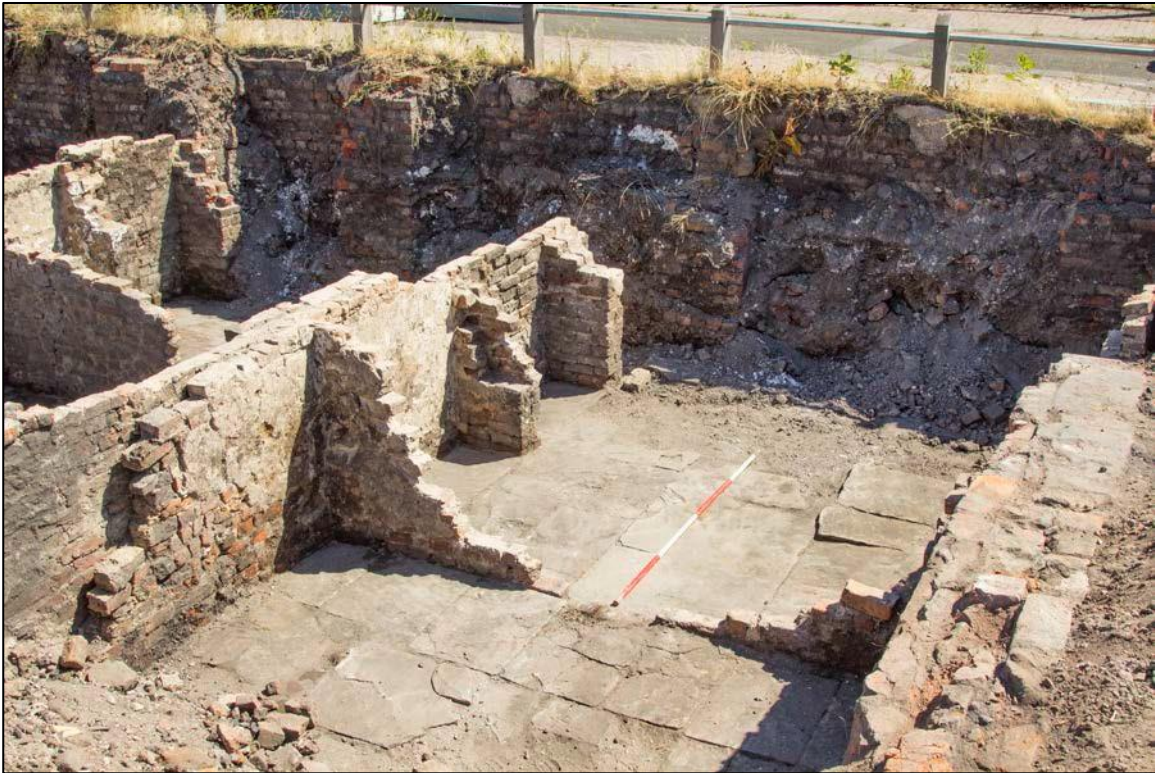
**Figure 15.** General view of House 3, showing walls, (0320, (034), (036) and (016) and floor (033).

House 3 lay in the south-eastern corner of Area 1, but unlike Houses 4, 1 and 2 extended westwards beyond the alleyway measuring 7.65m in length. This house appeared to be cut to both the southern and western sides by the later warehouse structures (016) and (036) although a section of the earlier southern wall (084) still existed in the eastern room of the house. This wall measured 0.24m x 2.88m and was 2 handmade brick courses wide, bonded with white lime mortar. Again, the eastern wall had been removed by the construction of (016) and the northern wall (032) was shared with House 2. This wall, however, extended further westwards to form the southern boundary of the alleyway and was constructed from a single course of handmade brick which grew to 2 courses within the alley. A short section of an additional course was also revealed in the north-eastern corner of the western room which measured 1.70m in length. As before the house was divided into two rooms by a single course plastered wall with a central doorway (034). The flooring in both rooms was composed of stone flags (033) and (035), although many were missing from the eastern room (033). Several setts were identified in the southern section of this area beyond walls (036) and (084) indicating that House 3 is likely to be the two roomed building seen on the corner of Sidney and Mason Streets on historic mapping.

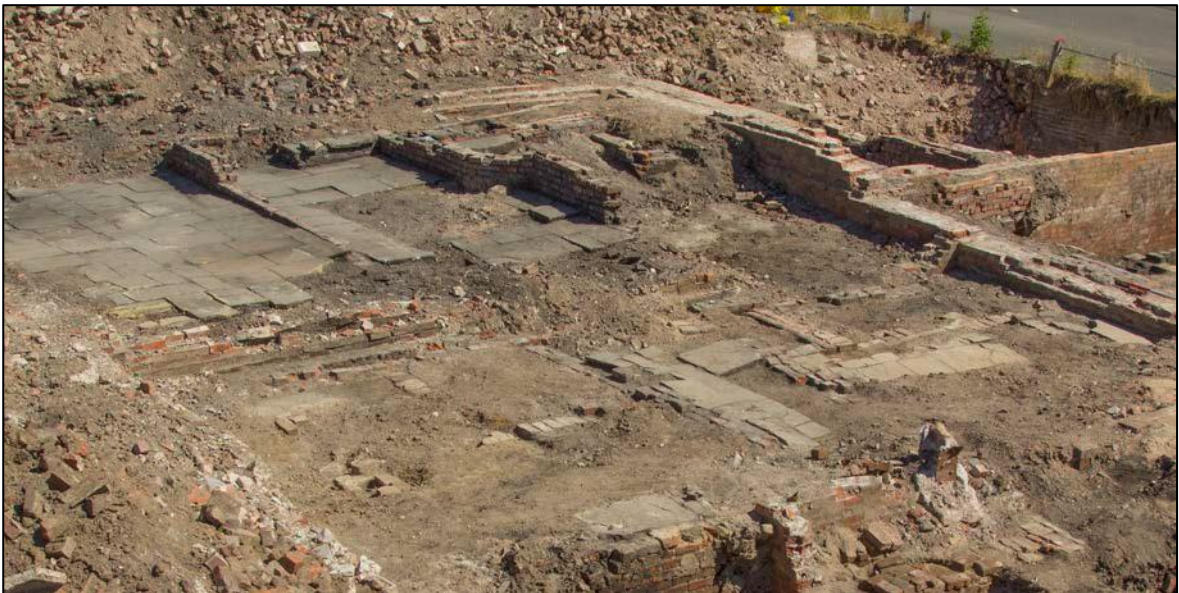
**Figure 16.** Flagged surfaces to the west of Area 1. Looking northeast.

To the west of the bisecting warehouse walls lay the remains of two flagged surfaces and several cellars associated with the housing at Butterworth Court and fronting onto Mason Street.

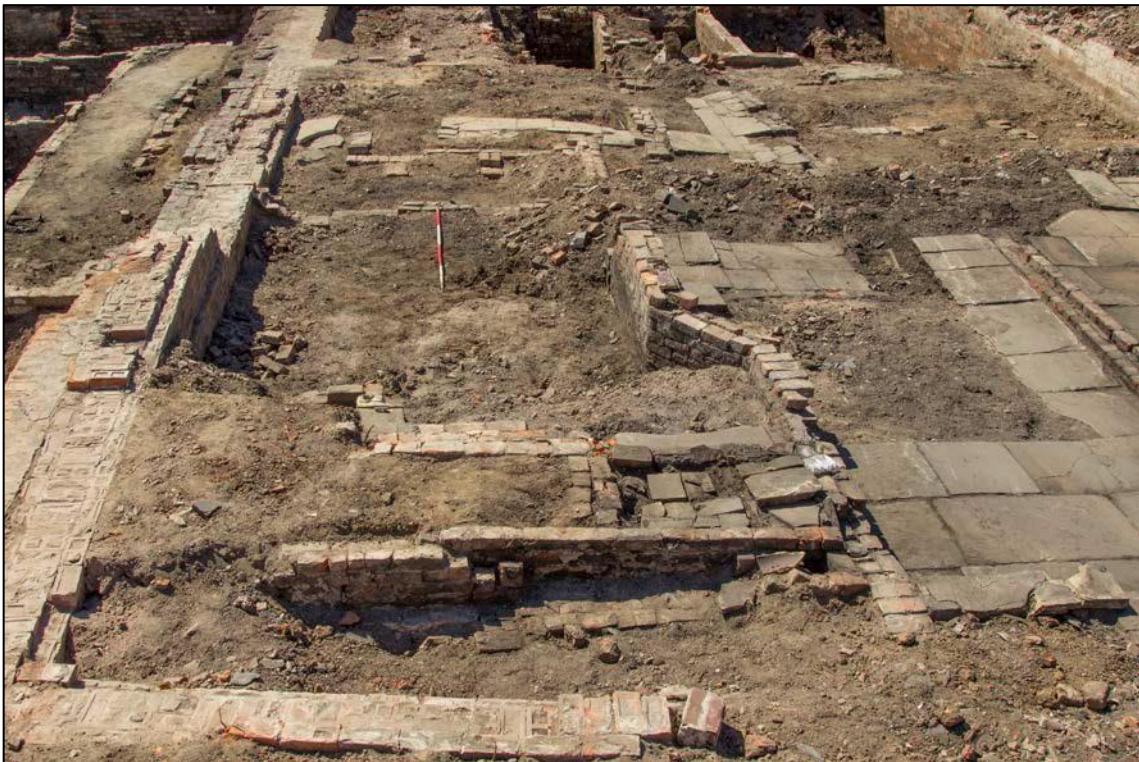
**Figure 17.** Northern flagged area showing walls (047) – (049) and (051) and surfaces (050) and (053). Looking south.

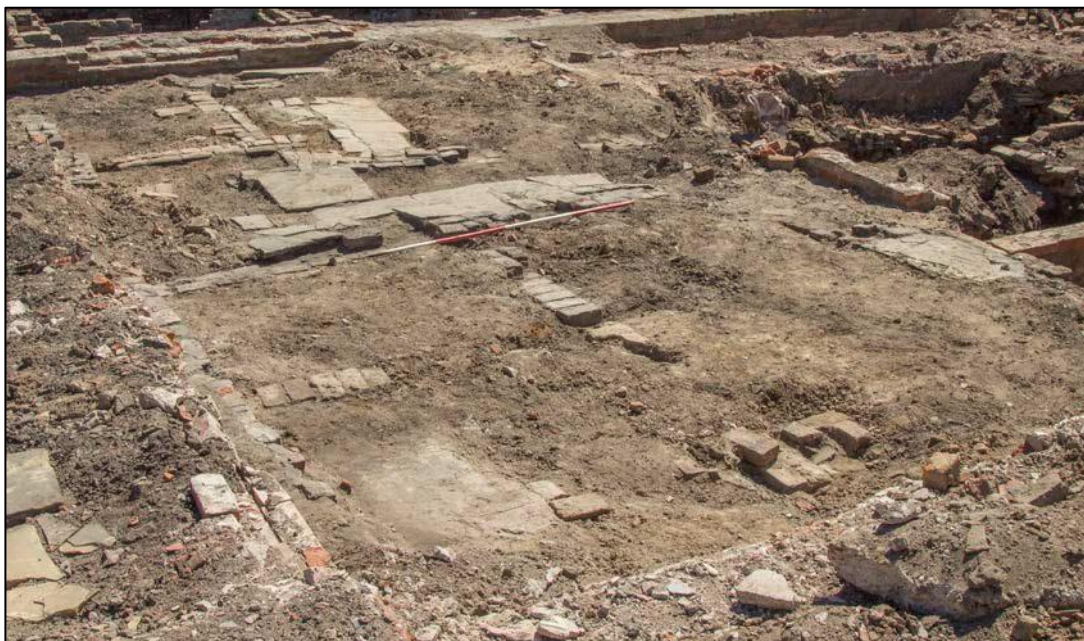
**Figure 20.** General view of southern flagged and walled area. Looking southeast.

Walls (060)-(062) were all constructed from handmade bricks laid 2 courses wide (0.24m) with a white lime mortar. Wall (060) was aligned east-west and lay 1.20m south of (059) with two 0.24m wide brick projections along the northern face. Wall (061) abutted (060) running north-south and measured 1.20m. Wall (062) lay at the western end of (060)

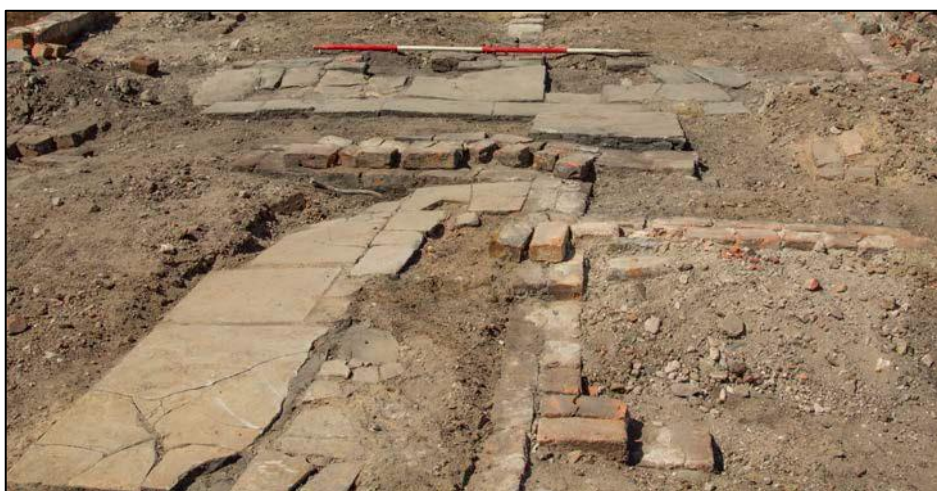
**Figure 21.** Detail of walls (060), (061) and (062) and floor (064). Looking west.

measuring 2.00m in length. The western brick course on both this wall and (061) showed evidence of black staining, although this did not seem to continue onto (063). To the west of (063) lay another handmade brick wall, (058) which abutted (059) to the north and measured 3.50m x 0.24m. Both the surface and the wall were truncated at the same point. Another 2 course wall (086) was identified 1.50m from (058) which also extended southwards from (059) but was heavily truncated after only 0.60m. Scars within (087), the light brown silty loam onto which the structures appear to have been built, suggests that wall (086) originally continued southwards to abut (065). This was another truncated section of handmade brick wall running east-west and abutting (058) to the east, measuring 1.40m. The only evidence of flooring in this area was the presence of two stone flags (066), one lying between (086) and (059) and one 3.50m to the south abutting (068), both measured c.0.60m x 1.00m. Lying against the more southerly of the flags, lay a short L shaped handmade brick wall (067) which measured 0.80m long and lay 1.88m south of (065).

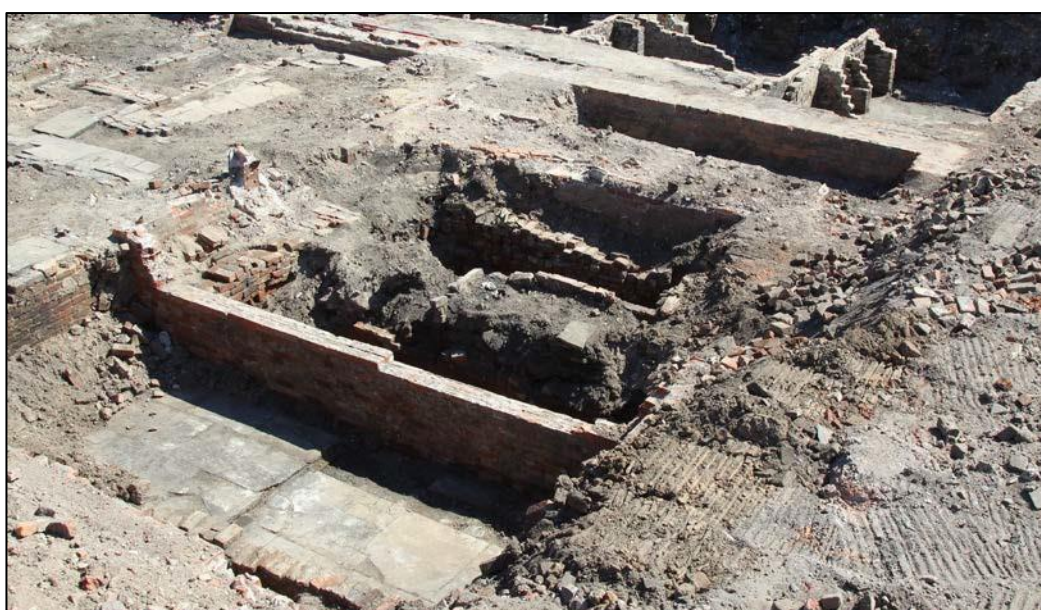
**Figure 23.** Cellars within the houses fronting onto Mason Street. Looking northeast.

To the south of the flagged areas, further remains of the 20<sup>th</sup> century warehouse were uncovered which again cut through several of the earlier, 19<sup>th</sup> century features. These were represented by contexts (070) and (080) and were identical in construction to those described above. The features cut by these walls were the remains of cellars within the buildings fronting onto Mason Street, the most complete of which lay in the south-western corner of the Area. The western and southern walls of this cellar were formed by the southern continuation of wall (085) and its eastern return, the cut of which, [072], truncated the flagged floor within the cellar (071). This floor was comprised of stone flags c.0.60m x 1.00m and extended 3.40m eastwards where it was cut by another 20<sup>th</sup> century warehouse wall (070). The northern wall of the cellar was formed by a heavily truncated handmade brick wall (068) which was again truncated by (085) and measured 1.20m in length. Another handmade brick wall had been constructed running north-south lying on top of surface (071). This was poorly constructed and laid 2 courses high with white lime mortar c.2.00m from (070).

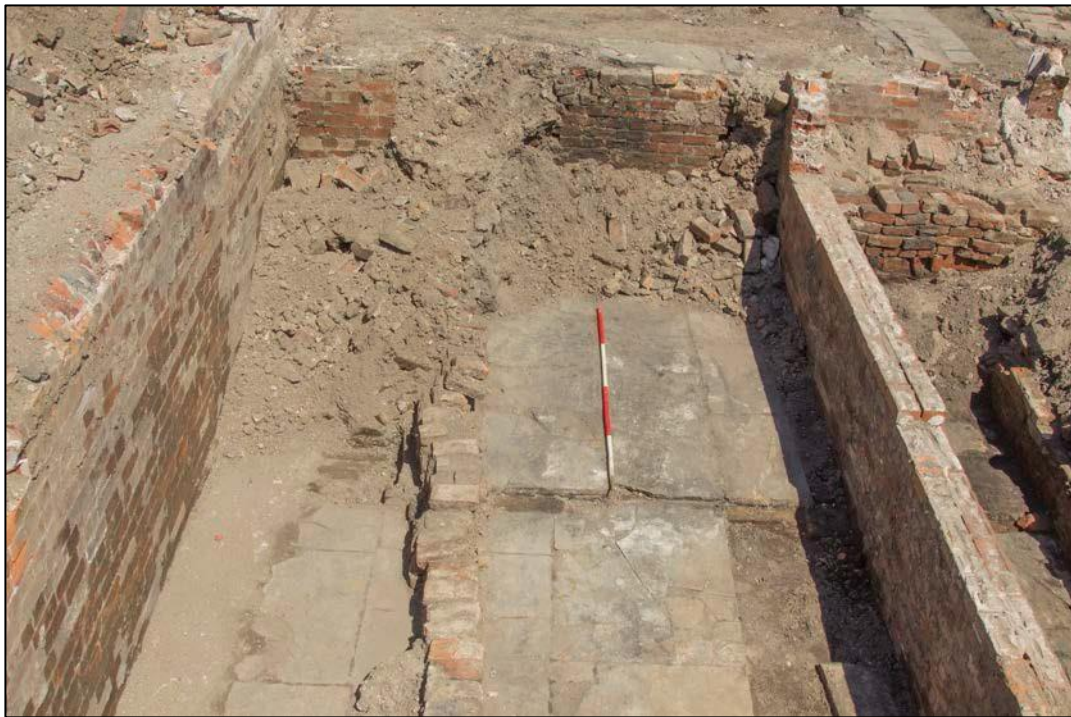
**Figure 24.** Westernmost cellar showing 20<sup>th</sup> century walls (085) and (070) (l-r) with flagged floor (071) and wall (073) in the centre. Looking north.

To the east of (070), a second flagged floor (074) was uncovered which had again, been truncated by the warehouse wall but was almost identical in construction to (071). A roughly constructed 2 course handmade brick wall (073) was constructed on top of this floor, measuring 0.25m x 4.00m. This floor abutted to the east, a single course handmade brick wall (075) measuring 3.70m in length. This wall lay 1.16m west of a second single course wall (077) measuring 3.40m long. The two were linked by a third single course wall (076) running east-west between, however this and the area between (074) and (077) could not be fully excavated. To the east of (077) lay a handmade brick floor (078) enclosed by wall (079) to the east and wall (088) to the south. Wall (079) was a 2 course wide handmade brick wall standing to a height of 1.00m and measuring 4.40m x 0.24m. an additional course was identified on the western side of the wall but this only stood to a height of c.0.35m. Wall (088) to the south appeared to have been missing its outer course as the northern face was poorly constructed with no evidence of mortar. Several broken stone slabs were identified to be set into the wall at varying heights and may have been related to steps allowing access to the cellar. Floor (078) had been removed at the southern end of the cellar to reveal the natural clay beneath.

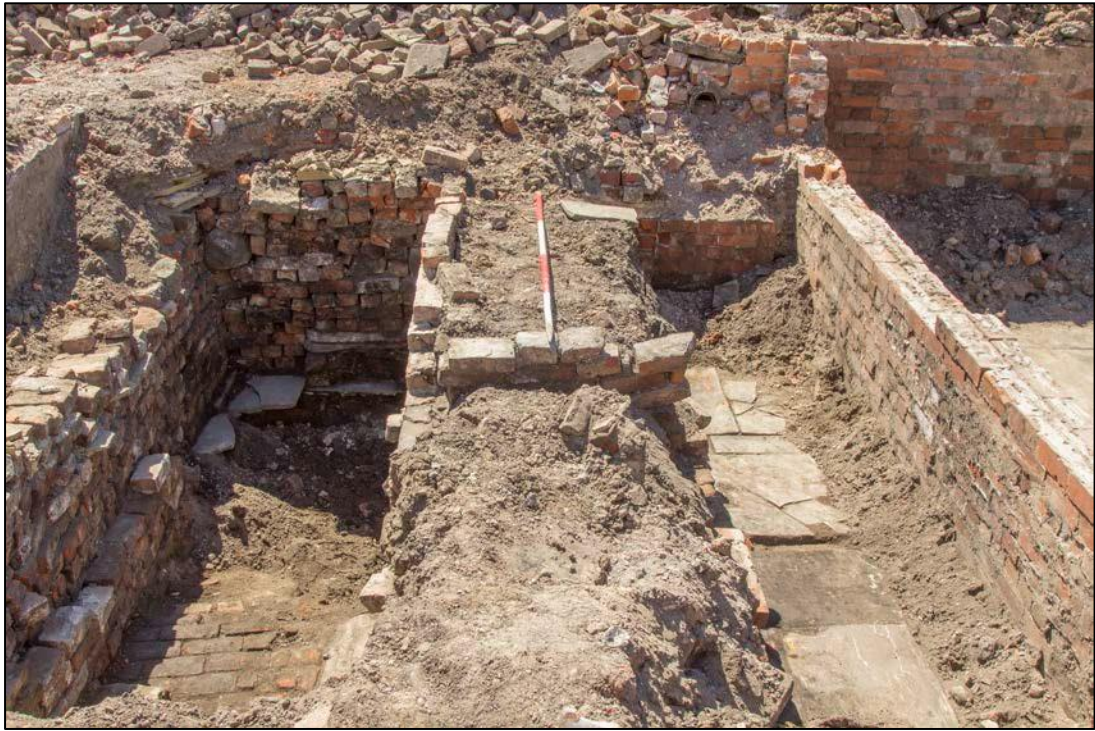
**Figure 25.** Easterly cellared area, showing walls (075), (076) and (077) in the centre, (088) and (079) to the left and floors (074) and (078). Looking south.

The easternmost of the Mason Street cellars had been removed by the construction of the 20<sup>th</sup> Century warehouse which caused the construction of a large concrete and machine made brick structure measuring 1.40m x 5.50m approximately 0.50m to the east of (079). This structure in turn, lay 1.20m from wall (044) with no evidence of 19<sup>th</sup> century structures between.

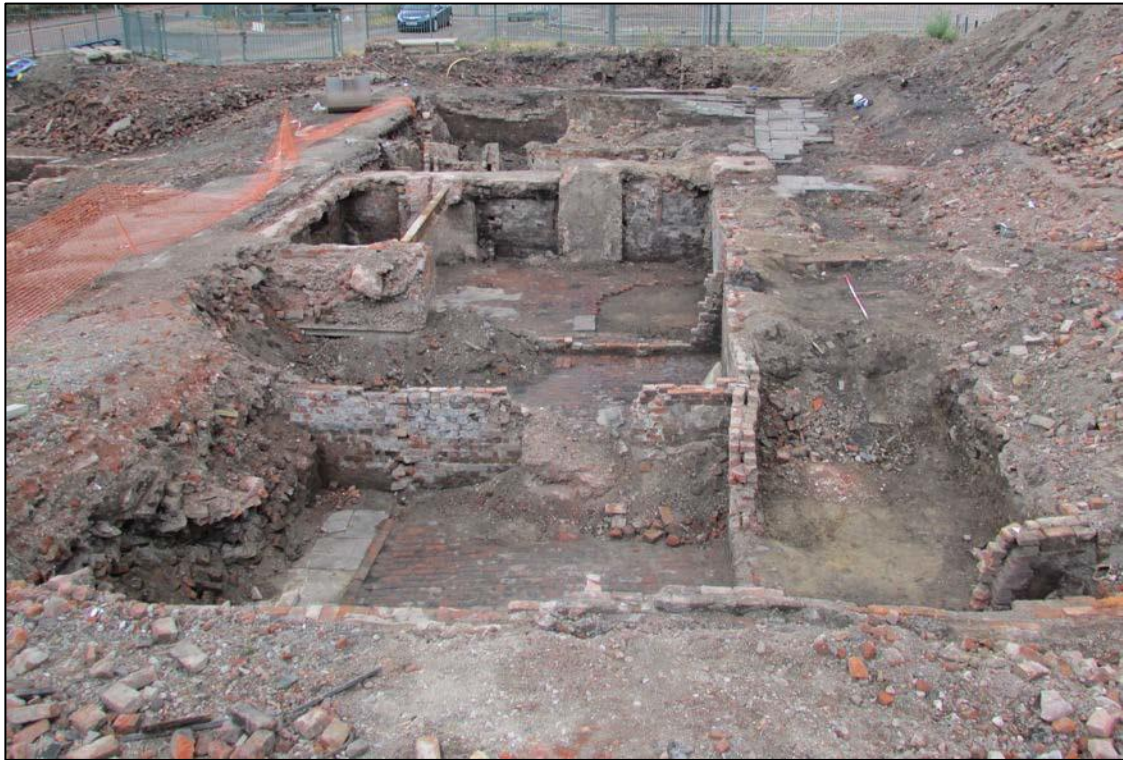
**Figure 27.** General view of Area 2 showing Houses 1, 2 and 3 in the foreground. Looking west.

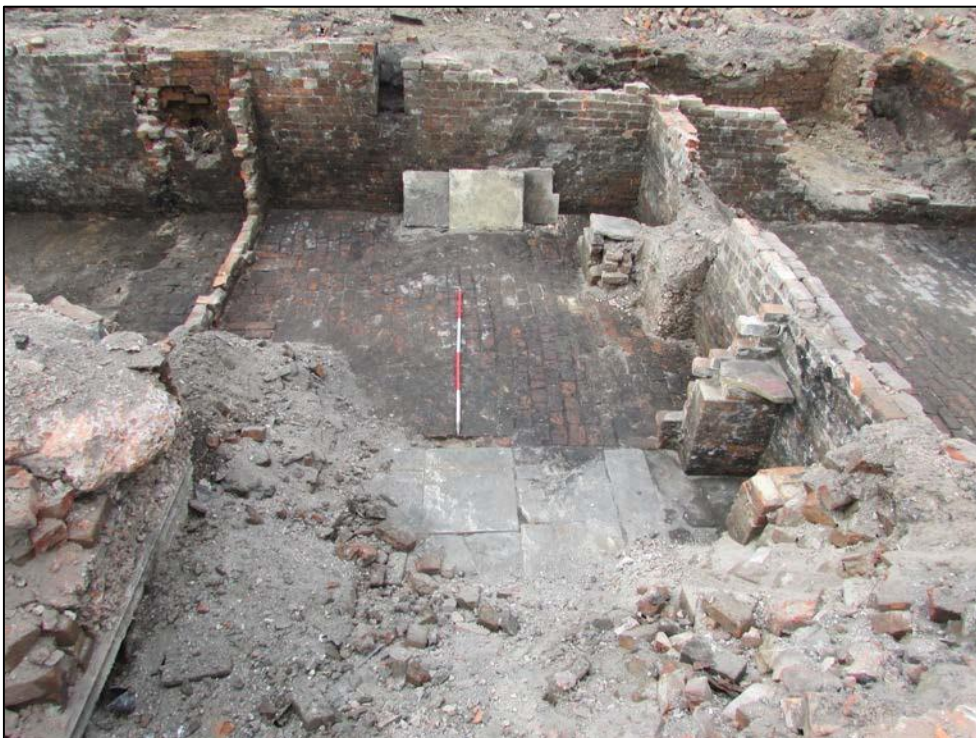
**Figure 32.** General view of House 2, showing walls (159), (151) and (155) and floors (160) and (158). Looking north.

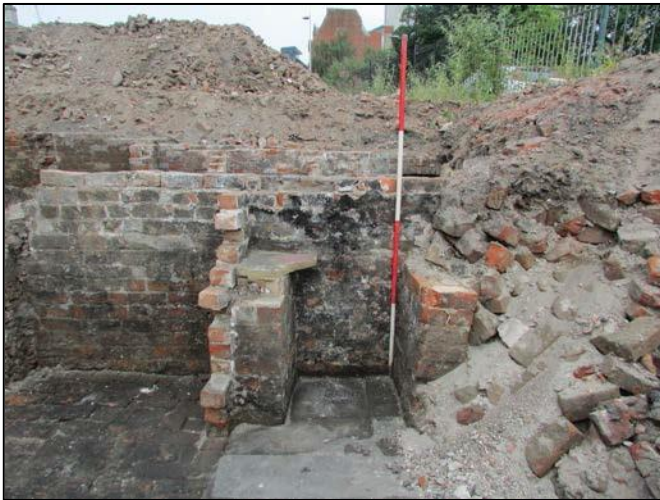
**Figure 34** Possible storage feature in the corner of the southern room of House 2. Looking east.

course handmade brick wall that had collapsed during excavation. Again, the southern room had a stone flagged floor (160) which had been truncated to the southwest by the concrete foundations of the later 20<sup>th</sup> century structure. The only feature to be revealed in this room lay in the north-eastern corner abutting wall (157) and consisted of two brick projections from (155) measuring 0.40m x 0.25m with the remains of a sandstone slab across at a height of c.0.80m. The black staining on the wall between the projections suggested its use as a fireplace, however the lack of hearth and furniture and the presence of the stone slab indicated that this was not the case and that this structure was more likely to be used for cold storage or as a workbench.

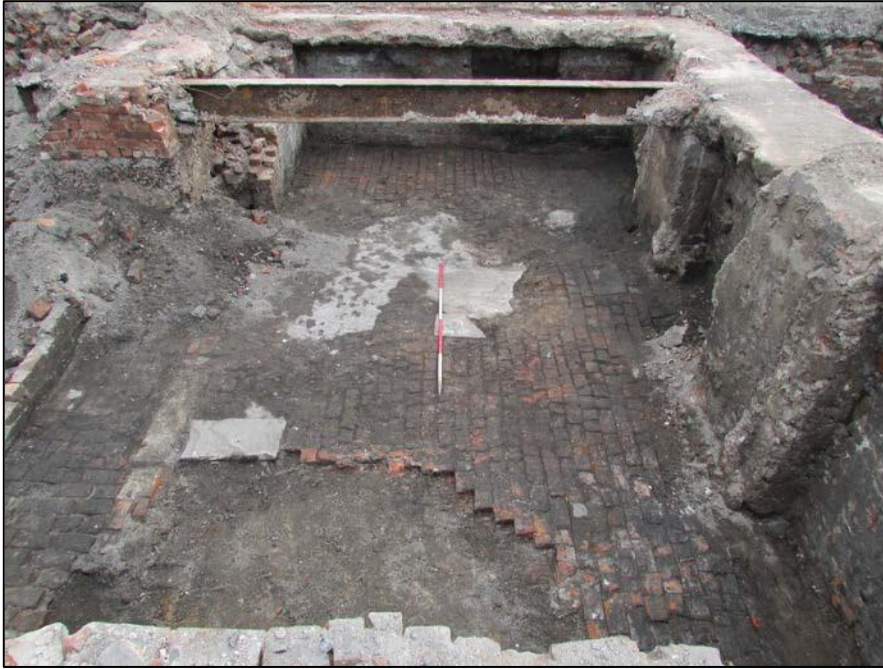
**Figure 35.** General view of House 3, showing floors (161) and (163) and the extent

House 3 lay to the west of House 1 but although the houses shared wall (159), the main cellar room lay further west on the other side of a narrow passageway. The passage ran the full depth of House 3, measuring 0.80m x 7.20m and was constructed from a handmade brick floor (161) with a 2 course handmade brick wall to the west (162). The northern section of the wall was only visible in plan and had been truncated to the north and in the centre, however a break in the standing section to the south suggested that this may have been a doorway. The position of the passageway directly corresponds with the position of an alleyway at ground level between the houses, the surfacing of which may account for the increased number of flagstones found in the fill of this room.

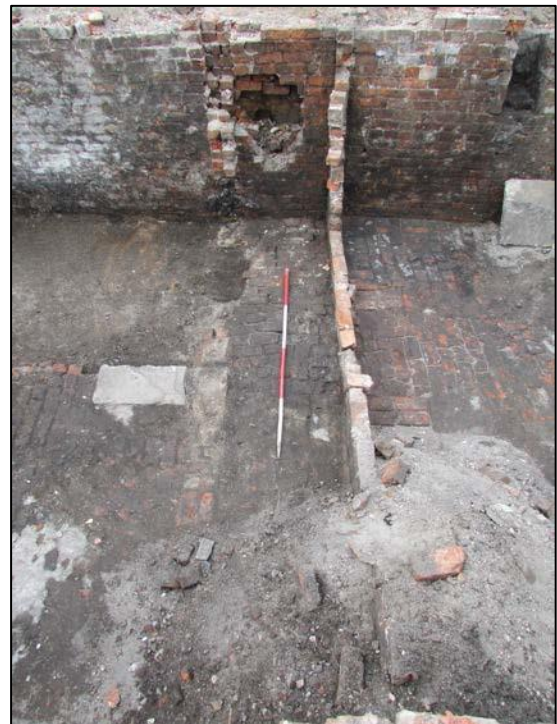
**Figure 36.** Passageway to the east of House 3, showing the truncated remains of walls (162) and (159). Looking north.

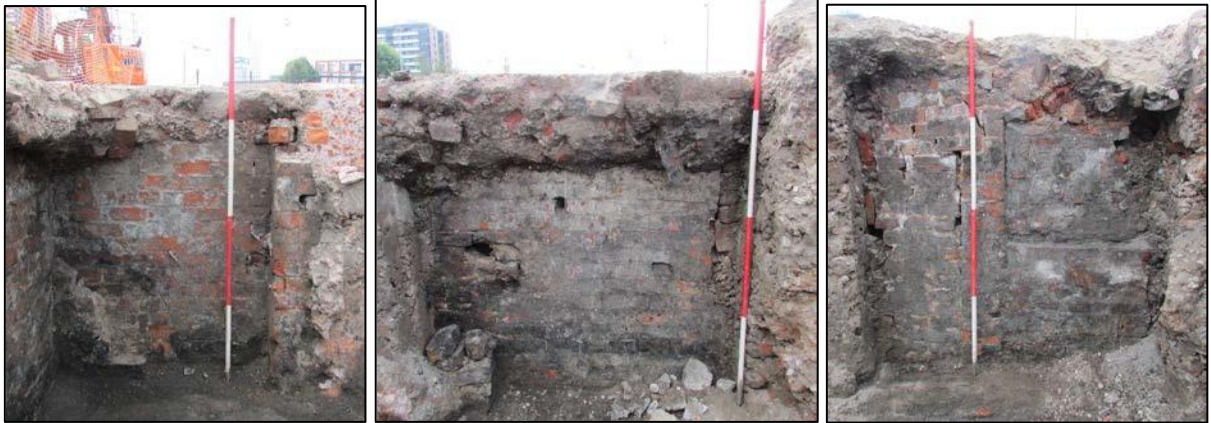
**Figures 37-39.** Southern, central and northern sections of wall (165) respectively, showing blocked fireplaces to either end and possible fixing holes in the centre. Looking west.

the room. A missing brick adjacent to the edge of the chimney breast and a fragmented course of bricks both at a height of 0.57m indicated that another structure, partially wooden may have occupied this area at some point. The central section of the wall measured 1.70m wide and also had two missing bricks, evenly spaced at 0.70m from the floor level, also interpreted as supports for a possible wooden structure such as shelving/workbench/storage etc. The northern section of the wall measured 1.80 in width and contained the remains of a blocked fireplace to the south with a 0.25m wide upright with a rounded corner to the north. Abutting the northern side of the fireplace lay a stone topped brick structure which was flush with the front of the fireplace and measured 0.90m wide. A second section of brick walling with a hard grey mortar was identified above this which appeared to have been inserted later. Due to its truncation, the purpose of these features could not be fully ascertained. The southern wall (164) abutted (162) and (165) and measured 4.30m in width and 1.30m in height. The top courses of this wall had also been lost to the concrete layer but below this the wall was reasonably well preserved. The

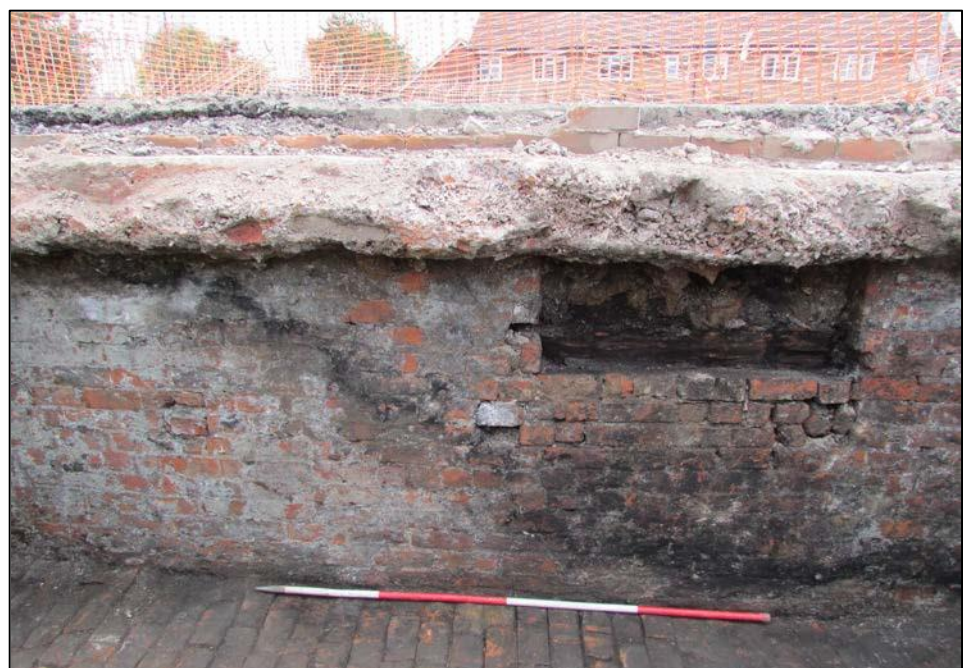
**Figure 40.**  
Wall (164)  
showing cellar  
light and  
possible fixing  
holes. Looking  
south.

main feature of the wall was the base of a cellar light window lying 1.06m from (165) and 0.94m from the floor level which measured 1.07m wide x 0.42m high. Within the opening a wooden beam was identified which was thought to be part of the window frame. The wall also had three further instances of missing bricks evenly spaced across the wall at a height of between 0.64m-0.74m, indicating additional workspace along this wall.

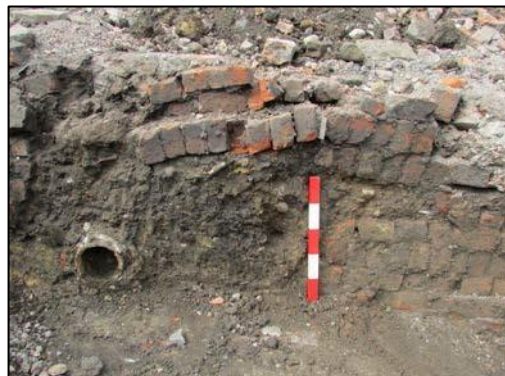
**Figure 42.** Arch in wall (166). Looking north.

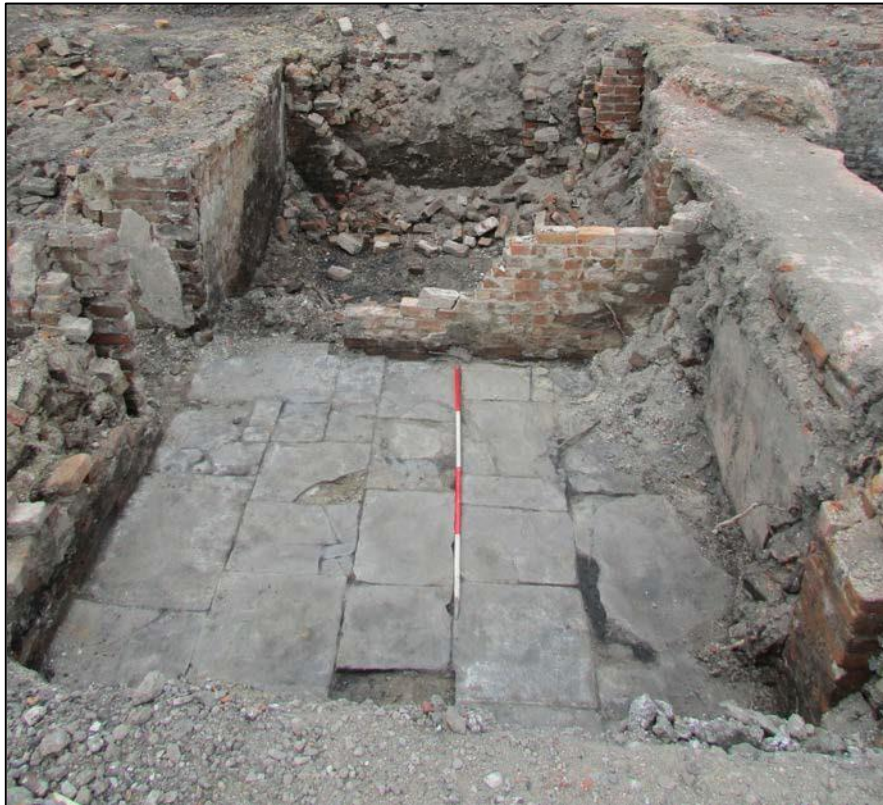
**Figure 44.** General view of House 4, showing walls (180), (182) and (177) and floor (201). Looking north.

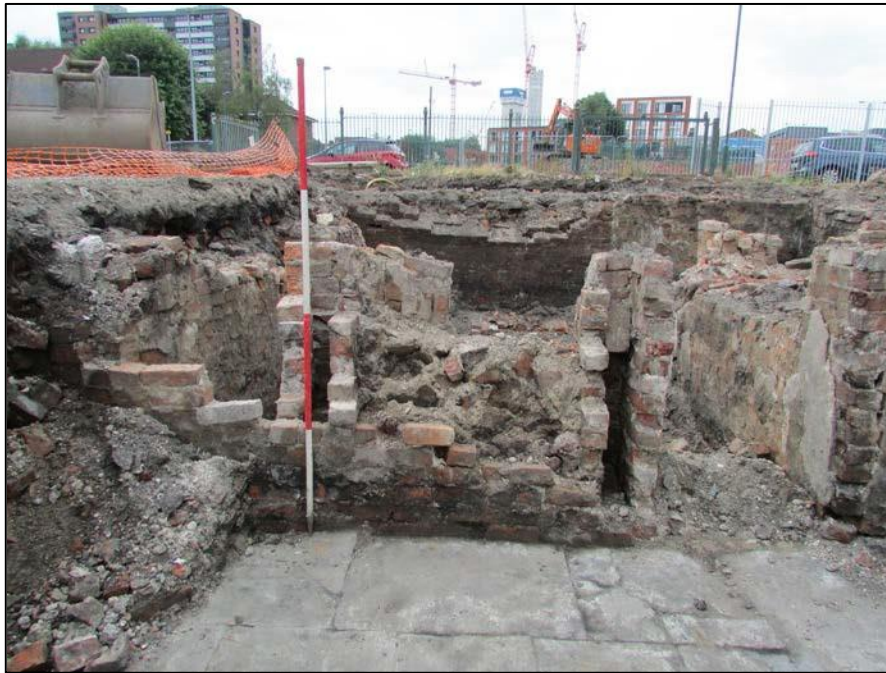
**Figure 45.** Rear of fireplace in House 5, visible from House 4 showing hollow uprights. Looking west.

(180) was fully excavated due to health and safety concerns but indicated that the fireplaces were built with hollow uprights and arched firebox openings. Walls (177), (181) and (183) formed the cross walls of the houses and were again found in varying states of collapse with (183) only visible in plan. No floor surfaces were identified within these houses, with the exception of a stone flagged floor in the southern room of House 4 (201). This was composed of limestone flags measuring c.0.80m x 0.60m. The only other feature to be revealed in these houses was a stone culvert (184) running north-south along the western side of House 6. This lay below the projected floor level and measured 5.60m x 0.40m, comprising handmade brick sidewalls and capping stone flags.

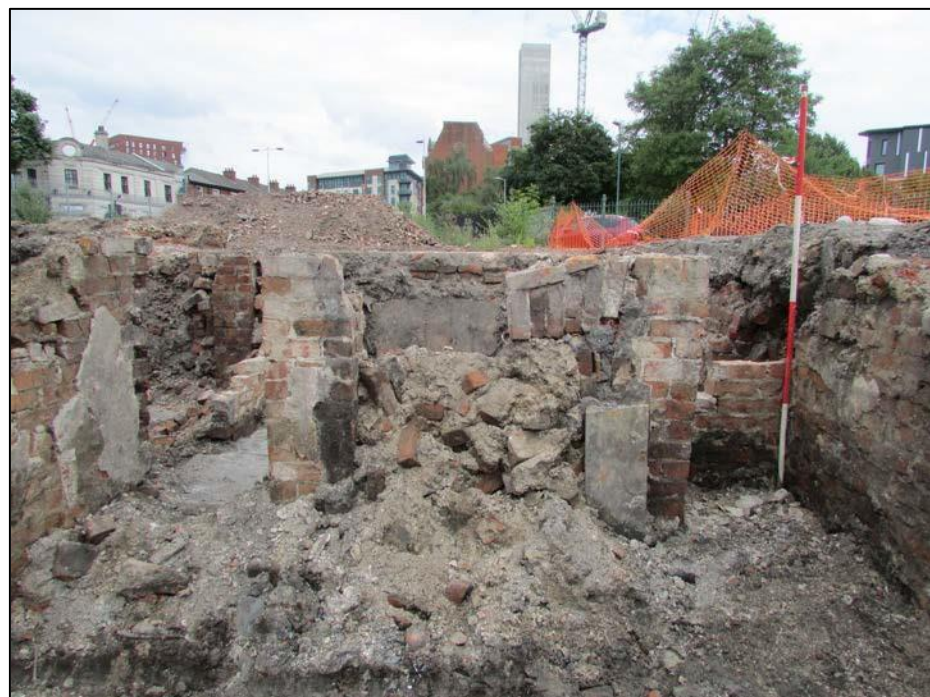
**Figure 46.** Front of fireplace in House 5, showing surviving pilaster to the south. Looking east.
