## **Archaeological Excavation**

Chapel Street,  
Plots E7 and E8,  
Salford

### **Technical Report:**

**Report No:** SA/2018/58

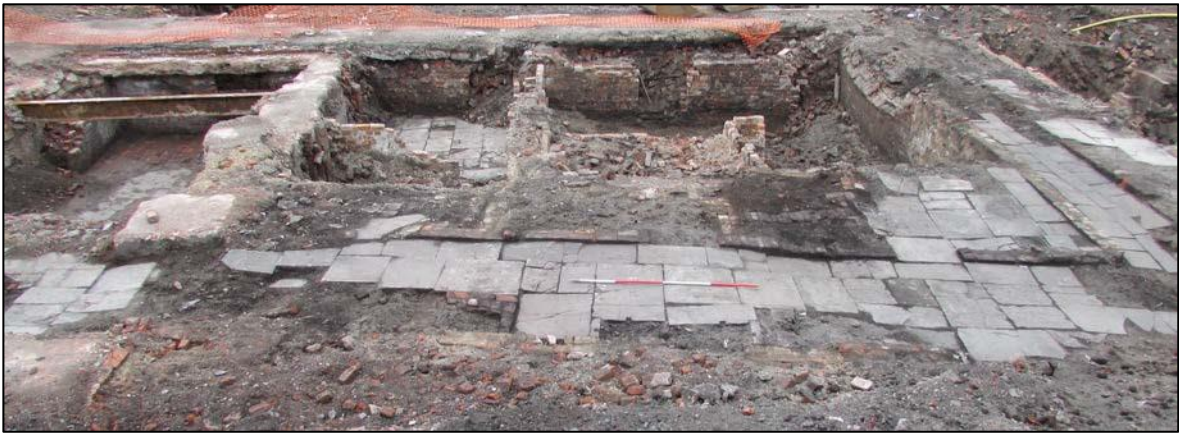
**Figure 49.** Yard areas and alley to the north of Houses 4-6, showing surface (174) and walls (176), (202) and (203). Looking south.

A large area of stone flags (174) was revealed to the north of (176), measuring 2.00m x 10.20m and comprising 0.40-0.60m x 0.70-0.90m flags. An L shaped, 2 course handmade brick wall (204) was found to abut the northern side of (174) which measured 1.40m/5.30m x 0.25m. It is thought that this may continue south to abut (175) however this area had been damaged by 20<sup>th</sup> century concrete. Surface (174) was also revealed to lie to the west of (186) to form an alley giving access from Sidney Street to the houses of Wiltshire Court. The western side of the alley was bounded by another 2 course handmade brick wall (187), measuring 8.70m x 0.25m with a 1.20m opening to the south. To the west of wall (187) lay the remains of the rear yards of three houses fronting onto Sidney Street. A small area of flag stones (192) was revealed to lie between (191) and (187) which was abutted by two single course brick walls identified in plan (205) and (206).

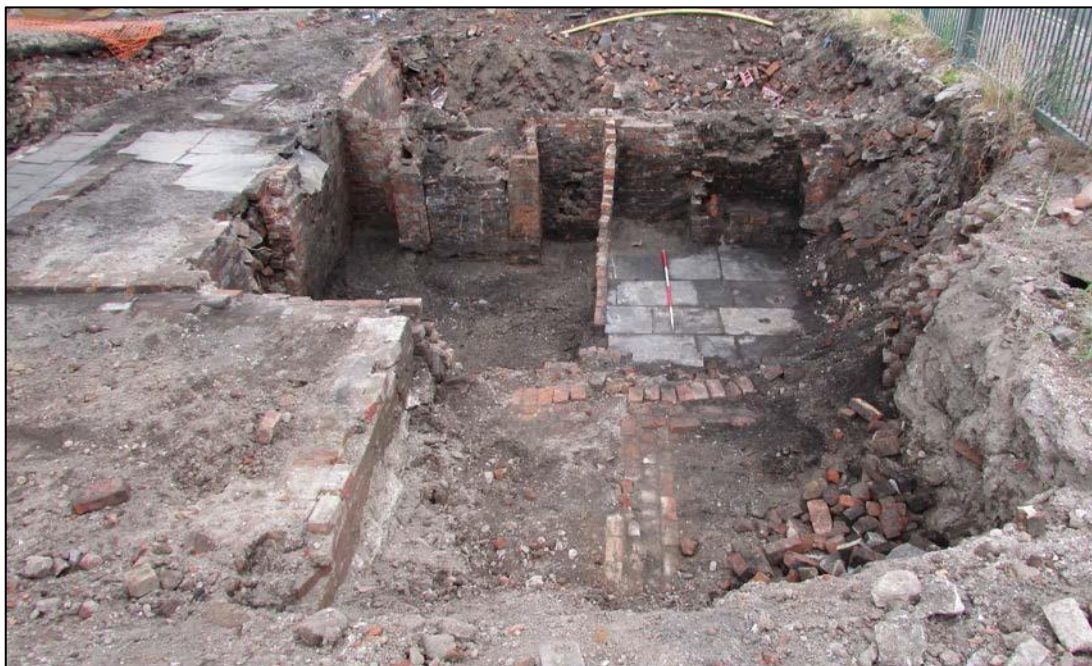
**Figure 50.** General view of Houses 7-9 and alley to the east, showing House 9 in the foreground, 8 in the centre and 7 in the background. Looking south.

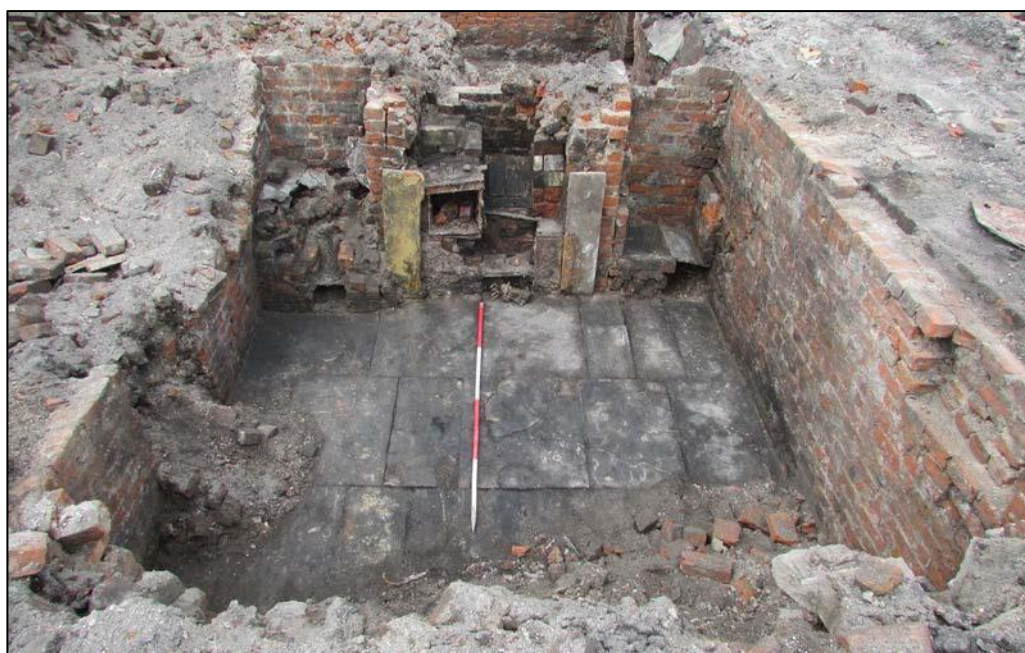
**Figure 51.** General view of House 8 showing walls (198), (197) and (191) and floor (200). Looking northwest.

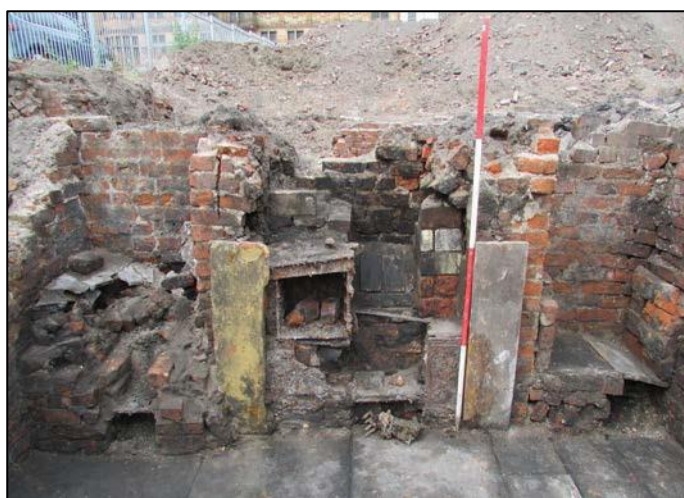
**Figure 53.** Detailed view of range and set pot inserted into wall (197). Looking north.

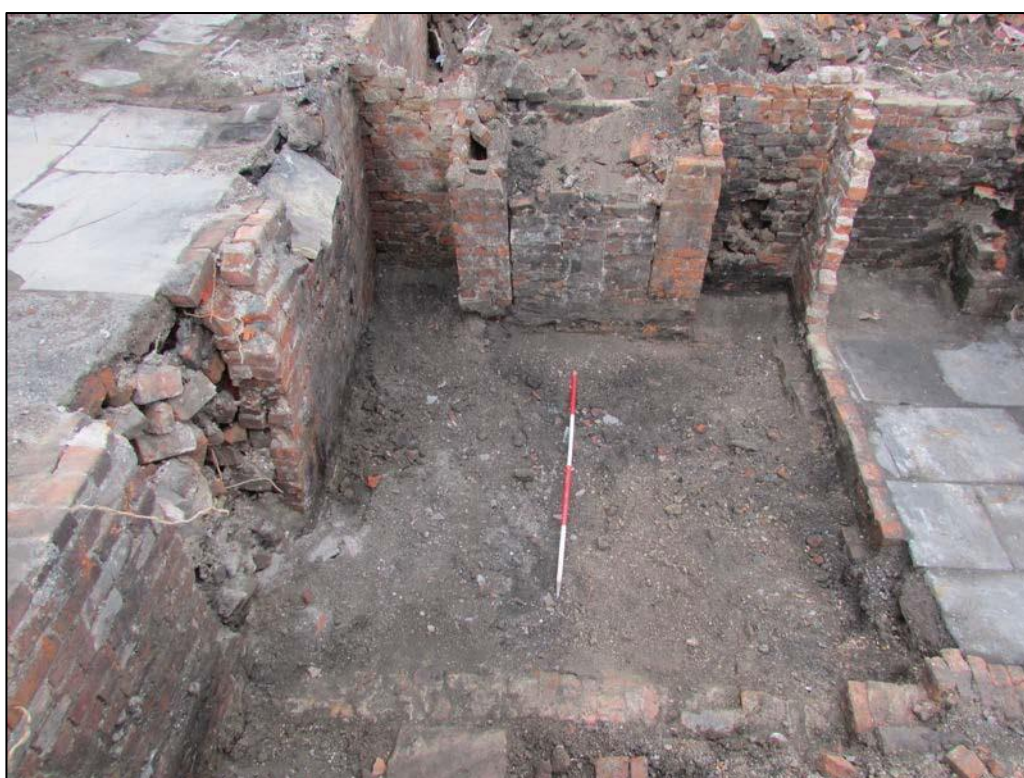
**Figure 54.** General view of eastern room of House 7 showing walls (191), (197), (195) and (193). Looking south.

As mentioned above, House 7 stood to the north of House 8, sharing the central wall (197) and the eastern wall (191) and measuring 6.00m x 4.80m overall. The eastern room of this house measured 3.00m x 3.20m and possessed an opening in wall (191) in the far north-eastern corner. Due to the fragility of the wall in this area the eastern side of (191) could not be excavated, however, the presence of an opening suggests there may have been a staircase in this part of the yard. The fireplace in the eastern room was the same shape and size as the one found in House 8, although it had been blocked by a course of handmade brick laid with a hard white mortar. The western wall was formed by wall (195) a single course handmade brick wall which had collapsed during excavation. The remains of a wooden step was revealed at the northern end of this wall linking the eastern and western rooms of the house. The northern wall of the room (193), spanned both rooms and was of an identical construction to (191), measuring 5.60m x 0.25m. A second stone step was

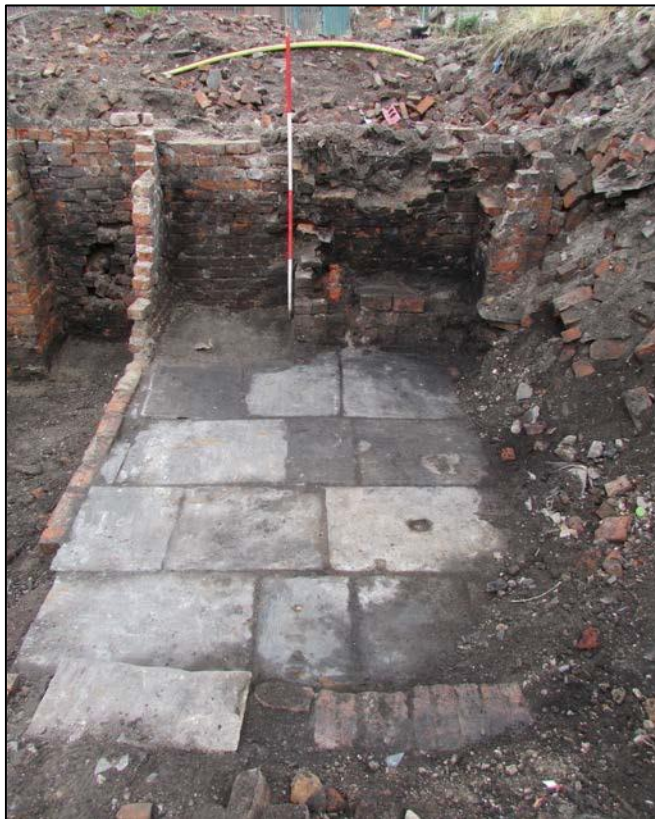
**Figure 55.** General view of western room of House 7, showing walls (195), (197) and (193) and floor (194). Looking south.

found to lie in this wall in the north-western corner of the western room which lead to a narrow passageway running the full depth of the house. No floor surface was revealed in this room. The western room of House 7 was almost identical in layout, although the western wall was not identified, and measured 2.60m x 3.00m. The fireplace on the southern wall was heavily truncated but appeared to have also been blocked in a similar way to the one in the eastern room. A stone flagged floor was uncovered in this room (194), formed from flags measuring *c.*0.50m x 0.90m, some containing round and square holes approximately 0.05m in diameter. The passageway to the north, accessed from a single step up from this room, measured 1.20m wide and contained a single flag stone. No

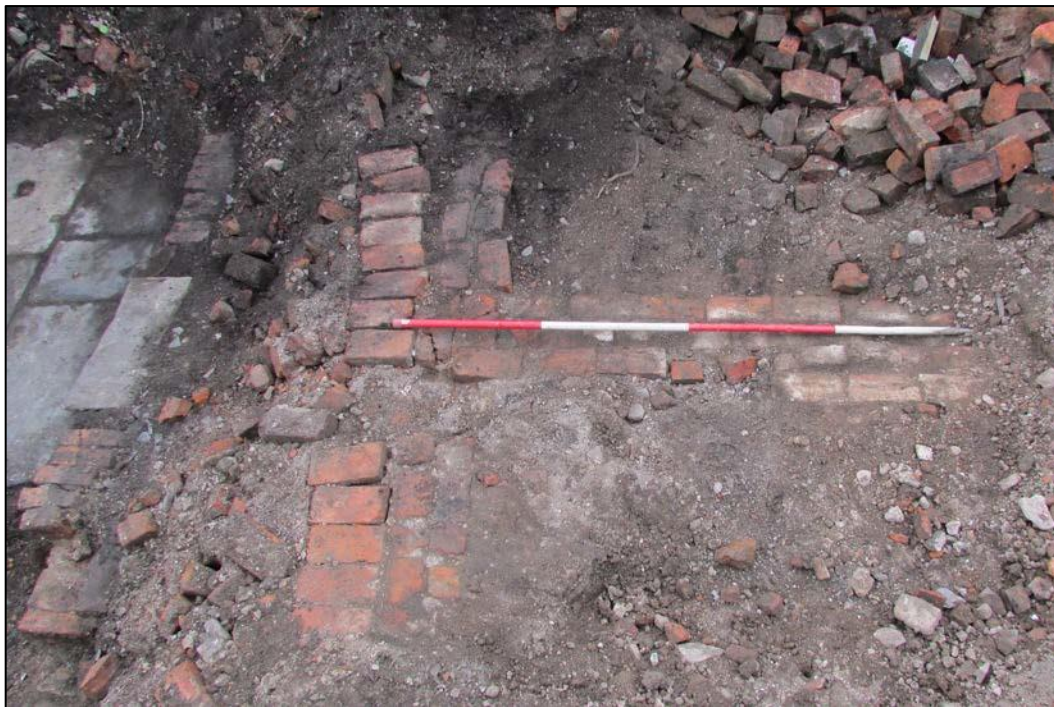
**Figure 59.** Remains of House 9 showing walls (188) and (190). Looking west.

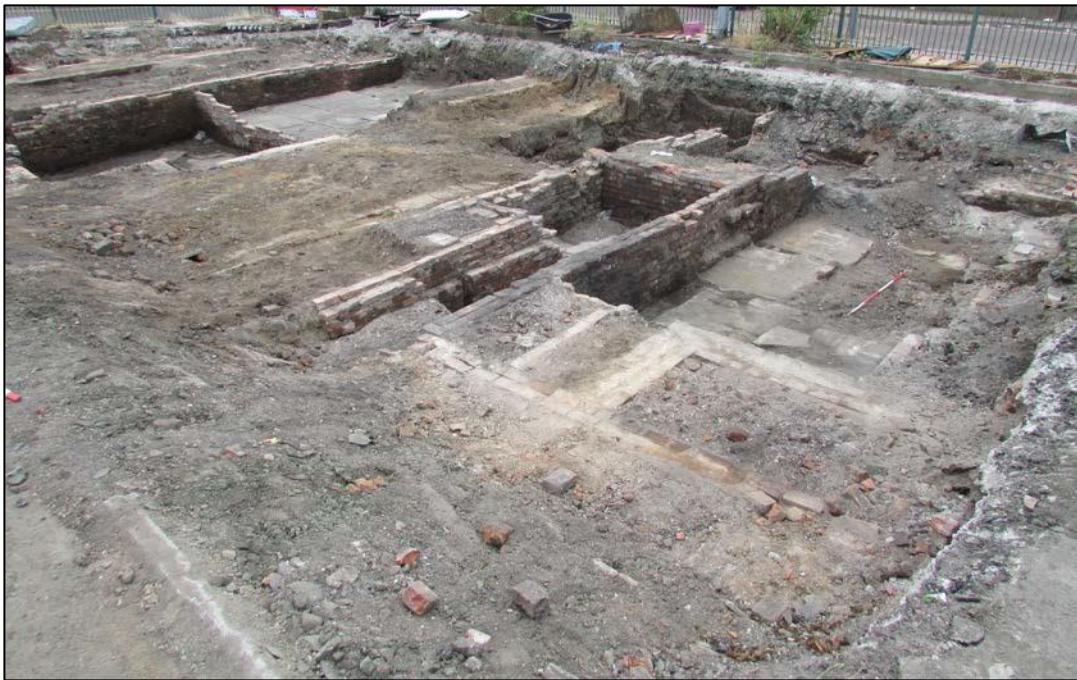
**Figure 60.** General view of the western end of Area 3, showing Houses 2, 3, 4 and 5. Looking southeast.

Following the removal of the existing overburden, tarmac and demolition debris, archaeological features were revealed at a depth of between 0.70-0.80m and took the form of handmade brick walls, brick and flagged floors and stone culverts. Where natural deposits were encountered, they were found to be composed of a greyish-yellow clay with inclusions of rounded pebbles.

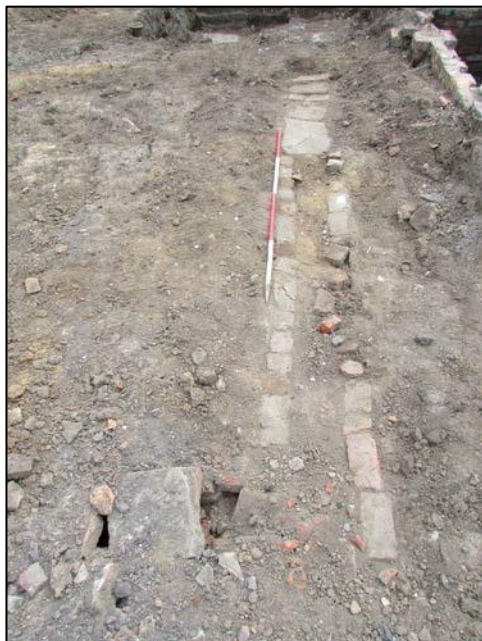
**Figure 61.** Culvert (111). Looking west.

Although the original road surface did not survive, the position of Wickham Street could be clearly seen by the absence of structural features and the presence of two stone drainage culverts (110) and (111). Culvert (110) was 0.50m wide, aligned north-south with handmade brick walls and a stone cap, although several of the capstones were missing. Culvert (111) was identified during the evaluation phase and was also aligned north-south. This was of a similar construction to (110) but slightly larger, measuring 1.40m in width and was identified at a depth of c.2.00m.

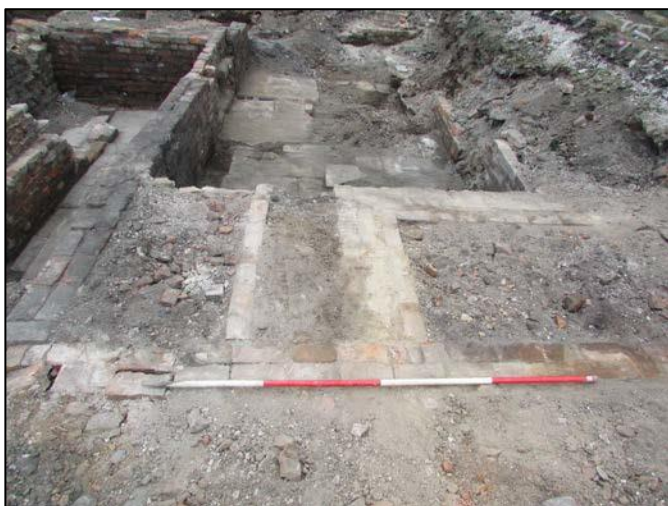
**Figure 64.** Walls (from foreground) (092), (098), (091) and (094). Looking south.

Wall (090) ran north-south, measuring 3.80m x 0.15m and stood to a height of 0.90m. The wall abutted (091) to the north and was truncated to the south, and in the centre by the 20<sup>th</sup> century concrete foundations. To the east, wall (097) was a 2 course wall which measured 10.00m x 0.25m and continued beyond the extent of (095) to both the north and south. A section of the western course of this wall was revealed to be missing close to the south-eastern corner of (095), again this was thought to have been caused by 20<sup>th</sup> century construction. The southern face of northern wall (094), which measured 0.89m in height, appeared to be a single construction with a truncated buttress to the east. However, when viewed in plan, the wall was a single course thick to the east but to the west appeared to form a western return for a wider, 3 course wall (091). This wall extended northwards for 1.40m where it abutted (092) and measured 0.42m wide laid in stretcher bond. A second, single course wall (093) also ran north-south between (092) and (094) 0.47m east of (091), with the space between the two filled by a dark blackish-brown demolition deposit. Wall (092) was a 2 course handmade brick wall measuring 3.00m x 0.25m running parallel to (094) and abutting the northern end of (097).

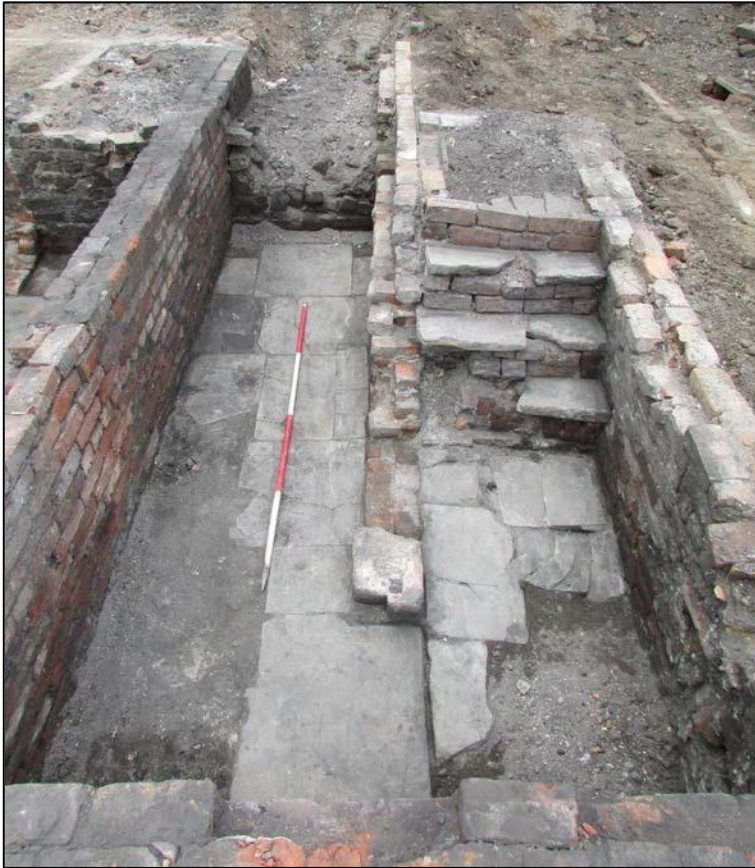
**Figure 66.** Entrance steps and flagged floor to the east of House 5. Looking north.

To the east of wall (097) lay the remains of the entrance steps seen on the historic mapping of the 19th century. An L shaped stone flagged floor (102) filled the area between walls (097), (099) and (101) and was composed of broken flags measuring c.0.75m x 0.60m. Wall (099) lay 1.00m east of (097) and was a 2 course handmade brick wall measuring 4.00m x 0.25m bonded with white lime mortar in English Garden Wall bond. The steps

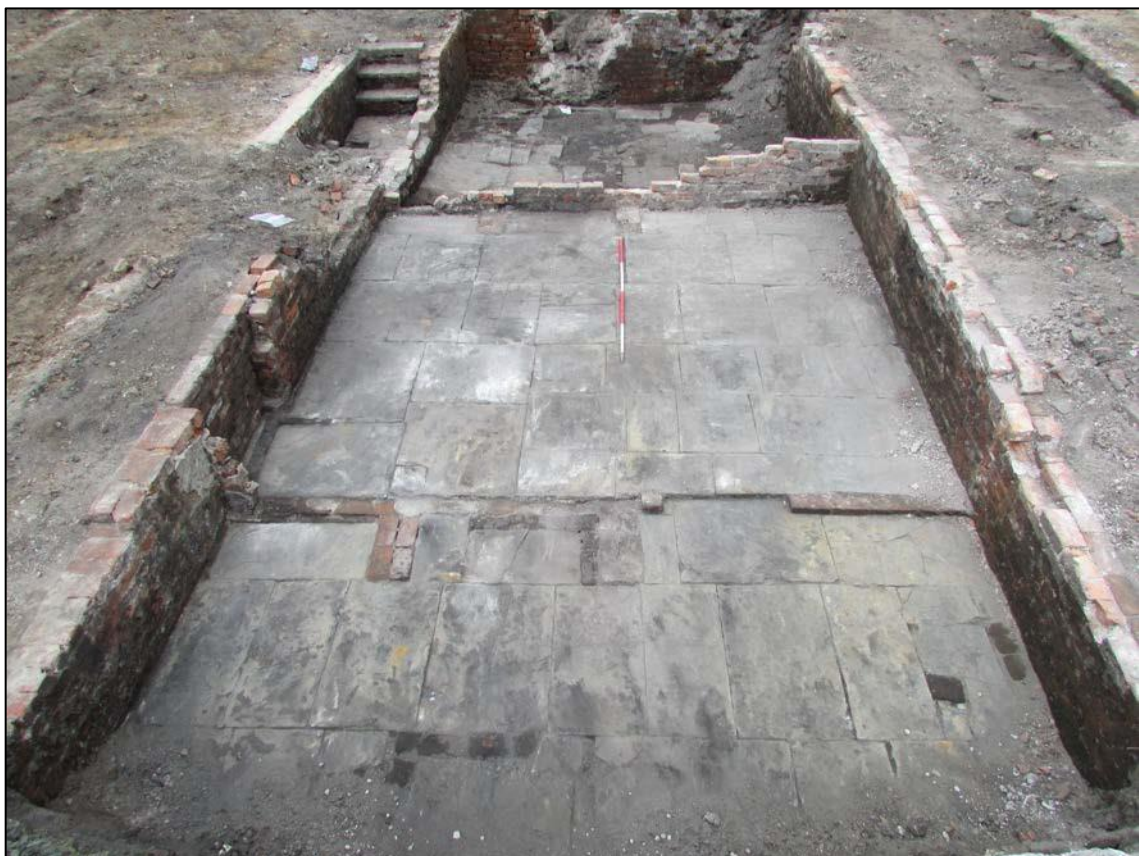
**Figure 68.** General view of Houses 2, 3 and 4, showing the entrance steps to the west and yards to the east. Looking north.

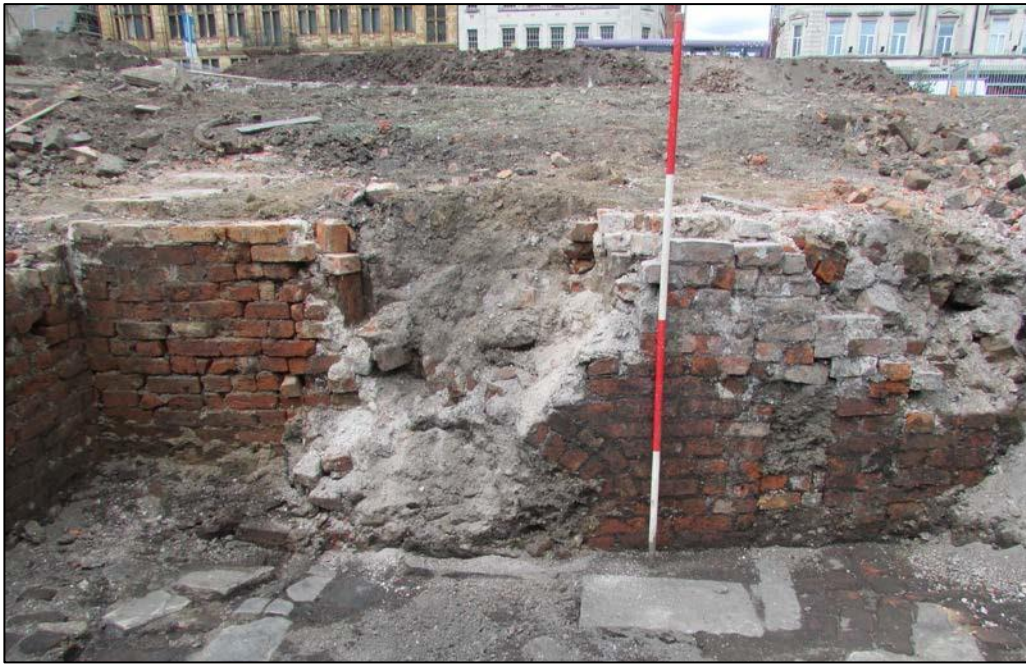
**Figure 71.** Projecting fireplace showing truncated arch at base. Looking north.

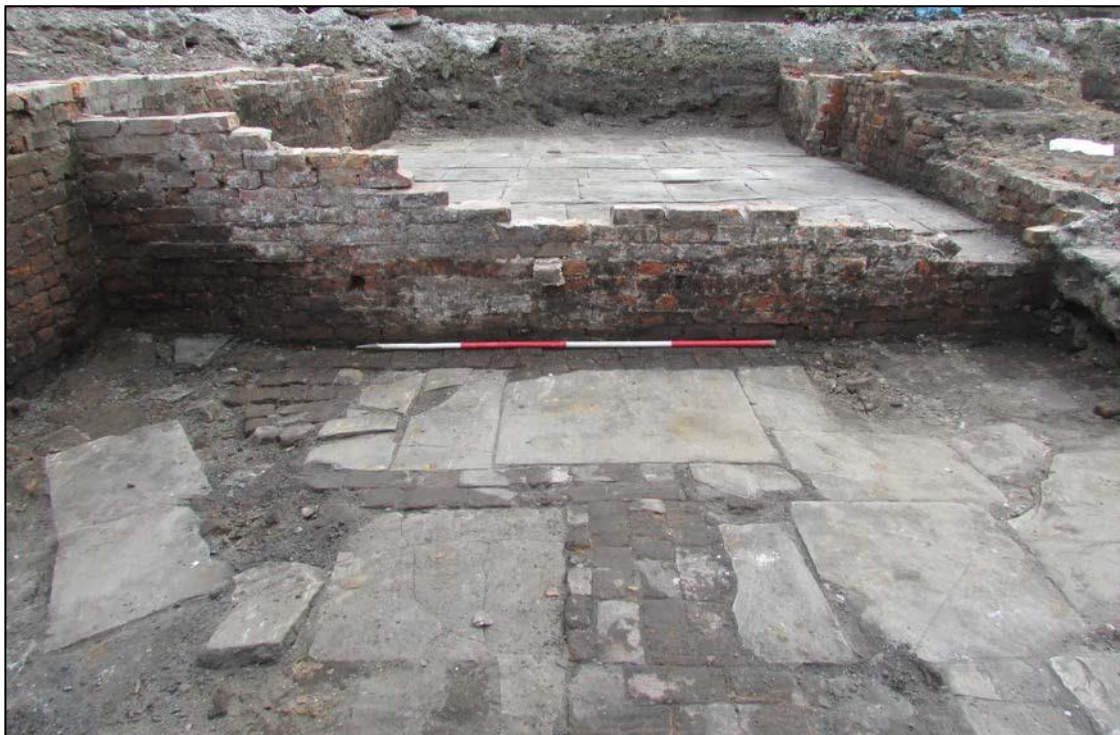
**Figure 72.** House 2 showing floor (124) and wall (123). Looking south.

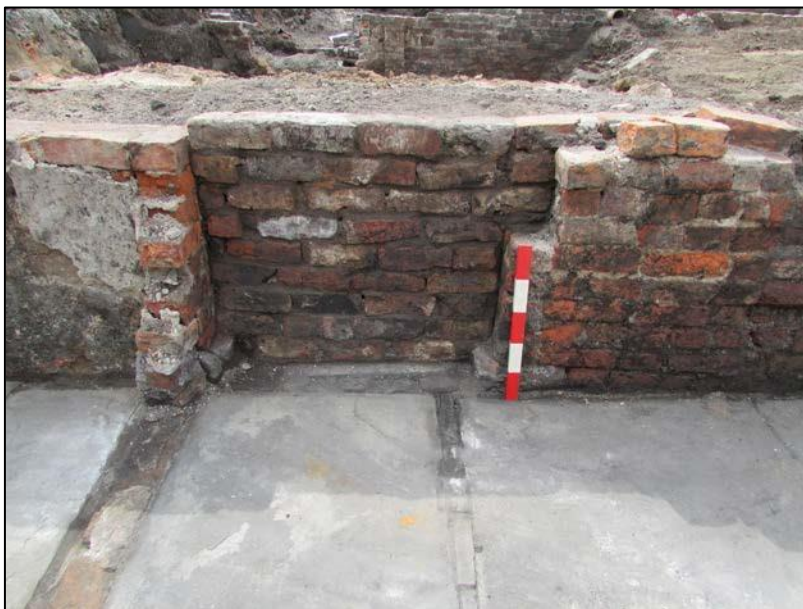
**Figure 73.** Blocked opening in wall (119) in House 3, showing truncated remains of (121) to the south. Looking west.

revealed within wall (119) comprised of two square red sandstone blocks measuring 0.31m with a sandstone sill between measuring 0.75m x 0.25m x 0.08m, although a course of three bricks were found to lie on top of the sill. No steps were identified to be associated with (118) to the south, however a single course of bricks (117) extending westwards from (119) were thought to be related to another set of entrance steps in this area. In addition, an opening was identified in (119) which had been subsequently blocked by a single course of bricks with black mortar, but which was in a similar position in relation to (118) as the stone sill was to (113). The opening measured 0.89m in width with the blocking on the outer wall course only.

measuring 1.55m wide and lying 0.95m from wall (119). The blocked opening in wall (119) mentioned above lay in the southwest corner of this room. House 3 was found to be slightly smaller than House 2 measuring 3.92m x 4.52m. The wall between House 3 and 4, (121), had been removed during demolition or later construction works and was therefore only visible in plan, but appeared identical to (123). House 4 was not fully excavated as it continued beyond the edge of the excavation area but was measured at 1.96m x 4.52m.

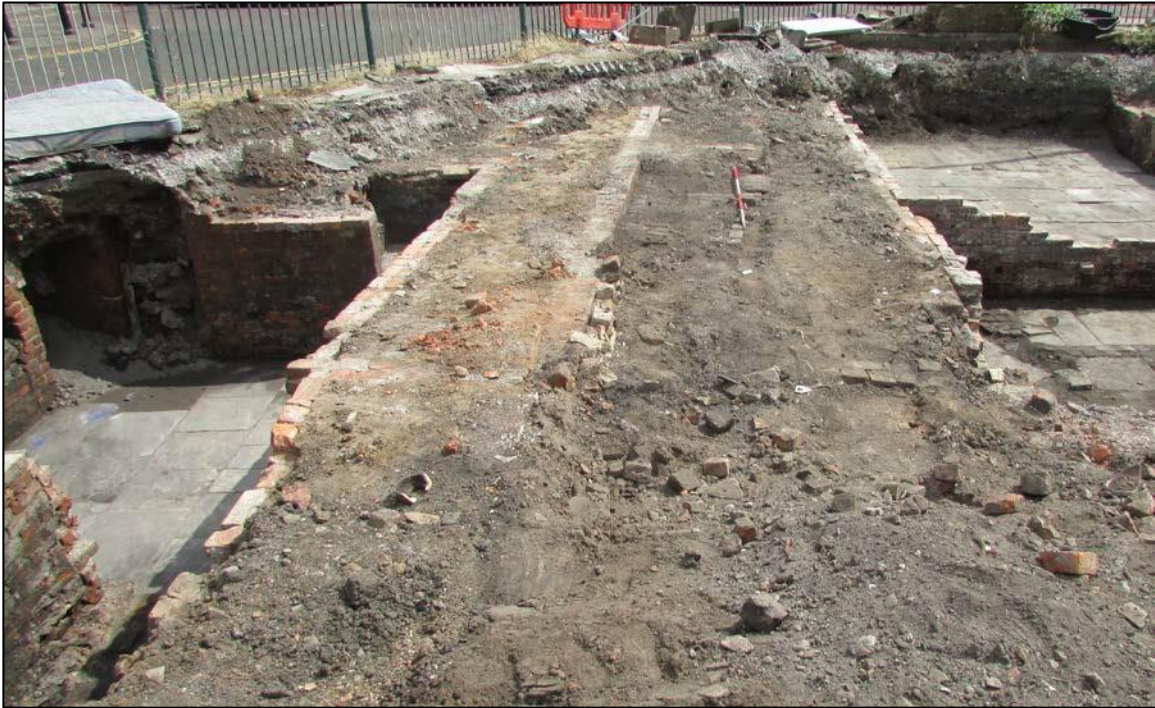
**Figure 74.** Yard area to the east of Houses 2, 3 and 4. Looking south.

Historic mapping indicates that the area to the east of this terrace was occupied by small yards and outbuildings (**Fig. 96**). This is reflected in the presence of a collection of small single and double course handmade brick walls to the east of (126). Wall (134) was the longest of these walls, measuring 8.60m x 0.25m with an eastern return abutting wall (136) of House 5. The wall lay 1.40m east of (126) and was 2 courses wide, bonded with white lime mortar. Two shorter 2 course walls were revealed to lie between (126) and (134), lying 1.20m east of (126), but were both badly degraded. Wall (130) was the more northerly of the two and lay parallel to House 2, measuring 3.60m x 0.25m. Wall (128) was located on the same alignment but lay 1m south of (130) but was identical in construction, measuring 2.80m x 0.25m. At its northern end the wall abutted a single course wall (129) running east-west to meet (134), which measured 1.00m x 0.15m, again bonded with white mortar. Wall (131) was a short L shaped 2 course wall abutting the eastern side of (130) measuring 0.25m x 0.60m (e-w) and 1.00m (n-s). A single course of bricks (133) was revealed to lie against (134), parallel to (130) and measuring 5.00m x 0.15m. All of the walls in this yard area were surrounded by (127) a dark black-brown demolition deposit with frequent inclusions of broken brick and mortar.

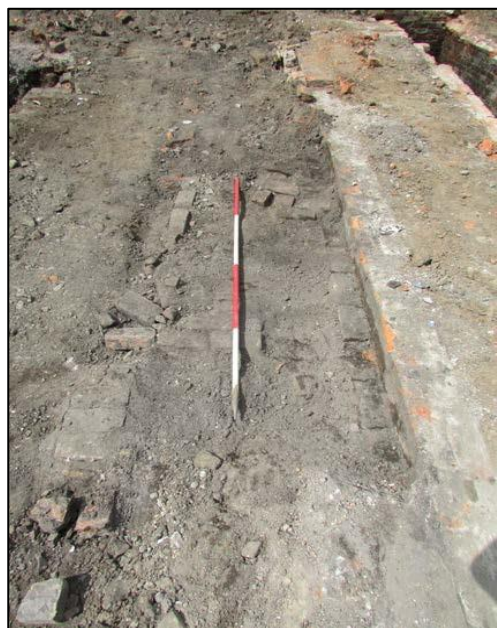
**Figure 75.** Possible outbuilding formed by walls (128) and (129) abutting (134). Looking north.

wall abutted the truncated remains of the eastern return of (134) which may have originally projected into form a doorway between the main part of the cellar room and a small antechamber to the north. This structure abutted the north-western corner of House 1, measuring 2.60m x 1.45m and constructed from three roughly laid 2 course handmade brick walls; (144), (145) and (146) to the east, north and west respectively, all with black staining. Evidence of a brick vaulted ceiling was identified at the northern ends of (144) and (146) and the floor (147) was also roughly laid brick. The location and height of this structure would suggest it was a subterranean chamber which lay beneath the pavement and road of Scholefield Street. A similar, albeit larger, structure of this sort was also found during excavations at Plots E3 & E6. Both examples appear to have had a storage function, possibly for coal or as a cold store, separate from the main room.

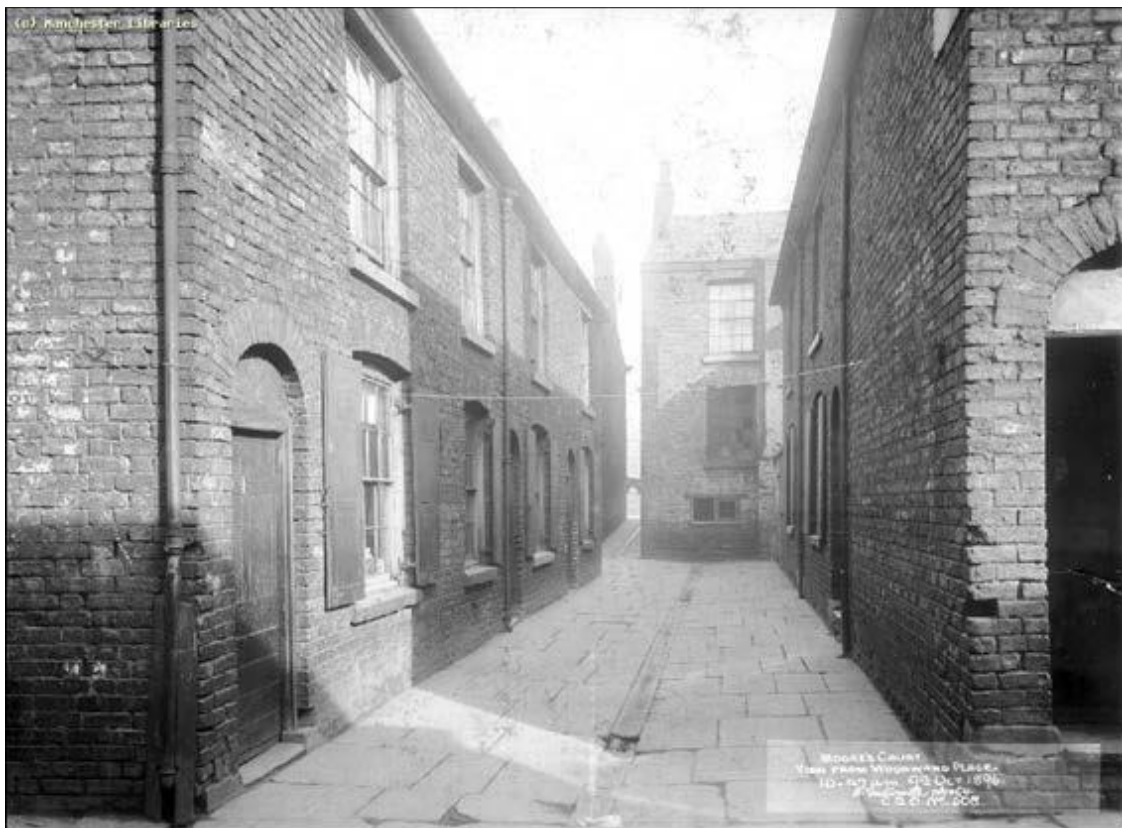
**Figure 86.** Example of Court houses at Morres Court, Ancoats. The narrow entrance alley can be seen in the background. Manchester Local Image Collection.

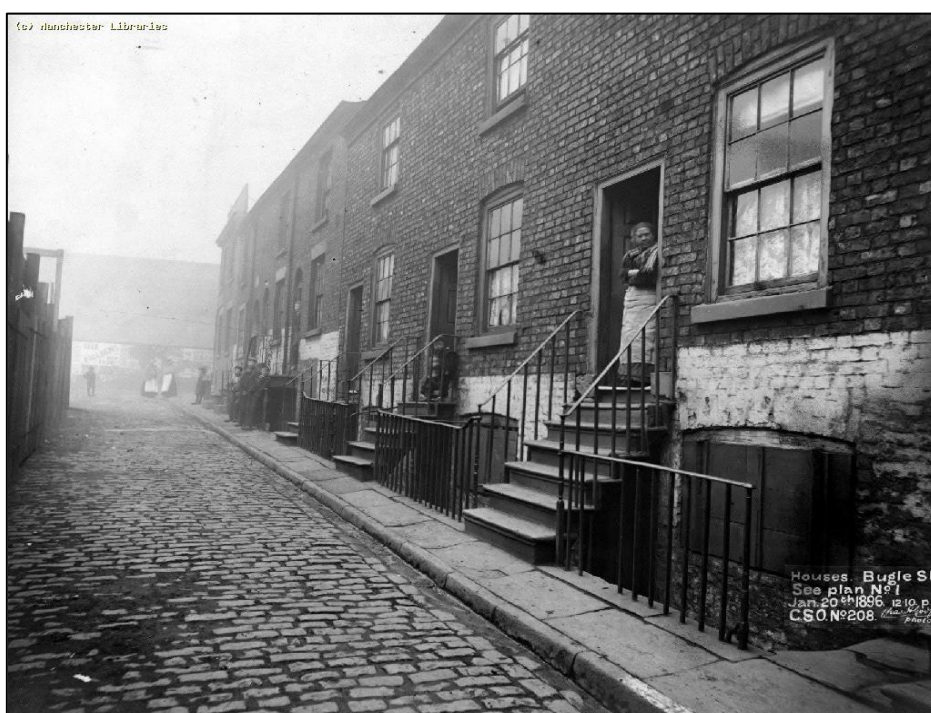
**Figure 87.**  
Example of  
terraced housing  
with cellar  
dwellings below  
from Knott Mill.  
Manchester  
Local Image  
Collection.

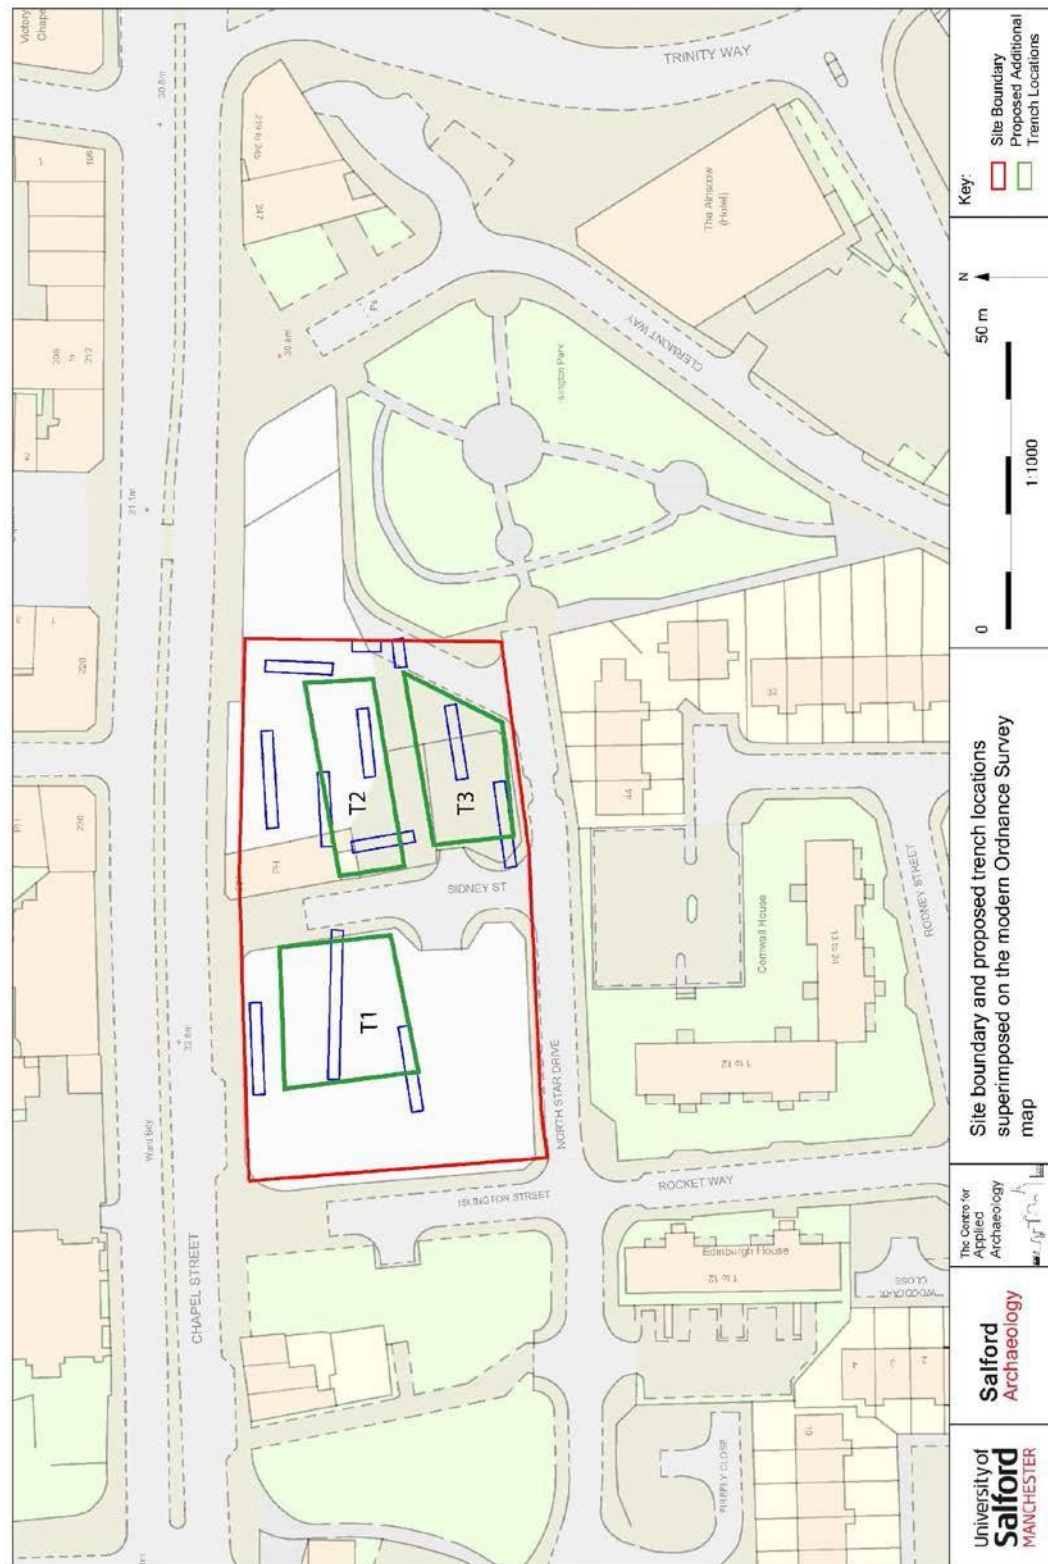
**Figure 89.** Trench location plan with previous evaluation trenches shown in blue.

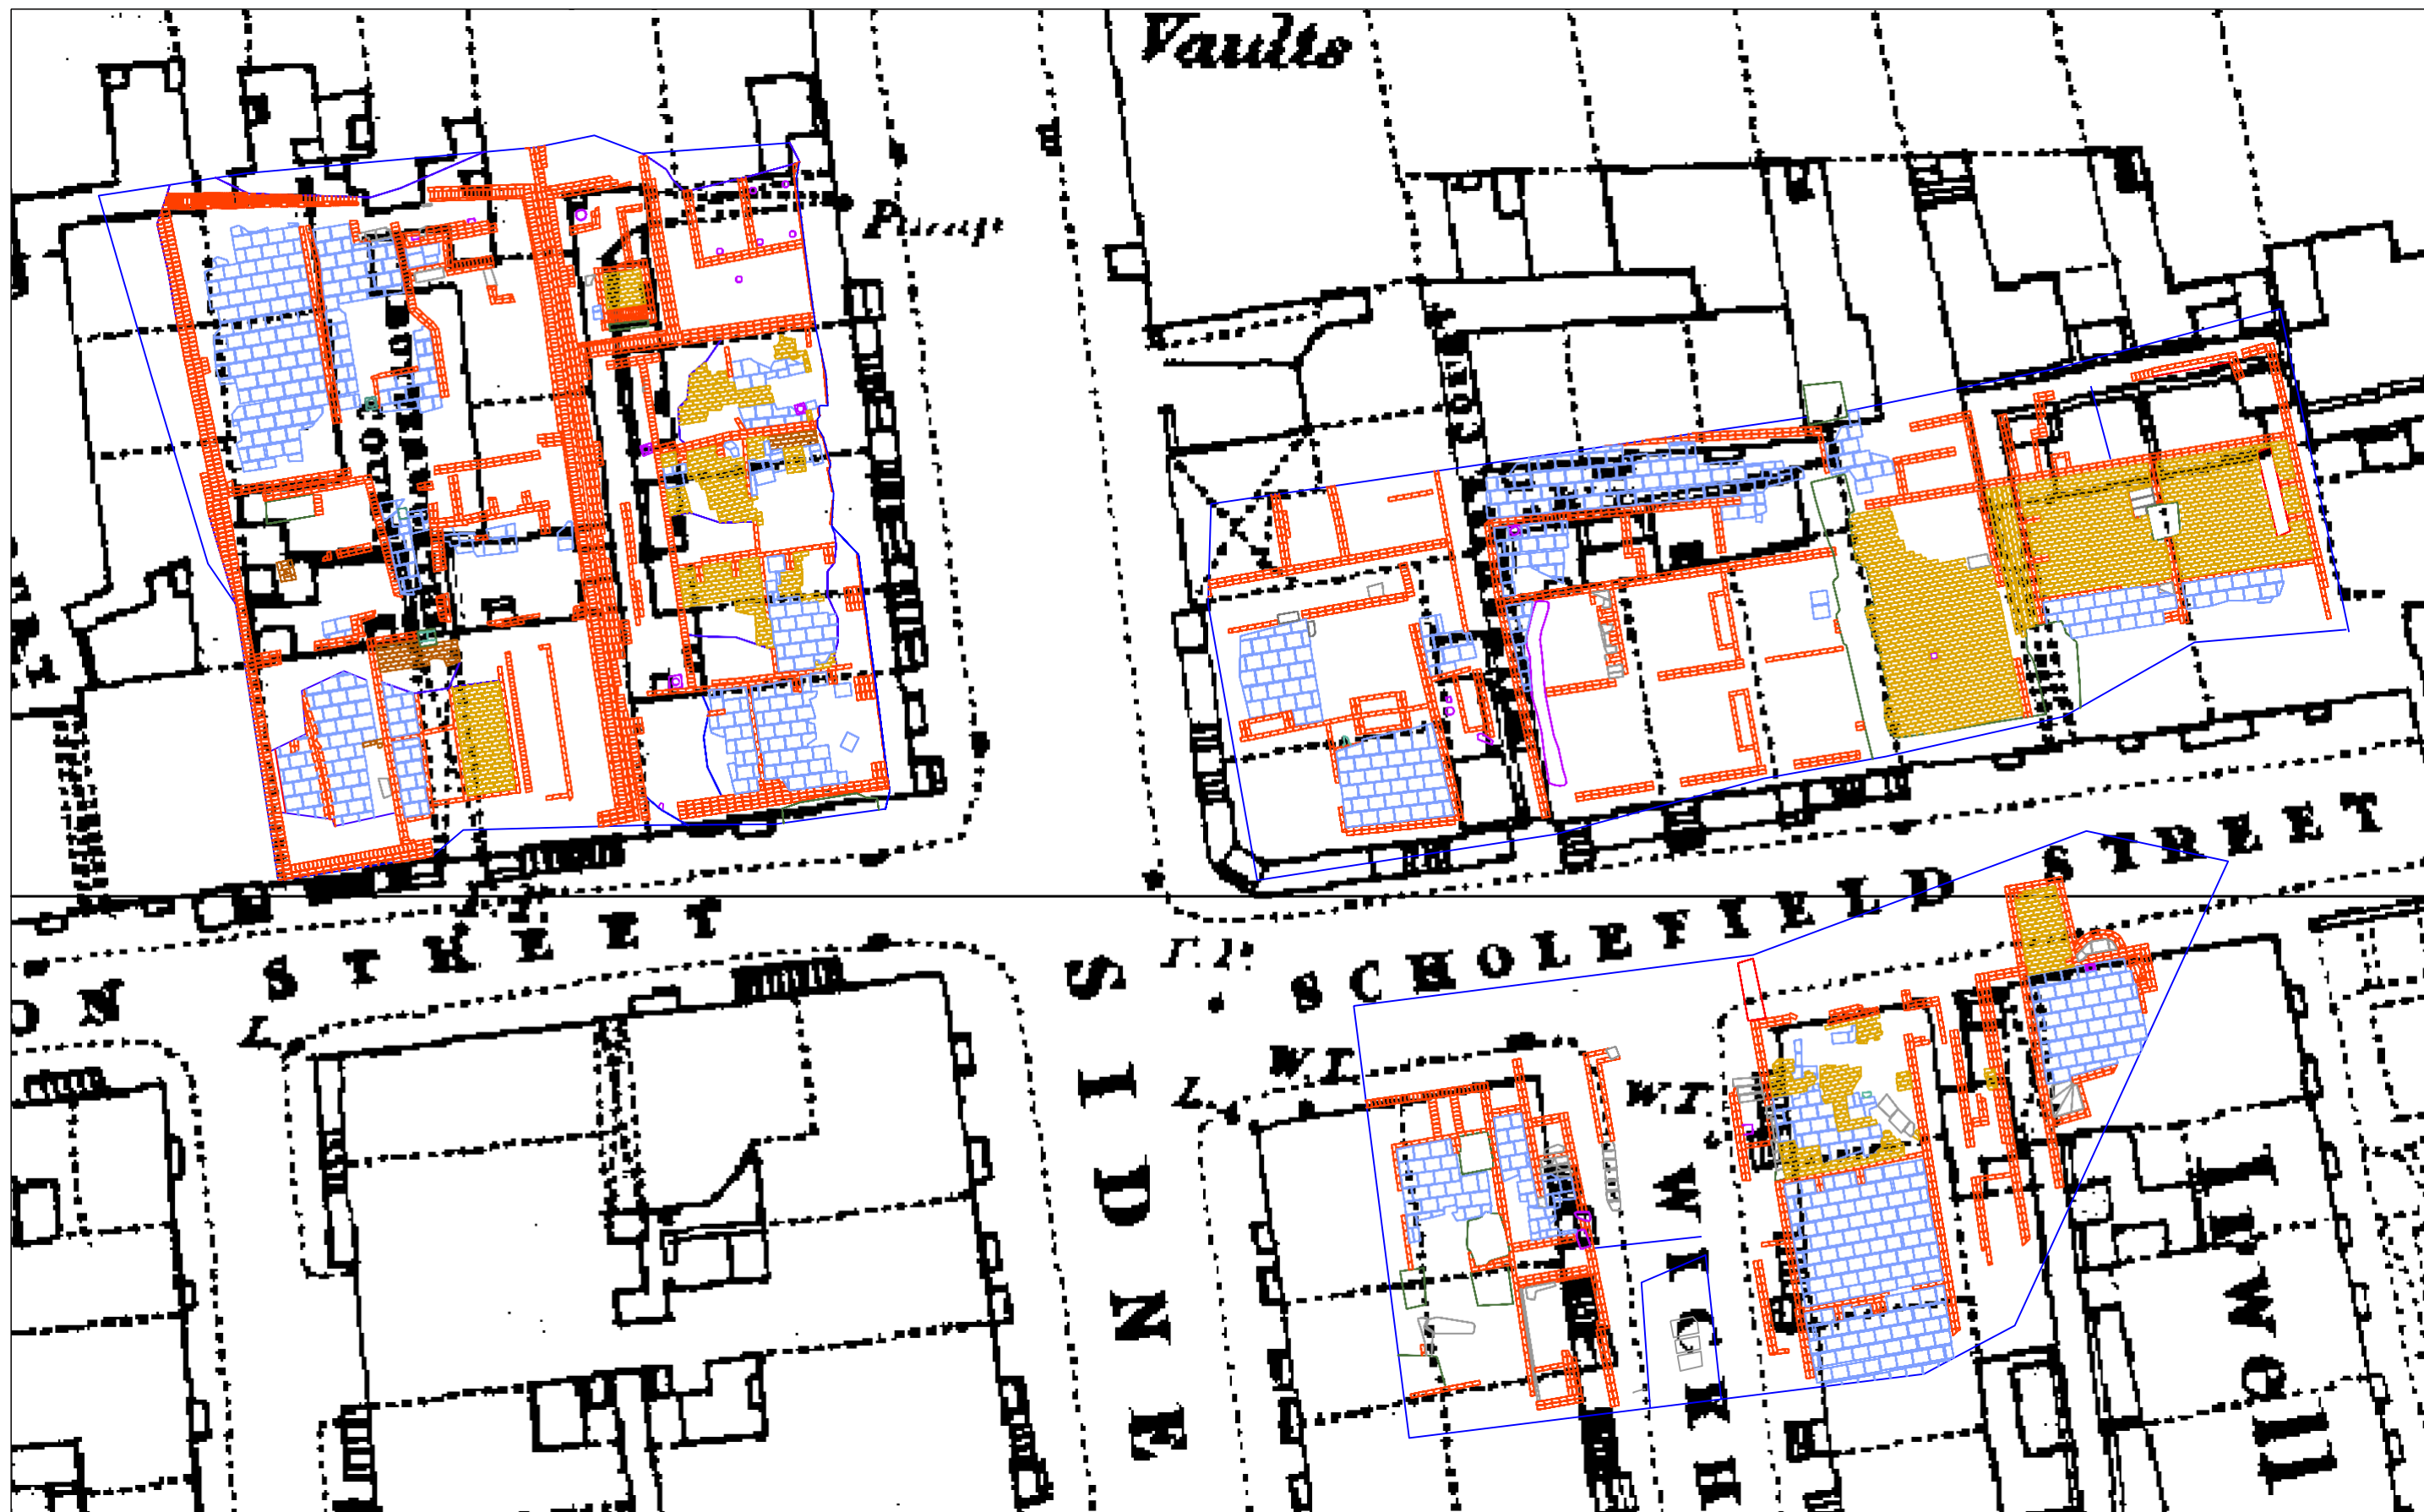
Figure 99:  
Area Plans Overlaid onto OS 1:1056 Town Plan of 1851
