**Community
Archaeological
Excavation**

Oldknows Lime
Kilns, Marple.

Document title: Archaeological Evaluation: Peak Forest Canal Tramway

Document type: Archaeological Excavation Report.

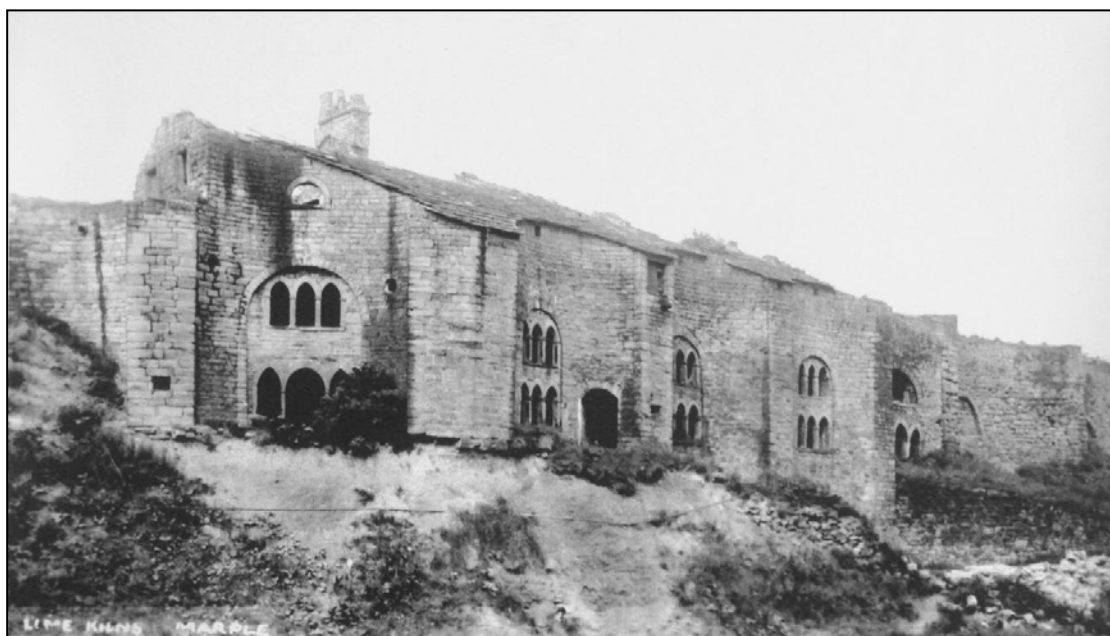
Figure 4. The lime kilns as they appeared in the early 20th century.

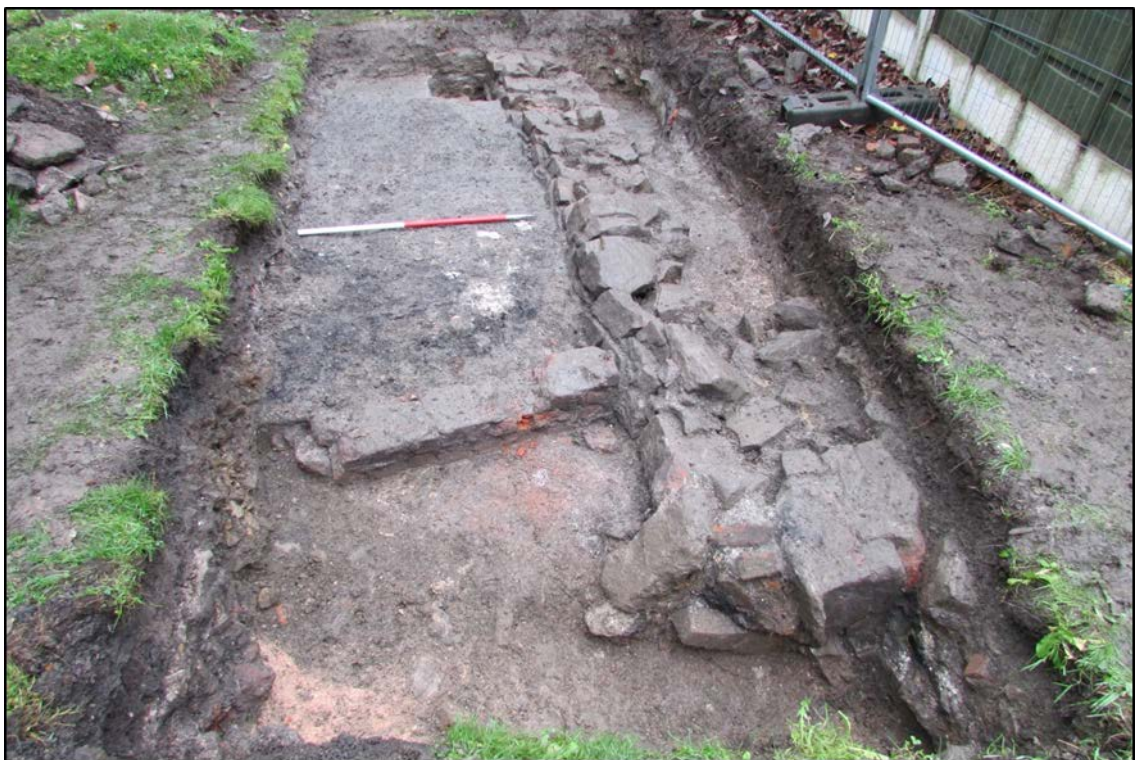
Figure 5. General view of Trench 1. Looking northeast.

This trench was located to investigate the site of the earlier, pre-1883 weigh house and measured 2.50m x 5.70m, orientated northeast-southwest. Following the removal of the turf and topsoil a demolition layer comprising a dark brown silty loam with frequent inclusions of broken brick and stone (003) was identified which covered all the features in this trench.

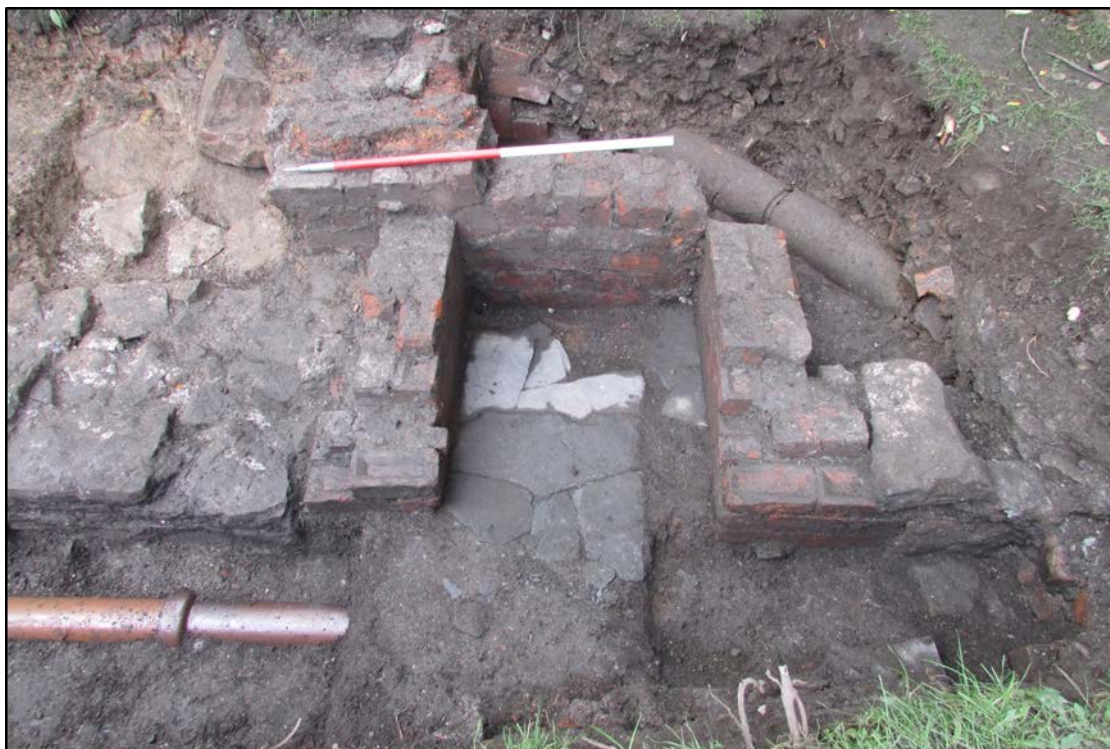
Figure 9. Walls (025), (026), (027) and floor (028). Looking west.

To the east these walls surrounded a degraded slate surface (028) and to the west they were found to enclose a deeper area filled with demolition debris (036). Surface (028) measured 0.75m x 1.00m extending 0.15m southeast beyond walls (025) and (027) and was composed of broken slates which abutted all three brick walls. Deposit (036) was comprised of whole and broken machine made bricks in a sandy brown matrix which appeared to continue below the level of (028) on the other side of wall (026).

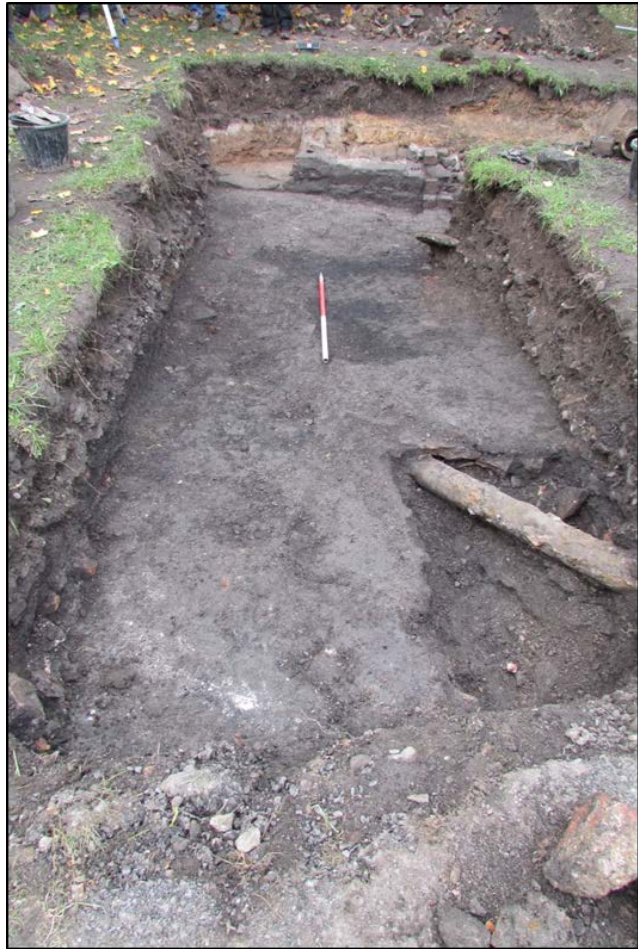
Figure 11. Southern section of Trench 2 showing compacted surfaces including (017). Looking east.

The area to the southeast of the building was found to have a layer of compacted silty loam mixed with mortar immediately adjacent to the building (023) which lay against (017). This layer was composed of angular stones set in a heavily compacted black-brown gritty silt which had been stained black. This surface had been cut by a trench for a late 19th/ early 20th century cast iron pipe which ran east-west. Other deposits were found to lie against and over this deposit which were also compacted with high volumes of charcoal and clinker (012)-(016). These layers were characteristic of

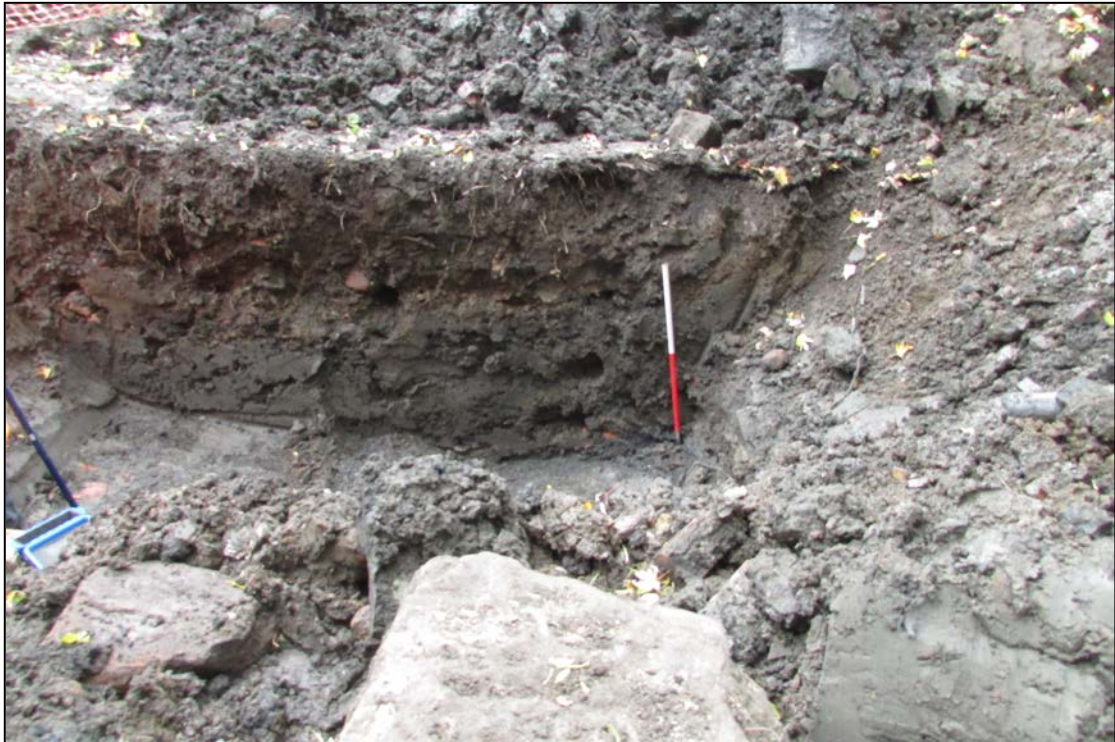
Figure 13. Southwest facing section of Trench 3. Looking northeast.

Due to successive phases of demolition and landscaping on this part of the site, the main deposit encountered in this trench was a mixed silty loam (019) with frequent inclusions of demolition debris containing fragments of 19th and 20th century pottery, metal and glass. This deposit was up to 2.00m in depth in places and as a result, no features were revealed in this trench, although a short section of tramway rail was found in the deepest part of the trench (c.1.90m deep).

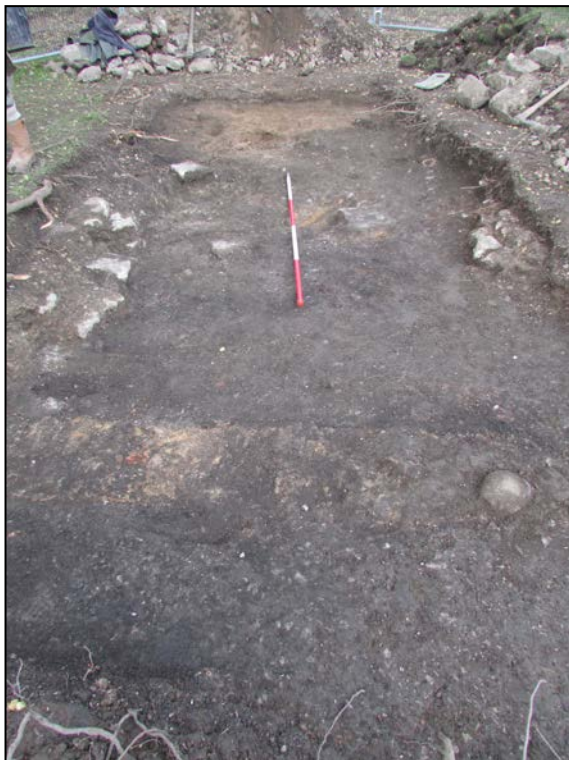
Figure 14. Trench 1 showing layers (104) and (106) with (105) in the background. Looking west.

Following the removal of the turf and topsoil, three compacted demolition deposits were encountered, (104), (105) and (106) (**Fig. 14**). Layer (105) was identified at the northern end of the trench and comprised a 2m wide deposit of black clinker and coal fragments. This lay against (106), a compacted mid grey-brown silty loam with lenses of sandy silt and frequent inclusions of sub-angular stones. Set within (106) were large areas of partially degraded concrete c.0.10m thick, containing fragments of brick (104).

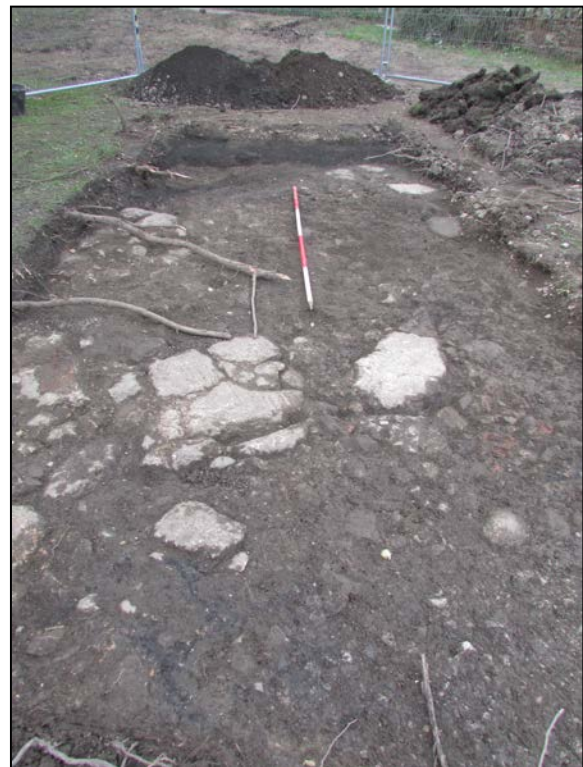
Figure 15. Trench 1 showing layer (116) with cut [121] in the foreground. Looking west.

Directly below these layers was another compacted layer (116), which was dark grey-brown with frequent inclusions of sub-angular stones, brick fragments and occasional flecks of mortar. This deposit was found to be c.0.20m thick in some areas and only 0.10m thick in others.

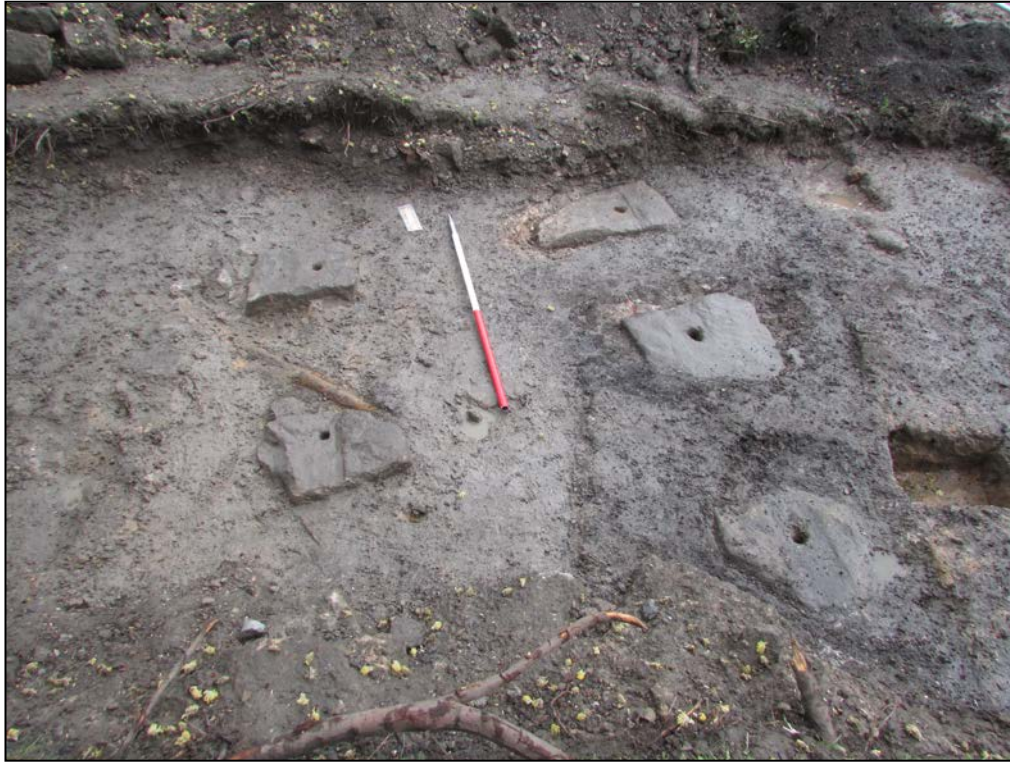
Figure 16. Stone blocks (020) set within surface (117). Looking north.

A final compacted deposit (117) was revealed below (116) which comprised a mid reddish-grey sandy silt with very frequent inclusions of sub-angular stone and occasional brick fragments. Five large limestone stone blocks were found to be set within this deposit, each with a single round hole and a shallow groove running northeast-southwest across the surface (120). The blocks measuring between 0.30m-

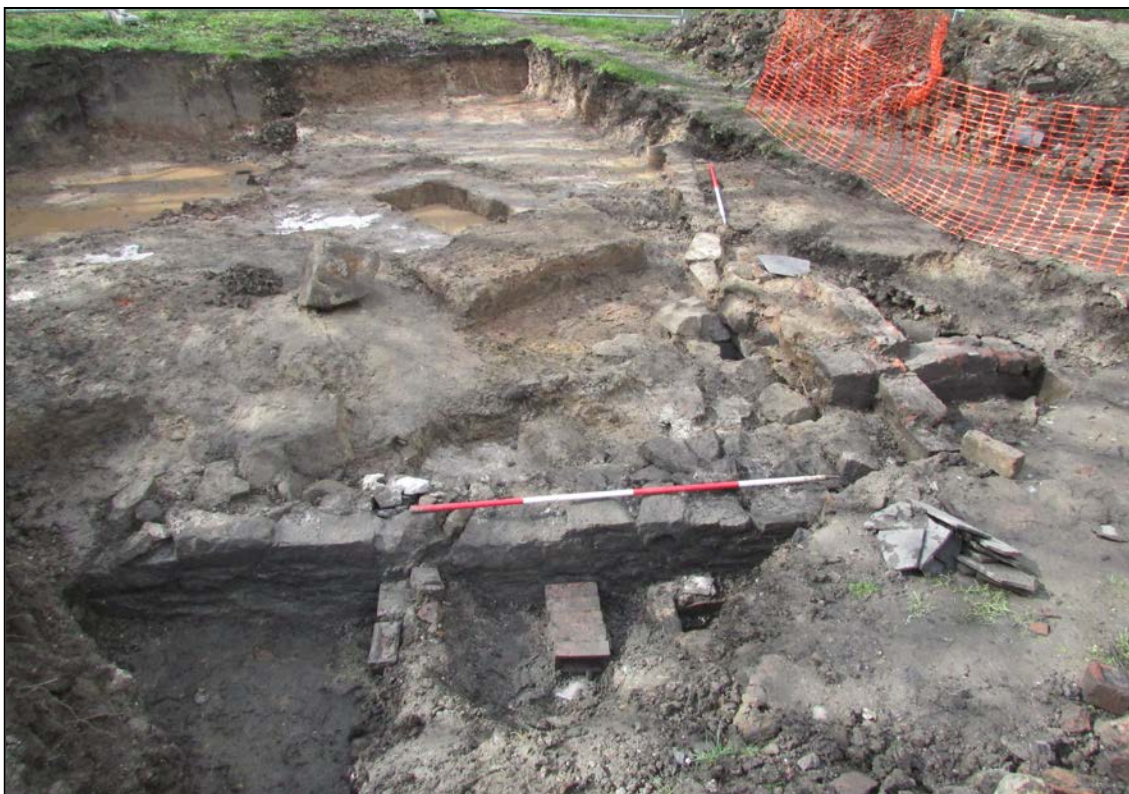
Figure 20. General view of Trench 2. Looking north.

This trench was intended to uncover further remains of the later tramway weigh house identified in 2016. The trench was located to the west of the one excavated in 2016 and measured 5.50m x 8.30m orientated north-south.

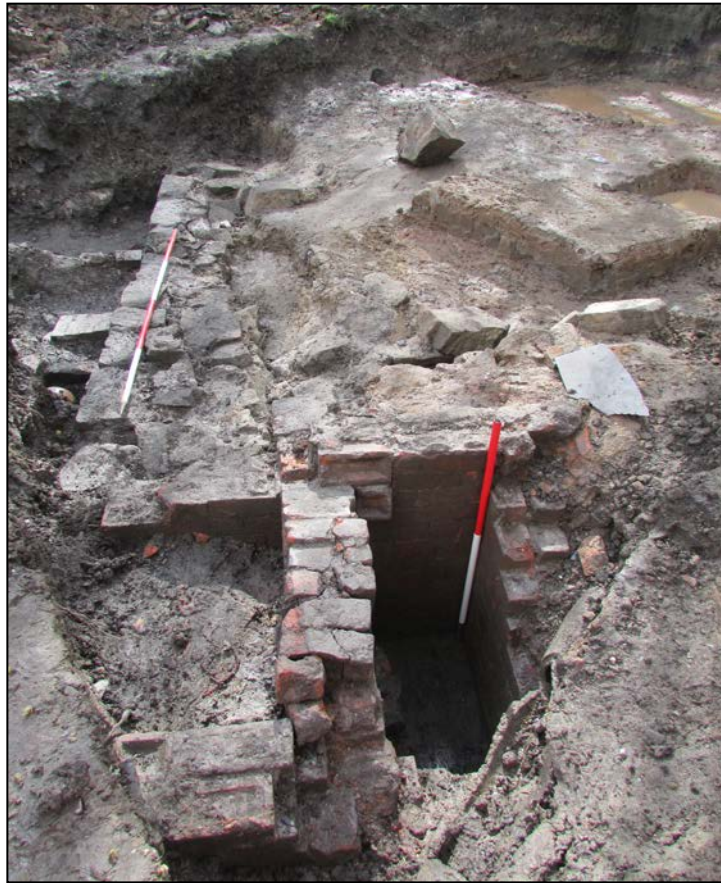
Figure 21. South-eastern end of Trench 2 showing walls (103), (110), (111) and (112). Looking north-west.

At the eastern end of the trench several walls from the 2016 season were re-exposed; (103), (110), (111) & (112) (context numbers (022), (025), (026) & (027) respectively in the 2016 season). Of these walls, (112) was revealed to extend northwards running parallel to (110) for 1.00m and was truncated to the north by the 20th century pipe

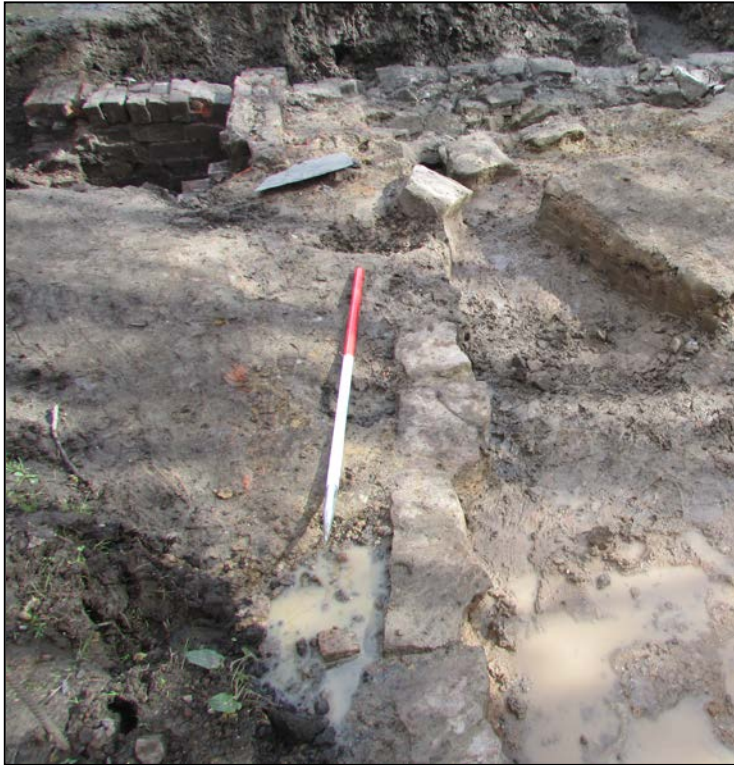
Figure 23. Wall (114). Looking south.

In addition to the re-exposed walls found in this trench, a second fragmented stone wall (114) was uncovered extending north from (103) for 2.00m. The wall was constructed from a single dressed course of irregular sandstone blocks laid two courses high with lime mortar. The wall was orientated north-south, sitting within (115) and was cut by a 20th century pipe. A section of cast iron possible tramway rail was found in the central section of the wall.

(114)	2	Fragmentary remains of stone wall, runs N-S and abuts (003) to south. Single dressed course of irregular sandstone blocks laid 2 courses high with lime mortar. Sits within (015) and cut by 20 th century pipe. Section of cast iron rail found in central section of wall.

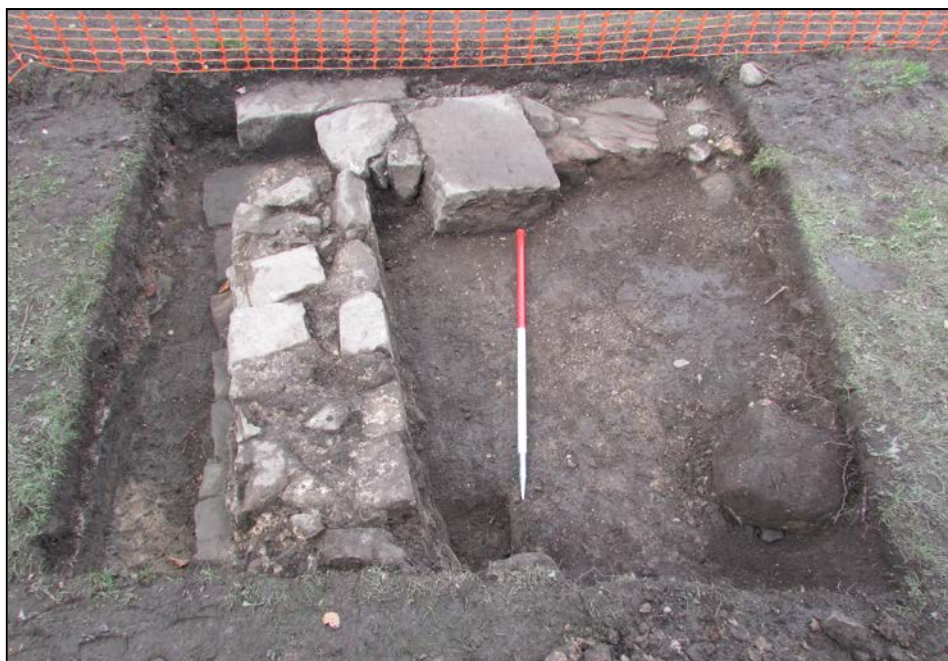
Figure 24. Test Pit 3 following excavation. Looking north-west.

These test pits were excavated by hand to locate the original northern wall of the lime kilns stables prior to its partial demolition in the 1960s. Test Pit 1 measured 1.00m x 4.00m and Test Pit 2 measured 1.00m x 1.00m, both were orientated northeast-southwest. No extant structural features were identified in either Test Pit 1 or 2, although a widespread demolition deposit (107) was found in all three pits to a depth of between 0.30m in Test Pit 3 and 0.60m in Test Pit 1.

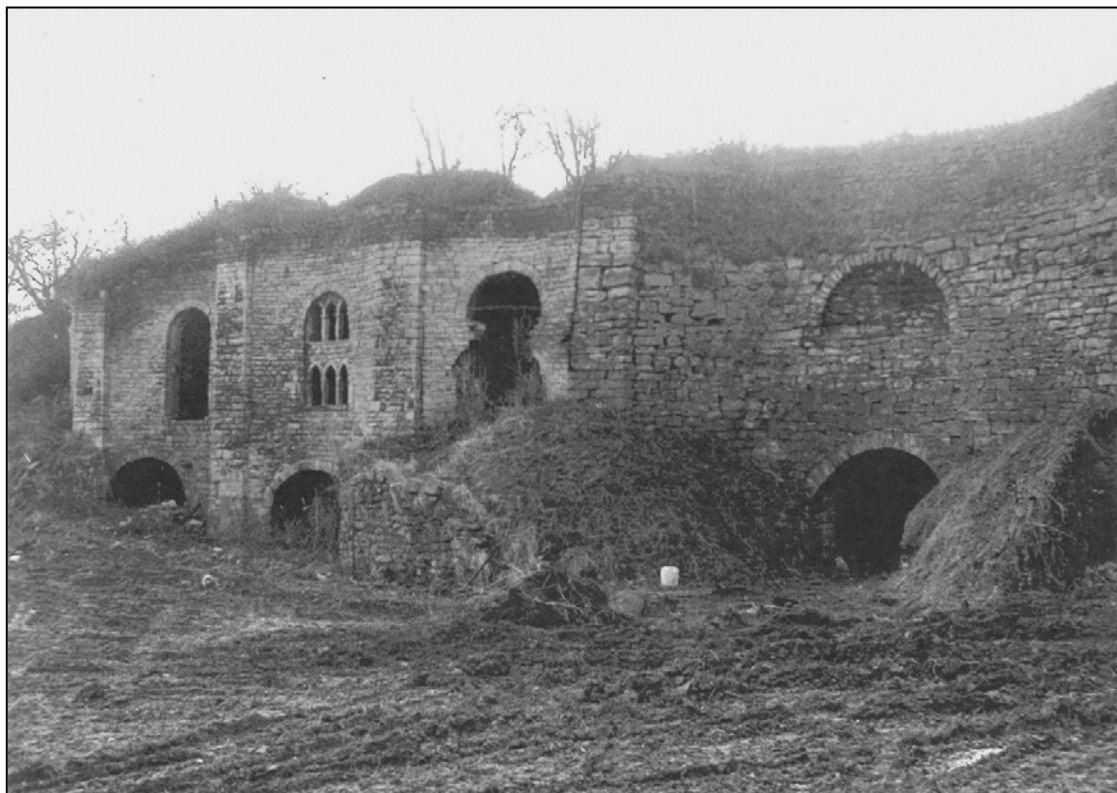
Figure 27. The Lime Kilns as photographed by Owen Ashmore 1972 (courtesy of Owen Ashmore Collection, MOSI, Manchester).

The various works carried out at and around the lime kilns, following their closure have resulted in considerable changes to the landscape immediately north of the standing kiln bank wall. It is unclear to what extent this included demolition of the semi-circular structures attached to the kilns although they were already partially demolished when photographed in the 1970s (**Fig. 27**). The lack of features identified in Trench 3 of the 2016 season would suggest that these structures were removed following this date. If any part of these structures, or indeed the tramway line, do survive it is likely to be at a depth in excess of 2.00m below the present ground surface.

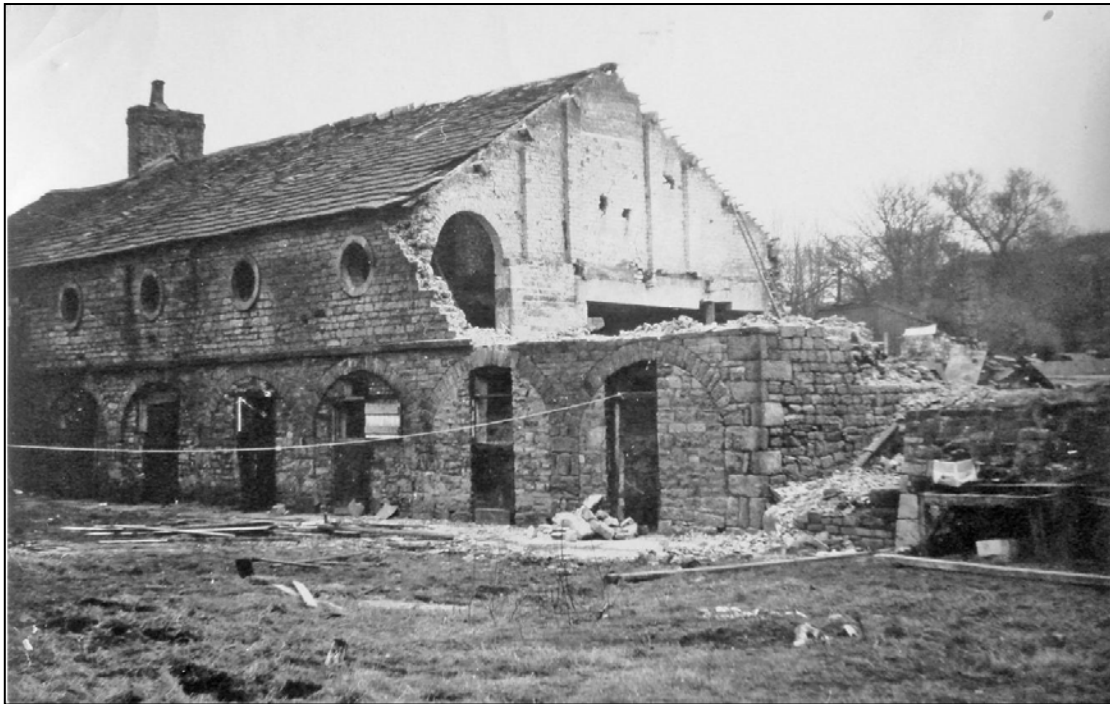
Figure 28. The Lime Kilns stables during demolition in 1964 (Arrowsmith, 2015).

Demolition in the mid-20th century was also responsible for the reduction in size of the kilns stable building which had its northern half demolished in 1964. The building originally consisted of 6 bays, each with a circular window at first floor level and arched double door below but was reduced to 3 bays with a later wing added in the 1990s. The purpose of the test pits was to ascertain whether any of the northern end of the structure survived and to what extent. The results of the excavation showed that the foundations of the main outer walls (108) and (109) survived to the current ground level but that the interior of the building had been filled by demolition debris to a depth of at least 0.50m which had removed any internal surfaces.

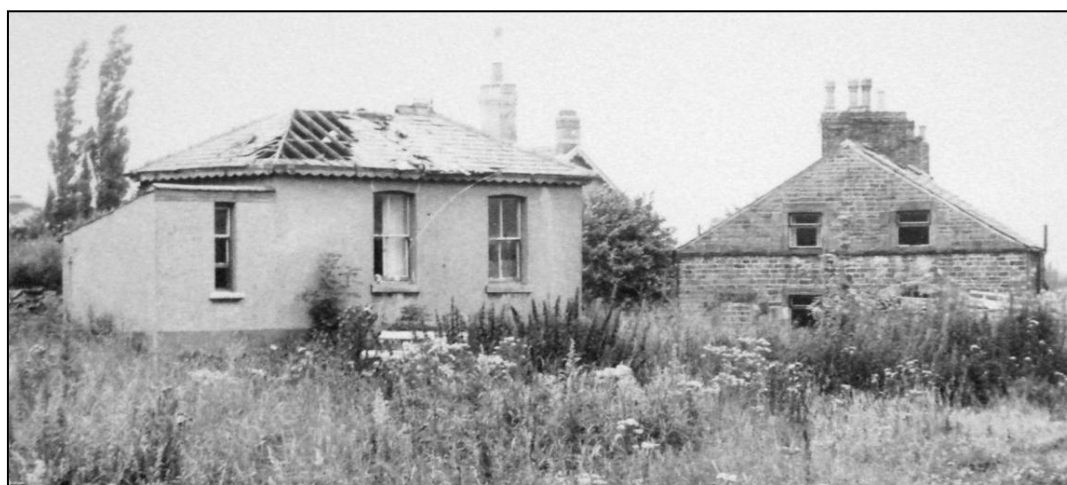
Figure 29. The later 19th century weigh house as it appeared in the mid-20th century (Arrowsmith,2015)

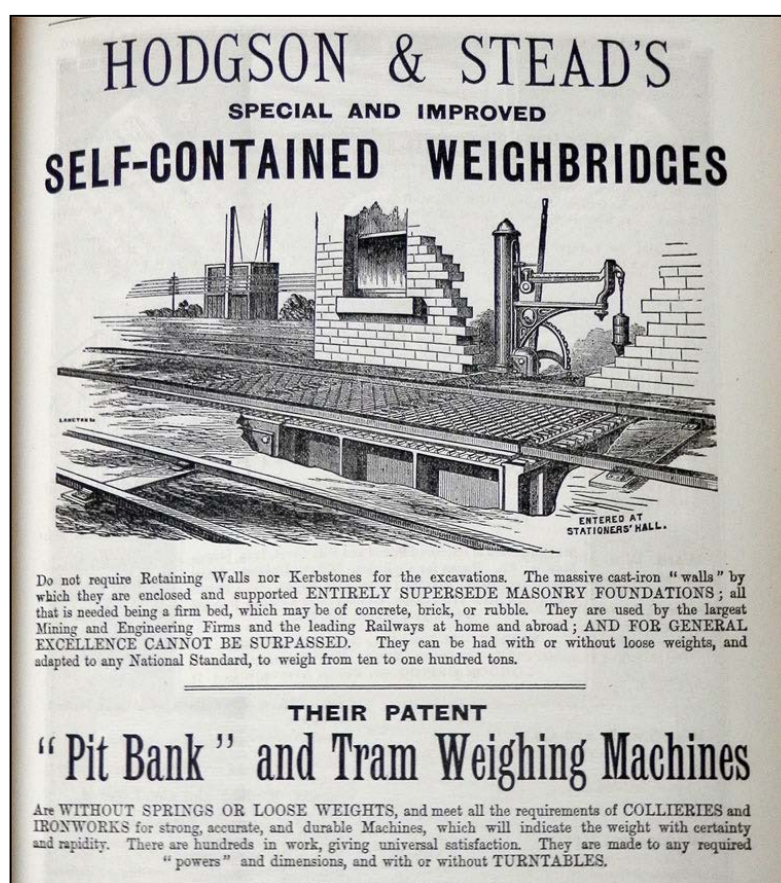
Figure 30. Late 19th century advertisement for a pit weighbridge by Hodgson and Stead showing a mechanism similar to that which was thought to have been used in the later weigh house at Marple.

Weigh houses have been identified on historic mapping at a number of lime kilns in Cheshire and Lancashire from the 1870s onwards, including at Bellman Park, Red Bull, Newbold Astbury and Bugsworth. Weighbridges were used as a means of quantifying the output of the kilns and assessing the cost of transporting the finished product to markets and customers. The more common type of machinery found in this period saw a ground level cast iron plate set within a pit over which the tramway rails were carried. The weighing mechanism was housed within the pit with an adjacent freestanding steelyard to take measurements (**Fig. 28**). It is likely that the machinery at Marple was a pit weighbridge although the pit itself has not yet been uncovered.

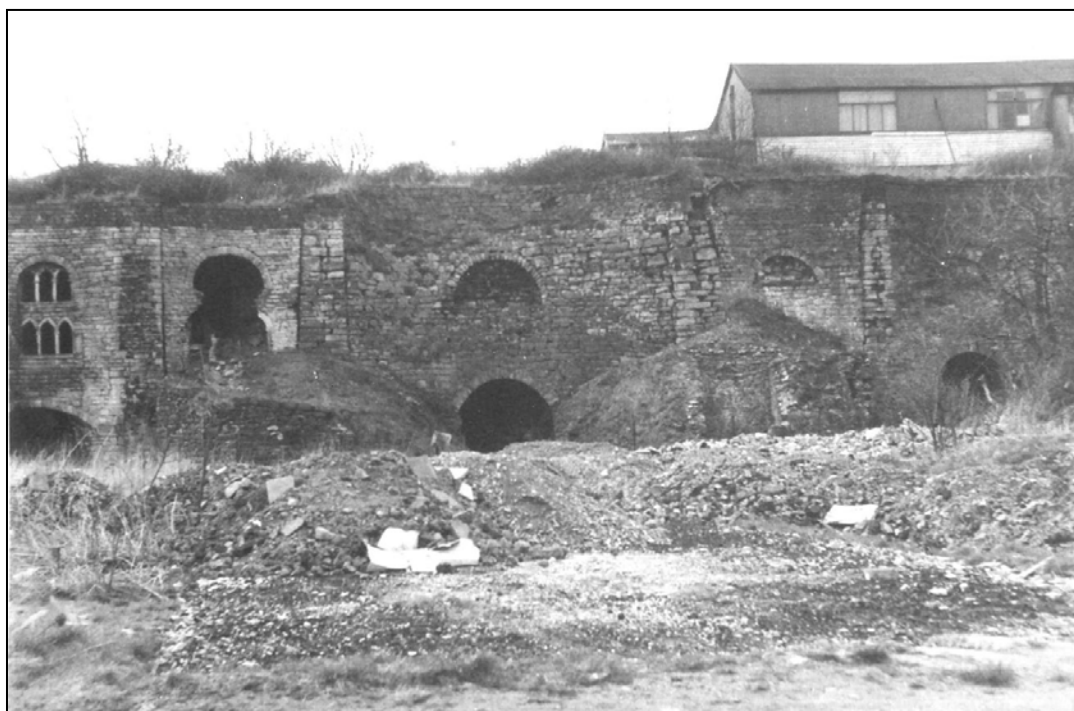
Figure 31. The semi-circular structures abutting the kiln bank wall as they appeared in the later 20th century. Marple Local History Society.

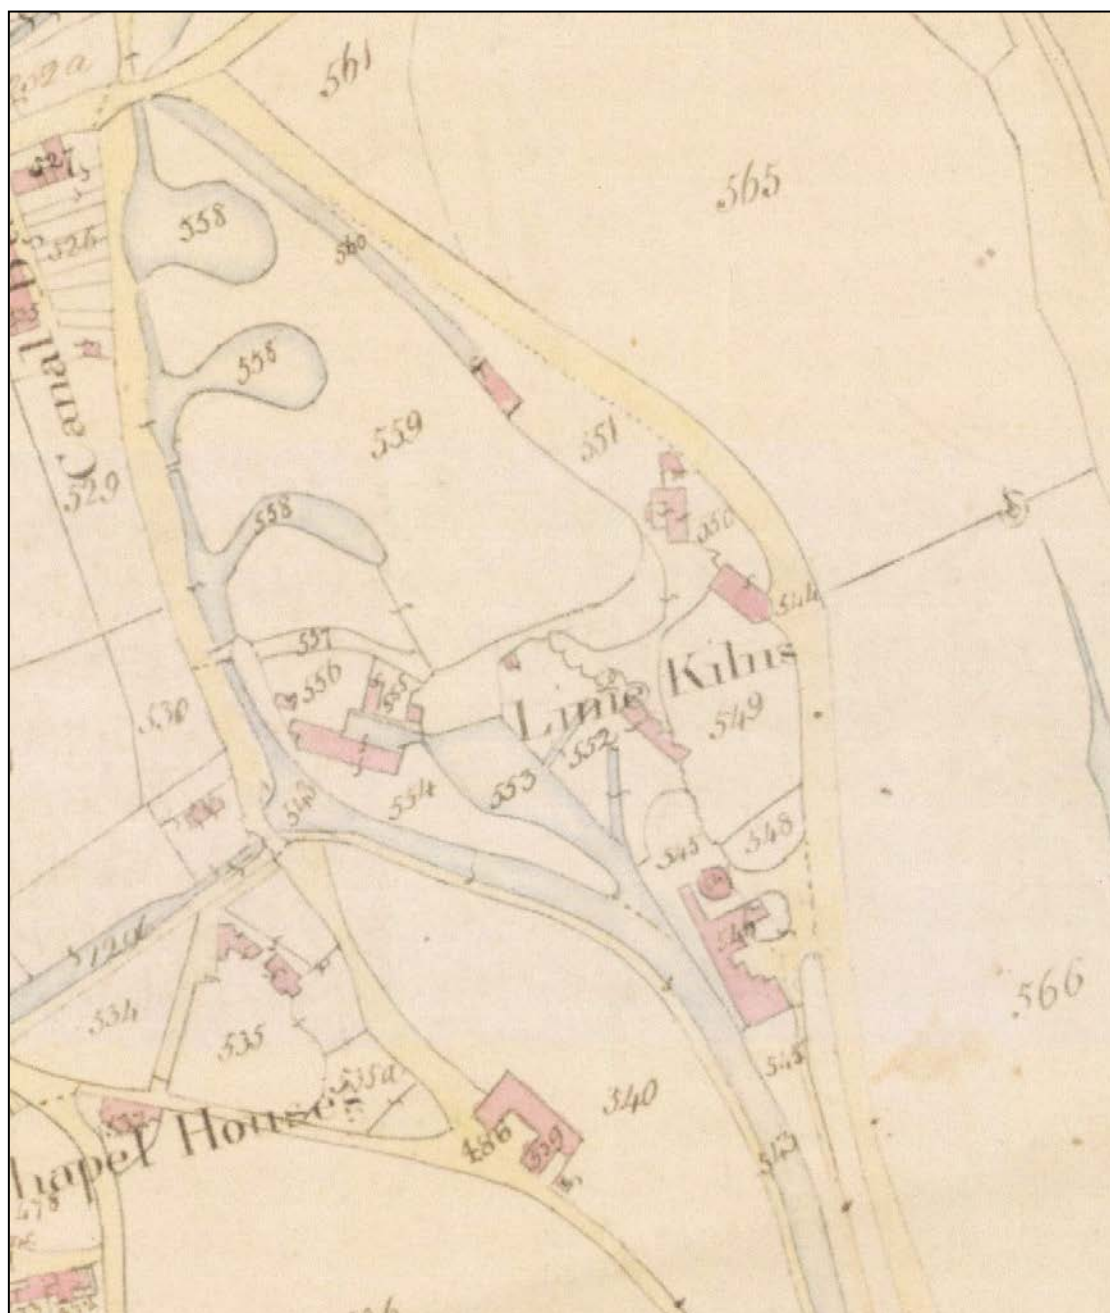
Figure. 35. Lime kilns and vicinity on the Marple tithe map (CRO EDT 262/2). After Arrowsmith, 2015.

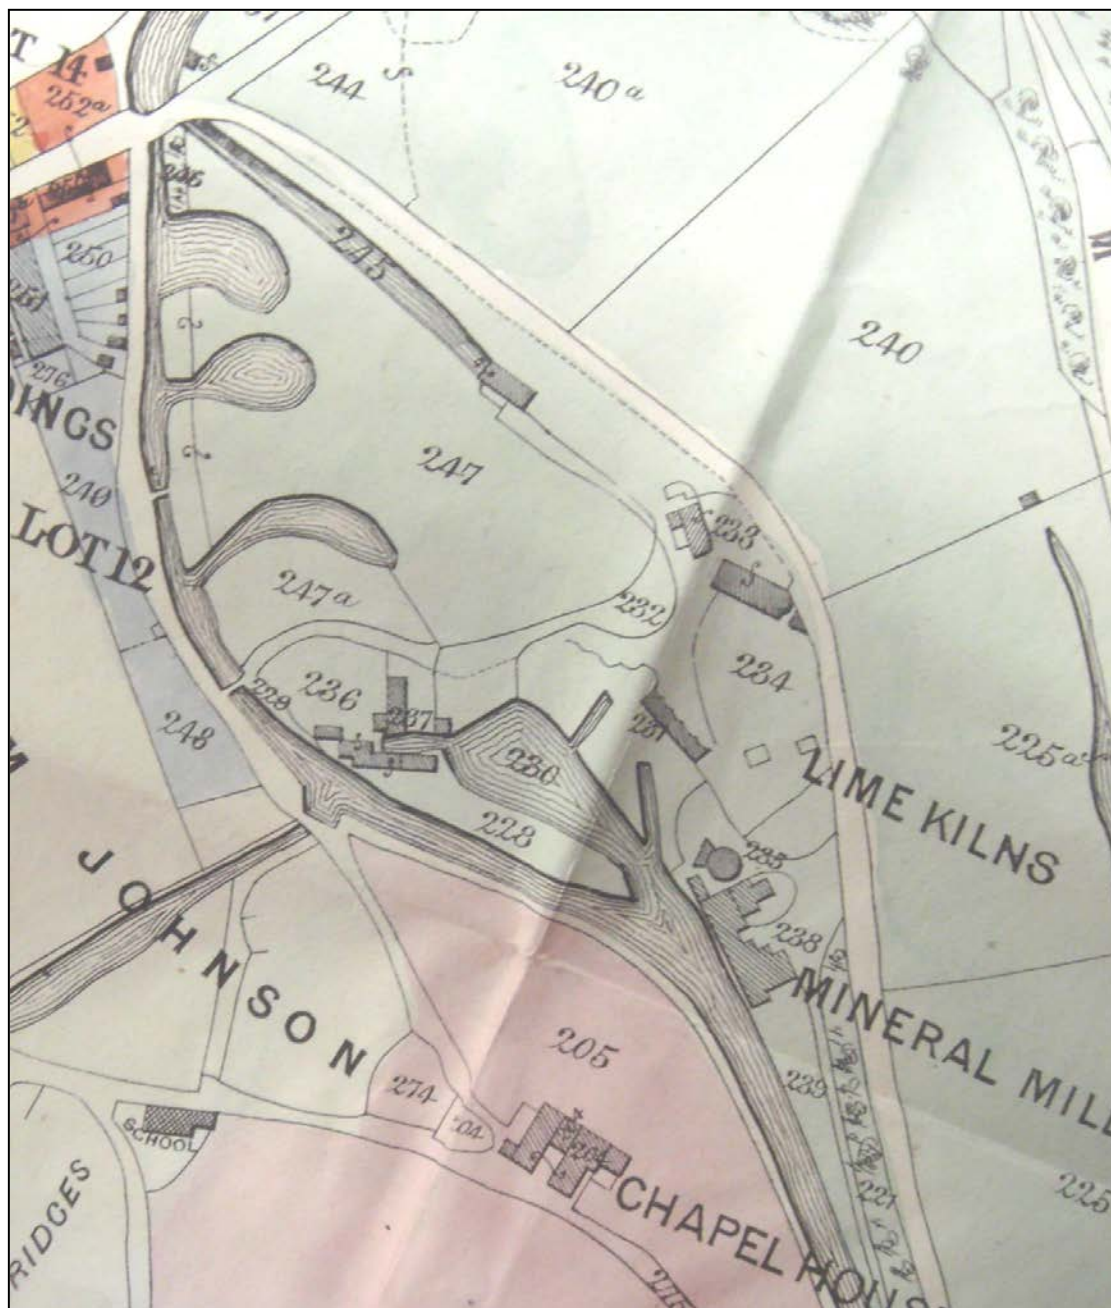
Figure. 36. Lime kilns and vicinity on the 1867 sale plan for the estate of Peter Arkwright (GMCRO Q15). After Arrowsmith, 2015.

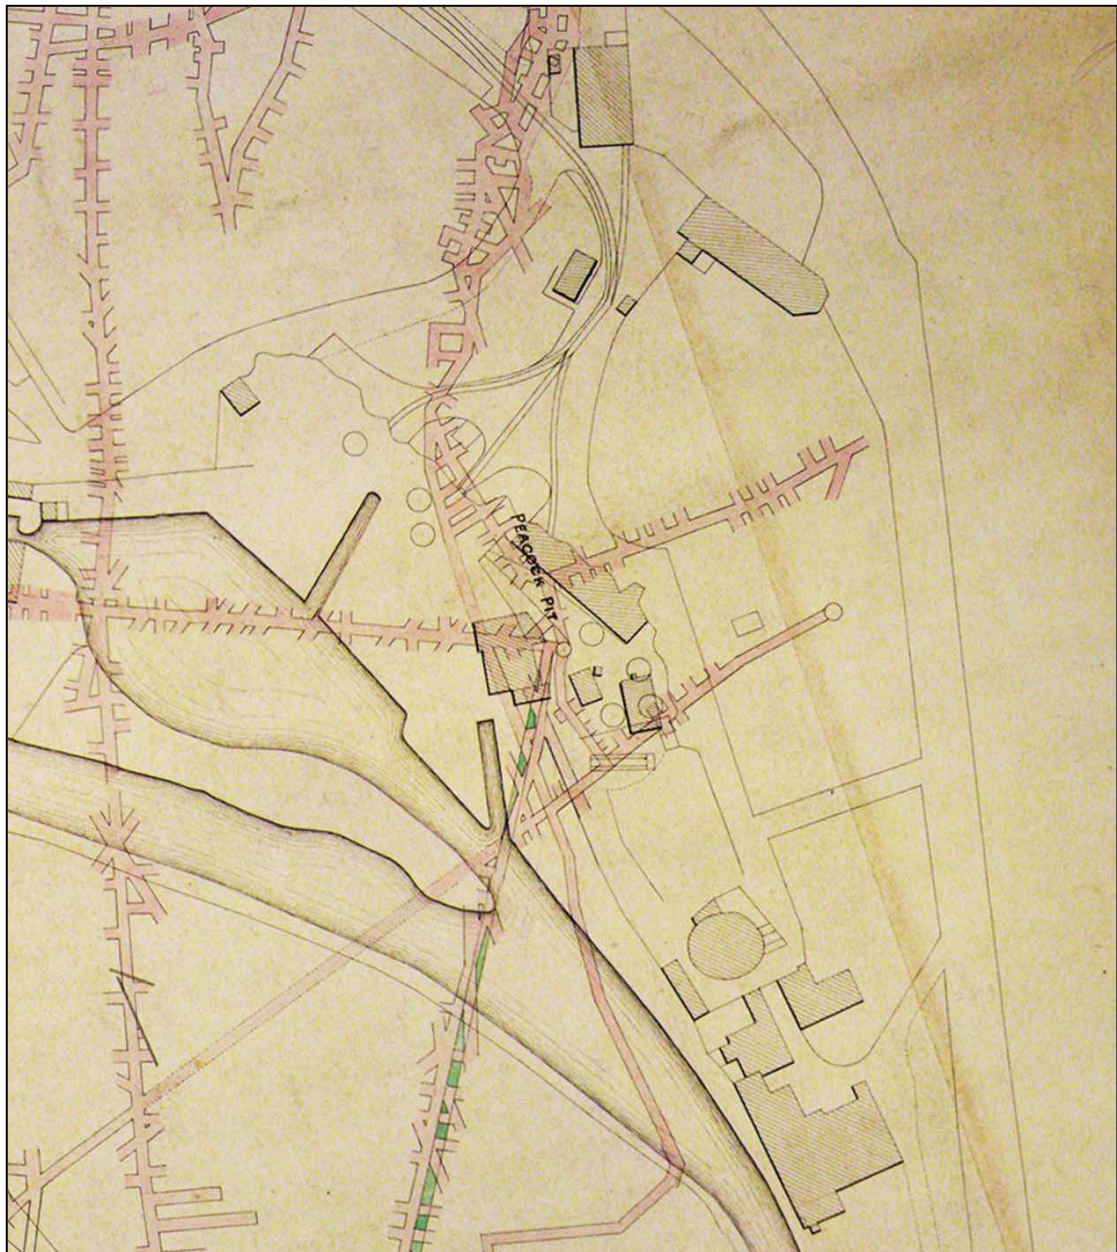
Figure. 38. Lime kilns on plan of Marple Colliery, 1883. After Arrowsmith, 2015.

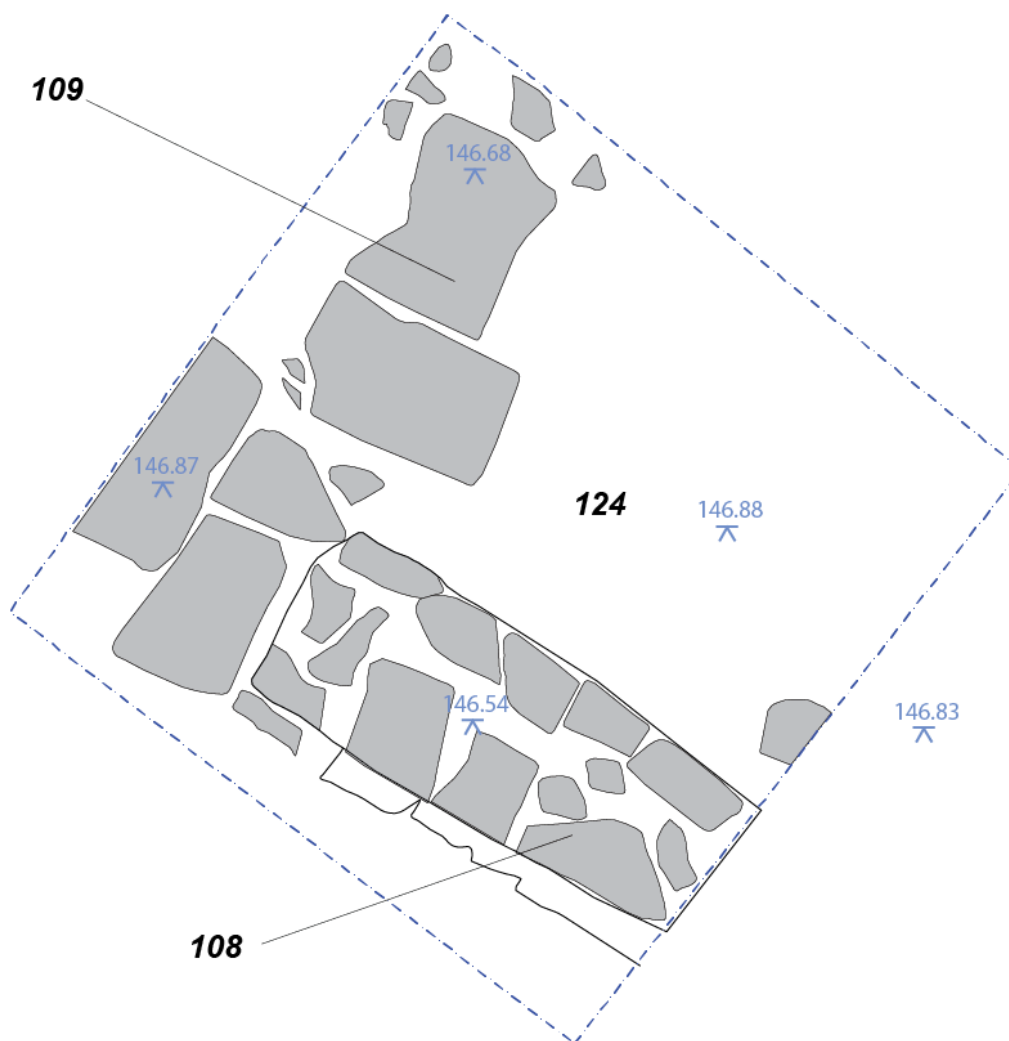
University of Salford MANCHESTER	Salford Archaeology	0 1 m 1:50		N 	Key: Stone 102 Context No. 146.88 Level AOD
The Centre for Applied Archaeology	Centre for Applied Archaeology College of Science and Technology The Crescent Salford M5 4WU	Title: Plan of Test Pit 3 2016 Season	Site Name: Marple Lime Kilns Site Code: MLK17 Drawing Ref: Fig. 48 Date Drawn: 31/06/17 Drawn By: SC & WO
