Archaeological Watching Brief Report

St Peter's Church,
Church Road,
Halliwell,
Bolton

Document Title: St Peter's Church, Church Road, Halliwell, Bolton: Archaeological Watching Brief

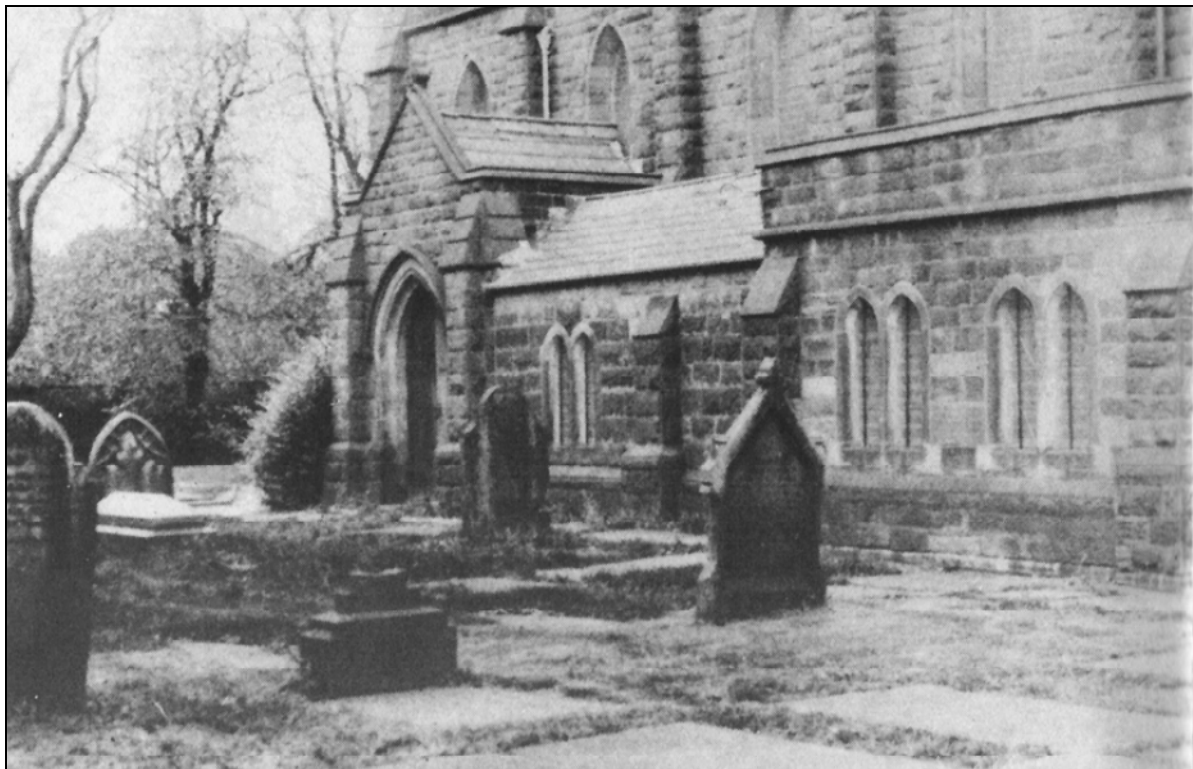
In 1933, another vestry was built between the existing vestry and the South Transept. To harmonise with the rest of the church, weathered stone, quarried from the same place, was donated from Ainsworth's old bleachworks buildings (Plate 4).

Plate 4: Archive photo from St Peter's website showing the 1933 vestry

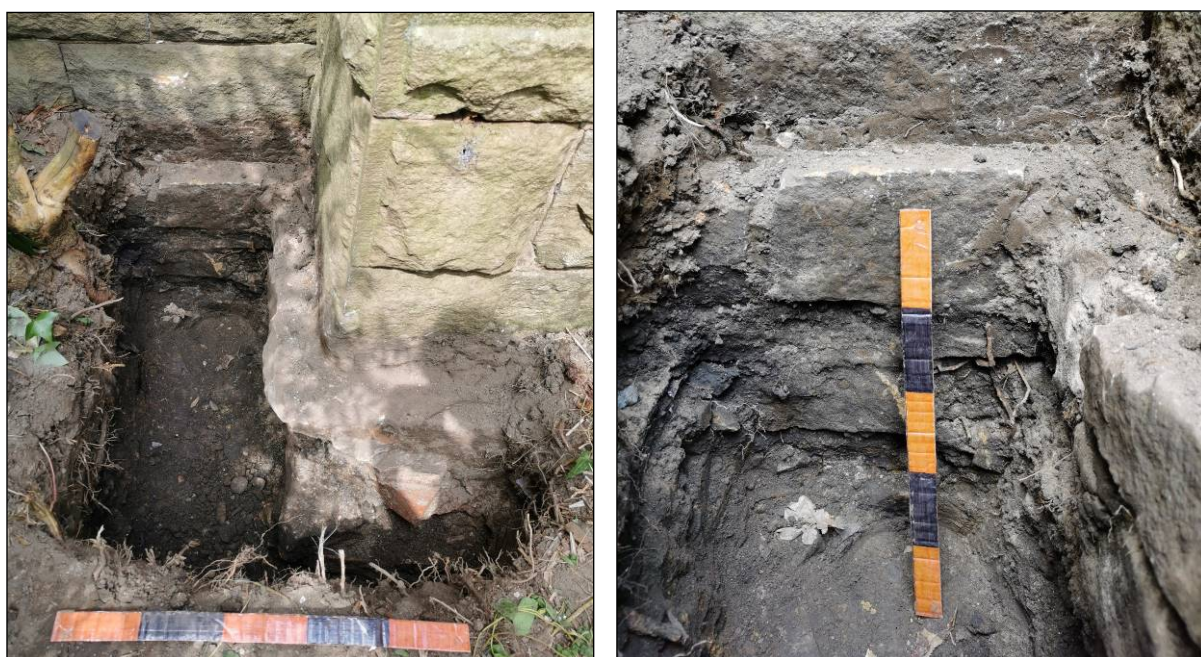
Trial Pit 1 had maximum dimensions of 1m x 0.8m, and was located on the south side of the church, forming an L-shape around a buttress. The trial pit was excavated to a maximum depth of 0.64m, exposing the foundations of the church and an associated buttress (Plate 6).

The stone foundations of the church were laid in regular courses and extended below the base of the excavated trial pit. The foundation courses stepped out from the wall by 80mm at a depth of 130mm below the current ground surface (Plate 7). In contrast to the regular coursing of the church walls, the fabric of the buttress comprised random courses of stone rubble, with occasional inclusions of brick.

Plates 6 and 7: View of Trial Pit 1 showing the offset in the foundation and the regular coursing of the church wall, looking north

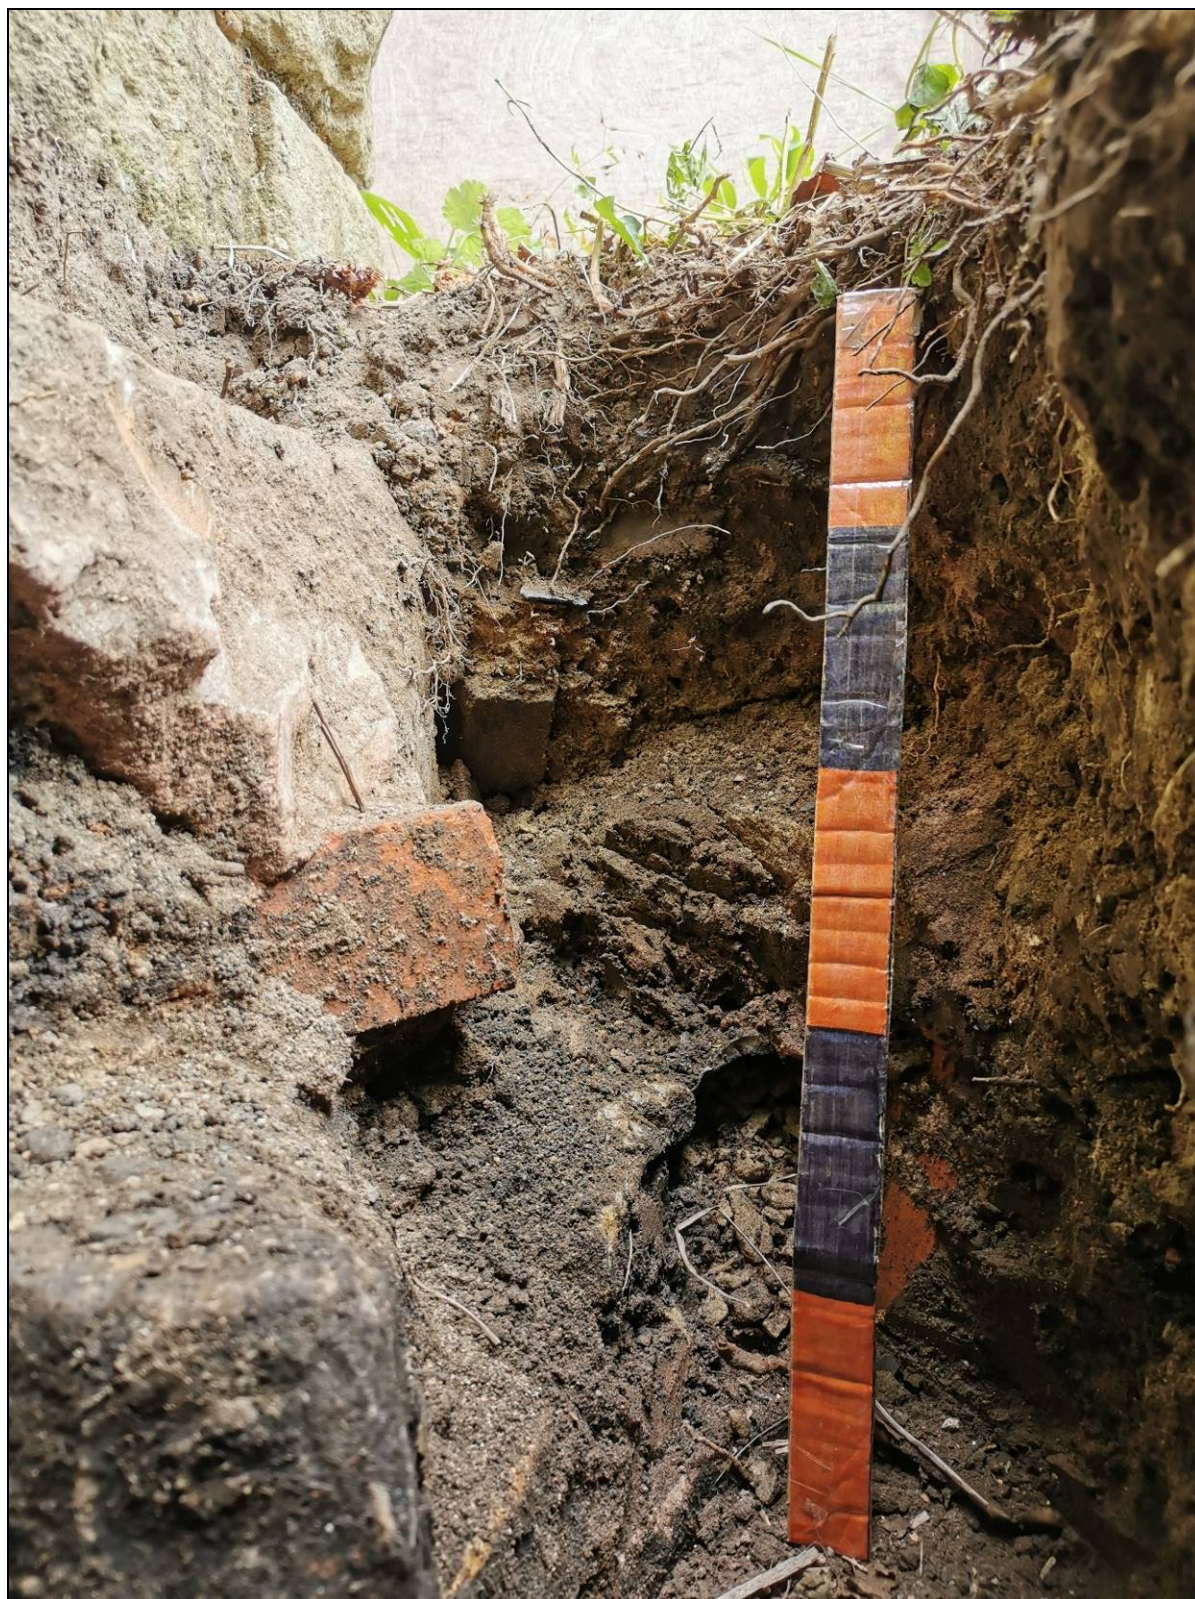
Plate 8: View of Trial Pit 1 showing stone and brick rubble, looking east

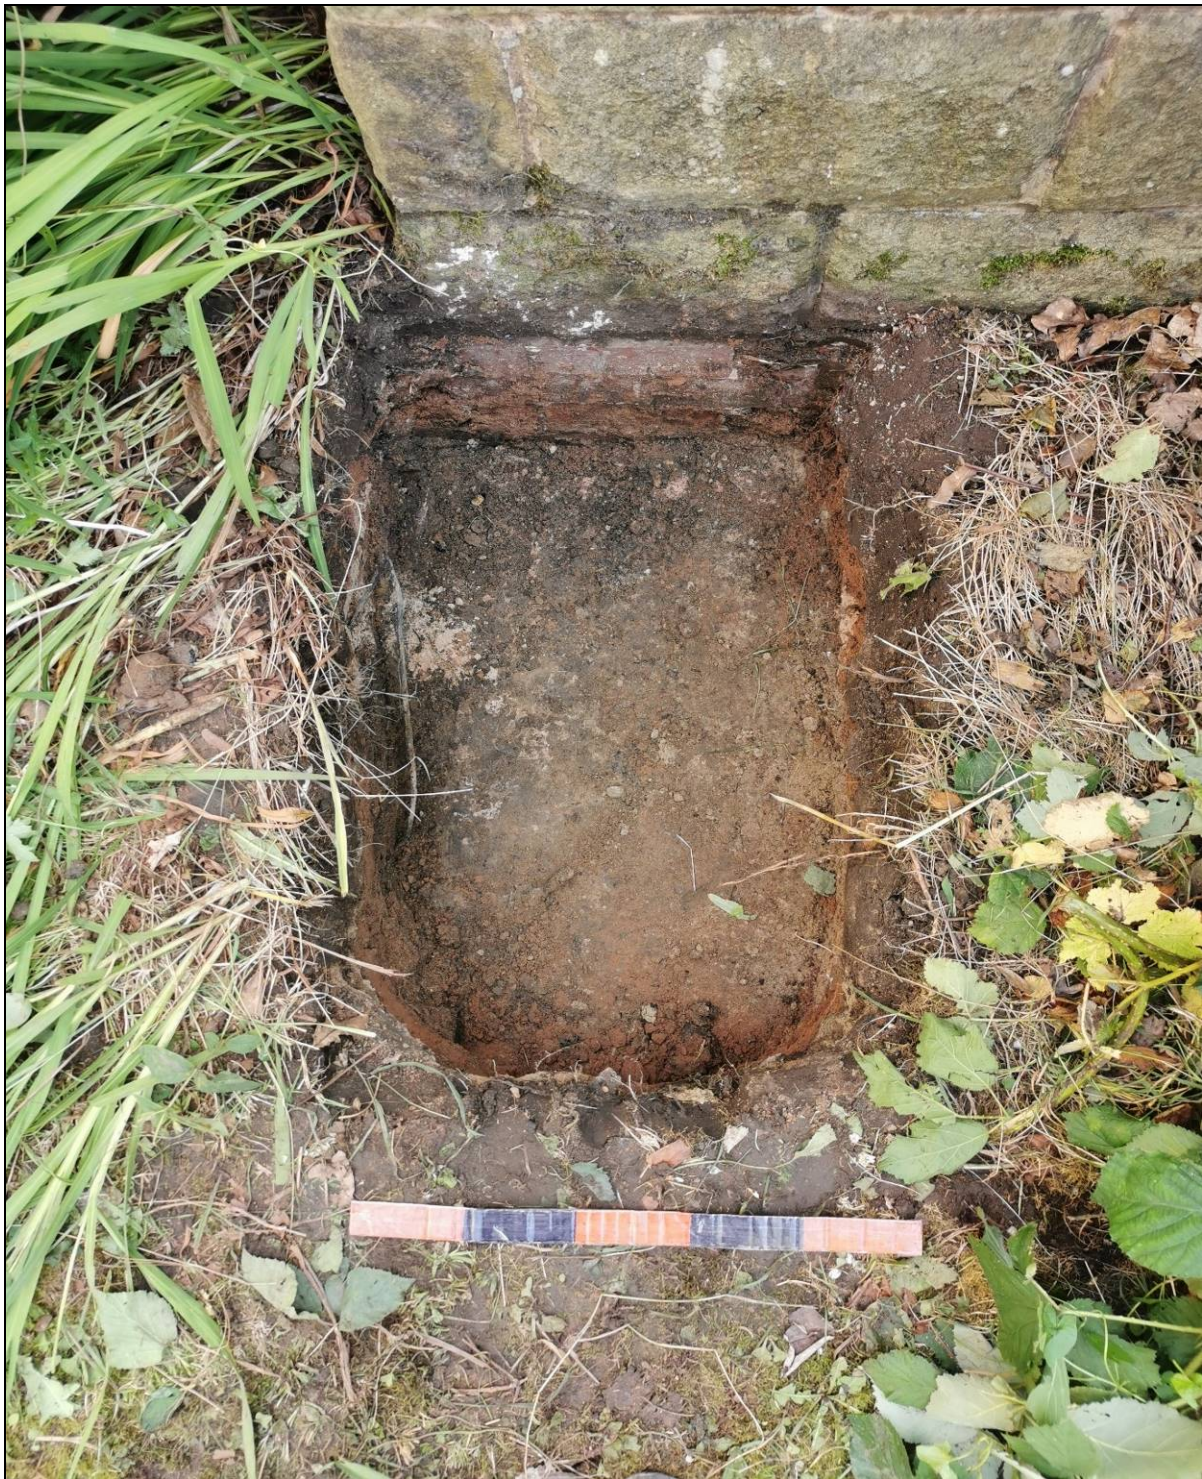
Plate 9: View of Trial Pit 2, looking west

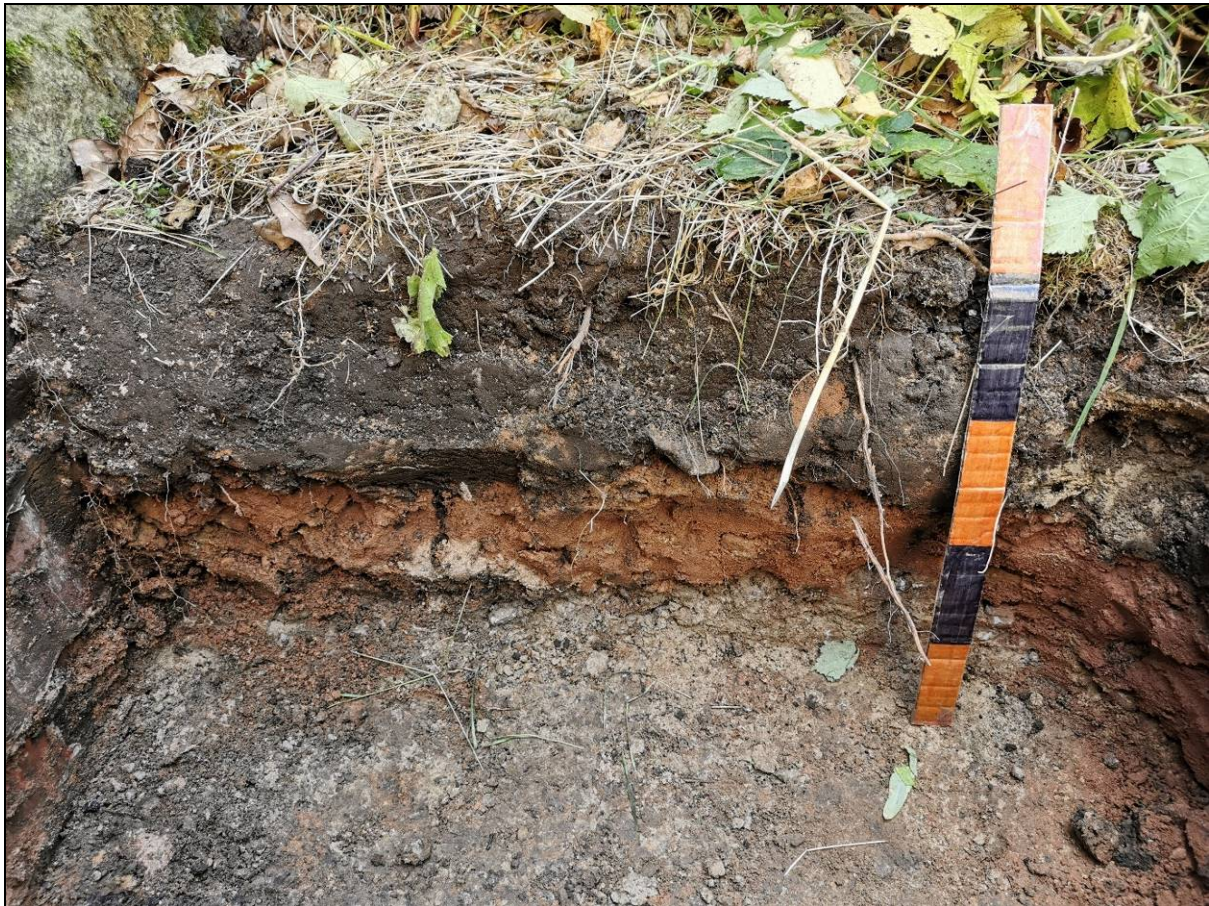
Plate 10: View of north-facing section of Trial Pit 2, looking south, showing the concrete raft and sand layer overlaid with garden soil.

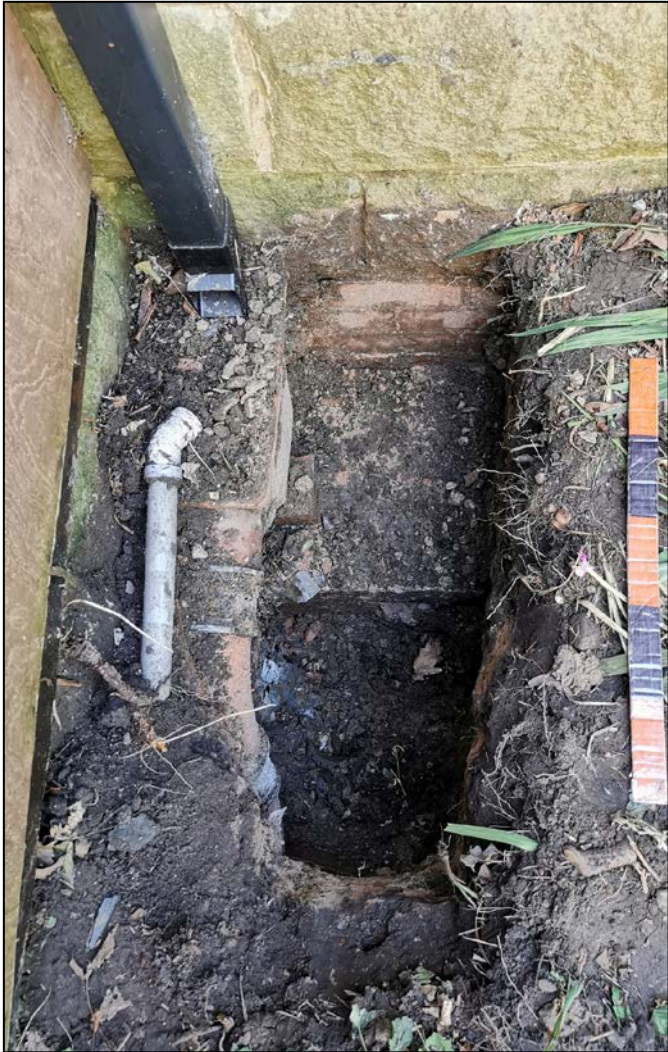
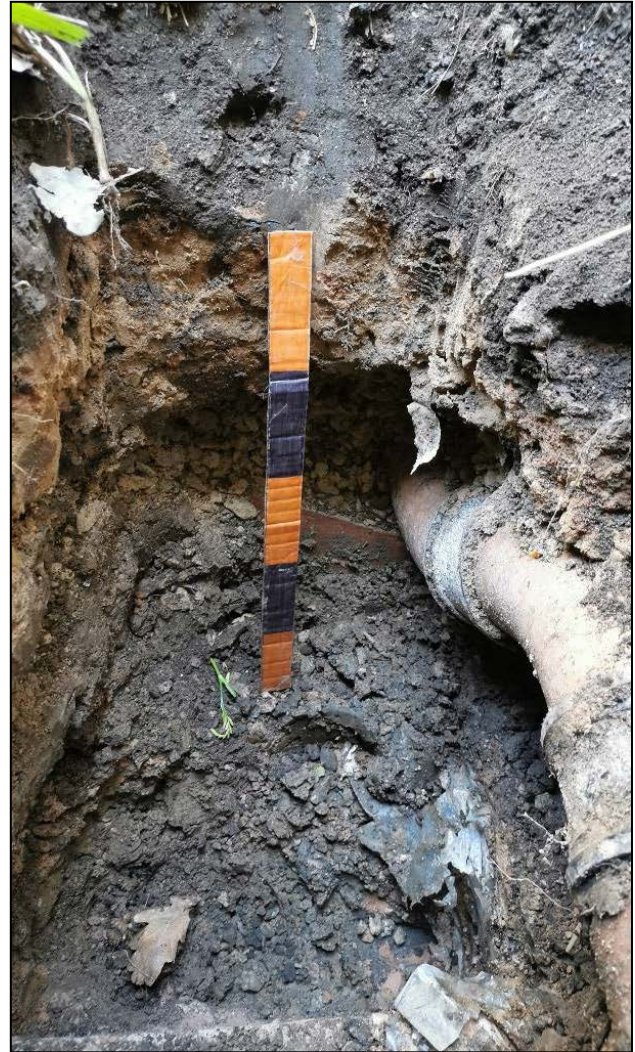
Trial Pit 3 was situated in the south-east corner of the site, between the north wall of the 1984 extension and the western glass corridor. The trial pit measured 1m x 0.5m, and was excavated to a maximum depth of 0.8m (Plate 11).

Part of the concrete raft for the 1984 extension was exposed in the trial pit, extending 0.4m to the north of the wall for the building. This had evidently been laid on a layer of levelling material that included a proportion of gravel and cinders. As was noted in Trial Pit 2, the concrete raft was overlain with a thin layer of sand, and sealed beneath topsoil.

Part of a drain was also exposed in the trial pit, running along the side of the glass corridor that led away from the extension gutter towards the church (Plate 12). The drain formed part of the 1984 extension. A damp-proof layer of plastic was visible under the drain.

Plates 11 and 12: View of Trial Pit 3, showing the concrete raft for the 1984 extension and the surface water drain

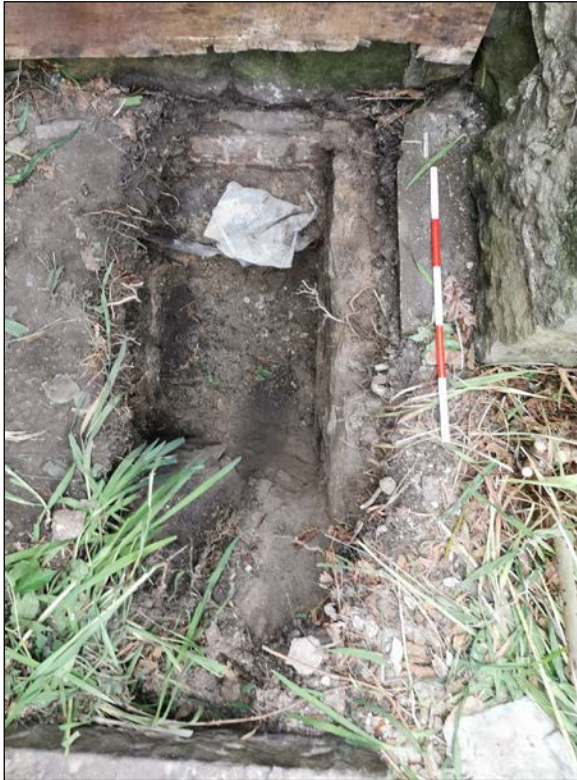
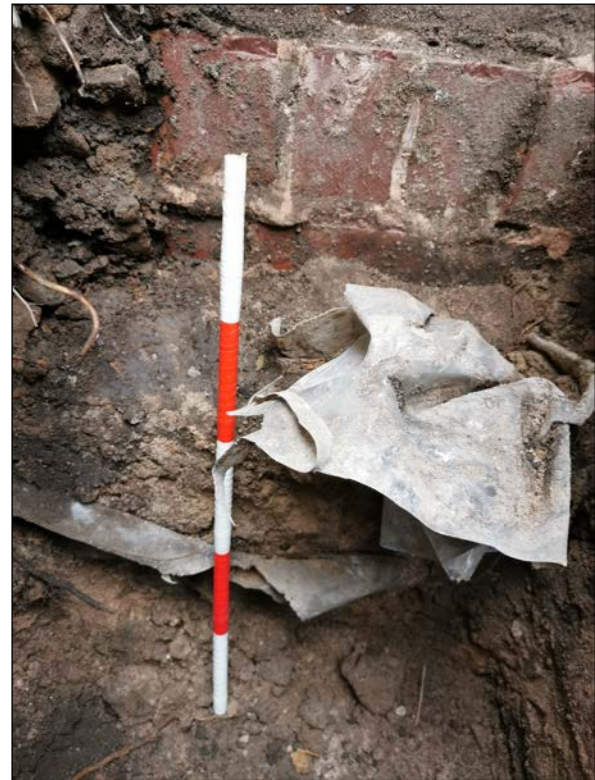
Geo-technical pit 4 was placed on the eastern side of the pair of connecting corridors, against the west wall of the south transept. The pit measured 1.16m long and 0.53m wide, and was excavated to a depth of 0.80m. A modern foundation of brick and sandy mortar beneath a single course of stone was exposed along the north edge of the pit, forming part of the eastern corridor (Plate 13). These foundations were set on top of a concrete block wrapped in plastic, and set on a 200mm-thick layer of coarse concrete (Plate 14). These foundations were probably associated with the 1933 vestry.

The eastern edge of the trial pit was formed by the buttress at the south-west corner of the transept, which was constructed of stone. A stone plinth with a width of 130mm protruded from the buttress at ground level. The below-ground foundations stepped out a further 100mm at a depth of 220mm. The foundation trench was packed with fragments of brick, stone and ceramic rubble.

Plates 13 and 14: View of Trial Pit 4, showing wrapped concrete

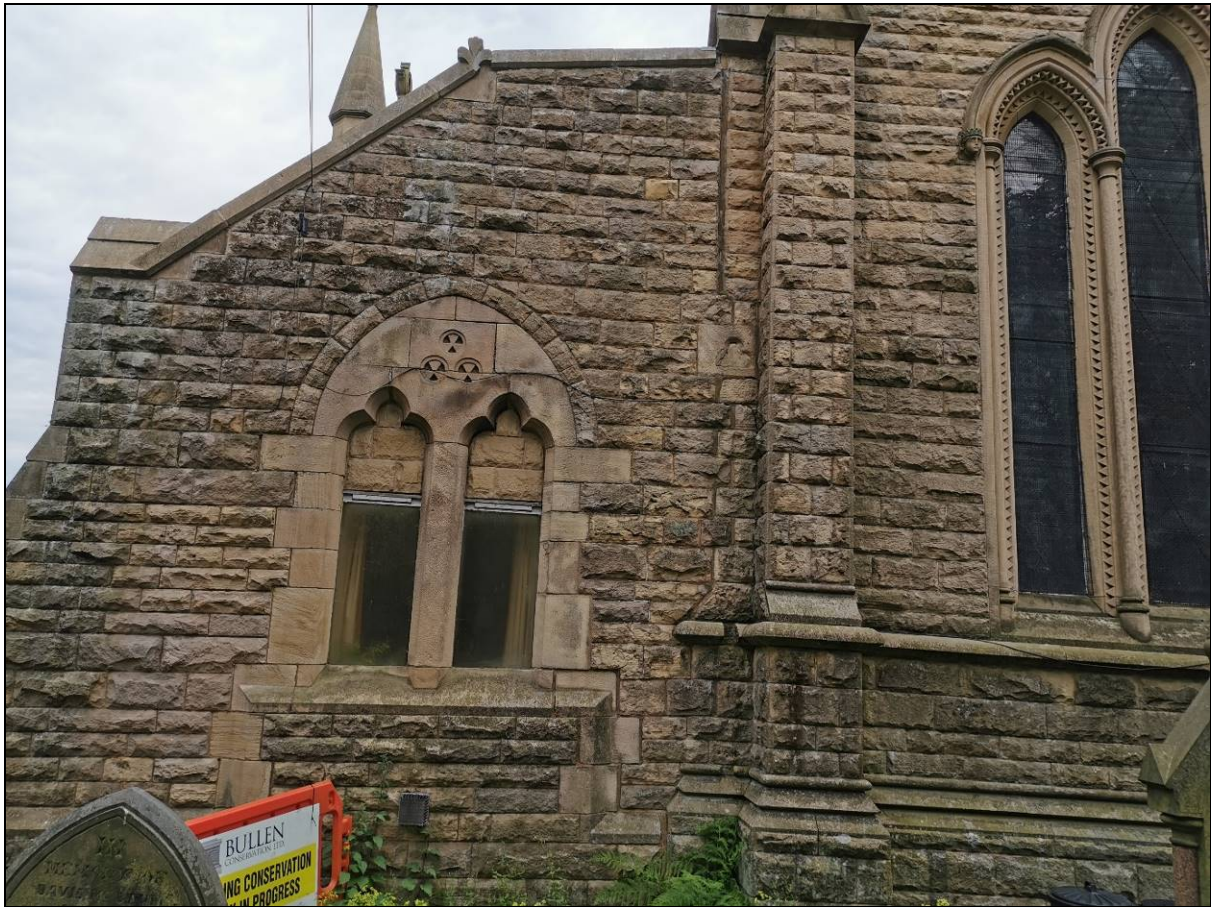
Trial Pit 5 was located at the south-east corner of the east wall, which appeared to be a later addition to the church (Plate 15). The trial pit measured 1m long and 0.5m wide, and was excavated to a depth of 0.9m, whereupon a layer of concrete was exposed. Three courses of bricks were laid on top of the concrete, above which were courses of stone masonry (Plate 16). It seems possible that these foundations were intended to underpin the foundations of the wall that formed the south-east corner of the east wall, perhaps in response to some subsidence.

Plate 15: View of east wall showing the joint in the stonework between two phases of construction
