## Archaeological Excavation Report

Manchester Engineering  
Campus Development,  
Grosvenor Street,  
Manchester

**Document Type:** Archaeological Excavation Report

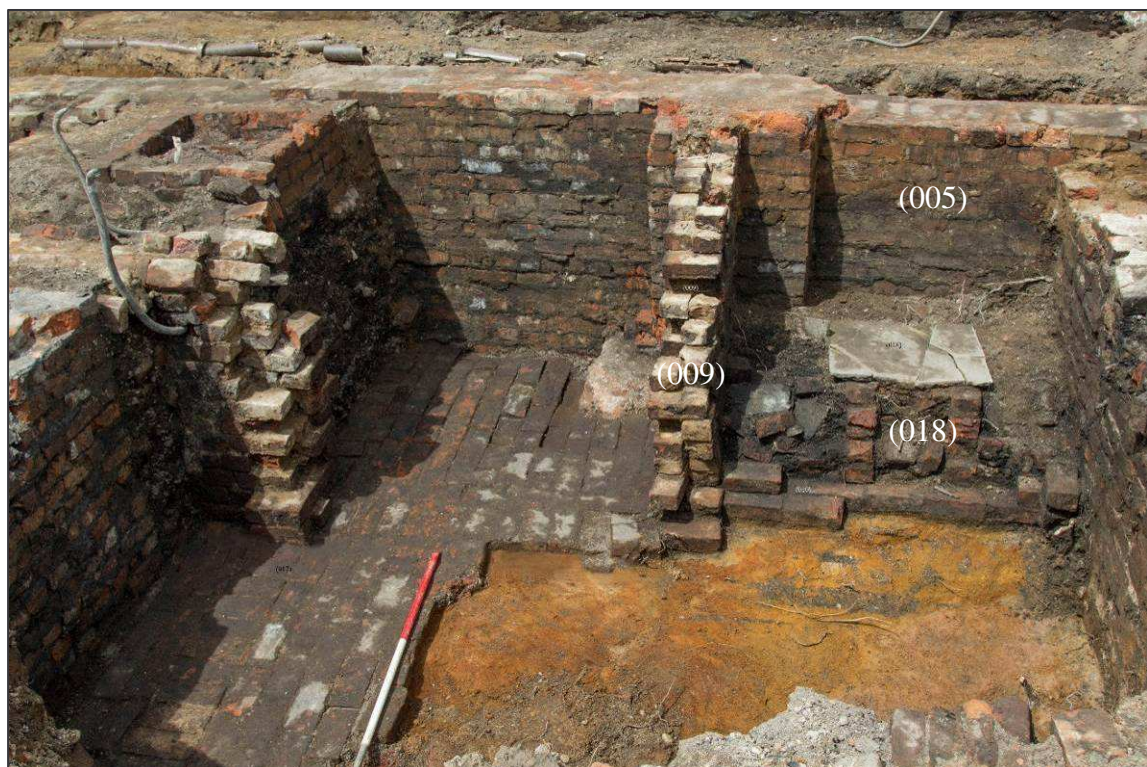
*Plate 4: Exposed cellar floor, and associated walls, looking north-west*

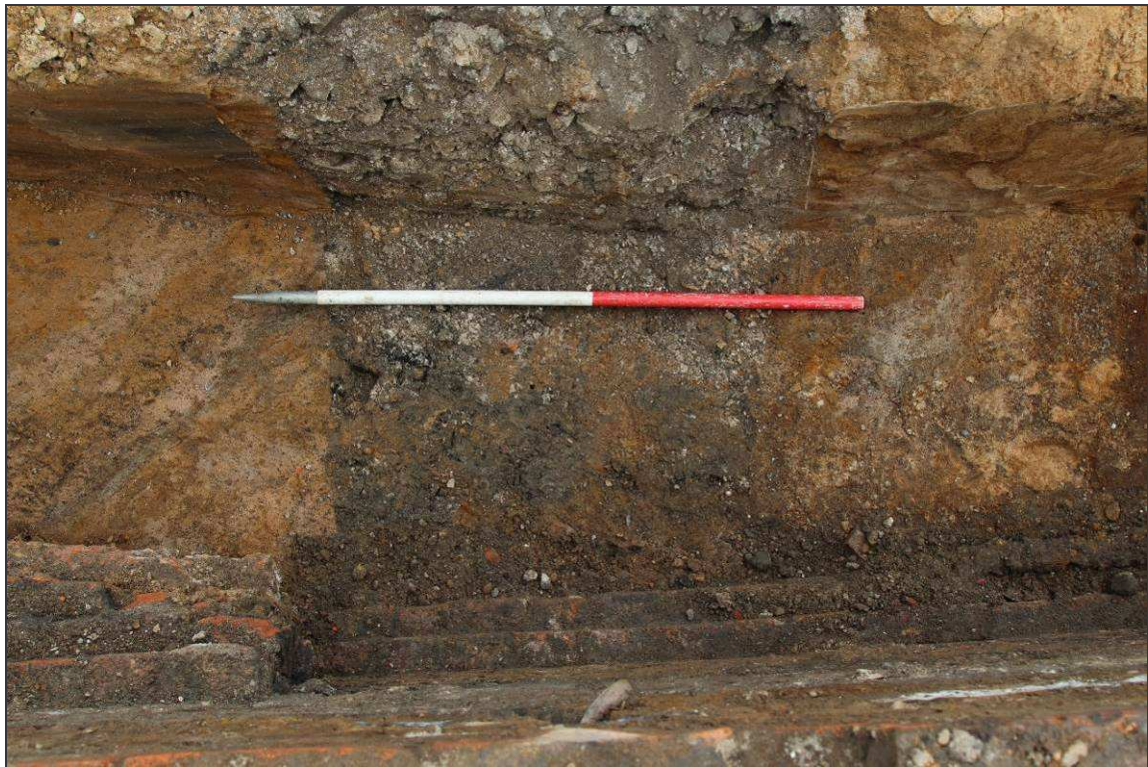
*Plate 5: Drain cut 012, looking north-west*

A series of three brick-built drains (**012**, **013** and **014**) capped by flagstones appeared to be the only other surviving remains from the early phase. All three of these drains had been cut deep into natural sand, and appeared to have ‘stepped down’ from south to north. Drain **012** comprised a linear cut aligned north-west/south-east that was visible in the natural sand, 0.80m in width and was excavated to a length of 1.20m by 1m in depth. No brick structure was found, and the cut was filled by a grey ashy deposit (Plate 5). Drain **013**, also a linear cut, was located 0.80m east of **012** measuring 0.70m in width and excavated to 0.90m in length and 1m in depth. The sides of the cut were vertical and contained the remains of two parallel rows of bricks laid header, which had been capped by rectangular stone flags (Plate 6). A further drain (**014**) was situated 0.88m east of drain **013**, which also contained the remains of a brick and stone constructed drain. Drain **014** measured 0.70m in width and was excavated to 0.90m in length and 1m in depth (Plate 7). The continuation of this drain (**018**) was found heading south, having been truncated by later wall (**005**; Plate 4). A further continuation could be seen in the north-facing section of the trench.

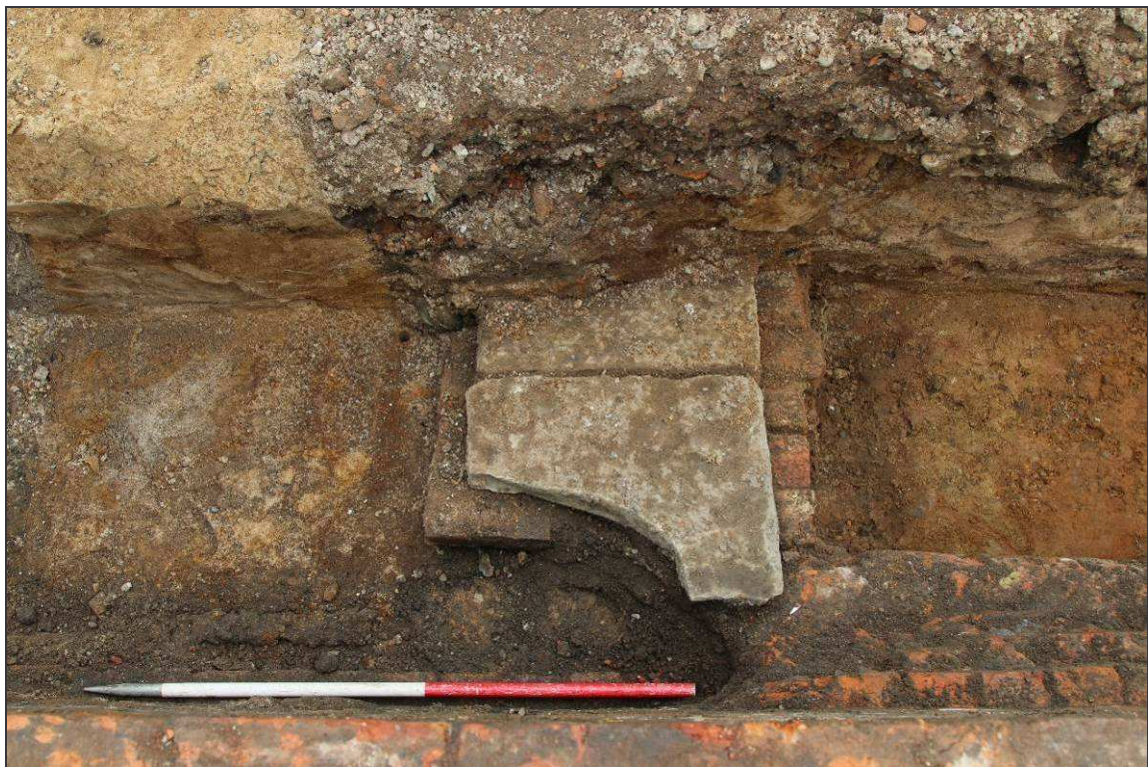
*Plate 6: Drain cut 013 and associated structure, looking north-west*

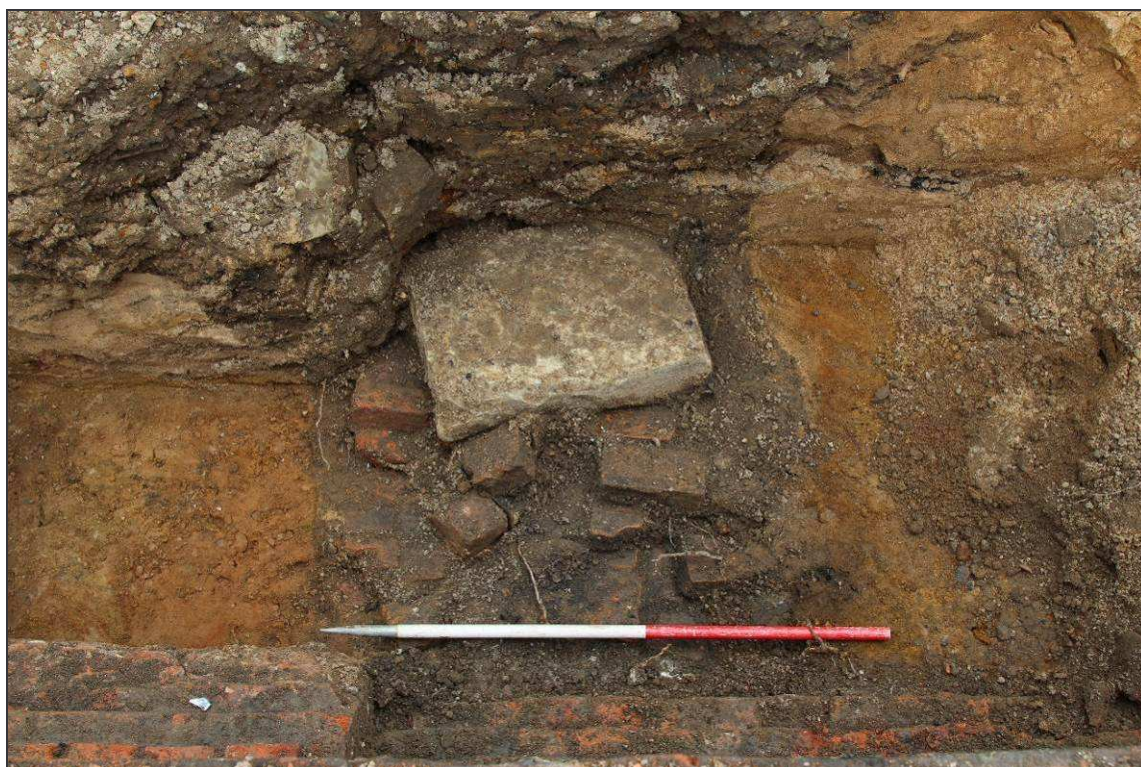
*Plate 7: Drain cut **014** and associated structure, looking north-west*

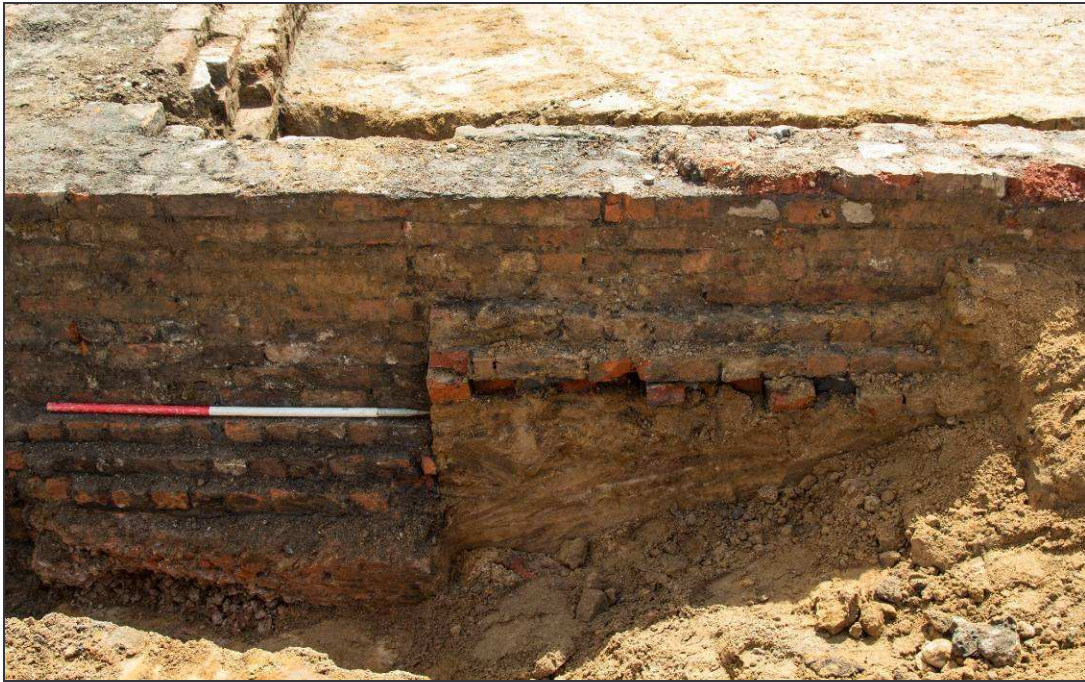
*Plate 9: Printing works wall (005), looking south*

Several walls relating to a later phase in development were found truncating the earlier remains. In particular, a substantial hand-made, mould-thrown brick wall (**005**), bonded with black ash mortar, which research suggests belonged to a twentieth-century printing works (brick dimensions 0.225 x 0.11 x 0.07m). This was a substantial wall excavated to 12m in length and 1.46m in height. The width of the wall was 0.38m plus 0.17m each side of the foundation steps, giving a total width of 0.72m. The wall was aligned east/west, and had been cut into or constructed on natural sand, whilst also truncating demolished earlier structures. The western half of the wall was fairly shallow and constructed directly onto natural sand. Whilst the eastern half had cut through natural sand, its foundations were much deeper than the western half (Plate 8). Buttresses approximately 0.30m wide had been incorporated on both sides of the wall with the cut visible in places (**015**), with a width of approximately 0.27m, which had been backfilled with redeposited natural material (Plate 10). A sondage was inserted along the southern side of the wall, aligned east/west in order to investigate the depth of the foundation and the foundation cut, and to establish a sequence of events (Plate 11). This revealed that in the centre of the wall **004** of the earlier structure had been partly demolished at its northern end for the purpose of constructing wall **005**, and the cut (**016**) was backfilled with demolition material.

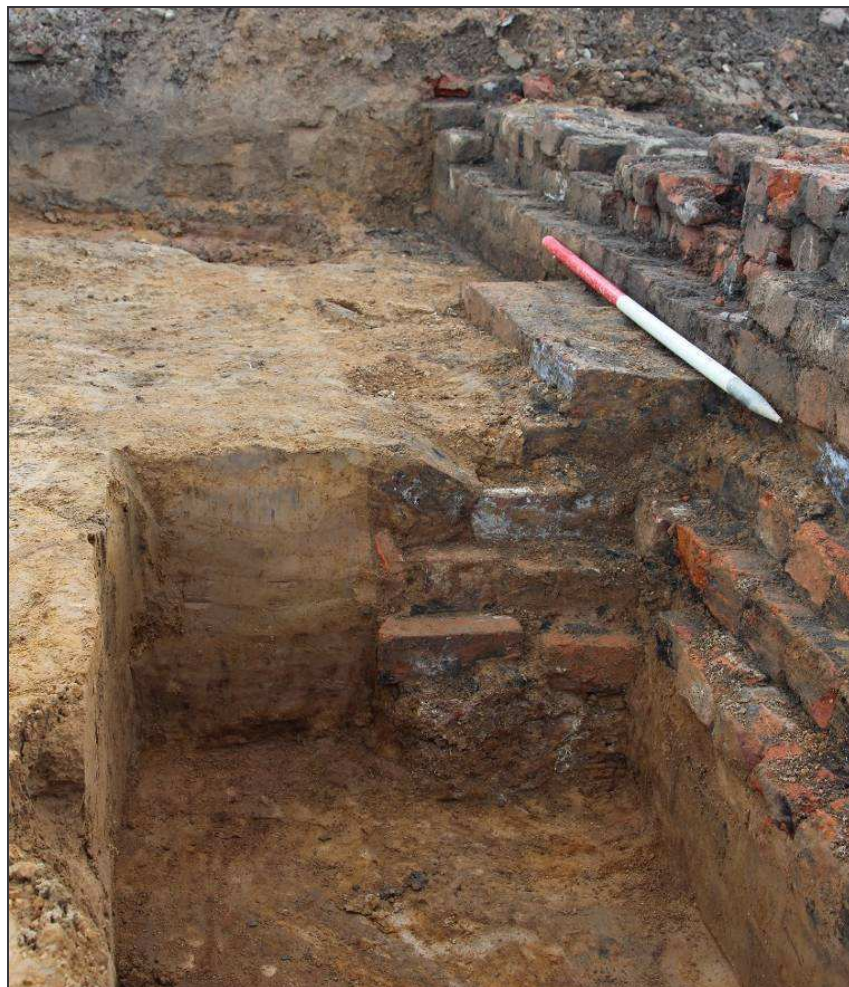
*Plate 10: Printing works wall (005), showing a buttress and associated cut (015), looking west*

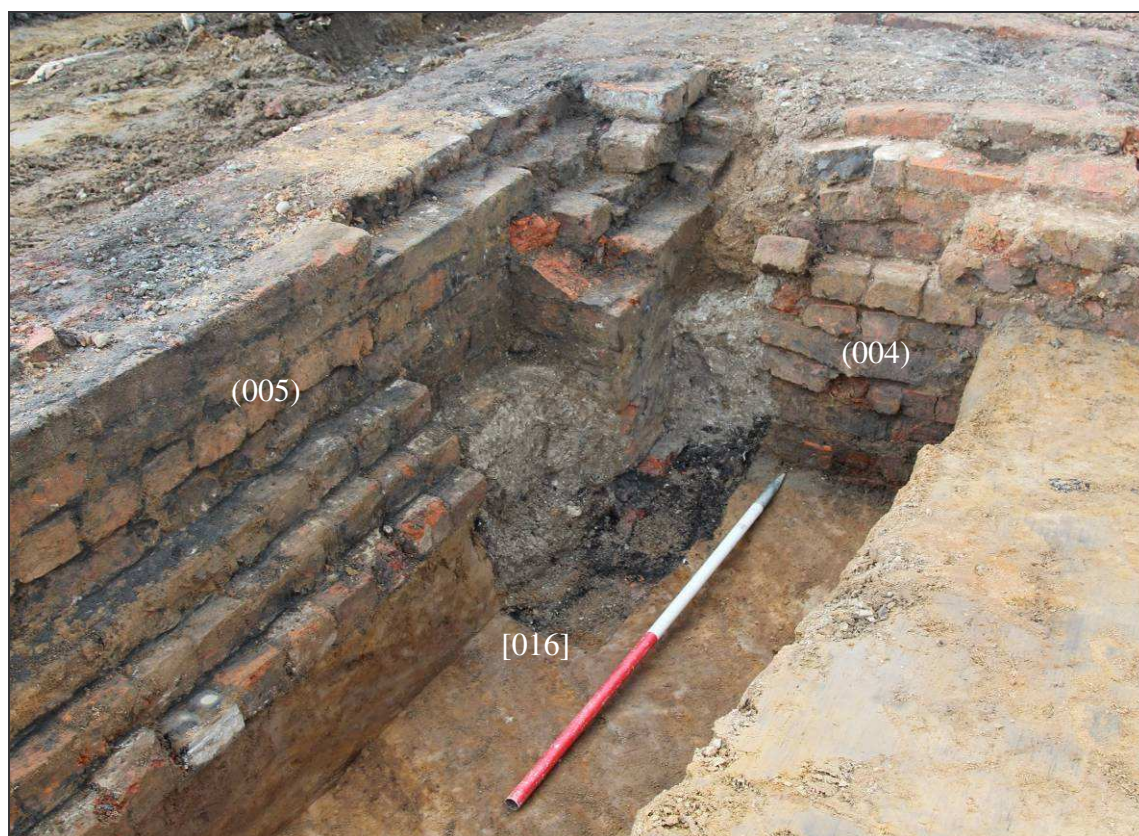
*Plate 11: Printing works wall (005) and associated cut (016), truncating wall 004, looking north-east*

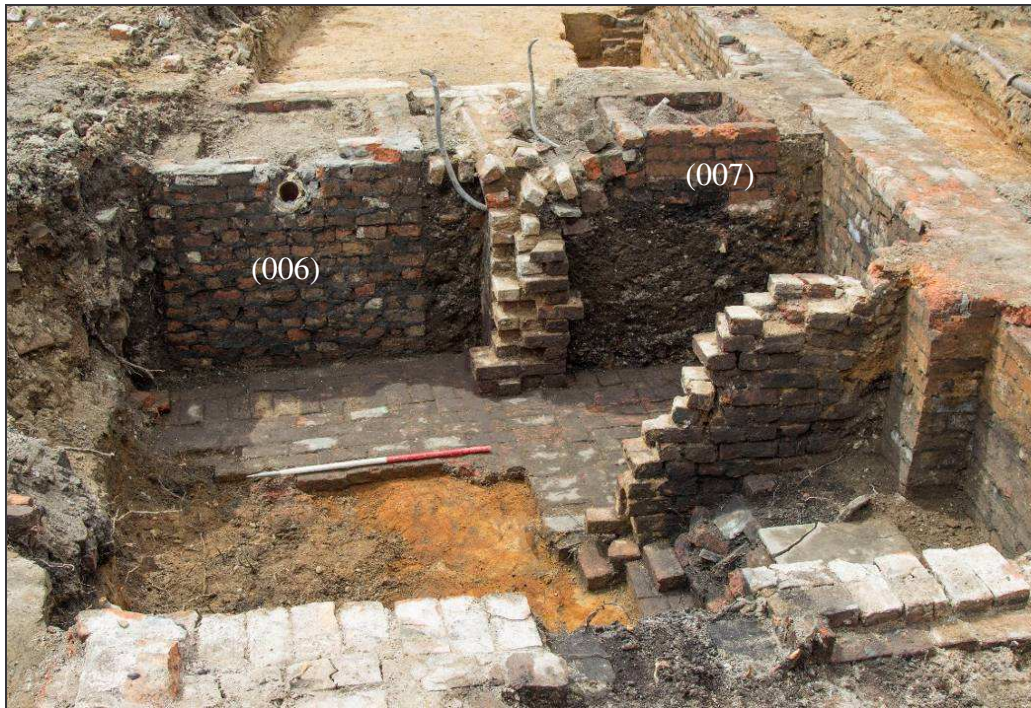
*Plate 12: Privy **006** on the left and the square feature (**007**) on the right, looking west*

Two features found cut into the backfill of the cellar consisted of an unidentified square feature (007) and a brick-built privy (006). The privy had been constructed on the eastern side of wall 004, into the remains of the backfilled cellar, having been constructed using hand-made bricks (0.23 x 0.11 x 0.07m) and bonded with black ash mortar. The structure measured 1.40m north/south, 1m east/west and survived to a height of 1.20m. The remains of a ceramic soil pipe/u-bend partly survived at the top of the structure. Missing bricks in the floor (017) suggests this structure probably truncated the floor, and its location had removed any remains of the southern vaulting of wall 008 (Plate 12).

To the north of the privy, truncating the northern vaulting of wall 008 was a square feature (007), which had also been cut into the backfill of the cellar, but this structure was relatively shallow, not reaching the cellar floor. The structure measured 0.85m square and survived to a height of 0.40m (five brick-courses), having been constructed using hand-made bricks and bonded with black ash mortar. The function of this structure could not be determined (Plate 12).

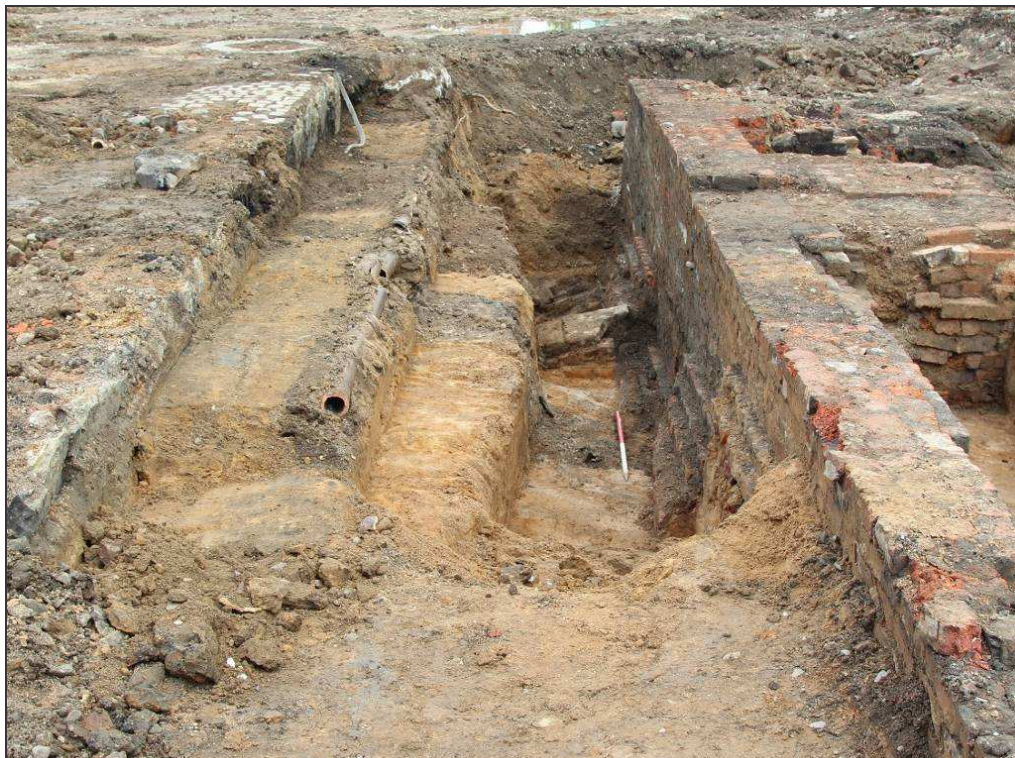
*Plate 13: Location of the southern footpath of Boundary Street East, looking east*

The southern footpath of Boundary Street East lay to the north of printing works wall **005**. None of the surface survived, having been truncated by the insertion of modern services consisting of a twentieth-century electricity supply and a ceramic drain pipe (**011**; Plate 13).

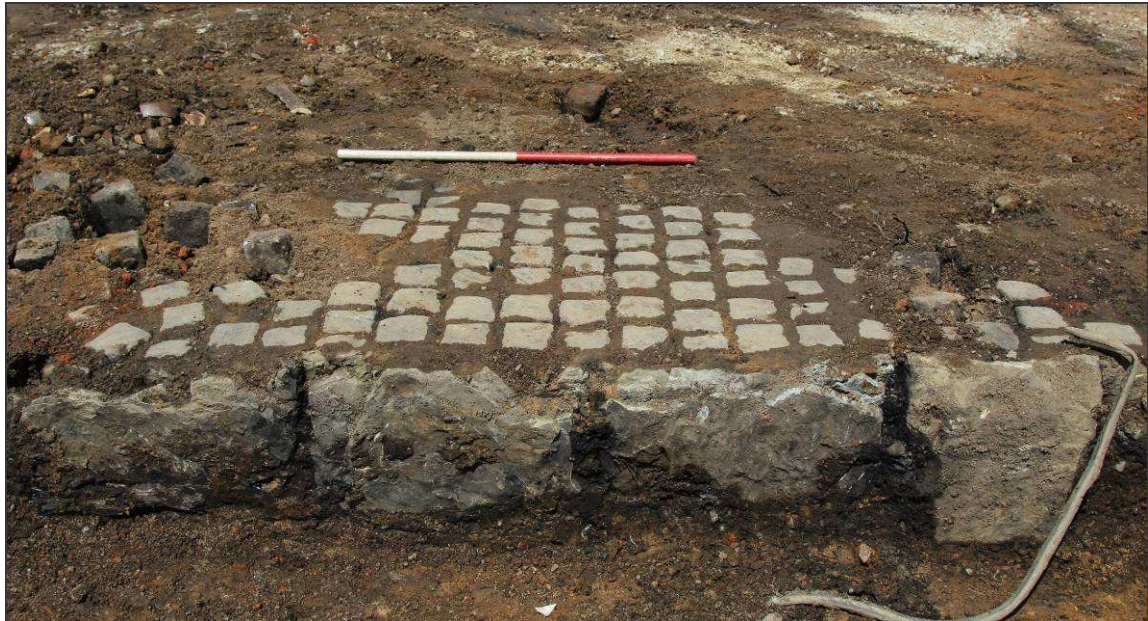
*Plate 14a: Patch 2 – small area of cobbles remaining of Boundary Street East, looking north*

The surface of Boundary Street East (022) survived in two areas, Patch 1 (Plate 14b) to the east of the trench and Patch 2 (Plate 14a) to the west. The surface had been formed using small square stone cobble setts, each measuring 0.11m cubed, bonded with pitch and secured in place along the edges by rectangular stone slabs (021) set upright on edge (Plate 14a), measuring 0.70m (varies) in length, 0.08m in width and 0.35m deep. Patch 1 measured 3m east/west by 2.50m north/south. Patch 2 measured 2.50m east/west by 1m north/south.

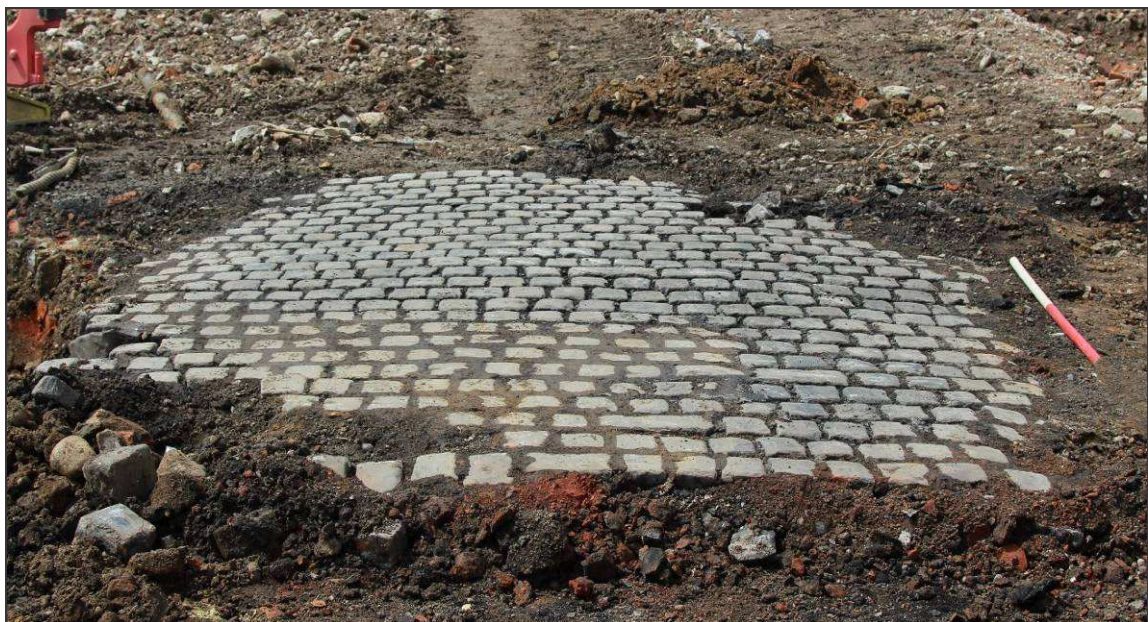
*Plate 14b: Patch 1 – large area of cobbles remaining of Boundary Street East, looking north*

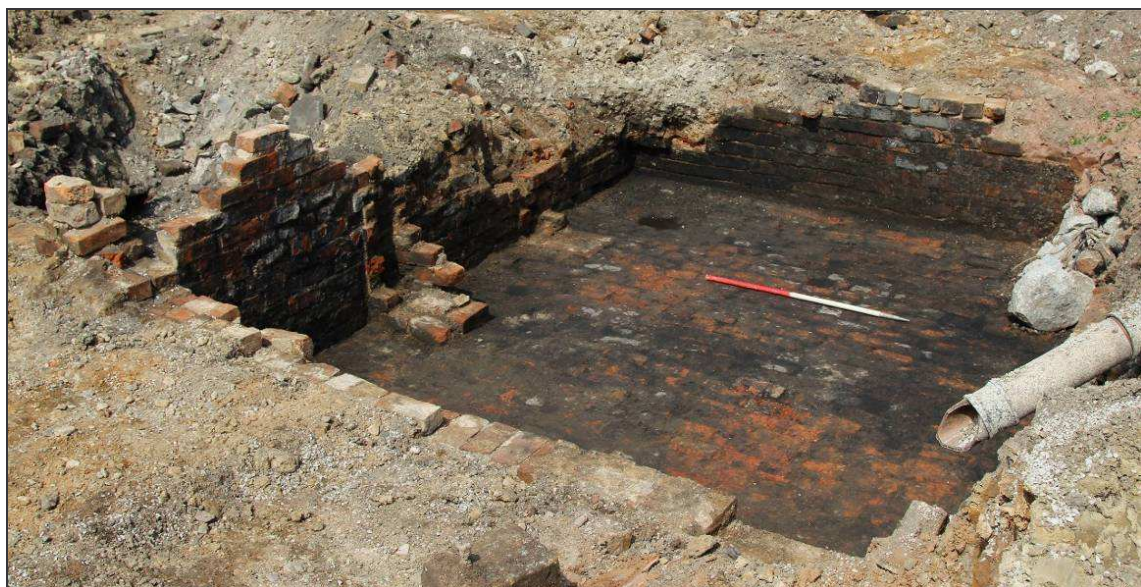
*Plate 15: House A cellar comprising the brick floor and fireplace cheeks, looking north-west*

House A was located at the northern end of Area 2, fronting Back Grosvenor Street, and aligned north-north-east/south-south-west. The house had been constructed using hand-made bricks (0.23 x 0.11 x 0.07m) and bonded with white lime mortar. The front of the house comprised a cellar room measuring 3.85m north/south by 3.45m east/west. The front wall was two brick-courses wide, and survived to a height of 0.80m and had been truncated at the eastern end by a modern pile associated with the former university building. The rear wall of the cellar was also two brick-courses wide and survived to a height of 0.60m. The eastern wall consisted of one brick-course in width and survived to a height of 0.72m, also having been truncated by the modern pile. At the southern end of this wall was a stopped-end, forming a gap of 0.60m in width, which contained the remains of metal boiler (diameter 0.34m) and a ceramic sink, neither being *in-situ*. Unstable trench sides made further excavation impossible, but it is most probable that this was the under-stairs storage cupboard as seen in all the other houses in this row. The western wall contained a fireplace measuring 0.98m wide with the cheeks measuring 0.35m in width and 0.49m in length and survived to a height of 0.33m minimum and 1.16m maximum, comprising only one brick-course in width. To the north of the northern fireplace cheek, a stone staircase could be seen in the elevation but this belonged to House B to the west. The floor comprised hand-made bricks laid east/west (Plates 15-18). The rear yard area remained unexcavated below modern services.

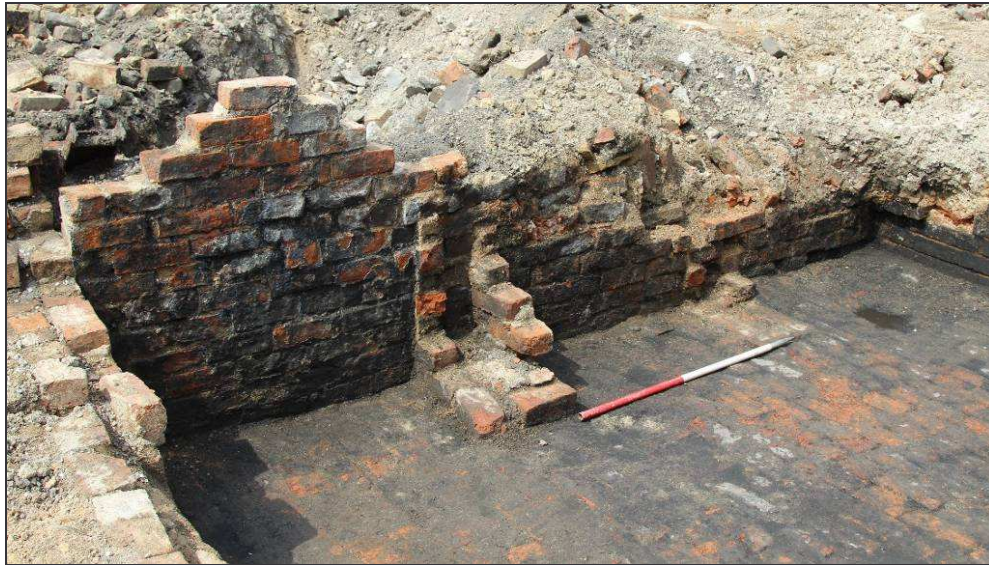
*Plate 16: House A cellar fireplace on the western wall, looking north-west*

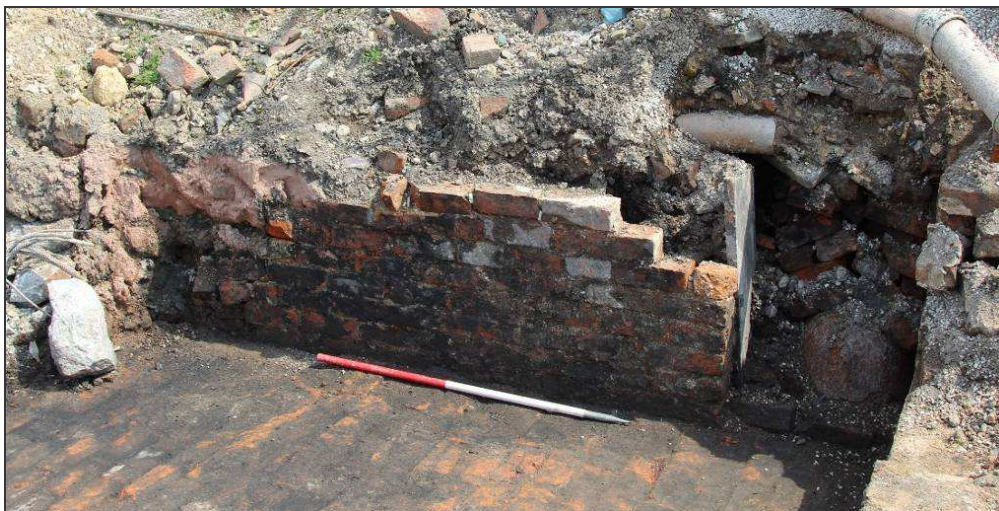
*Plate 17: House A, under-stairs storage space containing the upturned boiler, looking north-east*

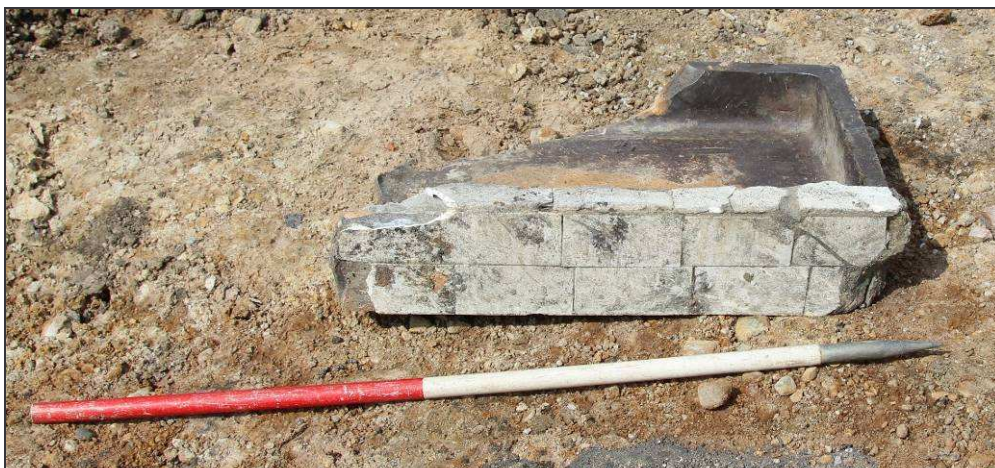
*Plate 18: House A, ceramic sink found in the under-stairs storage area*

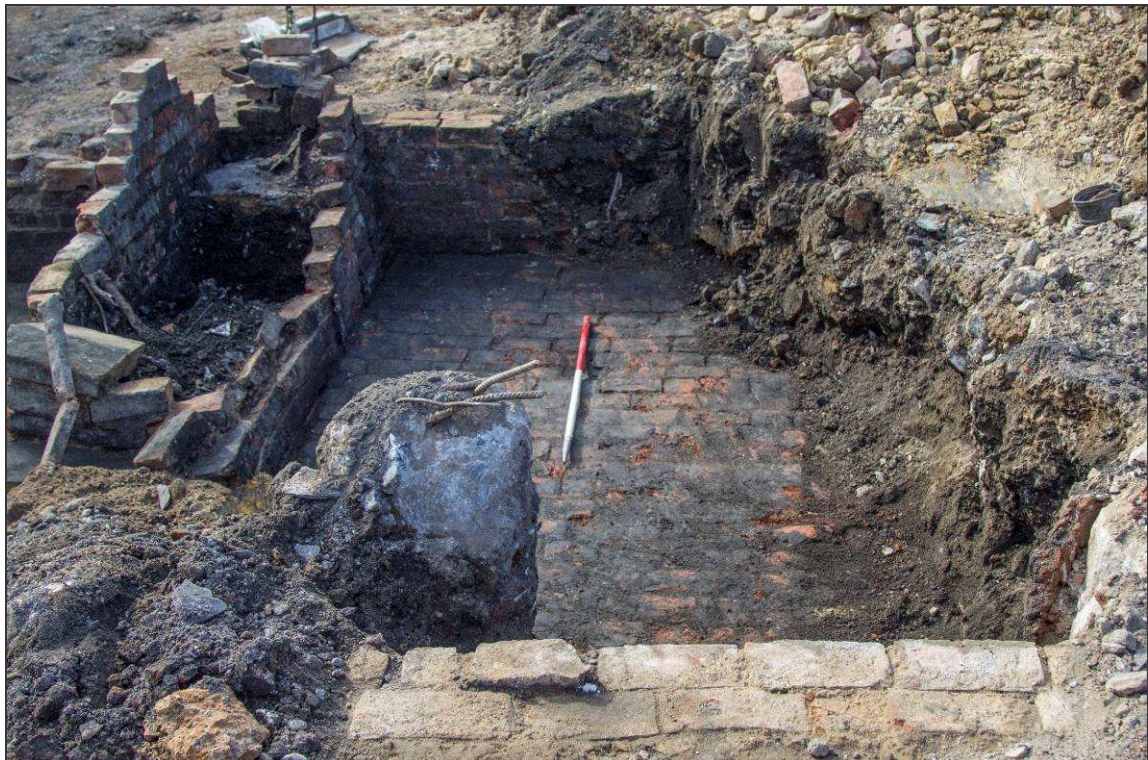
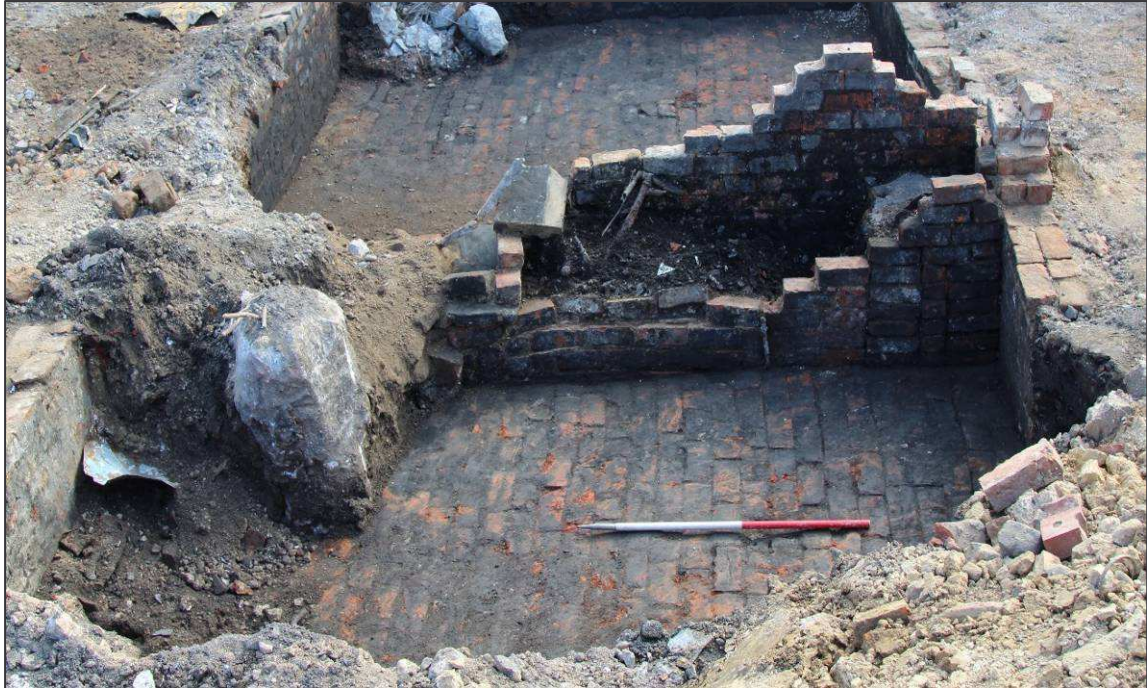
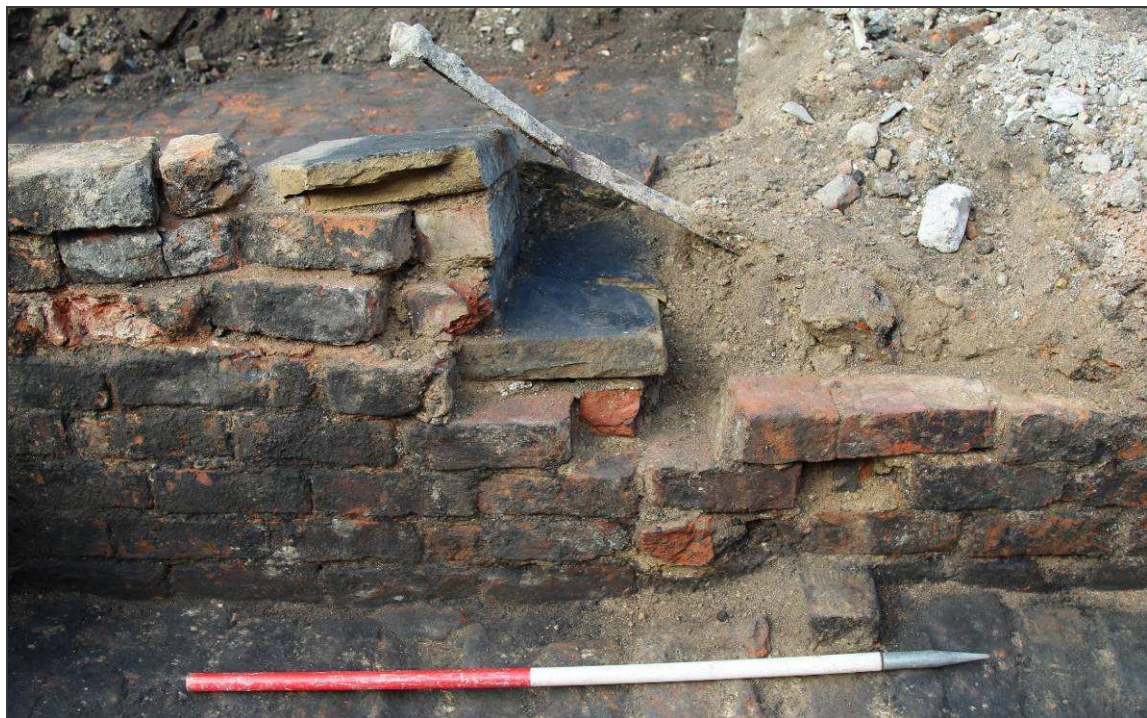
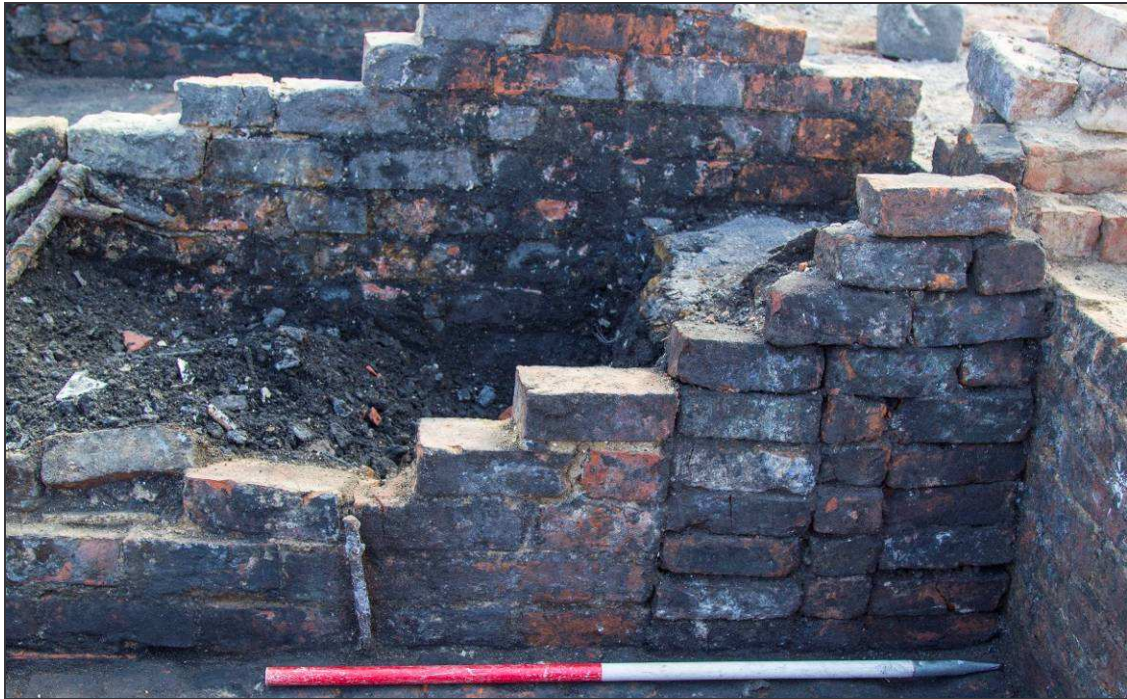
*Plate 19: House B, general shot of cellar room, looking south*

*Plate 20: House B, general shot of cellar room, looking east*

*Plate 21: House B, staircase as seen in the party wall from House A, looking west*

*Plate 22: House B, staircase wall and bricked-up section, looking east*

In the south-east corner of the room were the remains of a staircase, which appeared to have had an under-stairs storage area, which had been bricked-up at a later date (Plate 22). The in-fill contained large amounts of black cinder and domestic rubbish, including animal bone, glass bottles and some pottery fragments, some of which appeared to have been burned in a fire or mixed in with hot ash and cinder. By far the most unusual content was the remains of a bicycle frame. The wall of the staircase and bricked-up section comprised only one brick-course in width. The staircase wall measured 1.56m in length (north/south) and survived to a height of 0.45m. The bricked-up section of wall measured 0.58m and survived to a height of 0.78m. Only two of the stone steps of the staircase survived, which measured 0.74m by 0.33m (visible), the northerly-most step was 0.30m from the cellar floor surface. The bottom of the steps had been truncated by a modern pile as before (Plates 19-22).

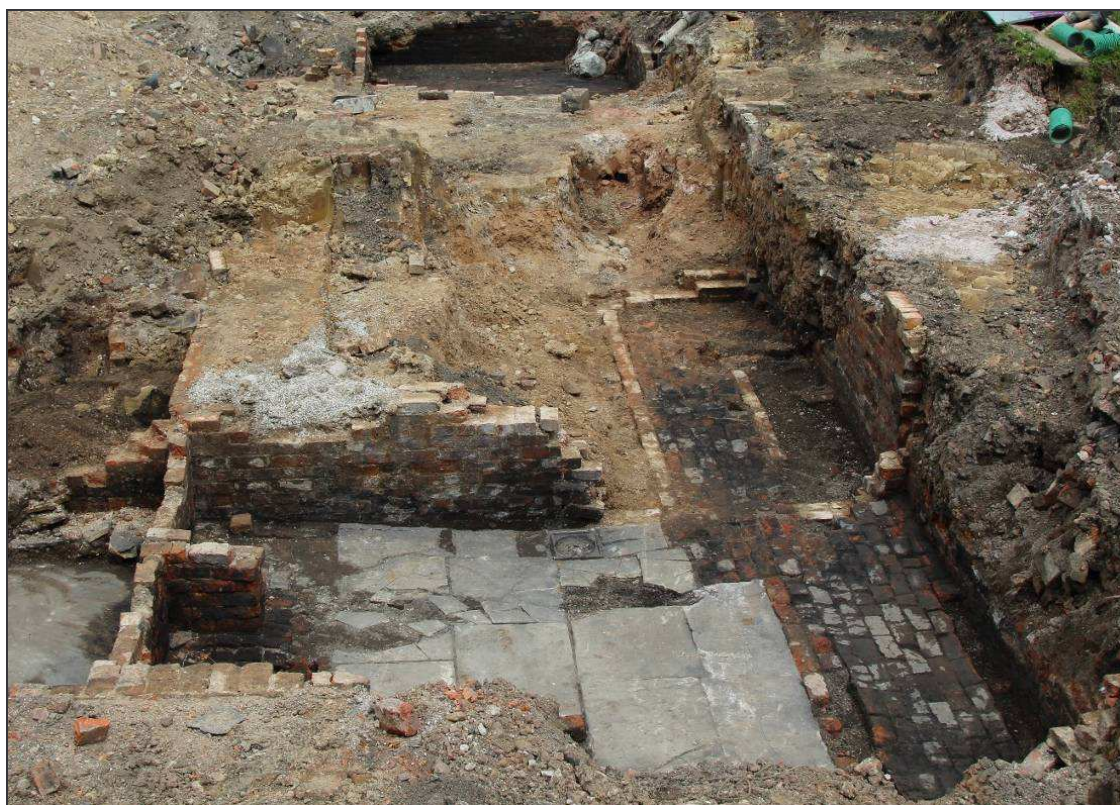
*Plate 23: House 1, cellar room, coal store and corridor (House A in the background), looking north-west*

House 1 (Plate 23) lay to the south of House A and fronted Boundary Street East, comprising a cellar at the front of the house (Plate 24) measuring 4.42m east/west by 3.40m north/south with what appeared to be a storage area along the eastern side of the room. The floor in the main cellar room consisted of flagstones, whilst the storage area, measuring 1m wide, had a brick floor and was separated from the main room by a single brick-course wall aligned north/south (Plate 25). A thick deposit of coal fragments and dust found at the southern end of the storage area suggest this may have been the coal store. The main room comprised a fireplace (Plate 27) on the western wall, 0.88m wide, flanked by two brick cheeks, two brick-courses wide. The floor around the fireplace and to the north in the corner of the room was brick-laid, which had been truncated during the evaluation trenching. A strip of brick floor, three brick-courses wide also lay along the front wall of the room stretching from the south-west corner to approximately half way across the room. A square ceramic drain, with circular recess, lay at the back of the room against the northern wall.

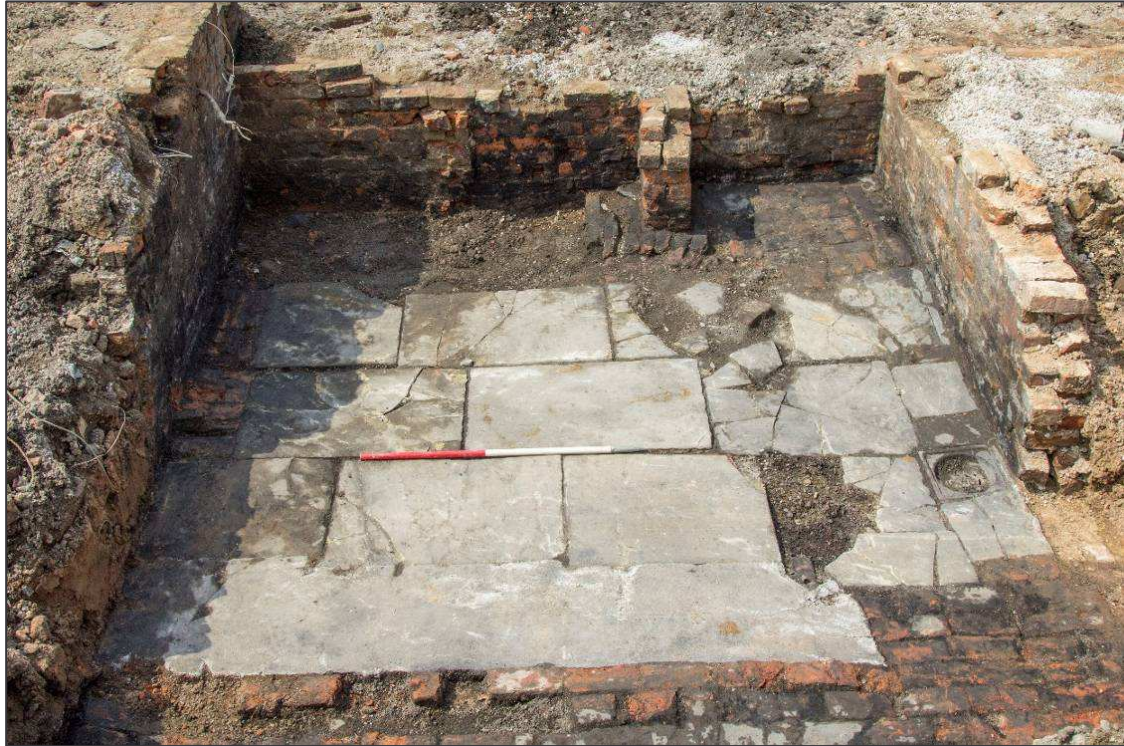
*Plate 24: House 1, cellar room with stone flag and brick floor, fireplace and drain, looking west*

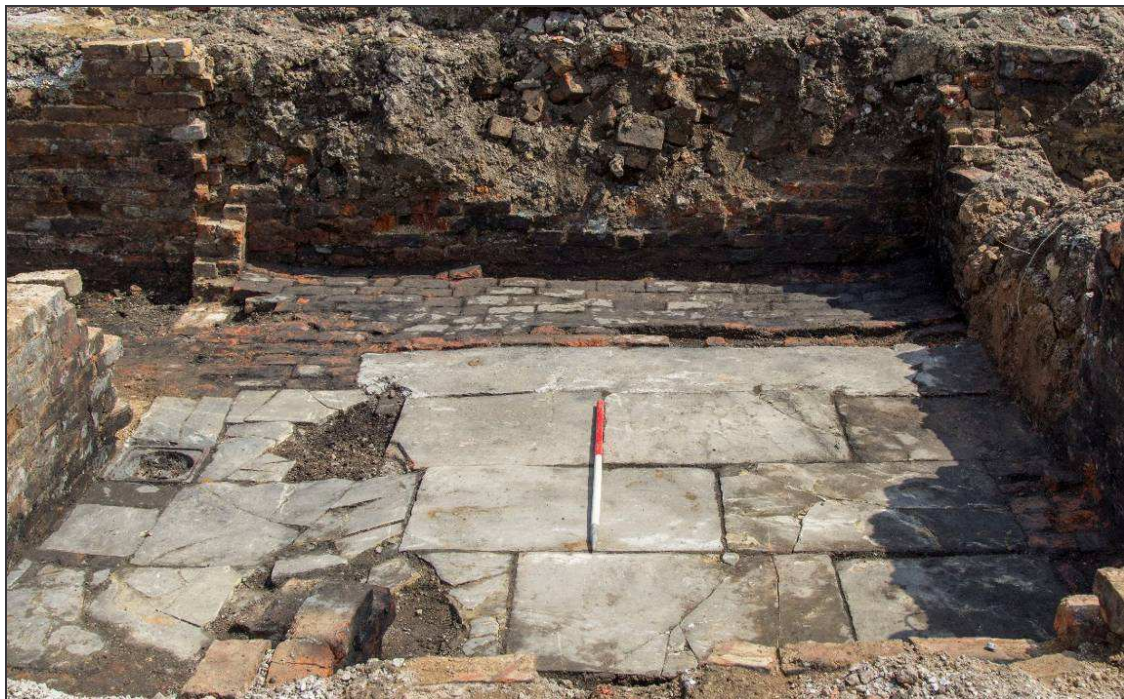
*Plate 25: House 1, cellar room. The remains of the doorway leading into the corridor can be seen on the left of the photo, looking east*

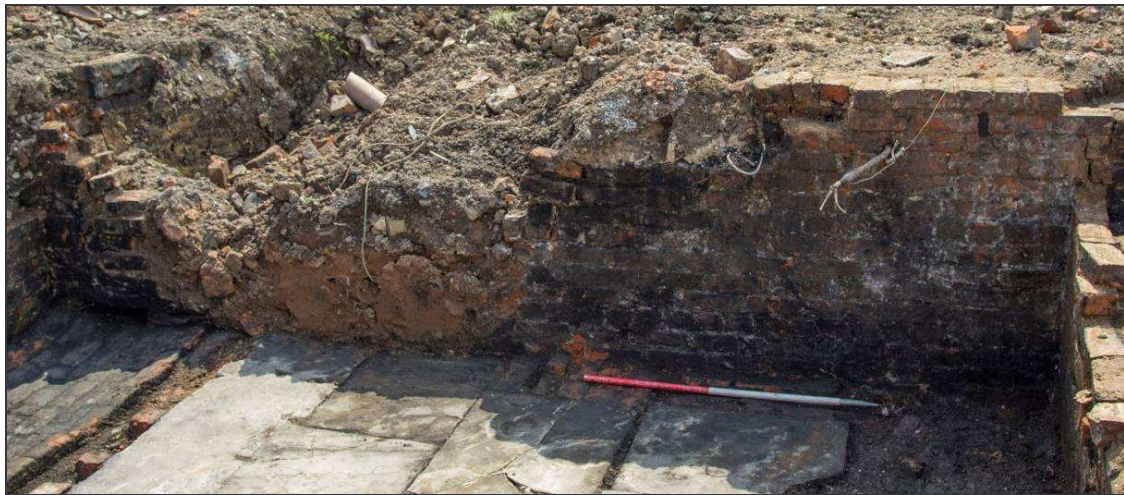
*Plate 26: House 1, front wall showing intrusion by modern services, looking south-east*

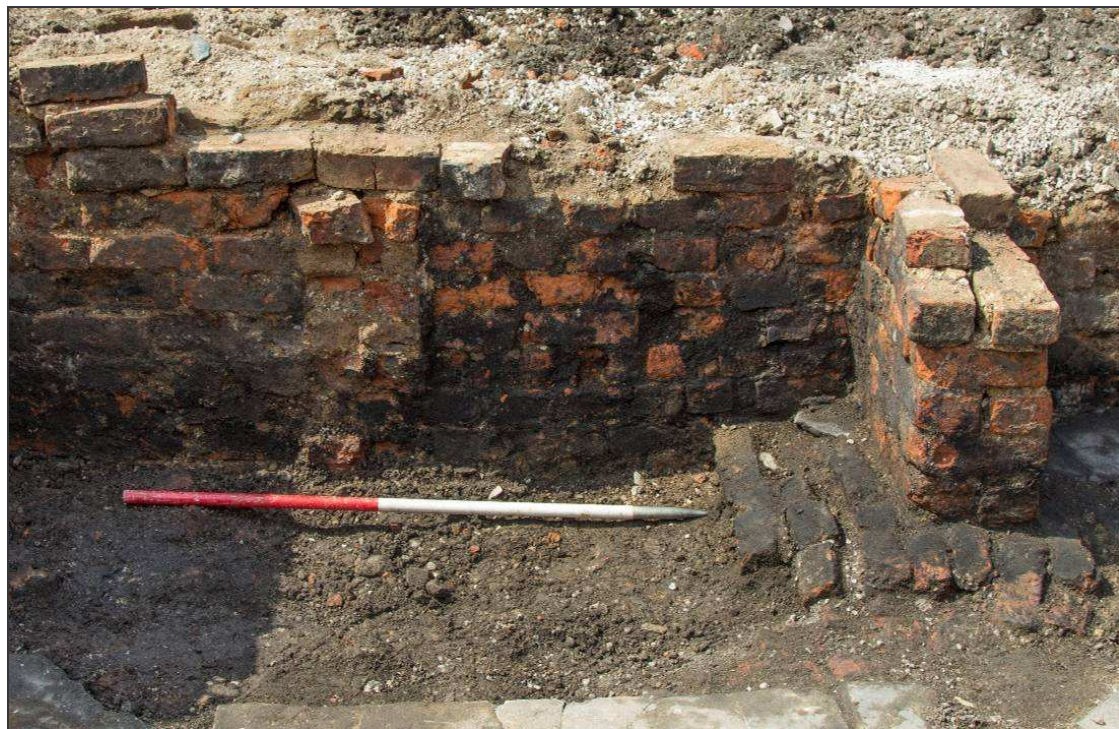
*Plate 27: House 1, fireplace detail, looking west*

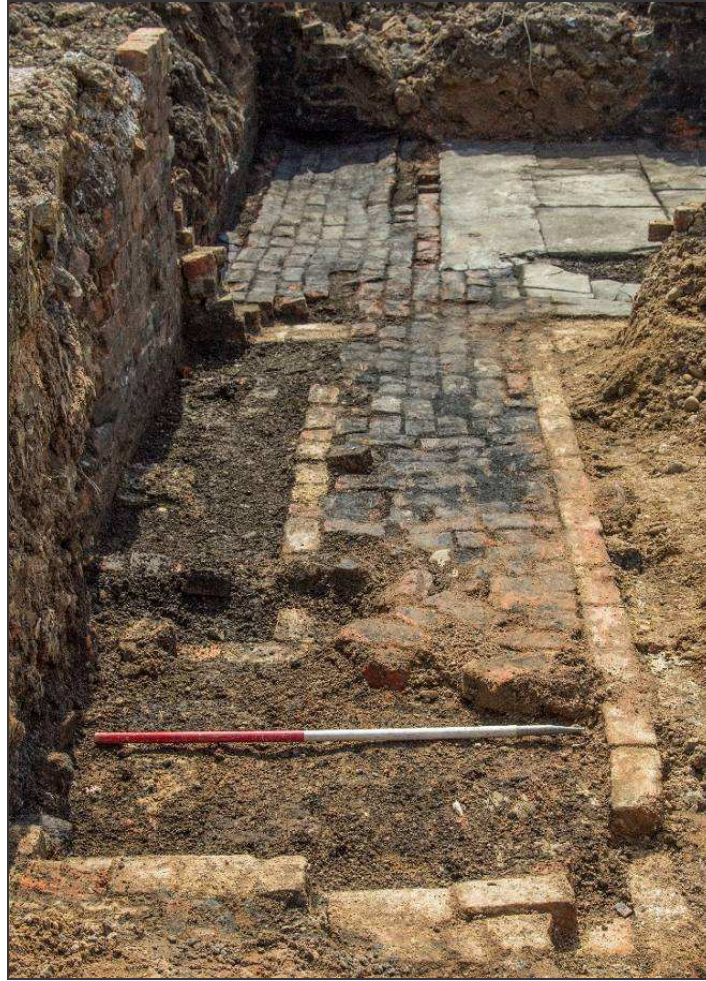
*Plate 28: House 1 rear courtyard area subterranean corridor, looking south*

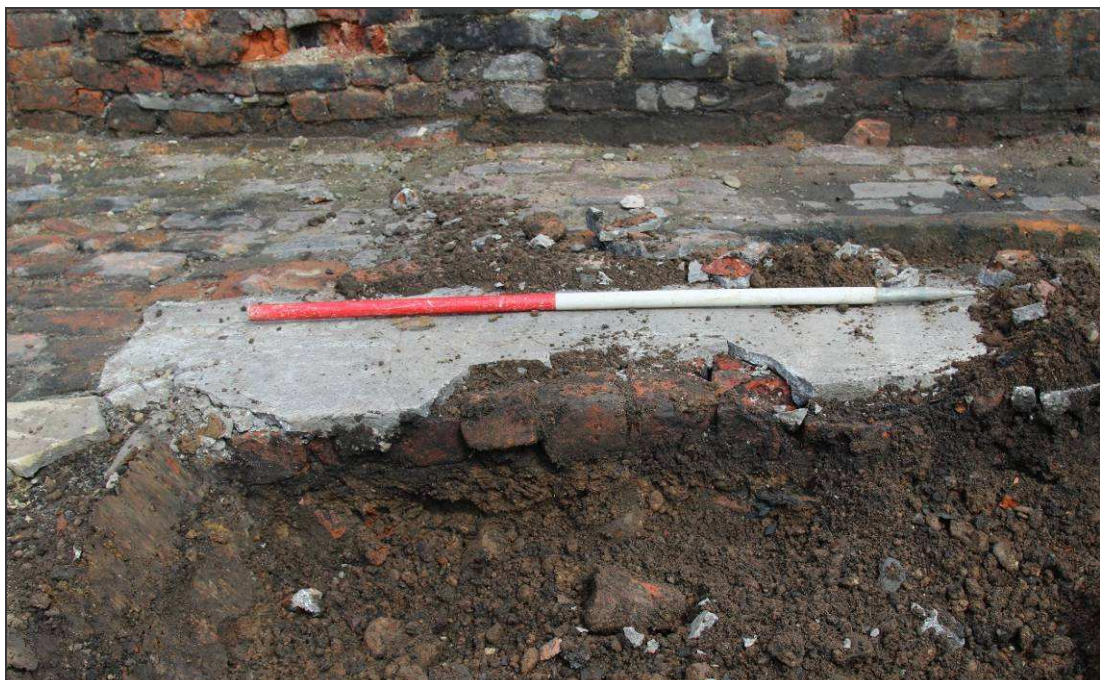
*Plate 29: Sondage through the floor of House 1 showing bricks beneath the strip of concrete and natural deposits below*

Post-excavation, a sondage was dug through the floor by lifting one of the flagstones to establish whether the floor was constructed with a stone-flagged floor or whether this was a later renovation. The presence of bricks under the concrete strip but absence below the flags, where natural sands and clay were found, suggests the stone-flagged floor was original to the construction, but the concrete was a later addition (Plate 29).
