## Archaeological Excavation Report

Manchester Engineering  
Campus Development,  
Grosvenor Street,  
Manchester

**Document Type:** Archaeological Excavation Report

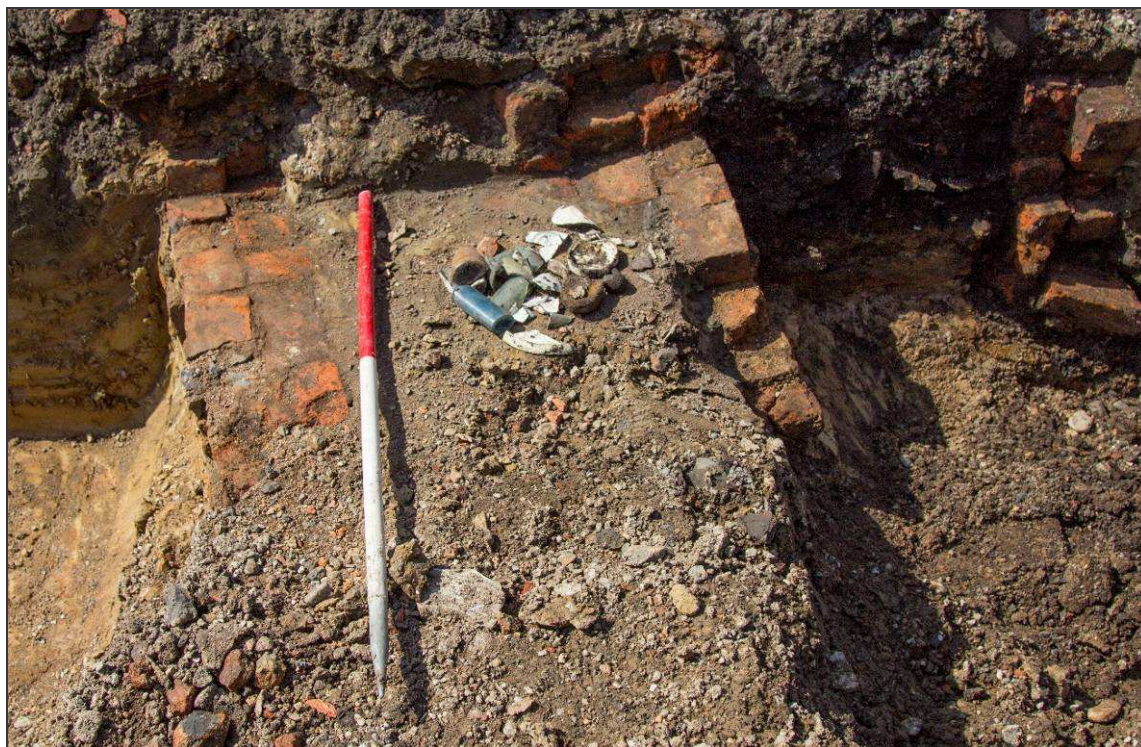
*Plate 30: House 1 and House A, rear courtyard/back alleyway area surviving walls as seen during the excavation of evaluation trench 3, looking west*

During the evaluation trenching, remains of the rear courtyard walls had been found, including a rubbish pit, which was likely to have lay within the narrow alleyway separating the two rows of houses. These were again located, but did not survive the backfilling and re-excavation process very well (Plate 30).

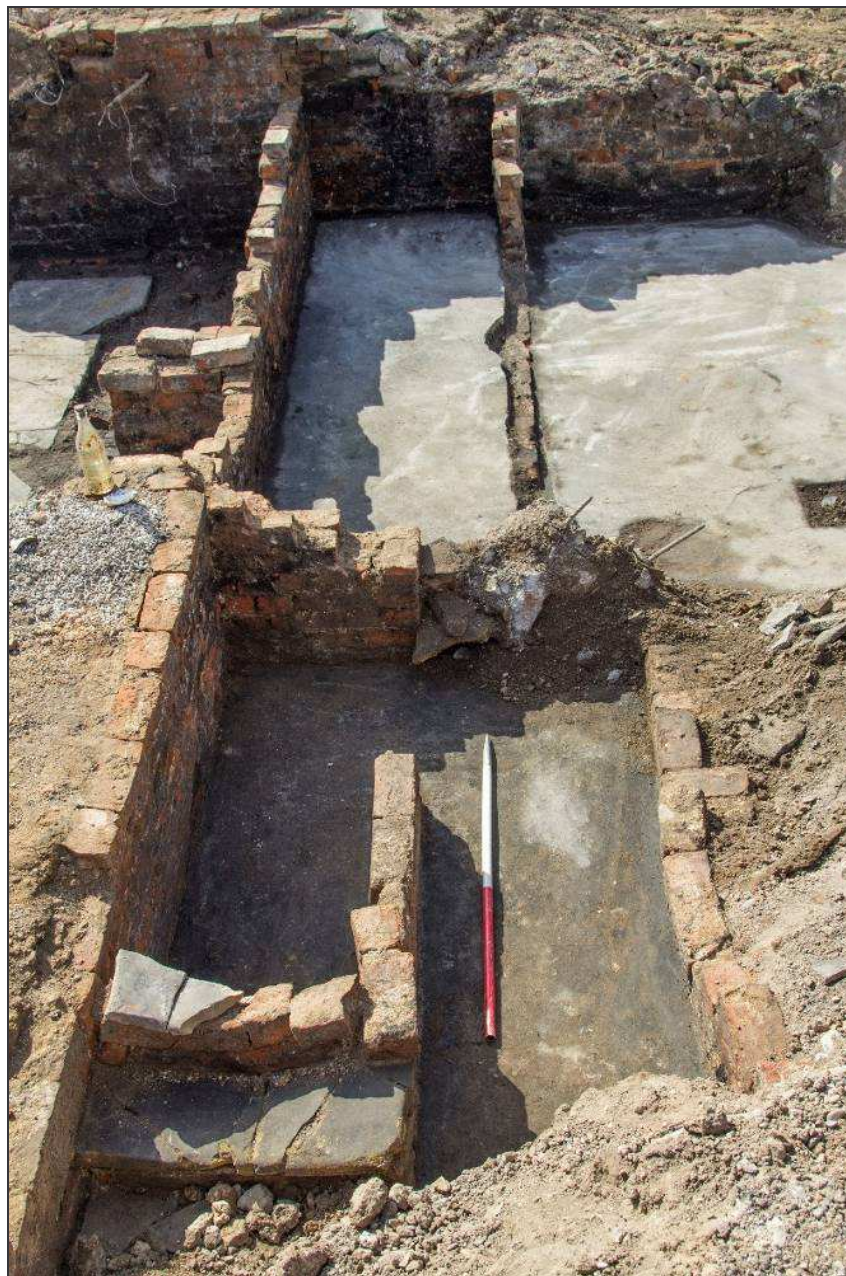
*Plate 31: General view of House 2 fully excavated, looking south*

House 2 (Plates 31-34) also fronted Boundary Street East on the western side of House 1. This too consisted of one cellar room at the front of the house with an internal storage area as seen in House 1, measuring 3.90m (total) east/west by 3.30m north/south. The floor in both the main room and the storage area consisted of smooth, light-grey concrete with a ceramic drain (0.30x0.30m) as seen in House 1, towards the north-east corner of the room. Along the eastern side of the room, the storage area was separated from the main room by a single brick-course wall aligned north/south, part of which survived to 0.64m in height. The front wall of the house, to the south, consisted of a continuation of the front wall of House 1, constructed using the same hand-made bricks and bonded with light-brown sandy mortar, surviving to 0.66m in height. This wall had been truncated by a modern pile, as seen previously. The eastern wall of the dwelling has been discussed previously, which formed the party wall with House 1. The western wall only survived to 1.40m in length and 0.55m in height, which again, appeared to be only one brick-course thick, having been truncated by modern piles to the south and partly covered in the north-west corner by a large spoil heap. The rear wall of the cellar room, to the north, remained partly covered by the large spoil heap as before, only surviving to 0.07m (one brick-course) in height, hence, it was not quite possible to ascertain whether the wall comprised one or two brick-courses in thickness. However, the continuation of the wall to the east, across a doorway, appeared to be a continuation of the rear wall of House 1, which was two brick-courses wide. No fireplace was present in the main room.

In the north-east corner of the room, within the rear wall of the cellar, were the remains of a doorway (blocked by a modern pile), which appeared to lead into an internal corridor (0.70m in width) and staircase, comprising single brick-course walls and a concrete floor with the steps formed by stone slabs measuring 0.54m in length (the width of the stairwell) and approximately 0.26m in width. Only two of the lower steps survived, and these were in a precarious condition (Plate 34). The stairwell and corridor were excavated to a length of 2m, further north towards the rear of the house remained covered by the large spoil heap and therefore, no further excavation could take place in this area and the bottom of the steps not reached. The walls survived to a maximum height of 0.50m along the corridor, and 0.68m east of the staircase.

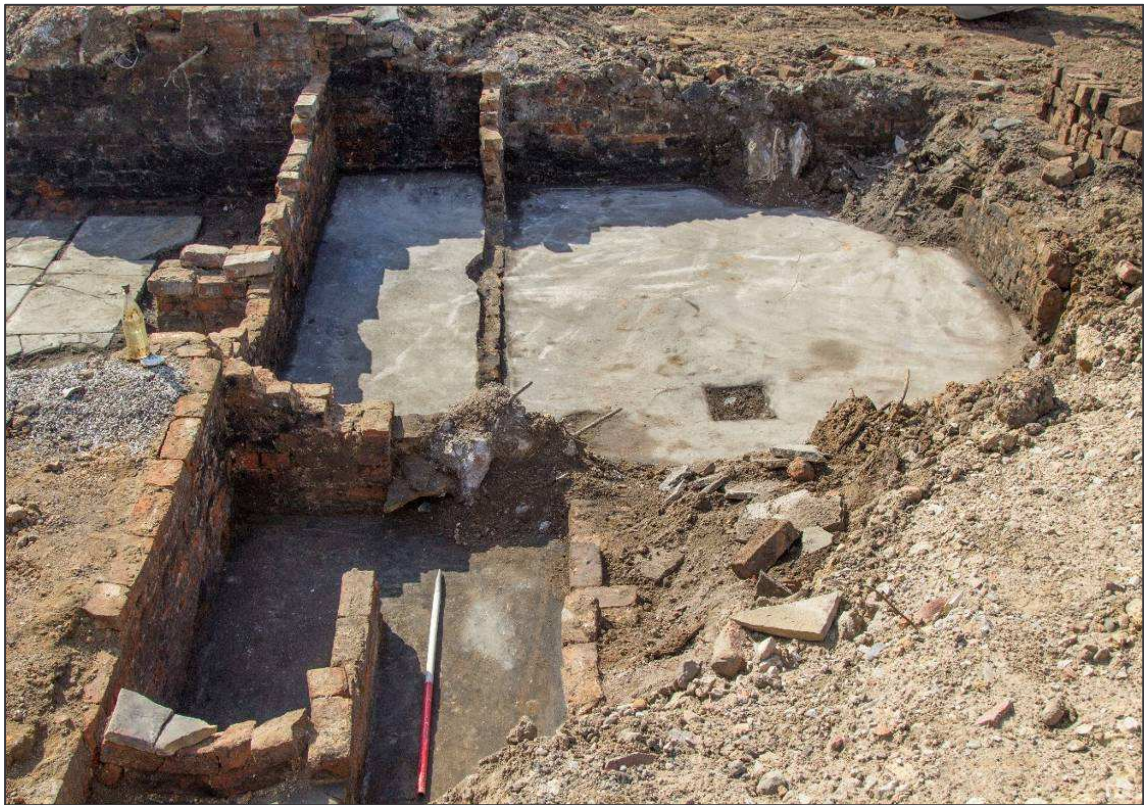
*Plate 32: General view of House 2 fully excavated, looking south*

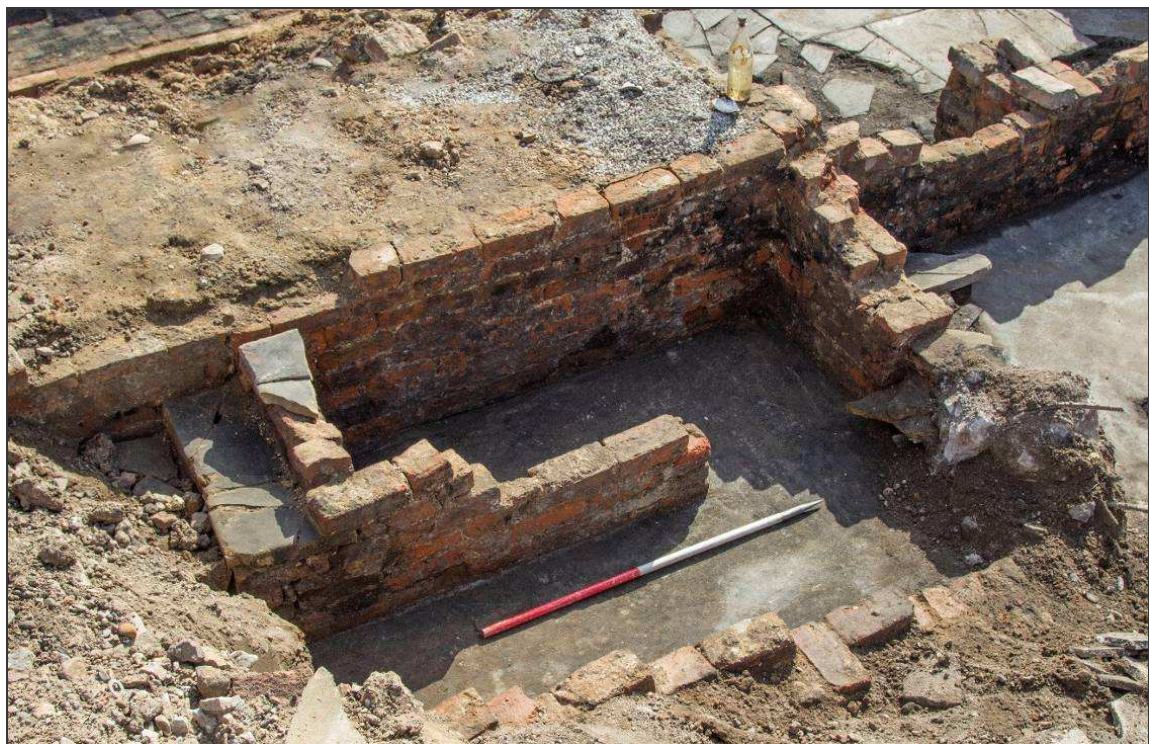
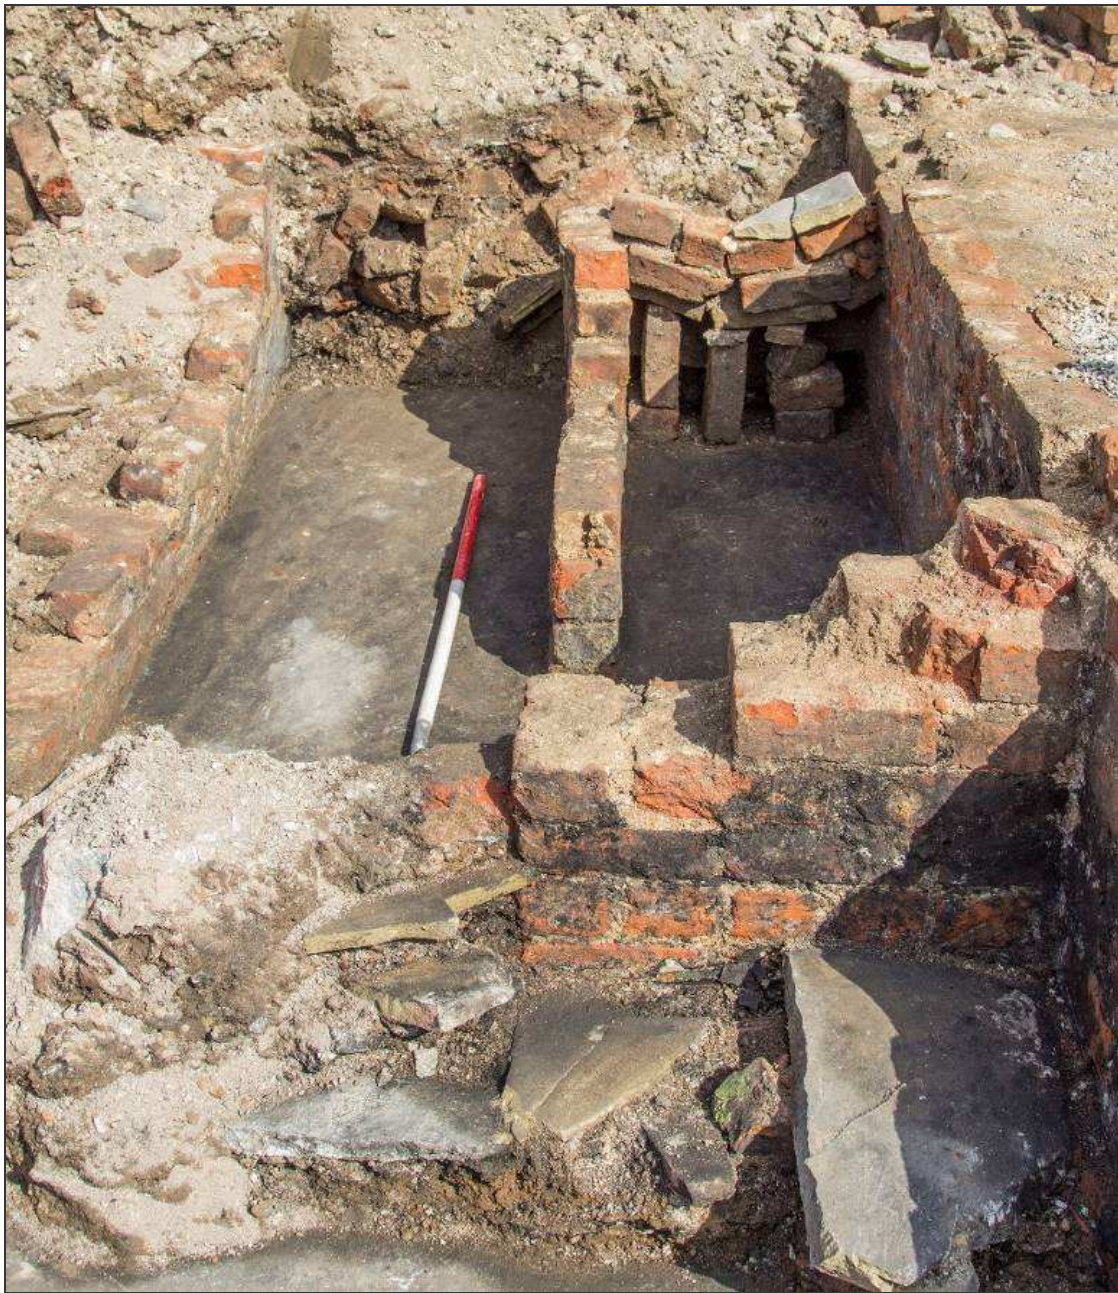
*Plate 33: House 2 staircase and corridor, looking south-east*

*Plate 34: House 2 staircase and corridor, looking north (upright bricks supporting the step are not in-situ)*

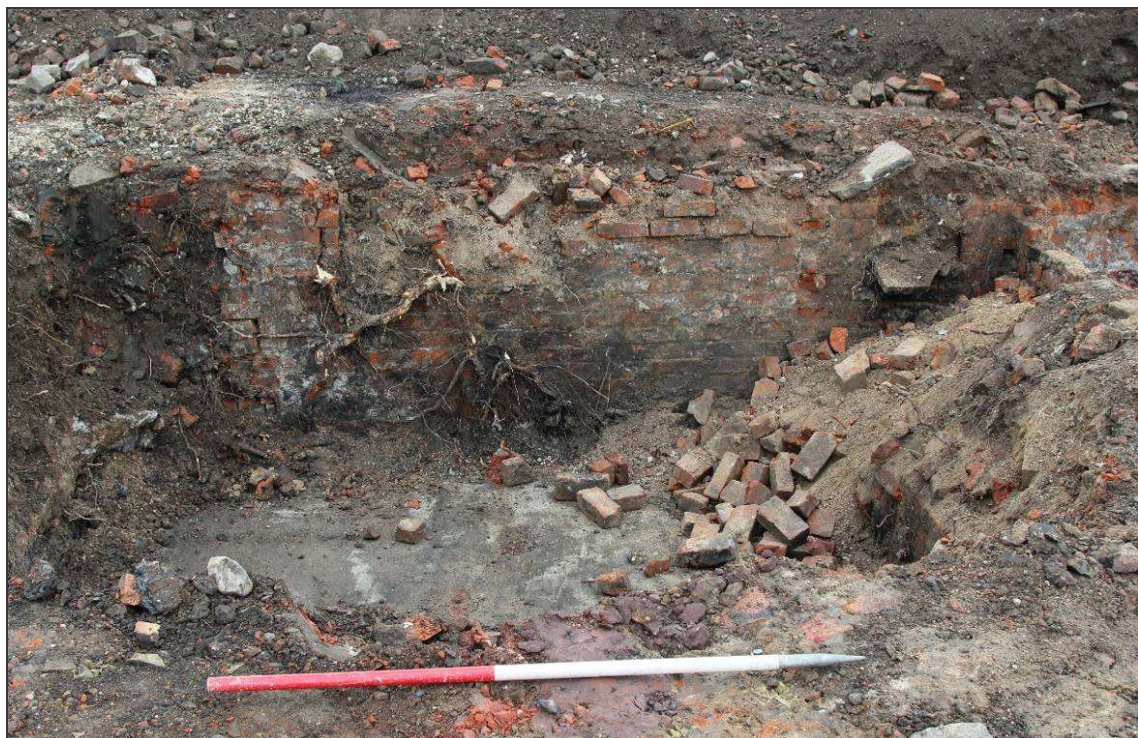
*Plate 35: House 3, looking south*

House 3 was constructed from hand-made bricks bonded with light brown sandy mortar measuring 4.60m east/west (excavated length) by 3.40m north/south. The remains of a staircase could be seen in the south-west corner of the room, but these did not appear to have survived very well. Any remaining walls survived to a height of 1.50m maximum. The floor surface was concrete and the southern wall appeared to have been truncated by a modern service and tree roots (Plate 35). The distance from the back wall of the cellar to the garden wall measured 4.10m, and the distance from the garden wall to the narrow alleyway measured 1.80m (Plate 36).

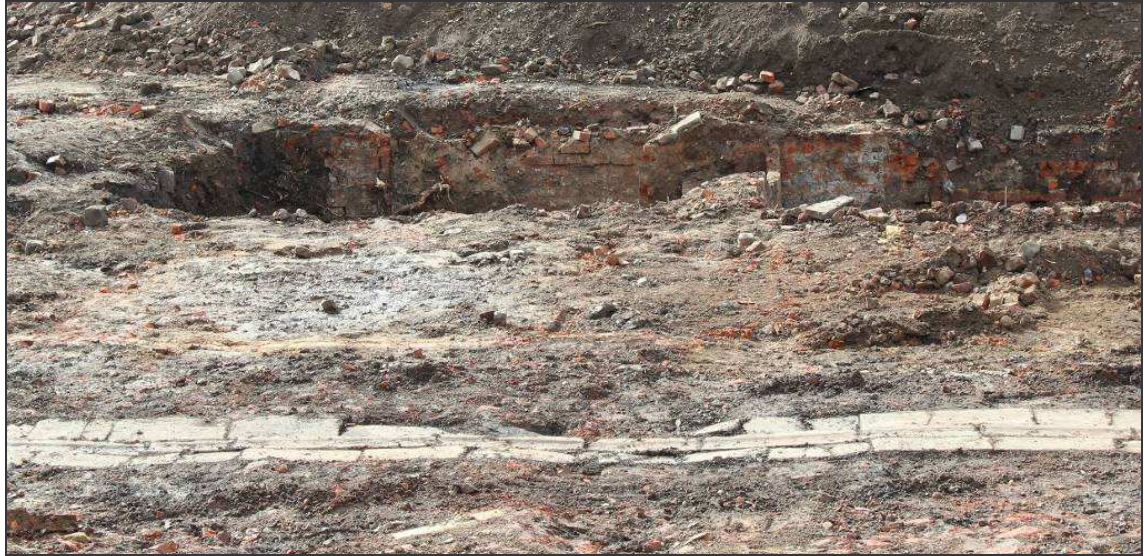
*Plate 36: House 3 showing alleyway in the foreground and back yard area, looking south*

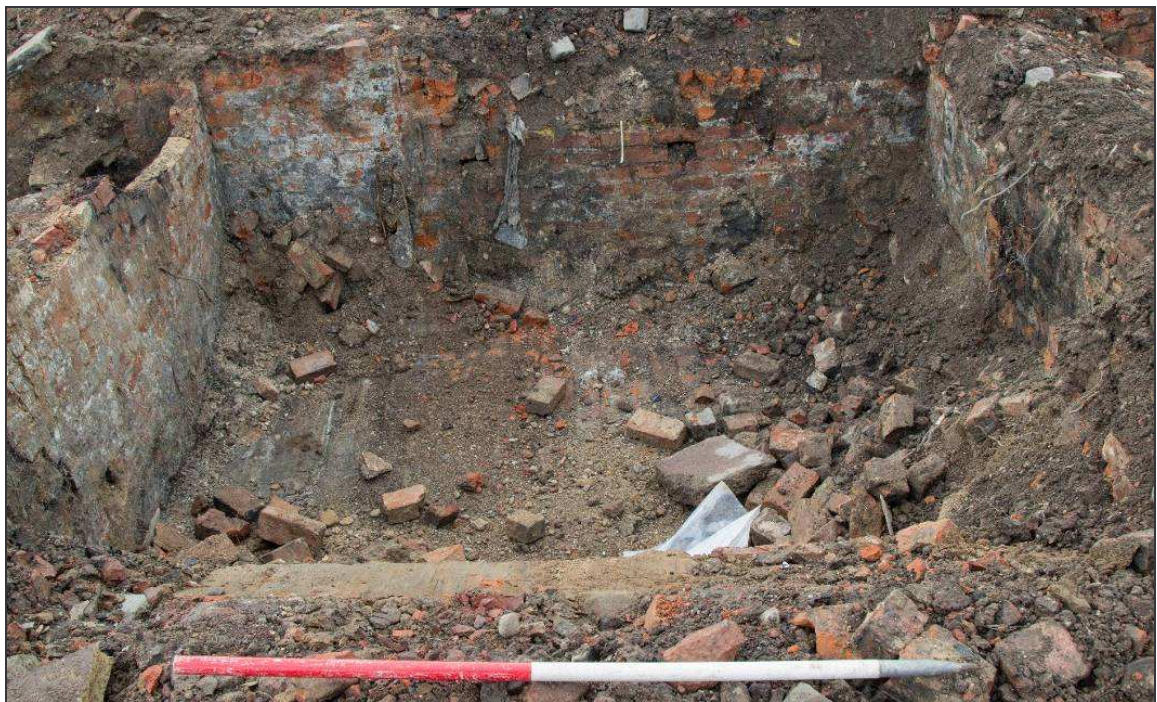
*Plate 37: House 4 cellar, looking south*

House 4 (Plate 37) lay to the south-west of House 3, sharing a single-skin party wall measuring 3.30m north/south by 3.35m east/west. The poorly preserved remains of a fireplace could be seen on the east-facing wall, however, no evidence of the staircase was apparent. The north-facing wall contained a vertical drain pipe and gaps in the brickwork which suggest the property might have been fitted with fixtures and fittings contemporary with commercial activity. The remains of the metal boiler were recovered from the spoil along with three glass bottles and a fairly large ‘polo-mint’ shaped object (Plate 38). The flooring appeared to consist of a strip of concrete approximately 1m wide along the eastern wall with the rest of room containing a brick-laid floor. The back yard arrangements appeared to be the same as House 3.

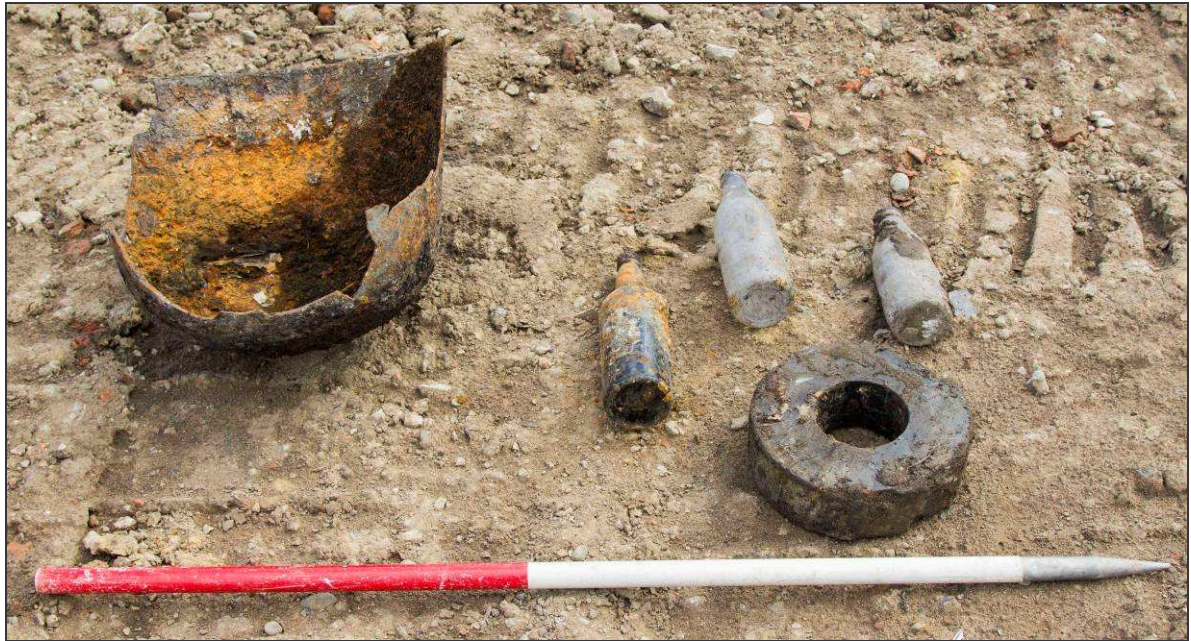
*Plate 38: House 4 finds recovered from the cellar*

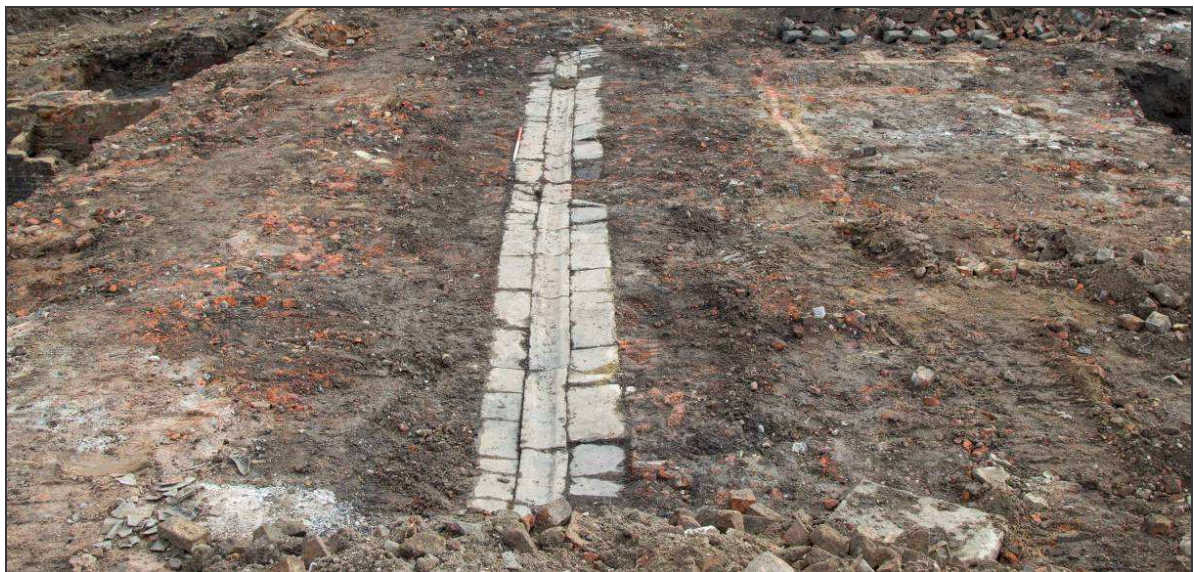
*Plate 39: The narrow, stone-flagged alleyway separating the backs of the two rows of houses. Boundary Street East houses to the right of the photo, Back Grosvenor Street houses on the left of the alleyway, looking east*

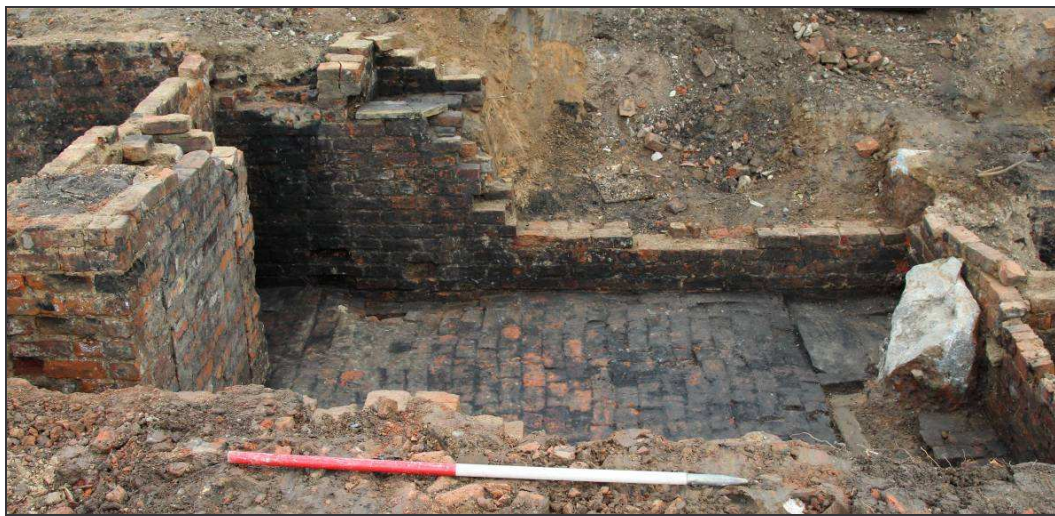
*Plate 40: House C cellar, looking north-west*

House C (Plates 40-41) belonged to the row of houses fronting Back Grosvenor Street. The front and back walls of the cellar comprised a double-course brick wall with the party walls comprising only a single-course in width, laid header. The room measured 4.14m in total east/west by 3.84m north/south, comprising a brick floor. The staircase (not surviving) ran north/south along the eastern wall, measuring 0.72m in width and 2.90m in length, comprising a brick construction with stone-flagged steps. Two stone flags lay at the bottom of the stairs in the north-east corner of the room.

The western wall comprised a fireplace measuring 1.50m in length by 0.48m in depth and survived to a height of 1.58m maximum. This fireplace had been bricked-up to a height of 1.33m at some point before demolition. The presence of hard, dark grey mortar could suggest this occurred around 1860 or later into the early twentieth century. The front wall of the house survived to a height of 1.36m maximum, 0.44m minimum, where the room had been truncated by a pile associated with the recently demolished university building. The highest surviving part of the front wall contained the remains of half a cellar light, which provided a useful cross-section, showing natural material to the north of the wall, where the footpath would have been located (Plate 42). The rear wall of the cellar survived to a height of 1.58m and had been truncated by a modern service pipe.

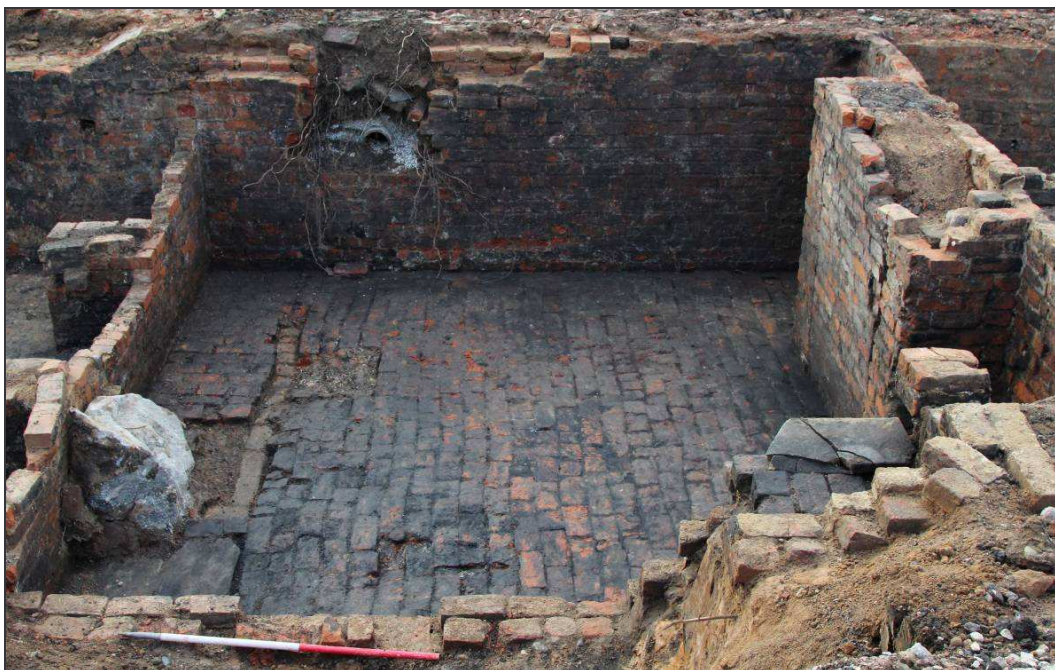
*Plate 41: House C cellar, looking south-east*

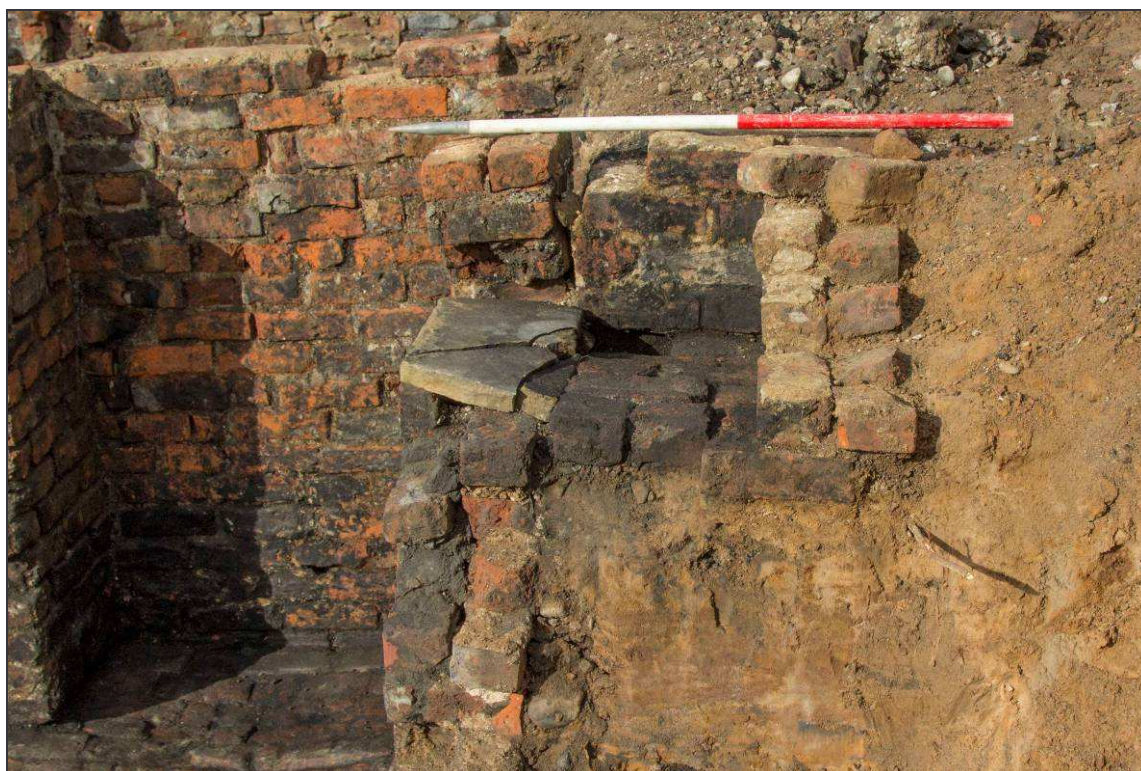
*Plate 42: House C cellar light – cross-section, looking west*

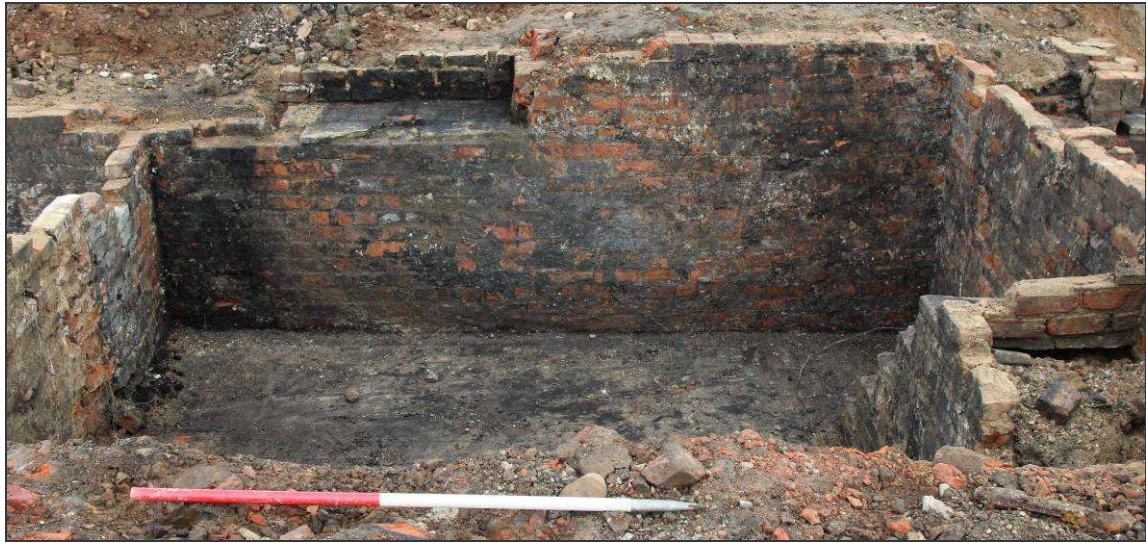
*Plate 43: House D showing the staircase on the right, fireplace on the left and cellar light at the top of the photo, looking north-west*

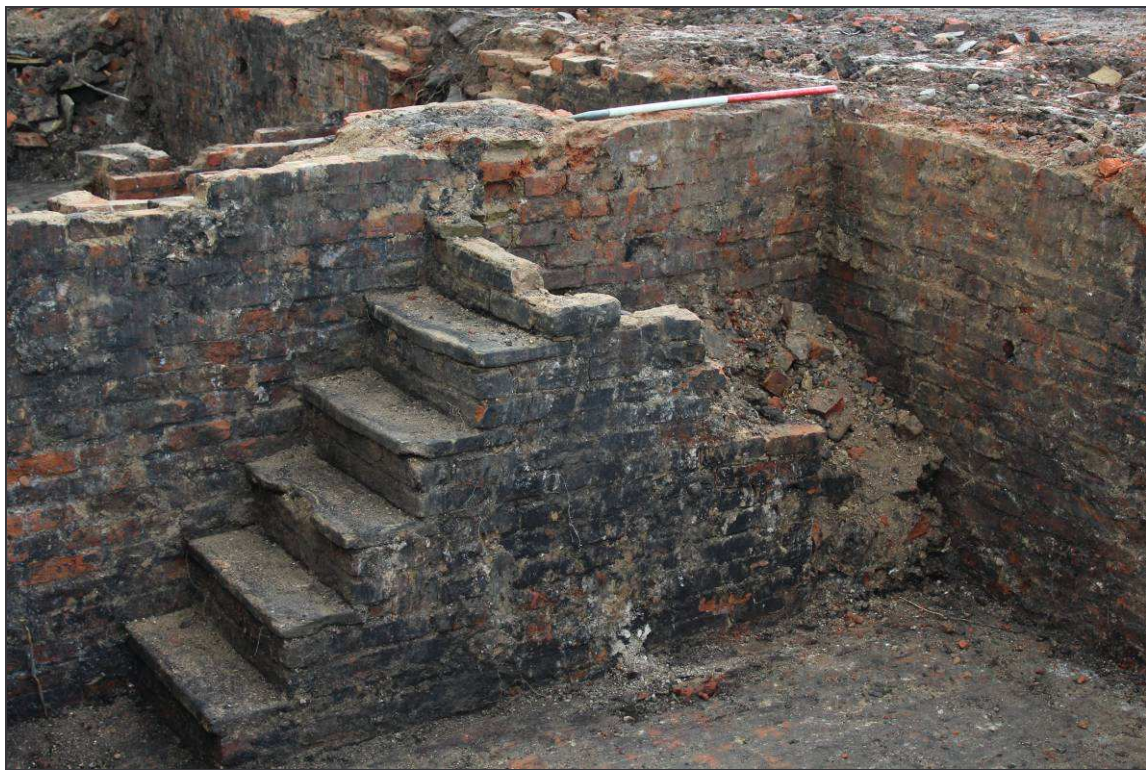
*Plate 44: House D staircase, looking east*

The staircase comprised five surviving stone steps at the lower end, whilst the top steps appeared to have been lost during demolition. The stone steps had been built into the fabric of the party wall confirming their contemporaneity with the original construction of the property. The western wall of the staircase survived to a height of 1.60m, as did the rear wall of the cellar, measuring 1.24m in length from the bottom step to a stopped-end where it remains probable that this formed access to the under-stairs storage cupboard (Plate 44).

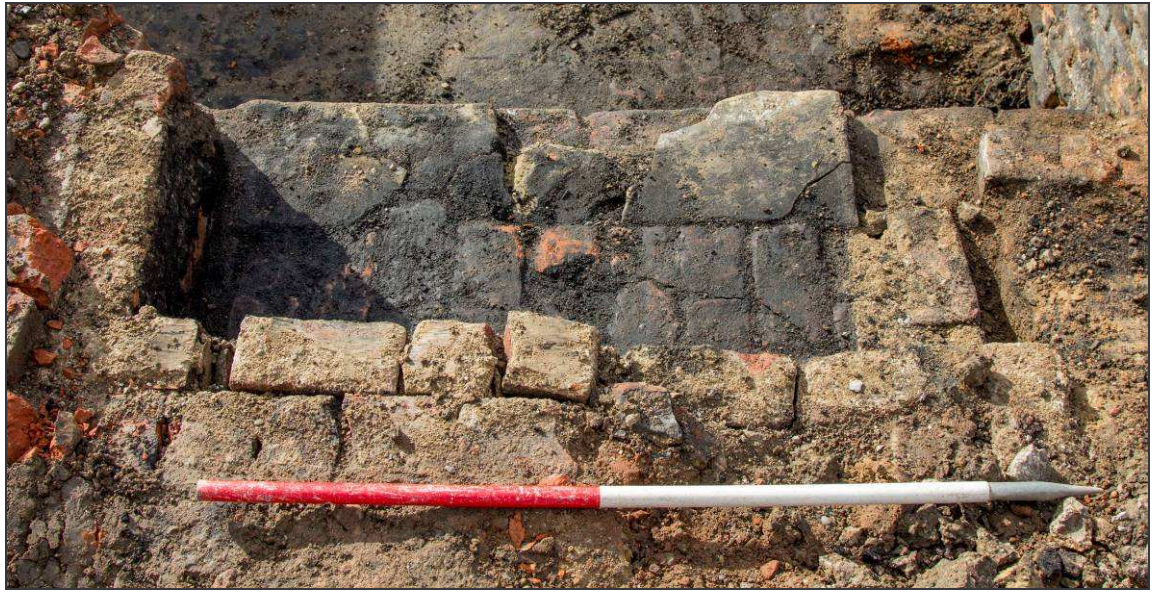
*Plate 45: House D cellar light as seen from above*

The fireplace did not survive excavation particularly well, however, the remains could be clearly seen on the western wall (Plate 46), which survived to a maximum height of 1.55m, forming the party wall with House E. The cellar light survived almost completely intact comprising a brick construction with stone sill (Plate 45).

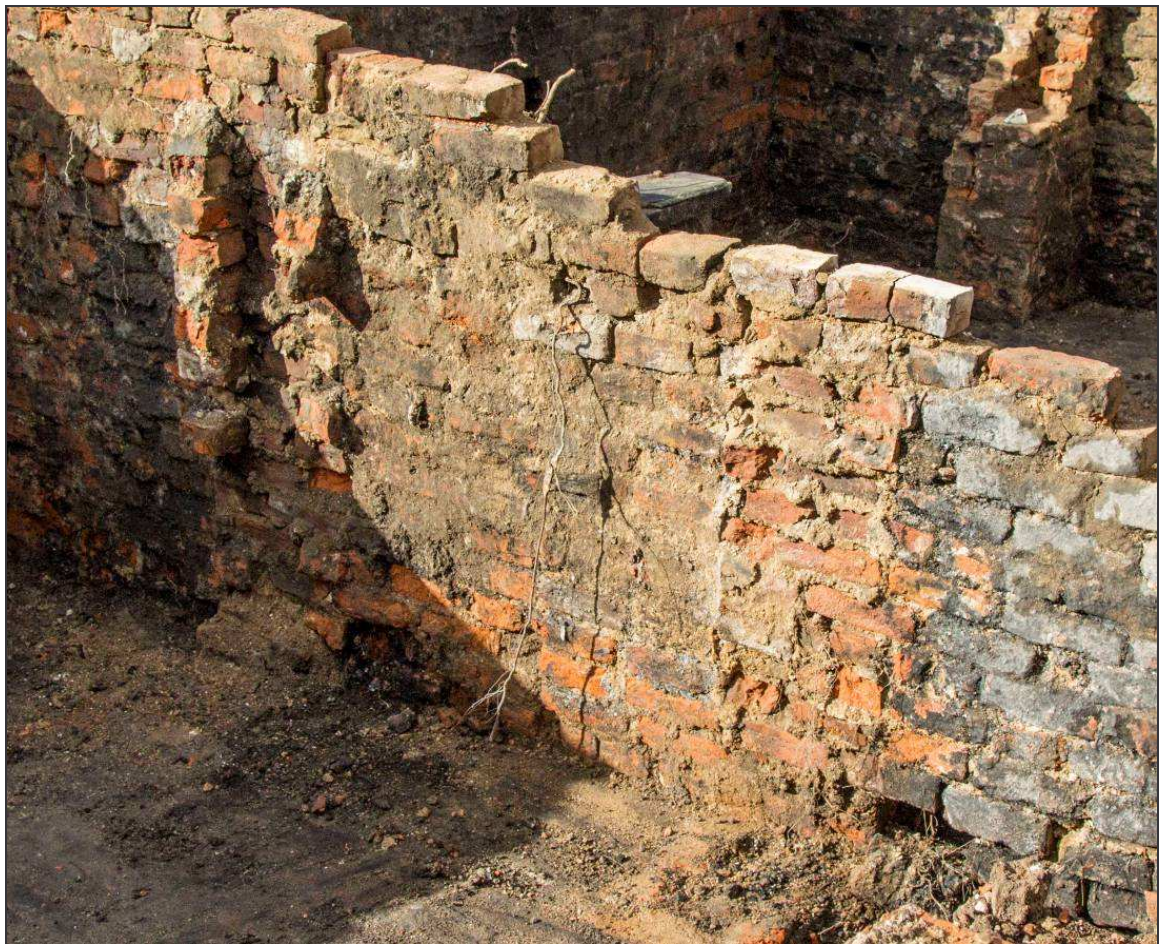
*Plate 46: House D fireplace on the western wall, looking south*

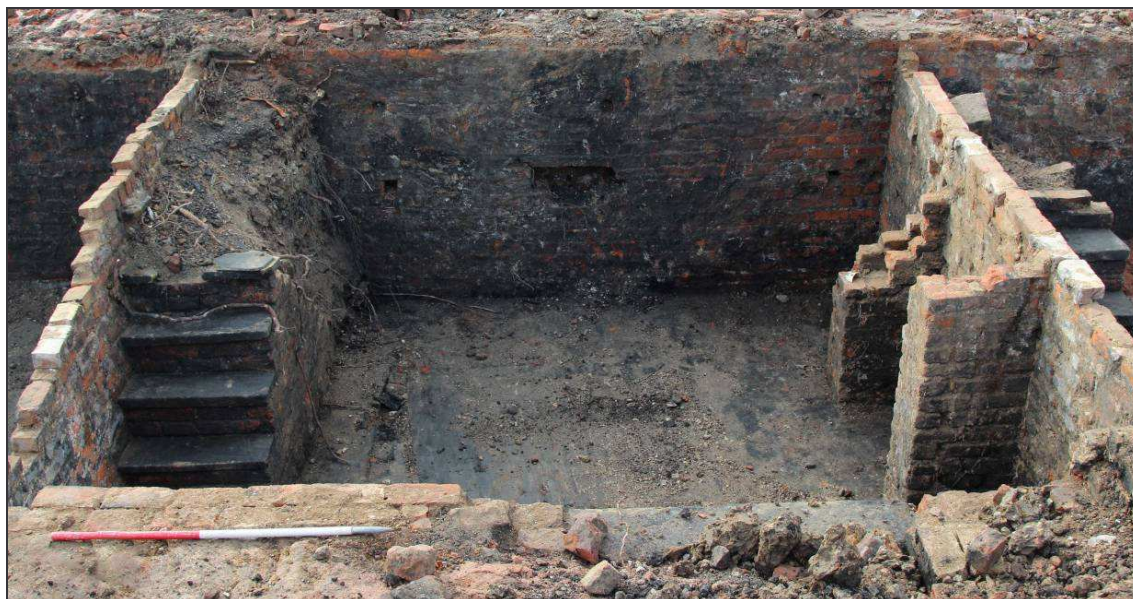
*Plate 47: House E, looking south*

House E (Plates 47-49) lay directly west, adjacent to House D, sharing a party wall, measuring 3.75m north/south by 4.15m east/west, comprising a brick-laid floor. The layout remained the same as House D with the staircase along the eastern wall and fireplace on the western wall. This room did not have flagstone at the bottom of the staircase or next to the fireplace, instead, there was a stone-flagged strip alongside the interior staircase wall (Plate 47).

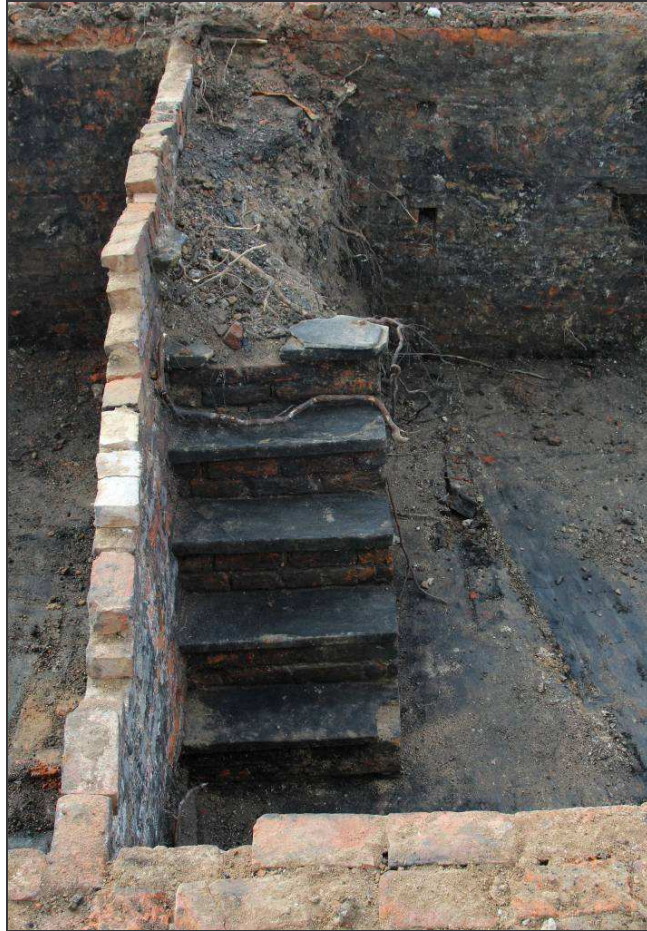
*Plate 48: House E staircase, looking south*

The staircase comprised five surviving stone steps at the lower end, whilst the top steps appeared to have been lost during demolition. The stone steps had been built into the fabric of the party wall confirming their contemporaneity with the original construction of the property (Plate 48). The rear wall of the cellar survived to a height of 1.70m maximum, gaps in the brickwork could have housed fixtures and fittings associated with commercial activity. The front wall of the house again, contained a cellar light constructed as reported earlier in Houses C and D, surviving to a maximum height of 1.31m.

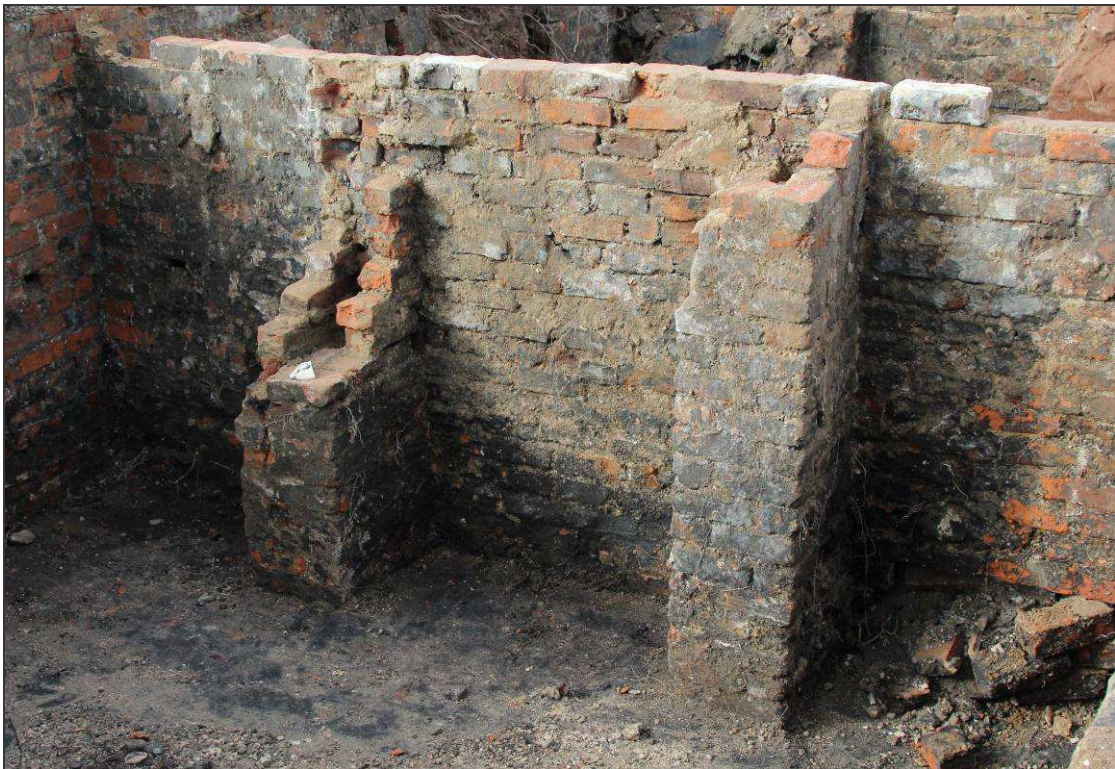
*Plate 49: House E fireplace, looking south*

The fireplace survived reasonably well with this example illustrating how the cheeks forming the sides of the fireplace were built hollow, perhaps to save on the number of bricks used (Plate 49). The northern pillar survived to a height of 1.65m maximum.

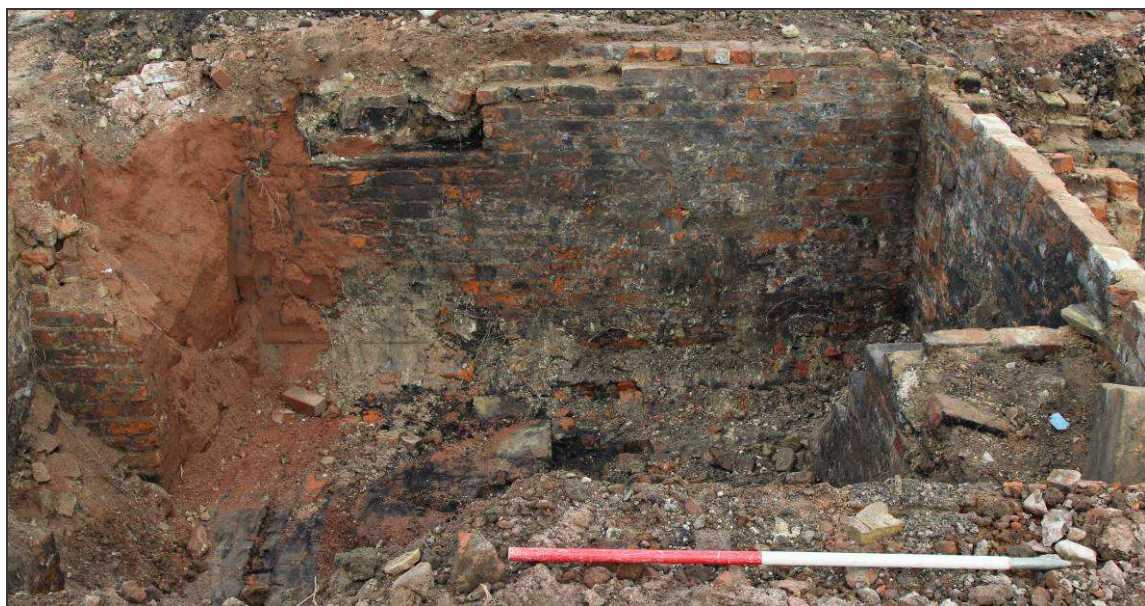
*Plate 50: House F front wall with cellar light, looking north-west*

The front wall of the house survived to a height of 1.75m maximum, contained a cellar light (Plate 53), and had been truncated by the recently demolished building marked by the large deposit of red sand in the north-west corner of the room (Plate 50). As with the other houses the eastern party wall remained only a single-skin wall comprising the staircase, which, again had only five surviving steps where the stopped-end formed the opening to the under-stairs cupboard (Plate 51). The rear wall survived to a maximum height of 1.70m and had been truncated near the top (Plate 52). The fireplace remained the same as in all the other houses (Plate 52).

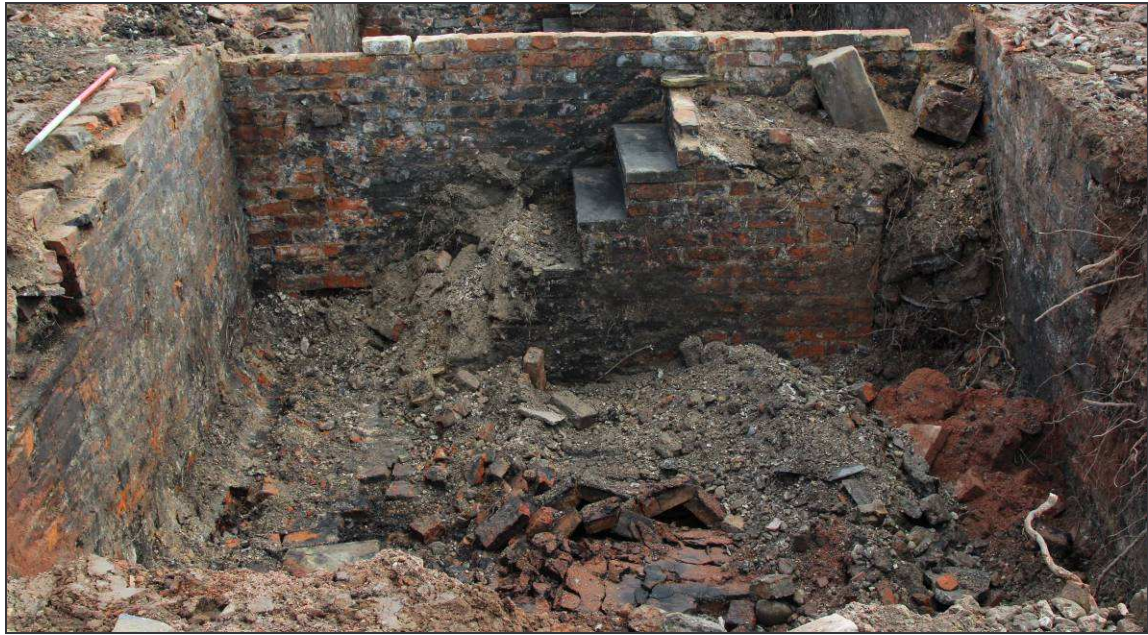
*Plate 51: House F staircase, looking north-east*

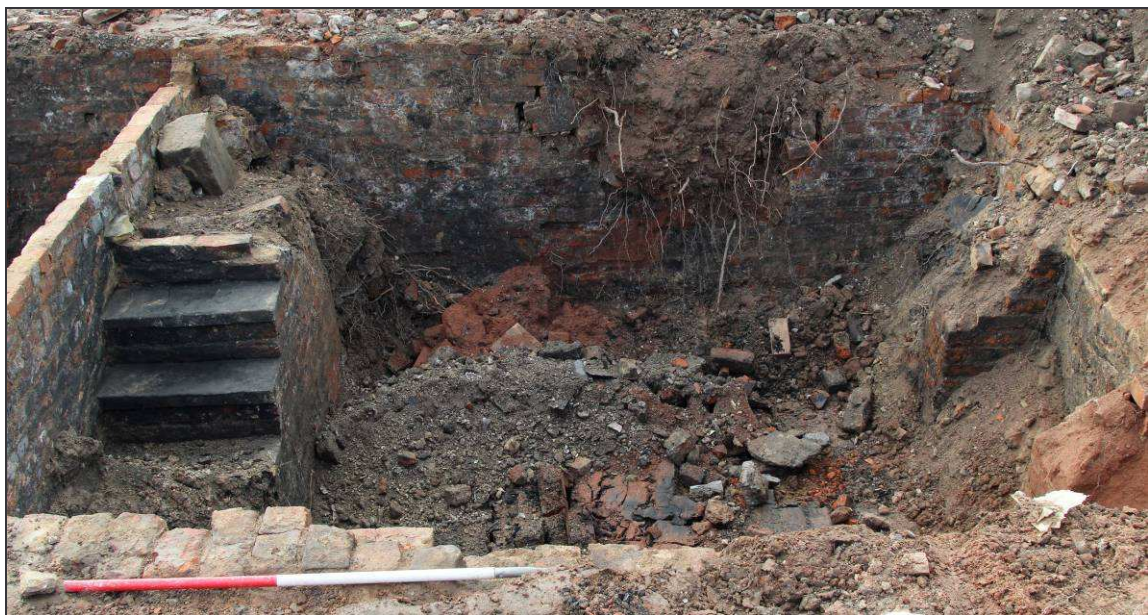
*Plate 52: House F rear wall with fireplace on the right, looking south-east*

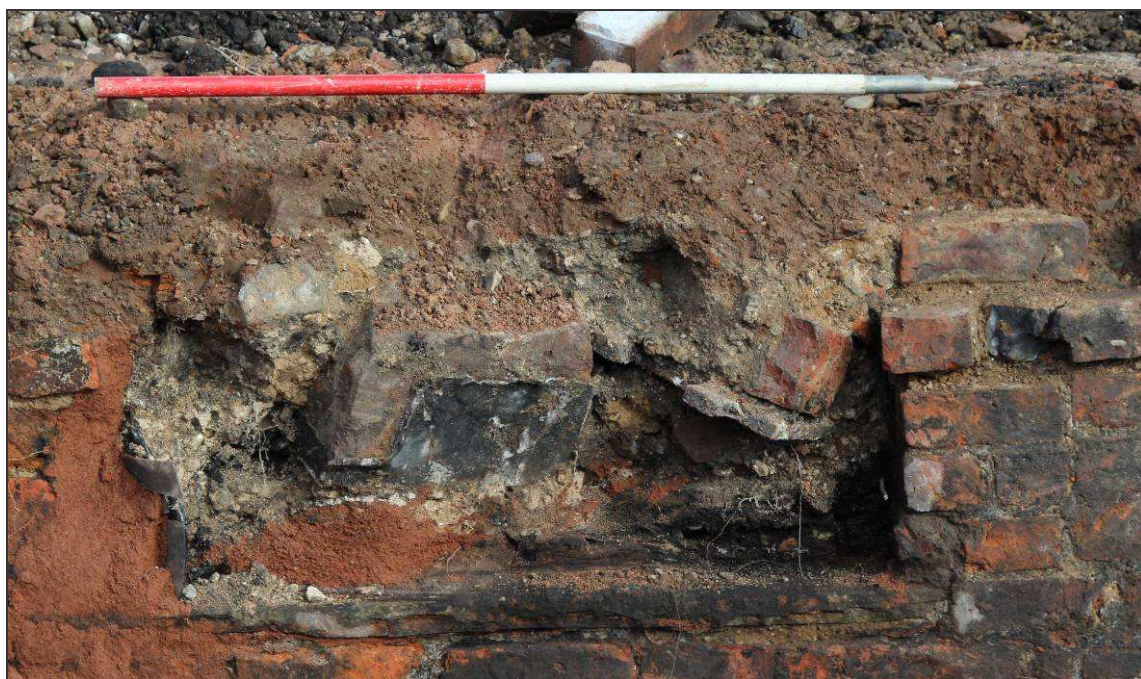
*Plate 53: House F cellar light, looking north-west*
