## Archaeological Excavation Report

Manchester Engineering  
Campus Development,  
Grosvenor Street,  
Manchester

**Document Type:** Archaeological Excavation Report

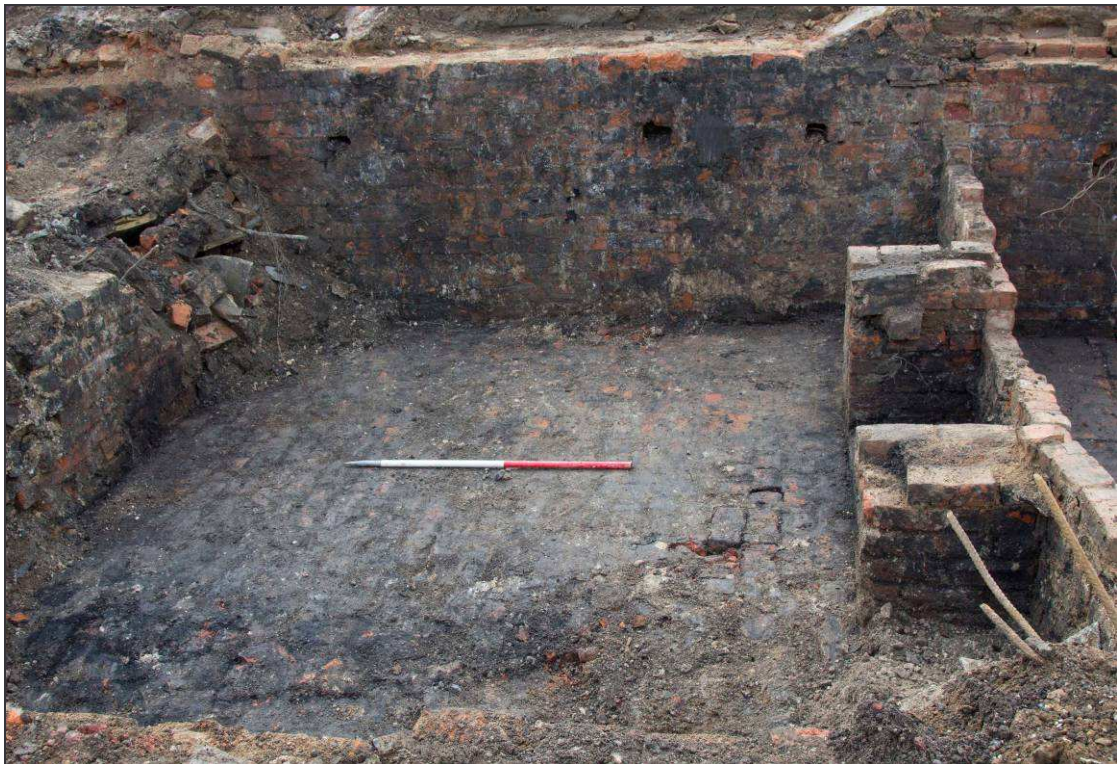
*Plate 54: House G, looking south-east*

The fireplace followed the same build format as all the other houses, with the exception of having a stone hearth 0.08m in depth. The width of the interior of the fireplace measured 1.02m with the cheeks projecting by 0.48m. The staircase had not survived very well, as seen on the left of Plate 54.

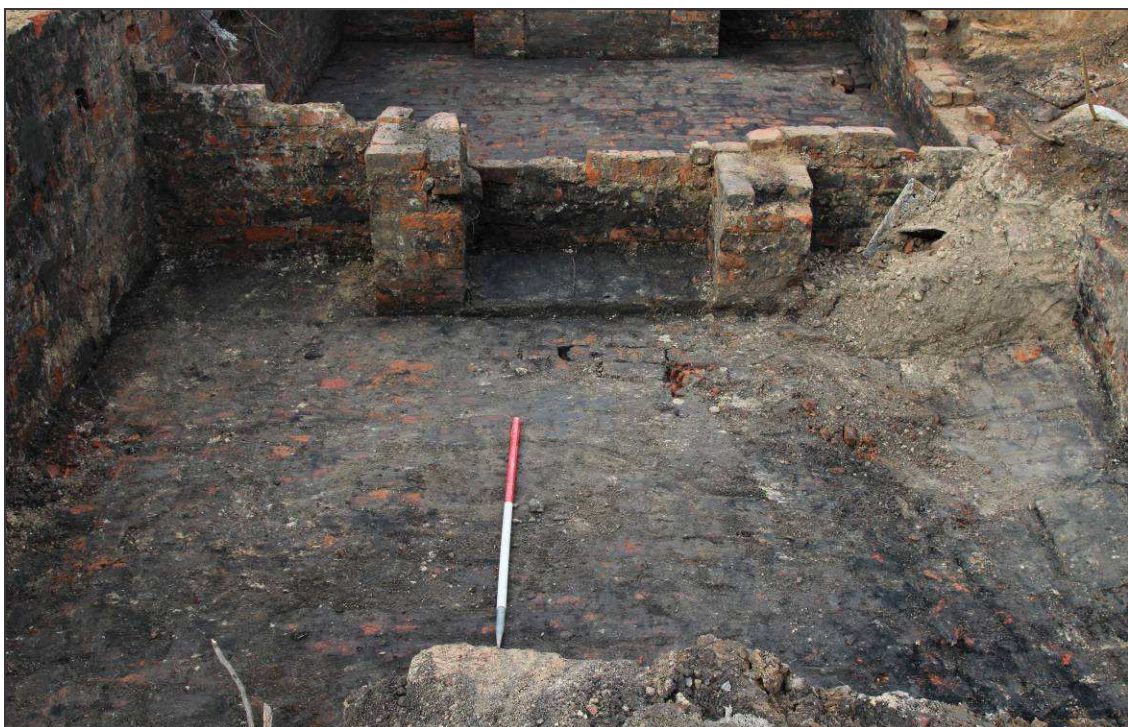
*Plate 55: House G fireplace, looking west*

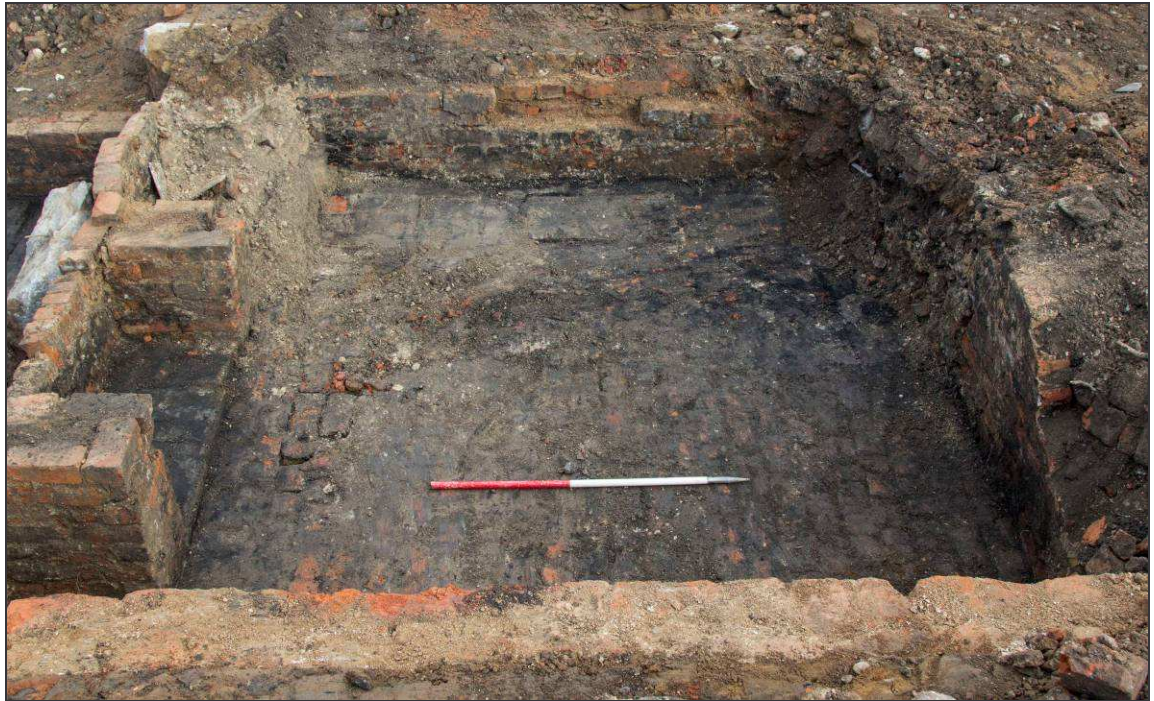
*Plate 56: House G, looking north-west*

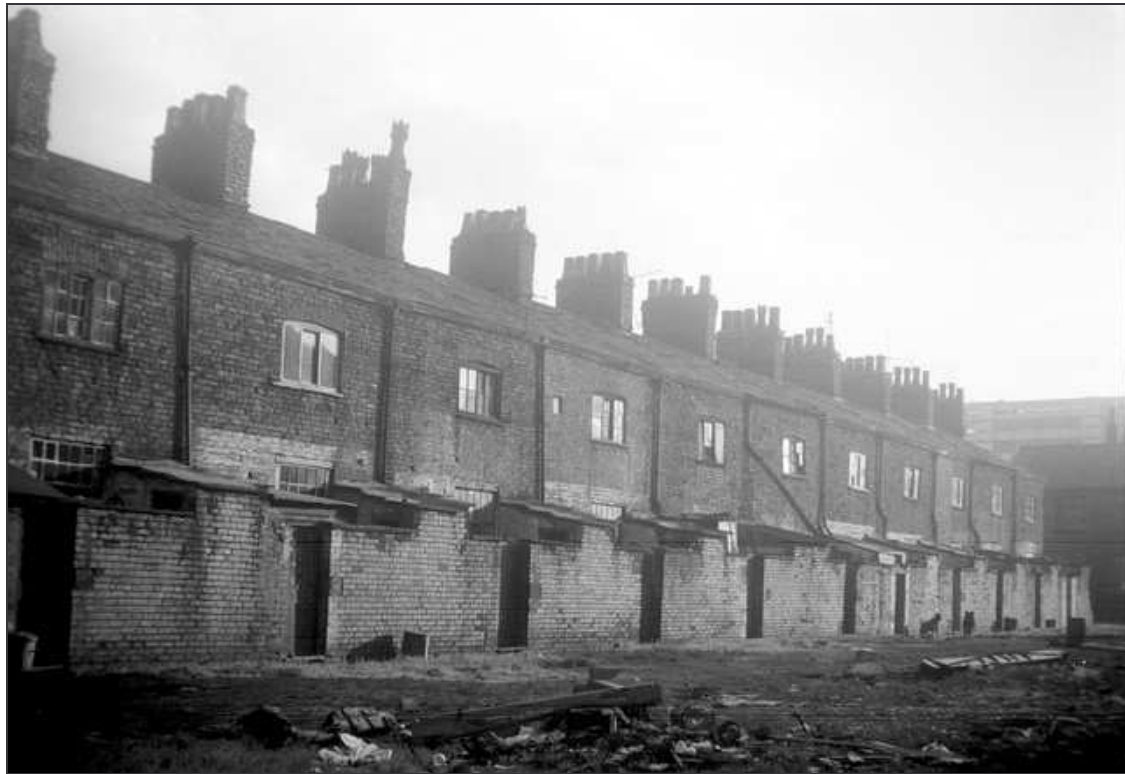
*Plate 63: a photograph from the 1960s showing the rear of the properties fronting Boundary Street East after the demolition of the row of houses behind, fronting Back Grosvenor Street, looking south-west*

The double-course wall revealed in the northern part of the trench almost certainly represents the front external wall of the houses on Back Grosvenor Street. In total, five houses were excavated as part of Area 1 and a further two in Area 2. In general, all of the houses in this row followed a uniform layout with the stairs to the cellar along the eastern wall leading in from the rear of the property. Fireplaces were positioned opposite the staircase on the western wall, all of which measured similar in size. Room sizes varied very little with only a 0.05m difference between some of them. All appeared to have cellar lights built into the front walls. The rear yard wall lay directly against the narrow stone passage floor to the south with access to the rear of the yard via a back gate. Two of the houses (E - no. 23 and G – no. 17) showed evidence for possible commercial use, having gaps in the brickwork of the rear cellar wall, which could have housed fixtures and fittings. By 1970, this row of houses has been demolished, whilst Boundary Street East remained extant (Plate 63).

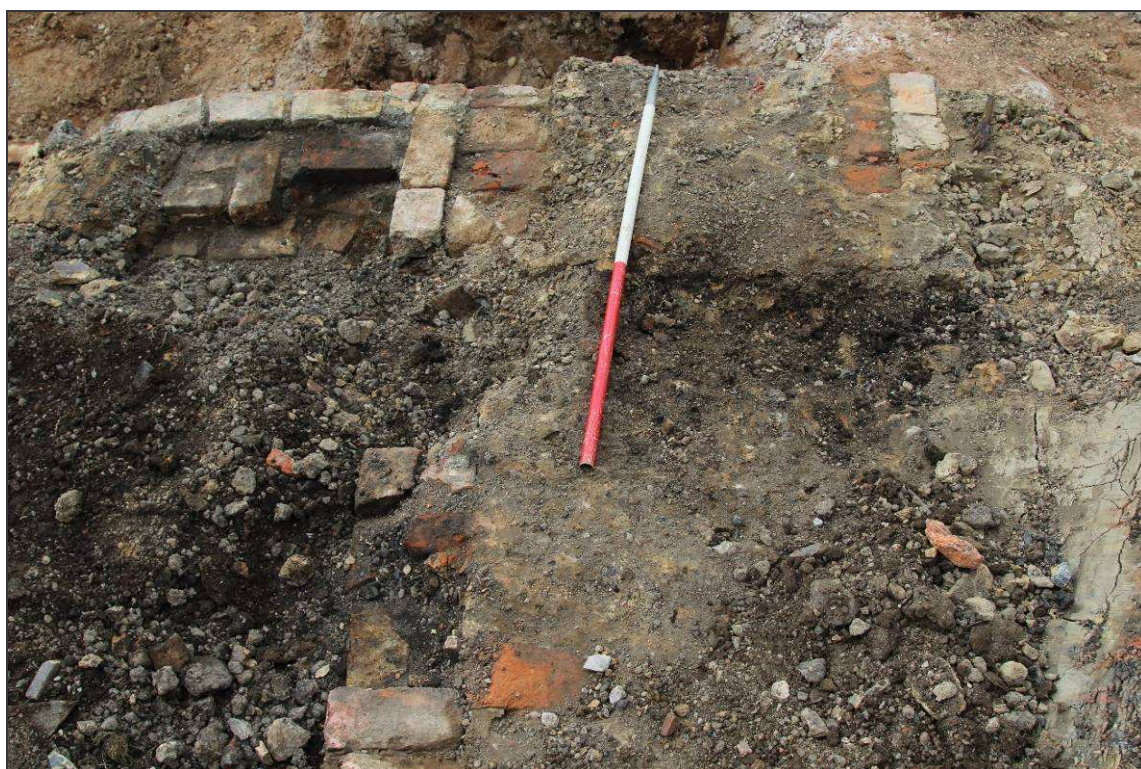
*Plate 64: Remains of outshuts in the rear yard area of the unexcavated house, no. 18 Boundary Street East, Area 2, looking north*

Whilst Area 2 was partially covered by spoil generated from the demolition programme at the time of excavation, substantial remains of the c 1824 terraced housing was nevertheless uncovered. Walls found during the evaluation trenching were relocated and fully recorded, which confirmed theories deduced from the evaluation results. The walls exposed at the northern end of the trench formed cellars from early nineteenth-century workers’ dwellings situated on the southern side of Back Grosvenor Street, as shown on the Ordnance Survey 60”:1 mile map of 1850. The shallow walls found in the central area of the trench can be confirmed as the rear yard area of both the houses fronting Back Grosvenor Street and those fronting Boundary Street East. As identified on historic mapping, only the front of the houses contained cellars, whilst the outer rear yard areas were not cellared, these had been built directly onto natural sands and clay. The partition wall between the second (no. 3) and third (no. 5) houses from the eastern end of the row, was exposed in the eastern trench edge, but the close proximity to a modern footpath, the depth of the trench and the instability of the trench sides prevented any excavation of no. 3, although some of the rear yard area walls were uncovered (Plate 64).
