**Archaeological
Excavation Report**

Durban Mill,
Hollinwood, Oldham

Report No:
2016/29

Document Type: Archaeological Excavation Report

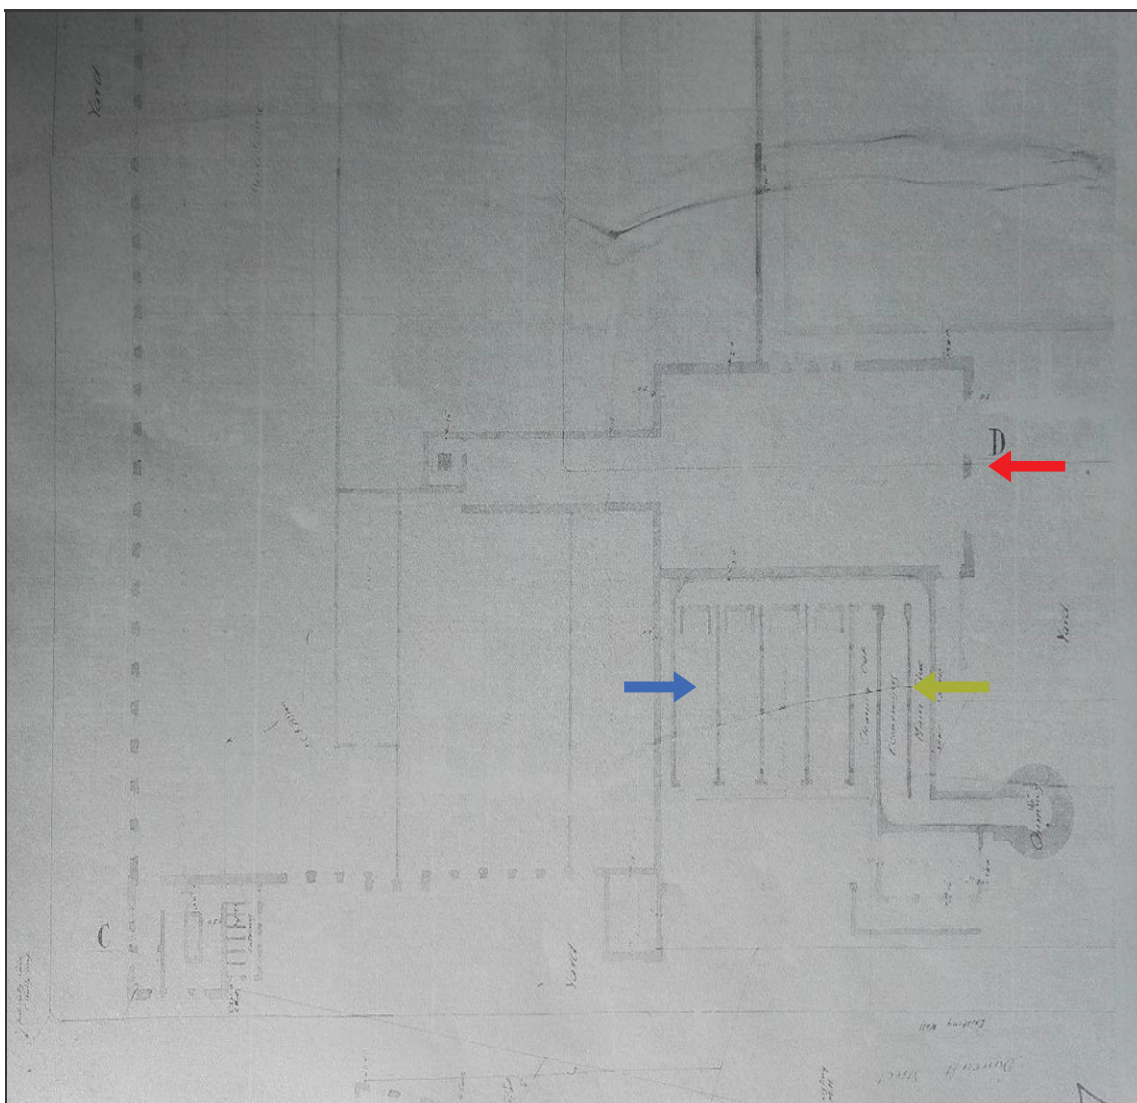
Plate 2: One of the original architect's drawings for Durban Mill, dated January 1905, showing the position of the engine house (red arrow), Boiler House (blue arrow) and economiser (green arrow)

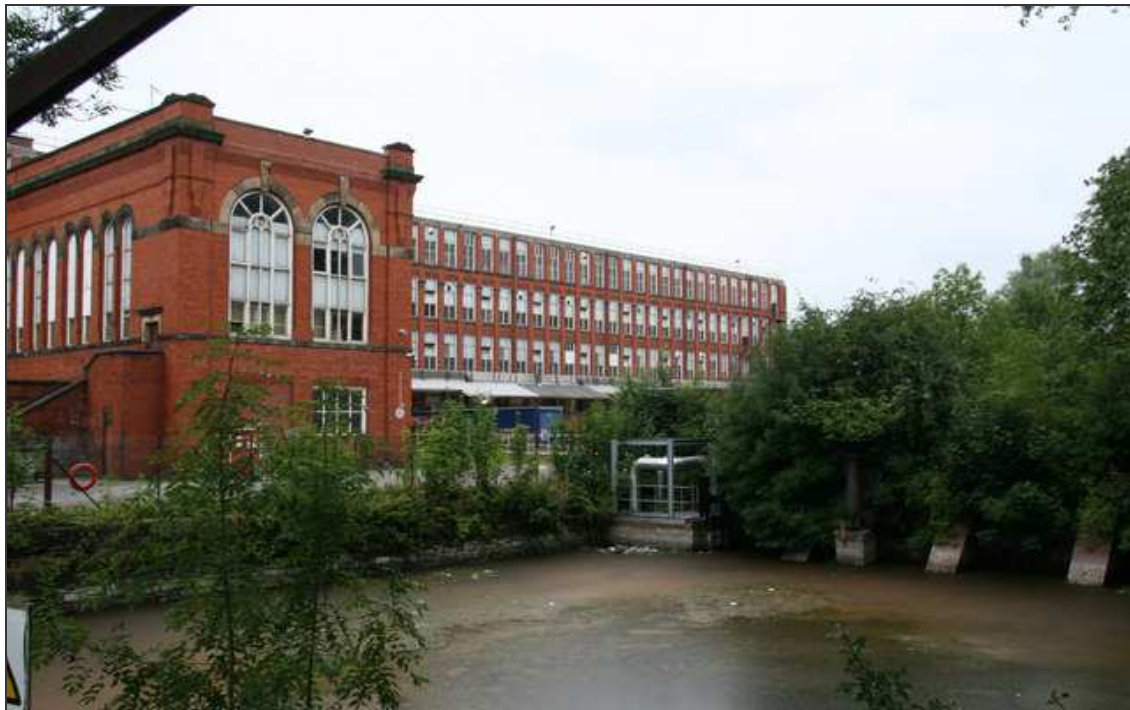
Plate 6: The east elevation of Durban Mill in 2014, showing the engine house in the foreground and possible staircase revealed during excavation (Plate 20)

Beyond the eastern wall limit of the engine house, it was discovered that there was a continuation of the dividing wall between the engine and boiler house (Plate 20). This continuation of the wall extended the footprint of the engine house an additional 4.00m to the east. At this point the partially exposed brick wall turned 90 degrees to the right and continued north. The wall was then lost beneath the site spoil. However, at 1.20m along this wall there appeared to be a slight step down in the brickwork for approximately 0.80m, at which point it stepped back up and continued to the wall corner for a further 1.60m. Although not shown on the plans, when viewed alongside the image of the eastern elevation in Plate 6, it is likely that area was the end of the engine house and an external staircase was visible.

The area to the south of this wall which would contain possible further evidence of the external brick staircase was not excavated. However, to the east of the economiser beyond an area of natural sandy clays a large wall was uncovered (Plate 21). This wall measured 0.60m wide and 7.60m long was not tied in to any other structures, but did appear to abut the southern elevation of the engine house. This should therefore be considered to be a yard boundary wall and part of the lower external staircase which can be seen in Plate 6.

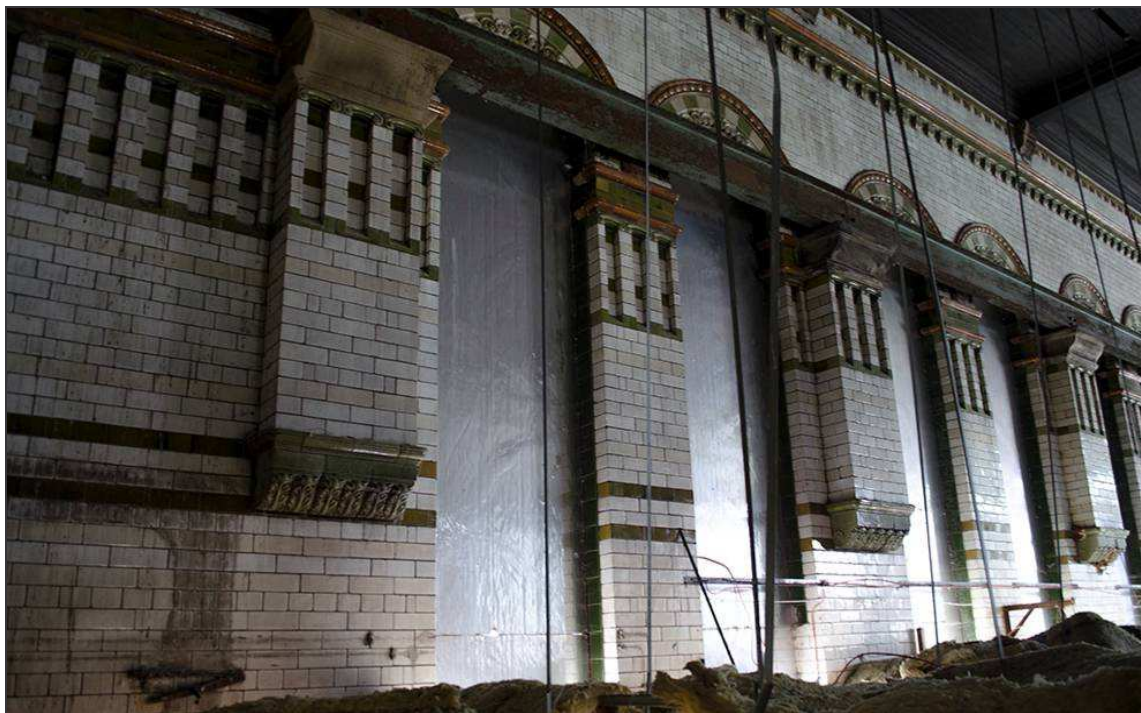
Plate 8: Another view of the interior of the engine house in 2014 (reproduced from www.28dayslater.co.uk)

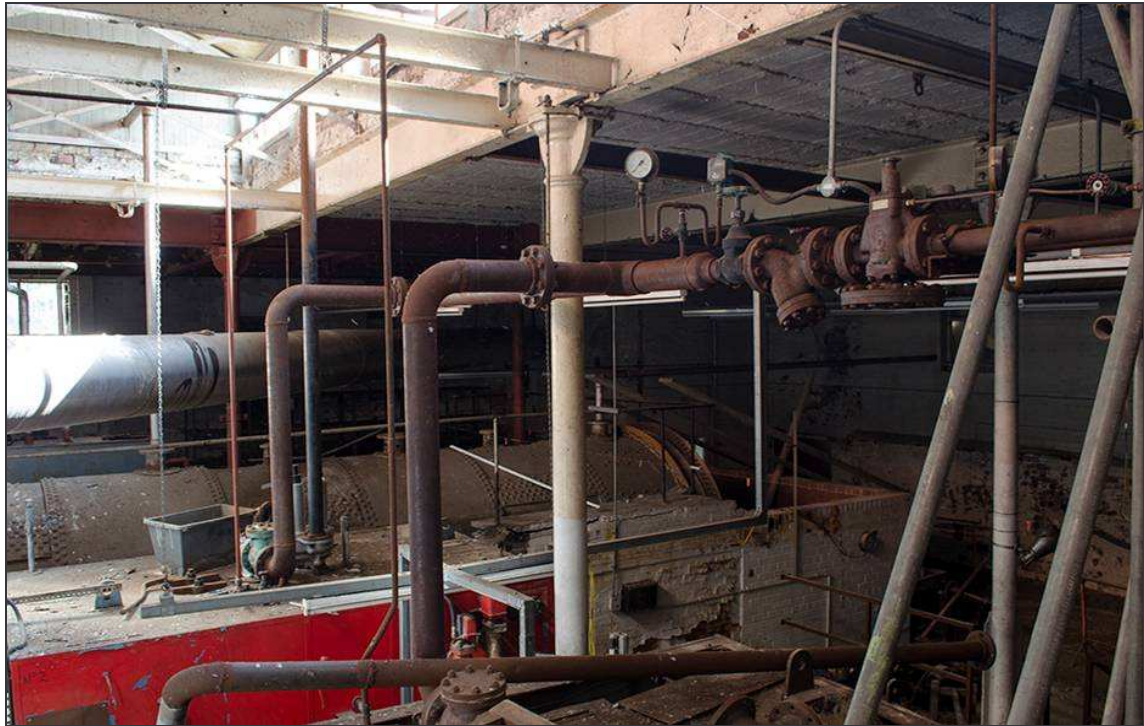
Plate 9: A view of the interior of the boiler house in 2014, showing one of the original boilers converted for use to store heating fuel (reproduced from www.28dayslater.co.uk)

The boiler house was not fully excavated due to the presence of contaminants in the pits which would have originally housed the boilers. As with the engine house there was no original machinery present on site. Desk-based research found images of the boilers *in-situ* during the mills demolition and an illustration of the workings of a Lancashire boiler (Plate 36 and Plate 37). These images demonstrate that the archaeological remains seen on site relate to the boiler flue pits. The contaminants within these pits will be related to the later phase of the boilers after their conversion to heating fuel storage.

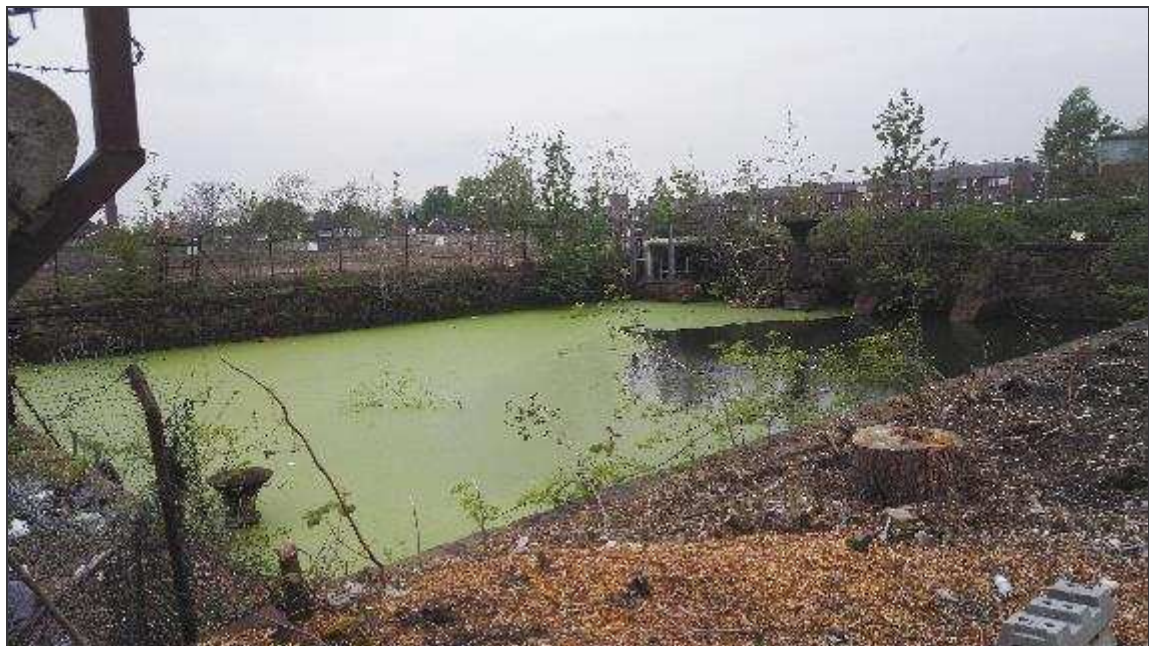
Plate 14: View across the mill reservoir in the eastern corner of the site

The water required for condensing purposes and for the steam-raising plant was stored in two reservoirs situated to the east of the mill. This layout is captured on a series of original plans for the mill, poor-quality copies of which are held by Oldham Local Studies & Archives (Plate 2).

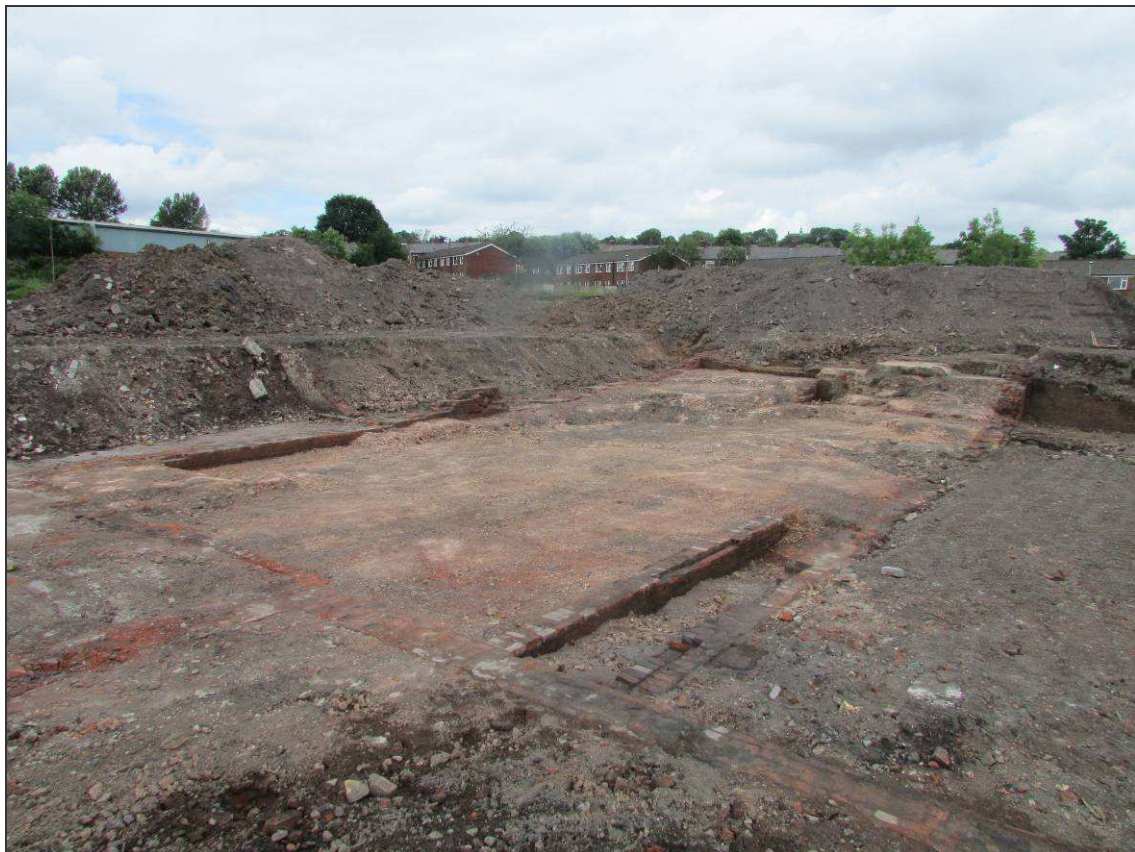
The footprint of the engine house was revealed as measuring 26.00 x 13.00m, and excavation showed that the majority of the structural fabric had been removed to foundation level. A natural, sterile ground deposit was not encountered at any point during investigations within the engine house.

Plate 15: Aerial view of the surviving footprint of the mill's engine house. Looking north-east

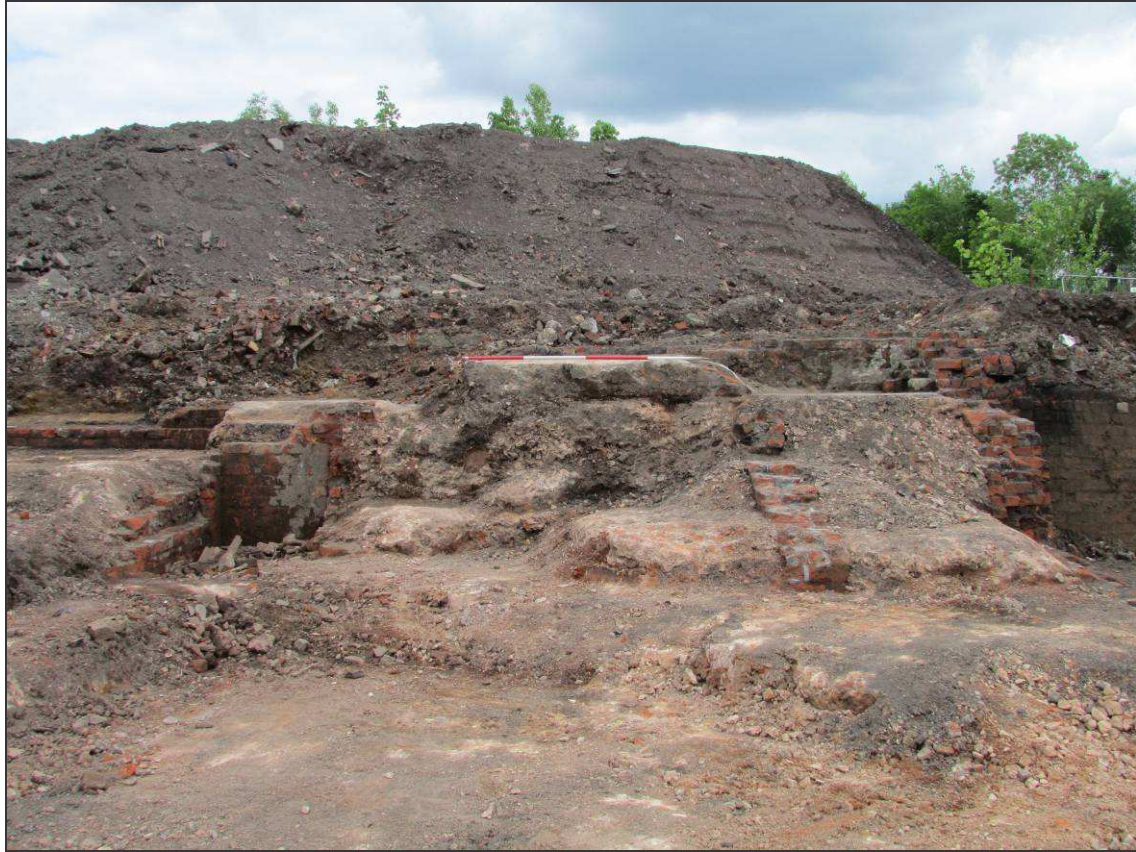
Compacted aggregate concrete containing brick fragments was visible across the internal dimensions of the engine house. Areas of this material lay flush with the levelled footprint of the engine house, although towards the east of the house it was seen at a much greater height (Plate 16). Two test pits were dug into the concrete to establish depth and a natural ground level, however, neither were seen due to rising water at a depth of 0.50m below the working slab level.

*Plate 16: Engine house structural wall remains encasing badly damaged concrete levelling/ floor deposit.
Looking East*

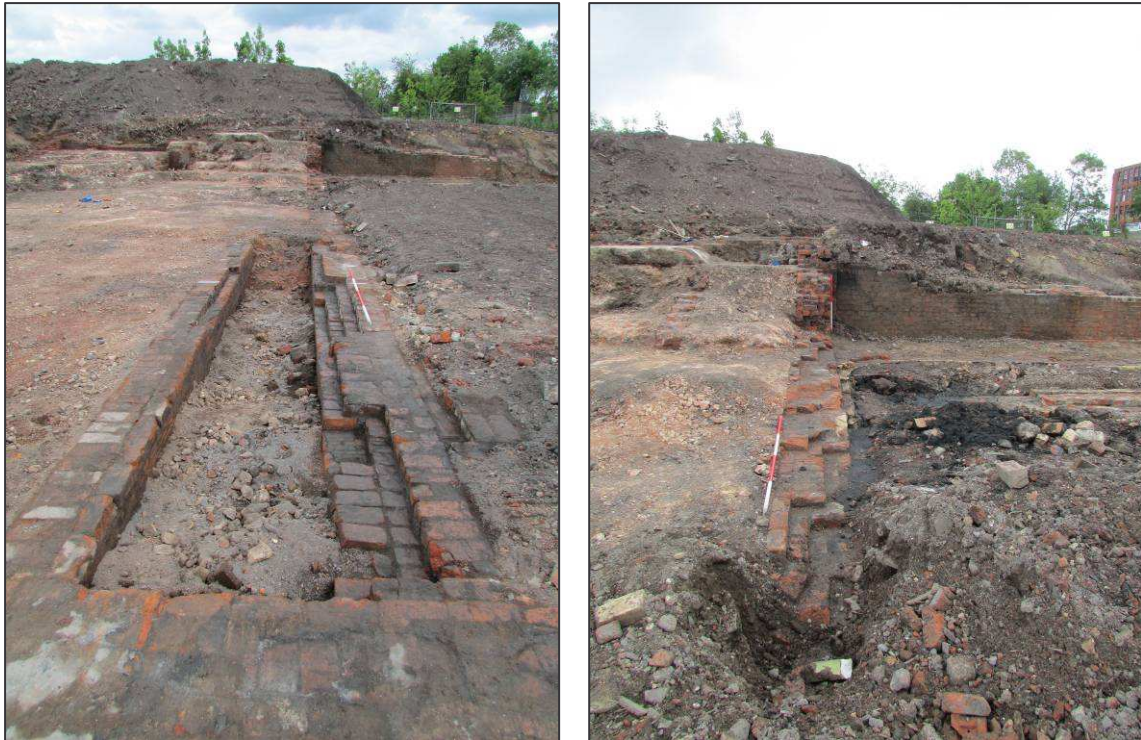
A red brick wall acted as a partition between the engine and boiler houses running east/west for a length of 26.00m and having a width of 0.65m (Plate 17). The fabric of this wall comprised machine-made bricks, each measuring 0.12 x 0.24 x 0.08m branded Smethurst Lowside laid in an English bond using a dark grey mortar. Although cleared to surface level, it was possible to see five courses of brickwork in depth below this inside a possible brick-built pit to the immediate north of the dividing wall.

Plate 17: Remains of dividing wall between the engine and boiler houses. Western end (left), Eastern end (right)

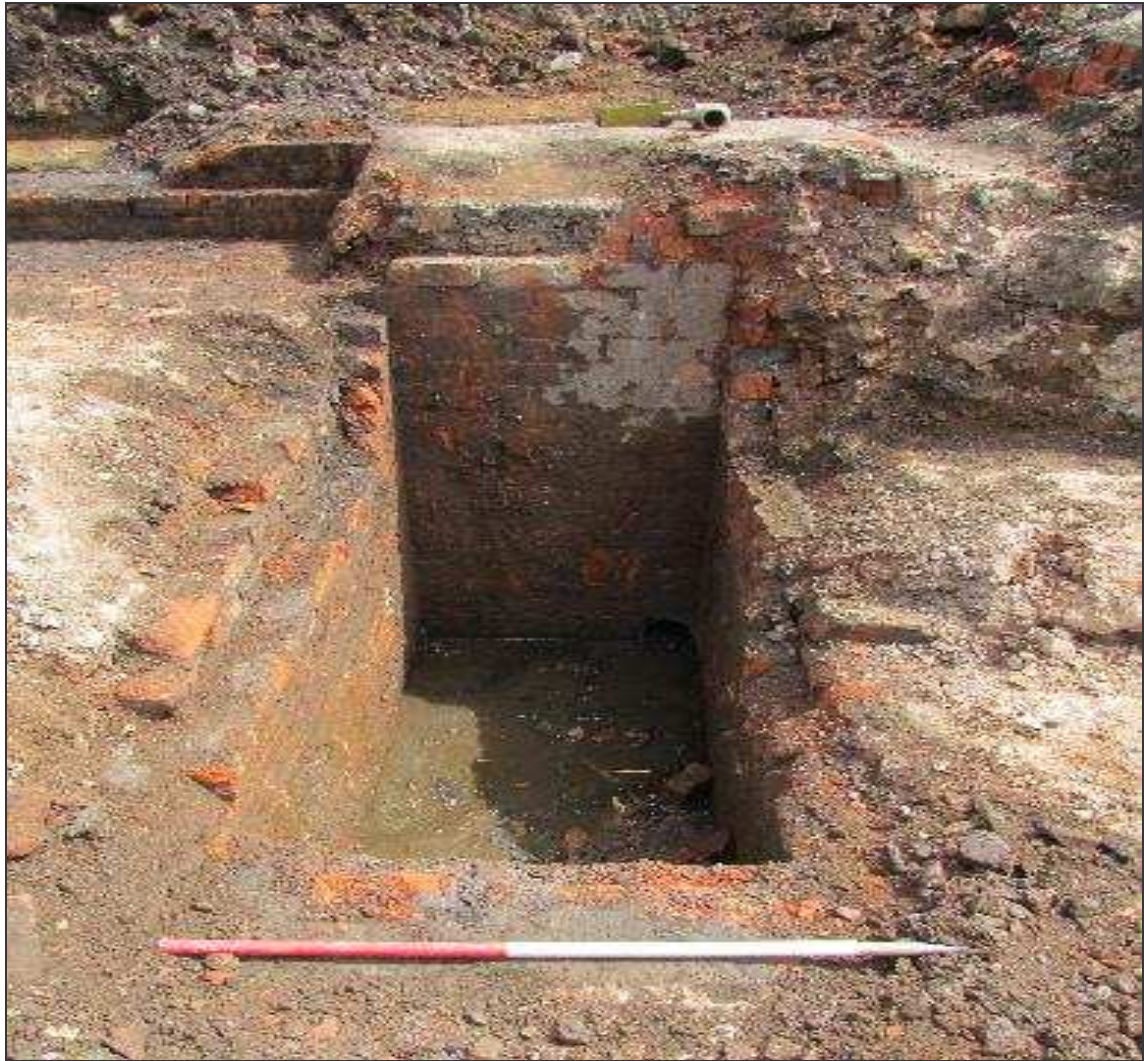
At the eastern end of the boiler house, machine excavation revealed that the concrete deposit seen across the boiler house banked up, with ledges 1m higher than at the western end of the engine house (Plate 16). A badly damaged brick wall was also seen emerging from the concrete towards the south-east. The wall measured 2 x 0.24m. To the north of this wall beyond a further area of concrete a brick constructed pit was seen (Plate 18). The walls of the pit on three sides were constructed two brick courses in width (0.24m) and the entire construct measured 2.20 x 1.40m. Removal of the pit fill which was made up of demolition material and large quantities of Accrington brick, revealed the pit to be 2m in depth. However, the base of the structure was not seen due to accumulation of water and oil within the pit. There were no distinguishing features to hint at the pits usage apart from a partially blocked drainage pipe constructed into the eastern wall of the pit near its base.

Plate 18: Engine house brick-lined pit. Looking east

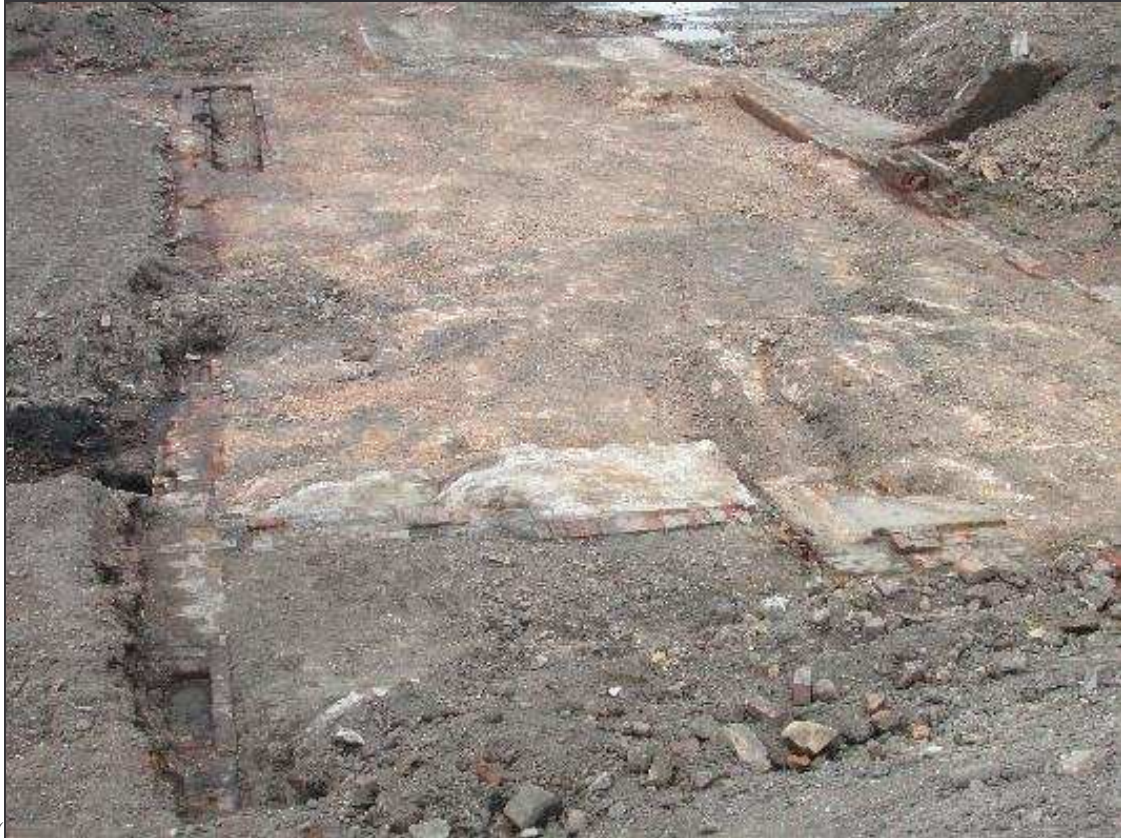
Plate 19). The two outer tiers sat level to each other whilst the central thicker ledge rose approximately 0.25m higher. This modern concrete plateau looked down over the engine house to its west and abutted the structural wall to its east. The overall length of the concrete ledges seen was 6.40m and they stepped out from the eastern wall by 1.20-1.80m. No engine house fittings were seen associated with these tiers. A cast-iron pipe within a brick culvert was noted running east beyond the limit of excavation from the northernmost concrete ledge, although this became dislodged during machine excavation. The location of the culvert was plotted on the site plan.

Plate 19: Tiered concrete ledges to the west of engine house wall. Looking south-east

Above the brick-lined pit, extending east and south, deposits of modern concrete were uncovered. The concrete had been laid over the top of the rustic earlier aggregate material forming three tiered platforms

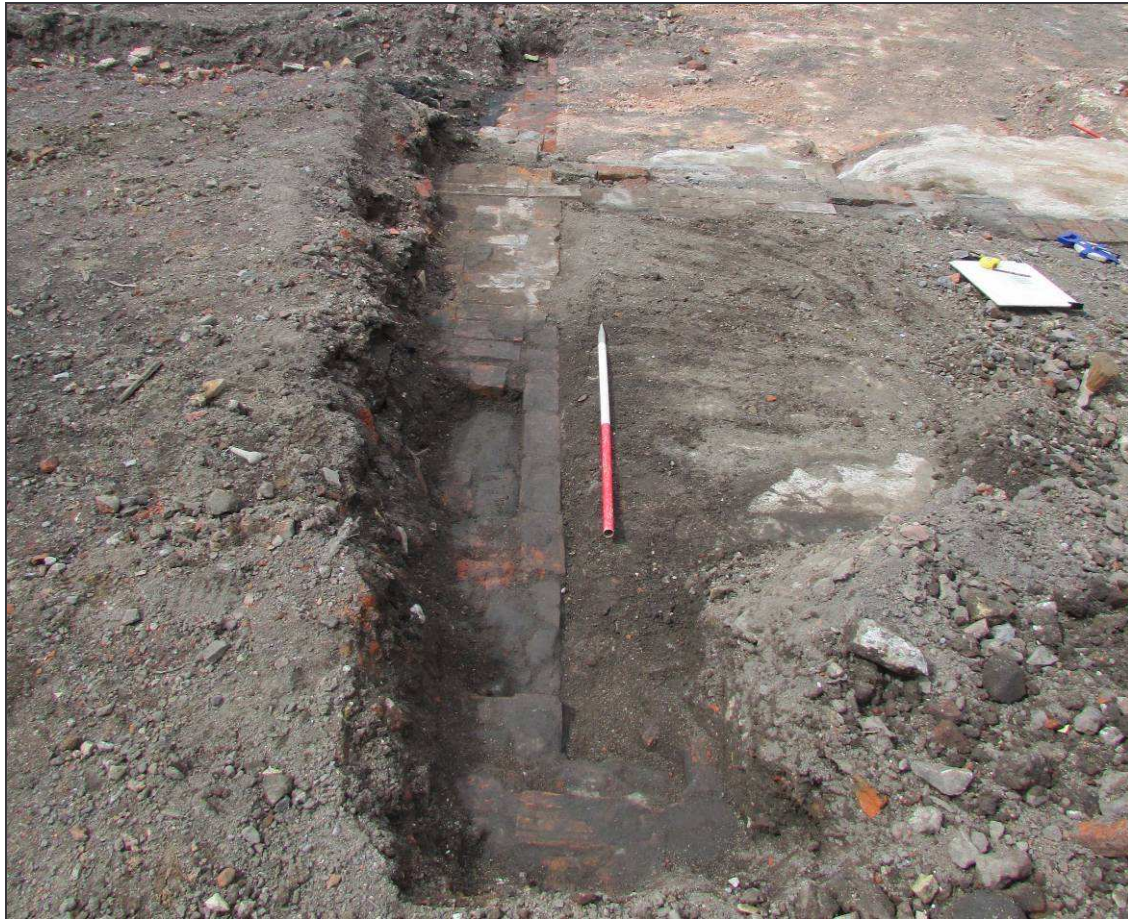
Plate 20: Continuation of southern wall of the engine house. Possible entrance located to the left of the scale. Looking west

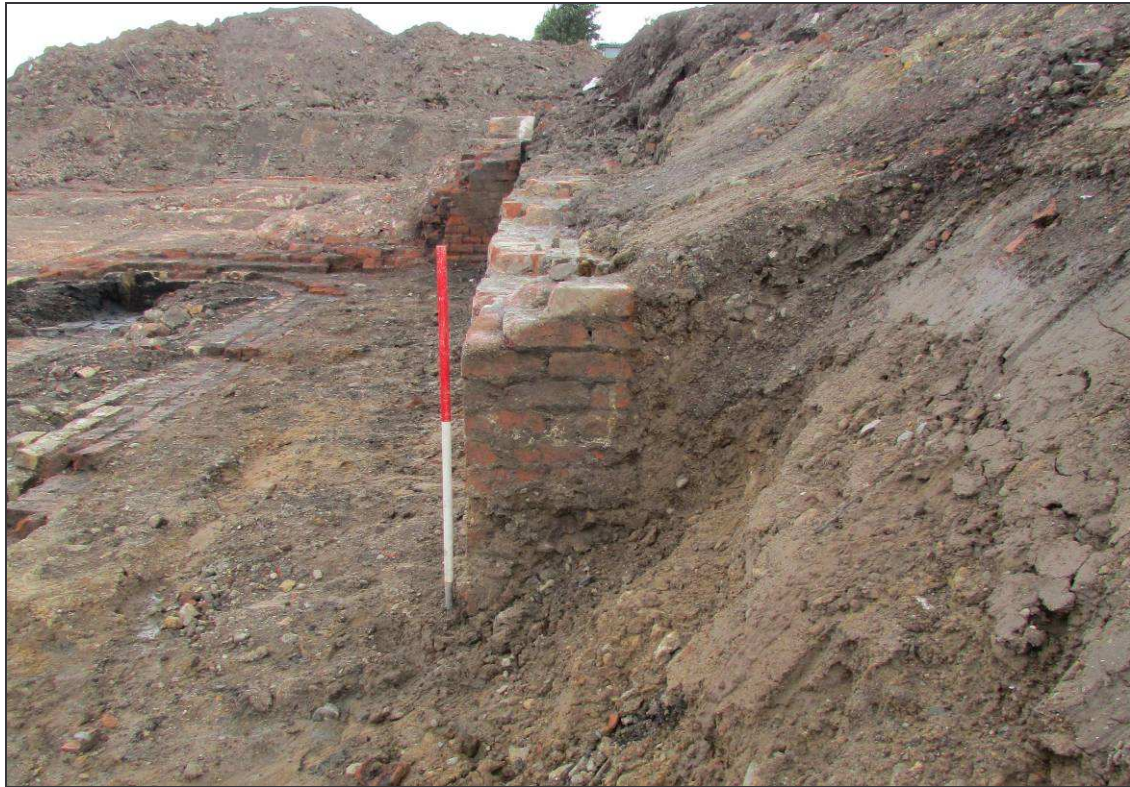
Plate 21: Possible yard wall associated with the engine house (looking north)

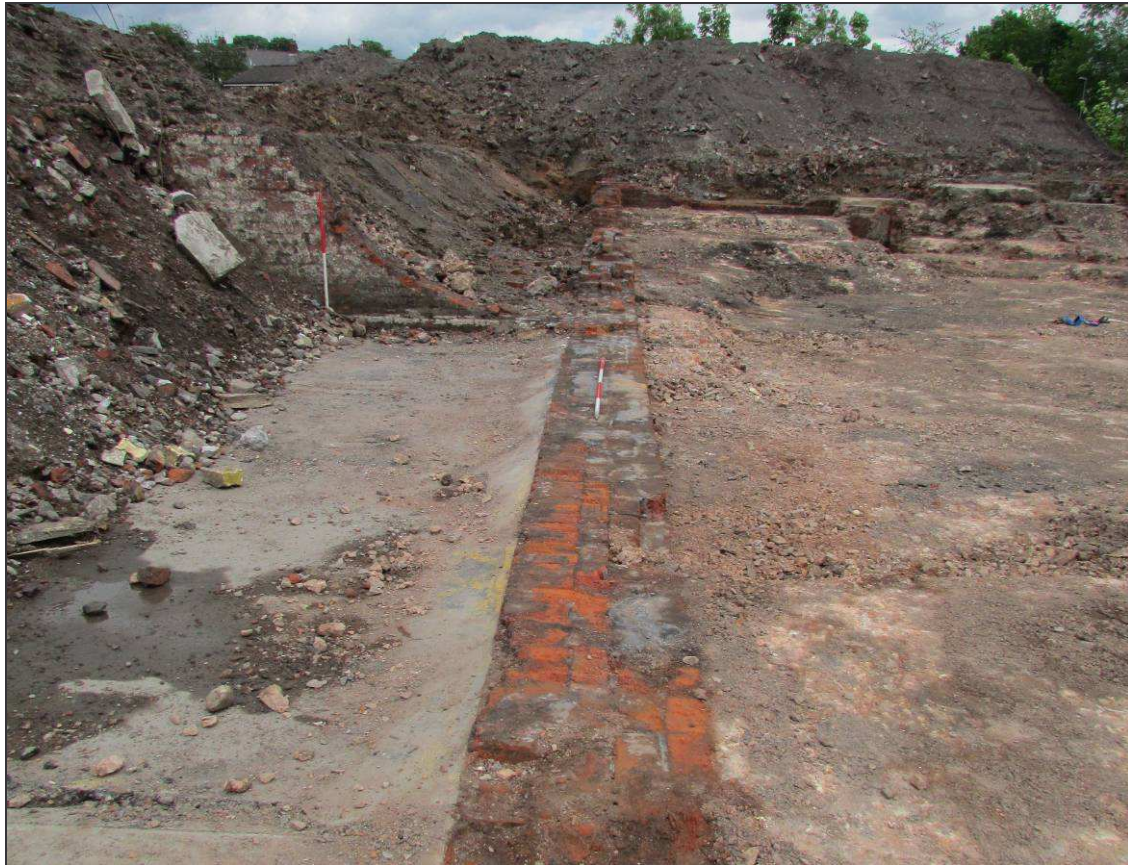
The northernmost wall of the engine house measured 0.60m wide, and had an east/west alignment running a length of 26.00m. The make-up, construction and surviving condition of this wall were similar to the above described walls. At 8.20 m from its western end a further wall was seen heading north from the engine house wall (Plate 22). This wall was the eastern external wall of the mill building, and matched with the OS 1909 map (Plate 3).

Plate 22: North-west corner of the engine house with the upstanding remains of the mill's eastern wall seen heading north (to the left). Looking east

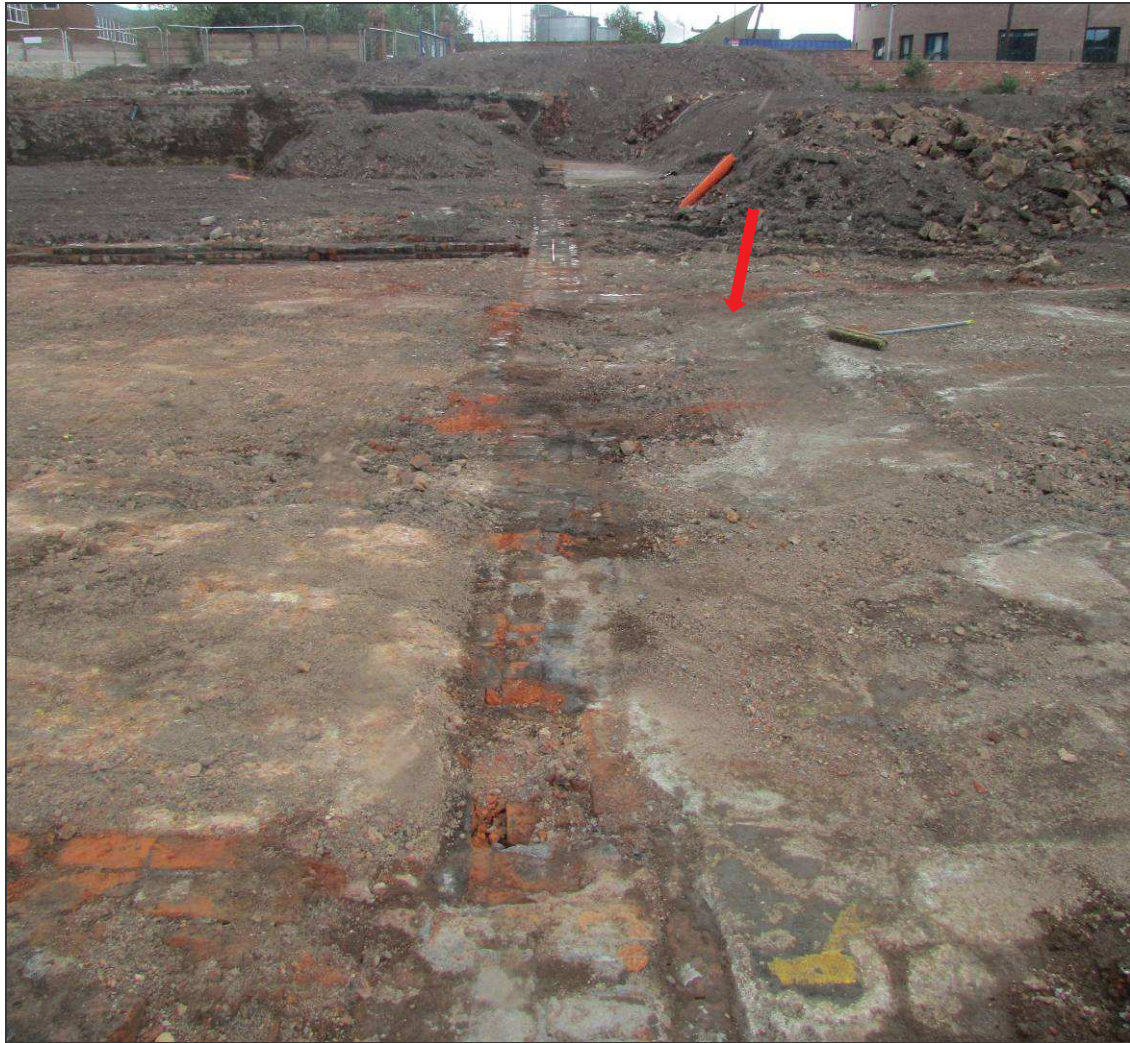
The final wall that framed the engine house was to the west. Seen as a footprint at a cleared slab level the remains of the wall were seen to be approximately 0.65m in width being made up of five brick courses and running the entire length; 31m of the engine and boiler houses. The northern most 13m of the wall forms the western limit of the engine house (Plate 23). Two walls aligned east/ west, running parallel to each other at a distance of 3.80m were seen connected to and heading west of the engine house wall. These relate to a rope race, which can be seen on the architects' plans (Plate 2), but fall outside of the study area.

Plate 23: Western wall of the engine and boiler houses. The rope race (arrowed) can be just seen to the right

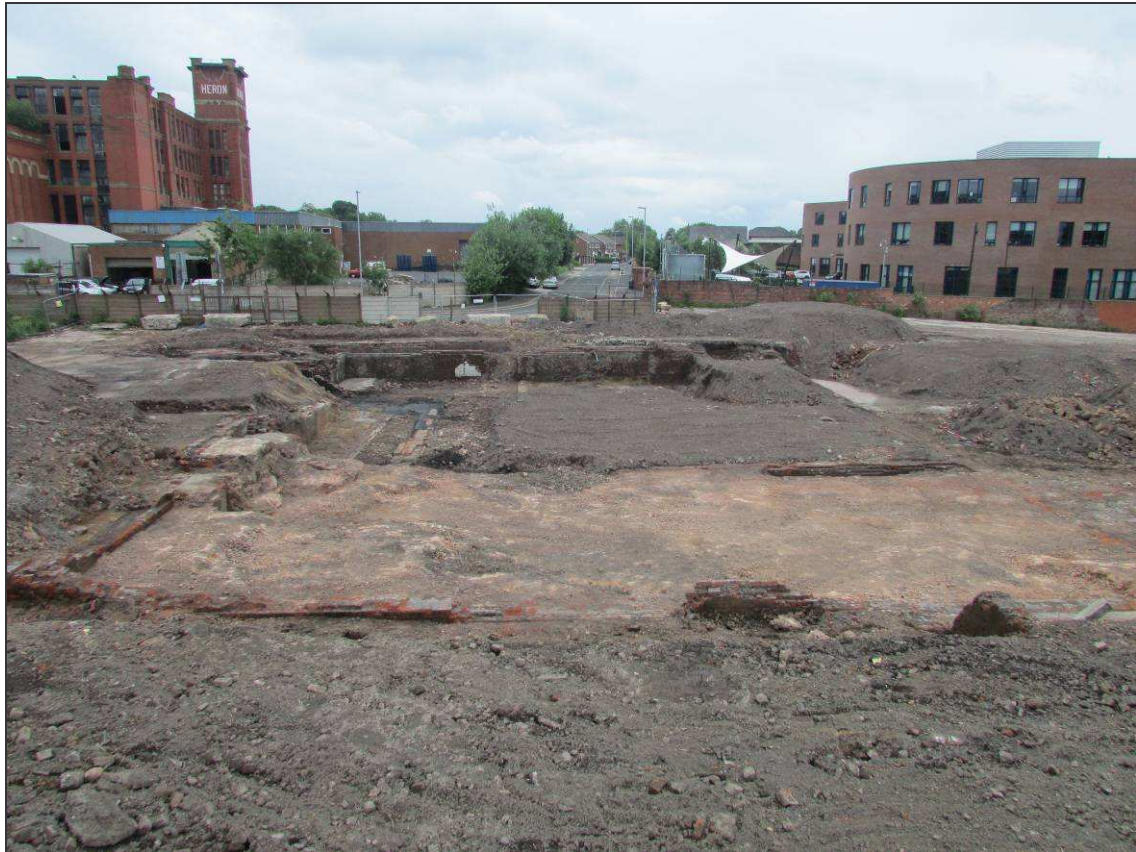
The area classified in this study as pertaining to the boiler house was an almost square building measuring 16.20 x 16.00m, and also included an attached rectangular area to the south of the economiser, measuring 8.40 x 4.00m. The boiler house area was framed on its north and western sides by the dividing wall with the engine house, and western exterior wall mentioned in the engine house descriptions. There were no natural levels encountered during the excavation of this area. This was due to the nature of the materials uncovered preventing further investigation.

Plate 24: General shot of engine house (foreground) and boiler house (background), looking south

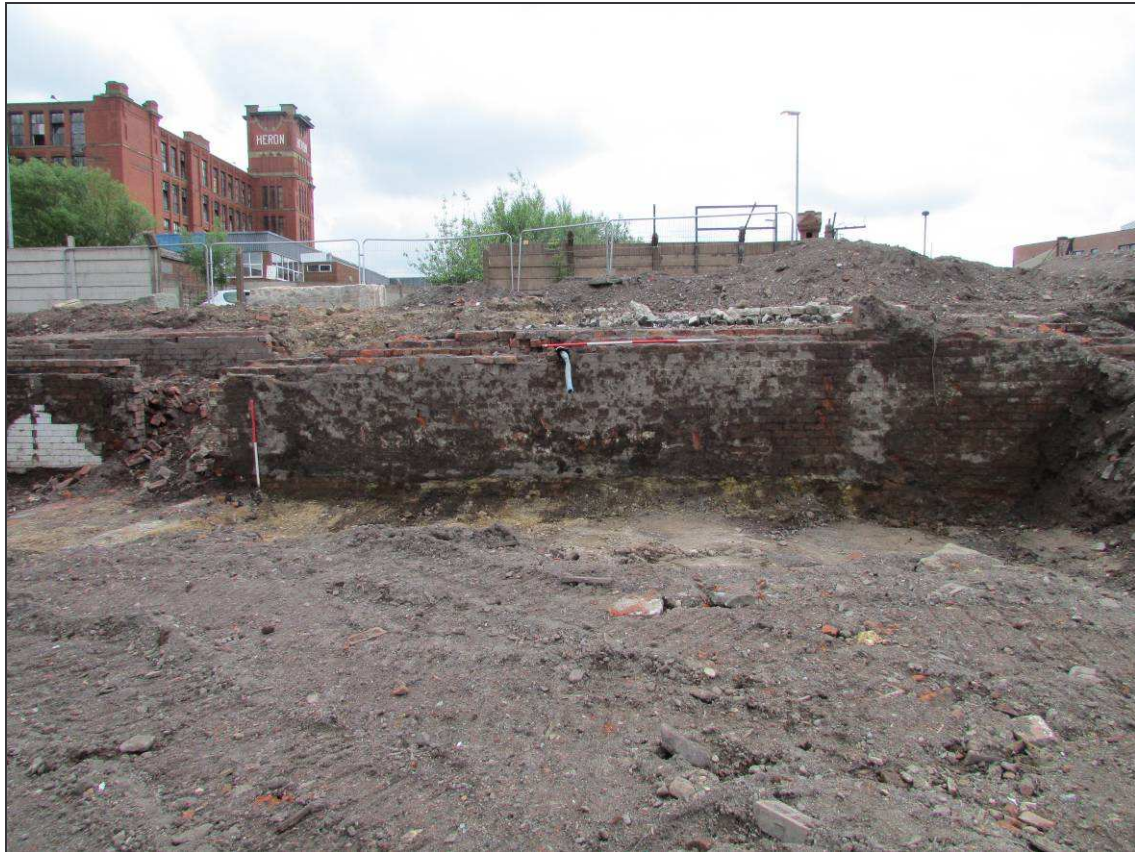
A large external wall was uncovered at the southern end of the excavation area which matched up to the southern limit of the boiler house on the architects plans. This wall was still standing to a height of 2.00m, and ran east/west from the eastern external wall for 14m with a width of 0.60m (Plate 25). The fabric of the wall comprised a mixture of machine-made red bricks, some branded Accrington and bonded together in an English pattern using a dark grey mortar.

Plate 25: Internal elevation of the boiler house southern wall. Looking south

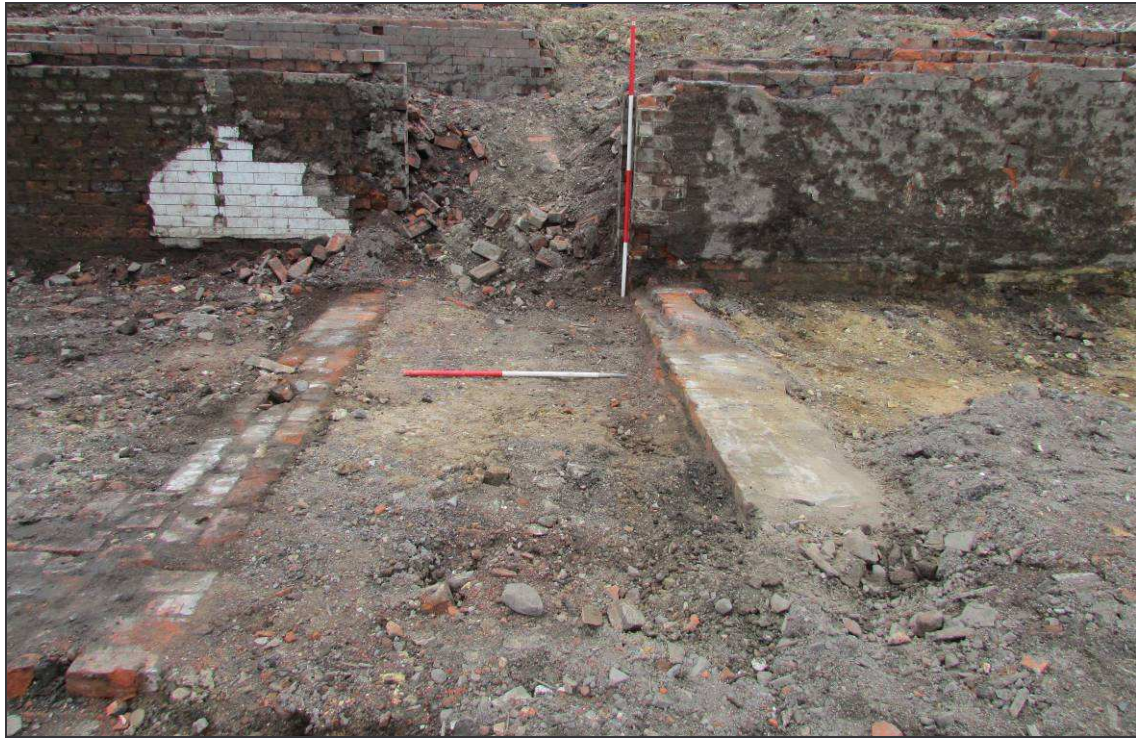
At the eastern end of this 14.00m section of wall, bull-nose bricks were seen and a gap of approximately 1.70m noted before the continuation of the external wall for a further 8.40m to the east. This entranceway was framed on both its east and west sides by the remains of two north/south-aligned walls, which were ran northwards but had been demolished to foundation level. These walls measured 2.50 x 0.40m. The wall to the east at its northern limit turned to run east and was 0.51m wide, forming a division between the boiler room and the economiser (Plate 26). The wall to the west probably met an internal dividing wall but due to the presence of contaminants this was not investigated further.

Plate 26: Boiler house entrance in southern wall. Looking south

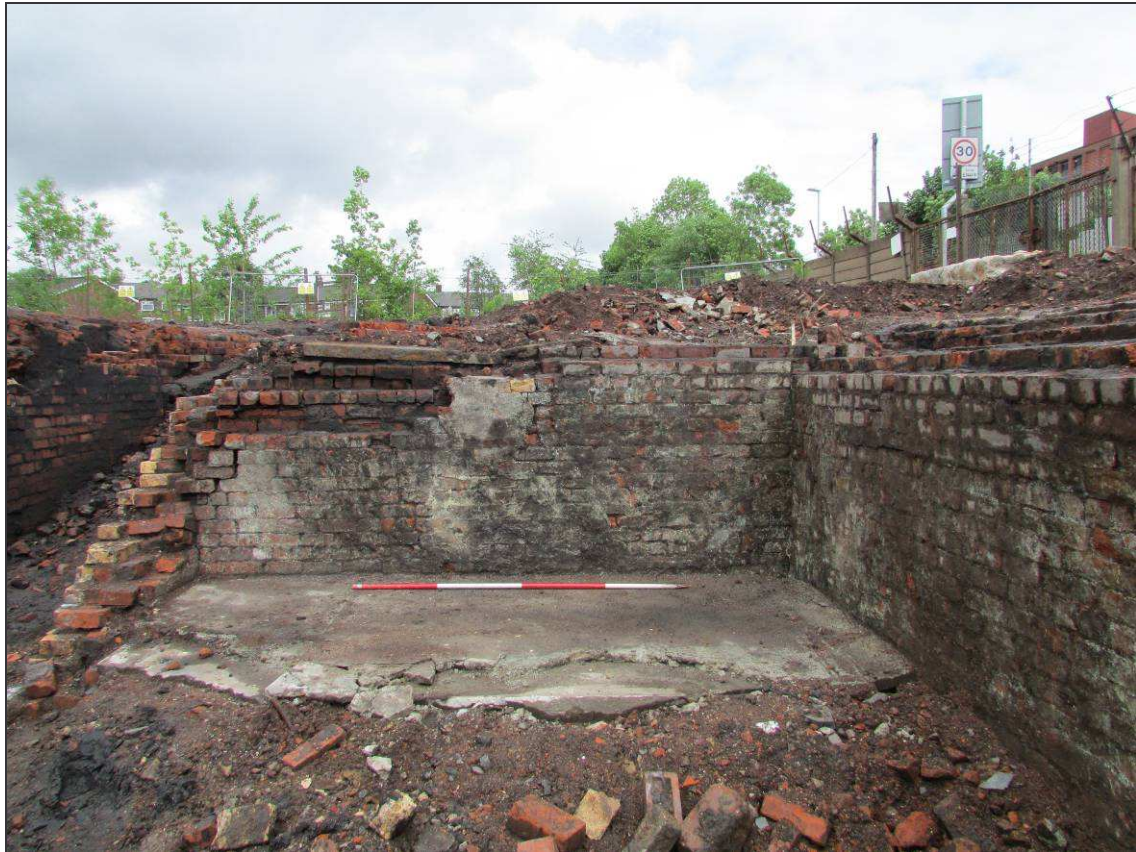
At the eastern end of the southern wall, another machine-made brick wall with a north/south alignment was keyed into this one. This wall ran north for 3.69m before it met the surviving foundational structure of the economiser/flue wall (see below). In the south-east corner of the boiler house a concrete platform was seen (Plate 27), which abutted the walls and measured 3.80 x 2.00m, although it was truncated on the west side.

Plate 27: Remains of a modern concrete surface in south-east corner of boiler house. Looking south-east

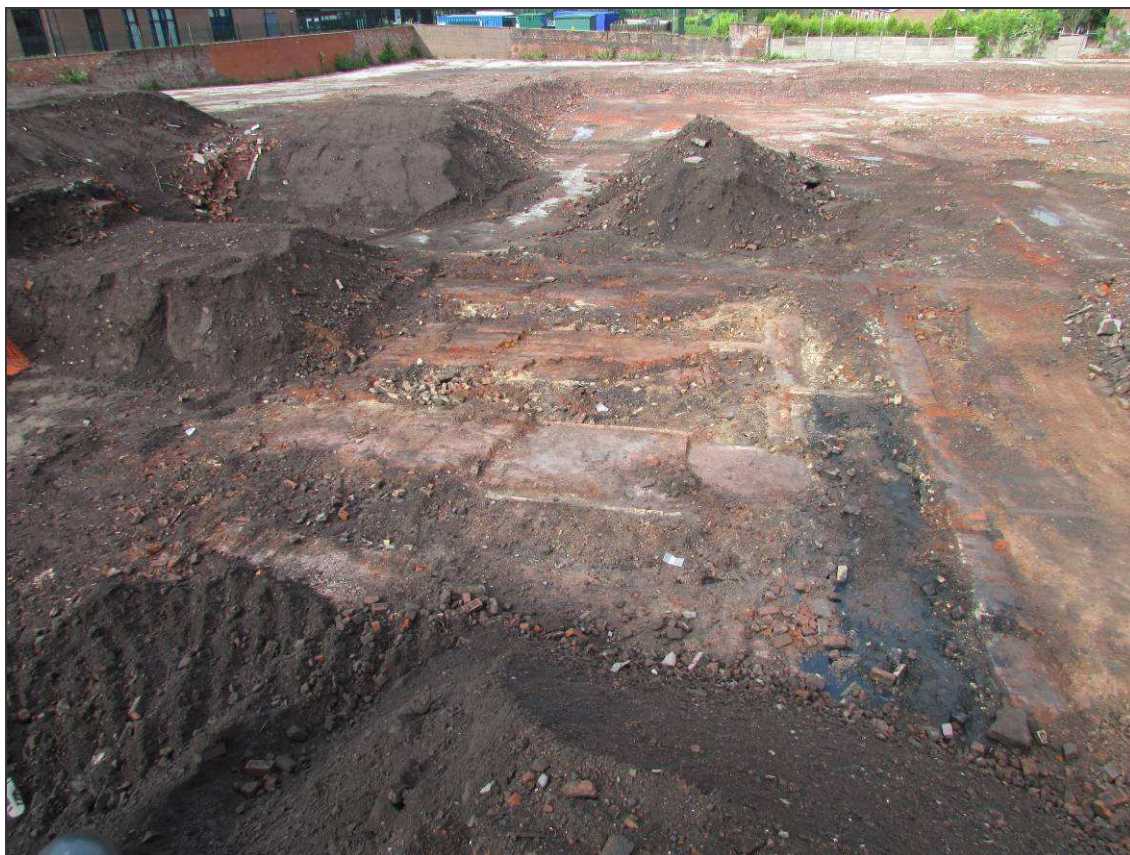
The central area of the boiler house immediately south of the engine house/boiler house dividing wall was excavated down to the slab level with the aim of finding features associated with the boilers. The remains of the lower levels of brick structures and bays were seen aligned north/south within this area. A total of four firebrick-lined bays each containing fill material was seen. These, as with the majority of the site, had been demolished to slab level (Plate 28). Investigation of the easternmost boiler structure found the remains of shallow pits lined with a single course of fire brick. Excavation into the fill material was stopped due to large accumulations of water and oil being exposed at this lower water table level.

Within the fill of the bays and also visible across the boiler house area, patches of fibrous material were noted. The amount of hazardous contaminant exposed informed the decision to cease investigation of this area and to immediately recover the area to prevent any further breaking up and spreading of the material. Due to this decision, no measurements were taken within this part of the boiler house. However, the areas where contamination was immediately visible were roughly plotted (Fig.4)

Plate 28: Mid-excavation shot of boiler housing bays with fill material. Looking west

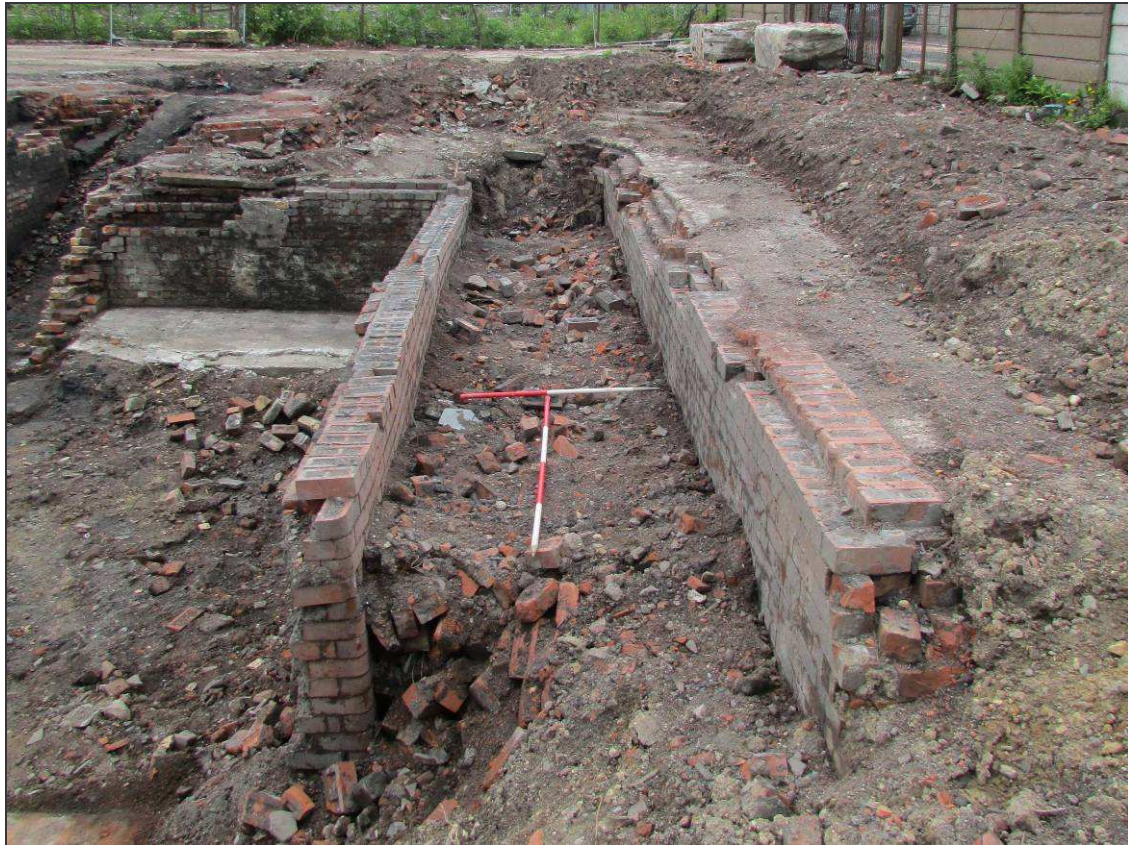
The western end of this wall was also lost just beyond the entranceway in the boiler houses southern wall. Comparing the remains of the wall with the 1909 OS map, a passageway matching this wall can be seen (Plate 3).

Plate 29: External passageway linked to an entrance at the southern end of the boiler house. Looking east
