**Archaeological
Excavation Report**

Durban Mill,
Hollinwood, Oldham

Report No:
2016/29

Document Type: Archaeological Excavation Report

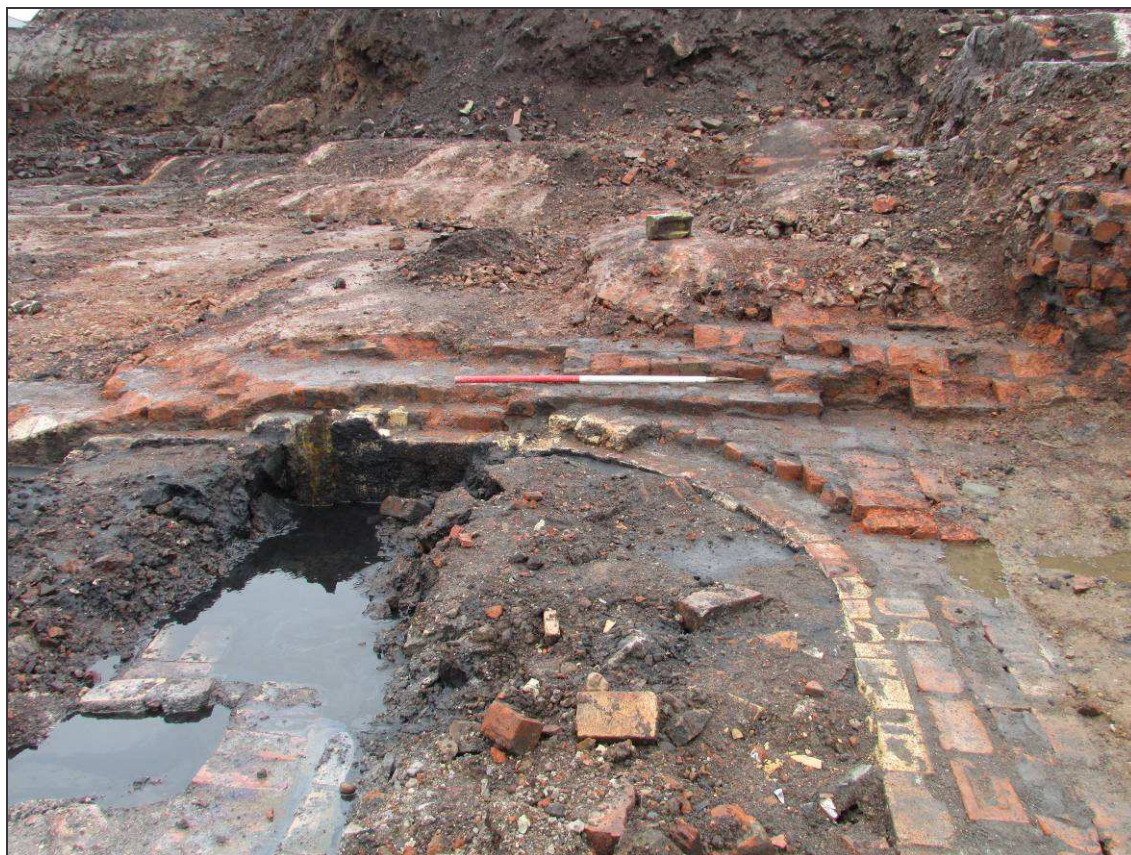
To the immediate east of the backfilled boiler house area, the surviving structural remains of the economiser was seen. The brickwork could be seen cut into an area of natural yellow silty clay to the west of the external stair case/yard wall. The economiser was constructed of red machine-made brick and internally lined with a single course of firebricks, forming a flue 0.80m in width. This extended east from the boilers alongside the dividing wall of the boiler and engine house. The exposed brick flue ran east for 1.00m and then split into two separate channels, the first turning 90 degrees to the north and the second continuing east through the remains of a metal gate (Plate 30). Beyond this the flue continued for 1.20m then the brickwork structure curved to the right diverting the flue direction northwards and aligning its axis parallel to the first flue. The two flues ran north for 12.00m before returning to the east/west alignment and re-joining. From here they extended east for 5.00m, entering the chimney flue.

Plate 30: The north end of the economiser, abutting the south end of the engine house. Metalwork for the gate is visible in oil pool (looking N)

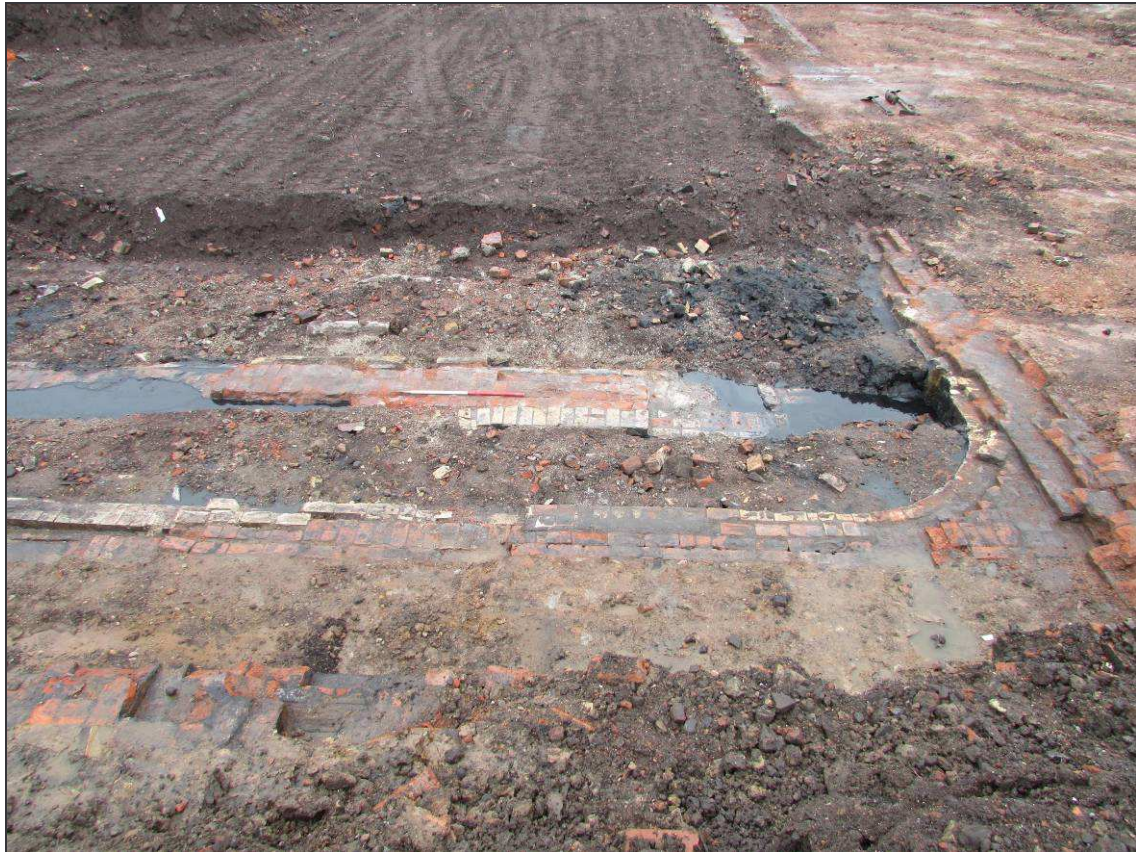
Excavation of the economiser flue fills / soot traps was abandoned due a level being reached below the water table and the presence of oil, which can be seen in both Plate 30 and Plate 31. The wet weather conditions endured throughout the excavation also contributed to flooding around the feature.

Plate 31: Elevated view of the backfilled economiser flue channels. Looking west

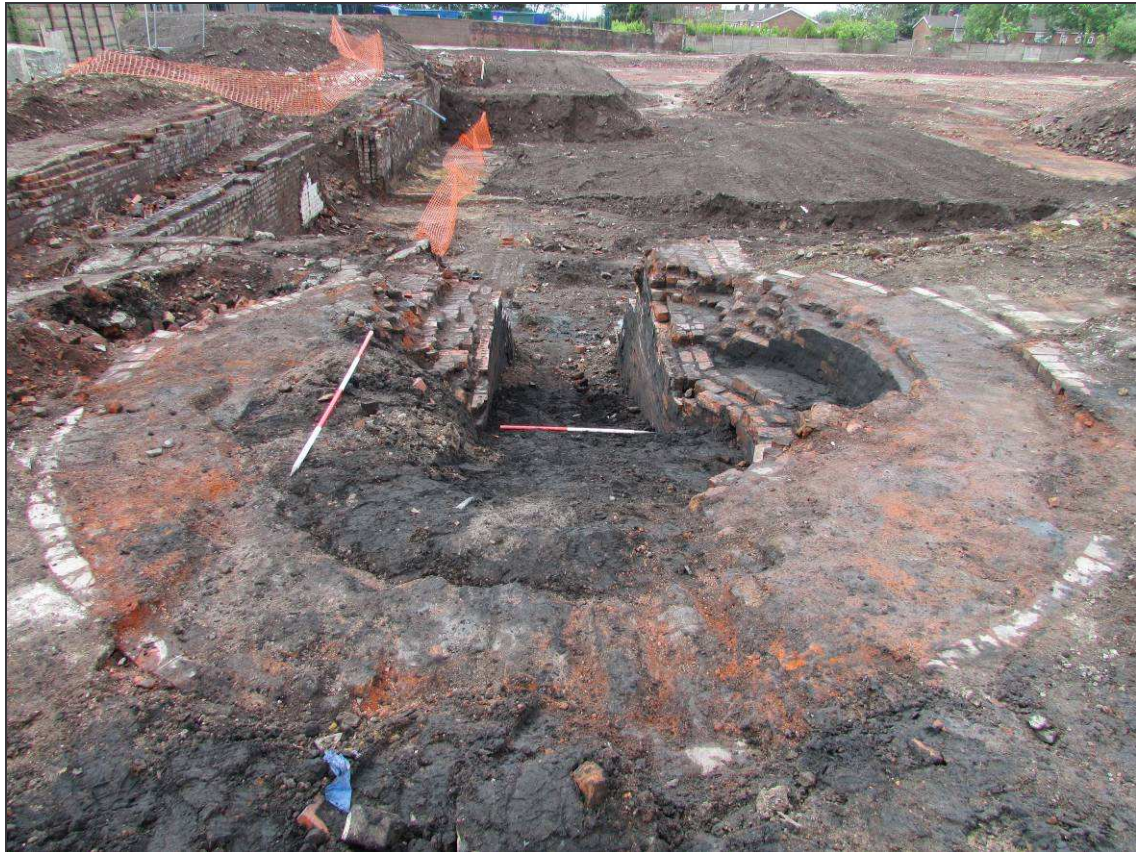
The economiser flue continued east into the chimney. The chimney stack was found to be of circular form, and had been levelled to a slab level height which was approximately 2.00m above the economiser remains in what would have been the mill yard (Plate 32). Surrounded by modern flags and demolition materials, the exposed chimney footprint measured 5.60m in diameter. Excavation into the soot fill revealed the chimney to be double skin in construction with the flue running to its centre.

Plate 32: Chimney footprint. Looking west

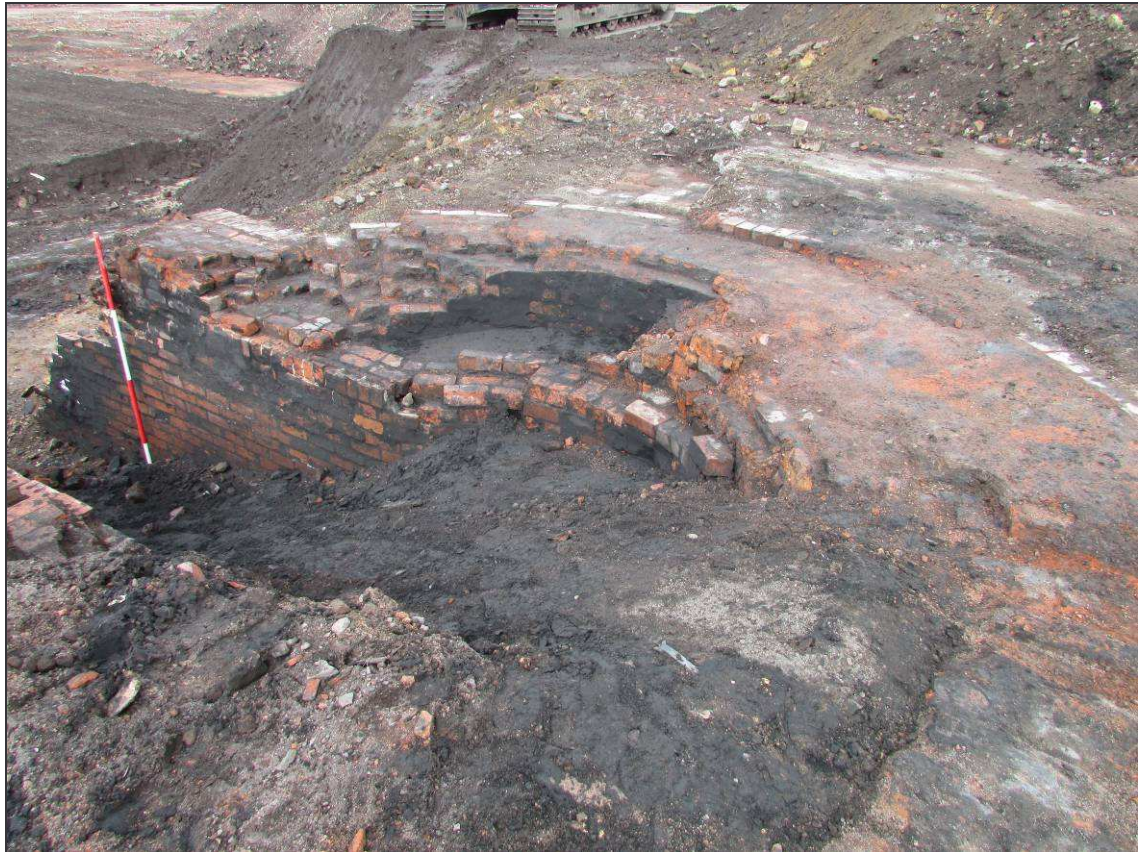
The flue entering from the economiser had a width of 1.35m and was seen to be flanked on either side by surviving walls to a height of 1.86m. The full flue soot fill was not excavated and no base was seen. Working in from the external face, the chimney stack had an external single course of Accrington bricks followed by six courses of damaged red brick stamped with either; Chamber Colliery, Hollinwood or Smethurt Lowside. The width of these courses was approximately 0.86m. In front of this a lower brick shelf filled with soot was seen before the inner course of specially moulded bricks formed the eye of the chimney (Plate 33 and Plate 34).

Plate 33: Inner chimney flue wall and structural brickwork to central eye. Looking north- west

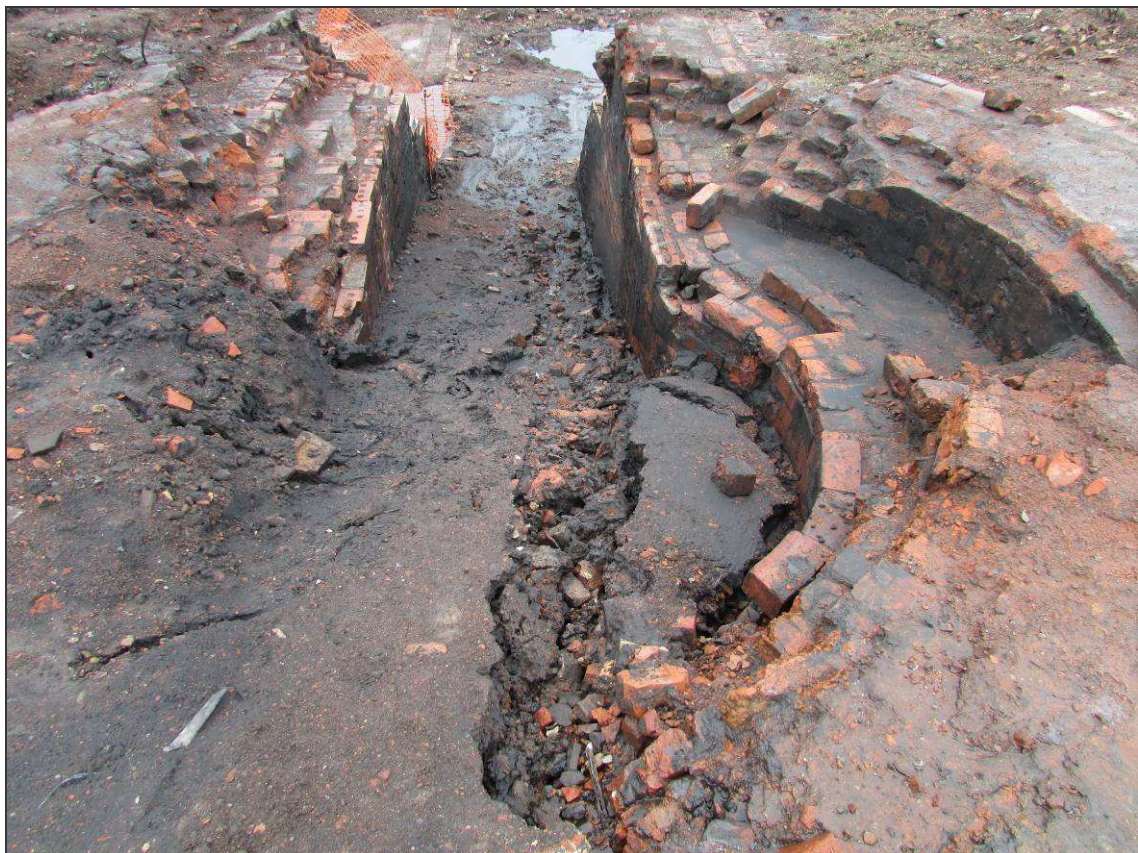
Plate 34: Exposed cross-section of the chimney stack. Looking west

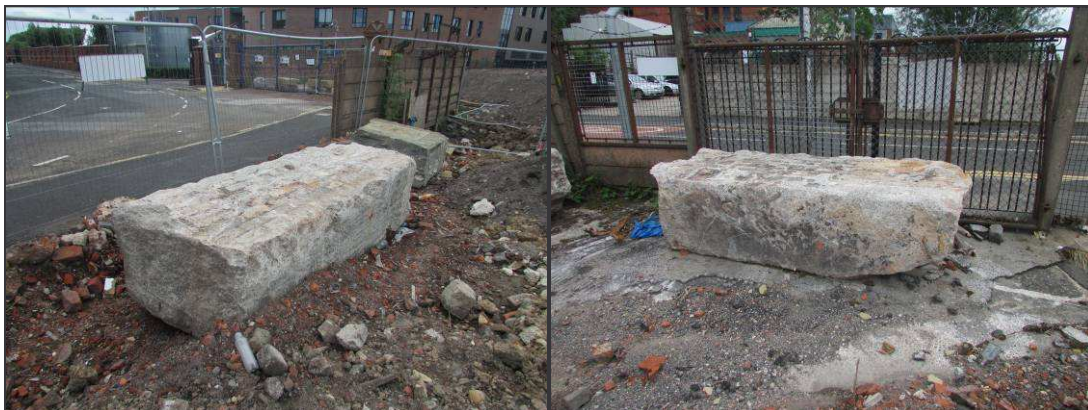
Within the engine room, there was no evidence of the original machines left *in-situ*. The crude aggregate concrete which was seen surviving in banked ledges would have originally formed a sturdy foundation for the placing of the machine beds. It is also unclear as to what the purpose of the internal east/west short wall was. It could be suggested that the remains form the foundation courses of a pit feature. At the southern end of the site however, large stone slabs were seen being utilised as site security. The upturned slabs had protruding steel bolts and carved footings similar to what would be expected for the footings of the engine house machinery (Plate 29).

Plate 35: Large stone blocks, possibly related to the engine house. Looking south

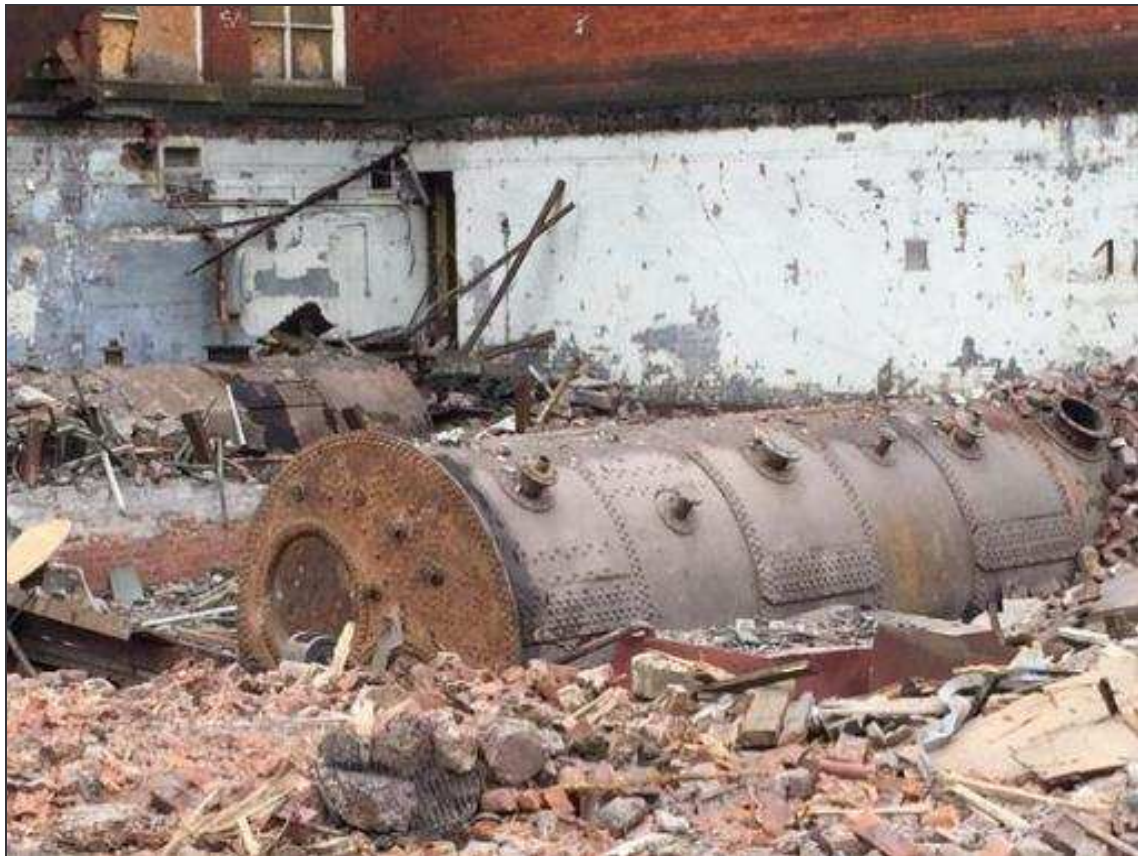
Plate 36: Durban Mill boilers in-situ during demolition. Looking south-east (Image taken from www.28dayslater.co.uk)

The boiler house was not fully excavated due to the presence of contaminants in the pits which would have originally housed the boilers. As with the engine house there was no original machinery present on site. Desk-based research found images of the boilers *in-situ* during the mills demolition and an illustration of the workings of a Lancashire boiler (Plate 36 and Plate 37). These images demonstrate that the archaeological remains seen on site relate to the boiler flue pits. The contaminants within these pits will be related to the later phase of the boilers after their conversion to heating fuel storage.

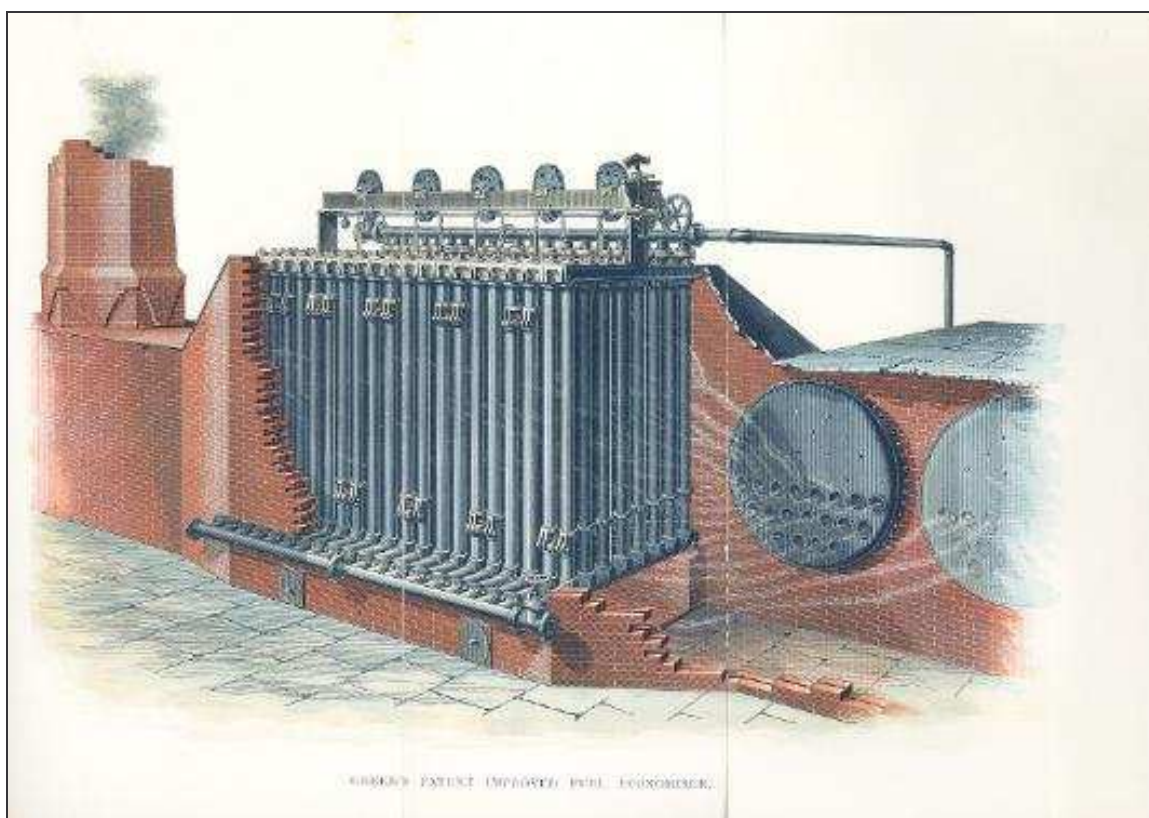
The efficiency of the Lancashire boilers and the running cost of the mill would have been improved by having an economiser, an energy saving device invented by Edward Green in 1845. This economiser comprised a bank of cast-iron pipes mounted in the flue between the boiler and the chimney (Plate 38). Water entering the boiler was first passed through the pipes and heated by the exhaust gases in the flue, this reduced the fuel costs for the mill. The remains of the economiser were seen to the east of the boilers with only the footprint of the flue and soot chambers.

Plate 38: Illustrated cross-section of the relationships between the boilers, economiser and the chimney.

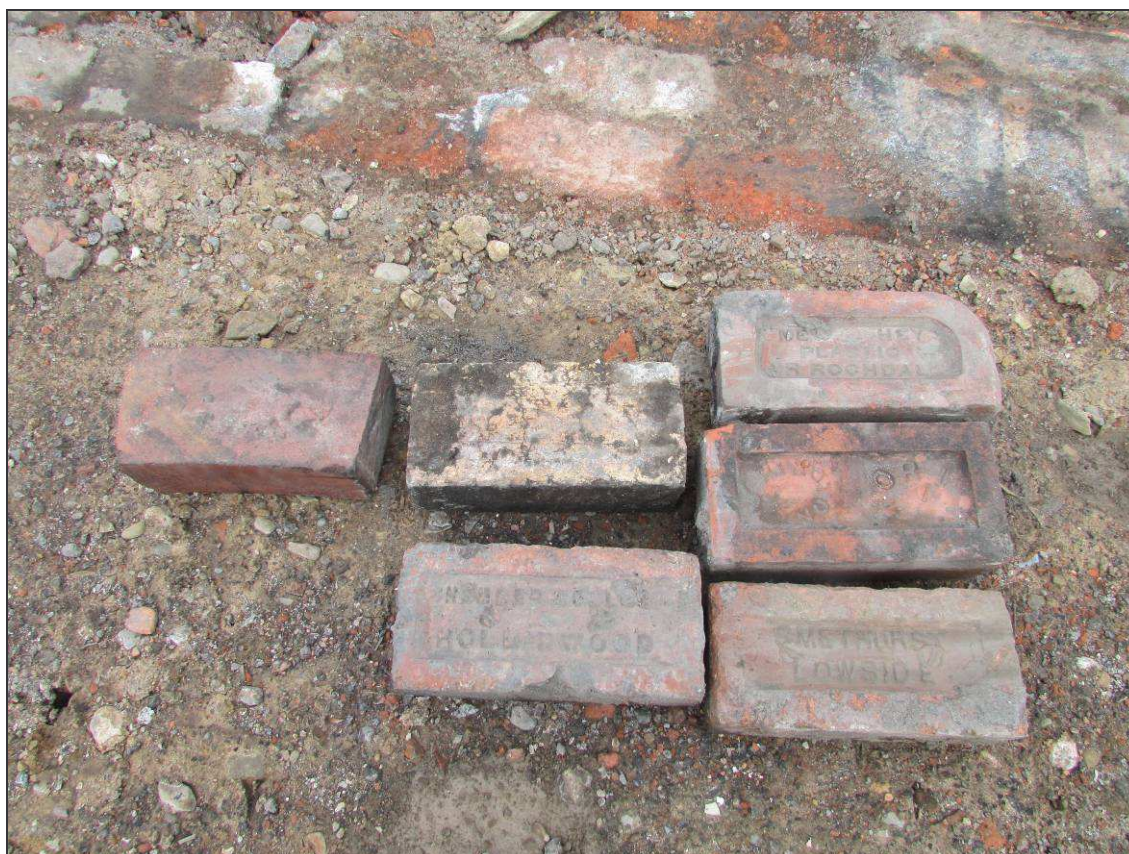
The excavation of the mill's engine house provided an opportunity to examine the buried remains of a textile mill in the nucleus of Oldham's cotton industry. It was noted that a number of different collieries provided the bricks for Durban Mill's construction (Plate 39). The collieries noted were:

- Accrington
- Smethurst Lowside
- Hollinwood
- Glossop
- New Hey

Plate 39: Multiple Collieries produced the bricks used in the mills construction
