## **Archaeological Excavation**

Trinity Way,  
Blackfriars,  
Salford

**Report No:** SA/2017/73

**Document Type:** Archaeological Excavation Report

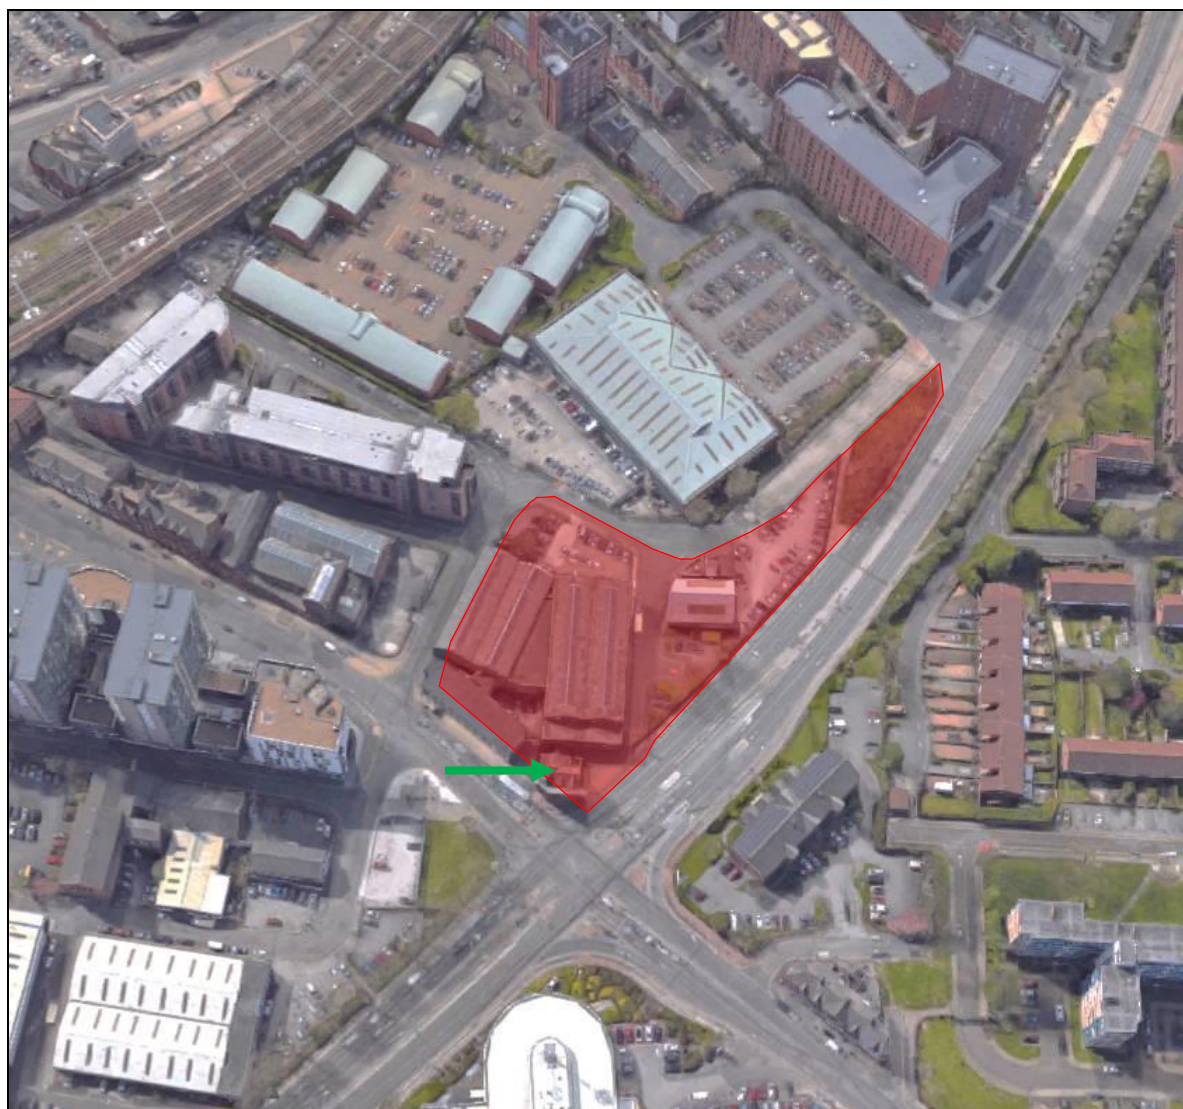
*Plate 1: Recent aerial view looking south across the study area prior to the clearance of the modern industrial buildings, with arrow marking the position of the Black Friar public house*

The study area (centred on NGR 383270 398860) lies to the south of the junction of Trinity Way and Blackfriars Road, in Salford. It is bounded by Trinity Way to the north-west, Blackfriars Road to the north-east, Garden Lane to the east and William Street to the south. The Blackfriars Pub is situated at the northern extent of the site. The remainder of the site had until recently been taken up by an engineering complex and garage, visible on a recent aerial image (Plate 1).

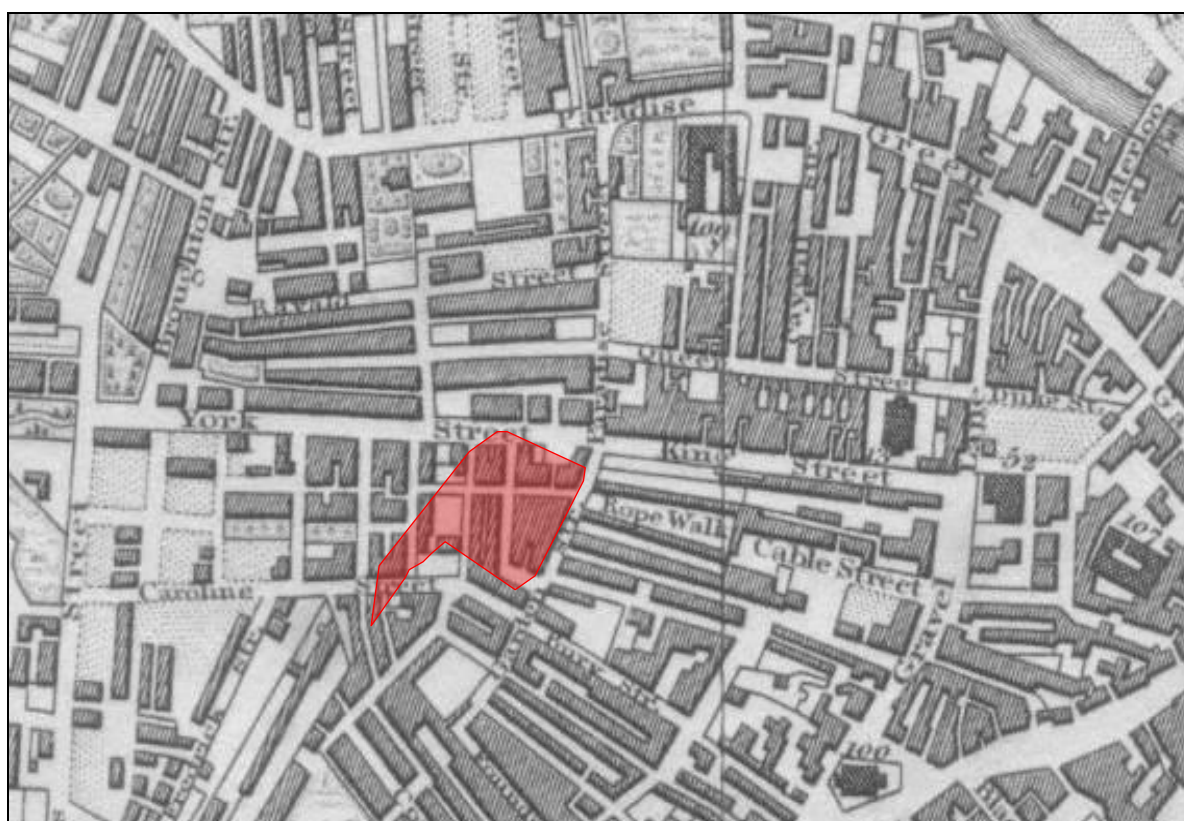
*Plate 3: Extract from Swire's map published 1824, marking the study area boundary*

The development of the newer plots within the study area is first captured on a map produced in 1824 by William Swire, which details the completion of the housing between Crown Street and Uxbridge Street (Plate 3). It also reveals an additional row of buildings built on the east side of Crown Street, including the Globe public house, which wrapped around the corner of Bury Street and Crown Street, placing its construction to *c* 1823.

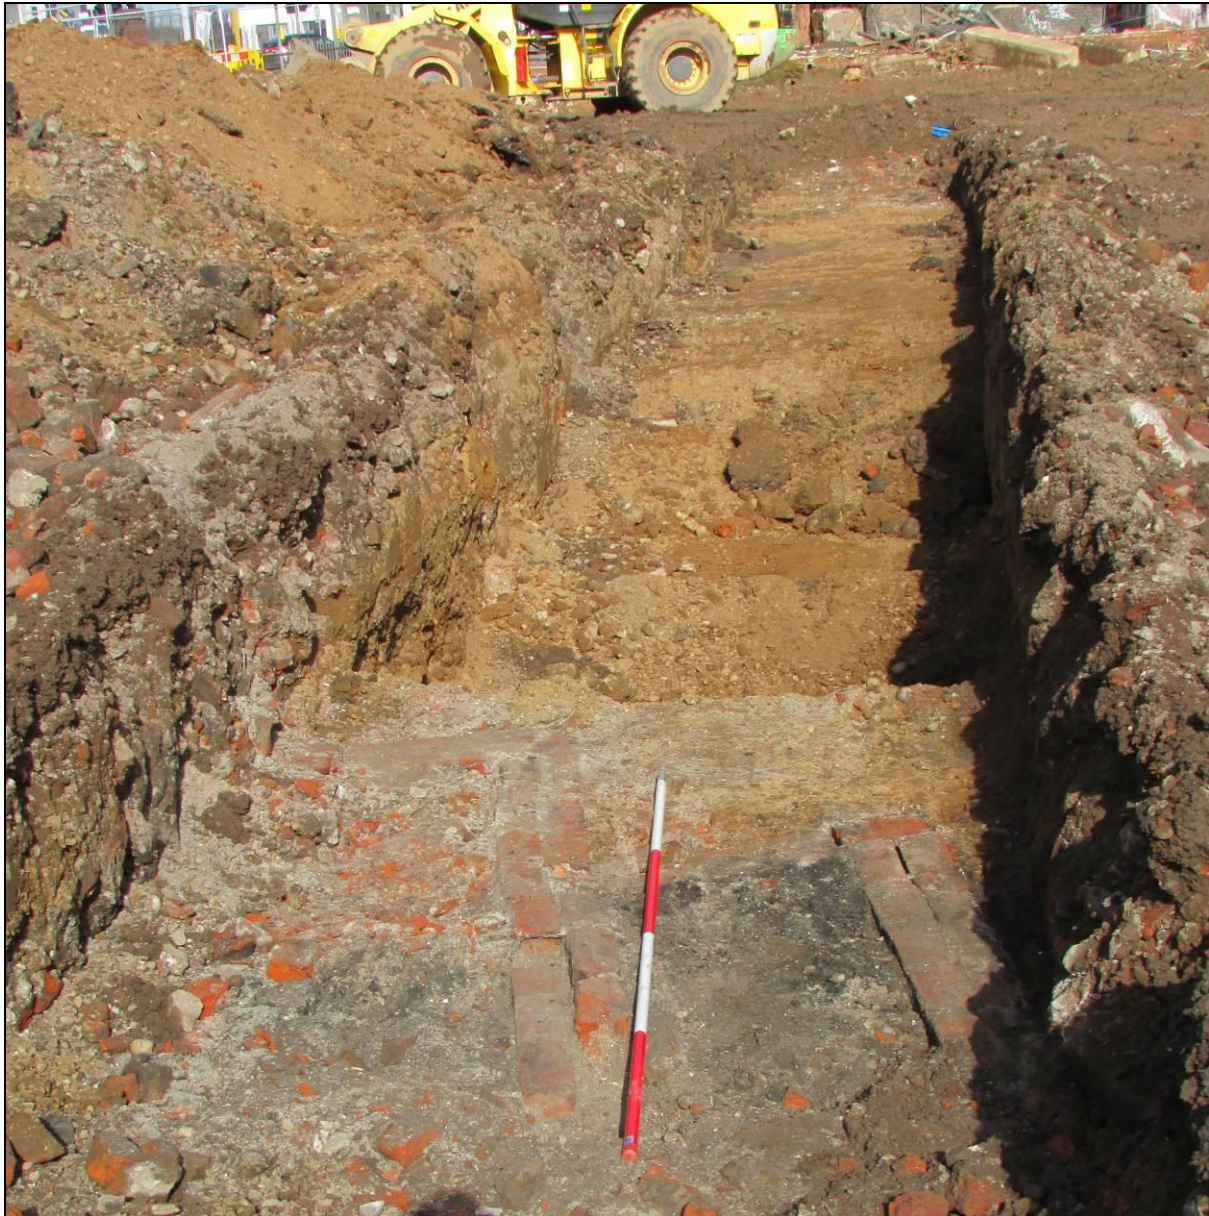
*Plate 7: View looking north along Trench 4*

Trench 4 measured 20 x 2m (Plate 7), was located across the footprint of a terrace of double-depth houses in the north-eastern part of the site, which appeared on historic mapping to contain cellars. The northern part of this trench was almost identical in character to Trench 3, with only layer **002** identified to be lying between the demolition debris (**001**) and the natural sand and gravel layer (**003**). In this trench, layer **002** was also found to be 0.30m thick, but had several clay lenses of the same colour present at the far northern end of the trench.

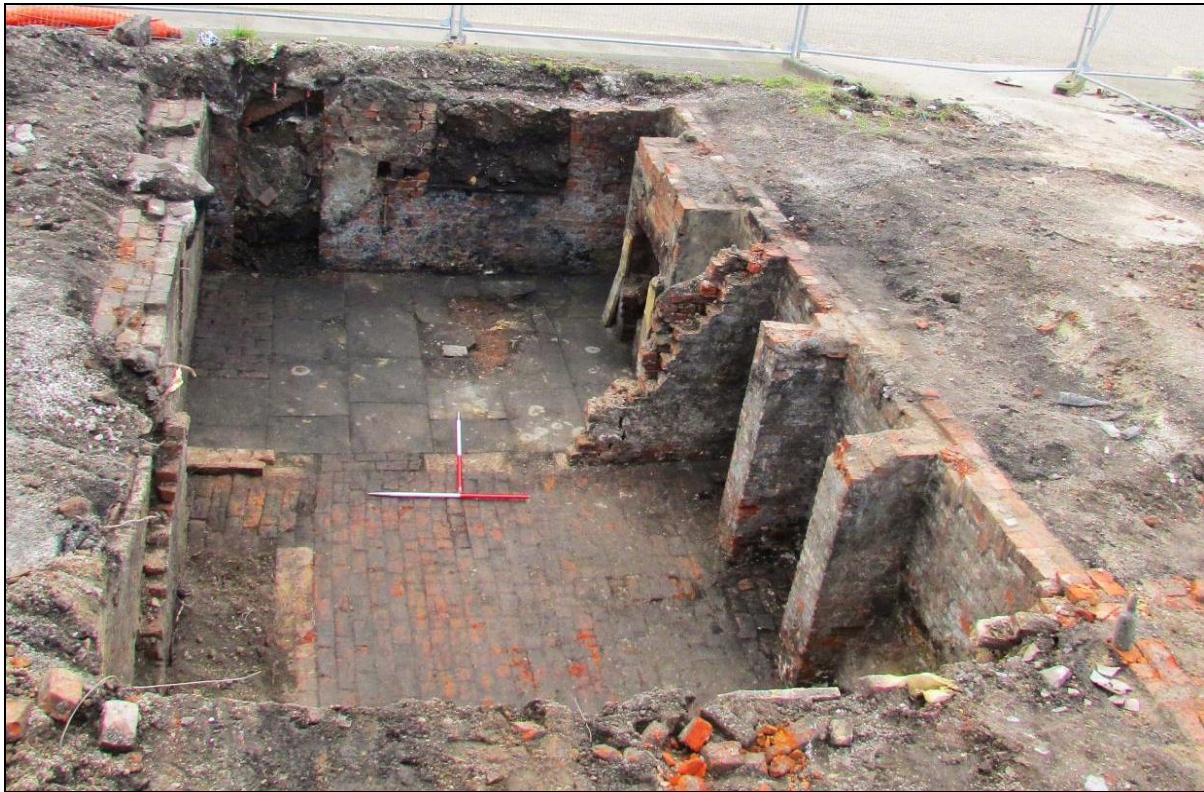
*Plate 8: The excavated remains of House A on the northern side of Bury Street*

The foundations of the two houses on Bury Street survived in good condition. They were built to a repeated pattern; Houses A and B were effectively identical in construction, consisting of a front, south-west room measuring 4.2 x 3.1m, and a back, north-east room, measuring 4.2 x 3.95m. The front rooms were floored with light grey sandstone flags, whilst the back rooms had brick surfaces.

A 1.3m wide window was positioned to the north-west of the doorway, housed in the middle of wall **104** (Plates 8 and 9). The window aperture was well-preserved and retained its sandstone sill, although what is likely to have been an arched crown had not survived. Given that the surrounding wall had survived in places to the present level of the street, it is probable it was positioned level with or above street height, which would have allowed a greater amount of light to penetrate the room.

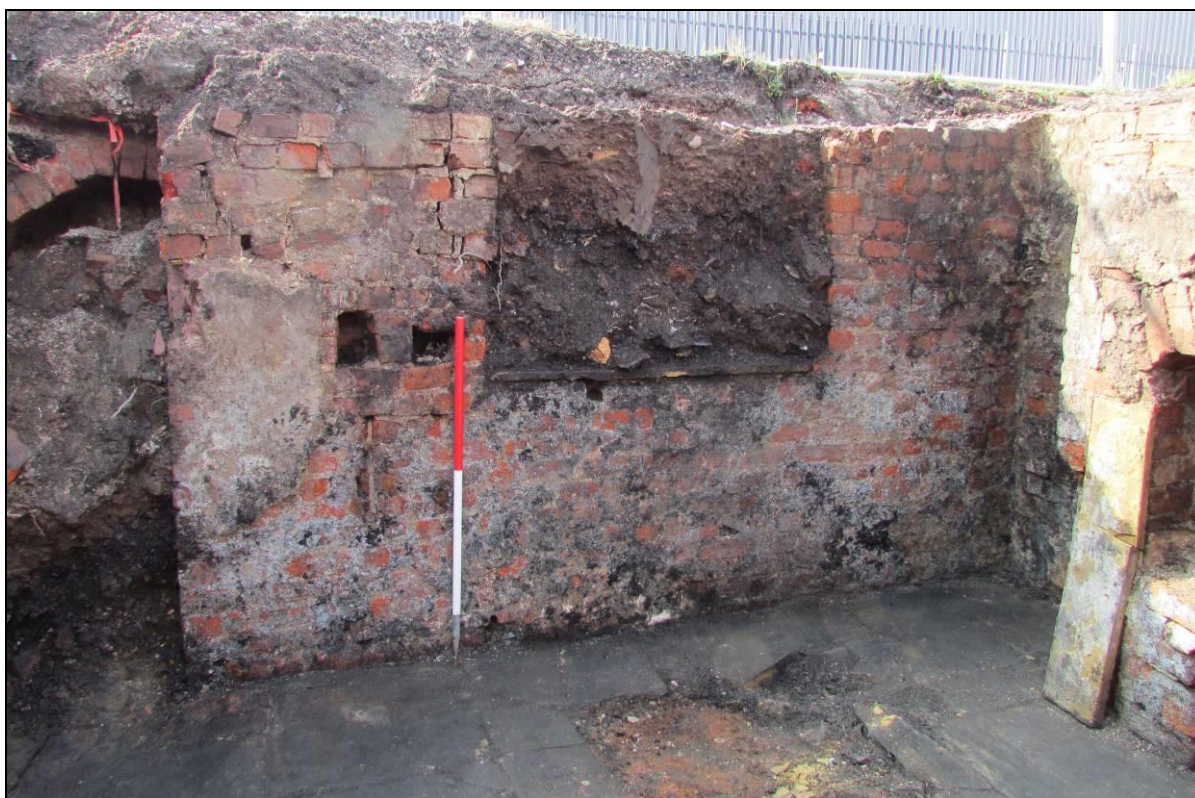
*Plate 9: The front wall (104) of House A*

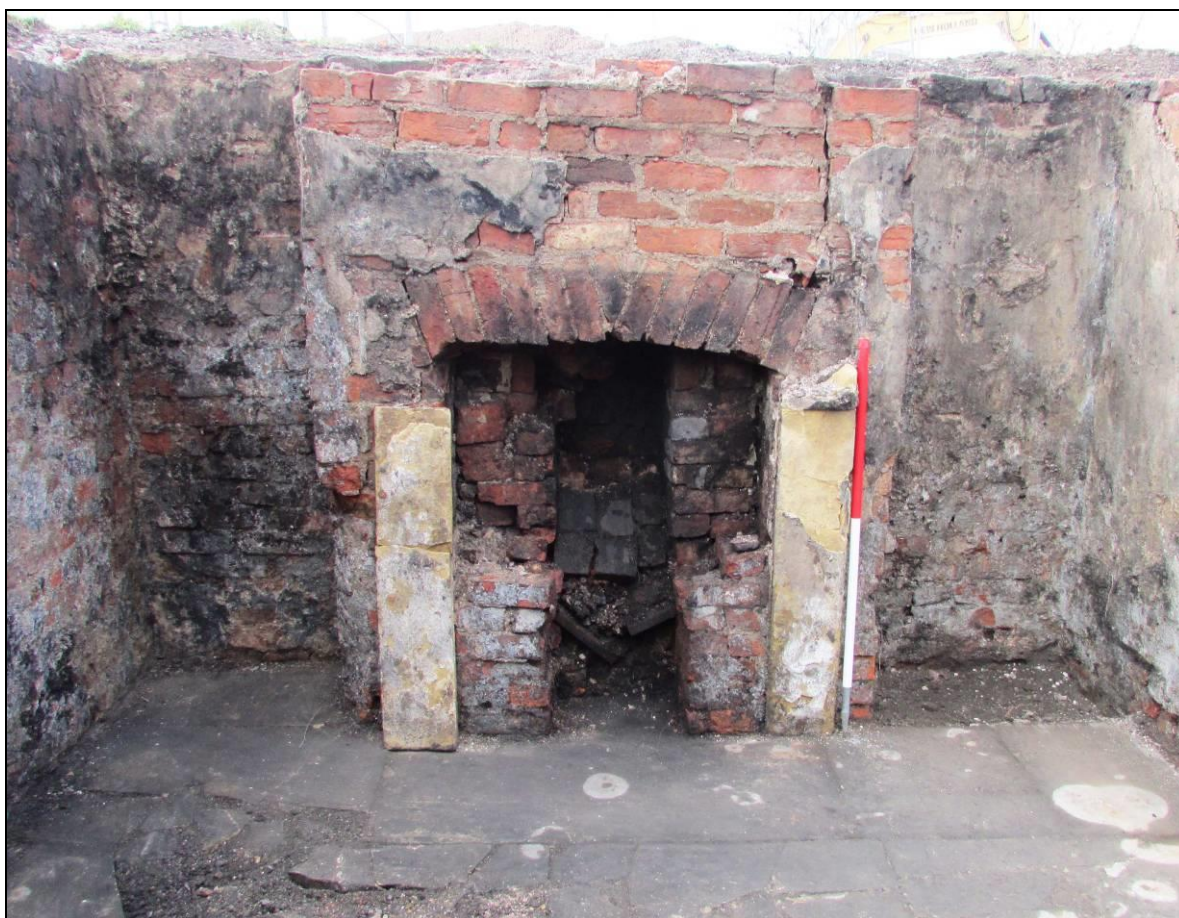
*Plate 10: Front room fireplace of House A*

The internal structure of the fireplace was more shoddily built, consisting of two solid inner cuboid pillars, which were stepped front to back to form an open fireplace. The front breast of the chimney was formed of a single-skin of bricks constructed between the outer pillars, supported by a shallow arch. A ceramic tile (0.12m in thickness) was in-built between the inner pillars at the back of the hearth, functioning as a shelf. The mouth of the fireplace was flanked by sandstone columns, topped with an overmantel. The brickwork was faced with a concrete render (Plate 10).

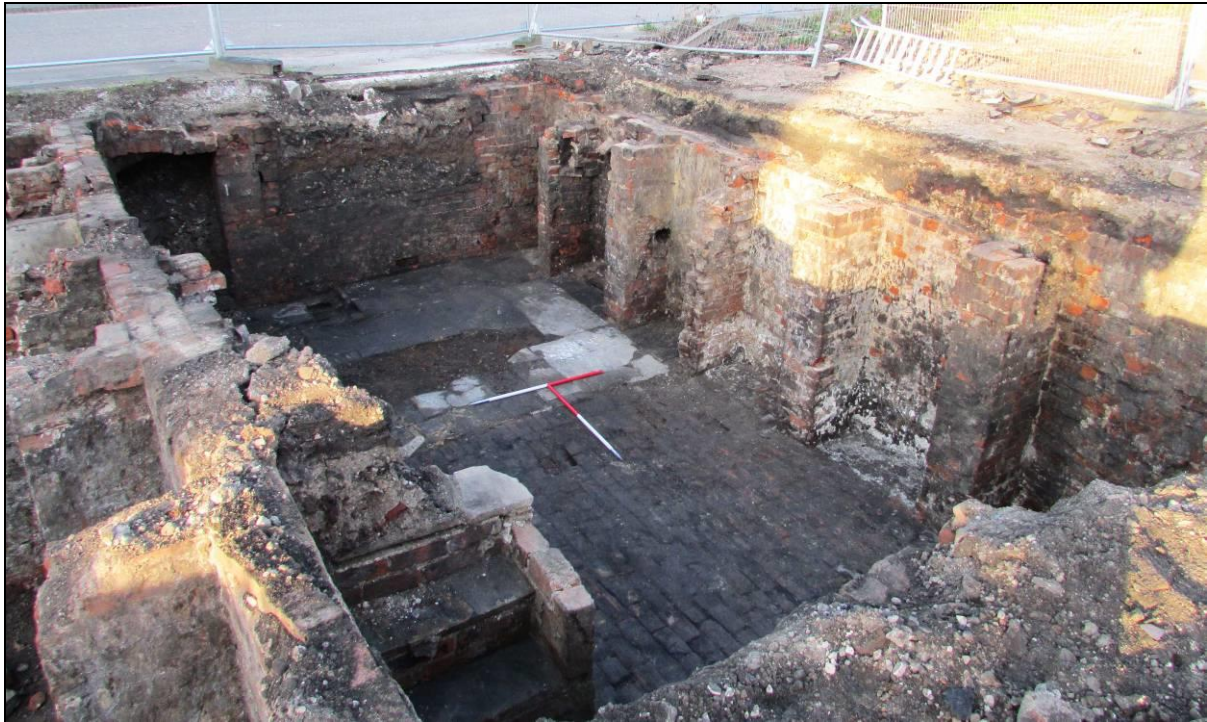
*Plate 11: The excavated remains of House B on the northern side of Bury Street, looking east*

**House B:** the remains of this property lay immediately to the north-west of House A, separated by party wall **002**. The building was delineated by walls **002**, **117**, **118** and **119**. It conformed to the same two-room arrangement as House A, differing only in its modifications and finish (Plate 11). The north-west party wall and front wall of the property were two brick-courses wide and contained the brick-built pillars for fireplaces in the front and back rooms. The dividing walls between the rooms (**123** and **124**) were also tied into the party walls.

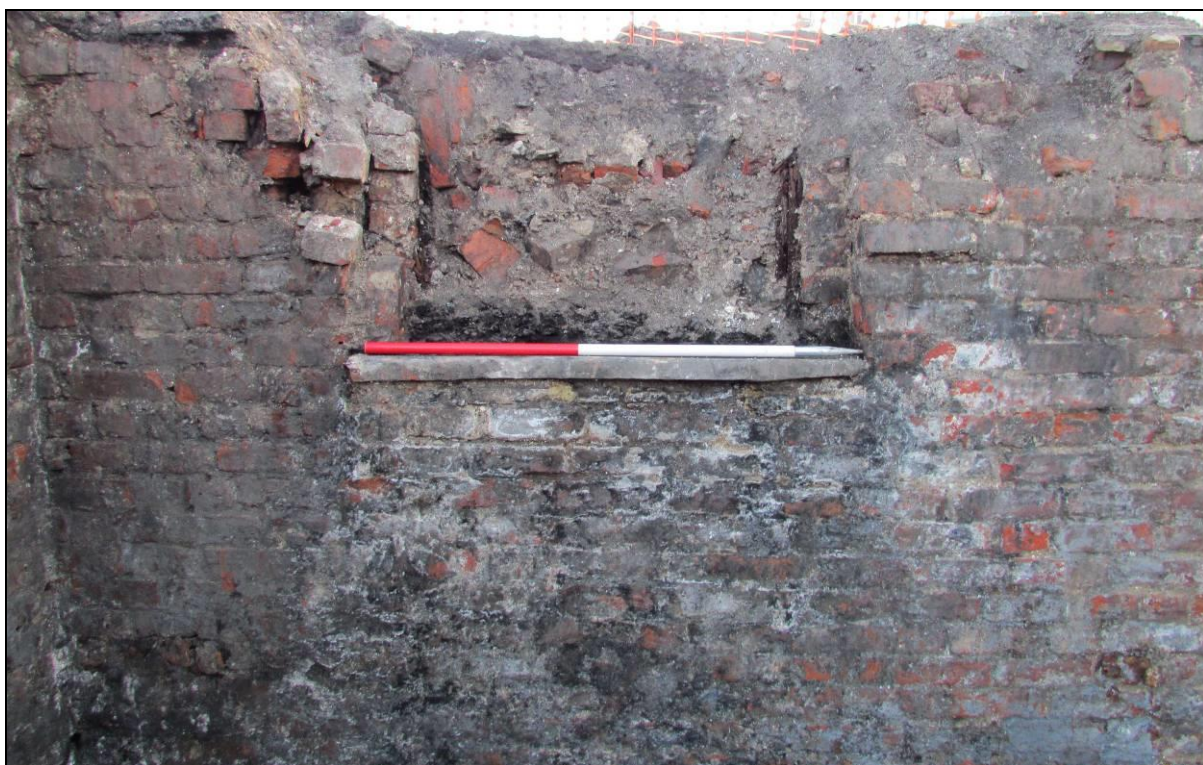
*Plate 12: Back room cellar light, House B*

Access to and from the cellar was similarly attained by an entrance within the front wall of the house and stairwell in the rear of property. The entrance was 0.76m wide and 1.7m high, topped with a shallow arch formed of whole bricks. Built into the end of wall **104**, on the south-east side of the entrance were red sandstone pads with iron pintels. On the opposite side was another sandstone pad with a looped iron fitting, perhaps to secure a sliding bolt or lock. To the north-west of the door was a large cellar light housed within wall **118**; this aperture measured 1.96 x 0.88m. Recesses within the brickwork at the base of the window, measuring 60 x 60mm on either side, originally housed a sill, presumably stone.

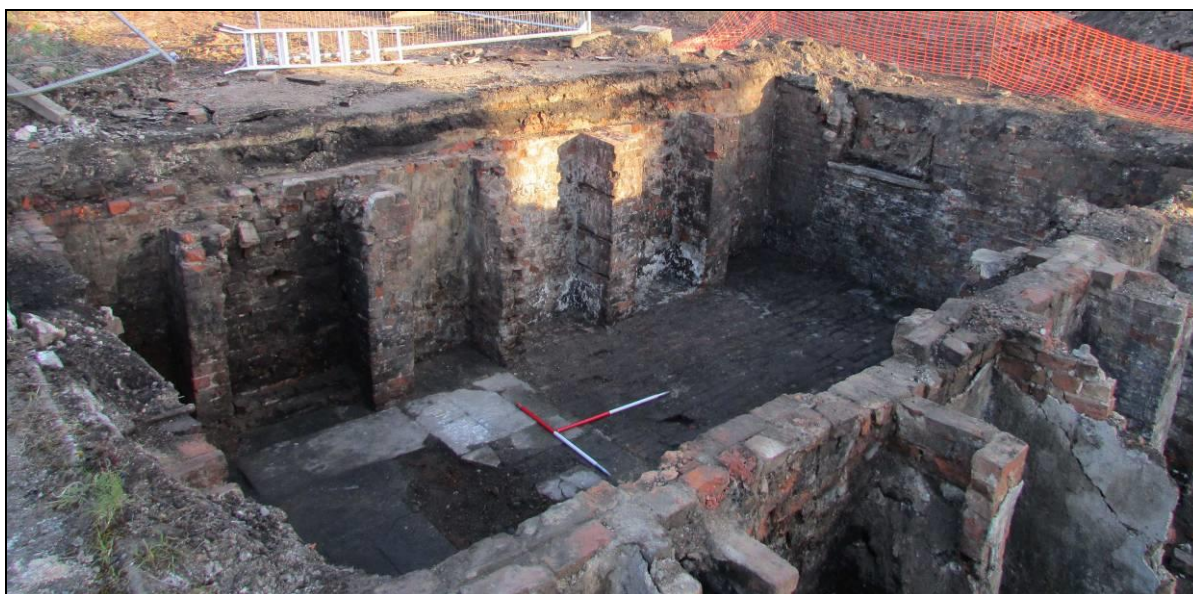
*Plate 13: The excavated remains of House B, looking north*

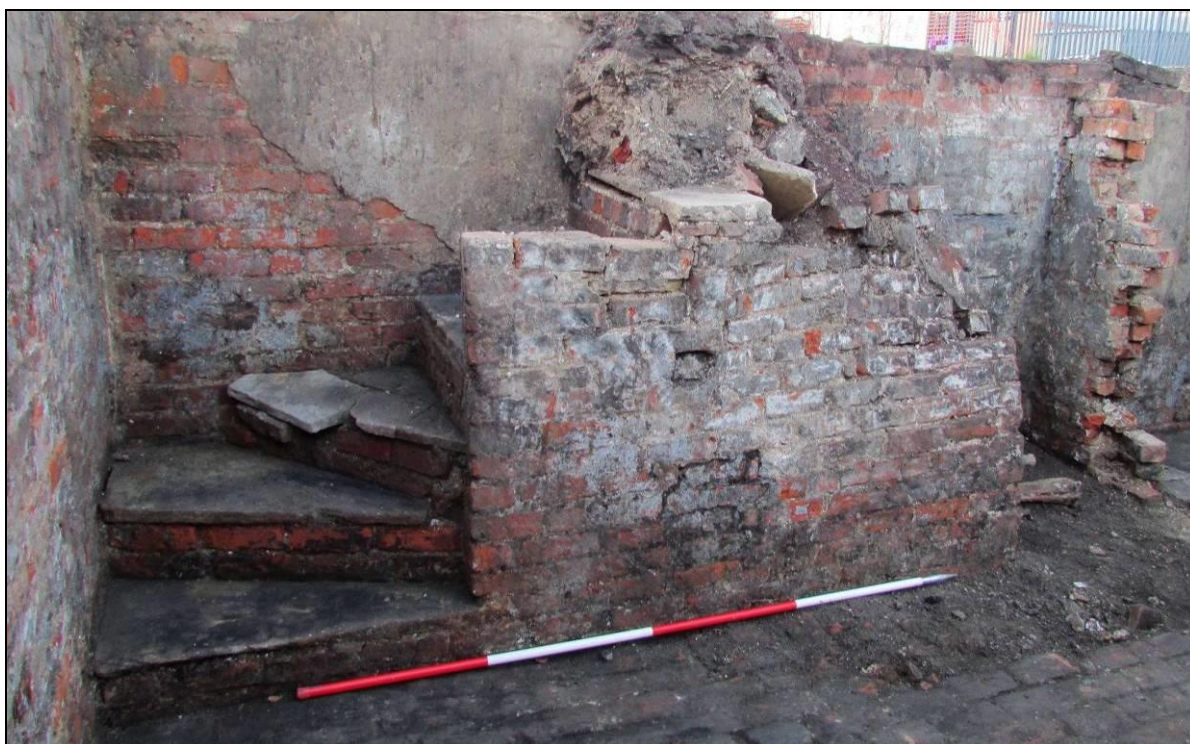
*Plate 14: Stairwell in the back room of House B*

A quarter-turn stairwell (**125**) was constructed in the back room of the house, affording access to the upper level of the building (Plate 14). It measured 2.7 x 0.9m, and survived to a height of 1.8m. The stairwell was formed of two parallel walls. A single-skin brick wall was added to the party wall **102**, and a two course-wide brick wall was situated 0.6m to the north-west. Single-skin brick risers supporting winder and rectangular sandstone tread (44mm thickness) were tied into the parallel walls. A cement render similar to that used in the front room of the house was added to the party wall within the stairwell (Plate 14).

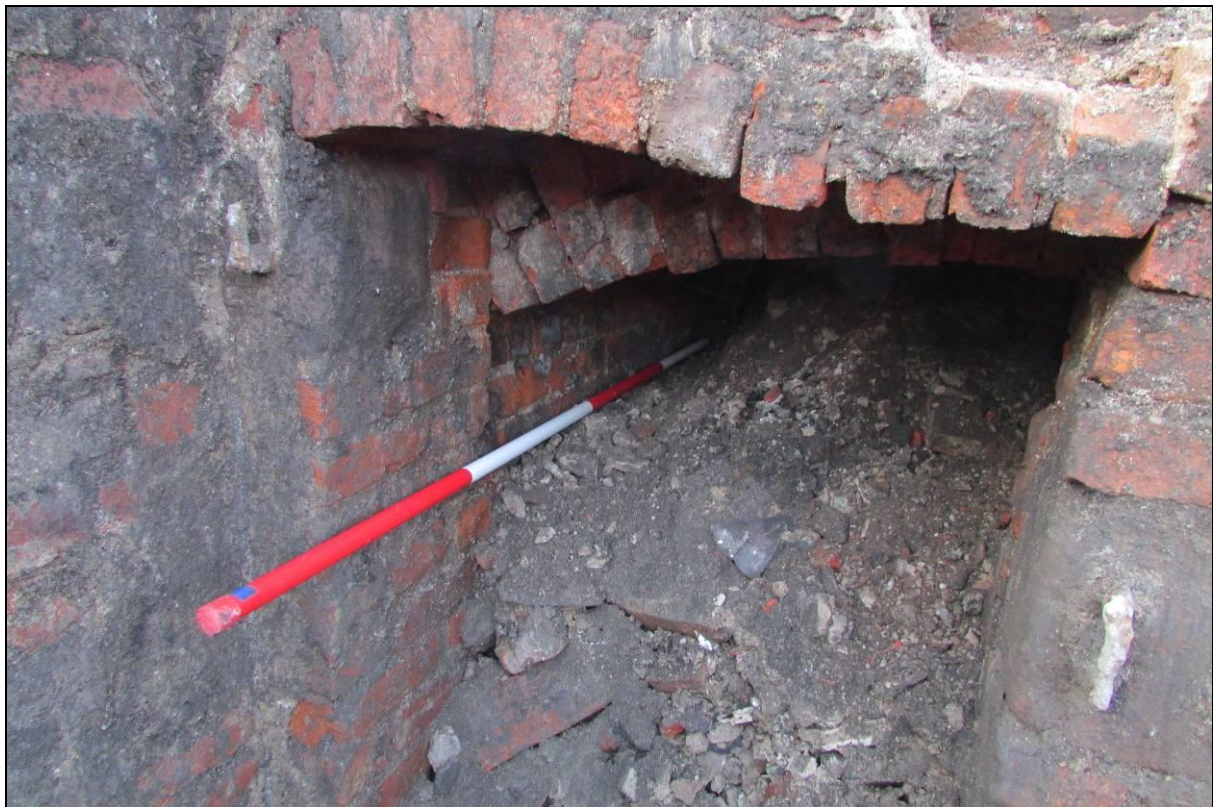
*Plate 15: Arched entrance at front of House B with vaulted storeroom behind*

A later addition to both House A and B were the storerooms constructed at the front of the buildings. The best preserved store was found at front of House B, occupying a rectangular plan (2.1 x 1.4m) with a barrel-vaulted roof. The outer walls and vaulted roof of the building abutted the front wall of the house; the arc of the roof also sat below the arched top of the entrance (Plates 15-17) and extended in front of the cellar light. It was constructed of hand-made bricks bonded with a lime-based mortar.

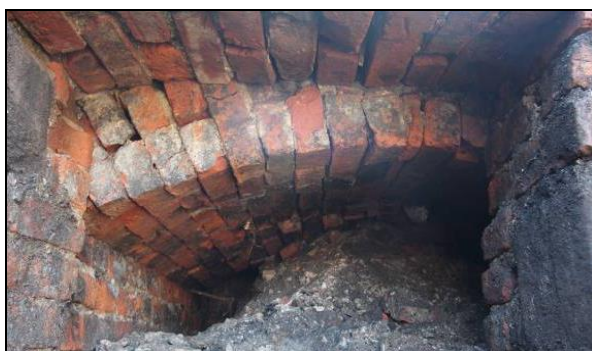
*Plate 16: Detail of vaulted roof of storeroom abutting the front entrance of House B*

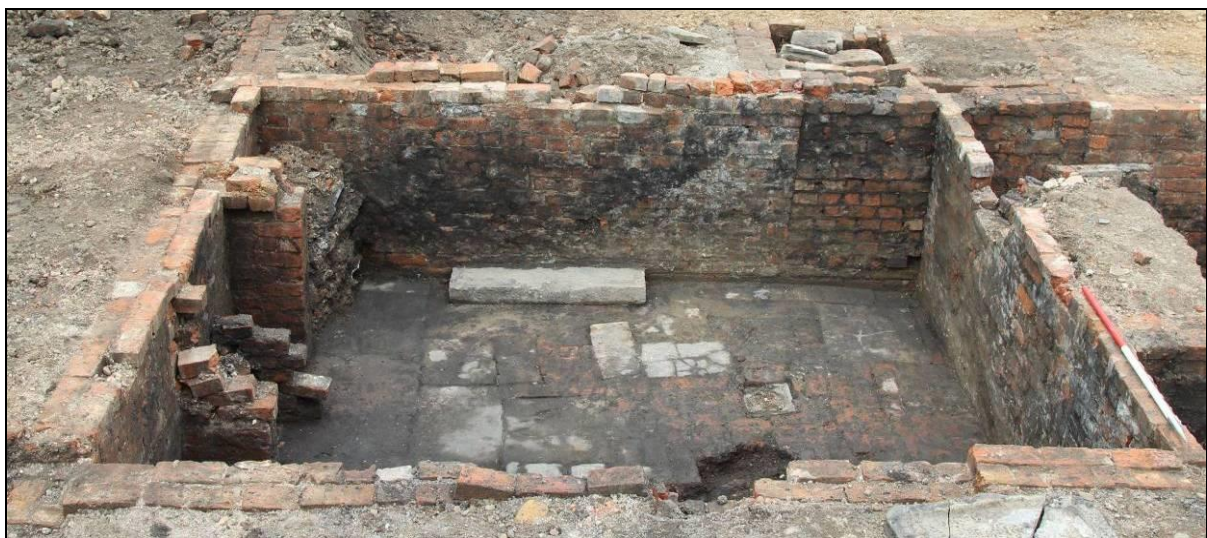
*Plate 18: Cellar 1, looking north*

**Cellar 1 (141):** this comprised the remains of a possible back-to-back dwelling found furthest west of Area 2. The interior of the room measured 3.78m east/west by 3.39m north/south. The fabric of the surviving sections of wall comprised hand-made brick (0.23 x 0.11 x 0.07m) bonded with light brown sandy mortar, typical of the first half of the 19<sup>th</sup> century. The entrance to the cellar was via an external staircase (**143**), leading down from the north. All four walls survived to a maximum height of 1.08m (Plate 18).

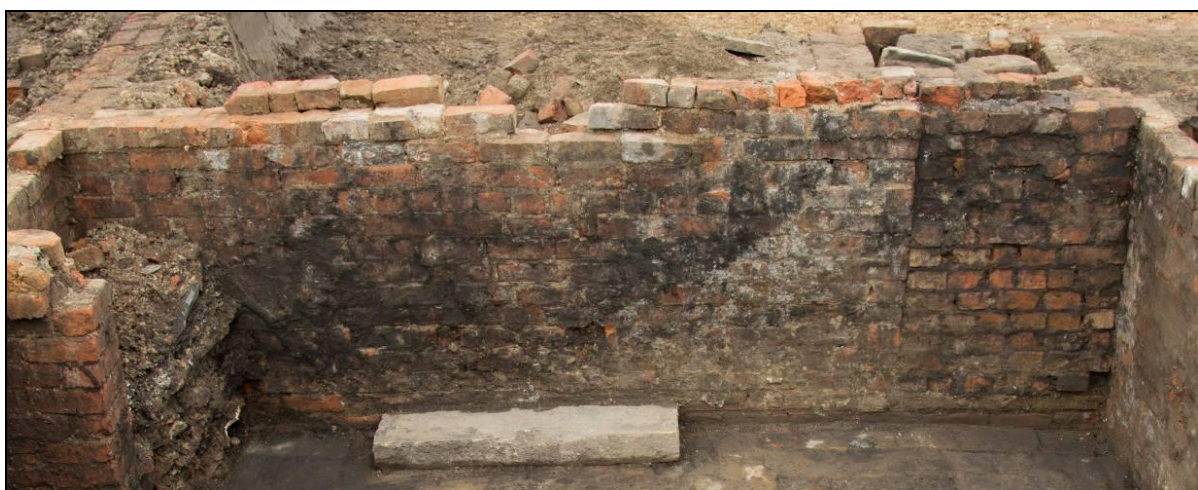
*Plate 19: The northern wall of Cellar 1 showing bricked-up doorway on the right, looking north*

The northern wall was aligned east/west, measured 4.14m in total and incorporated a single entrance doorway at its eastern end, which had been bricked-up. The doorway measured 0.75m and had been bricked-up at some point during the later 19<sup>th</sup>/early 20<sup>th</sup> century, using hand-made bricks bonded with black ash mortar, typical of construction materials used from about 1860 (Plate 19).

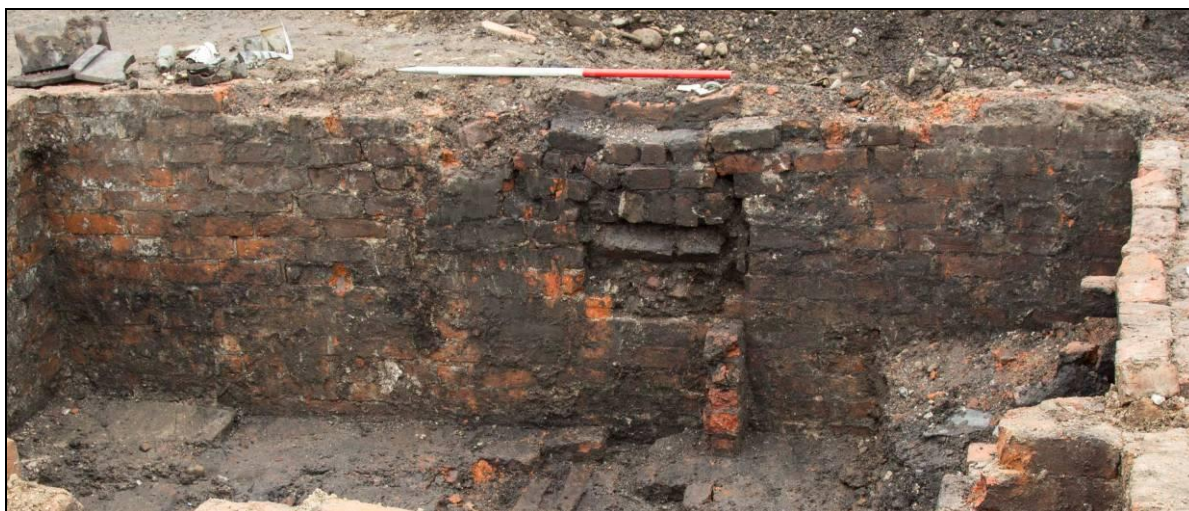
*Plate 21: The southern wall of Cellar 1 showing possible later modifications, looking south*

The southern wall was aligned east/west, measured 4.14m in total, and showed signs of later modification. Part of this wall appeared to have been rebuilt, due to the presence of black ash mortar in a 1m section towards the western end of the wall, below which, part of a small wall (damaged) protruded slightly (Plates 20 and 21). The southern wall appeared to have continued west, but had been truncated by what appeared to be the addition of a toilet block directly west of the cellar.

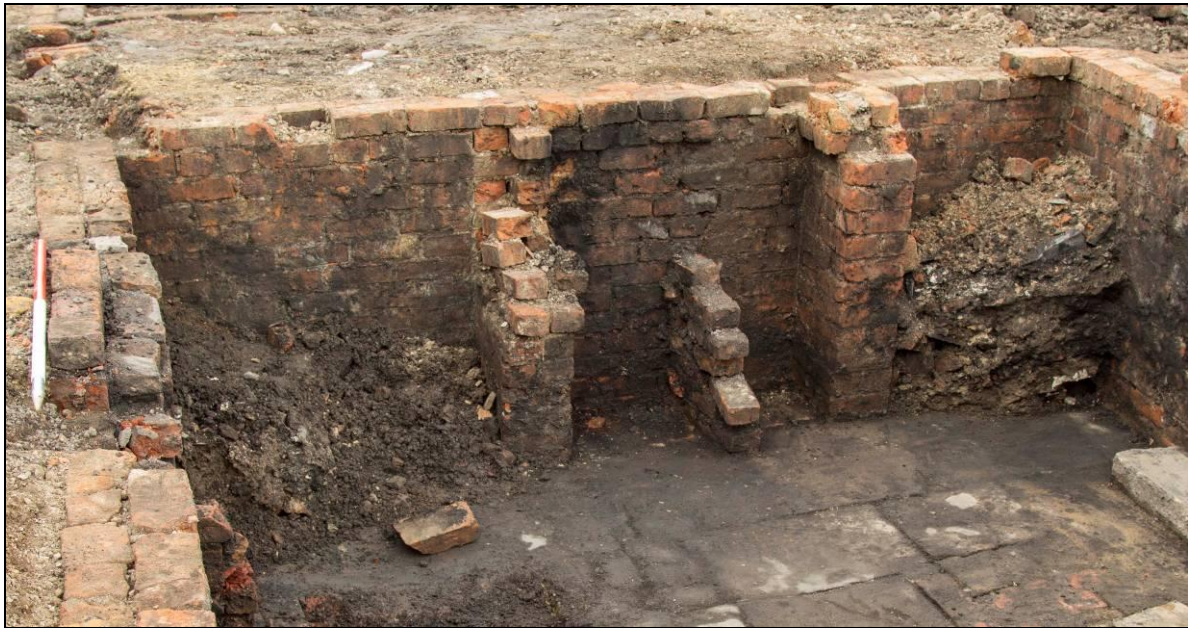
*Plate 22: The western wall of Cellar 1 showing the remains of a fireplace and the addition of a smaller wall, looking west*

The western wall, aligned north/south, measured 3.85m in total and contained the remains of a fireplace. The internal measurement of the fireplace was 0.97m, with the two flanking pillars measuring 0.23m wide and protruding 0.36m from the western wall. A small wall had been added slightly off-centre within the fireplace, consisting of only a single course of hand-made bricks bonded with black ash mortar, measuring 0.47m in length. This had probably supported a type of range used for cooking, heating water, etc (Plate 22).

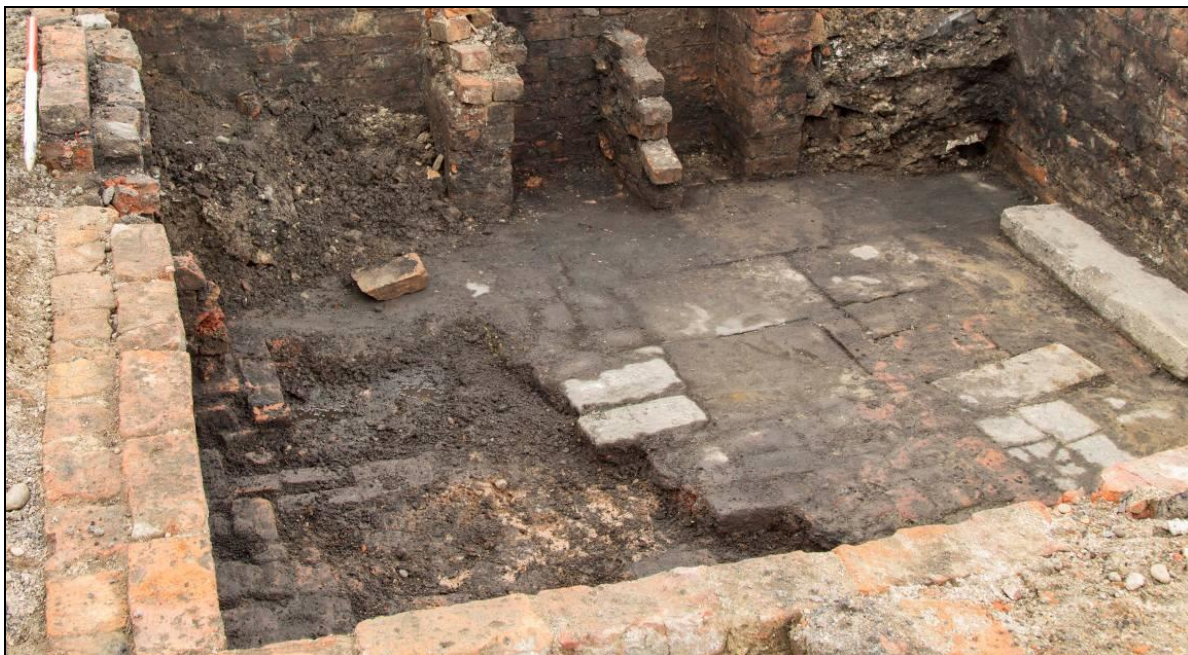
*Plate 23: Detail of the brick and stone-flagged floor in Cellar 1, looking west*

The floor of the cellar appeared to have been laid on yellow clay, consisting of an irregular mixture of hand-made bricks and flagstones (Plate 23). A square drain cover was uncovered in the north-east corner of the room (0.96m from the northern wall and 0.87m from the eastern wall), measuring 0.26 x 0.26m with a circular, slotted recess in the centre for drainage. A further drain was found constructed into the floor against the southern wall, below the area, which had been rebuilt. A late 19<sup>th</sup>-century broken glass bottle was found inside the drain, below the floor surface.

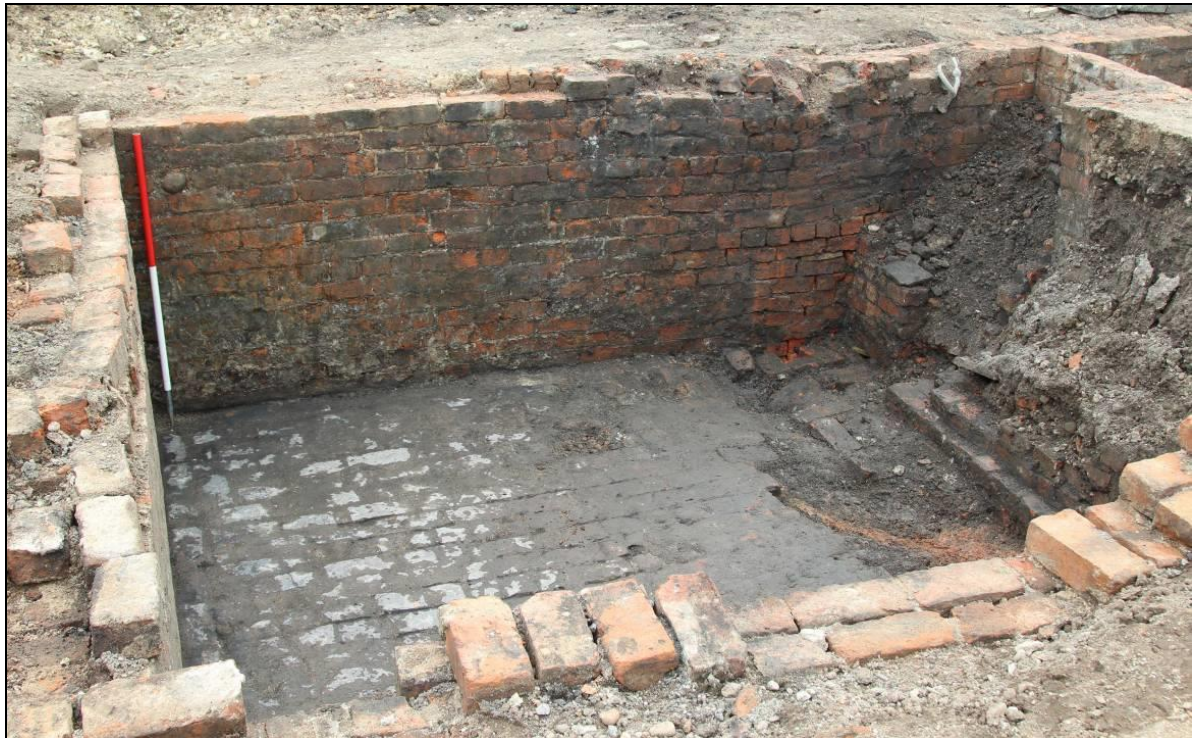
*Plate 24: Cellar 2, looking south*

**Cellar 2 (142):** this lay directly east of Cellar 1, adjoined by the party wall described above. Access had been via a separate staircase (**143**) next to and the same as those entering Cellar 1. The internal measurements of the room were 3.97m east/west by 3.40m north/south, not dissimilar to that of Cellar 1. The walls survived to a maximum height of 1.28m (Plate 24).

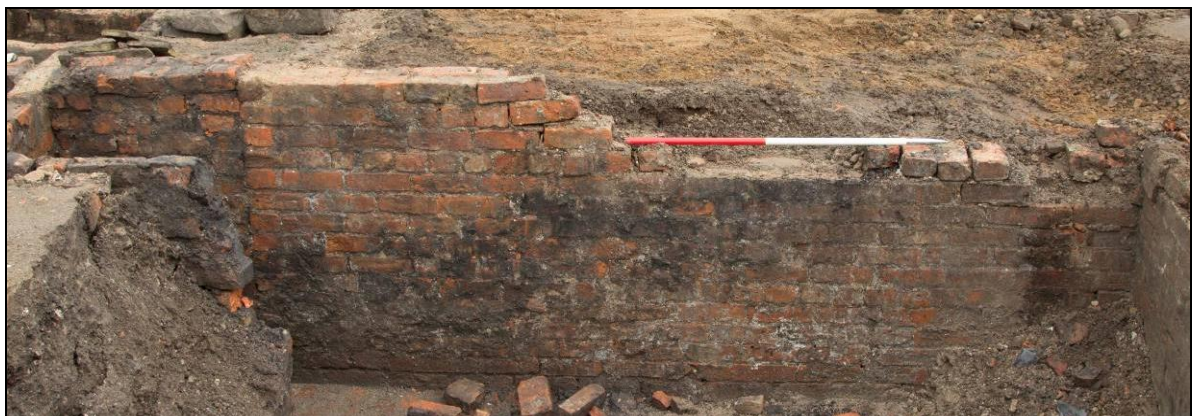
*Plate 25: The northern wall of Cellar 2 showing the bricked-up doorway on the left of the photo, the wall was lowered by machine on the right of the photo to allow safe access into the cellar, looking north*

The northern wall was aligned east/west, measuring 4.20m in total and incorporated a single entrance doorway (0.75m wide) at its western end, which had been bricked-up (Plates 25 and 26), as seen in Cellar 1. The foundation cut (**148**) for the wall could be seen cut into the natural geology (**003**) at a distance of 0.43m from the northern side of the wall (Plate 27), which in turn, appeared to join the cut for the staircase **147**.

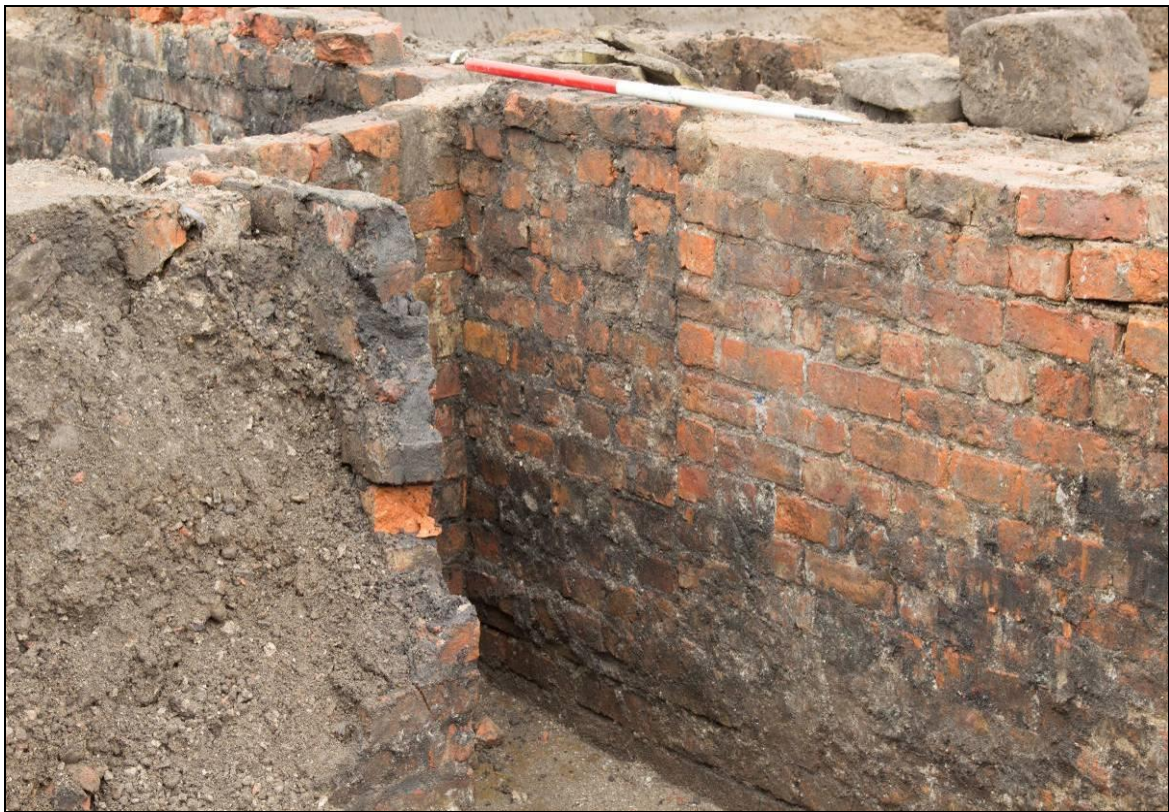
*Plate 26: Detail of the bricked-up doorway into Cellar 2, looking north-west*

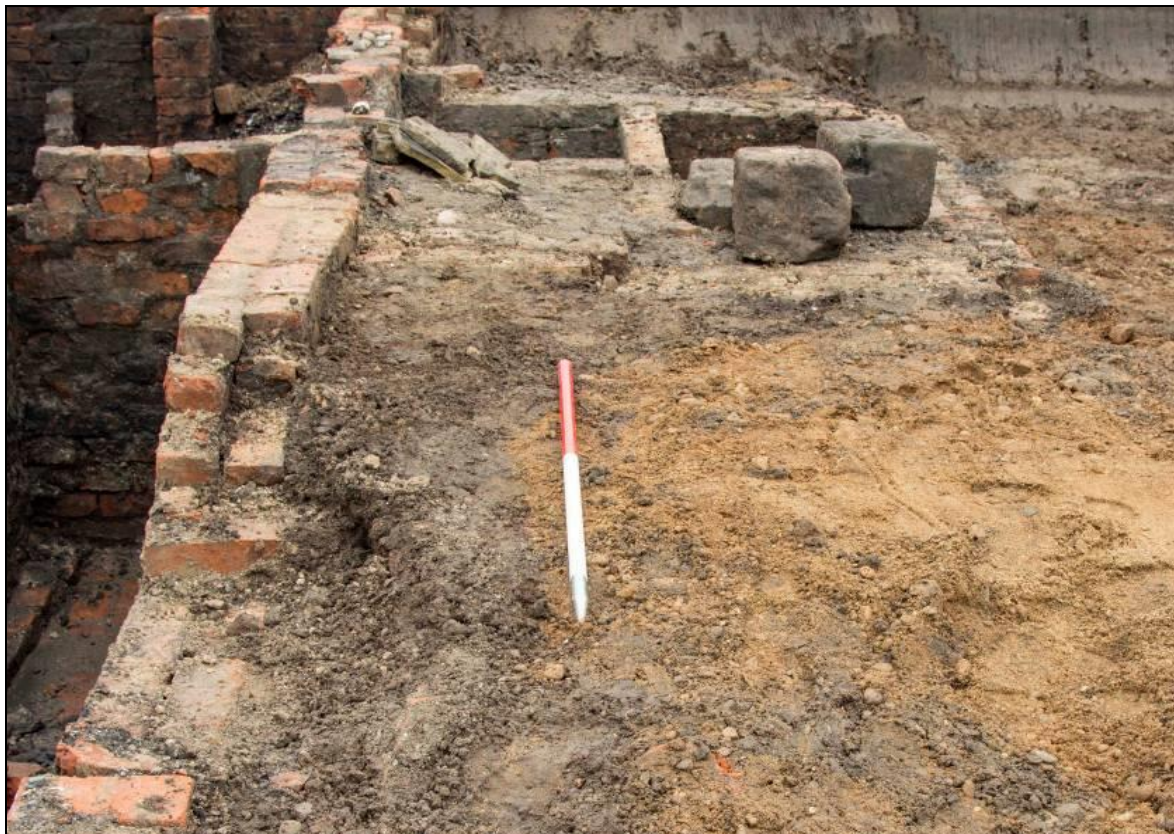
*Plate 27: Wall foundation cut **148** along the northern wall of Cellar 2*

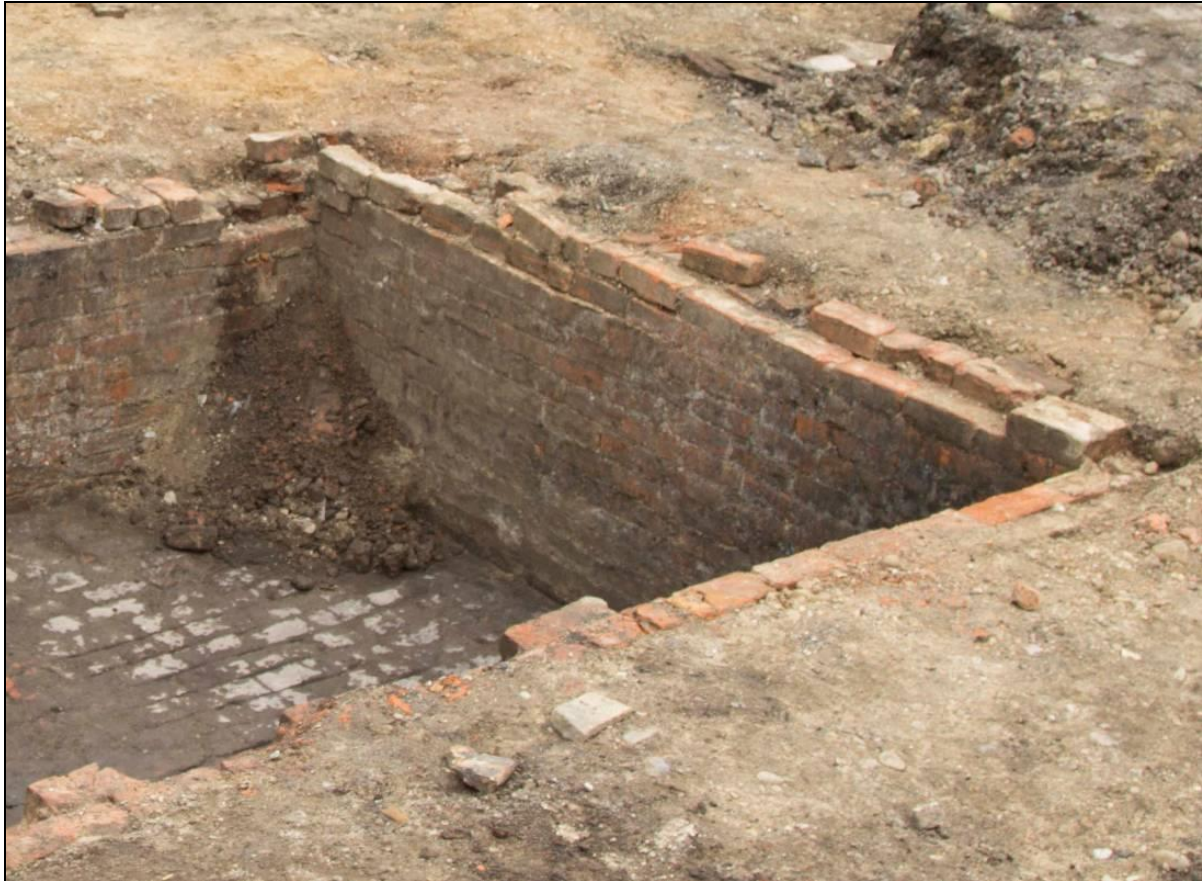
*Plate 28: The eastern wall of Cellar 2, looking north-east*

The eastern wall was aligned north/south, consisted of two brick-courses in width and appeared to have been an external wall of the house adjacent to the western edge of Brussell Street (**145**). All of the component bricks were hand-made, bonded with light brown sandy mortar, consistent with an early 19<sup>th</sup>-century construction date (Plate 28).
