## **Archaeological Excavation**

Trinity Way,  
Blackfriars,  
Salford

**Report No:** SA/2017/73

**Document Type:** Archaeological Excavation Report

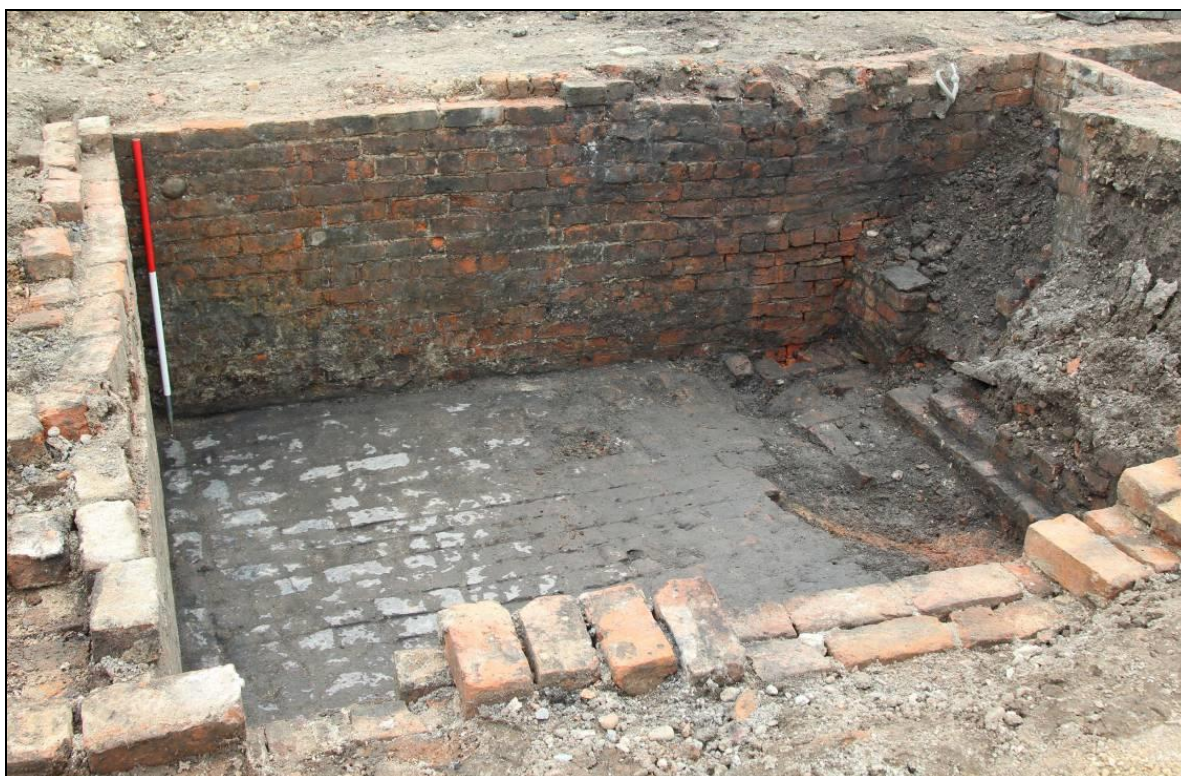
*Plate 29: The southern wall of Cellar 2 (after the collapse of the fireplace), looking south*

The southern wall was aligned north/south, measured 4.20m in total, and consisted of two brick-courses in width. Two low walls had been added to the north façade, which appeared to have supported a stone sink (Plates 30 and 31). The bricks of these later walls were hand-made and bonded with black ash mortar, suggesting a construction date in the latter part of the 19<sup>th</sup> or early 20<sup>th</sup> century. A lead pipe cutting through the wall above the sink area could possibly have been a water supply to the sink (Plate 30). The sink had been balanced precariously on one of the low walls, so it was removed, which enabled further cleaning of the floor area. This revealed a brick-built drain in the floor below the sink area (Plate 32). The floor of the cellar was constructed from hand-made bricks.

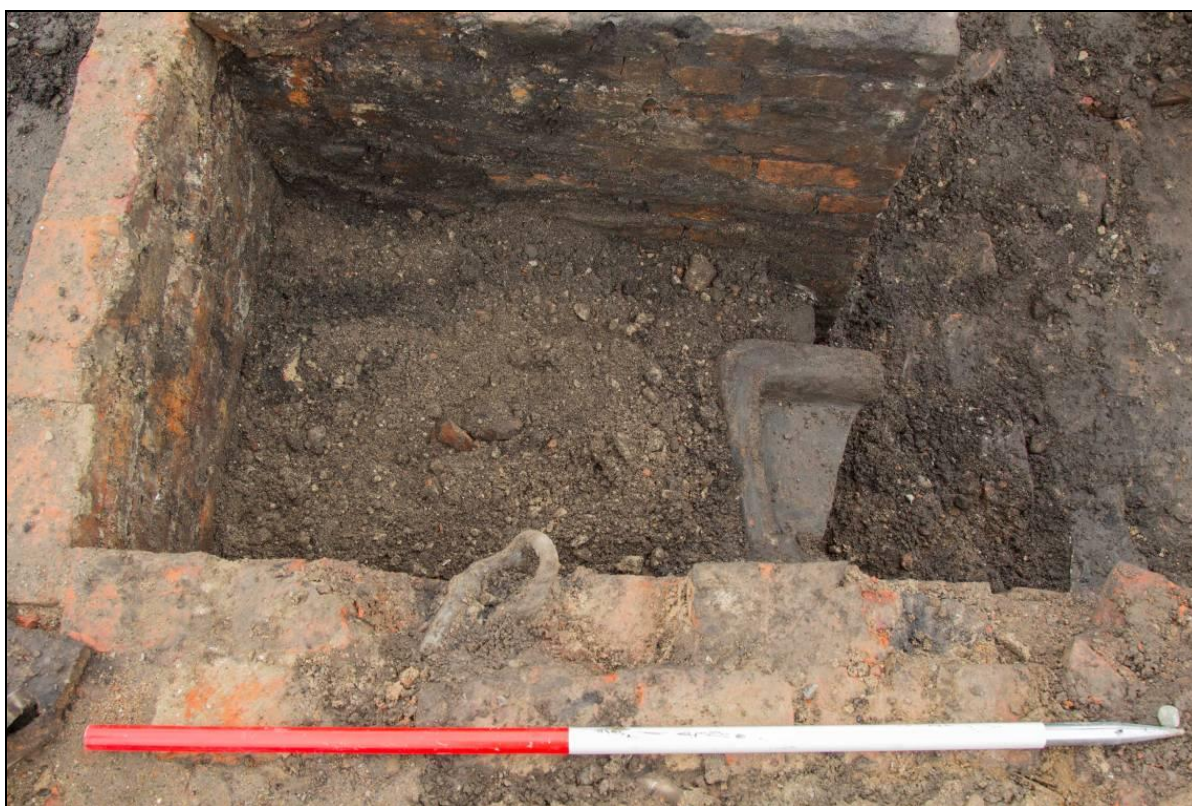
*Plate 30: Part of a stone sink found in the south-west corner of Cellar 2, from above, looking north*

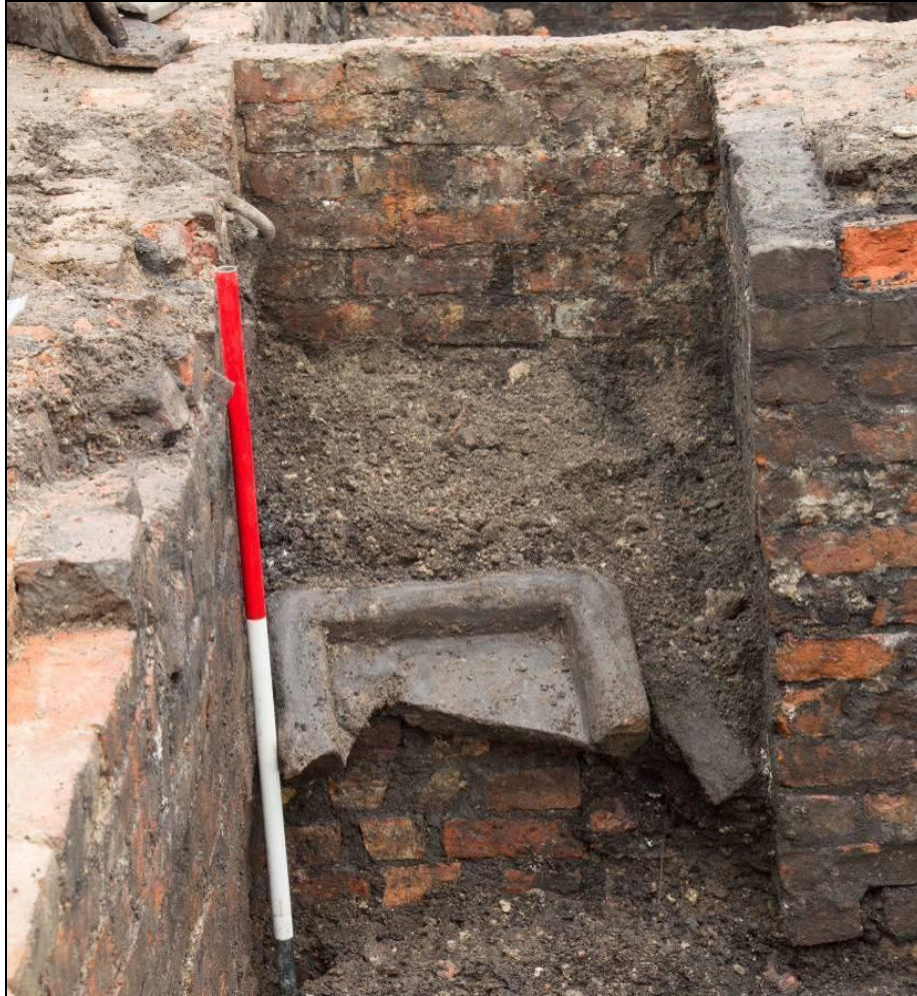
*Plate 31: Part of a stone sink found in the south-west corner of Cellar 2, looking west*

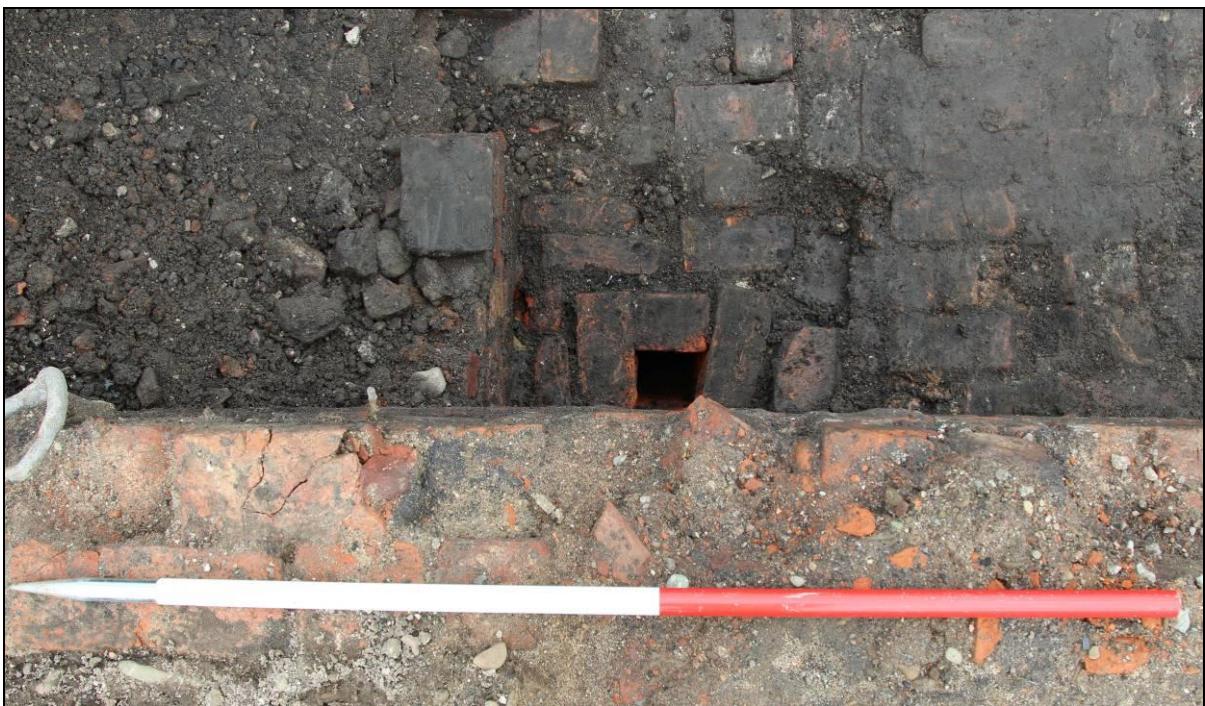
*Plate 32: Brick-built drain found in the floor of Cellar 2, below the location of the stone sink*

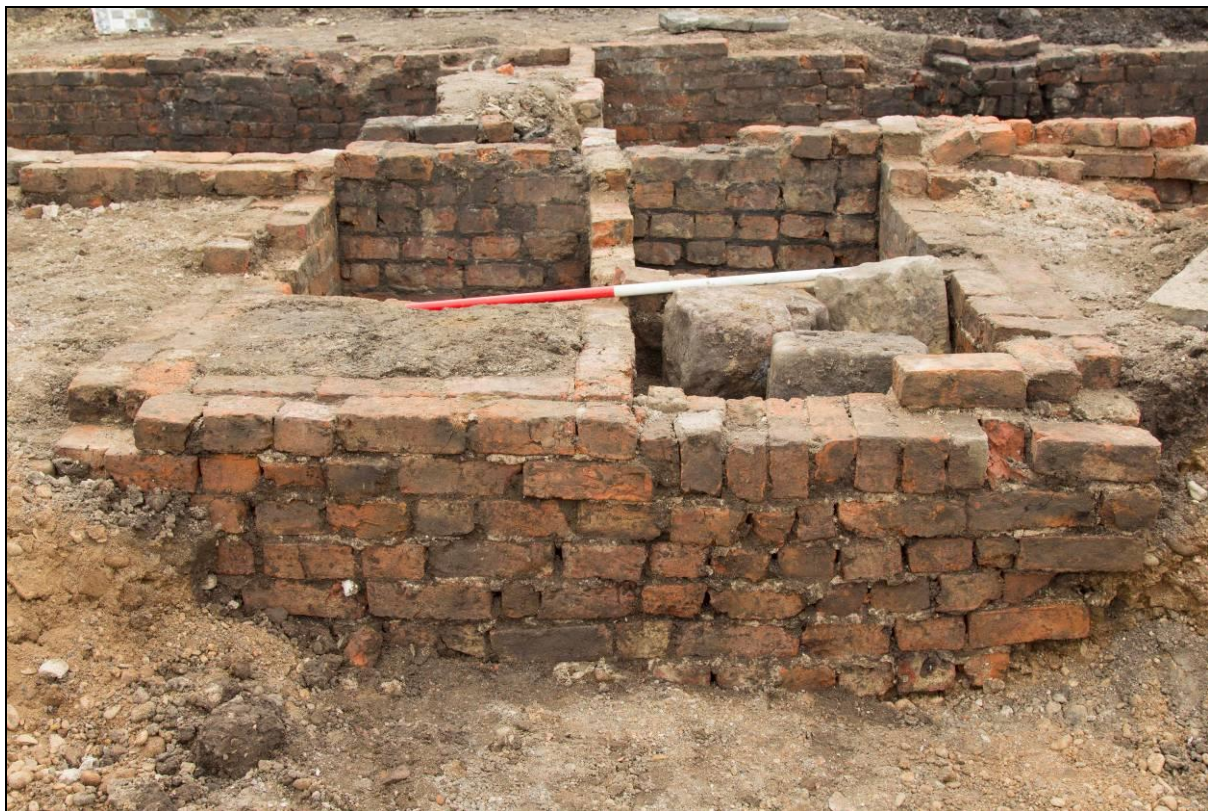
*Plate 33: The northern wall of the entrance staircase structure to both Cellars 1 and 2, looking south*

**Staircase:** the entrance to the cellars was via separate brick- and stone-built stairs (**143**) leading down from the north, side by side (Plates 33-35). The structure itself consisted of double-skin walls using hand-made bricks, bonded with light brown sandy mortar. The internal cross-walls used the same materials, but were only a single brick-course wide. The steps were stone slabs sitting on two rows of bricks. Within the backfill were broken stone slabs, which were possibly broken upper steps and large stone blocks, which showed working suggesting they were door jambs. The staircase wall appeared to have been cut into the natural geology (**003**); the foundation cut could be seen on the northern side, measuring 0.20m from the northern outer wall (Plate 27). The bottom of the wall was reached at six brick-courses deep, built onto natural sand and river pebbles (**003**). The bottom step into Cellar 1 could be seen below the bricked-up doorway wall.

The structure measured 2.08m east/west by 1.66m north/south. The width of the stairwells was 0.75m, the stone steps measured 0.75 x 0.22m, with the tread depth 0.25m consisting of the stone step 0.045m thick sitting on two rows of brick courses. The outer walls and single-course dividing wall were tied into the cellar walls, making them contemporary with the original construction of the houses.

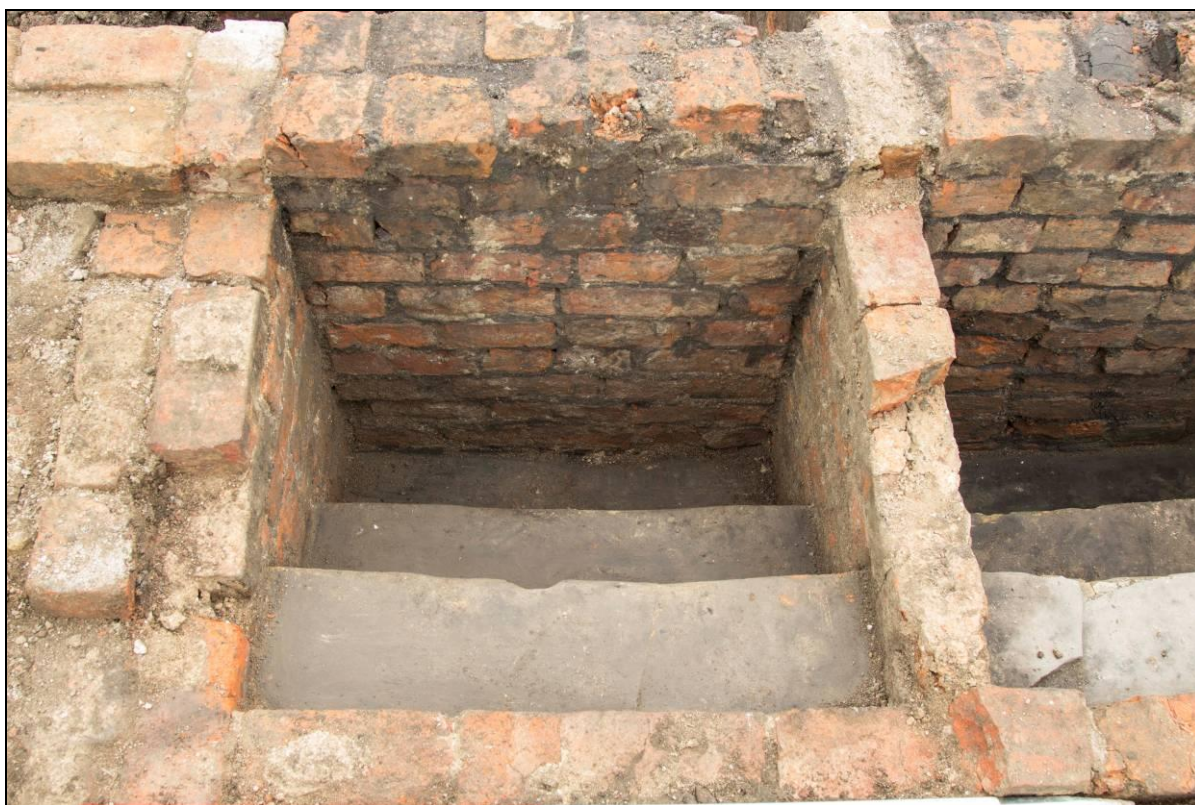
*Plate 34: Detail of the staircase leading into Cellar 2 and the later wall bricking-up the entrance doorway, looking south*

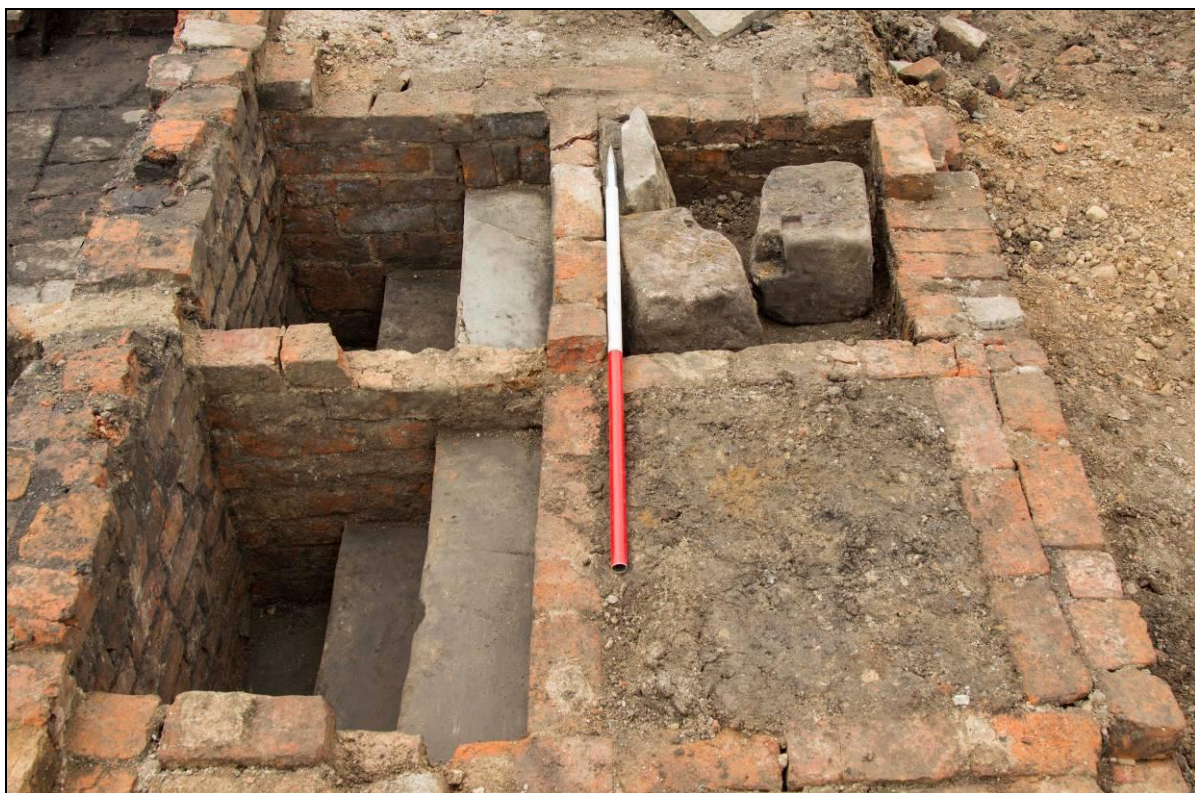
*Plate 35: Separate staircases into each of the cellars, looking west*

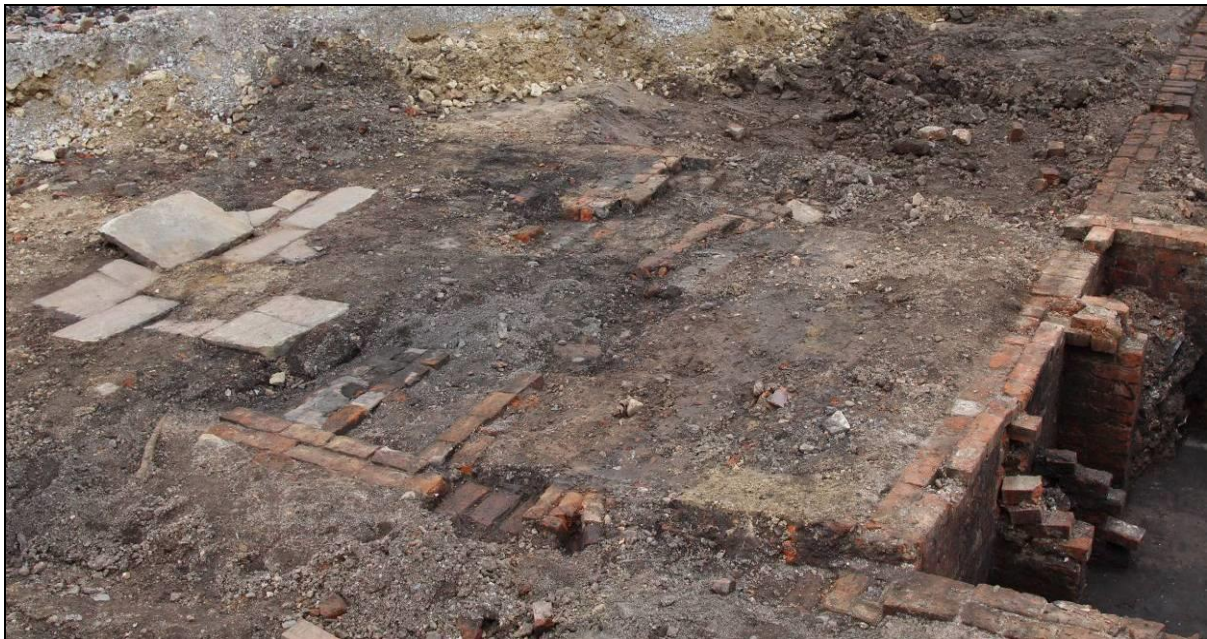
*Plate 36: Possible toilet block, west of Cellar 1 in the far western corner of Area 2, looking north-west*

**Later Toilet Block and Alleyway:** to the west of Cellar 1, whilst the southern wall continued west, it seemed that a toilet block had been added later in the 19<sup>th</sup> century. The southern wall had been truncated, and a ceramic drain pipe could be seen, aligned north/south about 1m west of the western wall of Cellar 1. West of the pipe, two further parallel walls had been added, a double-course wall with black ash mortar and a three-course wall 0.44m west, also with black ash mortar. However, these two walls appeared to have been truncated east/west, but this remained unexcavated. To the immediate west of the three-course brick wall was the remains of what appeared to be a stone-flagged path or alleyway, measuring 2.29m north/south by 1.90m east/west. A narrow lead pipe, which had truncated the southern wall, appeared to continue north below the flagstones. It remains possible that this pipe was associated with the water supply to the toilets. The northern wall of the cellars also appeared to have continued west in the area of the toilets, running parallel to the southern wall, with the two later walls running between them. Fragments of glass and domestic pottery recovered from the fill dated to the late 19<sup>th</sup> to 20<sup>th</sup> century.

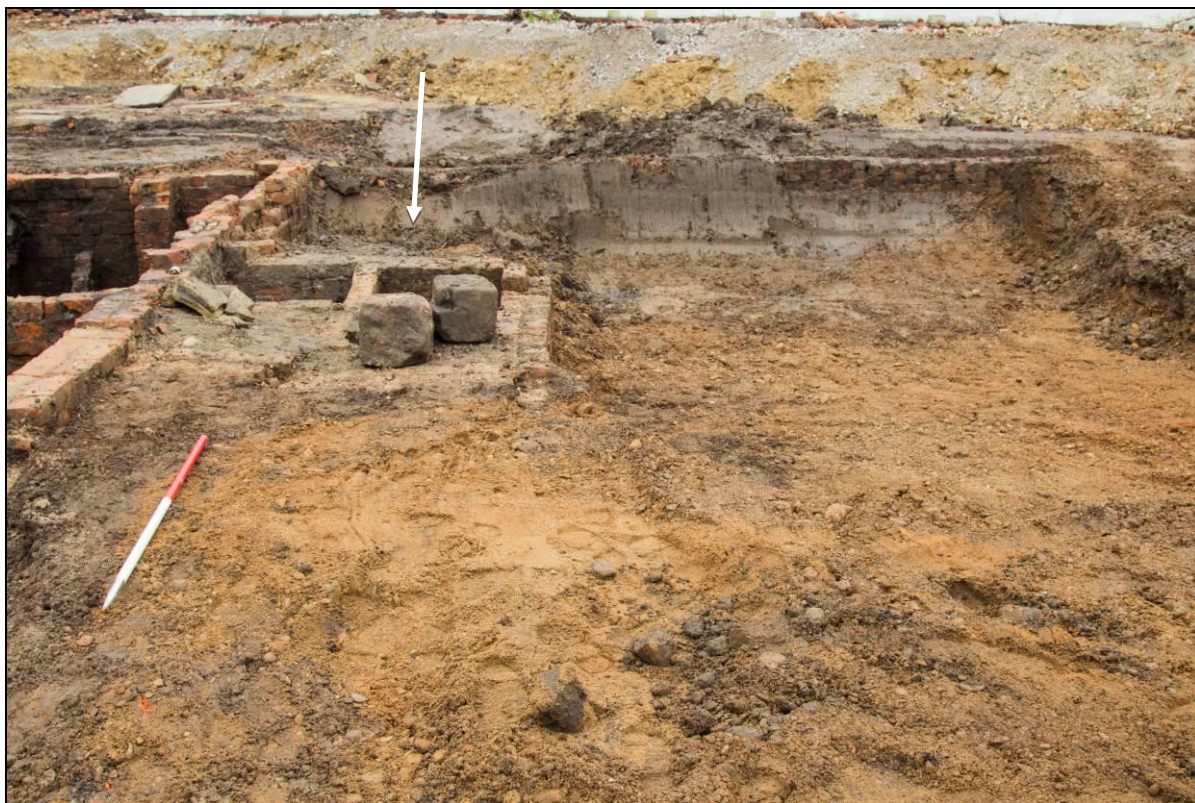
*Plate 37: Possible outer courtyard area north of the cellars (rubbish pit white arrow parking the position of the rubbish pit), looking west*

**Outer courtyard:** to the north of Cellar 1, the western wall continued north. However, this wall was not tied into the cellar wall and had been bonded with black ash mortar, placing it later in the 19<sup>th</sup> century than the houses. It was also shallower, having been constructed onto natural sand and river pebbles (003). A return to the east could be seen at its northern end, but this only survived in a fragmentary condition consisting of only three to four brick-courses. Either side of the wall had been backfilled with a slightly sandy, mid-brown clay with fairly frequent flecks of manganese (I39). Within this deposit, to the east of the wall and west of the staircase, was a 0.50m wide, circular, possible pub midden (I49) containing a significant number of broken, black-glass bottles and some domestic pottery dating to the late 18<sup>th</sup> century.

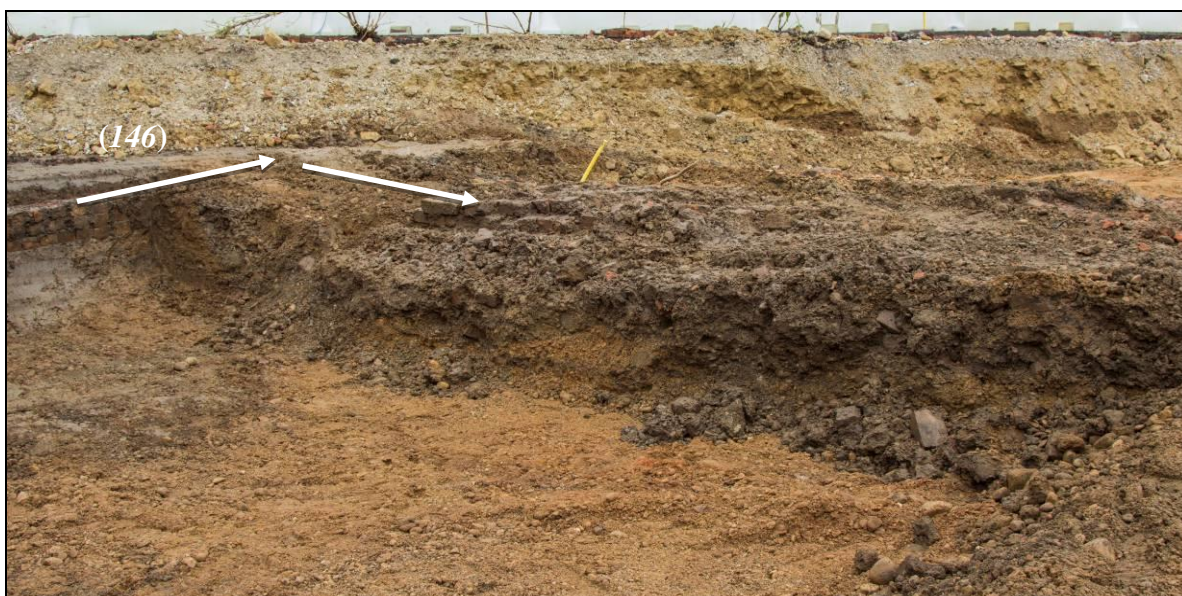
*Plate 38: Probable outer courtyard wall (146) heading north shown by the white arrow on the left and a possible return to the east shown by the arrow on the right, looking north-west*

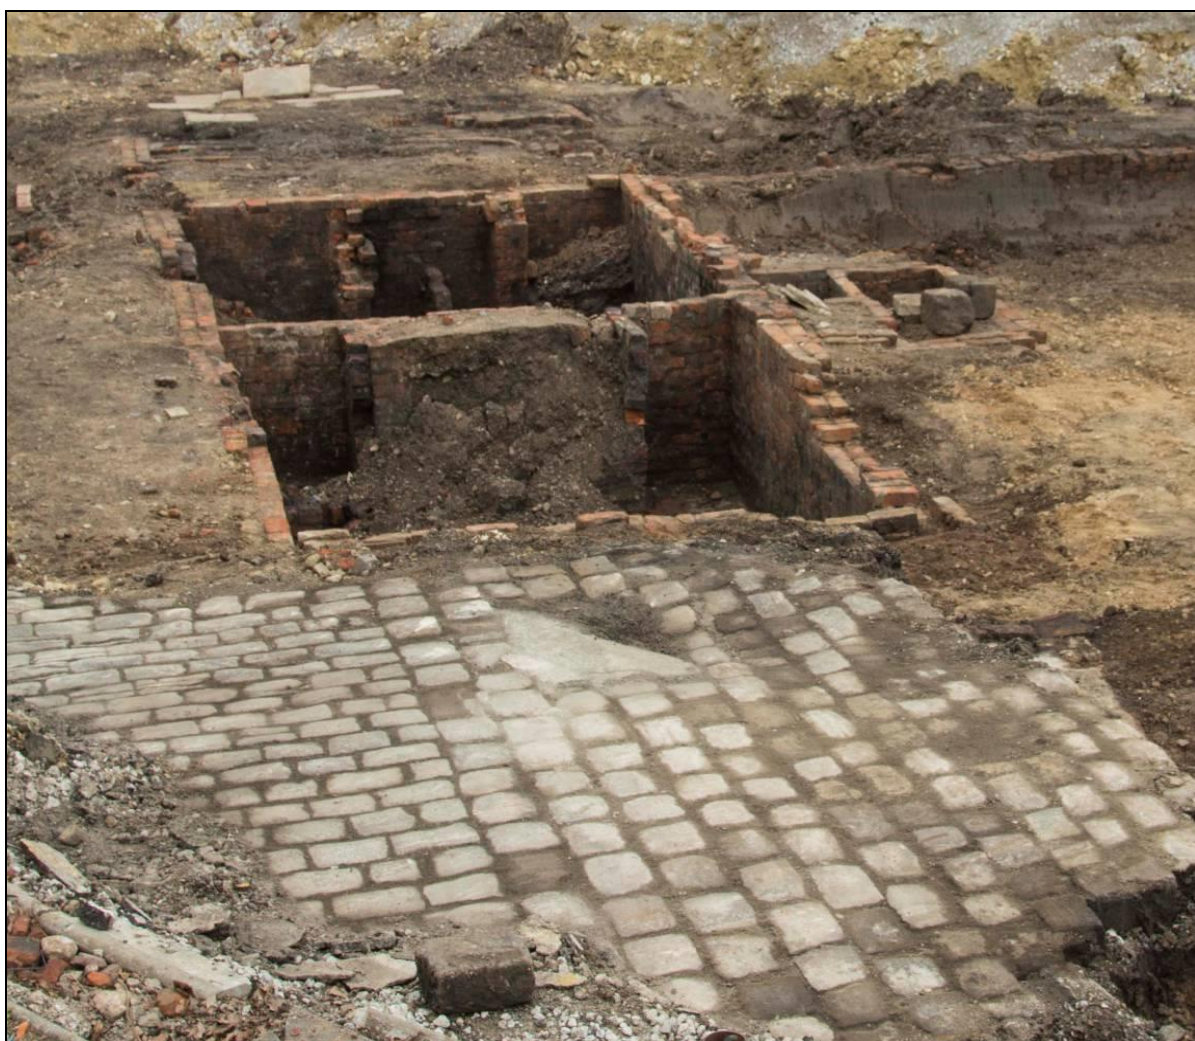
*Plate 39: Cobbled surface likely to have formed the southern end of Brussell Street, possibly with the junction of Bury Street, looking east*

**Brussell Street:** part of the cobbled surface of the former Brussell Street (145) was found to the east of the cellars, possible at its junction with Bury Street, suggested by a change in the size and orientation of the cobble setts (Plate 39). The area measured 4.22m east/west by 3.56m north/south, with the cobbles measuring an average of 0.21m in depth and had been set into a black clinker deposit. The northern set of cobbles, which formed the southern end of the street surface, measured an average of 0.28 x 0.17 x 0.21m and were aligned lengthways east/west, whilst the southern cobbles, which may have formed part of Bury Street were slightly smaller measuring an average of 0.23 x 0.15m (depth not excavated) and were aligned lengthways north/south. A possible edging stone was found consisting of a flagstone laid vertical on edge, which may have formed the separation between the road surface and footpath, had there been one (no surface was found), which would have measured 1.62m to the eastern wall of Cellar 2.

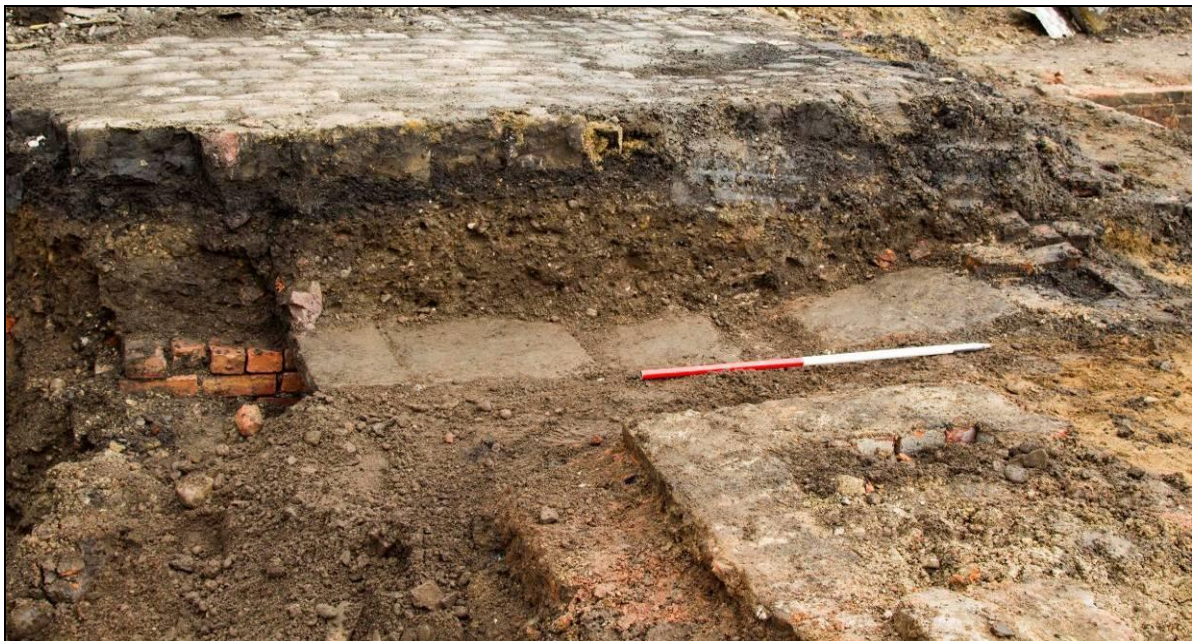
*Plate 40: Brick and stone constructed drain/culvert (**150**), looking south*

Below the cobble setts and clinker (0.06m thick) was a 0.42m thick layer of re-deposited natural material containing infrequent broken brick, below which a brick and stone constructed drain/culvert (**150**) was found aligned east/west and probably ran below the road (Plate 40). The length exposed measured 3.47m east/west, the stone caps 0.58m in width, the brick structure measured a minimum of 0.47m in height (only six brick-courses were visible but there could have been more below) with the thickness of the stone caps measuring 0.08m. The top of the drain was 0.65m below the top of the cobbles. The foundation cut (**151**) was seen on the northern and western sides, cutting through the natural geology.

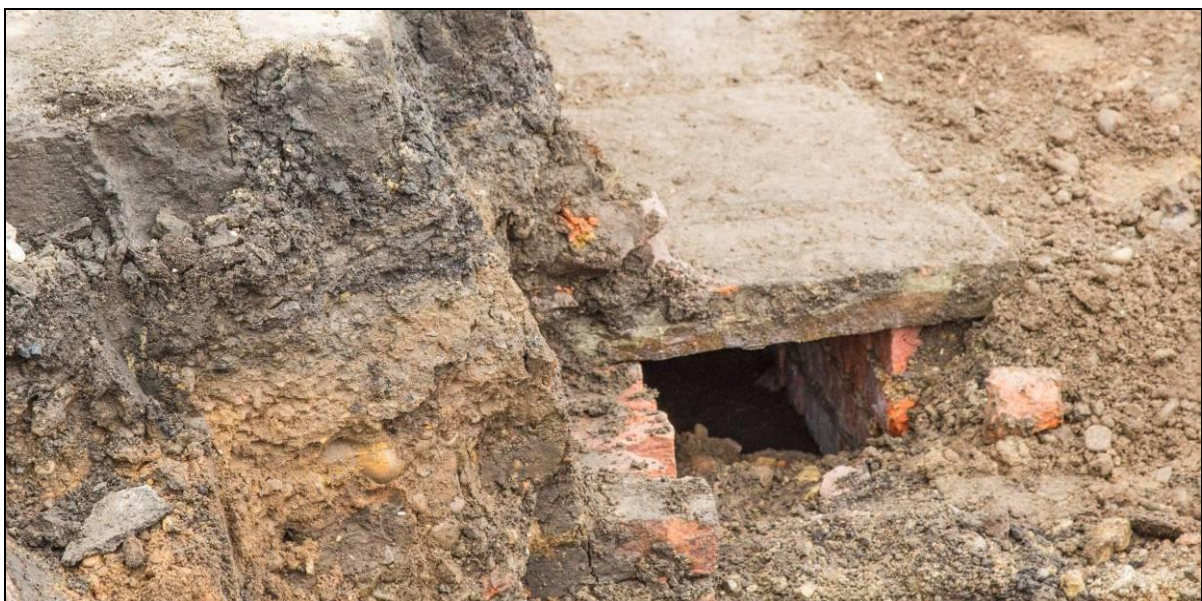
*Plate 41: A cross-section of the drain/culvert at the eastern end, looking west*

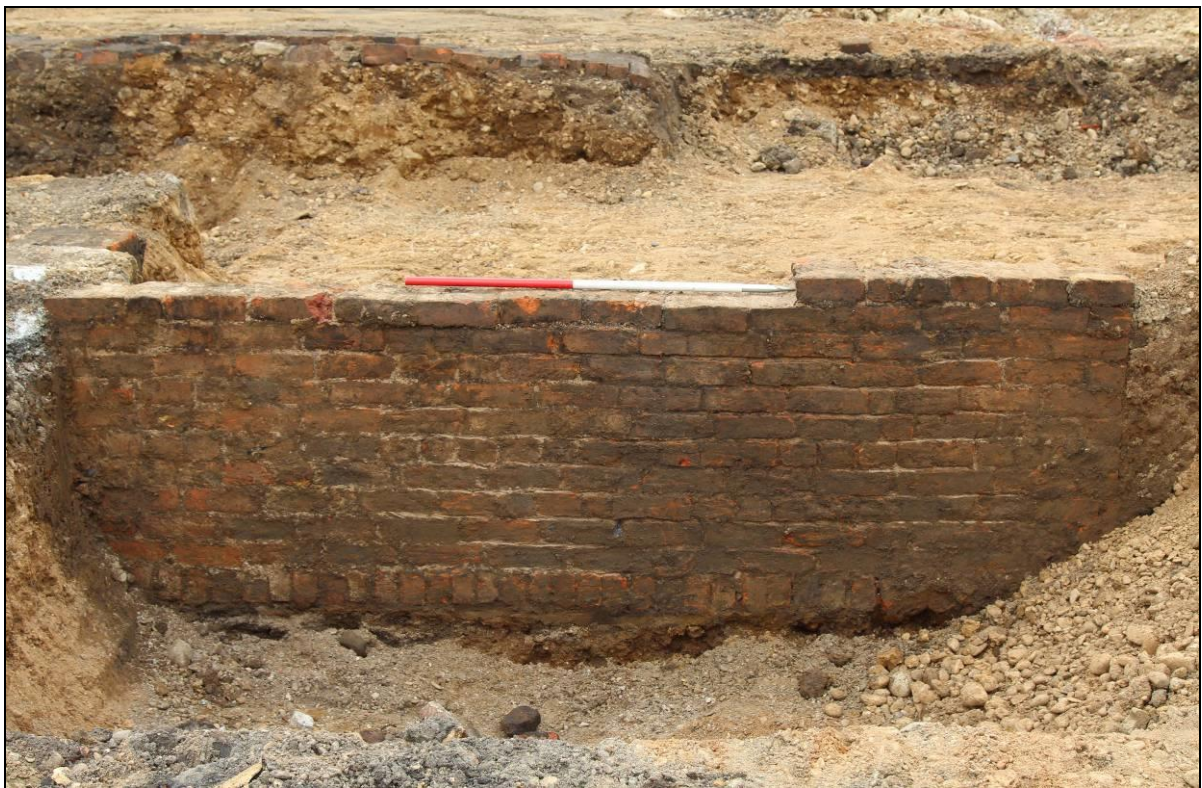
*Plate 42: Early 19<sup>th</sup>-century hand-made brick wall, looking west*

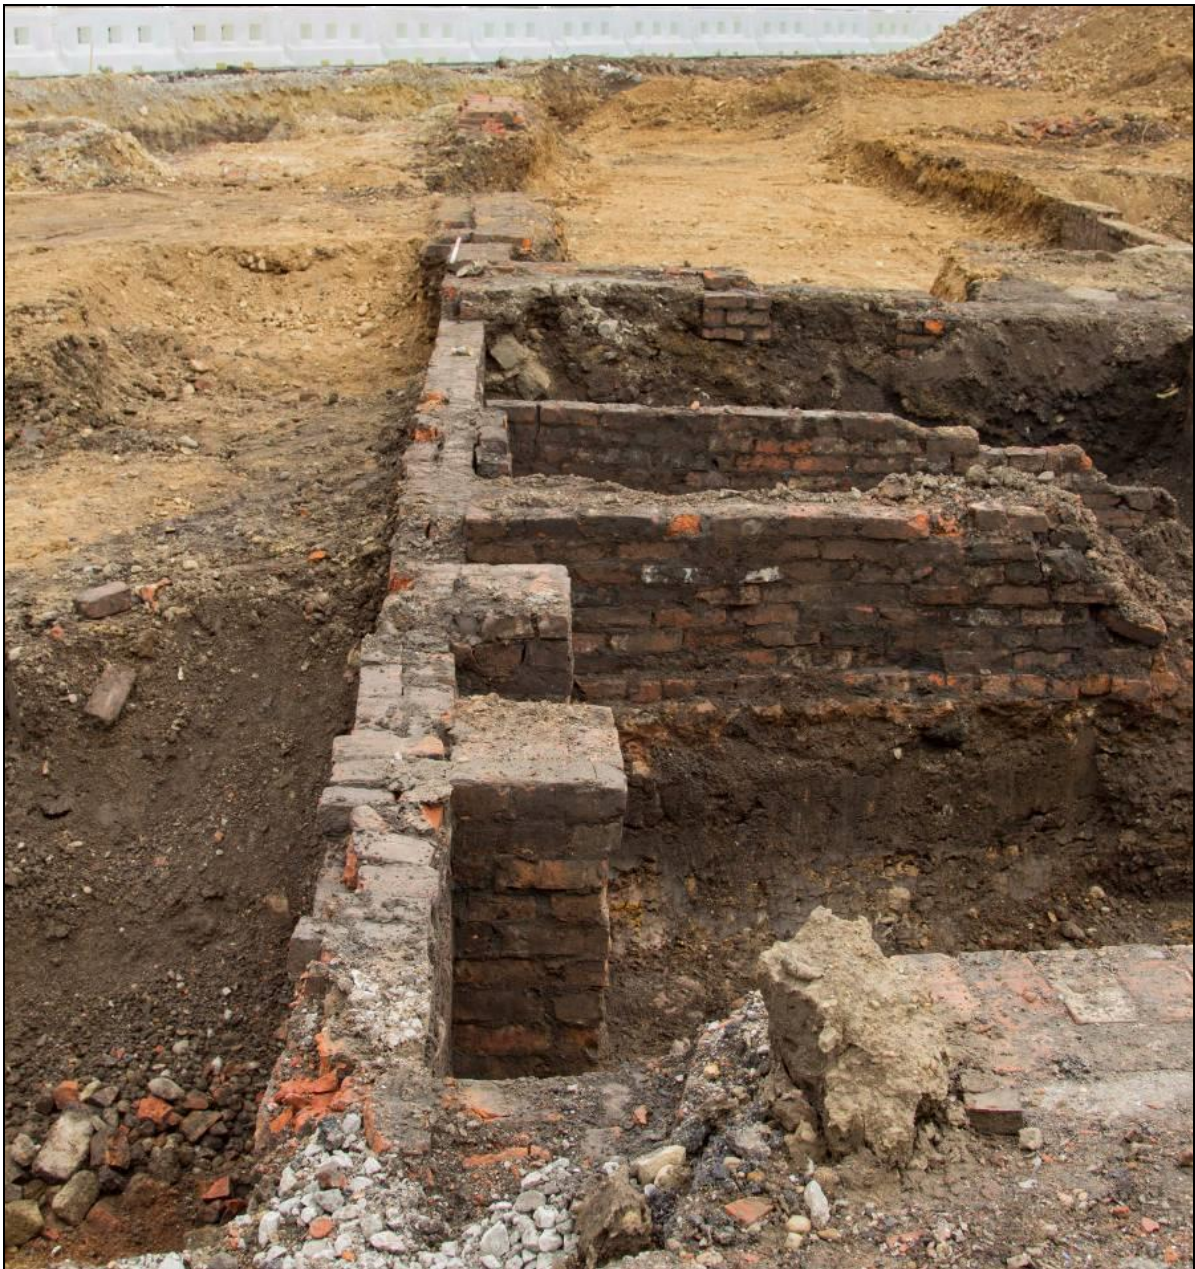
*Plate 43: The western wall of Rooms 3, 4, and 5, looking north*

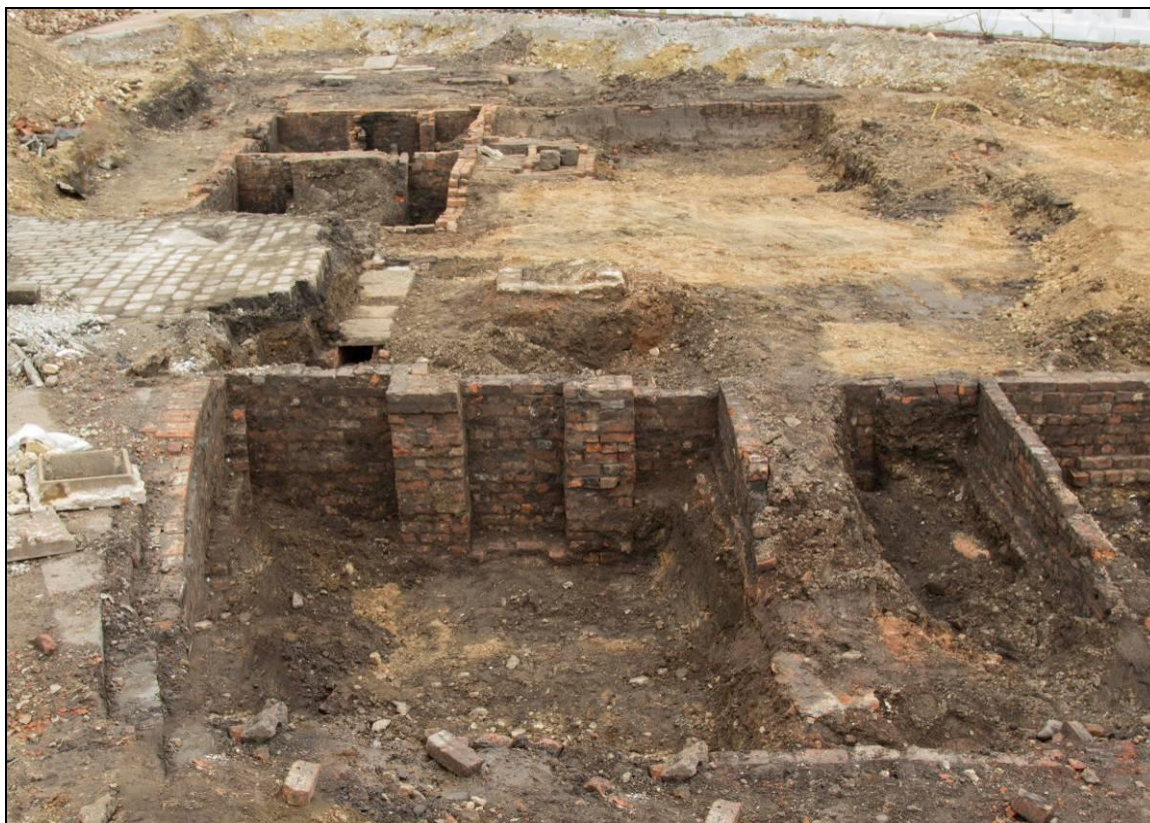
*Plate 44: The location of Room 3 in relation to the site, looking west*

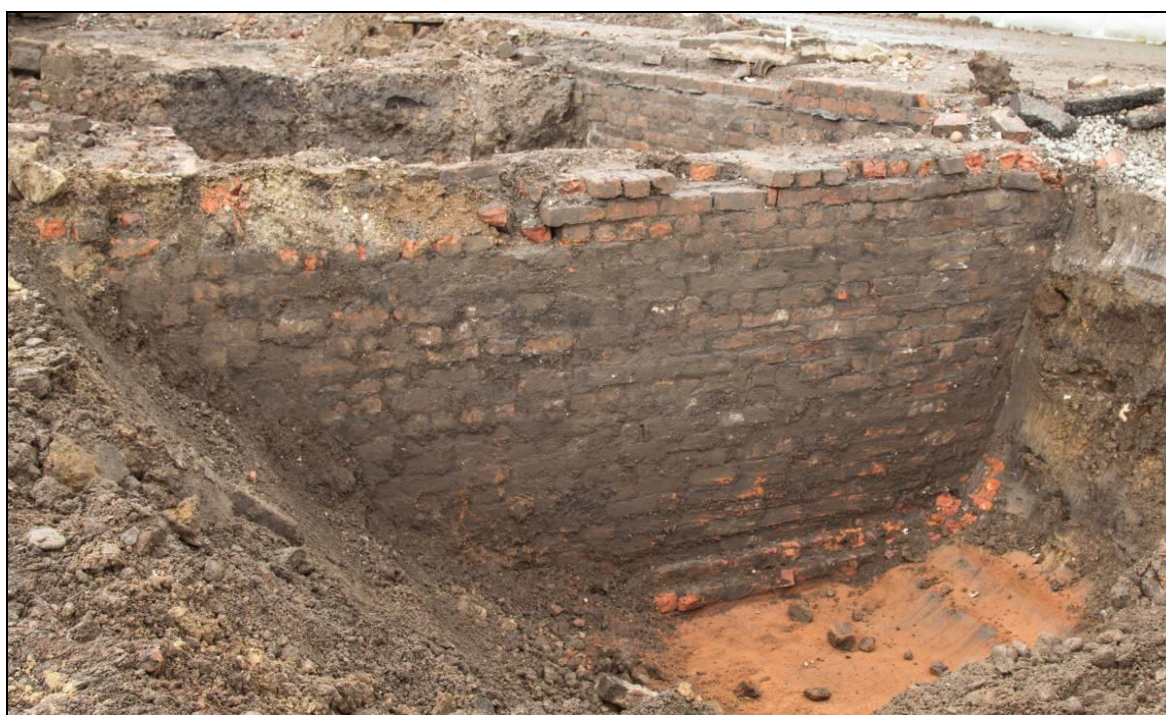
*Plate 45: Detail of the west-facing side of the western wall of Room 3 (155), showing the foundation sitting on red sand (171), looking east*

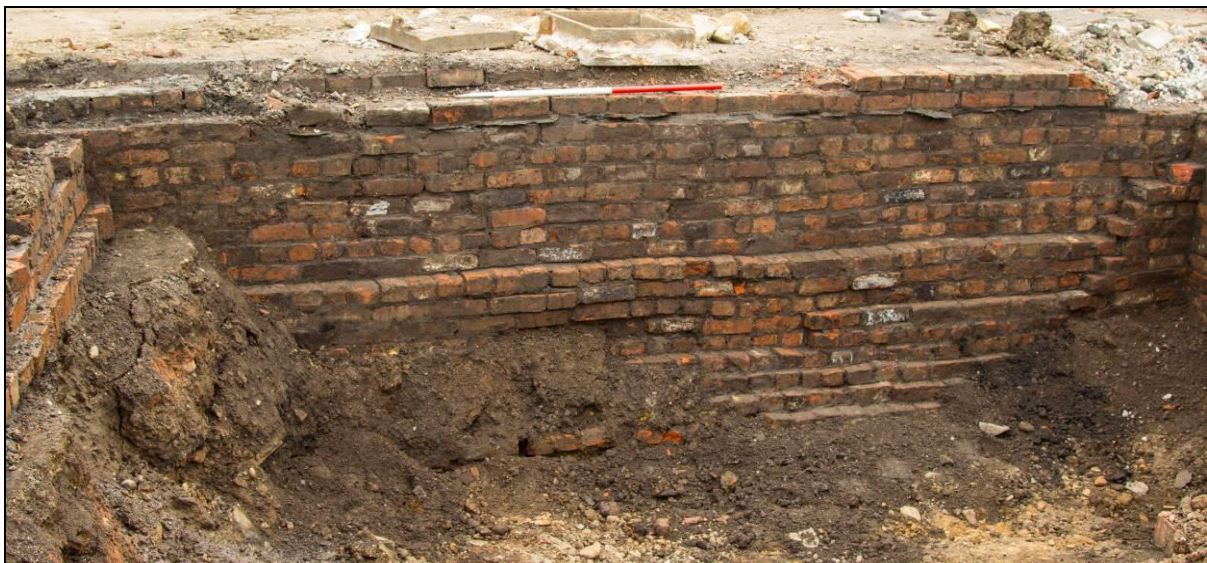
*Plate 46: The southern wall of Room 3, looking south*

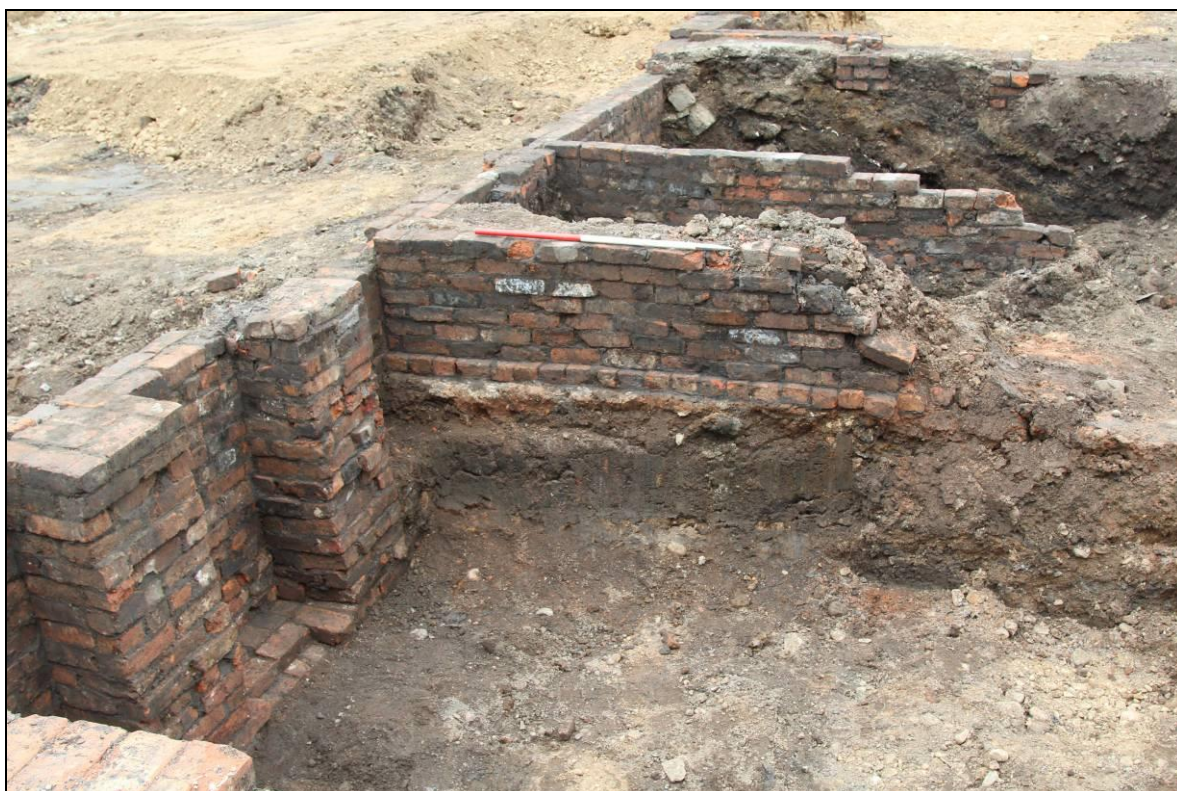
*Plate 47: The northern wall of Room 3, looking north-west*

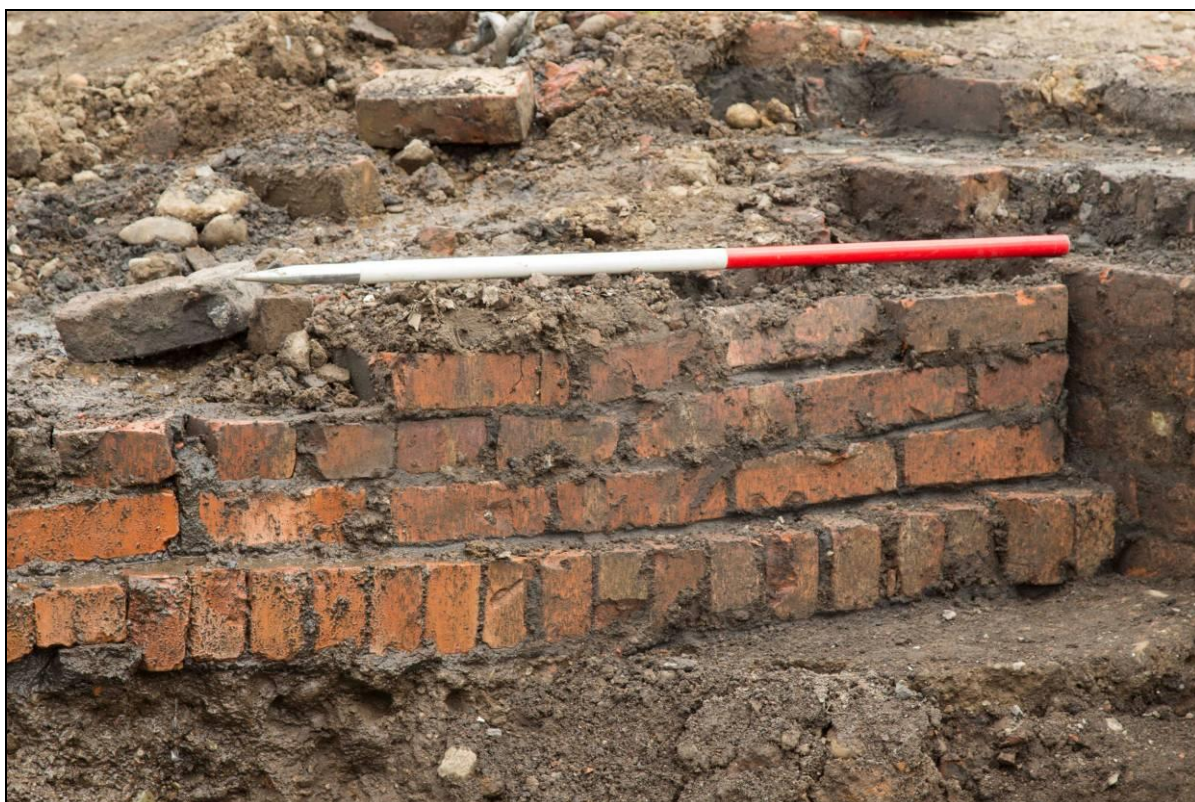
*Plate 48: The eastern wall of Room 3, looking east*

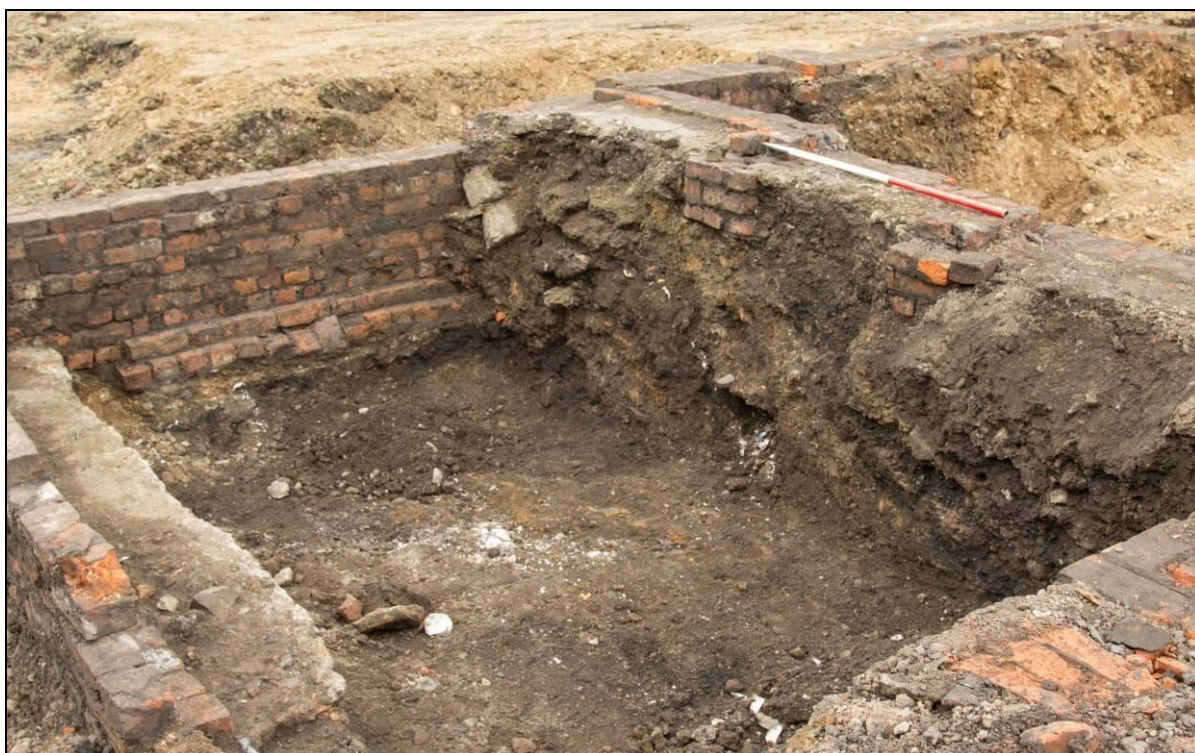
*Plate 49: The interior of Room 5, looking north-west*

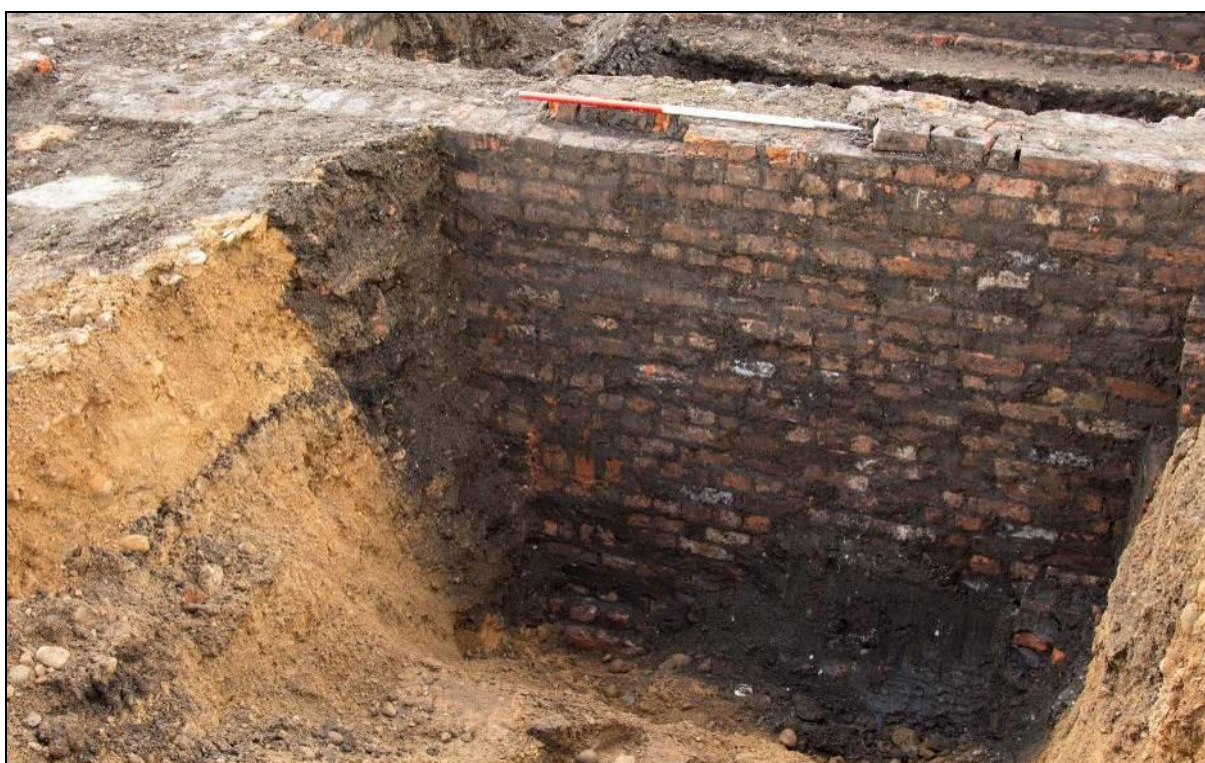
*Plate 50: The northern wall of Room 5 and associated cut through natural, looking south*
