## **Archaeological Excavation**

Trinity Way,  
Blackfriars,  
Salford

**Report No:** SA/2017/73

**Document Type:** Archaeological Excavation Report

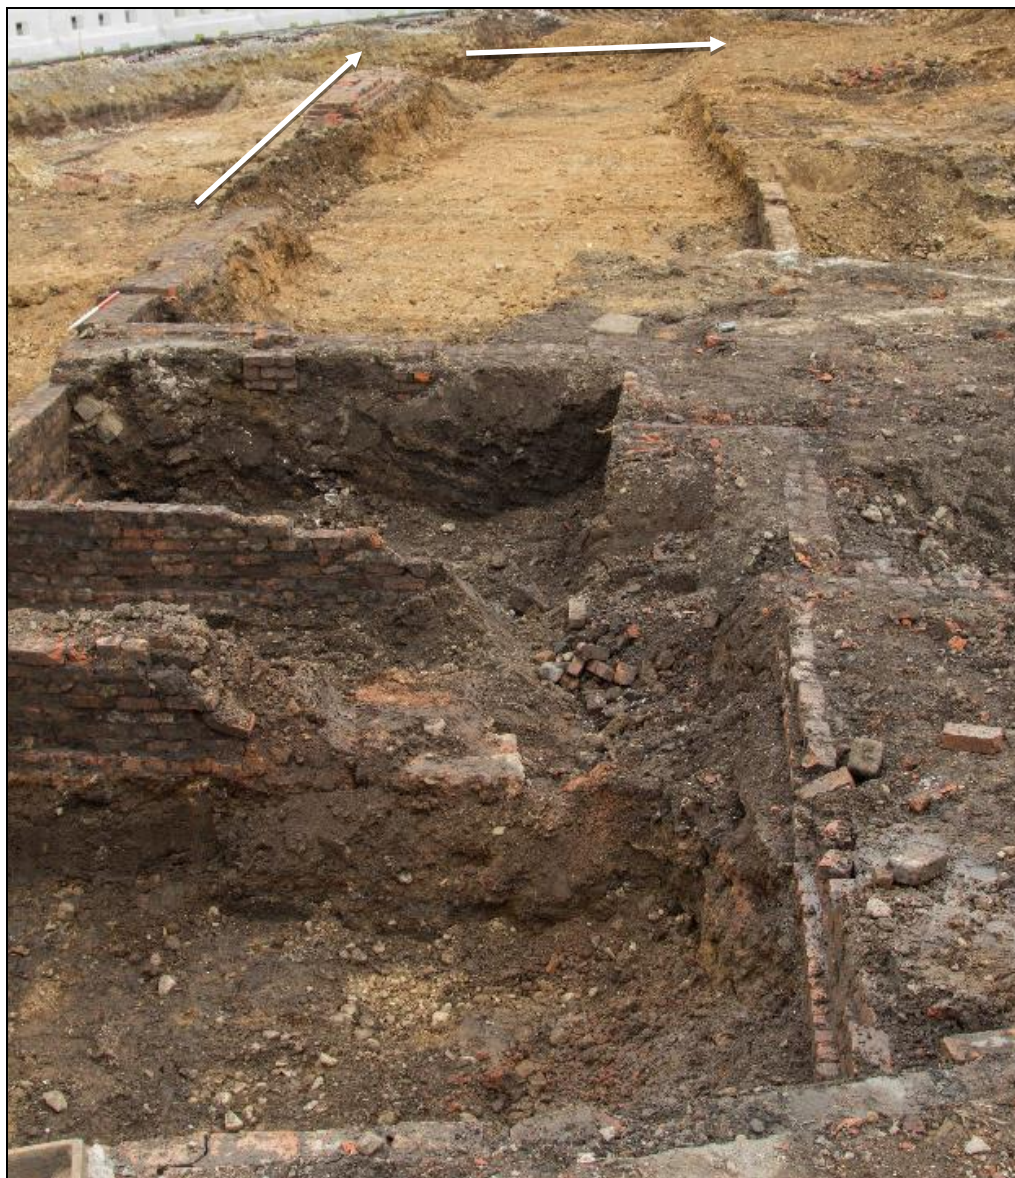
*Plate 51: The white arrow shows the western wall of the three rooms continuing north although truncated and much altered, and the possible eastern return, looking north*

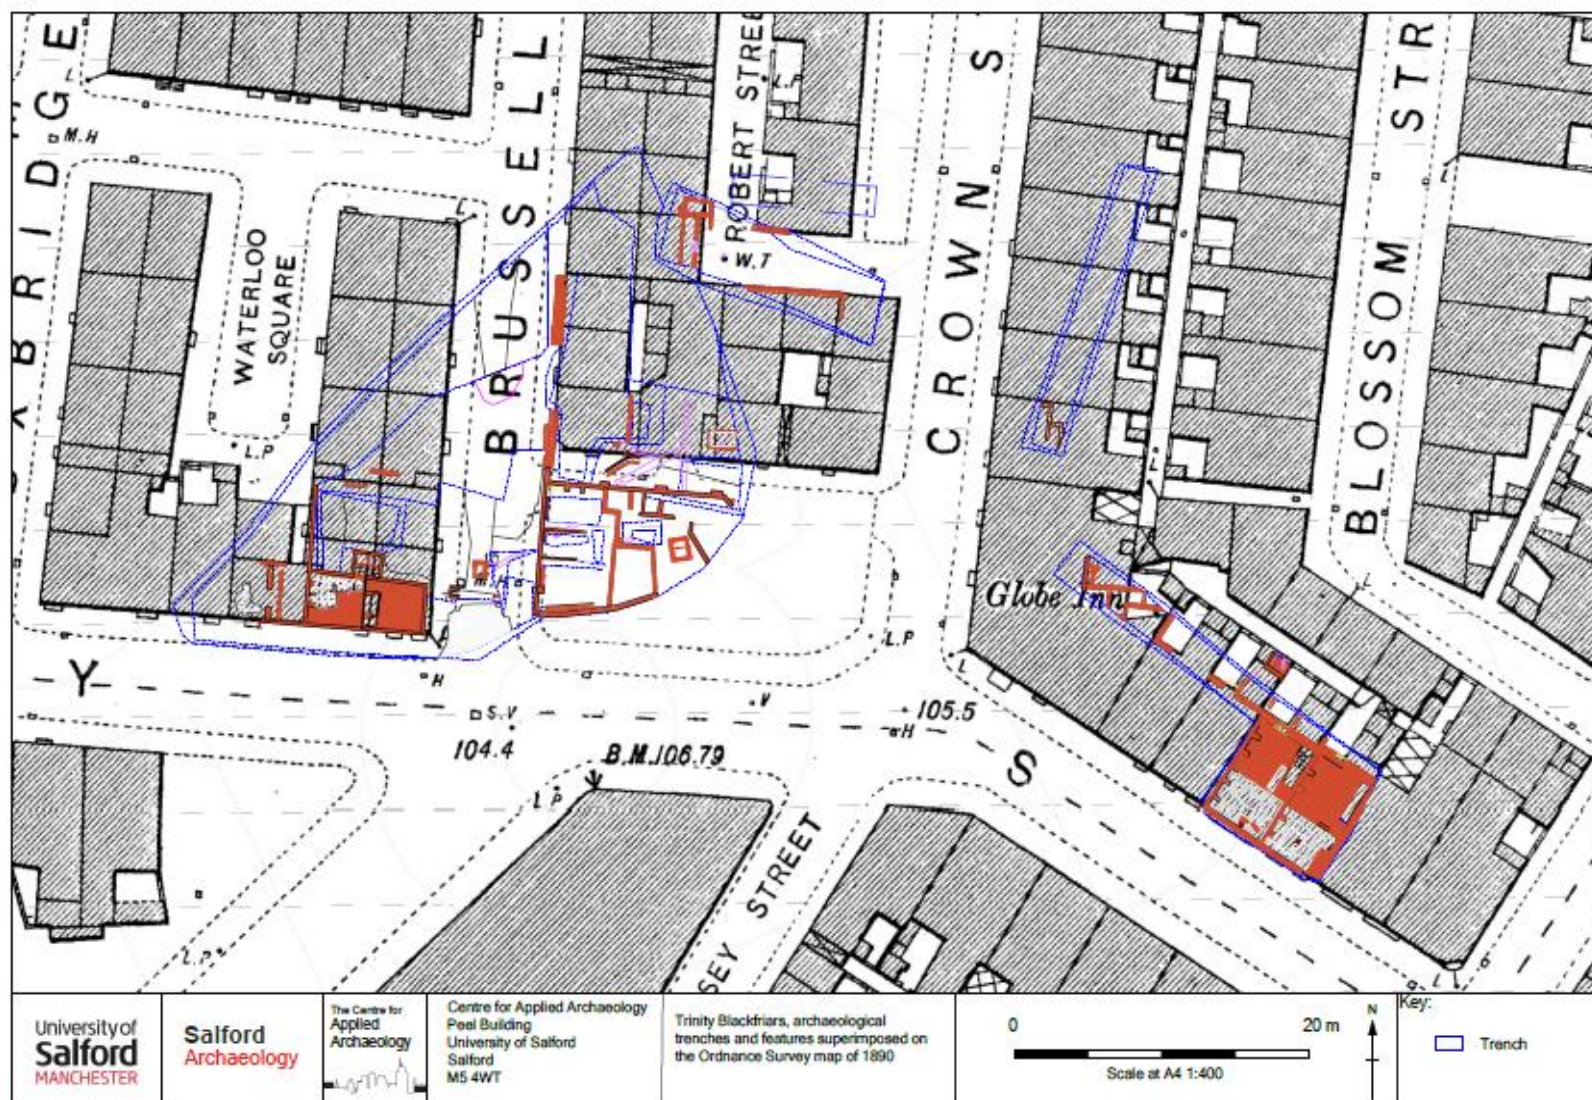
Figure 4: The excavated remains superimposed on the OS 1890 map

The next available editions of Ordnance Survey mapping was surveyed in the late 1880s and published at a scale of 1:500 in 1891 (Figure 4) and at 25":1 mile in 1894. These plans provide an additional detailed view of the buildings within the site. The most notable change came with the construction of Blackfriars Road in 1880, which led to large tracts of land to be cleared, including a number of properties fronting Garden Lane. Only a small portion of the study area was affected directly. A group of houses to the north of Pear Street were demolished and replaced by a block of irregular, oblong buildings erected along the newly completed road.
