Archaeological Excavation Report

Coalshaw Green
Farmhouse,
Coalshaw Green,
Chadderton

Report No:
SA/2017/33

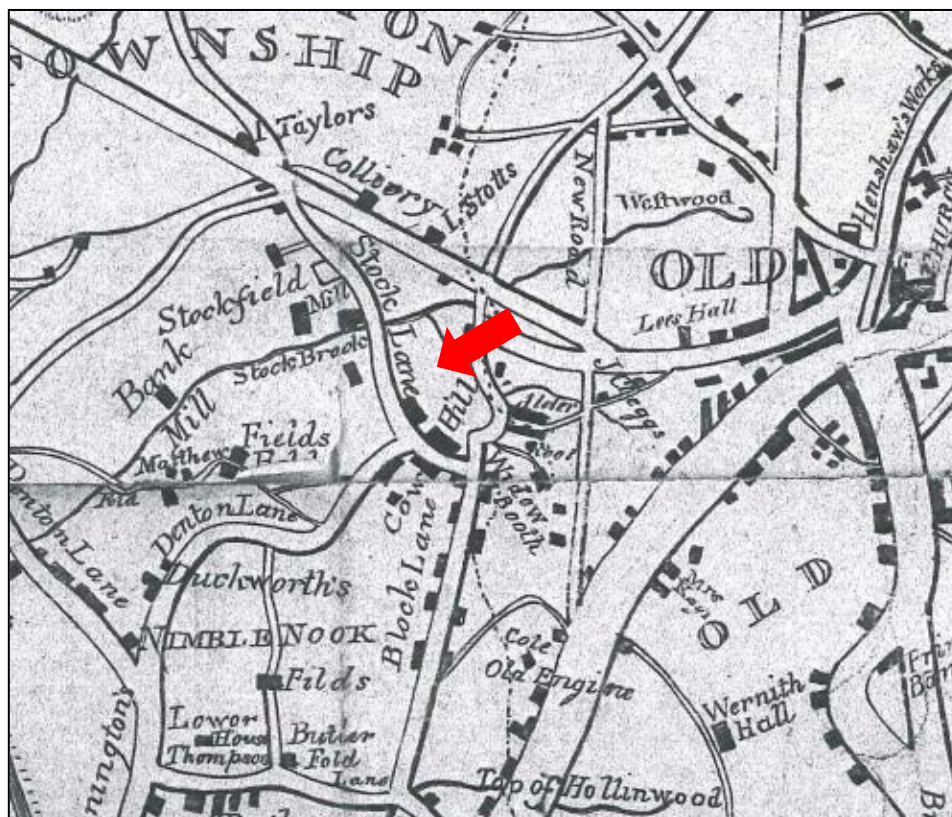
Plate 2: Butterworths Map of Oldham dated 1817. Site marked by red arrow.

One of the earliest cartographic sources to depict Chadderton in detail is Butterworths map of Oldham dated 1817, (Plate 2). The map shows that much of Chadderton was comprised of open agricultural and moss land which was dissected by a number of roads flanked by piecemeal development, mainly cottages and farms and several collieries. Butterworth notes that these roads were all denominated as lanes and lists the main thoroughfares as being Burnley Lane, Stock Lane, Block Lane, Old Lane, Denton Lane, Thompson Lane, Dowry (Drury) Mought Lane, Turf Lane, Tonge Lane and Bawtry Lane (Butterworth, 1817: 163).

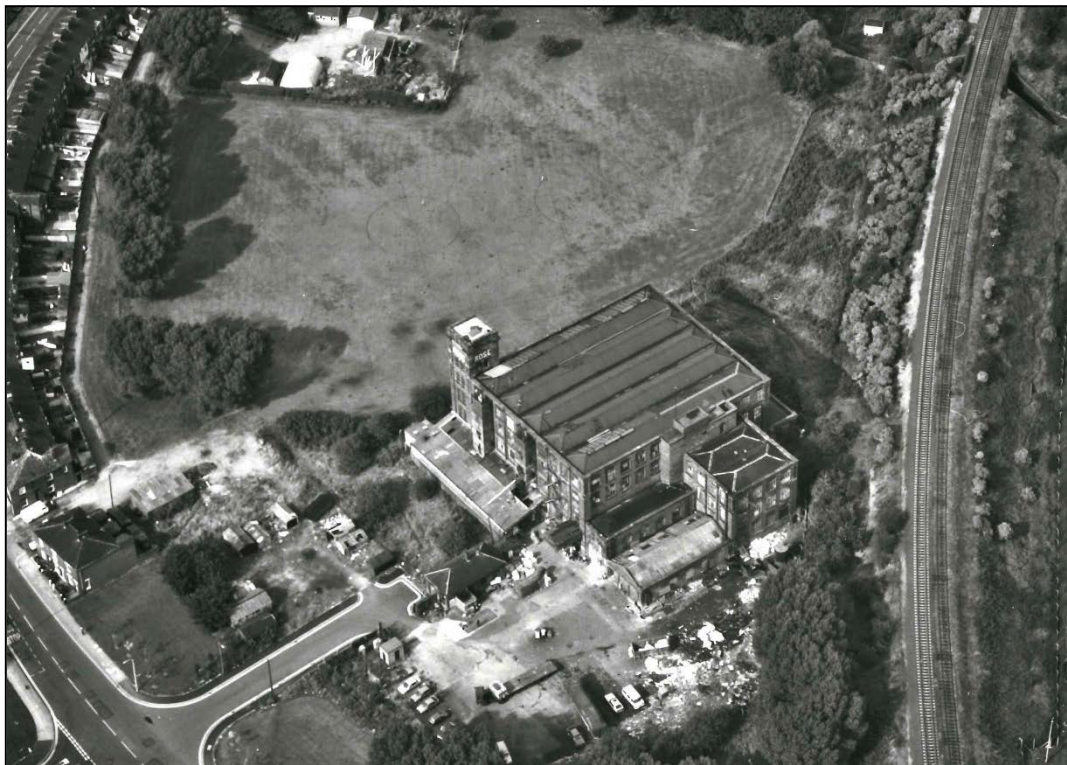
Plate 7: Aerial photograph of the site, dated 1986. Image reproduced with permission from Greater Manchester Archaeological Advisory Service (GMAAS).

Since the clearance of the site in the late 20th century the site remained largely unaltered until 2007 when Rose Mill was demolished due to damage caused by repeated arson attacks. The site has remained unaltered since this date.

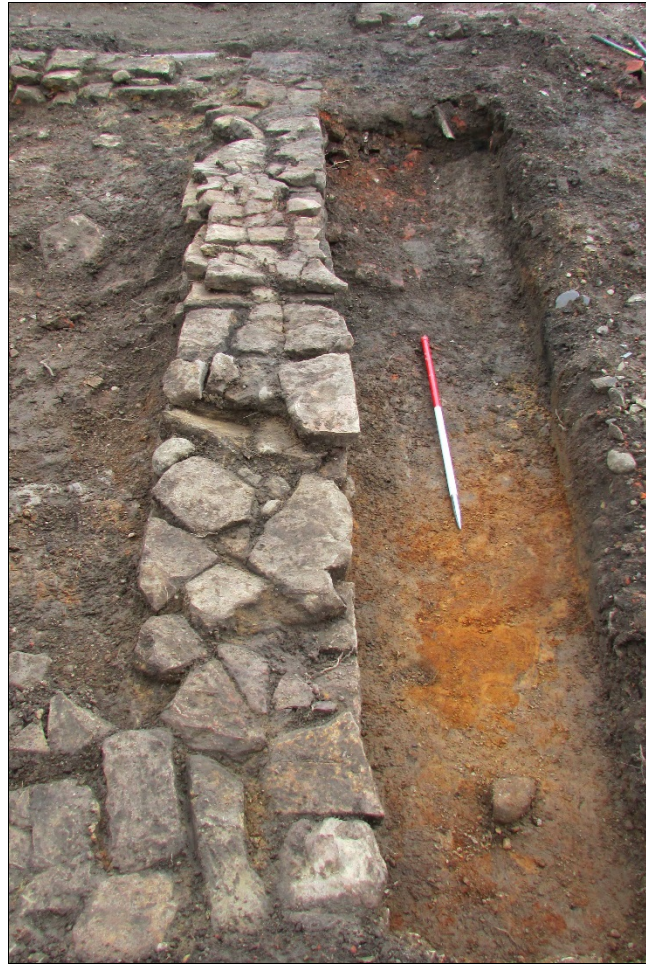
Plate 8: Stone wall (004) and stone wall (003) in the background, looking south-east

The initial archaeology at the south western end of the trench was stone wall **(004)** which was aligned north-west/ south east. Its exposed length was 5.98m with a depth of 0.56m and a width of 0.60m. The stones were roughly hewn, squared sandstone blocks that were laid in regular courses with no visible mortar. A test pit **(TP2)** was excavated at the north-western end of the wall, which was the limit of the excavation, to see if the wall extended further to the northwest. **TP2** revealed a layer of bricks **(069)** on top of stone continuing along the same alignment as the stone wall. The cut **[025]** for **(004)** was linear in plan and had a concave profile leading to a flat bottom. Test pits were excavated on both sides of the wall **(TP1)** and **(TP9)**. The test pits revealed further stone blocks that were a flat sub-rectangular shape with no mortar visible.

Tied into (004) at its south eastern end was stone wall (003) which was aligned south-west/ north-east and made up the south-east wall of the farmhouse. It had a length of 8.55m with a depth of 0.55m and a width of 0.60m. The stones were laid in regular courses with roughly hewn sandstone blocks. Smaller rubble pieces were used in the centre of the wall. It was bonded by a light brown, hard, sandy mortar that had inclusions of large limestone lumps. **TP5** was excavated to the depth of (003). It revealed further flat sub-rectangular stone blocks and a small stone and brick culvert (023), see below, in the base running parallel with (003).

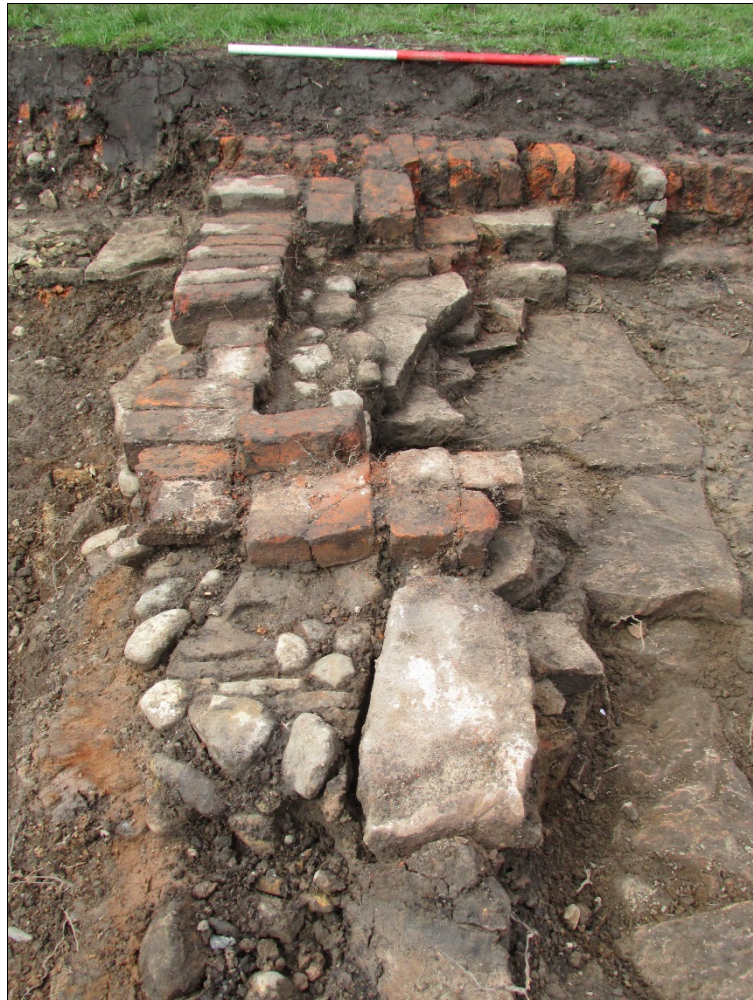
Plate 9: Cobbled surface (006), sandstone blocks (007) and brick wall (008), looking north-west

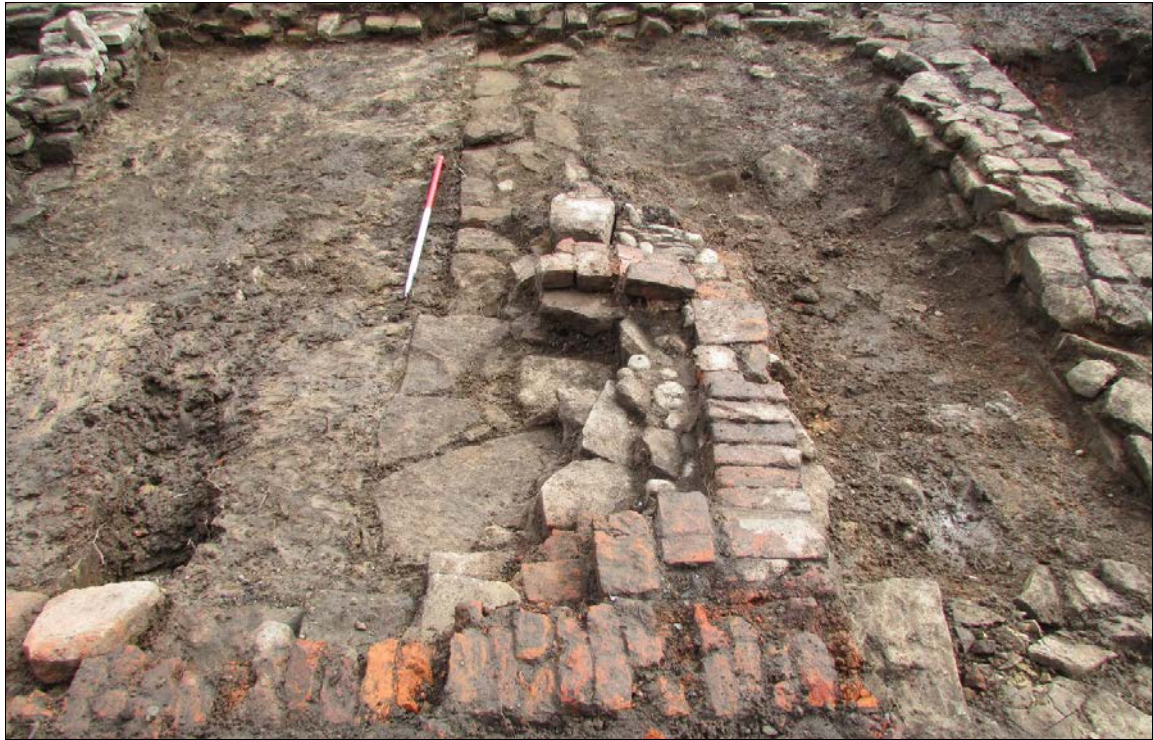
Plate 10: Room 1 (right) and room 2 (left), showing diving wall (005), looking south-east

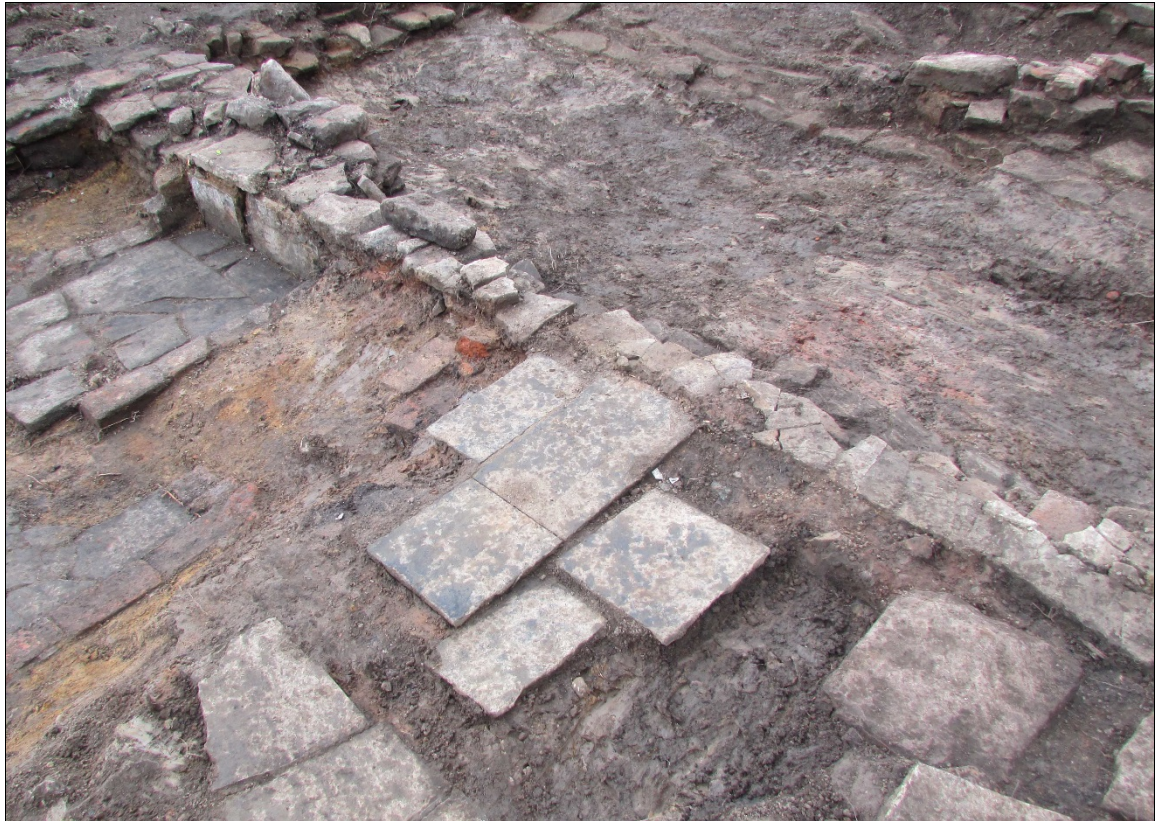
Plate 11: Stone wall (010) dividing room 2 and room 3, looking south

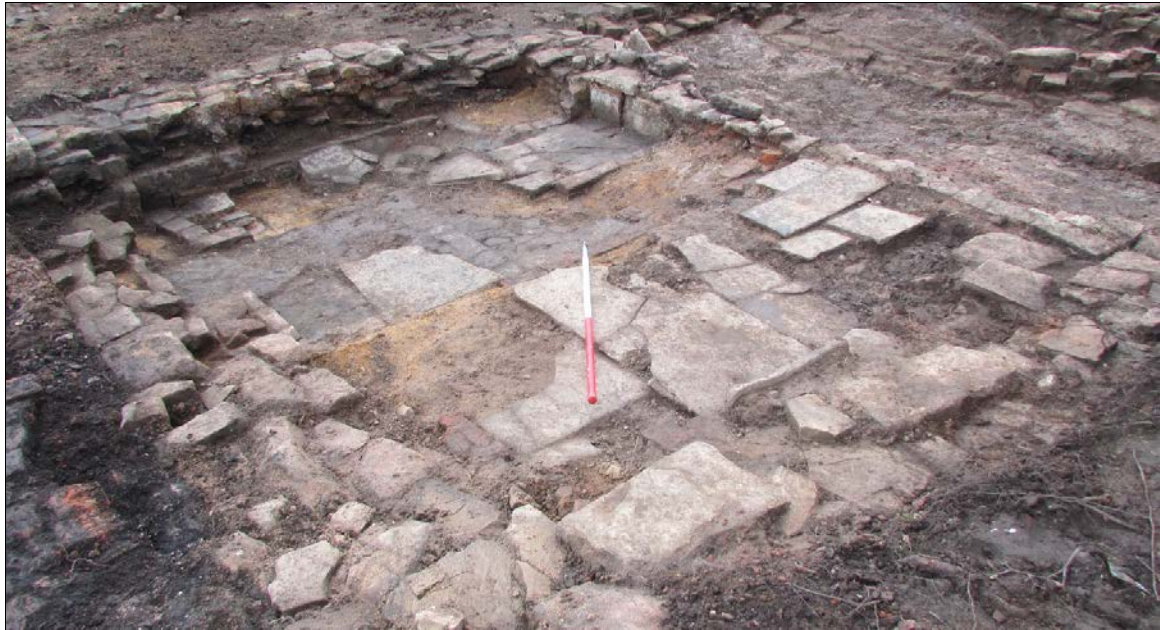
Plate 12: Room 3, looking south

Room 3 appeared to be split into an upper and lower half. In the upper north-western half, approximately 0.20m below ground level, there was a truncated stone flagged floor surface (011). The largest slab measured 1.14m x 0.60m and appeared to be adjacent to a possible door threshold in (009) linking rooms 2 and 3. The overall dimensions of (011) were 2.50m by 1.14m and they were laid on top of natural ground (001).

Separating the upper and lower halves of room 3 was a handmade brick wall (013). It was a single course brick wall with a length of 1.95m and a width of 0.11m. It had some small one brick abutments running off it towards the south-east. (013) also ran alongside the south-west edge of stone wall (012) which forms the north-east wall room 3. In the southern corner of the room was a handmade curving brick wall (014), the middle of the curve being 0.66m from the corner of the room where stone walls (003) and (010) meet. (015) was the stone flagged floor of the lower half of room 3 which had been severely truncated in some areas. In the east corner of the room there was a drain (016) which measured 0.69m x 0.23m. The metal drain cover measured 0.28m x 0.17m. Running between (014) and (016) along the north-west edge of (003) was a single course handmade brick wall (017) which had a length of 1.94m. Stone wall (012) was the linear wall marking the end of the farmhouse building and was aligned north-west/ south-east. It was constructed of grey sandstone blocks of various shapes and sizes that were roughly hewn and laid in regular courses. It was 4.60m in length, 0.70m wide, 0.58m in depth with a soft, sandy mortar.

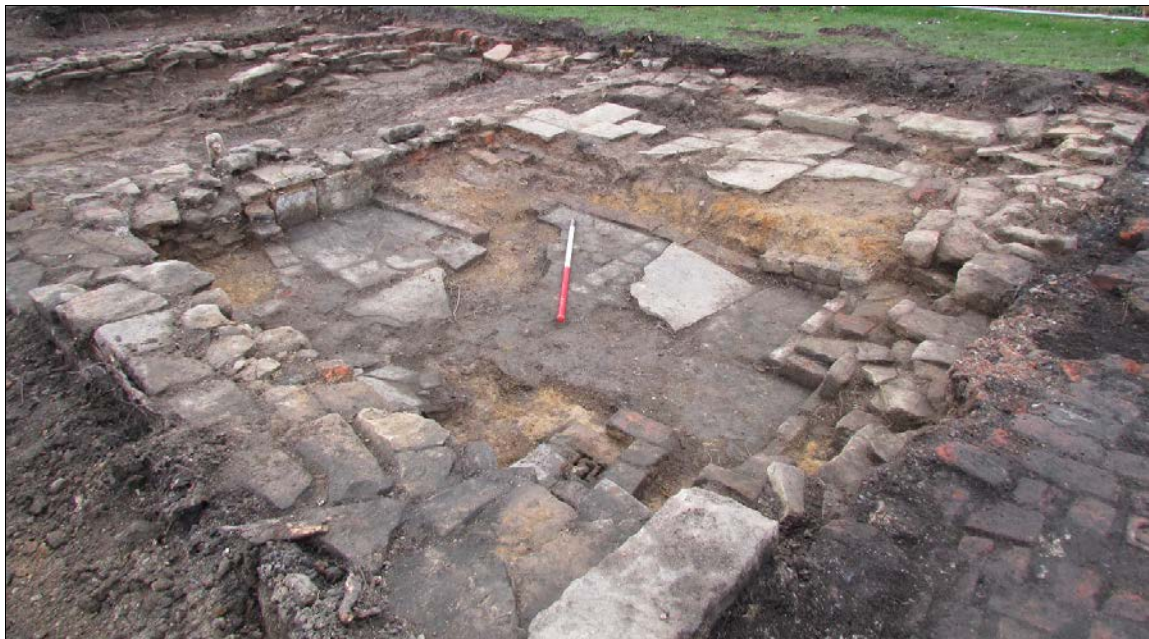
Plate 13: Room 3, looking west

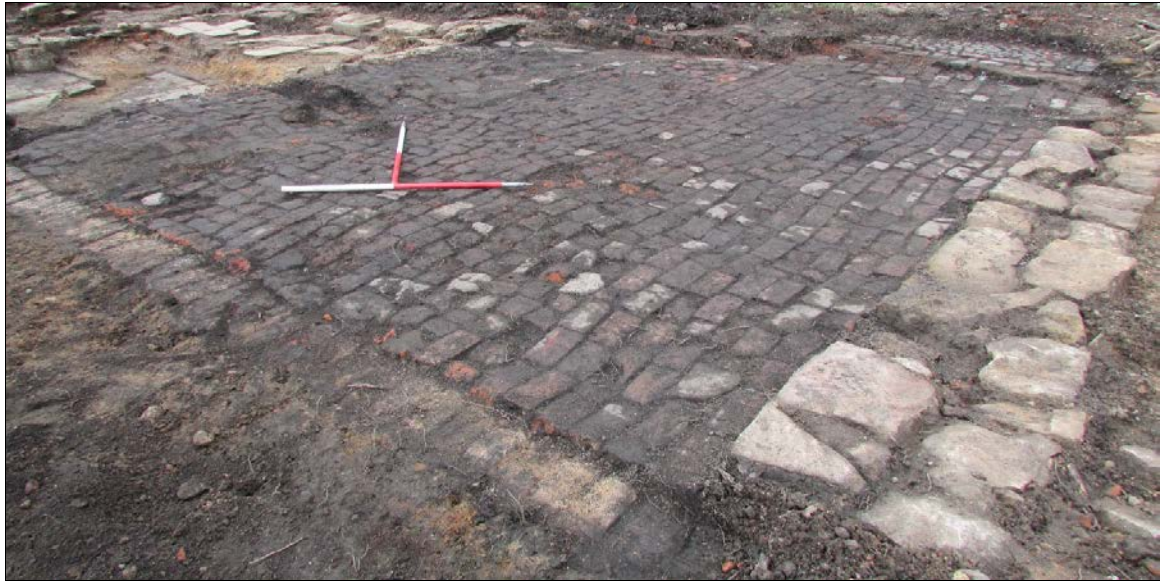
*Plate 14: Room 4 showing brick surface **(019)**, brick wall **(018)**, cobbles **(020)** and stone wall **(021)**, looking west*

Moving further along to the north-east, in room 4 there was a large brick surface **(019)** that had a length of 5.50m and a width of 4.85m. It was constructed out of full bricks, half bricks and occasional frogged bricks. The bricks in the north-eastern half of **(019)** were aligned north-west/ south-east and on the south-western half north-east/ south-west. The south-western half had a small amount of stone flag replacements as well as a dipped area aligned north-west/ south-east which may have been part of a drainage system. At the south-east end of **(019)** was a handmade brick wall **(018)**. The brick wall survived to one course high and had a length of 5.10m and a width of 0.25m. The bricks had a light brown sandy mortar and **TP6** showed that they were laid on top of stone rubble foundations. At the north-west end of **(019)** there was a small cobbled surface **(020)**. The cobbles were small and irregular with a length of 1.80m and a width of 0.60m. They seem to have extended further to the north-west beyond the limit of the

excavation. On the north-east side of **(019)** was stone wall **(021)**. The wall was aligned north-west/ south-east with a total length of 8.50m, width of 0.72m and a depth of 0.11m.

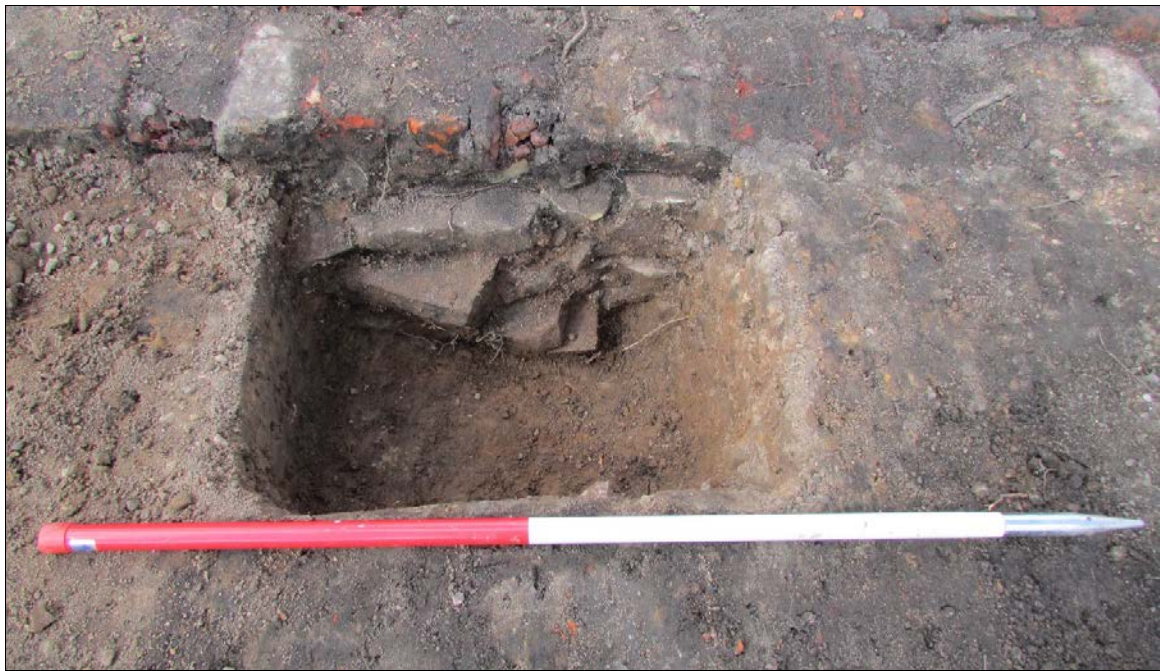
*Plate 15: TP6 showing stone rubble foundations of **(018)**, looking north-west*

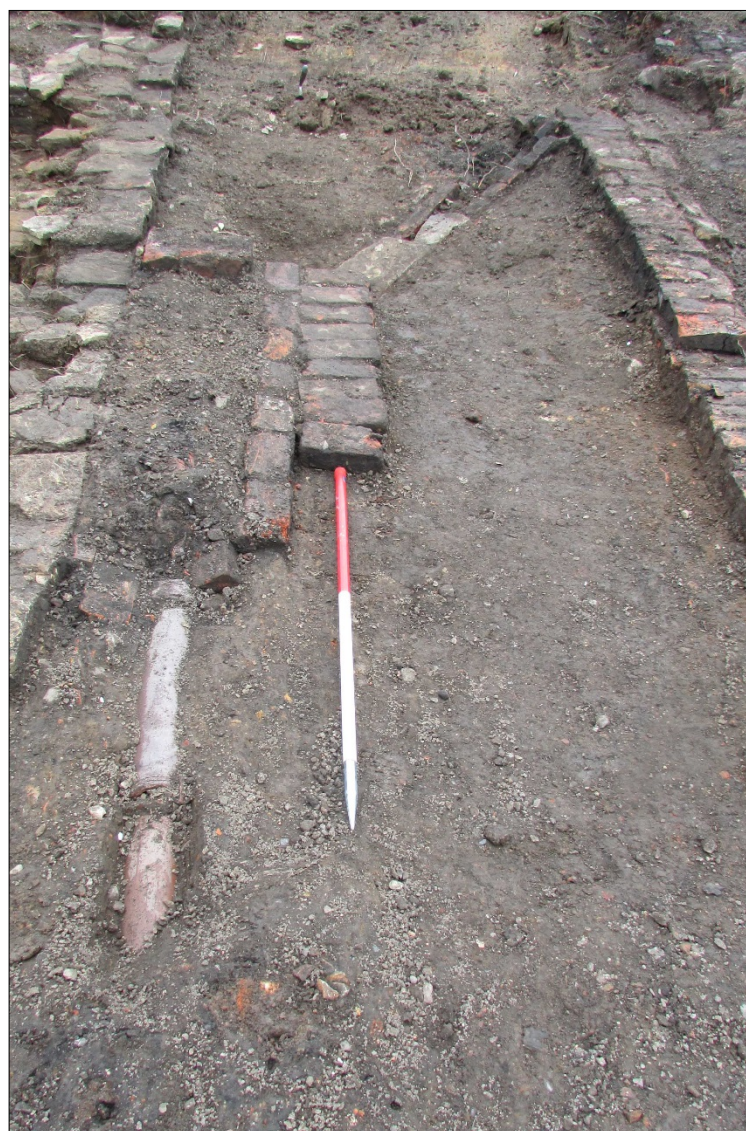
Plate 16: L-shaped brick feature (024) and brick lined culvert (022), looking north-east

To the south-east of stone wall **(003)** was a brick lined culvert **(022)** that appeared to run under **(024)**. The small culvert was topped by stone flags and had stone at the base. A reused roof tile measuring 0.41m x 0.24m that had a circular perforation within was used to cap the culvert. It was orientated east-west with a slope to the west and measured 1.60m in length and 0.25m in width. **(023)** was a small brick culvert that was discovered in **TP5** which was excavated along the south-east side of **(003)**. It was located 0.60m below the top of **(003)**. It was topped with stone flags and lay on top of natural clay. **(024)** was a handmade L-shaped brick feature to the south-east of **(003)**. It likely related to drainage and had two culverts **(022)** and **(023)** running through it.

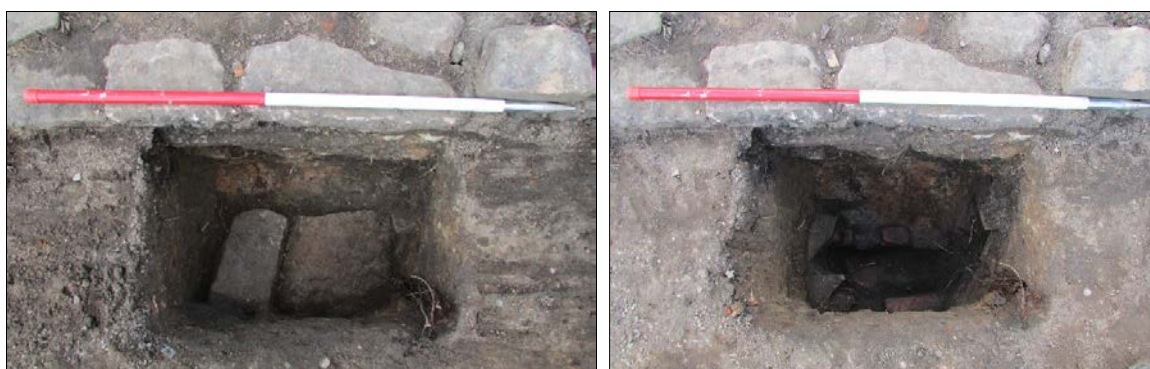
Plates 17 & 18: (023) in TP5, with stone flags (left) and after removal of stone flags (right)

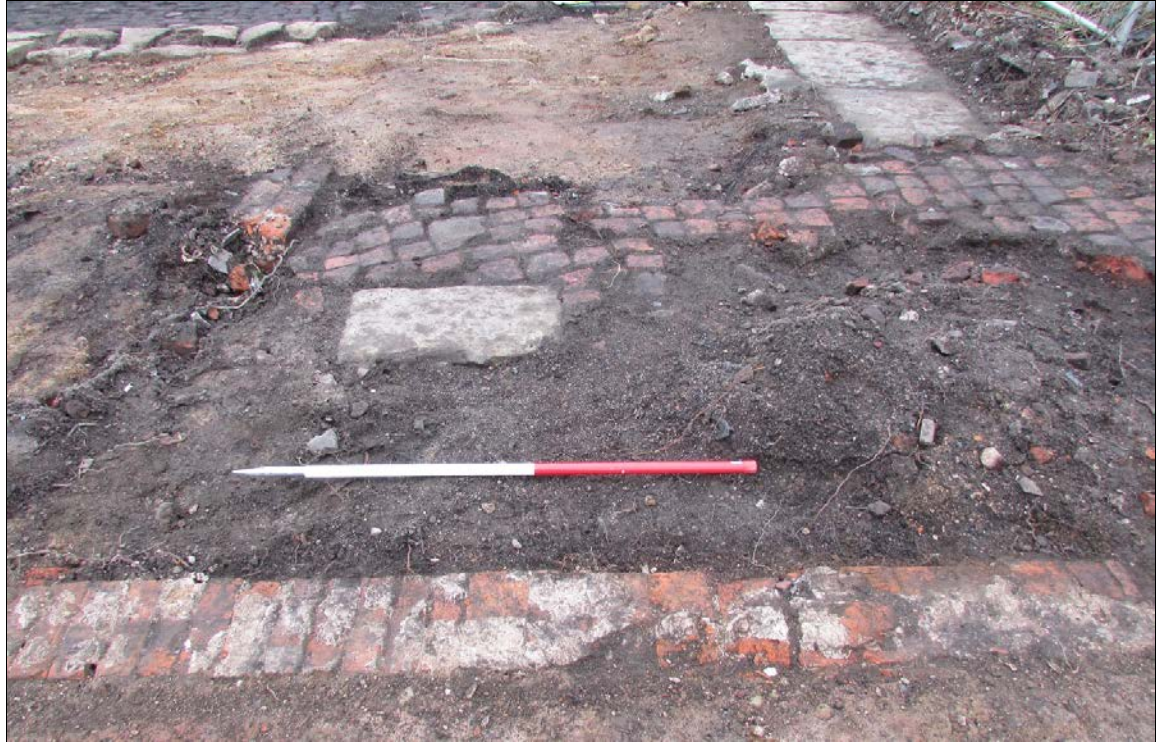
Plate 19: Stone flagged floor (026), brick surface (027) and brick wall (028), looking south-west

Abutting the north-east side of (021) was a small area of stone flagged floor (026) that was aligned north-east/ south-west. The length of this floor surface was 2.65m and it had a width of 0.75m and a depth of 0.05m. TP7 was excavated along the south-east edge of the flags and revealed a thin piece of timber running along the edge in the same alignment. To the north-east of (026) was a brick floor surface (027) which was seen during the evaluation. The floor surface had a length of 3.00m and a width of 1.04m.

(028) was a handmade brick wall located to the north-east of (027) that was aligned north-west/ south-east and had a length of 5.10m and a width of 0.24m. It survived to a height of three courses and had a lime mortar. At its south-east end there was a stone wall (029) that appeared to be a continuation of (028). It had a length of 2.40m and a width of 0.50m.

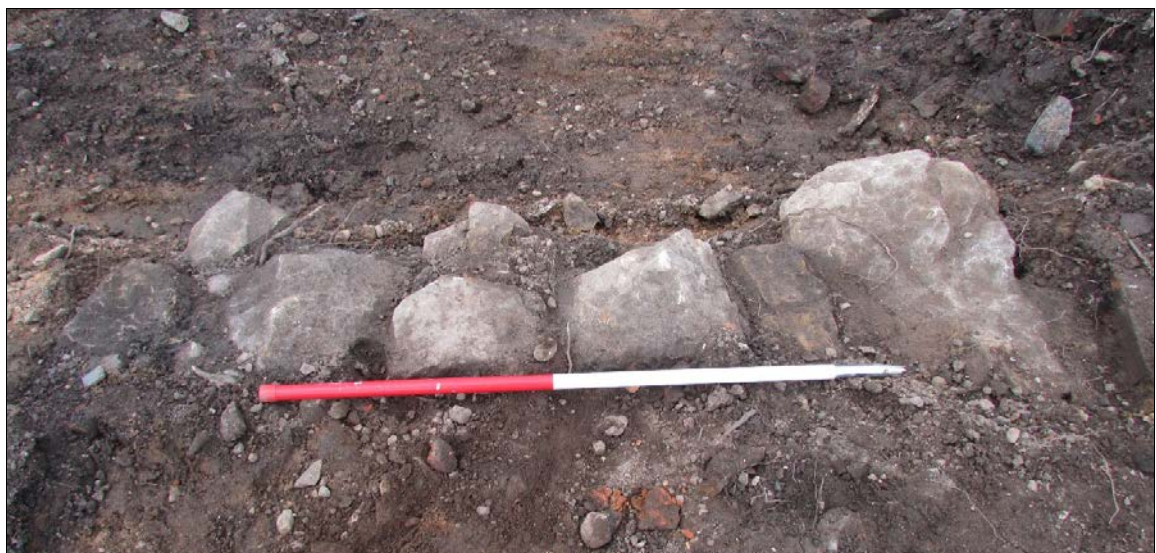
Plate 20: Stone wall (029), looking south-west

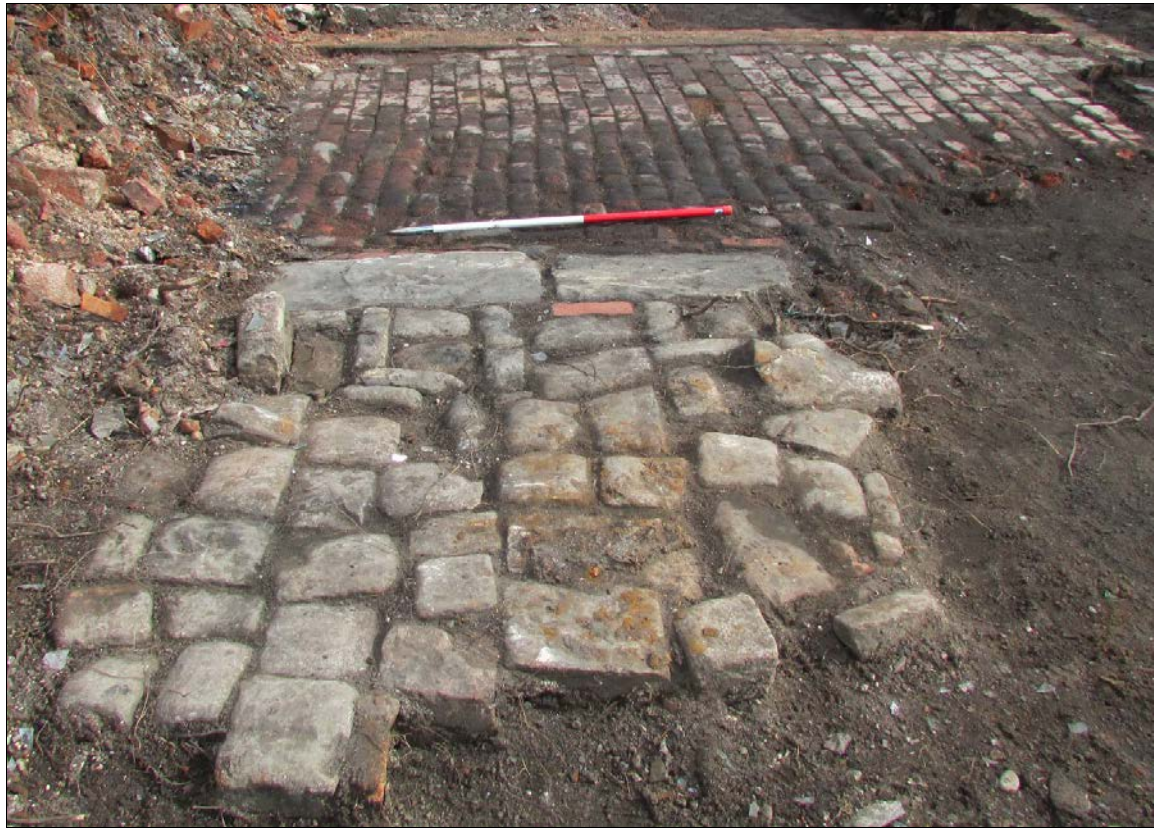
Plate 21: Cobble setts (030), sandstone flags (031) and brick floor (032)

Approximately 9.08m to the north-east of (028) there was a patch of large cobble setts (030). The setts were mainly square and had an average dimension of 0.17m x 0.17m x 0.09m. The overall length of the cobble setts was 1.70m and a width of 1.30m. Two large sandstone blocks (031) were to the north-east of (030). They were aligned north-west/ south-east and had a drain running parallel to them. The length of (031) was 0.82m and the width was 0.37m. To the north-east of (031) was brick surface (032) that was

4.14m long and 2.05m wide. The bricks were aligned north-east/ south-west and all laid stretcher. The surface was constructed of half bricks and broken bricks and appeared to be slightly truncated at its south-west end.

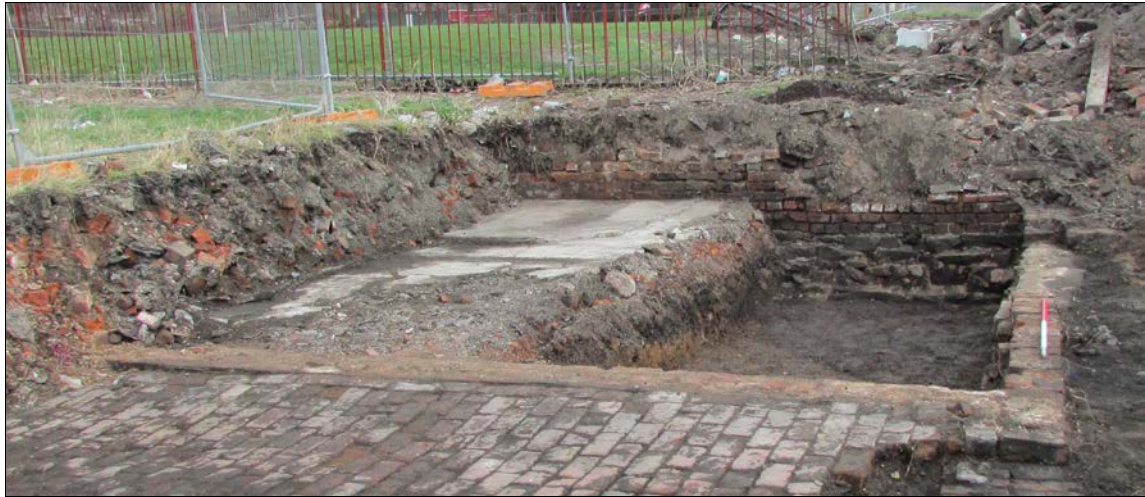
Plate 22: Room 5 showing walls (033), (034) and (036) and concrete floor (035), looking north

Directly to the north-east of (032) was handmade brick wall (036) that was aligned north-west/ south-east. The wall had an overall length of 5.00m with a width of 0.35m and a depth of 0.45m. The wall was six courses high before the foundation bricks stepped out and it was bonded by a light brown sandy mortar. The wall butted up to a brick and stone wall (033). (033) was aligned north-east/ south-west and had a length of 4.98m with a depth of 0.50m. The bricks survived to a depth of one course at the south-west end of the wall and were resting on top of a sandstone rubble foundation. The bricks were bonded with a white lime mortar. The brick wall had a width of 0.24m and the stone wall had a width of 0.38m. The sandstone blocks were bonded with a light brown sandy mortar. At its north-east end, (033) is tied into (034). (034) was a brick wall with stone foundations that had a length of 4.60m, an exposed width of 0.22m and a depth of 0.67m. There were eight courses of bricks on top of stone rubble foundations. The bricks had a white lime mortar and the stone blocks had a light brown sandy mortar. The north-western half of room 5 contained a truncated concrete floor (035). The floor was 4.35m long, 2.00m wide and 0.06m deep. Located 2.30m to the south-west of (034) was a shallow drain aligned north-west/ south-east.

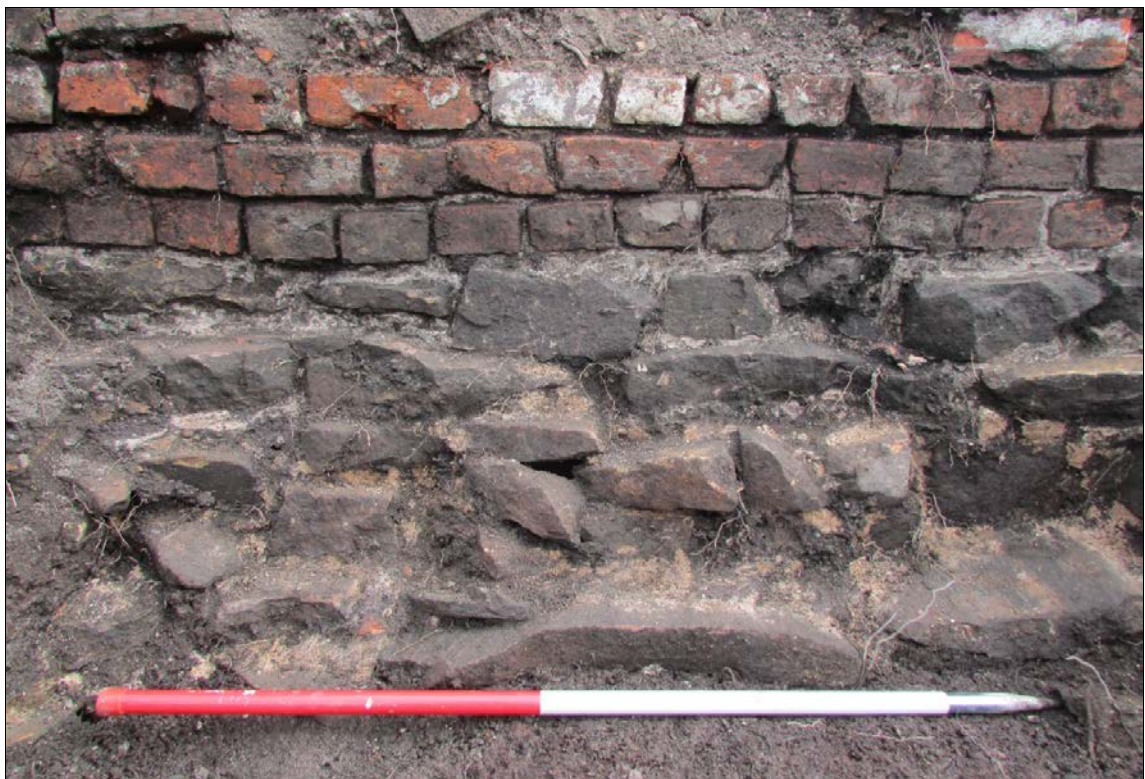
Plate 23: Detail shot of stone and brick wall (034), looking north-east

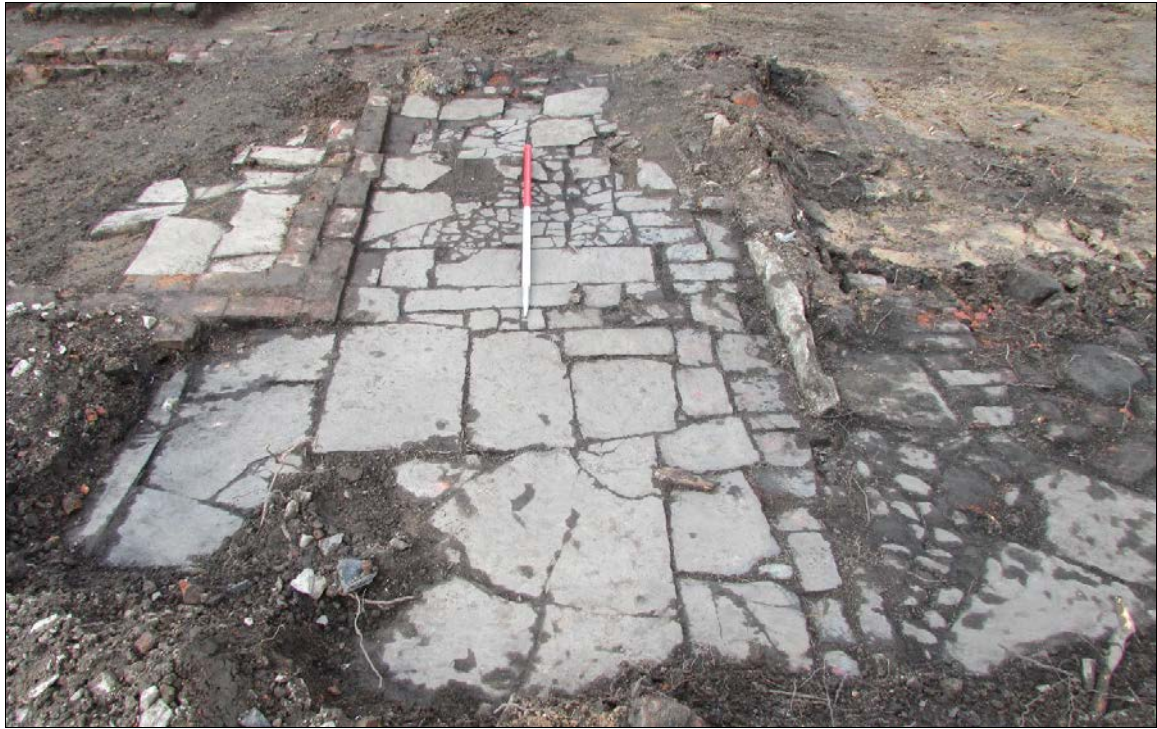
Plate 24: Stone flagged floor (055) and brick wall (056), looking north-west

2.94m to the south of stone wall (003) there was a stone flagged surface (055). It appeared to be heavily truncated with only a small section surviving. The remaining stone flagged floor measured 3.37m long by 3m wide. An upright flag marked the north-east boundary of (055) and beyond was an area of cobbles and stone flags. At the south-west end of (055) there was an L-shaped brick wall (056). The north-west/ south-east aligned section of the wall was 1.85m long and the north-east/ south-west aligned section had an exposed length of 1.45m and the wall had a width of 0.36m. To the north-west of (055) and (056) was brick wall (057). (057) had a length of 5.14m and a width of 0.36m. Drain (022) butted up to its north-western edge. Next to (057) there was a soil horizon (071) which included sherds of early 18th century pottery.

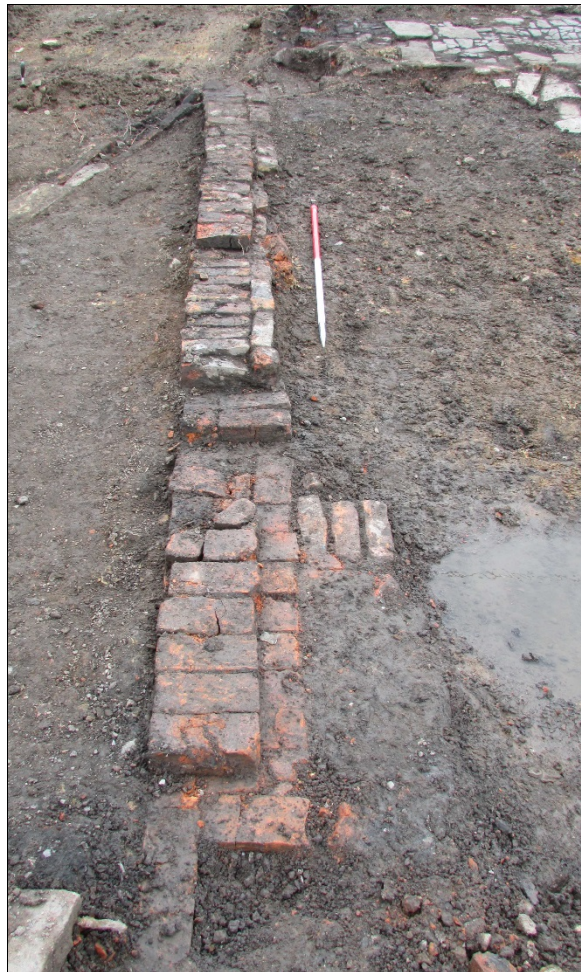
Plate 25: Brick wall (057), looking north-east

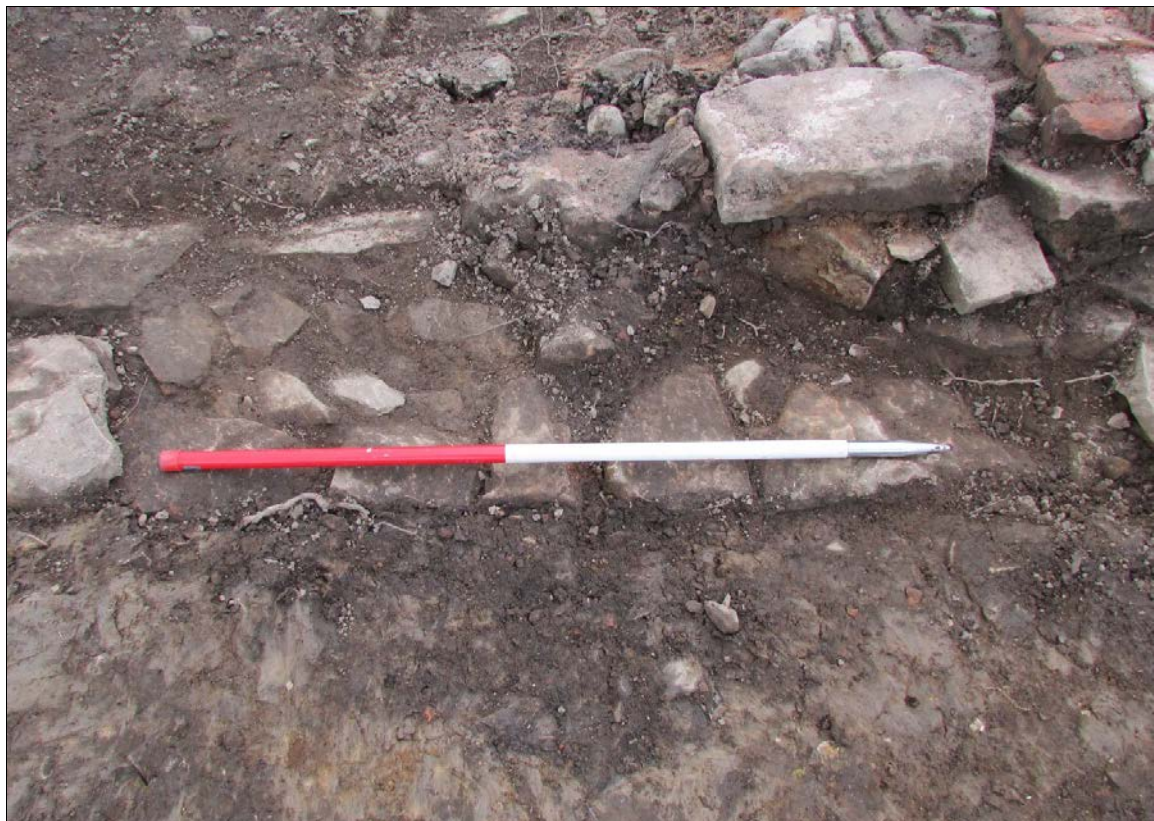
*Plate 26: Pit to north-east of **(005)**, looking south-west*

The earliest archaeology in the farmhouse area appeared at the south-western extent of the excavation area. The fill **(070)** of a sub-oval pit **(TP4)** that was situated on the north-east side of stone wall **(005)** produced early 18th century pottery along with fragments of CBM. The fill of TP4 appeared to be cut by **(005)** perhaps indicating that there was two phases of activity in this area. It is difficult to categorise this pit feature but it is possible that it is related to the construction cut of **(005)**. This would show that the earliest archaeological features in the area predate the mapping evidence. Soil horizon **(071)** also produced early 18th century pottery providing more evidence for earlier archaeological remains.

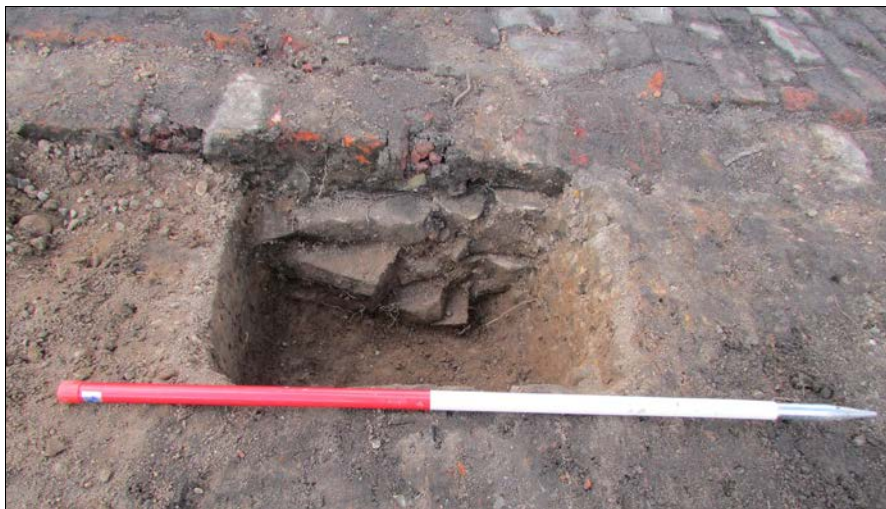
Plate 27: Stone foundations below brick wall (018)

The majority of the Coalshaw Green Farmhouse walls were constructed out of stone blocks with some evidence being present for later additions. One area of the farmhouse where there is evidence of later additions can be seen over dividing wall **(005)**. An additional layer of stone blocks **(007)** were placed on top of the wall and these were covered by a layer of small irregular cobbles **(006)** that were set into a layer of clay. The cobbles may have represented a new, later floor surface in the farmhouse with the bricks **(008)** that were on top of them being a later wall addition, perhaps representing a phase of activity which saw the original rooms being sub-divided. Another area which showed evidence of a possible later addition was at the south-east end of room 3. A test pit **(TP6)** was excavated next to handmade brick wall **(018)** which revealed that it was a single skin of bricks laid on top of a stone rubble foundation, similar to remains of the farmhouse at Booths End Farm which was a mid-19th century farmhouse (McCoy, 2015, 7). This was also seen with brick walls **(033)** and **(034)**. The stone rubble foundations of both walls had a light brown sandy mortar whereas the overlying brick courses were bonded with a white lime mortar, suggesting that the bricks were a later addition to the building. Similar additions to the ones at Coalshaw Green Farm were seen at Ashes Farm, Bolton and are believed to be 19th century modifications (Gregory, 2016, 59).

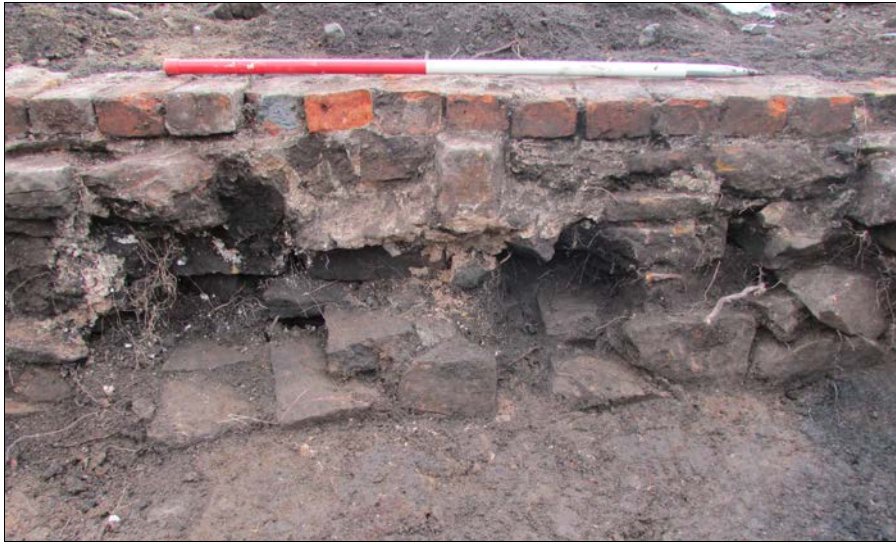
Plate 28: Stone foundations below brick wall (033)

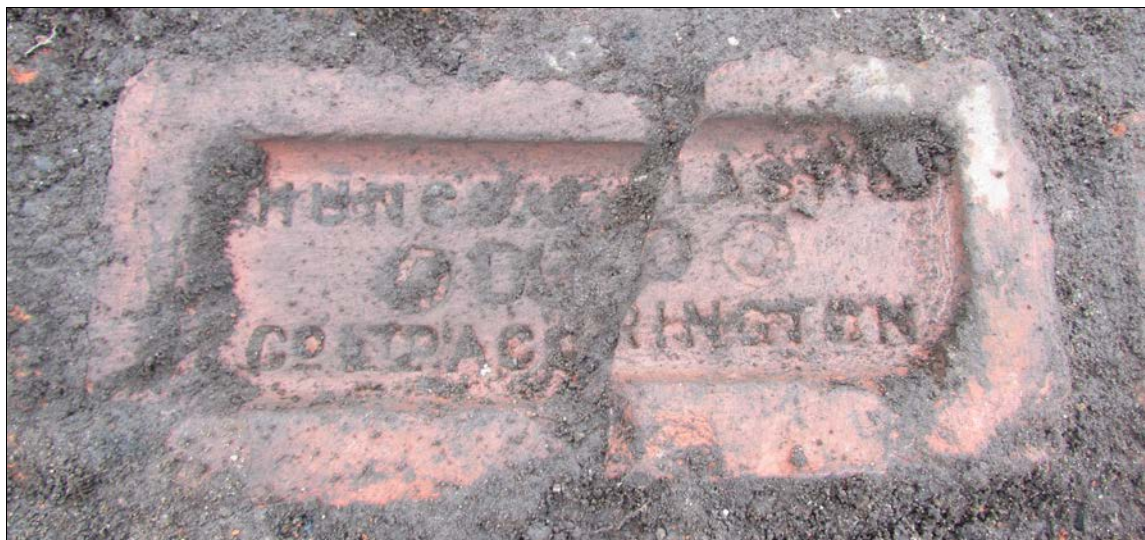
Plate 29: Frogged brick in floor surface (019)

The archaeological remains at the northern end of the development area also suggest that there has been later additions to the farmhouse. There was several different types of floor surfaces including cobble setts (030) and a brick floor surface (032). At Ashes Farm in Bolton, similar types of external floor surfaces were excavated and thought to have been from the 19th century (Gregory, 2016, 60). The external floor surfaces at Coalshaw Green Farm were found directly next to room 5 which consisted of three brick walls, (033), (034) and (036), and concrete floor (035) which were all probably constructed in the mid-late 19th century. Other evidence for 19th century activity was the use of frogged bricks as repairs to floor surfaces and walls. In brick floor surface (019) one brick had 'HUNCOATS PLASTIC CO LTD ACCRINGTON' stamped onto it. Frogged bricks were regularly used in the 20th century.

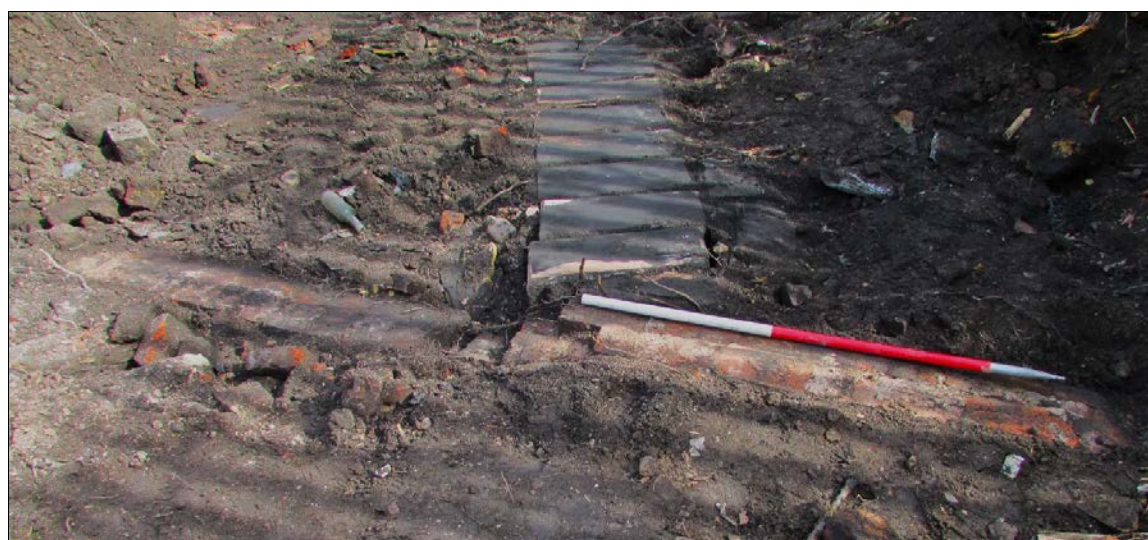
Plate 32: Brick wall (060) and stone blocks (061), looking north-east

Located 0.94m to the north-east was a handmade brick wall **(060)** aligned north/ south. The wall had an exposed length of 3.20m and a width of 0.25m. The wall was laid stretcher with the lower courses being laid headed with a light cream mortar. On the north-east side of **(060)** there was a row of stone blocks **(061)**, orientated north-east/ south-west. The row consisted of 9 stone blocks which were 0.22m wide each. The overall length of **(061)** was 2.05m with a width of 0.55m. To the east of **(061)** was a single course brick wall **(062)** aligned north-west/ south-east that continued beyond the south-east limit of excavation. The length of the wall was 1.06m and the width was 0.12m.

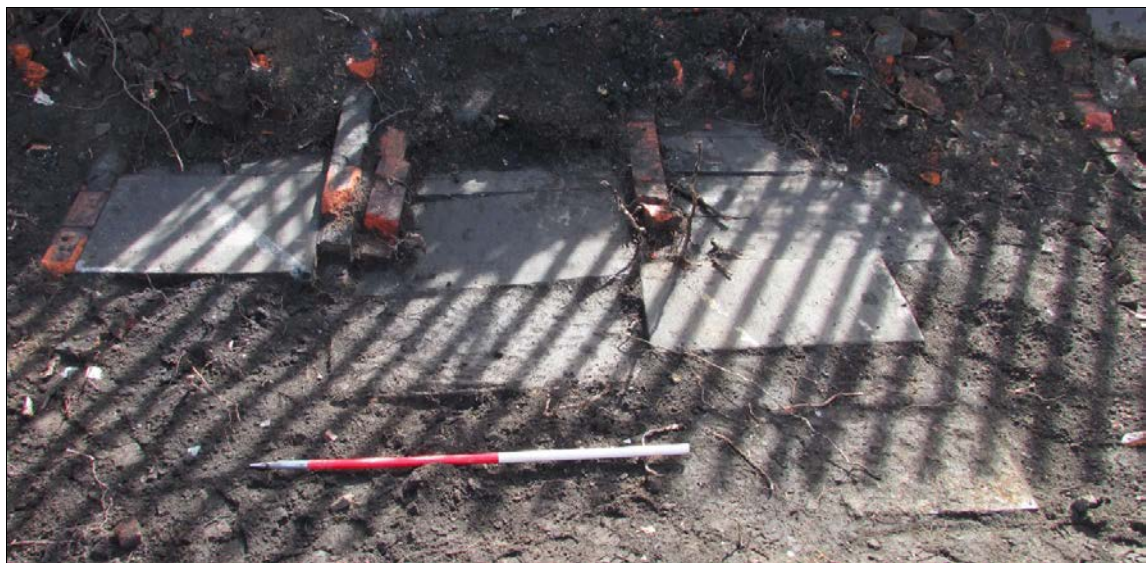
*Plate 33: Stone flagged floor **(063)** and brick walls **(064)**, **(065)** and **(066)**, looking south-east*

To the north-east of **(062)** was an area of stone flagged surface **(063)** that appeared to be separated into three separate bays by brick walls **(064)**, **(065)** and **(066)**. The flags had an overall length of 3m and an overall width of 1.40m and were not of a uniform size. To the north-west of **(063)** there was a possible metal drain cover. **(064)** was the brick wall most to the south-west. It was aligned north-west/ south-east and had a length of 1m and a width of 0.10m. It was constructed of a single course of bricks laid stretcher bond with a dark black mortar. 0.93m to the north-east was **(065)** which was aligned north-west/ south-east with a length of 1.16m and a width of 0.14m. The wall was two courses wide laid stretcher bond with a dark black mortar. 0.82m to the north-east was **(066)** which was aligned north-west/ south-east and had a length of 0.82m and a width of 0.10m. It was a single course wall laid stretcher bond with a dark black mortar. To the north-east of **(066)** was an L-shaped wall **(067)** which was two courses wide and bonded together with a light cream mortar. The north-west/ south-east aligned section of the wall was 1.65m long and the north-east/ south-west section was 1.02m long.
