Archaeological Excavation Report

Coalshaw Green
Farmhouse,
Coalshaw Green,
Chadderton

Report No:
SA/2017/33

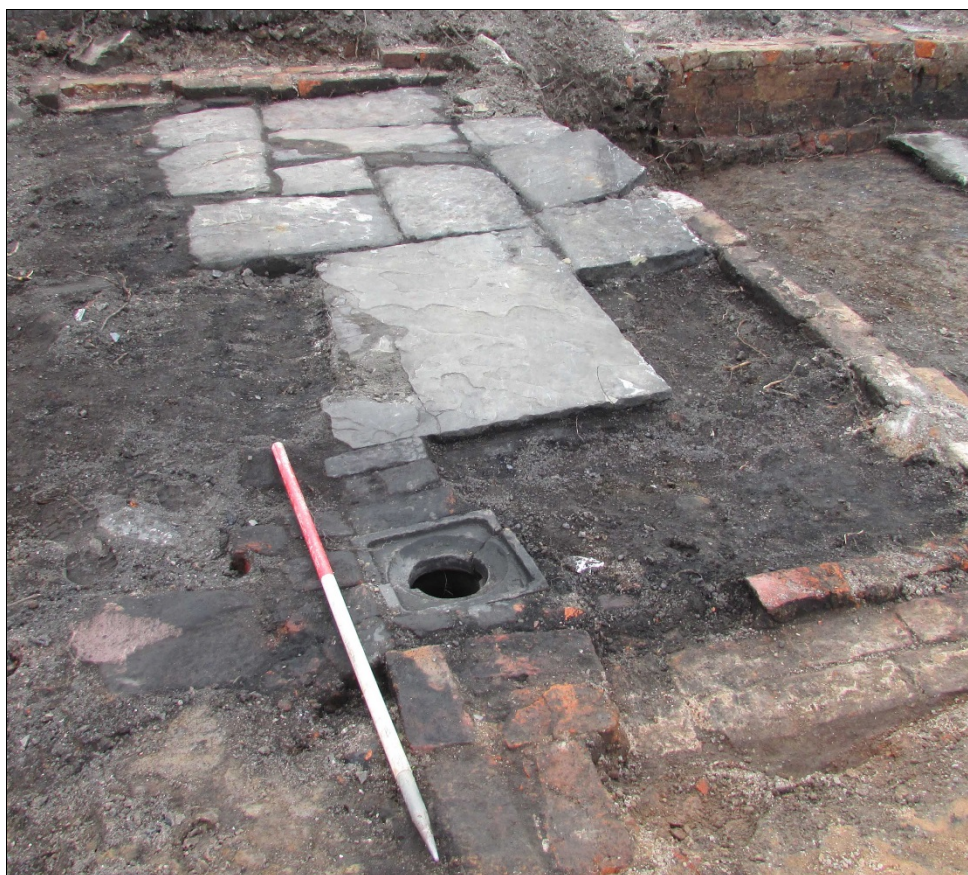
Plate 35: Room 4 showing brick wall (038), stone flagged floor (039) and drain (040), looking south-east

6m from the north-western edge of (058) was handmade brick wall (038). The wall was aligned north-east/ south-west and ran along the eastern edge of rooms 1 and 4 of the cottage. (038) was seven courses in height with the brick foundations starting at the sixth course. It had a length of 7m and a width of 0.24m with the bricks being bonded by a light brown sandy mortar. There was a gap in the wall of 1.5m which may have been a possible entranceway into room 1. The southern section of the wall had two small brick abutments aligned north-west/ south-east that were spaced 1.18m apart and were each 0.24m wide. To the north-west of the northern half of (038) there was a stone flagged area (039) which was the floor surface of room 4. The flags were irregular with no clear pattern and there were cobble repairs in some areas. (039) had a length of 2.78m and a width of 1.57m with the smallest flag being 0.32m by 0.33m and the largest flag being 1m by 0.74m. At the north-western end of (039) there was a square drain cover (040) with a possible drainage gully running off it to the north leading to a larger drainage gully aligned north-west/ south-east. The drain cover measured 0.31m by 0.31m with bricks surrounding it on three sides. To the east of (038) was a small patch of cobbles (041) that could have possibly continued further to the south-east. The cobbles were regularly laid and had a length of 0.84m and a width of 0.50m.

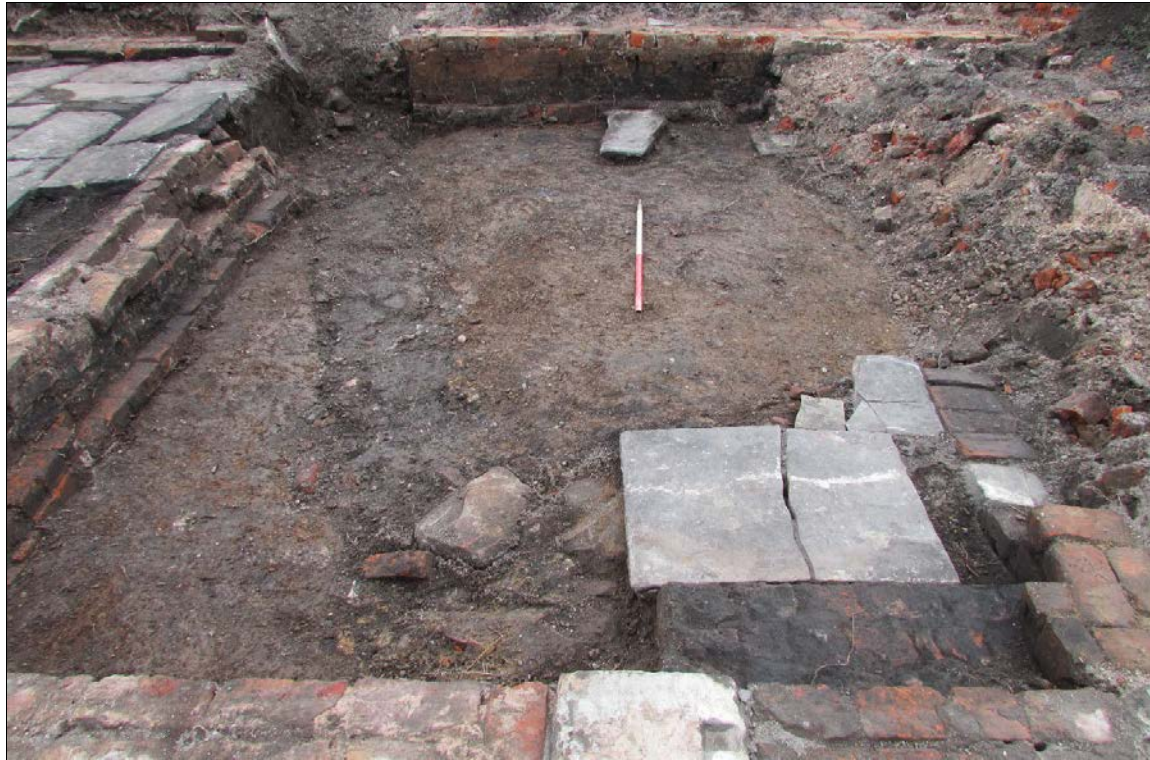
Plate 37: Room 1 showing brick walls (038) and (042), brick and stone flag feature (043) and linear feature [044], looking south-east

Separating rooms 1 and 4 was handmade brick wall (042) which was aligned north-west/south-east and had a light brown sandy mortar. The wall was five courses high with the lowest two courses being foundations which stepped out by 0.10m. It had a length of 3.20m, a width of 0.24m and a depth of 0.42m. It was tied into (053) at its north-west corner and stopped abruptly near the possible entranceway into room 1, perhaps indicating the doorway between the two rooms. In the north-western half of room 1 there was a brick and stone flag feature (043) which was 2.15m long and 1.13m wide.

The surface appeared to be resting on stone and brick rubble which may be related to [044]. The bricks were laid fairly regular and included one frogged brick with a light brown sandy mortar. Running across room 1 in east/ west alignment was a linear feature [044]. The feature appeared near the possible entranceway and continued underneath (043). It would appear that [044] was a later drain which possibly utilised the entrances into room 1 and between rooms 1 and 2 to avoid disturbing foundations. Ceramics from the 20th century were recovered from its fill (072).

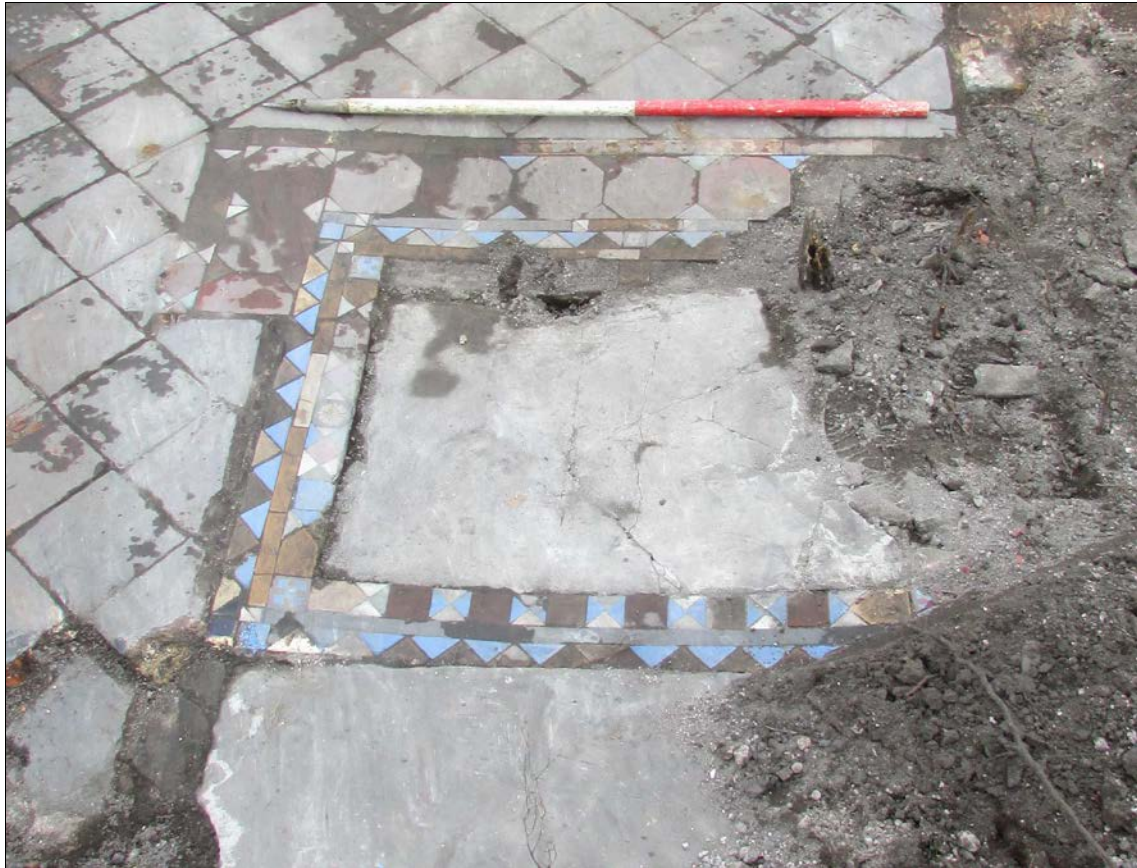
Plate 38: Tiled entranceway (045) into room 2, looking north-east

(053) was a handmade brick wall that was aligned north-east/ south-west and separated rooms 1 and 2. It was bonded by a light brown sandy mortar and had a length of 3.50m, width of 0.36m and a depth of 0.42m. Included in the wall were two stone blocks that were 0.68m apart and line up with (043). Both blocks had a socket within them indicating that they were part of a door jam and they had an average width of 0.30m. Directly to the north-west of (053) was a tiled area (045) which was a possible entranceway into room 2. The tiled area had a length of 1.30m and a width of 1.06m. The area comprised a central flag that was surrounded by small yellow, blue, green, maroon and patterned tiles. The small square tiles had dimensions of 0.06m by 0.06m. There was an area of larger coloured tiles surrounding the northern corner of the smaller tiles. These tiles were of a maroon colour and had dimensions of 0.15m by 0.15m.

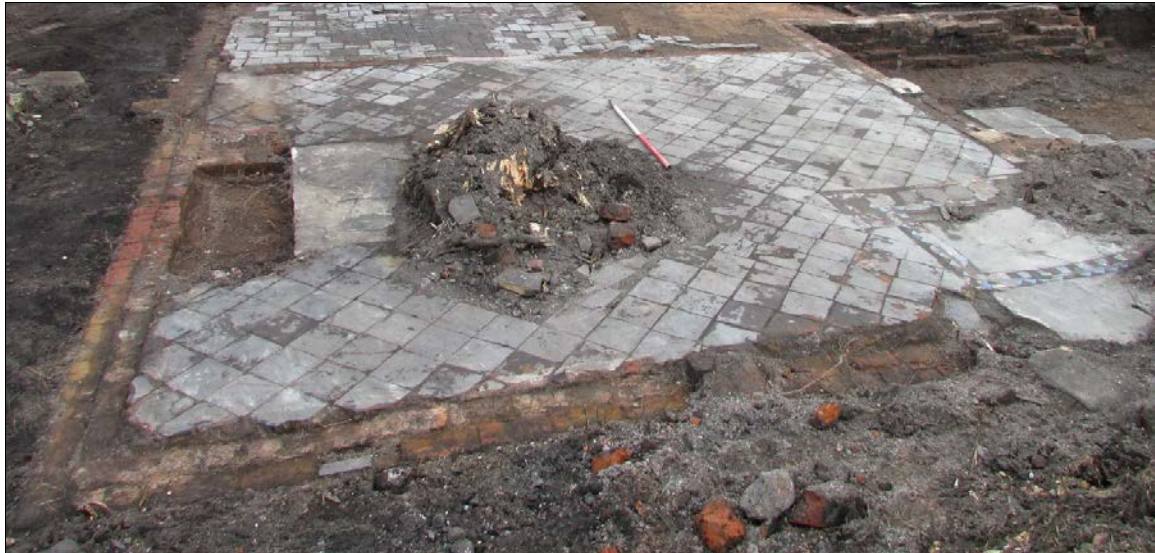
Plate 39: Room 2 showing tiled entranceway (045), tiled floor (046) brick walls (047) and (048) and fireplace (068), looking north-east

(046) was the tiled floor surface of room 2. (046) was 4.36m long and 3.75m wide. The tiles were laid in a diamond pattern and were all in good condition with the exception of where the floor had been truncated by tree roots. The tiles were 0.18m by 0.18m. Making up the south-west wall of room 2 was (047). The handmade brick wall was aligned north-west/ south-east and had a length of 3.22m and a width of 0.24m. The wall was bonded by a light brown sandy mortar and was tied into wall (048) at its north-west end. There was evidence for a tile being used as a repair. (048) was a handmade brick wall which was the north-west wall of rooms 2 and 3. The wall was aligned north-east/ south-west and had a light brown sandy mortar. Its length was 6.30m, width 0.24m and depth 0.23m. It was tied into wall (047) at its western end and wall (051) at its northern end. On the south-east side of (048) was a possible fireplace (068). There was two brick abutments which stepped out by 0.40m and were 0.94 apart. Tiled floor (046) in this area. Directly to the south-east of this was a large stone flag.

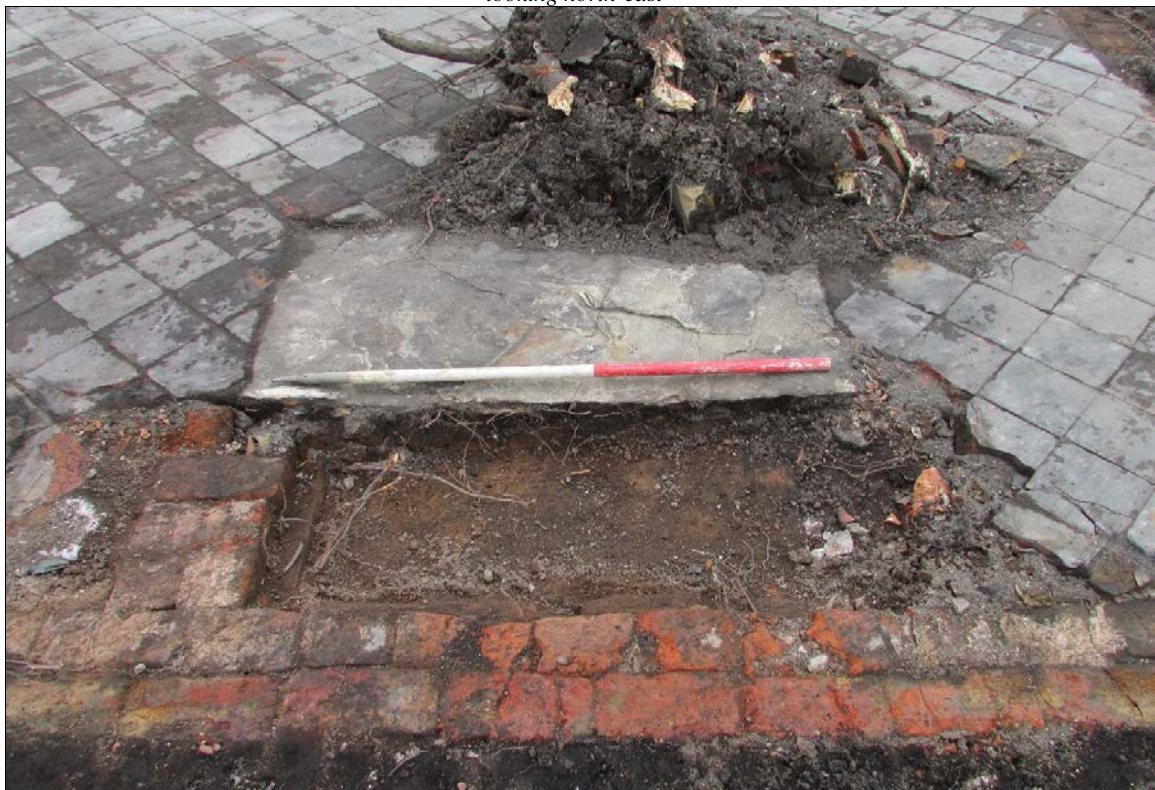
Plate 40: Fireplace (068) in room 2, looking south-east

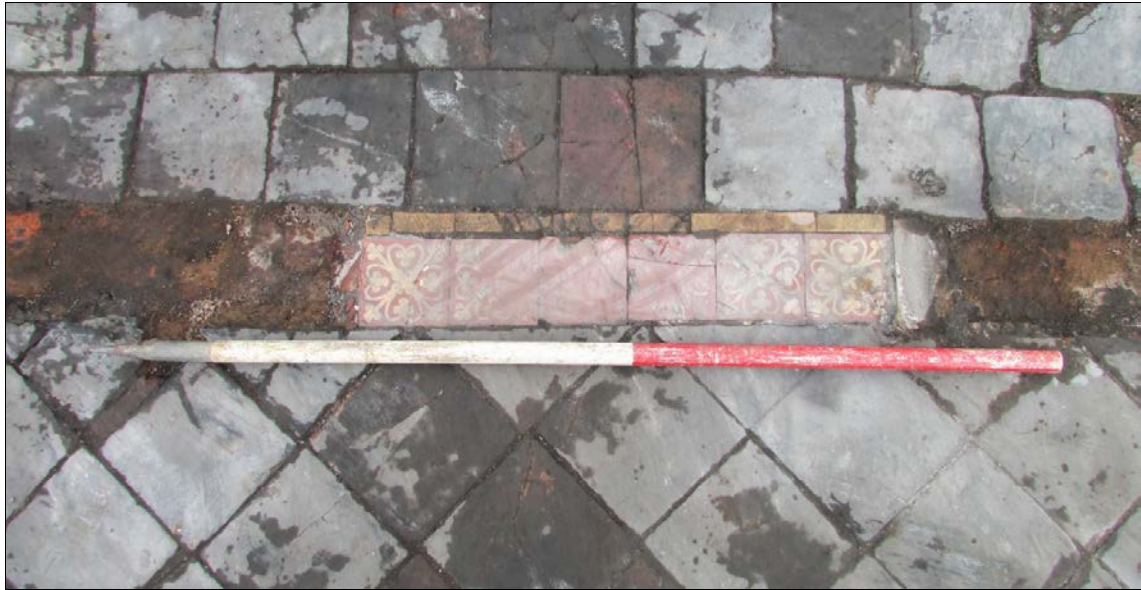
Plate 41: Tiled doorway in (049)

(049) was the internal dividing wall between rooms 1 and 2. It was a single course handmade wall that was aligned north-west/ south-east and had a light brown sandy mortar. It had a length of 4.36m and a width of 0.14m. Located 1.51m away from (048) was an area of tiles which may have been the possible doorway between rooms 2 and 3. It was 0.87m wide and consisted of small square red tiles with a yellow floral design and small yellow rectangular tiles. The square tiles were 0.11m by 0.11m and the rectangular tiles were 0.08m by 0.03m.

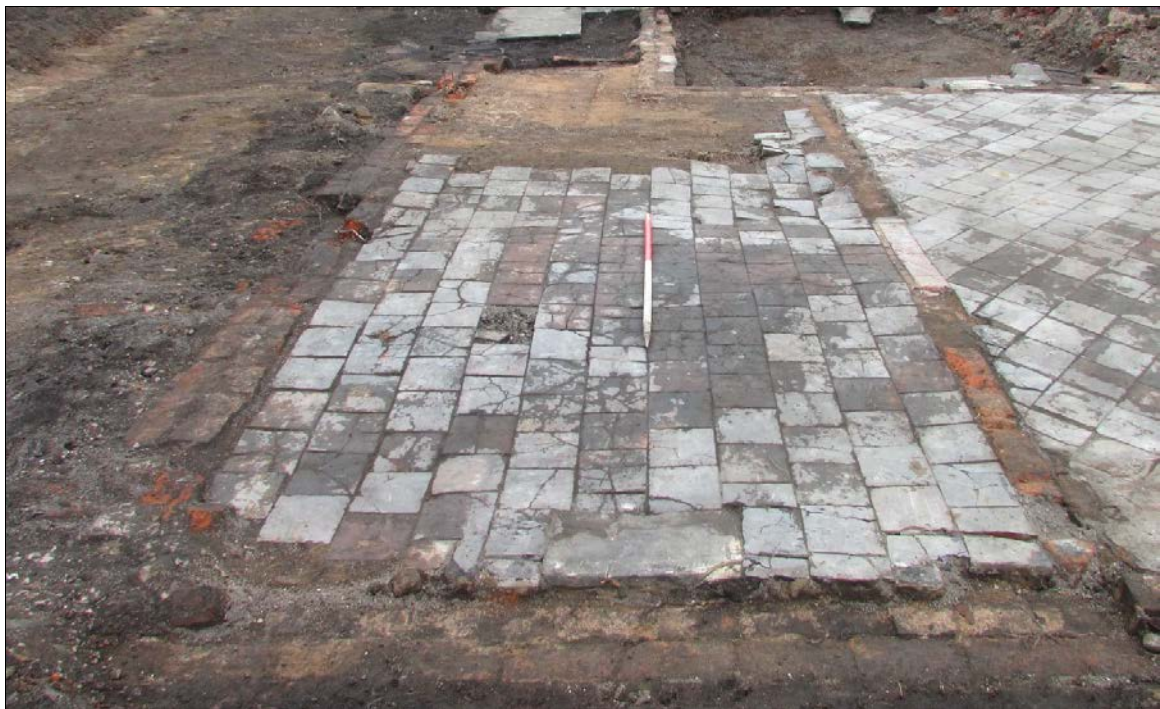
Plate 42: Room 3 showing brick walls (048), (049) and (051) and tiled floor (050), looking south-east

(050) was the tiled floor of room 3. A large percentage of the tiles in this room were cracked and broken and the surface was completely absent in the south-east end of the room. The tiles were laid in regular rows and measured 0.18m by 0.18m. The overall length of the tiled floor surface was 2.94m and the width was 2.04m. Making the north-east edge of room 3 was handmade brick wall (051). The wall was aligned north-west/south-east and was tied into (048) at its north-western end. The wall had an overall length of 5.85m and a width of 0.36. The wall was two courses wide with the exception of the middle section for 1.96m where it was three courses wide and the bricks were bonded with a light brown sandy mortar. At the south-east end of room 2 was handmade brick wall (052) that butted up to (042) and stopped at (040). The wall had a length of 1.35m and a width of 0.32m with the bricks being bonded by a light brown sandy mortar.
