**Archaeological  
Evaluation  
Report:**

Exchange Court,  
Greengate,  
Salford.

**Client: Renaker  
Build Ltd.**

**Report No: 2016/24**

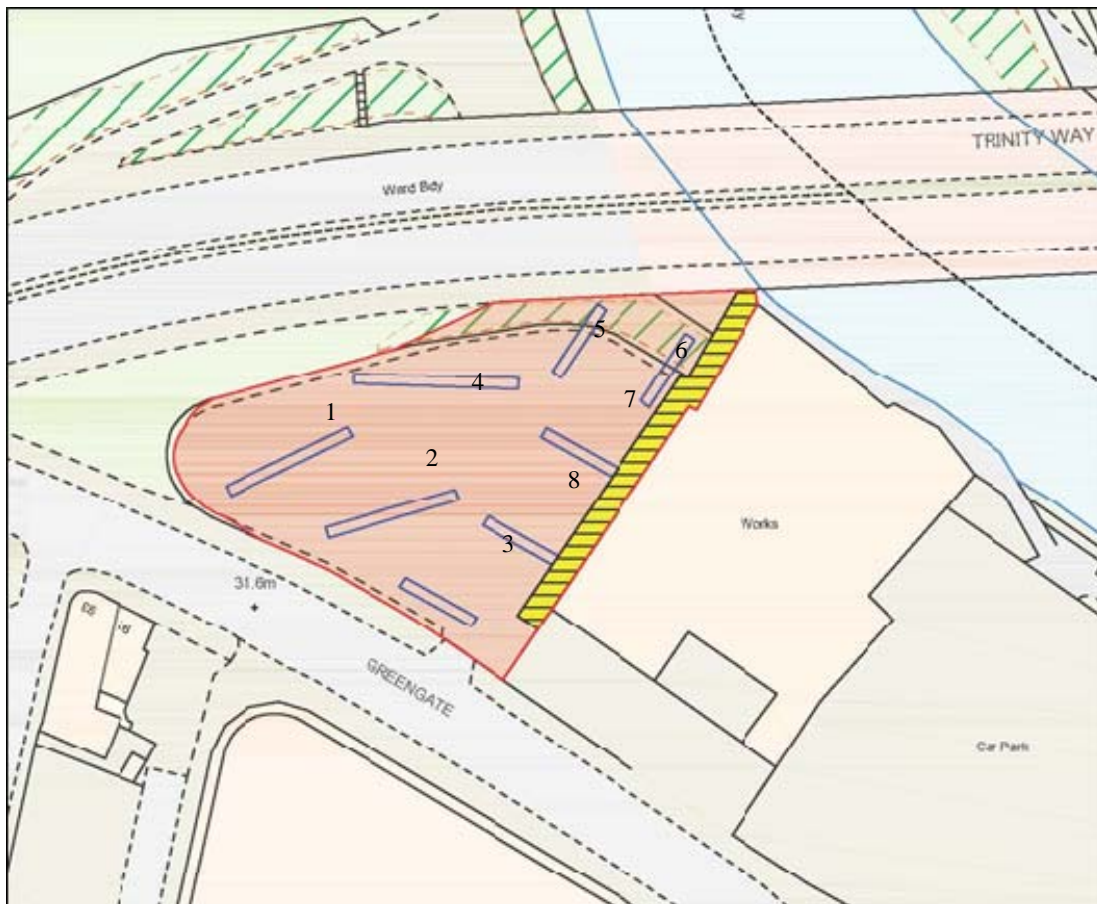
**Fig. 5:** Trench locations within the study area

The site (centred on NGR 383553 399050) is located within the heart of Salford on the southern side of Trinity Way. Eight trenches were placed within the triangular-shaped study area, flanked to the north by Trinity Way and to the south-west by Greengate, with the River Irwell passing on the eastern side (**fig. 5**).

The trenches were located within the space formerly occupied by a car park (**fig. 5**), and orientated at various angles, covering an area of approximately 200m<sup>2</sup>. The trenches were excavated to a maximum depth of 2.6m. The archaeological remains found within the trenches are discussed within Chapter 6.

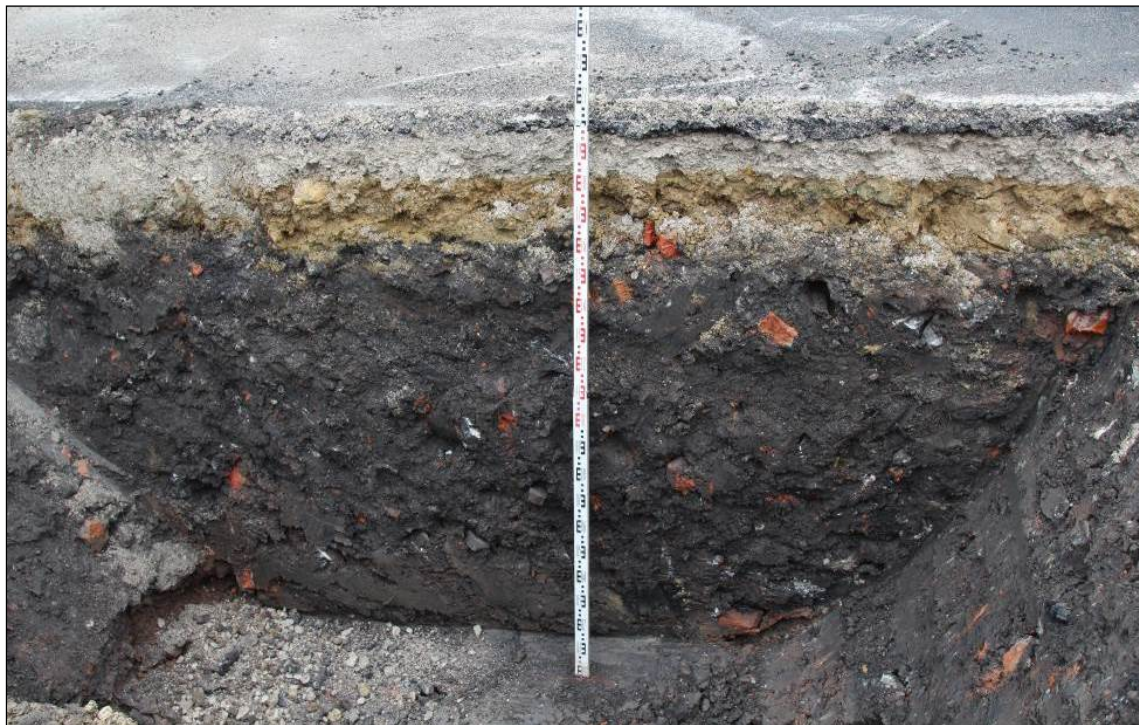
**Fig. 6:** *The south-western end of Trench 1, showing the depth of the concrete floor*

Up to 11m from the western end of the trench was a concrete floor at a depth of 2.60m (**figs. 6 & 7**), the depth of which meant only machine excavation could take place. The instability of the trench sides, which were prone to collapse, meant the south-western end of the trench had to be backfilled immediately after recording. At 11m from the south-western end was a hand-made red brick wall (**fig. 8**), two courses wide at a depth of 1.05m (surviving height) below the modern surface, which crossed the trench diagonally, aligned roughly north/south. The component bricks measured 0.23x0.11x0.07m and were bonded with hard black mortar indicative of a late nineteenth-century construction date. Directly east of this wall was another concrete floor surface, also 1.05m below the modern tarmac surface (**fig. 8**). As before, the instability of the trench sides made further recording impossible. The material on top of the concrete floor consisted of 0.08m of modern tarmac, 0.15m of grey limestone mot, the yellow mot was absent and the remaining material was crushed red sandstone.

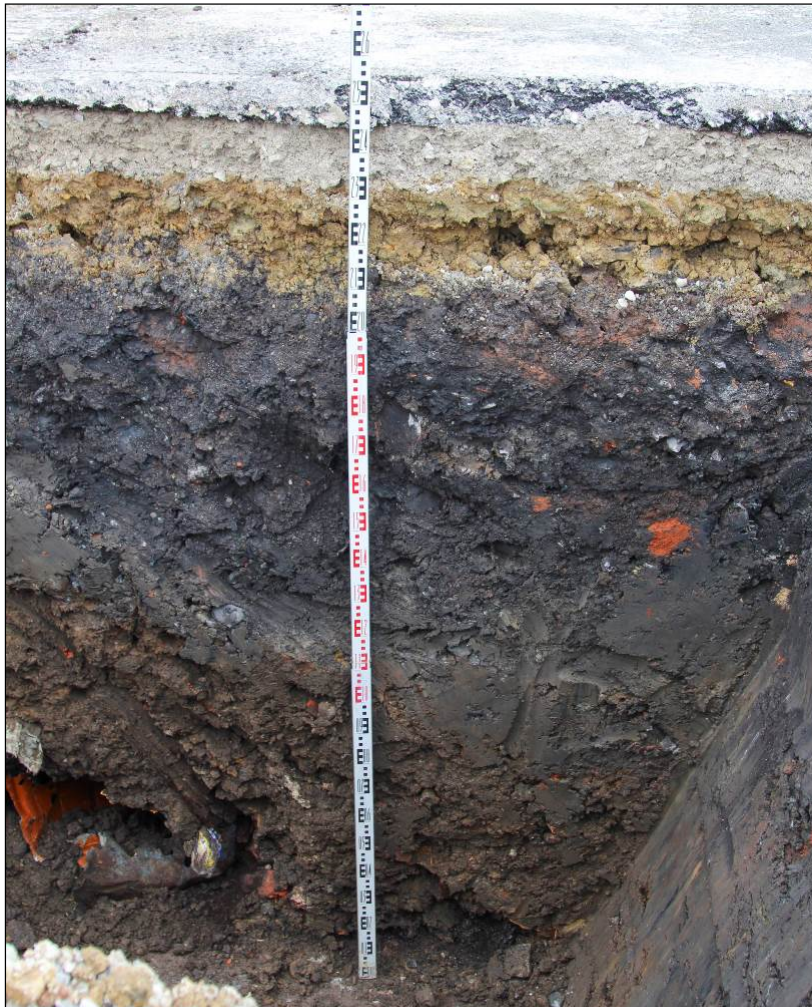
**Fig. 9:** The depth of the concrete floor and stratigraphy at the western end of Trench 2, modern plastic rubbish can be seen in the bottom left corner, looking south

Up to 9.60m from the western end of the trench was a concrete floor at a depth of 2.60m (**fig. 9**), the depth of which meant only machine excavation could take place. The instability of the trench sides, which were prone to collapse, meant the south-western end of the trench had to be backfilled immediately after recording. At 9.60m from the western end was a hand-made red brick wall, approximately 0.45m wide at a depth of 1.09m (surviving height) below the modern surface and aligned roughly north-west/south-east across the trench. The wall was bonded with hard black mortar and the bricks measured 0.23x0.11x0.07m, dating the wall to the late nineteenth century. Directly east of this wall was another concrete floor, also 1.09m below the modern ground surface (**fig. 10**). As before, the instability of the trench sides made further recording impossible. The material on top of the upper concrete floor consisted of 0.08m of modern tarmac, 0.10m of grey limestone mot, and 0.91m of crushed red sandstone containing brick fragments.

The remains found in Trench 2, when overlaid on to the 1922 map, suggest the wall found separated a large building fronting Greengate and the large building amalgamating the area of earlier buildings, with the concrete floor possibly representing an internal floor of the latter (**fig. 39 & 40**). Trench 3 appeared to be contained within the building fronting Greengate, containing only a concrete floor at what was probably cellar level, as seen in Trenches one and two.

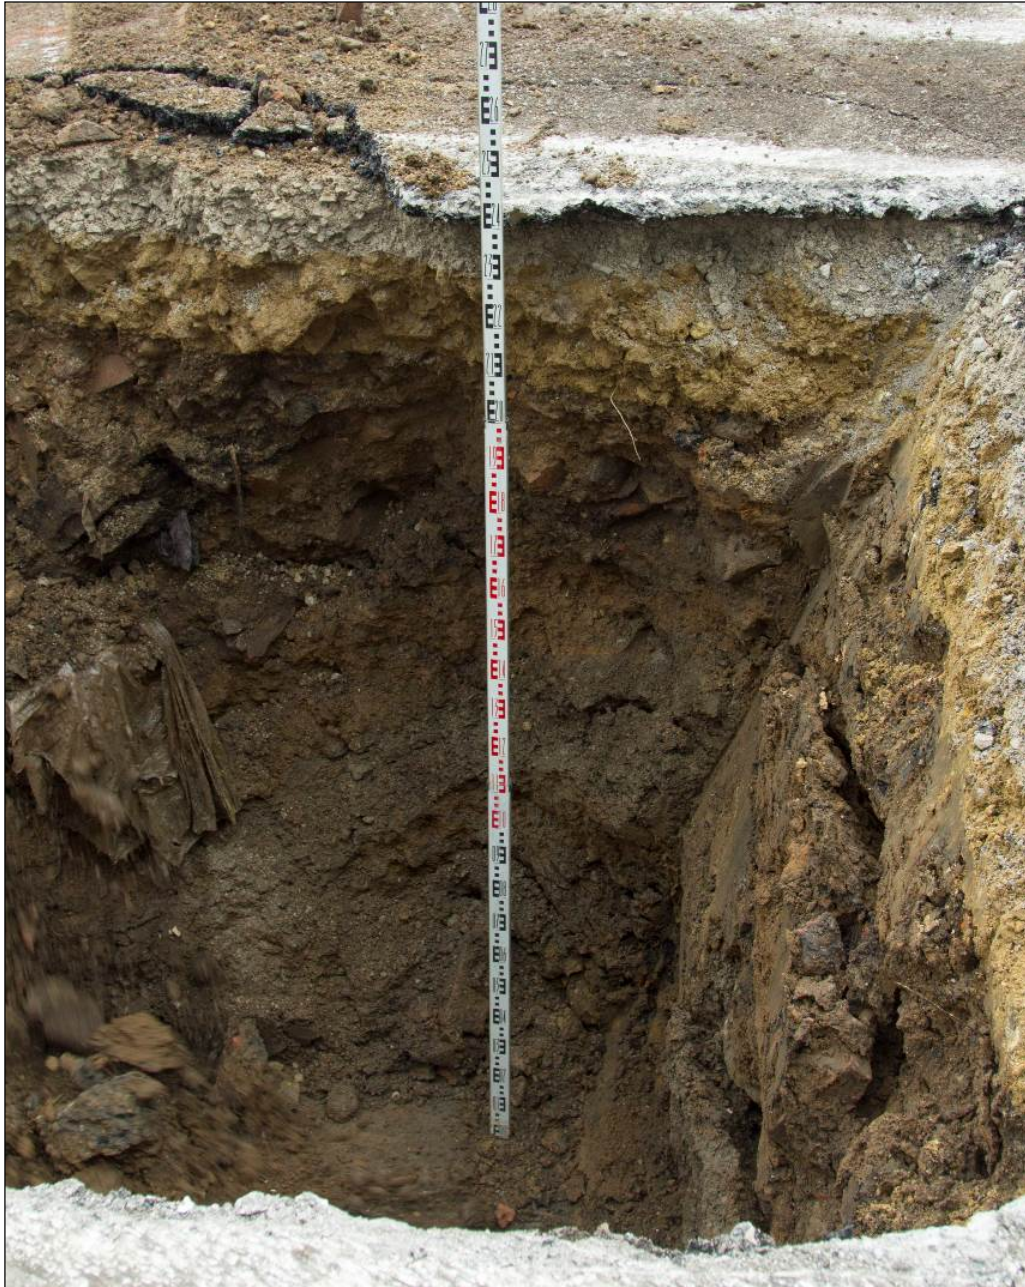
*Fig. 11: The north-western end of Trench 3 showing the depth of the concrete floor and the stratigraphy, looking east*

At the south-eastern end of the trench, the ground was made up of a modern tarmac surface 0.08m deep, 0.10m of light grey limestone mot, 0.20m of yellow mot and 1.98m of demolition material consisting of mid brown silty sand containing ashy patches, black cinder, infrequent fragments of broken red brick, fragments of stone and modern plastic rubbish (**fig. 11**).

As with trenches one and two, the material in the trench sides was very unstable, which meant this end of the trench had to be backfilled immediately. Due to the close proximity of the north-western end of the trench to trench two, it was decided not to excavate the remainder of the trench, based on evidence from historic maps (and health and safety issues), which suggested the rubber works had removed all traces of the earlier housing and shops. What was presumed to be the same concrete floor as found in trench two was located at a depth of 2.40m from the modern surface.

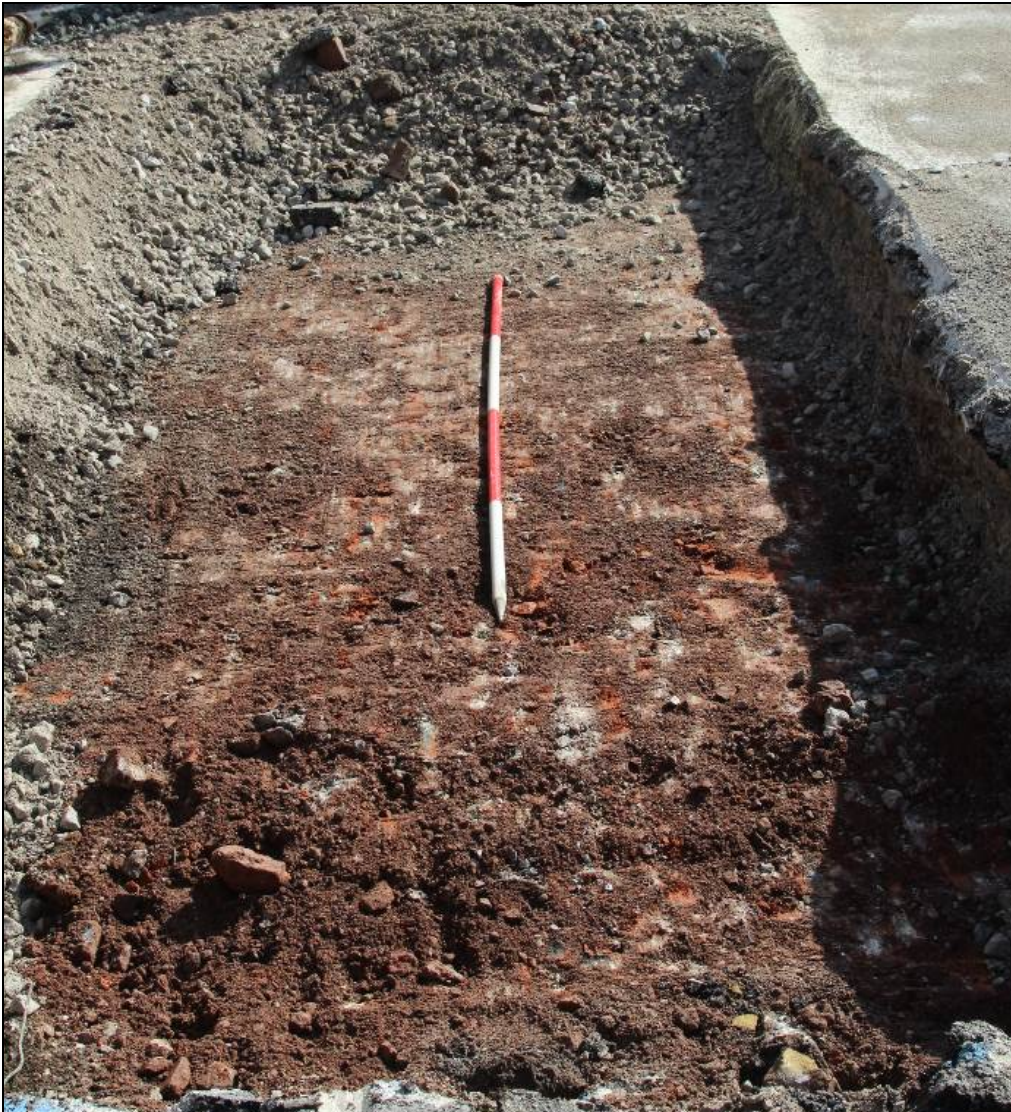
**Fig. 12:** The crushed and compacted red sandstone and brick during excavation, looking east

At the western end of the trench, the ground was made up of a modern tarmac surface 0.11m deep, 0.29m of light grey limestone mot, and 0.58m of crushed red sandstone containing broken red brick and small sub-angular white stones. At 0.90m from the modern surface was what appeared to be a hard, compact, concrete floor 0.20-0.40m thick, made up of a similar material to the fill above it (**fig. 12**).

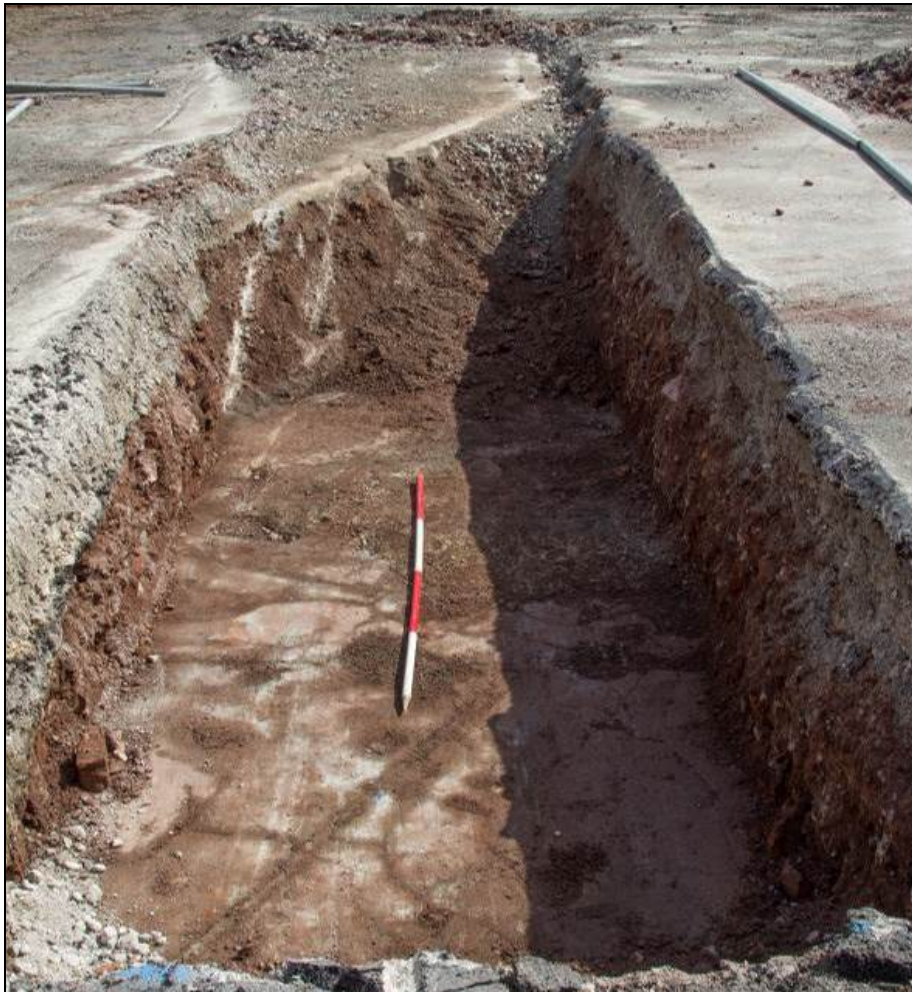
**Fig. 13:** The concrete surface below the crushed red sandstone and brick, looking east. The concrete ring beam can be seen at the top of the photo.

At 5m from the western end of the trench the stratigraphy included 0.11m of modern tarmac, 0.29m of mot, 0.70m of crushed red sandstone and broken brick with the compact surface at 1.10m from the modern surface. Here, a sondage (**fig. 14**) was dug through the compact surface to a depth of 2m, revealing natural yellow sand and river pebbles. At this point, a modern concrete ring beam crossed the trench at 5m from the western end along the northern trench edge, running diagonally, crossing the southern trench edge between 9 and 10m, measuring 5.10m in length and 0.14m thick at a depth of 0.12m from the modern surface (**fig. 15**). There remained a possibility that modern gas and electricity services could have been present along the eastern side of the beam and so a decision was made in respect of Health and Safety, not to try to remove this beam, which was at least 1m deep. To the east of the concrete beam, modern light grey concrete covered the remaining 10m of the eastern end of the trench (**fig. 16**). An attempt was made to break through the concrete with a breaker, but concerns were raised about disturbing any live services that may lie below the surface. Other than the possible concrete surface, no other remains of the hat manufactory were found.

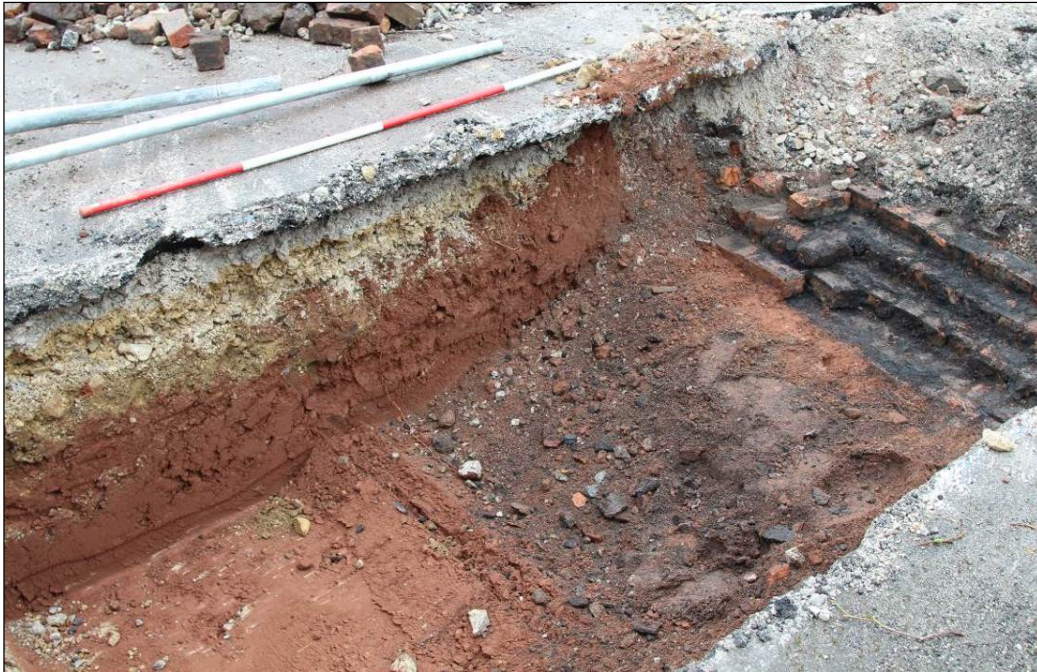
*Fig. 17: The stratigraphy and hand-made brick wall, looking north*

At the north-eastern end of the trench, the ground was made up of a modern tarmac surface 0.10m deep, 0.20m of light grey limestone mot, and 0.20m of yellow mot. Below this was a deep levelling layer of red sand, which continued to a depth of 2.40m from the modern surface, at the bottom of which, was a shallow, mid-grey, ashy deposit covering a red brick floor surface (**fig. 19**). The instability and depth of the loose red sand made any further excavation unsafe. At the south-western end of the trench was a hand-made brick wall aligned north-west/south-east crossing the entire trench, which appeared to be at least four-brick courses wide (**fig. 17**) and continued to the depth of the brick floor (**fig. 18**). The bricks measured 0.23x0.11x0.07m, and were bonded with hard black mortar, however, some of the bricks at the south-eastern end appeared to be of a later date, confirming the various changes made to the building over a period of almost 100 years.

In trench 5, it was possible to identify the remains of a wall as belonging to the southern wall of this early industrial building. It appeared that the original hand-made brick wall survived with later modifications using mould-made bricks. A brick floor found on the north-eastern side of the wall confirmed that this was likely to represent an interior floor, which may have been at cellar level as suggested by an early twentieth-century Goad Insurance map, which denotes a basement.

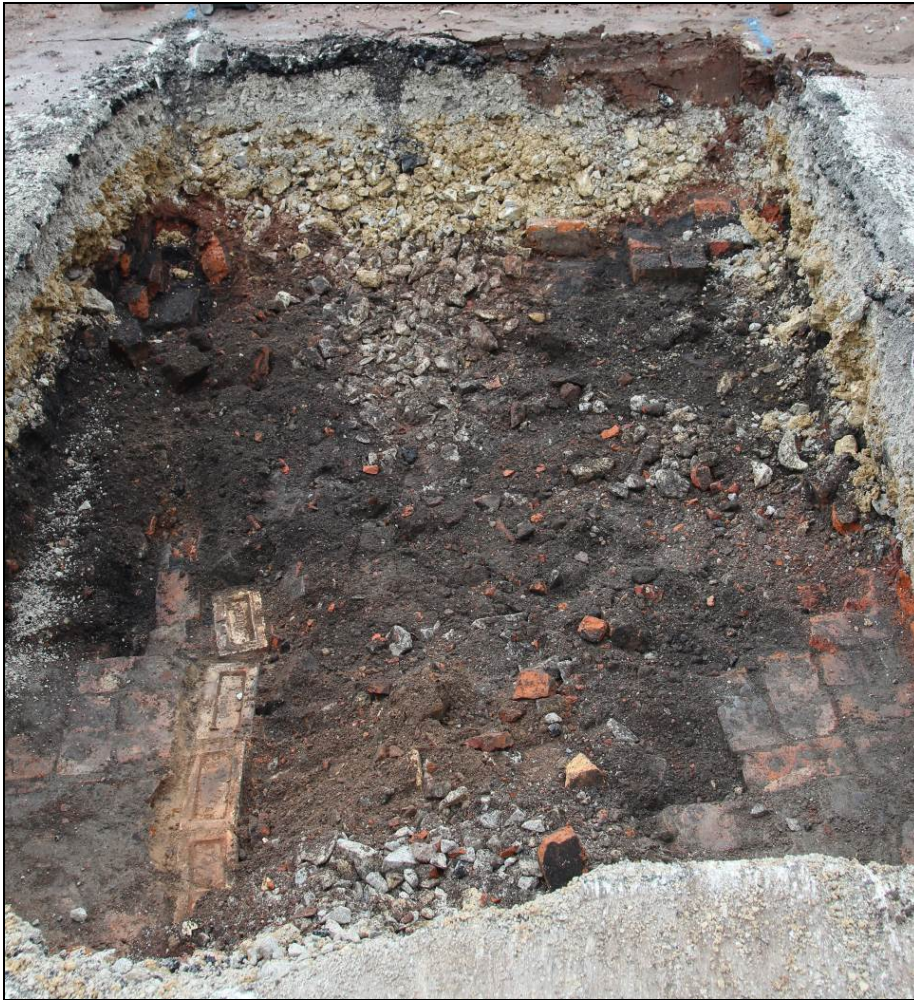
**Fig. 20:** Trench 6 after removal of the modern deposits showing two walls flanking the sides of the trench. The frogged bricks can be seen in the bottom left corner, looking north-east.

The modern upper layers consisted of 0.12m of tarmac, 0.16m of light grey limestone mot, 0.20m of yellow mot and 0.17m of black cinder, below which were found, two walls running parallel to each other. Both walls were at least four-brick courses wide (excavated), and were constructed from hand-made bricks (measuring 0.23x0.11x0.07m) with later glazed and frogged bricks (measuring 0.22x0.115x0.08m) added (**fig. 20-21**). Further machine excavation revealed that both walls continued down to a considerable depth with a narrow gap in between them. A small bucket on the machine was used to try to excavate between them, which was successful to a depth of around 1m, after which, the walls were collapsing, meaning it was not possible to reach the bottom without causing substantial damage to the earliest surviving archaeology on the site. Historic maps suggests there was likely to be another brick floor (or other type) at a similar depth to that found in Trench 5. A structure revealed between the walls at the north-east limit of excavation (**fig. 22**) is likely to represent the remains of a flue associated with the hat manufactory.

There is no suggestion on maps up to 1933 for the function of the two parallel walls found in Trench 6. However, the narrow gap between them and the blackened appearance of the two elevations facing each other suggest this was a flue, along with the close proximity to a chimney marked on the OS 1:500 map of 1891. The presence of frogged and stamped refractory bricks may indicate a re-lining of the flue at a later date (**figs 20-23 & 33-35**).

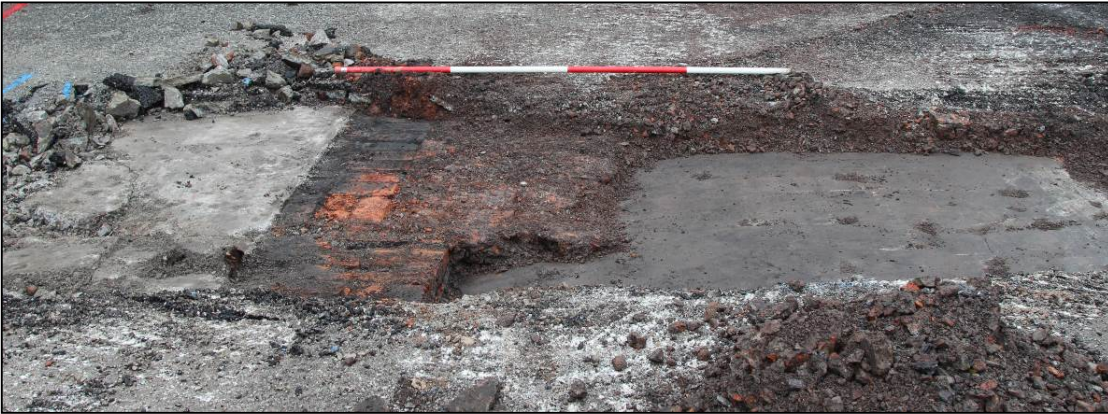
**Fig. 24:** The upper concrete surface can be seen on the left of the photo and the lower surface to the right, looking south-west

The upper surface consisted only of 0.08m of modern concrete forming the former car park surface. Below this at the south-eastern end of the trench was a concrete surface with a hand-made brick wall directly adjacent to it followed by another concrete surface approximately 0.15-0.20m lower than the first one. On top of the lower concrete was a layer of compact crushed red brick as seen in trench 4 (**fig. 24**). All these features were removed to access any archaeology below, which revealed that the brick wall continued to a depth of approximately 0.70m from the modern surface (**fig. 25**), sitting on natural sand, the upper layer of concrete was approximately 0.18m thick and the lower concrete appeared as only a thin lens on top of a slightly thicker layer of crushed sandstone. The lower layer of concrete appeared only on the north-western side of the wall. Natural sand was reached at a depth of approximately 0.85m.

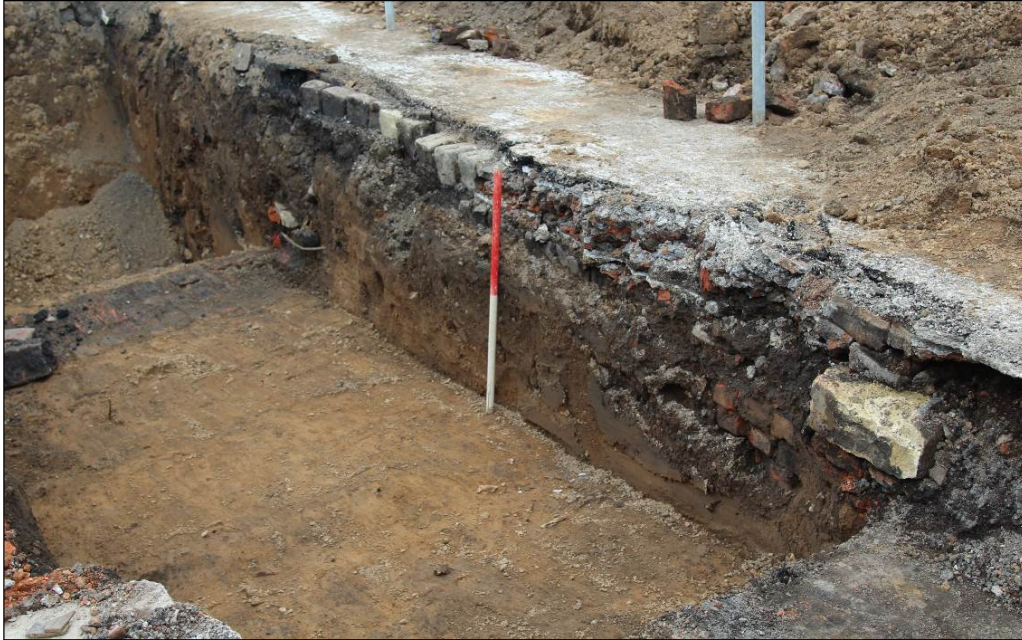
**Fig. 26:** *The mid-section of the trench, south-west-facing section, with natural sand at the base of the ranging pole, possible remnants of medieval plough soil, looking north*

The mid-section of the trench consisted of a thin lens of modern black tarmac (car park surface) below this, a thin lens of light grey concrete with a thicker layer below of the same crushed brick/red sandstone as seen at the south-eastern end of the trench mostly of natural sand with a very slight chance of medieval plough soil at the top (**fig. 26**). Further north-west at a depth of approximately 0.60m was a brick constructed flue with stone capping, likely to have been associated with the chimney marked on the 1891 Ordnance Survey map (**fig. 27**).

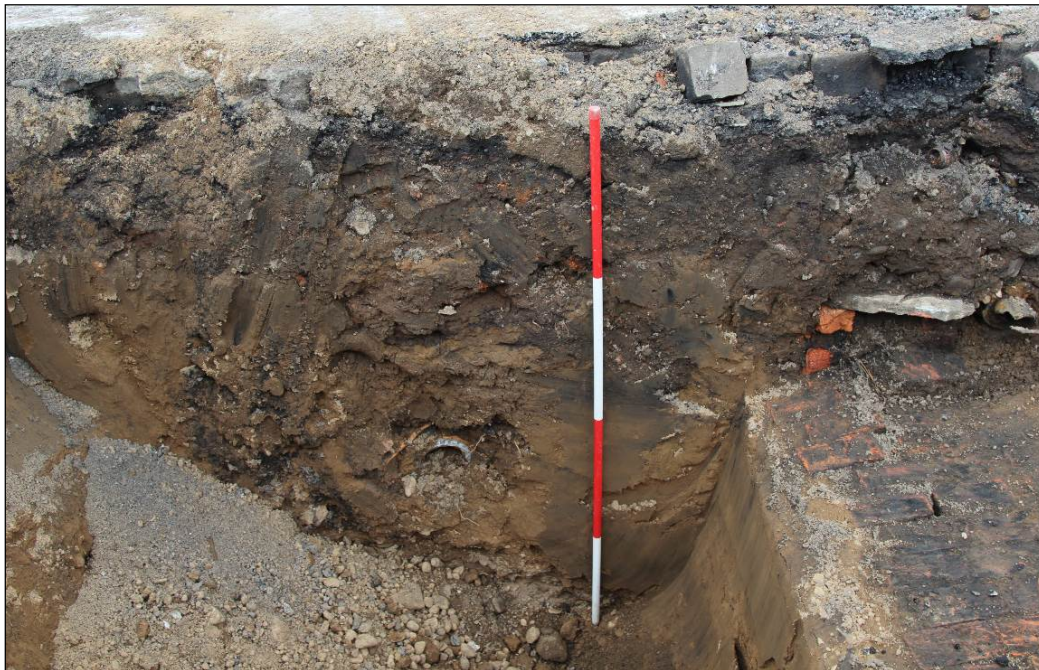
**Fig. 27:** *The drain cut into natural sand at the north-western end of the trench. On the right of the photo is the base of a possible brick-built flue with stone capping, looking north-east*

At the north-western end of the trench another drain was found cut into and backfilled with natural sand. This appeared to have been installed before the laying of the cobbled surface and was probably associated with one of the extensions to building 7 (**fig. 39**).

The brick wall found in Trench 7 could possibly represent the outer wall of an earlier phase of the building. It does not appear to be in the location of the final position of the outer wall of the building according to the 1922 map, but could represent an internal wall with concrete floors either side marking two floor surfaces of separate rooms as suggested by the 1908 map. Two possible cobbled floor surfaces seen in the south-east-facing section could represent the final two phases of the extension of the building (**fig. 24**). Another possible flue was found crossing the trench, appearing as a linear brick feature, which appeared to have been stone capped (see **fig. 27**), roughly aligned with the chimney referred to early. It remains possible that both this flue and the one found in Trench 6 could have fed into the same chimney.

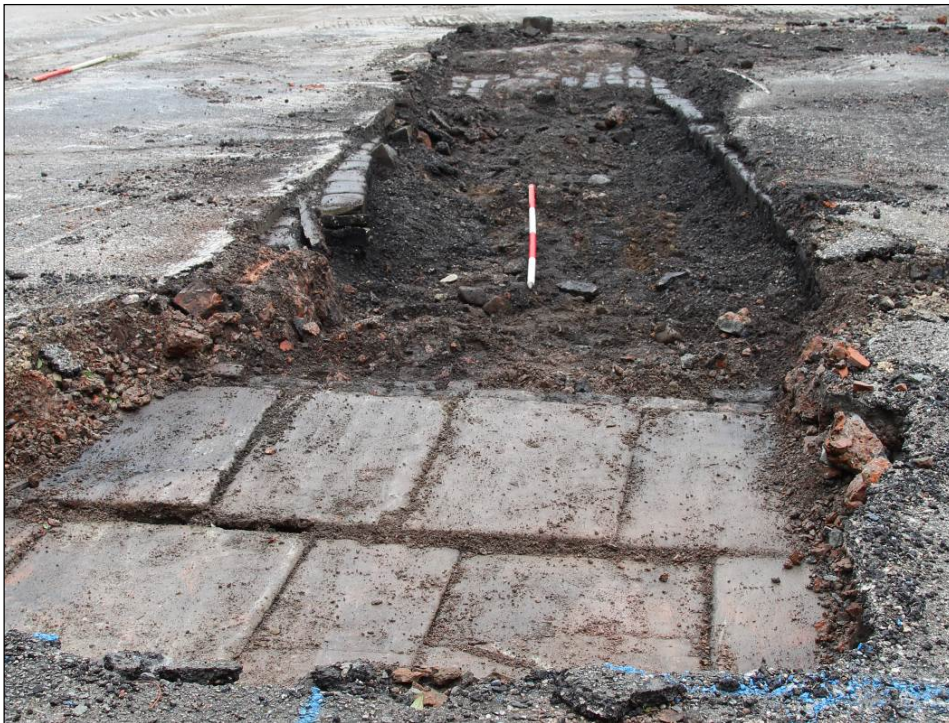
**Fig. 28:** *The stone-flagged floor and remains of the cobbled surface prior to removal, looking north-west*

At the far north-western end of the trench was the remains of a toilet, which appeared to have been within a brick structure. A protruding pipe to the left suggests there had been another toilet cubicle next to it (**fig. 31**). Natural sand was reached at a depth of 1.40m from the modern surface.

Within Trench 8, the remains of a stone-flagged floor, cobbled surface and twentieth-century toilets suggests only the later remains of the rubber works survived. However, **fig. 32** shows a hand-made brick wall, which, as with Trench 7 could have survived from an earlier phase of building seven. Historic maps show that over time the rubber works enveloped most of the site leaving only a small open area (where the toilet was found - **fig. 31**), and covered alleyways/entrances to the interior courtyard, likely to be marked by the cobbled surfaces. As with Trench 7, the stone-flagged floor at the southern end of the trench (**fig. 28**) is likely to have formed an interior floor. Cobbles at the northern end are likely to have formed the courtyard surface.

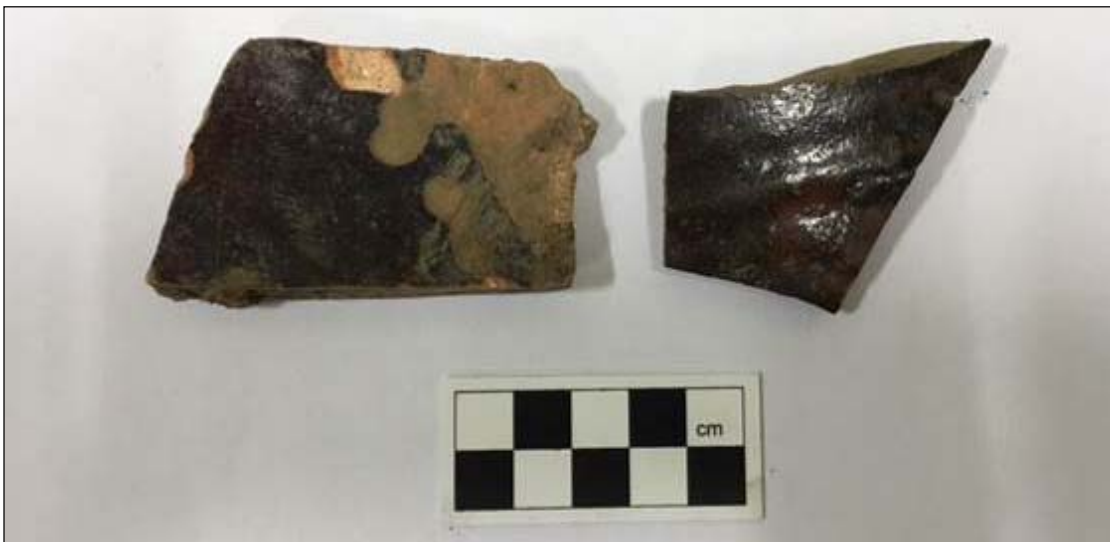
**Fig. 36:** Two sherds of pottery found in Trench 7. Left; nineteenth to twentieth-century iron glaze, right; possible seventeenth-century stoneware.

Only two pieces of pottery were recovered from Trench 7. The sherd of nineteenth-century iron glazed stoneware (on the left **fig. 36**), which dates to c 1820-50, was found in the fill of the brick-built flue. The sherd on the right could possibly date to the late seventeenth to early eighteenth-century, which was found in the only area of the site that had remained undeveloped, *ie* the courtyard, from a mid-brown deposit just above natural sand, which could be the only surviving area of medieval plough soil (**fig. 26**). This sherd was identified by Finds Archaeologist Kirsty Whittall as a regional variant of Midland Purple courseware with an iron-based glaze and possible slip decoration, which is the precursor to the sherd of iron-glazed stoneware found in the flue.
