Site Location: The study area lies between Store Street and Millbank Street in the

Project: Store Street, Ancoats, Manchester

Internal Ref: SA/2017/29

Document Type: Evaluation Report

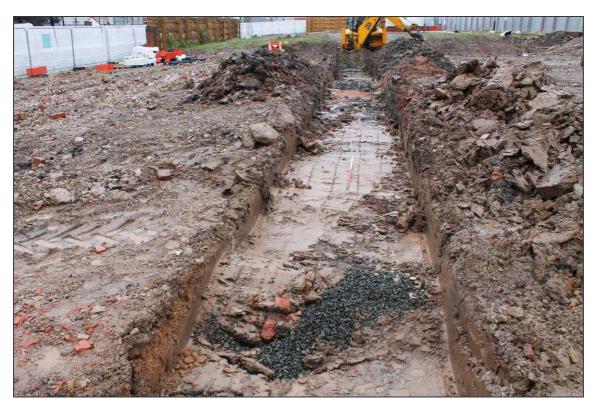
Plate 2: General shot of Trench 1, looking north-east, showing drainage and service disturbance

Natural light brown boulder clay 08 was observed at depths ranging from 0.1m in, at the south-western end of the trench, to 0.78m, at the centre of the trench. Cut into the clay across the south-western half of the trench were two linear drainage features (03 and 04). These were aligned broadly east-north-east/west-south-west and lay parallel to each other, set 1.6m apart, and were between 0.37m and 0.42m wide. Both features were filled with mixed clay and ash, which contained fragments of modern brick. Drainage feature 03 was cut by a later service trench (02), which was 0.3m wide, ran east/west and was filled with grey stone chippings. Drain 04 was cut by an east/west-aligned plastic pipe (05), which was 0.08m in diameter (Plate 2).

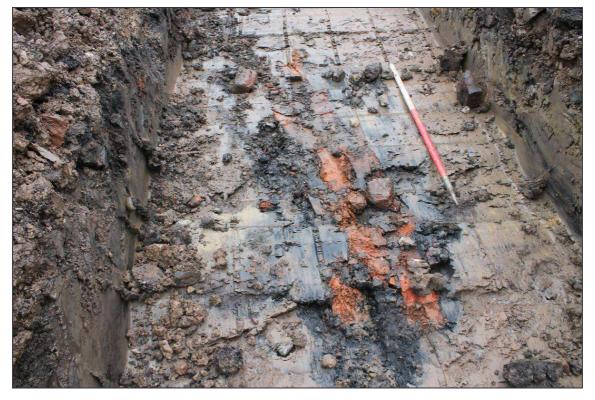
Plate 3: Truncated brick feature 07, looking north-east

Situated to the north-east of the area of modern disturbance was a single short section of a wall (07), composed of machine-made bricks of 20^{th} -century date. The wall was aligned north-east/south-west, was two stretcher courses wide, and survived to a length of 1.73m. It was cut into natural clay 08, and appeared to have been truncated at both ends (Plate 3).

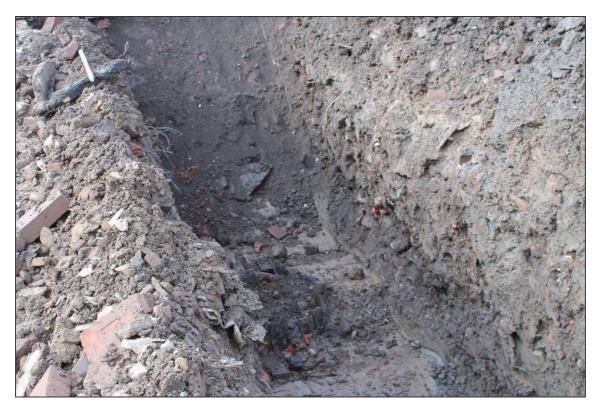
Plate 4: General shot of south-west end of Trench 2 showing depth of infill above natural clay, looking south-west

Natural boulder clay 08 was revealed along the entire length of the trench. At the northeast end this was at 1.6m below the current ground level. At 13.5m from the northeast end of the trench, the natural clay sloped downwards to a depth of 1.8m, appearing to have been reduced by c 0.2m. This reduction in ground level coincided with a yard area marked on the modern mapping at the rear (south-west) of the former Ash of Ancoats building. The clay continued to slope downwards to the south-west and at the southwest end of the trench was at 1.9m below ground level (Plate 4).

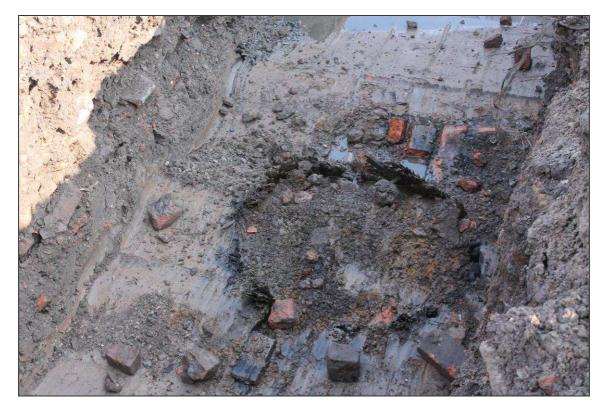
Plate 5: Circular feature 11 and associated truncated brick surface 12, looking north-east

Cut into the natural clay at 6.3m from the south-west end of the trench was a 0.9m diameter circular feature 11 (Plate 5). This was lined with wood and contained a mixed clay and cinder fill with brick fragments, stone, wood and modern glass. At the north-eastern side of this were the heavily disturbed remains of what may possibly have been a brick surface (12), although this was too damaged to ascertain with confidence where it was an *in-situ* feature. The fragmentary nature of the structure meant that it was not possible to determine whether the bricks were hand or machine-made and what, if any, mortar had been used to bond them. No other structural elements associated with feature 11 were identified.

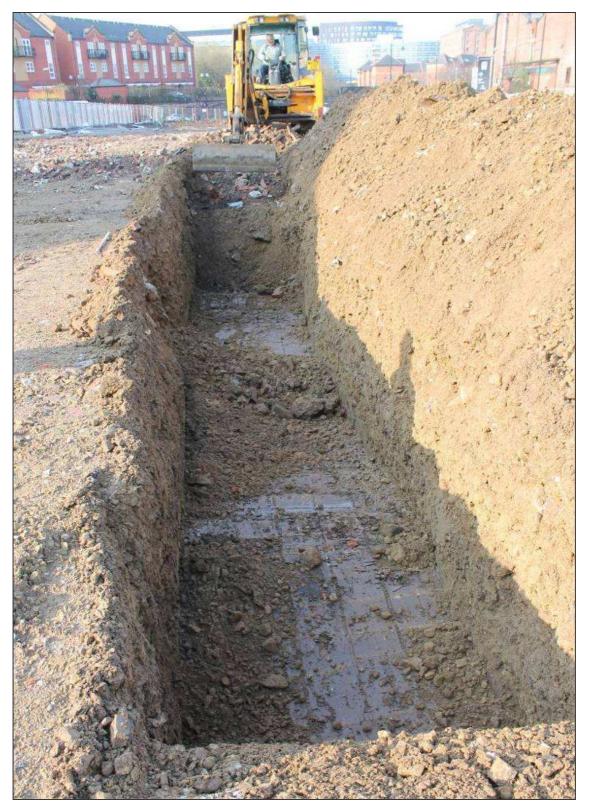
Plate 6: Depth of compacted modern hardcore levelling above natural clay at the north-east end of Trench 2, looking south-west

The south-west 17m of the trench was overlain by a homogenous mixed levelling layer 09 of clay, brick, stone, slate and modern refuse to a depth of between 1.75m and 1.9m. The north-eastern 13m of the trench, coinciding with the reduction of natural clay and the position of the former Ash of Ancoats building, was overlain with yellowish-brown hardcore (10), which appeared to have been compacted in layers (Plate 6). Both of these levelling layers were very unstable once excavated and continually collapsed.
