## **Archaeological Evaluation**

Worsley New Hall,  
Worsley, Greater  
Manchester.

**Client:** Peel  
Investments (North)  
Ltd.

**Report No:** 30

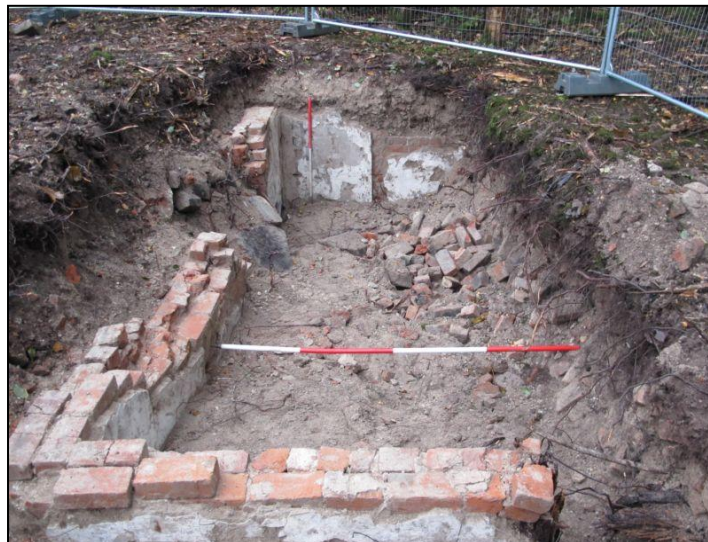
**WNH11 Fig. 19:** Detail of Room 1 in Trench 1 (looking east).

At the north-east end of Trench 1 excavations revealed a partially exposed room (Room 1) composed of three internal handmade brick walls (**007a**) (**007b**) and (**007c**) (**Fig. 19**). Each wall was two bricks wide and bound with a creamy lime mortar. A 30mm thick layer of plaster was found to coat the internal face of each wall. Room 1 measured 4.90 (east-west) x 2.30m (north-south). As the southern wall of Room 1 lay beyond the limits of excavation, the full north-south extent could not be established. The room was excavated to a depth of 1.40m. The full height of its walls could not be established due to risk of trench baulk collapse. Two possible routes of access were located in Room 1. The first was a 1.10m wide gap (**008**) in the mid section of wall (**007a**) (**Fig. 20**). The second was a 0.5m wide partially exposed wooden framed opening (**009**) at the south end of wall (**007**) (**Fig. 21**).

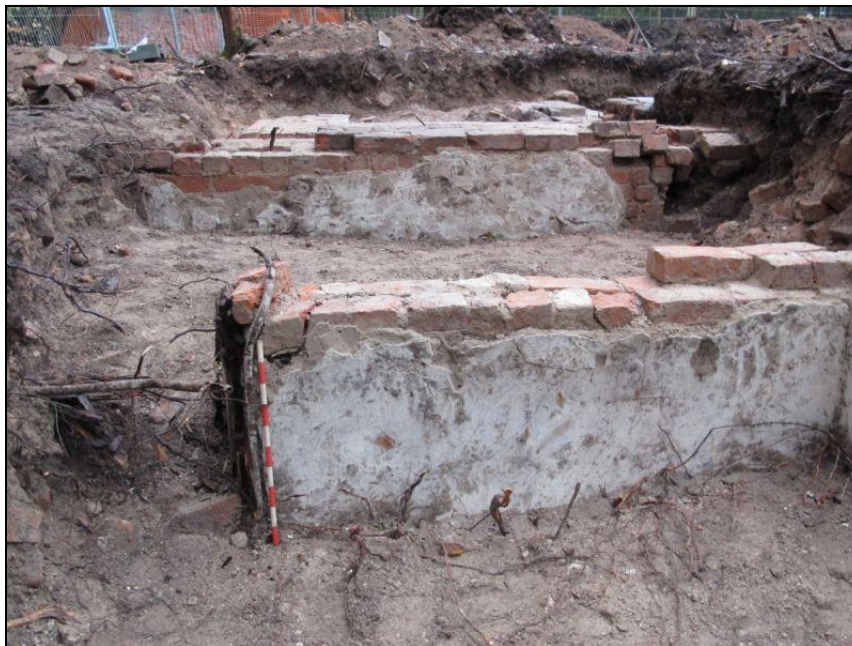
**WNH11 Fig. 21:** Detail of possible doorway with wooden frame linking Room 1 to Room 2. Trench 1 (looking west).

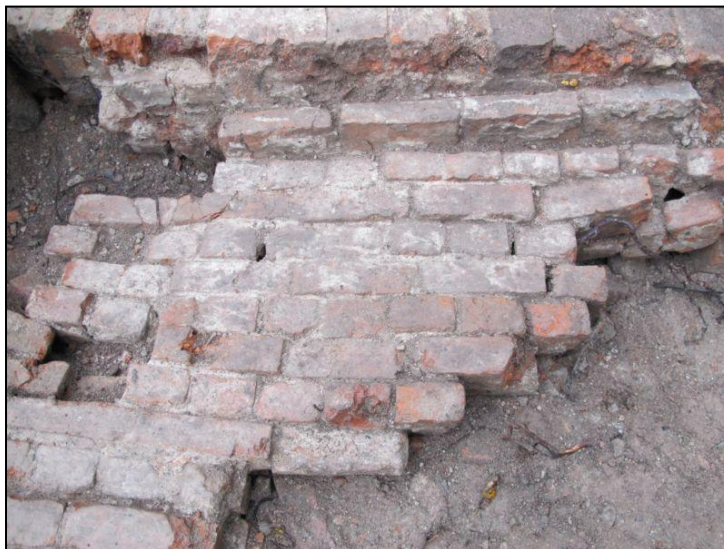
**WNH11 Fig. 25:** Detail of fallen brick wall (005) in Room 3. Trench 1 (looking east)

Within Room 3 a 1.60 x 1.40m section of a fallen handmade brick wall **(005)** was exposed lying upon brick rubble layer **(029)**. **(005)** had 16 courses intact, laid in English cross bond and bound with a creamy soft lime mortar. The average size of each brick was 0.23 x 0.10 x 0.07m. The wall was found to be two bricks wide (0.20m) and therefore an internal wall. Broken brick along the top course of wall **(006)** suggests that wall **(005)** was originally part of this structure (**Fig. 25**).

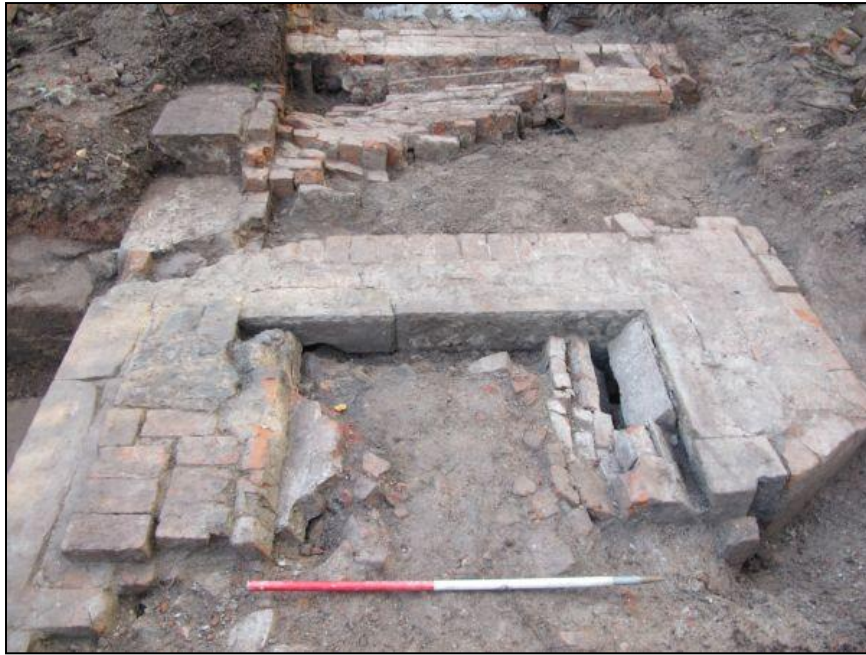
**WNH11 Fig. 26:** Detail shot of Room 4 with remains of barrel vaulted ceiling (004) in Trench1 (looking east).

The remains of the barrel vaulted roof (**004**) overlying Room 4 are evidence that excavations had revealed the top of a basement level room. Rooms 1, 2 and 3 had survived to a similar level and can be therefore also seen as basement level structures. A likely theory is that all rooms were cellars lying below the ground floor. Evidence for ground floor structures can be seen in collapsed wall (**005**). This partition wall was originally founded upon wall (**006**), standing above basement level. All walls exposed in Trench 1 appear to be contemporary. Brick size and mortar type are consistent across the area.

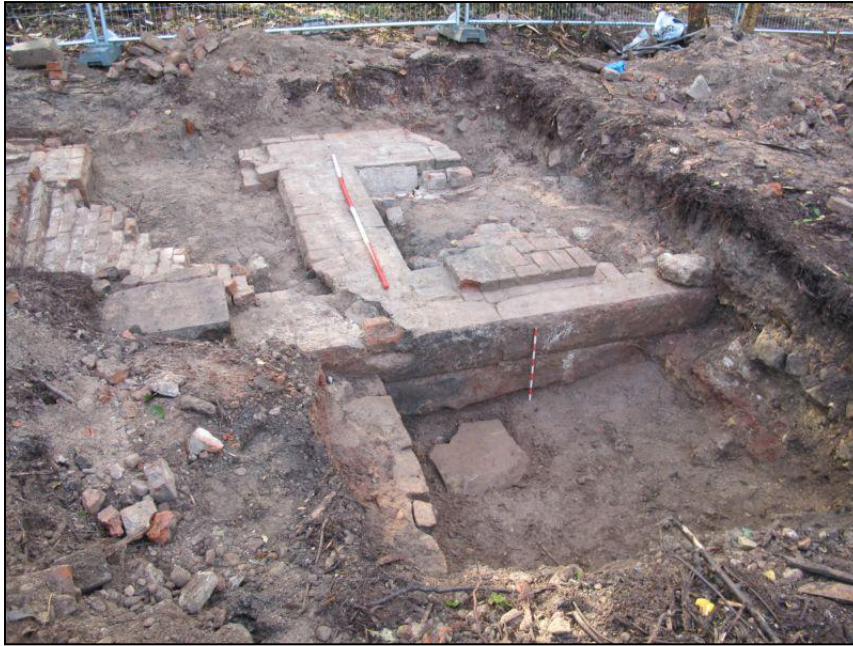
**WNH11 Fig. 28:** General shot of the west end of Trench 1 showing stones walls (001) and (002) (looking south).

Sandstone walls (**001**) and (**002**) are likely to be the external base walls acting as foundation plinths to walls of brick. The rusticated east face of (**001**) and the north face of (**002**) prove that the two walls make up an external southeast facing corner. The presence of stone capped drain (**011a**) in this corner further supports the external nature of these walls. This frontage can be matched to a northeast section of the hall depicted in a ground floor plan c1840 (**Fig. 10**).

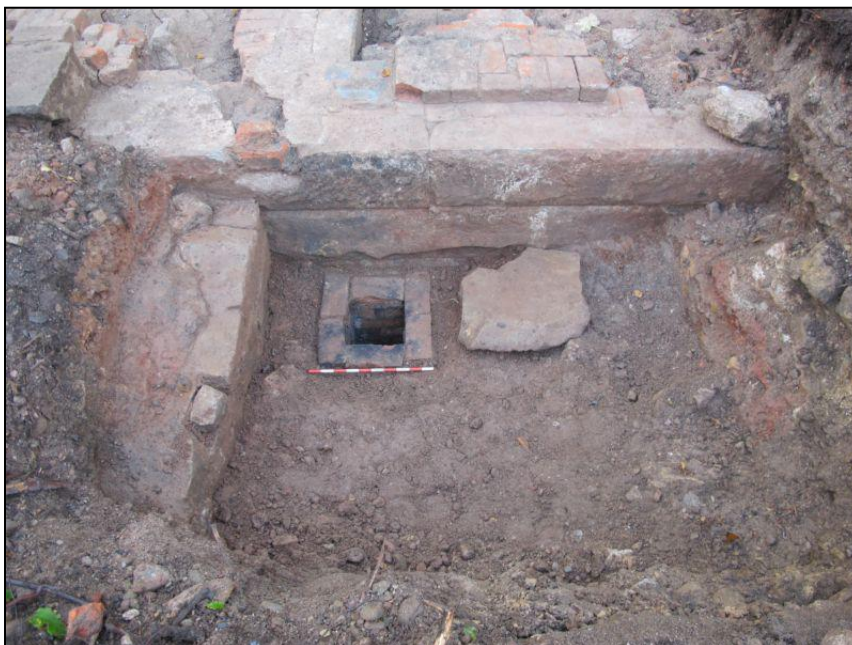
**WNH11 Fig. 29:** Shot of brick-lined drain (011b) with stone capping (011a), Trench 1 (looking south).

Excavations to the north of sandstone wall **(002)** revealed a stone capped brick lined drain **(011b)** located at a depth of 0.67m below the top of **(002)** (**Fig. 29**). The stone capping **(011a)** consisted of a 0.48 x 0.50m block of roughly cut sandstone. The drain itself measured 0.46 x 0.46m and was excavated to an arbitrary depth of 0.30m. The feature was found to be cut into a dark grey clayey sand deposit which was present to the north and west of wall **(001)** and **(002)**. A 0.15m wide cut **(034)** in the top of wall **(002)** was found to lead directly to **(011b)**. It is very likely that this was a cut of a drain pipe or 'run-off' that drained water from Room 3 into the drain below.

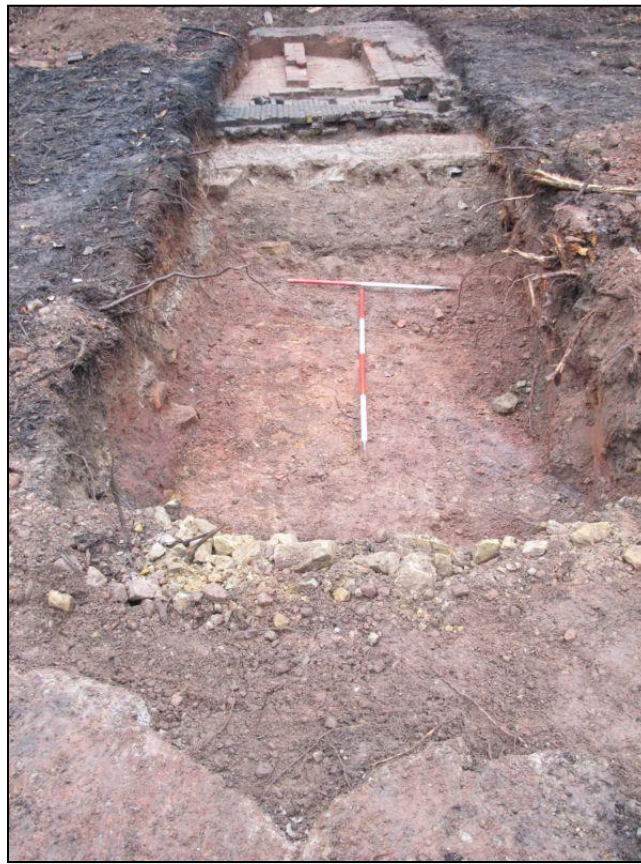
**WNH11 Fig. 30 :** General shot of Trench 2 after excavation (looking south).

The trench was excavated to a maximum depth of 2.60m. At a depth of 0.90m excavations exposed a pinkish red compacted sandy gravel containing poorly sorted sandstone fragments (**024**). It is likely that this was the natural geology and therefore the earliest deposit found across the site. Overlying (**024**) and extending across the northern portion of Trench 2 was a 0.30m thick deposit of reddish brown sand and gravel (**023**). (**023**) contained angular stones measuring <0.10m in diameter and occasional brick fragments. Overlying (**023**) and extending across the whole trench was a thick layer of brick demolition rubble (**029**). (**029**) reached a maximum depth of 2.60m and overlay most archaeological features in Trench 2. The topsoil was identified as a 0.30m thick carpet of roots and leaf mulch (**028**) (**Fig. 30**)

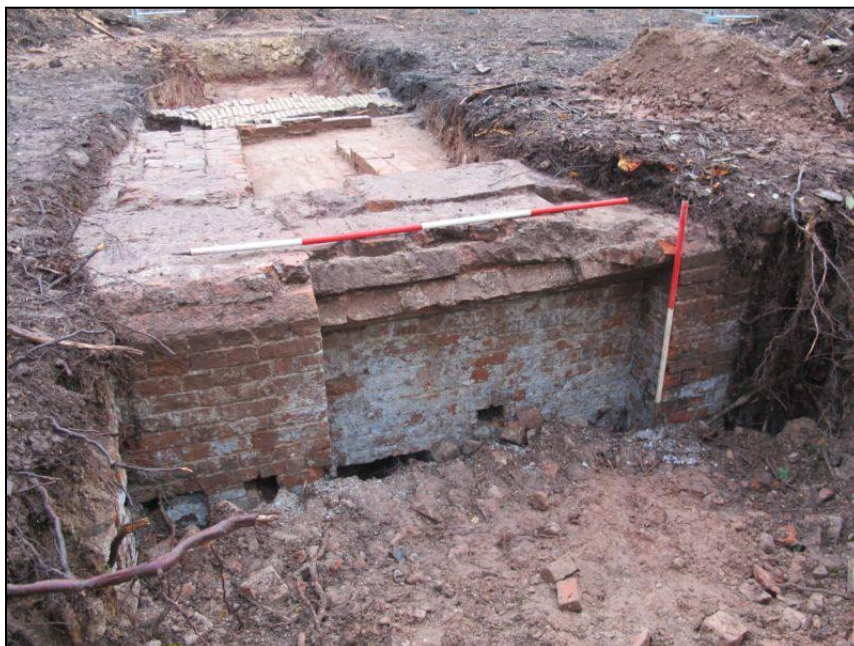
**WNH11 Fig. 31:** General shot of the southern end of Trench 2, showing wall (012) after Room 7 was in filled due to health and safety concerns (looking north-east).

Excavations at the southern end of Trench 2 revealed a 0.5m wide east-west aligned handmade brick wall (**012**) (**Figs. 31 & 32**). The full length of the wall could not be established as it extended into the eastern and western trench baulks. (**012**) had survived to a full height of 2.70m, made up of 26 brick courses displaying irregular brick bonding. The bricks were set with a soft cream lime mortar. The south face of (**012**) was found to be inset by 0.15m, creating a 1.2m wide niche. The north side of (**012**) appeared to be bonded to a 0.54m wide brick wall (**049**) (**Fig. 33**) with heavily applied mortar covering its top course. (**049**) had survived to be three courses high and span the width of the trench. Abutting the south face of (**012**) were two north-south aligned handmade brick walls (**013**) and (**014**). (**013**) measured 1.50m in length and had survived to be 16 courses high. (**014**) was of similar length and height. Both walls were laid in English garden wall bond. The three walls together created a three sided room (Room 7) measuring 3.16 meters wide. A course of broken bricks set an angle along the top two courses of wall (**012**) suggest that a barrel vaulted ceiling originally span from north to south across the top of Room 7. Room 7 was partially bound from the south by a 0.40m long wall extending from (**013**). At 0.40m (**050**) terminated and appeared to head south into the trench baulk. It was presumed that a mirror image existed on the western side of the room. Unfortunately the structural remains in this area had not survived to prove this notion. Machine excavation within Room 7 revealed a fully intact brick lined floor (**027**) (**Fig. 32**) at a depth of 2.70m from ground level. Due to health and safety concerns (**027**) could not be fully excavated and was infilled after photographs had been taken.

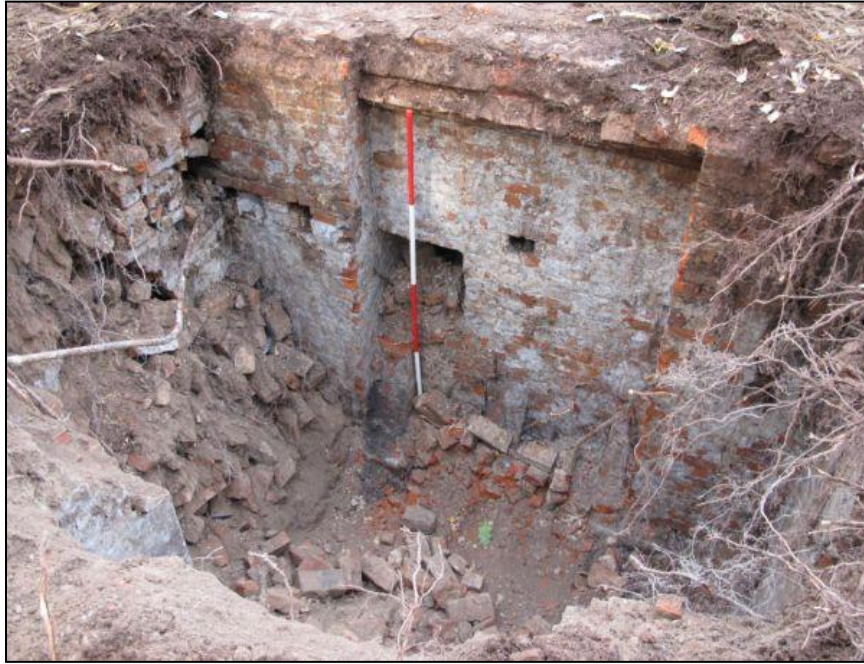
**WNH11 Fig. 32:** Detail shot of wall (012) and brick lined floor after Room 7 was machine excavated. Trench 2 (looking north- west).

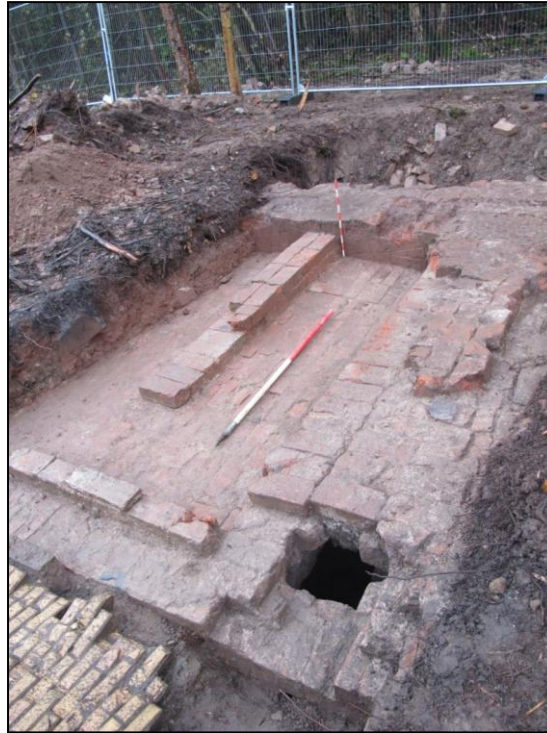
**WNH11 Fig. 34:** General shot of barrel vaulted roof (015), walls (018), and (019) and possibly later walls (016) and (017). Trench 2 (looking south-east).

Bonded to the top of ceiling **(015)** were the foundation courses of two north/south aligned brick walls, **(017)** and **(018)** (**Fig. 34**). Wall **(017)** was located along the east face of stone wall **(018)**. The terminal ends of **(017)** abutted the south face of **(049)** and the north face of **(019)**. **(017)** measured 2.5 x 0.46m and had survived to a height of three brick courses. 0.90m east of **(017)** was wall **(016)** measuring 2.30 x 0.20m and surviving to be two brick courses high. The bricks appeared to be very uniform and possibly machine made, an obviously later addition to the local architecture. Like **(017)**, the terminal ends of **(018)** abutting the south face of **(049)** and the east face of **(019)**.

A second enigmatic feature was wall (**016**), a north-south aligned wall built on top of barrel arch (**015**). The wall appeared to be constructed from machine made bricks and therefore represented a later phase of construction. If the architecture in the trench was related to the hall's north entrance then the placement of the wall in the middle of this feature was unusual. Again an explanation could be found in the use of the hall as a convalescent home. The entrance to the hall may have been partitioned to control in the inflow of pedestrians and patients into and out of the building.

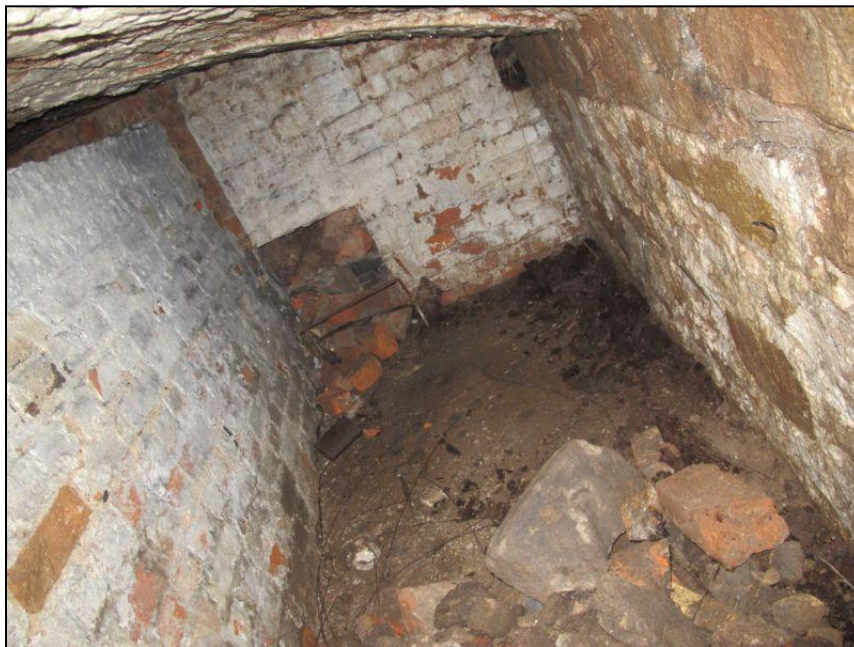
**WNH11 Fig. 35:** Detailed shot inside Room 6. Trench 2 (looking south).

Investigations under the vaulted ceiling revealed a completely enclosed rectangular room (Room 6) measuring 2.80 x 1.25m (**Fig. 35**). The room was bound from the west by stone wall **(018)** and from the south by wall **(012)**. The room was found to be void of brick rubble, with walls surviving to a full height of 16 brick courses. Photography inside Room 6 revealed a lowered partition wall measuring 15 brick courses high separating Room 6 from another unseen room directly to the east (Room 5). Both rooms were bound from the south by wall **(012)** and from the north by an east-west aligned single skin handmade brick wall **(019)**. The barrel vaulted ceiling was also shared by both rooms.

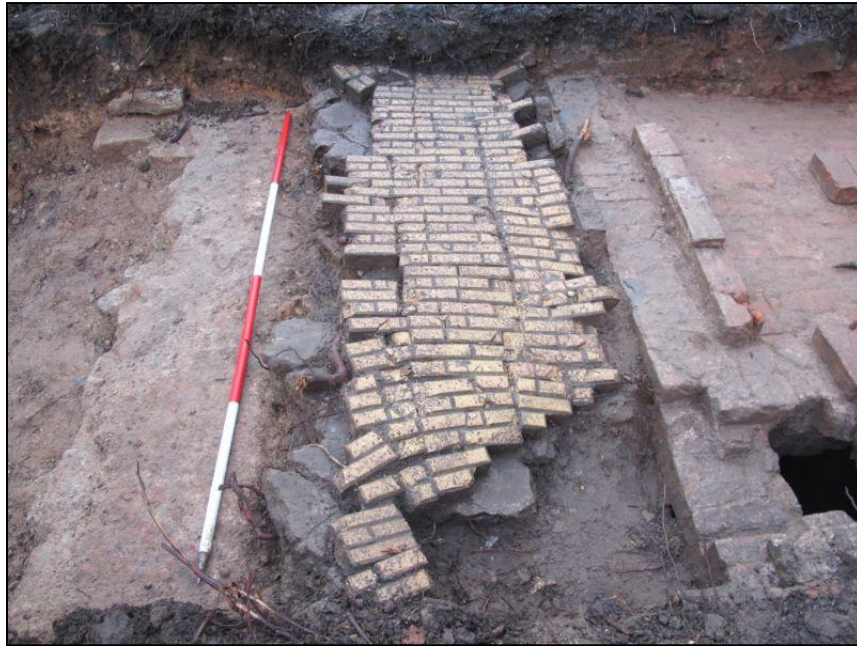
**WNH11 Fig. 36.** Detail shot of refractory brick surface (020) and underlying foundation layers (021) (022) and (023). Trench 2 (looking east).

Abutting the north face of wall **(019)** lay the partial remains of a one course thick brick surface **(020)** measuring 2.30 x 0.80m (**Fig. 36**). The surface was level with the top of vaulted ceiling **(015)** and was constructed from reused refractory bricks, whose original use would be to line fireplaces, kilns or furnaces. The bricks were laid in stretcher bond and had an average individual measurement of 0.16 x 0.06 x 0.05m. The surface extended across the width of the trench, continuing into the eastern and western trench baulk. **(020)** was founded upon a 0.20m thick layer of roughly cut stone fragments **(021)** < 0.30m. Directly underlying **(021)** was a 0.14m thick layer of blue/grey gravel **(022)** containing angular stone fragments < 0.10m. **(022)** extended 4m north of surface **(020)** and across the width of Trench 2. Directly underlying **(022)** was a 0.80m thick layer of very compacted pinkish yellow sandy gravel **(023)** containing small brick fragments. **(023)** originally extended from surface **(020)** across the northern end of the trench continuing into the northern, eastern and western trench sections. However in order to investigate what lay below **(023)**, the deposit was arbitrarily removed at 0.80m north of surface **(020)**. At a depth of 0.9m from topsoil level machine excavations revealed a pinkish red sand and gravel deposit **(024)** void of any archaeological deposits (**Fig. 37**). It is likely that **(024)** was the natural geology. **Figure 16** is an illustrated section of deposits **(021)**-**(024)** which clearly shows these layers in relation to archaeological structures in the trench.

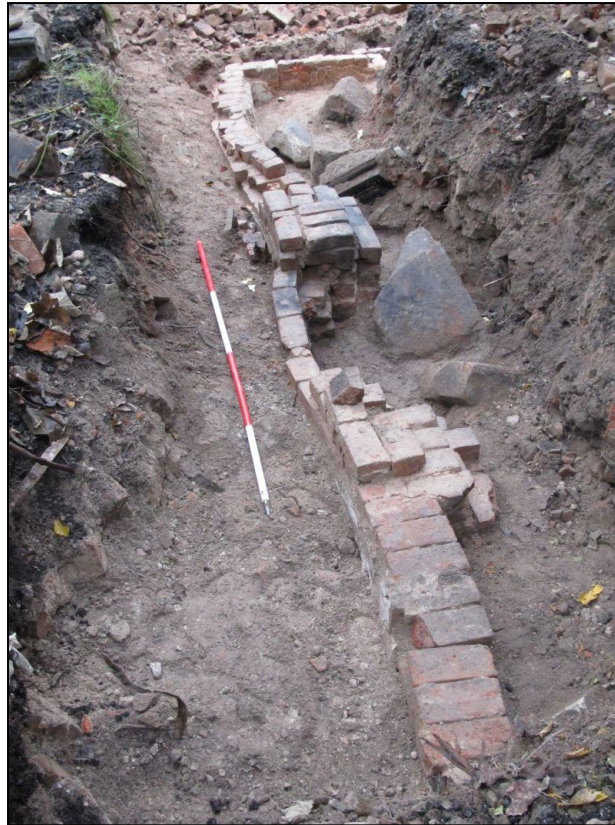
**WHN11 Fig. 40** Detail of wall (030) and possible fireplace. Trench 3 (looking south).

Excavations exposed a north/south aligned internal handmade brick wall (**030**) that was located approximately 0.60m below topsoil level (**Fig. 40**). The wall measured 6.20 x 0.20 m (two brick strings wide). The northern terminus of (**030**) could not be established to the limit of excavation. The wall was excavated to an arbitrary depth of 0.50m, revealing 5 brick courses. The bricks were bound with a degraded pinky brown sandy mortar. The average size of each brick was 0.23 x 0.12 x 0.07m. A 30mm thick layer of plaster coated both the east and west faces of (**030**). The wall was found to be slightly bowed the effect of pressure caused by fallen demolition rubble. Two brick buttresses were found built into the west face of (**030**). The buttresses were positioned 1.20m apart, each measuring 0.60 x 0.44m (**Fig. 41**). Between the buttresses, wall (**030**) narrowed and inset to become only one brick skin wide (0.12m). The wall face in the central part of this inset was found to be blackened, an indication of an episode of burning. All these elements are very indicative of a fire place.

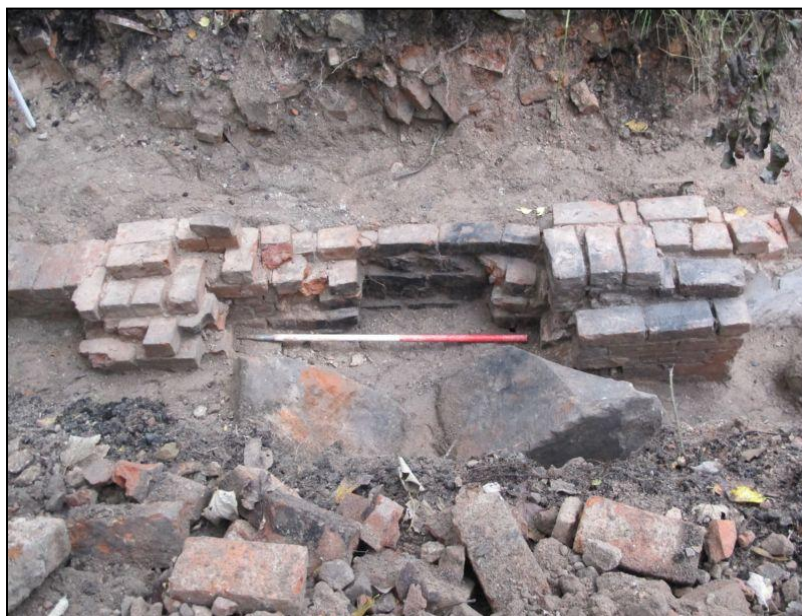
**WNH11 Fig. 41.** Detail of possible fireplace built into the west face of wall (030). Trench 3 (looking east).

The first possibility is that this room was the main kitchen. The possible fireplace that was found integrated along the west face of **(030)** would be an expected feature in this room. However it would be expected the main hearth would be a more substantial structure, and likely to be more than 1.20m in width. In addition the basement plan shows at least two fireplaces adjacent to each other along the eastern wall of the kitchen, a feature that was not identified in Trench 3.

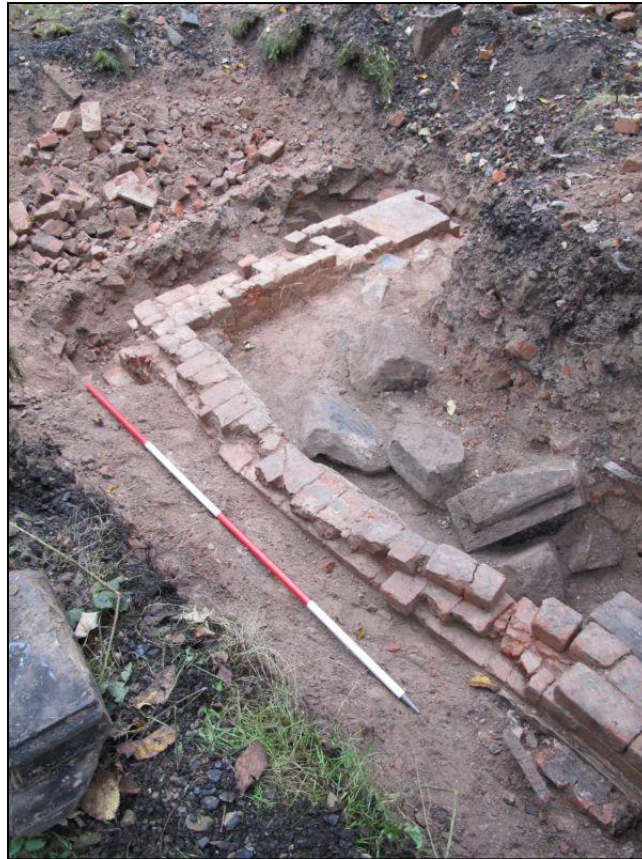
**WNH11 Fig. 42.** Detail of walls (030) and (032), the south-east corner of Room 8. Trench 3 (looking south-west).

The discovery of two handmade bricks walls (**030**) and (**032**) bonded to each other at a right angle signified the presence of a southeast corner of a room (Room 8). As both faces of each wall were found to be plastered it was concluded that these walls were internal partition walls. When attempting to correspond this structural

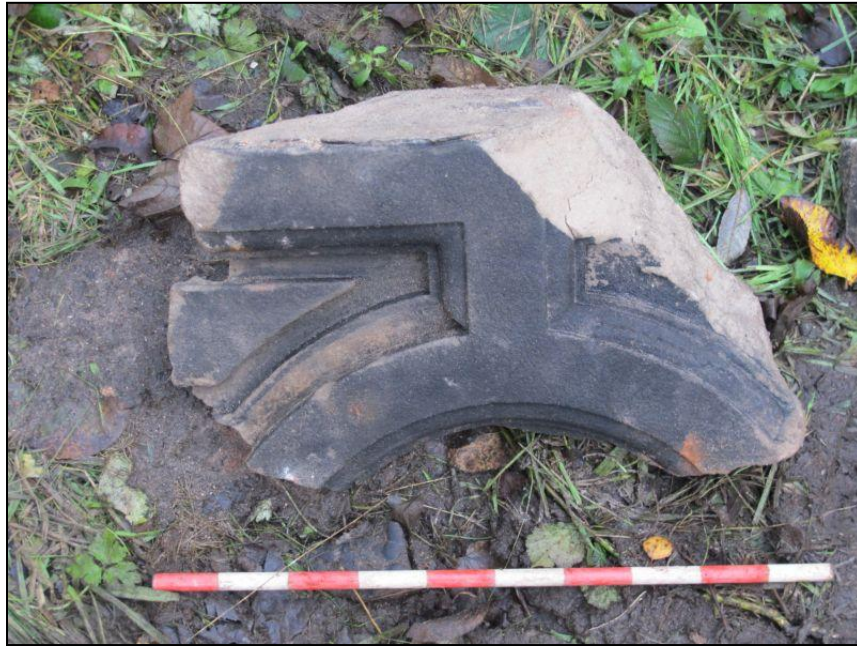
**WNH11 Fig. 46.** Detail of carved masonry fragments (033) recovered from the demolition rubble in Trench 3. Note blackening on the external face of the stone work.

exposure to fire or a result of exposure to air pollution caused by the smoke and chimneys of industrial Manchester and Salford.

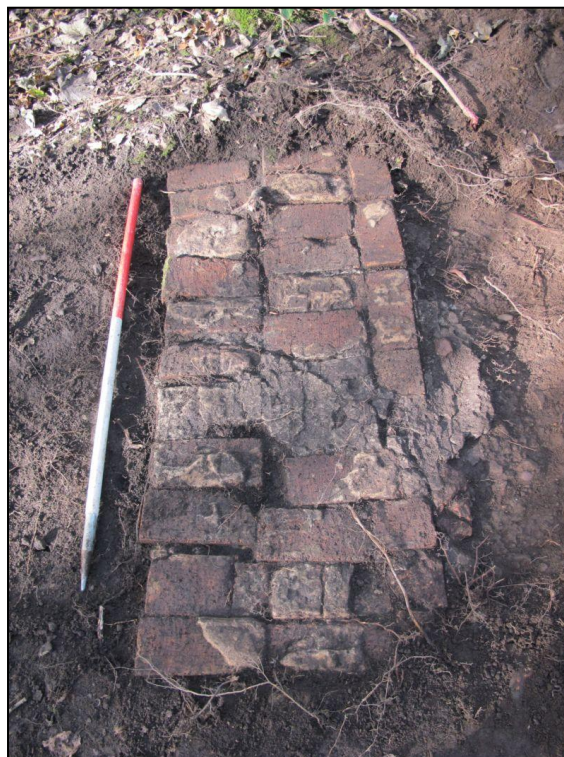
**WNH11 Fig. 49.** Detail of brick wall (041) in Trench 4 (looking west).

The preservation of all features in the trench was poor. The high concentration of roots from the surrounding woodland had caused severe damage to the garden wall and surrounding deposits. It is likely that any future excavations in the gardens would expose archaeology with a similar degree of preservation.

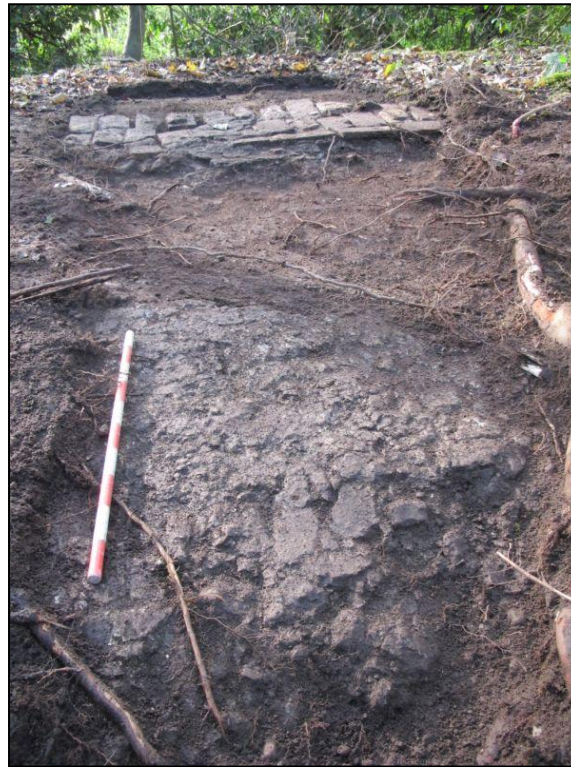
**WNH11. Fig. 50.** Detail of compacted gravel surface (040) overlying pea gravel layer (042). Trench 4 (looking south).

balusters incorporated in to the brickwork (Rice, 2009: 85,86) The pea gravel and compacted gravel deposits found to the north of the wall are likely to represent compacted gravel hollows used as the foundation for garden beds (Currie, 2005:03)
