**Archaeological
Building Survey:**

The Garden Cottage,
Worsley Hall Garden
Centre, Worsley.
Final Version

Client: Peel
Investments (North)
Ltd.

Report No: 7/2012

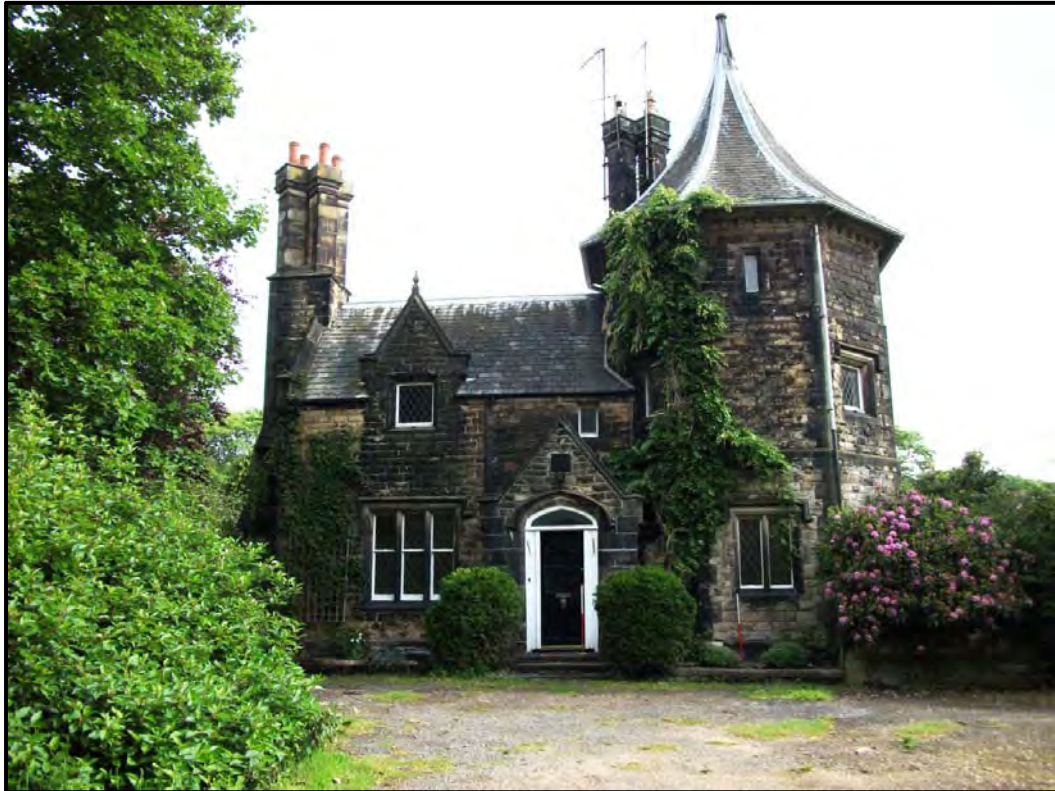
This elevation was two storeys high and three bays long. An octagonal tower with a conical swept roof rose to three storeys at the southern end of the range. The northern Bay 1 was gabled and had a stone copings, kneelers and quoining to the western gable where there was an extruded chimney stack (see below). The roof was covered in small, thin, blue-green slates. There was a three-light chamfered stone mullion window with label eaves on the ground floor and a first floor gabled dormer window with quoins, coping stones and kneelers topped by a stone finial. Bay 2 contained a projecting gabled porch with a Tudor- arched doorway and hoodmould and a coped gablet topped by a stone finial. At first floor height there was a one-light stone chamfered window just below the eaves. At the southern end of the elevation was a three storey octagonal stone tower. It had quoins and bracketed eaves supporting a conical swept roof covered in this grey-blue slates. To the west of the two was a

set of four cross-shaped diagonally-set small ashlar chimney stacks. The ground floor had a two-light chamfered mullion window with a stone label mould above; the first floor had two single chamfered stone mullion windows, also with label moulds, and the third floor had a small one-light chamfered stone mullion window.

Figure 10 - View of the Garden Cottage, southern elevation. Looking north-east

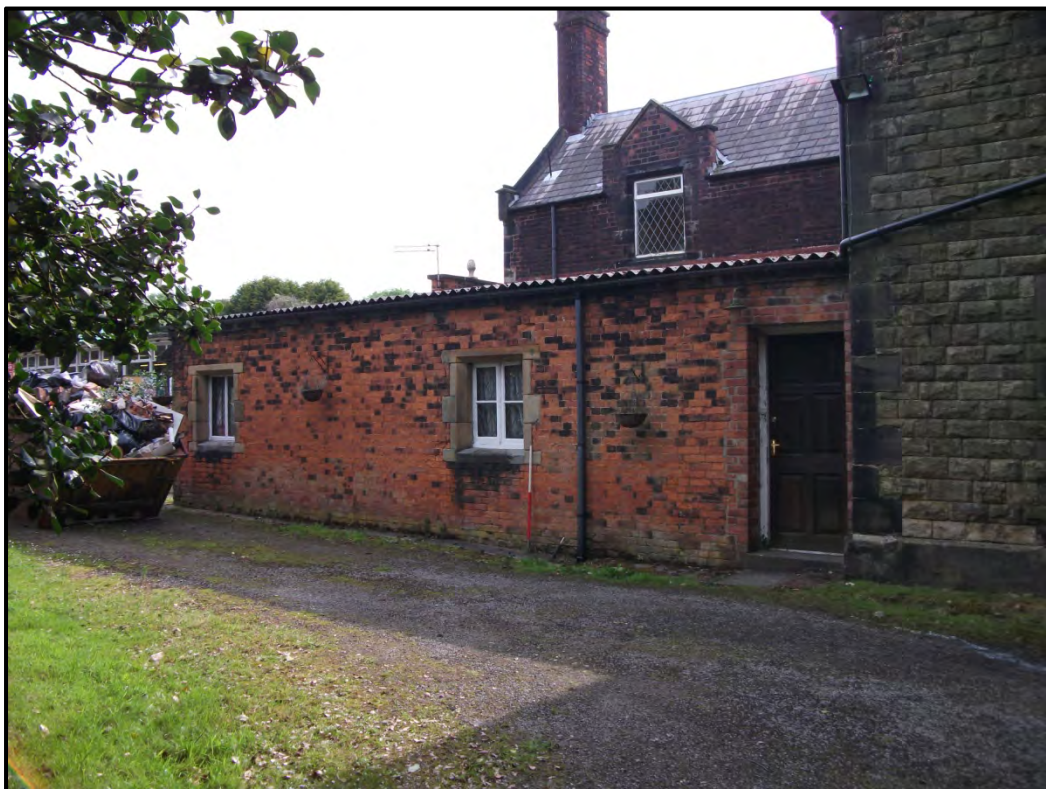
This elevation encompassed the original 1834 wing and the late 19th century single storey brick extension. The original stone 1834 wing occupied the two bay south. The southernmost bay, which rested on a stone plinth and had quoins, had an extruded chimney stack which was topped by four cross-shaped diagonally-set small ashlar chimney stacks. Bay 2, which was also gabled and two storeys high, had a two-light chamfered mullion window on the ground floor and a single-light chamfered mullioned window on the first floor. The gable was coped and had kneelers. Bays 3 and 4 formed the later single storey late 19th century extension built in English Garden Wall bond. This contained a doorway and two chamfered mullion windows all with stone surrounds. It had a shallow sloping roof covered in plastic corrugated sheeting.

Figure 11 – View of the north end of the Garden Cottage, western elevation. Looking north-east

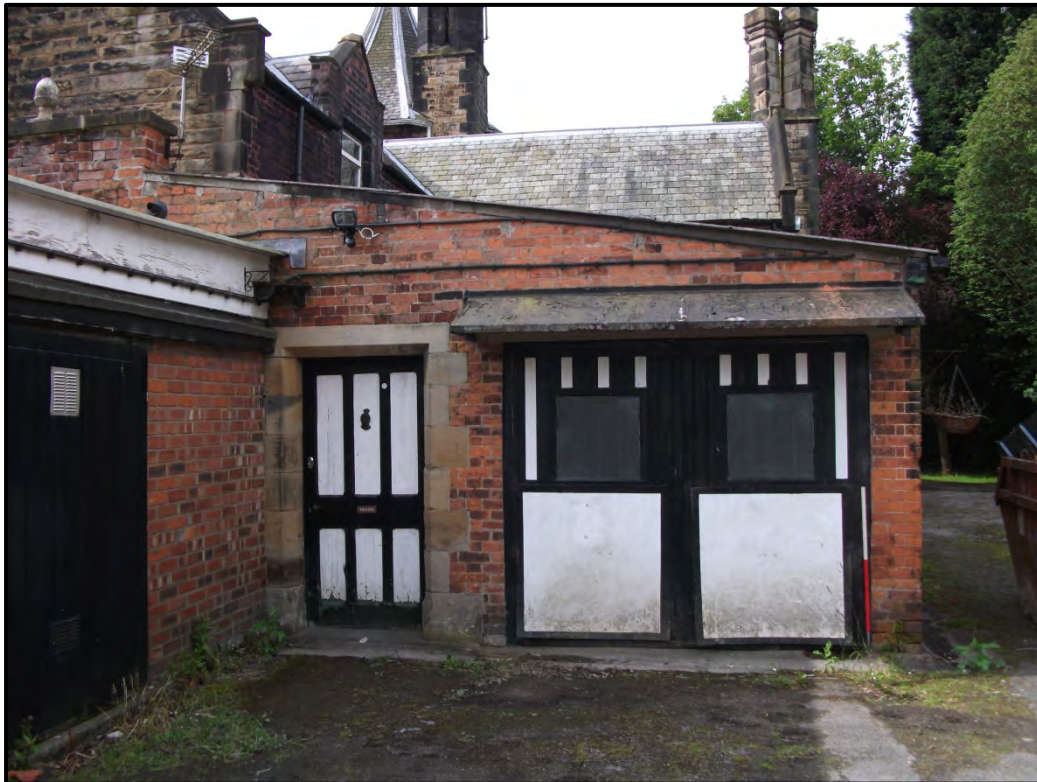
This elevation was partially obscured by the addition of the single storey brick-built range of toilets, which had a slightly sloping roof hidden by a brick parapet that was coped with stones and which had two acorn finials. The upper portion of the gable was coped and had kneelers at either end. There was also a tall gable-end brick chimney stack which was topped by two stone chess-piece chimney pots. The western end of this elevation included the gable end of room G11 which contained a four-panel door and to the west of this a cart entrance with a pair of double doors.

Figure 12 – View of the entrance ways into the garage at the northern elevation of the Garden Cottage. Looking south-west

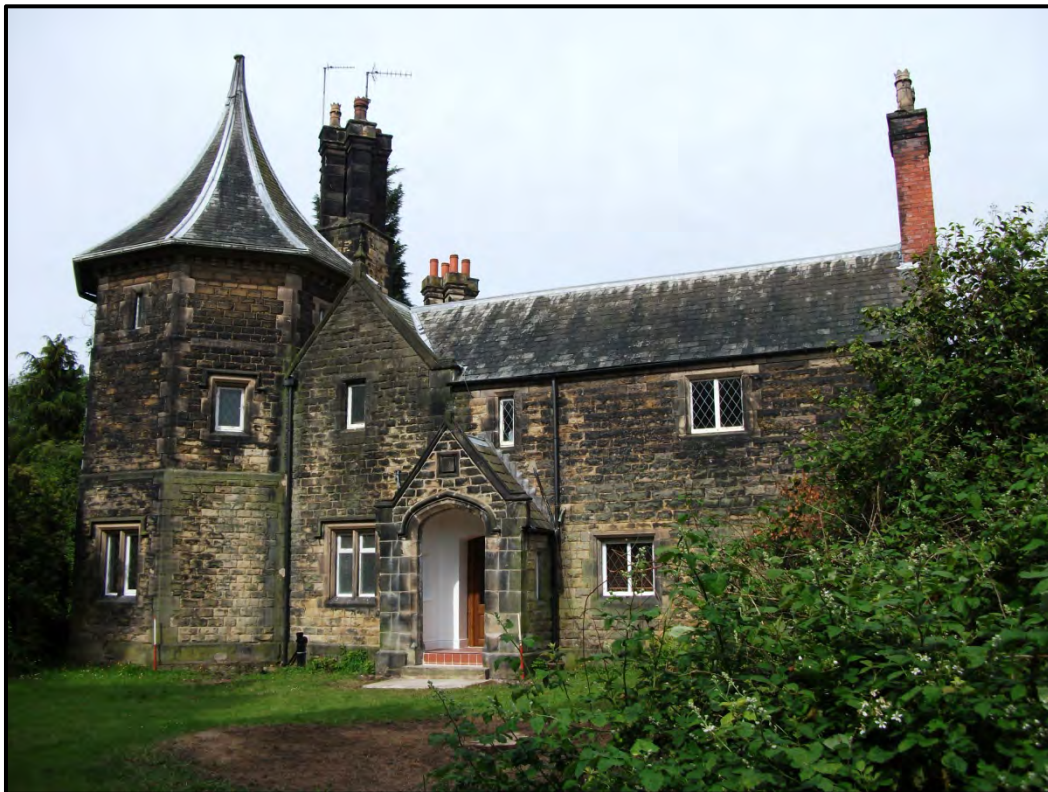
This elevation was two storeys high and five bays long with a roof covered in small, thin, blue-green slates. The octagonal tower lay at the western end of the range. The western Bay 1 containing the tower rose to three storeys. The ground floor had a two-light chamfered mullion window with a stone label mould above; the first floor had a single chamfered stone mullion window, also with a label mould, and the third floor had a small one-light chamfered stone mullion window. Bay two had a two-light chamfered mullion window with a stone label mould above and at first floor level a single one-light chamfered stone mullion window. The elevation was surmounted by a coped gablet with kneelers and a stone finial. A vertical joint at the eastern end of the bay and a line of quoins marked the original eastern elevation of the garden cottage. Bay 3 contained a projecting gabled porch with a Tudor-arched doorway and hoodmould and a coped gablet topped by a stone finial. There was a square panel in the centre of the gablet. At first floor height there was a one-light stone chamfered window just below the eaves. Bay 4 contained a two-light chamfered window on the ground floor and Bay 5 contained a similar two-light chamfered window. There was a gable-end ridge brick chimney stack which rose almost to the height of the conical roof and was topped by two stone chess-piece chimney pots. Abutting this elevation was a single storey brick-built range of toilets.

Figure 13 - View of the Garden Cottage, eastern elevation. Looking west

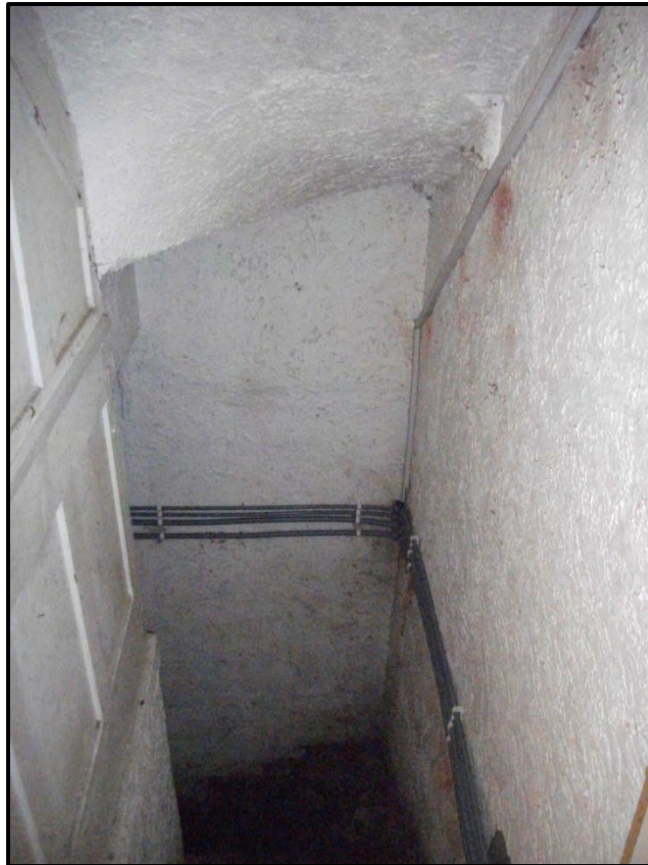
This stairwell consisted of a two straight flights of solid stone steps that rose around a solid brick core. The core of this stairwell was a cupboard accessible from the corridor. Twelve steps made up this stairwell. The walls were white stuccoed plaster. The western wall at the top of the first set of steps was covered by a decorative wooden screen, divided into four quadrants.

Figure 14 - A view of the entrance into the cellar from the ground floor hallway. Looking north-west

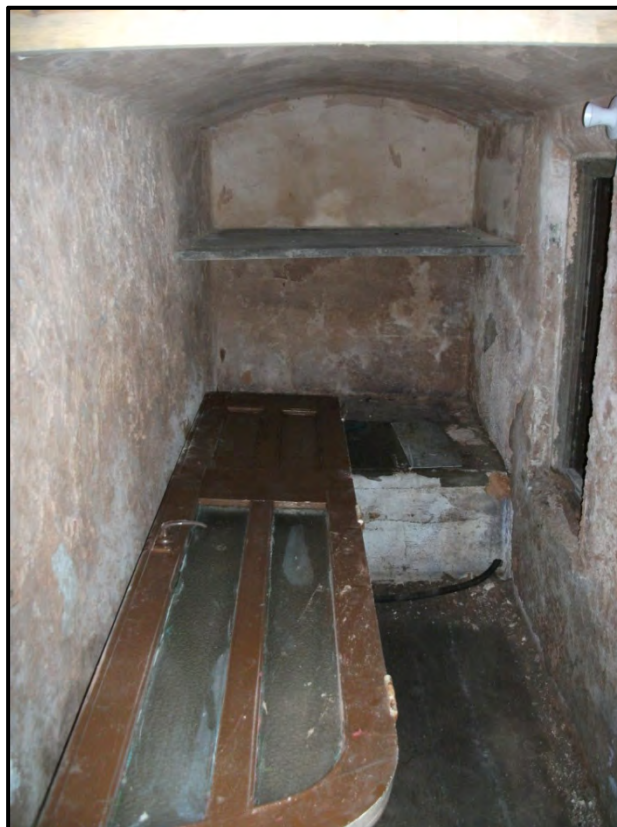
The corridor was rectangular in plan. Its walls were brick, finished in plaster. At its northern end was the stairwell and a cupboard that formed the core of the stairwell. The cupboard was open to the room and had two stone shelves within it. Above the highest shelf was an iron container set into the walls of the cupboard. At the southern end of the corridor was a stone plinth and above this there was a stone shelf. The stone plinth ran along the eastern wall of the corridor, extending northwards. The western wall had a one light window. It had a segmented chamfered brick lintel. The western wall was interrupted by two doorways. One leading to the North Room and one to the South Room. In between the doorways was a semi-rounded dividing wall. The corridor had a barrel vaulted ceiling and a stone floor throughout.

Figure 15 - View of the southern end of the Cellar Corridor. Looking south-west

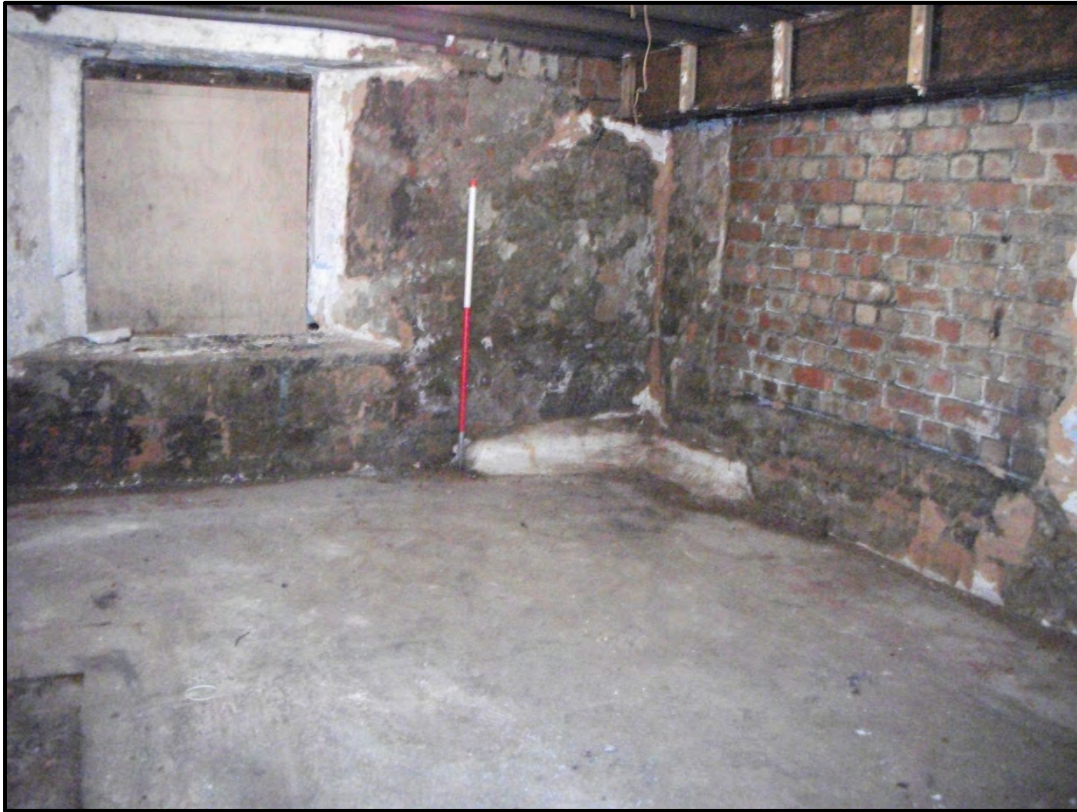
This room was square in plan. The walls were brick, covered in plaster. It was not possible to ascertain the bond used. The northern wall had exposed brick work that may have been used as a replacement. This was bonded in traditional English Bond. The western wall had a deep sill window with a stone lintel. The eastern wall had the doorway in the south-eastern corner. The doorway was open and had no frame. The northern and eastern walls had steel girders below the ceiling. These were not original and had been added for structural support. The ceiling had exposed lateral beams and the floor was concrete.

Figure 16 - View of the northern & western walls of the Cellars north room. Looking north-west

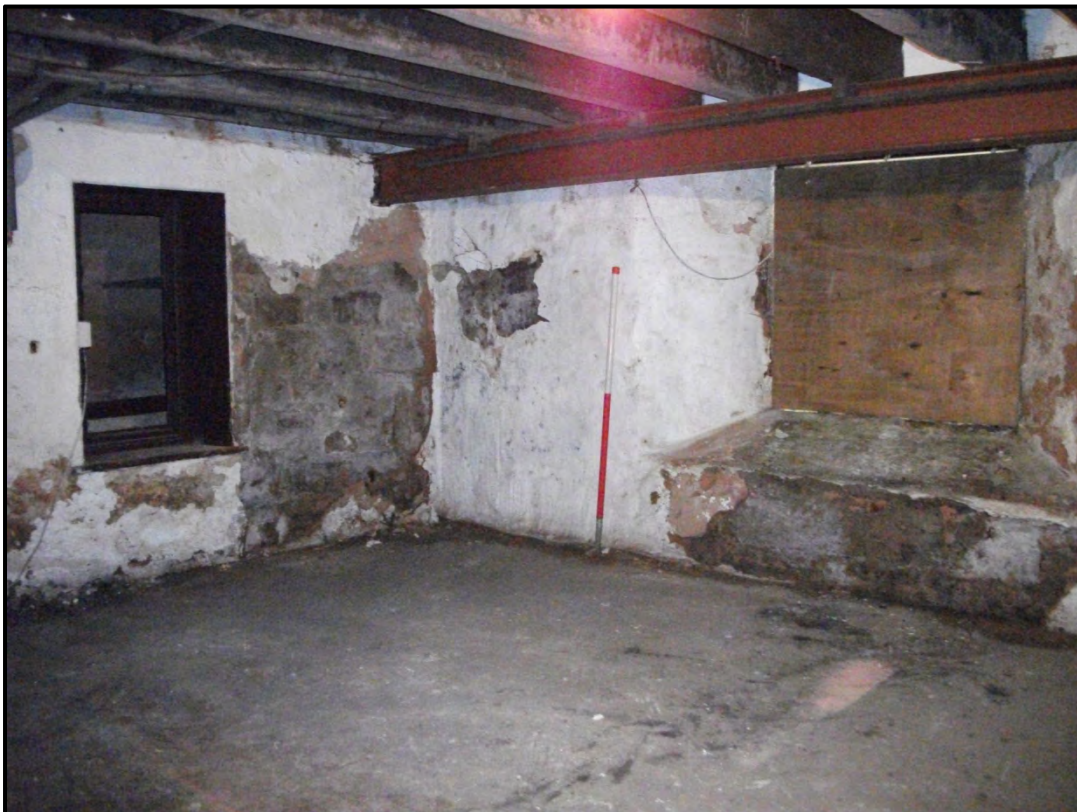
This room was square in plan. The walls were brick, covered in plaster. The southern wall had a deep sill window with a stone lintel. The eastern wall had a window with a wooden sill and stone lintel. The doorway was located in the north-eastern corner of the room. The doorway was open and had no frame. The southern part of the room had a steel girder that ran the length of the room below the ceiling beams. The ceiling had exposed lateral beams and the floor was concrete.

Figure 17 - View of the southern and eastern walls of the Cellars southern room. Looking south-east

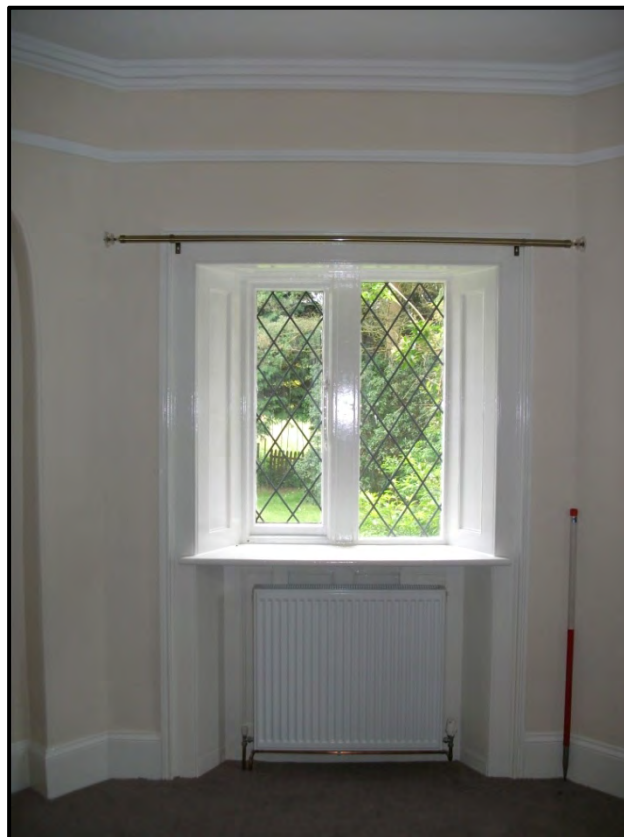
This room is octagonal in plan. It was accessed by a doorway in the central western segment. This doorway had a square headed frame. The door was four panelled. The room had four recessed arched alcoves. These were positioned in the north-west, north-east, south-east and south-west segments of the room. The room had a cavetto skirting board running around its edge. This continued to the window frames. The room had two windows. One was positioned in the central eastern segment and the other in the central southern segment. The windows were two lights each. They were lozenge leaded. The lights were separated by a mullion, with a single panelled wooden panel on either side, connecting the internal frame to the window itself. Both windows were had a splayed wooden sill. Below both windowsills were iron radiators. The central northern segment had a fireplace. This was boarded up and no longer in use. The mantelpiece and hearth were stone and of a modern design, not original features. This room had a moulded decorative picture rail that ran around the room, just above the alcove arches. The floor was carpeted. The ceiling was papered with a decorative motif and in the centre of the ceiling was a decorative plaster ceiling rose that surrounded the light fixture.

Figure 19 - Wood panelled window in the eastern wall of the Octagonal Sitting Room. Looking east

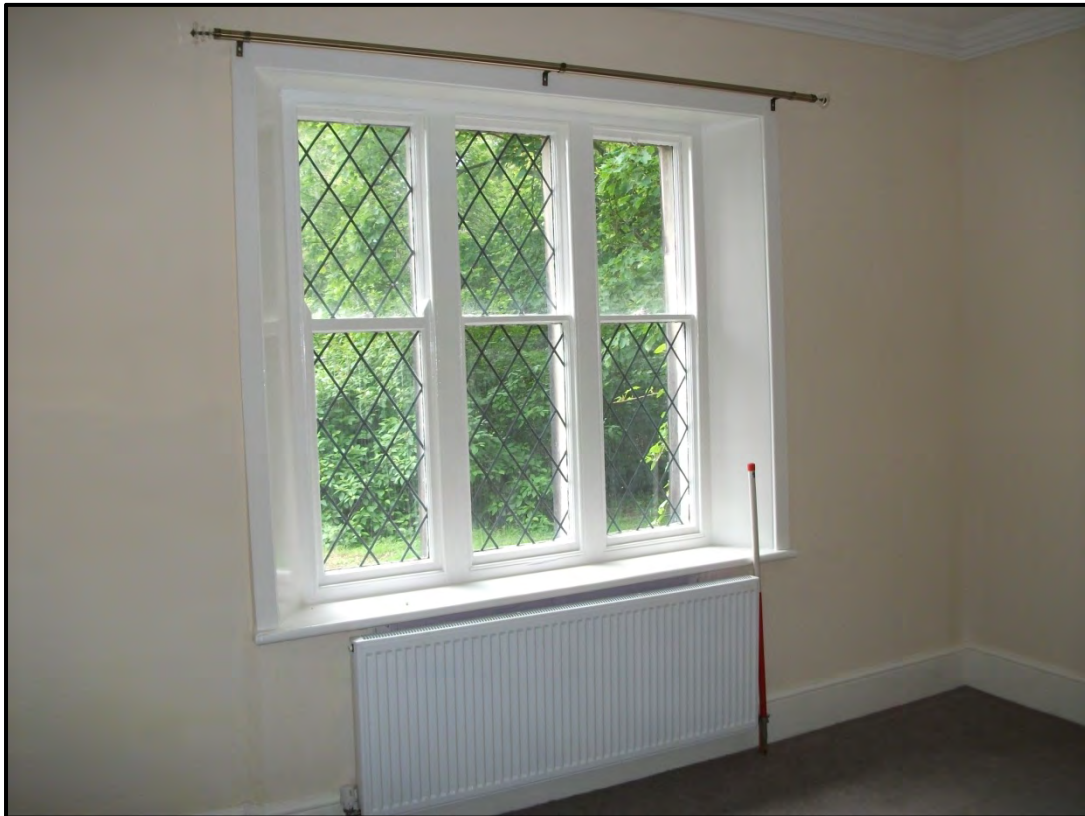
This room was rectangular in plan. It was accessed by a doorway in the eastern wall in the north-east corner of the room from the hallway, G2. The doorway had a square headed frame. The door was four panelled. This room had a window in the southern wall. The window was three light and lozenge leaded. It had stone mullions dividing each light. This window had a splayed wooden sill. The western wall had a blocked fireplace. There was an air-brick in place of the fireplace. The northern wall was a later insertion partition wall. This separated G4 from G5. The partition wall created a shallow rectangular alcove. The room had an ovolo moulded skirting board and a decorative plaster ceiling rose that surrounded the light fixture. The ceiling was papered with a decorative motif. The floor was carpeted.

Figure 20 - Detail of the stone mullion window on the southern wall of the Dining Room (G4). Looking south-west

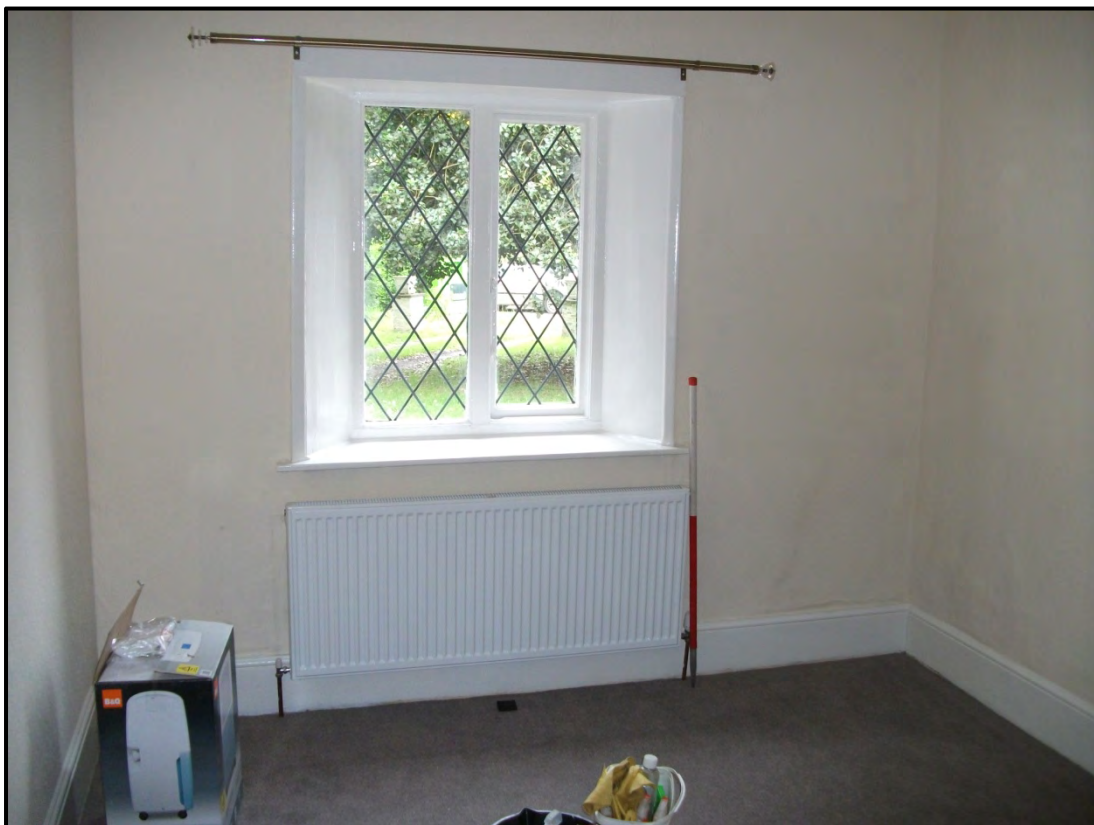
This room was rectangular in plan. It was accessed by a doorway in the eastern wall in the south-eastern corner of the room from the hallway G2. The door way was square headed and the door was four panelled. This room had window in the western wall. It was a two light,

mullioned, lozenge leaded window. The window had a splayed wooden sill. The room had an ovolo moulded skirting board. The floor was carpeted.

Figure 21 - View of the western wall of the ground floor Sitting Room (G5). Looking north

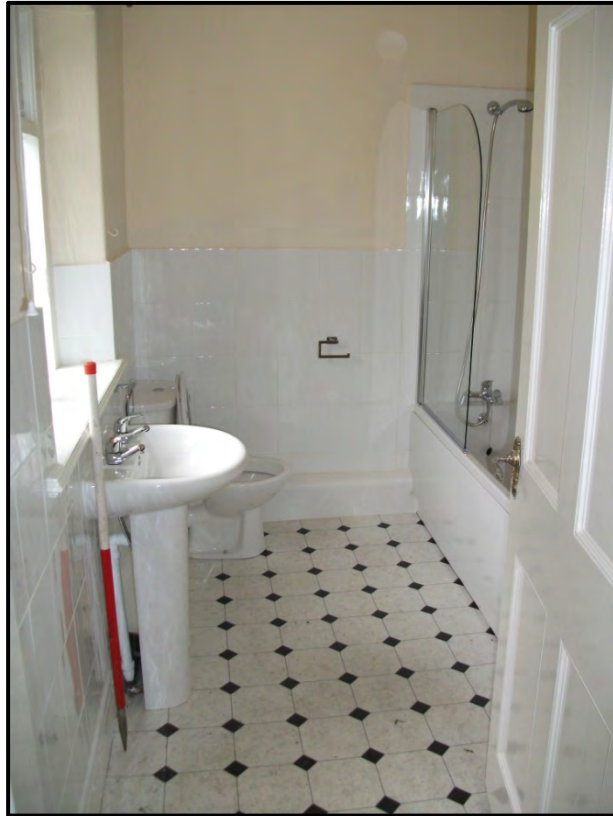
This room was rectangular in plan. It was accessed by a doorway in the northern wall at the eastern end. The doorway had a square headed frame and the door was four panelled. The bathroom suite included bath on western wall, toilet and sink on eastern wall. The room had a window on the eastern wall. This was a one light sash window with wooden sill. The walls had a tiled facade all the way round spanning half the height of the walls. The floor was linoleum.

Figure 22 - View of the ground floor bathroom (G6). Looking south-west

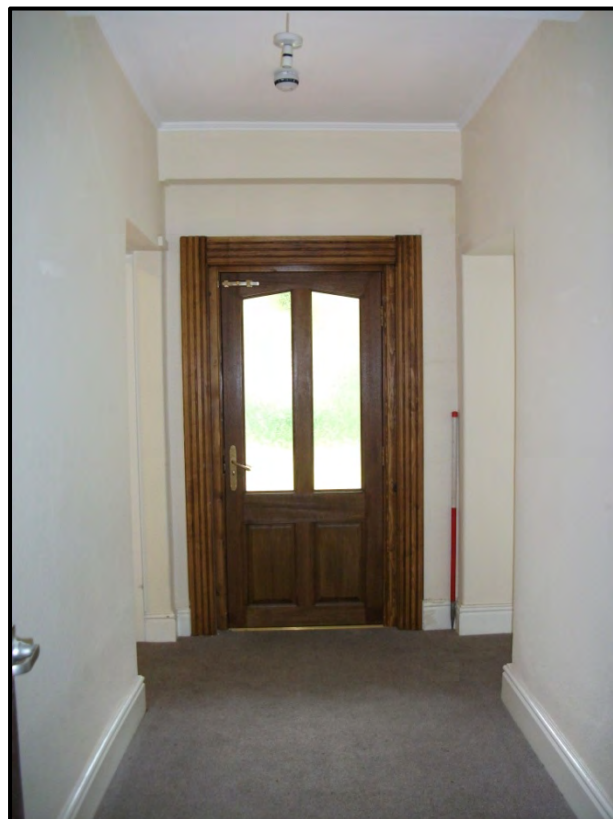
This hallway was rectangular in plan. It led to the rear porch, G9. The hallway led to rooms G6, G10, G8 and the hallway G2. The doorways all had square headed frames. The hallway had an ovolo moulded skirting board running the base of each wall. The doorway to G9 was framed by varnished decking board. The door had two panels below the middle rail and two glass panels above. The floor was carpeted.

This room was rectangular in plan. It had an external door in the eastern wall, leading out of the eastern elevation and a door in the western wall leading to the hallway G7. The northern and southern walls had lozenge leaded one light windows. These windows had a stone lintel and a stone sill.

*Figure 23 - View of the ground floor, rear Hallway (G7) and door to Rear Porch (G9).
Looking south-east*

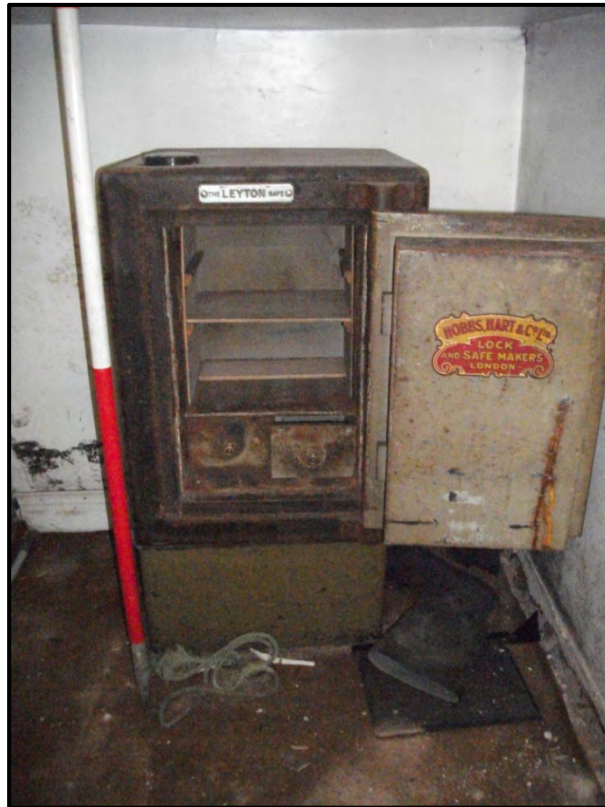
This room was rectangular in plan. It was located at the western end of the hallway G7. It was accessed by a doorway in its eastern wall. The doorway was square headed and had a stone step leading down into the room. The cupboard contained a steel safe. This was manufactured by the Hobbs, Hart & Co. Ltd and was a Leyton model. The cupboard had a moulded skirting board.

Figure 24 - Detail of the safe housed within the Cupboard (G8) at the western end of the ground floor, Rear Hallway (G7). Looking north-west

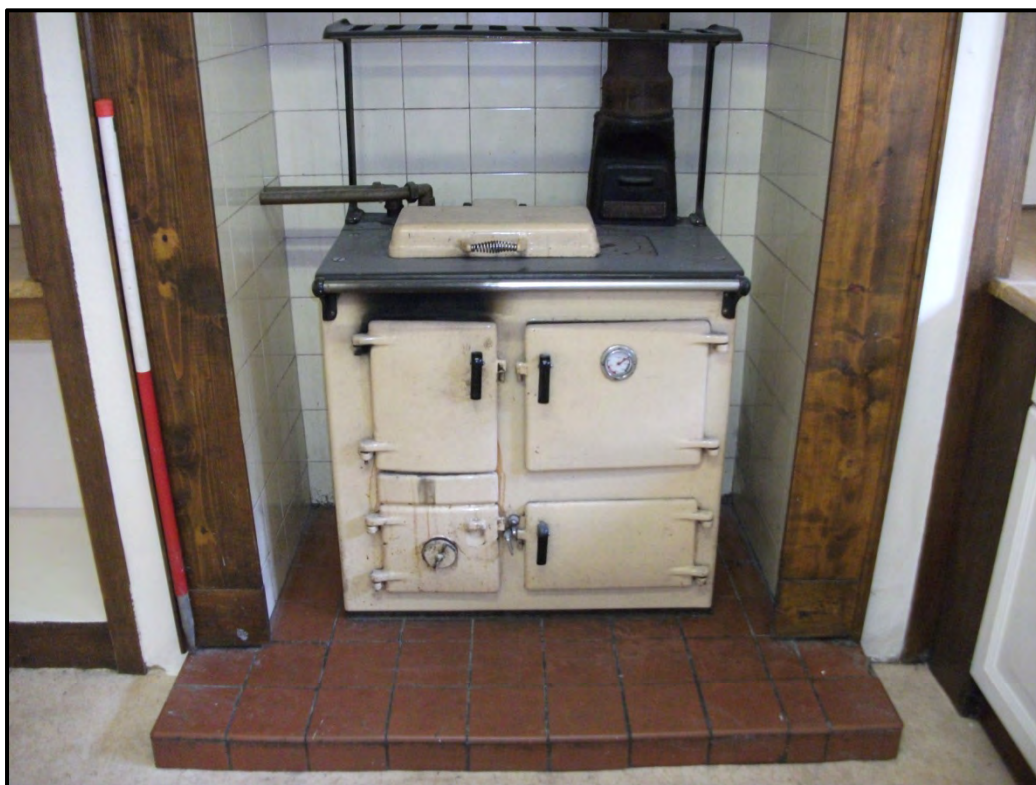
This room was rectangular in plan. It was located north of hallway G7 and east of the garage, G11. It was accessed via the garage from a doorway at the southern end of the western wall and from the hallway from a doorway in the eastern end of the southern wall. Both doorways were square headed frames. The door to the garage was a twenty panelled door and the door from the hallway was a four panelled one. The kitchen had four windows, two in the eastern wall and two in the western wall. The windows in the eastern wall were two light sash windows, with a wooden sill. The two in the western wall were two light mullioned, lozenge leaded windows, with wooden sills and stone lintels.

The northern wall had a central range fixture with wooden cupboards either side. The range was in a recess with a heavy wooden frame. The Aga stood on a ceramic tiled plinth. The range alcove was lined with tiles. To the west of the range, there was an alcove. This had a shelf within it and at the top a two cupboard. To the east of the range was an alcove that the

eastern walls work surface emerged from and above this was a single door cupboard. The eastern and western walls held kitchen cupboards. The exposed wall at the southern end of the eastern wall and the southern wall both had a chair rail. The room had a moulded skirting board and a moulded crowning. The ceiling was plastered with a plastered and covered roof beam. The flooring was linoleum.

Figure 25 - Detail of Aga, abutting the north wall of the Kitchen (G10). Looking north-east

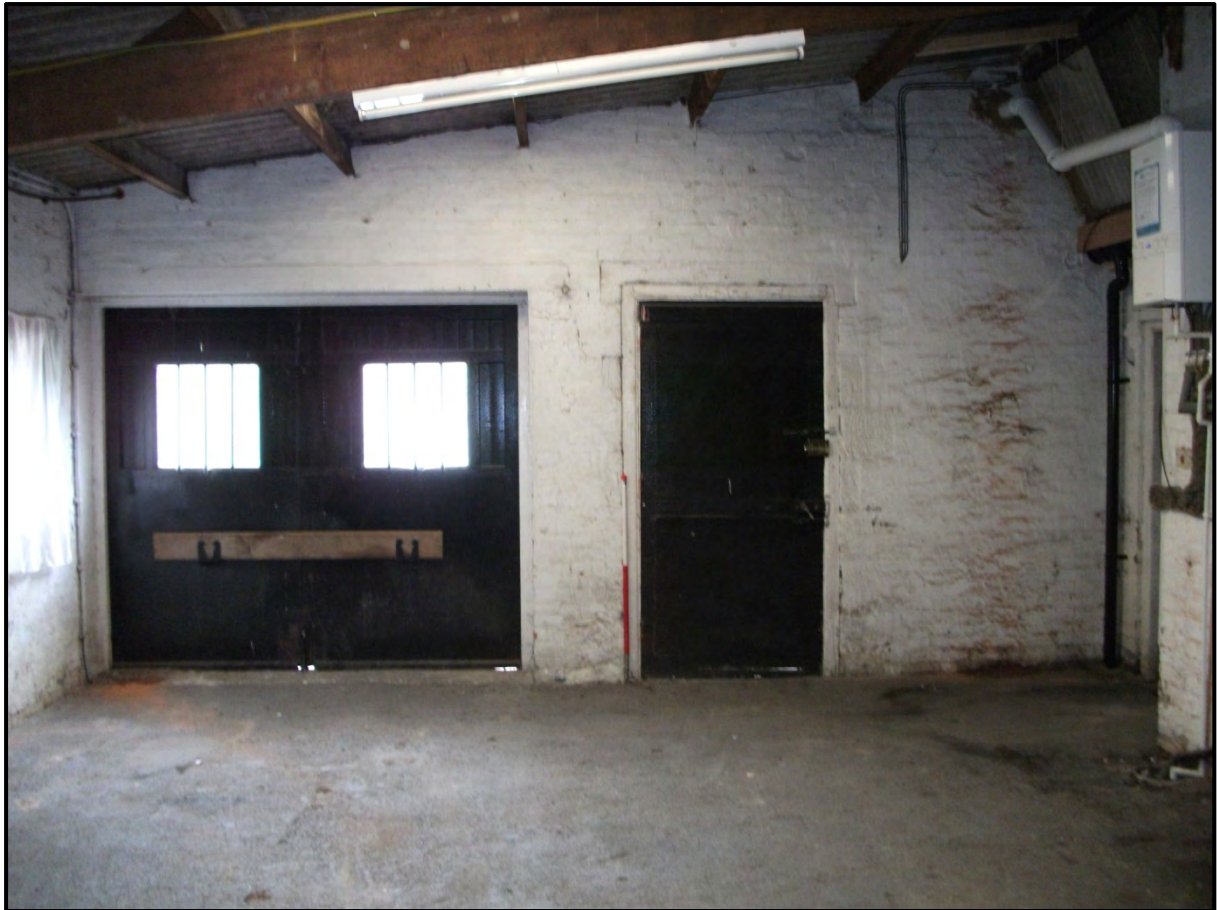
This was the largest room in the ground floor and was rectangular in plan. It was accessed by a set of double garage doors and a doorway in the northern wall. It led into corridor G12, G14 and the kitchen, G10. All the walls were laid in a stretcher bond and white washed. The western end of the northern wall had an external double garage door with windows. East of these garage doors was a single external doorway. Both doorways had a square headed frame and stone lintels. The eastern wall had a doorway at the northern end that led into the Privy Corridor, G12. The wall also had two windows. The windows were one light sash windows. They had stone lintels and stone sills. At the southern end of this wall was a doorway into the kitchen, G10. This doorway had a square headed frame and a tile lined stone step leading up to it. The southern wall of this room had a single doorway at the western end. This led into hallway G14. The doorway had a square headed frame. This wall had two brick pilasters. The western wall of the garage had two windows. These were both one light lozenge leaded windows with stone sills and lintels. The ceiling was constructed with a wooden frame and corrugated steel sheeting. The ceiling had two plastic sections to allow light in. The floor was concrete.

Figure 26 - View of the northern wall of the Garage (G11). Looking north-east

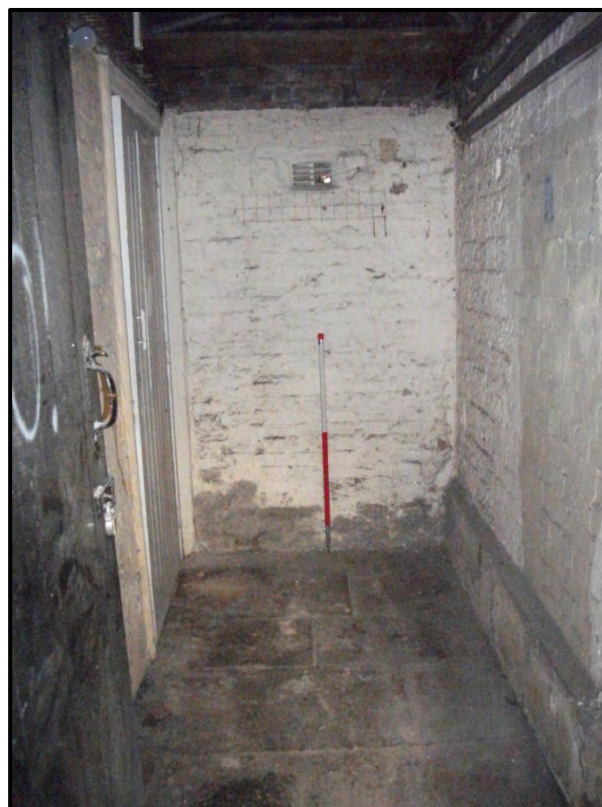
This room was rectangular in plan. It was located north of G10. It led to the Privy, G13 and was accessed via the garage, G11, by a doorway in the western wall. The doorway from G11 had a square headed frame. The door was a plank and batten style. The walls of the corridor were brick. They were covered in lime-wash. The bond was not visible. The northern wall of the corridor had a one light window at its western end. The eastern end of the northern wall had a doorway that led into the Privy. This doorway had a square headed frame and had a plank and batten door. The eastern wall of the corridor had a ventilation brick at the top of the wall, centrally. The southern wall had a stone plinth at its base that ran the length of the wall. The floor of the corridor was stone flagged. The roof was gabled and had exposed beams. These had signs of fire damage.

Figure 27 - View of the Privy Corridor (G12). Looking east

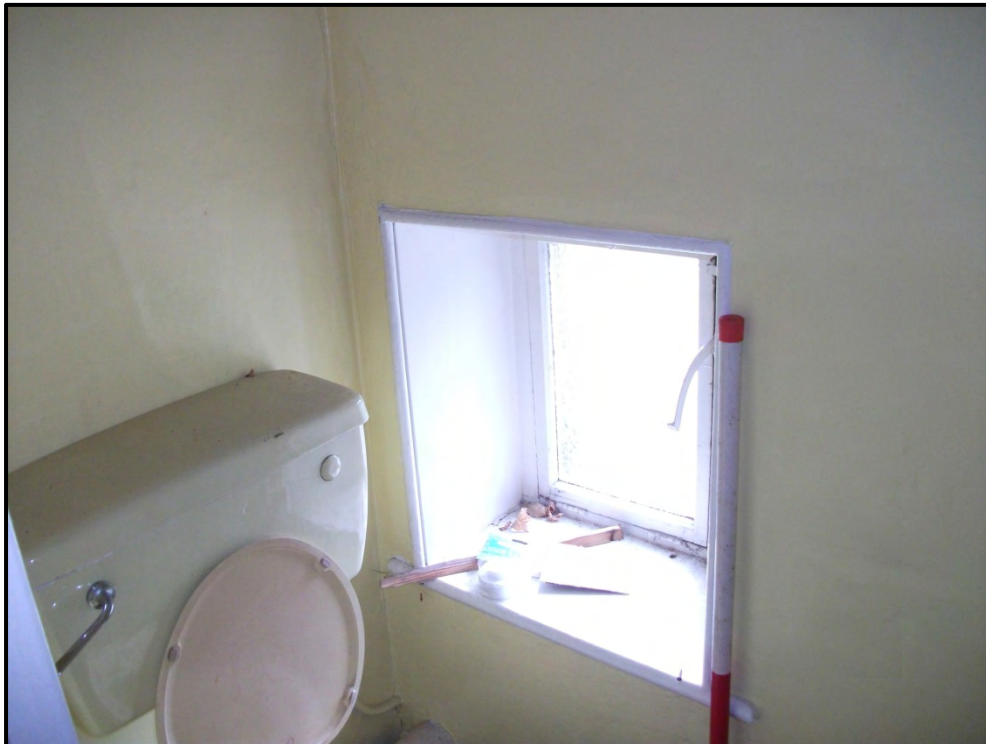
This room was rectangular in plan. It was accessed from the hallway F2. The room had one deep silled window in the southern wall.

Figure 28 - Detail of window on the south wall of the first floor WC (F1). Looking south-west

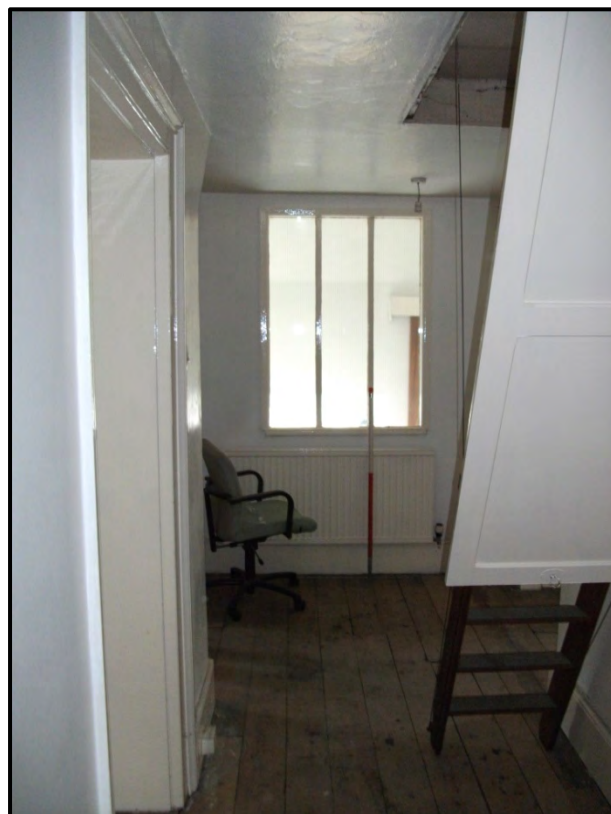
This room was roughly T shaped. It had one, three light window on the northern wall. A wooden ladder was in place to allow access to the attic. The floor was bare floor boards.

Figure 29 - View of the First Floor, Front Hallway (F2). Looking north east

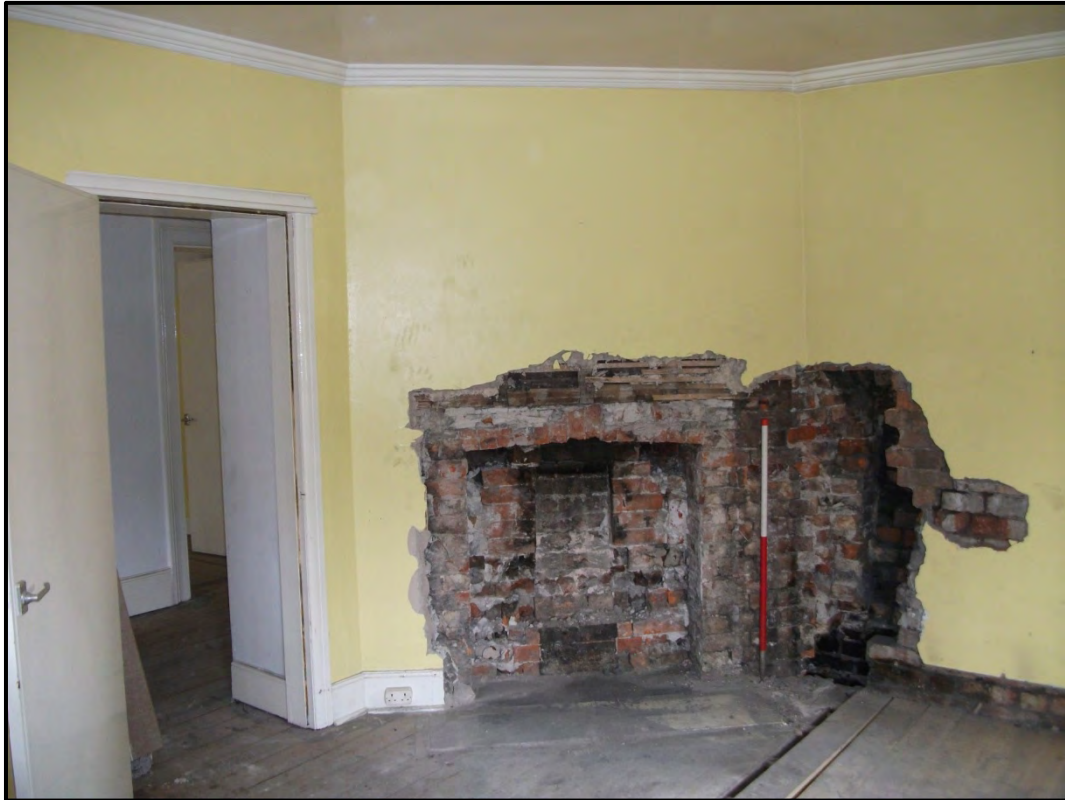
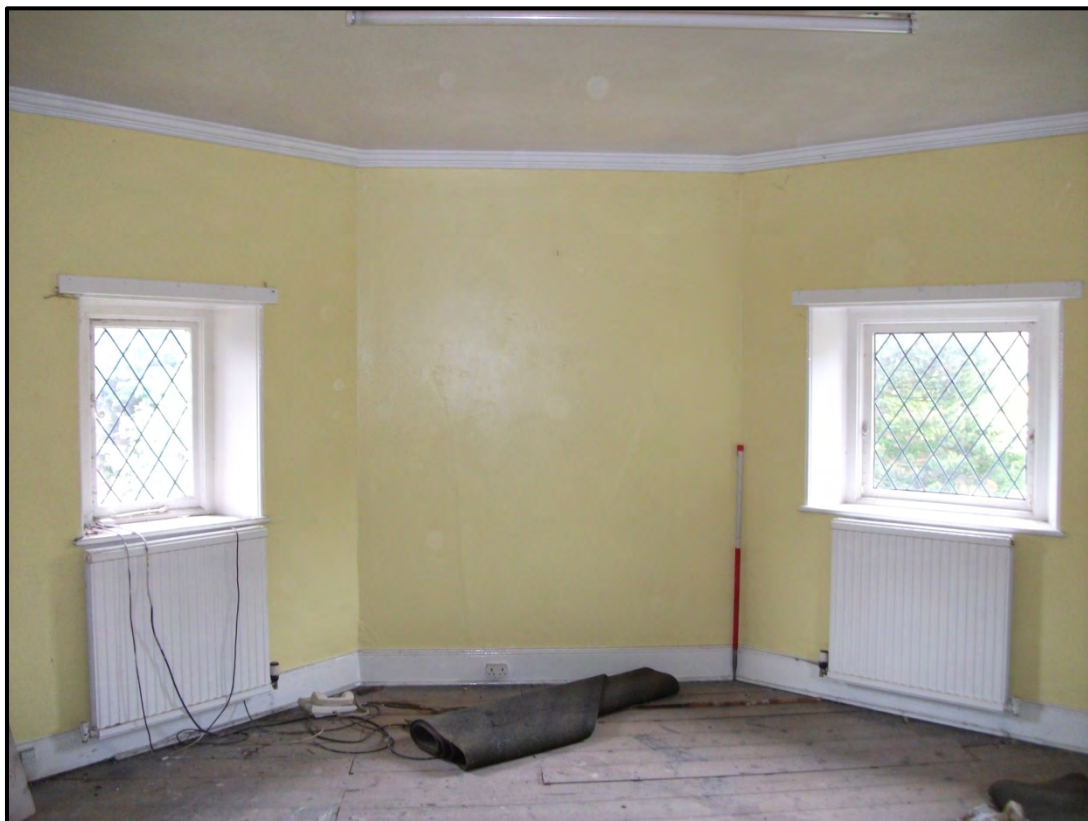
This room was octagonal in plan. It was accessed by a doorway in the central western segment, from the hallway, F2. The doorway had a square headed frame. The north-west segment had a partially dismantled fireplace. The hearth and surround had been removed, leaving exposed brickwork. The plaster had also been damaged on the wall of the northern segment, exposing more brickwork. The room had three windows. They were on the north-eastern segment, the south-eastern segment and the south-western segment. The windows were single light, deep silled, lozenge leaded windows. The room had a skirting board that encompassed the whole room and the same pattern continued around the door. The ceiling was plastered with a single strip light. The flooring was bare floor boards.

Figure 30 - View of the fireplace in the north-western wall of the Octagonal Bedroom (F3). Looking north west

Figure 31 - View of the eastern walls of the Octagonal Bedroom (F3). Looking south-east

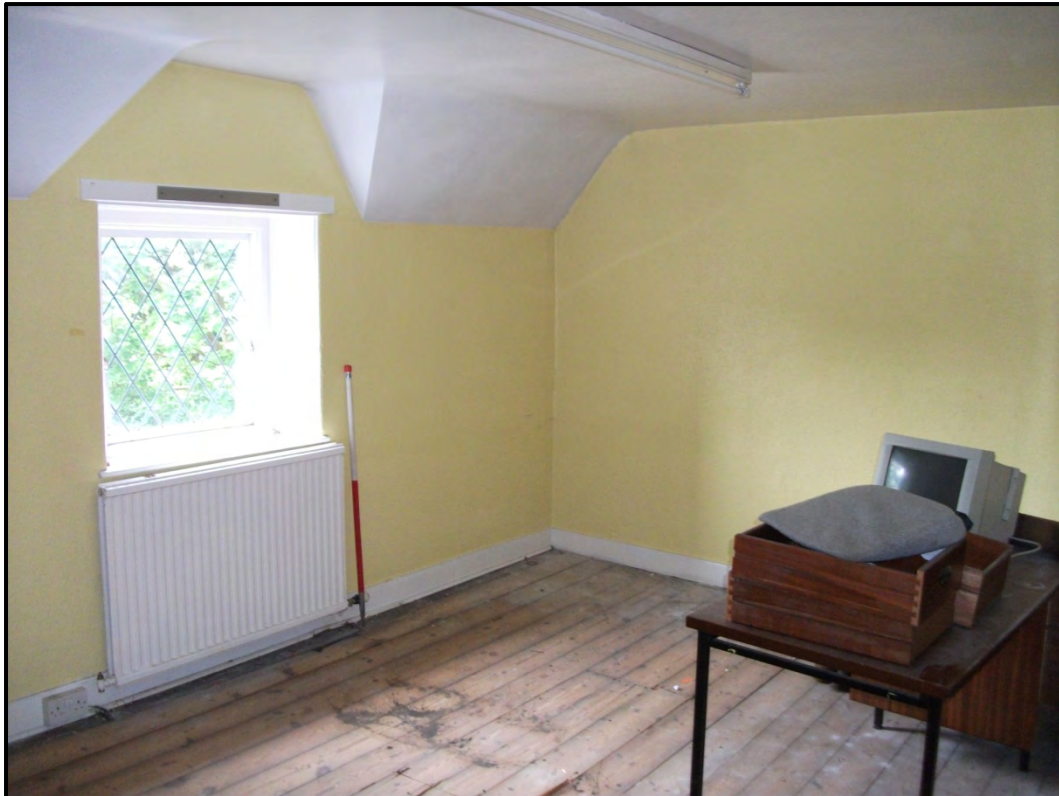
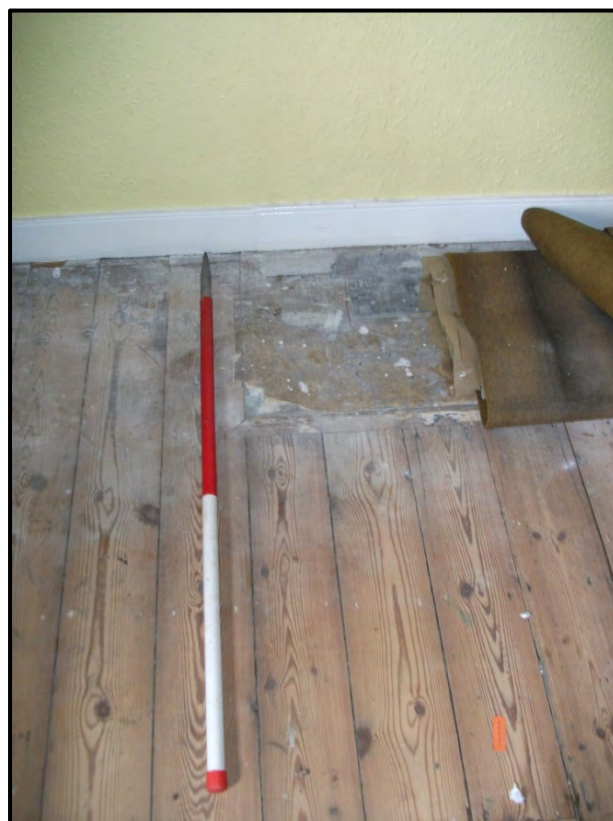
This room was rectangular in plan. It was accessed via a doorway in the north-east corner of the room from the hallway F2. The doorway had a square headed frame with a plain wooden doorway. This room had a window in the southern wall. It was a single light lozenge leaded window with a wooden sill. In the western wall there was a blocked fireplace. The base for the hearth was visible in the floor. The room had a moulded skirting board. The flooring in this room was bare floor boards. The ceiling was plastered and curved along the eastern and western walls to allow for the roof above.

Figure 32 – View of the southern and western walls of the South Bedroom (F4). Looking south west

Figure 33 - Detail of blocked fireplace in western wall of the South Bedroom (F4). Looking west

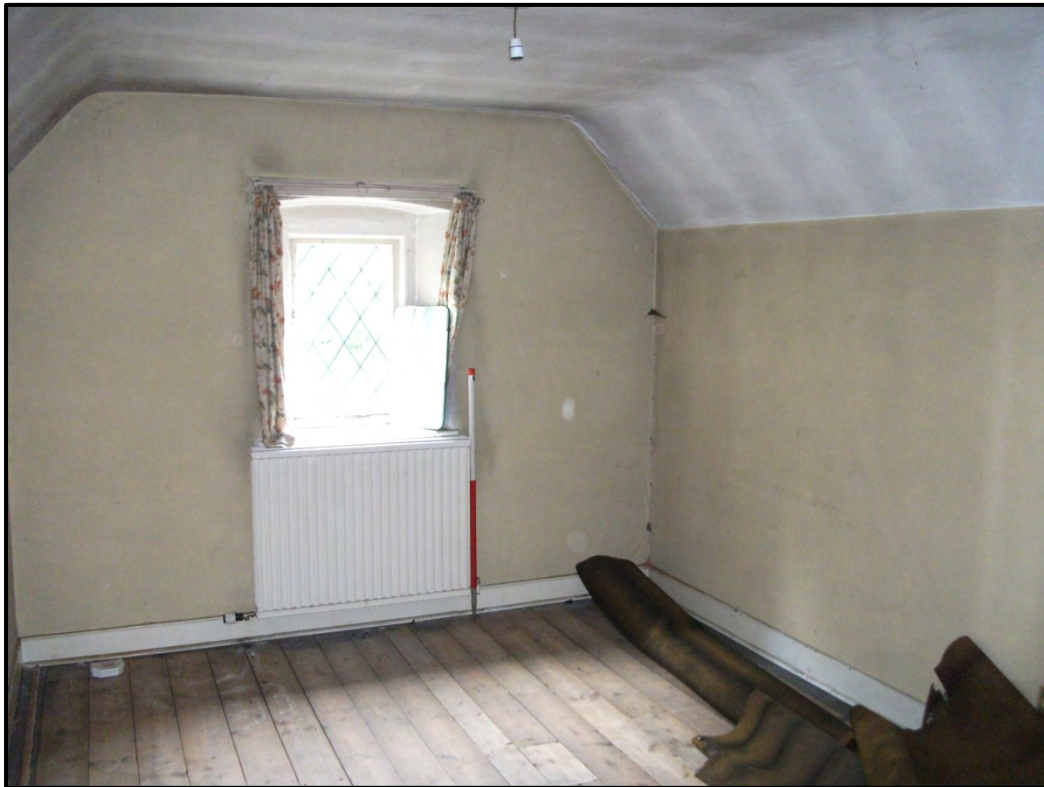
This room was rectangular in plan. It was accessed by a doorway in the southern end of the eastern wall. This door way had a square headed frame and a plain wooden door. The western wall had a single light window. This was lozenge leaded with a wooden sill and an arched stone lintel. The room had a moulded skirting board and the flooring was bare floor boards. The ceiling was plastered and curved along the north and south walls to allow for the roof above.

Figure 34 - View of western and northern walls of the Central Bedroom (F5). Looking north-west
