**Archaeological
Building Survey:**

The Garden Cottage,
Worsley Hall Garden
Centre, Worsley.
Final Version

Client: Peel
Investments (North)
Ltd.

Report No: 7/2012

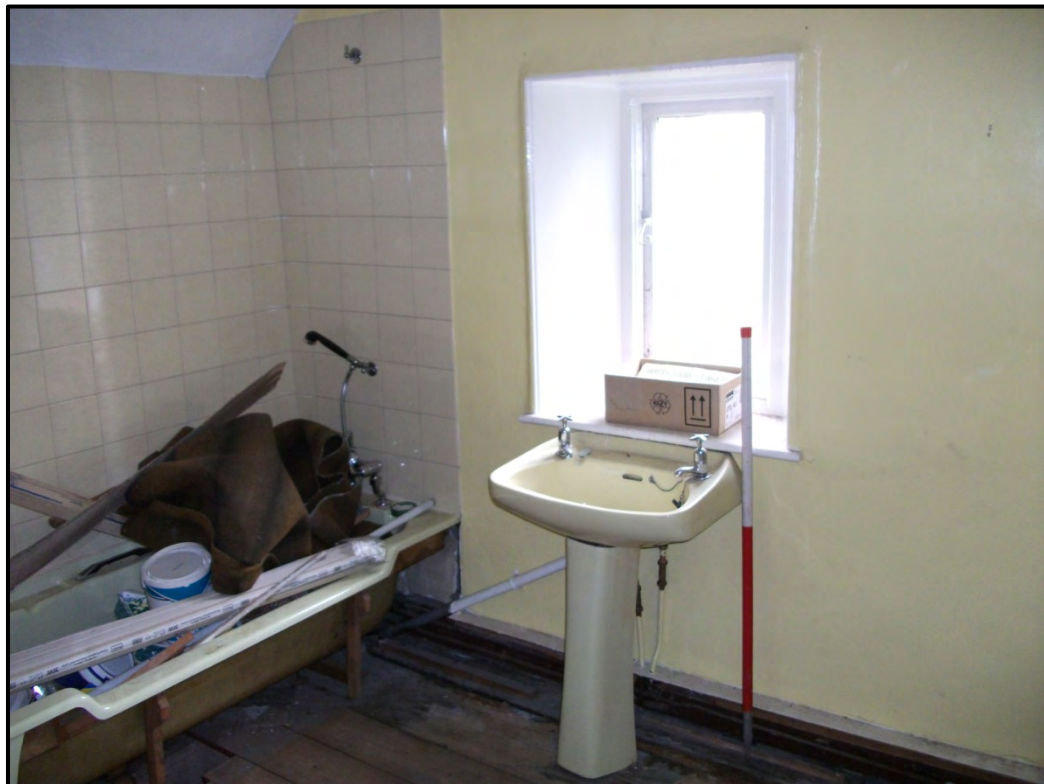
This room was rectangular in plan. The eastern wall had a single light window. It had a splayed wooden frame and sill. The bathroom had a suite including a bath and sink. The southern wall was tiled over the bath. The flooring was bare floorboards.

Figure 35 - View of the eastern wall of the First Floor Bathroom (F6). Looking north-east

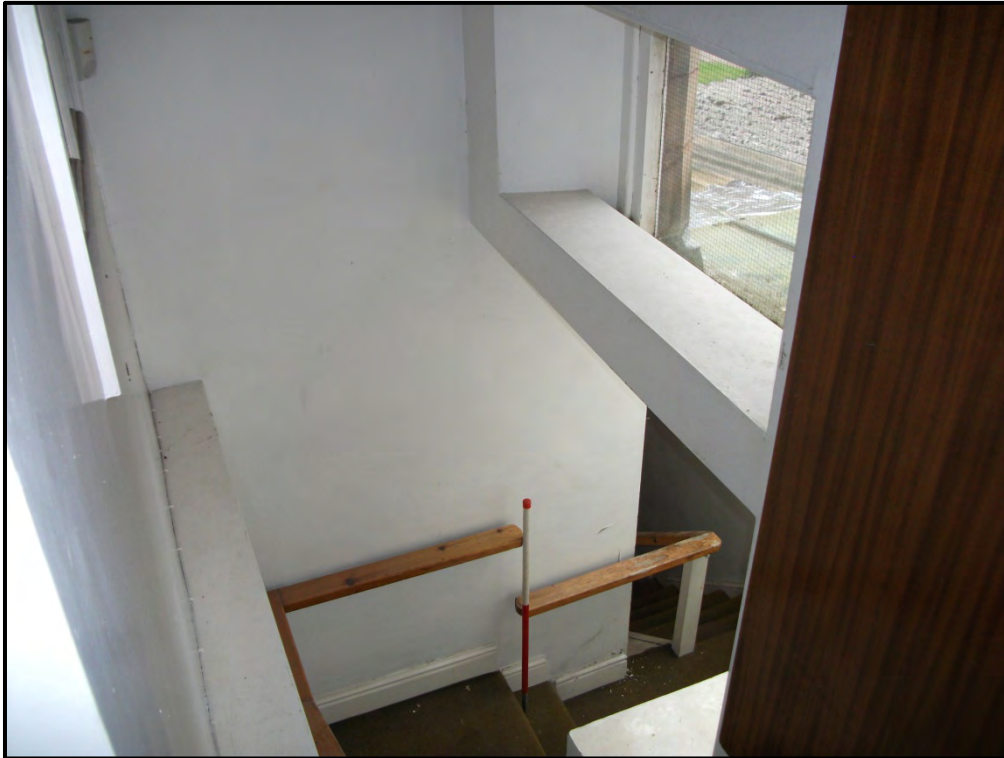
This stairwell leads up from hallway G14. Above the stairs in the northern wall of the stairwell was a single light window. The stairwell led onto the rear hallway, F8.

Figure 36 - View of the Upper Stairwell (F7). Looking north-west

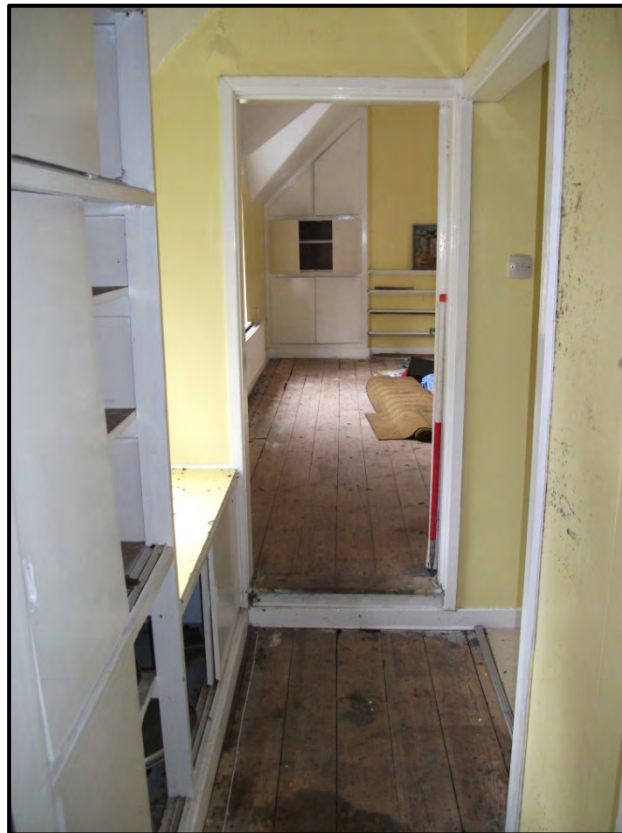
This room was rectangular in plan. Rooms F6 and F10 led off from it. Its western wall had a single light window. South of this window on the same wall was a cupboard with multiple shelves, on three levels. The hallway had bare floorboards. The ceiling was open to the roof and the beams and insulation of the roof space were exposed.

Figure 37 - View of first floor, Rear Hallway (F8) leading to the North Bedroom (F100 and Kitchenette (F9). Looking north

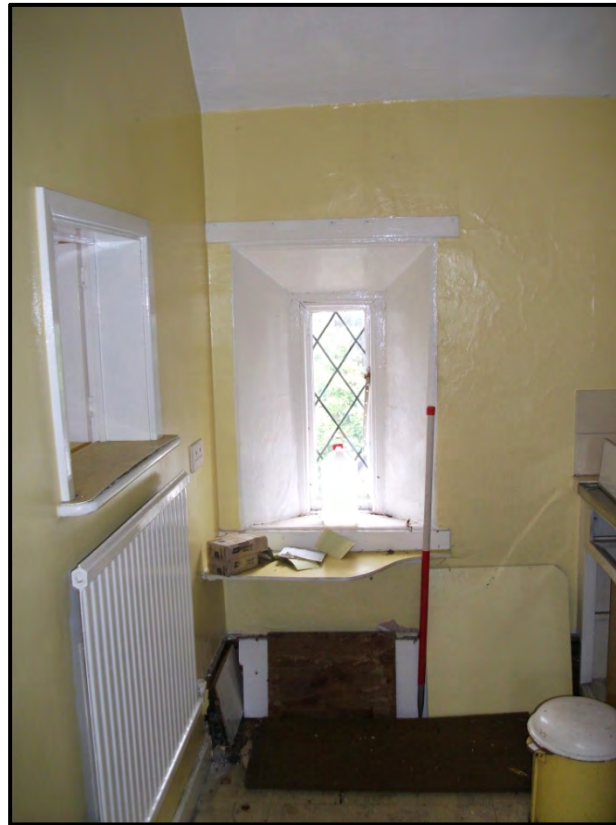
Figure 38 - Detail of window and serving hatch on the eastern and northern walls of the Kitchenette (F9). Looking east

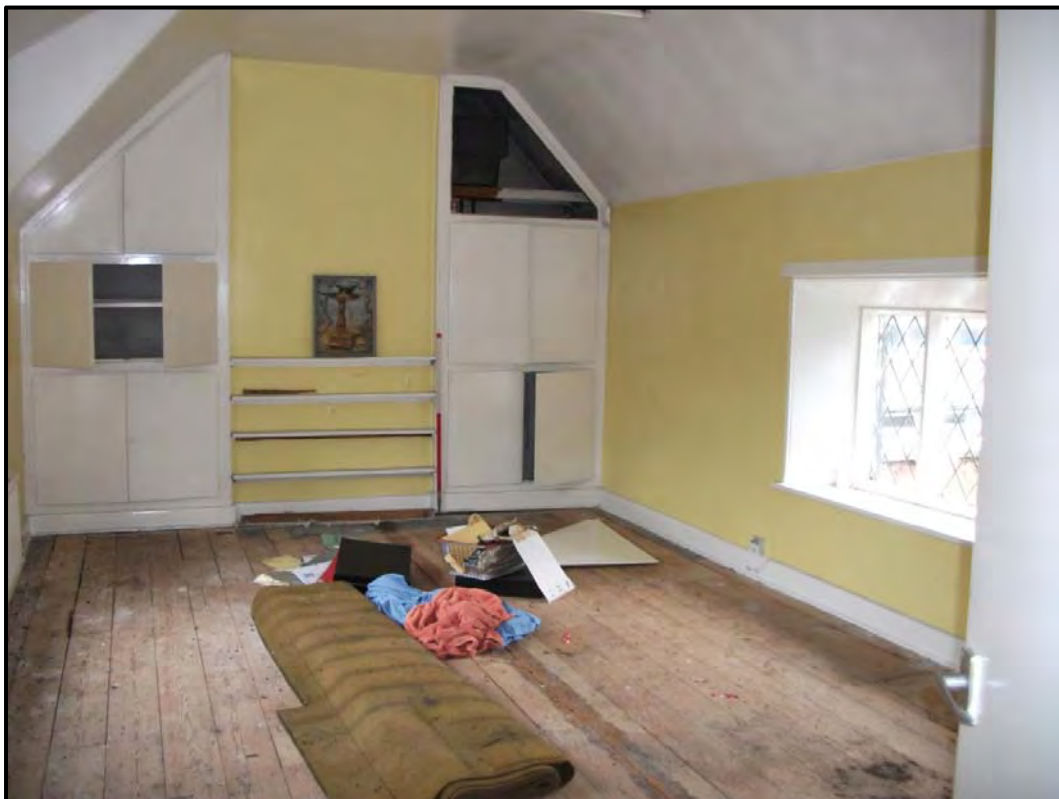
Figure 39 - View of the northern and eastern walls of the North Bedroom (F10). Looking north-east

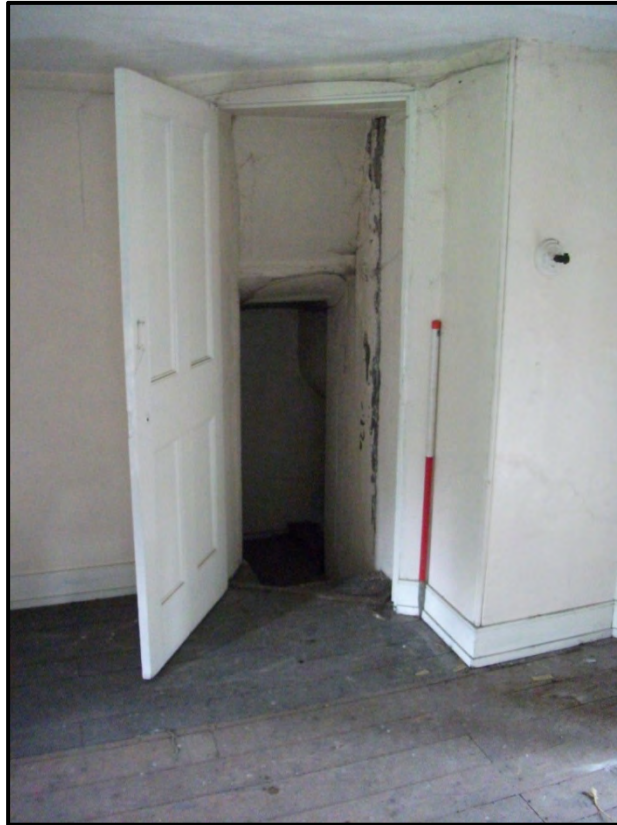
Figure 40 - View of the doorway in the north-western wall of the Octagonal Attic Bedroom (A1). Looking north west

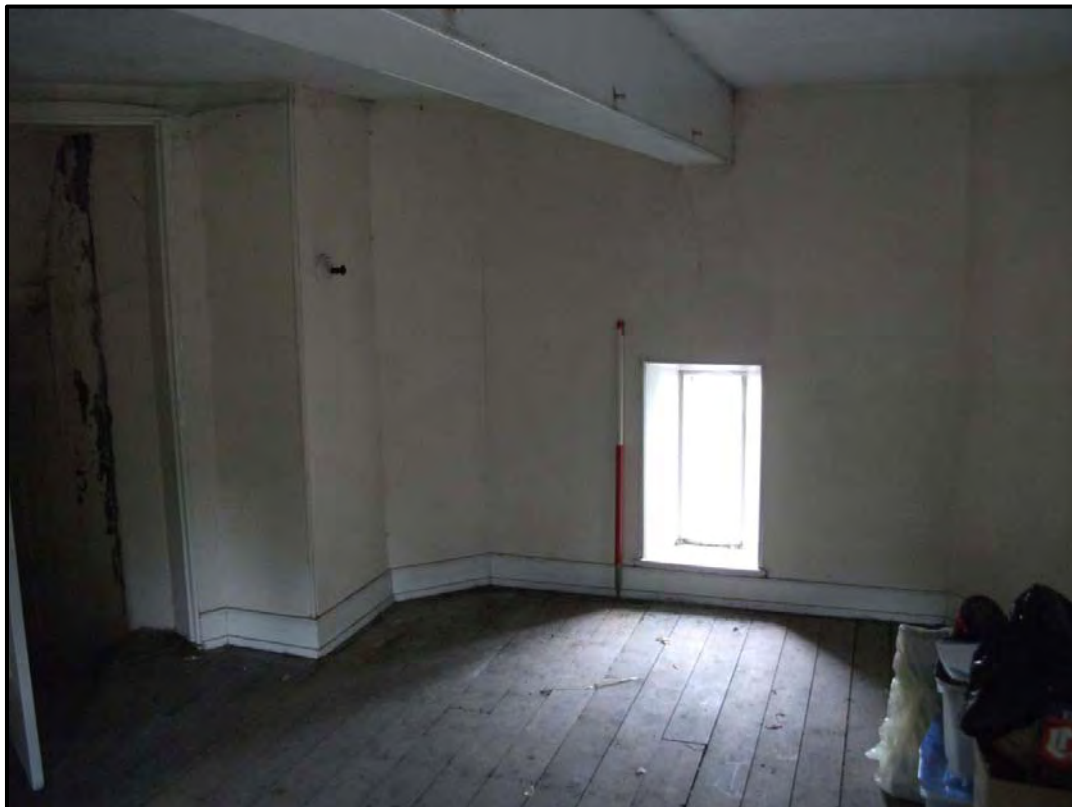
Figure 41 - View of the window in the northern wall of the Octagonal Attic Bedroom (A1). Looking north
