Site Location: Within the former Granada Television Estate, Water Street,

**Project:** The Factory, St Johns, Water Street, Manchester

**Internal Ref:** SA/2017/55

**Document Type:** Evaluation Report

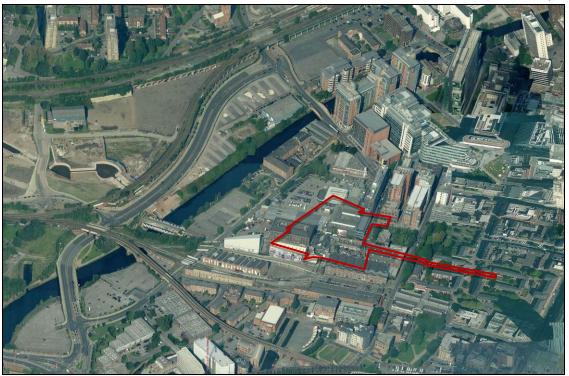
Plate 1: Recent aerial looking north, showing the Site Area boundary

The study area comprises a parcel of land at the southwest side of the former Granada Television Studios, St Johns, Water Street, Manchester (centred on NGR SJ 383030 397910). This lies within the south-western part of the St. John's Masterplan, on a site broadly bounded by the River Irwell and surface car parking (currently in use for construction of the Ordsall Chord) to the west, Grape Street and the Bonded Warehouse to the east, the Museum of Science and Industry (MSI) complex, including the 1830 Warehouse (Grade I Listed) to the south and Water Street and surface car parking to the north (Figure 1, Plate 1).

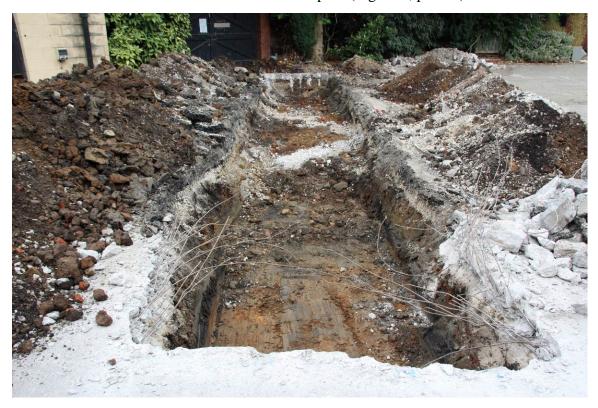
Plate 2: Trench 1 general shot, looking north

Trench 1 measured 20m by 1.8m and was aligned north/south. It had to be foreshortened at the north so as to not damage the Granada Studios entrance gate and at the south to avoid live services. It was excavated to a maximum depth of 0.8m and was located at the western side of the southwest car park (Figure 3, plate 2).

It was overlain by 0.13m of tarmac 101, laid onto a 0.12m bedding layer of stone 102 with 0.19m of mixed clay, cinder and brick rubble levelling material 103 below it. Beneath this was a 0.22m thick capping layer of compact clay 104 above 0.14m of mixed black ash, brick and cinders 105. This layer sat upon natural mid to light orangey brown sandy clay 106. At the south end of the trench an irregular 2.2m wide drainage cut 111 ran across the excavation containing two ceramic drain pipes. At its northern

end this was cut by a later service trench 110 which ran northeast/southwest and was filled with stone (Plate 3).

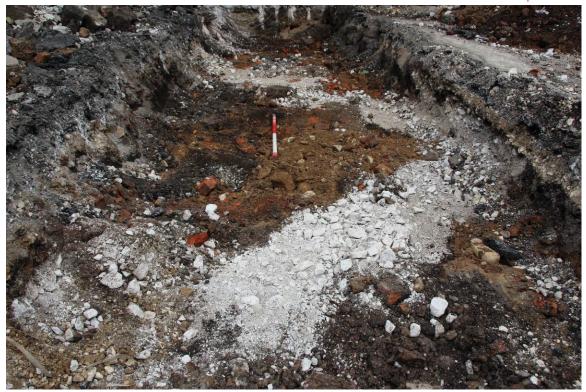
Plate 4: Service trenches in centre of trench 1, looking north

To the north of this another service trench 109, also filled with stone, ran northwest/southeast towards a lighting column at the northwest side of the trench. To the north of this an electricity cable 108 ran east/west. To the immediate north of the cable, at the north end of the trench was modern disturbance 107 within the entrance way to the studios (Plate 4).

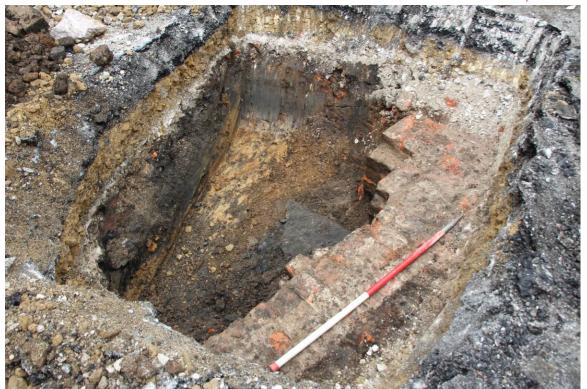
Plate 5: General shot of trench 2, looking west

Due to the restrictions of the fenced area and live services present it was decided that trench 2 was instead to be excavated as a trial pit which was able to be placed within a small blank area between the numerous services. It measured 2.1m by 2.0m and was excavated to a maximum depth of 0.98m. It was located within the fenced storage area in the southwest side of the northeast car park, in an area slightly outside the main boundary on the line of a proposed fence (Figure 4, plate 5).

This trench was overlain by 0.18m of tarmac 201 with 0.14m of yellow stone bedding material 202, which in turn sat upon 0.08m of compact white stone 203. Beneath this was 0.58m of mixed demolition rubble infill 204. At a depth of 0.53m a brick wall 207 was observed. This was built from hand-made bricks with white lime mortar and ran northwest/southeast. It had outer stretcher courses with two inner header courses and stepped out to the southwest at its northwest end. Visible partially sat upon this wall in the northeast trench edge were sandstone blocks 211 (Plate 6). The map evidence suggests that this was part of the original southwest canal wall.

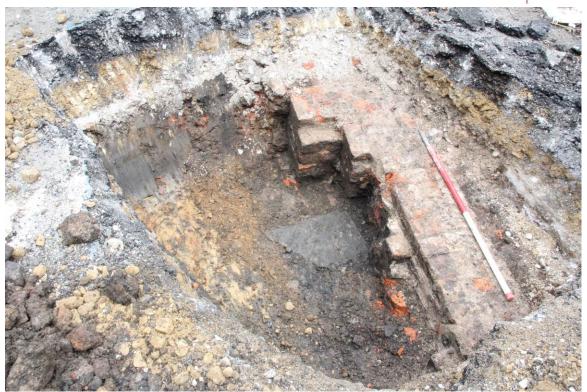
Plate 7: Fill of canal wall cuts and drain, looking north

At the southwest side of the wall was a construction cut for the canal wall which was filled with mixed clay and rubble 209 up against the wall. To the west of this fill the cut contained a reddy brown gravel 206, with finely puddled clay 205 to its west, probably the clay lining of the canal. A stone capped drain 208 ran across these deposits at the centre of the trench from the wall. To the southeast of the drain was a mixed fill of rubble, clay and gravel 210, which appeared to be a modern intrusion, possibly for one of the services (Plate 7).

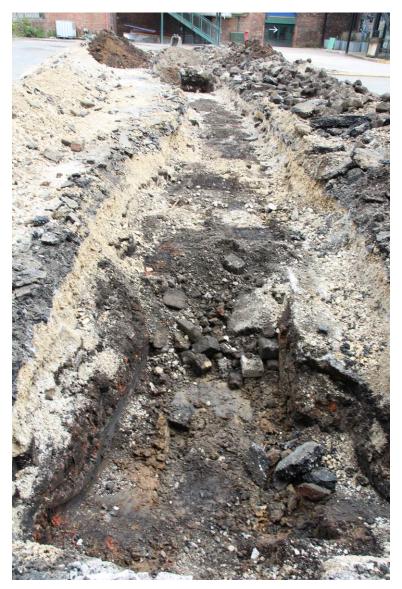
Plate 8: General shot of trench 3, looking southeast

Trench 3 measured 30m by 1.8m and was excavated to a maximum depth of 1.7m. It was aligned northwest/southeast and located in the centre of the southwest car park (Figure 5, plate 8).

This trench was overlain by 0.28m of tarmac 301 laid onto 0.18m of stone bedding material 302 with a 0.12m deep surface of stone sets 303 below it set in bitumen. Beneath this was mixed semi-compact demolition rubble and clay 204.

At the northwest end of the trench natural clay 309 was observed at a depth of 1.2m. A modern excavation 305 cut the natural for 2.3m along the centre of the trench. At the immediate southeast of this a service trench 306 filled with stone cut northeast/southeast across the trench. From this point the trench had to be narrowed for 7m to avoid a live gas main, part of the cut of which 307 was observed within the trench.

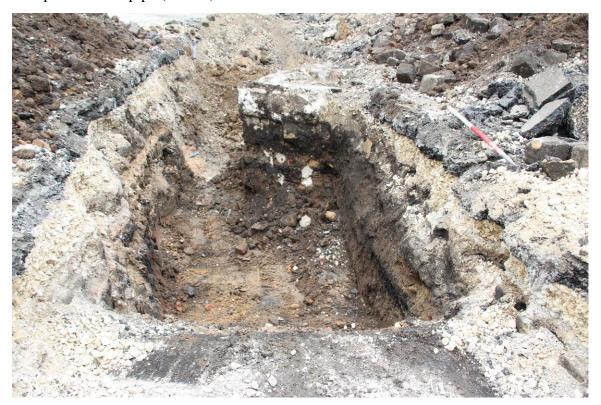
Plate 9: Southeast end of trench 3, looking southeast

At 15m from the southeast end of the trench was a northeast/southwest service trench 308 filled with stone. To the southeast of this the trench was then excavated down to natural clay 309 at a depth of 1.7m. A large concrete block 310 surrounding a drain cut into the trench at this point. At 4.5m from the southeast end of the trench was another

service trench 312 which cut through a deposit of yellow sand 311 containing a modern blue plastic water pipe (Plate 9).
