Archaeological Post-Excavation Assessment

Globe and Simpson,
Old Granada Studios,
Quay Street,
Manchester

Technical Report:
Katie Harvey and
Graham Mottershead

Report No:
SA/2019/59

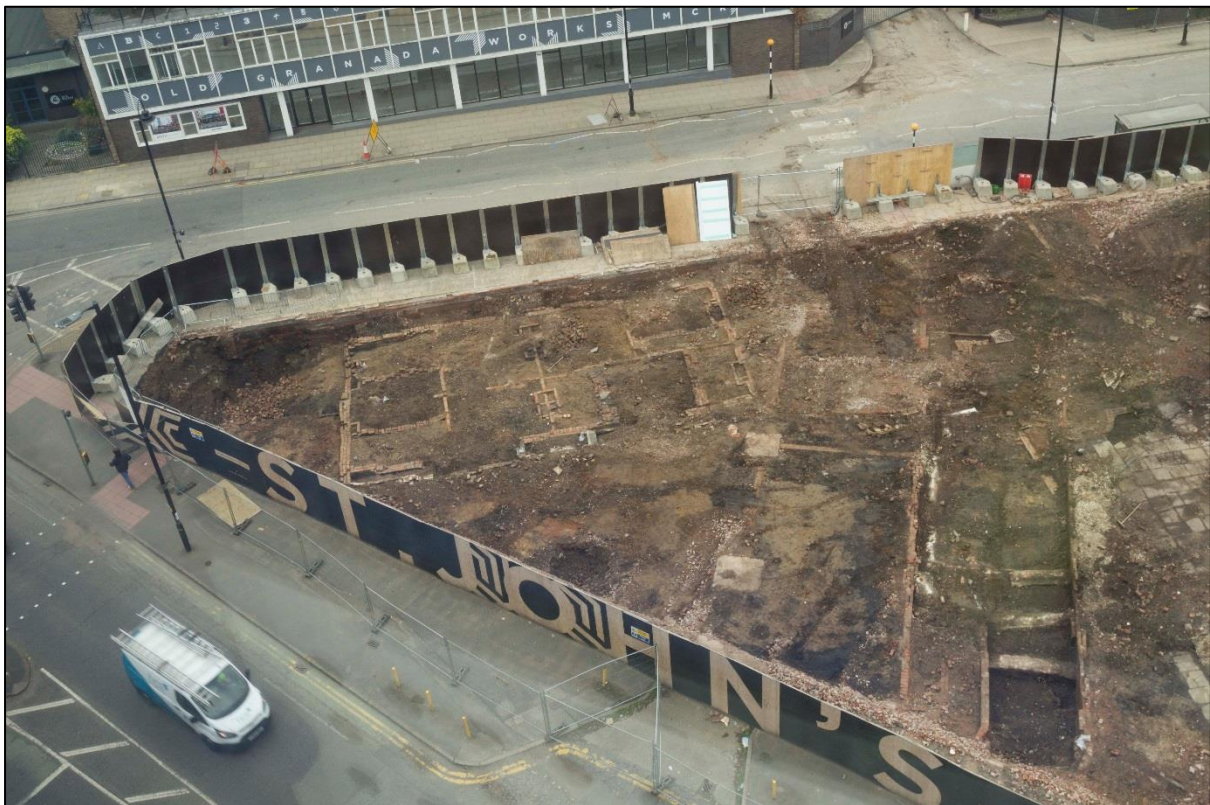
Plate 4: View of the eastern tip of the excavation area showing 19th-century structural remains and garden features, looking south

Natural sands and gravels were encountered within discrete parts of the excavation at a depth of 0.5m - 1.4m. Natural deposits were overlain by modern demolition rubble accumulated during the demolition of the former Globe and Simpson building (Plate 4).

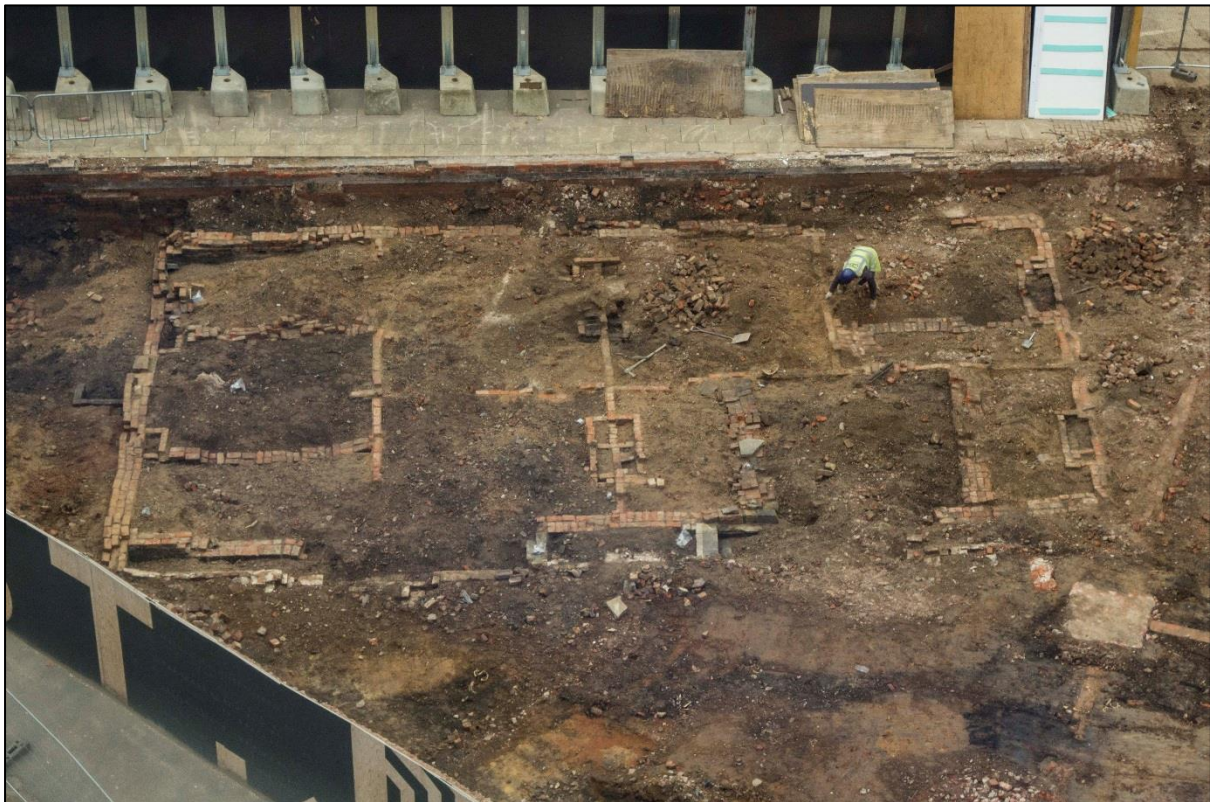
Plate 5: Houses 1-4 from east to west, looking south

Following the removal of modern demolition rubble, the footprint of four terraced houses was exposed and are likely to represent a block of terraced dwellings first depicted on the Ordnance Survey map of 1891, Phase 4 (Plate 5; Figure 19). The original phase of building was constructed in handmade bricks and sandy lime mortar with later modification bonded by black mortar. The installation of copper boilers, surviving in two of the cellars, may imply that they were constructed and inhabited after legislation in 1853, which sought to ban cellar dwellings and prior to the Artisans and Labourers Dwellings Improvement Act of 1875. Access into the cellars was provided from the front and rear of the properties, with no evidence of internal staircases up to the ground floor, reinforcing the notion that they formed a separate

The four dwellings have been named respectively as Houses 1, 2, 3 and 4 from east to west. House 1-4 were demarcated to the south by wall **023** and to the north by wall **012** and stairwell corridor **028**, implying that the four dwellings were contemporary. Evidence of staircases to the rear of all four properties contradicts the Ordnance Survey mapping of 1891, which only depicts one set of stairs, situated to the rear of House 3.

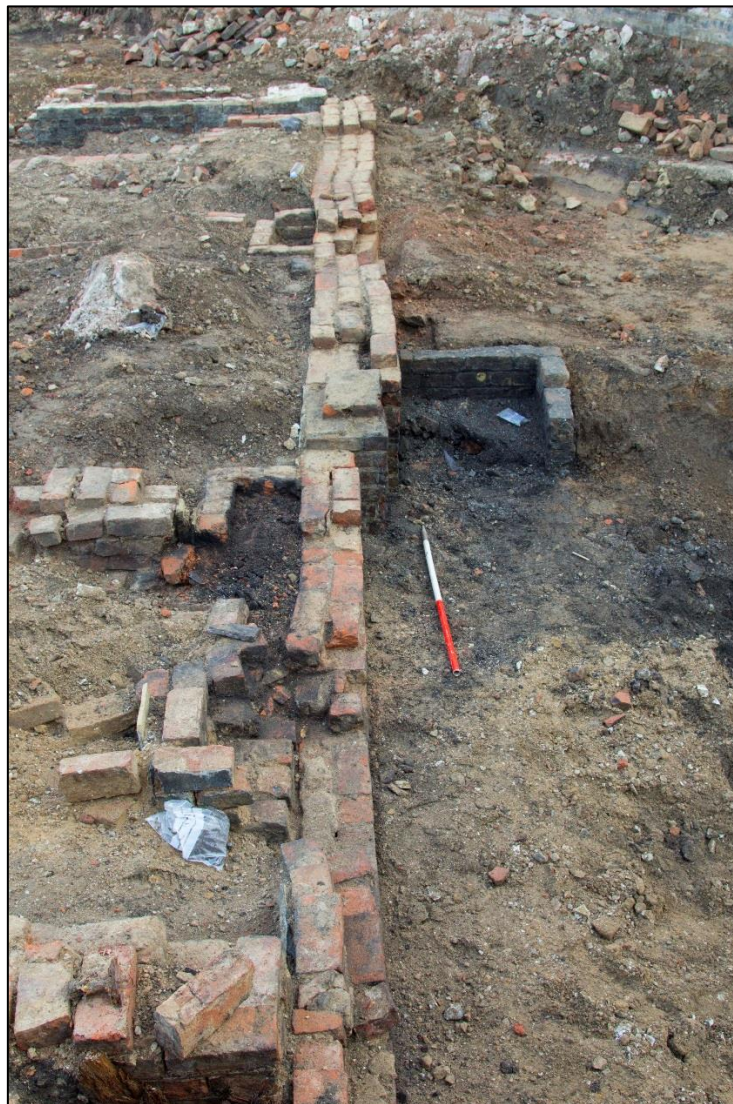
*Plate 6: Eastern gable-end wall **003** of House 1, looking north. Scale 1m.*

House 1 was demarcated to the east by gable-end wall **003** measuring 3.32m by 0.23m-0.36m, aligned north/south (Plate 6). The majority of wall **003** comprised handmade bricks bonded with sandy lime mortar, however, signs of later alterations were evident in the addition of wall **004**. Wall **004**, aligned east/west, was keyed into **003** in the eastern corner and was bonded with black ash mortar, implying that it had been constructed at a later date. A third skin of bricks **005** reinforced the northern half of wall **003** and was abutted by L-shaped wall **001**. Wall **001** comprised handmade bricks bonded with black ash mortar and measured 0.83m by 0.63m by 0.11m. Presumably, wall **001** formed a small outdoor coal store, which was filled by black cinder **002** that contained 20th-century clay pipe and pottery remains.

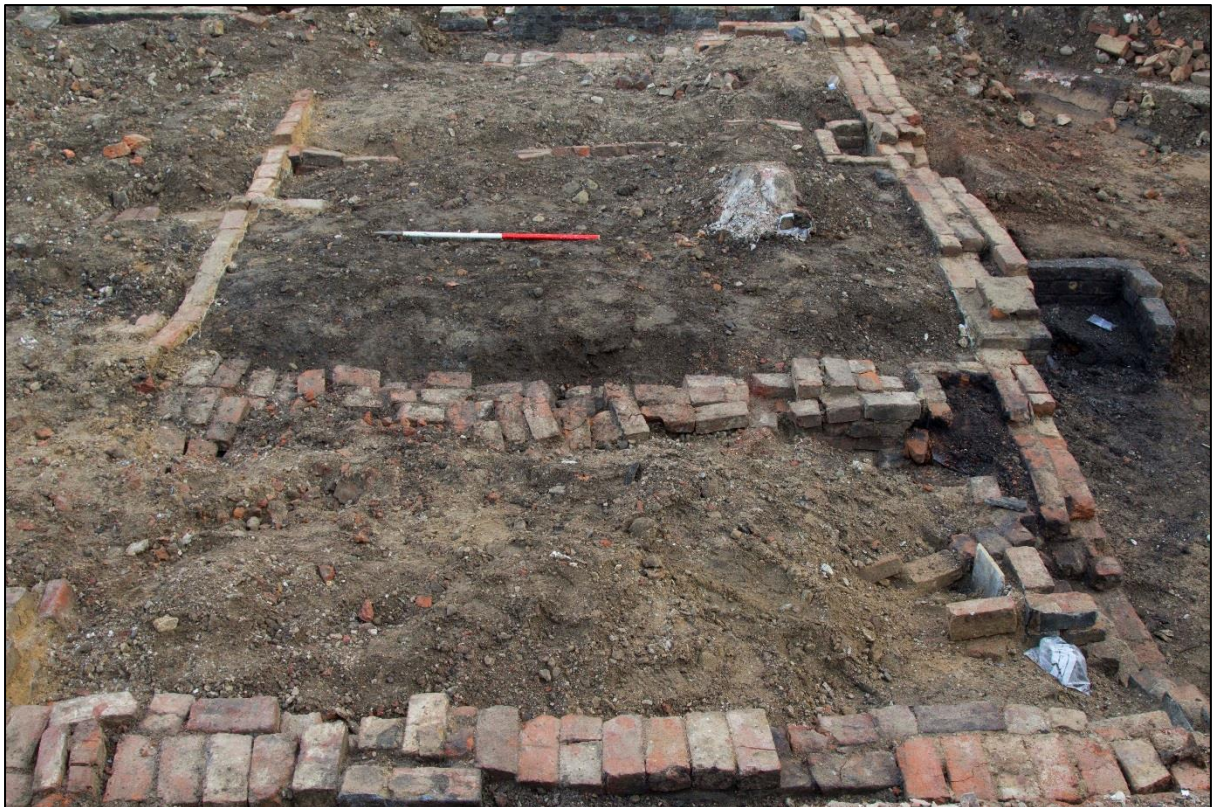
*Plate 7: House 1 showing **008**, **010**, **013**, looking north. Scale 1m*

The front and back rooms of House 1 were divided by single skin wall **013**, measuring 3.60m by 0.11m wide (Plate 7). Fireplaces **006** and **011** were constructed against the western side of wall **003**. Fireplace **006** was situated in the front room and comprised a single skin of handmade bricks bonded with sandy lime mortar measuring approximately 1.40m by 0.38m. Fireplace **011** was located in the back room and was

Two strange walls **008** and **010** were found crossing both the front and back rooms. These two walls abutted the dividing walls between House 1 and House 2 to the west and abutted the fireplaces to the east. The bricks were handmade (no mortar visible) and were arranged haphazardly in no particular pattern, three to four courses wide. Both walls measured 3.25m in length, aligned east/west (See Houses 3 and 4 for more detail.).

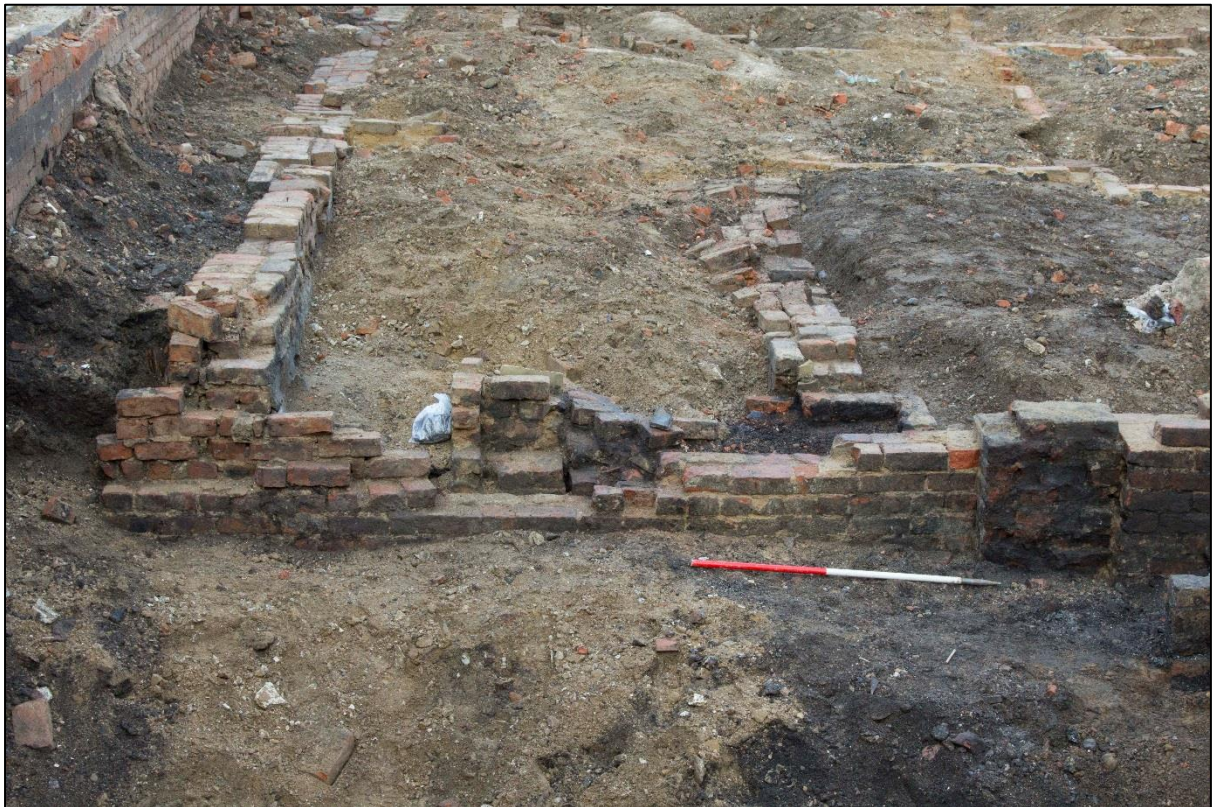
*Plate 8: Eastern gable **003** at the front room of House 1, looking west. Scale 1m.*

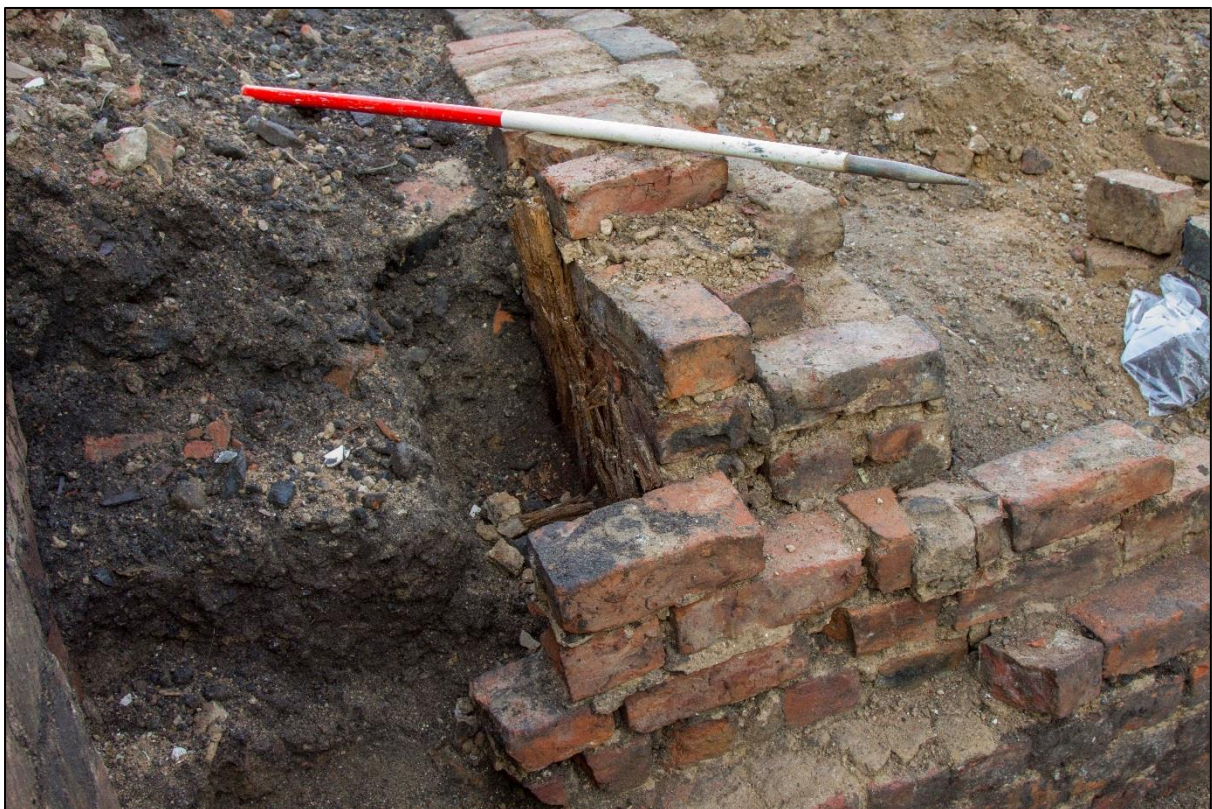
*Plate 9: Detail of House 1 eastern gable-end wall **003** and wall **023**, looking northwest. Scale 1m.*

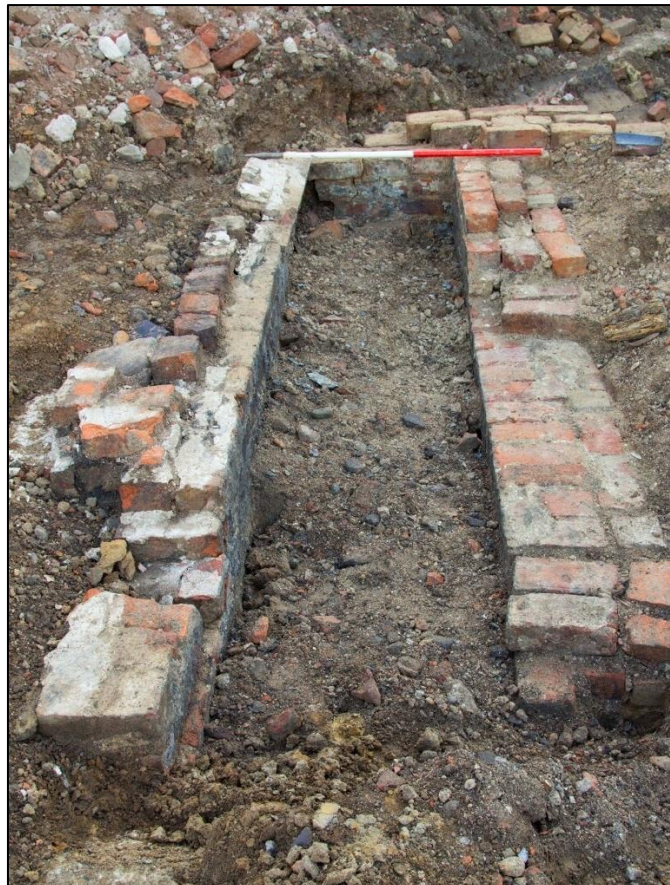
*Plate 10: Rear wall **012** of House 1 on the right and the stairwell **028** on the left, looking east. Scale 1m.*

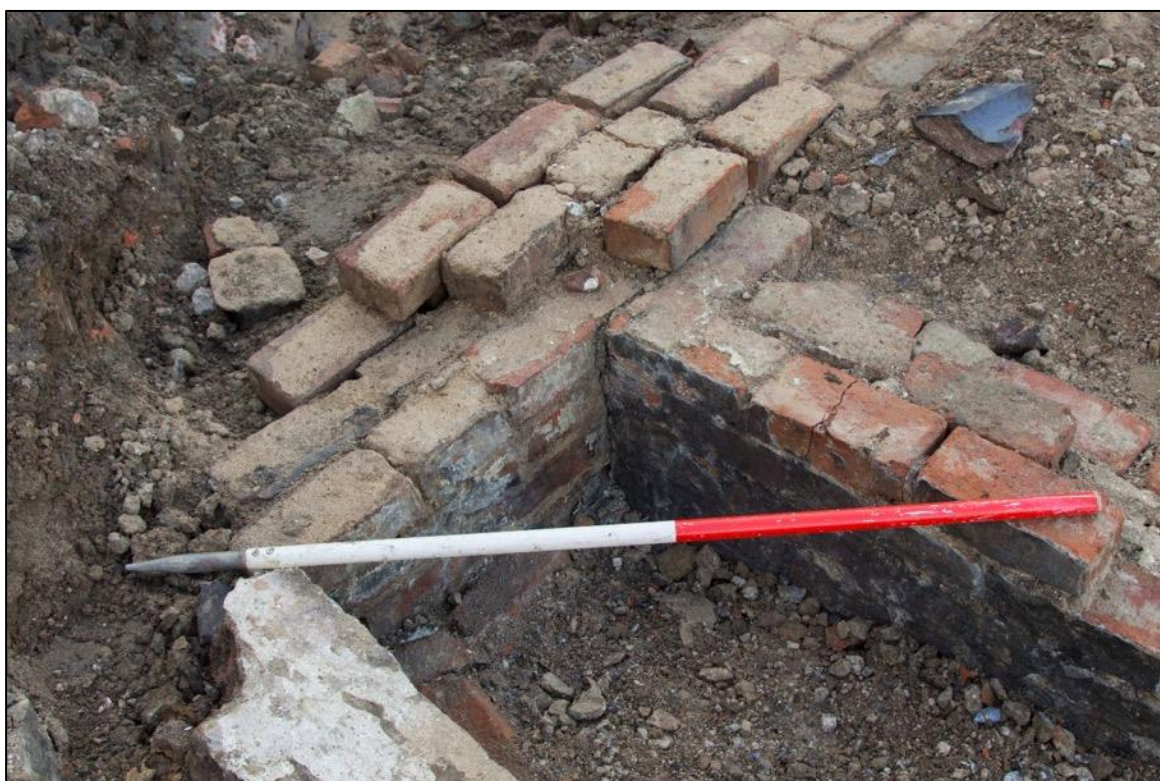
*Plate 11: Detail of rear wall **012** abutting eastern gable-end wall **003**, looking southeast. Scale 1m.*

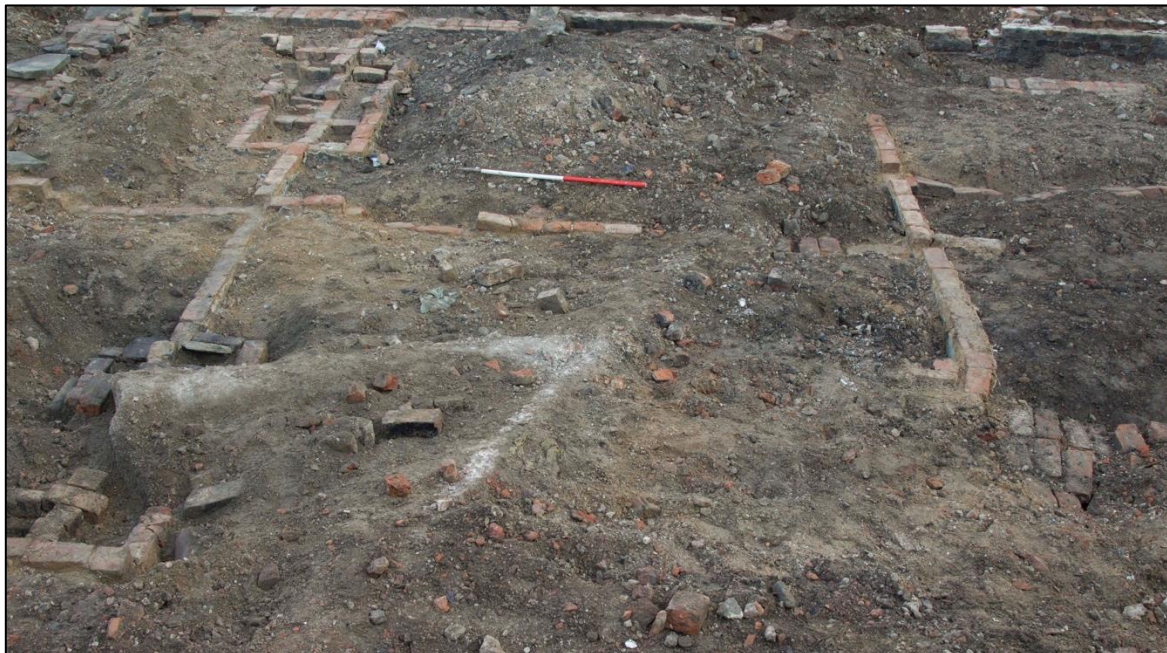
Plate 12: House 2, looking north. Scale 1m

Single skin walls **014** and **015** formed a partition between House 1 and House 2. Wall **014** measured 3.10m long and separated the back rooms, whilst wall **015** measured 4m long and separated the front rooms. The remains of walls **014** and **015** showed that the front cellar rooms, and no doubt the front rooms of the floors above, were larger than the back rooms (Plate 12). Both walls had lime plaster on each side, measuring approximately 1cm thick.

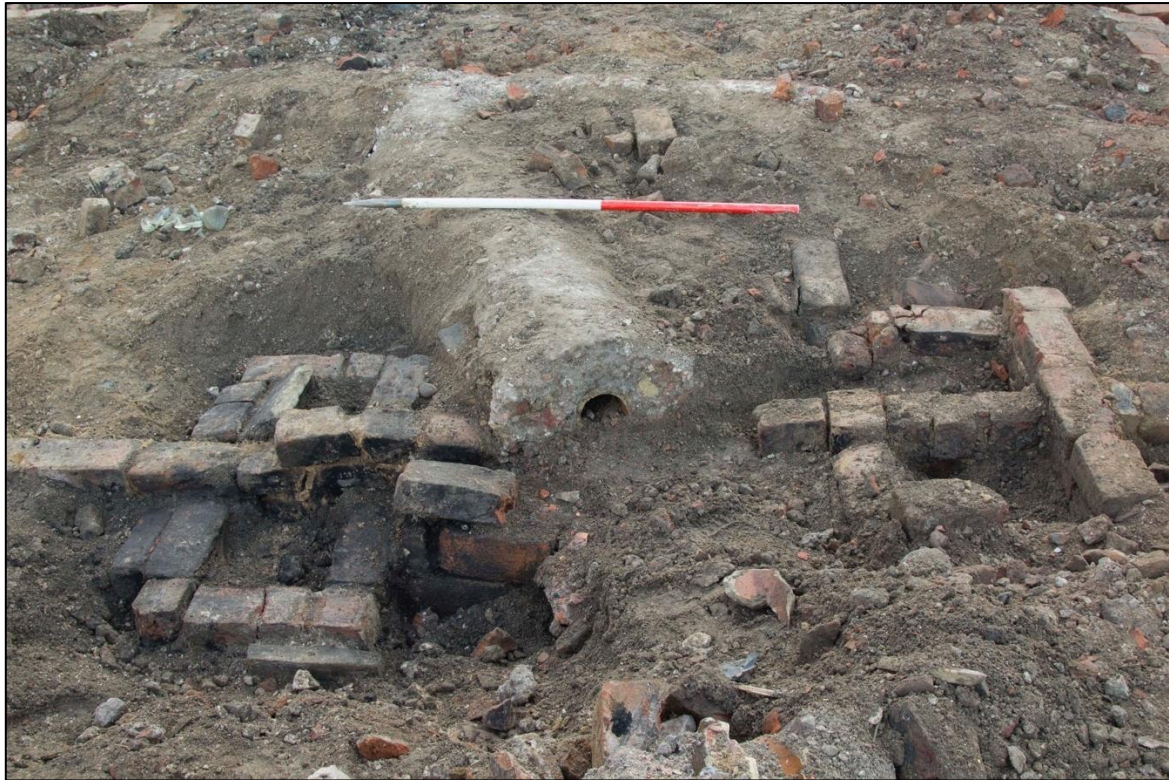
*Plate 13: Fireplace **020** truncated by a concrete encased drain pipe, looking east. Scale 1m*

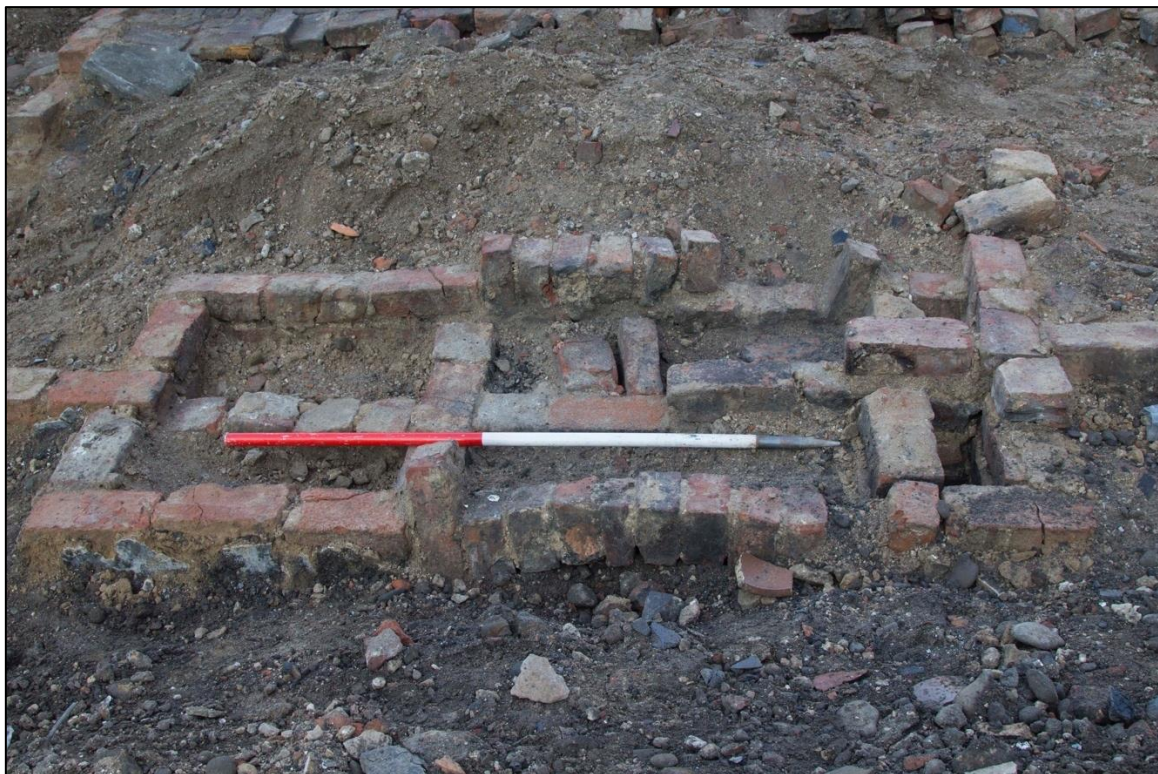
*Plate 14: House 2 back room fireplace **018** brick arch lintel detail, looking west. Scale 1m*

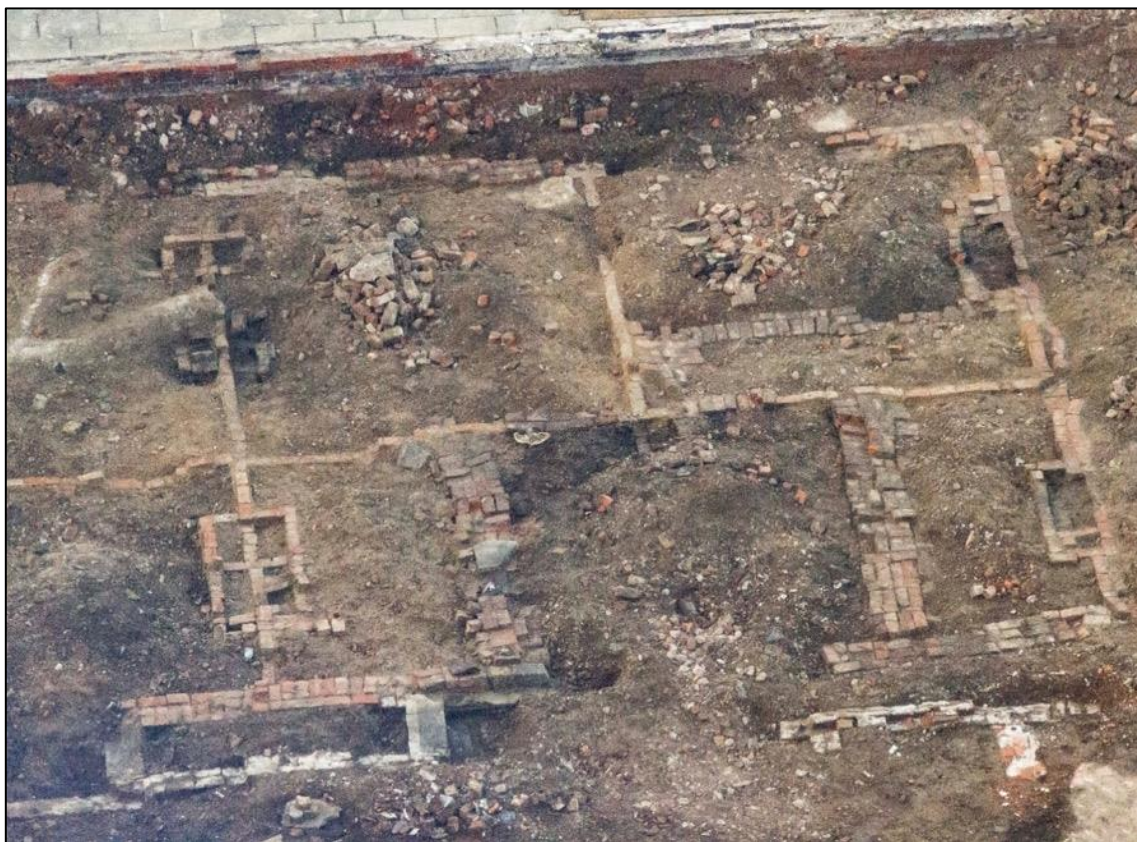
Plate 15: Houses 3 & 4 as seen from above prior to excavation (taken from the NCP car park, looking south).

House 3 was fully excavated in order to better understand the construction of the houses and the living conditions and habits of its former occupants (Plate 15 shows the house prior to the removal of rubble **071**). Demolition rubble **071** was removed

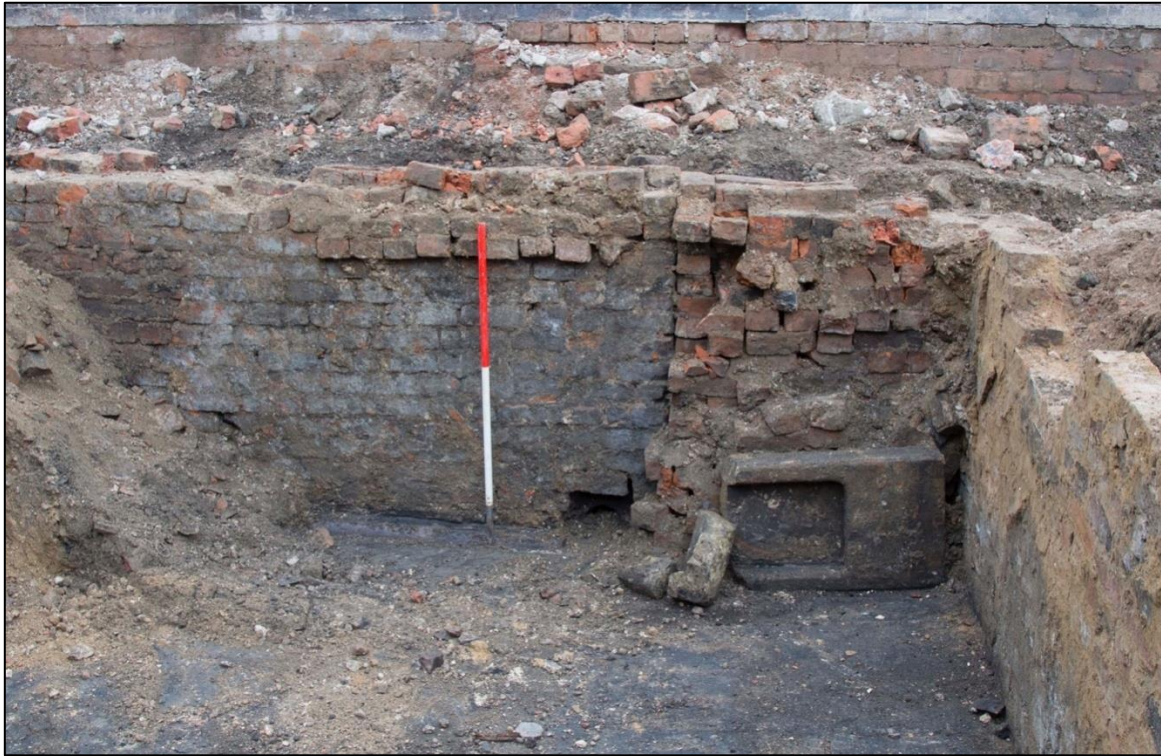
*Plate 16: Front wall **023** of House 3 showing bricked-up doorway and bricked-up cellar light, looking south. Scale 1m*

At the base of wall **023**, set into the stone floor, were the remains of a shallow drainage channel, which led into a circular drain set through a square hole that passed through wall **023** (Plate 16).

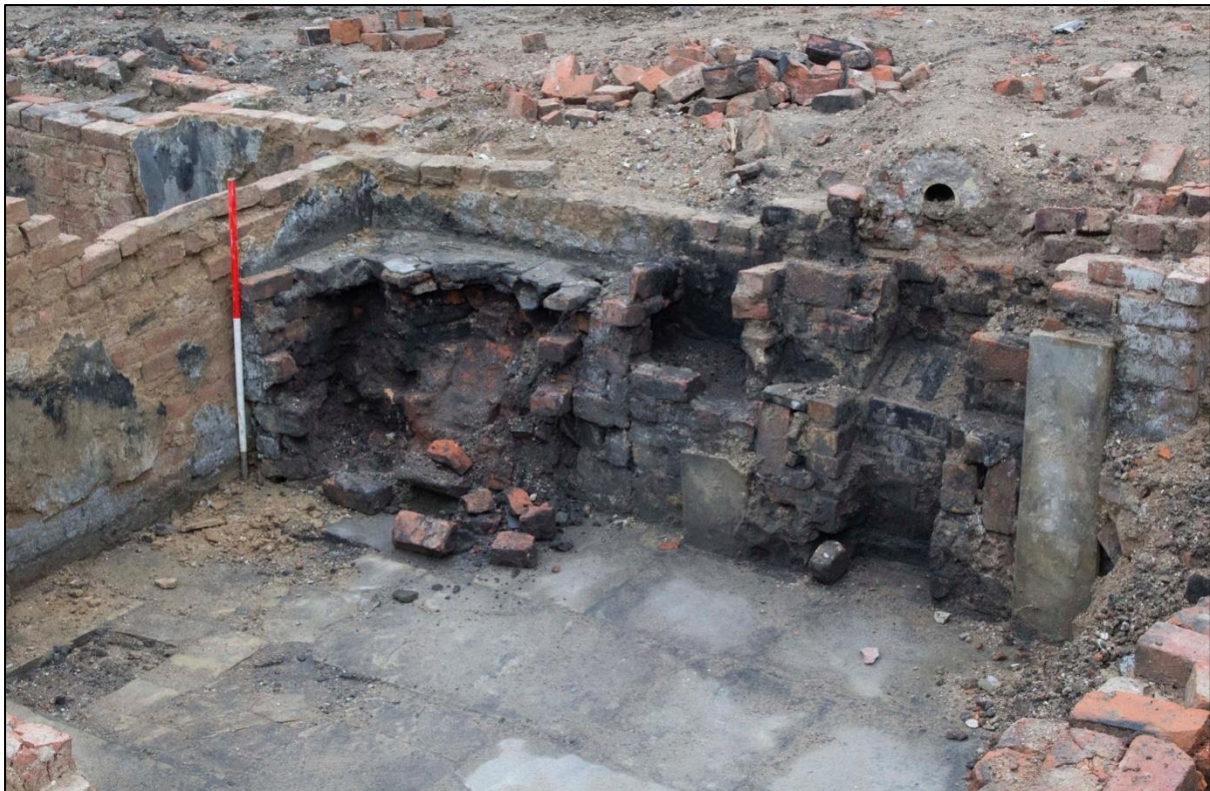
*Plate 17: fireplace and boiler **021** against the eastern wall **019** in the front room cellar of House 3, looking northeast. Scale 1m*

Eastern wall **019** comprised the remains of a fireplace and boiler **021**, the copper boiling pot was not present but a recess in the upper surface revealed where it had been as did a curvature of brickwork below within the structure. Boiler **021** measured 1.38m by 0.72m wide and had been constructed against the northern side of the fireplace, comprising two brick walls, one against the fireplace and one against the dividing wall, both measuring 0.23m wide, and survived to their original height of 0.90m, capped with a stone surface. The majority of the bricks were wire-cut (230 by

Two original brick-cheeks of the fireplace (measuring 1.90m by 0.37m by 1.20m) could be identified by sandy lime mortar used to bond the brickwork, which had been clad with stone. The presence of black mortar indicated that the interior structure had been modified, possibly during the installation of boiler **021**. The remains of both structures were blackened and soot stained. (Plate 17).

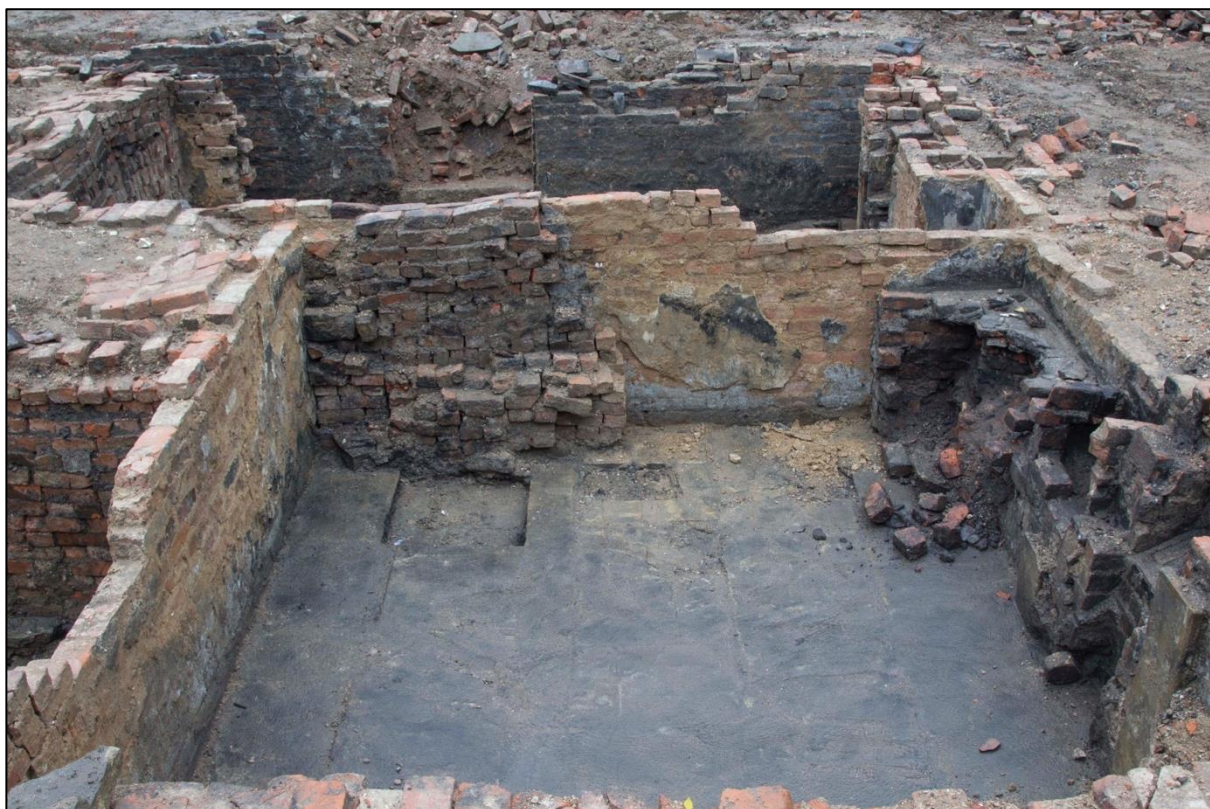
*Plate 18: Dividing wall **022** with bricked-up doorway and western party wall **024**, looking north.*

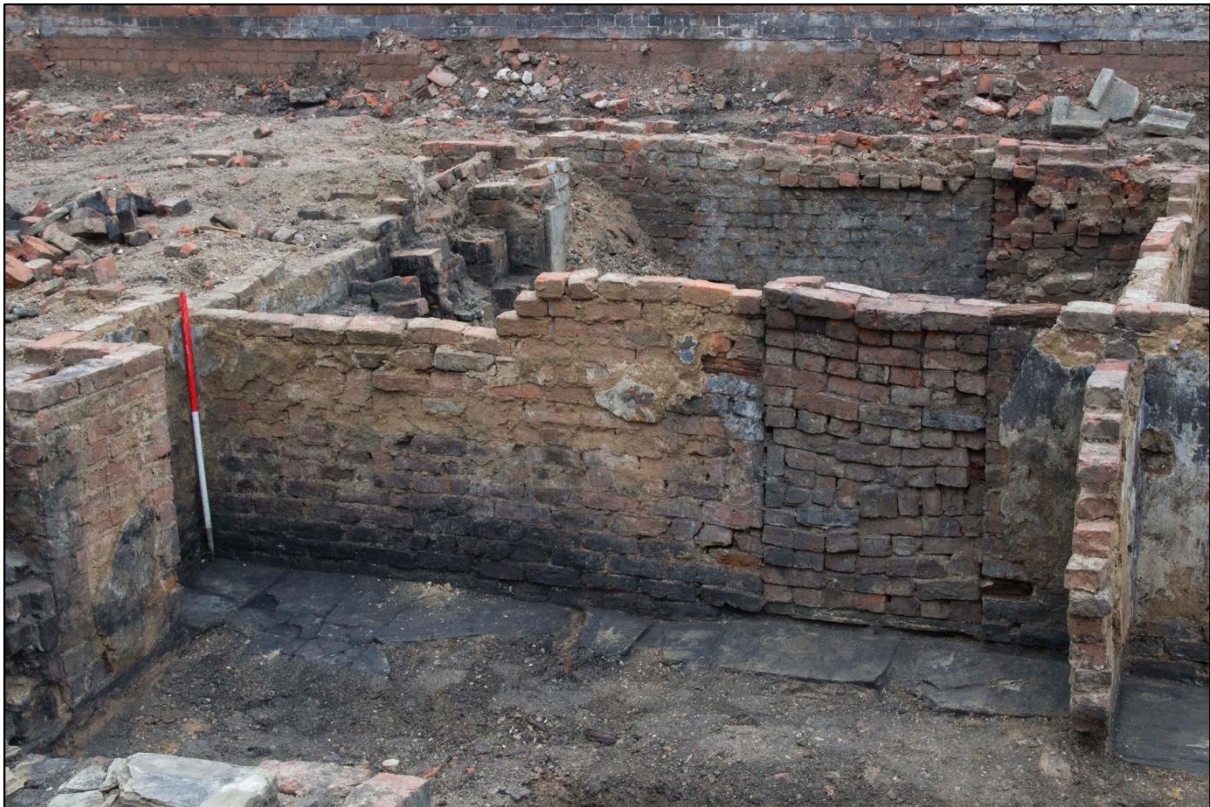
*Plate 19: Dividing wall **022** and bricked-up doorway as seen from the back room of House 3, looking southeast. Scale 1m*

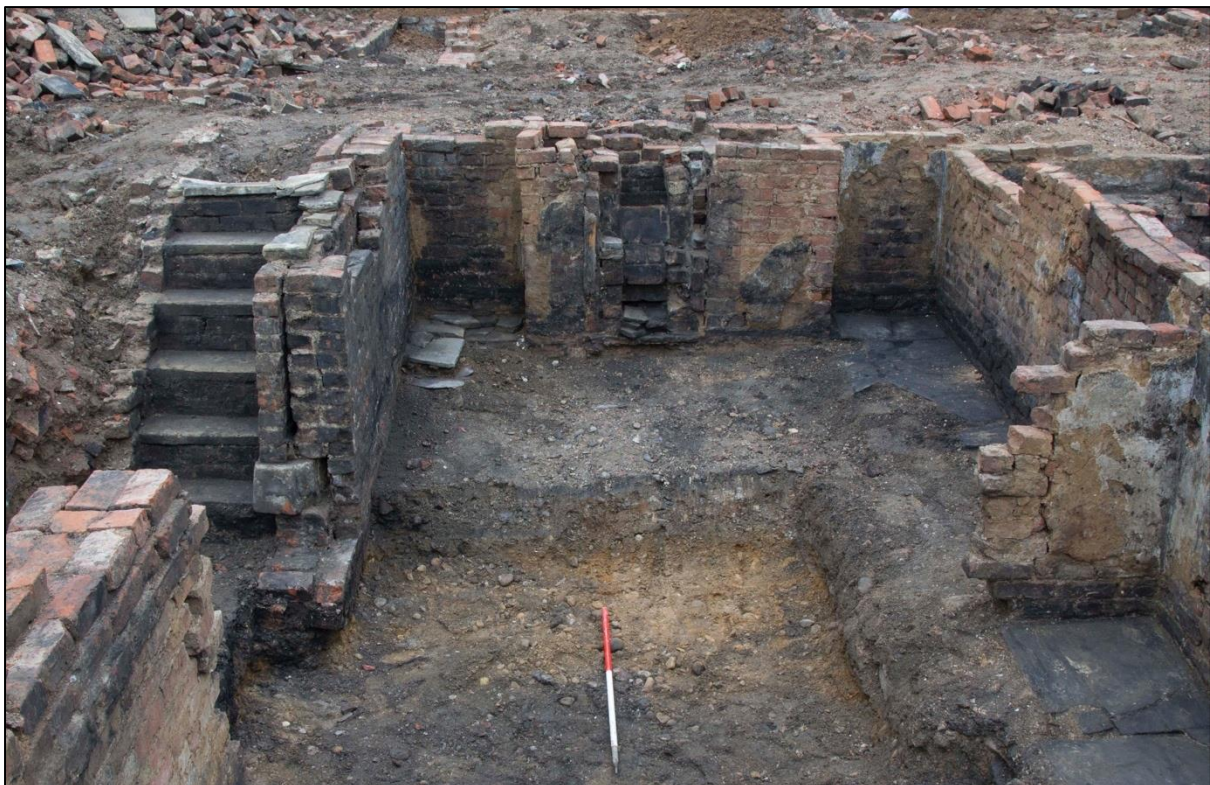
*Plate 20: Back room of House 3 showing fireplace **083**, staircase **031** and remnants of dividing wall **026**, looking east. Scale 1m*

Stairwell **031** was built into wall **012** and comprised six stone steps aligned east/west. Staircase **031** also provided access into the cellarage of House 4, situated to the west of House 3. Each step measured 0.69m wide with a tread depth of 0.24m, capped with a stone flag measuring 0.06m thick. The stone flag was positioned above two brick-courses, with the height of each step measuring 0.24m. The steps appeared to be original comprising handmade brick bonded with sandy lime mortar.

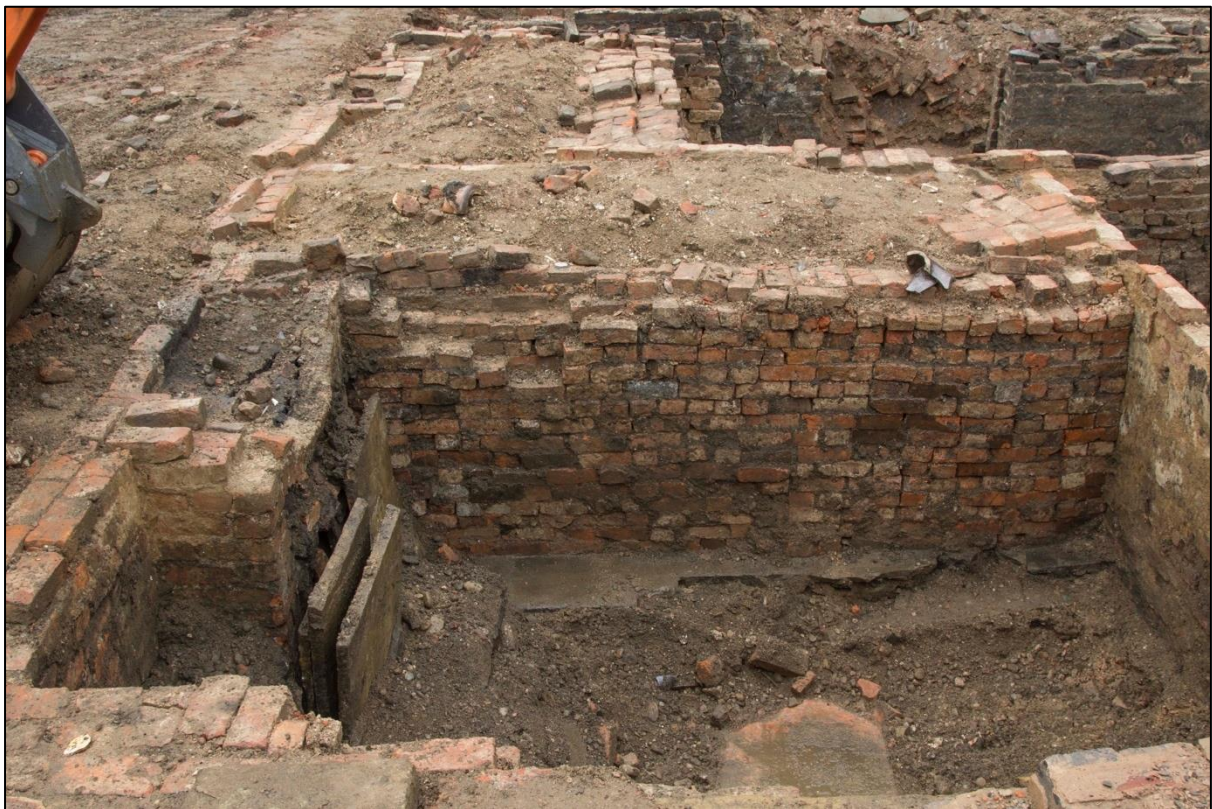
Plate 21: Wall (036) in the front room of House 4 prior to removal, looking north.

During the excavation of the front room, demolition rubble was removed from the southern side of wall **036** in an attempt to understand its function and to retrieve any dating evidence (Plate 21). Wall **036** abutted the eastern end of wall **024**, the northern end of fireplace **038** and the western end of wall **027**. Wall **036** was removed by hand in order to preserve the original walls of House 4, which revealed that the entire northern end of the front room was filled by stacked bricks with no visible trace of mortar. Wall **037** initially appeared as a surface but on further investigation was actually part of the stack of stored bricks.

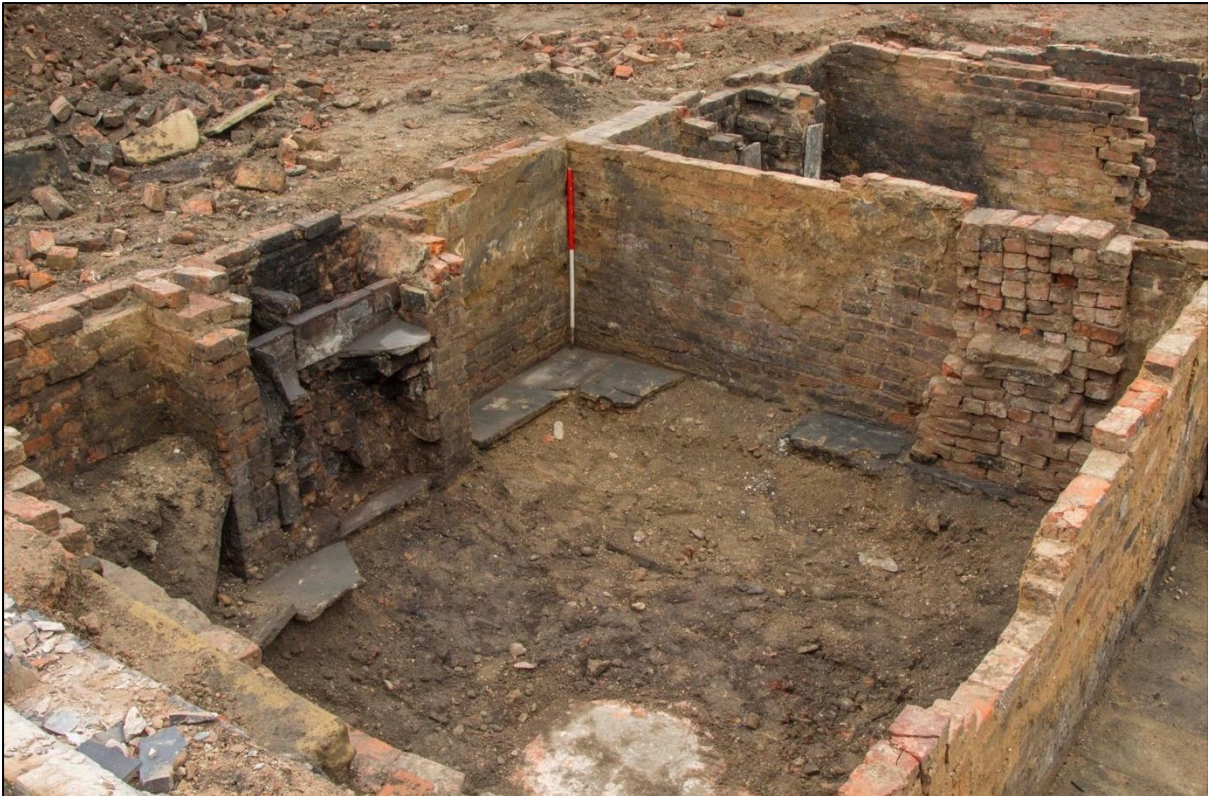
*Plate 22: Fully excavated remains of the front room in House 4 showing fireplace **038** on wall **027**, looking northwest. Scale 1m*

Removal of the stacked bricks exposed the remains of a blocked-up doorway (0.82m wide), originally connecting the front and back rooms. The blocked doorway was positioned within single skin partition wall **025** (Plate 22). Wall **025** measured 3.68m and survived to a height of 1.38m with evidence of plaster measuring 0.02m thick and paint. Remnants of a stone flagged floor survived around the edges of the room and below the fireplace and doorways.

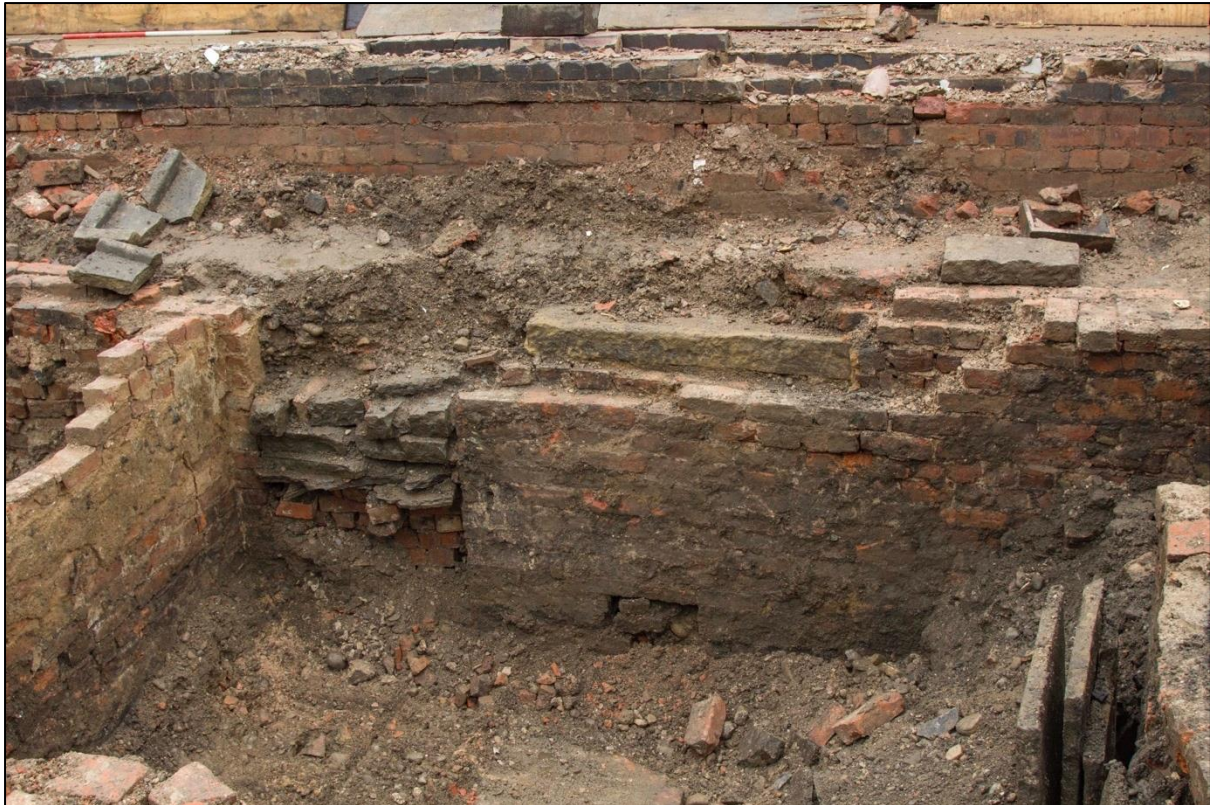
*Plate 23: Wall **023** with blocked-up doorway, looking south.*

Wall **023** demarcated the front of House 4 and survived to a maximum height of 1.50m. In the centre of wall **023**, were the remains of a stone sill measuring 1.24m long and 0.13m thick, presumably forming the bottom of a cellar light in the front stairwell (Plate 23). The entrance into the cellar measured 0.83m wide however, it had been blocked-up by roughly laid bricks situated below a layer of randomly positioned stone blocks. At the base of the blocked doorway were the remains of a door threshold.

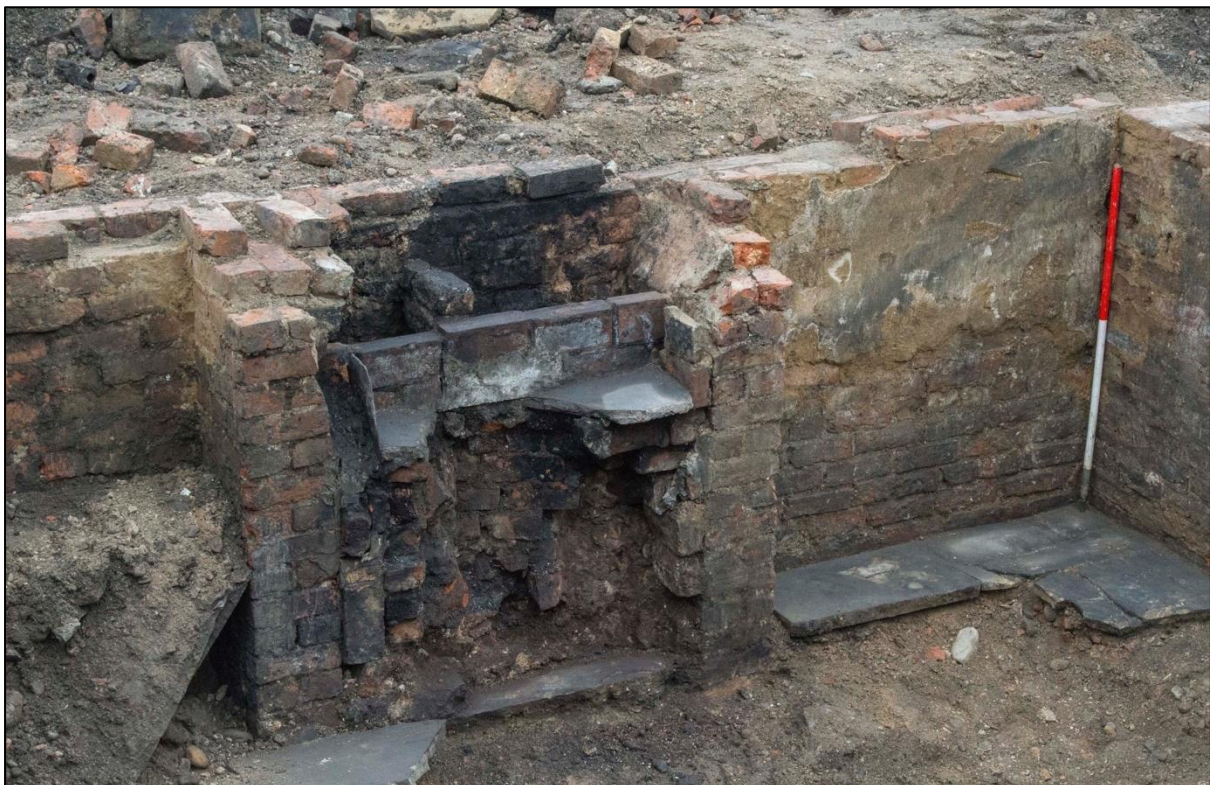
*Plate 24: Fireplace **038** detail, looking northwest. Scale 1m*

Fireplace **038** was built against western wall **027**, measuring 1.55m by 0.46m and survived to a height of 1.25m. The remains of fireplace **038** comprised original cheeks indicated by hand-made bricks bonded with sandy lime mortar and a brick arch lintel, which collapsed during the excavation. The interior of fireplace **038** had been modified in order to hold a boiler indicated by the presence of black ash mortar and a stone slab with curved recess where the copper pot would have been positioned (Plate 24). On top of the stone slab, two courses of bricks laid stretcher-on-edge spanned the interior. These brick were visually different being more purple in colour and measuring 250 by 110 by 85mm. A soot stain marked the original line of the flue, visible at the back of fireplace **038**.

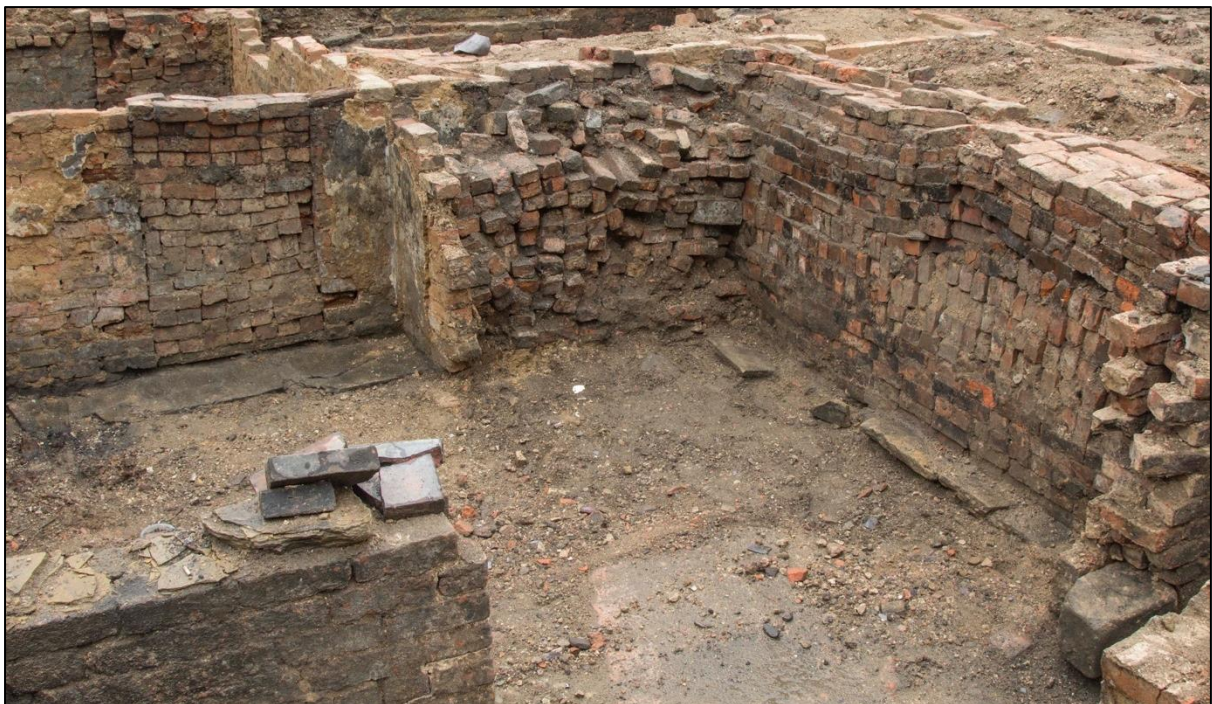
Plate 25: Collection of bricks **034** in the back room of House 4 prior to removal, looking southwest.
