Archaeological Post-Excavation Assessment

Globe and Simpson,
Old Granada Studios,
Quay Street,
Manchester

Technical Report:
Katie Harvey and
Graham Mottershead

Report No:
SA/2019/59

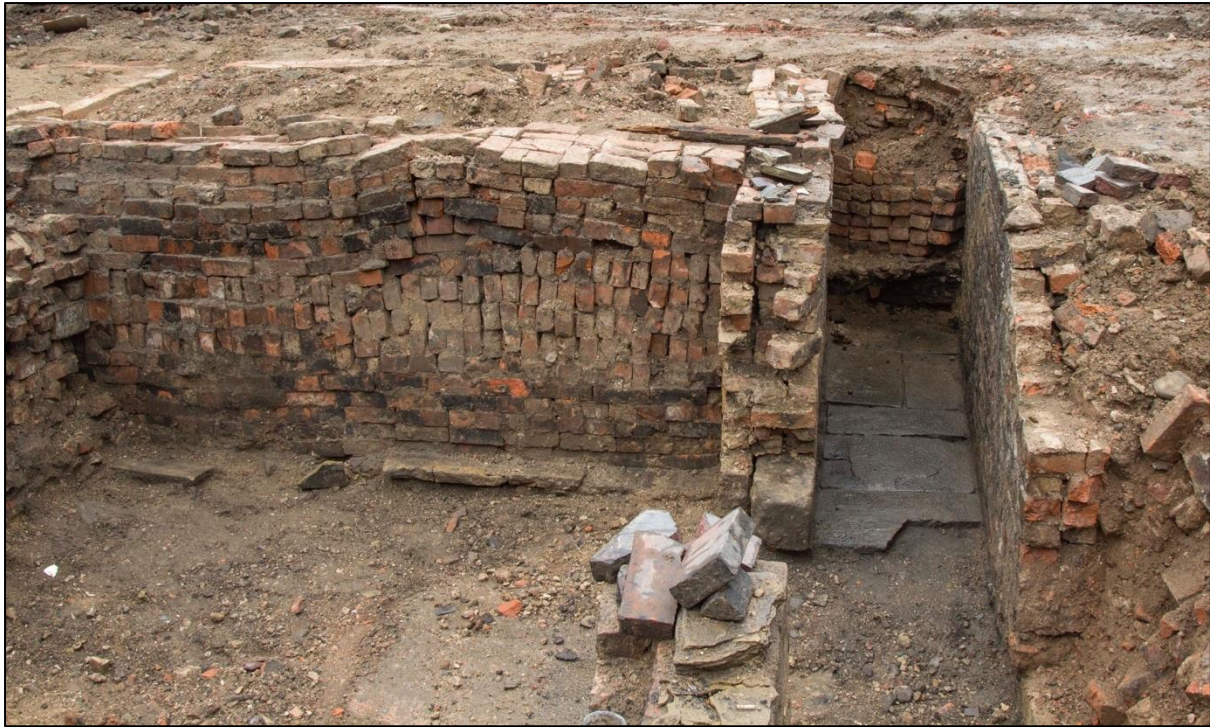
Plate 26: Collection of bricks **034** in the back room of House and stairwell corridor **028**, looking west.

The remains of stairwell **028** survived at the rear of House 4, providing access into the back room. Stairwell **028** was well-preserved, however, the northwestern corner had been removed. At the western end of the corridor, more loose bricks had been stacked up (Plate 26).

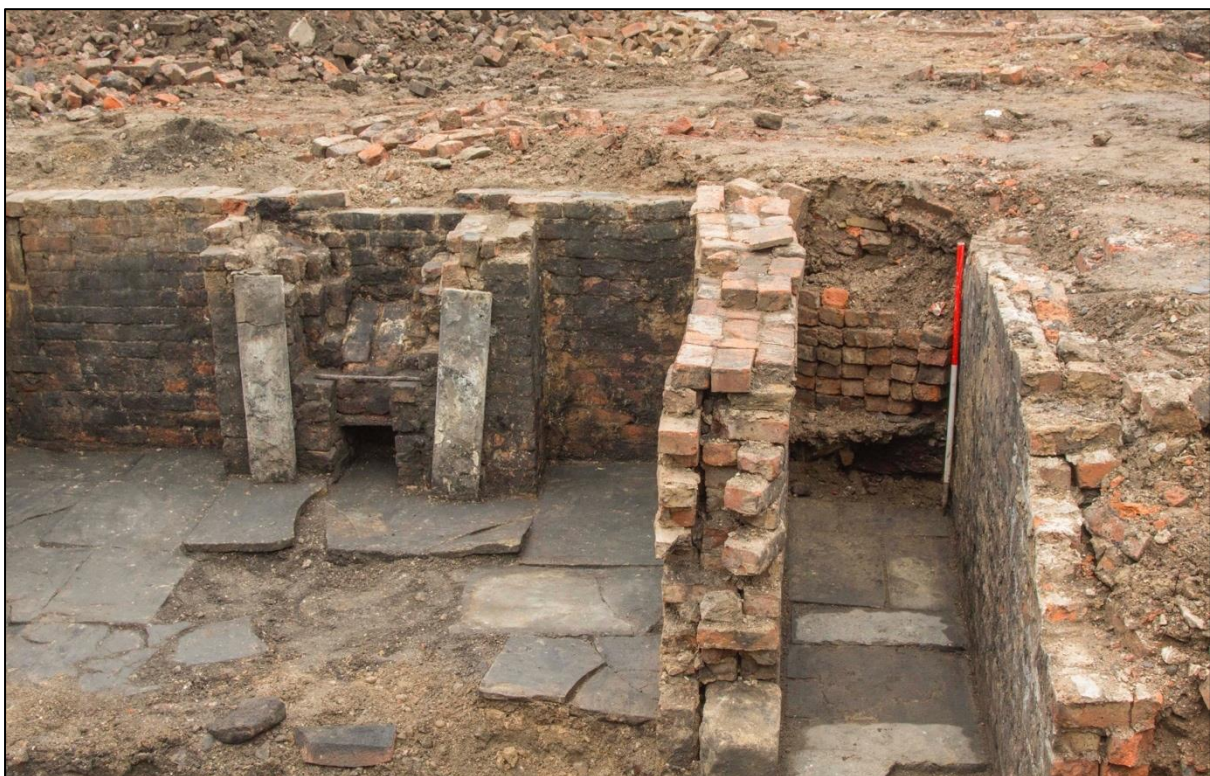
Plate 27: Back room fireplace **035** and stairwell corridor **028**, looking west. Scale 1m

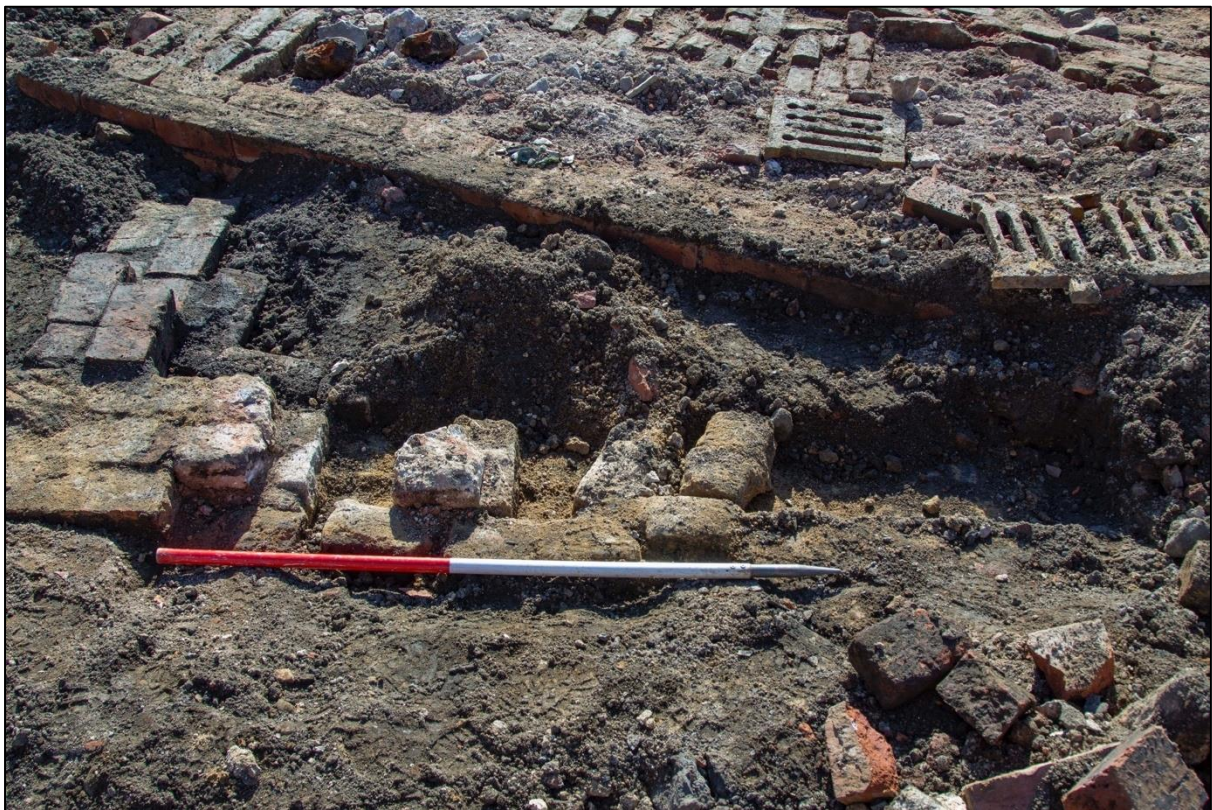
*Plate 28: Wall **051** in the foreground, truncated by modern wall and surface **050** situated in the background, looking south. Scale 1m*

A group of walls **051** were positioned to the north of surface **050**, but had been truncated by a modern wall and survived in poor condition. Wall **051** formed an L-shape, measuring 0.35m wide, and was likely to have been associated with surface **(050)** (Plate 28).

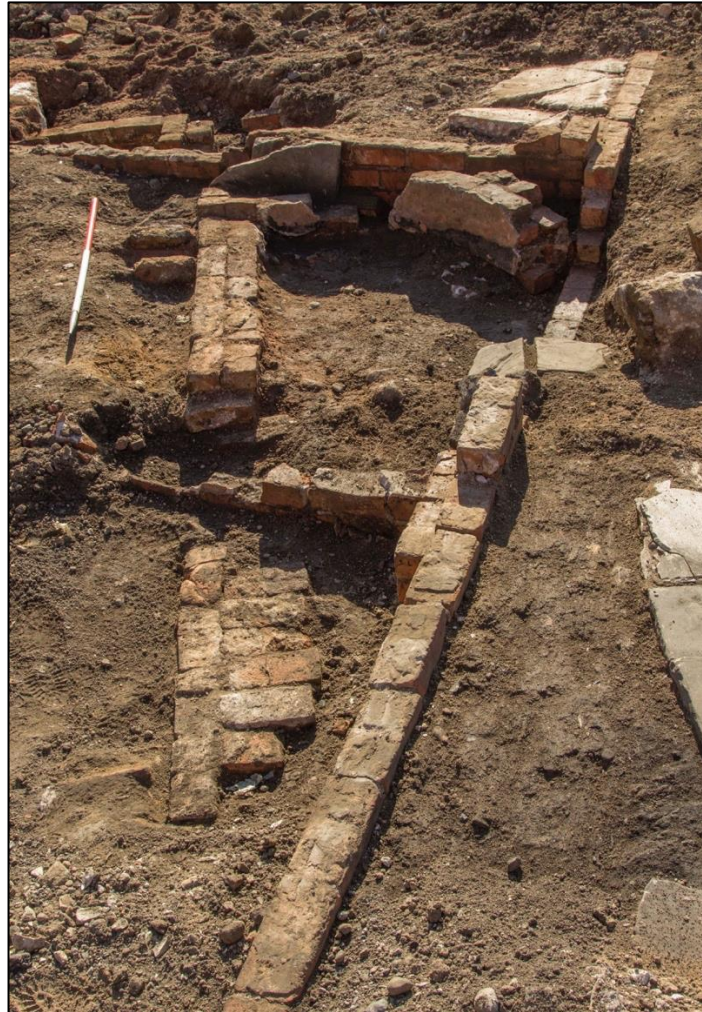
*Plate 29: Walls **054** in the foreground, and wall **056** above. The eastern side of 'Apse' **062** is visible to the immediate right of wall **056**, looking south. Scale 1m*

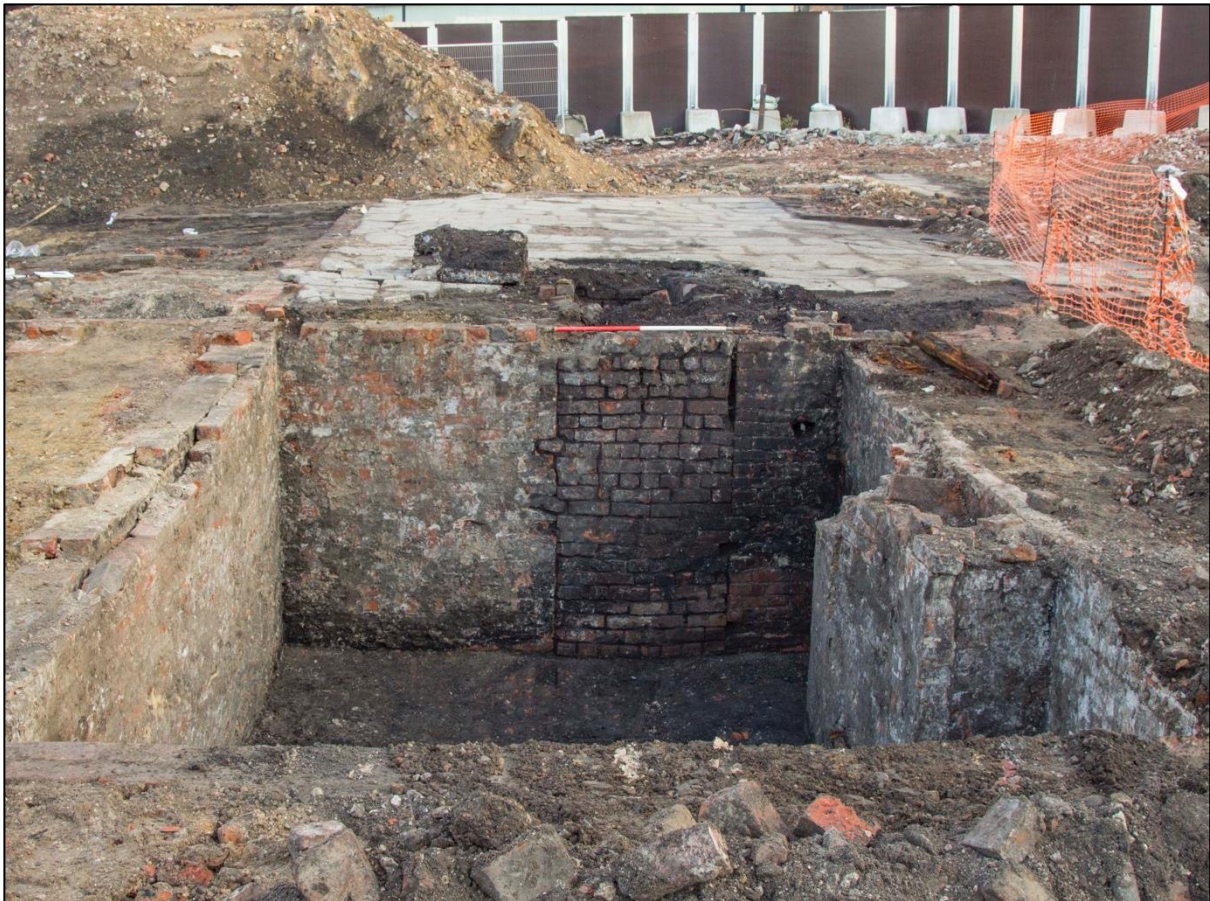
*Plate 30: Western cellar of 'apse house' showing western wall **057** on the left, northern wall **110** with blocked doorway and flagged courtyard **061** beyond, looking north. Scale 1m.*

The cellar of a large building that had an apse at the northern end, was situated to the west of Houses 1-4 (Figures 20 and 21). The remains of the building were demarcated by wall **057** measuring 11.10m north/south and wall **112** measuring 3.30m east/west. The eastern side of the building, was truncated by a 1920's building. Western wall **057** extended north beyond the 'apse house' forming the western edge of a flagged courtyard **061**. Within the cellar, **057**) had a third skin of bricks added on to the western side, surviving to a height of 1.90m and comprised hand-made bricks bonded with sandy lime mortar. The remainder of the wall to the north of the 'apse house' measured 0.24m wide. Wall **110** demarcated the north of the building and measured 3.26m x 0.24m and survived to a height of 1.90m. A bricked up doorway was situated within the eastern extent of wall **110**, measuring 1.04m wide. The bricked up doorway was removed by hand and was constructed by hand-made bonded with black ash mortar dating it to the late 19th- to early 20th- century. Hand-made bricks bonded with sandy lime mortar **111** paved the floor surface (Plate 30).

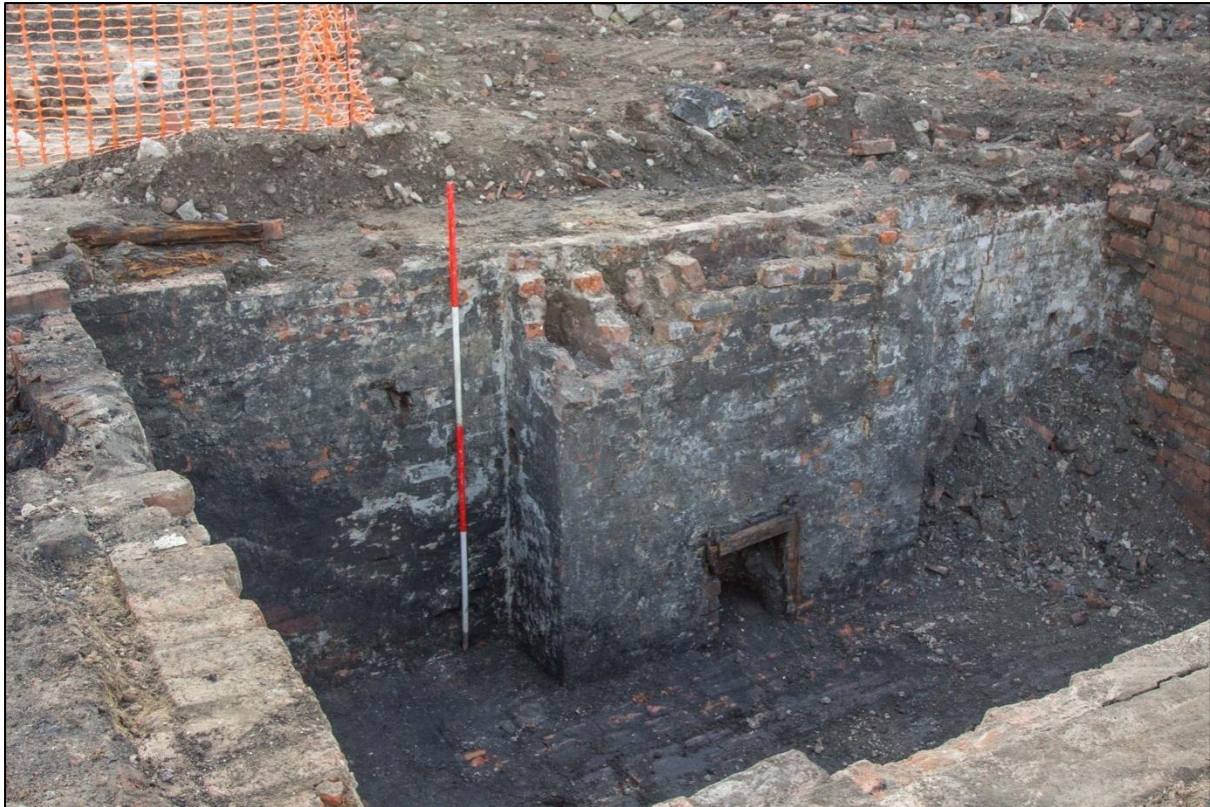
Plate 31: the eastern wall of the 'apse house' 113 and fireplace 115, looking southeast. Scale 2m.

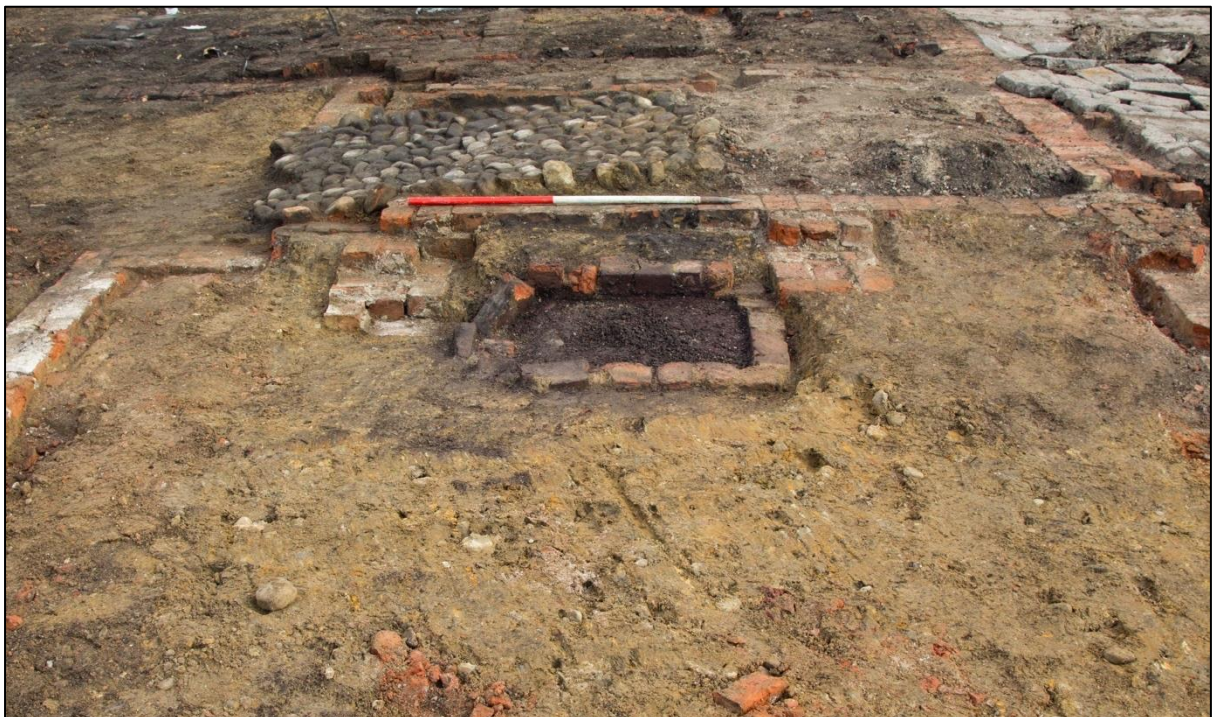
*Plate 33: possible room next to the 'apse house' showing fireplace and possible addition of a boiler, wall **068** to the left and wall **065** in the centre looking northeast. Scale 1m.*

To the west of the 'apse house' were the remains of another possible room formed by walls **065** and wall **068** that formed a return at the western end. Wall **065** was aligned southeast/northwest, measuring 3.53m x 0.23m, and abutted wall **057** at the eastern end. Wall **068** was aligned northeast/southwest, and was exposed to a length of 3m by 0.23m, where it had been truncated at the southern end. On the southern side of wall **065** were two possible fireplace cheeks (0.50m x 0.36m, 1.03m apart), filled by pebbles. In front of the fireplace were the remains of a rectangular structure (1m by 0.72m) that was filled with ash and could formed the base of a later boiler (Plate 33).

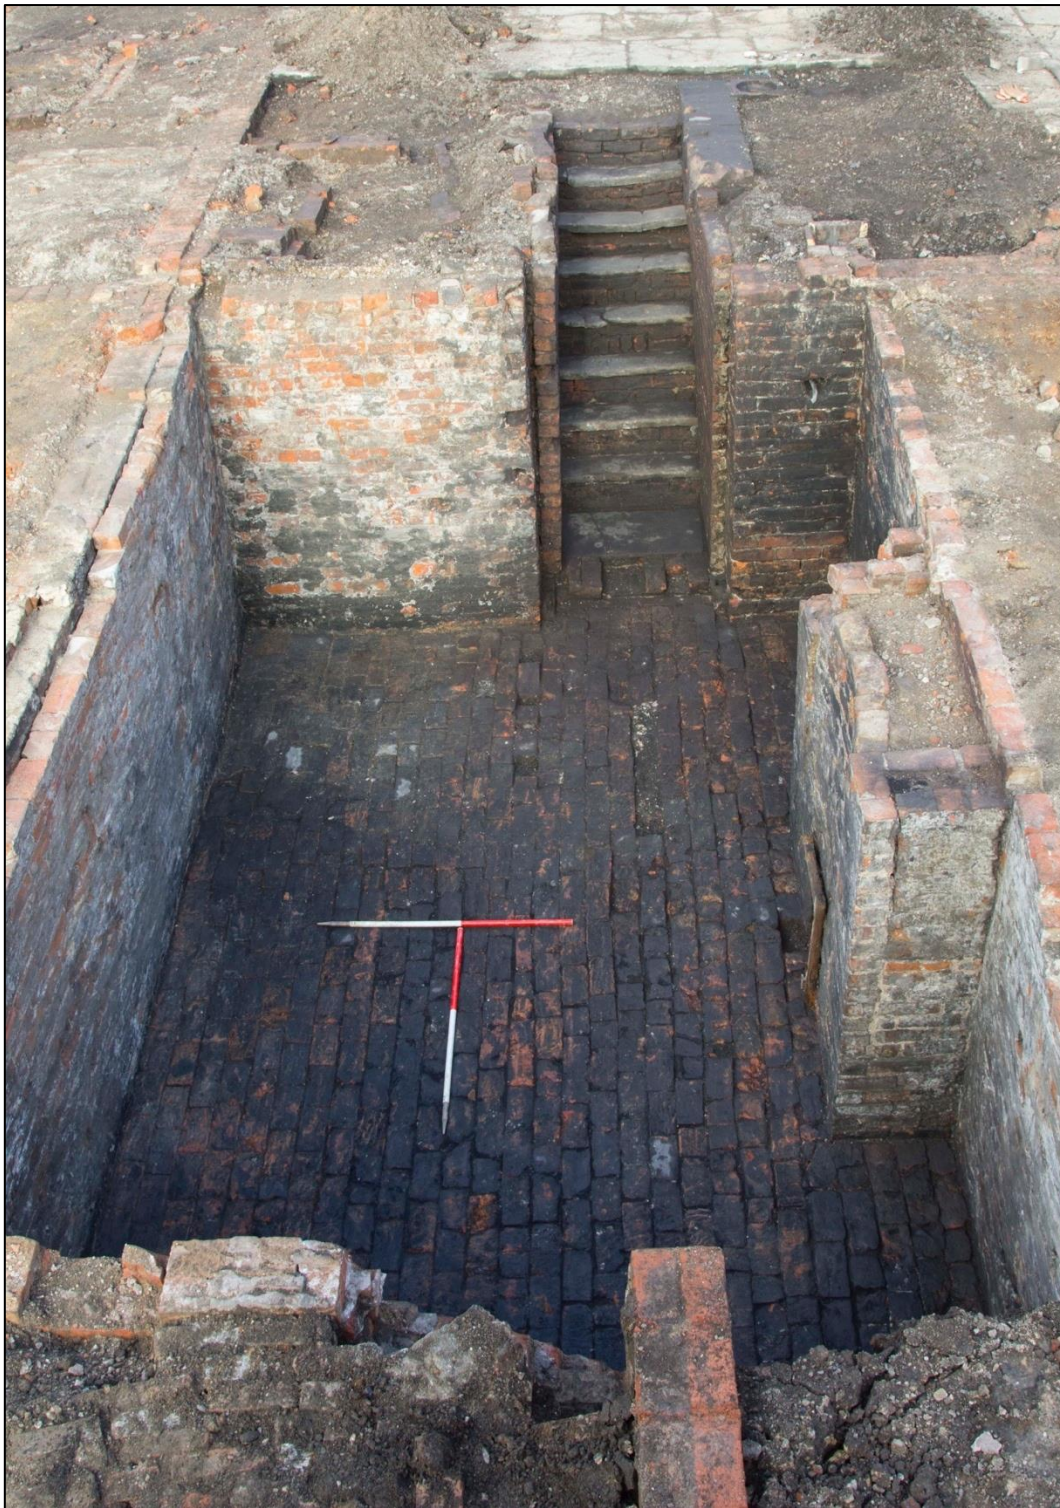
Plate 34: View from above of the 'apse house' cellar fully excavated showing brick floor 111 detail and staircase, looking north. Scales 1m.

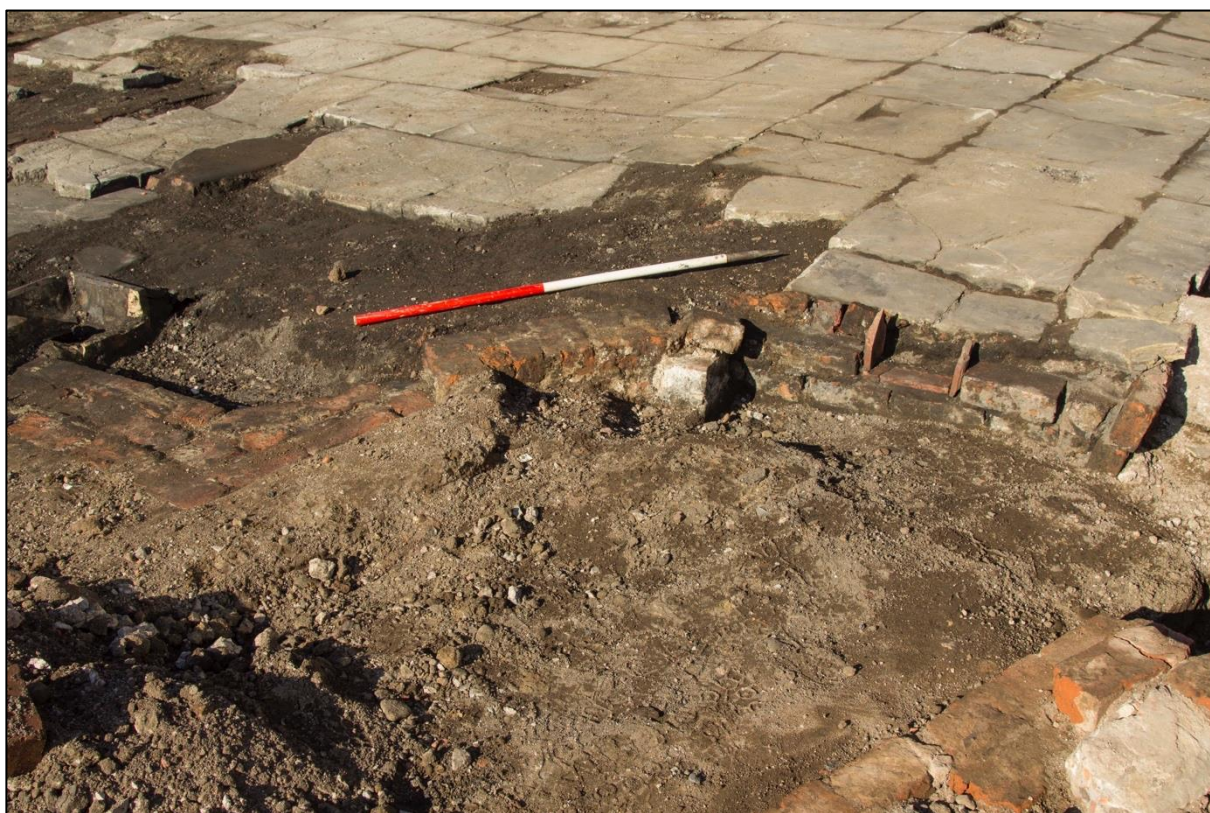
*Plate 36: Remains of the brick-built apse **062** and flagged courtyard **061** beyond, looking northwest. Scale 1m.*

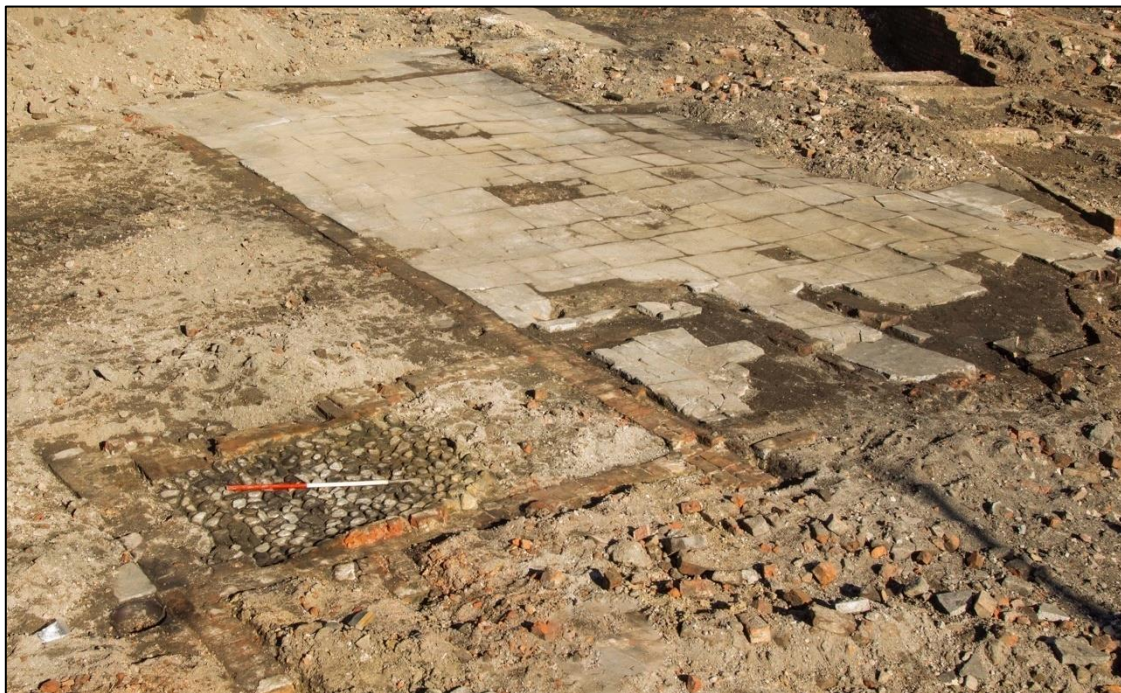
Plate 37: Flagged courtyard **061**, looking northeast. Scale 1m.

To the north of the 'apse house' was a large stone flagged courtyard **061** (Figures 20 and 21). The courtyard was flanked by wall **057** to the west, wall **058** to the north, the 'apse house' to the south and had been truncated by the construction of the Globe and Simpson building. The total length of the courtyard measured 10.30m north/south by 6.80m east/west. In the northeast corner, group of walls **060** represented the remains of two outside privies. Wall **060** measured 2.27m by 0.22m north/south, 1.25m by 0.22m east/west and was built using a mixture of hand-made and wire-cut bricks bonded with black-ash mortar suggesting a date later in the 19th or earlier 20th century.

An L-shaped wall **059**, north of walls **060** and **058**, measured 1.15m north/south by 0.22m by 1.50m by 0.22m east/west, represented another outside privy. Bricks were handmade (0.22m by 0.10m by 0.07m) bonded with black-ash mortar. A concrete floor was situated within L-shaped wall **059**, which had been truncated by the modern drain to the east (Plate 37).

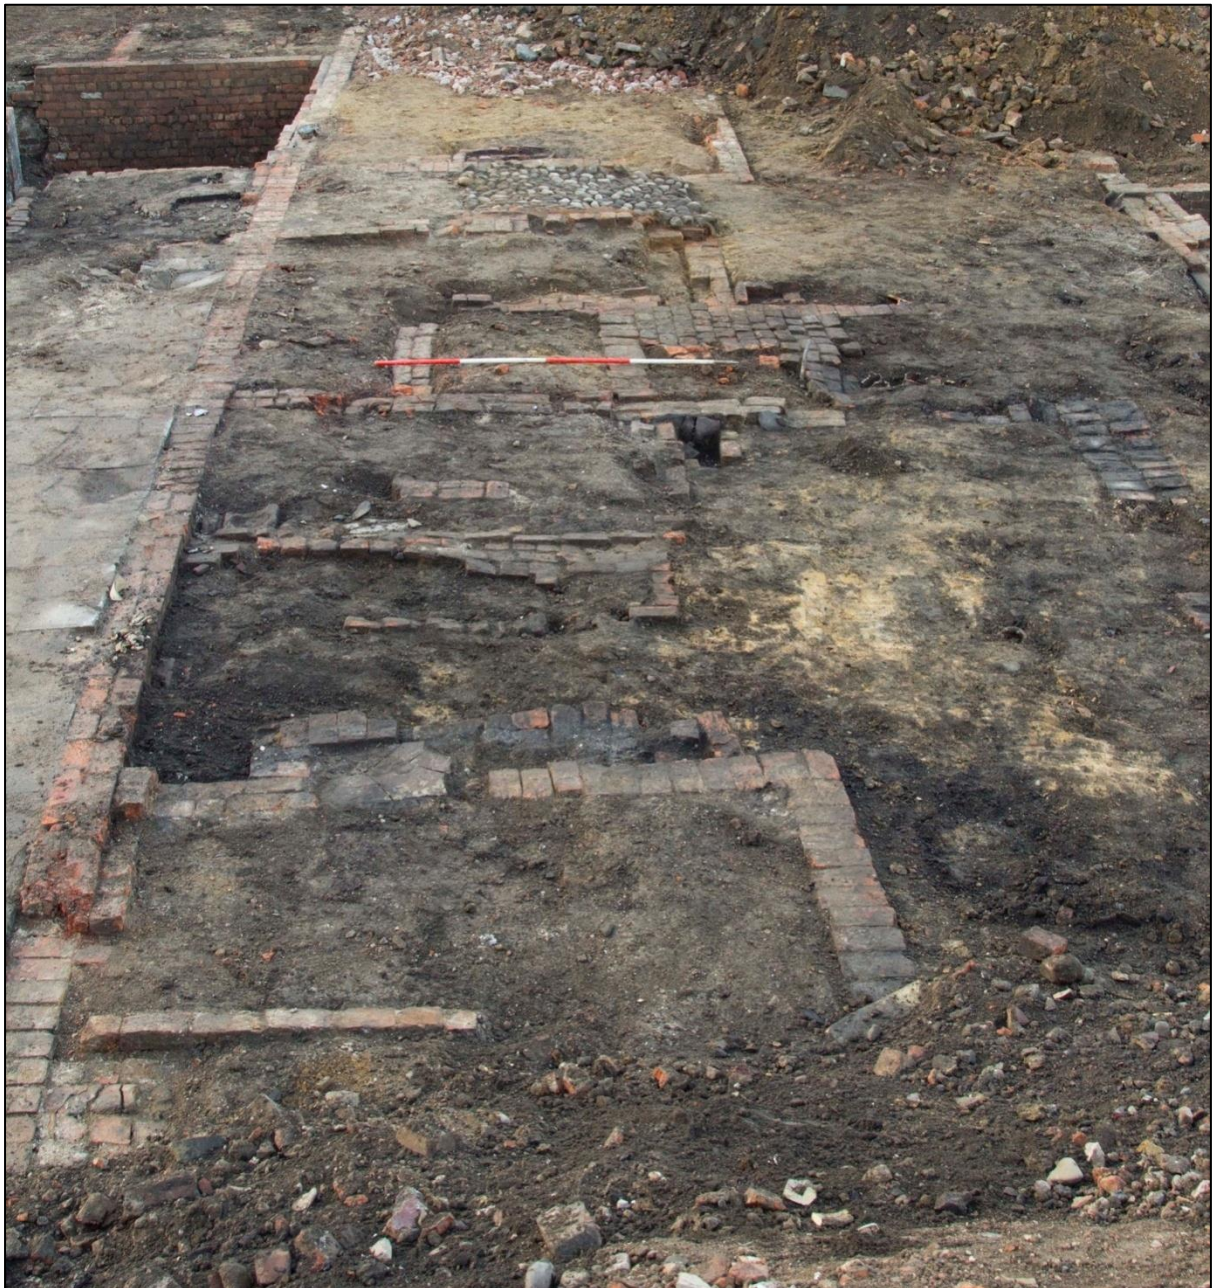
Plate 38: Series of out-building remains, looking southwest. Scale 2m.

The remains of wall **131** were situated 0.91m to the northeast of wall **125**, aligned southeast/northwest, and measured 0.60m by 0.23m (Plate 38).

To the northeast, were the remains of wall **144**, which formed an L-shape, measuring 2.30m along a southeast alignment, before returning 0.83m along a northeast alignment. Wall **144** survived between a single skin and 0.46m wide, indicating that some of the brickwork may have formed an adjacent yard or privy surface, and may have been associated with wall **147**, which was situated opposite, to the northeast (Plate 38). Single skin wall **147** measured 0.90m and presumably demarcated the same structure at **144**.

Other walls associated with wall **144** included wall **145**, comprising a small remnant of brick wall adjacent to wall **057**, and single skin wall **146** that was laid stretcher-on-edge, measuring 1.26m (Plate 38).

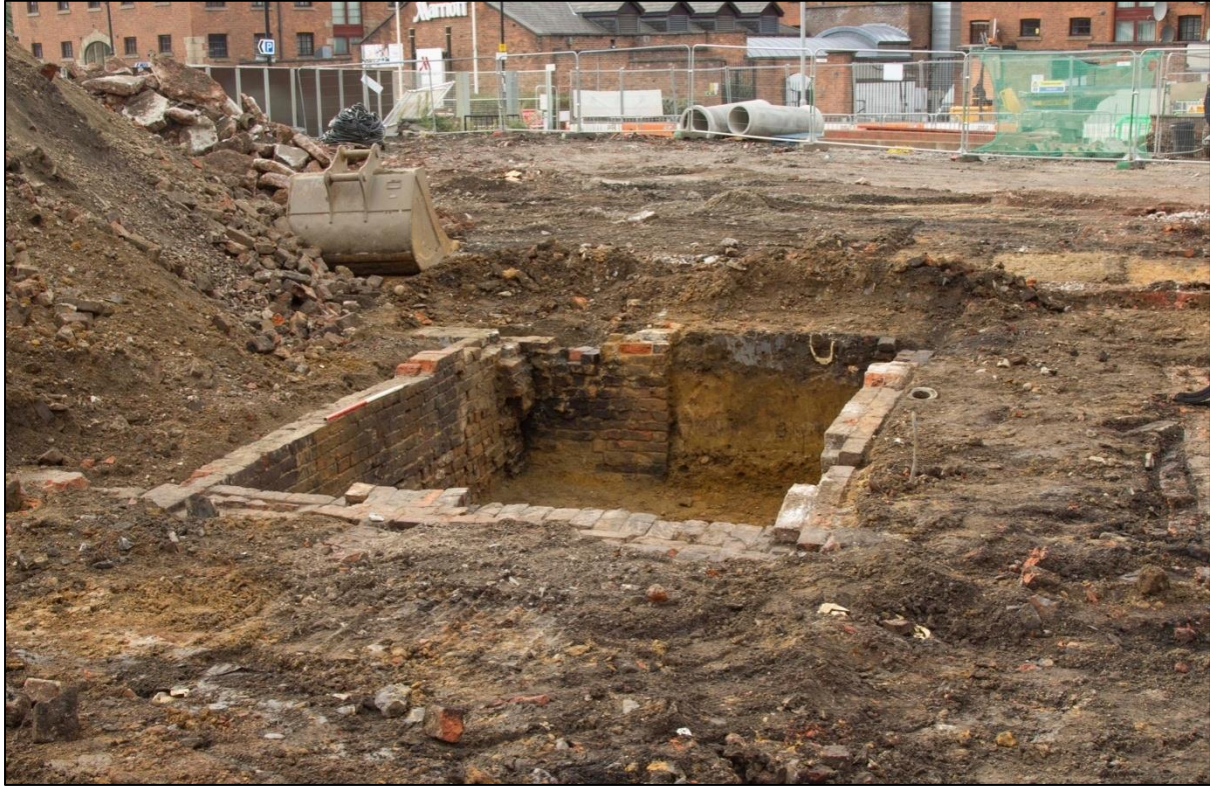
*Plate 39: multi-phase walls of the out-buildings **133-139**, looking west.*

Approximately in the centre of the excavation of Area 1, walls **133-139** were excavated to investigate the foundations of a small sample of walls that formed outbuildings (Plate 39). The excavation revealed that foundations of wall **133** survived 1.15m below the top surviving course and that the bottom six courses were not well laid. The remaining courses above were much better quality, with a partial row of headers-on-edge laid above the lower brickwork. The full extent of wall **133** measured 4.30m by 0.23m and appeared to be keyed into wall **134** at the southeastern end, while at the northwestern end it appeared to be keyed into wall **138** (Plate 40).

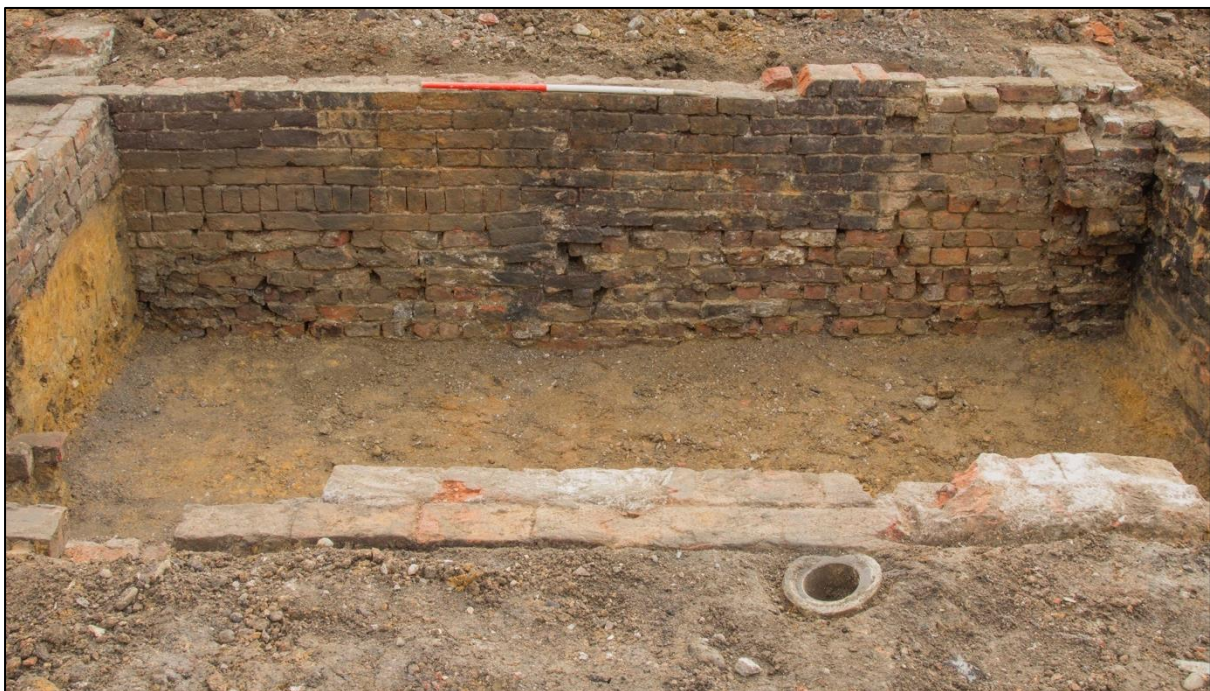
*Plate 40: Wall **133** and **138**, with part of **135** in the foreground, looking southwest. Scale 1m.*

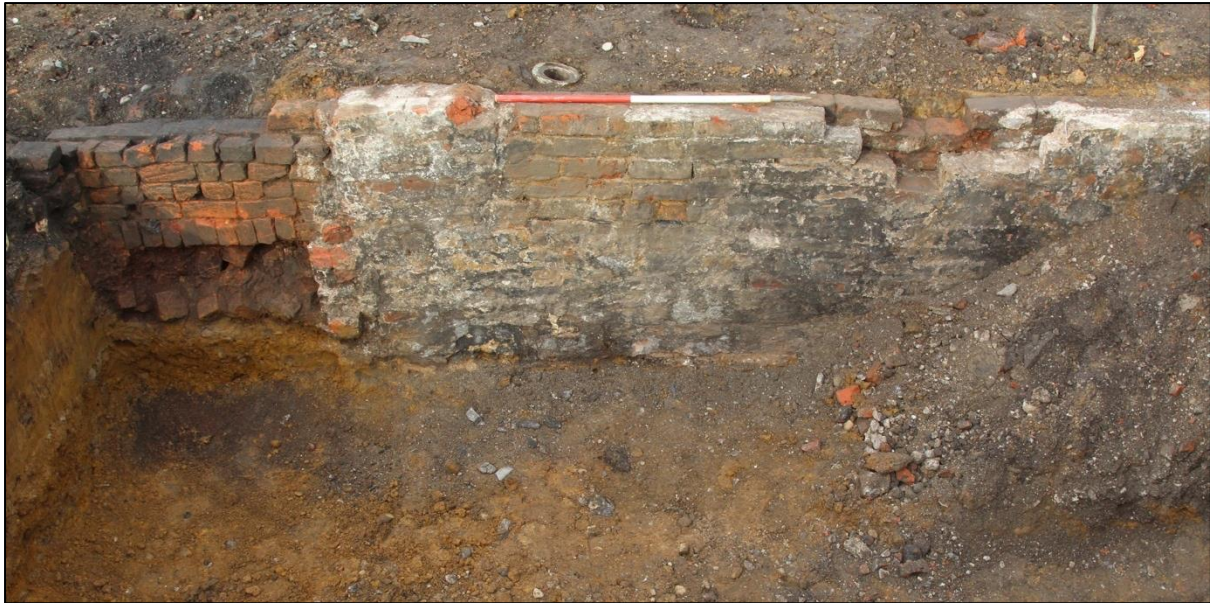
Plate 41: From left to right wall 137 and wall 135 looking northeast. Scale 1m.

of wall **135**, implied that two phases of construction or later modifications had been undertaken (Plate 41).

The remains of wall **137** measured 1.20m x 0.24m, surviving to a height of 1m and abutted wall **135** to the southeast. Wall **137** comprised very loose, broken brick rubble laid header-on-edge, sat below five brick-courses of brickwork (Plate 41).

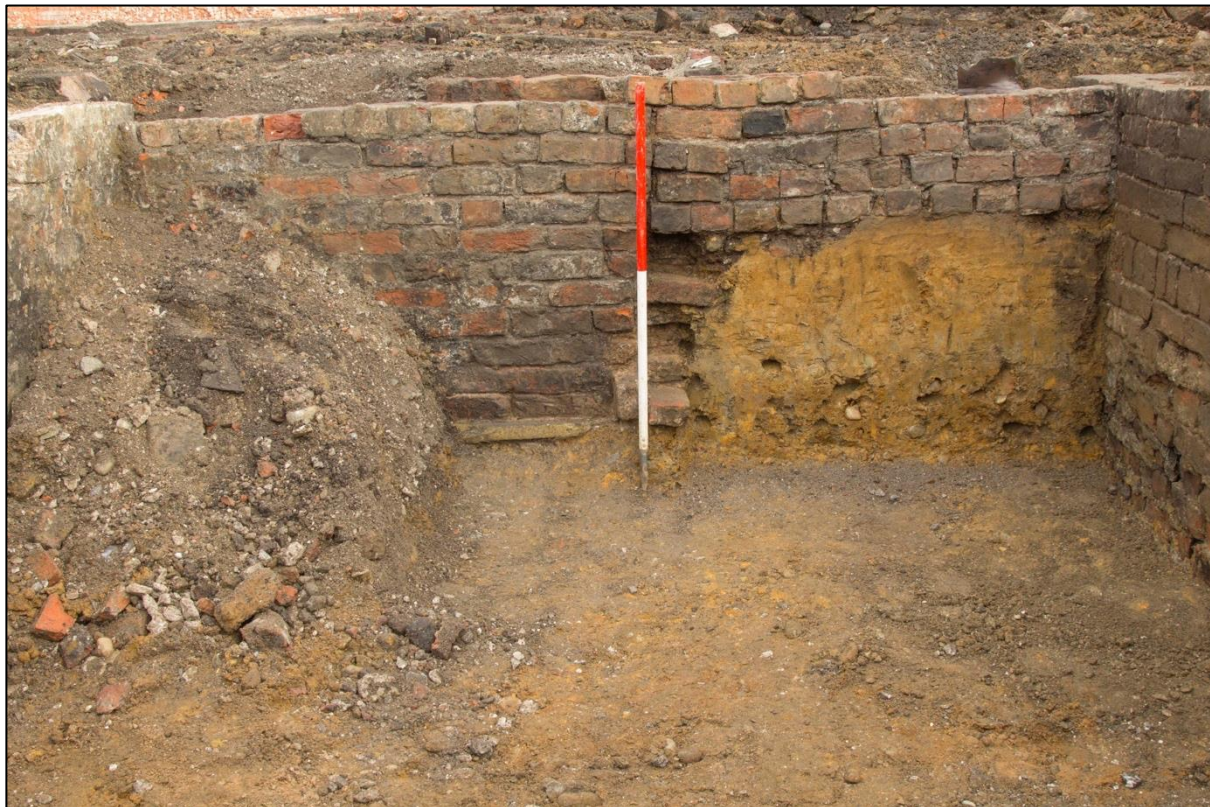
Plate 42: Wall 136, looking southeast. Scale 1m.

Constructed against wall **134**, were the remains of wall **136**, aligned southwest/northeast. Two phases of construction were visible within the fabric of wall **136**, comprising a possible joint in the centre of the wall. The northeast side of wall **136** was constructed above a stone flag and survived to a height of 1m, while the southwest extent comprised only five brick-courses constructed above natural sand and gravel (Plate 42).

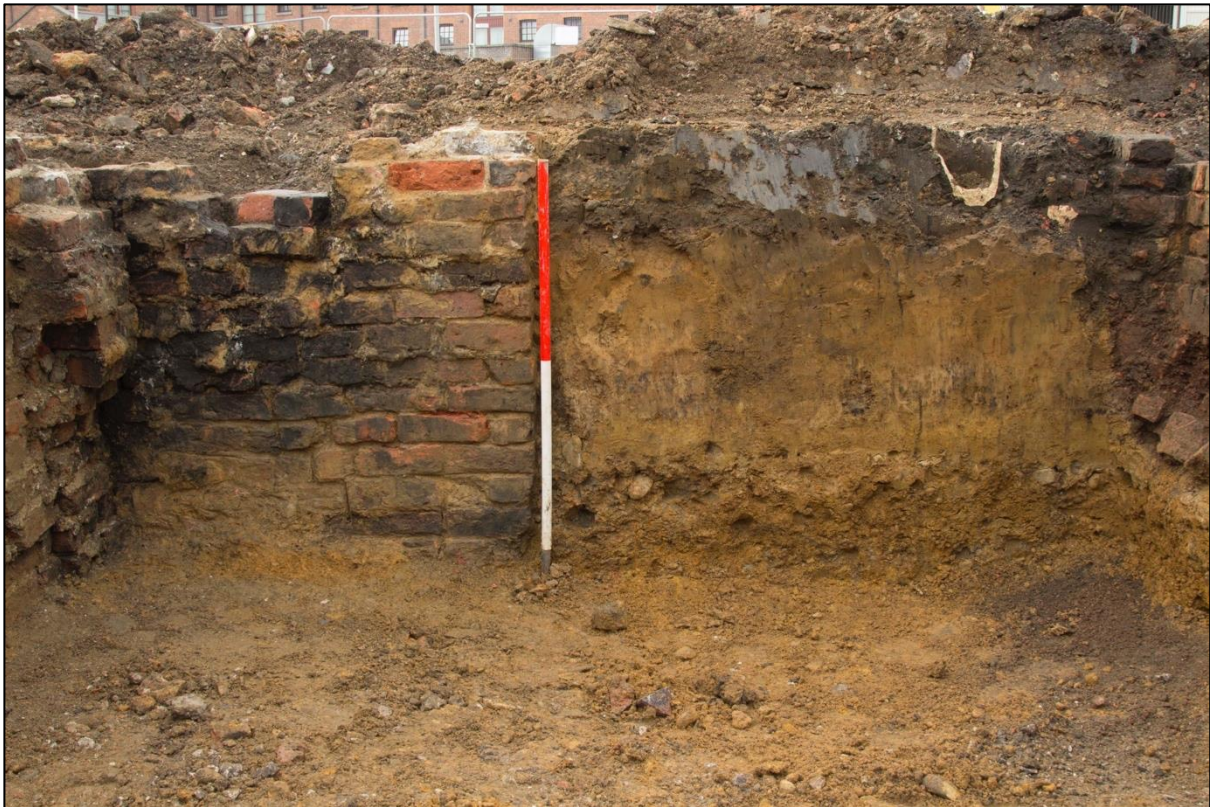
*Plate 43: wall **139** with the remains of a ceramic U-bend to the right, looking northwest. Scale 1m.*

Wall **138** abutted wall **139** at its northwest extent and was roughly keyed into wall **133** to the southeast. The full extent of wall **138** was not excavated, with the exposed remains measuring 0.80m x 0.35m (Plate 39). Wall **139**, measured 1.42m by 0.24m and was aligned southwest/northeast. Wall **139** had a butt-end cut into natural sand and gravel to the northeast (Plate 43).

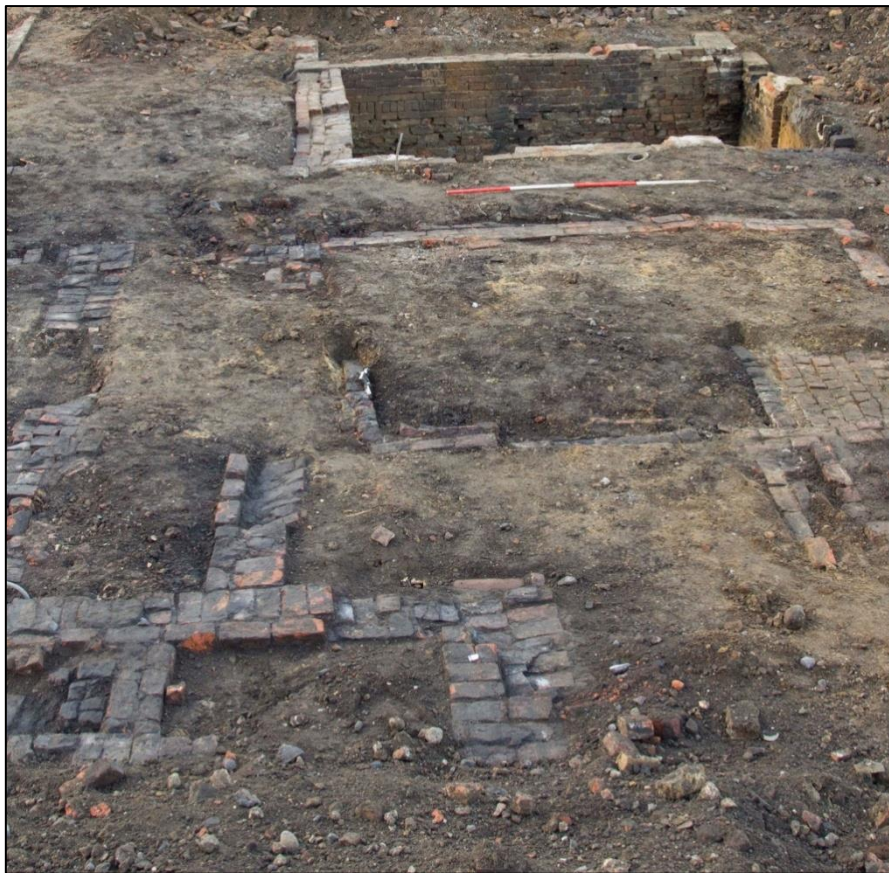
Plate 44: Shot of the out-buildings, looking southwest. Scales 2m and 1m.

of 1.15m to the northeast. The southeastern extent of wall **149** abutted wall **057**. On the southwest side of wall **149**, were the remains of wall **148**. Wall **148** extended 0.24m to the southwest of wall **149**, returning along a northwest/southeast aligned, parallel to wall **149** for 1.54m until it returned along a northeast alignment where it abutted wall **149**. Single skin wall **150** was constructed against wall **057** and abutted wall **149** to the southwest, measuring 1.10m. Wall **150** was also likely to have been associated with the structure that was demarcated by this series of walls (Plate 44).

Single skin wall **159**, was aligned southwest/northeast and measured 1.40m and extended southeast of the privy block formed by wall **155** and other associated walls. Wall **159** formed the northwest return of wall **160**, which measured 1.90m, aligned northwest/southeast. Together these walls formed an L-shape, which contained two sunken bricks that possibly covered a drain (Plate 44).

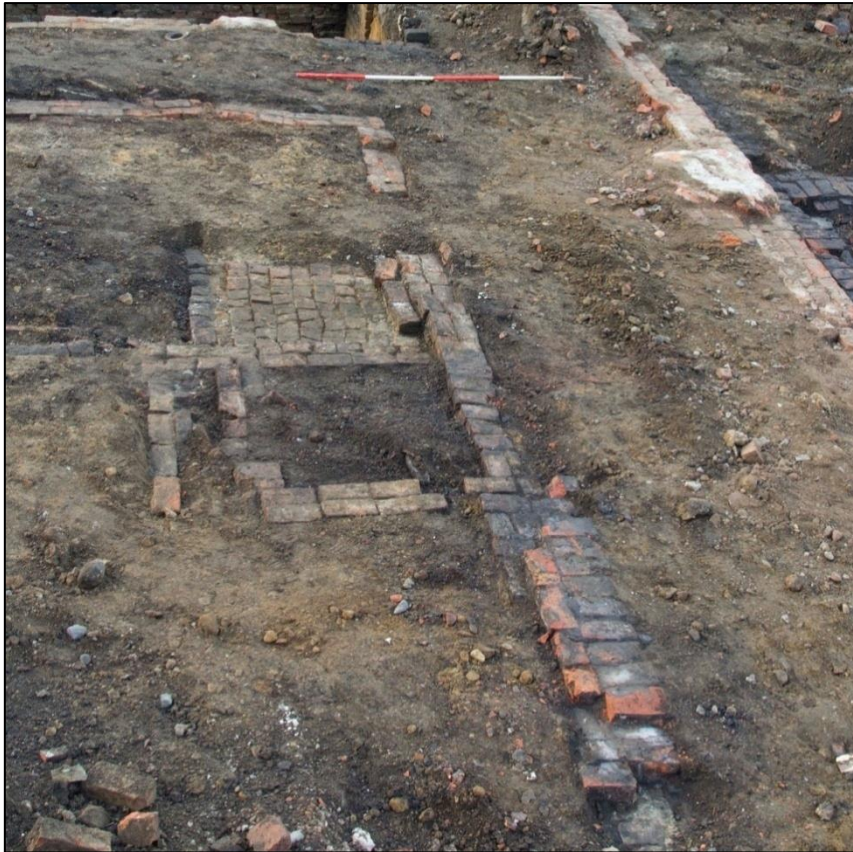
*Plate 45: Remains of privy formed by walls **154**, **155** and **156** situated at the western end of the site, looking southwest. Scale 2m.*

Wall **154**, **155** and **156** demarcated the remains of a privy block. Wall **154** formed a continuation of wall **152**, comprising a T-shaped wall measuring 2.30m before returning 1.10m to the southeast at the northeast end. Remnants of a handmade brick floor survived on the southeastern side of wall **154**. The northeastern extent of wall **154** had been truncated by wall **158** (Plate 45)

Single skin wall **155** ran parallel to wall **154**, situated at a distance of 0.98m to the southeast. Wall **155** measured 1.14m, was bonded with black mortar and demarcated the southeastern extent of the brick floor associated with wall **154**. The presence of

black mortar indicated that wall **155** formed a later addition or modification to the out-building or privy. Wall **156** was similar to wall **155** comprising a single skin of bricks bonded with black mortar, situated parallel to wall **154** at a distance of 0.88m to the southeast. The southwestern extent of wall **156** abutted wall **154** and probably once abutted **157** (measuring 0.88m by 0.24m, aligned northwest to southeast) to the northeast.

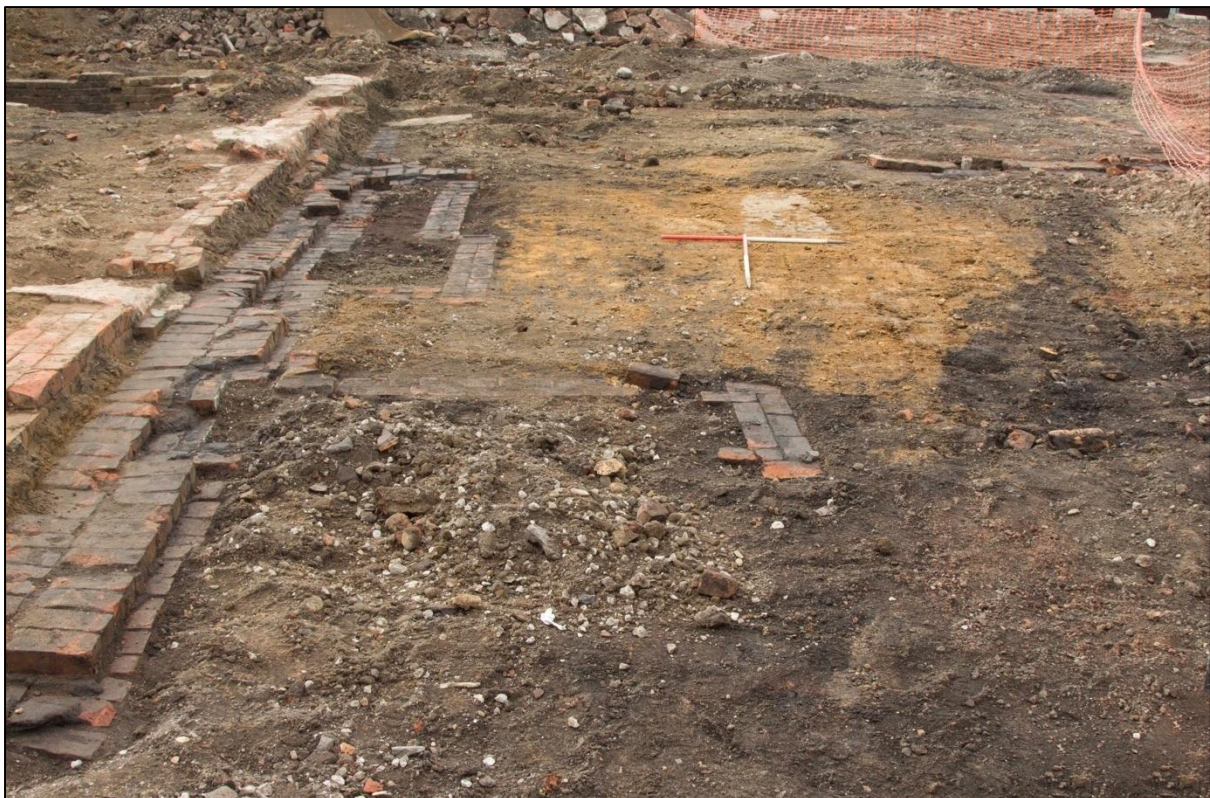
*Plate 46: Partial remains of buildings, showing walls **165-167** and walls **172-176** looking southwest.
Scales 1m.*

Several other walls associated with the Phase 4 buildings were recorded including wall **173** (measuring 0.87m by 0.23m) which abutted wall **172** at its southwestern end, wall **174** (measuring 1.61m by 0.23m) situated parallel to wall **166**, wall **175** (measuring 0.47m by 0.23m) that formed a cross-wall between walls **166** and **174** and L-shaped wall **176** (measuring 2.07m along its longest extent before returning for 0.92m) (Plate 46).

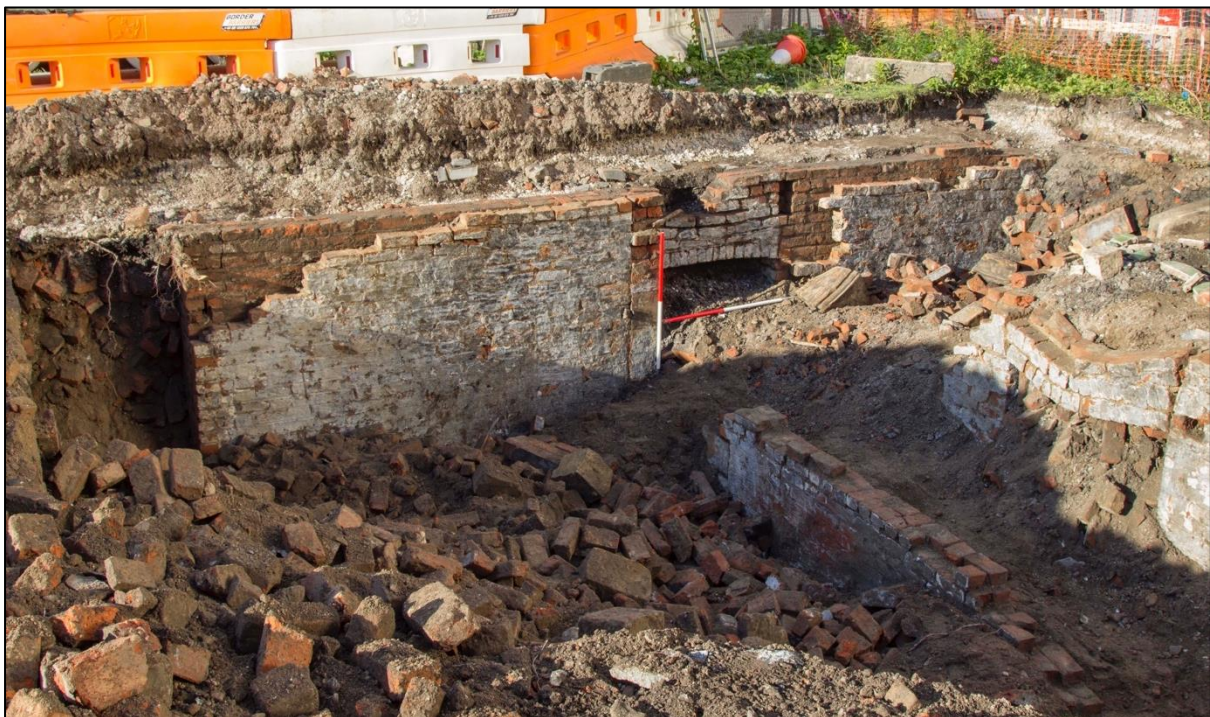
Plate 47: Pub wall **322** with brick-arched doorway, looking north. Scale 1m.

Area 2 comprised extensive structural remains associated with the houses shown on the 1787-94 map and the Three sugar Loaves Inn depicted on mapping from at least 1831, Phase 3. External wall **322**, aligned northeast/southwest, was exposed to a length of 7.30m and survived to 2.60m, where it continued to the northeast, beyond the limits of excavation. Two phases of construction were evident within the fabric of wall **322** comprising a single skin of bricks bonded, which was poorly preserved and a double skin wall bonded with black mortar. A return was found at the southwestern end of wall **322**, presumably forming a doorway into another room but this was too close to the edge of the trench to excavate. Wall **322** also comprised a brick-arched doorway, 1m in width, which led into a room to the northwest (Plate 47 and Plate 48).
