Archaeological Post-Excavation Assessment

Globe and Simpson,
Old Granada Studios,
Quay Street,
Manchester

Technical Report:
Katie Harvey and
Graham Mottershead

Report No:
SA/2019/59

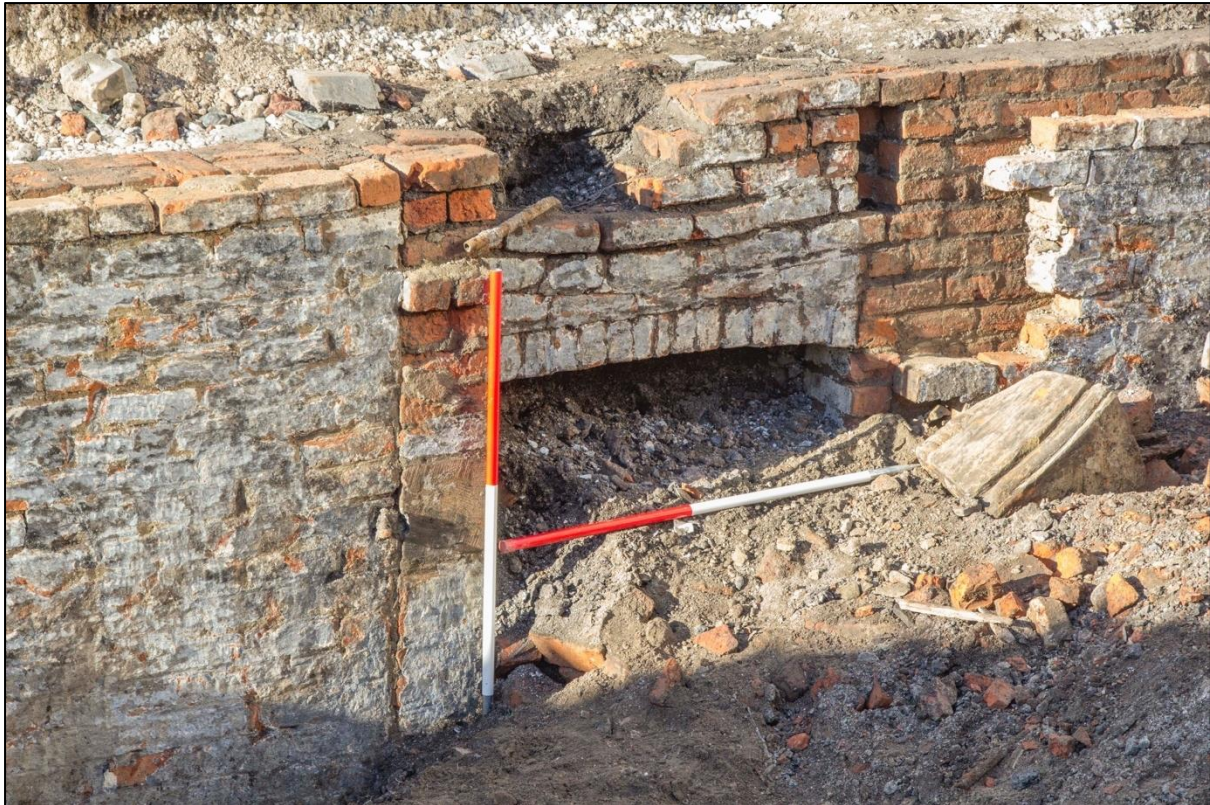
*Plate 48: Detail of the brick-arched doorway in pub wall **322**, looking north. Scale 1m.*

Area 2 comprised extensive structural remains associated with the houses shown on the 1787-94 map and the Three sugar Loaves Inn depicted on mapping from at least 1831, Phase 3. External wall **322**, aligned northeast/southwest, was exposed to a length of 7.30m and survived to 2.60m, where it continued to the northeast, beyond the limits of excavation. Two phases of construction were evident within the fabric of wall **322** comprising a single skin of bricks bonded, which was poorly preserved and a double skin wall bonded with black mortar. A return was found at the southwestern end of wall **322**, presumably forming a doorway into another room but this was too close to the edge of the trench to excavate. Wall **322** also comprised a brick-arched doorway, 1m in width, which led into a room to the northwest (Plate 47 and Plate 48).

Internal wall **323** ran parallel to wall **322** and was excavated to a length of 2.60m by 0.24m. A stopped-end was visible at the to the southwest extent of wall **323**, before it continued under the modern footpath to the northeast. White paint was present on both sides of the wall (Plate 48). Abutting wall **323**, were the remains of wall **324**, aligned northwest/southeast, which was excavated to a length of 4.70m x 0.23m and survived to a height of 1m. White paint was present on the exposed side of wall **324**, which also incorporated an arched doorway, measuring 1.10m in width, which had slumped down with the demolition rubble. Walls **324** and wall **327** presumably demarcated an internal corridor, with wall 327 situated at distance of 1.06m from wall **324**. Stone block inserts associated with a doorway were visible at the northwest end of wall **327**. Wall **324** returned to the southwest, forming wall **325** (Plate 50).

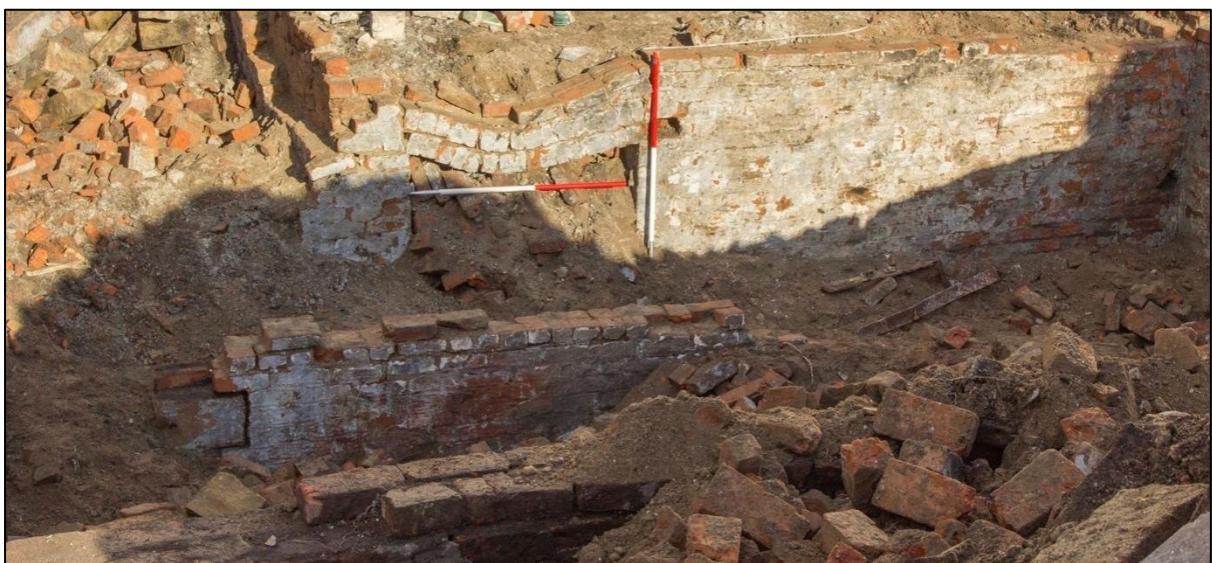
*Plate 49: pub walls **323** and **324** with slumped brick-arched doorway, looking northeast. Scale 1m.*

Wall **325** formed a return to the southwest of wall **324**, measuring 1.20m x 0.24m and was excavated to a depth of 1.10m. A return was visible at the t the southwestern extent of wall **325**, extending in both directions although these were badly damaged. A possible doorway or large gap was visible in wall **325**, which appeared to continue southwest, however this area could not be excavated. The return inside the excavated area was part of a truncated wall **327** (Plate 49).

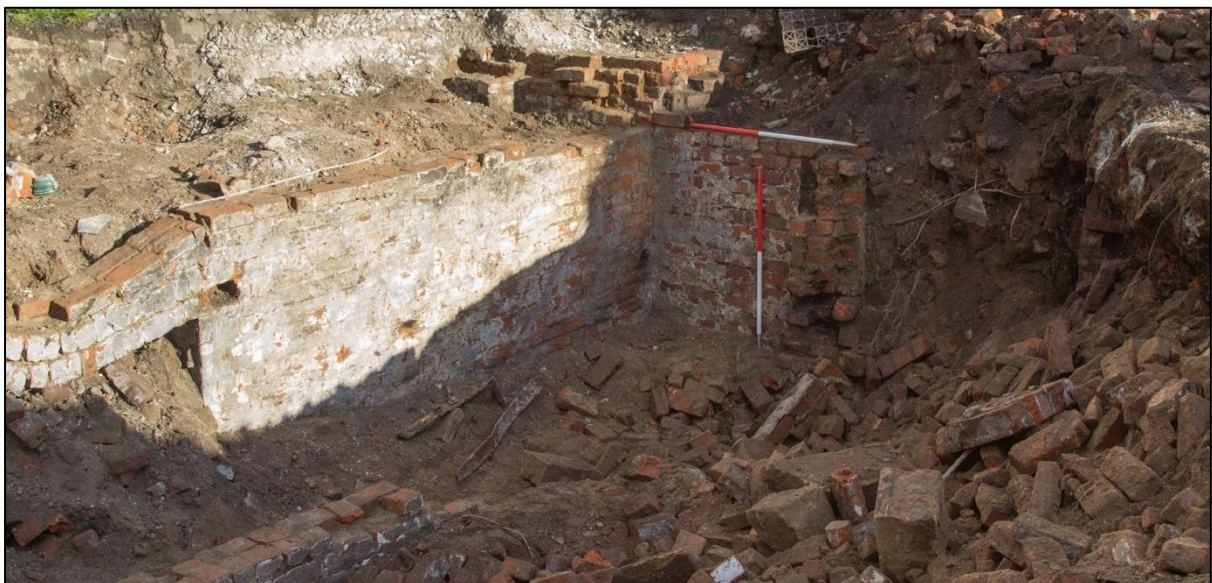
*Plate 50: Pub walls **324**, **325** & **326**, looking northeast. Scale 1m.*

A substantial L-shaped wall **326** was partly excavated in the northeast extent of Area 2. Wall **326** survived up to four courses high, measured 0.34m wide and abutted wall **324** to the southwest. Wall **326** returned to the southeast comprising a 0.34m wide wall, which showed signs of later repair work bonded in black mortar and possibly formed an external wall (Plate 50). At the southwest side of the trench was wall **328**,

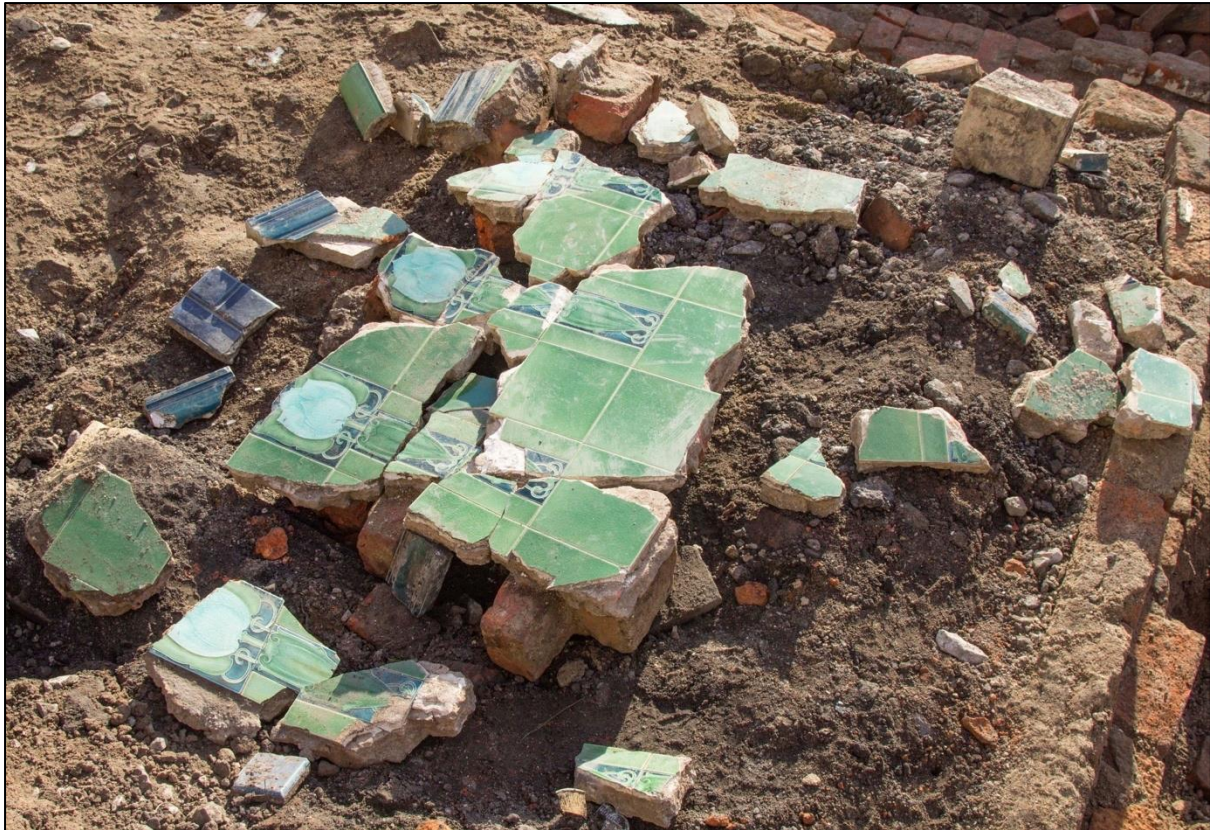
Plate 51: Decorated tiles found in the demolition rubble

The cellar was filled entirely by demolition rubble related to the building and comprised decorative stonework from the exterior and green, glazed tiles from the internal decoration (Plates 51 and 52). An interesting find within the cellar were two Second World War tank shells. These were solid shot with intact firing caps and were found in the proximity of the heath, suggesting that they may have been souvenirs from the war.

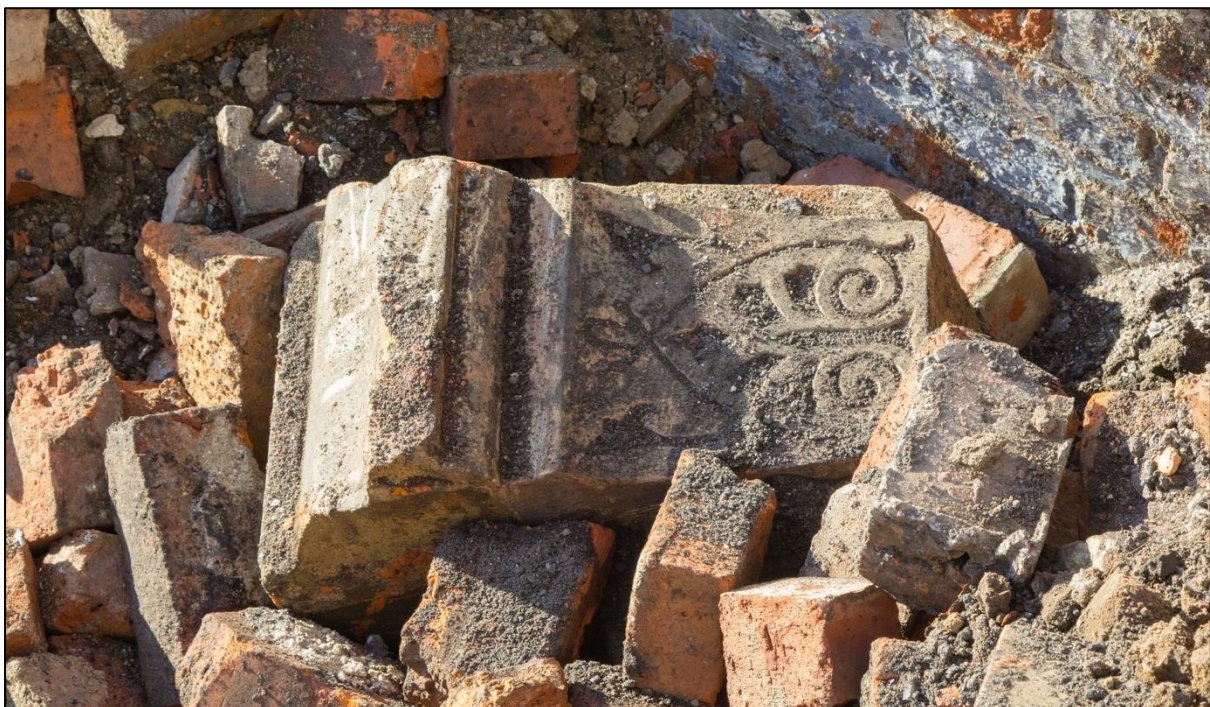
Plate 52: Decorative stonework found in the demolition rubble

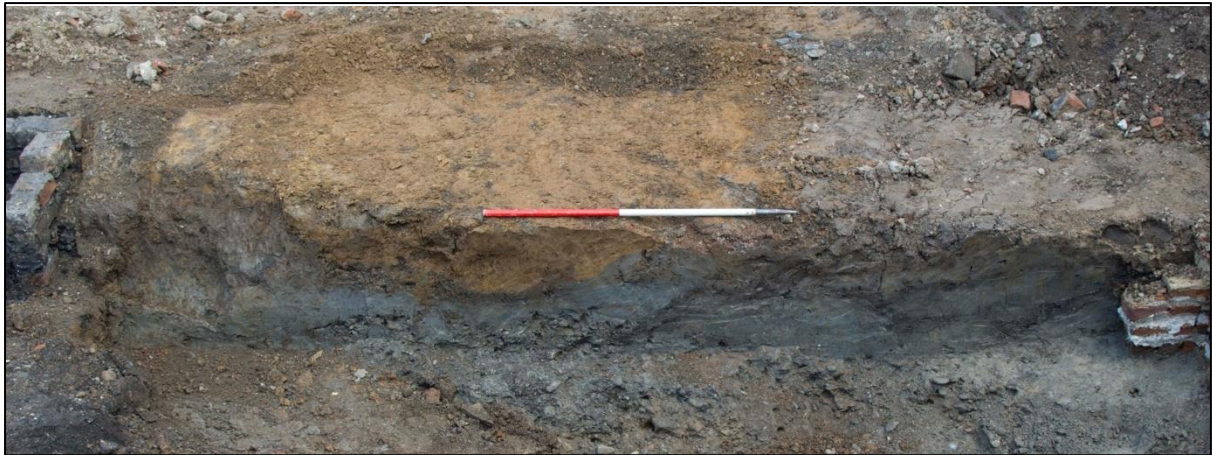
*Plate 53: post-medieval ditch **073** after removing overburden, looking northeast. Scale 1m.*

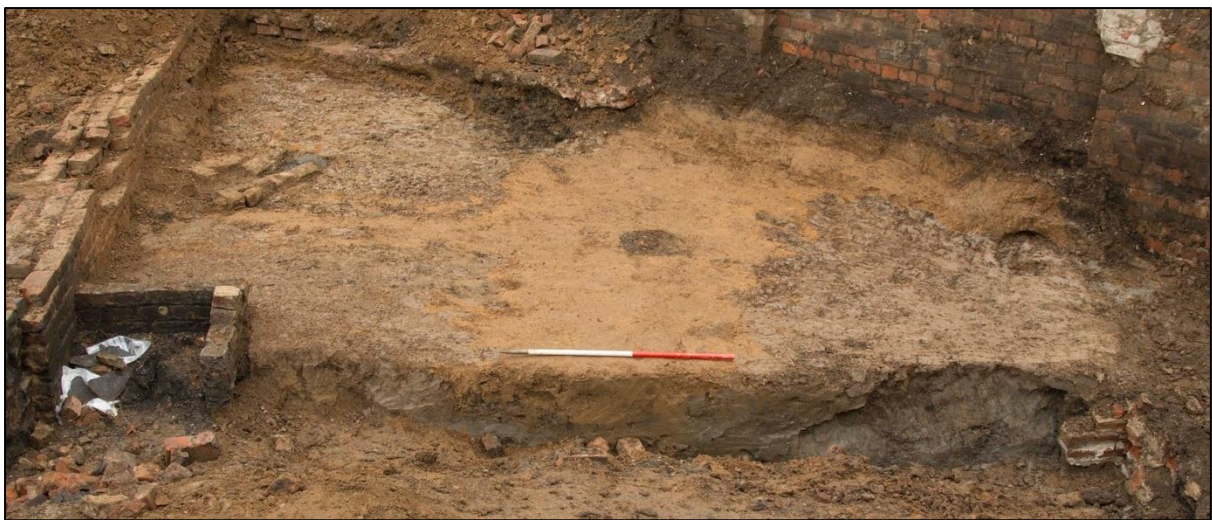
*Plate 54: ditch **073**, looking northeast. Scale 1m.*

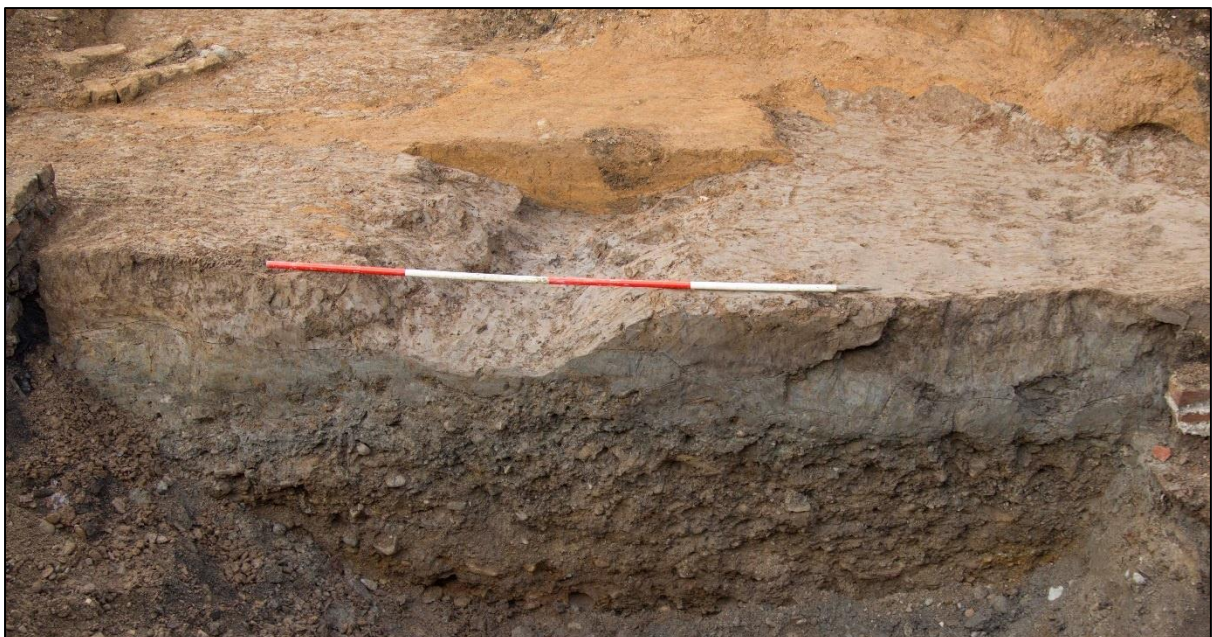
*Plate 55: the southwest facing machine-excavated section of the post-medieval ditch and glacio-fluvial stratigraphy below **073** looking north, scale 2m.*

At the very base of **073**, below **074** were the remains of very light greyish clay, river-laid deposit **077**. Similarly, below **075**, were the remains of very light greyish clay **076**, which was very similar in colour and composition to **075**. Light-mid grey clay **108**, containing frequent rounded and angular stones was exposed below **076** and **077** and was probably associated with a river deposit. Deposit **107**, overlay natural glacio-fluvial sand and gravel **078** (Plate 55).

The remains of a shallow sub-circular post-hole formed by cut **081** and filled by **080** and **106**, were cut into earlier ditch fill **072**. Cut **081** was sub-circular in plan and contained upper fill **080**, comprising mid grey, sandy clay, and lower fill **106**, consisting of dark reddish brown sandy clay, containing occasional flecks of charcoal. A half-section excavated through the feature revealed that cut **081** measured a diameter of 0.35m and a depth of 0.22m comprising steep sides and a flat base (Plate 55).

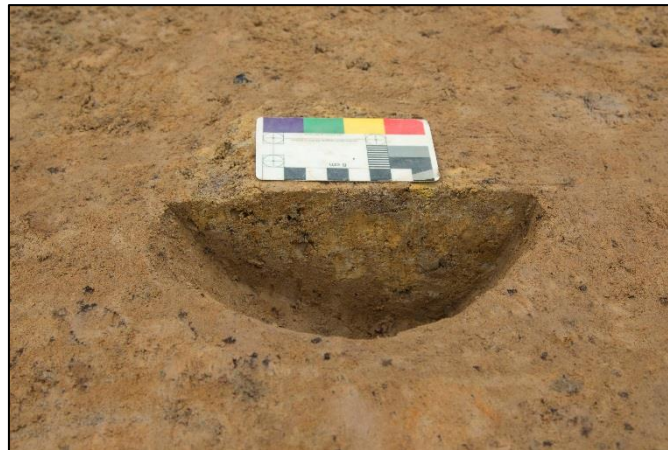
*Plate 56: Southwest facing section of feature **095** showing the southwest facing section, looking northeast, scale 8cm.*

In addition, sub-circular cut **095**, also cut into the base of ditch **073**, below fill **072**. Cut **095** was sub-circular in plan and had gradually sloping sides with a concave base. It was filled by yellowish grey silty clay **082** (Plate 56).

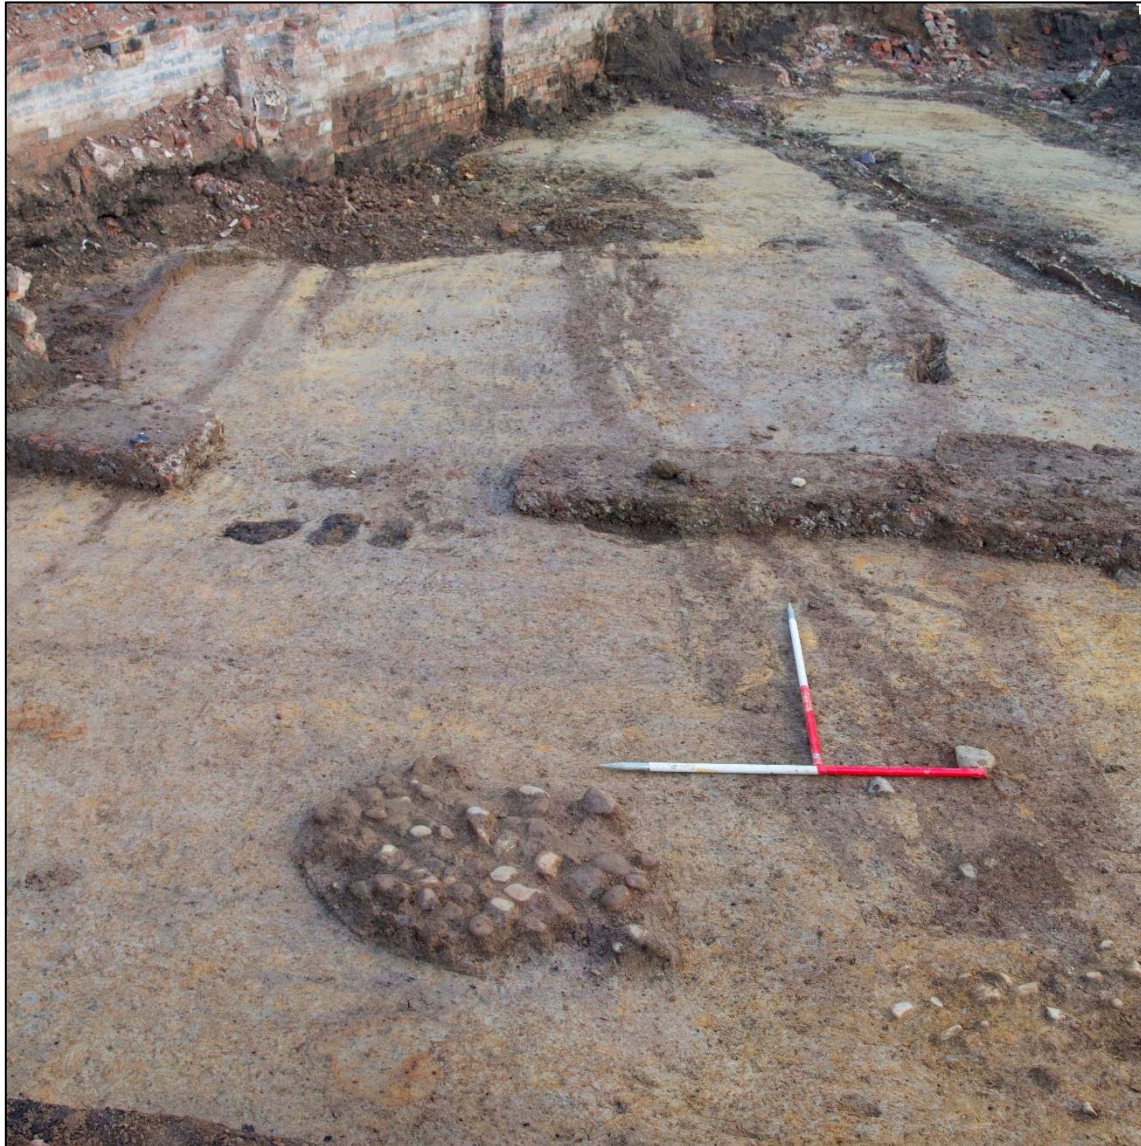
*Plate 57: Eastern area showing plough-scars **291**, **292**, **293**, patch of ploughed stones **290**, looking north-east, scale 1m.*

contained no artefactual evidence. At the point of convergence brick wall **220** cut across them but beyond this the features converged into a large feature with a curving northwest end. This was interpreted as the point at which they plough turned around at the edge of the field and to the immediate northwest were two spreads of stoney silty clay deposit, **271** and **290**, which represented piles of stones removed over time by continuous ploughing. The stone piles both contained 17th and 18th century pottery (Plates 57 and 58).

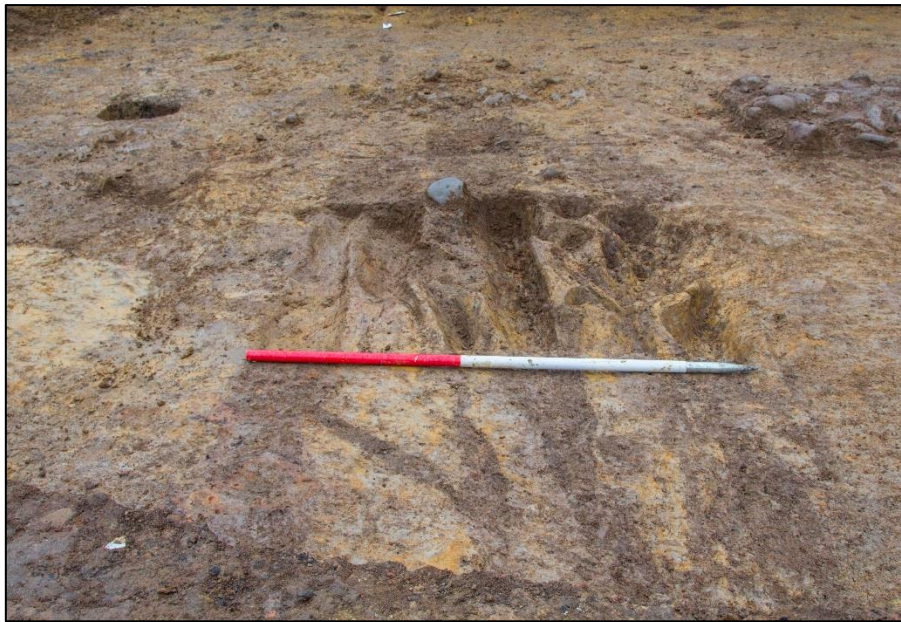
*Plate 58: East-facing section through plough-scars **292/293**, looking west, stone piles 271 and 290 visible at the top of the photograph, scale 1m.*

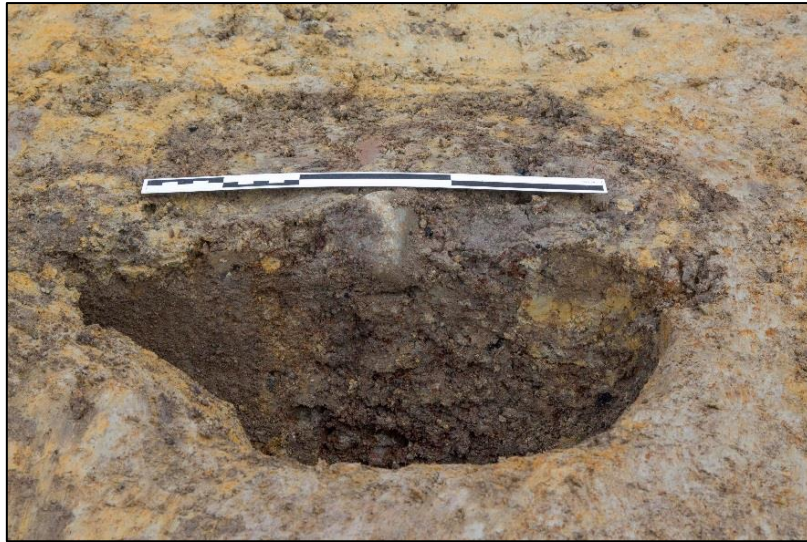
*Plate 59: Feature **184** filled by **183**, looking north-east, scale 30cm*

At the southwest side of the central area were a row of five pits (**286**, **199**, **184**, **186** and **288**) which ran in a line from southeast to northwest (Plates 59 and 60). These varied slightly in size and shape, had very mixed fills and showed a high rate of bioturbation. These were interpreted as a row of planting pits from a kitchen garden, possibly a row of fruit trees or bushes.. Only the fills of **184** and **288** contained any dateable material, 18th and 19th century pottery, but as they were cut into the top of layer **202** they are likely to be early 19th century in date. Between pits **199** and **184** was a small rectangular posthole **313** with an associated much smaller rectangular feature **315**. These were very shallow and the fill of the larger pit **313** contained pottery dated to the 17th and 18th centuries. These were likely to be the fragmentary remains of a timber fence, **313** as one of the main uprights and **315** as one of the smaller upright stakes between, from an 18th century garden.

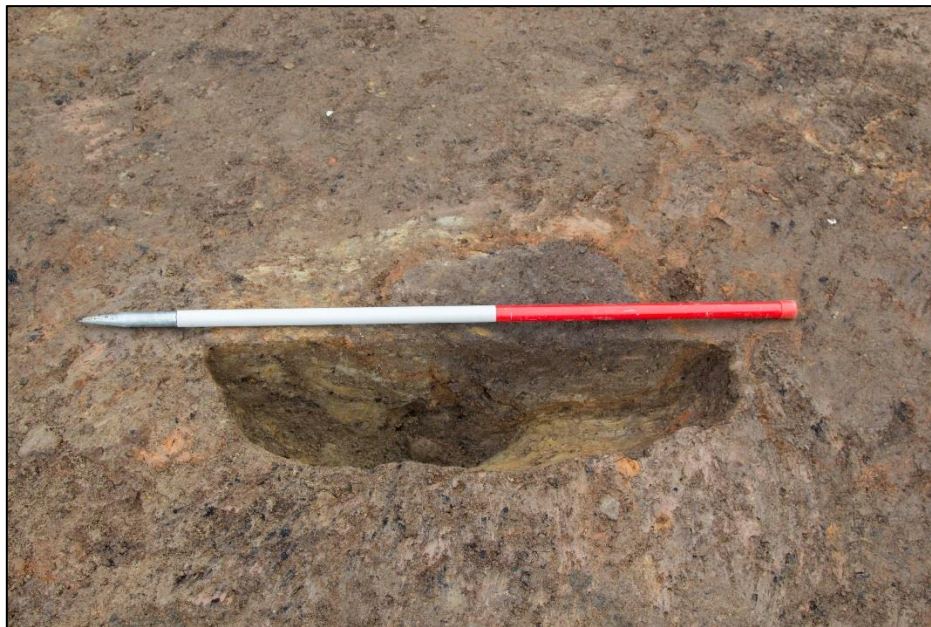
*Plate 60: south-west facing section of feature **199**, looking north-east, scale 1m.*

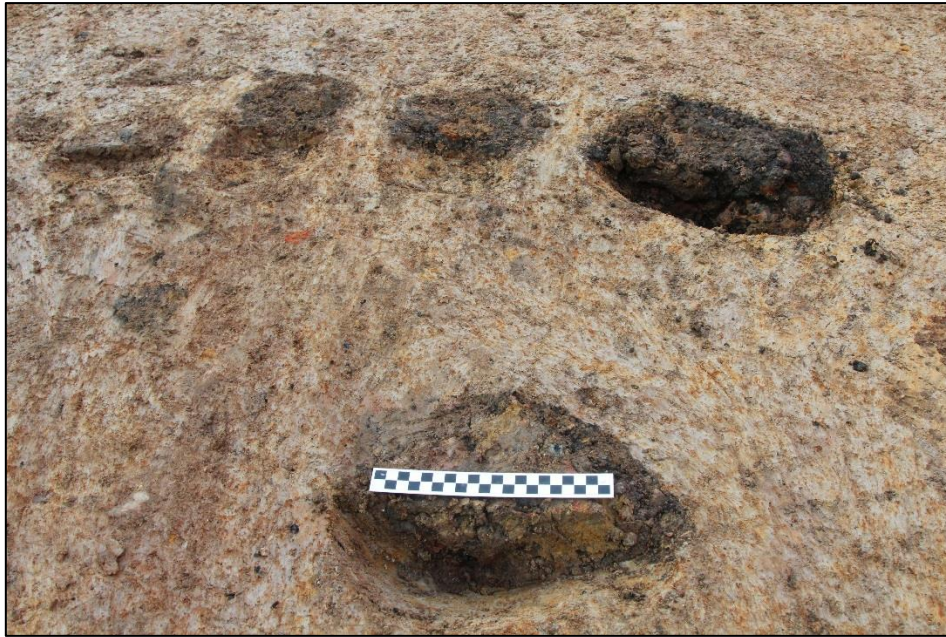
*Plate 61: East-facing section of features **303/305/307/309/311**, looking west, scale 20cm.*

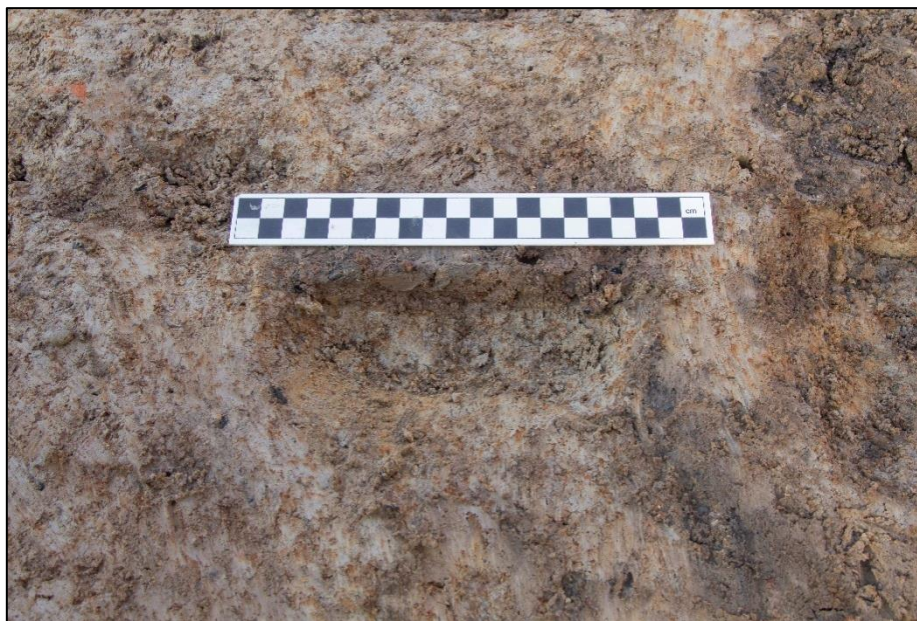
*Plate 62: East-facing section of **311** looking west, scale 20cm.*

To the northeast of wall **220** was a tight row of small rectangular pits (**305**, **307**, **309** and **311**) running southwest/northeast, with a small sub-circular pit, **303**, to the southeast (Plates 61 and 62). None of these pits contained dating material but were able to be attributed stratigraphically to the 18th or early 19th centuries and were also probably planting pits for fruit or vegetables.

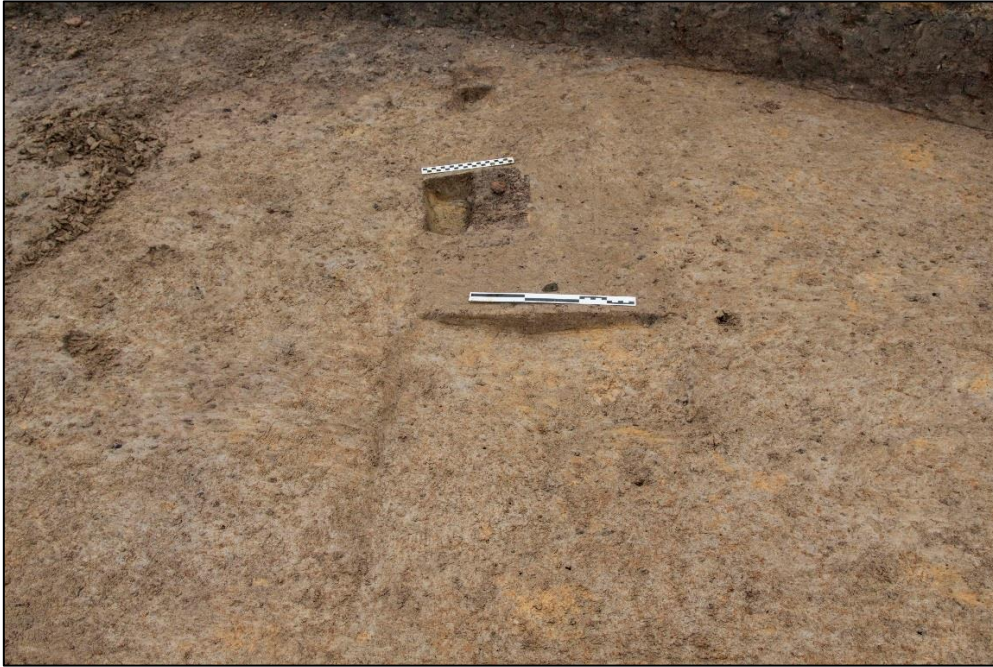
*Plate 63: Showing features **297**, **299** & **301**, looking north, scale 30cm*

In the northern portion of the central area were two linear features cut into layer **202**. The earliest was a 0.6m wide and 0.12m deep linear feature **297** running northeast/southwest (Plate 63). It had been truncated by modern disturbance at its northeast end and by linear feature **235** at its southwest end. As it did not appear to continue southwest beyond linear **235** it is likely to have ended there, although its shallow nature and the presence of wall **220** to the southwest may indicate that it had simply not survived further in that direction. The fill **298** was very mixed with brick fragments and cinder and contained 19th and 20th century glass. It may be that this was a drainage feature associated with the timber yard depicted on the 1851 Ordnance Survey map. Cut into the top of this linear feature were two small sub-

circular pits or post-holes **299** and **301**. These were shallow both very shallow and contained mixed clayey fills. The only artefacts from the fills of these pits was a piece of 17th century pottery from pit **301**, interpreted as redeposited due to the fact that the pits were cut into the top of a late 19th century drainage ditch.

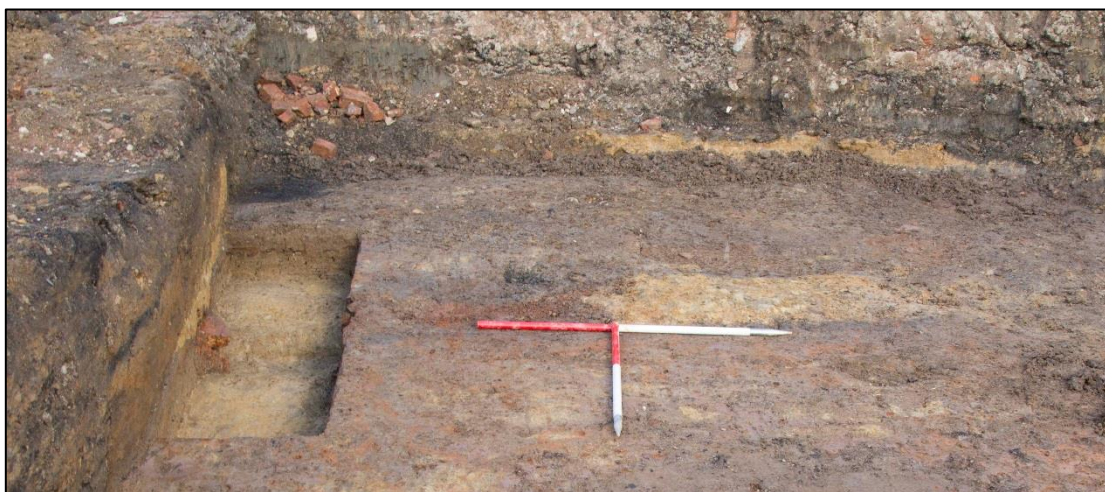
*Plate 64: Part-excavated ditch **235** showing yellow clay **213** capping the ditch, looking north-east, scale 1m.*

Running northwest/southeast was another drainage ditch **235** which cut linear feature **297**. This was 0.48m in width and 0.23m deep. It had a mixed fill **236** which contained abundant cinders, brick, a large amount of kiln waste and pieces of late 19th century ceramic soil pipe. It was capped with a yellow clay (Plates 64 and 65). The kiln waste suggested the presence of a kiln nearby but its exact function and location were impossible to determine.

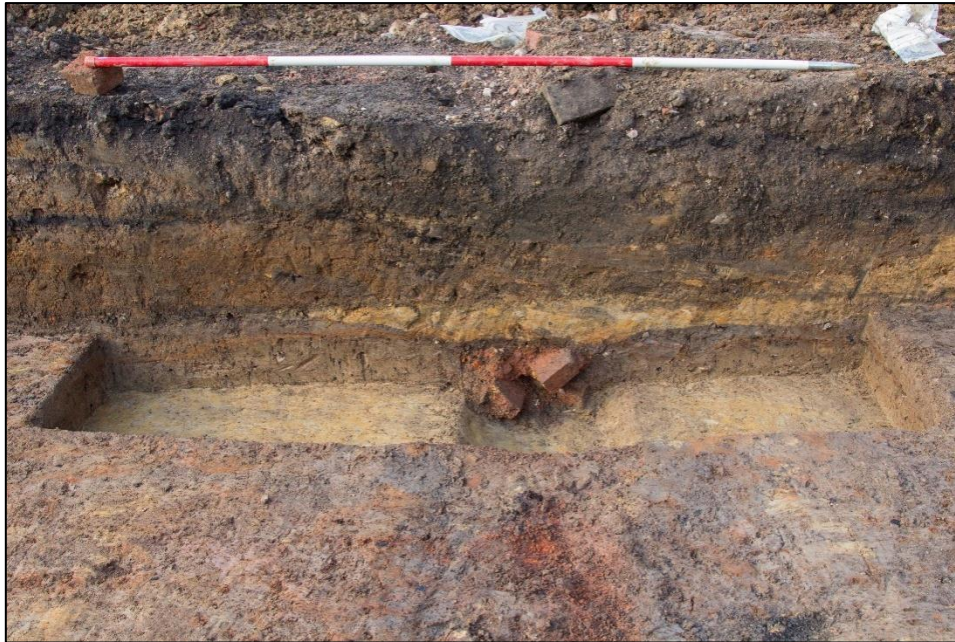
Plate 65: drainage ditch 235, looking west, scale 2m

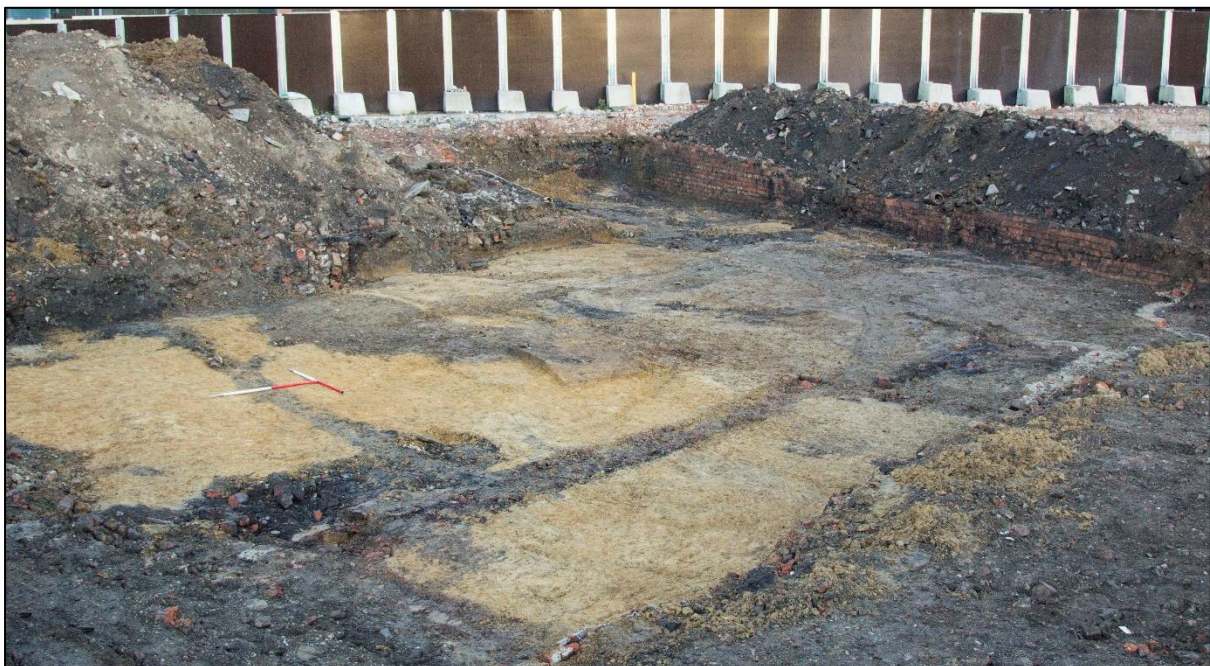
Plate 66: The western part of Area 1, looking north-east, scale 1m.

The trench investigating the relict soils was extended from the western side of the Globe and Simpson building basement almost to Water Street at the western side of the site. The western 27m of the trench had been heavily disturbed by modern activity and contained no visible features of archaeological significance. However, a 12m wide area at the eastern side of this excavation, up to the modern wall footings of a basement associated with the Globe and Simpson building, contained relict soils with features cut into them (Plate 66; Figure 26).

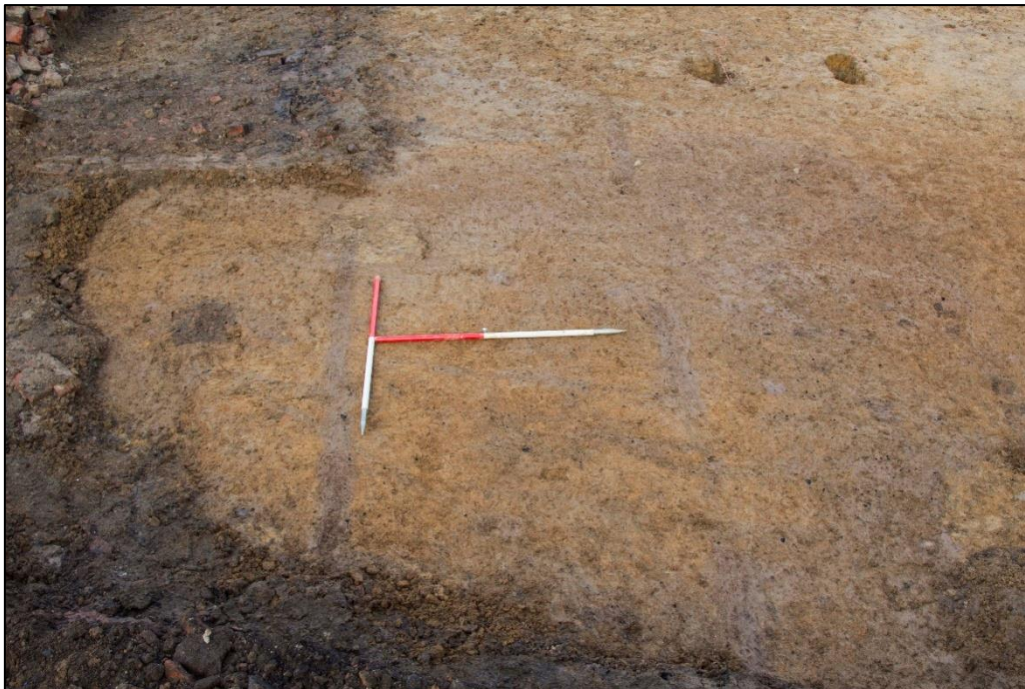
*Plate 67: View of plough scars **279**, **277** and **273** from left and pit **283** looking west, scale 1m*

The only features surviving below layer **202**, cut into plough soil **197**, were three narrow linear furrows **273**, **277** and **279**. These were interpreted as plough furrows, although feature **277** ran at right angles to the other furrows and so may be associated with a boundary of some kind. No dating evidence was recovered from these features but they could be stratigraphically associated with Phase 1 (Plates 67 and 68) .

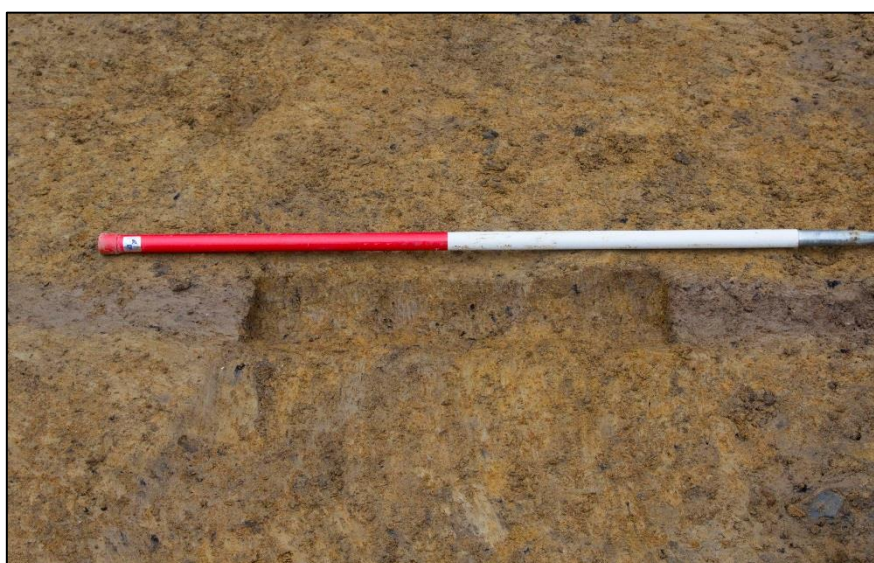
*Plate 68: Section of plough-scar **279**, looking north, scale 1m.*

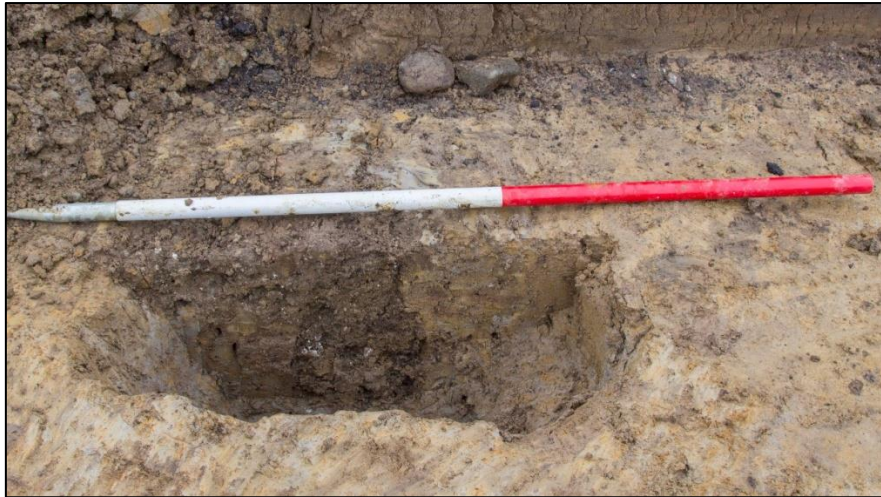
*Plate 69: South-facing section of **244**, looking north, scale 1m*

To the east of wall **057** several pits, all associated with Phase 2, could be seen cutting relict garden soil layer **202**. Pits **244**, **242**, **247**, **249** and **281** were all sub-circular and of varying but similar sizes and depths. All had similar very mixed fills with cinder and brick fragments. Only the fills of pits **244** and **242** contained dateable material, namely 18th and 19th century pottery, but all can be stratigraphically placed within the 18th or early 19th century and represent kitchen garden planting (Plates 69 and 70).

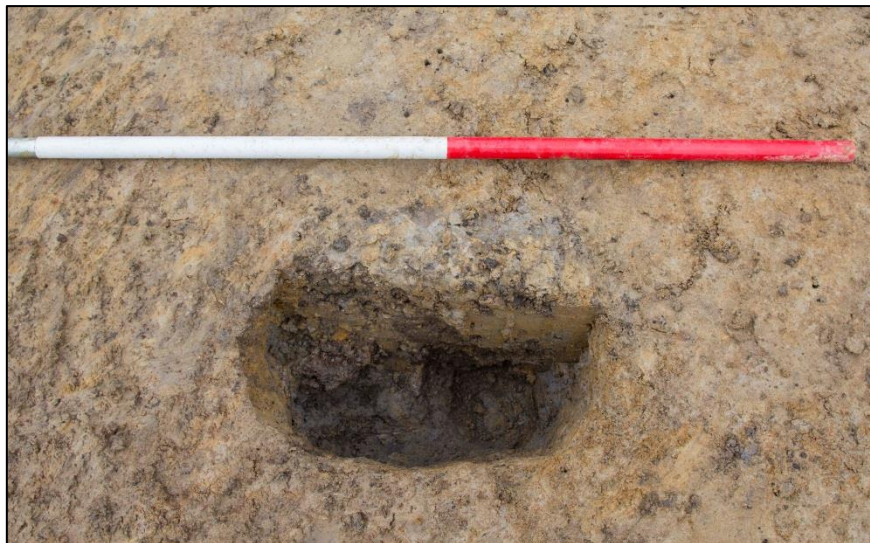
*Plate 70: South-facing section of **247**, looking north, scale 1m.*

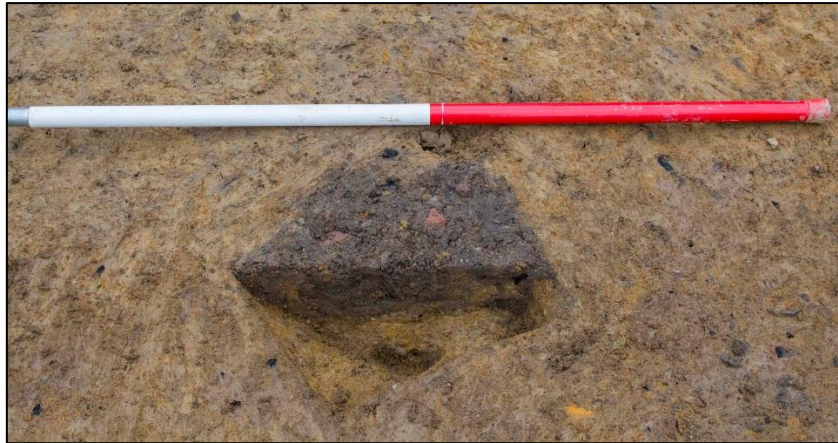
*Plate 71: south-east facing section of **283**, looking north-west, scale 1m.*

To the south of these features was another pit **283** cut into layer **202**. This was different as it was rectangular and slightly deeper. This was probably the remains of a fence running across the garden plot, the rest of the postholes probably having been removed by the later 19th century buildings surrounding it (Plate 71).

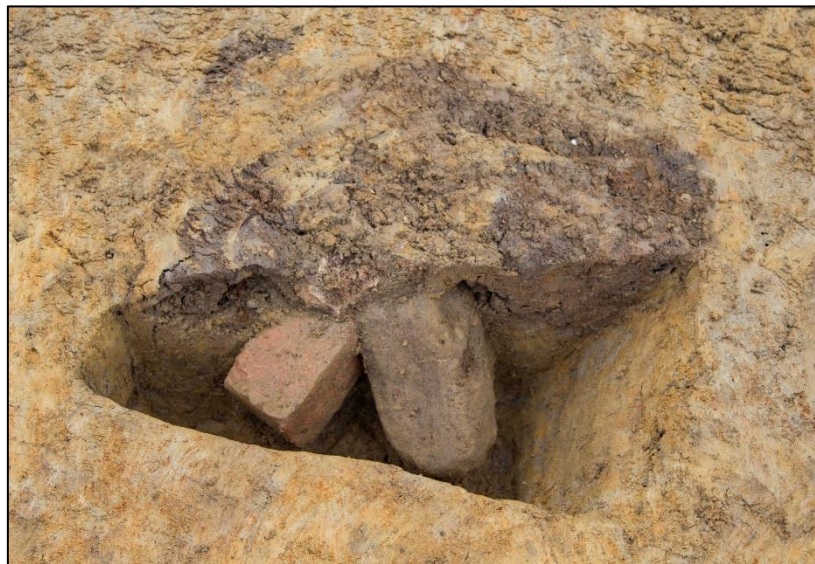
*Plate 72: West-facing section of **223**, looking east*

At the western side of wall **057** layer **202** was not present, possibly as **057** represented the boundary of the kitchen gardens in this area. Plough soil **197** continued for a short distance before being truncated by later activity. At the south side three pits were cut into layer **197**. Pit **225** was sub-circular and shallow and contained 19th century pottery and glass. Pit **223** was sub-rectangular and contained a handmade brick in its fill. Pit **228** was irregular in shape, and possibly had been truncated at its eastern side, and contained 18th century clay pipe. Although all three pits were cut into layer **197** the material within the fills suggested they were associated with the later buildings depicted on the mapping (Phase 3) rather than any pre-industrial agricultural activity (Plates 72 and 73).

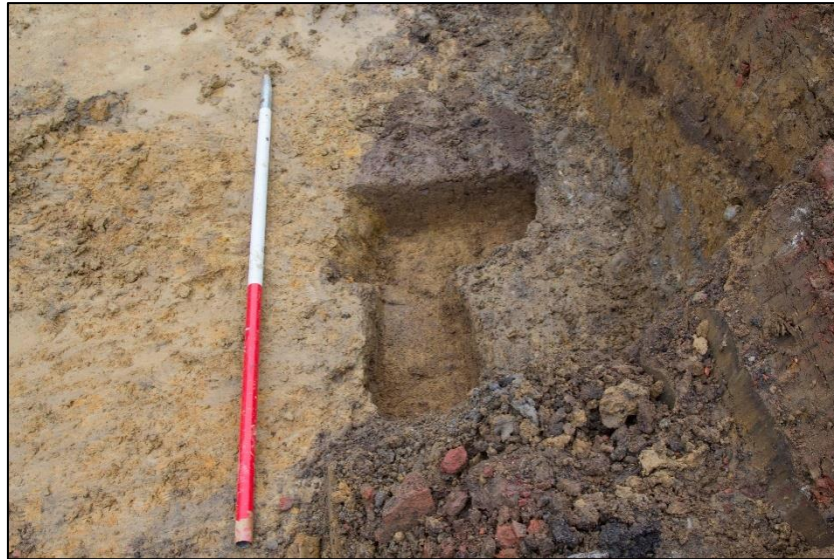
*Plate 73: West-facing section of **228**, looking east, scale 1m.*

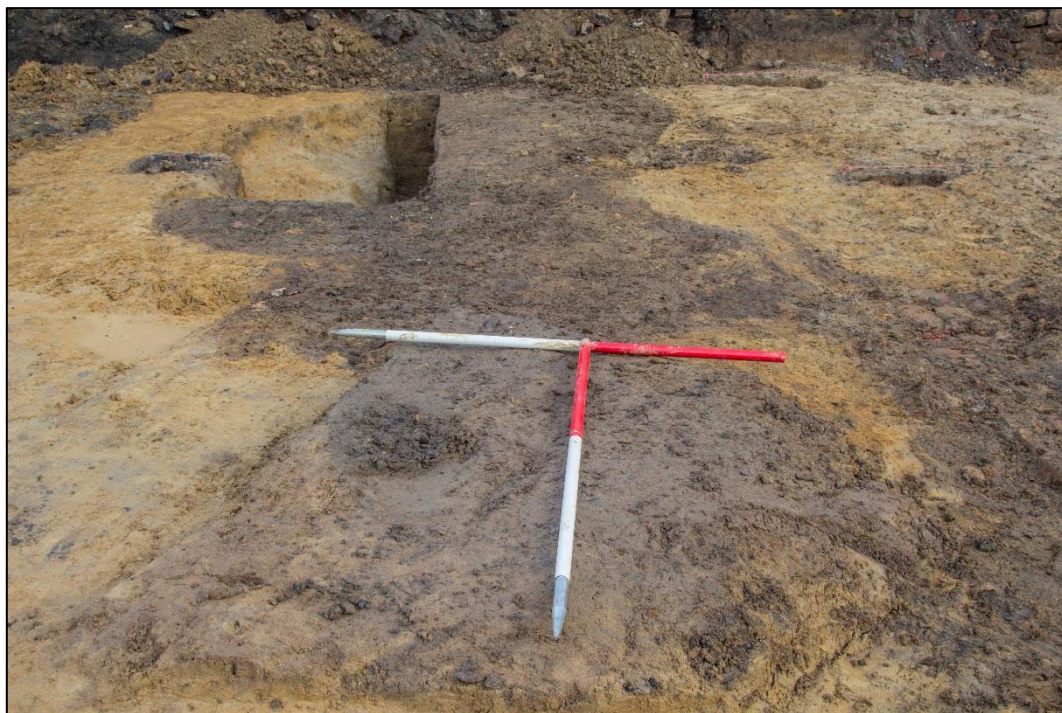
Plate 74: series of inter-cutting rubbish pits, looking north-east, scale 1m.

Similarly a series of larger intercutting pits to the north was associated with Phase 3 rather than the agricultural/horticultural activities of Phases 1 and 2. Pits **251**, **253**, **255**, **257**, **259**, **260**, **264** and **269** formed an amorphous series of intercutting pits with fills containing a mixture of pottery, glass and clay pipe dating from the 16th to 19th centuries. As the earliest pits in this sequence contained an equal amount of 19th century material to the later cuts it can be surmised that all the earlier material was redeposited and that these pits represented the digging and infilling of rubbish pits at the rear of the 19th houses to the north (Plates 74 and 75). As such it is not necessary here to describe the exact stratigraphic relationships in detail.

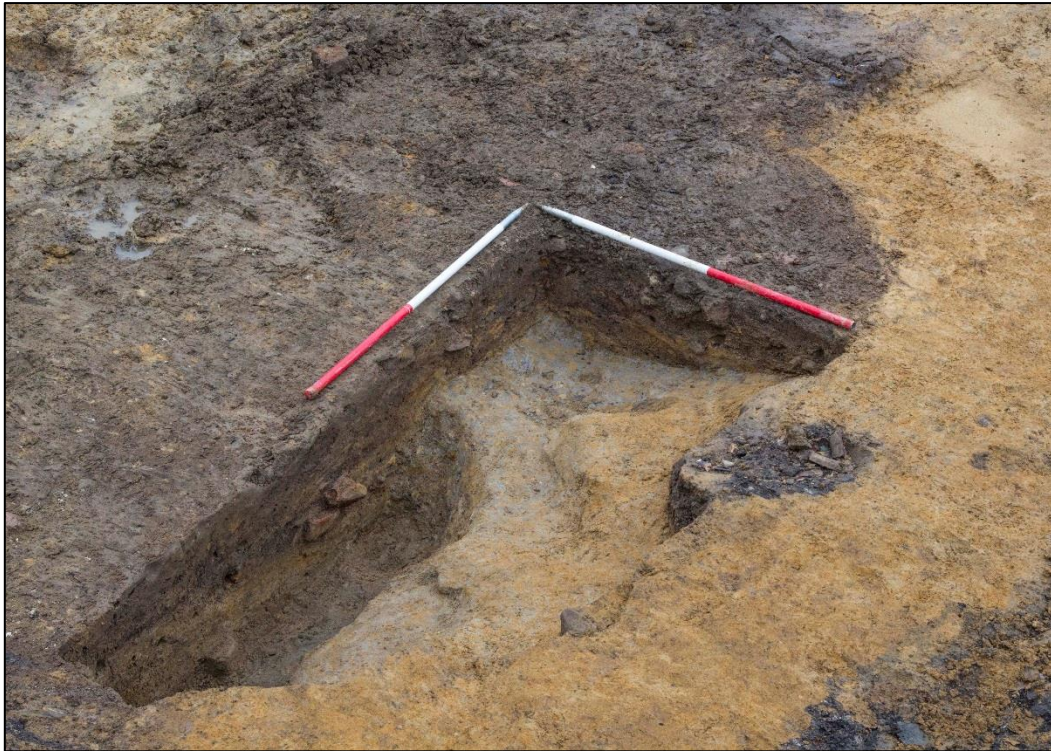
Plate 75: Series of inter-cutting pits, looking south-east, scale 1m.

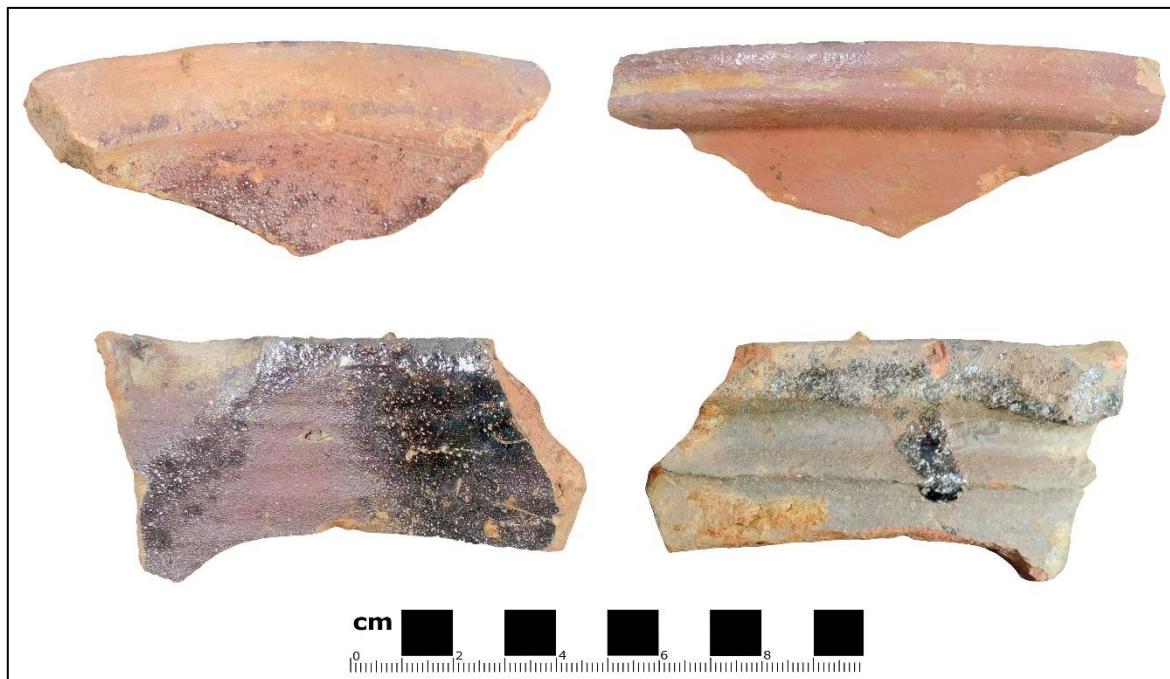
Plate 76: Midlands Purple jar rims, from occupational deposit 197
