Archaeological Post-Excavation Assessment

Globe and Simpson,
Old Granada Studios,
Quay Street,
Manchester

Technical Report:
Katie Harvey and
Graham Mottershead

Report No:
SA/2019/59

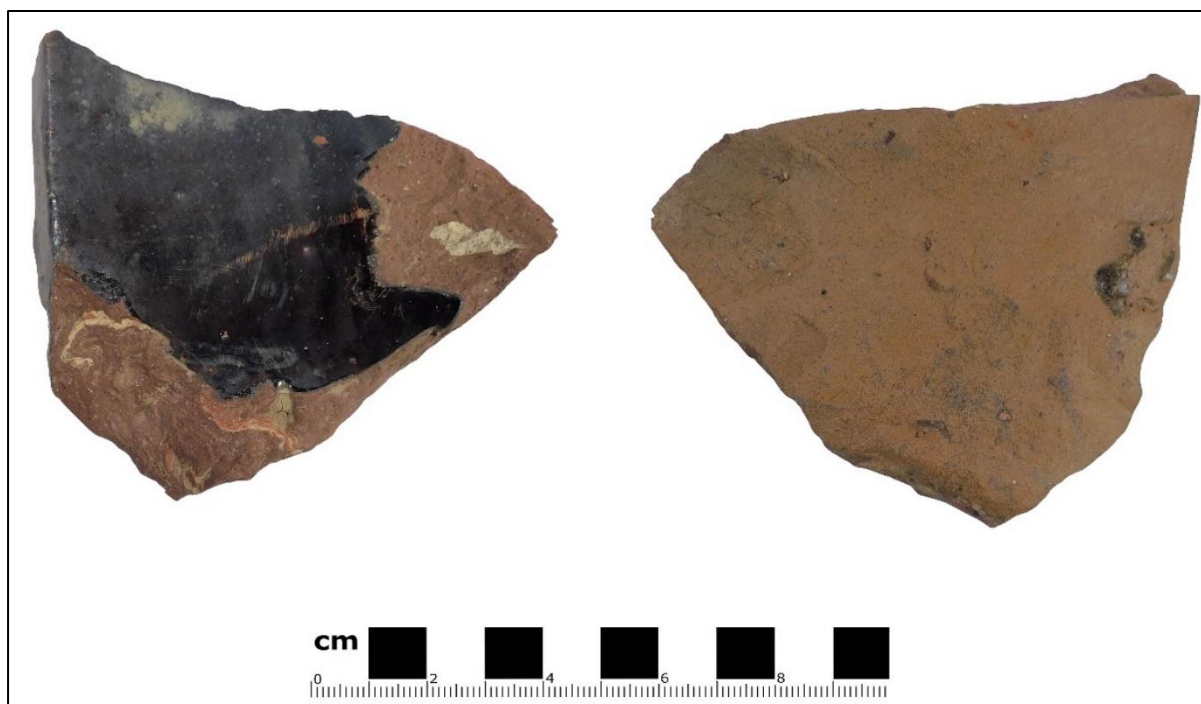
Plate 77: rim of probable dripping pan, unstratified

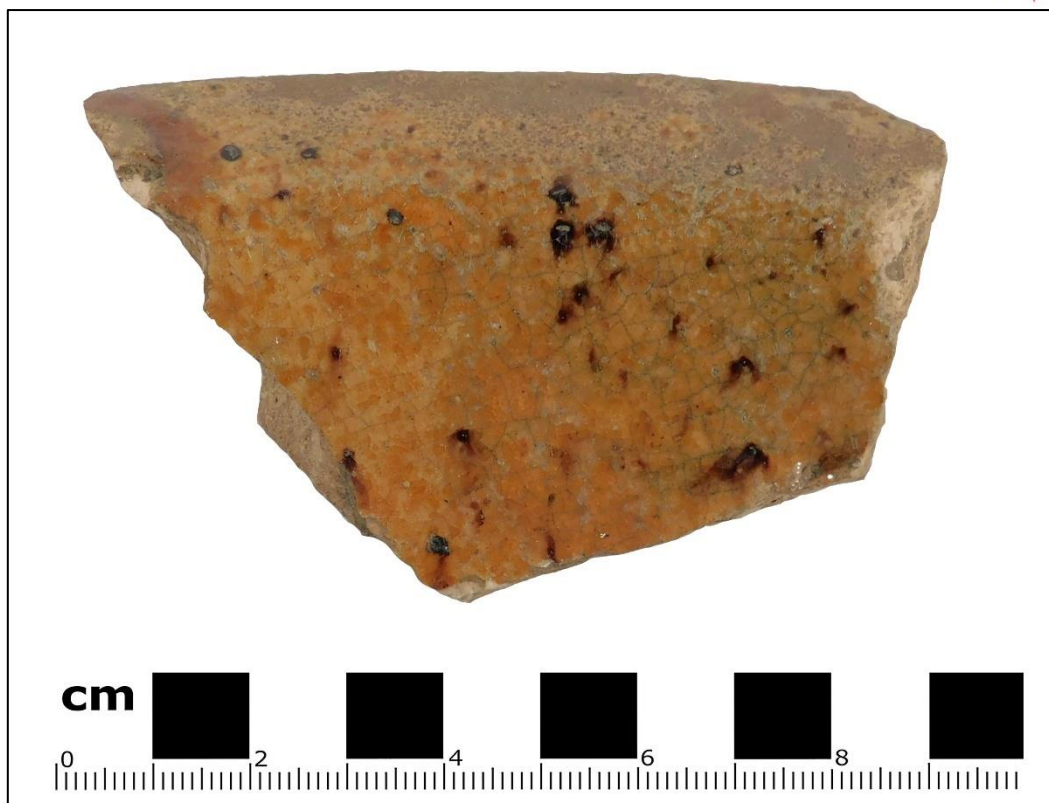
Plate 78: yellow ware dish rim from post-medieval garden soil 42

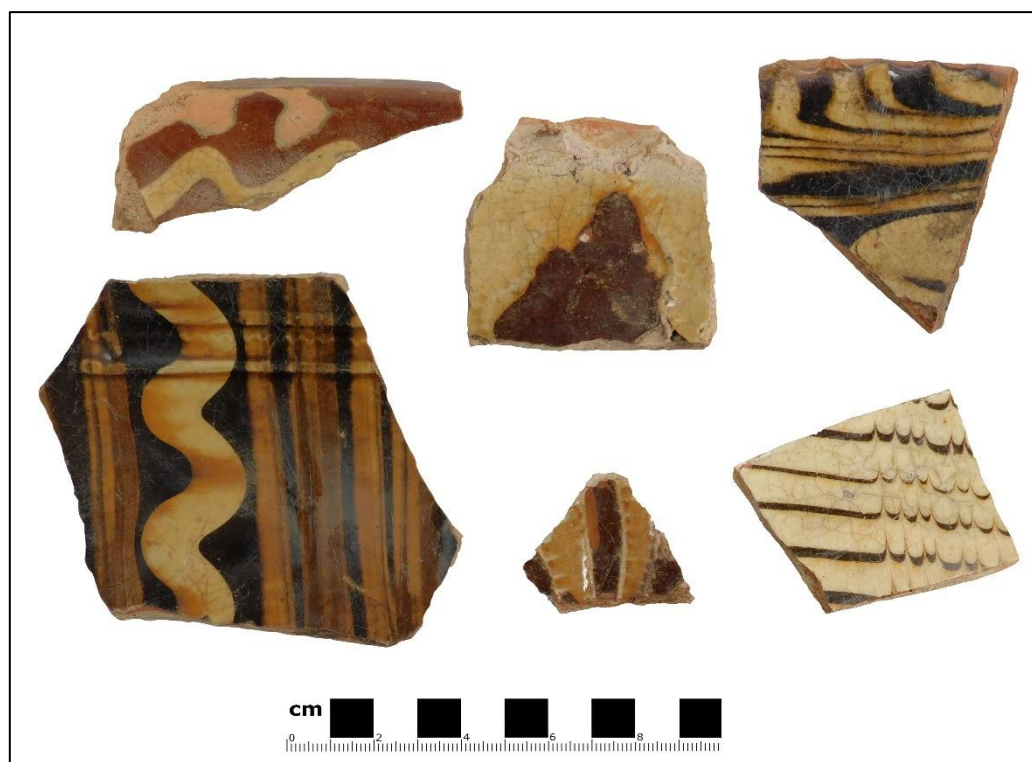
Plate 79: variety of slipware sherds from garden soil deposits 197, 202, 219

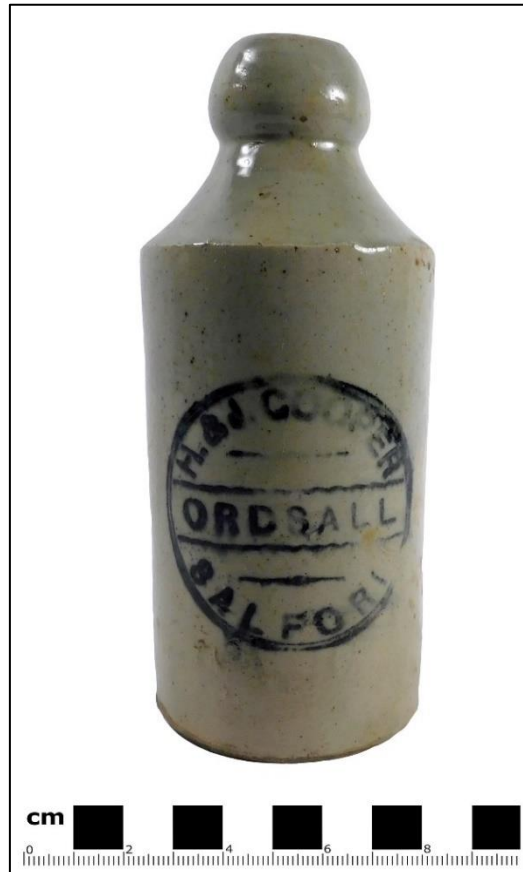
Plate 80: complete stoneware bottle, unstratified

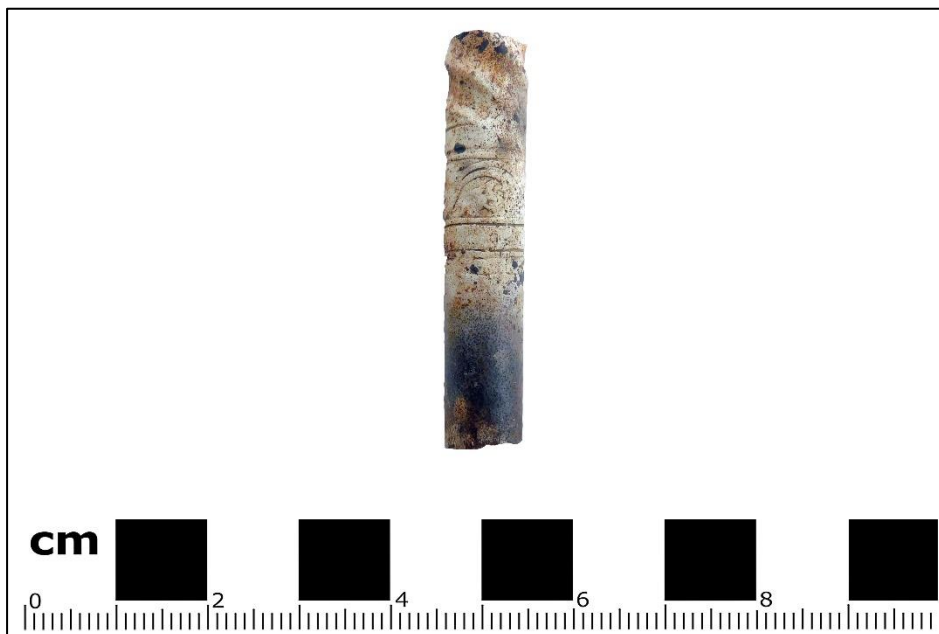
Plate 81: clay pipe stem with roller and spiral decoration, deposit 258 fill of pit

The majority of the stems are plain, except two which exhibit roller decorative stamps (Plate 81) and one which has a makers' mark: 'ELIZ: SAVAGE' (Plate 82). This stamp is rare and has been recorded from an excavation in Warrington and in collections in Kendal museum (Davey, Elsworth and Mace 2016, 69, Higgins 2008, 156). Recent excavations in 2018 carried out by Salford Archaeology at Lancaster Castle also recovered two pipe stem fragments with the same makers' mark. No pipe-maker is recorded under this name, though Elizabeth Savage is recorded in parish records in Warrington (1728) and Lancaster (1732).

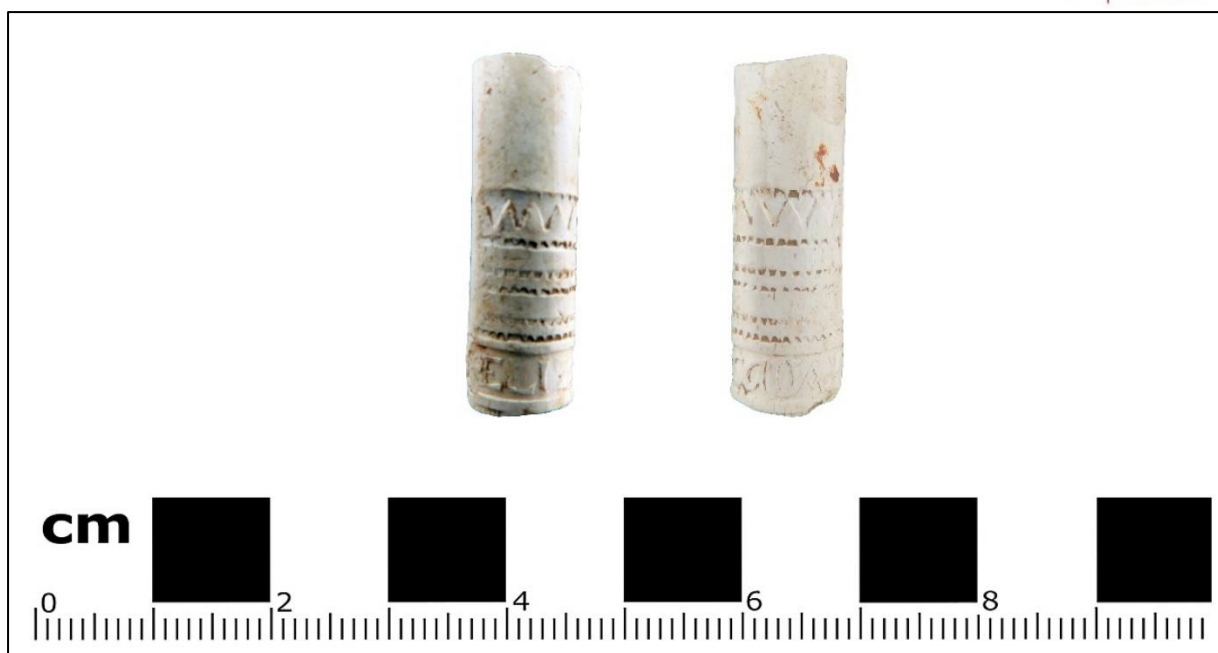
Plate 82: stamped pipe stem 'ELIZ: SAVAGE', deposit 197 relict soil

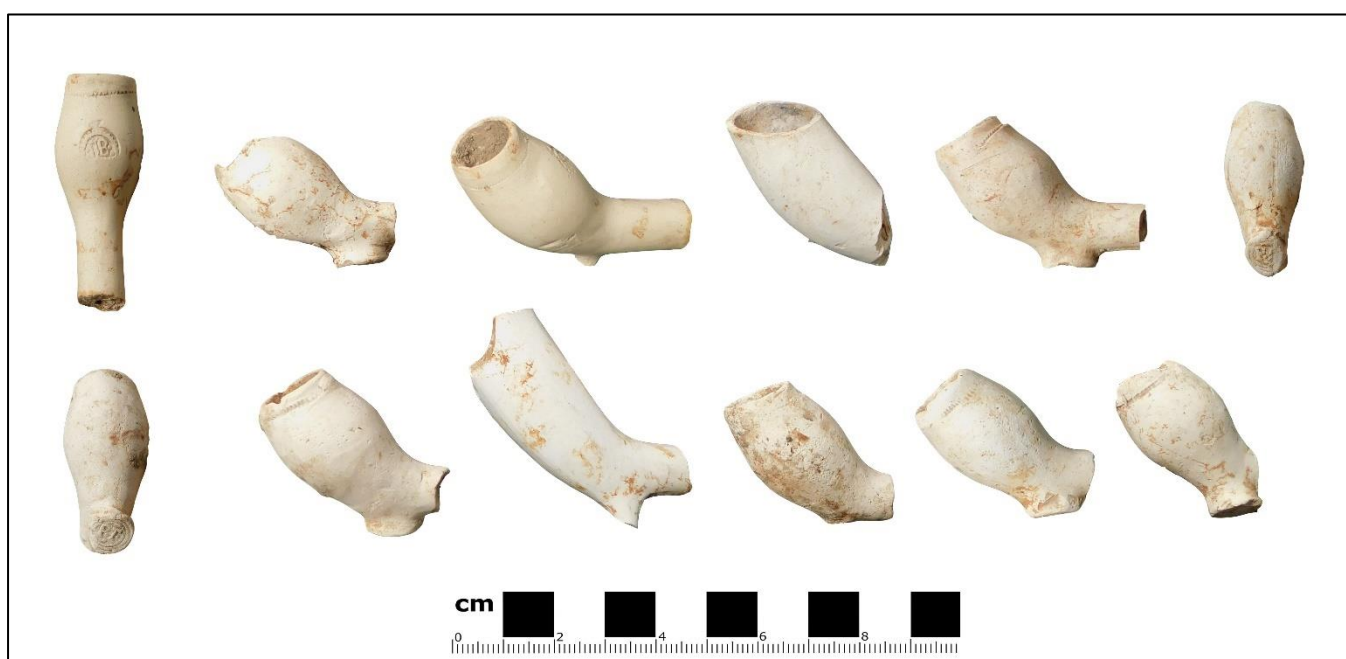
Plate 83: variety of 17th and 18th century clay tobacco pipes from the excavations, including makers' mark stamped examples

A total of 64 complete or partial clay pipe bowls were collected during the excavations. This includes a number of 17th century stamped bowls, details of which are given in table 3. The pipe bowls range in date from the 1630s to 1910, though the majority of bowls date to c.1640-1680 (Plate 83).

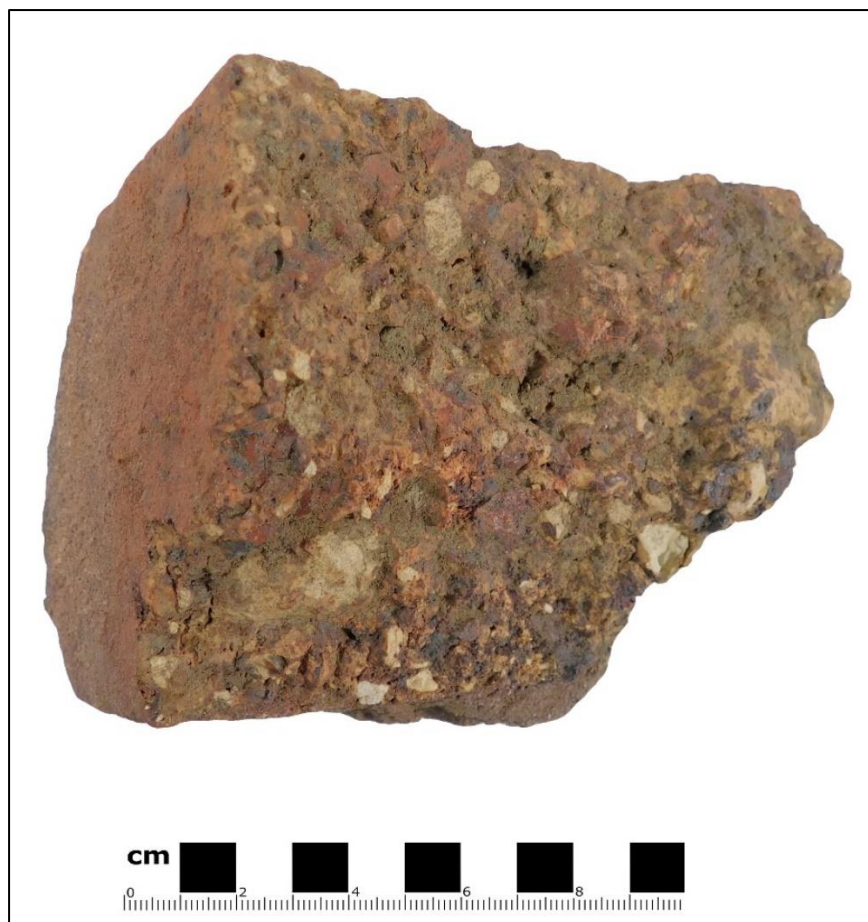
Plate 84: brick fragment from occupational layer 221

A small fragment of architectural plaster was also retrieved from topsoil deposits, which has very limited research potential. Two partial bricks were retrieved from occupational layers and a ditch fill. Both are handmade, one of which exhibits burning and may have lined a kiln (Plate 84).

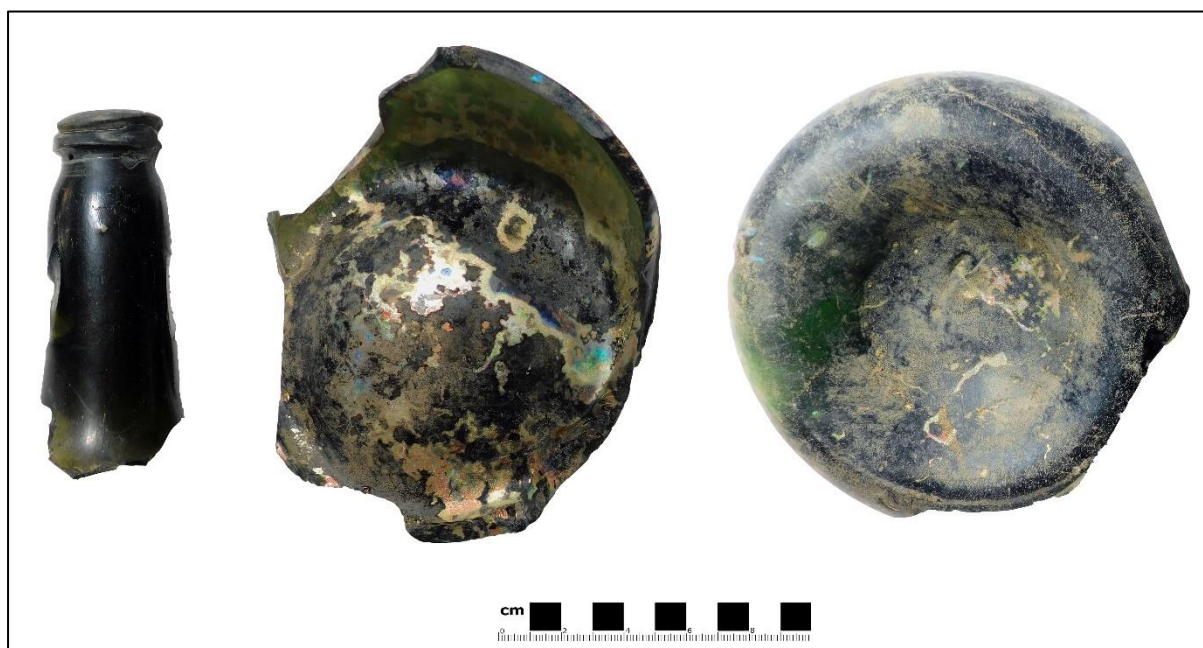
Plate 85: base and neck of late 17th century onion bottle, deposit 202

A total of 275 fragments of glass were recovered during the excavations. The vast majority of the assemblage consists of 19th-20th bottle glass, as well as a small portion of window glass. At least 40 partial or complete glass bottles are present in the assemblage, a list of which is compiled in table 4. The earliest glass is the base of a probable onion bottle dating to the late 17th to early 18th century (Plate 85).

| Context | Identification | Date (century) |
|---|--|---|
| (202) fn 13 | Base and neck of probably onion bottle (Plate 85) | c.1680-1720 |

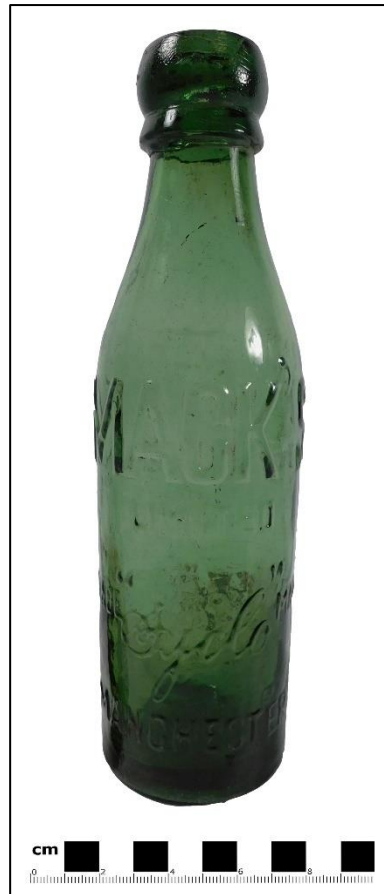
Plate 86: green ale bottle 'MACK'S LIMITED TRADE 'SYCLO' MARK MANCHESTER', deposit 99

| Context | Identification | Date (century) |
|---|--|---|
| (99) fn 50 | Complete green beer bottle with internal screw stopper 'MACK'S LIMITED TRADE 'SYCLO' MARK MANCHESTER' (Plate 86) | Late 19 th century |

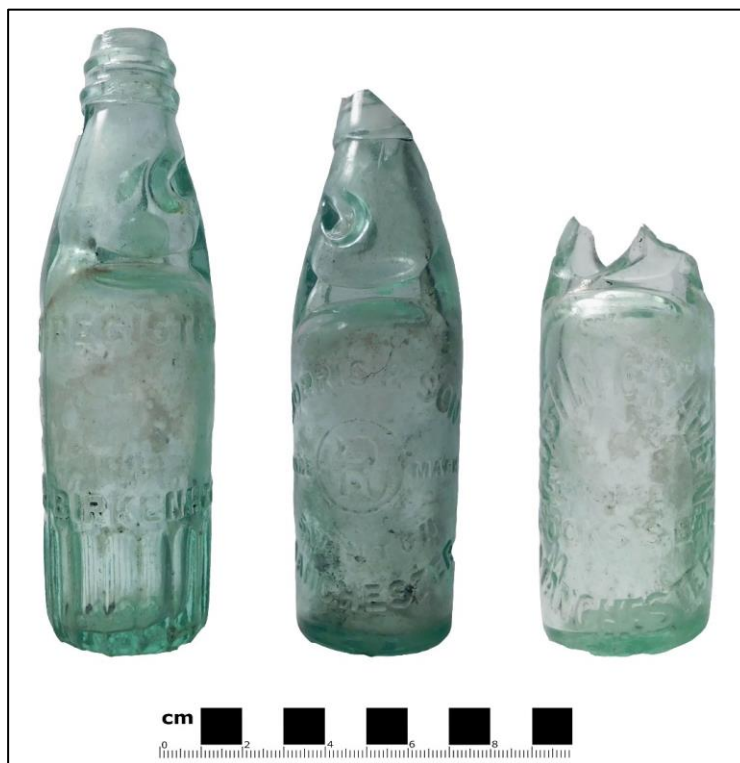
Plate 87: selection of codd bottles, deposit 99

| | 'MORRIS & SON SWINTON MANCHESTER' 'AUSTIN CRAVEN BROOKS'S BAR MANCHESTER EST.D 1842' (Plate 87) | |

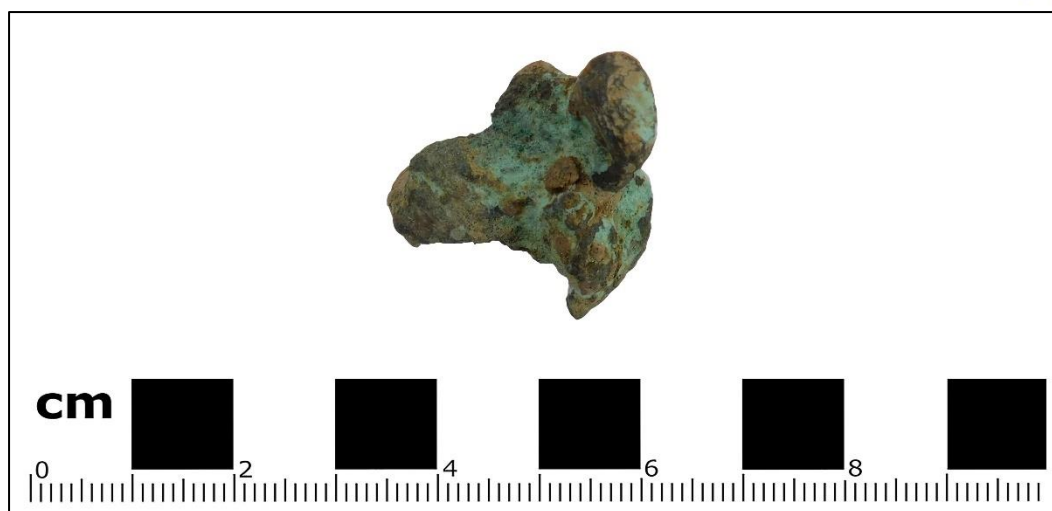
Plate 88: corroded copper lump from occupational deposit 202

Three copper objects were retrieved during the excavations. This includes a modern copper pipe fitting, and illegible post-medieval corroded coin, and a corroded lump (Plate 88). It is unclear whether this lump was part of another object and may be mistaken for a medieval or earlier object. However, due to its vicinity in an occupational layer which predominantly produced 17th-18th century material it is likely to be post-medieval in date.

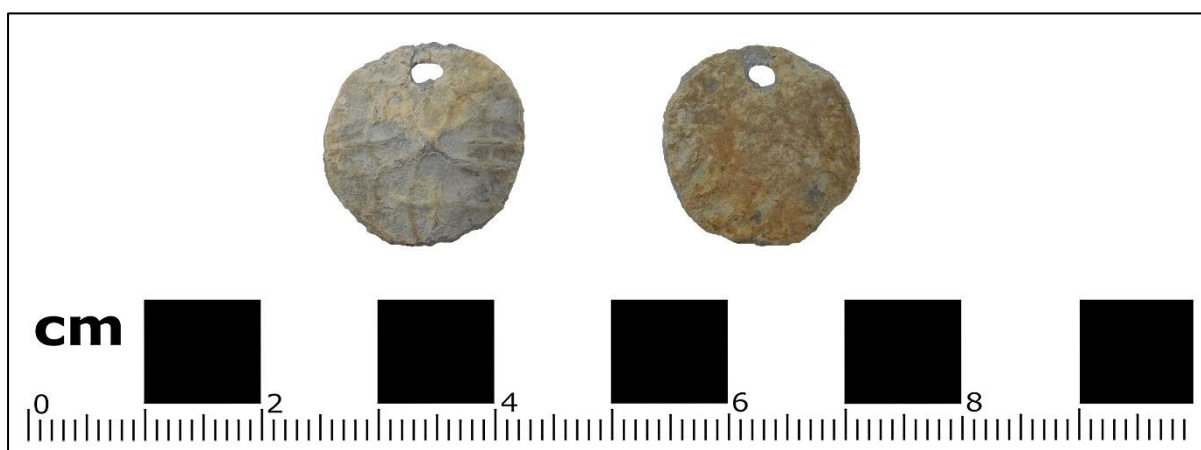
Plate 89: post-medieval lead token depicting petalled flower, from deposit 202

A lead token was also retrieved from deposit (202); a post-medieval occupational layer. Though worn and faded, the token is roughly circular with decoration on both sides, though one side is almost illegible. One face is decorated with a six petalled flower with hollow ovals in relief forming the petals. One of the faces is heavily worn but may have also depicted petals (Plate 89). Lead tokens were used for a variety of purposes including gaming pieces, tickets, and weights. They are likely to have been locally produced and are therefore difficult to date. They mimic Medieval penny designs and date to c.AD1500-1850.

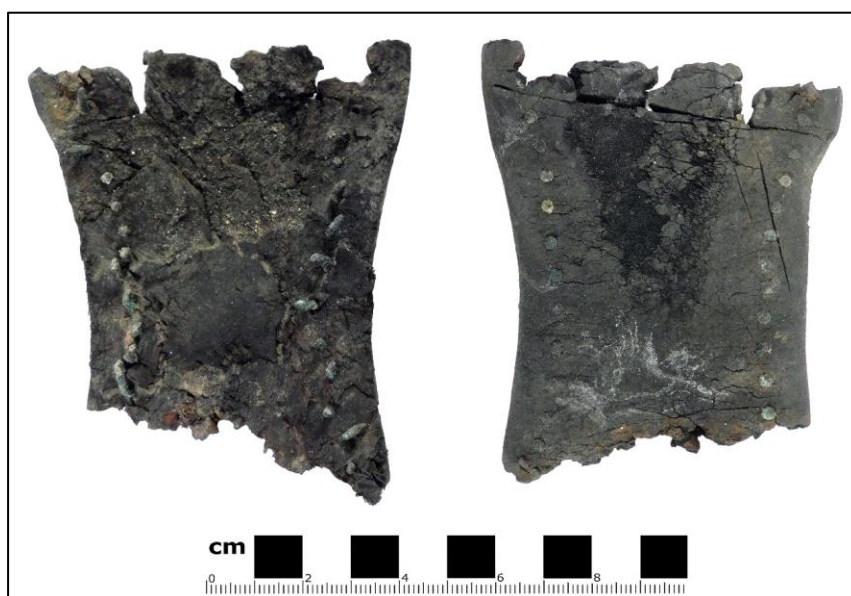
Plate 90: fragment of leather shoe with copper nails. Unstratified.

Three pieces of leather were retrieved from an unstratified context on the site. These all appear to be fragments of a leather shoe. One piece has two lines of copper nails still intact to fit the sole to the rest of the shoe (Plate 90). It is difficult to establish the shoe form due its fragmentary state, but it is likely to be a 19th century workers' shoe.

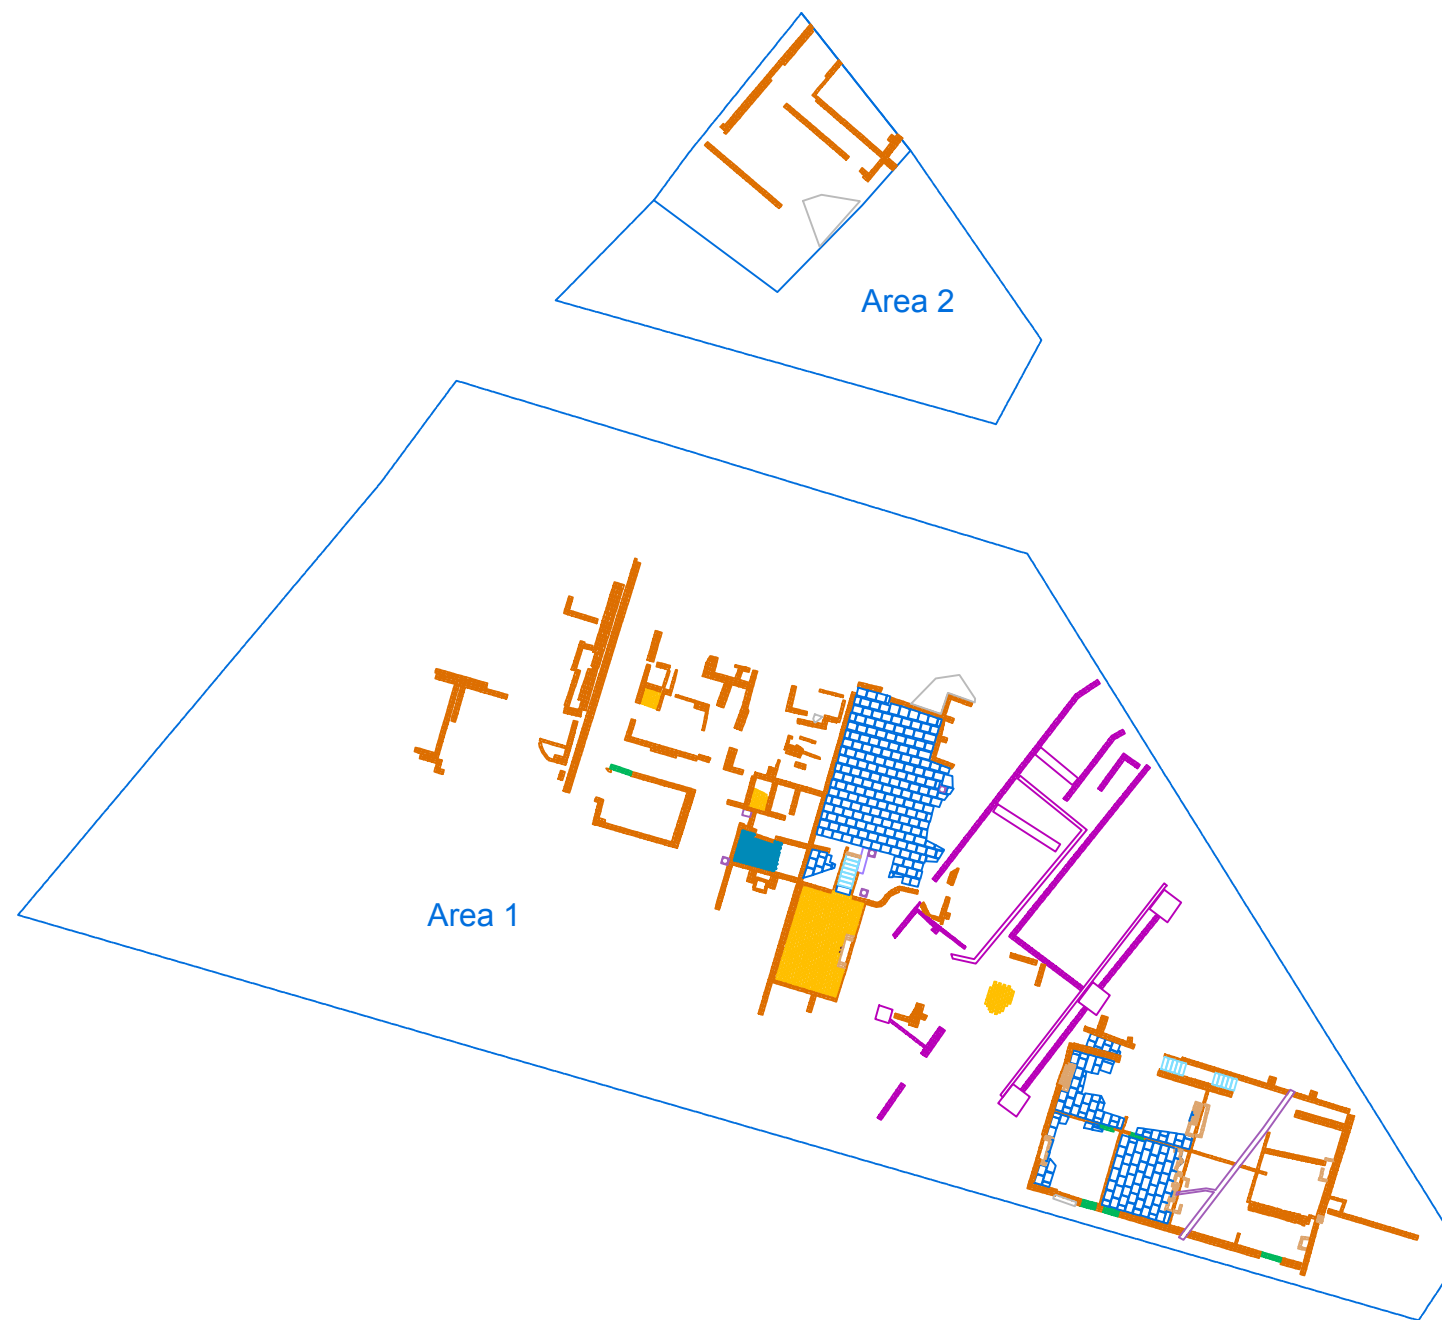
Figure 18:
Overall plan of structural remains in excavation areas 1 and 2
