Historic Building Investigation

Greysfield,
Ferma Lane,
Great Barrow,
Cheshire West and
Chester

Report No:
SA/2017/19

Document Type: Archaeological Investigation Report

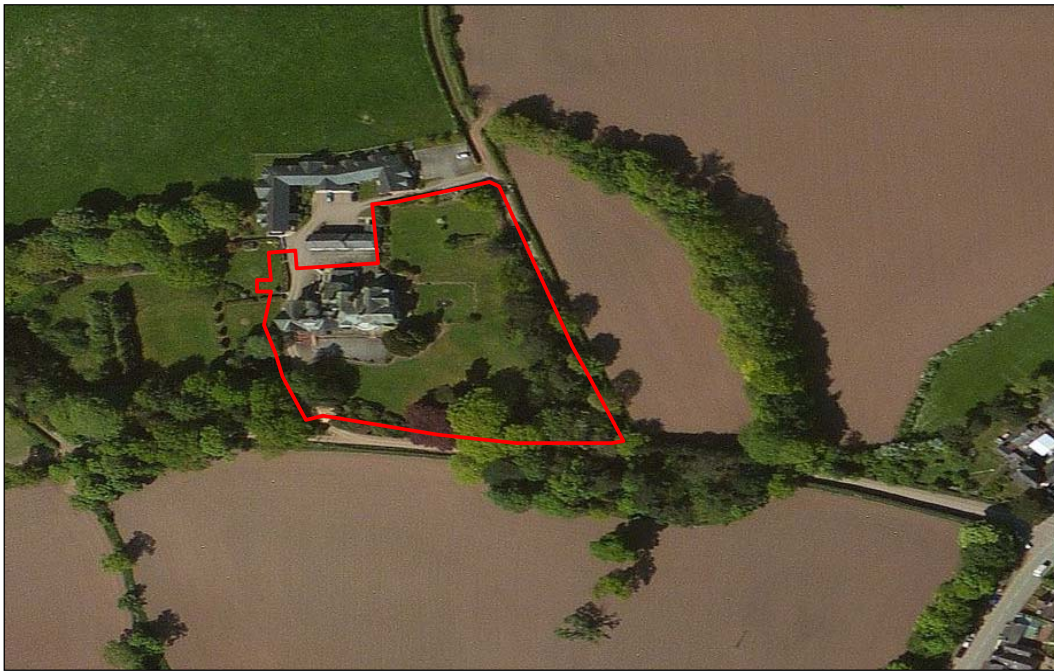
Plate 1: Recent aerial view across the study area, showing the proposed development area boundary

The site (centred NGR 346733 368614) lies in Great Barrow, situated approximately 7km to the north-east of Chester city centre. Greysfield lies within the Great Barrow Conservation Area, and is bounded to the west and south by Ferma Lane and to the east by Barrow Lane (Plate 1).

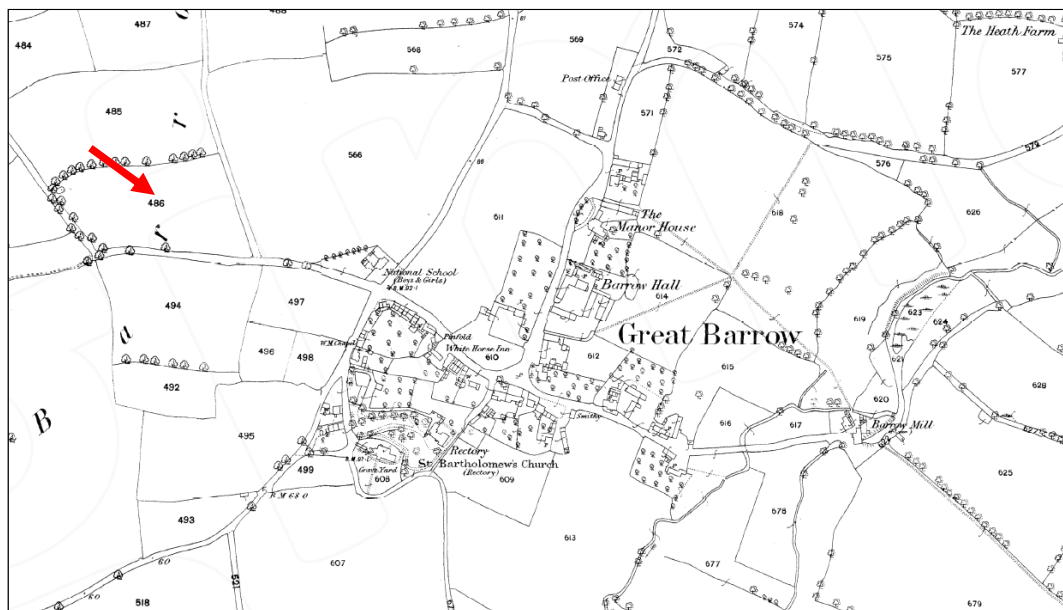
Plate 2: Extract from the Ordnance Survey map of 1875, with arrow marking the site of Greysfield

The site occupied by Greysfield lies some 375m to the north-west of the church in Great Barrow, and the historic core of the settlement, as shown on the Ordnance Survey map of 1875 (Plate 2).

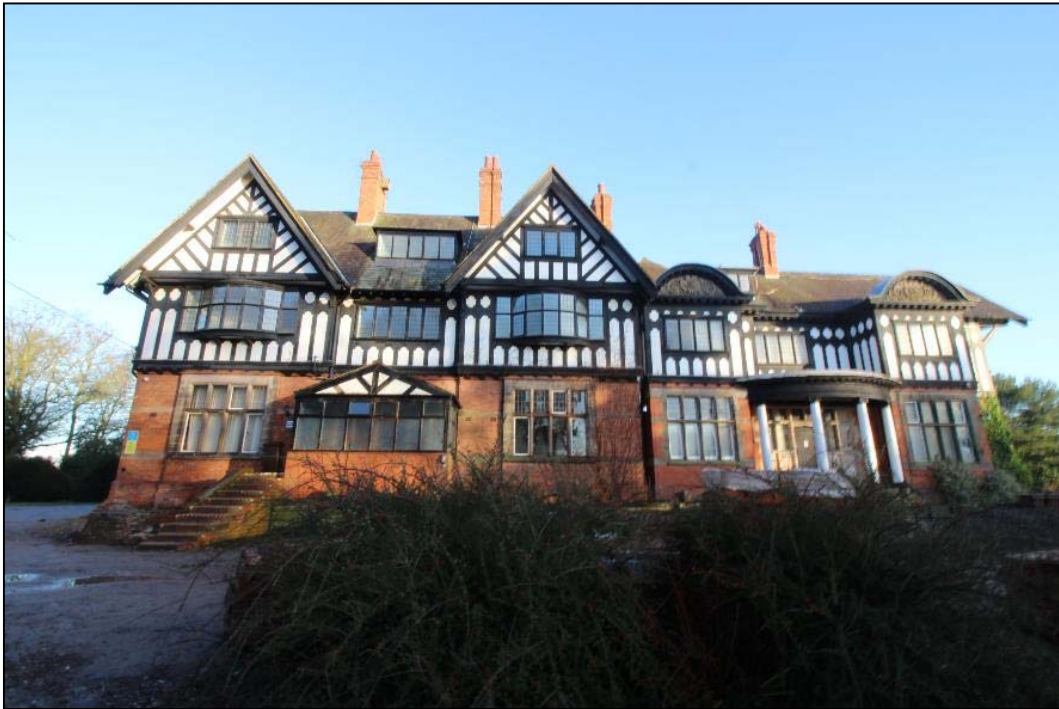
Plate 7: The southern elevation of Greysfield

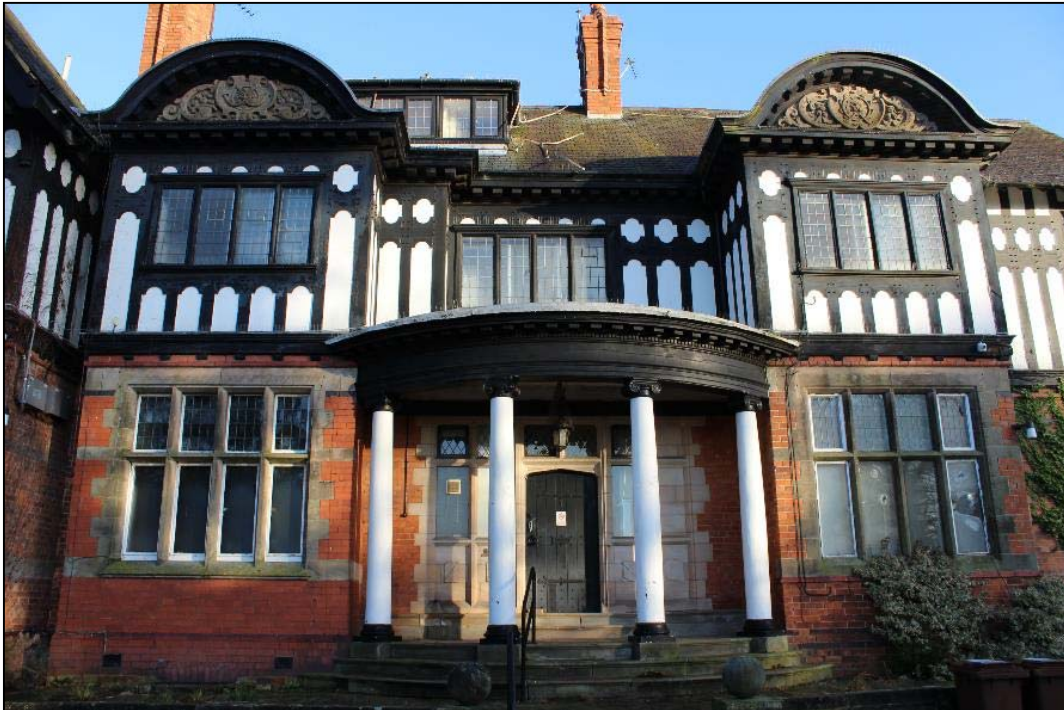
The eastern entrance to the house is accessed via a set of sandstone steps, which are covered by a half-round porch. The porch has a flat roof and is supported by four rendered sandstone, Ionic-style columns. The door is of oak and has been hung on a sandstone doorframe, which has a false four-centred arched head with a two-light fanlight along with a splayed jamb.

Plate 8: Main doorway at the eastern end of the southern elevation

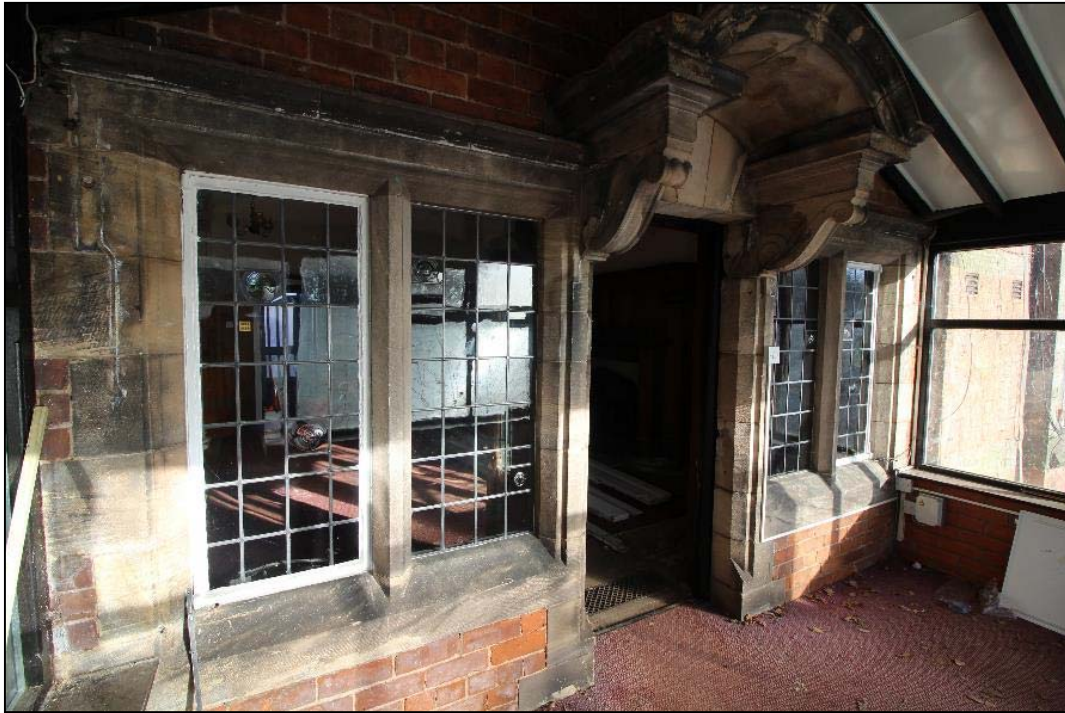
The western entrance is accessed via a set of brick risers and tread steps to the west. It is covered with a brick-built porch with timber-framing, which has a pitched slate roof. This porch conceals an oak door, hung on a sandstone doorframe, which has sandstone segmental pendant. Either side of the door is a set of windows, which has a stone mullion, chamfered stone sills and lintels. The first-floor windows are a mixture of bayed and rectangular shape, which all contain single-glazed panes. Dormer windows are located on the second floor, and are single glazed timber-framed with half-round moulded beading (Plates 7-9).

Plate 9: Doorway at the western end of the southern elevation

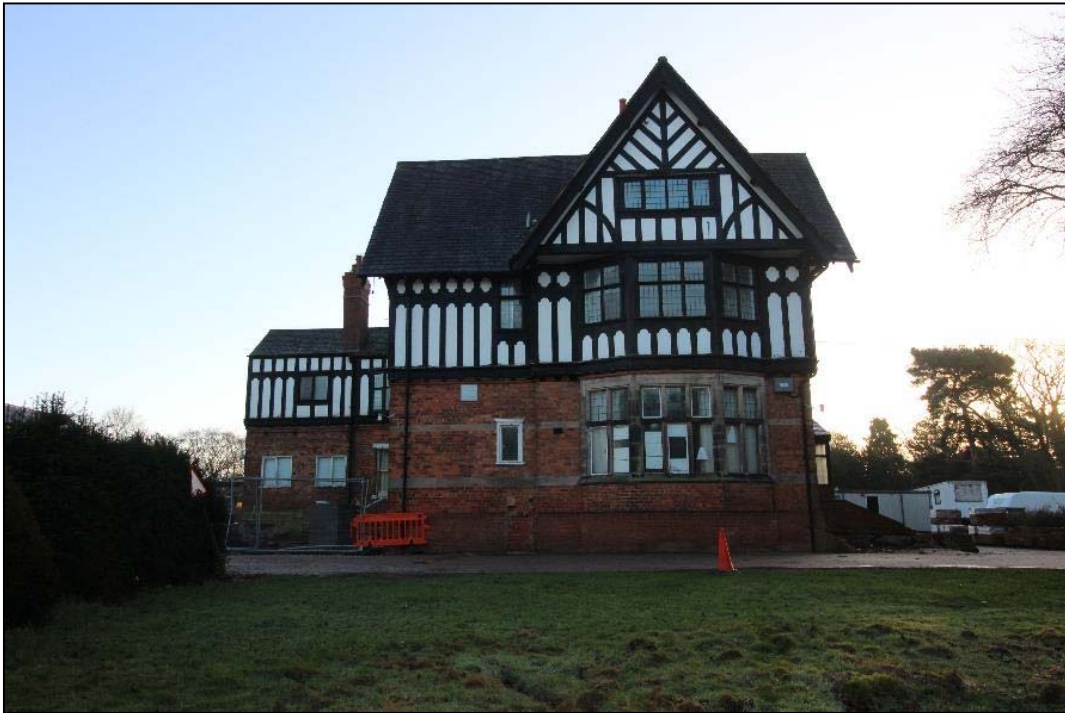
The western elevation is again constructed from brick and sandstone with timber-framing on the first and second floors. A large bay window is located on the southern end of the ground floor. This has a sandstone seven-light by two-light mullion and transom design, with chamfered stone lintel and sill. A small uPVC window has been inserted into the northern end of the ground floor. The second floor has another bay window above the ground-floor bay. This window has a timber-frame and contains seven-light by two-light single-glazed pains. A small timber-framed rectangular-shaped window is located north of the bay and is directly above the modern uPVC window on the ground floor. On the second floor, a gabled dormer is situated above the first-floor bay at the southern end. The dormer has pain bargeboards and a slate roof. The window is timber-framed with a four-light timber mullion (Plate 10).

Plate 10: The western elevation, showing the bay windows and dormer in the roof

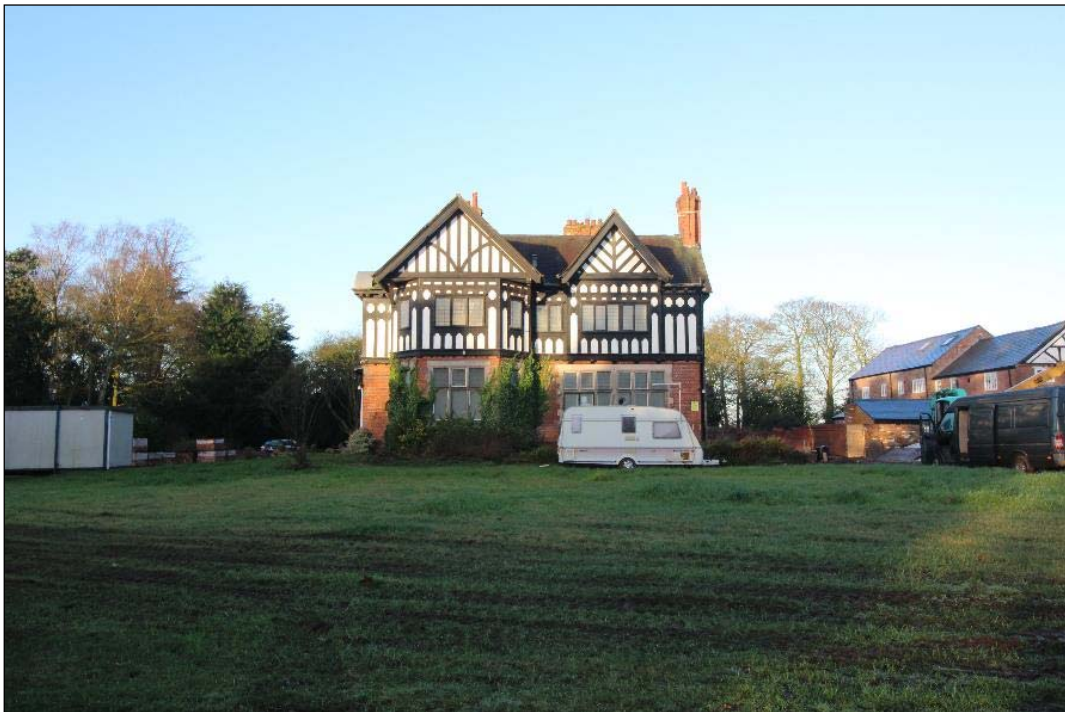
The eastern elevation is two-bays wide and three-bays high, and is again constructed from a mixture of brick and sandstone with timber-framing on the upper level. A bay window is located at the southern end of the ground floor. This window is of the same style as that of the western elevation bay window, with sandstone mullion and transoms housing timber-framed single-glazed glass pains. A stone mullion and transom with chamfered stone lintel and sill is situated on the northern side. On the first floor, as with the western elevation, a timber-framed bay window is located above the ground-floor bay. The window is five-lights wide and had a timber frame with single-glazed pains. The second floor of the house had no windows within the projecting roof space (Plate 11).

Plate 11: The eastern elevation, showing its setting within the gardens

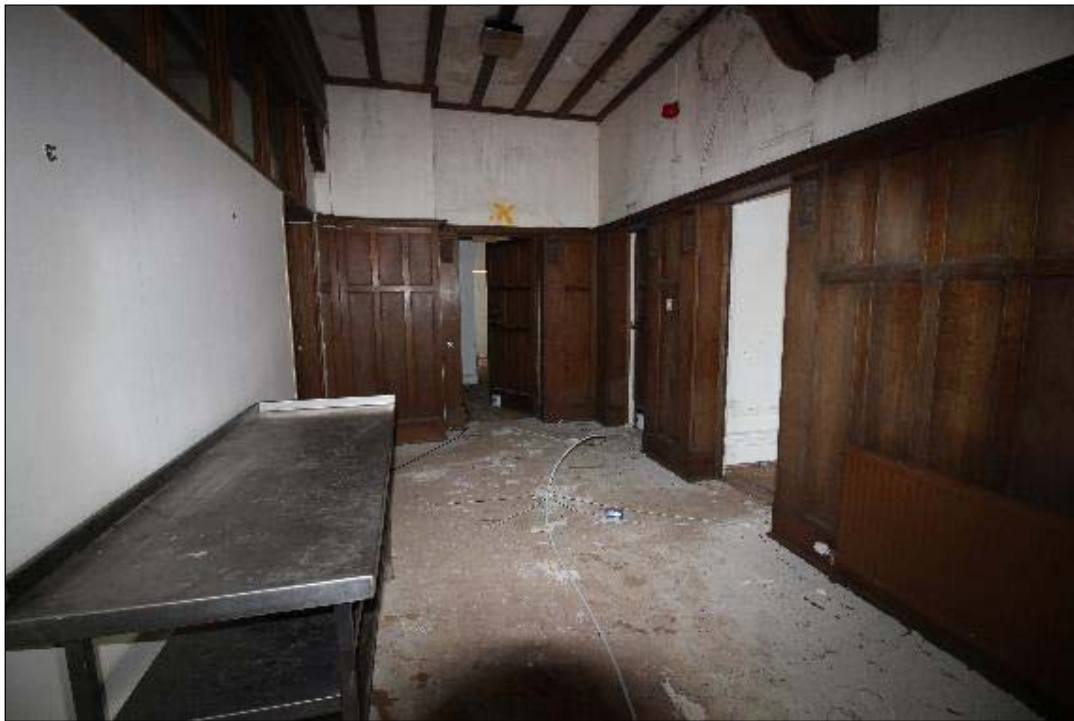
The ground floor was separated into several different compartments, which are divided by both modern partition walls and original dividing walls. The entrance from the eastern doorway has a tiled green and white patterned floor with a plasterboard ceiling. At the northern end, a fire door provides access into the main reception hallway. This hallway has been panelled with stained oak panels, which have decorative panels at each of the four doorway leading off into other rooms. The floor had been carpeted, although at the time of the site visit the carpet had been removed. The ceiling has exposed ceiling joists and beam (Plate 12 and 13).

Plate 12: The main reception hallway

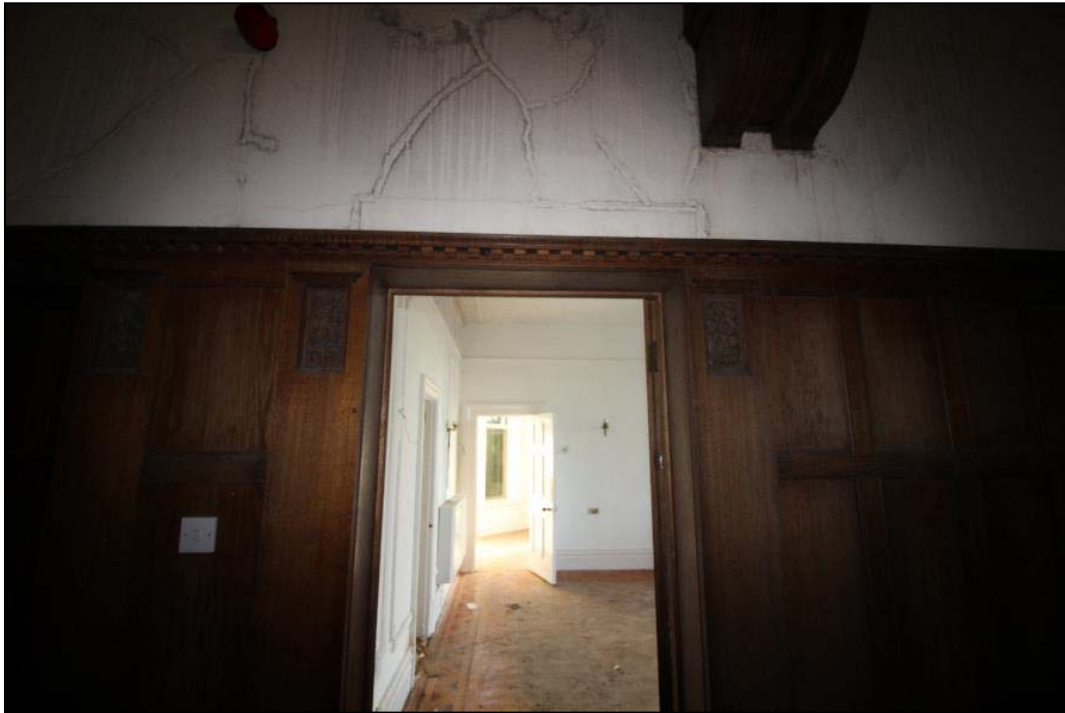
Plate 13: Panelled doorway looking into the reception room, east of the hallway

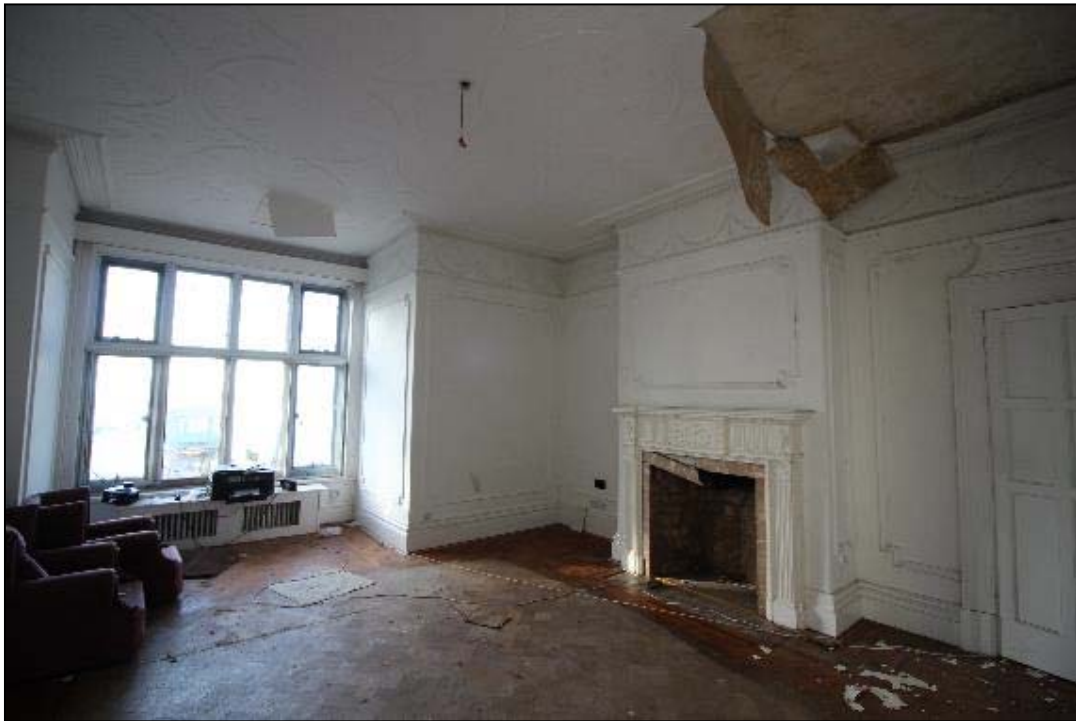
The floor comprises tongue and groove timber boards laid in a herringbone design with a decorative border. To north of the eastern wall, a six-panelled door affords access to a room which has been heavily modernised, but retains the herringbone wooden floor (Plates 14 and 15).

Plate 14: The eastern reception room

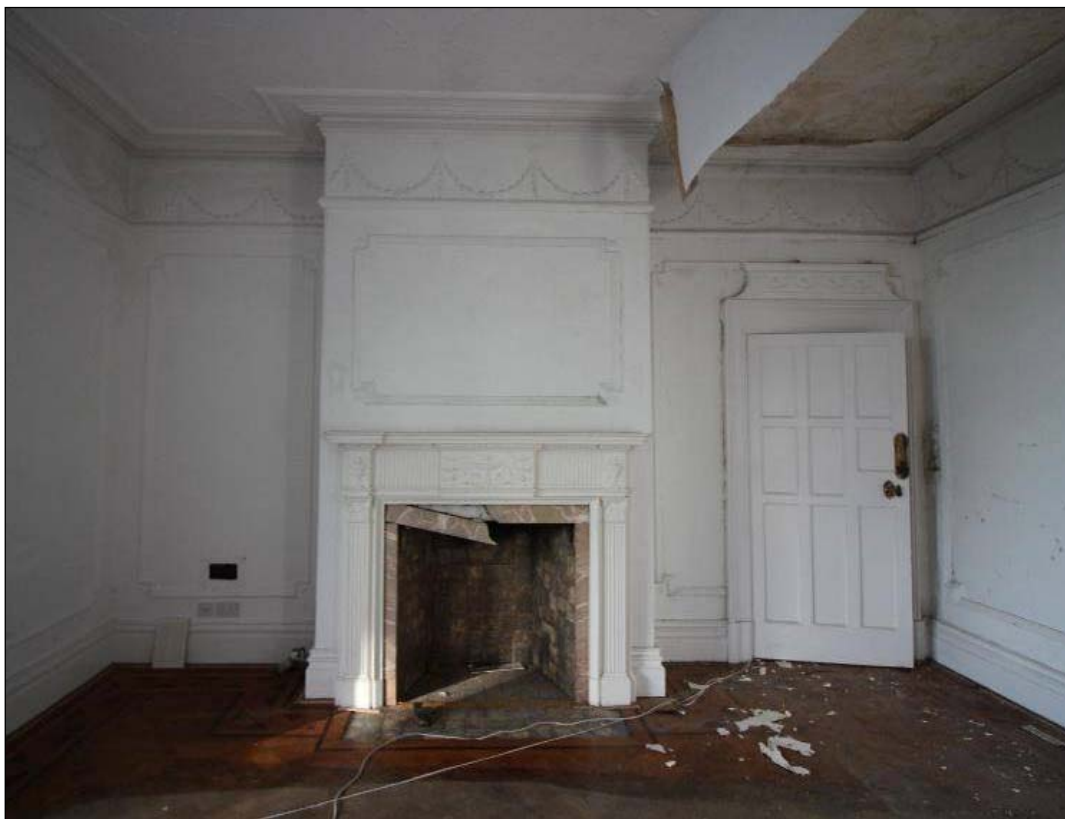
The room to the east of the main hallway has been modernised, although the original fire place survives *in-situ*. It had a fluted wooden surround with classically-inspired decoration with shallow mantel. The plaster on the chimney breast above the fireplace is moulded to surround a painting or a mirror. This type of moulding continued around the room, splitting the walls into panels.

Plate 15: Detail of the fireplace in the eastern reception room

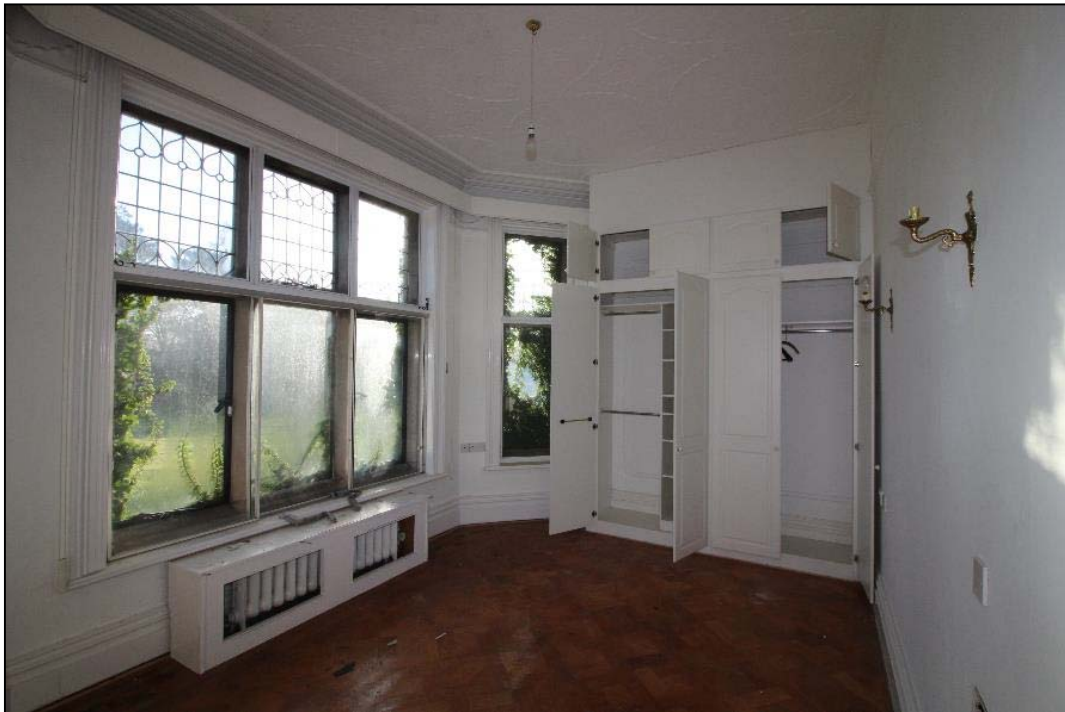
Several rooms accessed from the northern wall of the hallway have all been modernised, and have been changed into a kitchen, toilet and shower rooms (Plates 16 and 17).

Plate 16: Modern interior of the eastern room on the ground floor

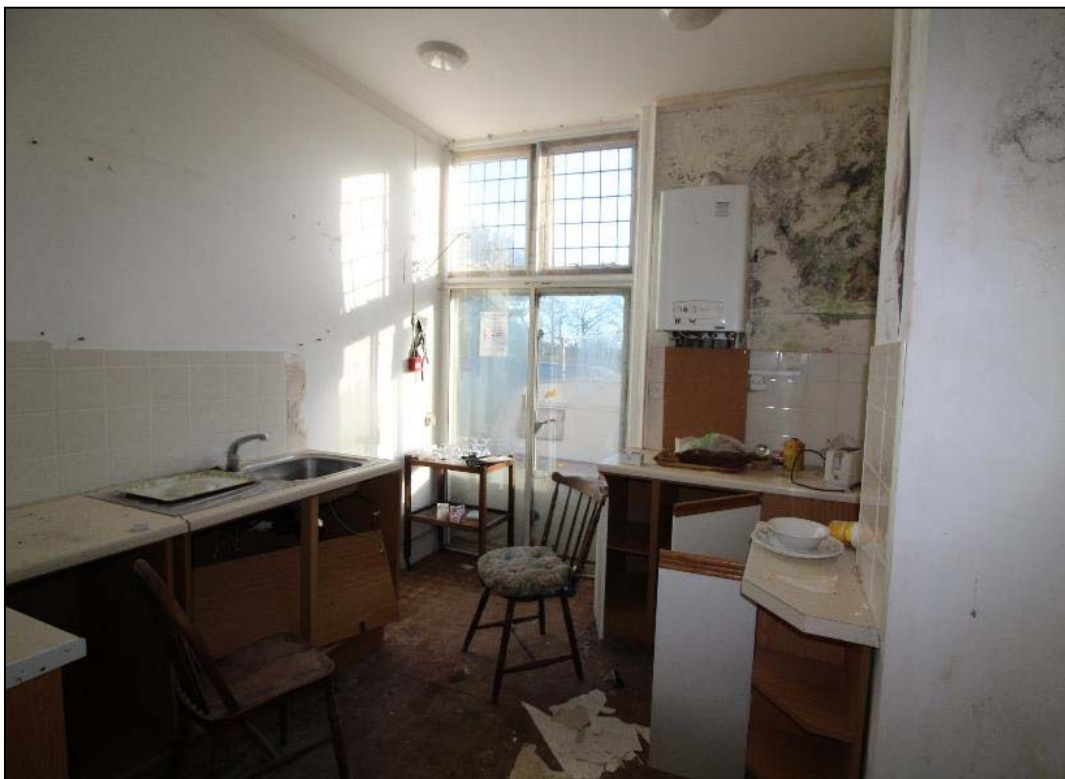
Plate 17: Modern interior of the north-eastern room on the ground floor

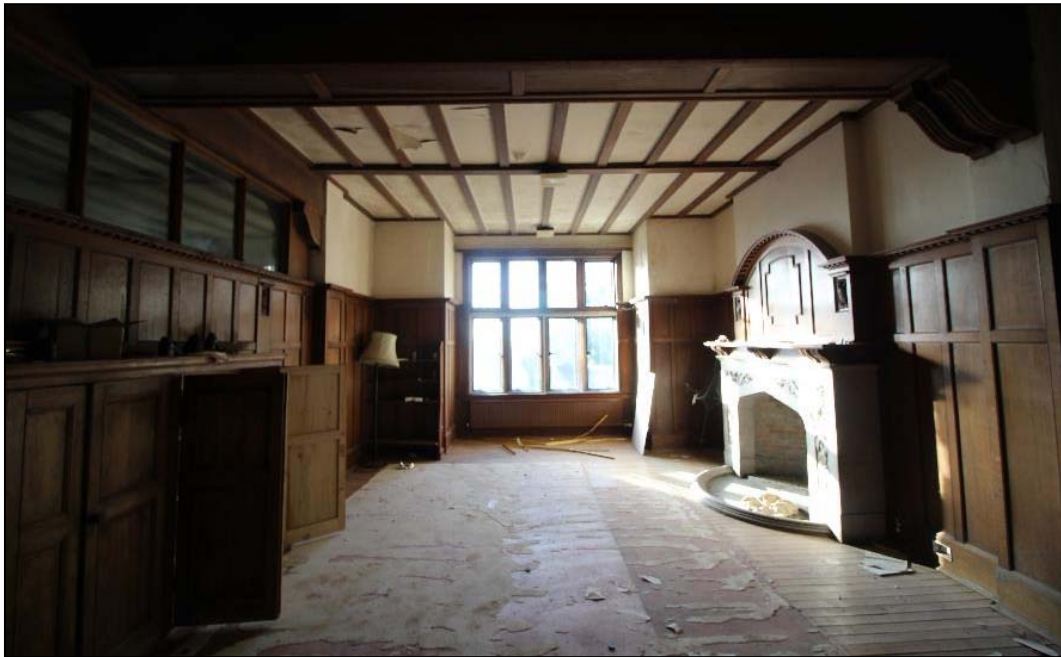
The doorway in the western wall of the main hallway opens out into a reception room. This room had been panelled with oak panelling, with the ceiling also panelled. An ornate fireplace on the eastern wall survives *in-situ*. It has a stone surround that has classical-inspired carvings with a wooden mantel piece. Above this is a decorative oak panel, which has carvings of birds at either end (Plates 18 and 19). At the northern end of the room two doorways are located, one on the northern wall and a second on the western wall. The northern door leads into a long narrow corridor, and the western doorway leads into long narrow hallway.

Plate 18: Interior of the second reception room, west of the entrance hallway

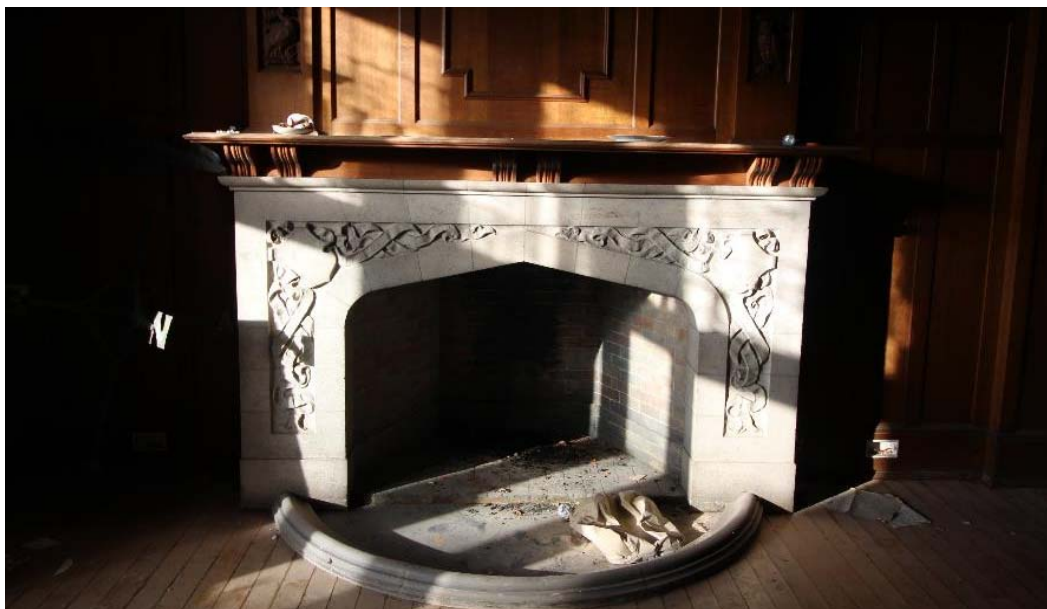
Plate 19: Decorative fireplace on the western wall of the second reception room

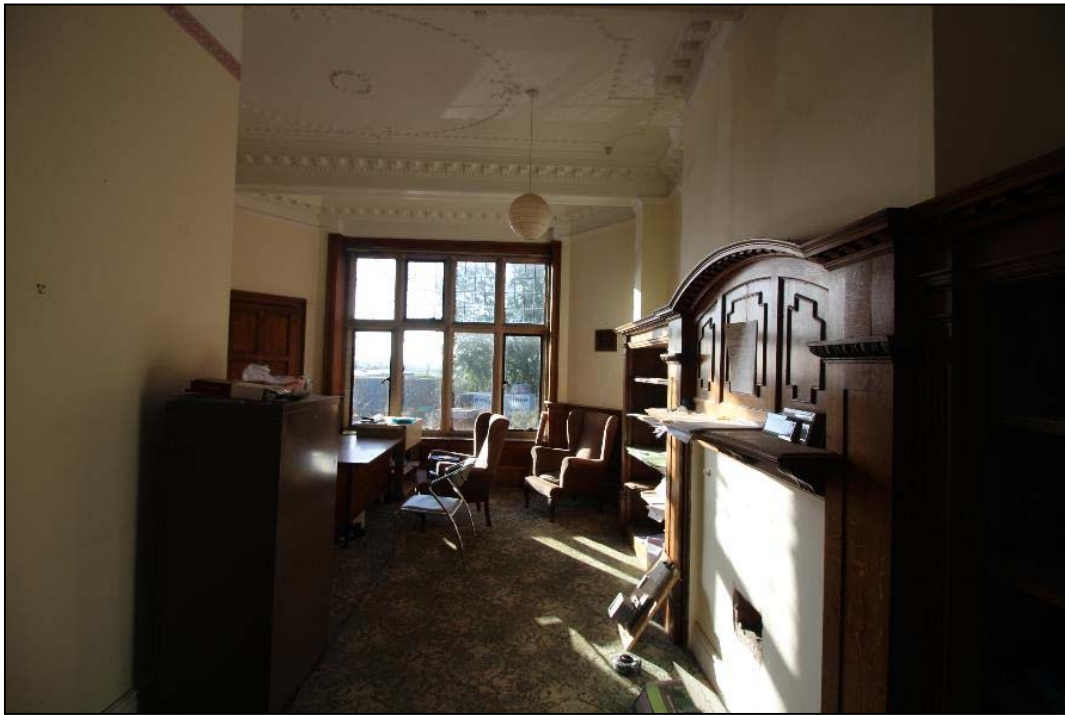
Another reception room is located at the eastern end of this hallway. This room has been clad in decorative wooden panelling around the walls with a modern carpet floor. The fireplace has been blocked with plasterboard (Plate 20).

Plate 20: Modern interior of the eastern room on the ground floor

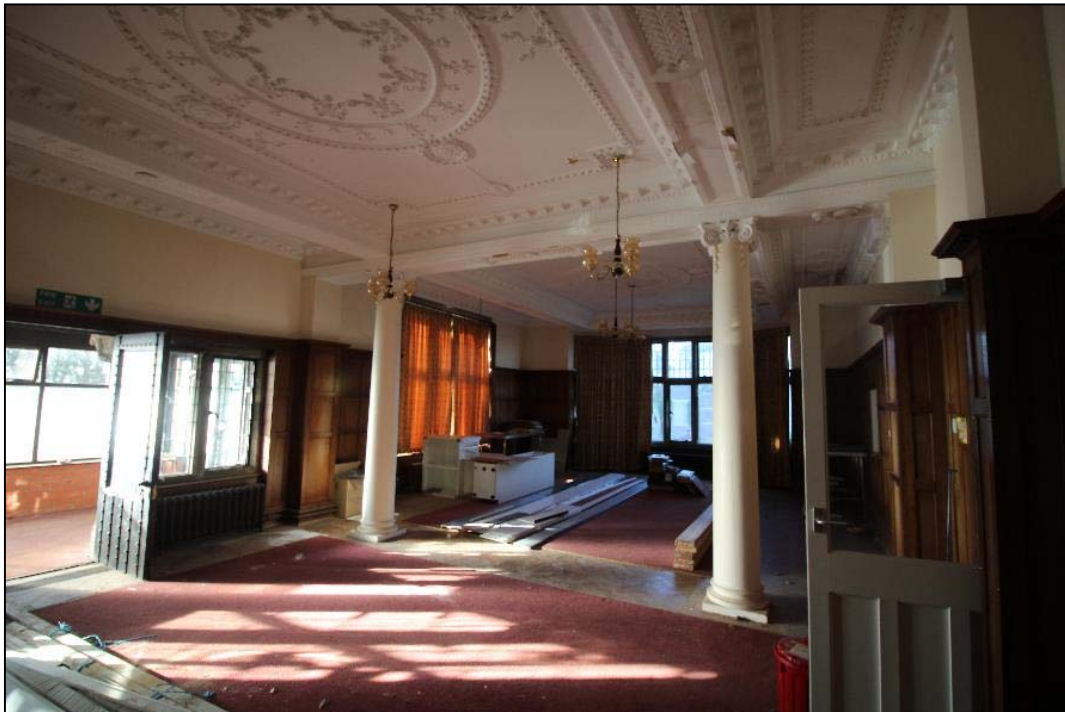
The hallway opens out into the main entertaining room at its northern end, which had two decorative Corinthian columns in the centre. This room has been clad in decorative wooden panelling around the walls, with an ornate fireplace in the eastern wall. This fireplace has a stone surround which is set between wooden pilasters. The floor has been carpeted throughout (Plates 21-23).

Plate 21: The main entertaining room at the western end of the ground floor looking west

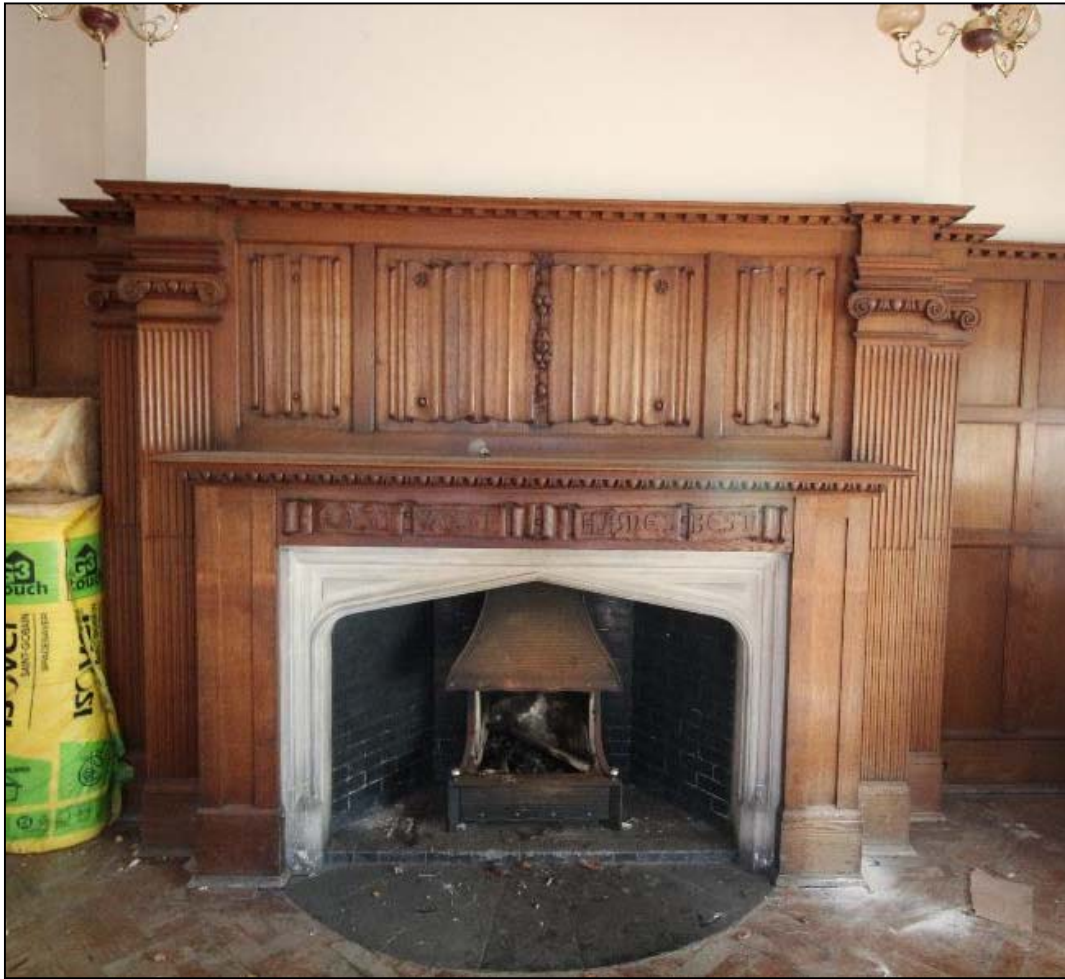
Plate 23: Decorative fireplace on the eastern wall of the main entertaining room

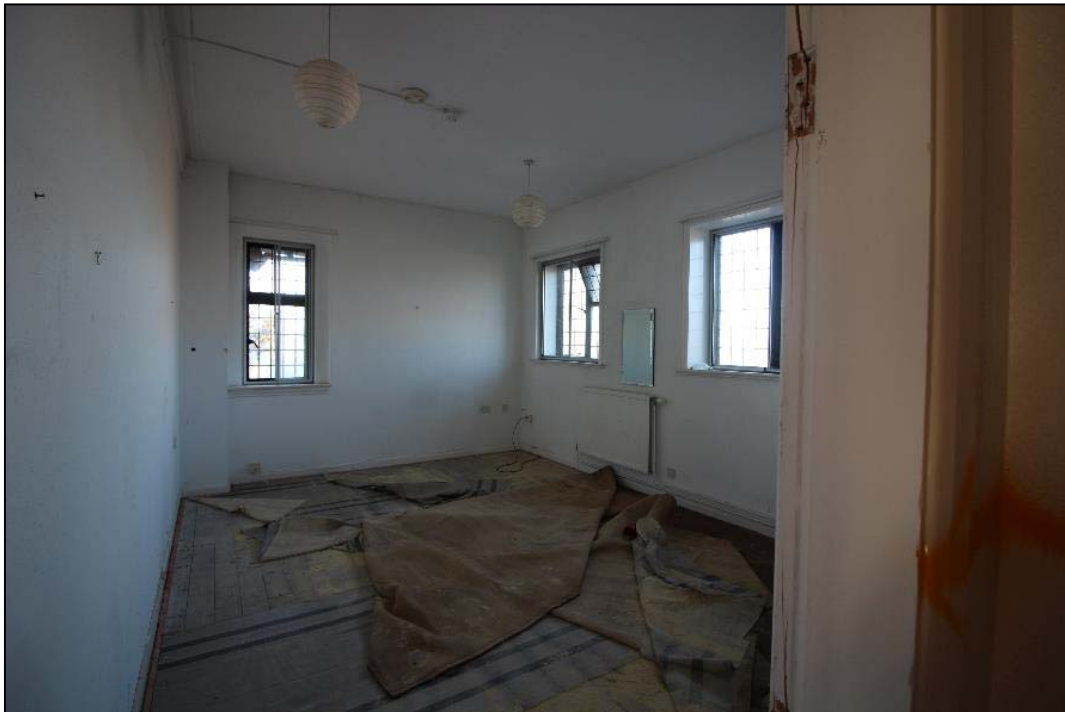
The first floor has been heavily modernised, and separated into several different rooms. These rooms seem to have followed the original layout for the bedrooms, but several timber-framed partitions have been inserted to create toilet and shower rooms, presumably during its conversion to a residential care home (Plates 24 and 25). Some of the original tiled hearths are exposed in the floor, although the fireplace surrounds have been blocked up and small plastic vents inserted (Plates 26 and 27).

Plate 24: One of the modernised bedrooms on the first floor

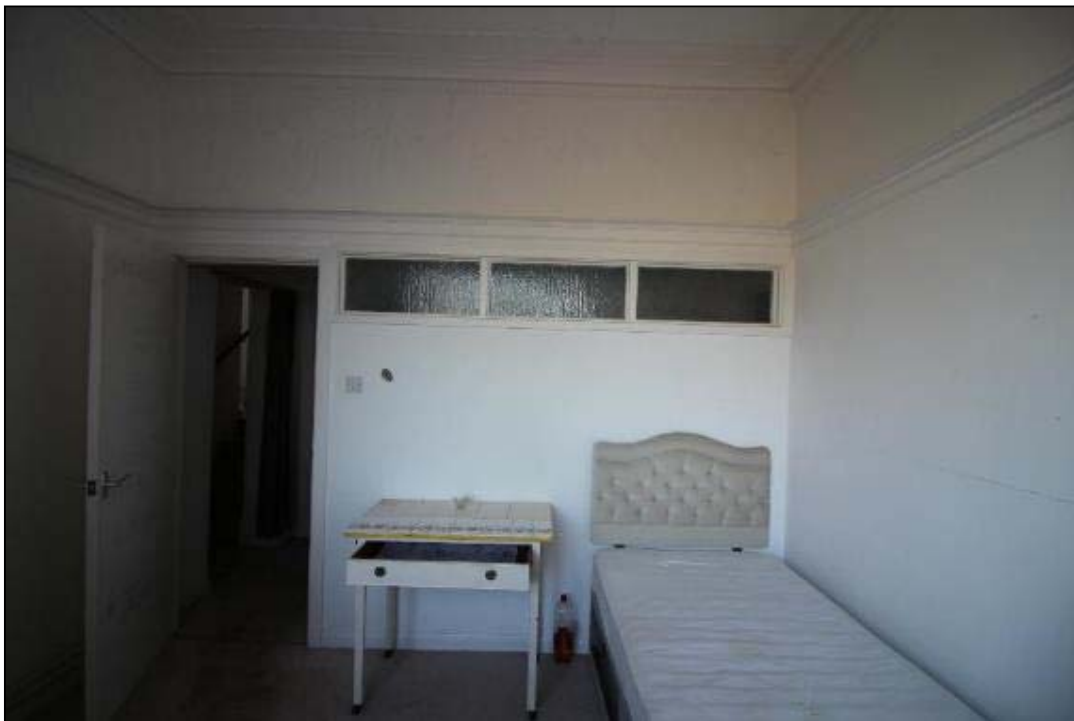
Plate 25: View of one of the bedrooms on the first floor

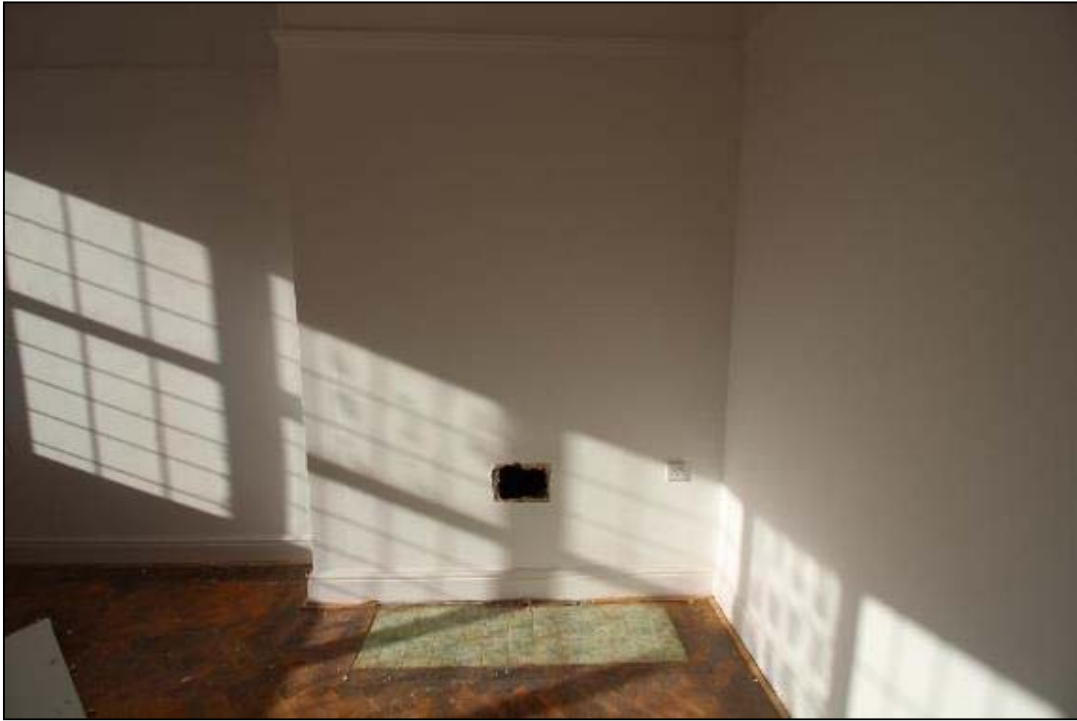
Plate 26: View of a blocked up fireplace on the first floor

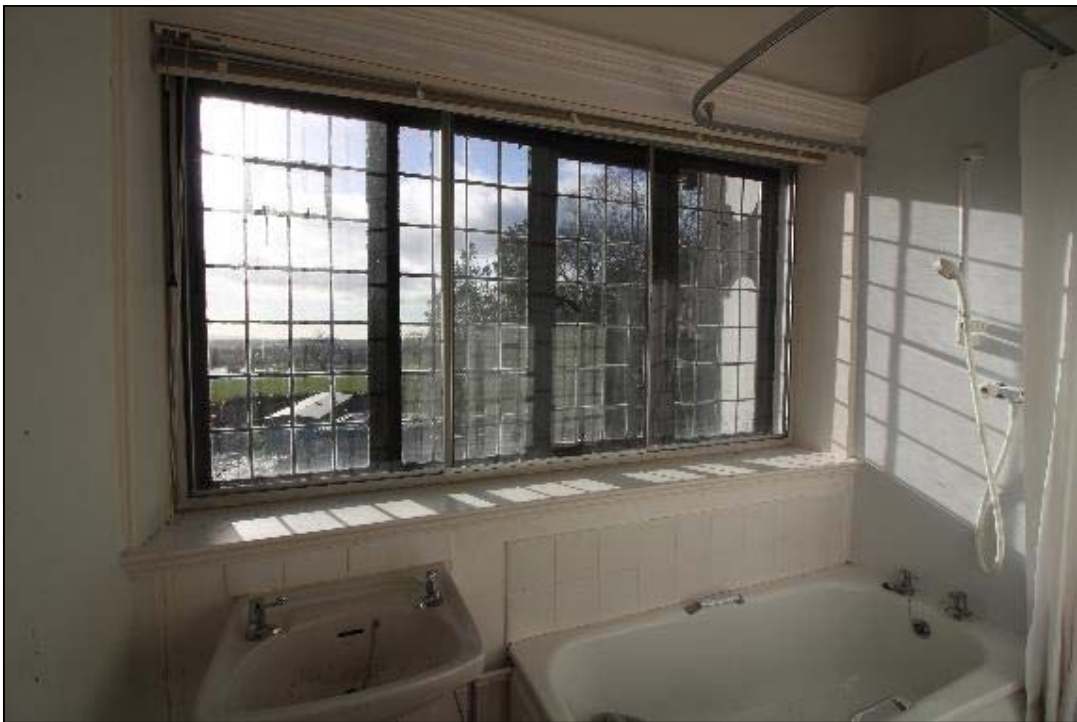
Plate 27: A modern bathroom of the first floor, which still contains its original timber-framed window

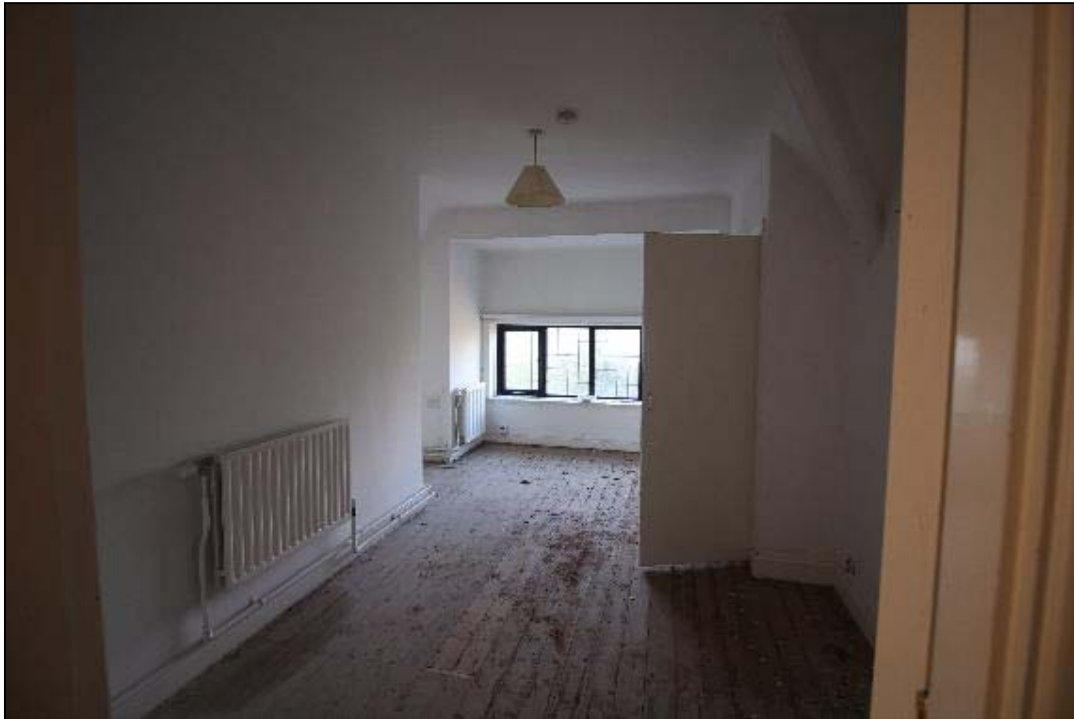
The second floor has been substantially modernised with the creation of several bedrooms and bathrooms. It seems possible that these rooms were intended originally as servants' quarters (Plates 28-31).

Plate 28: General view of one of the bedrooms on the eastern end of the second floor

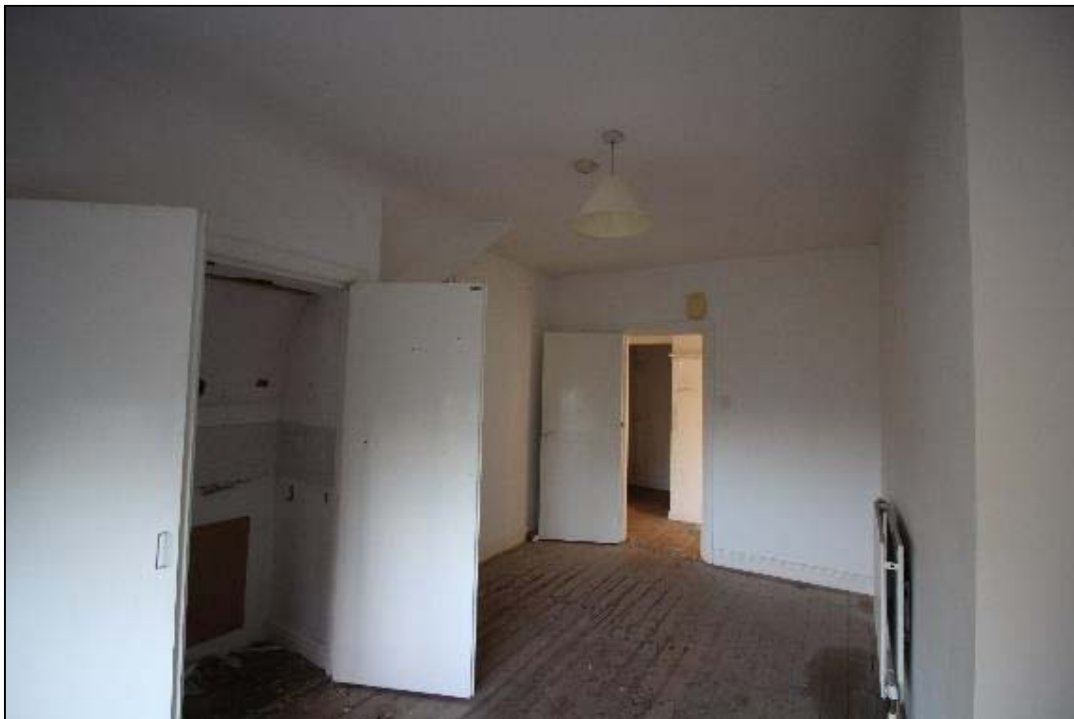
Plate 29: One of the bedrooms on the western side of the second floor

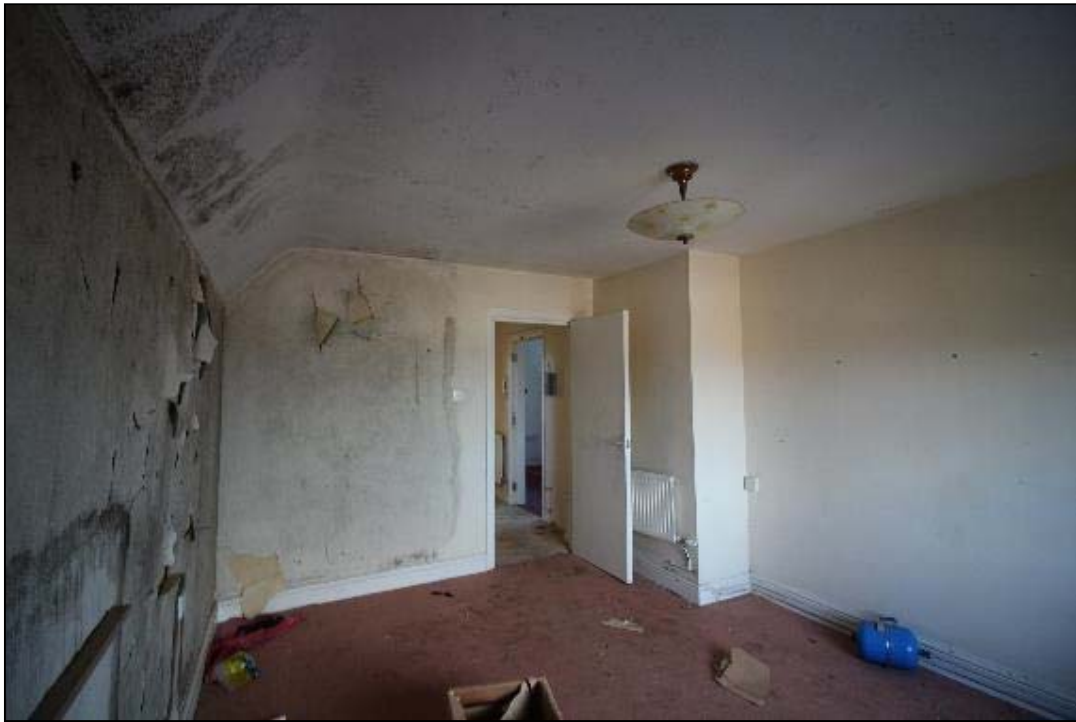
Plate 30: General view of a bedroom in the centre of the second floor

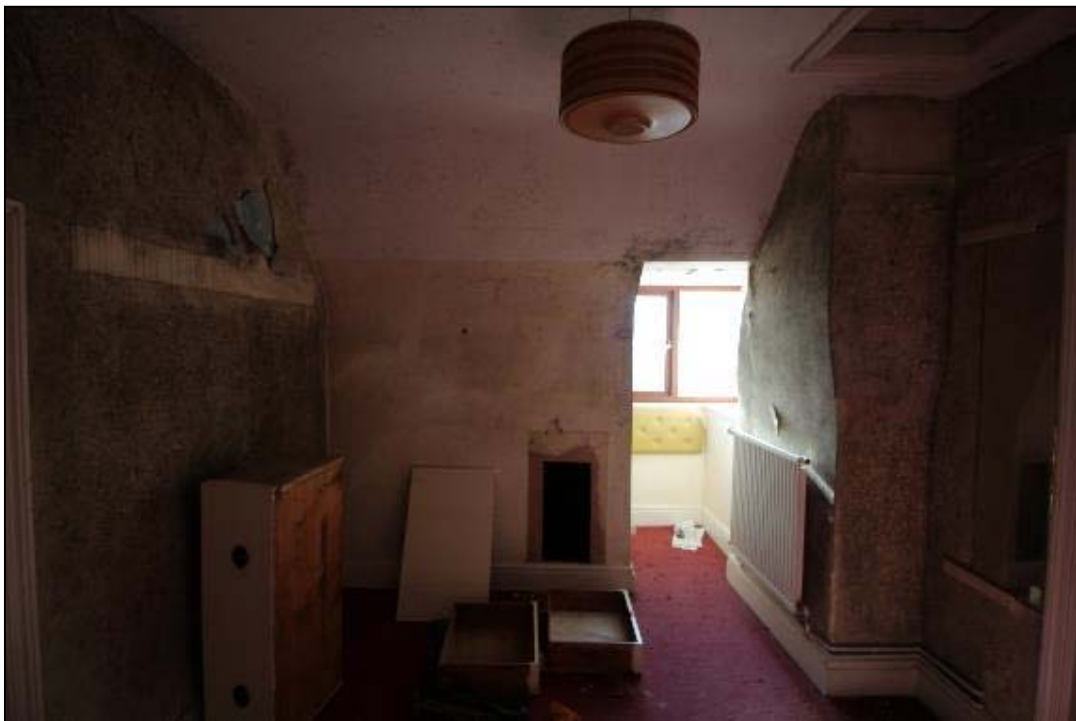
Plate 31: The eastern bedroom on the second floor, looking east

The eastern room of the second floor provides access into the roof of the dormer on the eastern elevation. The roof is constructed from king post trusses (Plate 32). This is only accessible at the eastern end of the second floor. A door leads out onto the eastern projecting wing on the northern side.
