Historic Building Investigation

Greysfield,
Ferma Lane,
Great Barrow,
Cheshire West and
Chester

Report No:
SA/2017/19

Document Type: Archaeological Investigation Report

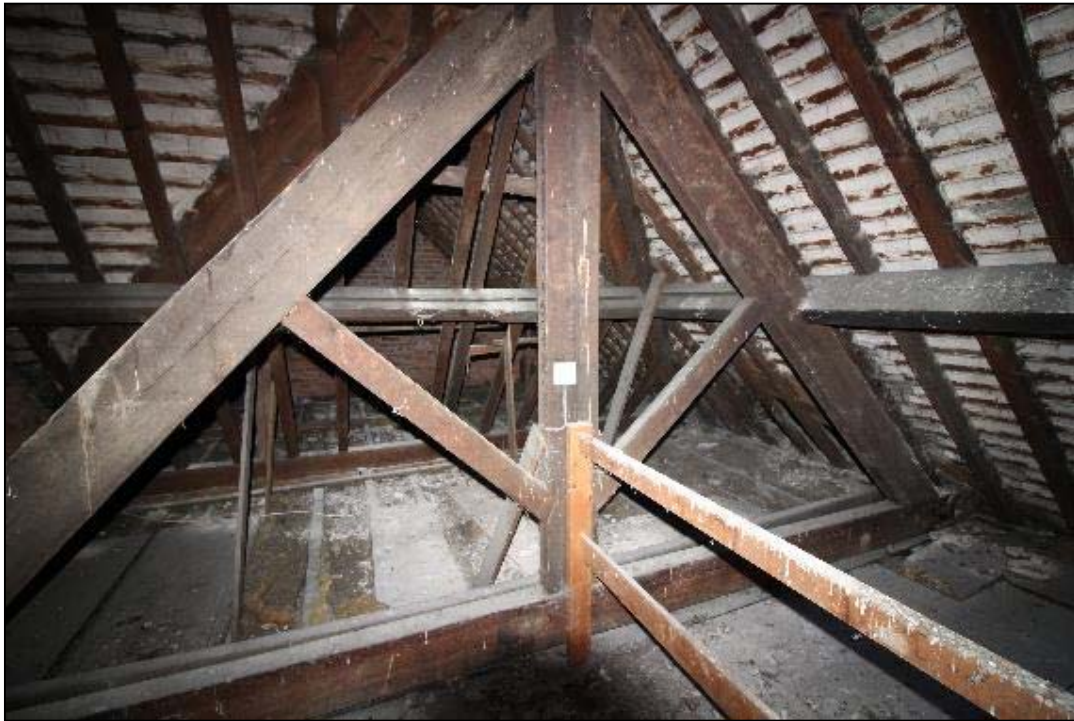
The eastern room of the second floor provides access into the roof of the dormer on the eastern elevation. The roof is constructed from king post trusses (Plate 32). This is only accessible at the eastern end of the second floor. A door leads out onto the eastern projecting wing on the northern side.

Plate 32: King post truss in the dormer on the eastern elevation

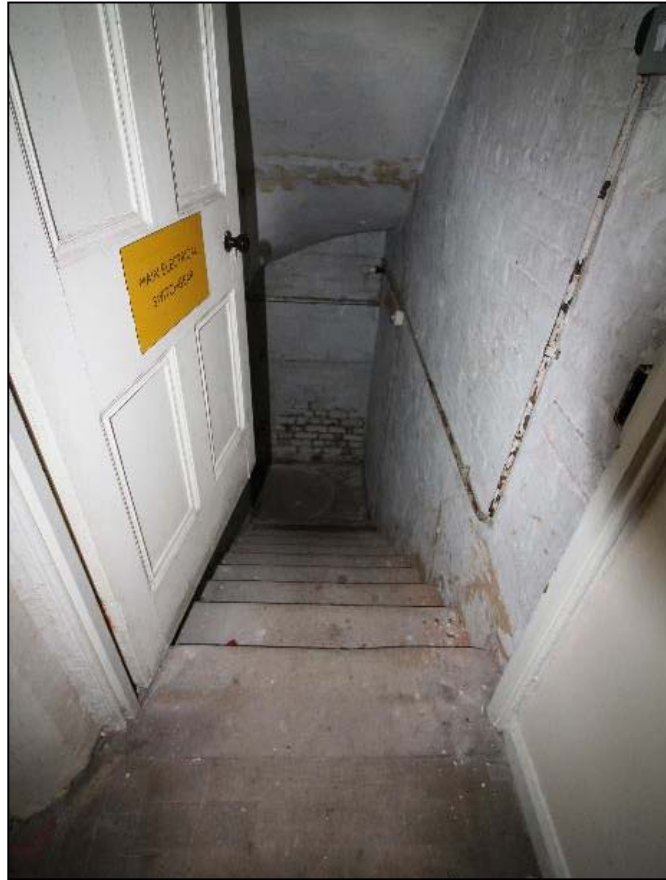
The basement is accessed by a set of stone tread and brick riser stairs from one of the hallways in the ground floor (Plate 33). It has been divided into several different compartments, which have all been subject to alterations, and partitioned off with machine-made brick. The main room contains a mixture of early twentieth-century and late twentieth-century electrical units and wiring (Plate 34-36).

Plate 33: Stone stairs leading to the basement

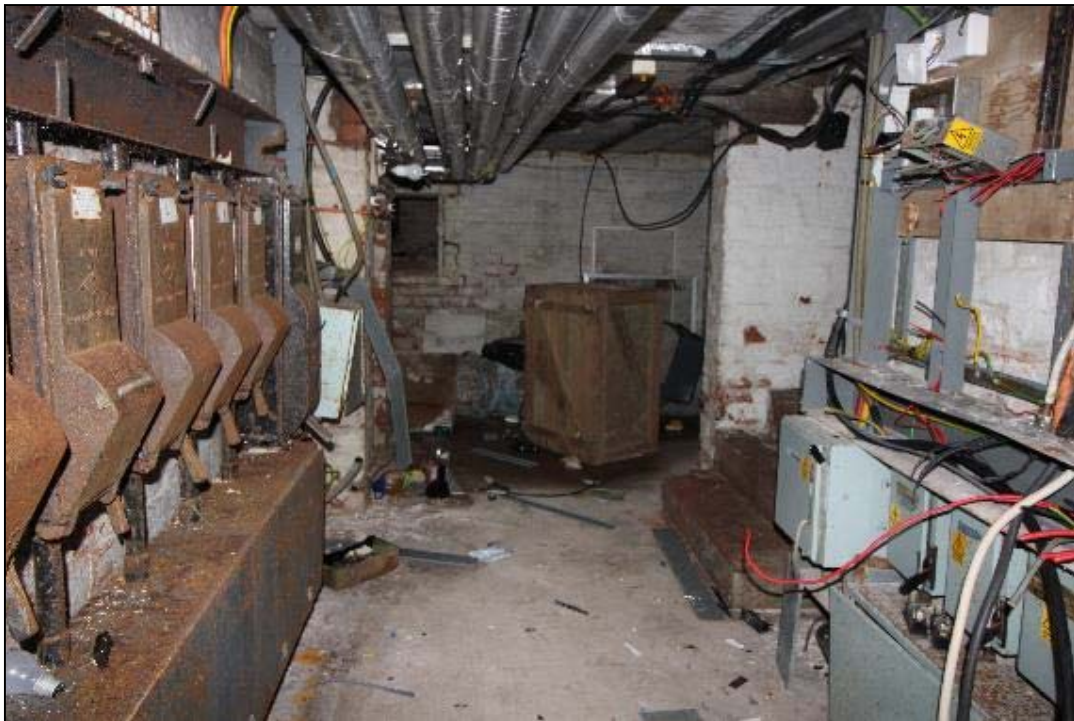
Plate 34: The main room in the basement, showing twentieth-century electrical installation

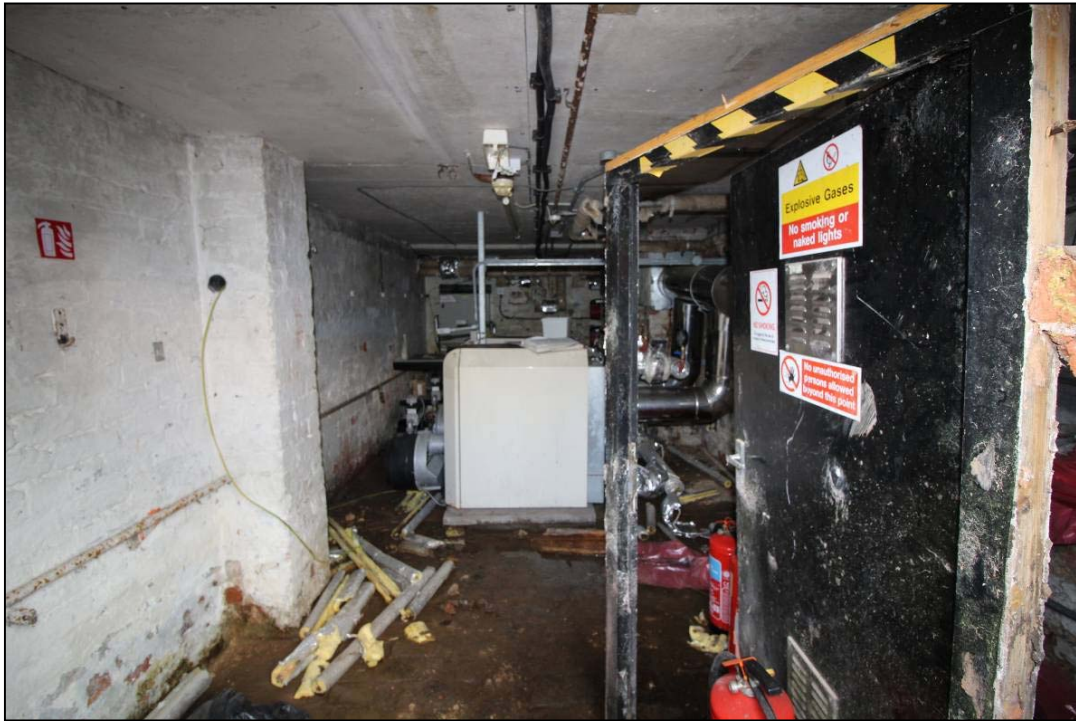
Plate 35: Modern boiler at the northern end of the basement

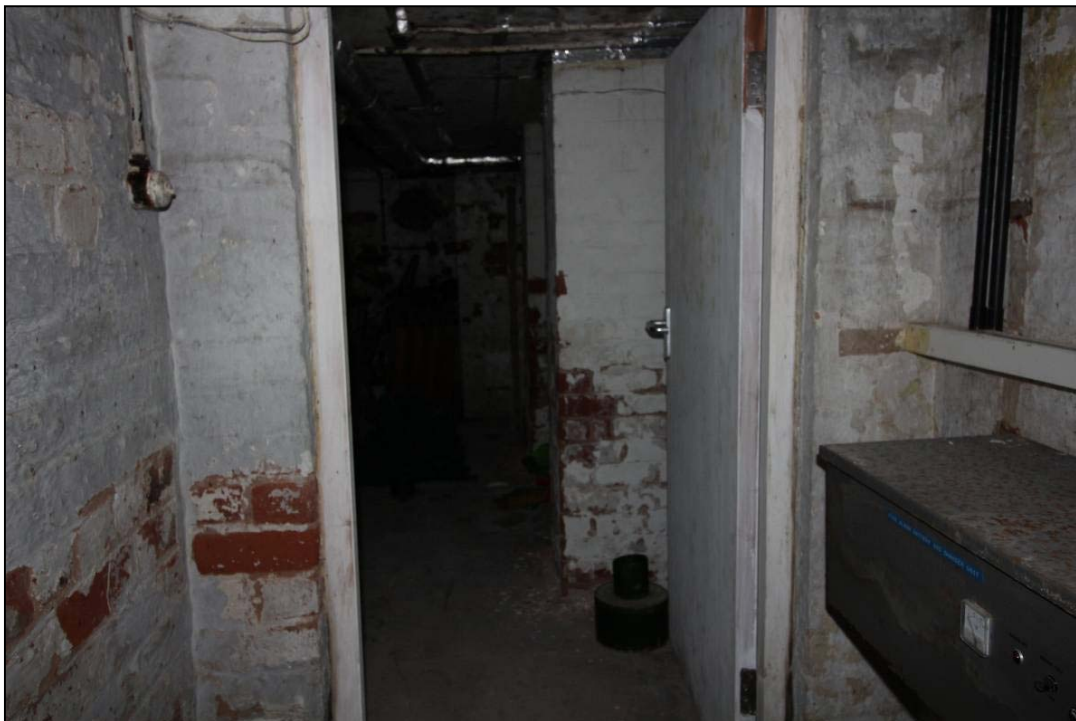
Plate 36: One of the small rooms in the southern end of the basement
