## Archaeological Excavation

Rochdale Riverside  
Phase 1, Rochdale,  
Greater Manchester

**Report No:** SA/2018/27

**Document Type:** Archaeological Excavation Report

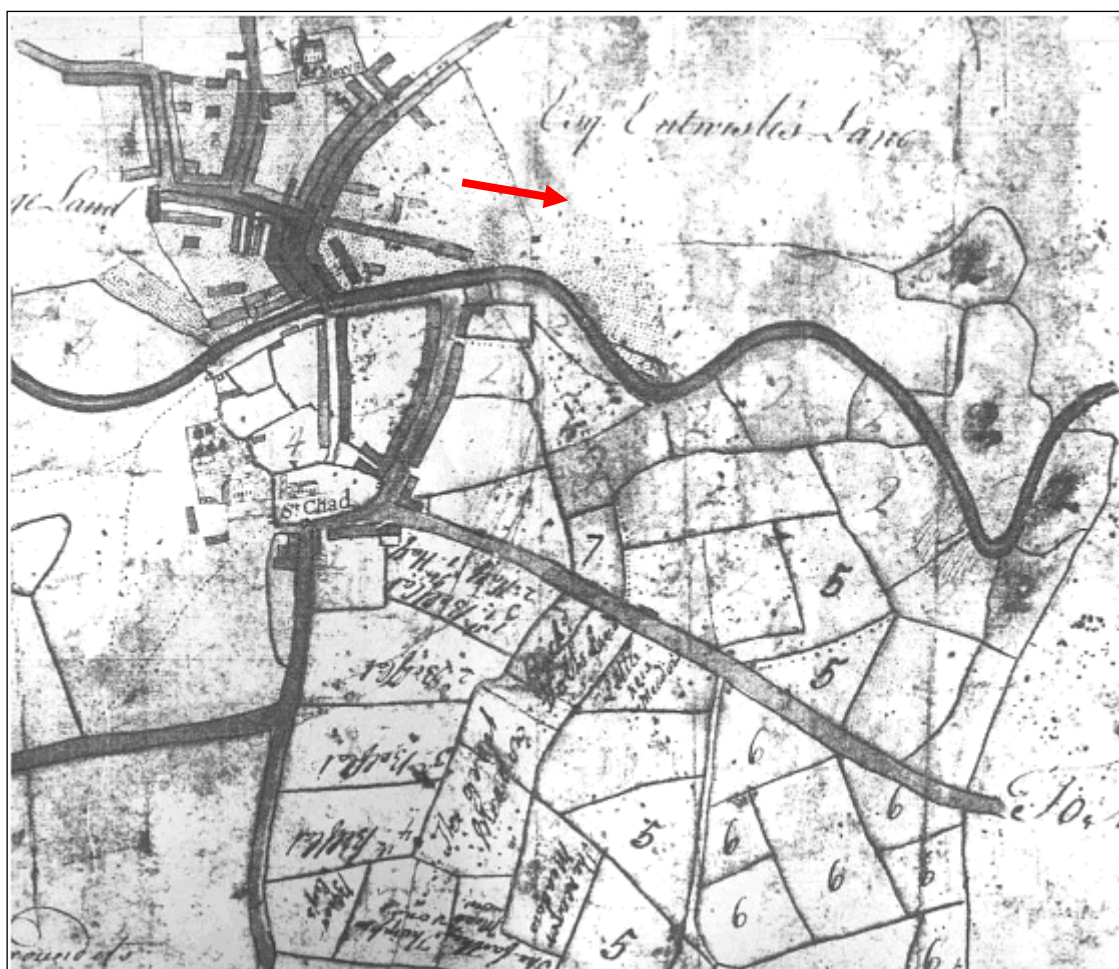
Plate 2: Extract from a Plan of the Vicarage, dating to 1764, with arrow marking the approximate centre of the Site Area

The layout of the town is captured on *A Plan of the Vicarage* of 1764, which shows settlement on both banks of the river, with ribbon development extending northwards along Whitworth Road and north-eastwards along Yorkshire Street (Plate 2). The plan also shows Church Lane as a principal thoroughfare; this lane had superseded the medieval packhorse road northwards

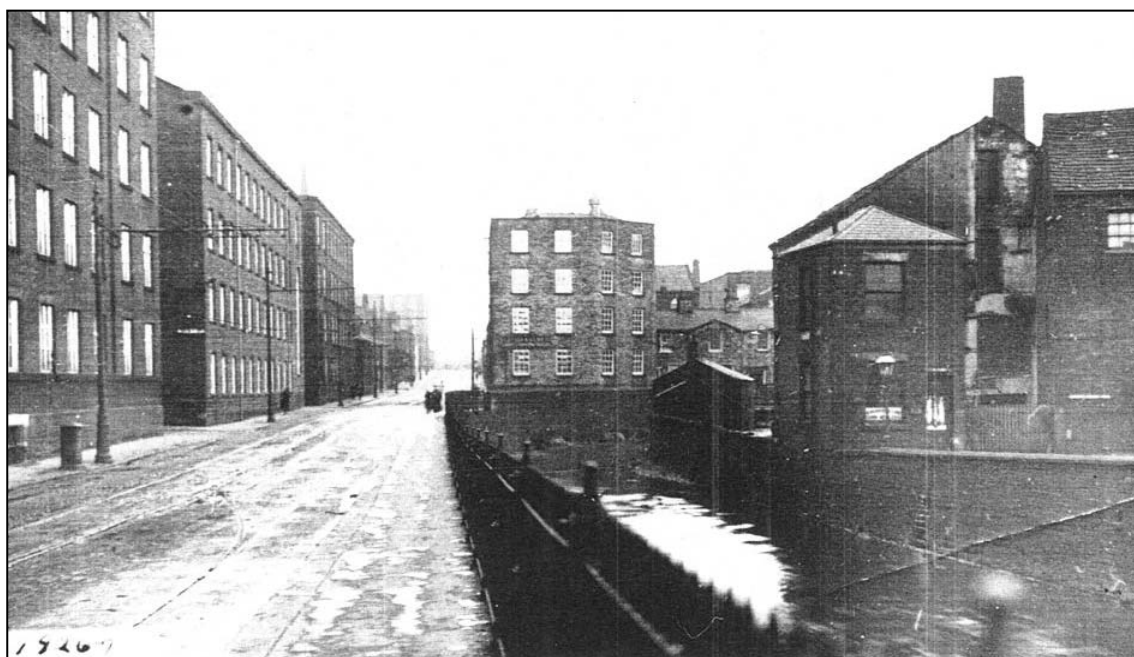
*Plate 4: The River Roch at Smith Street before 1924, showing Butts Mill, and Bowling Green Warehouse (photo reproduced courtesy of Touchstones Local Studies Centre)*

By the 1890s, development had taken place in most of the open spaces across the site, as shown on Ordnance Survey mapping published in the early 1890s (Figure 5). Much of the new development comprised streets of back-to-back, and other terraced housing. New public buildings include a baths, and a church and Sunday school on the north side of Smith Street, and to the east of the established textile factories (Plate 4).

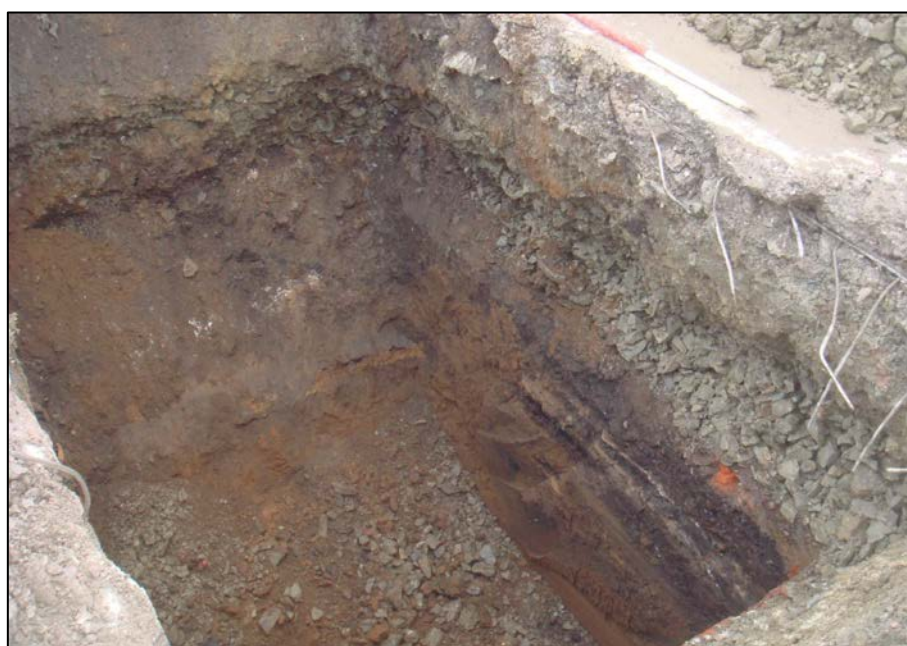
Plate 5: Depth of levelling material in Trench 1a, natural sand at base, looking north

Trench 1a was excavated through the concrete car park surface and its stone bedding. Below this was 2m of compact stone levelling/infill with 0.5m of mixed compacted demolition rubble below. This overlay natural mid brown clay at 2.7m below the current ground level (Plate 5).

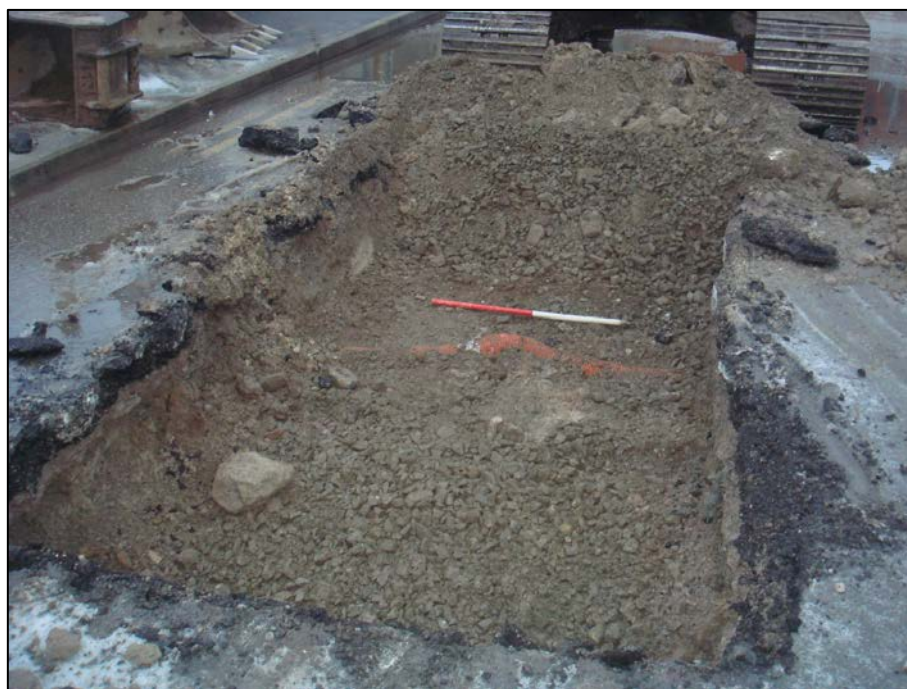
*Plate 6: Cable duct in Trench 1b, looking northwest*

Trench 1b was excavated to a depth of 0.68m through tarmac and stone bedding and into compact stone levelling material (Plate 6). Within this material, at a depth of 0.68m, was an orange plastic duct running east/west with a live electricity cable within it. This was in line with the car park lighting columns.

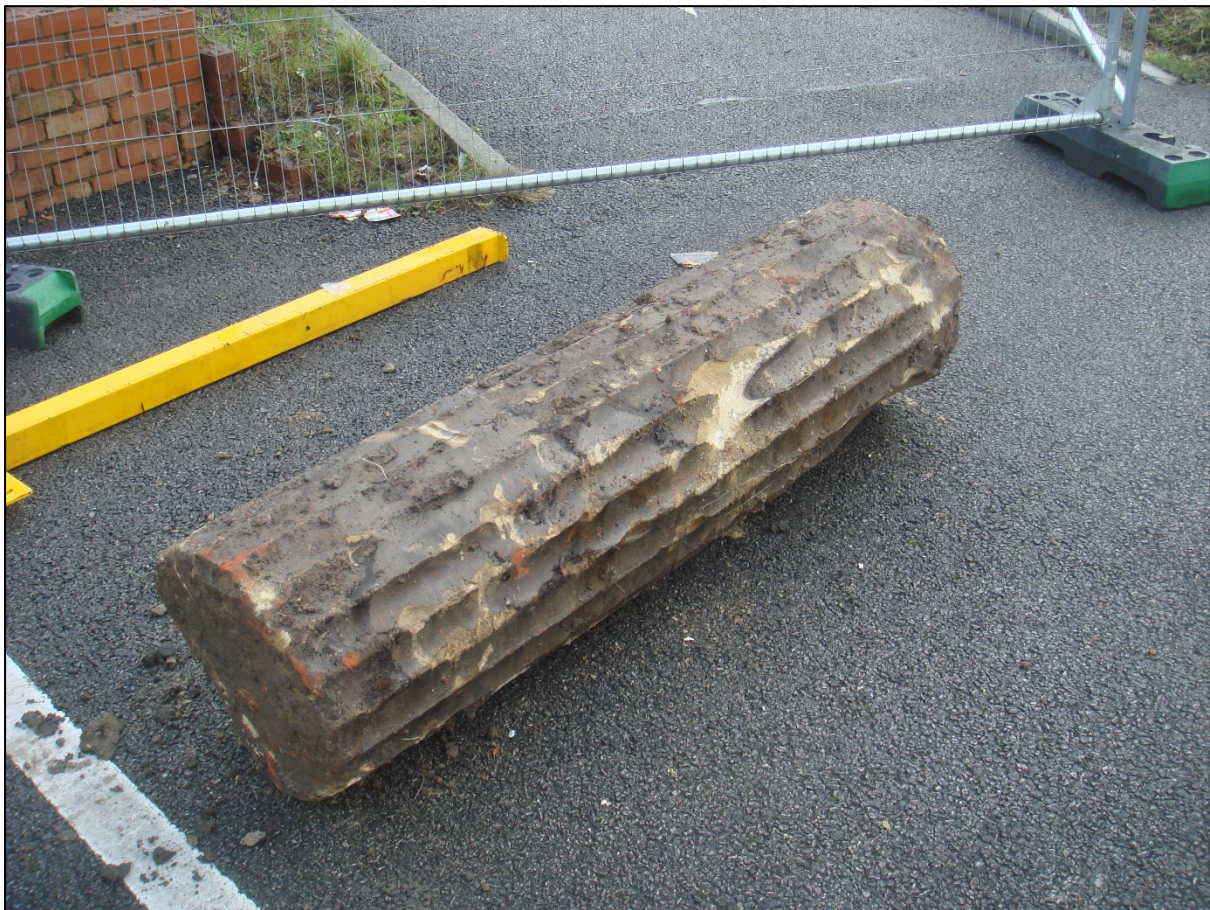
*Plate 7: Fluted column from demolition rubble in trench 8*

Below the tarmac three concrete piles with concrete ring beams were encountered at a depth of 0.98m to 1.01m. These ran across the trench, radiating from the curved front of the former health centre. Between these piles were rough concrete ducts, all giving strong live electrical signals on the CAT scan. At the east end of the trench a 6.9m long section was clear of services and concrete and could be excavated deeper through mixed loose demolition rubble. The rubble contained fragments of architectural masonry including a fluted column (Plate 7).

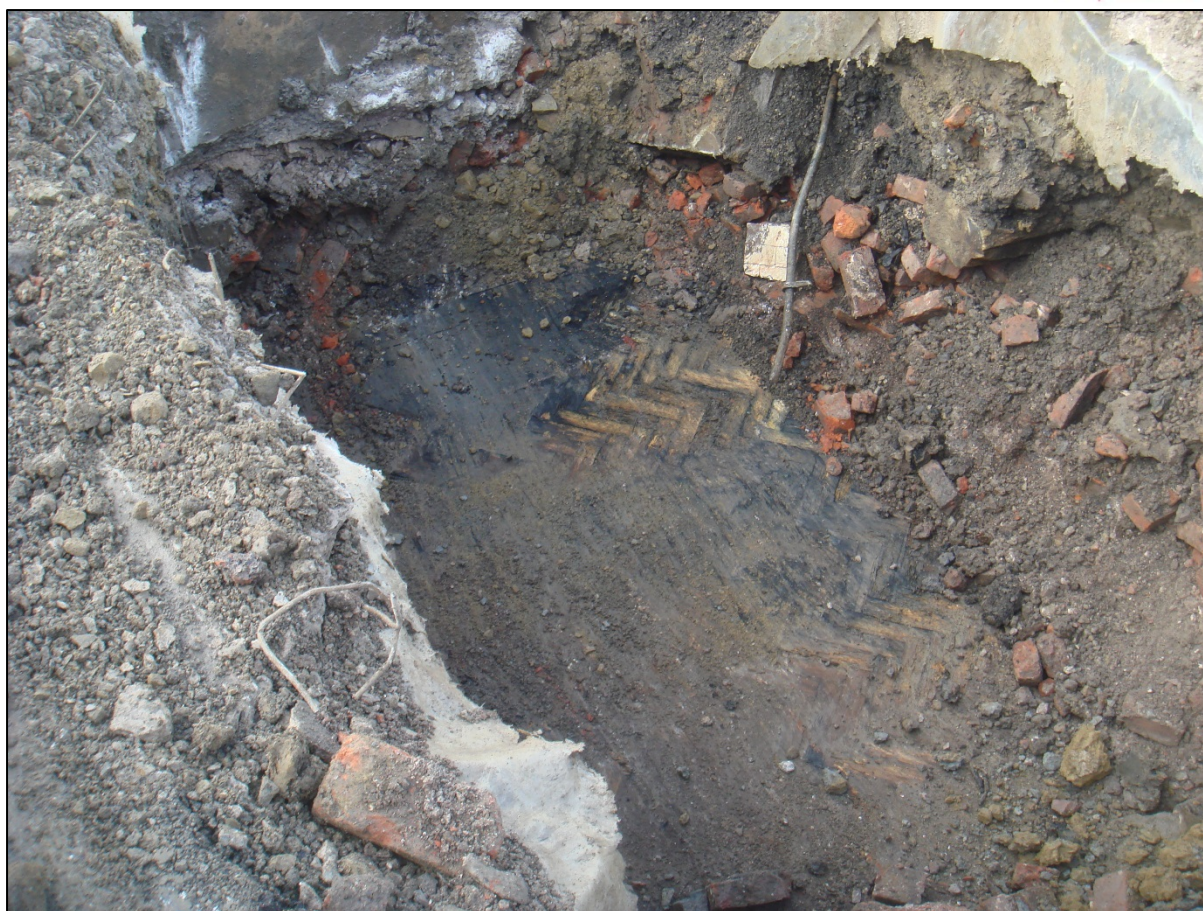
*Plate 8: Wooden parquet flooring at base of Trench 8, looking southeast*

Below the rubble, at a depth of 2.2m and running below the concrete ring beams, was a wooden herringbone-pattern parquet floor surface, probably from the former chapel (Plate 8).

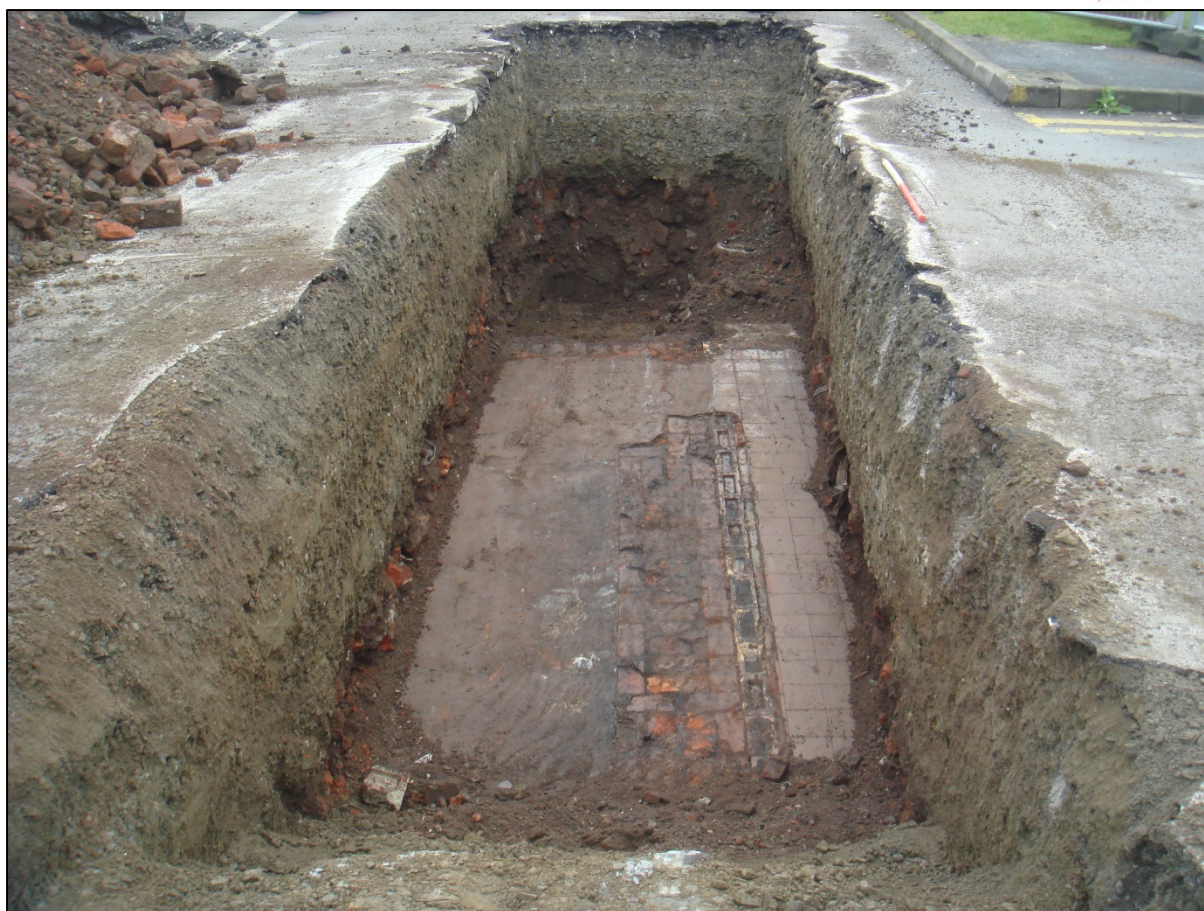
*Plate 9: Floor surface and walls in Trench 9, looking south*

The northern 5.3m of the trench, below the tarmac, had been heavily disturbed and comprised mixed loose demolition rubble to a depth of 2.6m at which point natural clay was observed. At the immediate south side of this was a concrete duct which gave off a strong power signal with the CAT scanner. This concrete duct had cut through part of the floor of the former school which comprised very hard orangey red square tiles at the west side and a concrete floor surface at the east side. Between these was a five-course wide brick wall. The central two courses appeared to be the original wall, of machine-made brick with hard dark cement. The two courses running along the east side of this, also machine made brick with hard cement, appeared to have been roughly added at a later date. The western course was also later and comprised modern frogged and glazed bricks with a narrow concrete channel, presumably for drainage, running alongside it. At the south side of the floor surfaces was a four-course wide east/west wall of machine made brick with hard black cement. At the south end of the trench, beyond the southernmost brick wall, was mixed loose demolition rubble to a depth of 2.1m at which point natural clay was observed (Plate 9).

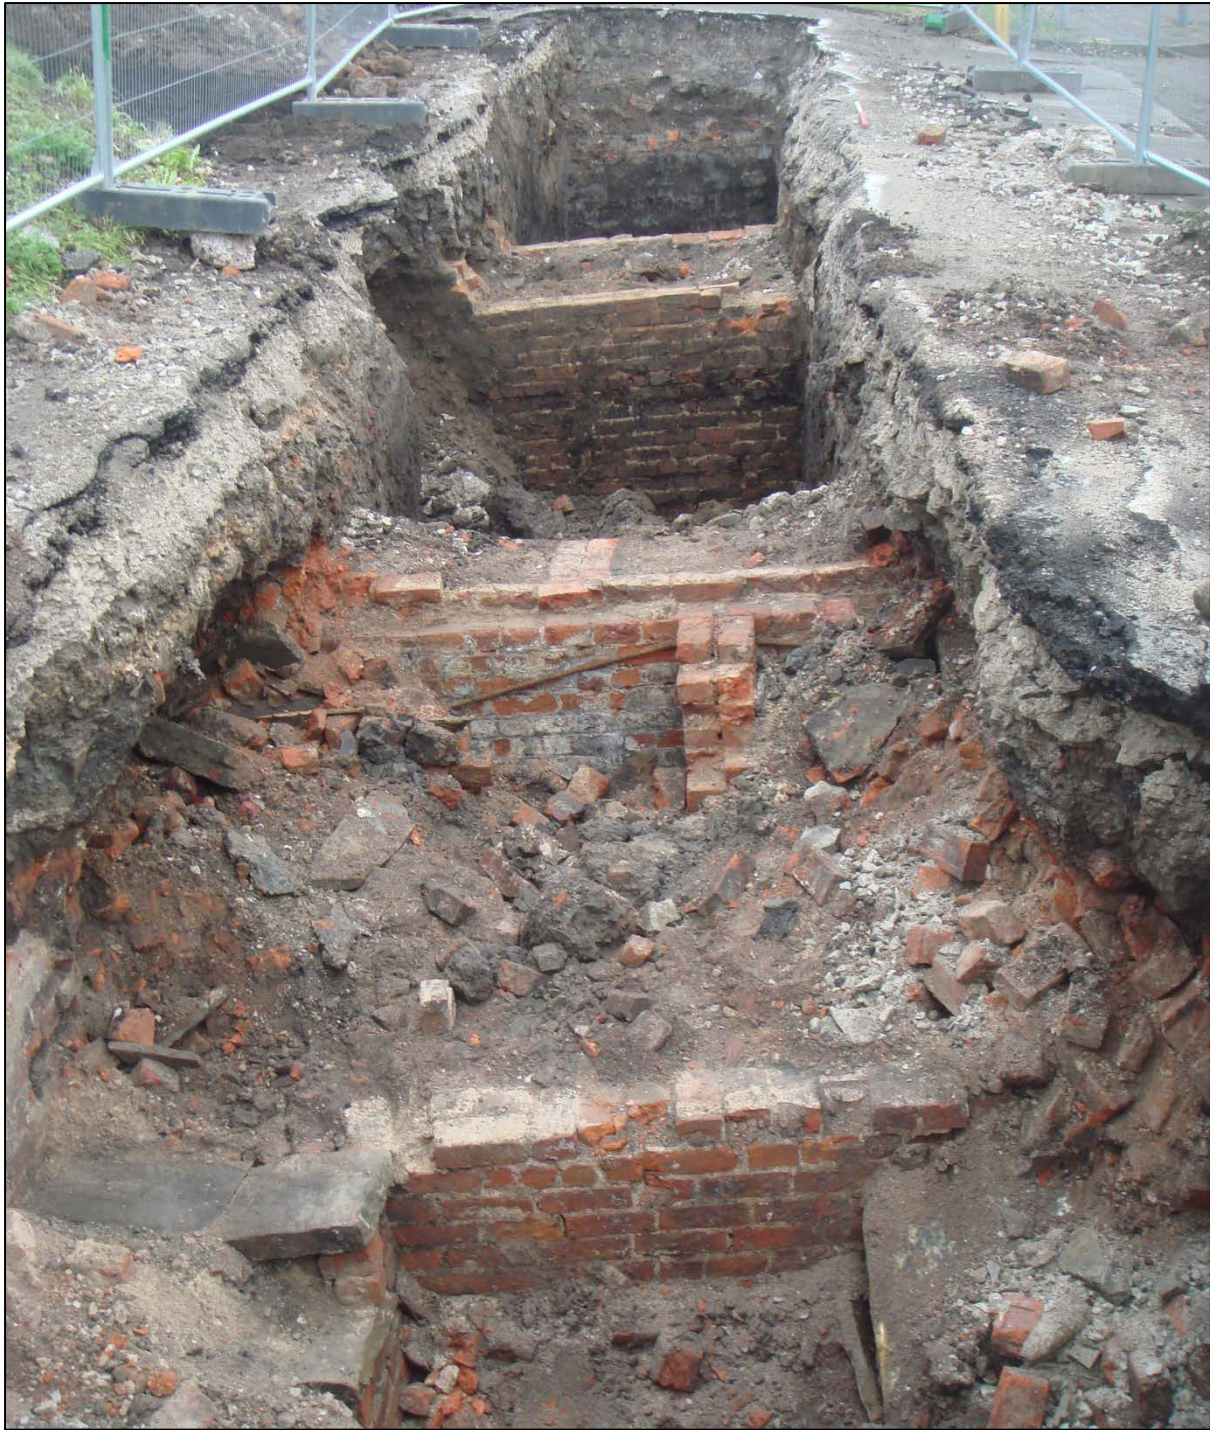
*Plate 10: Walling of back-to-back house cellars in trench 10, looking east*

A series of handmade brick walls with lime mortar ran north/south across the trench forming the internal division walls between the cellars of the back-to back housing (Plate 10).

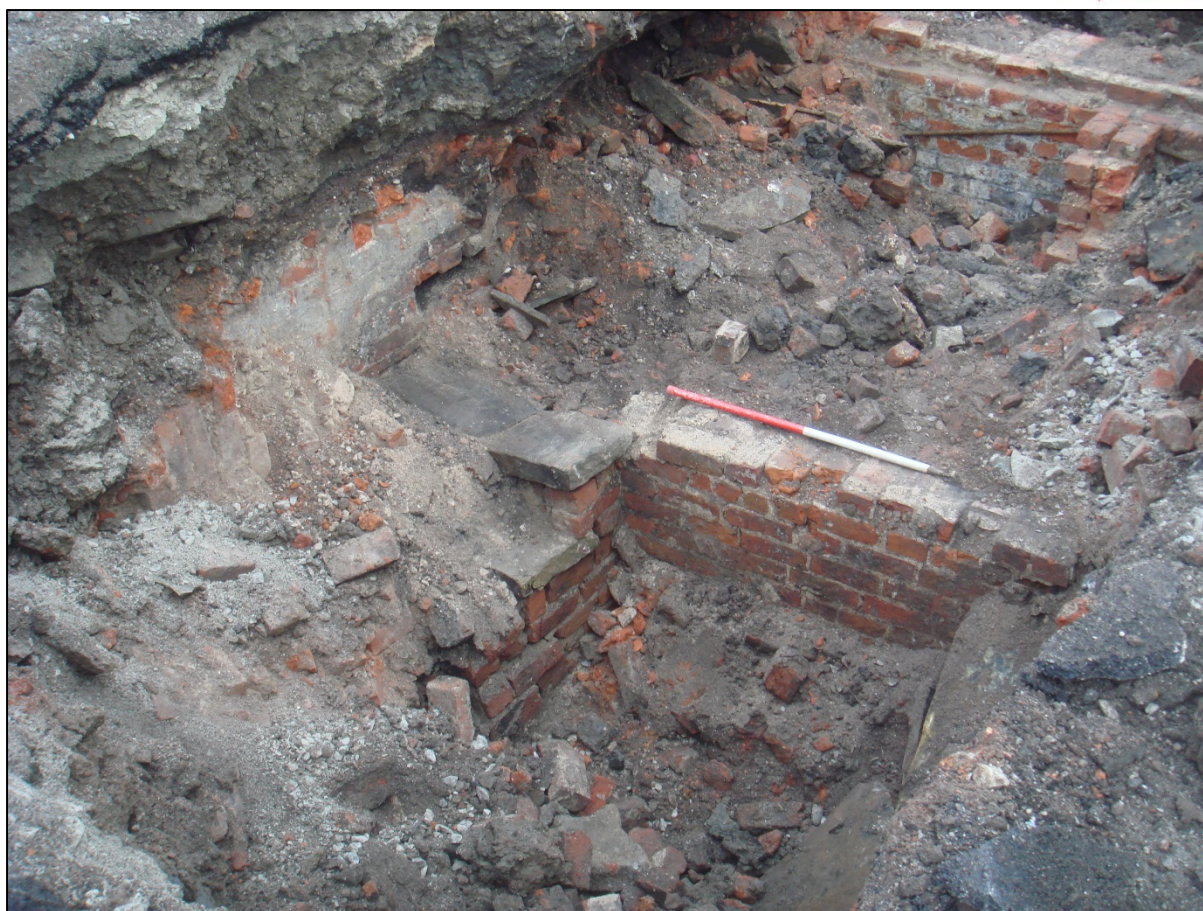
*Plate 11: Western cellar stairs in trench 10, wall dividing the north and south sides of the range visible at left, looking northeast*

The dividing wall between the north and south sides of the range was also visible in the northern trench edge. Two sets of brick and stone stairs were uncovered leading down into the cellars. The narrowness of the structures within the trench meant that the cellars could not be emptied by machine without destroying the *in situ* walling but the presence of the intact stairs and of mixed loose demolition rubble filling the cellars strongly suggested that the cellar floors and any internal features survive below.

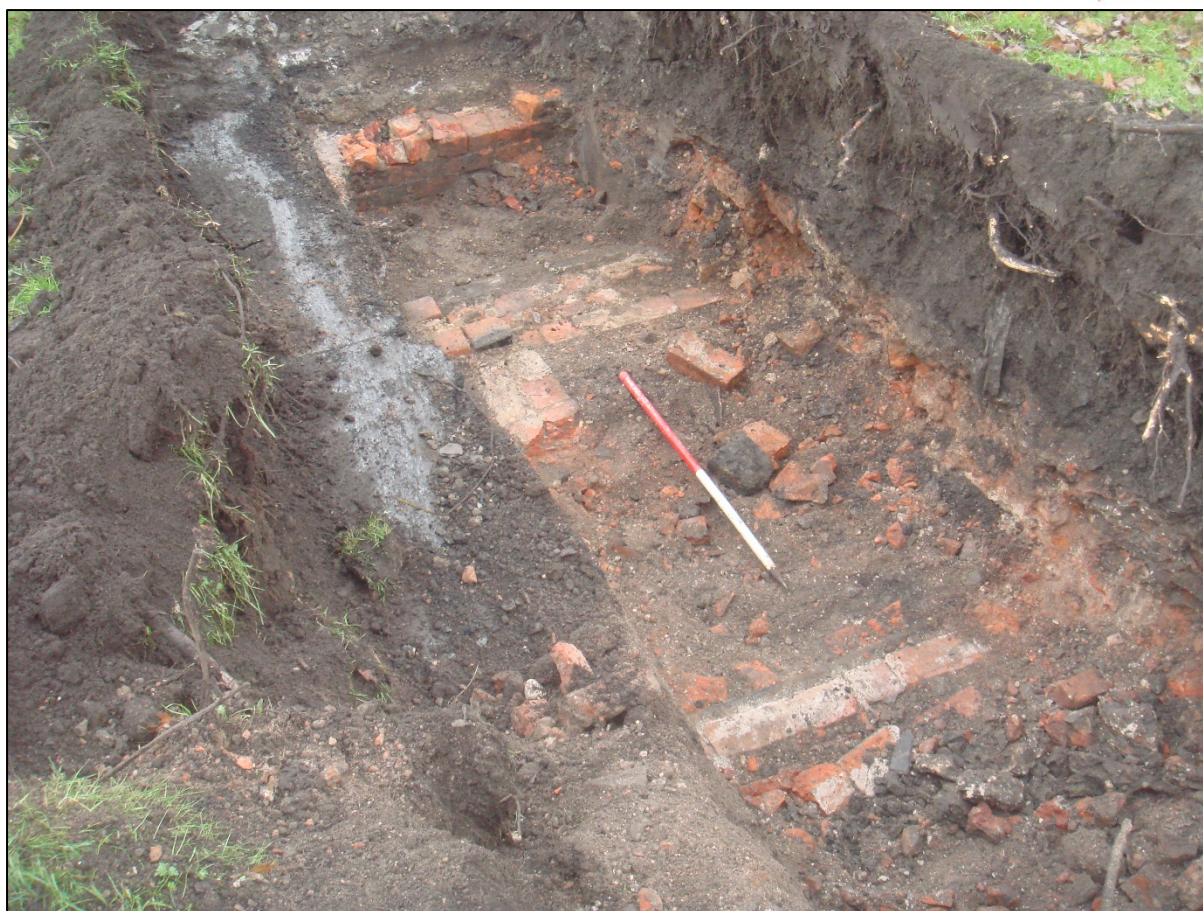
*Plate 12: Walling of back-to-back house cellars in Trench 11, looking northwest*

The western 17.6m of the trench could not be excavated to any depth due to the presence of a number of strong CAT scan signals and a very thick 6.5m wide tarmac surface of a former roadway. The eastern 6.4m of the trench was excavated to a depth of c. 0.7m and revealed three handmade brick walls with white lime mortar running across the trench. Between these walls was loose demolition rubble. These represented the internal dividing walls of the back-to-back houses (Plate 12).

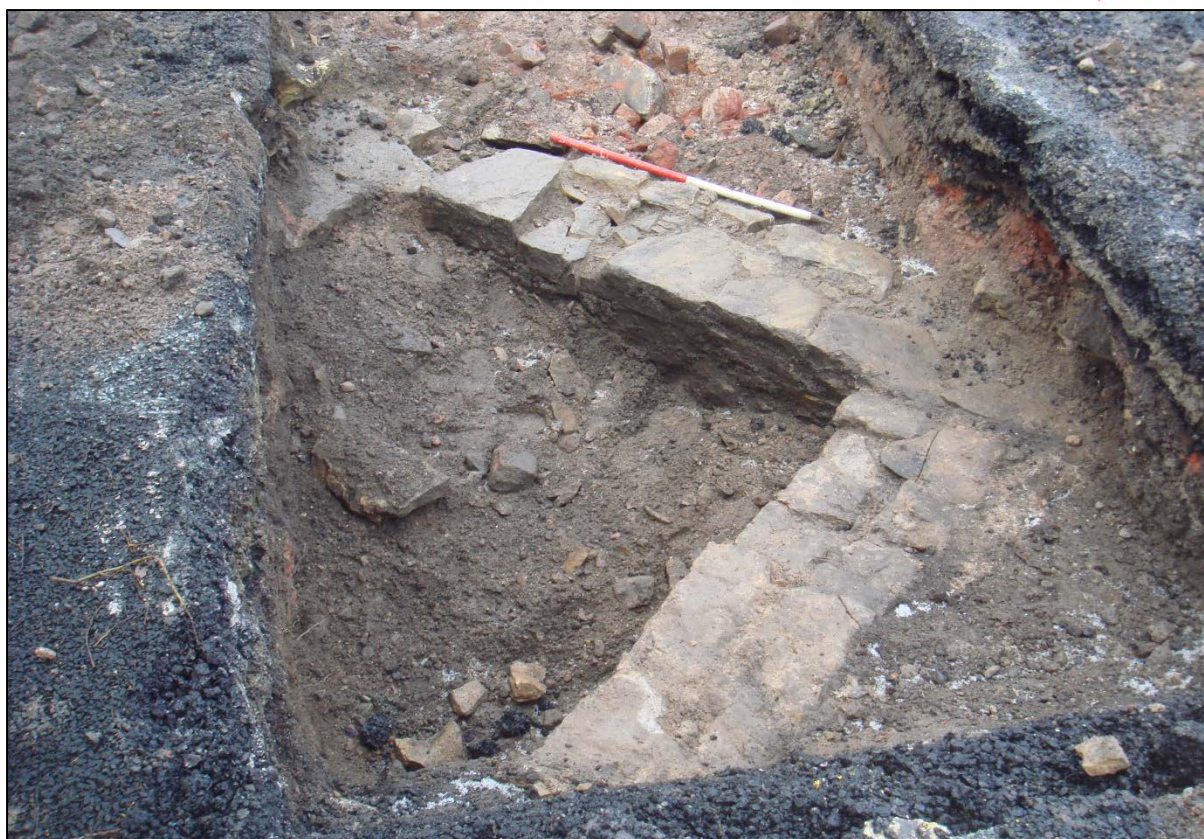
*Plate 13: Southern stone walled room in trench 12, looking north*

At the south end of the trench were a series of 0.4m wide stone walls forming a 2.3m wide room filled with loose demolition rubble. This ran northeast/southwest with the northwest, northeast and southeast walls visible within the trench (Plate 13).

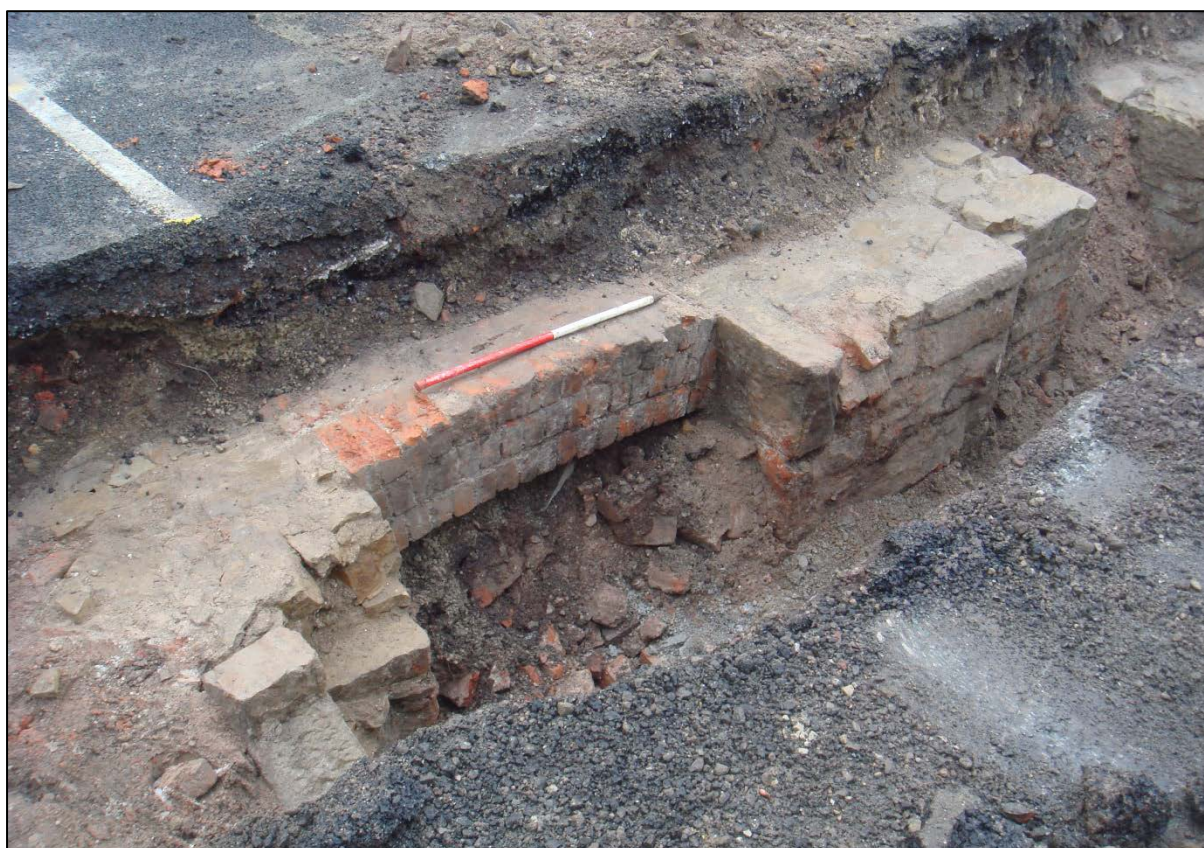
*Plate 14: Stone structures and brick arch, looking northwest*

To the north of this were a series of stone structures. The northern and central structure were *c* 1.9m wide and stepped inwards on the east side. The northern structure stepped in at the south side of its edge and the central structure at the north side of its east edge, mirroring each other, with a 0.8m gap, possibly a basement corridor between the two. To the south of the central structure was a 0.84m wide stone structure. The 1.4m gap between the two was bridged by a four-course wide handmade brick arch with lime mortar (Plate 14).

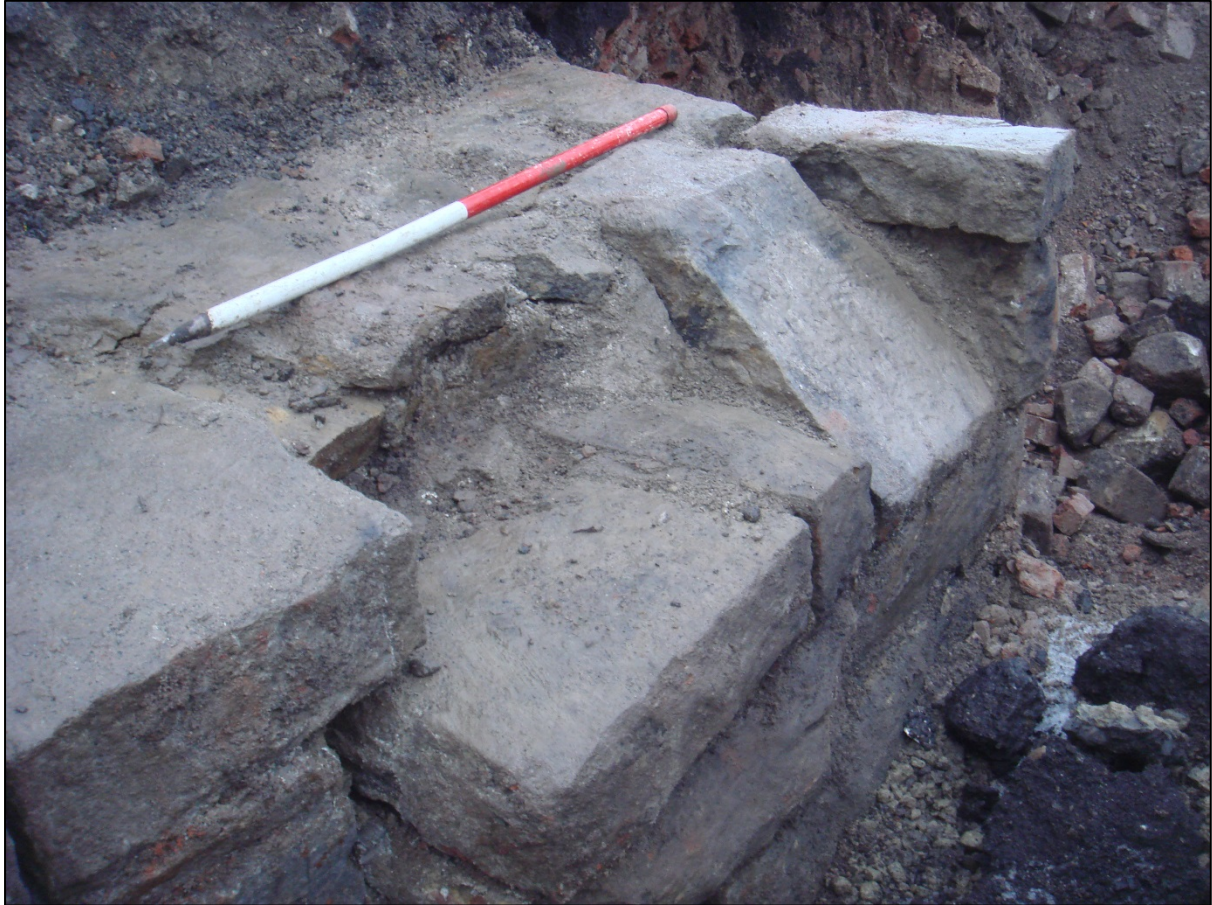
*Plate 15: Chamfered stone block, looking northwest*

The south structure had a chamfered stone block at the south side of its east edge and the northern structure had a similar block at the north side of its east edge. These suggested that originally brick arches sprang from these chamfered blocks running east, possibly forming a north/south basement corridor (Plate 15).

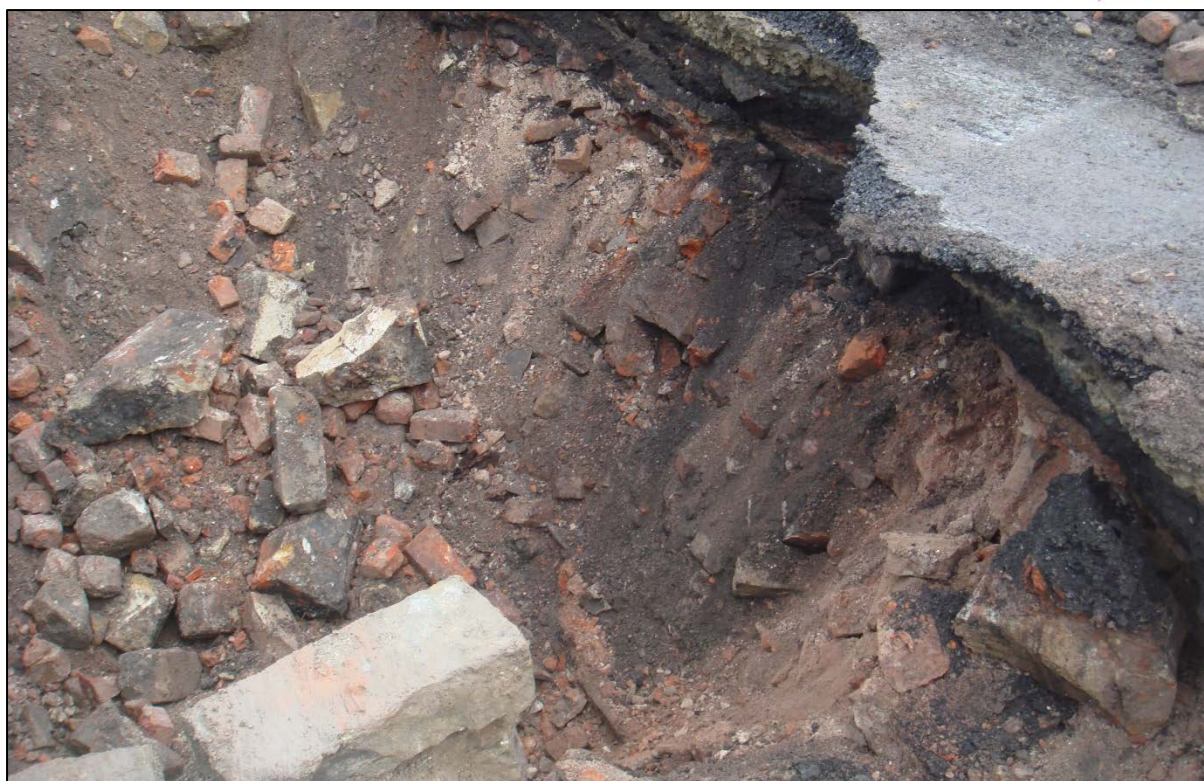
*Plate 16: Rubble filled basement, live cable visible at bottom centre, looking northeast*

The area to the north of the northern structure appeared to expand into a large basement which was filled loose demolition rubble. This was not bottomed due to the presence of a large live electricity cable at 2.02m below the current ground level, which appeared to run north/south along the basement corridor, possibly having removed the former brick arches (Plate 16).

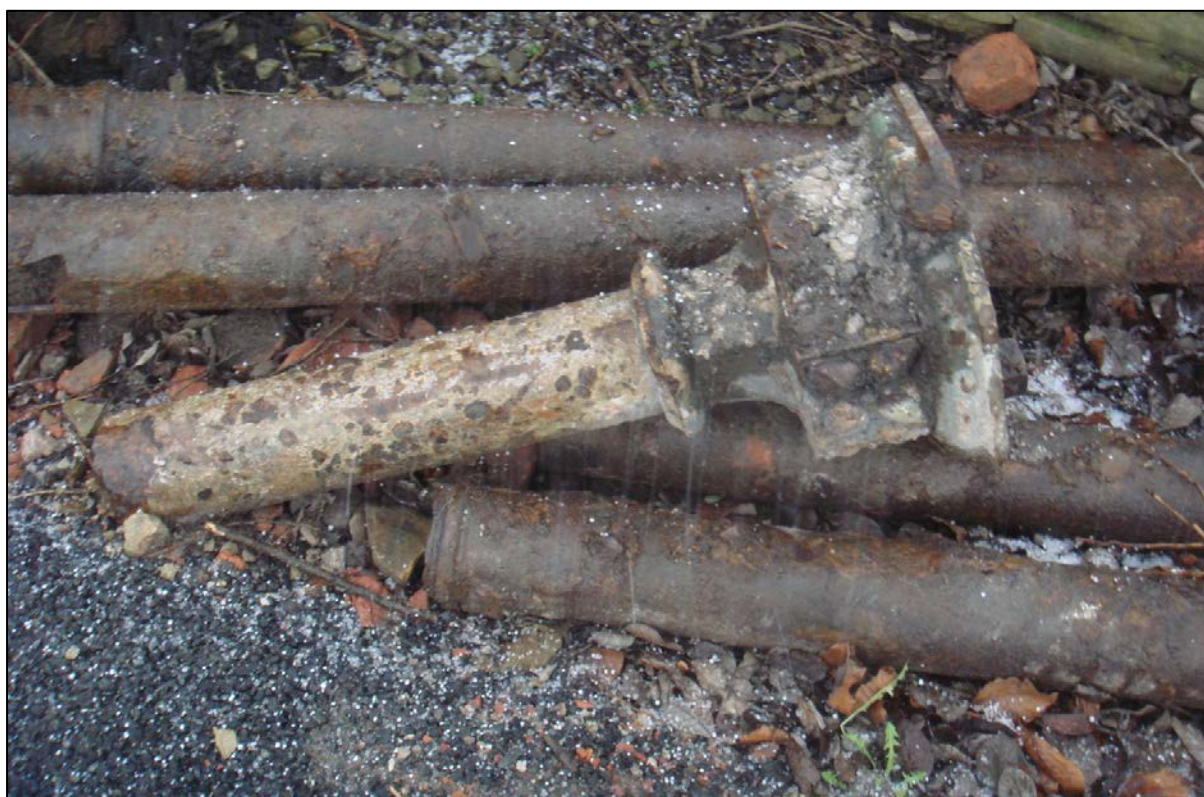
*Plate 17: Ornamental cast iron column capital and pipes from former trial pit*

Within the demolition rubble were large pieces of ornate architectural masonry. Beside the trench a geotechnical trial pit had been excavated and backfilled. Some cast-iron objects had been removed during the excavation of this trench and had been deposited beside the trench. This comprised some piping and an ornate column capital with a florally decorated crush box attached (Plate 17). This trench led to the excavation of open area 3, see section 4.12 below.

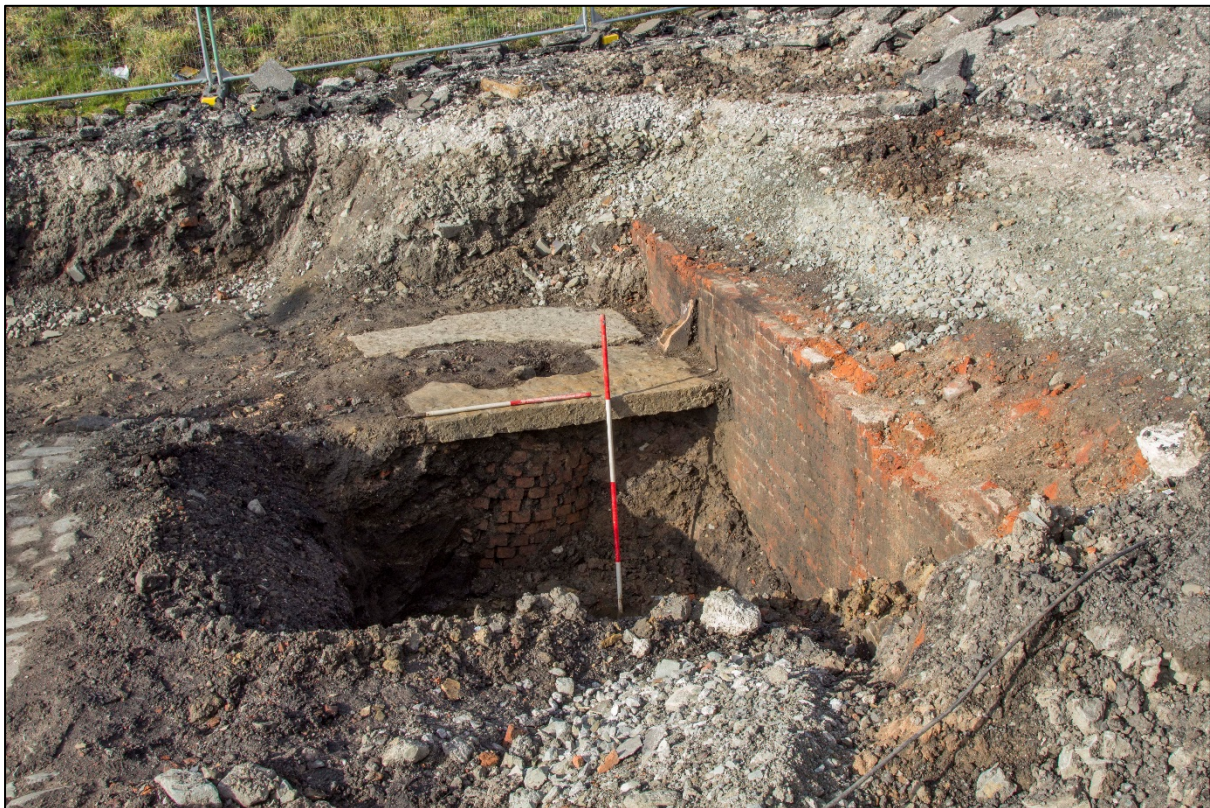
*Plate 18: The southern, front wall of the houses fronting Portland Place showing the sondage against the southern elevation and the remains of a pump well behind, looking west*

At the far north of the trench was a hand-made, brick wall bonded with lime mortar, two brick-courses wide excavated to a length of 5.80m. The bottom of the foundation for this wall was found at a depth of 2m from the top of the wall in a sondage dug against the southern elevation (Plate 18). The foundation was found sitting on natural clay, above which lay a thick layer of garden soil, which produced 11 fragments of 17<sup>th</sup>/18<sup>th</sup>-century pottery sherds and an 18<sup>th</sup>-century clay pipe. This wall represents the southern, front wall of the houses formerly fronting Portland Place, shown on both the OS 1851 and 1892 maps.

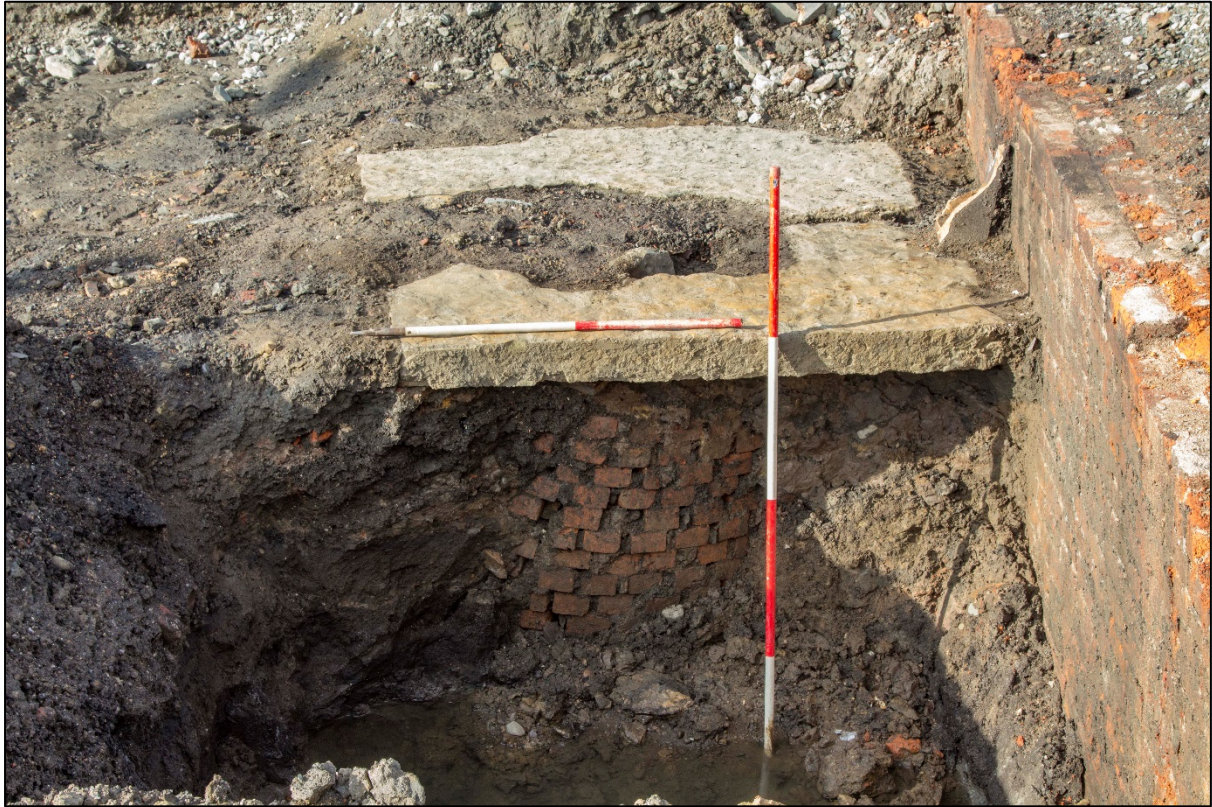
*Plate 19: Detail of the pump well*

a large, thick stone slab (Plate 19). The stone slab abutted the wall of the houses and a ceramic down-pipe was found still attached to the wall, which led into the soak-away.

The stone slab measured 1.97m east/west by 1.80m north/south and the hole in the middle measured 0.96m in diameter. It was not clear whether the hole had been deliberately broken through for drainage or had been caused by accidental damage.

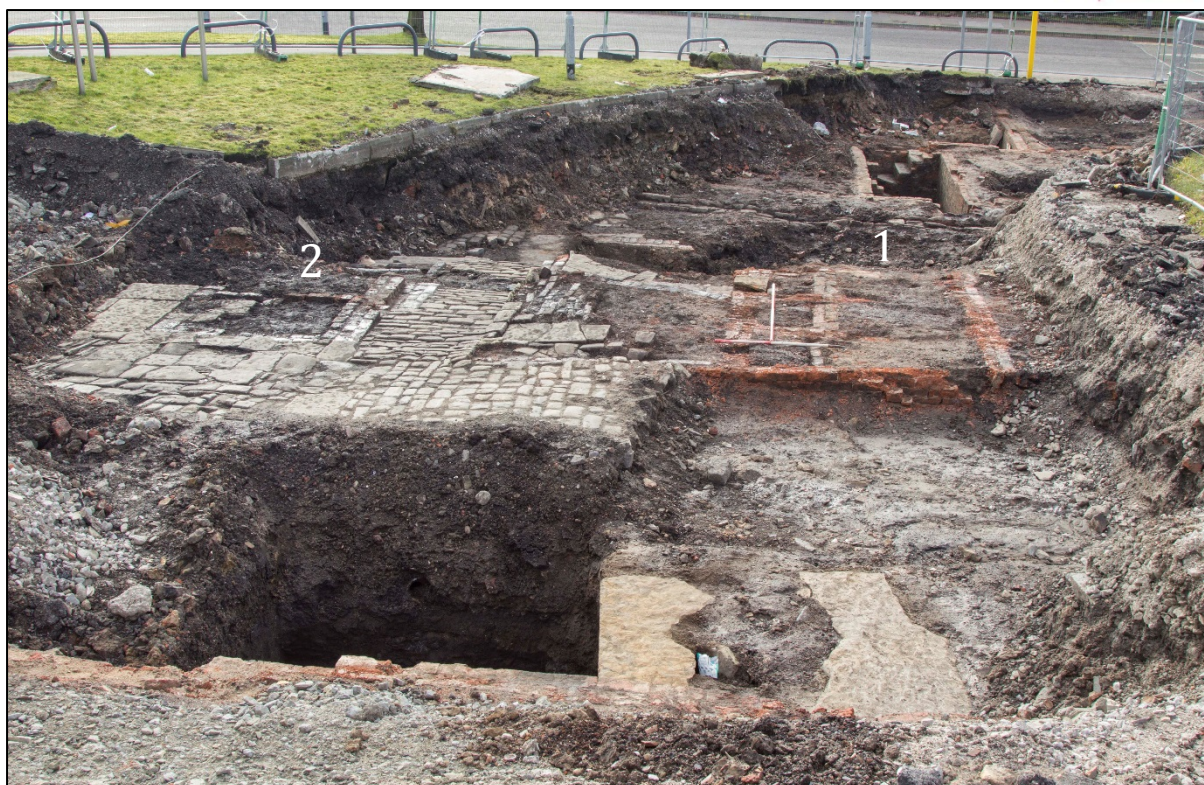
*Plate 20: Wash house block 1 to the east and toilet block 2 to the west with cobbled and flagged courtyard surface, looking south*

The majority of the courtyard surface comprised large cobbles with a stone-flagged area to the east. A cobbled path ran between the wash house 1 and a toilet block 2 (Plates 20 to 22). The walls of the wash house block comprised hand-made brick bonded with lime mortar, typical of the first half of the 19<sup>th</sup> century. One, later 19<sup>th</sup> century wall 3 was found within the structure identified by black-ash mortar. The block measured approximately 6m (north/south) by 4m (east/west).

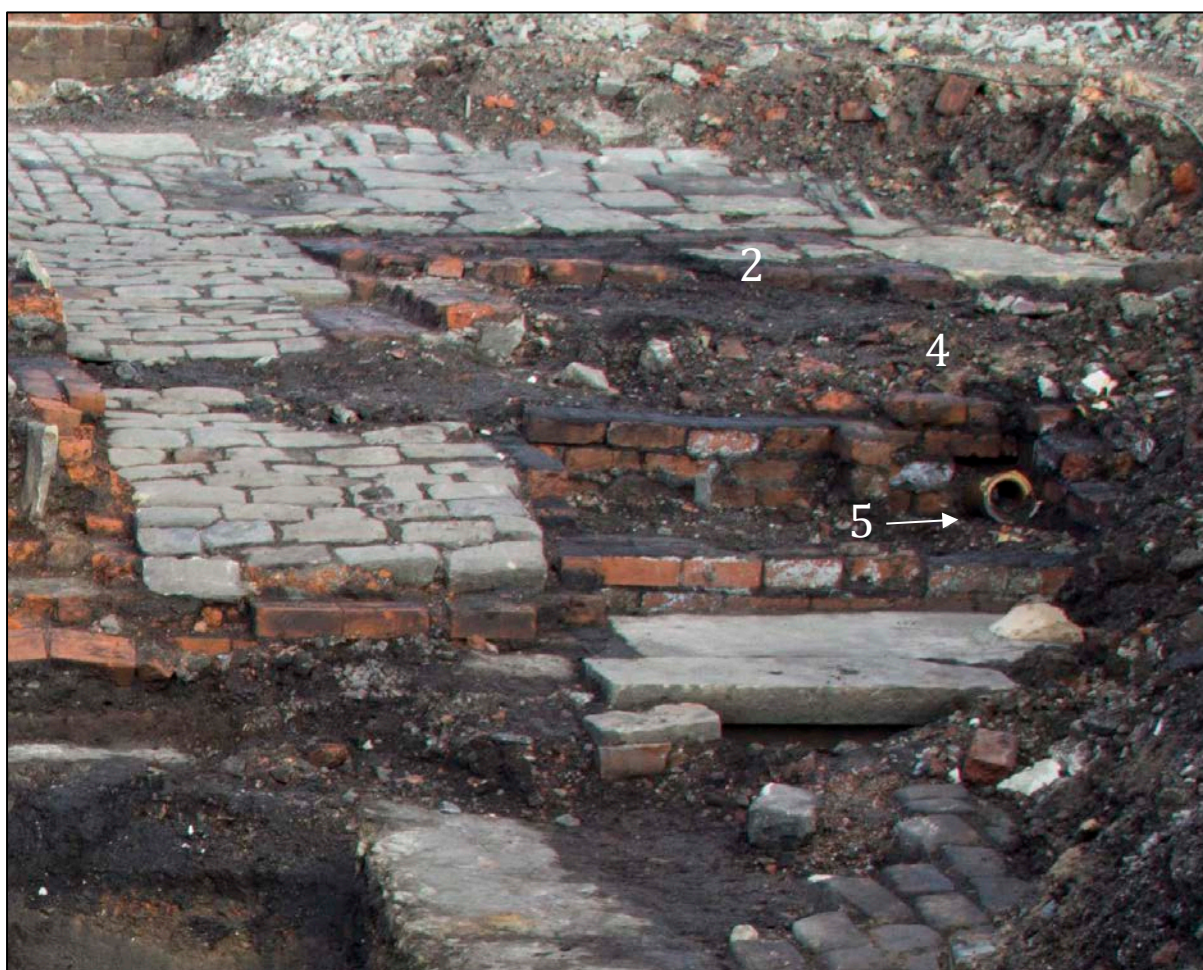
*Plate 23: Toilet block 2 showing a ceramic soil pipe 4 and base of a toilet 5, looking north*

Toilet block 2 measured approximately 1.80m by 2.20m and comprised the partial remains of stone-flagged flooring, a ceramic soil pipe 4 and part of the base of a ceramic toilet 5 (Plate 23). The area south of the toilet block 2 was contaminated with asbestos associated with the garage and so was left unexcavated.
