## Archaeological Excavation

Rochdale Riverside  
Phase 1, Rochdale,  
Greater Manchester

**Report No:** SA/2018/27

**Document Type:** Archaeological Excavation Report

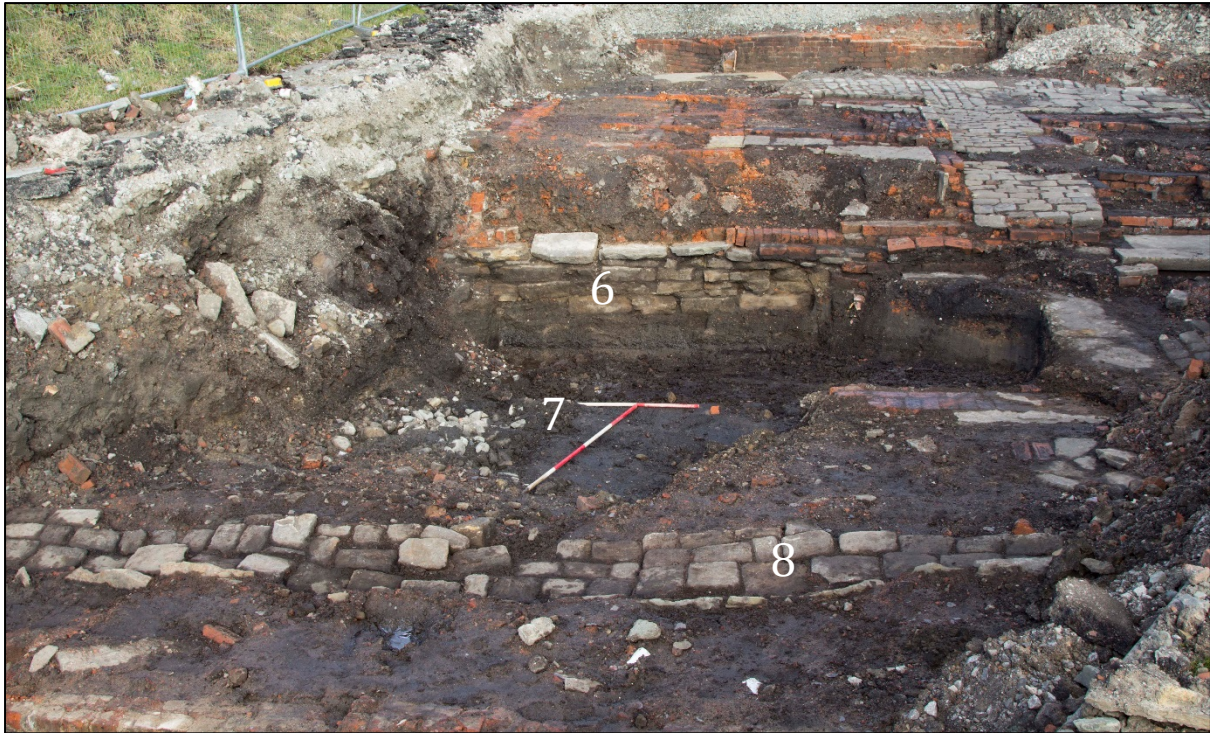
*Plate 24: The southern part of Portland Place courtyard showing the remains of stone wall 6, 18<sup>th</sup> century pond feature 7 and footpath 8, looking north*

The southern wall of the wash house appeared to have been constructed on top of a stone wall foundation 6, which itself was cut into garden soil. Prior to the construction of the workers housing area 1 was the location of a terraced garden associated with a building higher up the slope. The stone wall was possibly the remains of a terrace wall constructed during the 18<sup>th</sup>-century.

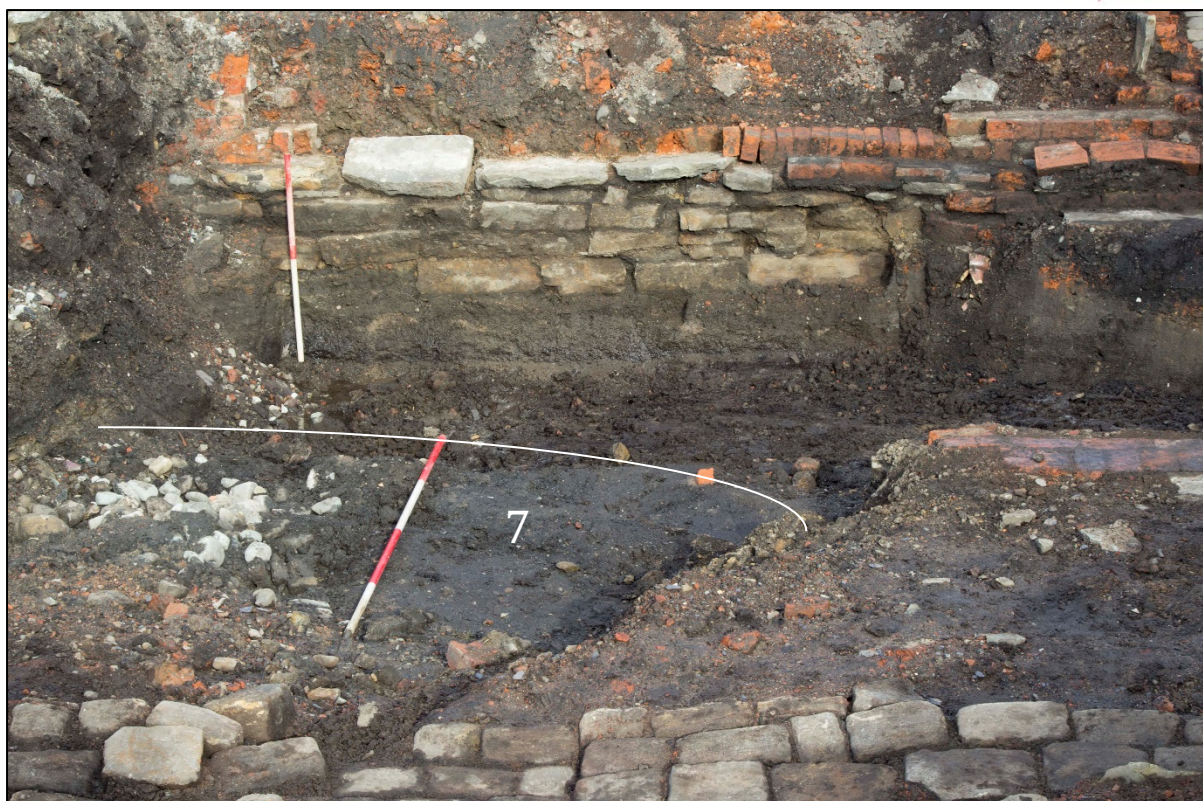
*Plate 25: Detail of the garden feature 7 in the location of the 2m scale bar with the clump of river pebbles to the left of the photo. The difference in colour of the black silty sand 7 can be seen against the richer brown colour of the garden soil, looking north*

The remains of Portland Place to the south had been truncated, by the former garage, hence deeper excavation to the south of stone wall 6 was merited. This again revealed a thick layer of garden soil, within which was circular feature 7 (Plate 24 and 25). The exposed circumference suggested a large feature more than 2m in diameter with a clump of river pebbles in the centre. This feature may be the remains of post-medieval pond within the fields that predated the construction of the worker's housing. Full excavation of the feature was made impossible due to flooding.

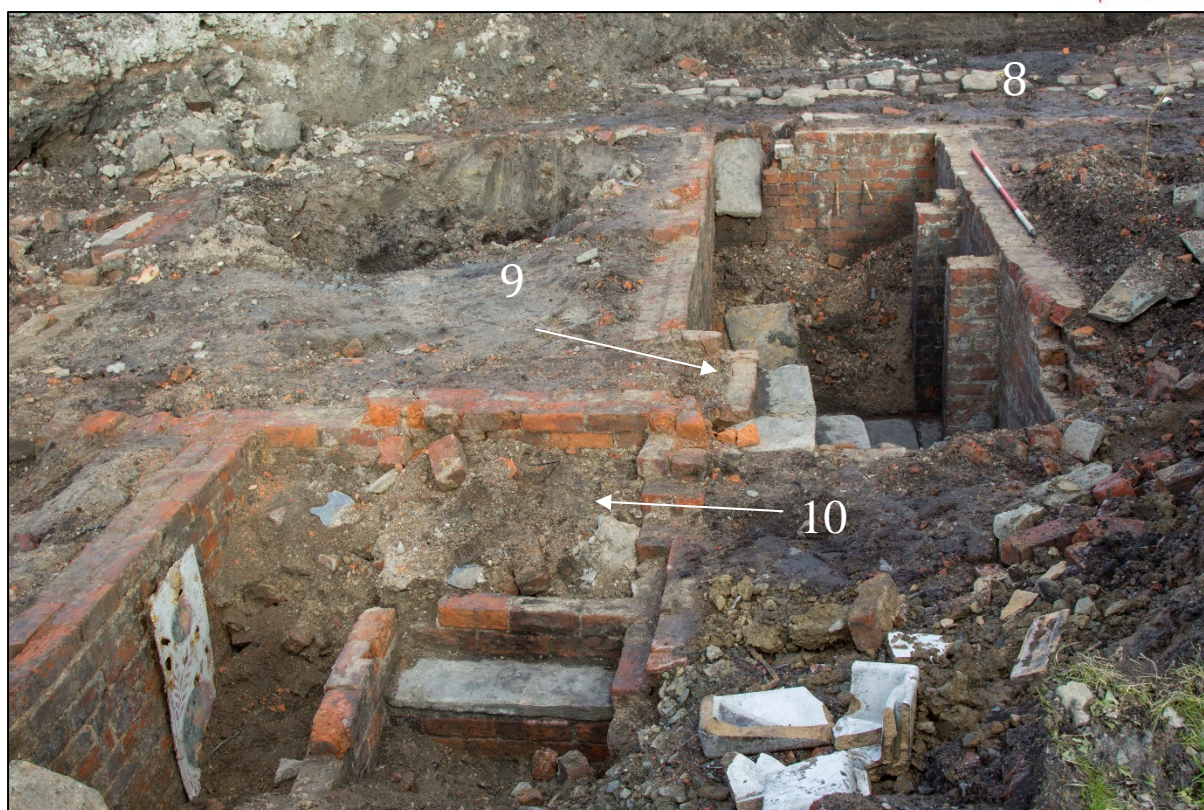
*Plate 26: The remains of two cellars, south of the cobbled footpath, looking north*

The houses excavated to the south of footpath 8 appeared to be the remains of back-to-back houses shown on the OS 1892 map, one of which (9), can be seen in Plate 26. The ground-floor level footprint shows a room to the west with a brick and stone-constructed staircase leading down to the east into a cellar, with a coal chute (0.84m x 0.35m) built into the northern wall of the house. The well-preserved curving staircase, which lay along the southern wall of the coal cellar, was an unusual feature, not seen in similar houses throughout Manchester and Salford. It comprised a stone slab forming the tread resting on two brick-courses, comprising hand-made bricks (0.23x0.11x0.07m) bonded with lime mortar. Along the eastern wall were the brick foundations for the cheeks of the ground floor fireplace above (1.20m apart). The walls survived to a maximum height of 1.42m and the floor comprised stone flagging (Plate 27). A sondage through the main room of house 9 confirmed it was not cellared.

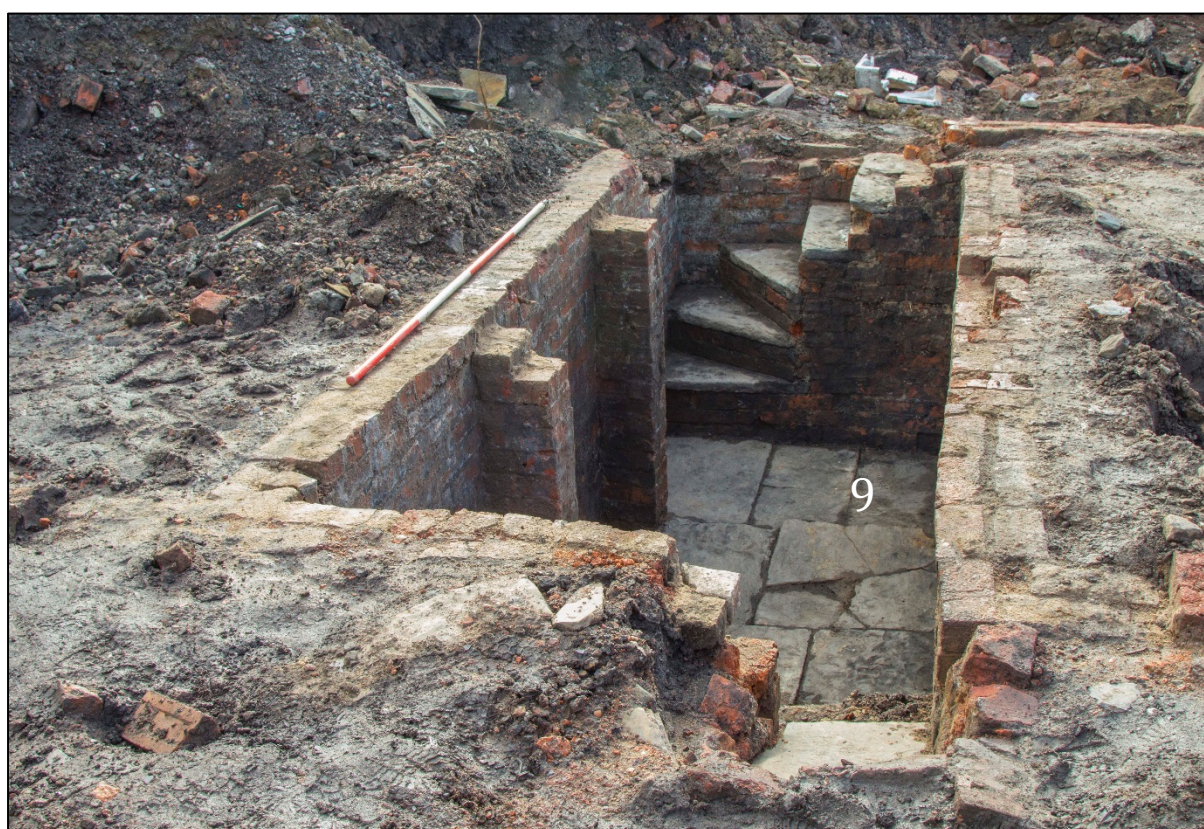
*Plate 27: The remains of the cellar within house 9, with curving staircase and fireplace foundations, looking south*

House 10, also visible in plate 27, was the back-to-back house to the rear of house 9, with associated staircase and coal cellar. This could not be fully excavated due to the presence of asbestos. A broken Belfast sink was excavated from the upper fill and a metal hearth-plate can be seen against the western wall of the coal cellar.

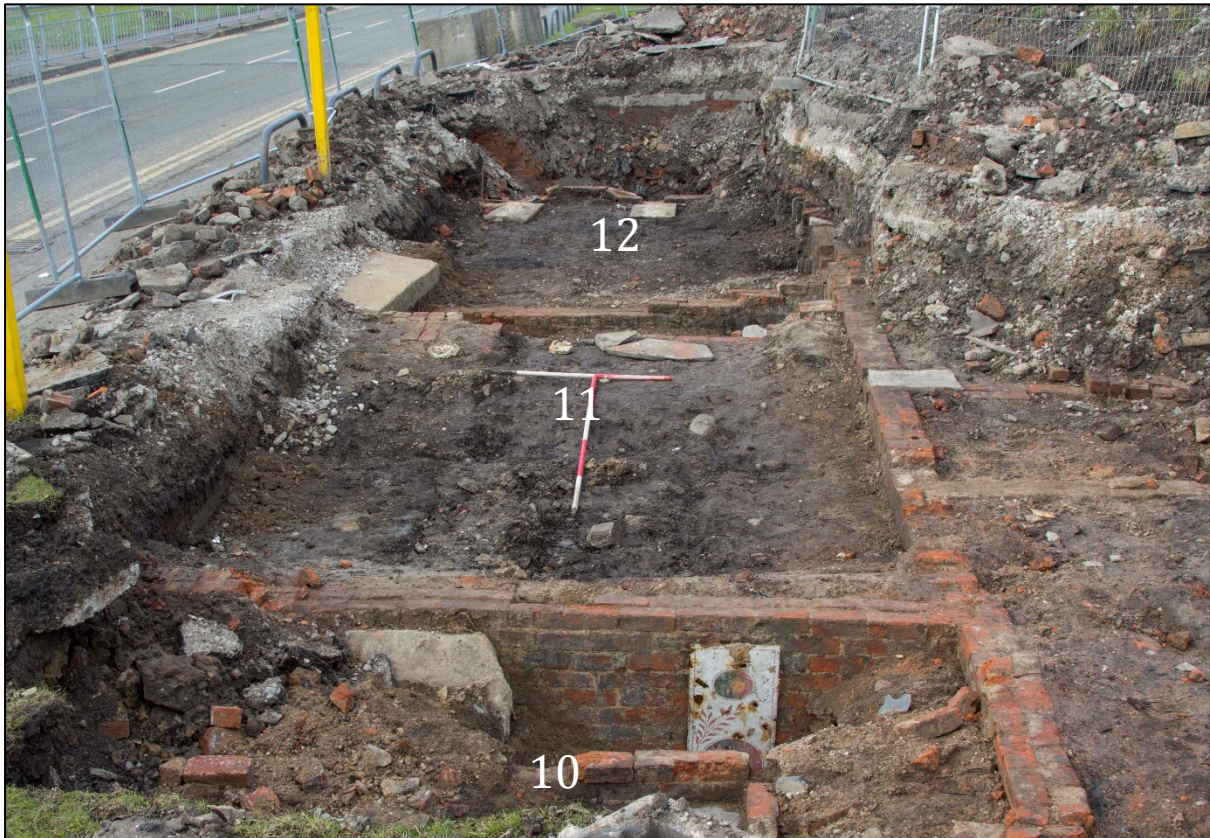
*Plate 28: The southern part of Area 1 showing house **10** in the foreground, looking west*

To the west of house **9** lay the remains of two more houses and part of a further two (Plate 28). Houses **11** and **12** comprised the same footprint as house **10**, having the main room to the east and a cellar to the west. The dividing walls between adjacent houses and back-to-backs were two brick-courses wide comprising hand-made brick, bonded with lime mortar. The front walls of the houses fronting Baillie Street lay beyond the trench edge.

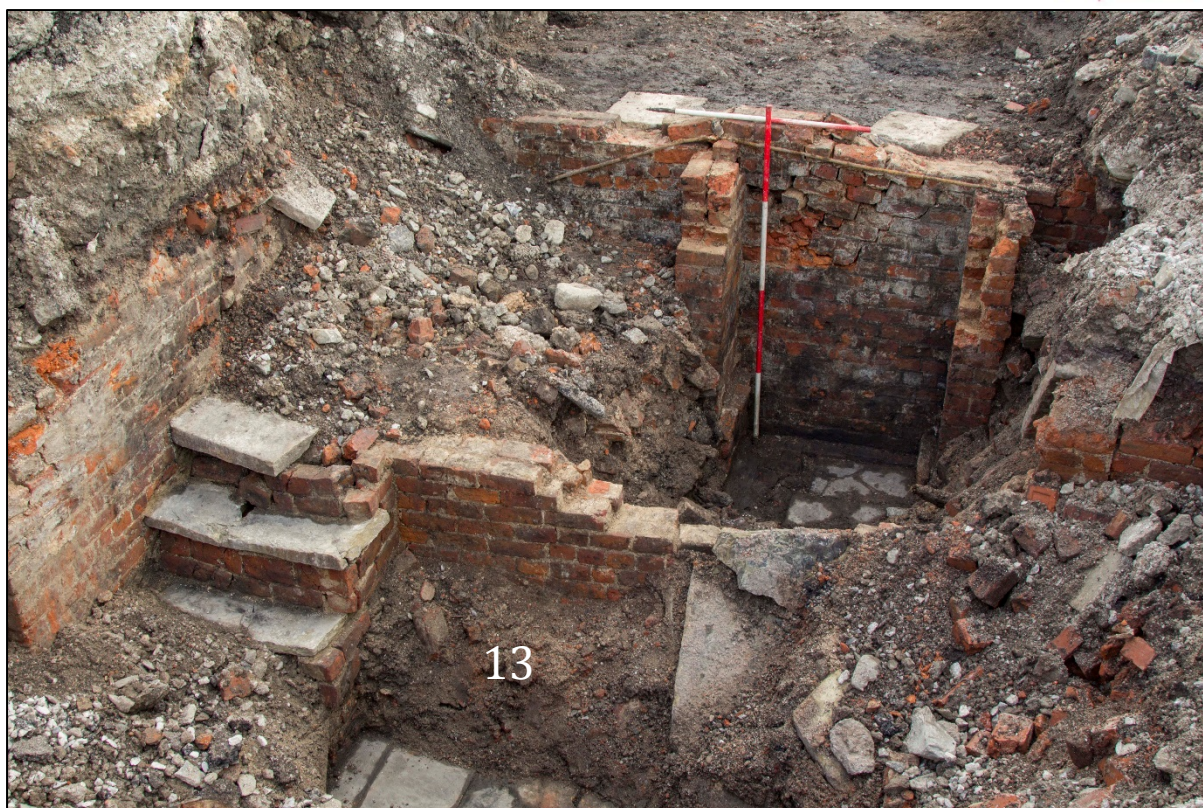
*Plate 29: House 13 showing a deep cellared room with fireplace foundation pillars and a shallower cellared room with staircase, looking east*

To the west of house **12** lay a deeper cellared room, house **13** (Plate 29). The eastern wall had the remains of fireplace pillars and the floor was stone-flagged, but the front wall of the house to the south remained beneath the trench edge. The top of the walls were found at approximately 1m from the modern surface and survived to a height of 1.80m, at the bottom of which was a stone-flagged floor. The room to the west with the staircase also had a stone-flagged floor but this was much shallower than that in house **12**. The staircase led down from east to west. All walls had been constructed using hand-made bricks, bonded with lime mortar.

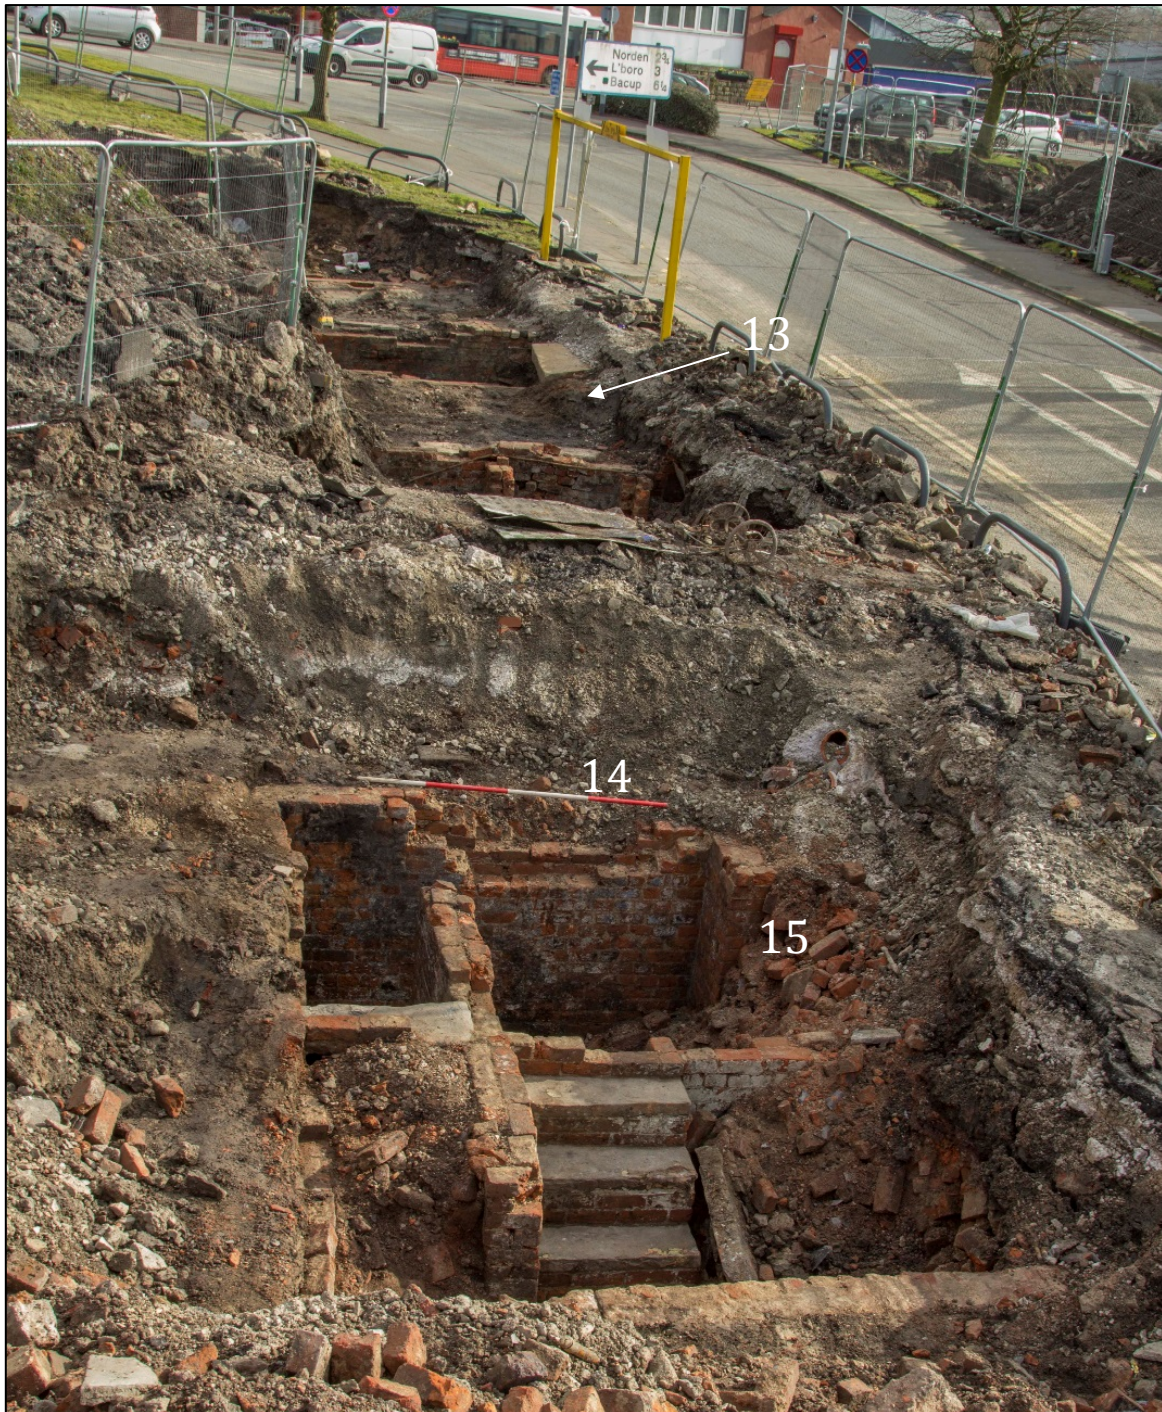
*Plate 30: The southern part of area 1 showing the unexcavated baulk between **13** and **14**, due to the presence of interceptors, looking east*

Due to the presence of modern interceptor gullies, an area west of house **13** remained unexcavated (Plate 30). To the west of this was the remains of two small cellared houses shown on the OS 1851 map, houses **14** and **15** (Plates 31 and 32). The remains of the walls of house **14** were first encountered at approximately 1m below the modern surface, the walls survived to a height of 1.66m at the base of which was probably a stone-flagged floor. The staircase led down from west to east in the north-west corner of the dwelling, constructed using the recognised method of a stone flag forming the step supported on two brick courses. Unusually, the void under the stairs of house 15 seems to have been accessible from house **14**, perhaps as a storage area.

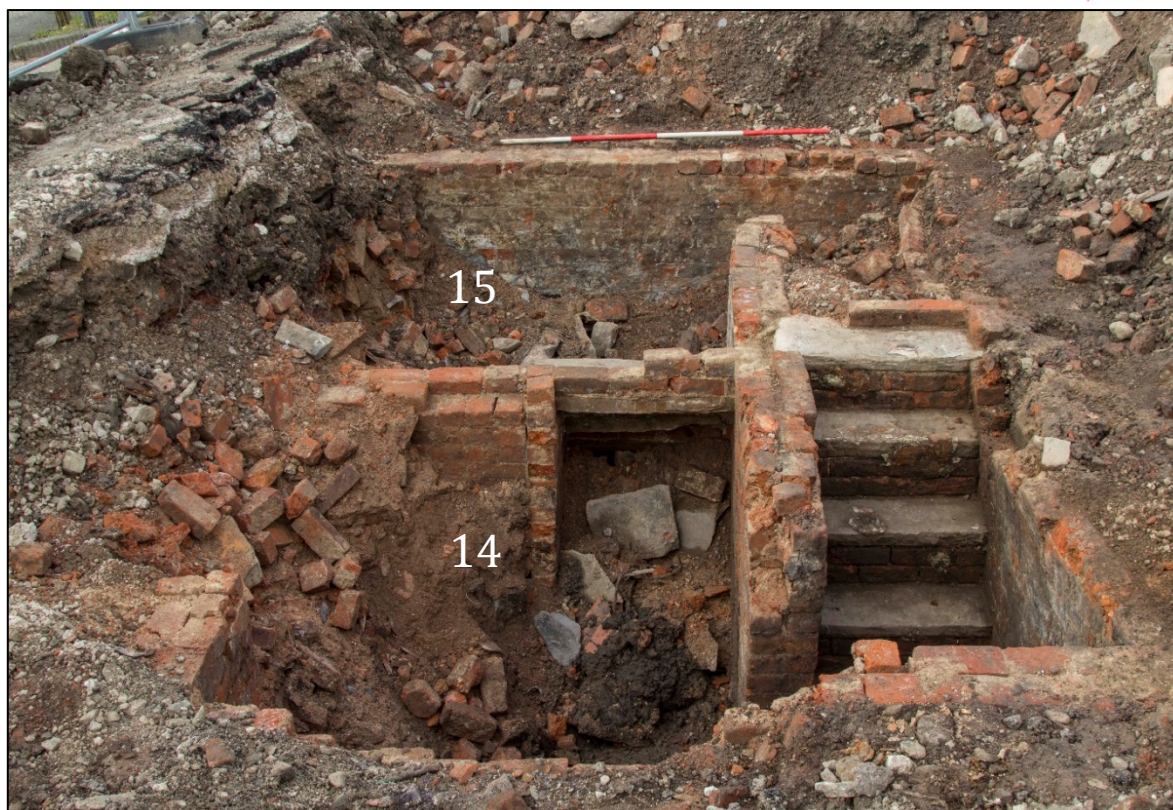
*Plate 31: House 14 in the foreground showing the under-stairs storage area of house 15 appearing to be open from house 14, looking west*

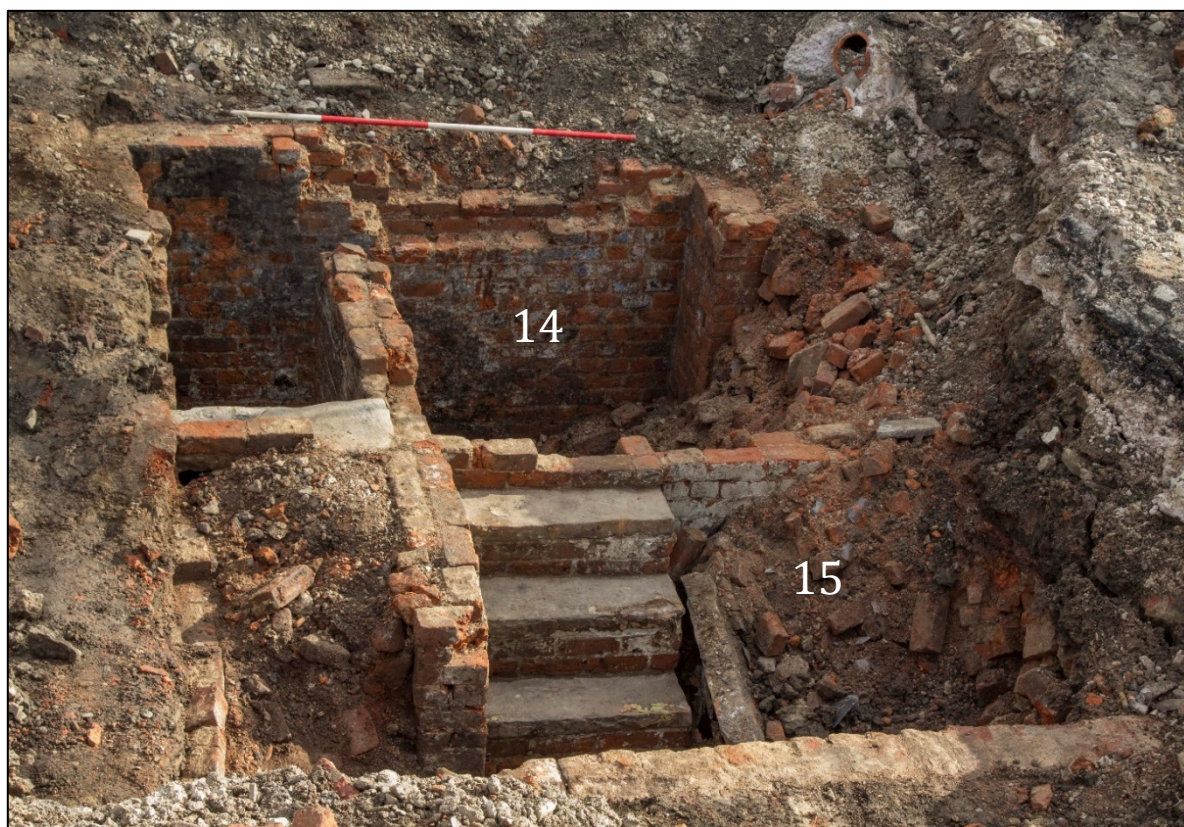
*Plate 32: House 15 in the foreground showing part of the staircase and traces of white paint on the wall, looking east*

House **15** appeared to be the south-western house of the block of six houses visible on the 1851 mapping at the western end of the southern range of Portland Place. The staircase led down from east to west and, as seen in house **15**, had access to the under-stairs void of their neighbour.

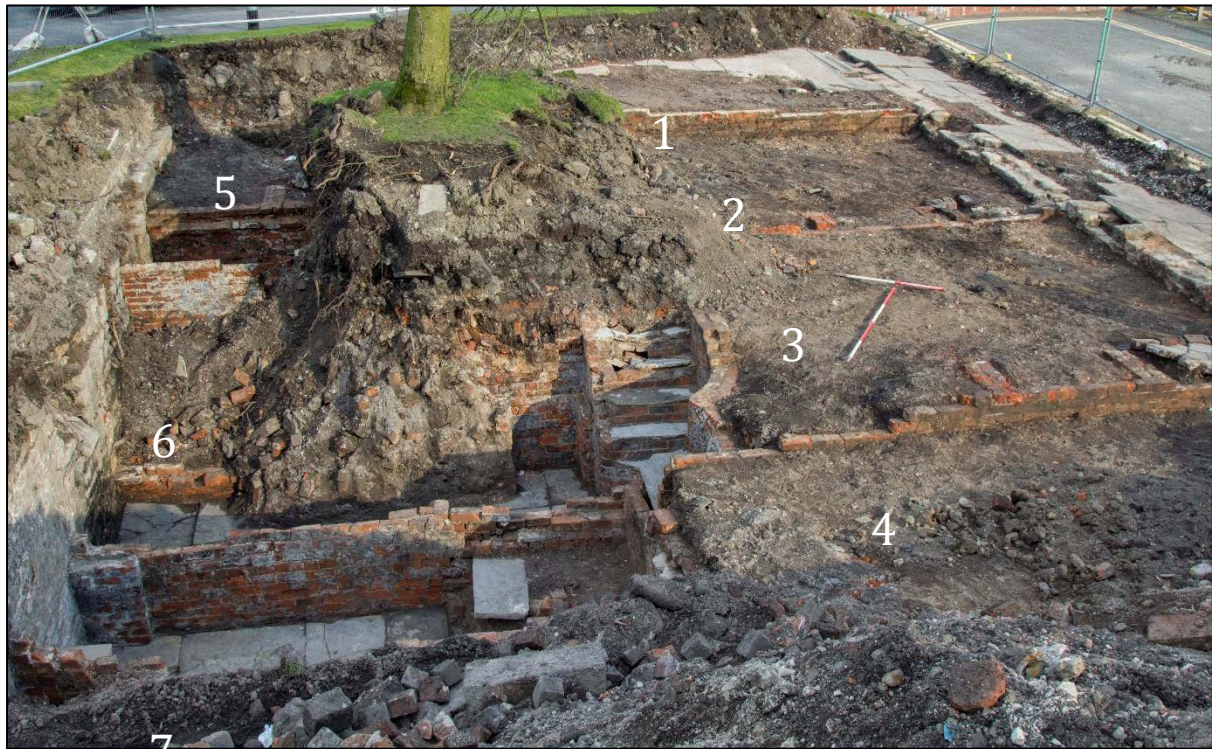
*Plate 33: General photo of area 2 fully excavated, looking east*

Area 2 was located to the south of area 1 on the southern side of Baillie Street, covering a grassy mound measuring 13m north/south by 20m east west. The area targeted part of a block of back-to-back houses fronting Baillie Street to the north and Kelsall Street to the south. The houses are shown on the OS 1851 and 1892, maps where they appear to have remained unchanged during that period. A total of seven houses were uncovered (Plate 33; Figure 11).

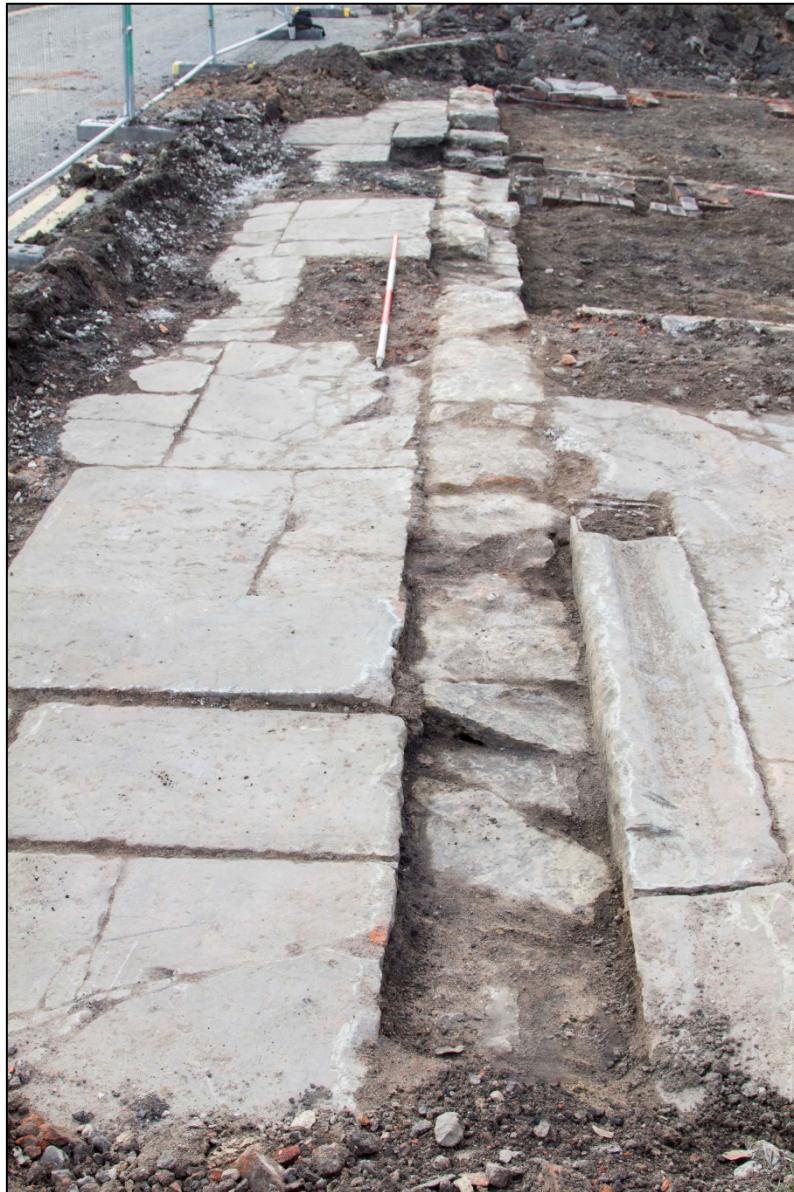
*Plate 34: The footpath, front wall and later drain of House 1, looking west*

House **1** lay in the south-east corner of area 2. Part of the stone-flagged floor survived in the south-east corner of the room, which had had a later repair in concrete. Along the interior of the front wall ran a stone channel, which drained into a square ceramic drain (Plate 34). This is unusual as the channel and drain would have been exterior features. The mapping suggests that between 1893 and 1910 the two easternmost houses along Kelsall Street, including house **1**, had been incorporated into the public house to their immediate east, outside the excavation area. It may be that these houses had been converted from domestic properties into commercial use and required extra drainage to be inserted. The dividing wall with house **2** comprised a single-course wide, hand-made brick wall, bonded with sandy lime mortar, excavated to a

length of approximately 6m and 4 brick-courses in height, aligned north/south. The return of the wall to the east was found and excavated into the trench edge to a length of 1.56m, this was also only a single brick-course wide. The threshold into the house more than likely beyond the trench edge to the east.

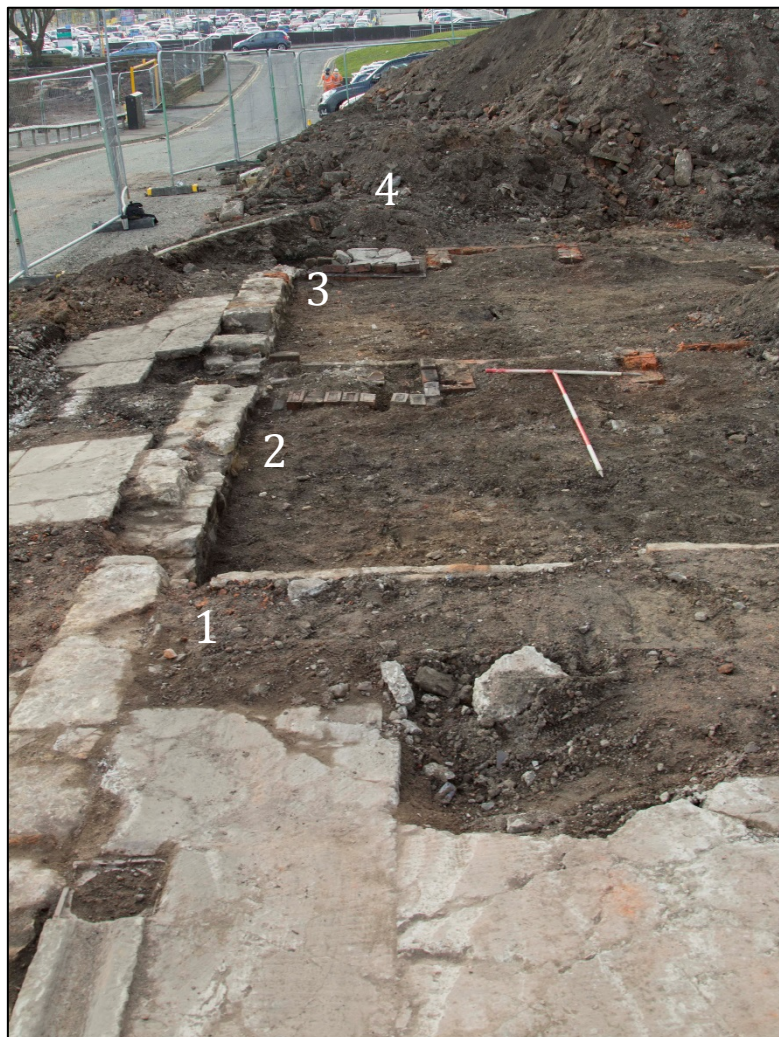
*Plate 35: The remains of house 2, looking west*

House 2 lay to the west of house 1 (Plates 35 and 36). The rear wall of the house to the north lay mostly beneath a tree but most probably was a continuation of the rear wall of house 1. The western party wall with house 3 was a single brick-course wide, hand-made brick bonded with sandy lime mortar, excavated to a length of 3.78m. Two brick pillars suggested a fireplace on this wall. To the south of the fireplace and against the front wall, a later wall had been added comprising 20<sup>th</sup>-century frogged bricks bonded with black ash mortar. Within the small area this wall contained was a ceramic drain, which passed through the front wall of the house. The

exact function of this arrangement, which measured 0.92m by 1.25m, could not be determined. The threshold into this dwelling could not be determined from the remains of the front wall.

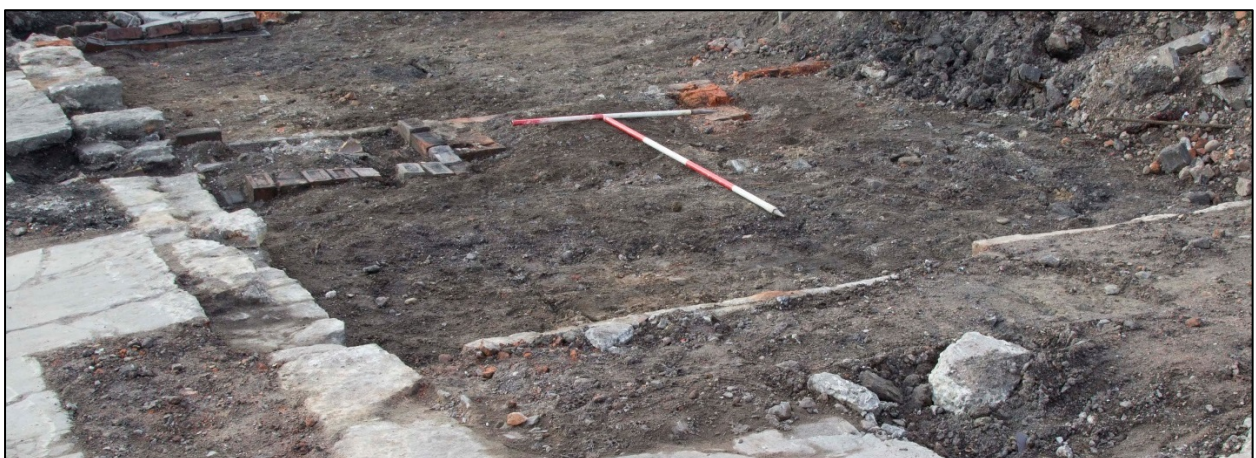
*Plate 36: House 2, looking north-west*

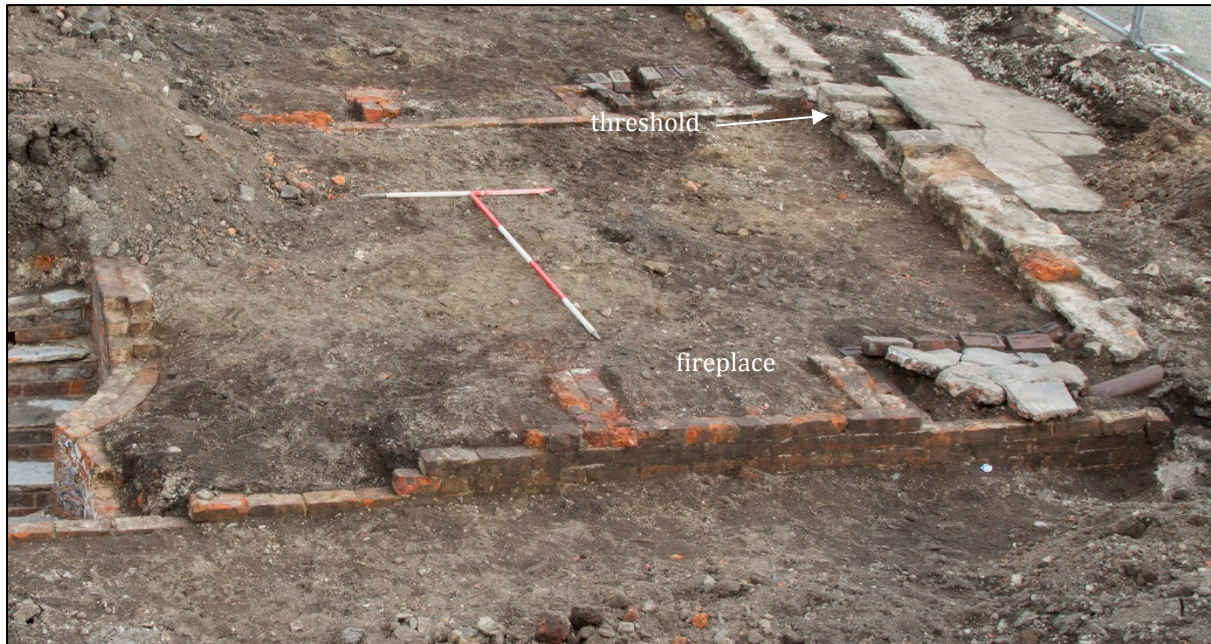
*Plate 37: Remains of house 3, looking east*

House 3 lay to the west of house 2 (Plate 37). The rear wall of the house was unusual in that it curved to form part of the staircase of house 6 back-to-back with it and comprised two brick-courses in width. As with house 2, the pillars of a fireplace were found on the interior of the western wall (3.78m in length) and there was a similar arrangement in the south-west corner of the room, where there were the partial remains of stone-flagged flooring, a frogged-brick wall and ceramic drain passing through the front wall. No flooring survived in the main room. Evidence in the stonework at the eastern end of the front façade suggested this was the location of the threshold, which could, in turn, identify the threshold of the other three houses excavated.

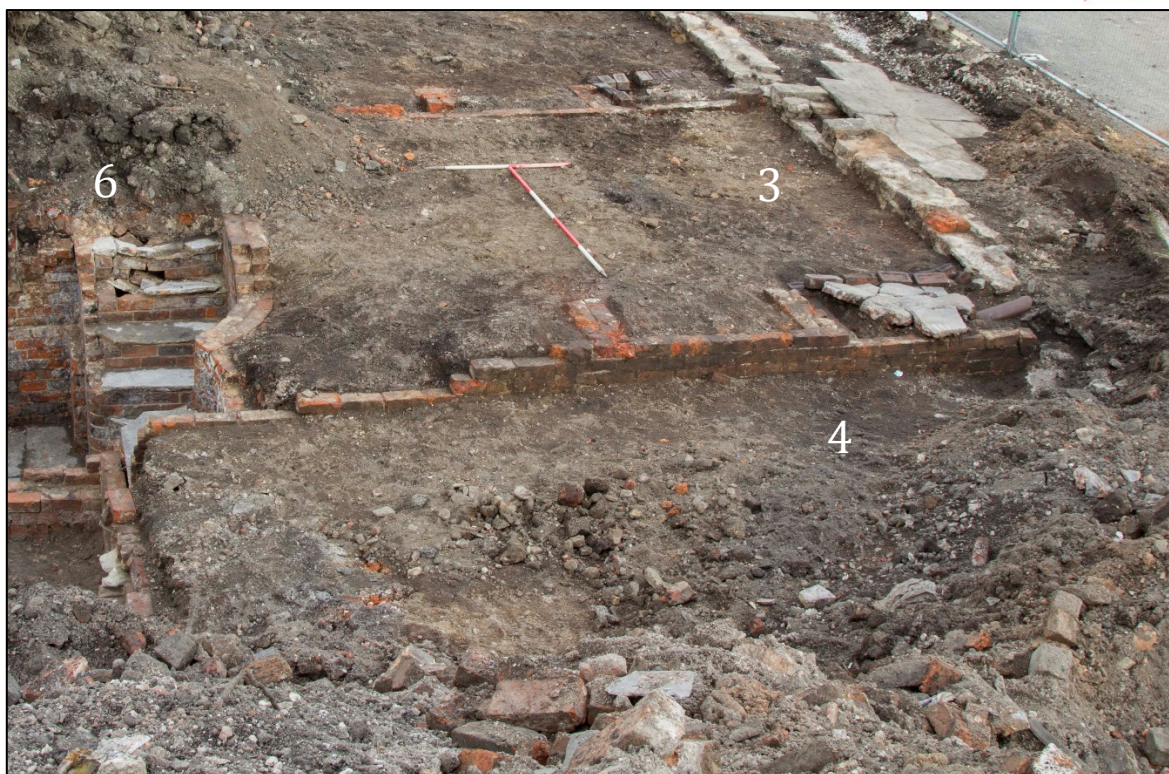
*Plate 38: The partial remains of house 4 in the south-western corner of the trench, looking east*

House 4 lay to the west of house 3 and could only be partially excavated due to limited space (Plate 38). This appeared to have had a larger main room, measuring 5.65m north/south with 2.53m east/west excavated. The rear wall of the house appeared to be only a single brick-course in width. No flooring survived and the front wall of the house appeared to have been truncated during the installation of the modern kerb.

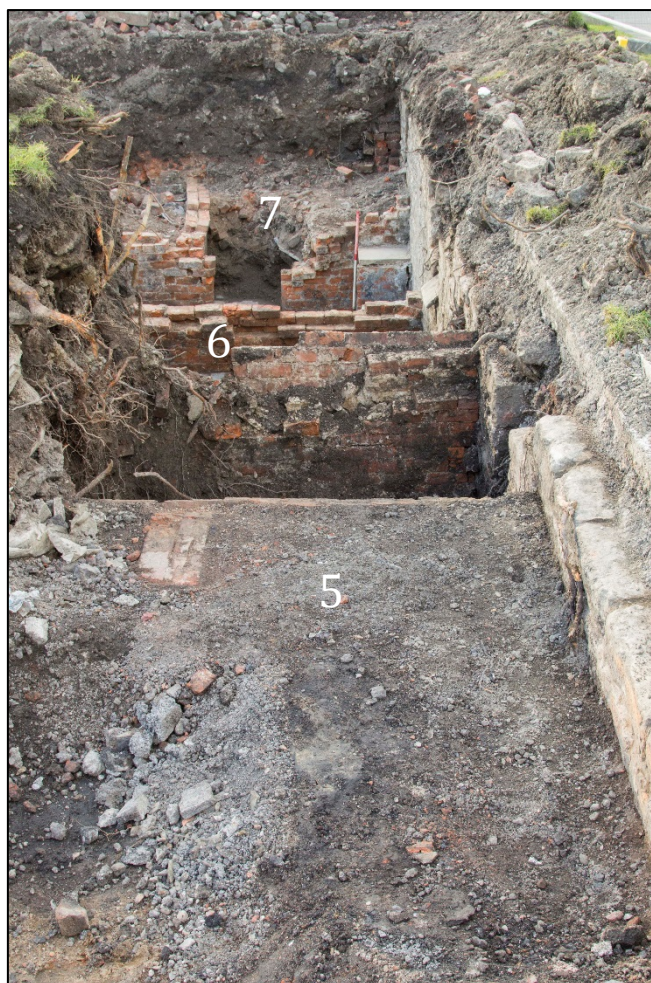
*Plate 39: The row of houses formerly fronting Baillie Street on the southern side, looking west*

House 5 lay in the north-east corner of the trench to the rear of house 1. Very little of this dwelling was exposed due to the presence of a large tree within the excavation area. The front wall of the house to the north was found in the northern section of the trench and was found to have been constructed on a stone foundation as seen in the houses to the rear. The rear wall of the dwelling was of course shared with house 1, previously discussed. The western wall comprised hand-made brick with lime mortar and had a short two brick-course wide wall abutting it (0.60m by 0.26m), which could have been a fireplace pillar. The western wall, shared with house 6 showed evidence at the top for the remains a brick-vaulted roof. This wall was excavated to a length of 1.90m and survived to a height of 1.20m as seen from the western side. The tree covered the access staircase to this room. The basement here was interpreted as the coal cellar, indicated by the coal chute visible in the front wall. The western wall of this coal cellar was brick-built, again with evidence at the top of a springing point for two barrel-vaulted ceilings (Plate 39).

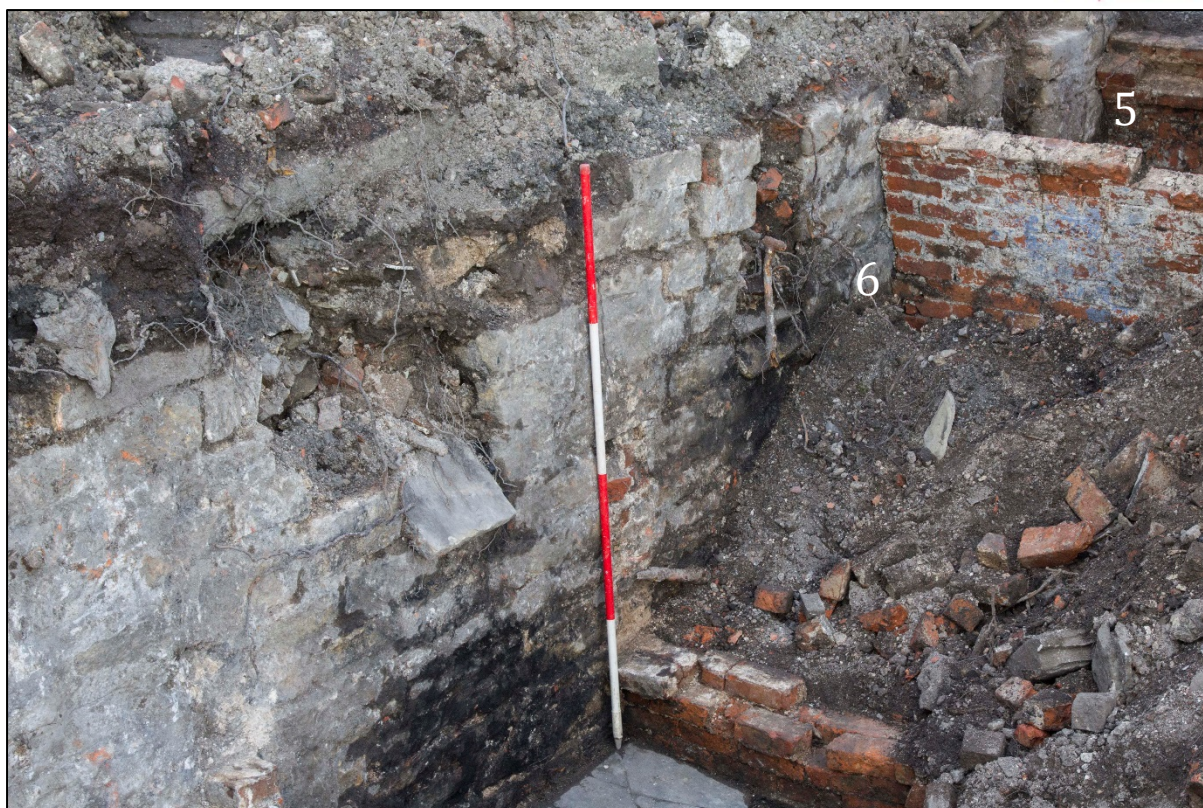
*Plate 40: Three coal chutes visible in the front wall of houses fronting the southern side of Baillie Street. The visible brick walls show evidence of springing points of barrel-vaulted ceilings, looking north-east*

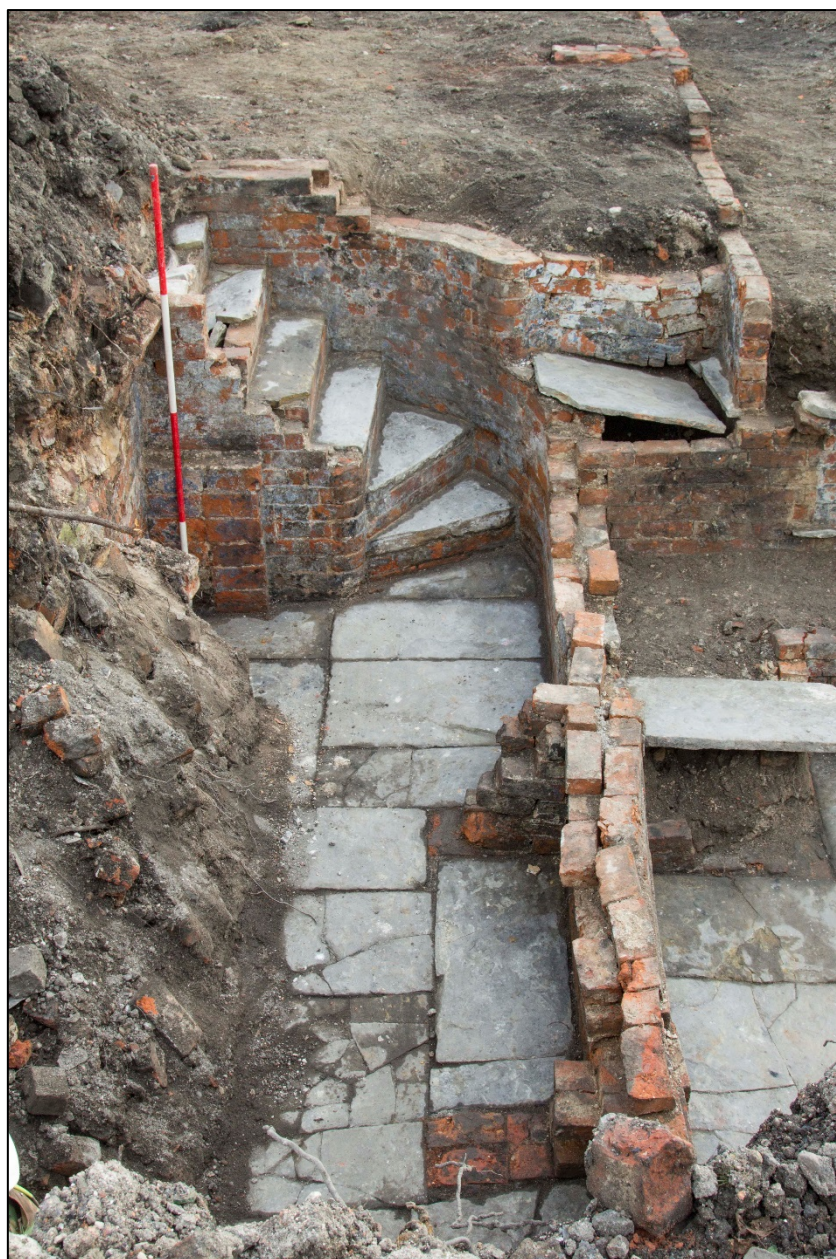
*Plate 41: Staircase, flagged-floor and fireplace foundations in house 6. Springing point for a barrel vaulted ceiling visible at the left of the scale, looking south*

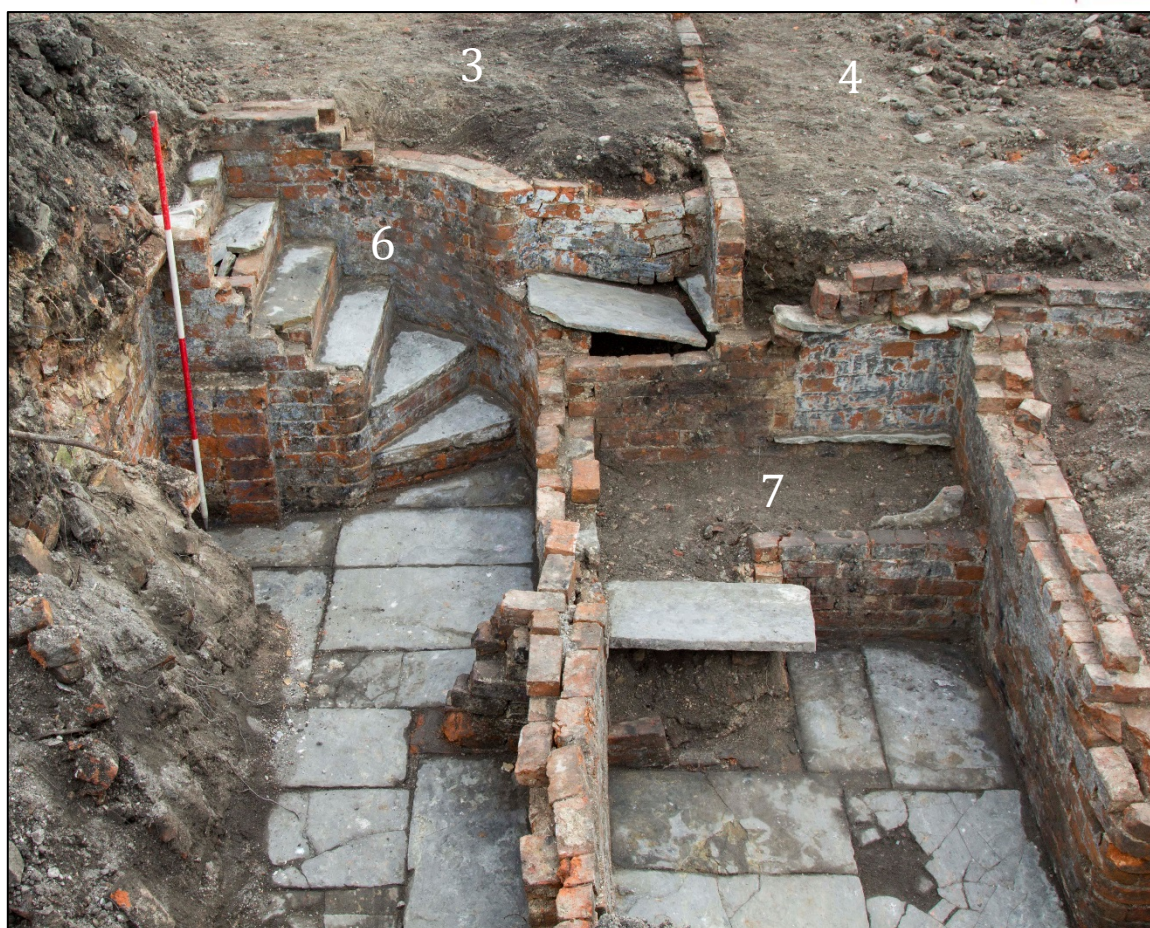
*Plate 42: Truncated staircase into cellar of house 7, house 6 is visible at the left, looking south*

House 7 lay in the north-west corner of area 2, west of house 6 and to the rear of house 4. The cellar appeared to contain a number of rooms but the location of the access staircase could not be determined. The access staircase seemed to descend from the south into the cellar but had been heavily truncated (Plate 42). Extensive remains of the stone-flagged floor survived and at the northern/front of the house, set against the wall was a brick and stone structure, which could quite possibly have been the 'cold-slab', if not, almost certainly a storage shelf (Plate 43).

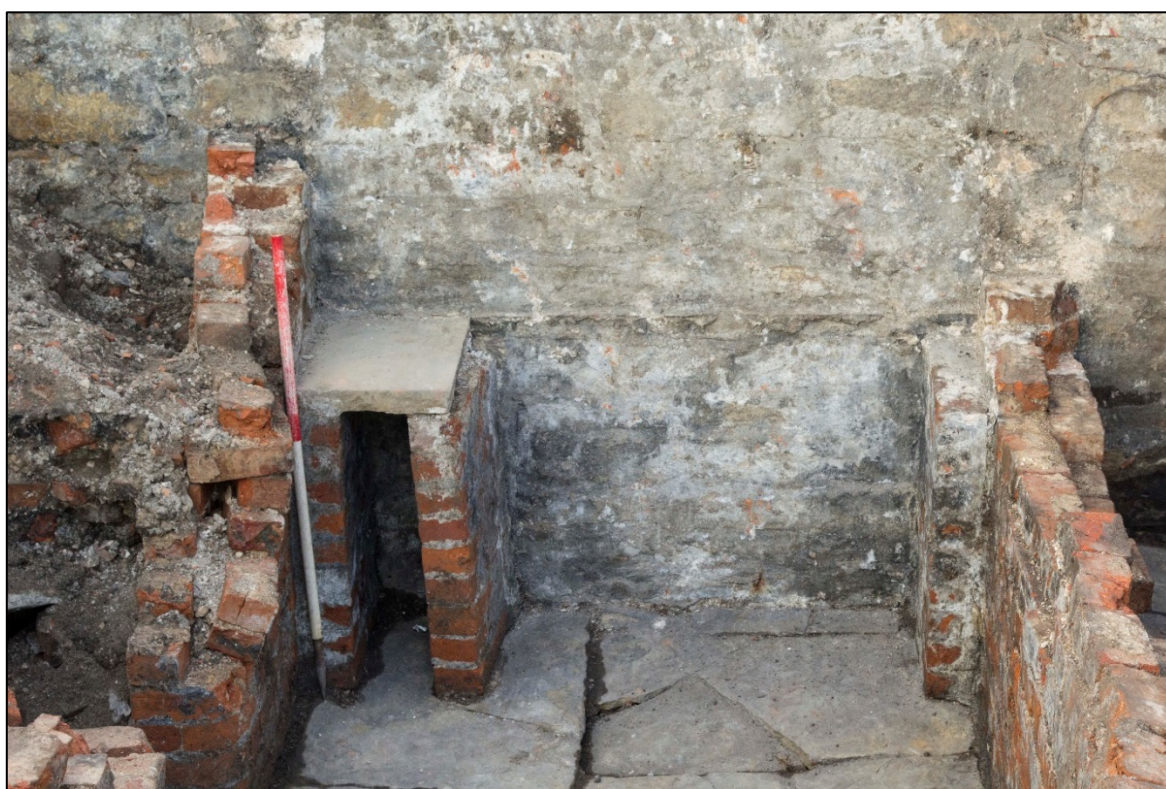
*Plate 43: The remains of a probable 'cold-slab' at the front of house 7, looking north*
