## Archaeological Excavation

Rochdale Riverside  
Phase 1, Rochdale,  
Greater Manchester

**Report No:** SA/2018/27

**Document Type:** Archaeological Excavation Report

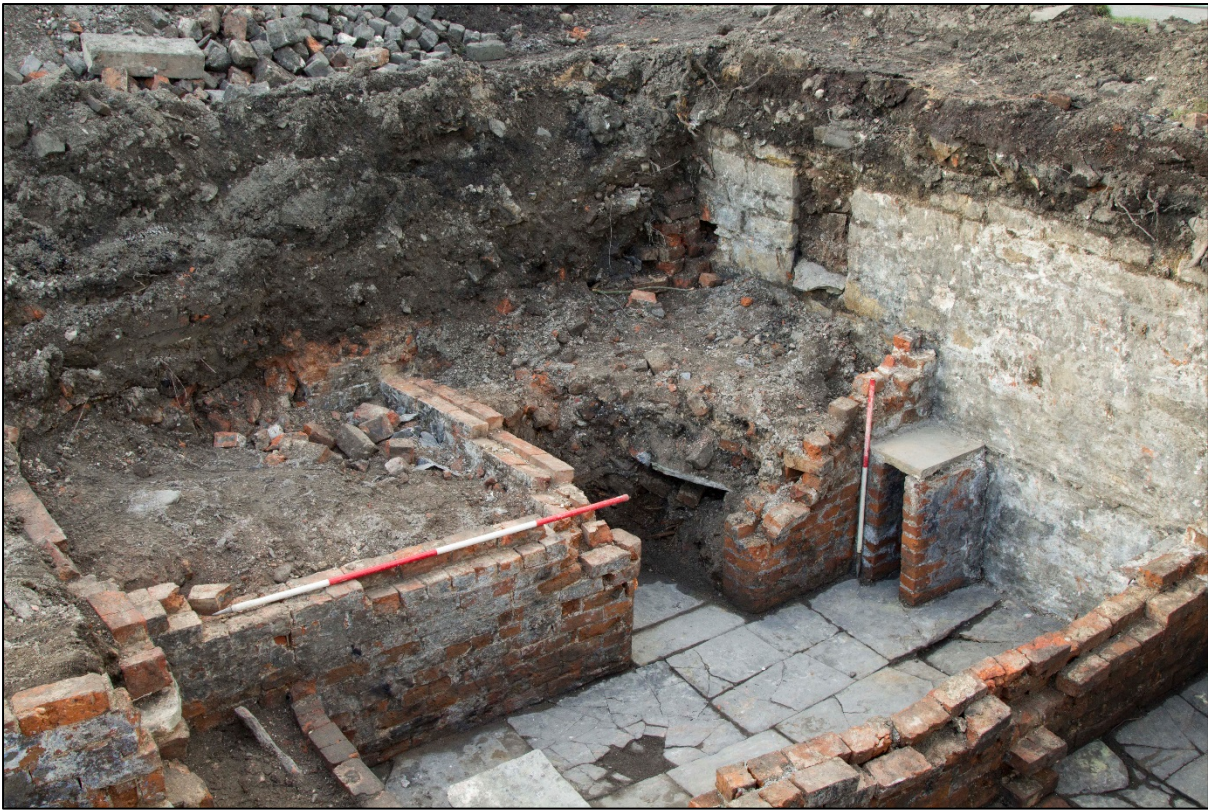
*Plate 44: Rooms within the cellar of house 7, looking north-west.*

To the west of the cold-slab a doorway comprising bull-nose bricks led into another room with a coal chute in the front wall. The walls comprised hand-made bricks, bonded with lime mortar, two brick-courses in width and survived to a height of 1m. The fill could not be completely cleared due to its proximity to the deep trench edge. To the south of this room was another room measuring 2.55m by 1.70m, again, with double-skin walls. The entrance to the room was not encountered. The walls survived to a height of 1m and the fill could not be safely removed. The front wall survived to a height of 2m (Plate 44).

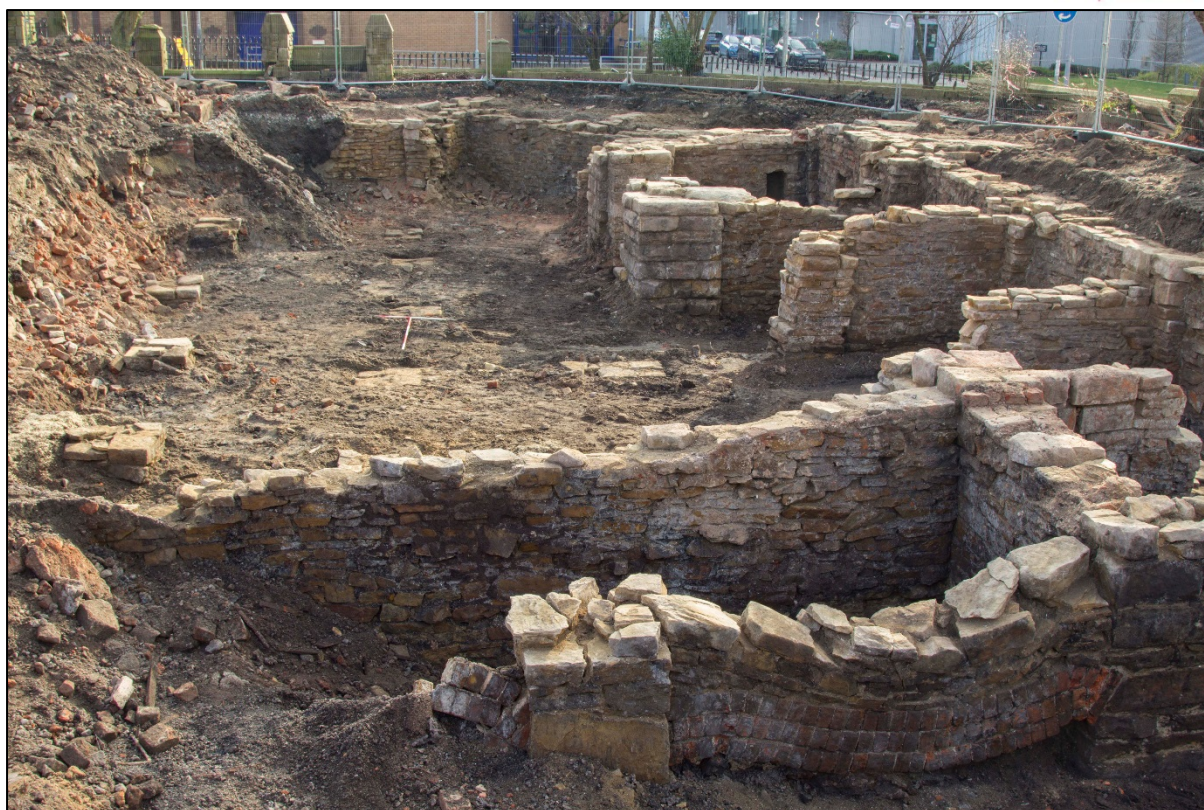
*Plate 45: Area 3, the Congregational Church fully excavated, looking south*

Area 3 lay to the south-west of areas 1 and 2 on the southern side of Kelsall Street, measuring approximately 32 m north/south by 20m east/west, and covering the full footprint of Milton Street Congregational Church (Plate 45; Figure 12). The eastern wall could not be excavated however, due to the depth of the excavation. The remains of a 20<sup>th</sup>-century building was encountered on the eastern side of the trench, suggesting that the remains of the church had been truncated. The church was aligned north/south. The entrance was not encountered within the excavation area but historical mapping suggests that it lay to the south. The basement floors had been removed during demolition.

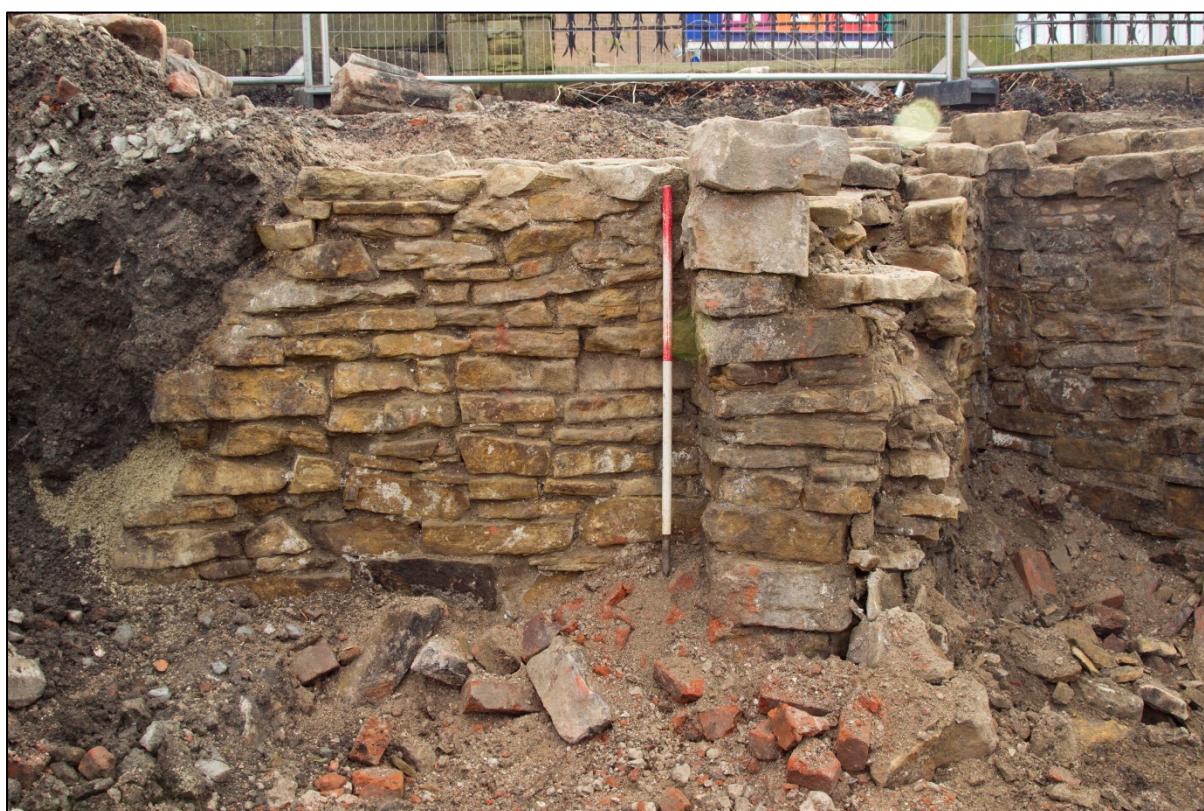
*Plate 46: Truncated wall at the southern tip of the church, looking south*

At the far southern end, the church wall had been truncated, possibly by services installed after the demolition of the church in the 1950's (Plate 46). The wall still survived to over 1m in height, measuring 1.70m east/west, with a small buttress extending to the north by 0.24m, 0.48m in width. The wall then returned south by 1.70m at the end of which, on the exterior of the wall, was a stone block/buttress base.

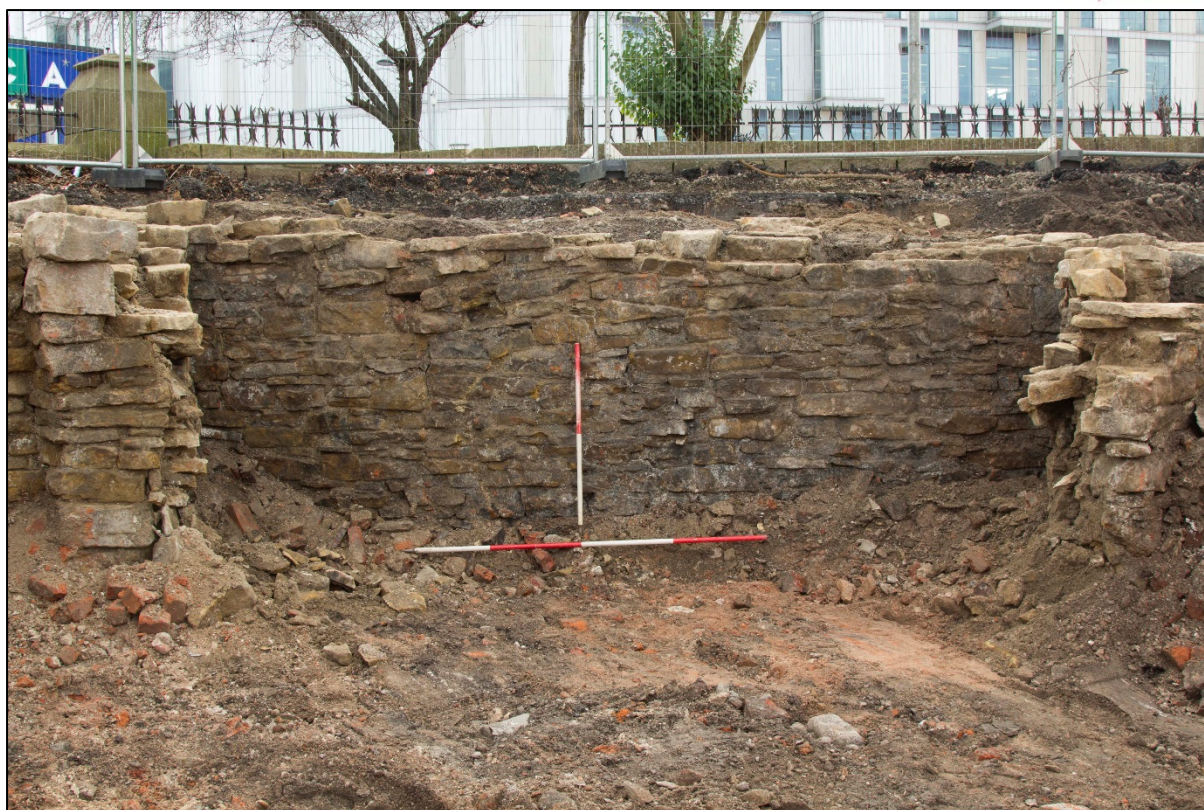
*Plate 47: Part of the south-western wall, looking south-west*

The southern end of the church was angular-apsidal so the wall then returned to the north-west by 4.83m, 0.44m wide, surviving to a height of 1.80m, with two stone buttresses on the exterior and an interior wall protruding into the church by 2m (Plate 47). This wall formed the southern wall of a triangular bay *I*, with an entrance 1.46m wide (Plate 48). It was not possible to remove the fill from this room. The northern room of bay *I* was shared with bay *2*, measuring 2.20m on the southern side and approximately 3.40m on the southern side or 3.39m in total with a width of 0.55m. A chamfered block on the top of the end of the wall provided evidence of vaulting (Plate 49). A chute (approximately 0.36m wide) passed vertically through this wall and exited into bay *2*. The eastern end of the wall measured 1.20m, stepped back/west by 0.16m then north by 0.72m where it formed the side of a doorway (width 1.07m) into bay *2*. There were small internal buttresses in each corner of the room measuring 0.17m by 0.17m on average. A further chute led into this room through the western wall. The northern wall of bay *2* was shared with bay *3*, surviving to a height of 2m, measuring 3.39m in length, 0.55m in width at the narrowest point, widening out at the eastern end to 1.94m, where it formed the other side of the doorway into bay *2*.

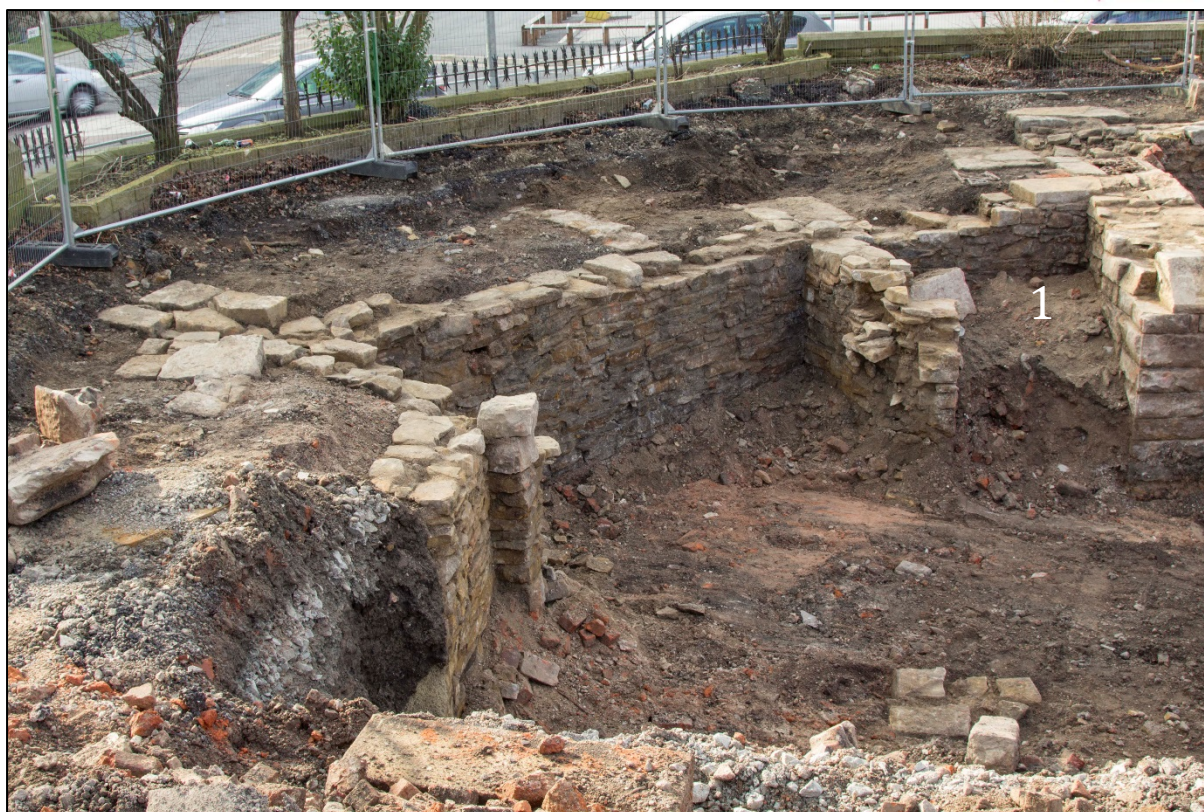
*Plate 48: The south-west corner showing bay 1, looking west*

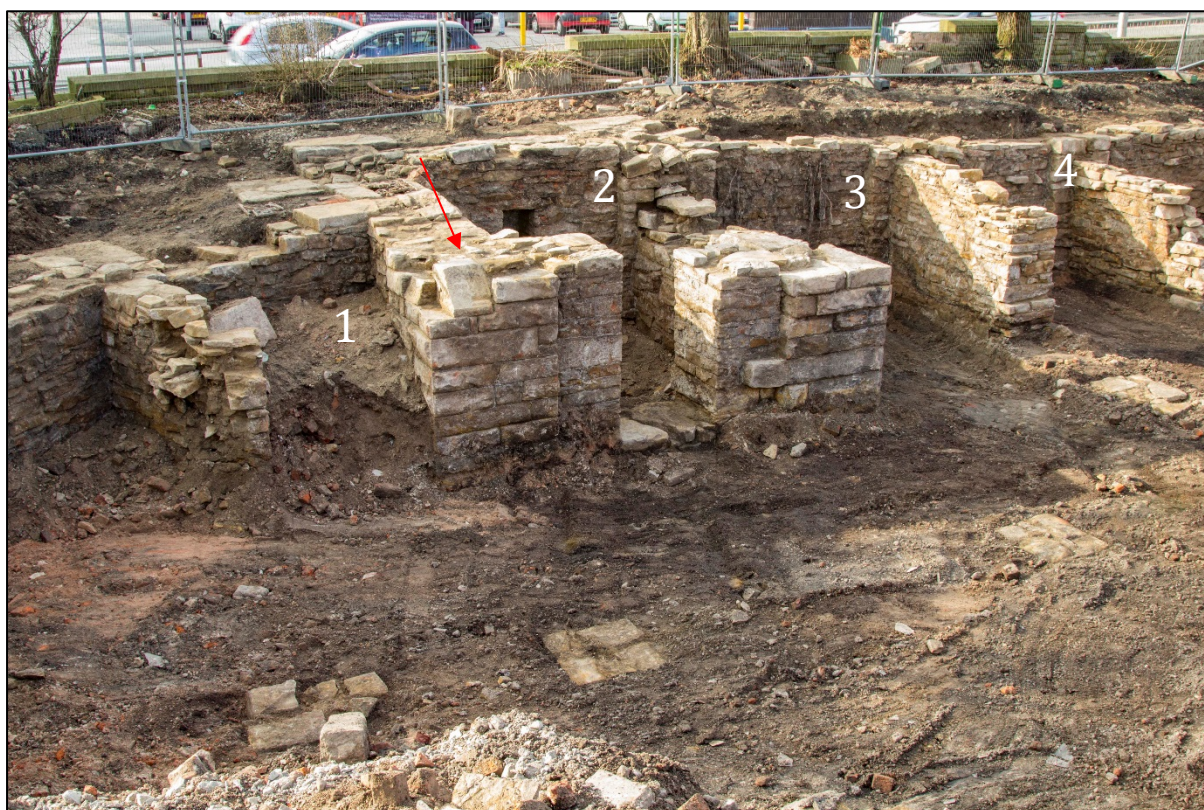
*Plate 49: The western wall showing the first four bays from south to north. The red arrow shows a chamfered block indicating vaulting, looking west*

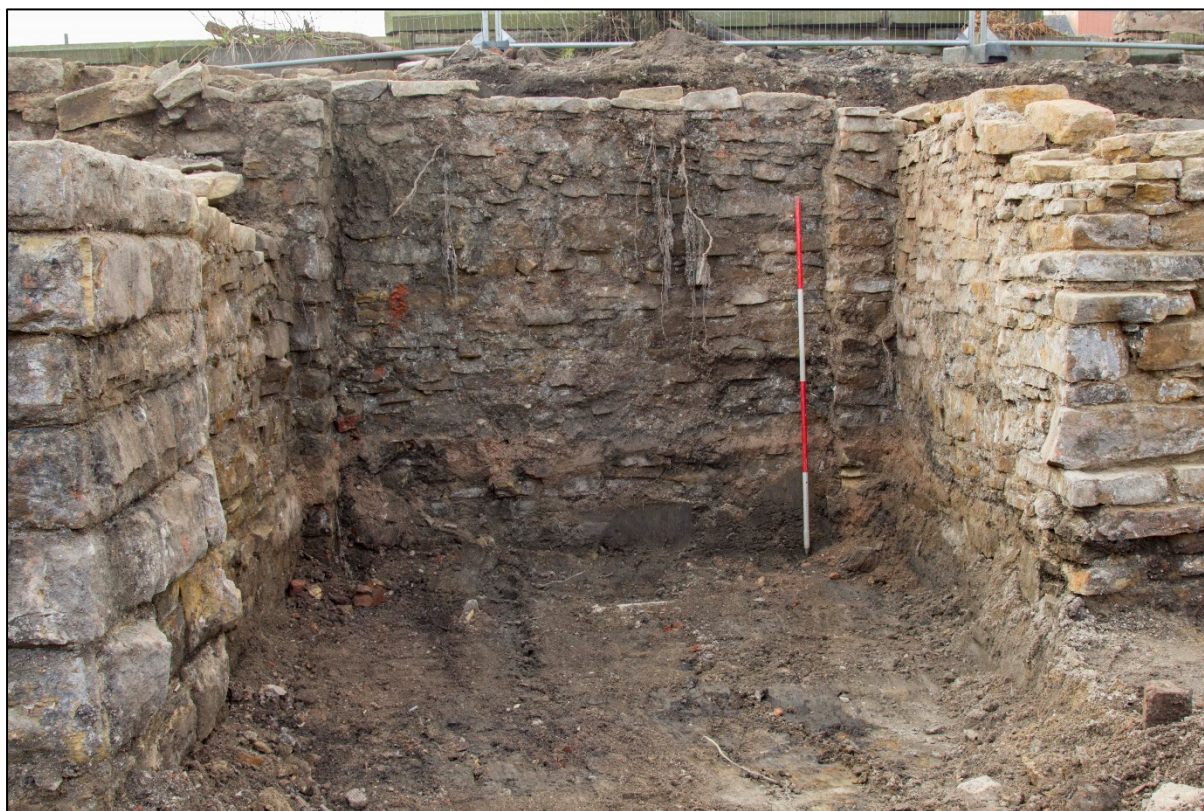
*Plate 50: Bay 3 on the interior of the western wall of the church, looking west*

Bay 3 lay to the north of bay 2 and did not have a doorway (Plate 50). The bay measured 3.02m north/south and at this point the western wall survived to a height of 2.5m. The two corners had small buttresses measuring 0.15m by 0.48m (southern corner) and 0.22m by 0.48m (northern corner).

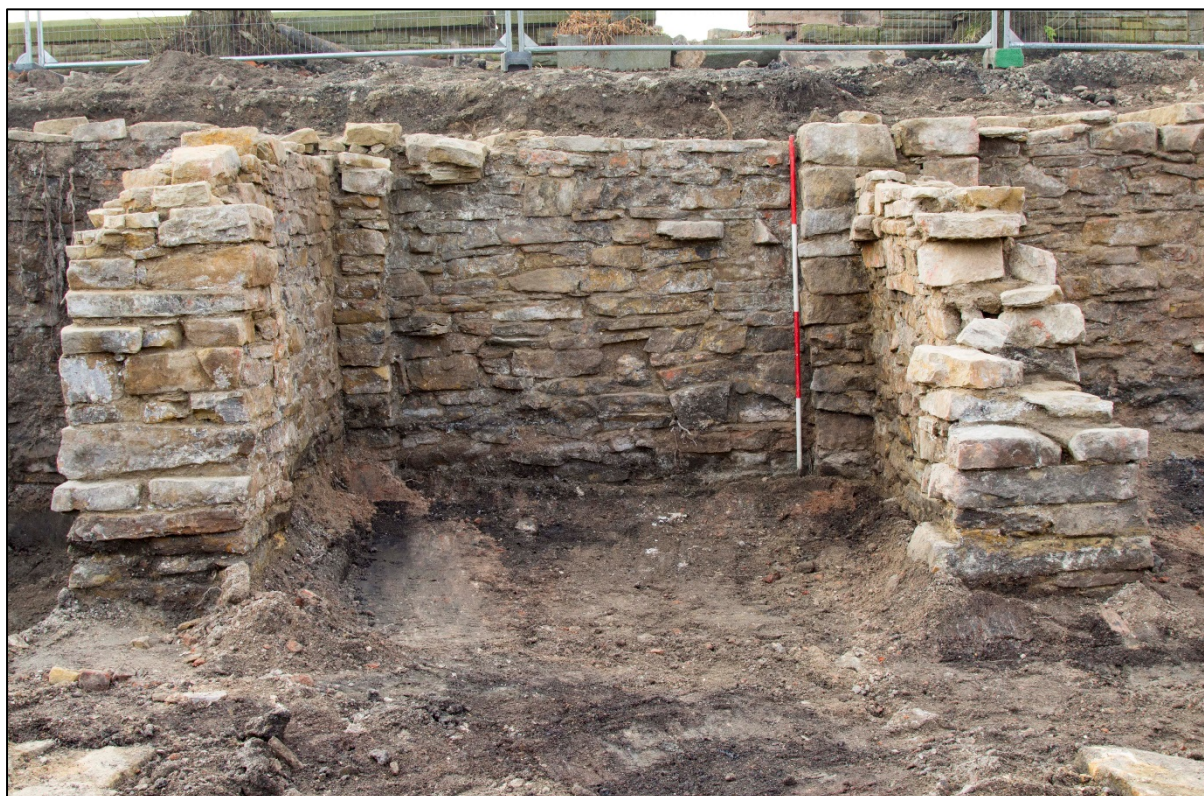
*Plate 51: Bay 4 on the interior of the western wall of the church, looking west*

Bay 4 shared its southern wall with bay 3 measuring 2.92m north/south (Plate 51). The northern wall survived to a maximum height of 1.5m, measuring 4.10m in length and 0.50m in width, widening out to 0.75m at the eastern end. There were buttresses in both corners measuring 0.27m by 0.25m.

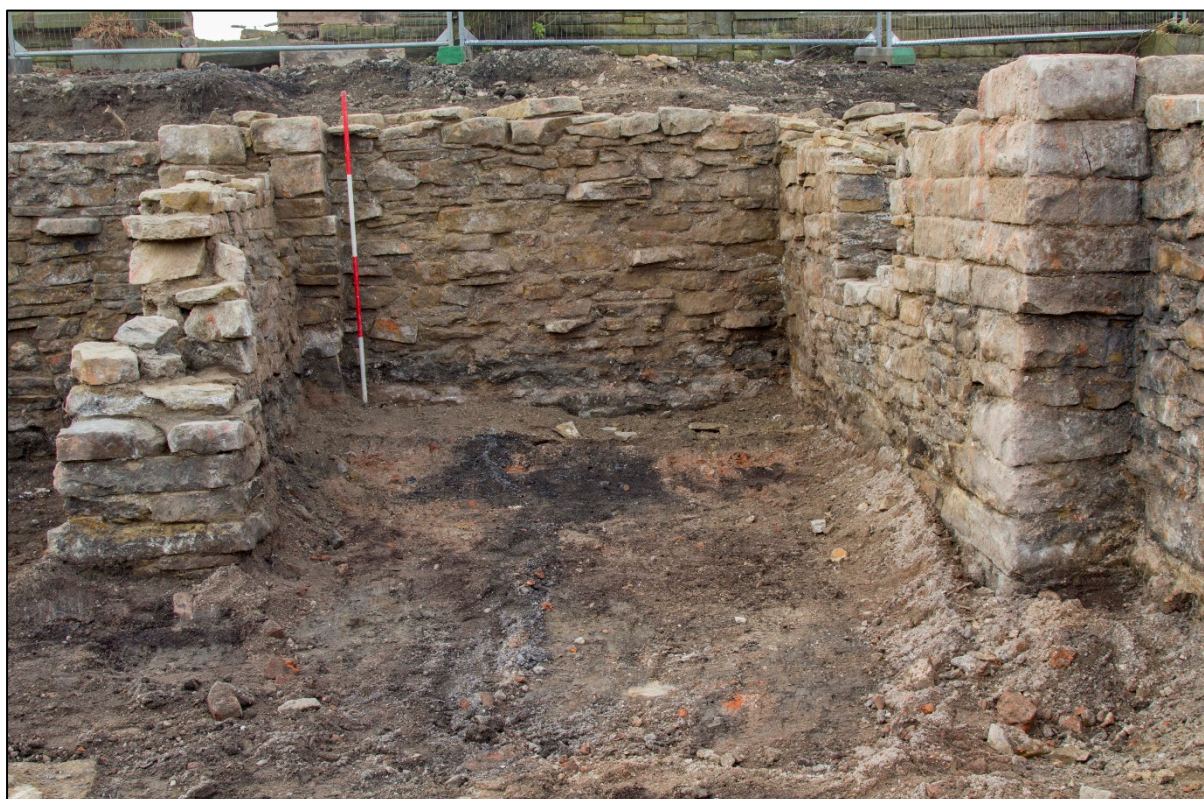
*Plate 52: Bay 5 formed the last of the open bays along the western wall of the church, looking west*

Bay 5 formed the last of the open bays along the western wall of the church, measuring 3.02m north/south, the northern and western walls surviving to a height of 2.5m (Plate 52). A buttress in the southern corner measured 0.26m by 0.22m. The northern wall measured 3.95m east/west where it stepped north by 0.45m into what appeared to be a separate and narrower wall. There was an aperture in this part of the wall, 0.62m wide, resembling a window (Plate 53). This part of the wall returned north to form bay 6, a room with no obvious access to it, measuring 1.65m north/south by 3.42m east/west. It is possible that this room once had a wooden staircase for access.

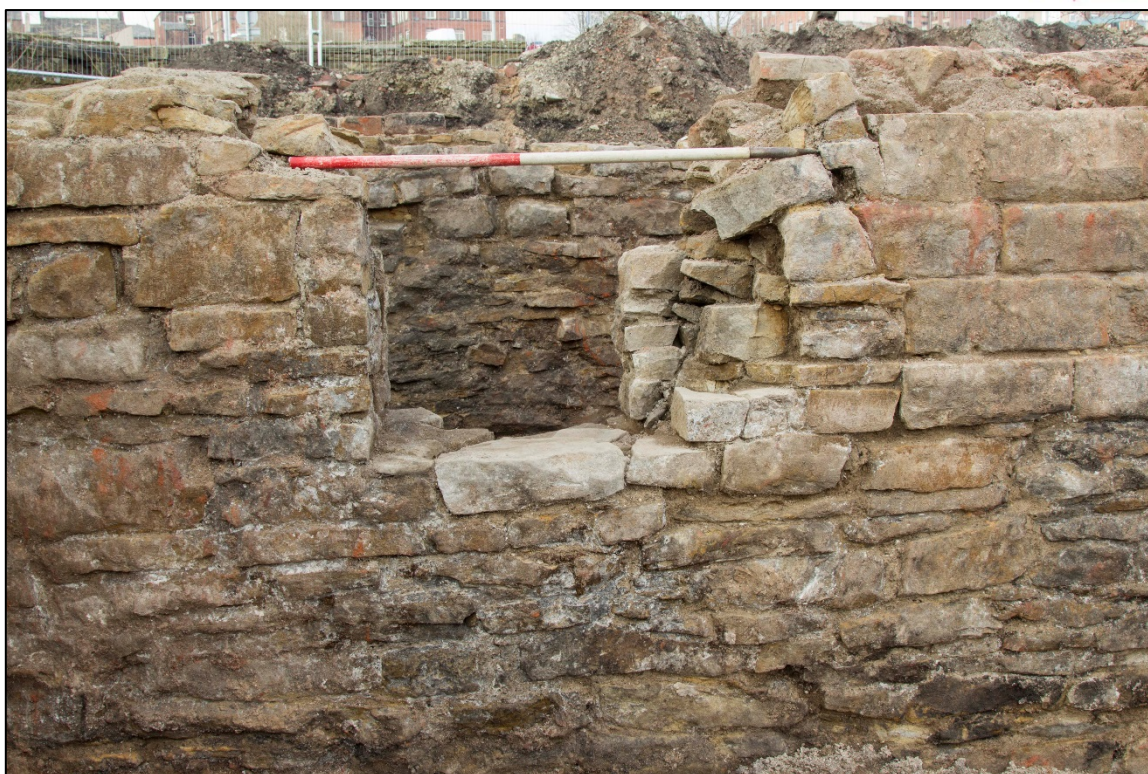
*Plate 53: Aperture on the southern wall of bay 6, looking north*

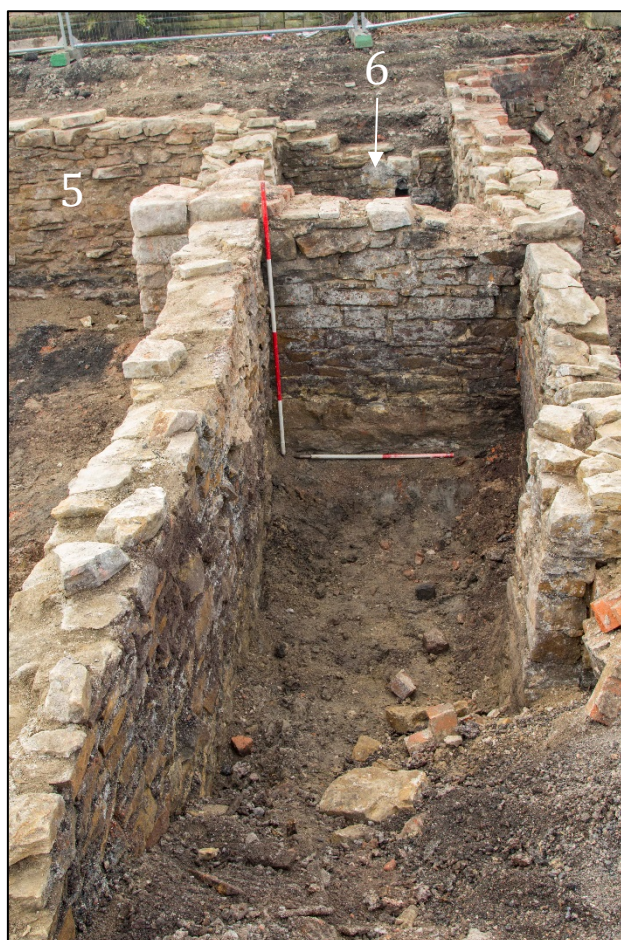
*Plate 54: Bay 6 at the northern end of the church, looking west*

Closing off the church at the northern end was a stone wall reaching from bay 6 to the west across the trench to the east, where it had been truncated by a modern man-hole. This wall was excavated to a length of 6.10m east/west, survived to a maximum height of 1.75m, 0.48m wide. The wall was keyed into the eastern wall of bay 6 but was a later addition (Plates 54 and 55).

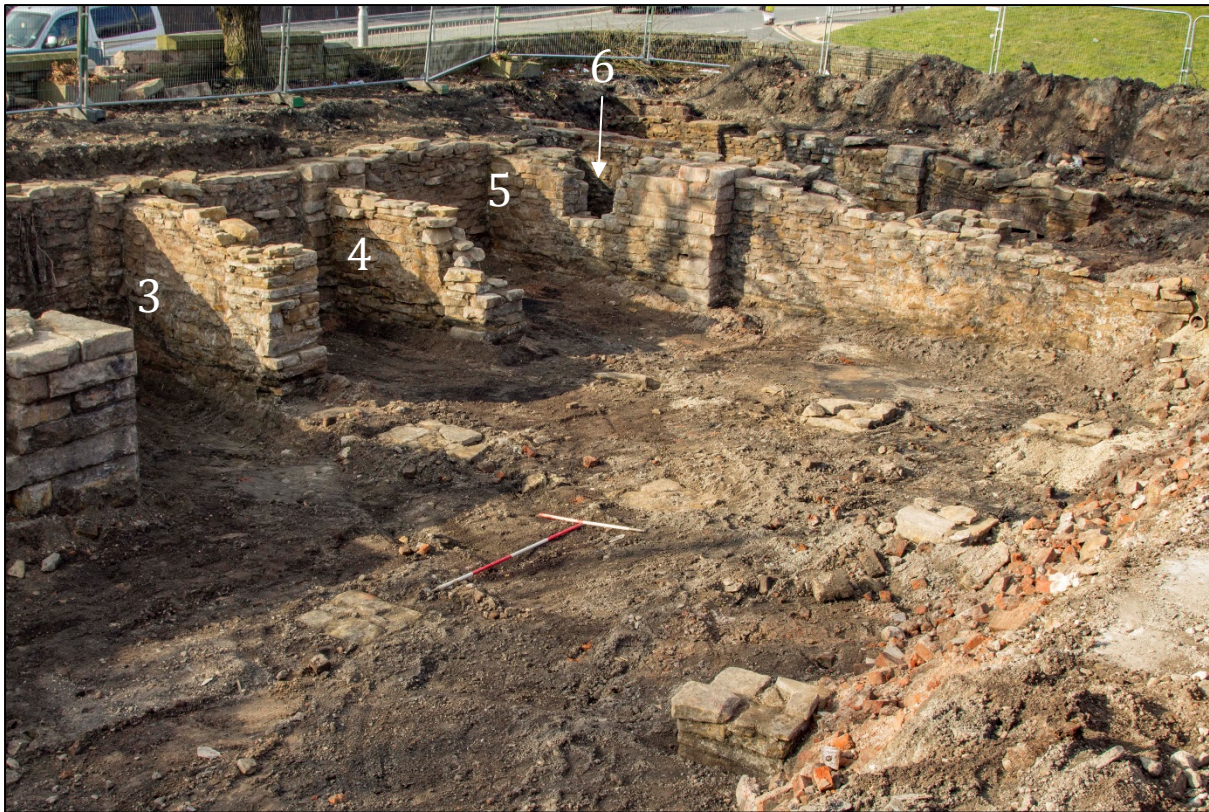
*Plate 55: Bays 3 -6 in the north-west corner of the church, looking north-west*

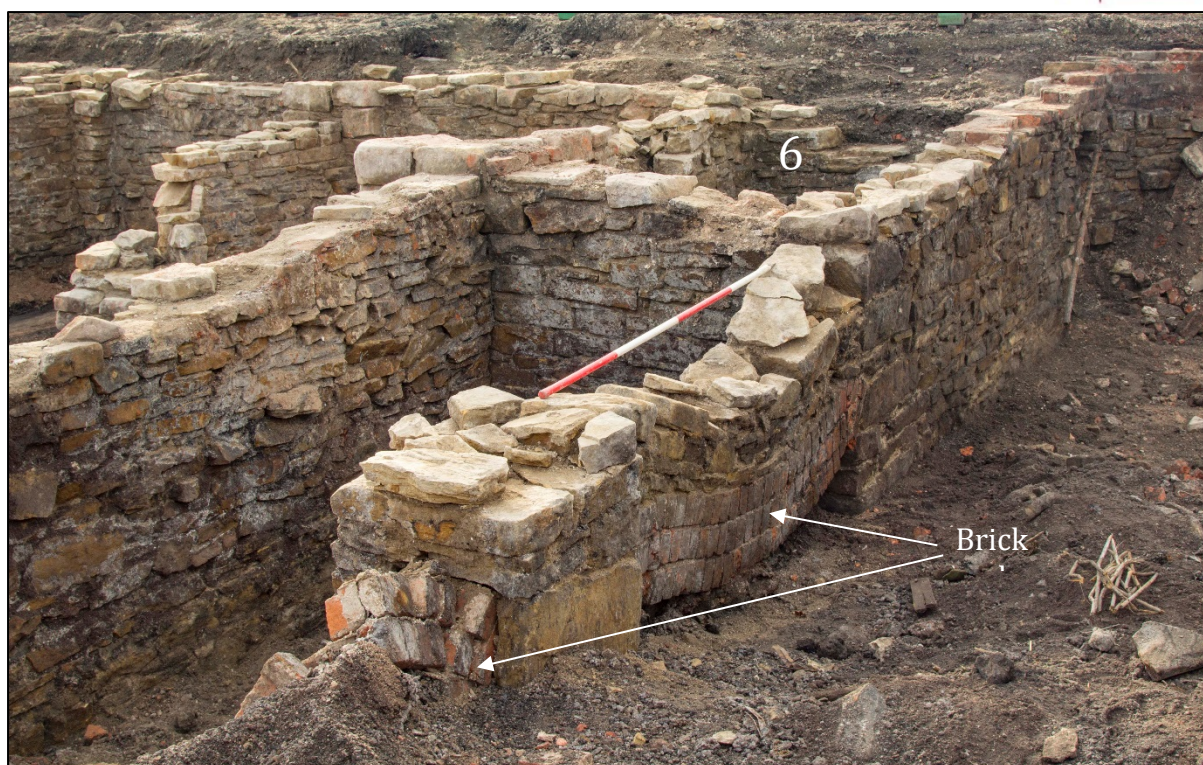
*Plate 56: Wall at the corner of bay 6 comprising a slumped brick arch, looking south-west*

Beyond the northern wall was an area that appeared to be a later addition, possibly for a boiler. The area was only partially excavated as it was found to contain possible insulation materials, and was backfilled. A second east/west wall, running parallel to the first, started at the corner of bay 6 and was excavated to a length of approximately 6.5m measuring 0.38m in width and an excavated height of 1.50m. Low down in the wall was a collapsed arch comprising three rows of bricks, which had slumped under the weight of the wall above it. The arch measured approximately 2.5m in length constructed using hand-made bricks bonded with lime mortar (Plates 56 and 57). At the eastern end of the brick arch was a stone pillar with the remains of another brick arch similar to the first, which collapsed during excavation, the remains can be seen in Plate 56. Another slumped arch was found in the wall to the north at the far northern end of the trench measuring approximately 2.20m in length (Plates 58 and 59). The wall itself measured 4.50m and stopped at the eastern end of the trench. Voids visible within the fill on the northern side of the wall suggest that this was not the northern extent of the chapel, and that the northern exterior was beyond the trench.

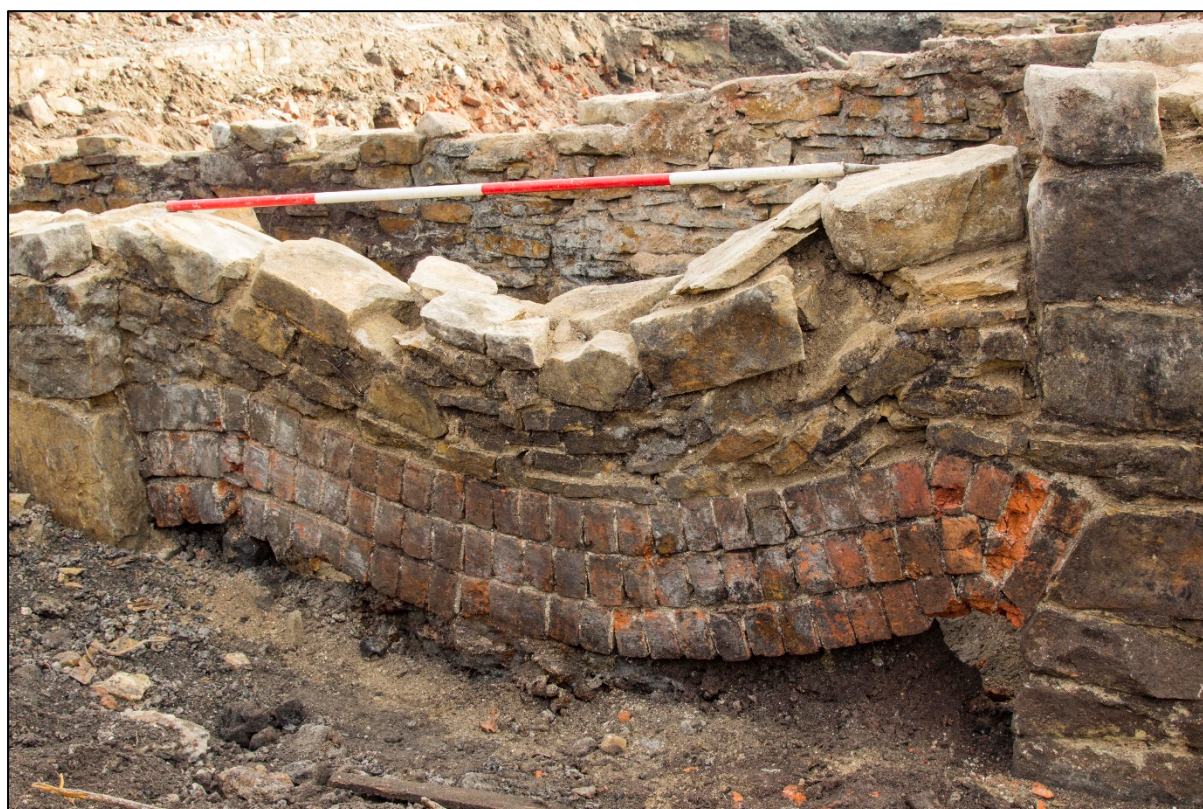
*Plate 57: Slumped brick arch at the northern end of the church, looking north-north-west*

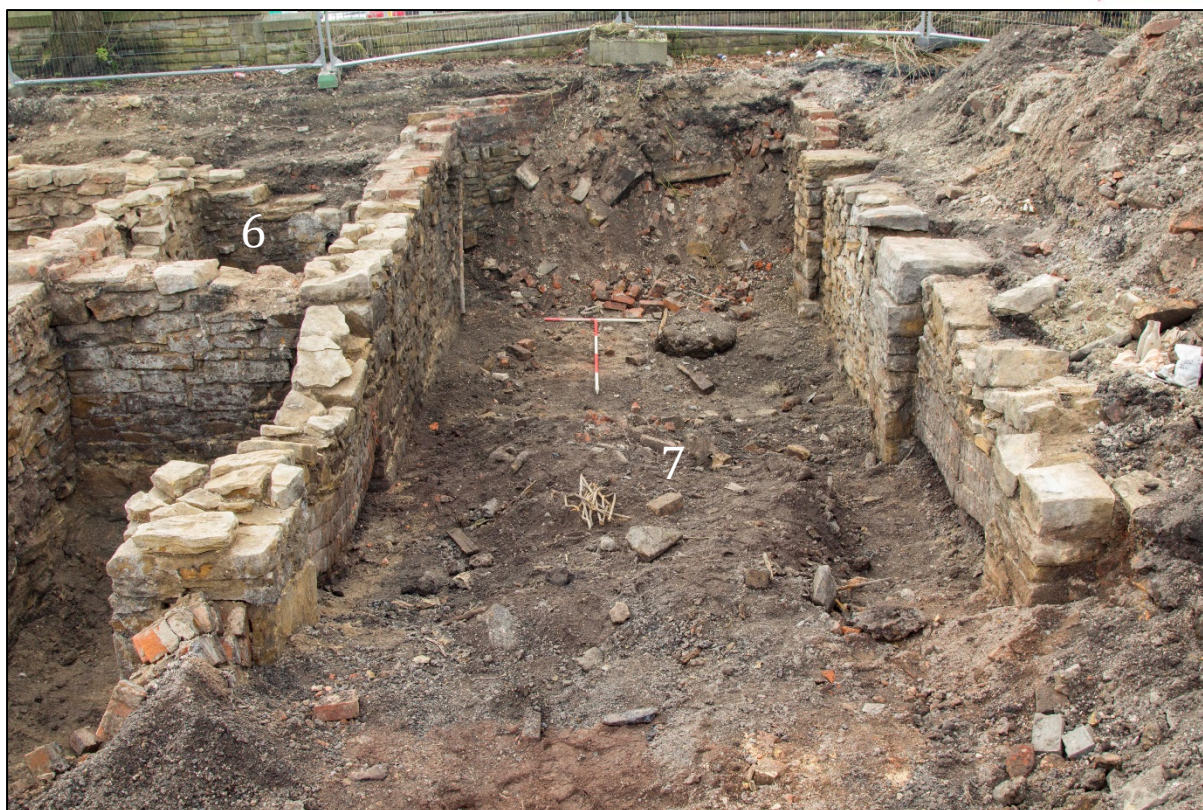
*Plate 58: Wall at the furthest north of the trench comprising brick arches, looking west*

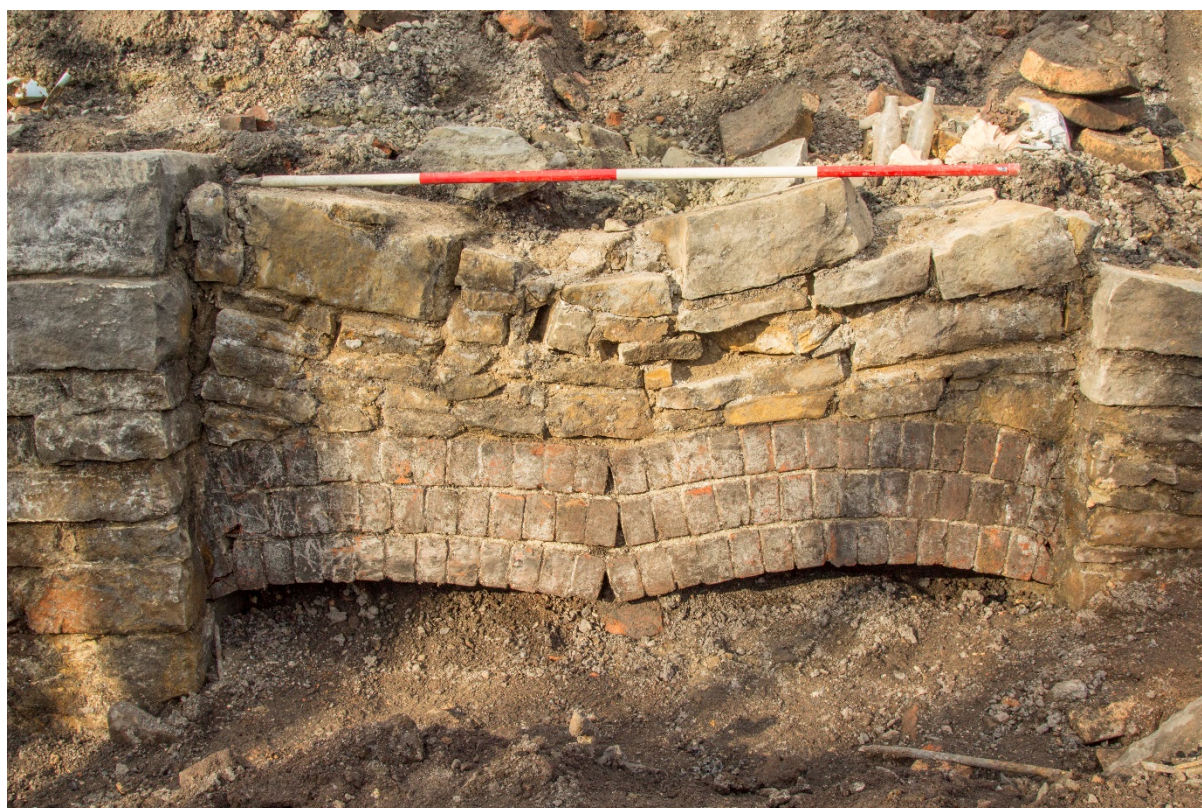
*Plate 59: Slumped brick arch in the wall furthest north of the trench, looking north*

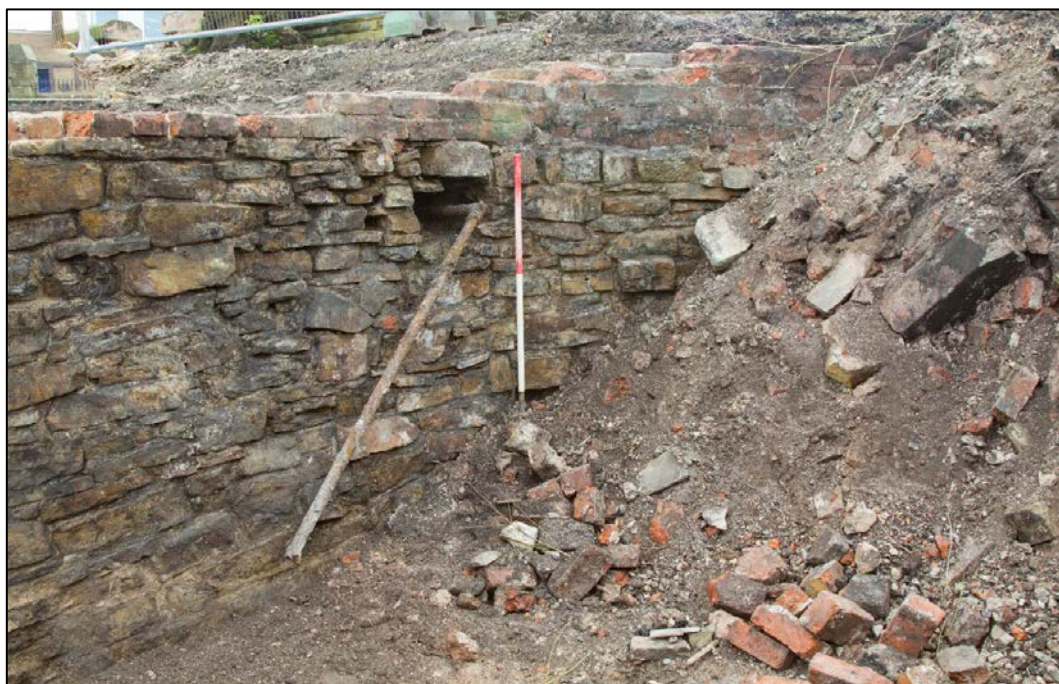
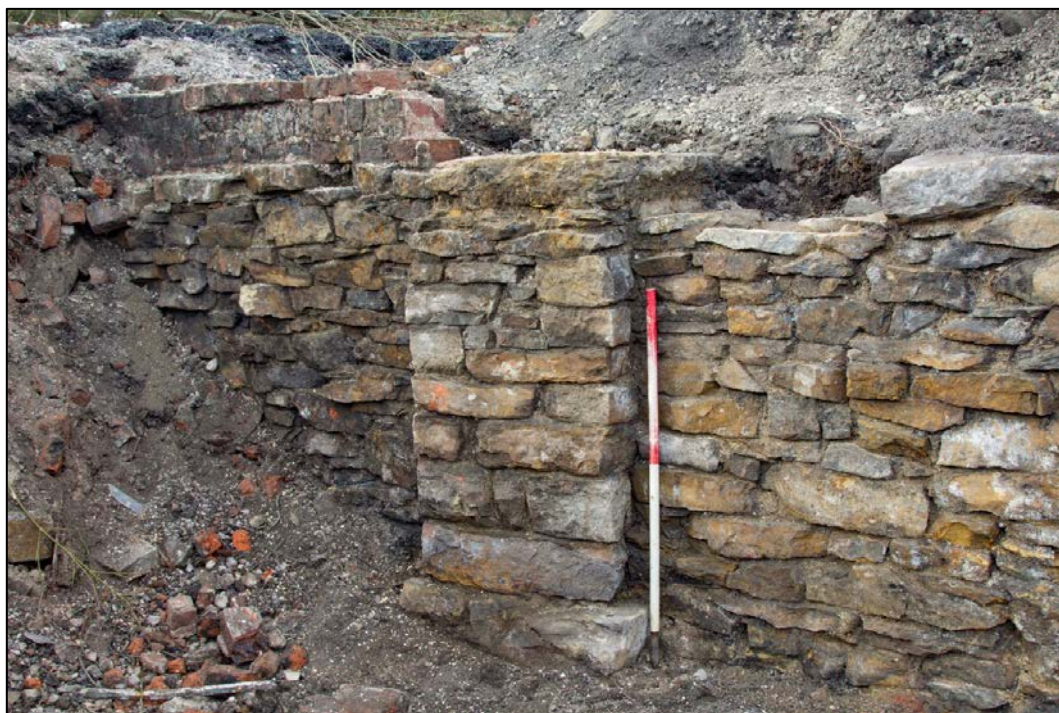
*Plate 60: Southern interior of the apsidal shaped building at the north-west corner of the church, looking south-west*

*Plate 61: Northern part of the apsidal building showing brickwork on top of the stone foundation, looking north-west*

At the western end of the two parallel walls were the remains of brick walls 7, also running parallel, 3.58m apart. These lay at the northern end of the trench and had been built on top of the stone foundation. This was part of a later addition of a more modern form of heating (Plates 60 and 61).

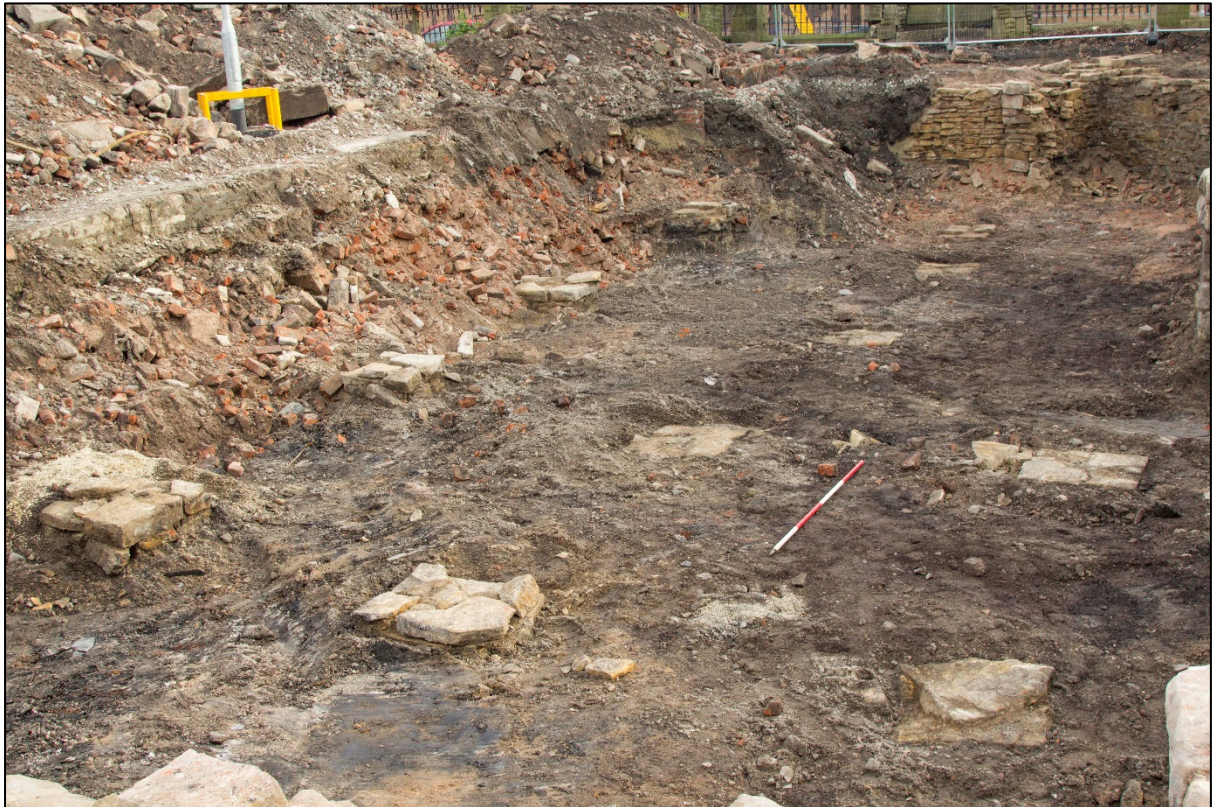
*Plate 62: The layout of the eleven column bases found in the centre of the church, looking south*
