## Archaeological Excavation

Rochdale Riverside  
Phase 1, Rochdale,  
Greater Manchester

**Report No:** SA/2018/27

**Document Type:** Archaeological Excavation Report

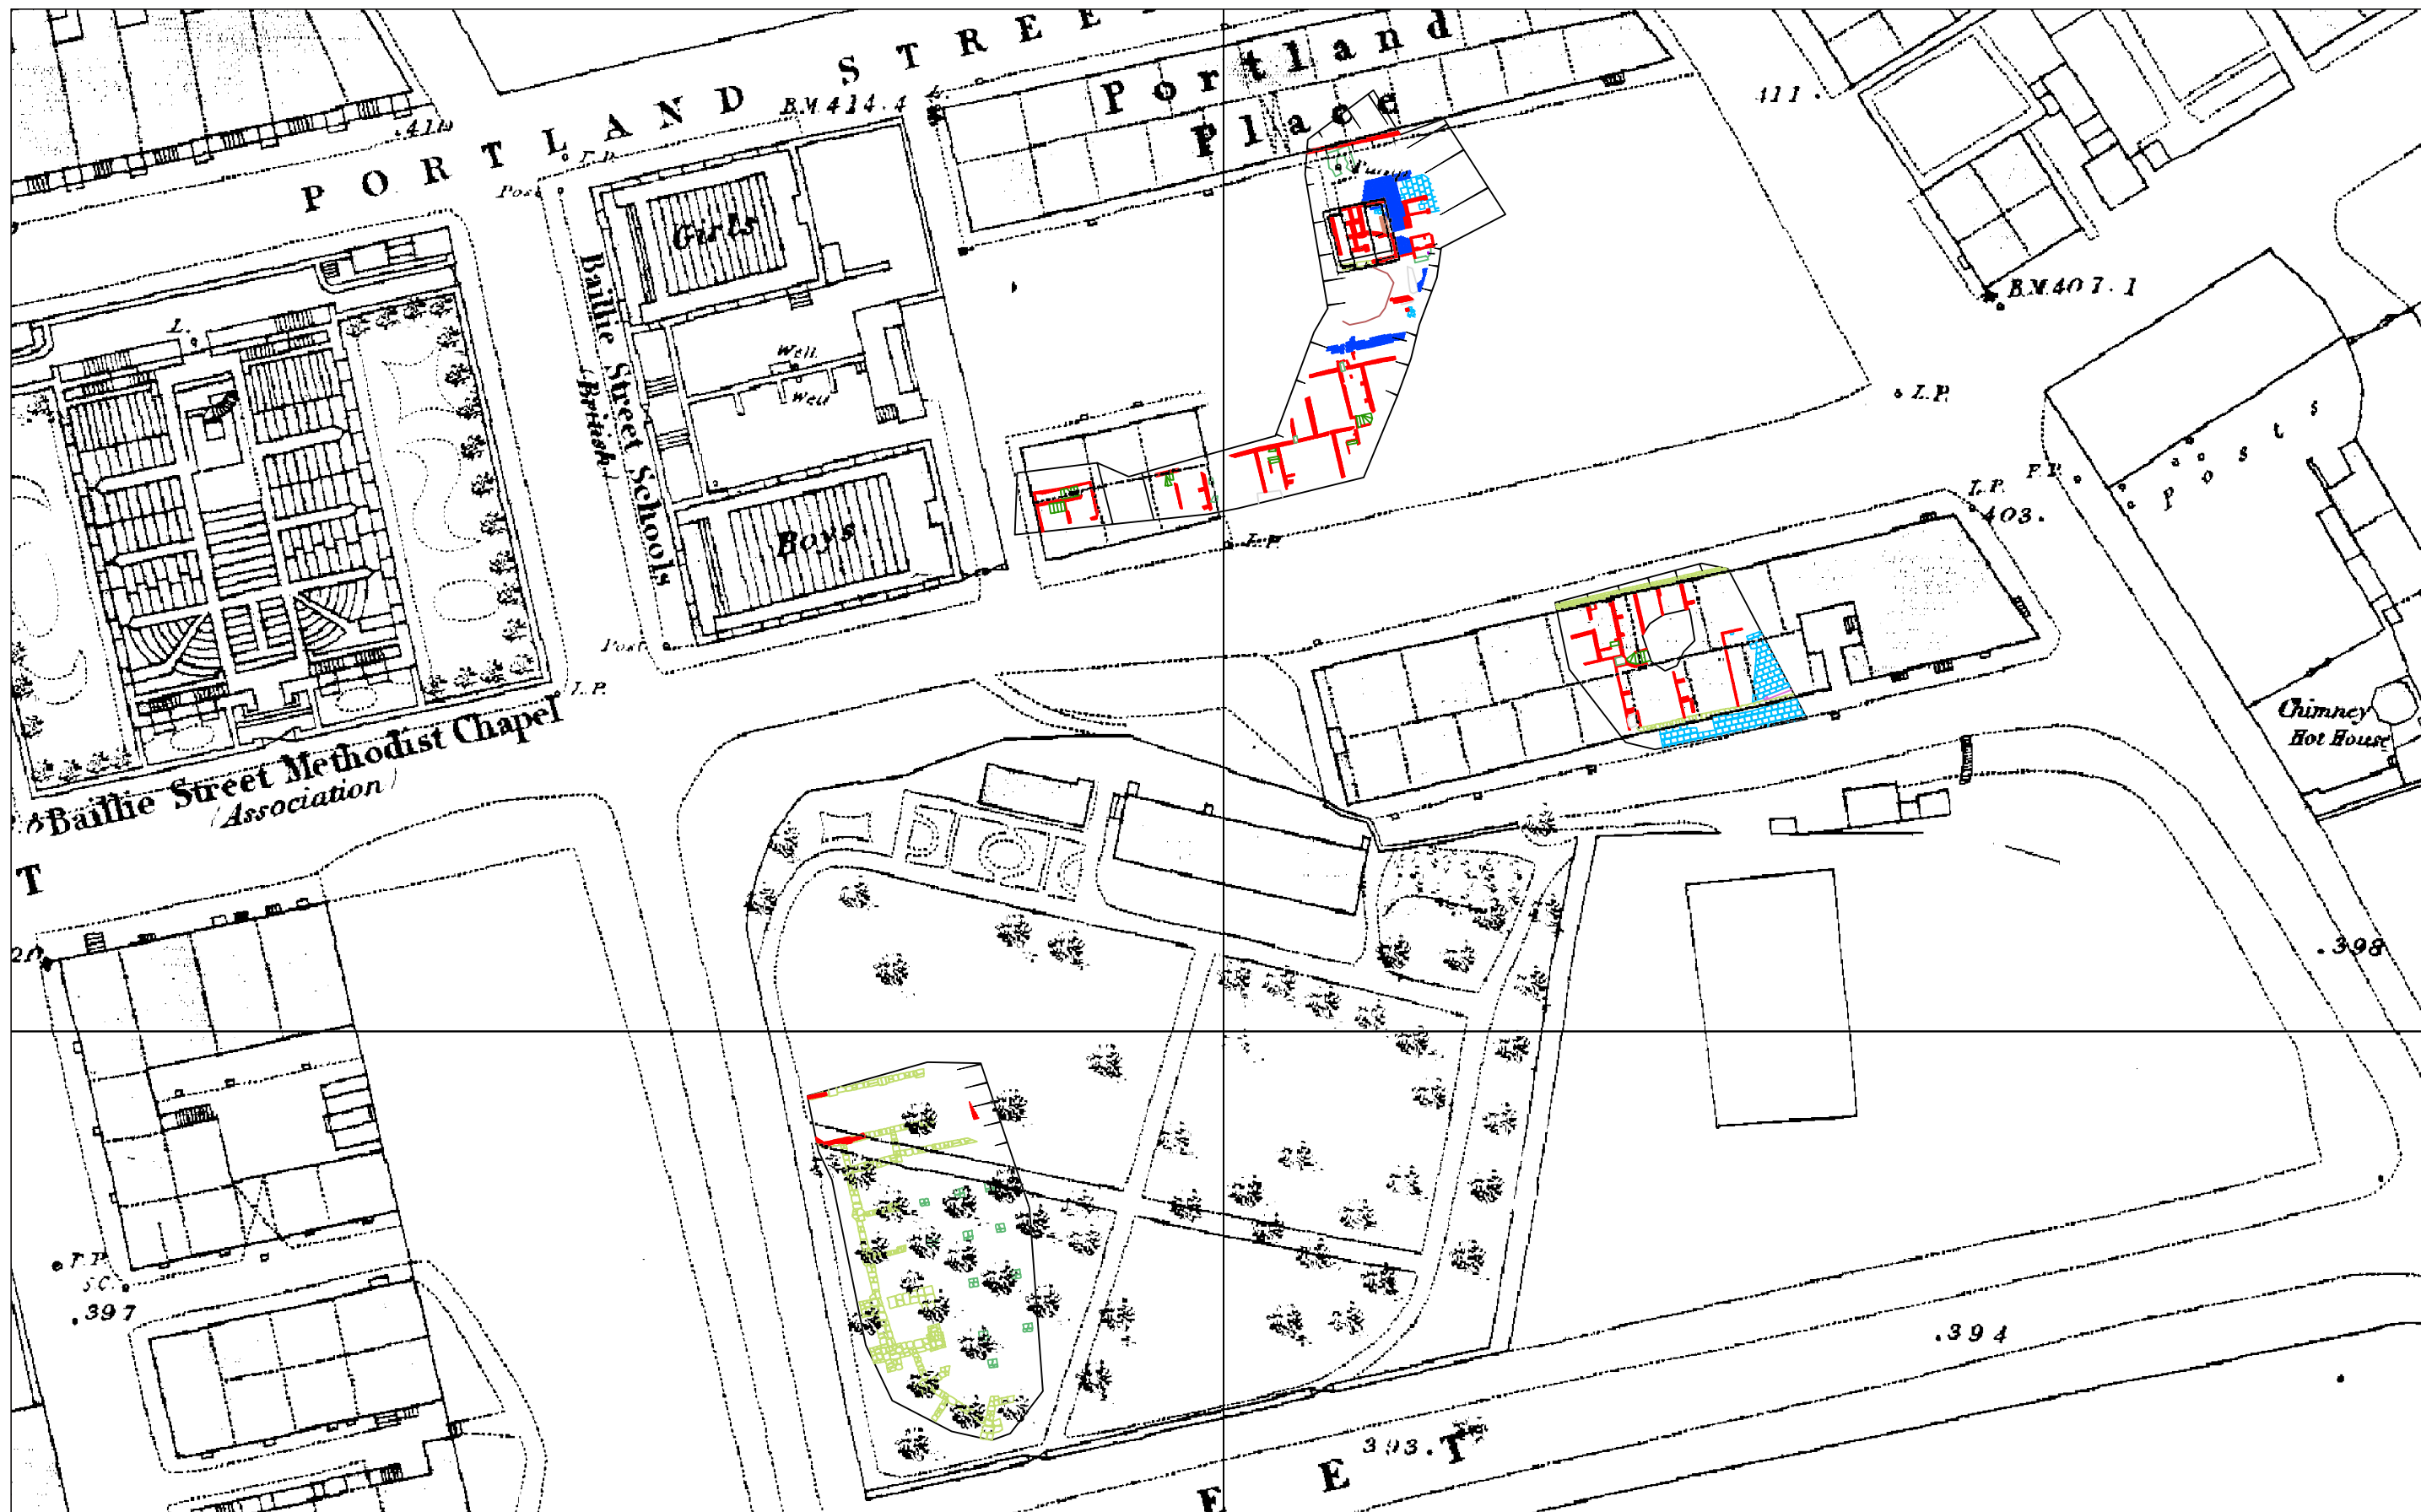
Figure 13:  
Excavation Plans Superimposed onto 1851 OS 1:1056 Town Plan

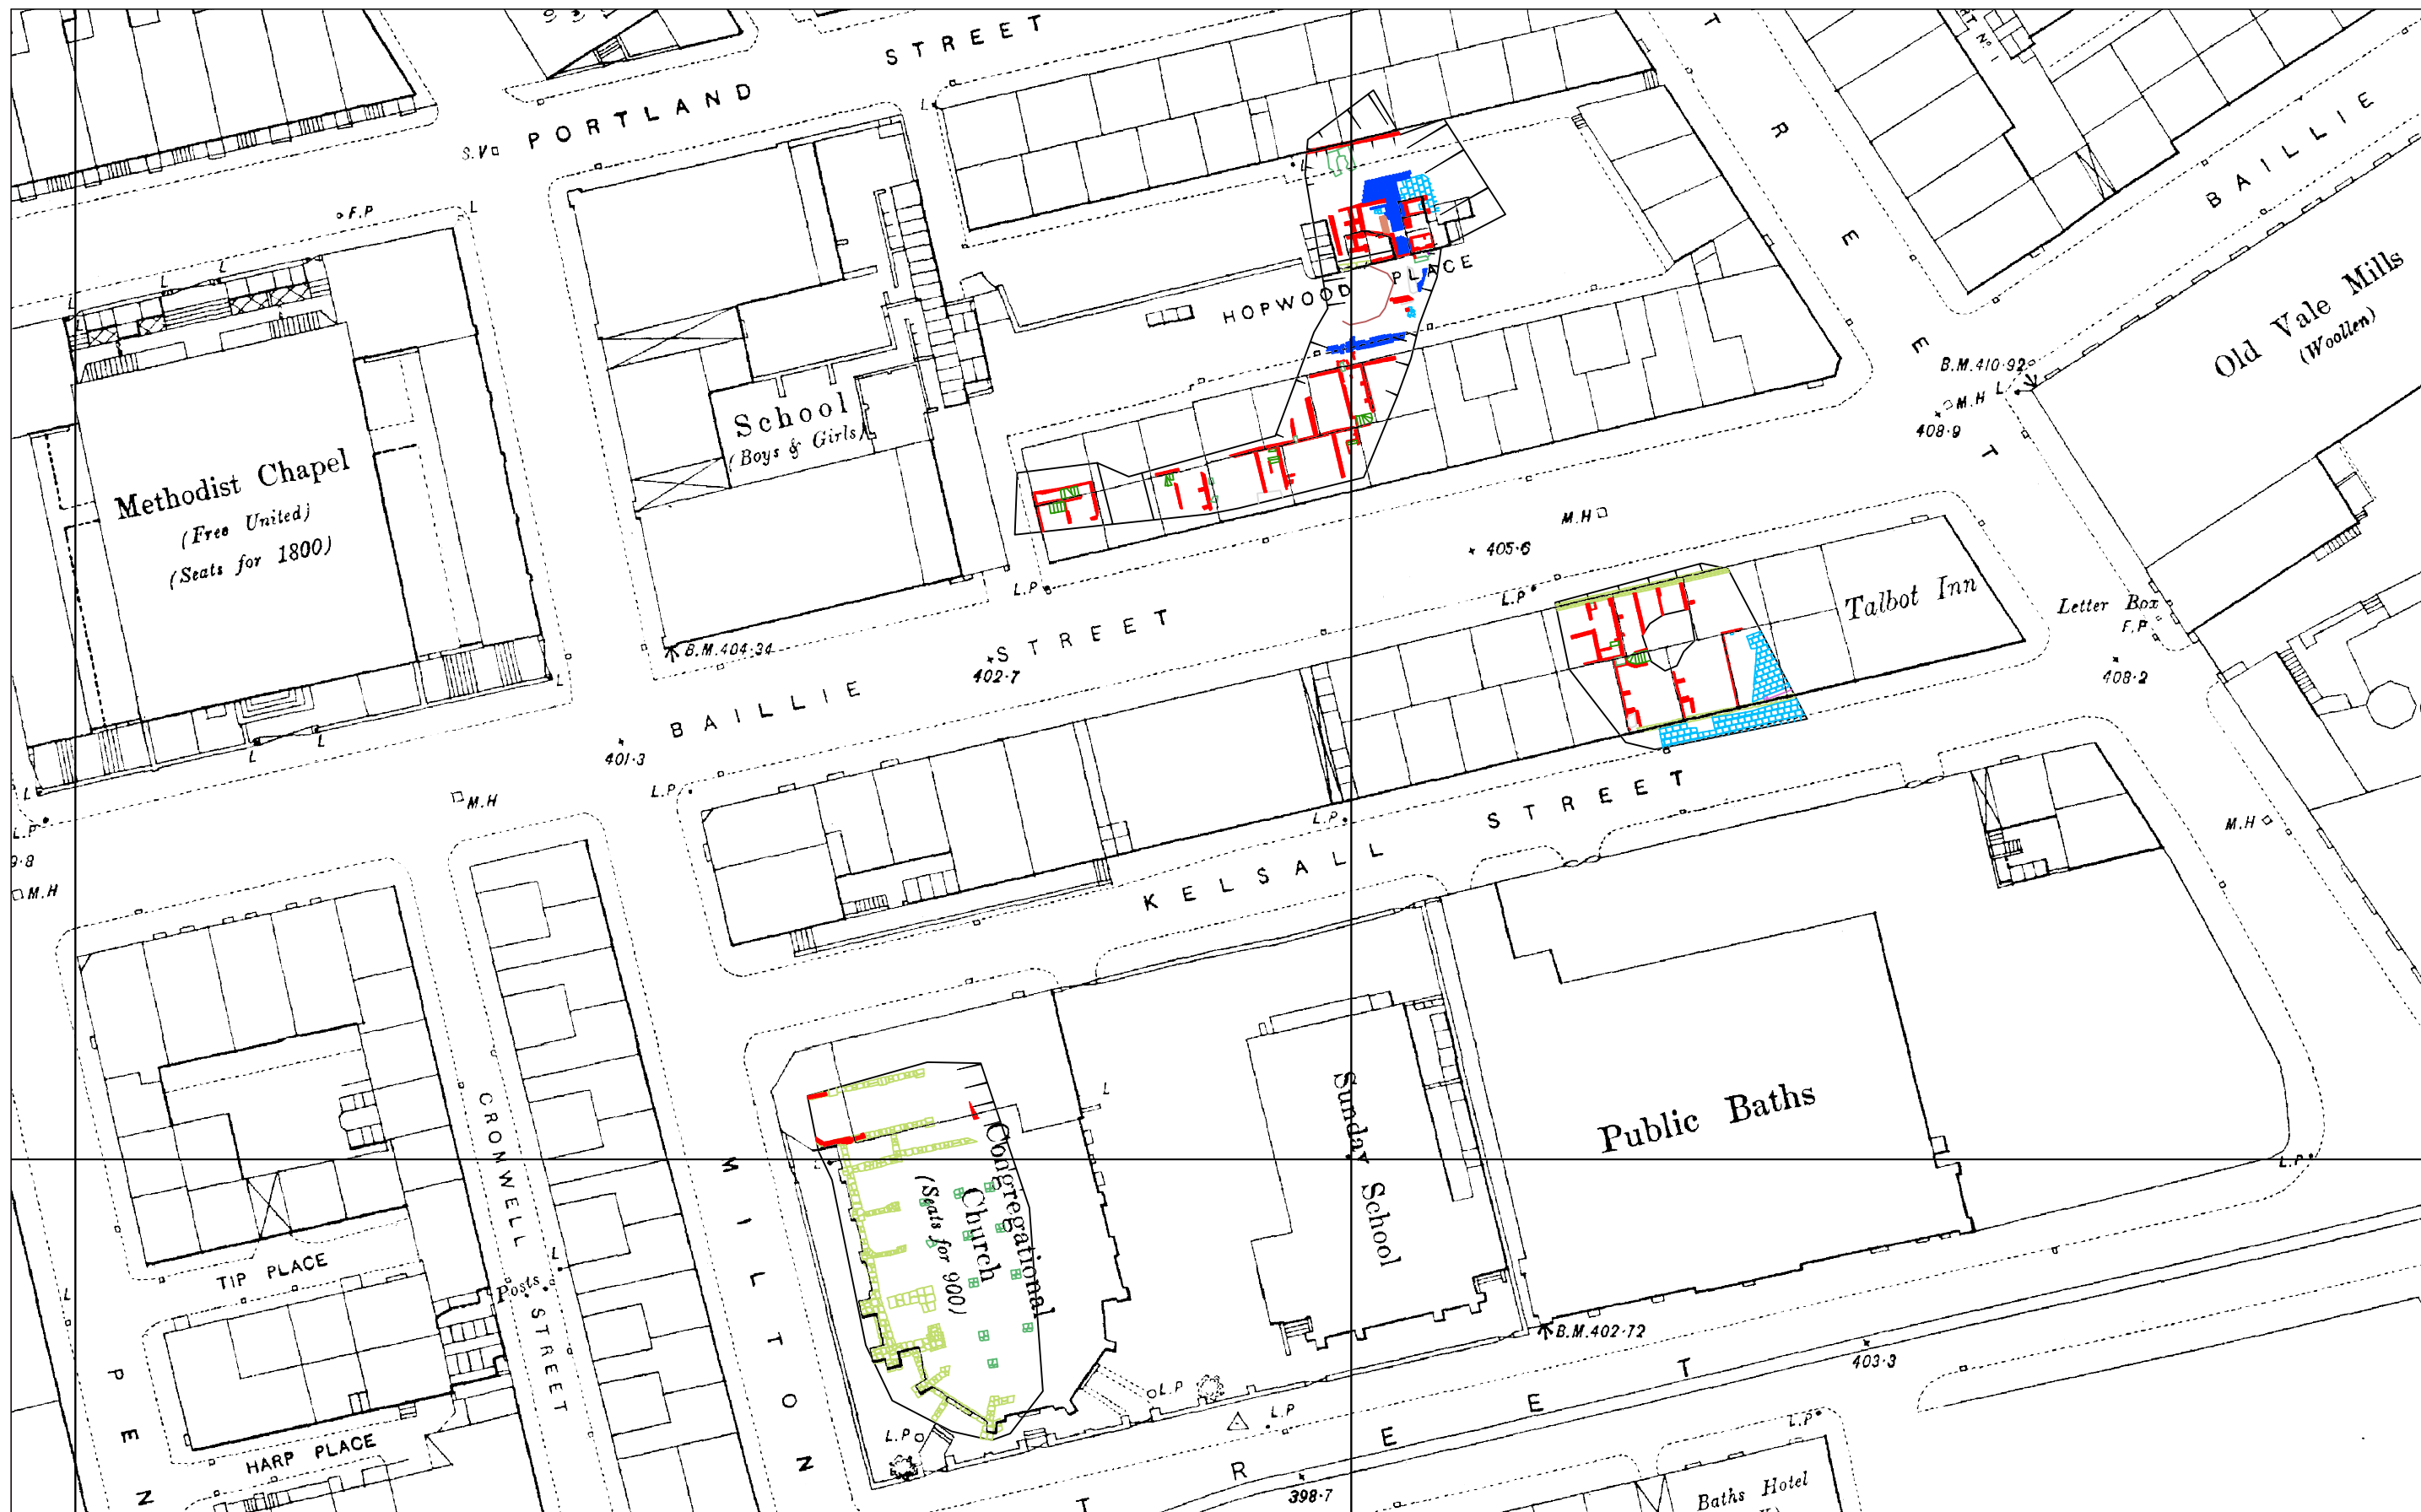
Figure 14:  
Excavation Plans Superimposed onto 1892 OS 1:1500 Town Plan
