Historic Building Investigation

Black Friar Public House,
Blackfriars Road,
Salford

Report No:
SA/2017/55

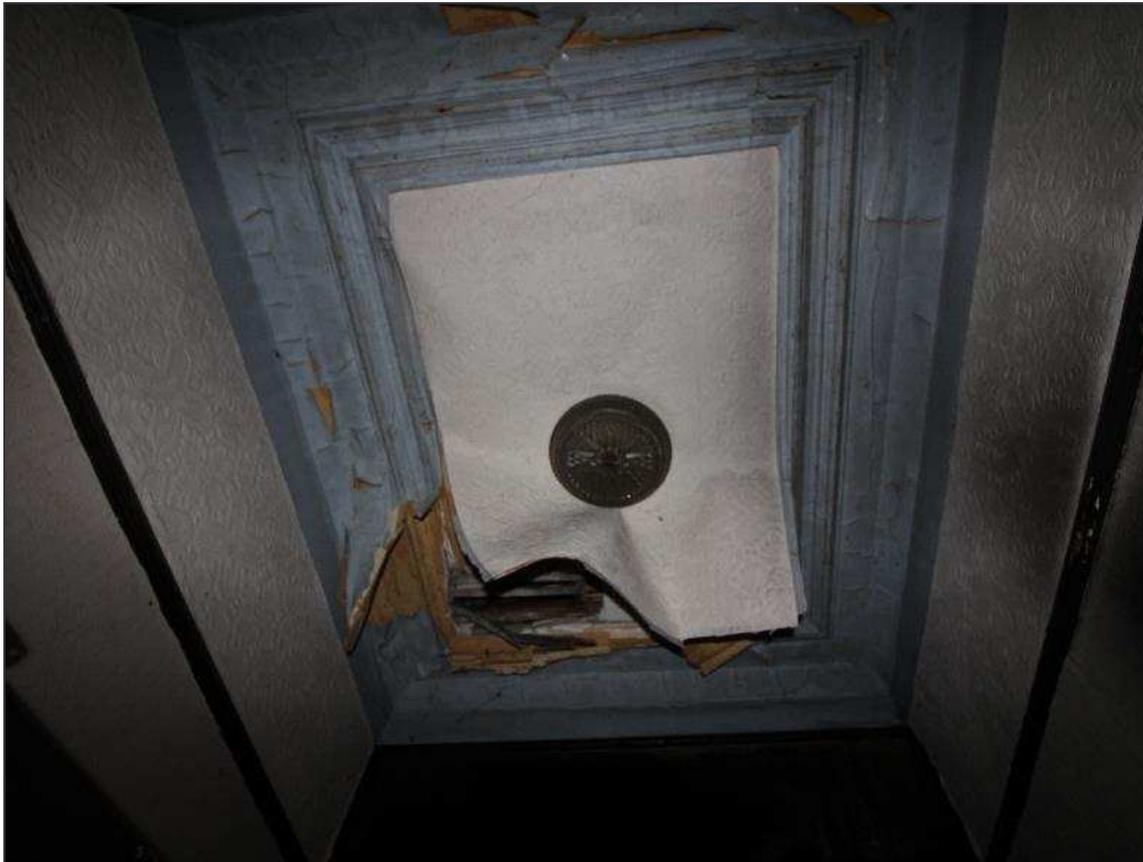
Plate 34: The ceiling of the main entrance, detailing the ceiling rose

The southern wall mainly contains a second door that leads into the central area of the pub. This door is similar to that in the eastern doorway, comprising a two-panelled lower half and a frosted glass pane above the lock rail. It has a swirl motif below the text 'BLACKFRIARS', both of which have been etched into the frosting of the glass. The floor of the hallway is tiled with white and brown square tiles, encompassed by a border of rectangular-shaped brown tiles (Plate 33). The ceiling is covered using a white painted flowery design wallpaper. The edges had timber gothic design timber cornices that had been previously been painted blue. A glass ceiling rose has been used as a cover for a light, which would have given light into the entrance hallway (Plate 34).

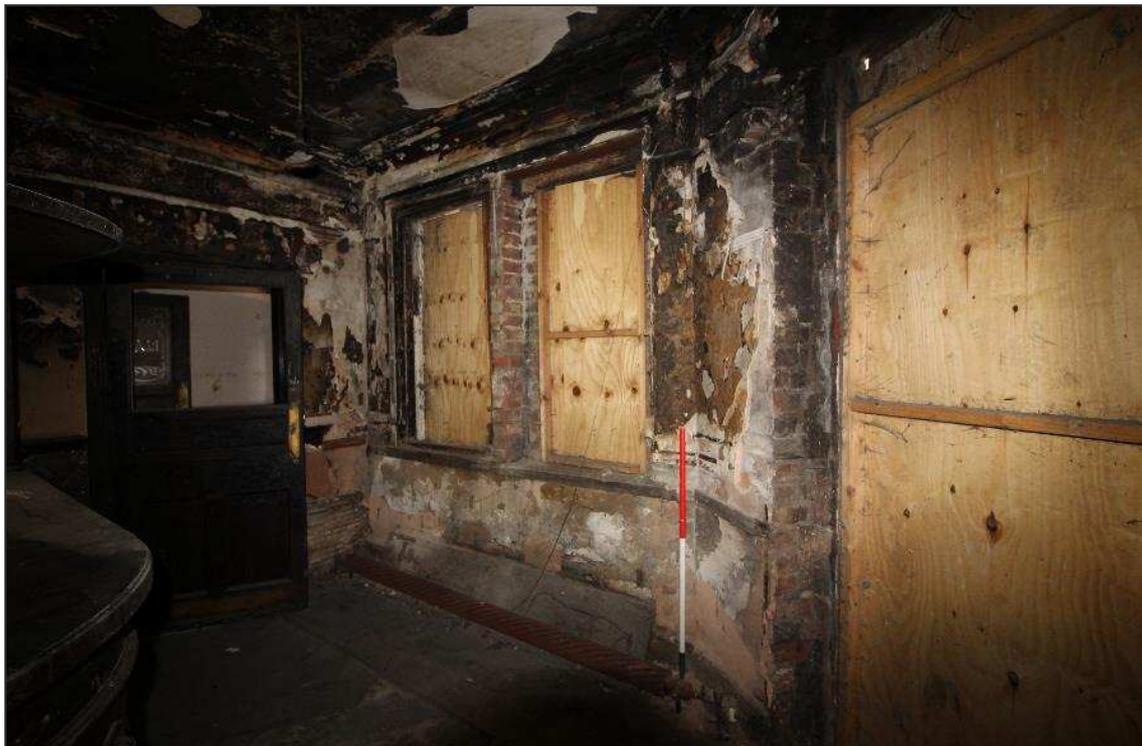
Plate 35: The northern wall of the main bar area

The main bar area has been split into four separate areas. The main area is accessed through the eastern and southern internal doors of the entrance hallway. The northern wall is dominated with two windows. These are both rectangular in shape with timber frames inside sandstone reveals. The frames have been badly fire damaged, but the remains of a moulded timber-header casing survive. A 2” timber baton had been inserted into the wall below the windows and has been used as their internal sills. Above and below the windows the wall has been rendered in plaster, which has been directly applied to the inner face of the external wall (Plate 35).

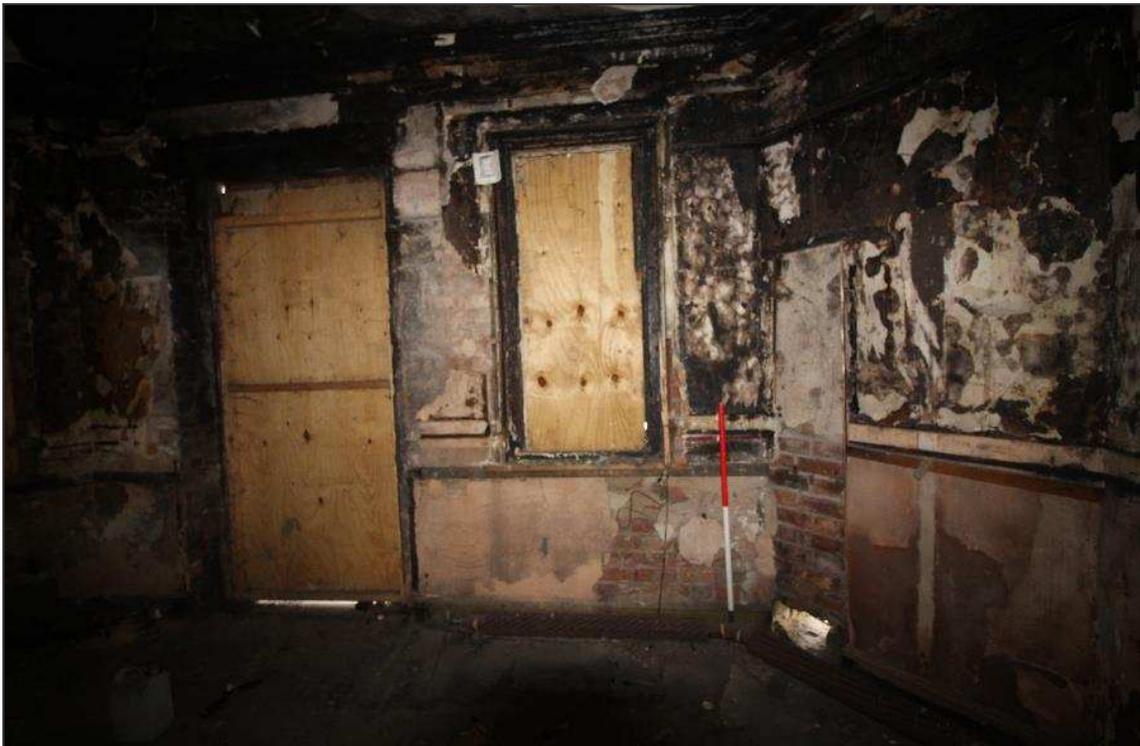
Plate 37: The internal view of the window on the north-eastern façade

A second main entrance door is located at the north-western side of the north-eastern wall. The door and doorframe have been removed completely, presumably due to the fire (Plate 36). A window is situated 500mm south-east of the door. This window is rectangular in shape with brick reveals that support a sandstone lintel. The timber frame, as with the windows on the northern wall, had been badly fire damaged. The frame has moulded timber side and header casings. The window is supported by a 2” timber baton inserted into the wall and has been bedded using cement mortar. The wall below and above the window has been rendered in plaster, although due to water ingress the majority of the plaster has been removed, exposing the inner face of the external wall (Plate 37).

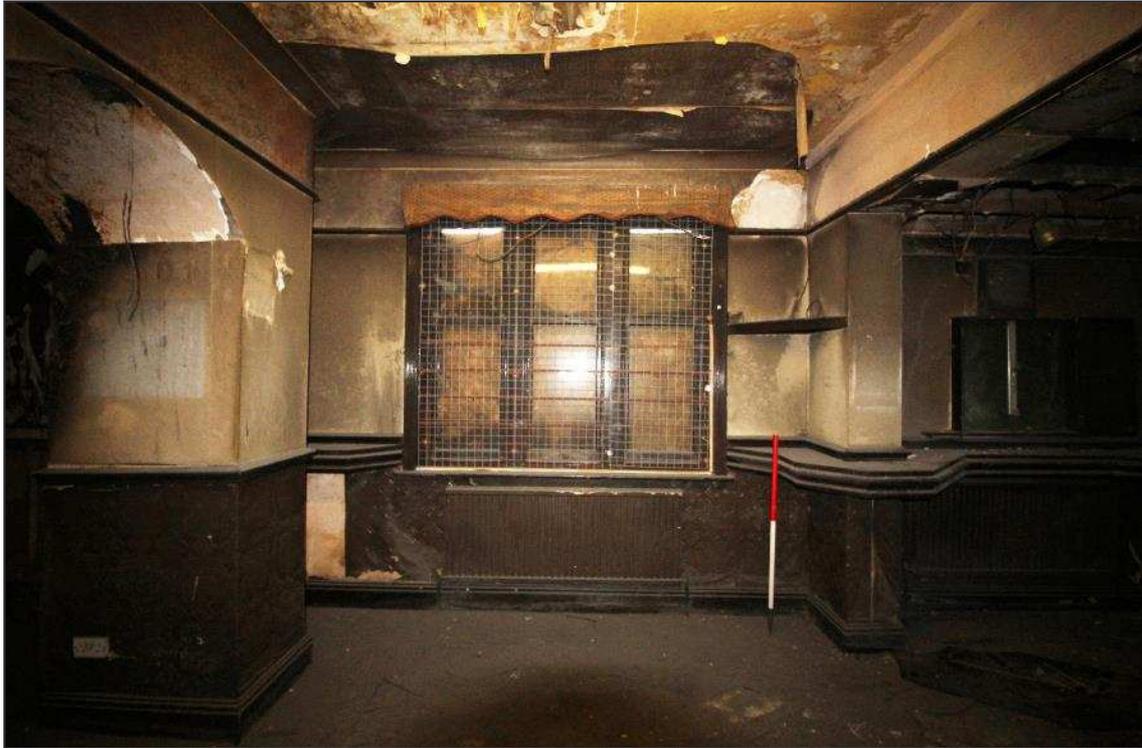
Plate 41: Window on the eastern wall of the second room

The eastern wall has a window 0.3m in from the northern end. This comprises a six-light sash window that has roll-moulded side and head casings along with an internal timber sill. It has steel security bars on the inside on the lower three lights, but has been boarded up from the outside (Plate 41).

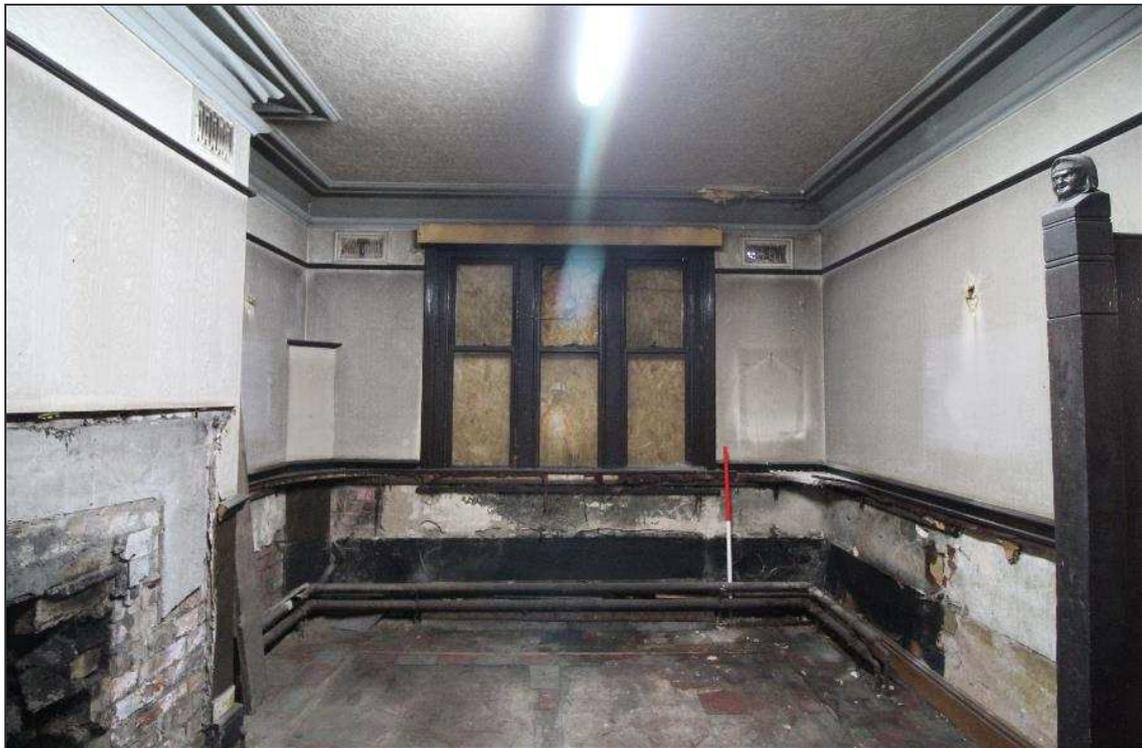
Plate 43: The window and heating pipes in the northern wall

The window is supported by a 2" timber baton that has been inserted into the wall and bedded using cement mortar. Beneath the window, are a set of 2 1/2" heating pipes. These would have been used to heat the room and would have been encased below a bench seating that has been removed recently (Plate 43).

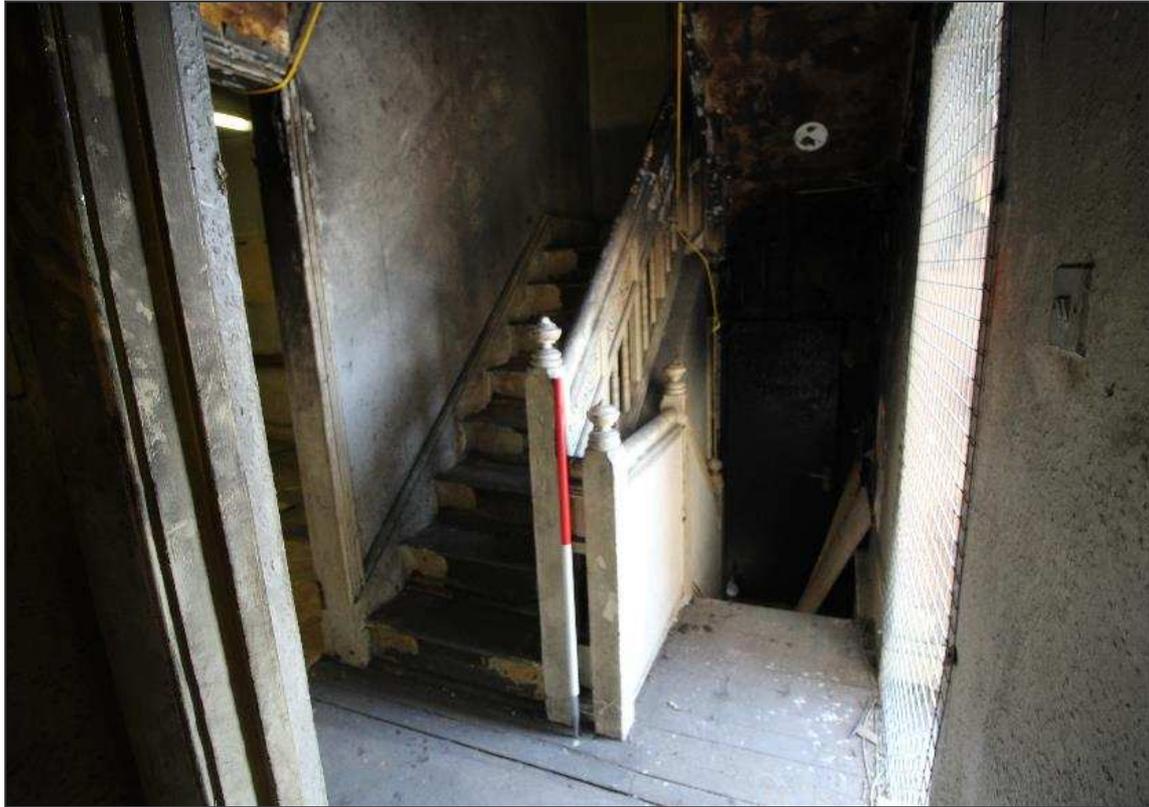
Plate 51: General view of the first-floor landing

First Floor: the first floor is accessed from the central stairwell. The slender-turned balustrades, decorative carved panels and half-round hand rail continue up from the ground floor (Plate 51). The newel posts have elaborate turned tops, which differ from the ground floor (Plate 51). The floor has been split into three separate compartments that are accessed from a small hallway which doubles as the first-floor landing (Fig 2). The hallway has a timber floor that has been partially removed in places. These measure 100mm wide, 12mm thick and are various sizes in length. The ceiling had originally been papered, presumably with wallpaper that was similar to that on the ground floor, although this had been severely damaged in the fire and only the charred remains could be seen. A modern fire exit has been inserted into the western wall. This doorway, as previously described on the western external façade, has been inserted into an earlier window. The door casing has been set into the external wall facing and is constructed from pine. The door has been removed completely, although the remains of the emergency push-pad door lock are still attached to the door frame.

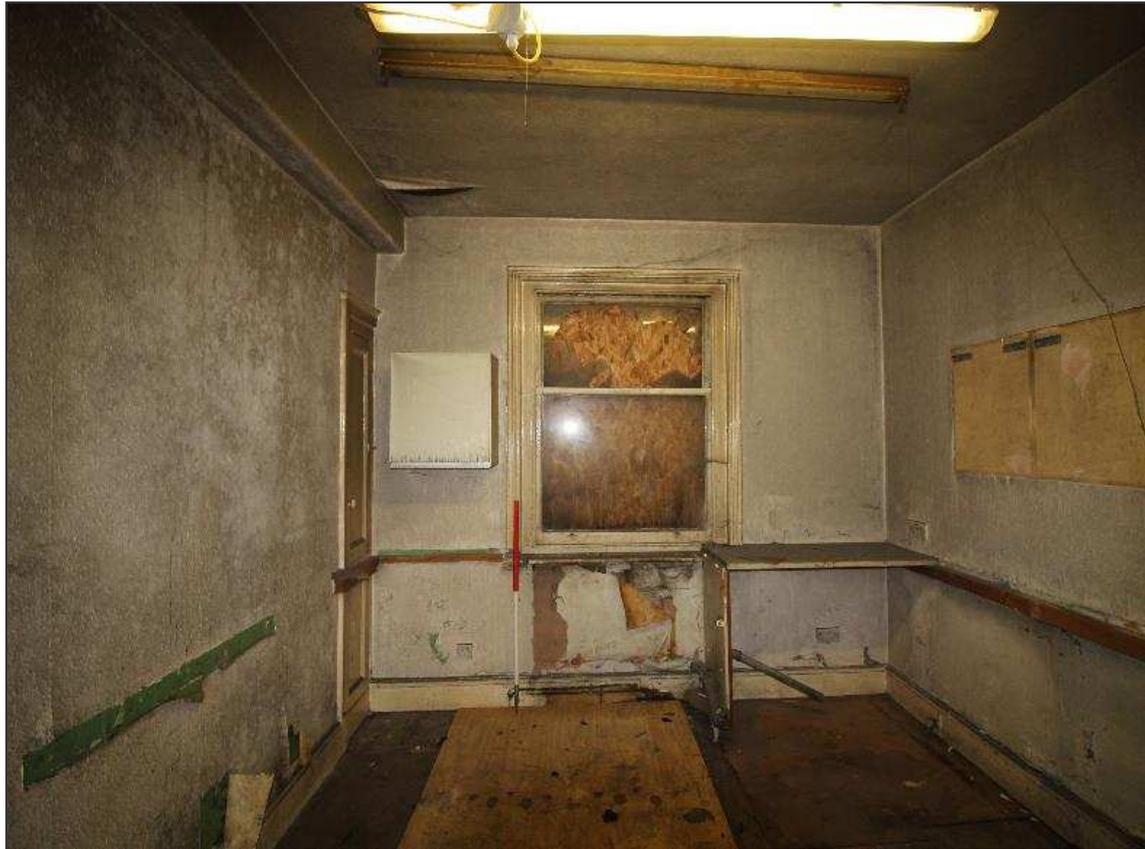
Plate 53: The window in the eastern wall of the first room

Inside the room, a 980mm wide window is located on the eastern wall. It is a two-light, timber-sash window that has timber moulded sides and header casing. The internal sill is a chamfered 1 ½” thick timber sill that is bedded directly onto the internal face of the eastern elevation. The single-glazed glass pain in the bottom light survives intact, although the pain in the upper light has been partially broken, probably from vandalism as it had been boarded up from the outside. A timber dado rail is situated directly below sill level, and extends from the northern wall to the southern wall. A modern wall-mounted cupboard is located to the north of the window (Plate 53).

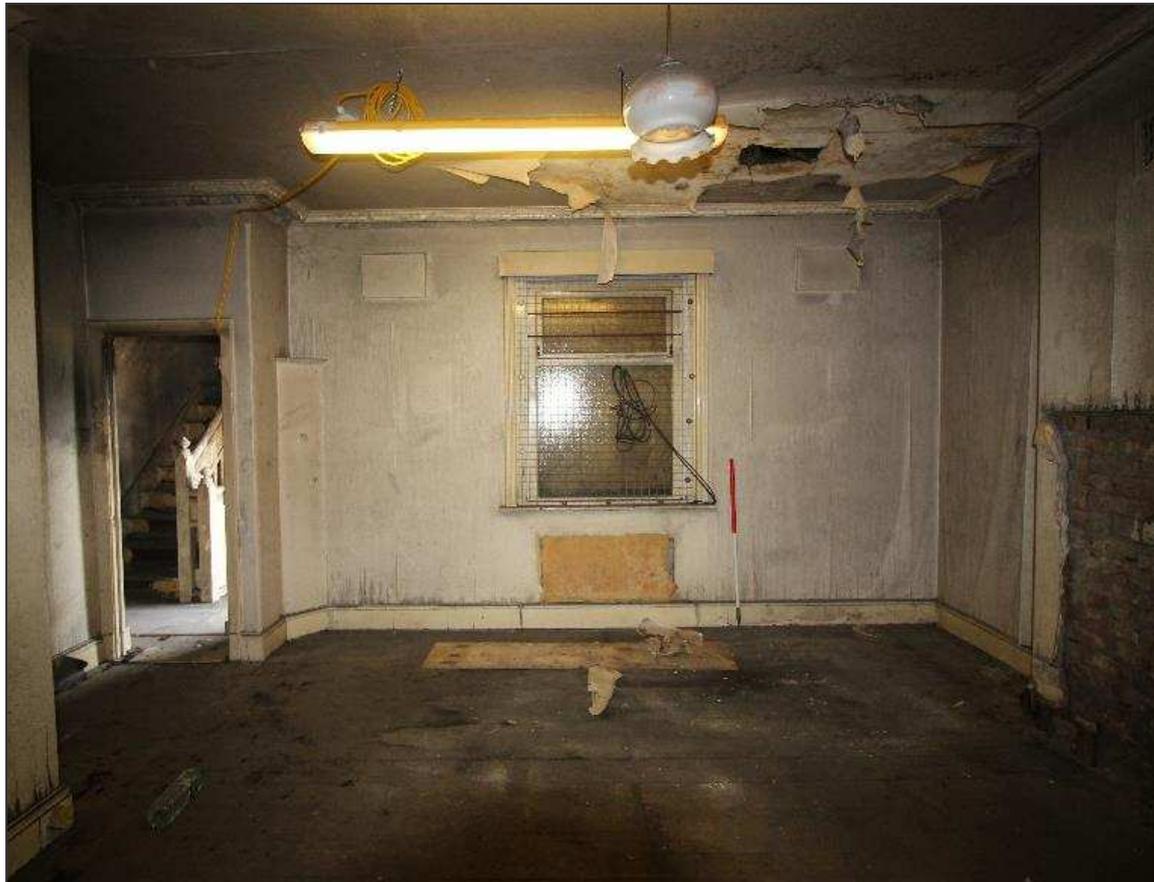
The southern wall contains the doorway at the eastern end and a window in the centre of the wall. This window is 1.25m long, and has brick reveals that support a stone lintel, as described on the southern external elevation. The two-light, timber window frame is similar that that on the northern wall. Below the window are the remains of the L-shaped brackets that support a radiator that is screwed to the wall (Plate 61).

Plate 61: Window within the southern wall of the third room

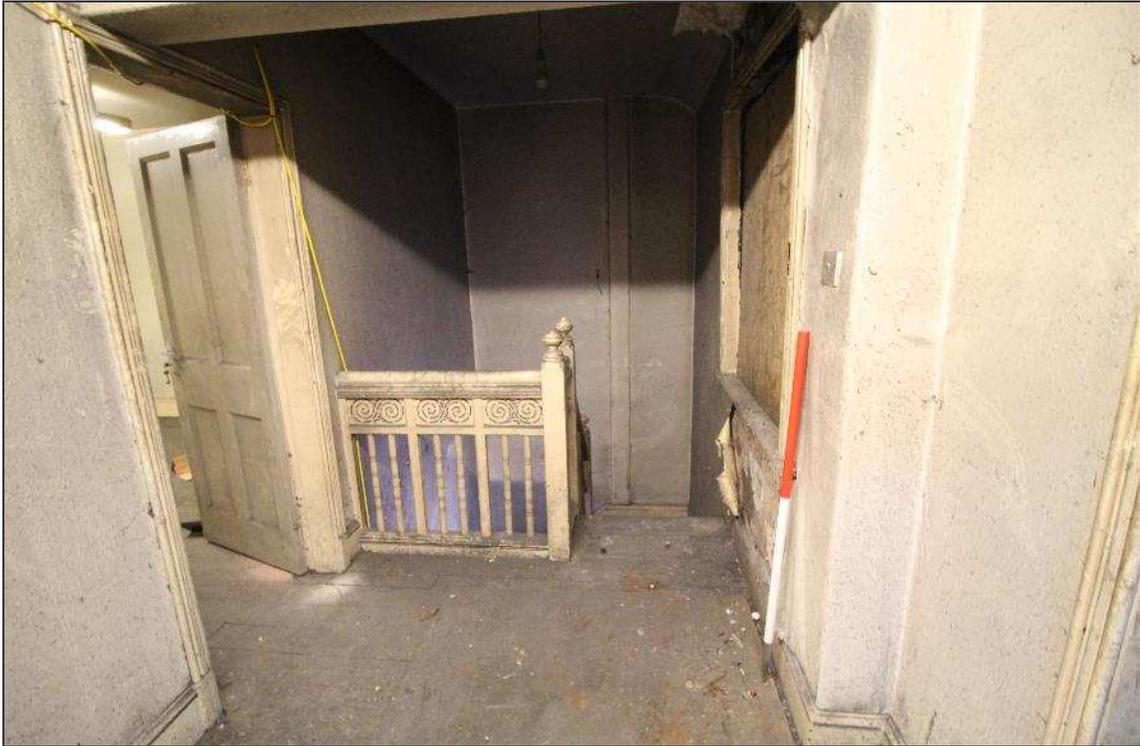
Second Floor: the second floor is accessed from the central stairwell. The slender turned balustrades, decorative carved panels and half-round hand rail continue up from the first floor, which ends as a guardrail on the top-floor landing. The tops of the newel posts have similar design to those on the first floor (Plate 62).

Plate 62: The top guardrail on the second-floor landing

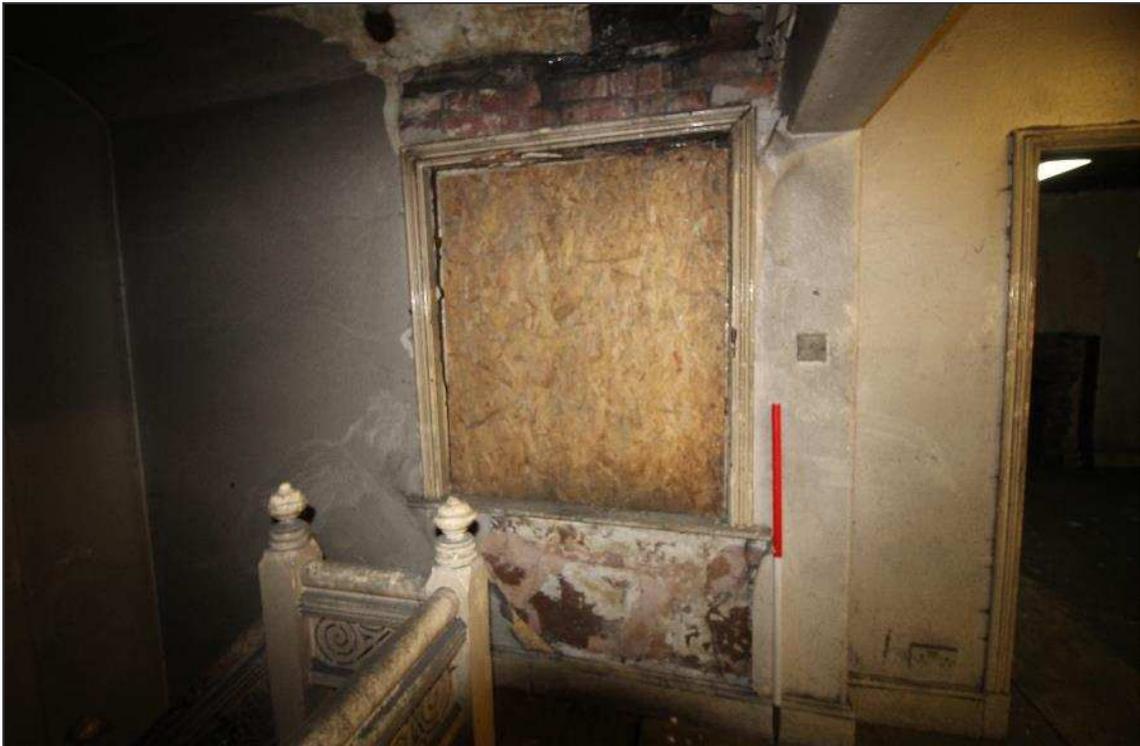
This floor has been separated into three bedrooms, a bathroom, and a large landing that doubles as a hallway (Fig 3). The floor of the hallway was originally timber boards, similar to those on the first floor. On the western wall a window, measuring 1.48m wide, 1.5m high is located 700mm up from floor level. It has been boarded up using 10mm thick plywood, although the Victorian mould designed side and header casing are still visible. The internal timber sill is ½” thick and has a half-round external safety edge (Plate 63). Upon removal of the timber sill, a rubbed sandstone sill was exposed, which had formed part of the original aperture (Plate 64).

Plate 63: View of the window on the western wall of the hallway on the second floor

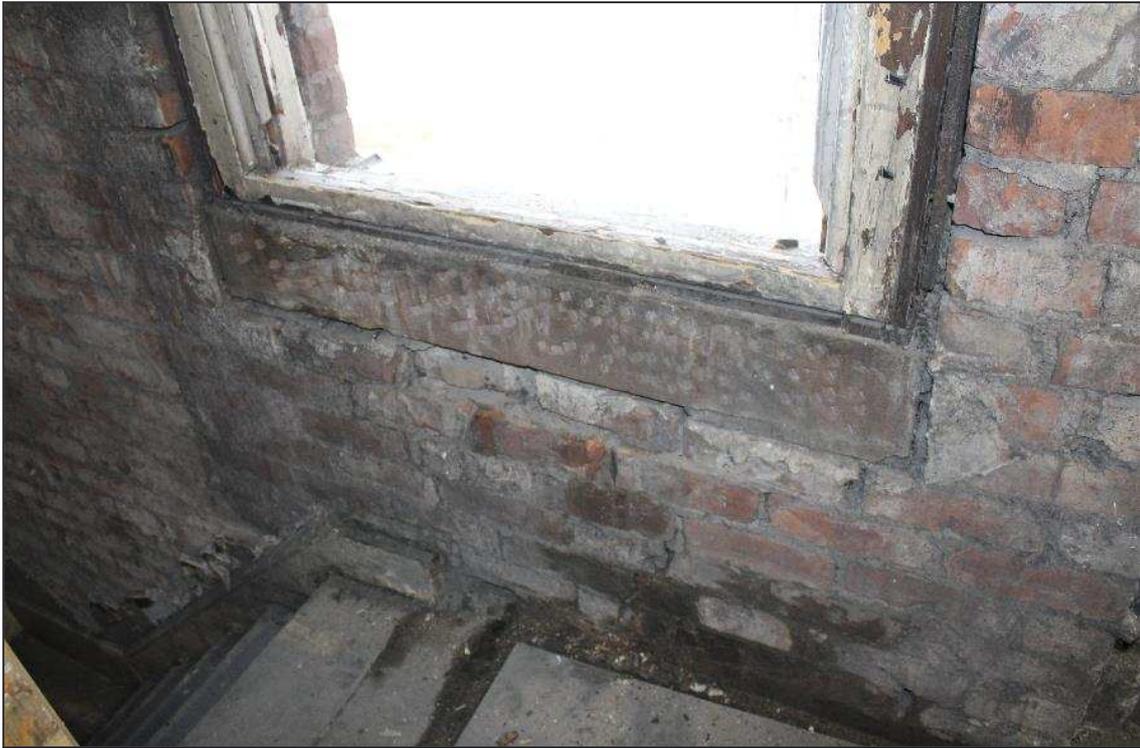
Plate 64: Detail of the original dressed sandstone sill within the western wall

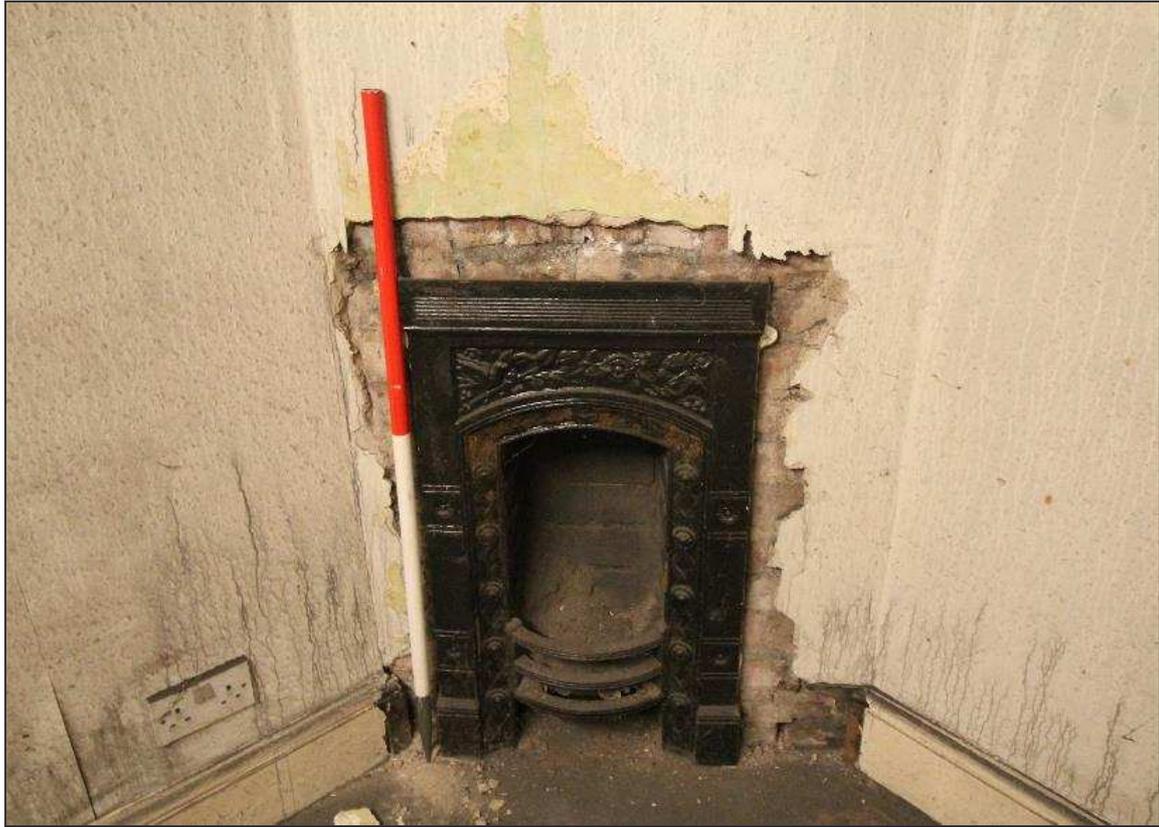
The north-eastern wall contains a small cast-iron fireplace at its north-western side. This has decorative flowery detail on the columns and header, along with a fluted cast-iron panel that would have been below the mantel along with a curving grate at the front (Plate 65).

Plate 65: Detail of the fireplace within the north-eastern wall

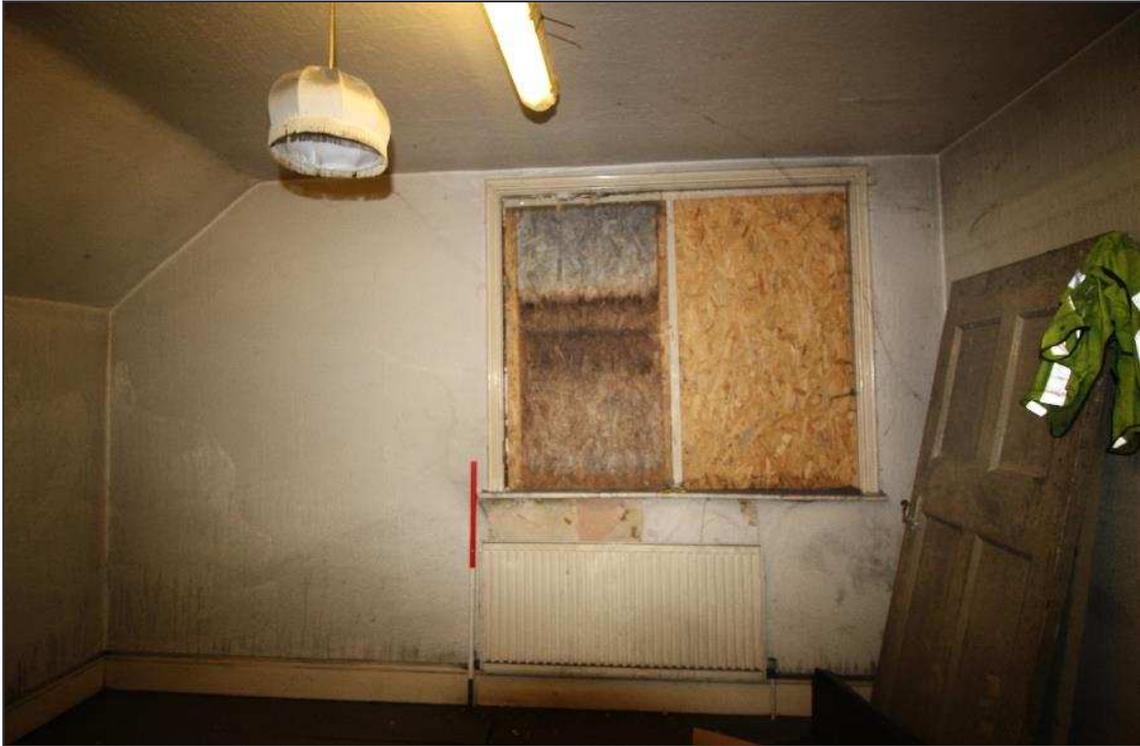
The southern wall contains a two-light side hung window that has been boarded up using 10mm-thick plywood. The frame window casing has been made from Victorian-style design moulded timber that has been painted white. The sill comprises ½” thick timber that has been sat directly upon the internal face of the southern elevation (Plate 66).

Plate 66: View of boarded-up window in the southern elevation

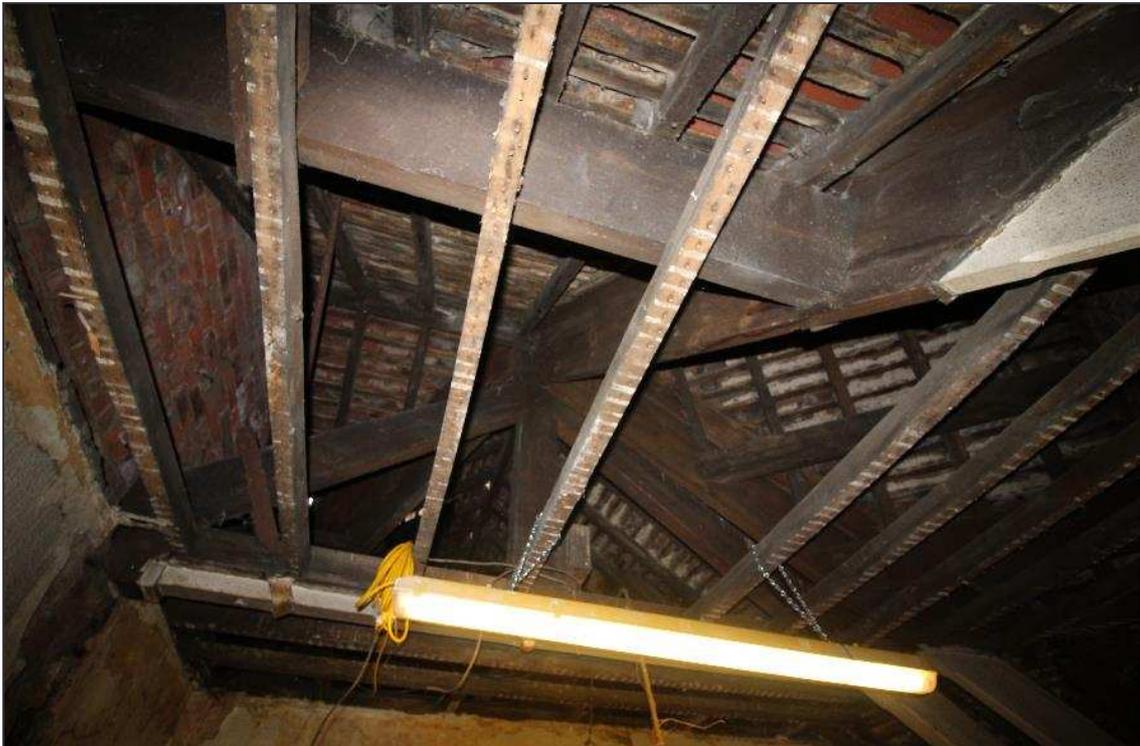
Access to the second bedroom is gained via a doorway that is 840mm north of the first room’s door. This door also has side and header casing that has been moulded in a Victorian profile. The floor is also built from timber boards that extend in from the hallway. The ceiling would have been originally been plastered and papered, although this had been removed completely, exposing the ceiling and roof timbers. The ceiling joists have the remains of the lath and plaster. The hipped roof trusses and king post trusses can also be seen. The central king post truss has the tie beam supported by a timber beam measuring 100mm wide and 50mm thick. This has been bolted through the tie beam using square 30mm square-head bolts and has been socketed into the wall-plate (Plate 67-68).

Plate 67: King post truss as seen through the ceiling joists

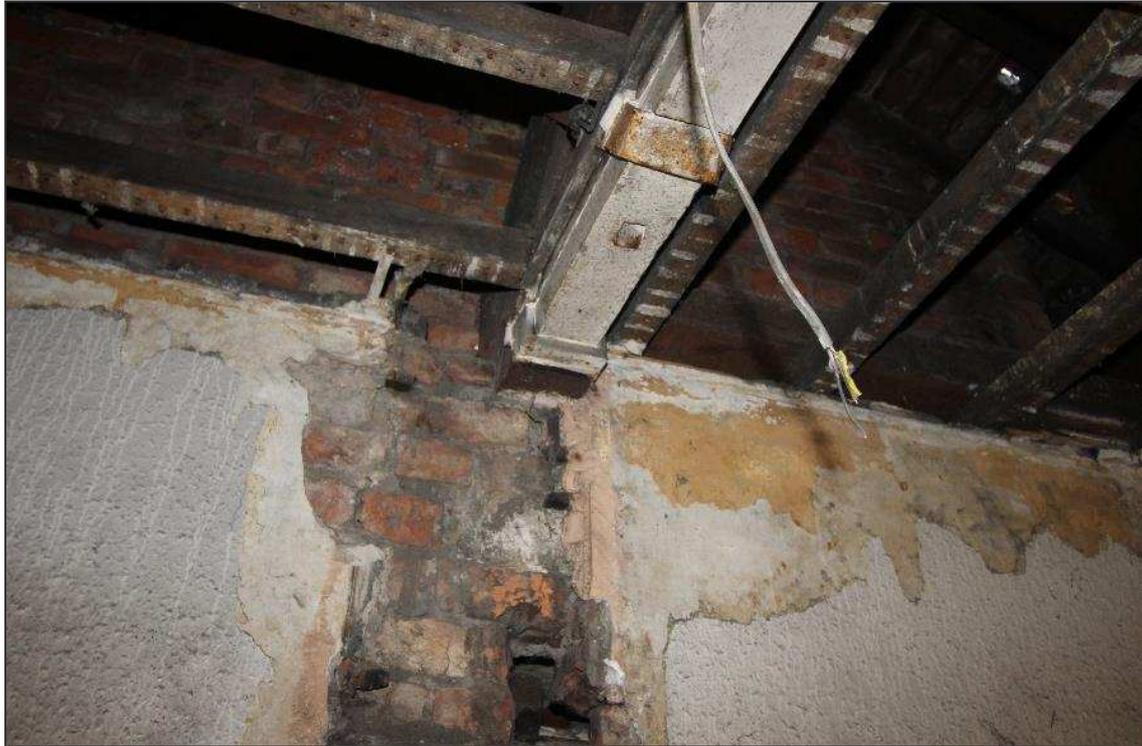
Plate 68: Detail of the of the tie beam support

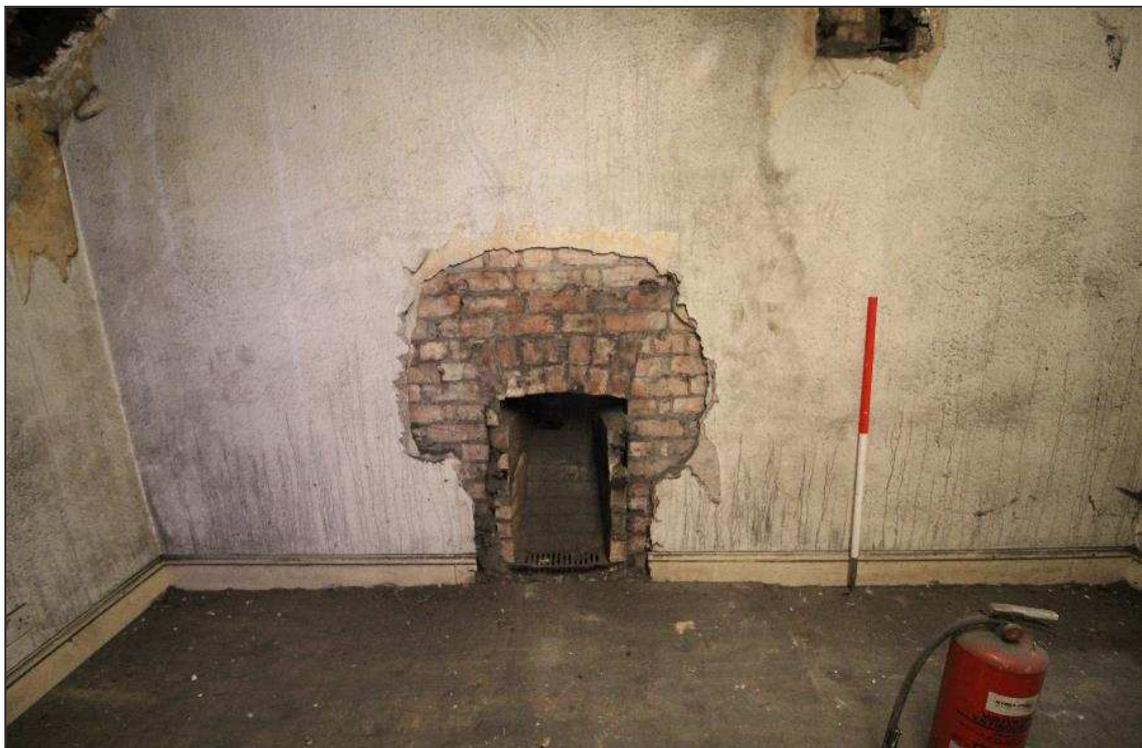
The southern wall incorporates the northern face of the chimney in the first bedroom, and contains a brick-built fireplace at its centre. The cast-iron surround has been removed completely, exposing the firebrick sloping back and segmental brick-arch head. The cast-iron fire grate and stone hearth survive *in-situ* (Plate 69).

Plate 69: Detail of the fireplace in the southern wall of the second bedroom

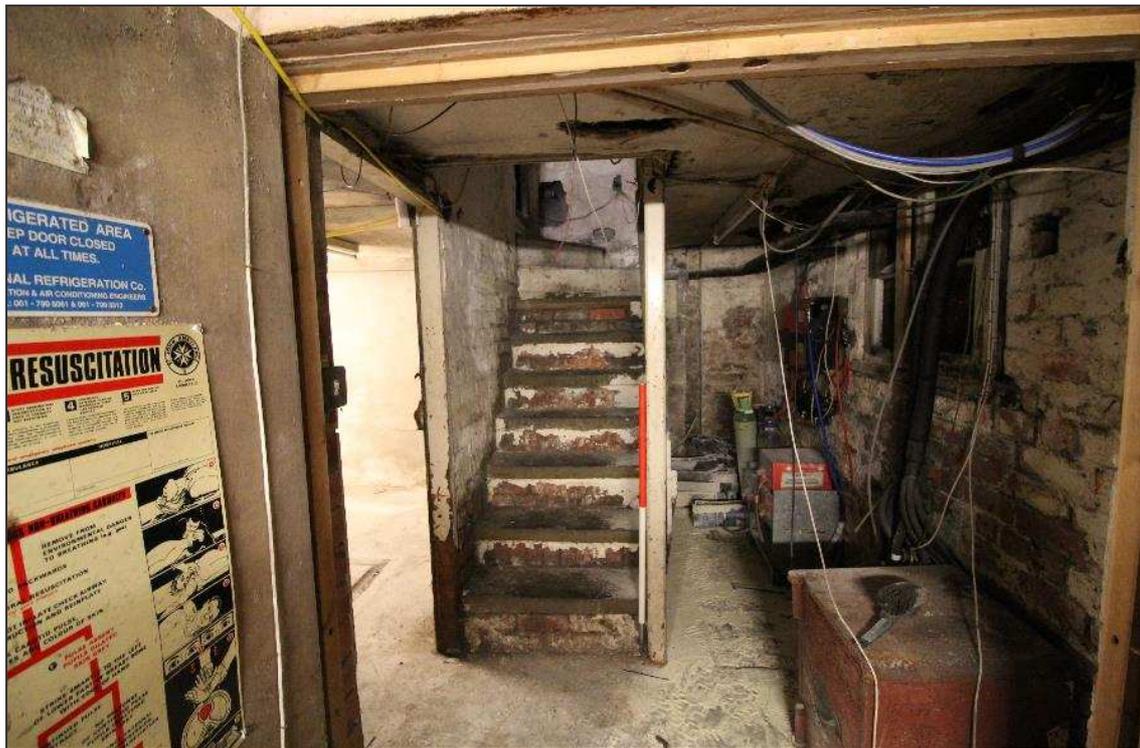
Basement: the basement is accessed from a set of brick riser and stone tread stairs that are located under the central timber staircase. The treads measure 260mm and have been built into the side walls. The stairs lead down into a small hallway that has a concrete floor, and concrete rendered walls, that have been partially removed. A timber four-light double-casement window is located on the western wall. The majority of the hallway has been used to house various modern electrical fuse boxes and beer-pumping equipment (Plate 71).

Plate 71: Staircase leading from the basement to the ground floor

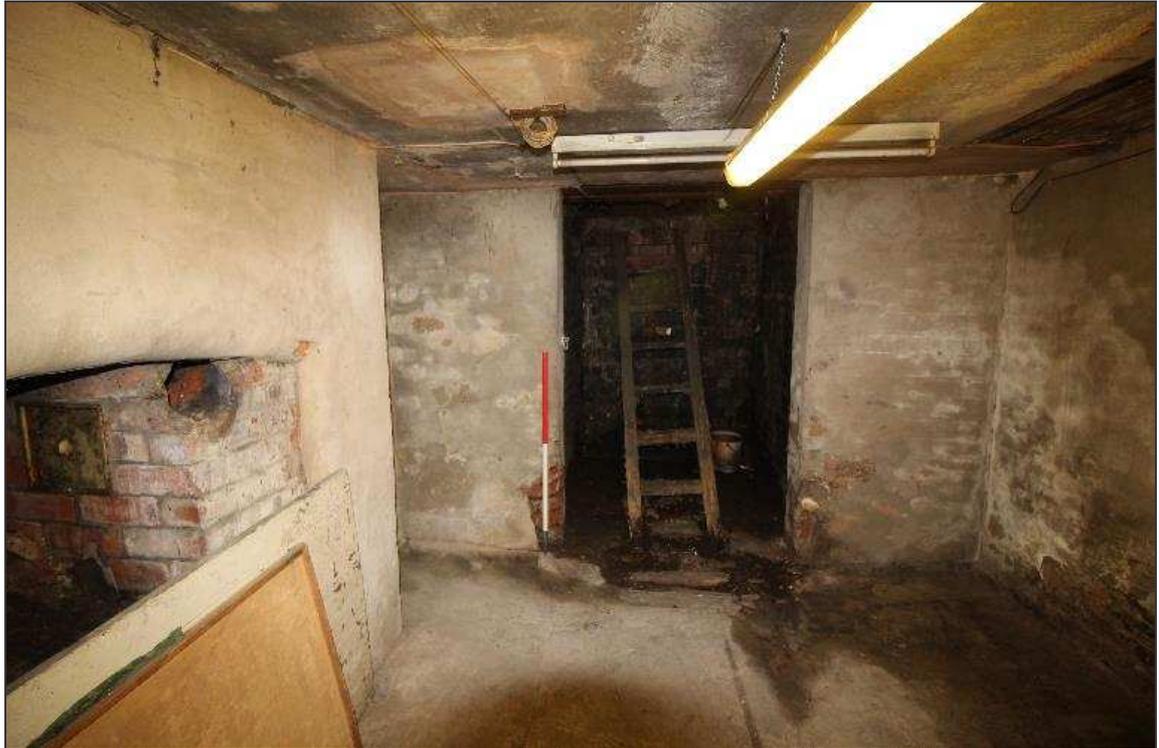
The basement has been split into two separate rooms that have been heavily modernised by rendering them in a concrete screed (Fig 4). The first room is located off the east end of the hallway, through a brick reveal doorway that has been supported latterly by a steel frame. The door frame comprises 20mm thick pine wood that has been painted white and has a 150mm thick timber lintel. There was no evidence of a door being hung on the frame, suggesting there was direct access from this room into the hallway. All four walls, the floor and the ceiling have been covered in concrete render, although some had been removed on the southern and eastern walls exposing the original wall. The eastern wall has a small extension in the centre, which measures 1.43 x 1.74m. This extension has a doorway that has a bull-nosed brick reveal and a steel I-beam lintel. The ceiling of the extension contains a cast-iron double-door hatch, which leads up to street level on the eastern side of the building. This hatch would have been used as access for the delivery of beer barrels. A wooden ladder has been left *in-situ*, would have been used as secondary access into this cellar room (Plate 72-74).

Plate 72: General view of the eastern access into the cellar

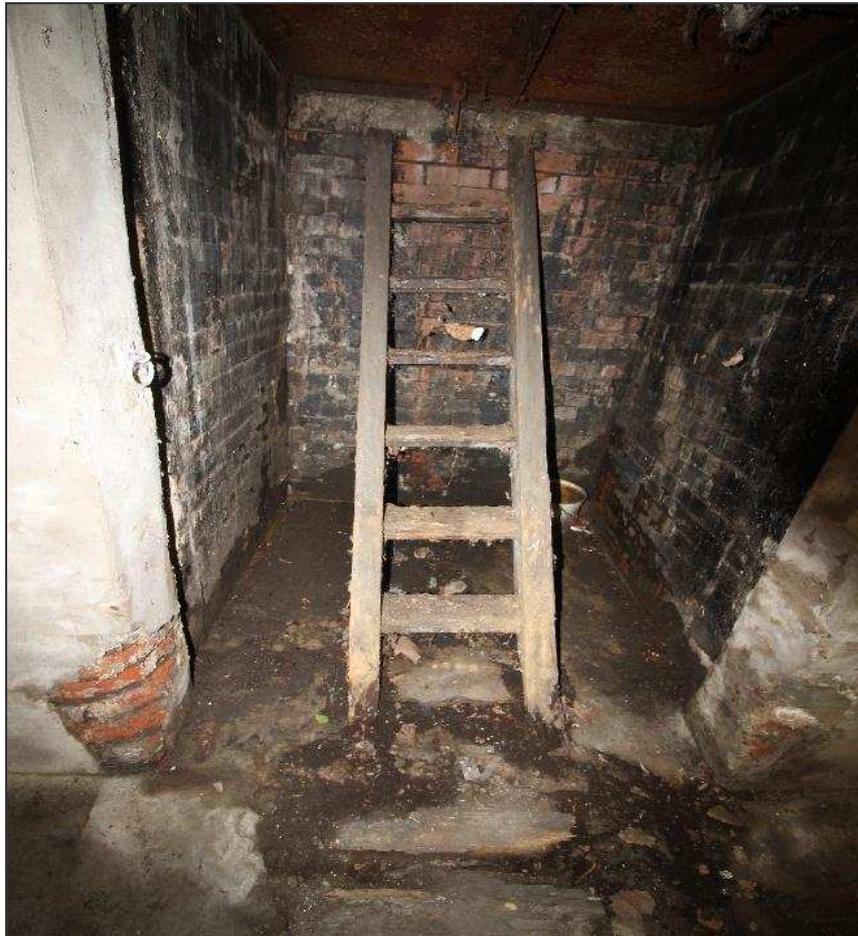
Plate 73: Timber ladder leading from street level into the basement

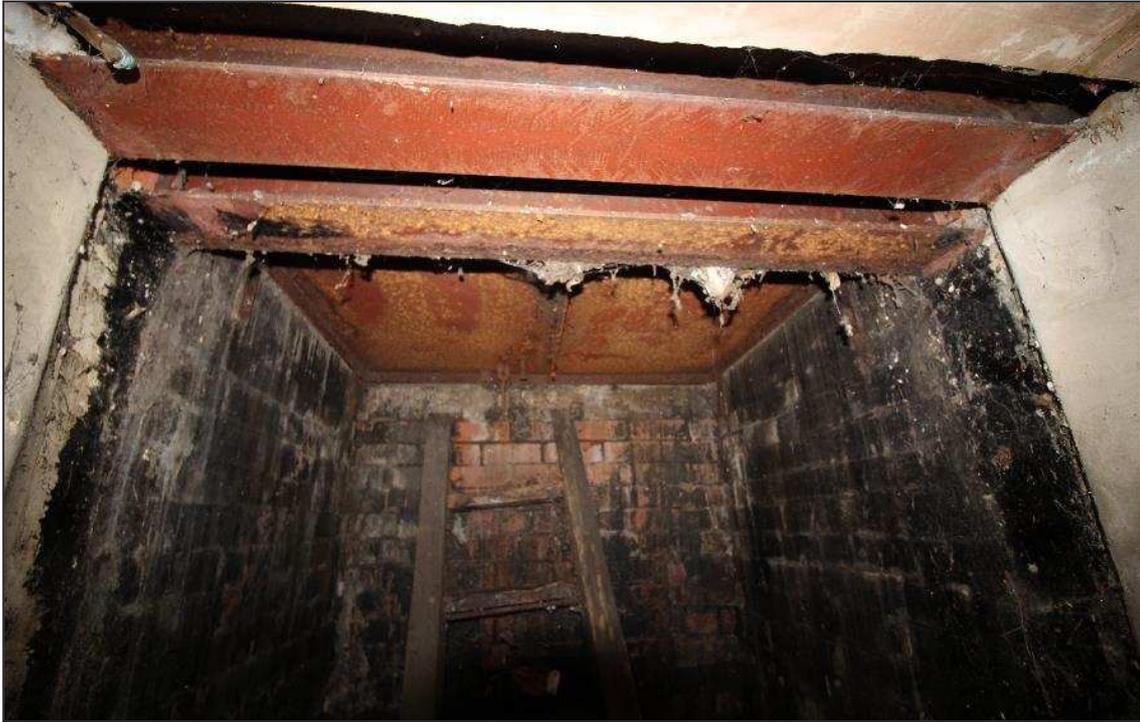
Plate 74: Cast-iron hatch doors leading to street level

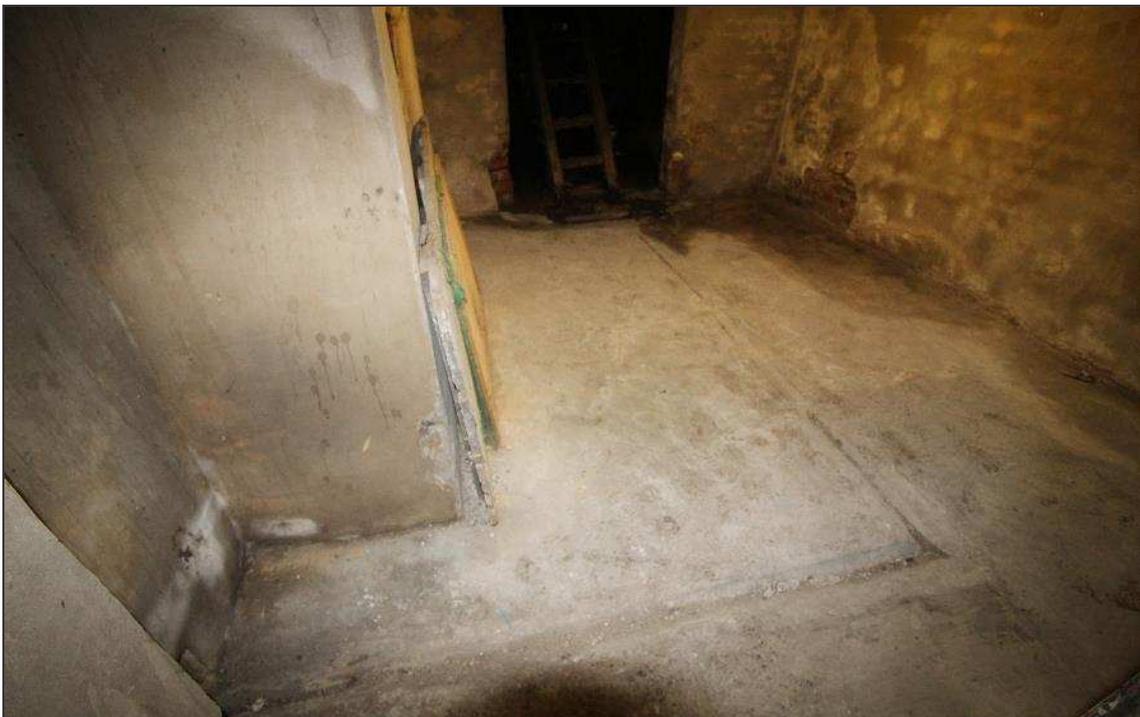
The northern wall contains a central chimney, along with an associated fireplace. The fireplace surround has been removed, and has been partially blocked up, although the firebrick back was partially visible. A 25mm deep drainage channel has been formed in the concrete floor. This has a small fall to it, running from the extension to the western side of the chimney where it enters the northern wall of the room (Plate 75).

Plate 75: Concrete floor of the first room, detailing drainage channel formed within it

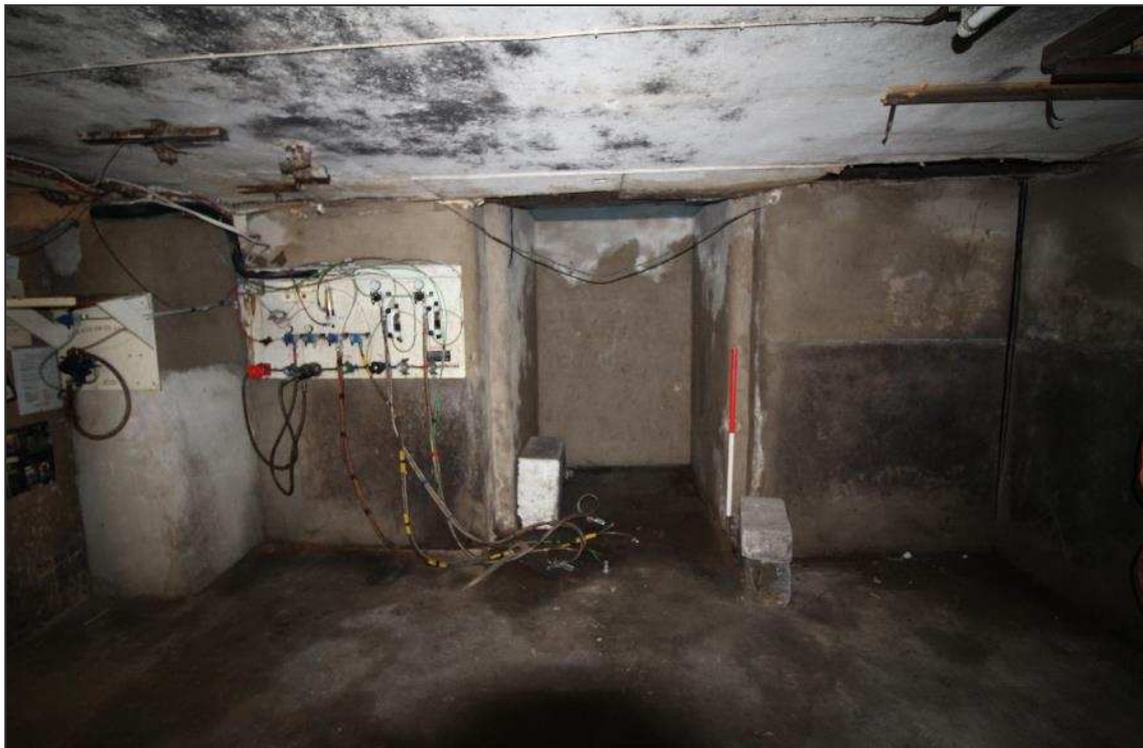
The second room of the cellar is located at the northern end, and is accessed from a double doorway in the northern wall of the hallway. The doorway has a pine timber doorframe. The doors are of a modern composite of a timber frame which supported fire proof panels. As with the first room, the walls, floor and ceiling in this room have been rendered in concrete. The southern wall contains several different types of modern beer-pumping equipment. At the western end of the wall is a small alcove, measuring 1.53m wide and extending south by 1.66m. The function for this is unknown, although it would probably have been used for storage of alcohol (Plate 76).

Plate 76: General view of the storage area within the second room of the cellar
