Historic Building Investigation

Black Friar Public House,
Blackfriars Road,
Salford

Report No:
SA/2017/55

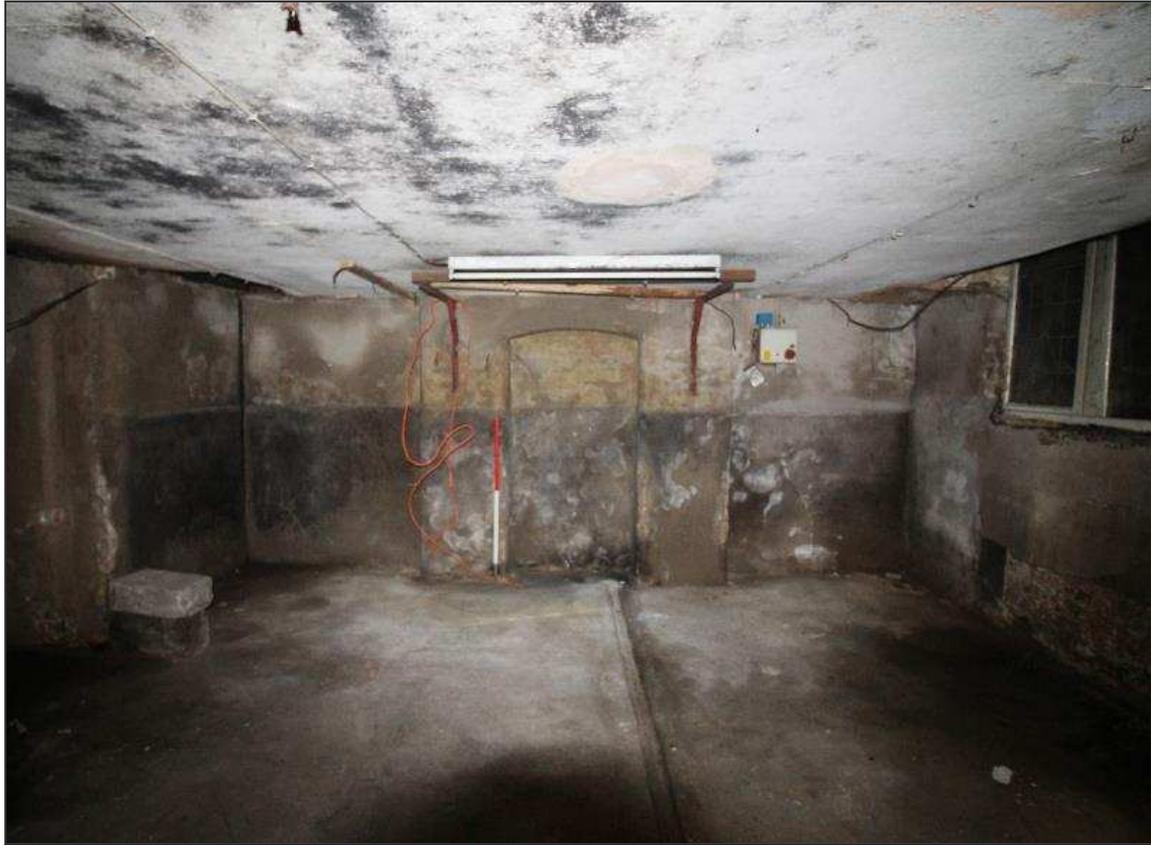
The western wall contains the base of the chimney that continues up through the building on each floor. At the centre of the chimney, an associated fireplace is located. This has the surround removed and its flue blocked up at the throat. The removal has exposed the segmental arched head that is 1.6m up from the floor (Plate 77).

Plate 77: Detail view of the fireplace on the western wall of the basement

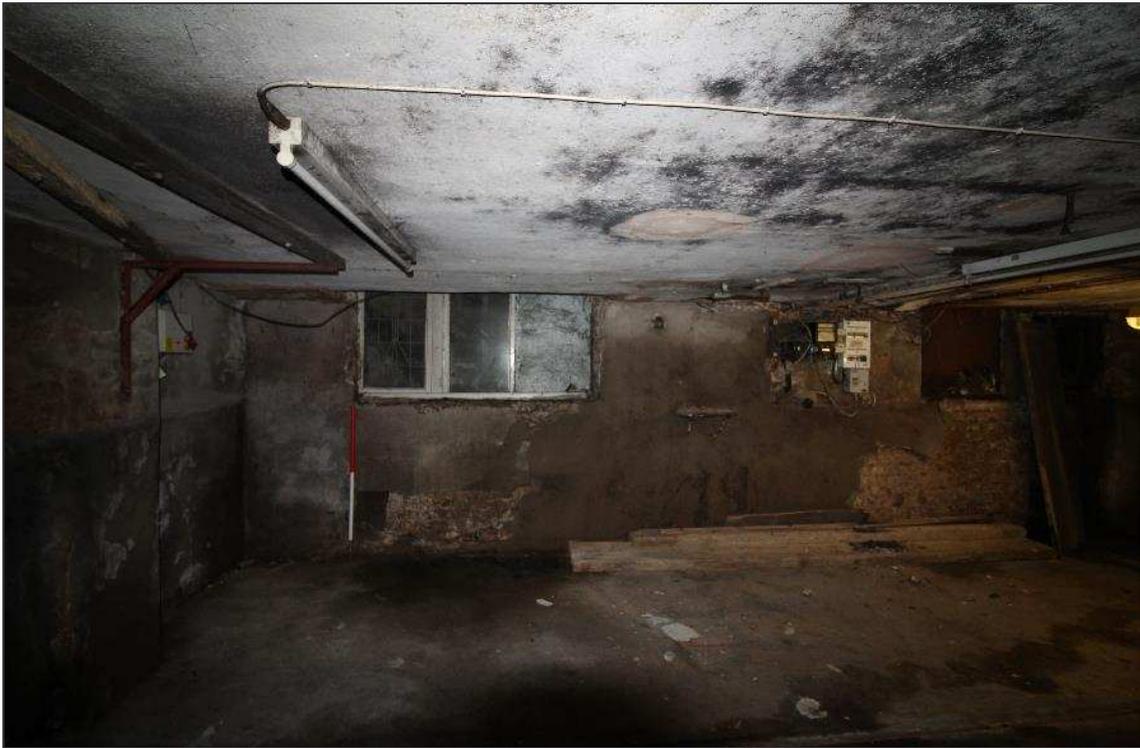
The northern wall has a three-light timber-framed window at the western end that is situated 1.2m above floor level, and served as a cellar light in the northern elevation. The reveals and sill have been rendered in concrete, although parts of this have been removed, revealed that the original brick fabric of the sill. The lintel has also been rendered internally, although externally the chamfered sandstone is visible. The glass panes have been removed and boarded up on the central and eastern light, although the western light retained its glass (Plate 78).

Plate 78: Window at the western end of the northern wall

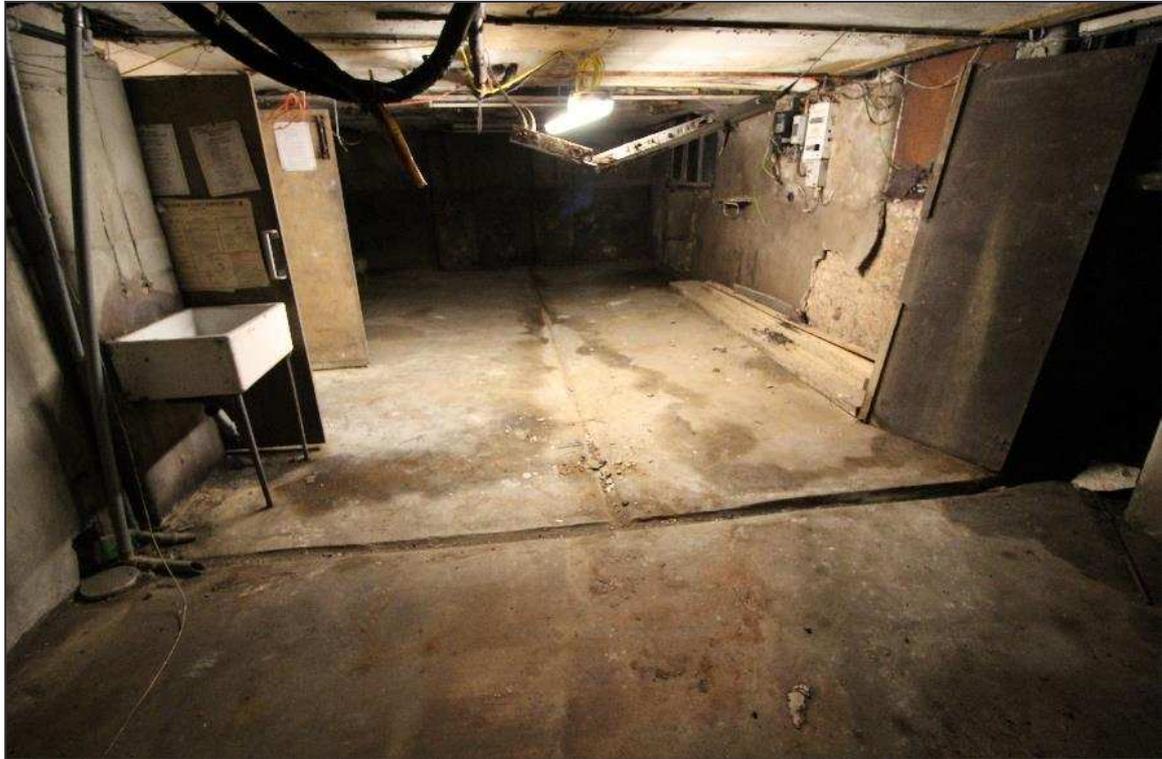
The floor, as with that in the first room, has a 25mm deep drainage channel formed in the concrete. This has a slight fall that starts at the fireplace at the western wall, and finishes at the small drain that is located to the east of the main door in the southern wall of the room (Plate 80).

Plate 80: General view of the second room of the basement, detailing the drainage channel formed within the concrete floor
