**Community
Archaeological
Excavation**

Mellor Mill

Report No: SA/2017/45

Document title: Archaeological Excavation: Mellor Mill

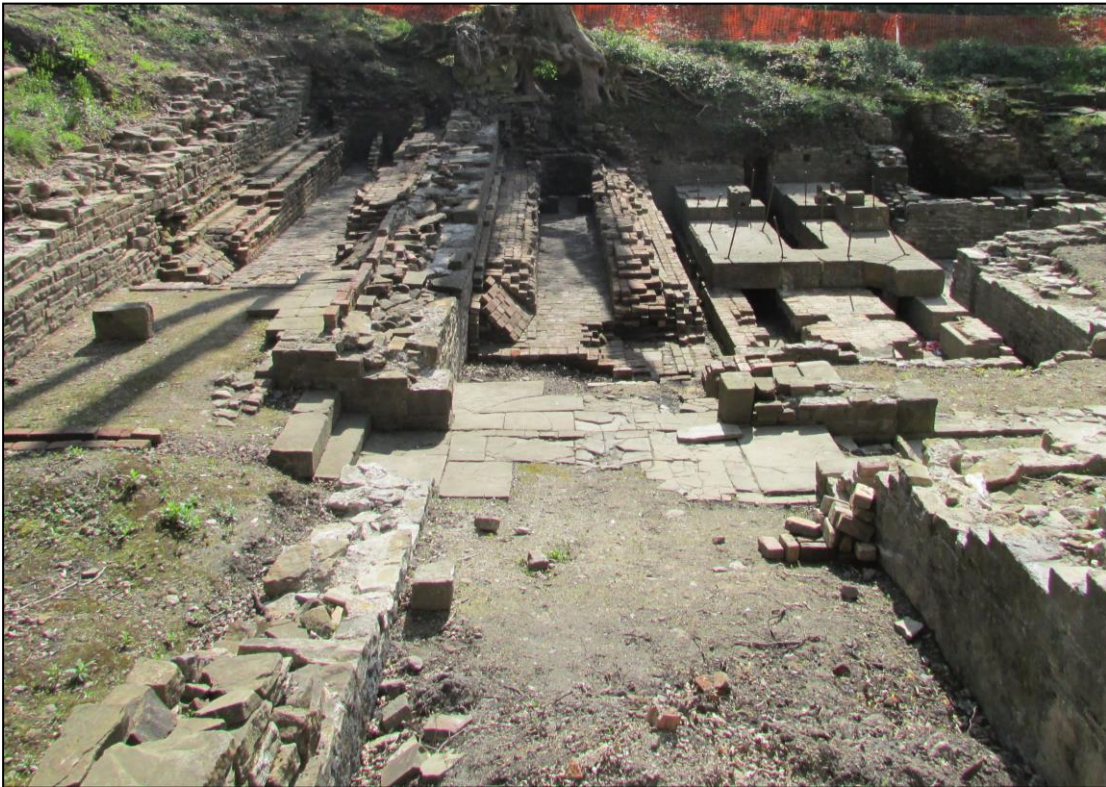
Figure 3. General view of Sub Divisions 1 and 2. Looking East.

For the purpose of this report the descriptions of the excavated areas have been separated into sub divisions. These sub divisions are identified on the site plan as Sub Division 1 and Sub Division 2.

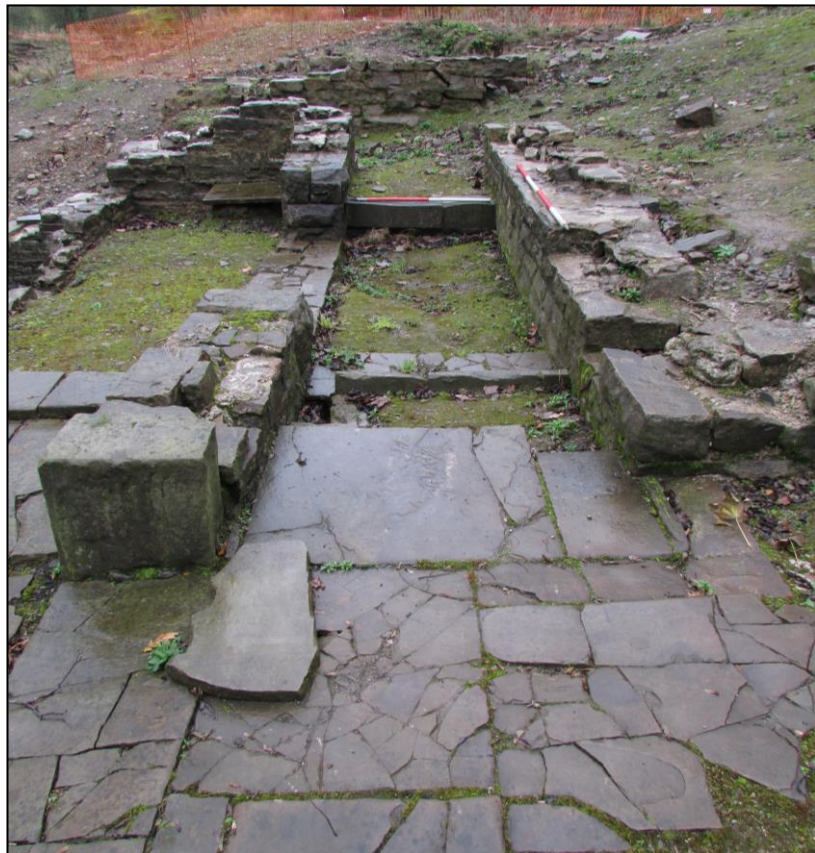
Figure 4. Walls *76 to the north and *77 to the south at the boundary of Sub Divisions 1 & 2. Looking southwest.

Sub Division 1 occupied the north western corner of the site, bounded on the north, south and west sides by substantial gritstone walls (*04) – (*07) & (*76), and a central rough built gritstone wall (*09). The southern boundary wall (*04) was aligned east – west and measured 4.50m long. The height of the wall varied significantly from 0.60m at the eastern end where it was heavily truncated, rising to 2.33m at the western end, and was constructed of ashlar blocks varying in length and width up to 0.60m x 0.20m, with a rubble core and bonded with solid white mortar. To the south this wall abutted wall (*76) which was of identical construction and extended 5.50m southwards to align with (*79) in Sub Division 2 (**Fig. 4**).

lay a narrow 1.25m wide corridor bounded by (*76) in Sub Division 1 which had no evidence of flooring but retained two stone steps, one to the south and one to the north linking the lower level of the corridor with the areas to the north and south (**Fig. 4**).

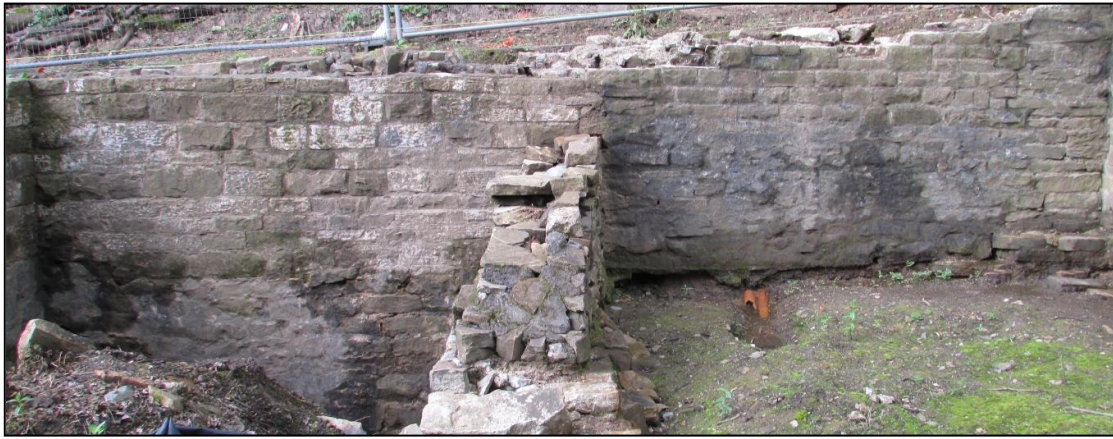
Figure 5. Differing depths of (*05) and (*06). Wall (*09) in the foreground. Looking north.

The western boundary wall (*05) was aligned north – south, and stood to a height of 2.33m. It abutted (*04) at its southern end, (*06) at its northern end and was constructed of ashlar blocks measuring up to 0.52 x 0.24m with a rubble core. This wall measured 3.55m long x 0.45m wide, bonded with solid white mortar, and was extended to the north for a further 4.40m by a similar gritstone wall (*06). Wall (*06) measured 0.90m wide and stood to a height of 1.60m, constructed from ashlar blocks measuring up to 0.52m x 0.25m. It was not clear if (*05) and (*06) were one complete wall or two separate walls. The internal face of (*05) and (*06) was obscured in the centre by wall (*09) (**Fig. 5**).

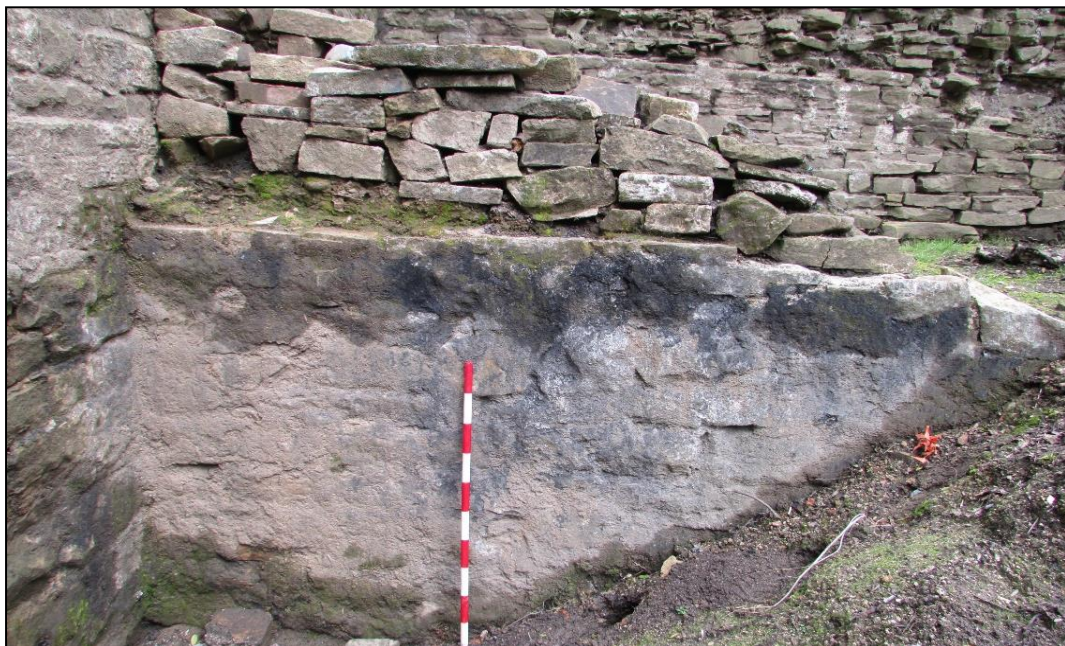
Figure 6. Depth of wall (*09). Looking north.

Wall (*09) was aligned east-west and formed a central dividing wall located approximately 3.00m to the north of (*04) and 3.20m to the south of (*07), abutting (*39) at its eastern end and (*05) & (*06) at its western end. The wall stood to a height of 1.93m on its southern side which consisted of a lower course of ashlar blocks to a depth of 0.95m from its foundation stones, with a further course of rough blocks above measuring 0.98m (**Fig. 6**). This wall also stood to a height of 0.98m on its northern side (**Fig. 7**) and measured 5.75m long x 0.68m wide. The rough built wall was constructed of gritstone blocks which varied in size from 0.40m x 0.15m and

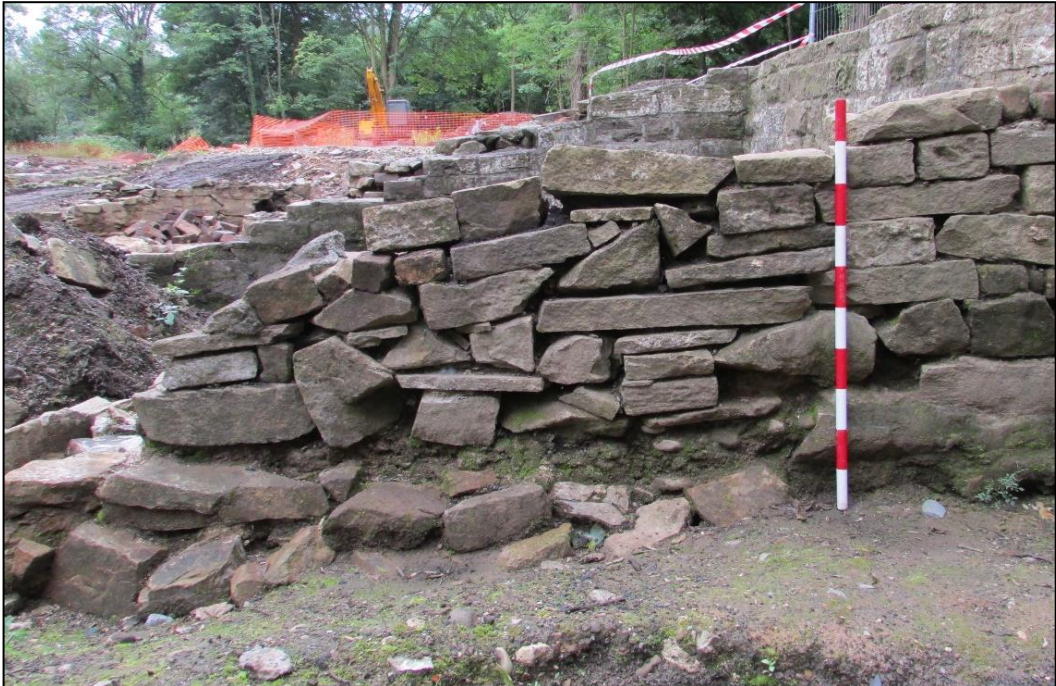
Figure 7. Depth of wall (*09). Looking south.

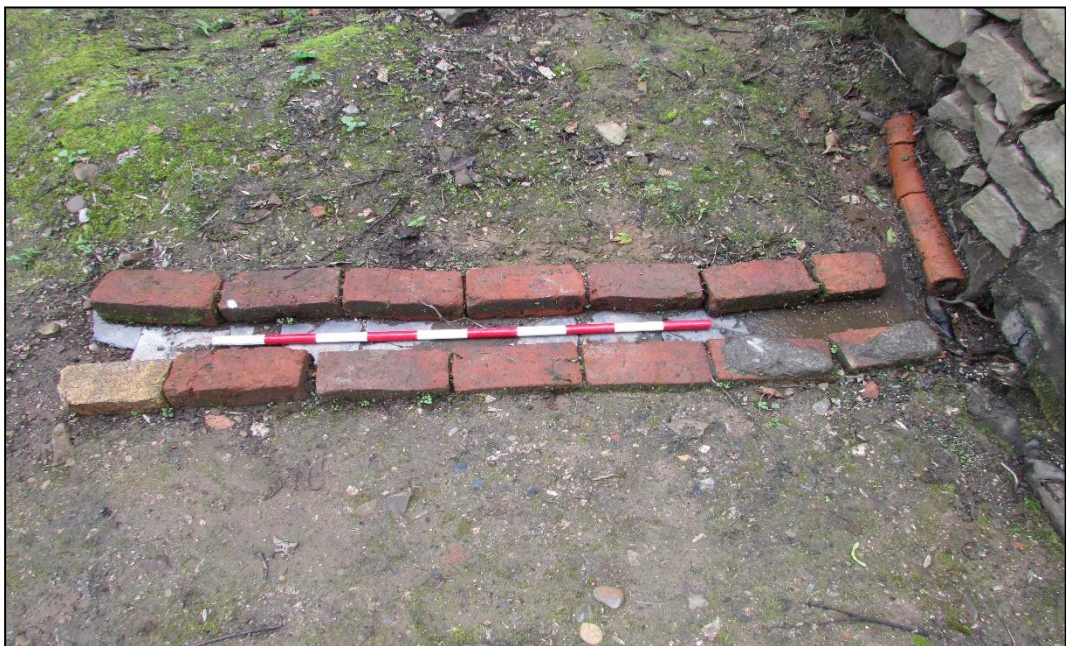
Figure 8. Detail of features (*11) – (*13). Looking northwest.

A red brick and slate feature (**Fig. 8**) was identified lying directly on the natural clay (*03), aligned north – south, and which abutted (*07) at its northern end. It comprised nine rough edged, dark grey slate pieces (*12), each approximately 0.20m length and width, laid end to end from (*07) for a total length of 1.80m. Two parallel lines of single red brick (*11) with a gap in between of 0.12m, and laid in stretcher bond, sat on top of (*12). A third field drain pipe was identified lying on natural (*03), was aligned east-west against (007), and abutted (*11) – (*12) at its eastern end. This pipe measured 0.52m long x 0.07 diameter (**Fig. 8**).

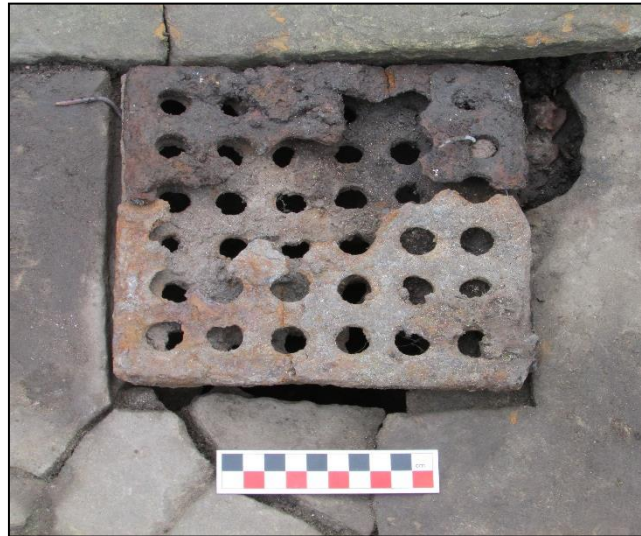
Figure 9. Detail of (*40). Looking east.

away steeply. This surface comprised York stone flags of varying sizes 0.25m x 0.22m – 0.08m x 0.91m, of which approximately 80% were cracked or broken (**Fig. 11**). Towards the south eastern end of this surface, a drain (*40) was revealed, with an iron grid placed on top. This drain appeared to be constructed from small stones deliberately laid to create a vertical square drain shaft with a depth of c.0.40m. The drain measured 0.18m long x 0.14m x c.0.40m (**Fig. 9**).

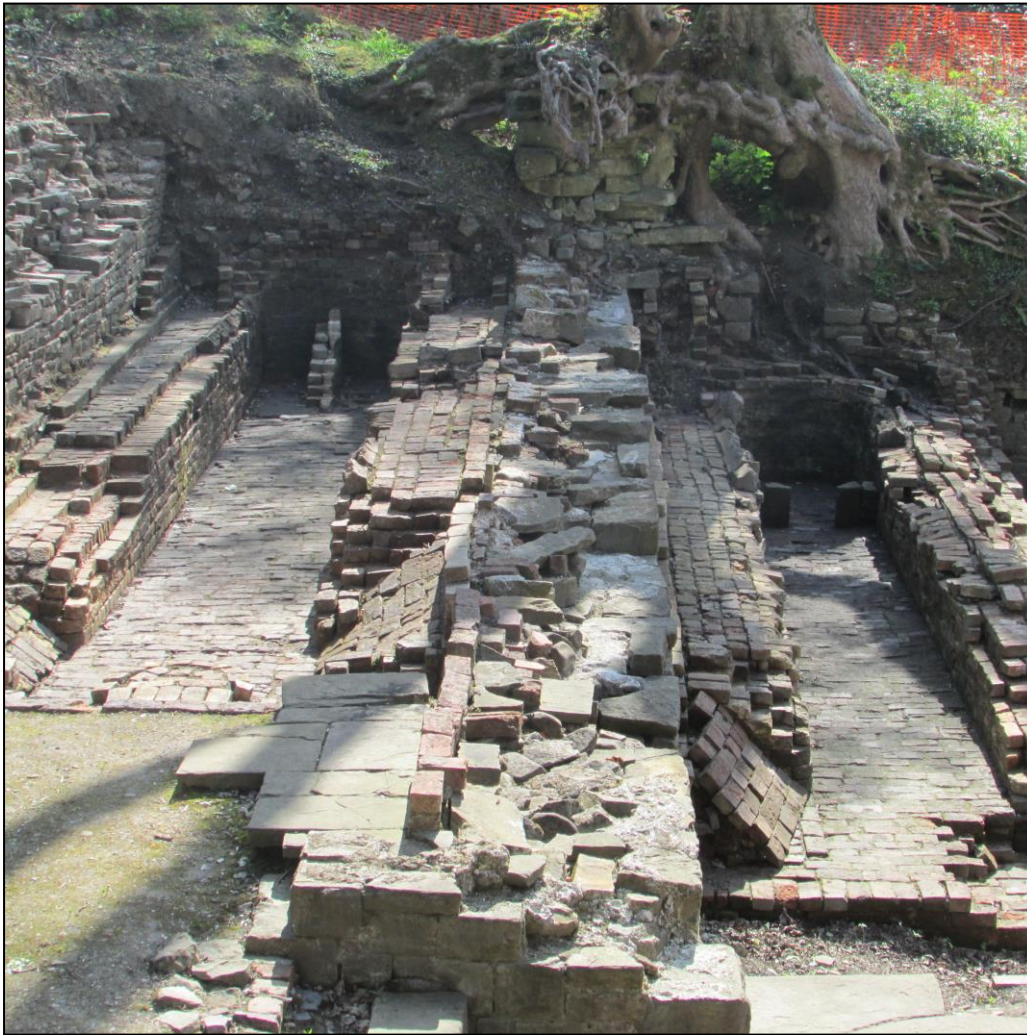
Figure 10. General View of Brick Structures 1 and 2. Looking east.

Sub Division 2 occupied the north eastern corner of the site and lay to the east and south of Sub Division 1 (**Fig. 10**). The whole of the eastern end of Sub Division 2 was truncated by the growth of a large sycamore tree and its associated root system. It was likely that all associated features continued beyond the limits of the accessible excavation area. The area was bounded to the north by wall (*07), to the south by (*79), to the west by (*77) and to the east by the limit of excavation.

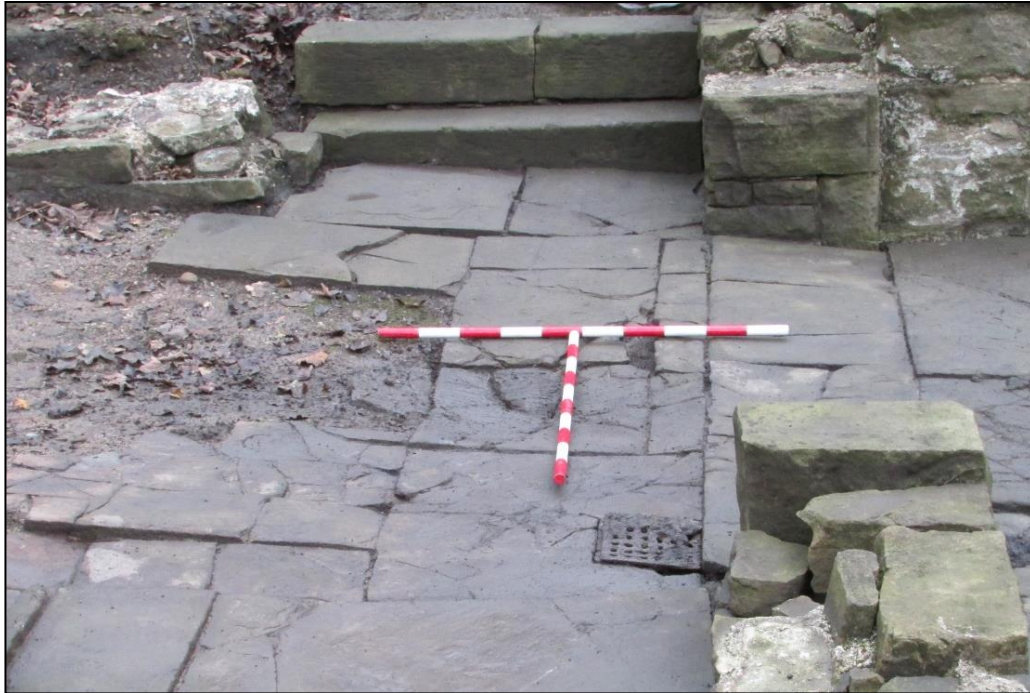
Figure11. General view of features (*39), (*40) and (*48). Looking North.

Two large, dressed, stone steps (*48) were identified which abutted the northern end of flags (*39) (**Fig.11**). Aligned east-west, the lower step measured 1.25m long x 0.16m high x 0.25m wide. The upper step partially obscured the lower step and measured 1.26m long x 0.20m high x 0.30m wide. Directly north of, and in line with (*48), a concentration of broken red brick (*37) was revealed which lay on slate pieces surrounded by small stones, measuring an area of c.1.00m x 0.55m (**Fig.10**). The eastern end of (*39), (*48) and (*37) abutted the longest internal large stone wall (*43) which was aligned east – west, with a short return wall 0.65m to the north at its western end. Wall (*43) was constructed of ashlar blocks bonded with solid white mortar, and had a rubble core that comprised rough cut gritstone blocks and a substantial amount of broken red brick probably used to fill in gaps. This wall measured c.13.2m long (excavated length) x 1.00m wide, and stood to height of c.1.68.

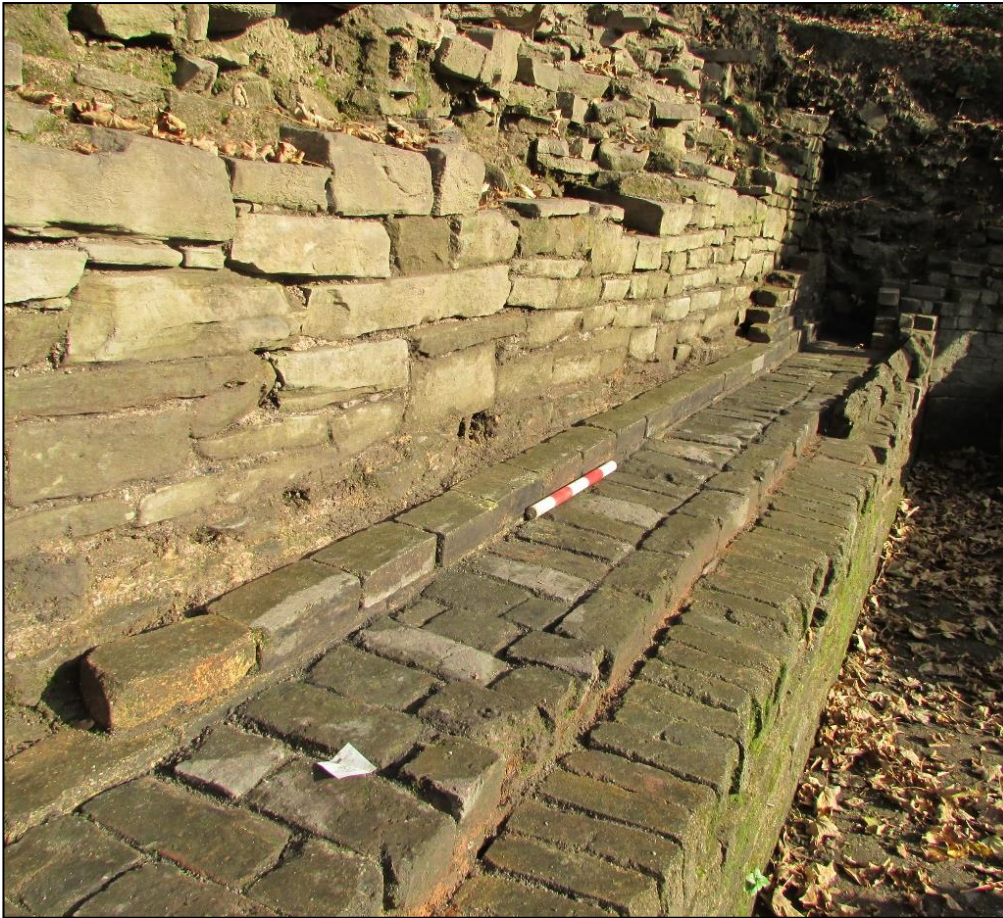
Figure 12. General view of differing wall sections (026) – (028). Looking northeast.

Wall (*28) abutted wall (*30) at its eastern extent (**Fig. 12**). Wall (*30) was aligned north – south with curved sides which adjoined (*28) and (*32) respectively. Its northern return measured 0.53m long x 0.11m wide, and its southern return measured

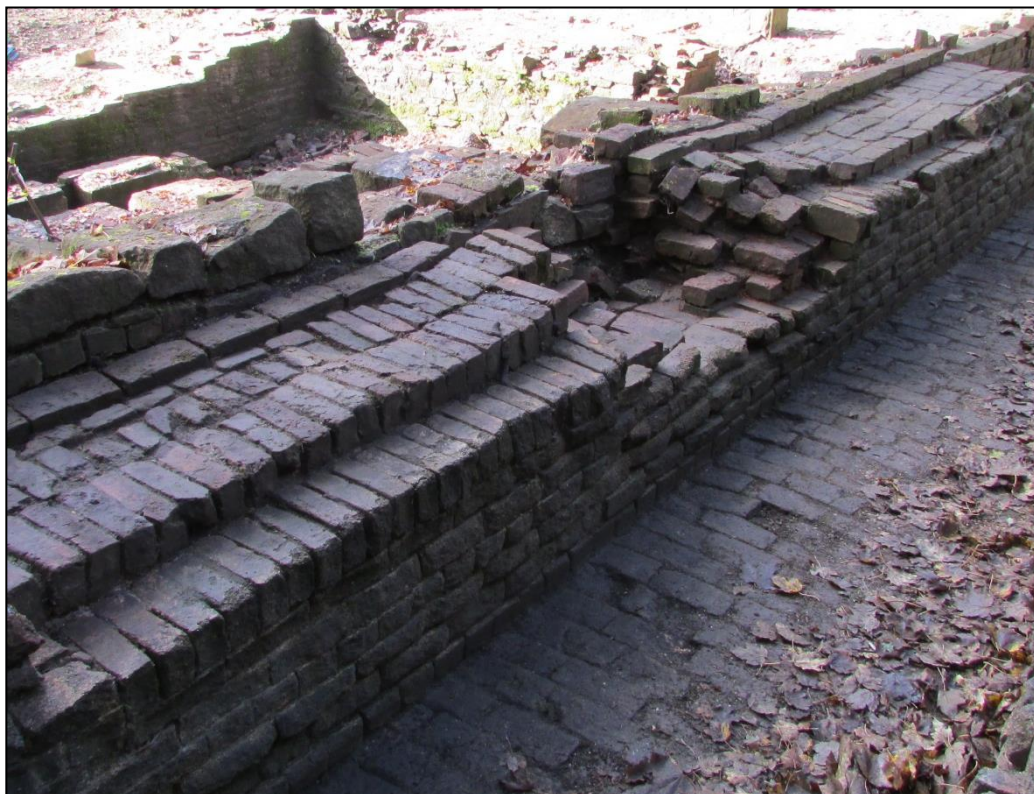
Figure 13. Detail of truncated walls (032), (033) and (035). Looking southwest.

to extend west for a further 3.50m, abutting (*43) at its western end and (*15) along its northern face. Walls (*32), (*33) and (*35) were found to be severely truncated in a concentrated area approximately 2.90m from its eastern end, which reduced the height to 0.24m (**Fig. 13**).

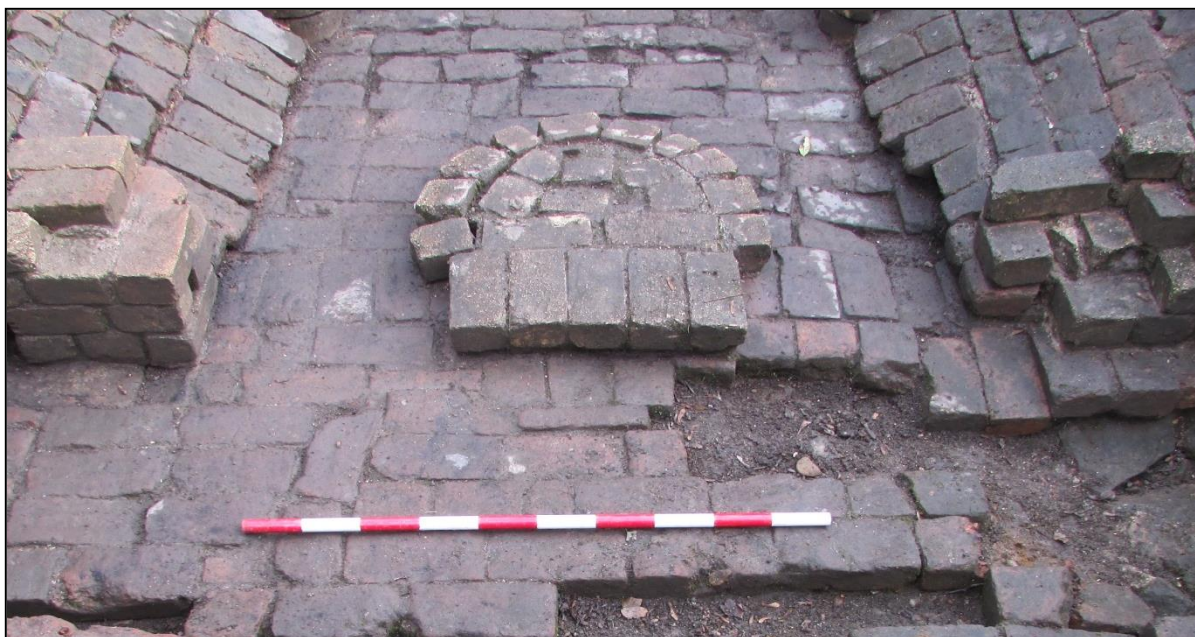
Figure 14. View of features (*20, (*23) and (*24) sat on floor (*19) at western end of Boiler Bed 2. Looking east and down.

A semi-circular feature (*20) was identified lying at the western end of Brick Structure 2, central between the walls and c. 0.72m east of (*17). Constructed of firebrick and measuring 0.75m long x 0.73m wide and surviving to a single brick depth, the feature comprised a line of five bricks laid as headers with three bricks laid as stretchers along its east side, and a semicircle of half bricks then laid again to the east. Within the semi-circle were randomly placed broken firebricks and a brownish sandy silt deposit (**Fig. 14**).

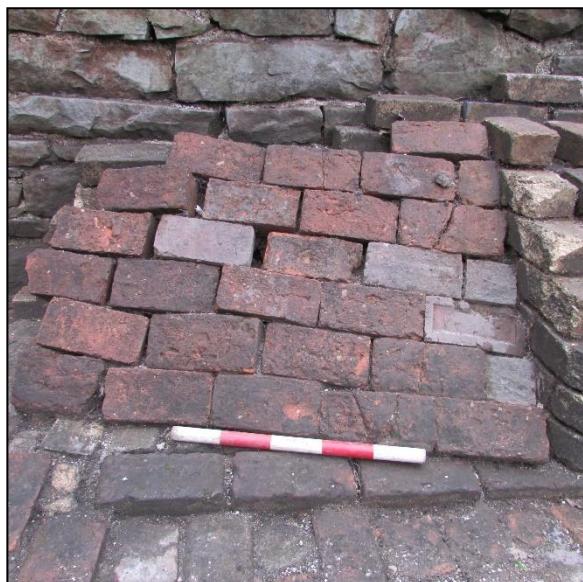
Figure 15. View of sloping wall (*55) abutting stone wall (043), with floor (*61) in the foreground. Looking north.

A red brick sloping wall (*55) was found which abutted (*61) along its southern edge and sloped upwards at an angle of approximately 45 degrees and abutted (*44) along its northern edge, and abutted the return wall of (*56) to the east (**Fig. 15**). Similar in construction to (*23) and (*24) it measured c.1.10m long x 0.68m wide and stood at a height of c.0.64m.

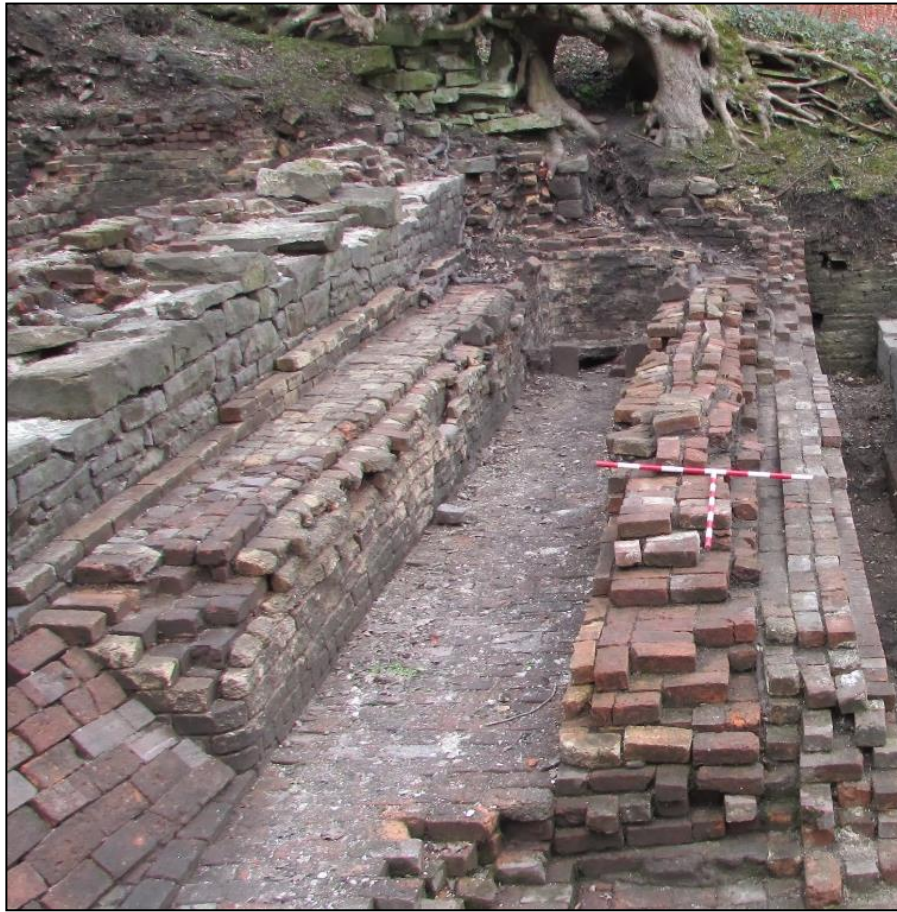
Figure 16.
General view
of the lower
boiler, Brick
Structure 1.
Looking east.

formed the central section and was aligned between (*44) along its northern edge and (*56) along its south edge (**Fig. 16**).

The top course was laid in stretcher and header bond, and was found to lie level with the floor (*61) of boiler bed 1 (**Fig. 16**). This wall was constructed on foundation stones as evidenced by several stones identified at the southern base of (*62) (**Fig. 18**). These foundation stones protruded c.0.08m and measured c.0.32m long, but were not fully excavated due to flooding. Wall (*62) abutted a large stone lintel (*63) at its west end which was aligned east – west and measured 1.02m long x 0.32m wide x 0.18m high. The east end of the lintel was keyed into (*62) for 0.20m while the west end was keyed into a red brick feature (*64) (unexcavated) for 0.30m which created a void under the lintel c.0.40m depth (**Fig. 19**).

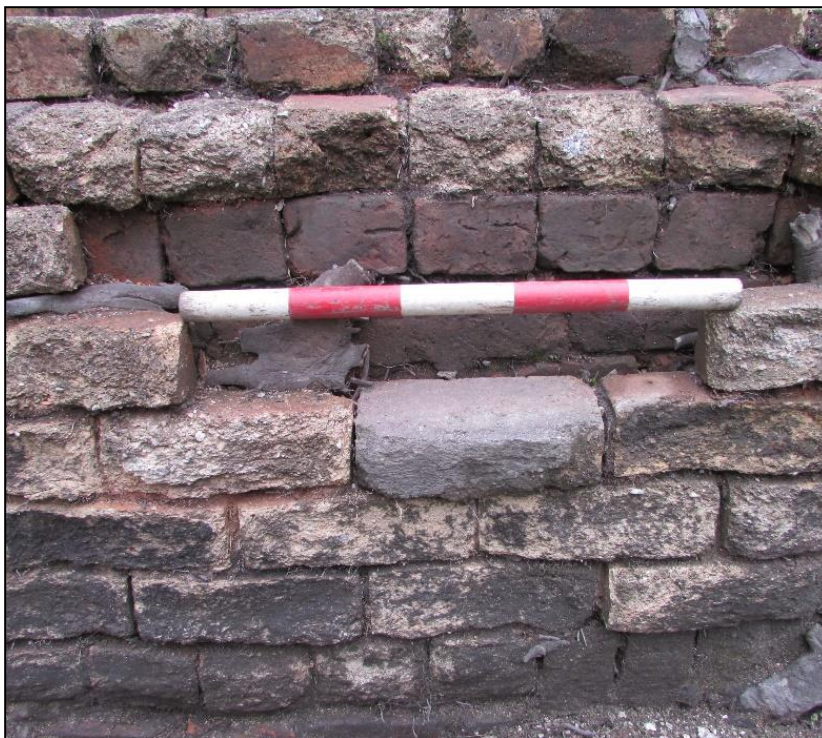
Figure 17. Detail
of exposed red
brick core of (*54).
Looking north.

A third firebrick section (*56) lay along the south face of (*54) with a short return that abutted (*44) at its northern edge and (*55) at its eastern edge. Although this wall was constructed in a similar manner to (*32), the top course comprised degraded half bricks along its entire length, with a central section severely truncated approximately 2.60m from the western end which exposed the red brick core of (*54) (**Fig. 17**).

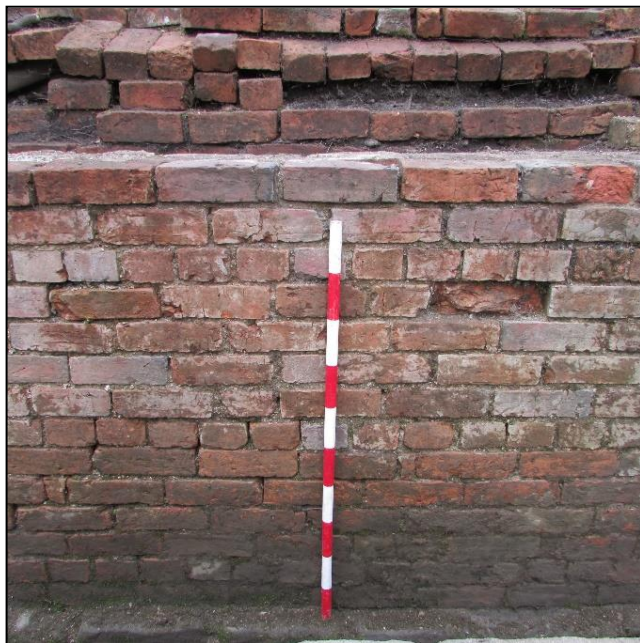
Figure 18. Detail of central section of wall (*62). Looking north.

A substantial red brick wall (*62) was identified orientated east – west which adjoined (*60) along its northern edge and abutted a large stone lintel (*63) at its western end. This wall measured c.9.00m long x 0.36m wide and was constructed of red brick laid in English bond, it survived to a depth of seven courses (0.48m) at its west end where it was heavily truncated, fourteen courses along the central section (1.10m high) (Fig. 18) and to a maximum of twenty two courses (c.1.50m) at its easternmost end (excavated depths).

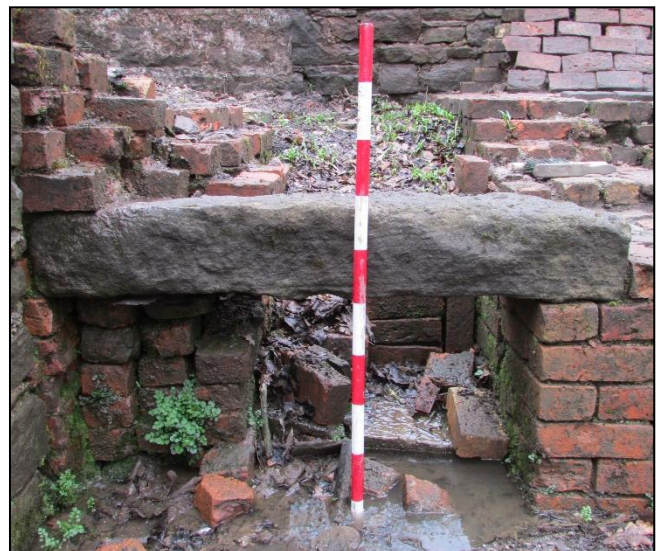
Figure 19. View of stone lintel (*63) showing depth. Looking north.

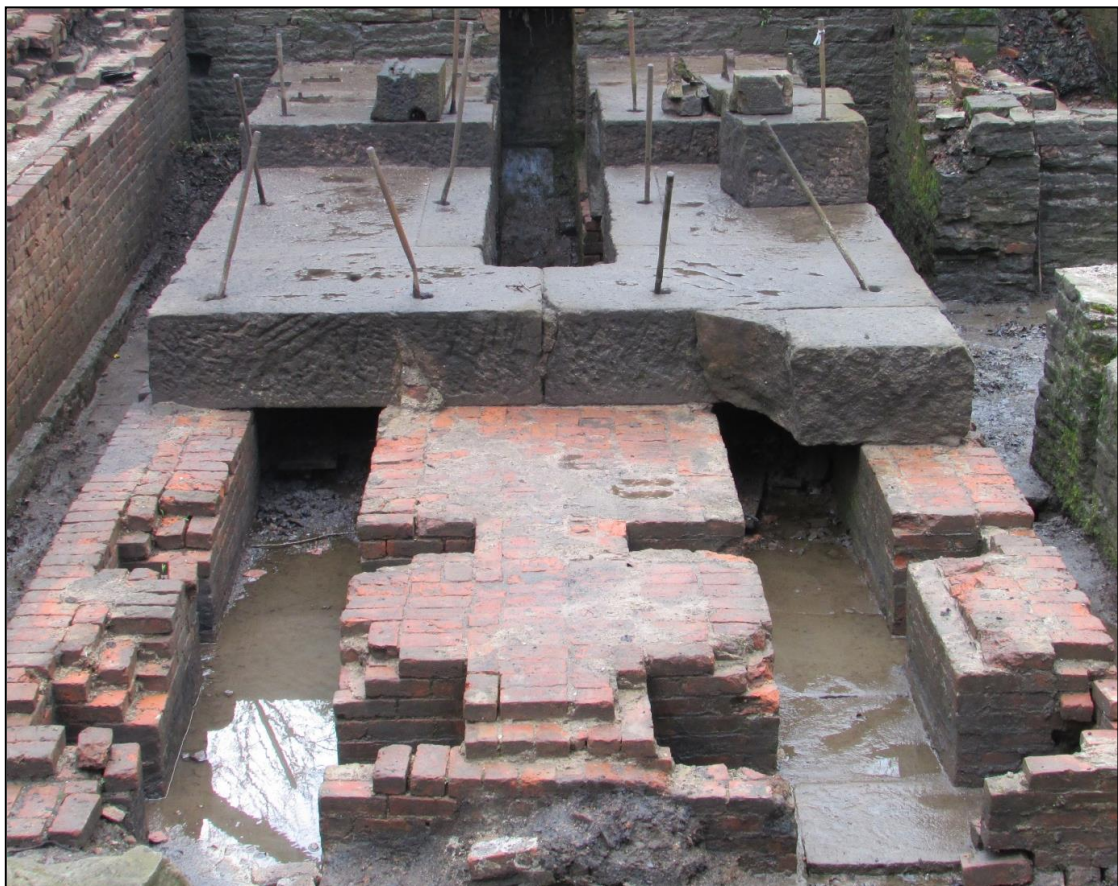
Figure 20. General view of steam engine bed (*69) with protruding iron bars, and red brick supporting plinths (*72) – (*74). Looking east.

The deepest feature identified within the excavation area occupied the far south eastern corner of Sub Division 2 and was revealed c.0.70m south of wall (*62). It aligned with the curved rear walls of the large brick structures and was dominated by a single large dressed stone surface (*68) supported on a red brick plinth (*72). The surface was orientated east – west and measured approximately 5.50m along its northern edge, 6.10m along its southern edge and 3.60m wide, it consisted of eight large symmetrical dressed blocks deliberately placed to create a central sunken area (*71) (**Fig. 20**).

Surface (*68) was found to be supported by three red brick plinths (*72), (*73) and (*74) orientated east – west, and laid 0.60m apart. Each plinth was constructed of seven courses of handmade red brick laid in a combination of stretcher and header bond with areas of smaller degraded red brick, and bonded with solid white mortar of which large patches were visible on the surface. While each plinth measured 3.30m in length, the central plinth (*73) measured 1.56m at its widest point, with two recesses built into either side. Each recess measured 0.48m long. The easternmost recesses of the central plinth measured a width of 0.30m and the westernmost recesses measured a width of 0.36m (**Fig. 20**).

The two outer plinths (*72) and (*74) unlike the central plinth, had straight outer sides which aligned with the north and south sides of (*68) (**Fig. 20**). Each plinth measured 0.56m at its widest point and had two recesses built into the inner side which measured c.0.34m x 0.30m. It is likely the red brick plinths continued to underlie (*68) as evidenced by the presence of a line of red brick laid east – west in header bond protruding out from under the northern side by 0.12m. The plinths (*72) – (*74) were constructed directly onto a flagged floor surface (*75) which measured approximately 3.30m x 3.40m although the size of individual flag stones could not be ascertained. The area below (*68) and around the base of the plinths have not been fully excavated due to repeat flooding of the lowest levels.

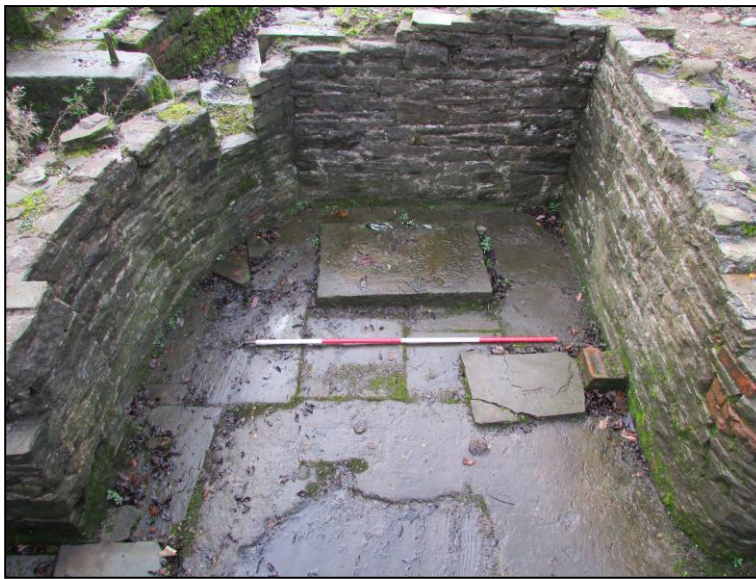
Figure 24. Wall (*80) & surface (*82). Looking south.

Lay on the southern side of (*82) measuring 1.25m x 0.70m which had the remains of four iron bolts associated with a square imprint on the face of the stone measuring 0.60m x 0.60m (**Fig. 24**). On the north-western side of the surface lay a small machine made frogged brick projection comprising two courses of brick wide and two courses high. The eastern extent of wall (*80) returned northwards and abutted the end of (*79).

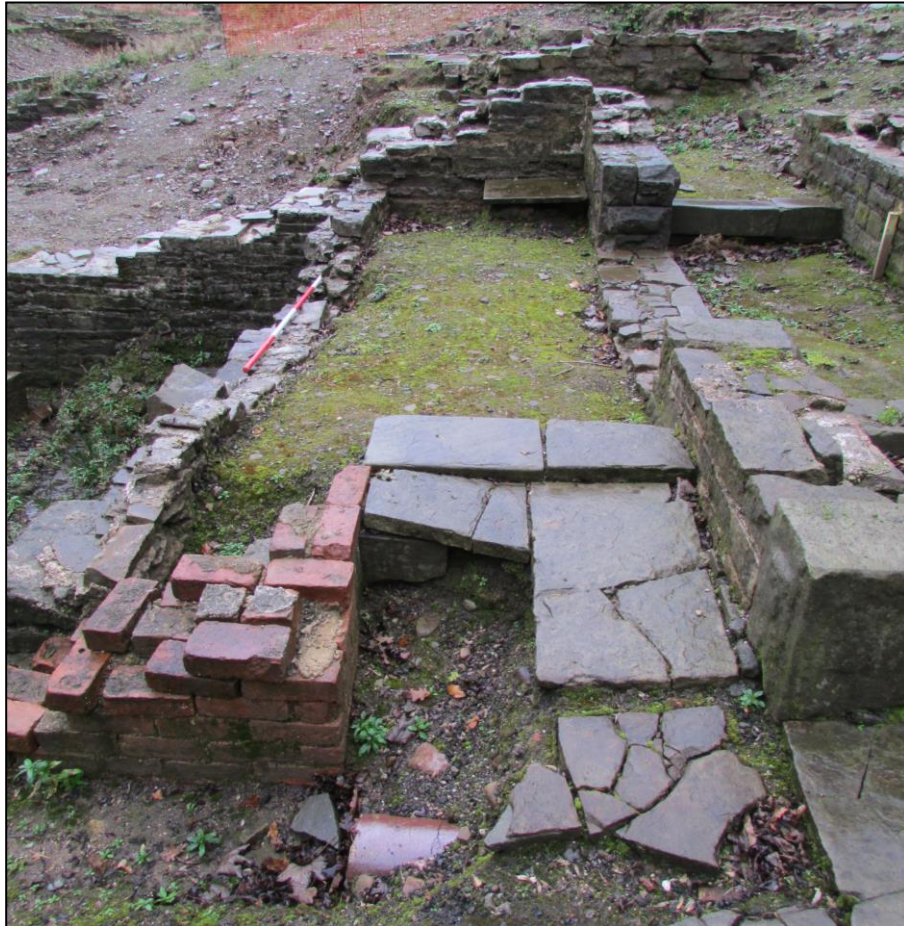
Figure 25. Walls *77 and *78, showing floor *81 in the background and *101 in the foreground. Looking southwest.

At the western end of wall (*79) and abutting it, two stone walls were identified; (*78) to the east and (*77) to the west (**Fig.25**). Both were constructed from dressed stone blocks with a rubble and lime mortar core measuring 0.35m wide and extending 2.50m north from (*79). To the north wall (*78) abutted a handmade brick structure (*101) which appeared to form the corner of a small narrow room to the west. The structure comprised an L shaped wall extending northwest 0.75m before returning southwest 0.90m measuring 0.34m wide and standing 6 courses high. Wall (*77) abutted surface (*39) to the north and had a central opening measuring 2.50m wide flanked by dressed stone blocks with ironwork protruding from their eastern faces. A single stone flag (*81) was revealed to lie between walls (*79) and (*77) but scars could be seen at the same level on all three walls including (*78) indicating that this surface formerly covered the space enclosed by these walls. To the west of wall (*77)

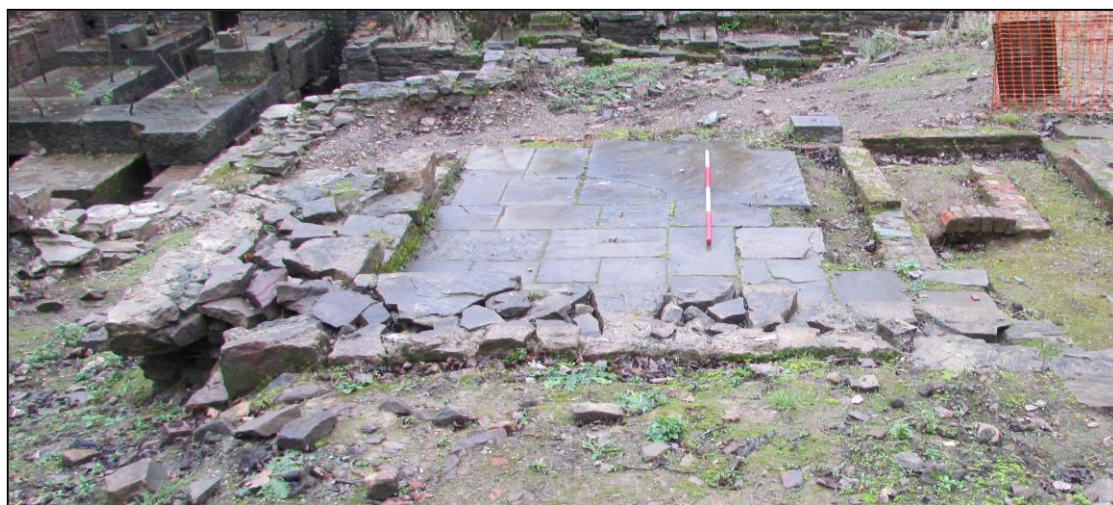
Figure 26. Walls *83 and *84 enclosing floor *86. Looking southeast.

To the southwest lay several stone and brick features which were in line with the northern end of the main mill structure. Two stone walls (*83) and (*84) were found to form the northern corner of a flagged stone surface (*86) abutted by handmade brick structures to the south (**Fig. 26**). Walls (*83) and (*84) were both constructed from dressed gritstone with a rubble and mortar core and measured 0.90m wide and 4.50m in length. Wall (*83) possessed an opening at its southern extent to accommodate an abutting U shaped brick structure (*89) measuring 0.90m x 0.90m. This was constructed from two course brick walls standing to a height of 0.80m with two small square openings supported by stone lintels on the southern and western sides. The southernmost of these openings appeared to correspond with the fragmentary remains of a stone culvert which abutted to southern face of (*89) (**Fig. 29**).

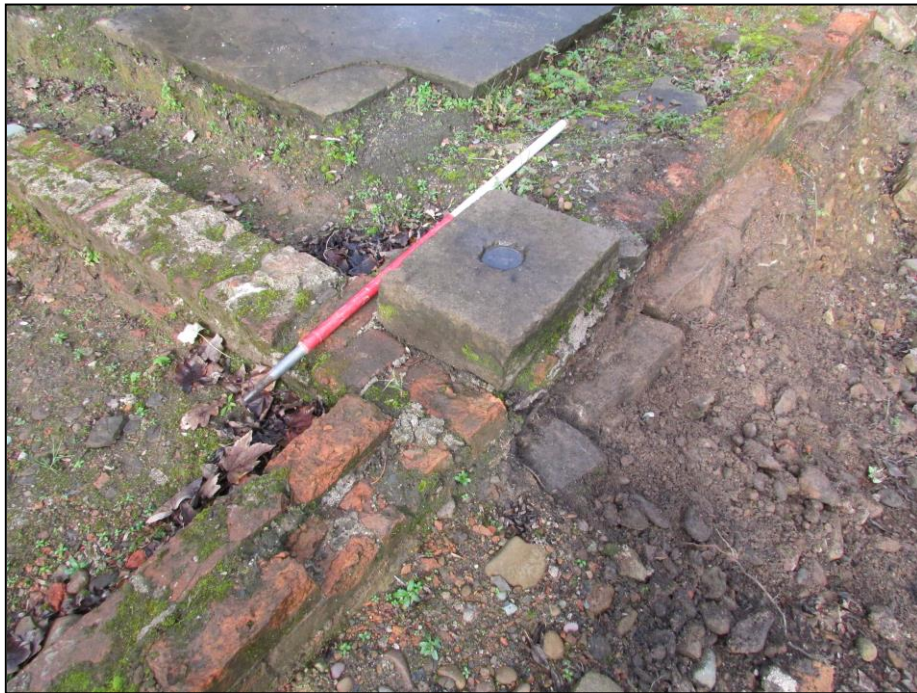
Figure 27. Wall *85 showing the central stone with hole. Looking north

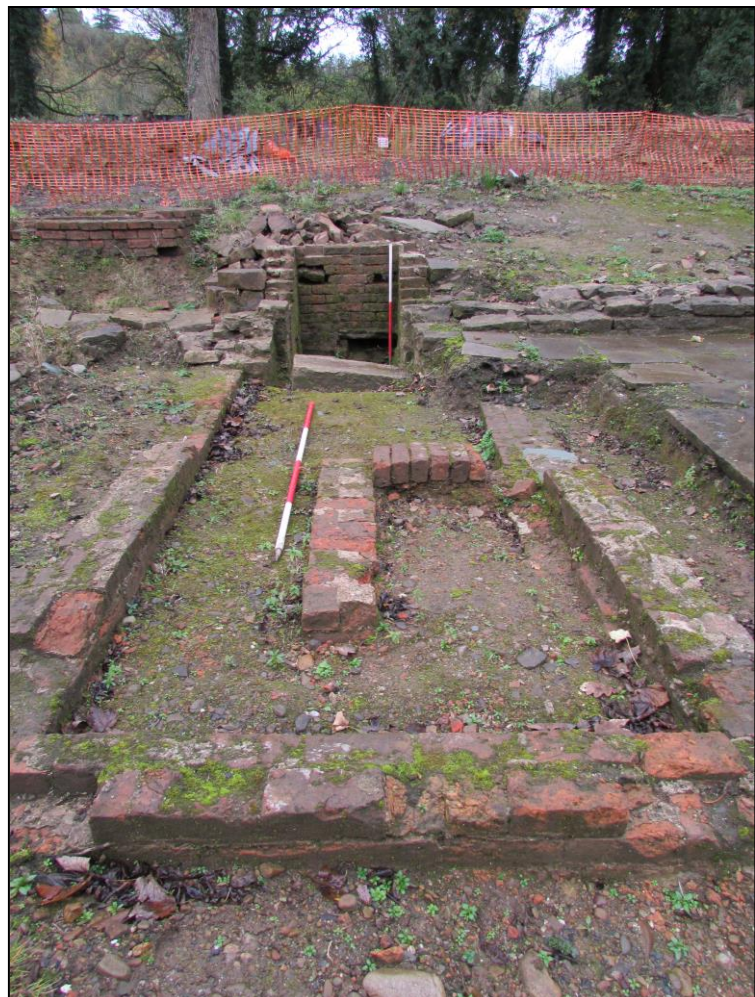
Figure 28. Brick features to the south of *86, showing walls *87 - *89 and *91 and *92. Looking northwest.

Surface (*86) comprised varying sized flag stones between 0.30m-0.80m and abutted walls (*83), (*84) and (*85) but lay approximately 0.25m higher than (*87) which appeared to continue below the surface to the north. Wall (*85) was constructed from two courses of degraded brick laid on a single course of gritstone blocks with a central square stone block possessing a circular hole (**Fig. 27**). The wall formed the south-eastern boundary of the surface and continued southwards to abut wall (*88). Wall (*87), measuring 2.60m long, lay along the southern edge of (*86) and was constructed from handmade bricks laid two courses wide (0.24m) in stretcher bond with fragmented evidence of a projecting foundation course. The wall was abutted in the centre of its southern face by a small handmade segmental brick arch (*91) which measured 0.23m x 0.75m running northeast-southwest. The arch was in turn, abutted by another, shorter handmade brick wall (*92) measuring 0.23m x 1.30m laid in header bond (**Fig. 28**). Approximately 0.50m south of this lay wall (*88) which was

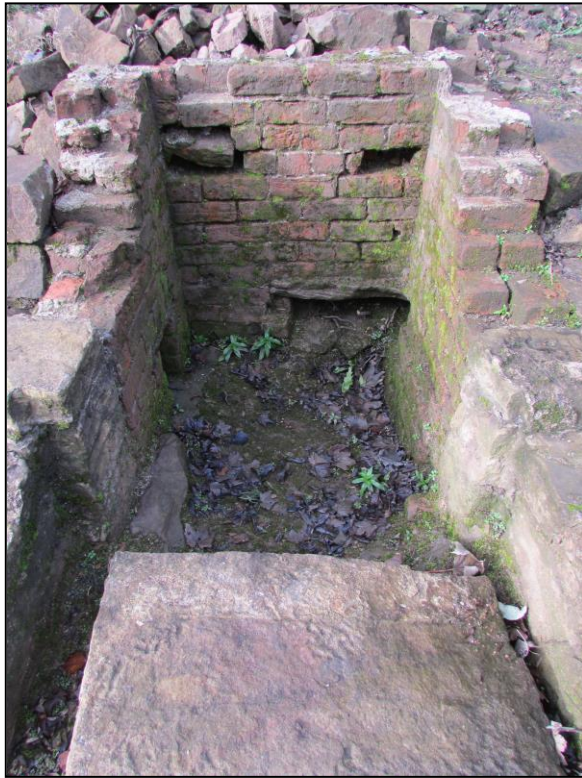
Figure 29. Detail of wall *89 showing the lower openings. Looking northwest.

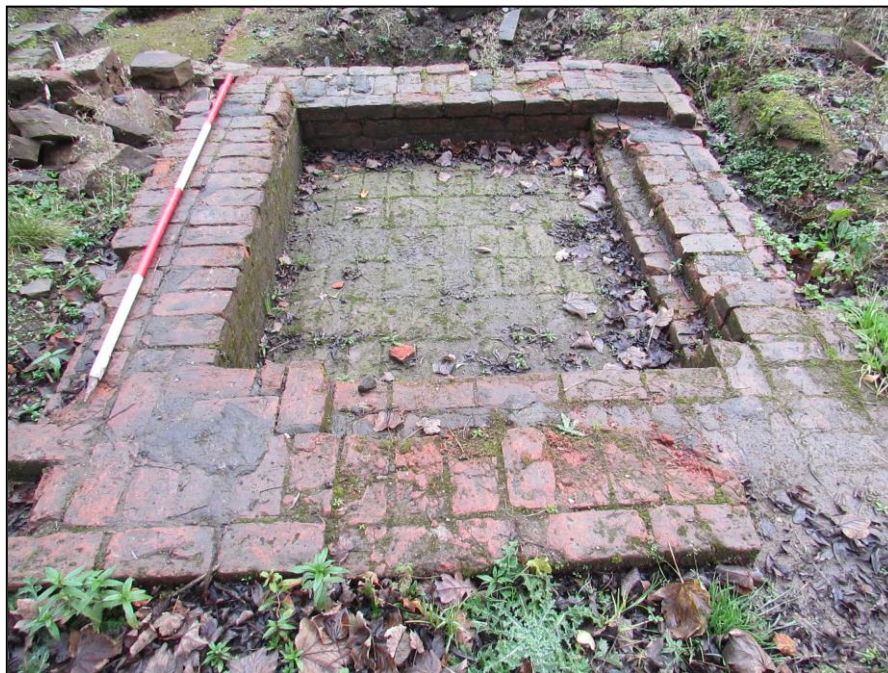
Figure 30. Handmade brick feature *93. Looking southeast.

Approximately 1m west of (*89) lay a small rectangular handmade brick feature (*93) measuring 2.50m x 2.80m, comprising 0.48m wide outer walls surrounding an inner brick surface (*94) (**Fig. 30**). The walls forming (*93) were laid with black mortar in what appeared to be English Garden Wall bond, four courses wide. Surface (*94) lay at a depth of 0.48m (four courses) and measured 1.50m x 1.80m. The whole structure was constructed directly onto the natural sand and gravel and showed no evidence of fixtures or fittings.

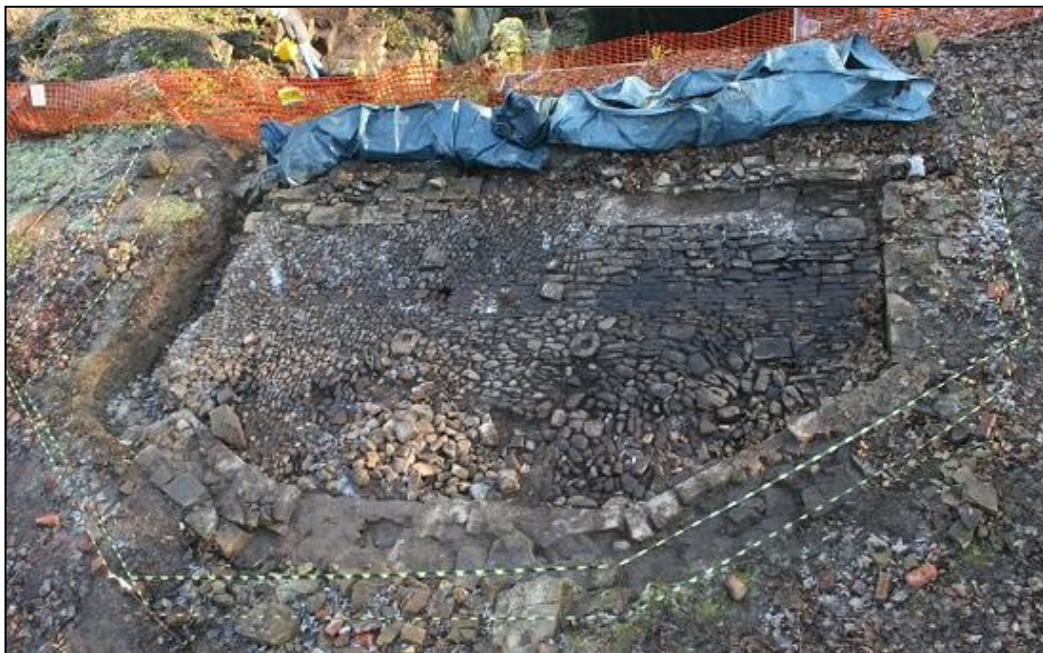
Figure 31. Cobbled area to the west of the Wellington wheel pit. Looking southeast.

Although not part of the recent excavations of the mill and engine house, one of the earliest areas of the mill to be excavated by TAMAS was the cobbled area immediately west of the Wellington Wheel pit (**Fig. 31**). The excavation revealed an area of sub-rounded cobbles of varying sizes between 0.05m-0.25m (*97) which was enclosed by a large canted gritstone wall (*95). The wall was constructed from dressed stone blocks on the exterior faces with a rubble and mortar core and measured 1.00m x 17.50m in total, abutting wall (*96) to the east. Wall (*96) was of a similar construction to (*95) but measured only 0.50m in width and formed the eastern boundary of (*97). Surface (*97) was found to slope inwards to a channel on the eastern side of the space which continued northeast-southwest across the full length of the surface and which had two central carved stone drainage holes measuring 0.18m diameter *c.* 1.50m apart. In addition, four larger cobbles (*99) were identified at 1.85m intervals across the centre of the surface which had square holes measuring 0.12m x 0.13m cut into them. An area of flag stones (*98) was revealed abutting the western face of (*96) which measured 0.70m in width and continued to abut (*95) to the north and south. The northern and southern halves of the surface had been separated by a 2.40m wide continuation of (*97).

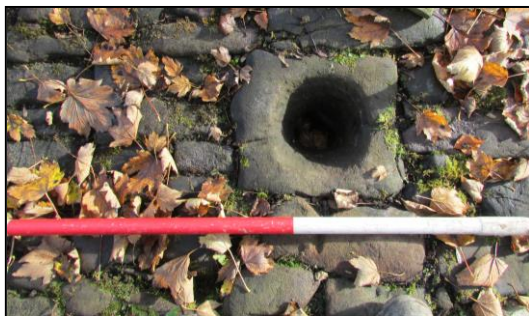
Figure 32. Detail of drainage hole in *97.
