**Community
Archaeological
Excavation**

Mellor Mill

Report No: SA/2017/45

Document title: Archaeological Excavation: Mellor Mill

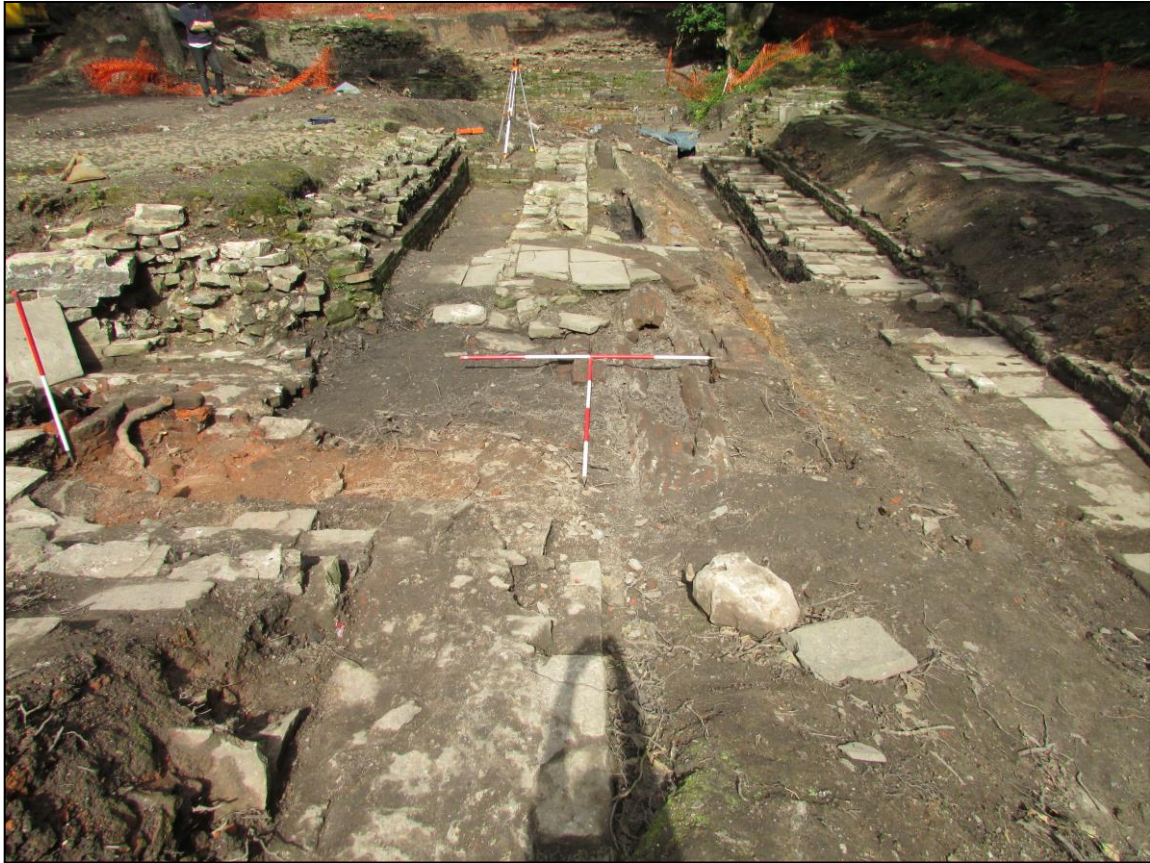
Figure 34. General view of SA Area. Looking north.

This area incorporated the remains of the northern end of the main mill building comprising the three storey wing and projecting six storey tower. The excavation area measured 22.00 x 14.00m and was aligned northeast-southwest.

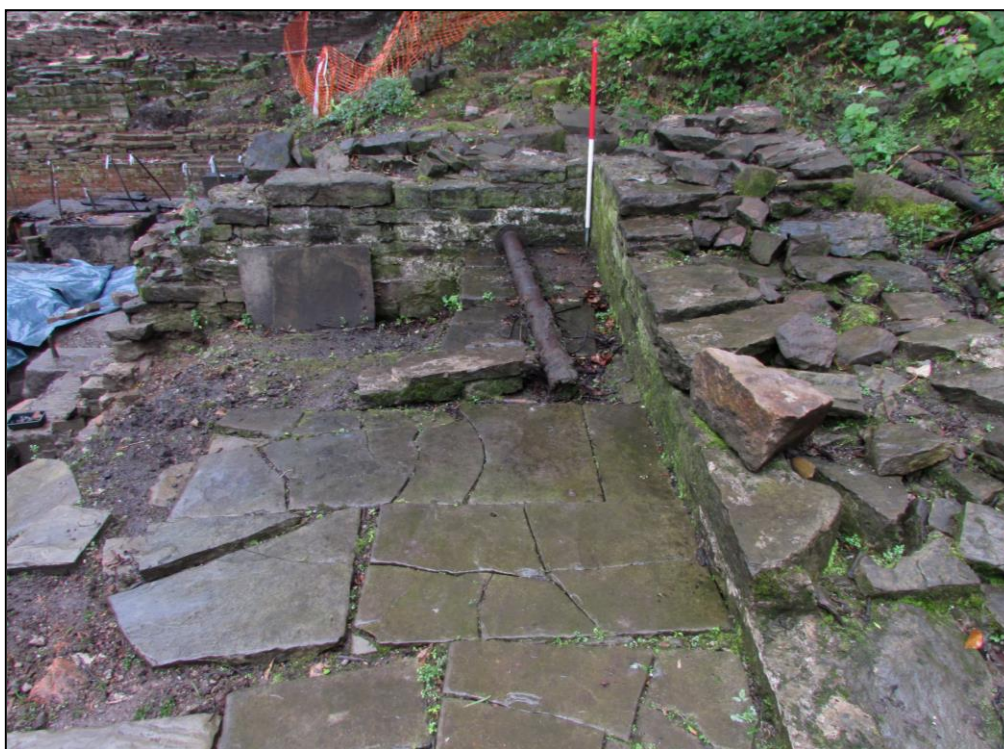
Figure 35. Junction between walls (004) and (005) showing broken floor (006). Looking northeast.

although no foundation cut was observed, however the lower core of the wall appeared to be made up of this natural deposit. A stone flagged surface (006) was revealed to lie between and abutting (004) and (005) but was heavily truncated to the west where the underlying natural ground dropped away steeply (**Fig. 36**). This surface was comprised of stone flags of varying sizes around 1.04m x 0.70m 75% of which were broken or cracked.

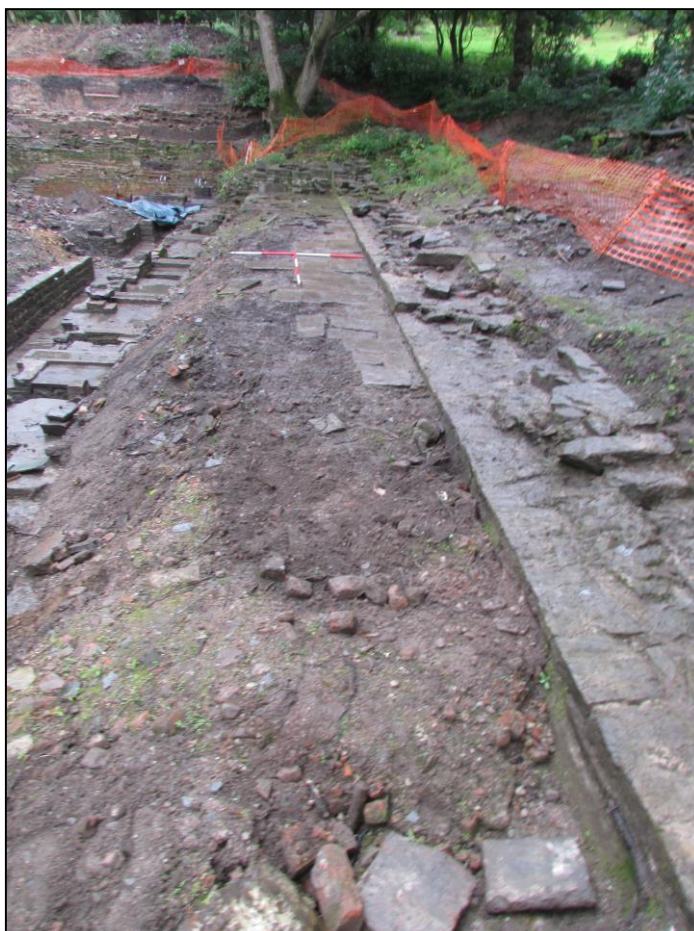
Figure 36. General view of higher eastern level of the mill showing wall (005) and floor (006). Looking northeast.

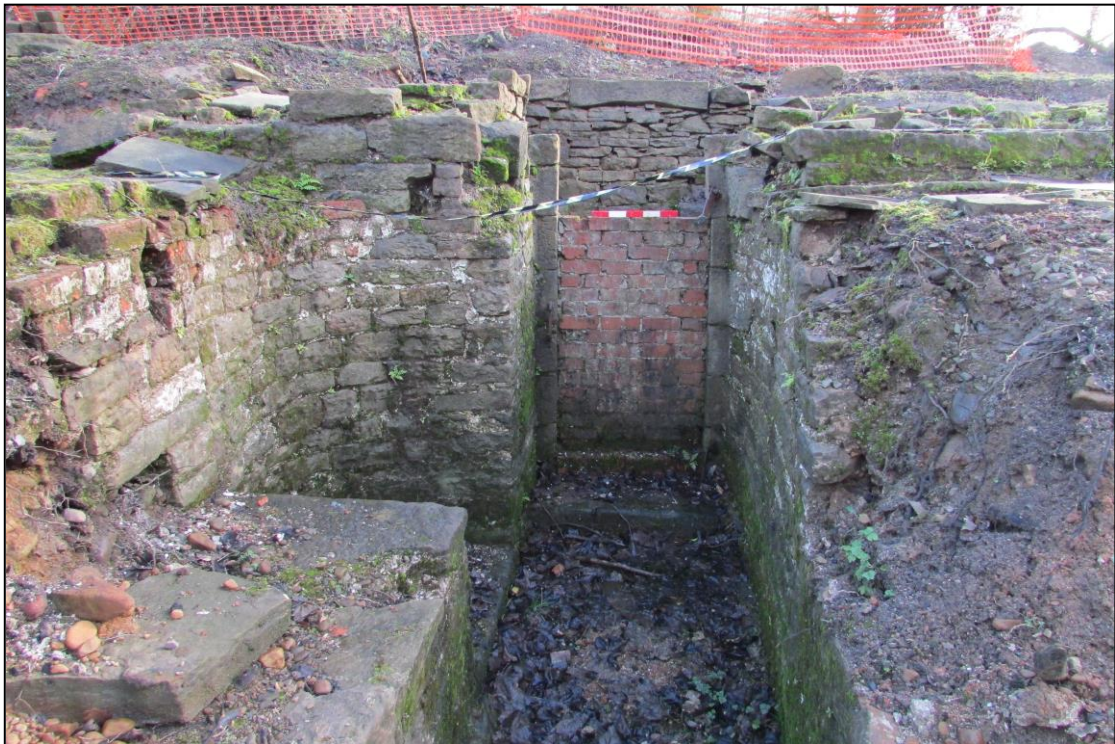
Figure 37. Staircase area to the south of (034), showing (034) with integrated stair case, blocked doorway in wall (005) and wall (038).

The south-western end of (006) abutted a third stone wall (034) which was almost identical to (004) and (005), constructed of dressed, coursed gritstone blocks with a rubble and natural core. Wall (034) measured 1.00m wide, 2.00m long and stood to a height of *c.*2.00m and was bonded with white mortar. The south-western face of the wall was clearly visible as it formed the boundary of a small basement room to the south of the flagged area, into which was set a truncated curving flight of 3 stone steps leading to the ground floor. This room measured 1.08m x 3.69m and was bounded to the south by (038) a stone wall comprising dressed blocks *c.*0.25m x 0.40m laid with white lime mortar, to the northwest by a single course of handmade brick (046) which blocked an earlier opening in wall (007) and to the southeast by a single course brick wall (041) made from frogged machine made bricks stamped with the name 'Tymm' which blocked an doorway in the main mill wall (005) (**Fig. 37**).

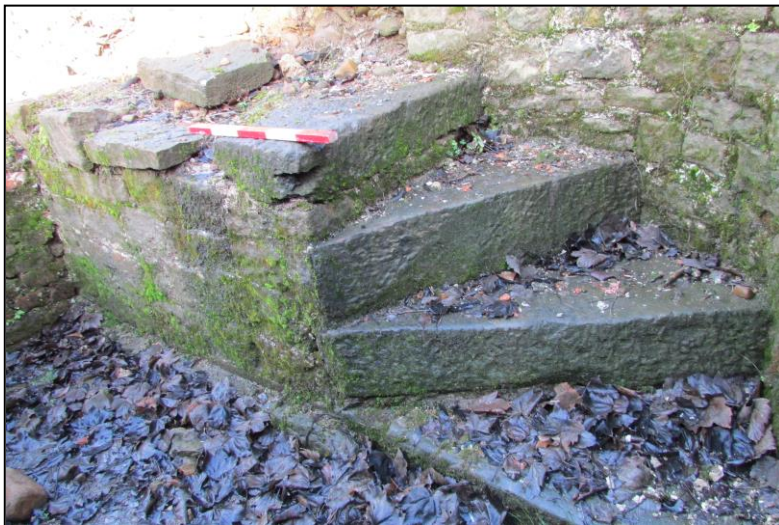
Figure 38. Staircase set within (034). Looking north.

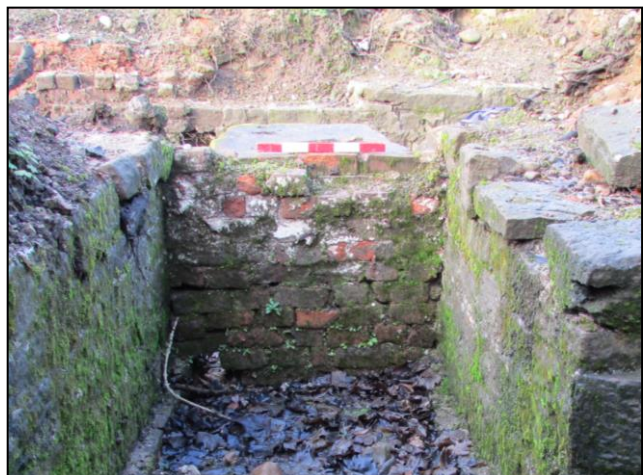
Figure 39. Below. Brick blocking (046) in wall (007). Looking northwest.

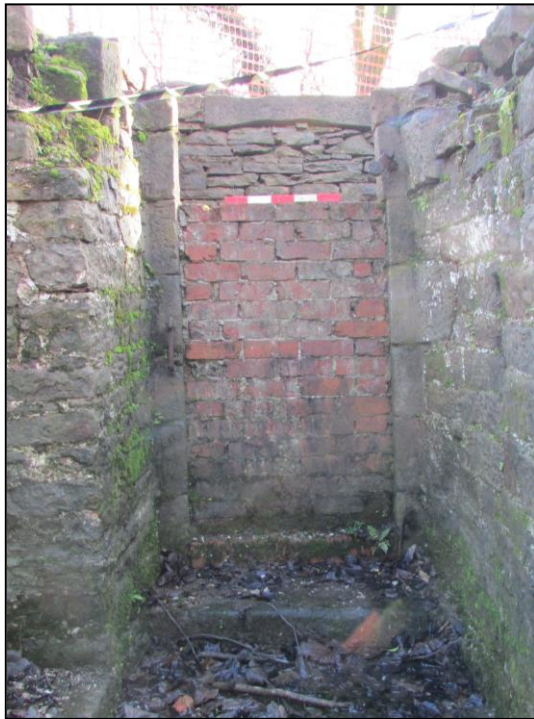
Figure 40. Blocked doorway in wall (005).
Looking east.

This doorway had a single step up to it and retained both the hinges and latch fastened into the stonework (**Fig. 40**). To the southeast of this wall lay an external flight of 8

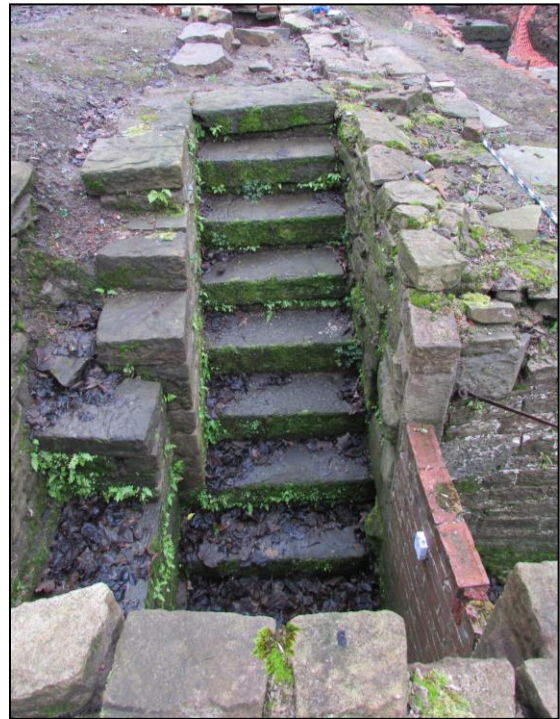
Figure 41. External staircase area (040)
To the east of (005). Looking south.

stone steps (040) enclosed by a dressed stone wall (039) and leading up to the rear of the mill (**Fig. 41**). This wall measured 0.50m x 3.83m comprised of two sections of

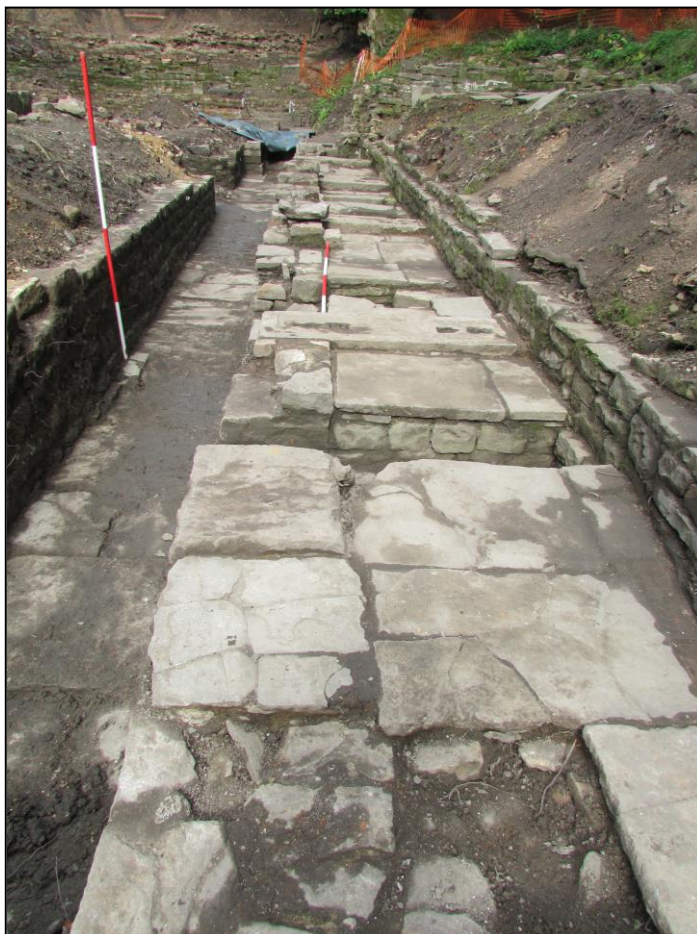
Figure 42. General view of
surface (010) showing sunken
sections, supporting wall (011),
flagged surface (012), stone
blocks (009) and wall (007).
Looking northeast.

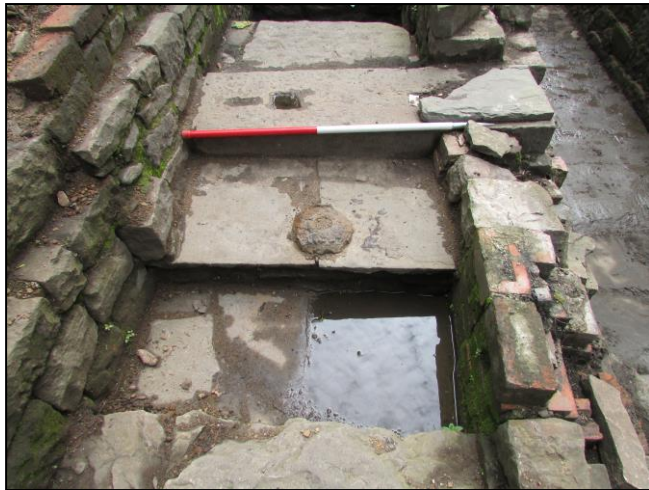
Figure 43. Detail of pierced stone block (009) and sunken section in (010). Looking southwest.

Both walls (004) and (034) and floor (006) appeared to have been truncated by the construction of a group of more deeply buried structural linear features. Abutting the western ends of walls (004) and (034) lay a single course gritstone and sandstone wall (007) constructed from roughly dressed, regularly coursed blocks and bonded with solid white mortar (**Fig. 42**). The wall measured 0.36m wide x 0.65m high, was aligned northeast-southwest and was constructed directly against the natural deposit (003). A number of repairs could be seen along the wall made visible by the use of brick rather than stone (**Fig. 43**). Running alongside the western face of (007) a stone flagged surface (010) was revealed which had a number of sunken sections interspersed with pierced sandstone blocks (009) (**Fig. 43**).

Blocks (009) abutted (007) to the east and were cut into the retaining wall (008) to the west of surface (010) (**Fig. 43**). Wall (008) was constructed from roughly dressed Sandstone blocks bonded with white mortar and aligned northeast-southwest with a projecting foundation course. The wall ran parallel to (007) with a curving section at its northern end where it abutted a large Sandstone block set within (004). Wall (008) measured 0.50m wide x 0.82m high x 18.80m long The blocks used to construct (008)

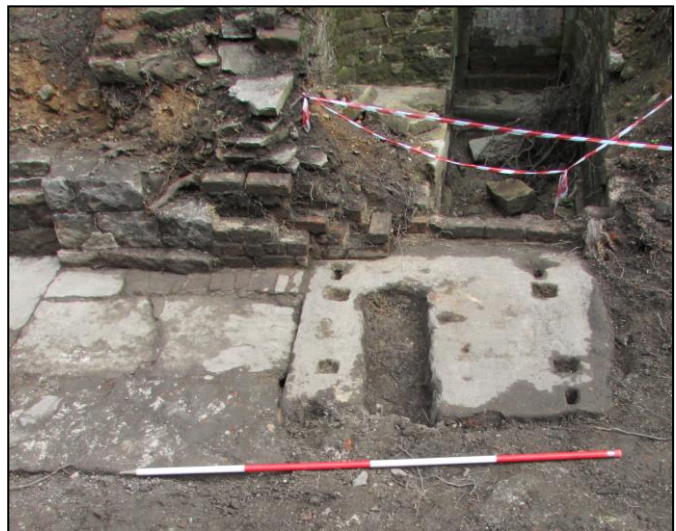
Figure 44. Detail of larger stone block at south-western end of (010) showing truncated remains of wall (034). Looking southeast.

Although the linear arrangement of blocks and walls continued at this level as far as the central wheel pit of the mill, their character within the six storey section of the building was entirely different and is thus described as a separate section. All of the blocks identified as (047), to the south of the terminus of (009) and (010), were of a similar size to it and unlike the smaller ones to the north, lay on individual brick plinths with large gaps of between 1.20m and 2.35m between each block. Two types of block were revealed in this area, four larger examples measuring c.1.50m x 1.70m with four fixing holes and two central T shaped grooves and four smaller, measuring c.0.80m x 1.70m with two holes and a rectangular recess, similar to the blocks of (009). The northernmost block, however, measured 1.36m x 1.45m with the same square and rectangular holes in each corner but had a large recess extending 1.00m from its western edge and measuring 0.25m wide, lying just to the northeast of centre (**Fig. 44**).

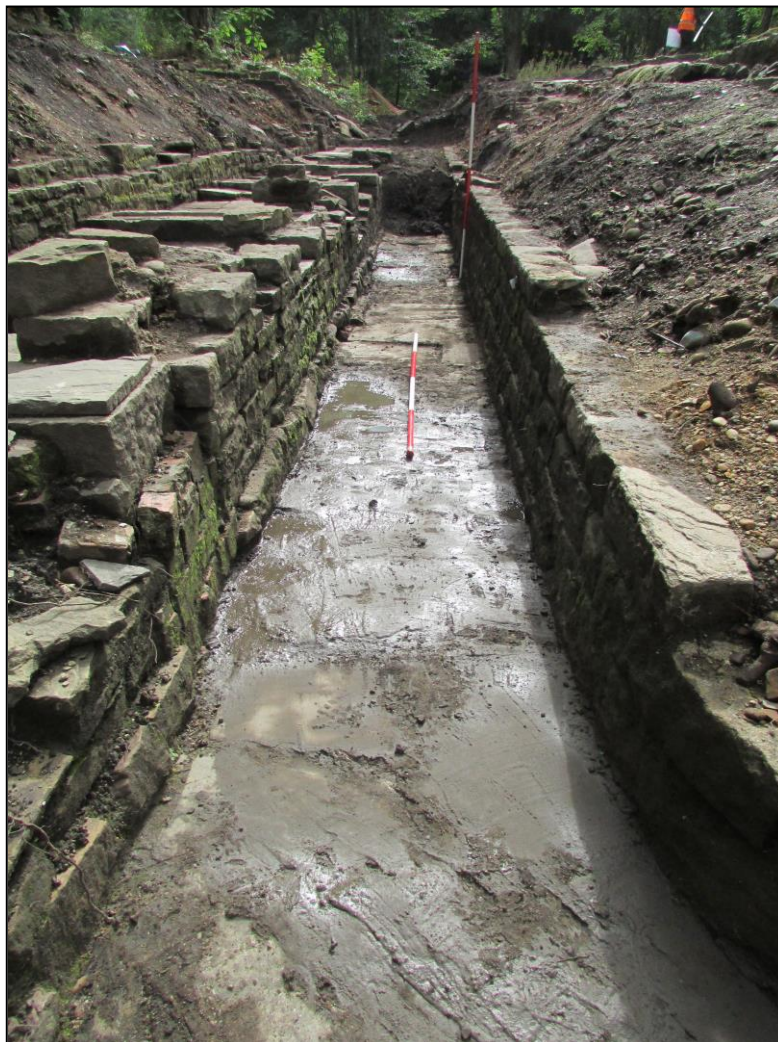
Figure 45. General view of walls (008) and (013) lying either side of surface (012), before excavation continued further southwards. Looking southwest.

A narrow flagged floor surface (012) was identified lying between (008) to the southeast and (013) and (014) to the northwest at a level approximately 0.85m lower than the level of (010) (**Fig. 45**). The surface measured $1.00\text{m} \times 45.00\text{m}$ and comprised stone flags measuring $c.0.90\text{m} \times 0.65\text{m}$ with occasional smaller flags used as packing/repairs. The surface continued to the northwest between the western returns of walls (013) and (014). Walls (013) and (014) were almost identical in nature to (007) as they were both constructed from a single course of dressed gritstone and sandstone blocks measuring $c.0.28\text{m} \times 0.13\text{m}$ and stood to a height of 0.74m (5 courses) (**Fig. 44**). Approximately 3.00m south of the northern limit of excavation both walls possessed a north-western return with a curved corner which extended $c.3.75\text{m}$

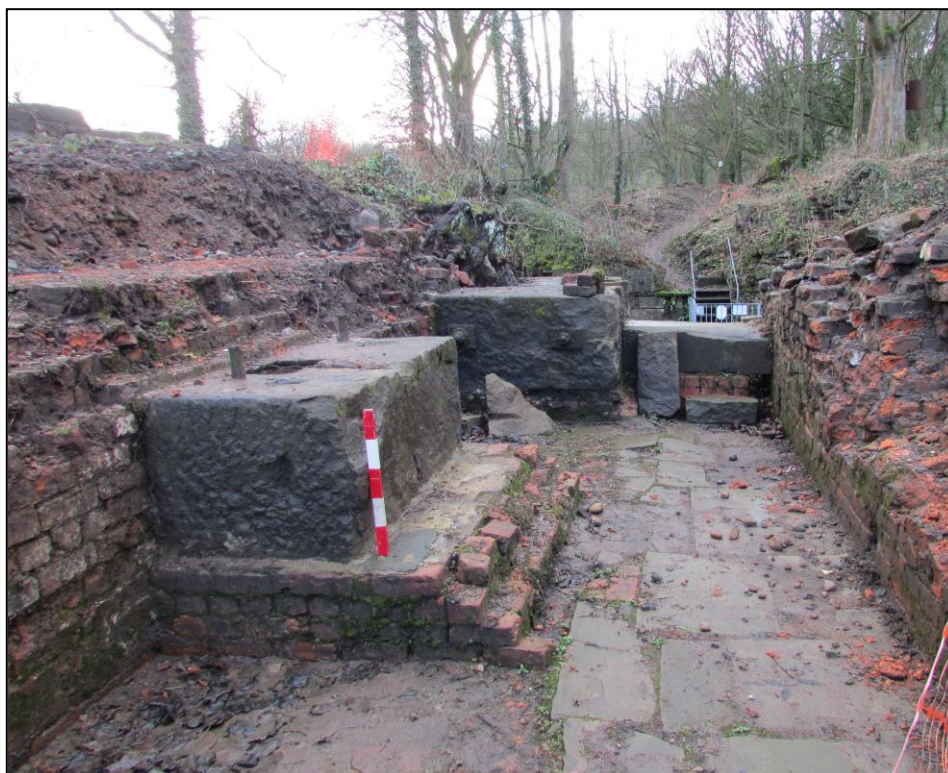
Figure 46. Southern section of channel showing blocks (047), flags (012) and walls (007) and (013). Looking south.

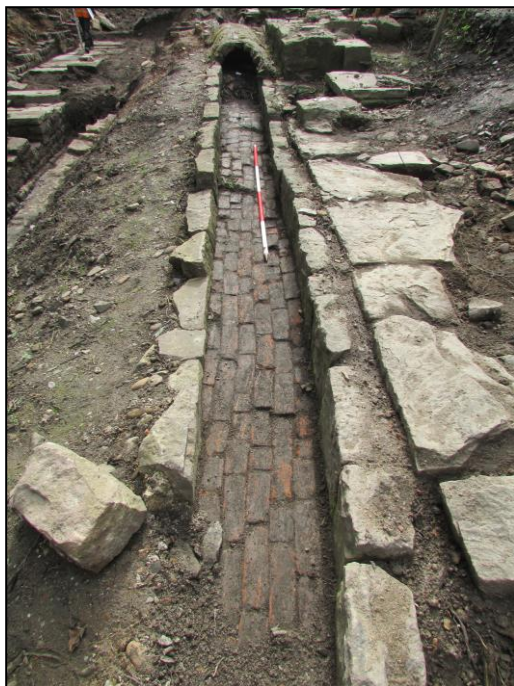
Figure. 47. General view of (015). Looking Southwest.

A concentration of brick and stone features were found at the north-eastern end of the main mill building, approximately 1.50m west of (013) at a level *c.*1.35m higher than surface (012). The first of these to be encountered was a linear feature (015) constructed from a handmade brick base with stone uprights and a vaulted brick top, although this was missing in places, all bonded with a very solid white mortar (**Fig. 47**). Feature (015) was aligned northeast-southwest and measured 0.70m wide x 12.00m (excavated length) x 0.60m high from the brick base to the top of the vaulted arch (**Fig. 48**). The feature was filled by (019) a very dark black brown loam with frequent finds of corroded iron objects, 19th century ceramics frequent fragments of animal bone and a piece of corroded copper. The north-eastern end of this feature was truncated by the growth of a tree meaning the relationship between this and the north-western return of (013) could not be ascertained. At its south-western end this feature was overlain by a brick and a stone flag surface (026) and (020) respectively, before continuing southwest beyond the limit of excavation. At its north-western end the western side of (015) was found to lie against a row of a badly damaged stone blocks (016) (**Fig. 49**). This feature measured 0.63m x 4.00m and was composed of 6 stone blocks with dressed eastern faces and roughhewn western faces. It was abutted to the

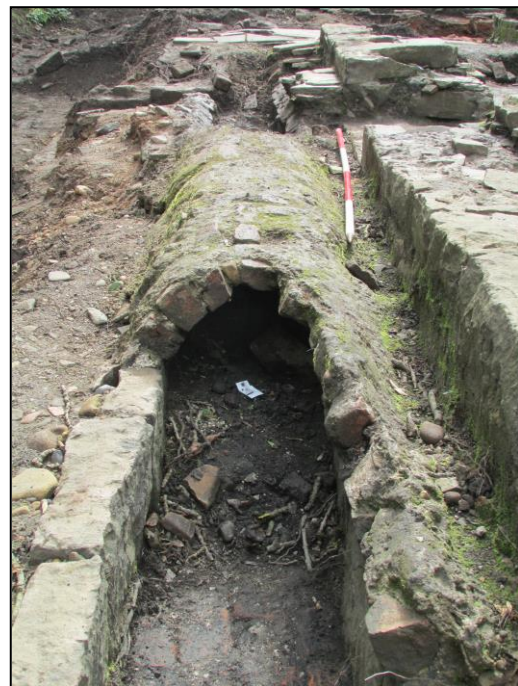
Figure. 48. Detail of vaulted top of (015). Looking southwest.

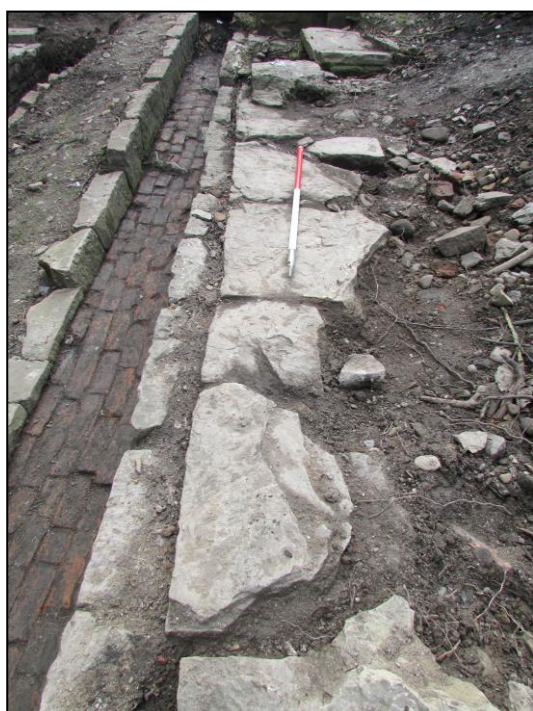
Figure 49. Detail of stone blocks (016)
Looking southwest.

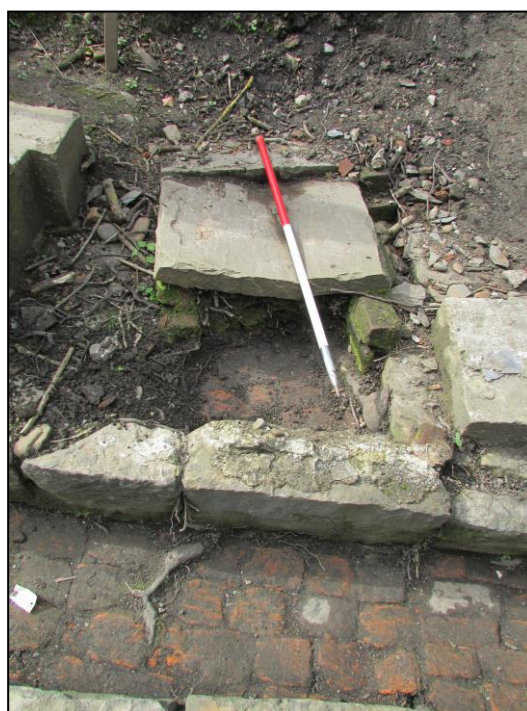
Figure 50. Structure (017) showing (015) in
The foreground. Looking west.

Southwest by a stone and brick covered channel (017) which continued west beyond the edge of excavation measuring 0.73m wide x 1.50m excavated length x 0.32m deep (**Fig. 50**). The feature had a similar handmade brick base to (015) with 2 courses of bricks to either side forming the walls which were capped by gritstone slabs measuring *c.*0.75m x 0.55m x 0.05m thick. Channel (017) had been truncated at its

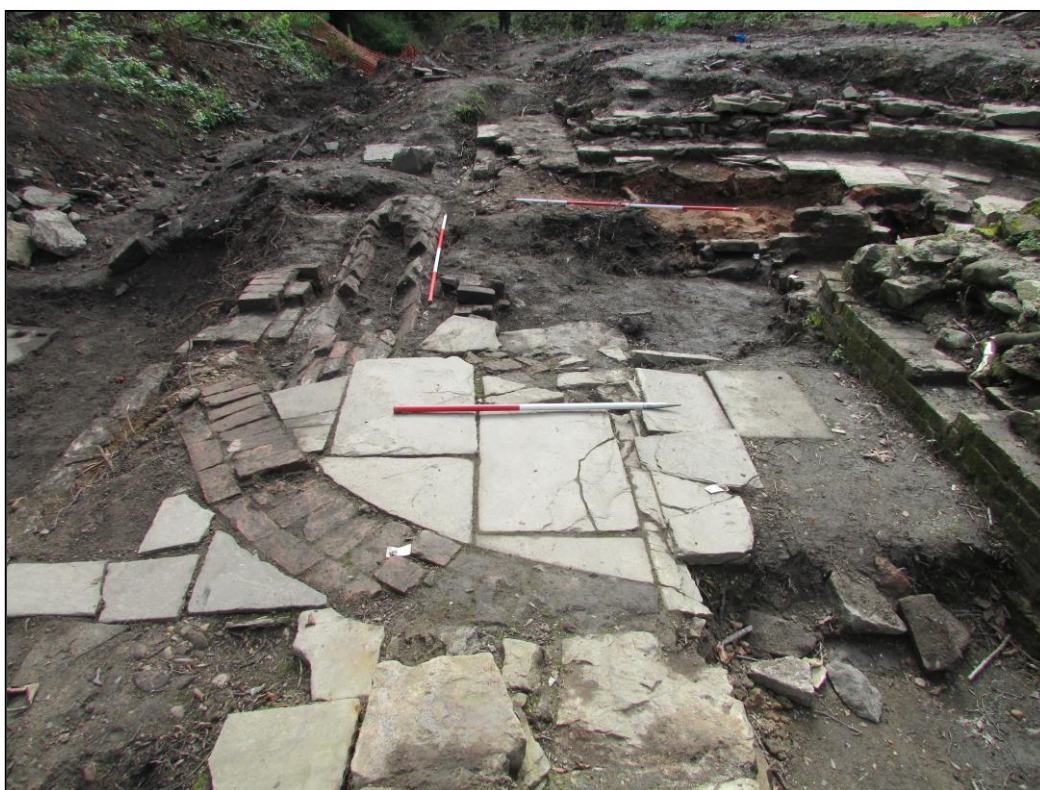
Figure 51. Features on the raised north-western part of Area 1 showing deposit (035) and (015) in the background, surfaces (020) and (026) and walls (018) and (027) in the foreground centre and left respectively. Looking southwest

A gritstone wall (018) was identified lying approximately 0.50m southwest of (017) which measured 0.88m wide x 7.60m long and stood to a height of 0.42m (**Fig. 51**). The wall was constructed from dressed gritstone blocks with a narrow rubble core bonded with white mortar and had a slightly projecting foundation course. At the north-eastern end of the wall a single well dressed large block spanned the width of

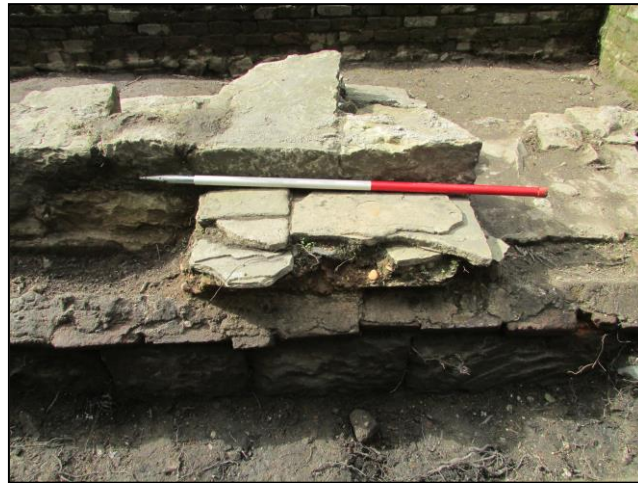
Figure 52. The fragmentary remains of possible surface (033) showing (015) in the foreground and (018) in the background. Looking northwest.

(017) which had a stepped cut reminiscent of a doorway or opening, although no other evidence was found to support this. A single broken flag stone (033) was revealed to lie against the south-eastern face of (018) which overlay the remains of (015) (**Fig. 52**). This appeared to be the only remaining piece of a larger surface which may have been associated with (006) or (020). The south-western end of wall (018) abutted (026) a curved brick surface. Approximately 2.40m from the north-eastern extent of (018) a second stone wall (027) was identified which was similar in nature to (018) but which had an internal single course of handmade bricks with an underlying stone foundation course (**Fig. 53**). The stone courses of wall (027) were abutted to (018), however the

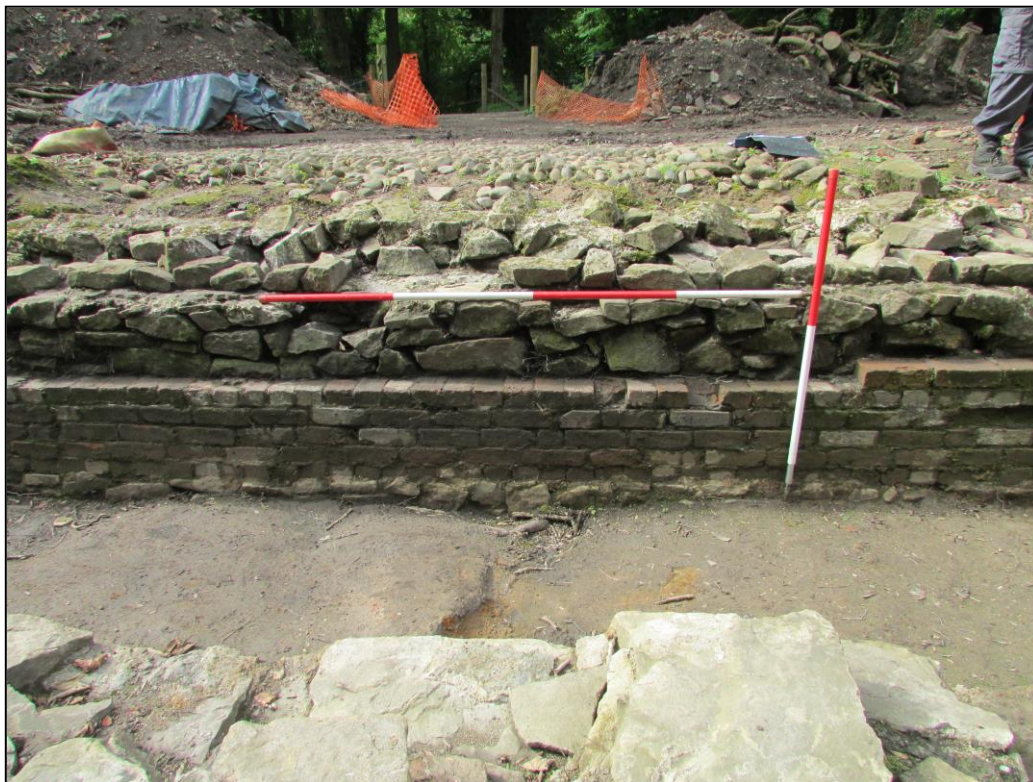
Figure 53. South-eastern face of wall (027) showing internal brick course, stone footings and rubble core with (018) in the foreground. Looking northwest.

Brick lining course was keyed into the lower courses of (018) indicating that the two were constructed at the same time. Wall (027) measured 0.90m x 9.00m x 0.75m and was aligned northeast-southwest with a south-eastern return abutting (018). To the southwest wall (027) was revealed to abut a semi-circular stone wall (037) measuring 1.00m x 7.30m (**Fig. 55**). It was constructed from dressed, coursed stone blocks measuring c.0.0.30m x 0.40m x 0.15m with a rubble core and bonded with white mortar. Wall (037) abutted an almost identical stone wall (036) which continued southwest beyond the limit of excavation. The wall was composed of dressed gritstone blocks with a rubble core and measured c.1.00m wide. This wall was not fully excavated therefore no further measurements were taken.

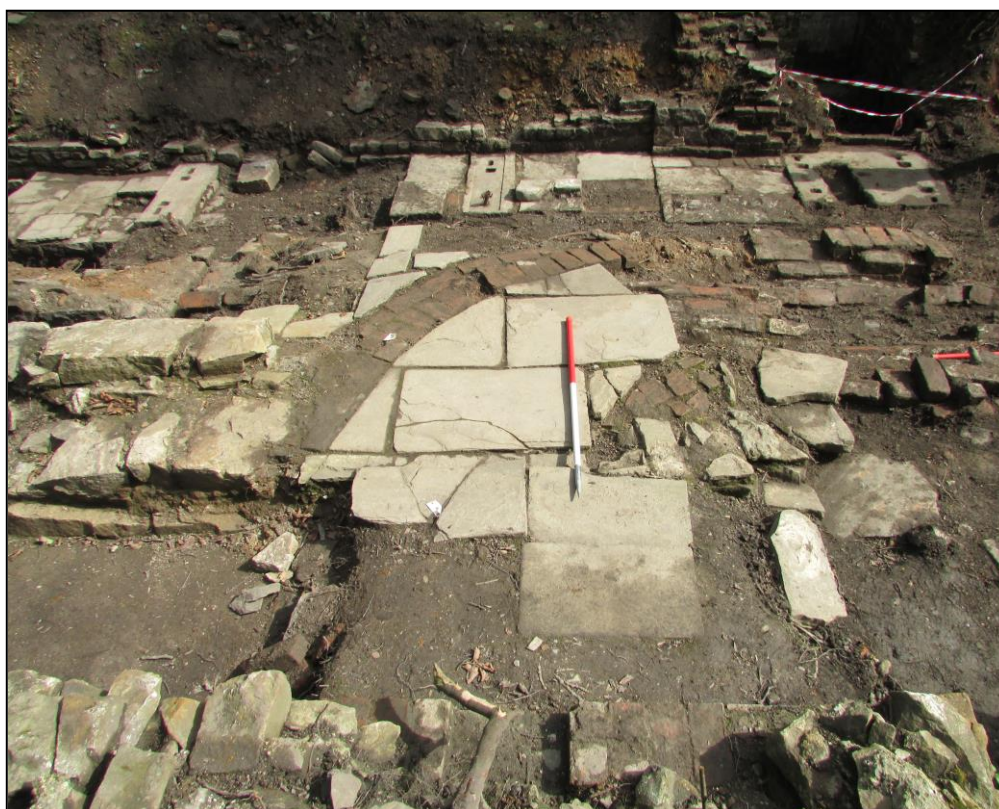
Figure 54. General view of surfaces (020), (026) and (031). Looking southeast.

A number of *in situ* structures and surfaces were found to lie within the area enclosed by wall (037) but all had been damaged or truncated by a large tree bole in the centre of this area. At the south-western end of wall (018) the truncated remains of surfaces (020), (026) and (031) were identified to be lying at the same level and overlay (015) (**Fig. 54**). Surface (020) measured 1.60m x 2.70m and was composed of stone flags measuring c.0.50m x 0.70m x 0.08m. Surface (026) was set within and lay flush with (020) and comprised 2 courses of handmade brick which curved round from northwest to southeast. This feature measured 0.36m x 2.90m and had been truncated to the south. Surface (031) which was also composed of handmade brick, was considerably shorter than (026) and far more badly damaged however the cut edge in

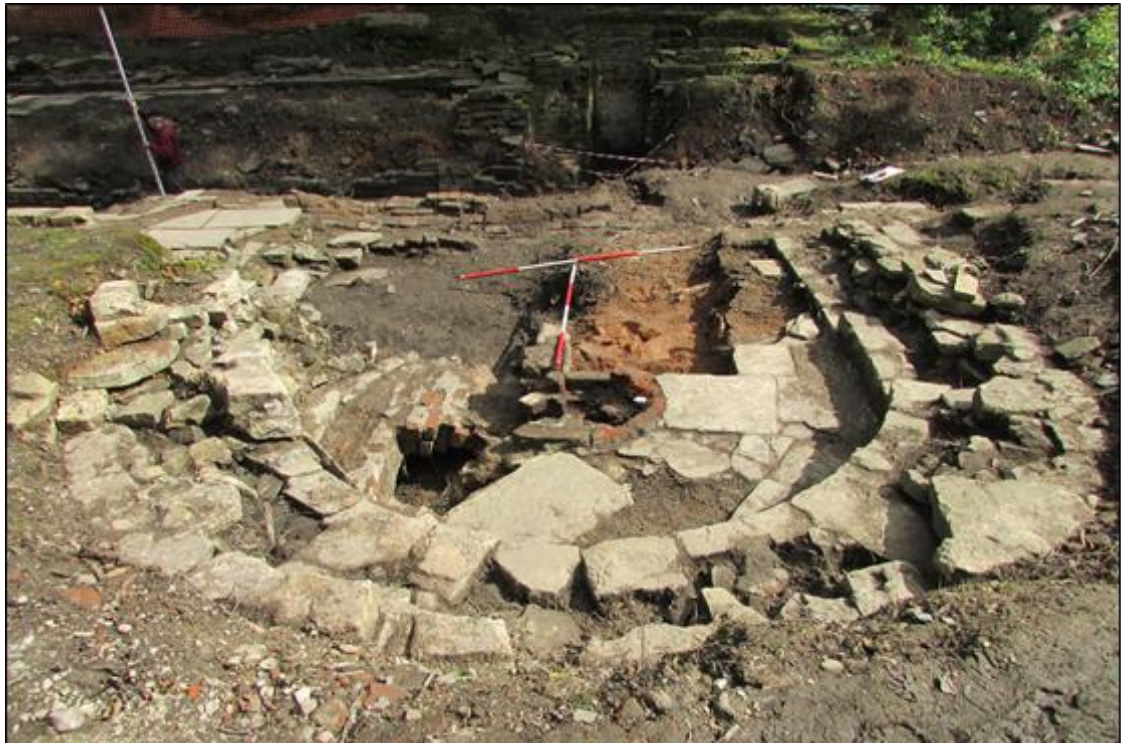
Figure 55. General view of features enclosed by wall (037). Looking southeast.

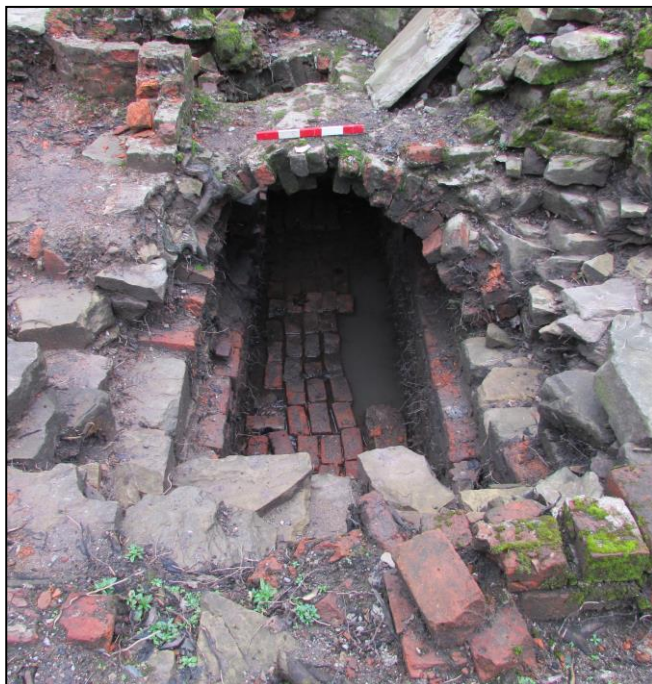
Figure 56. Detail of (021). Looking northwest.

Extending southeast from below the north-western inner face of (037) a second, larger brick vaulted structure (021) was identified (**Fig. 56**). This feature was composed of a handmade brick barrel vault with white mortar which measured 1.00m wide and extended 2.20m from (037) before being truncated by (035). Following partial excavation this feature was found to be filled with brick rubble which overlay a level brick base at a depth of 1.60m. The internal walls of this feature were constructed

from handmade brick with a projecting course identified 0.77m from the base and ended with a square terminus where it abutted (036).

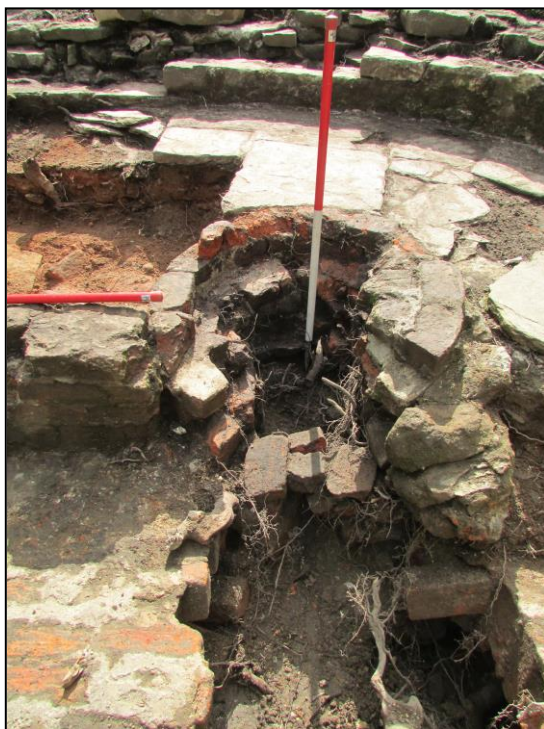
Figure 57. Detail of (023). Looking southwest.

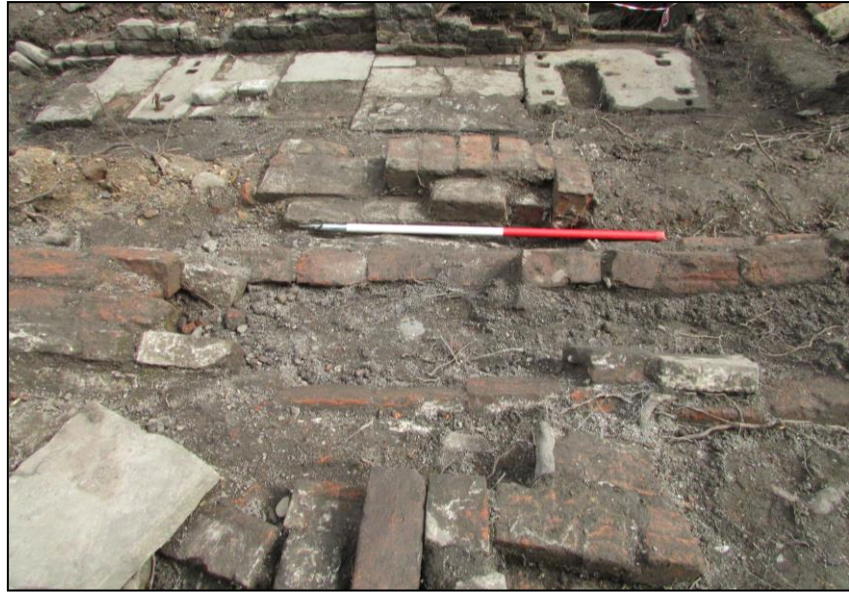
Figure 59. Detail of brick features showing (032) in the foreground, (015) in the middle and (030) in the background. Looking southeast.

At the far south-eastern end of the area enclosed by (037) two small brick features were identified on either side of (015). The westernmost of these was a 2 course northeast-southwest alignment of handmade bricks (032) measuring 0.25m x 0.56m with no clear relationship to any other feature. Approximately 0.15m southeast of (015) lay a U shaped handmade brick structure (030) measuring 1.30m x 0.60m comprising 2 courses of brick laid with white mortar. This feature was set within (003) and aligned with the north-western end of (034).

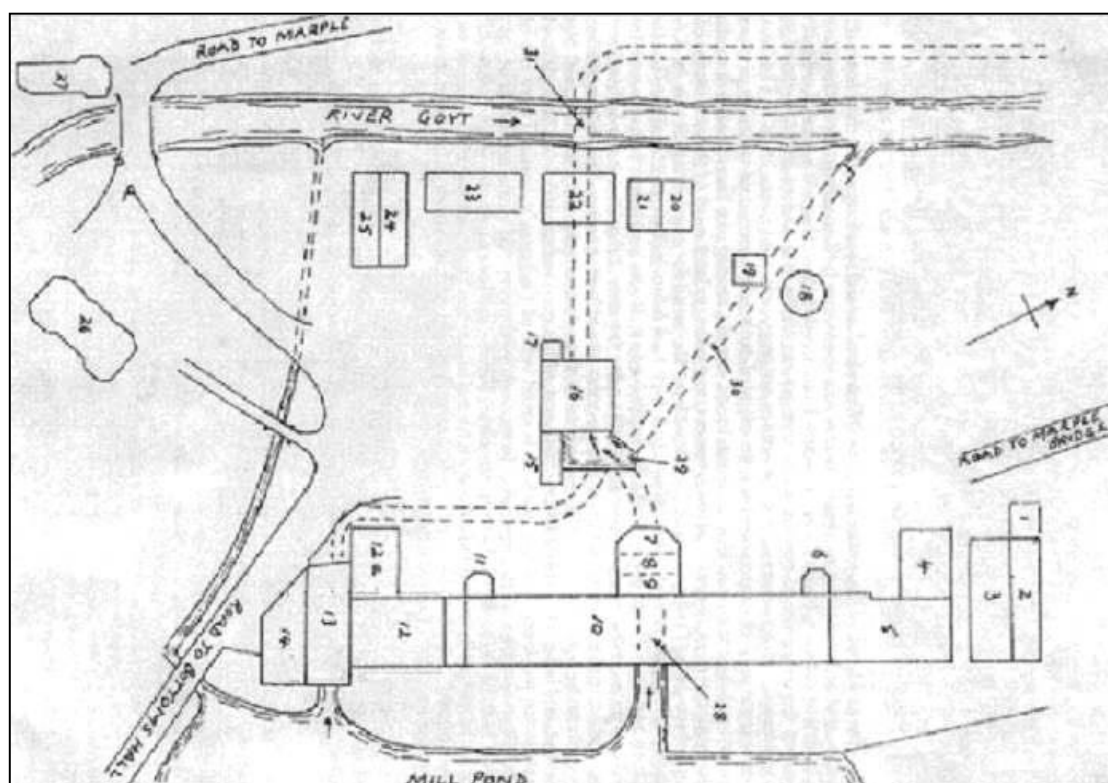
No.	1st STOREY	2nd STOREY	3rd STOREY	4th STOREY	5th STOREY	6th STOREY	7th STOREY
1	Coal Place						
2	Boiler House						
3	Engine House						
4	Cotton Rooms						
5	Blowers						
6	Stairs	Carding	Warping	Lumber	Attic	Stairs	
7	Offices	Ditto	Throstles	Empty	Stairs		
8	Passage	Stairs	Stairs	Stairs			
9	Store & Making up Rooms	Store Rooms	Store Rooms	Store Rooms	Store Rooms	Store Rooms	Attic
10	Throstles	Throstles	Throstles	Carding	Carding	Reeling & Warping	Lumber
11	Stairs	Stairs	Stairs	Stairs	Stairs	Stairs	Attic
12	Throstles	Throstles	Throstles	Warehouse			
12a	Warehouse	Warehouse	Ditto				
13	Wheelrace & Drying Kiln						
14	Corn Mill	Store Room					
15	Shaft Shed						
16	Wheelrace						
17	Ditto						
18	Gasometer						
19	Retort House						
20	Warehouse	Warehouse	Warehouse				
21	Cottage	Cottage	Ditto				
22	Mechanics' Shop	Mechanics Shop					
23	Workshop	Workshop					
24	Warehouse	Warehouse					
25	Stables & Coach House	Hay Loft

ADDITIONAL DETAILS							
26	Mellor Lodge, Oldknow's House.						
27	Marple Lodge.						
28	Position of Waterwheel in Mill Basement.						
29	Water Junction.						
30	Tunnel to take water to river from upper wheelpits.						
31	Tunnel under river discharging into the river at a lower level some distance downstream

Fragmentary remains of floor surfaces at the ground floor level of the three storey wing were also identified and it is possible, given the similarity in height, that (006) and (033) may originally have been part of the same surface. Documentary evidence from an 1867 auction plan (**Fig. 46**) indicates that this room contained 'Blowers' which appeared to occupy the full width of the building with an unbroken floor. It is probable that the alteration of the drive shaft below meant that this floor surface was cut and then re-laid, possibly with wooden boards or large flag stones over the central void. Another feature to be found below this floor surface on the north-western side of the mill was a linear brick vaulted channel which ran the full length of the present excavation area and can also be seen in other exposed areas of the mill site. It is possible that this channel was associated with the heating/ humidifying system within the mill used to make the raw cotton less brittle for the spinning process.

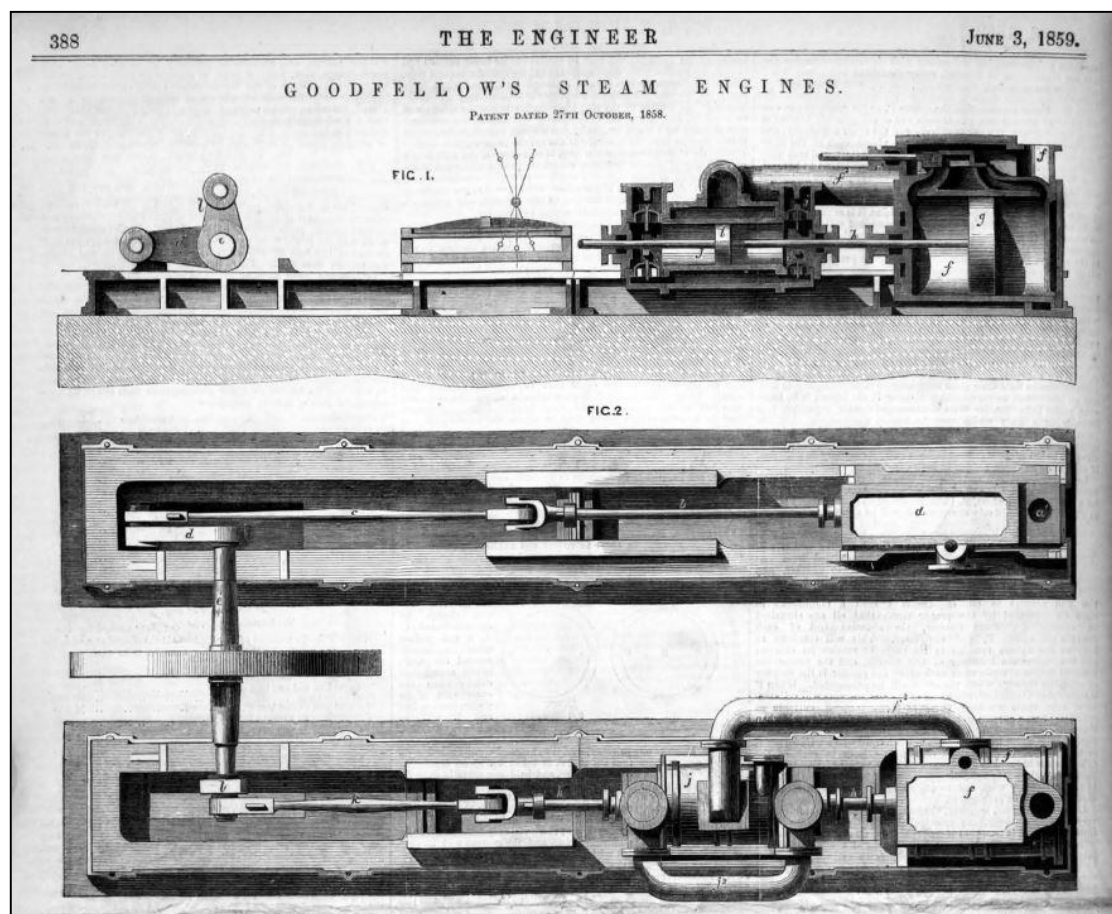
Figure 45. Technical drawing of a Goodfellow engine of a similar type to that fitted at Mellor (courtesy of John Glithero).
