**Community
Archaeological
Excavation**

Mellor Mill

Report No: SA/2017/45

Document title: Archaeological Excavation: Mellor Mill

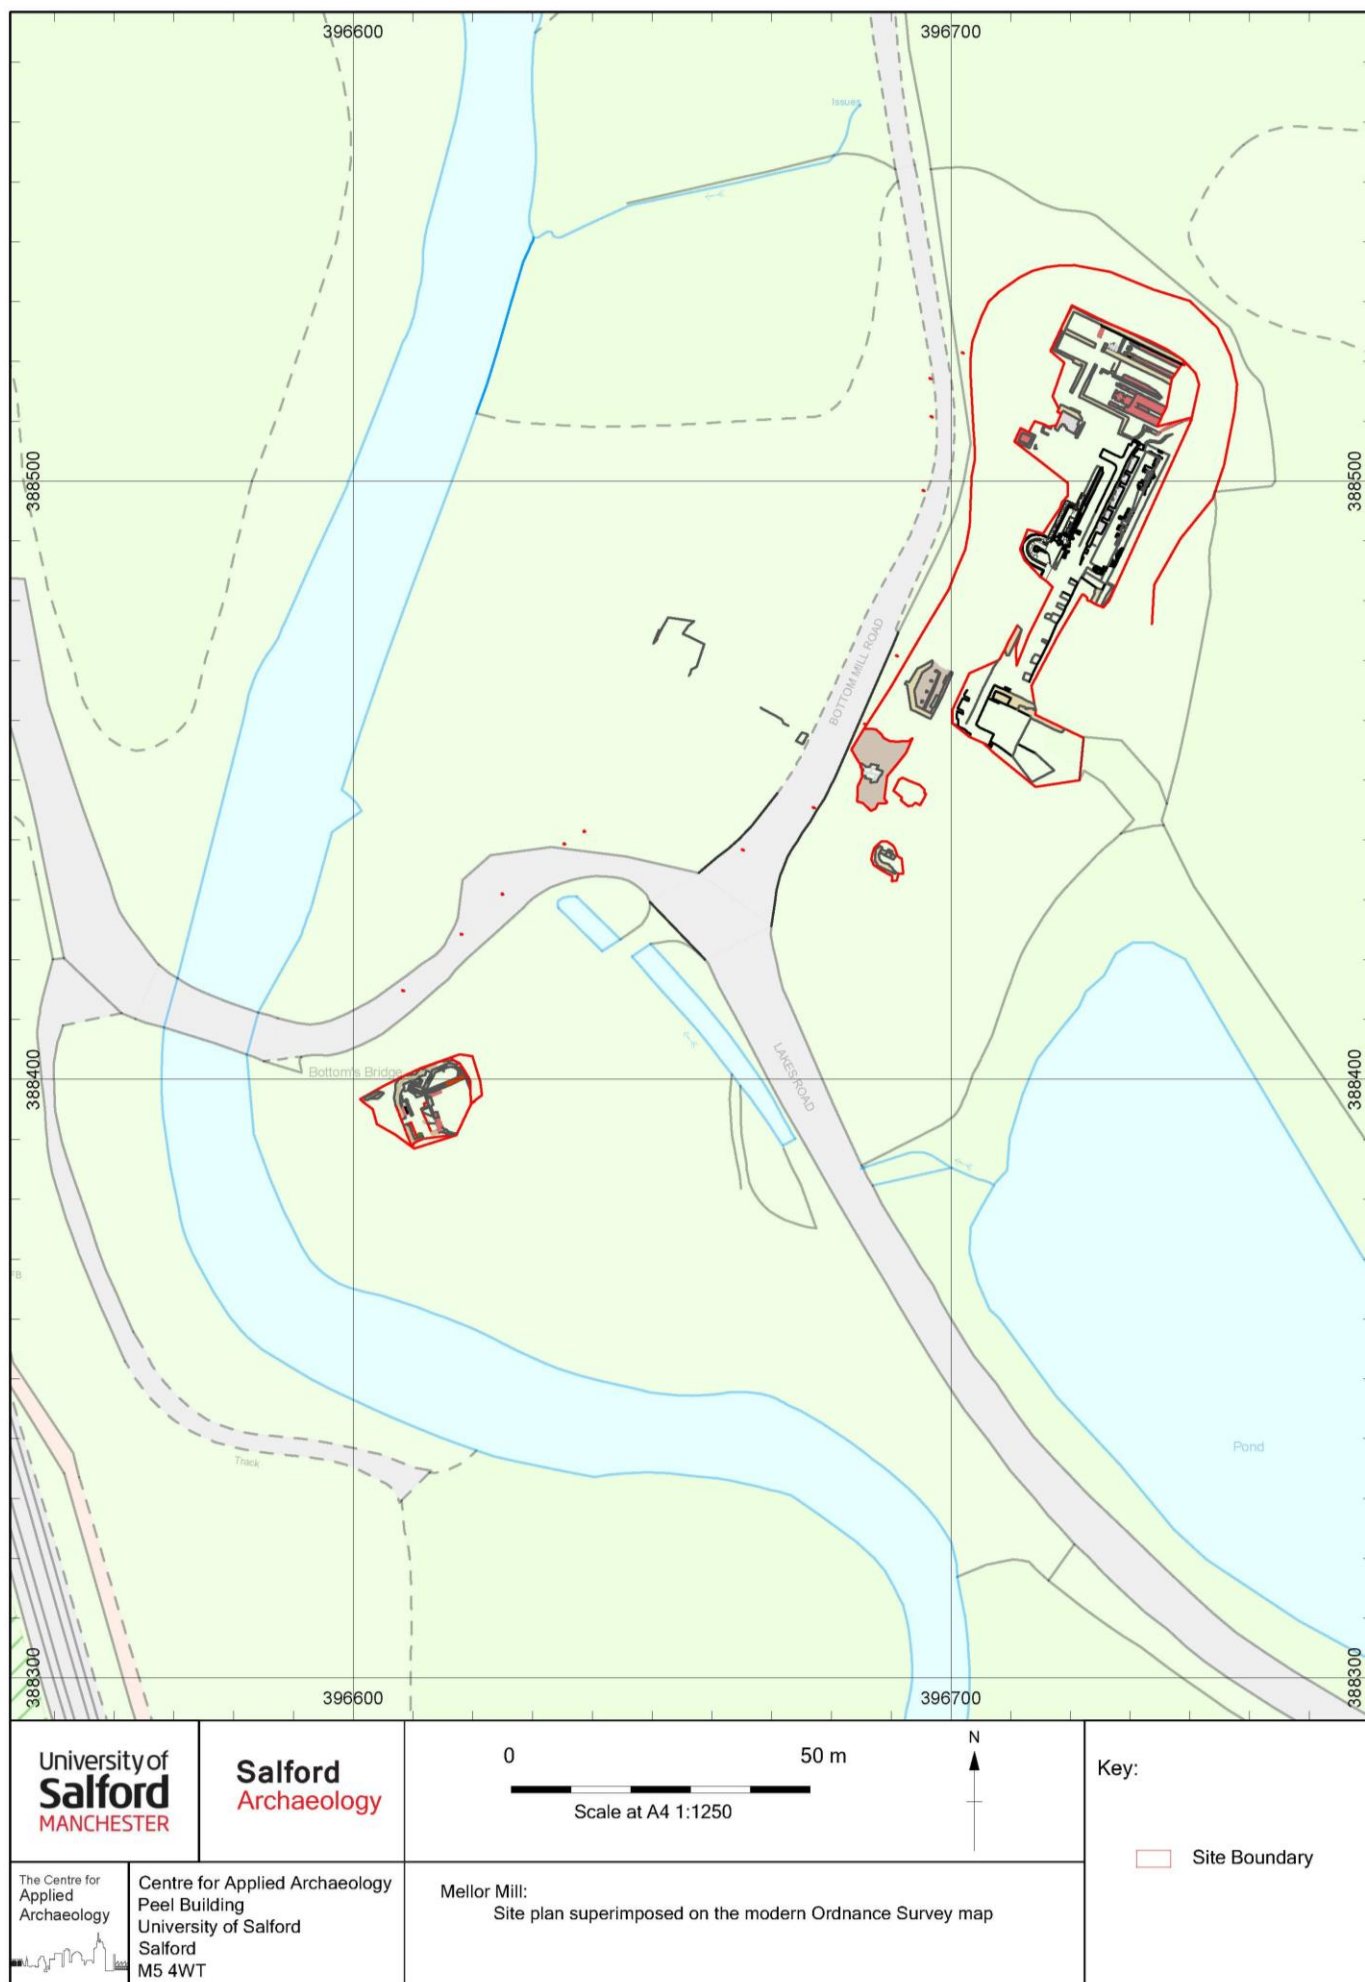
Figure. 48. Site plan superimposed on modern OS Mapping.

A ‘site location plan’ indicating the site north and based on the current ordnance survey 1:1250 map (reproduced with the permission of the controller of HMSO) was prepared. This was supplemented by a trench plan at 1:200 (or 1:100), which shows the location of the areas investigated in relation to the investigation area and National Grid Reference (**Fig. 48**).

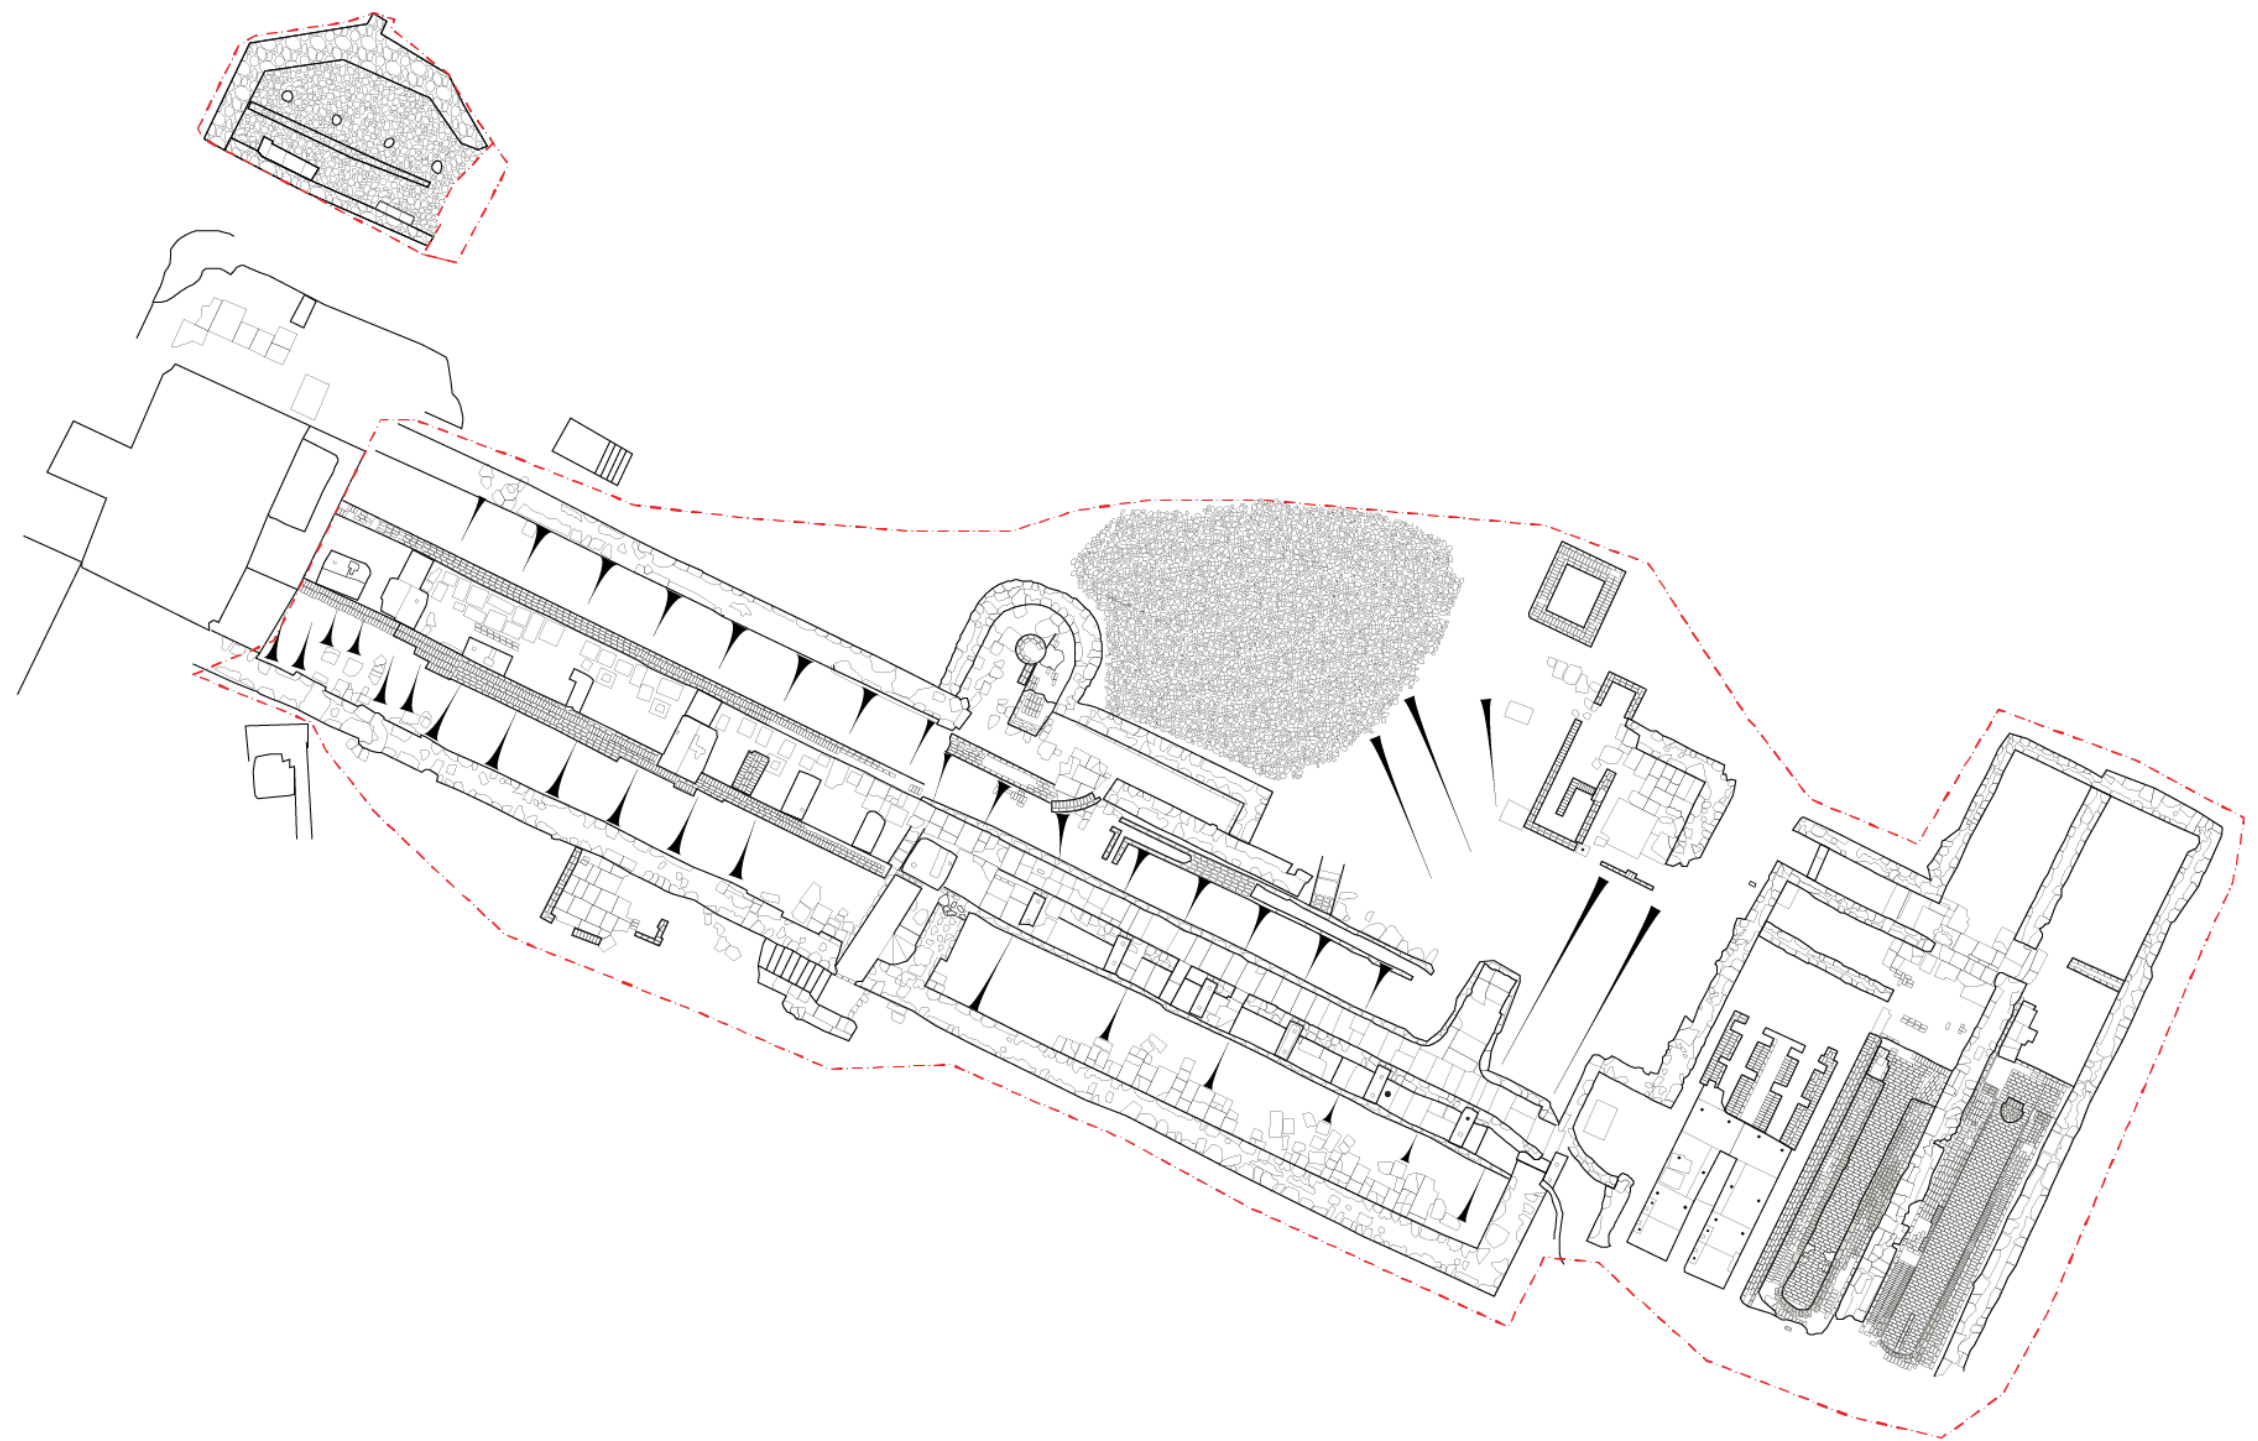
Figure 49. Mellor mill plan drawing.

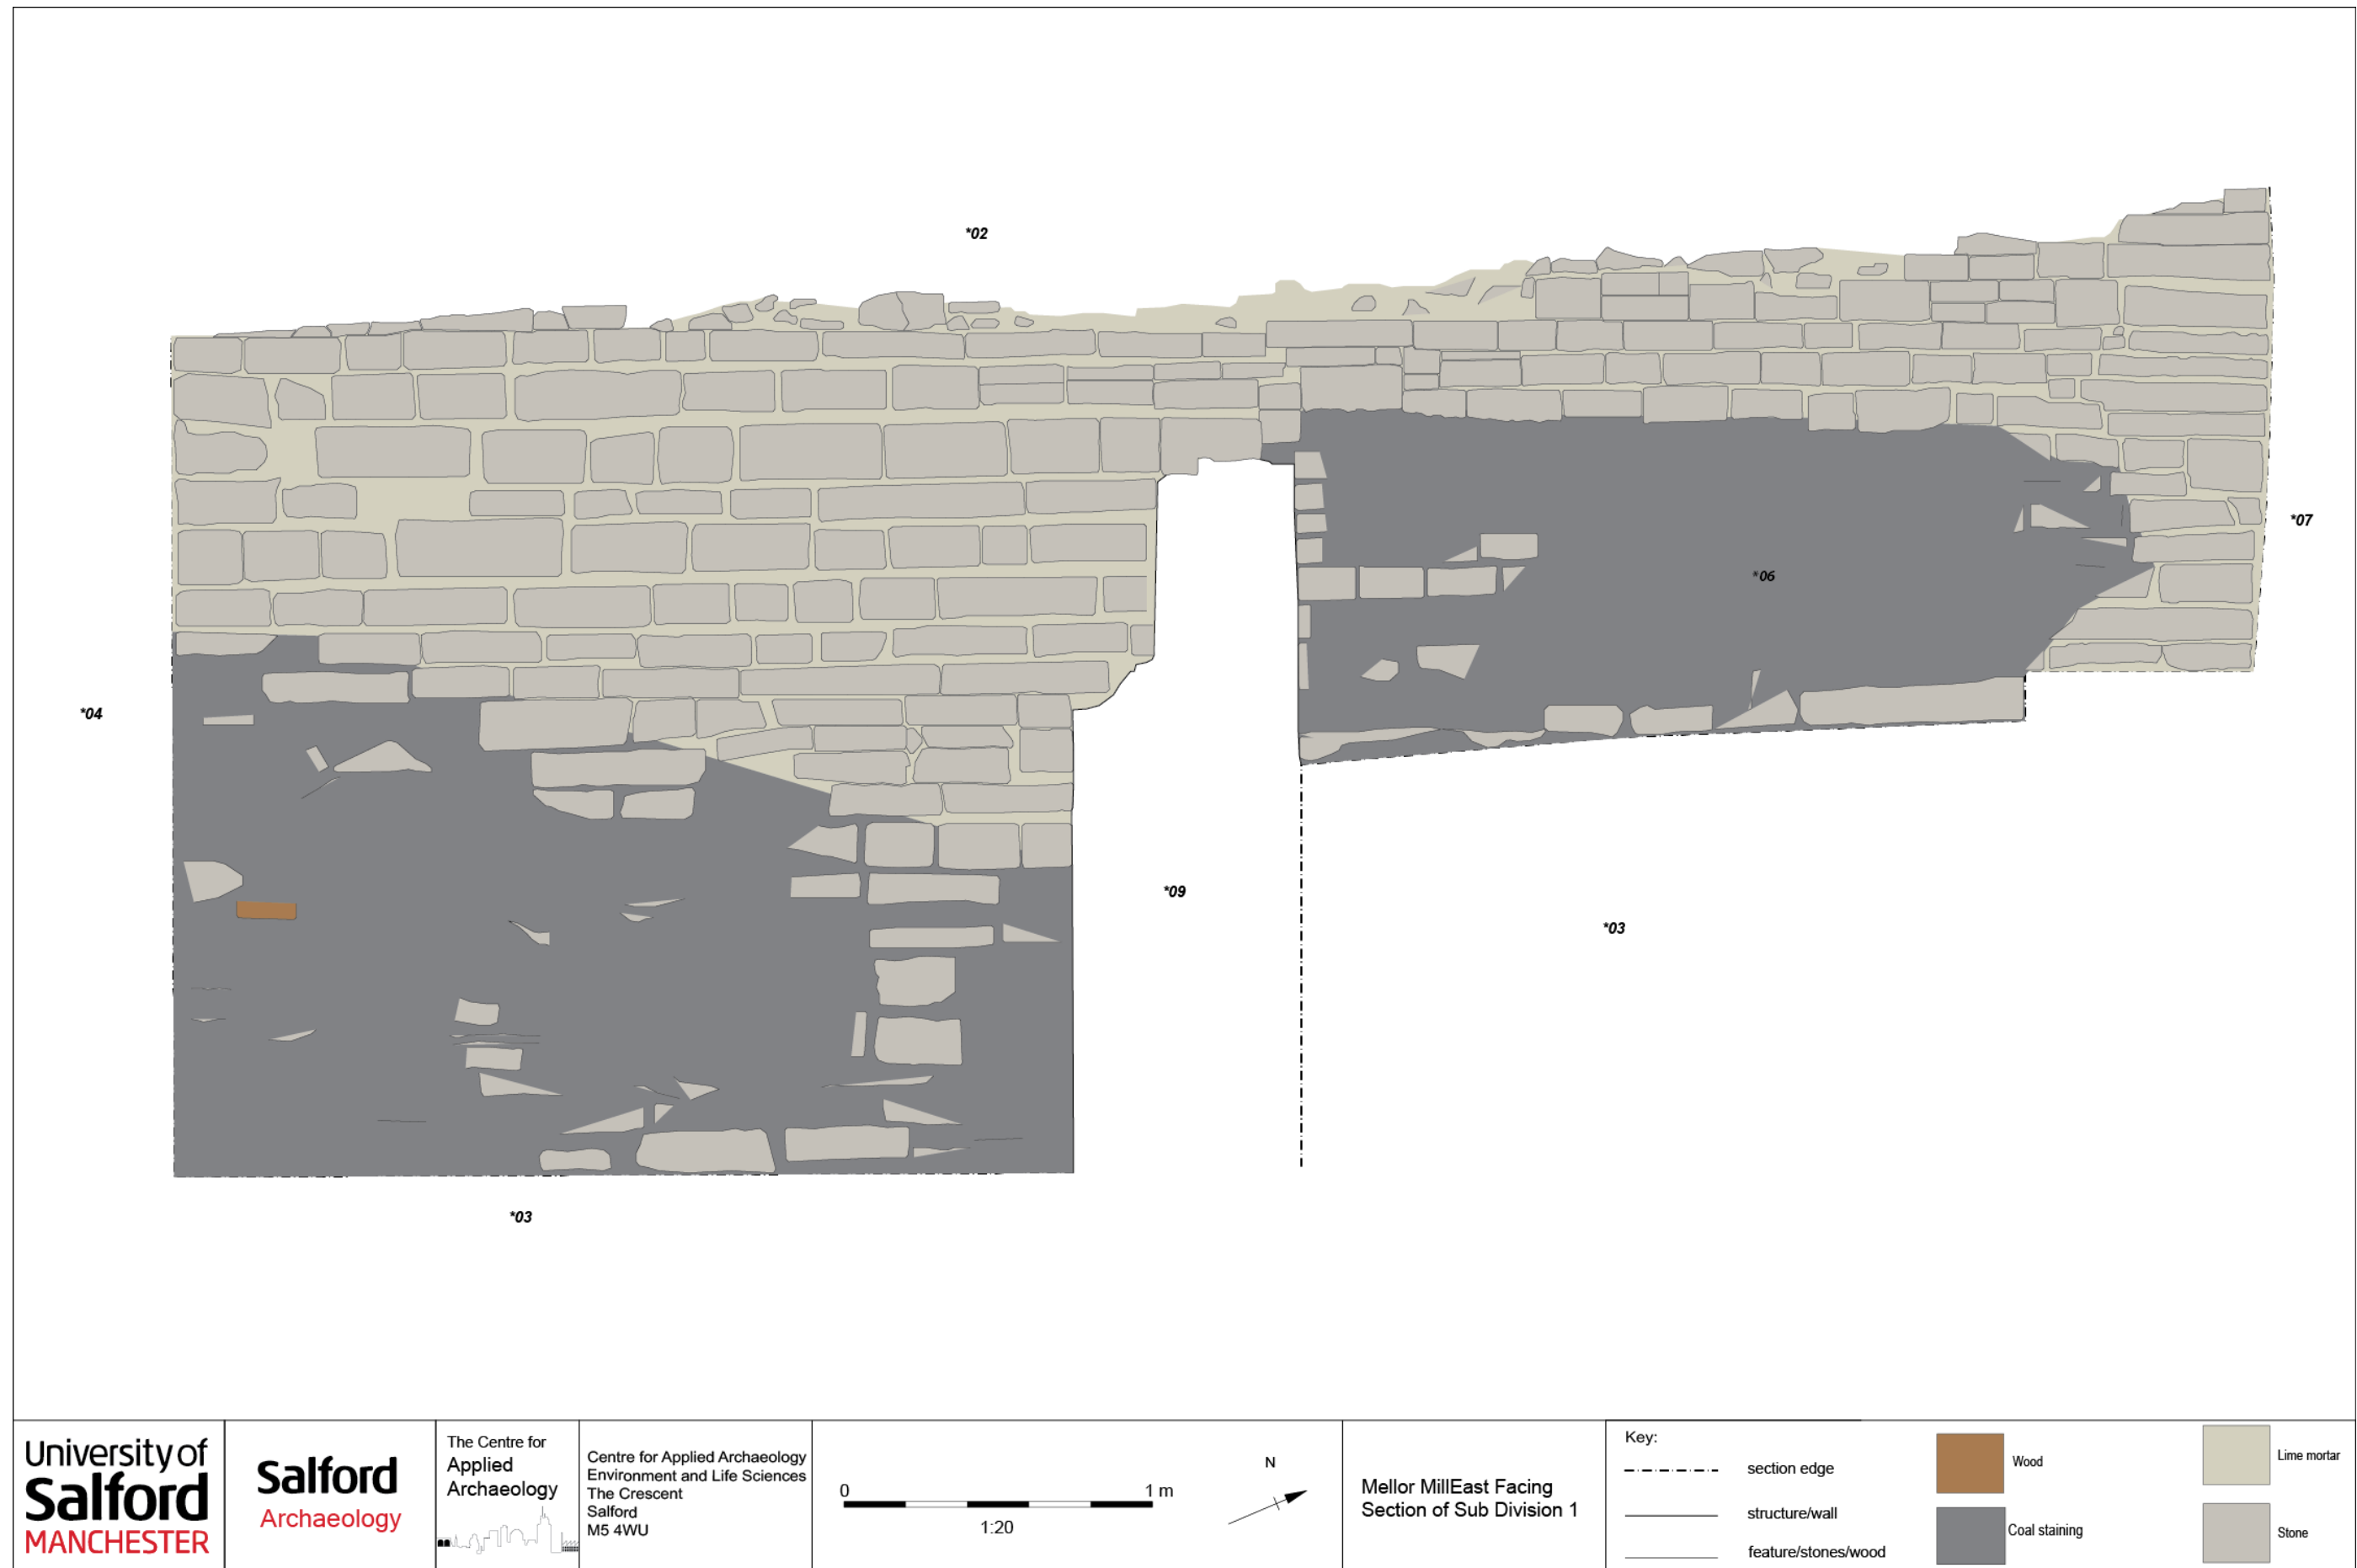
Figure 51. East facing section drawing of Sub-Division 1.

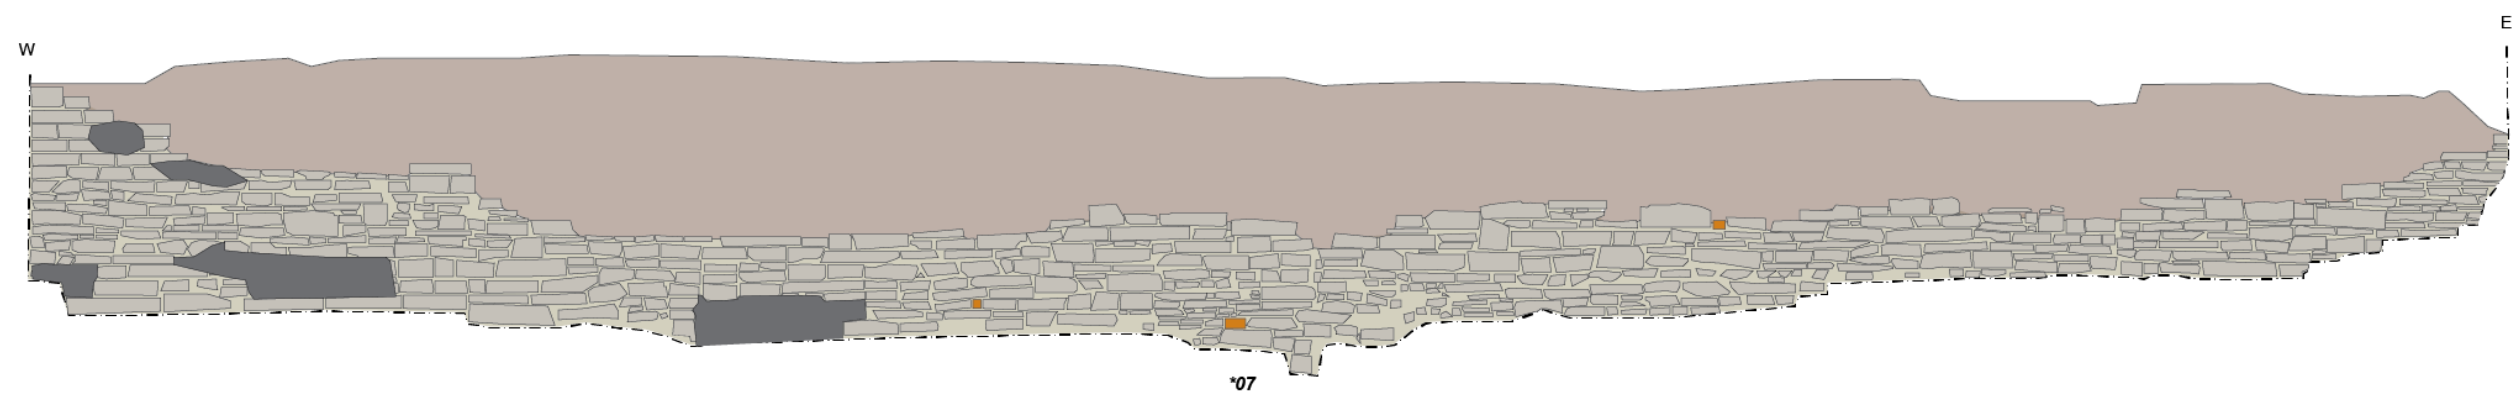
Figure 52. Section drawing of southern face of wall *07.

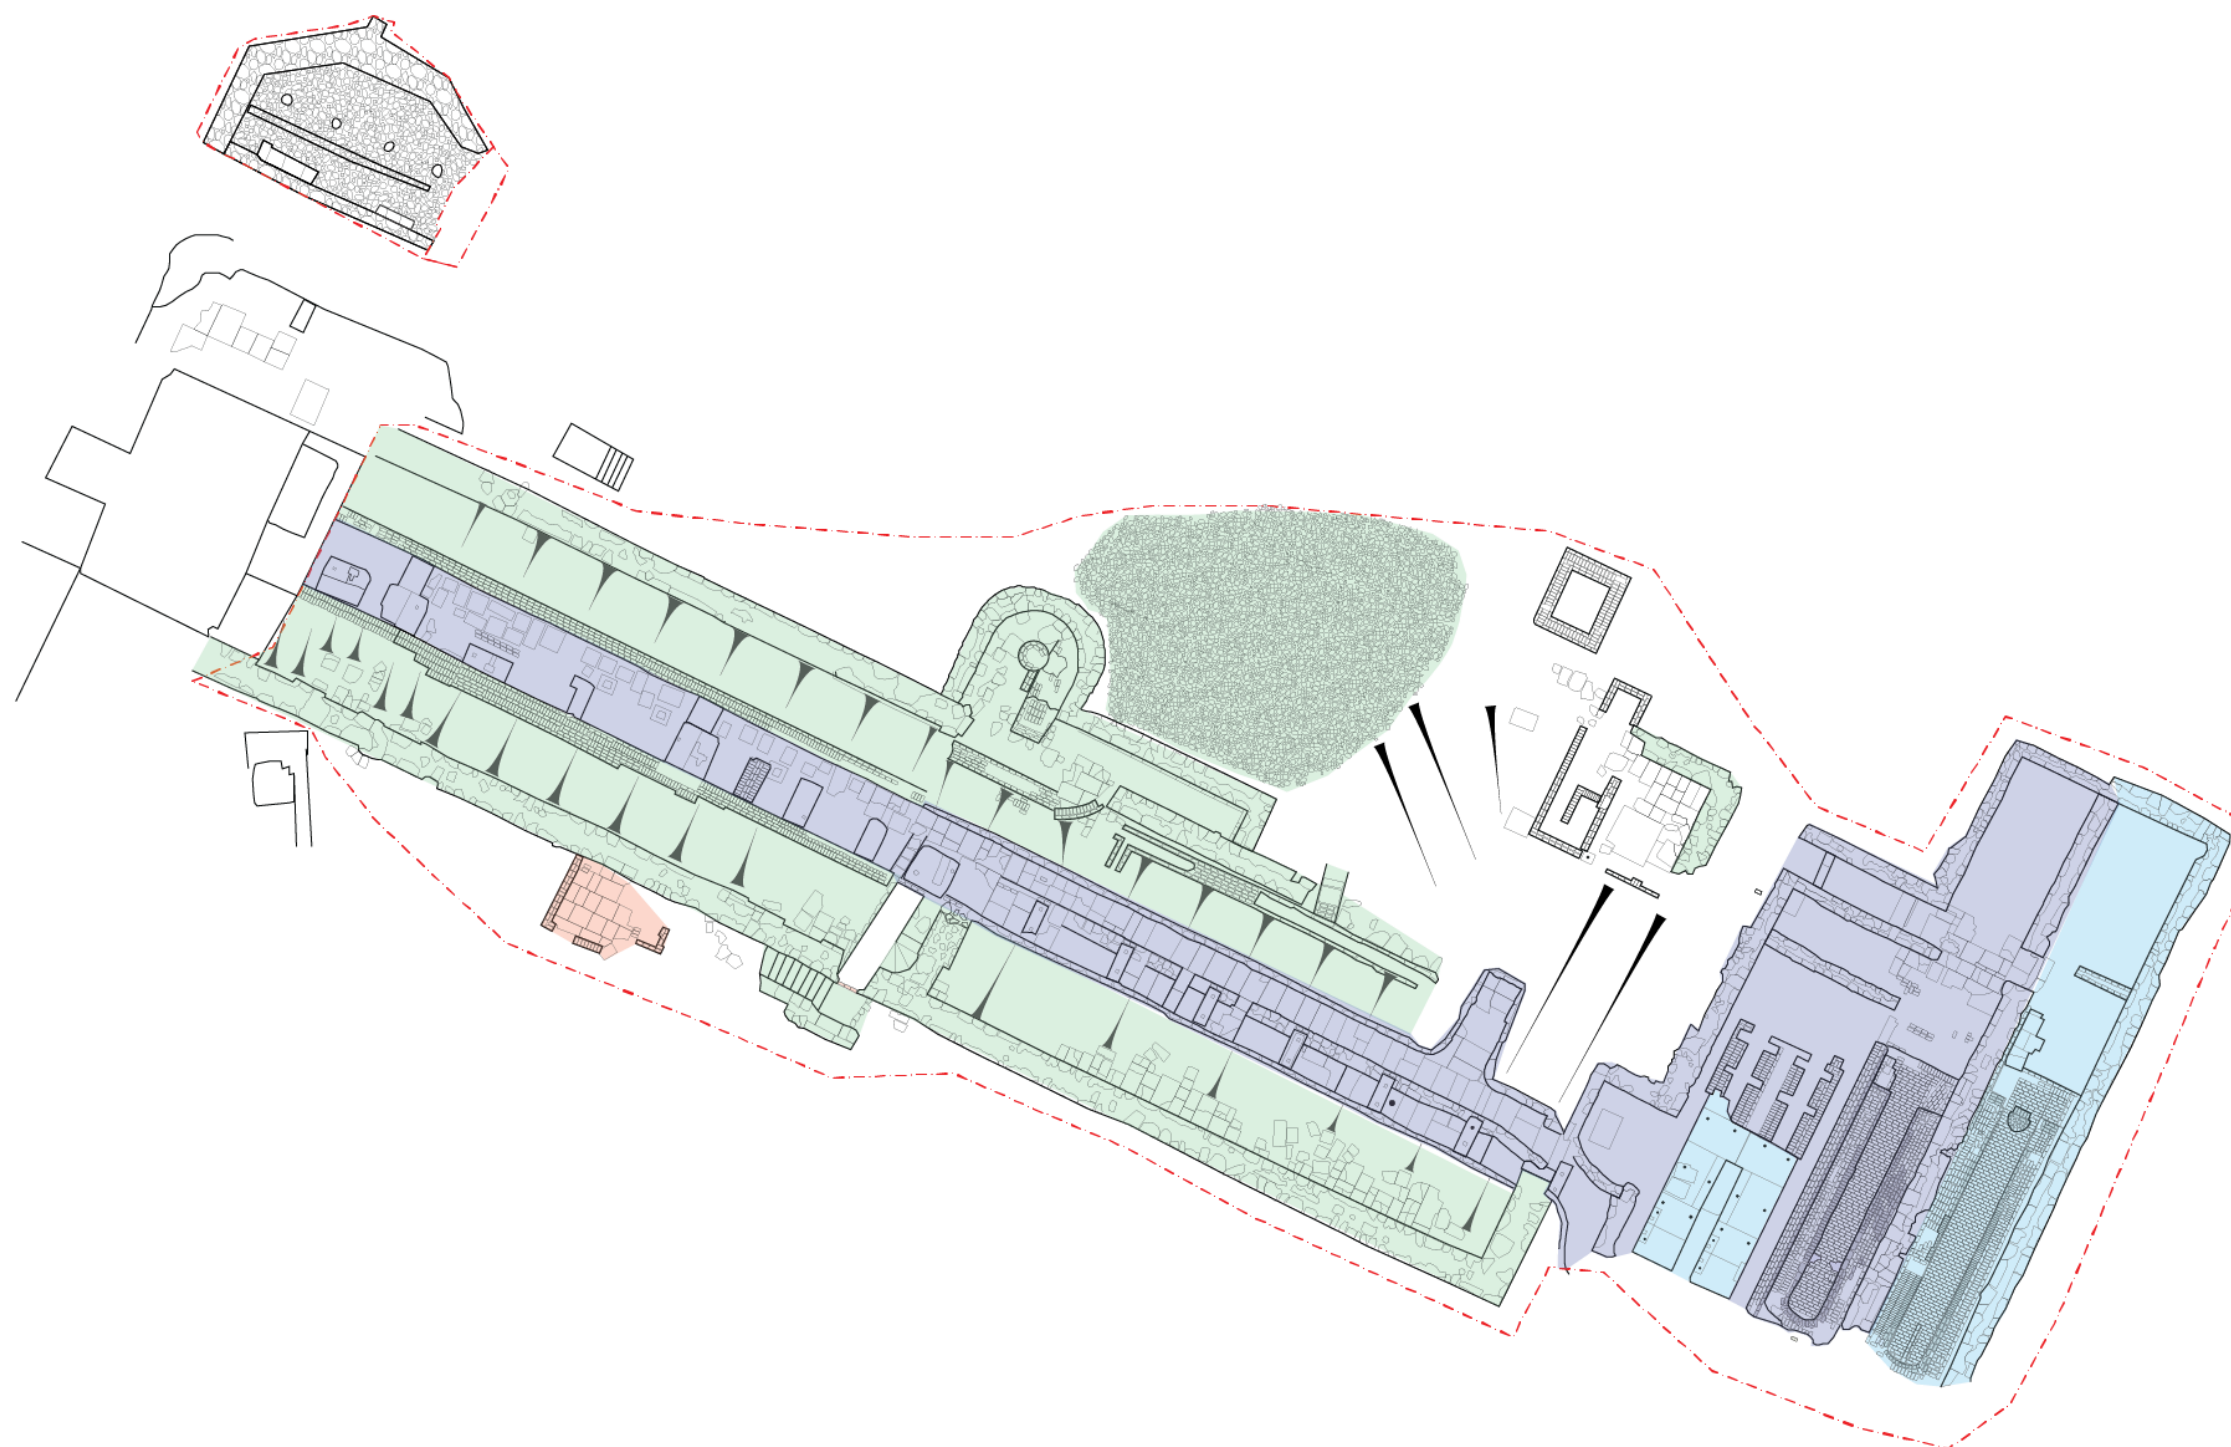
Figure 53. Phased plan of Mellor Mill.
