Archaeological Evaluation

Rose Mill, Coalshaw
Green, Chadderton

Technical Report:
Simon Hinchliffe

Report No: SA/15/2017

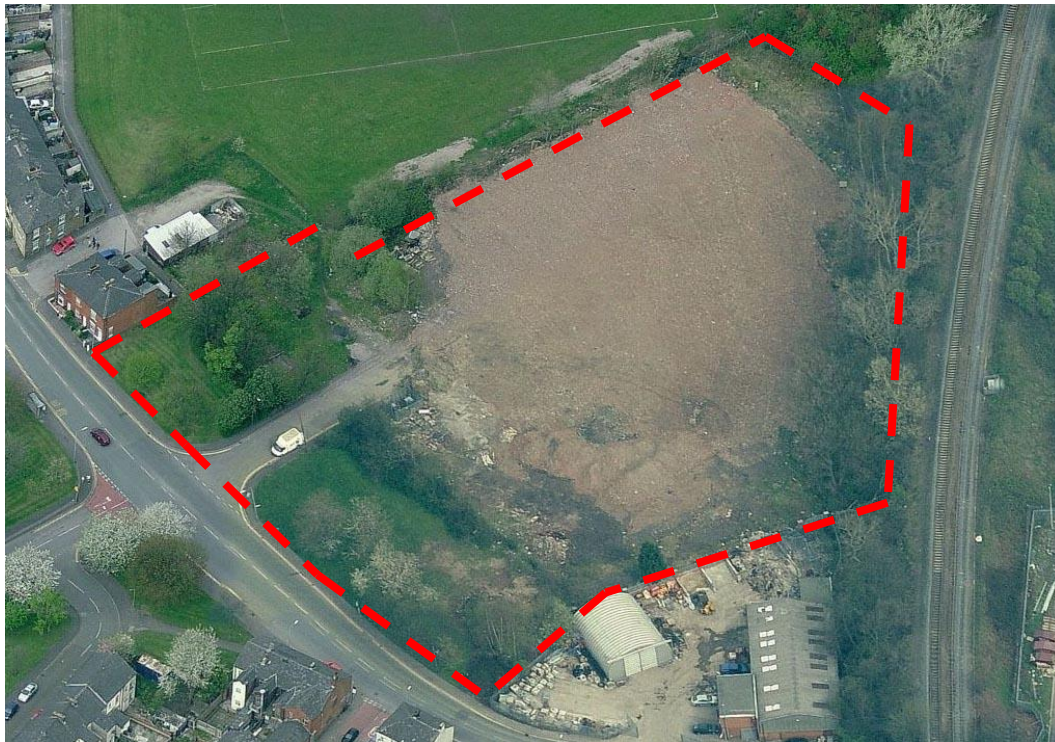
Plate 1. Recent aerial view of the Evaluation Area. Looking North

The evaluation area is located within Chadderton, Oldham, Greater Manchester, (centred on SD 90379 03319) and is bounded by Coalshaw Green Park to the north, Coalshaw Green Road/ Drury Lane to the west, and to the east by the Hollinwood Branch of the London and Yorkshire Railway (Plate.1).

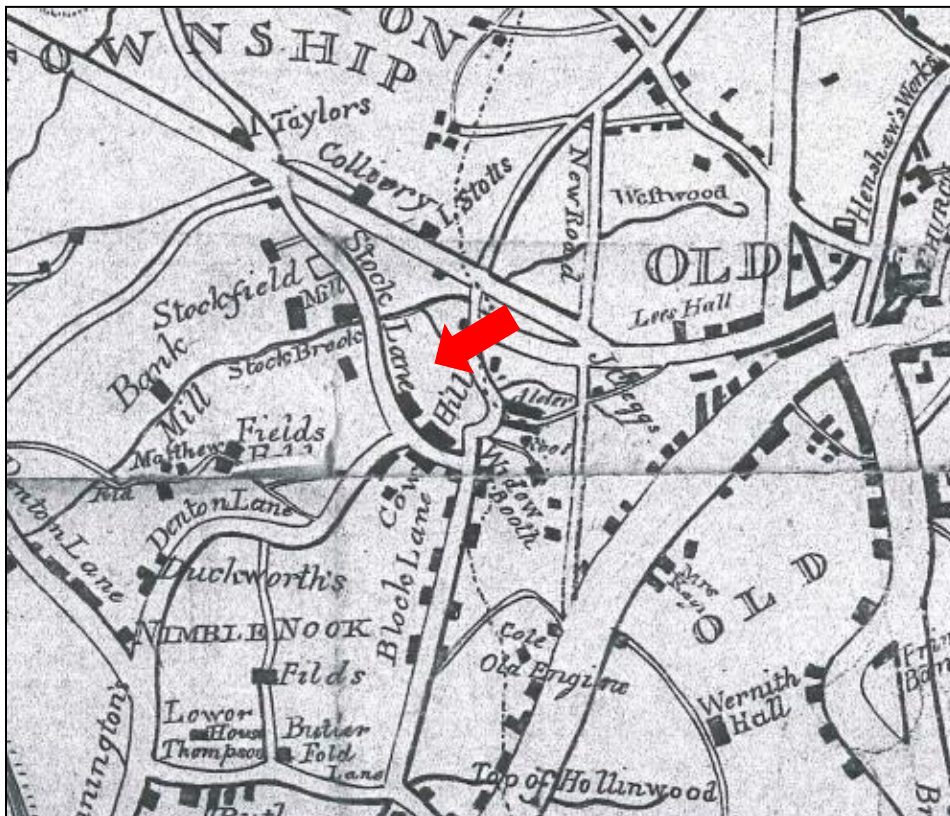
Plate 2: Butterworths Map of Oldham dated 1817. Site marked by red arrow.

One of the earliest cartographic sources to depict Chadderton in detail is Butterworths map of Oldham dated 1817, (Plate.2). The map shows that much of Chadderton was comprised of open agricultural and moss land which was dissected by a number of roads flanked by piecemeal development, mainly cottages and farms and several collieries. Butterworth notes that these roads were all denominated as lanes and lists the main thoroughfares as being Burnley Lane, Stock Lane, Block Lane, Old Lane, Denton Lane, Thompson Lane, Dowry (Drury) Mought Lane, Turf Lane, Tonge Lane, and Bawtry Lane (Butterworth, 1817: 163).

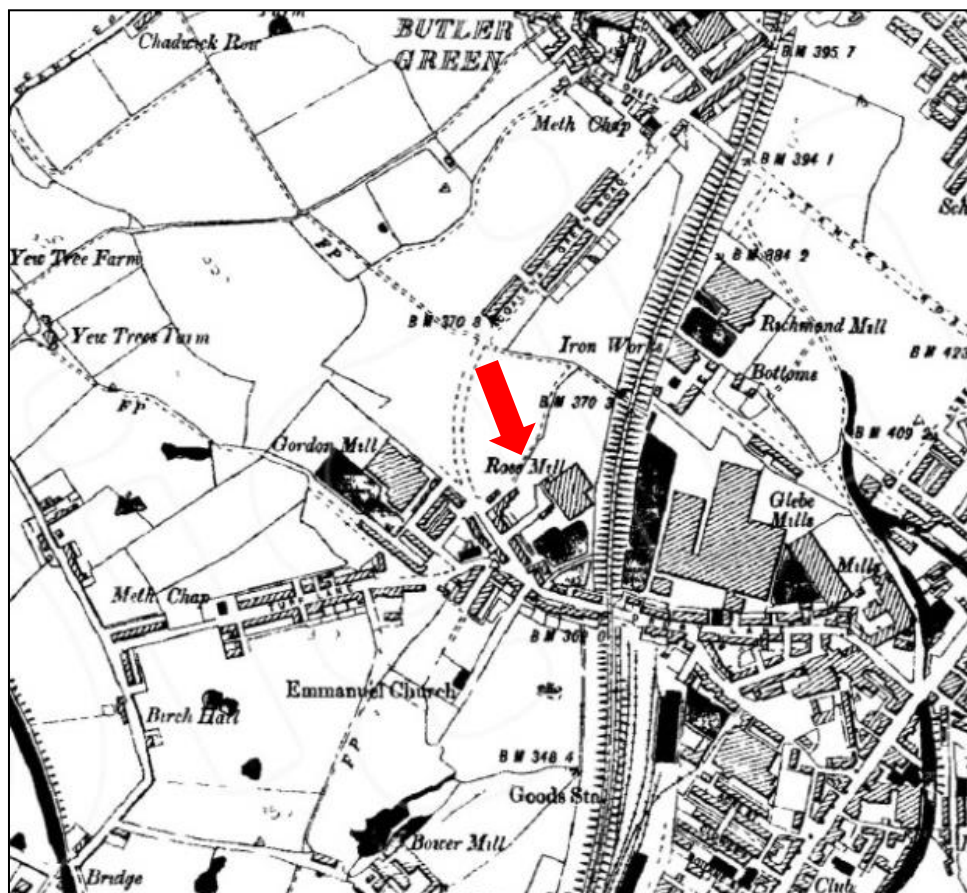
Plate.3: OS map of 1893-4. Site marked by red arrow

During the mid to late 19th century Chadderton became increasingly industrialised. The OS survey of 1893-4 shows that several industrial works had emerged within the sites immediate surroundings which included Glebe and Victoria Cotton Mills and Hardmans Works to the east, Gordon Cotton Mill to the west, Richmond Cotton Mill and Bottoms Iron Works to the north, (Plate.3).

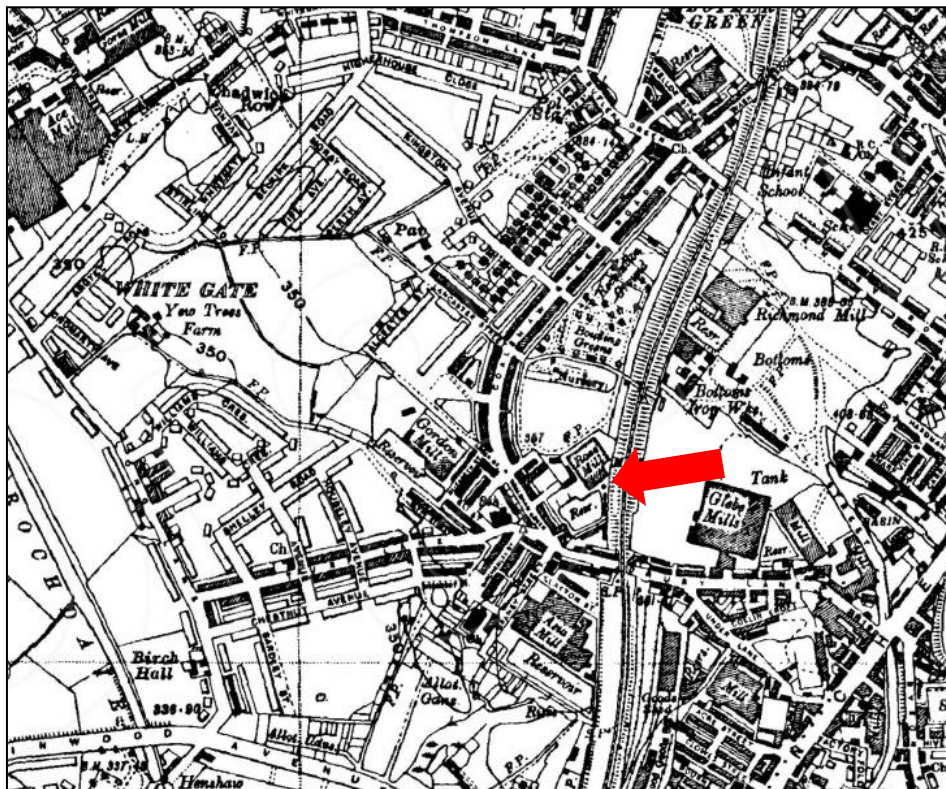
Plate 4: OS map of 1922. Site marked by red arrow.

During the early 20th century Chadderton continued to be increasingly industrialised with most of the land to the east of the site being filled with development whilst the land to the west retained large portions of agricultural land (Plate.4). In contrast to its surroundings the OS survey of 1910 shows the site to be relatively unaltered. The only notable change was the erection of a further three houses along Coalshaw Green and construction of several enclosed yards to the immediate south and east of the farm.

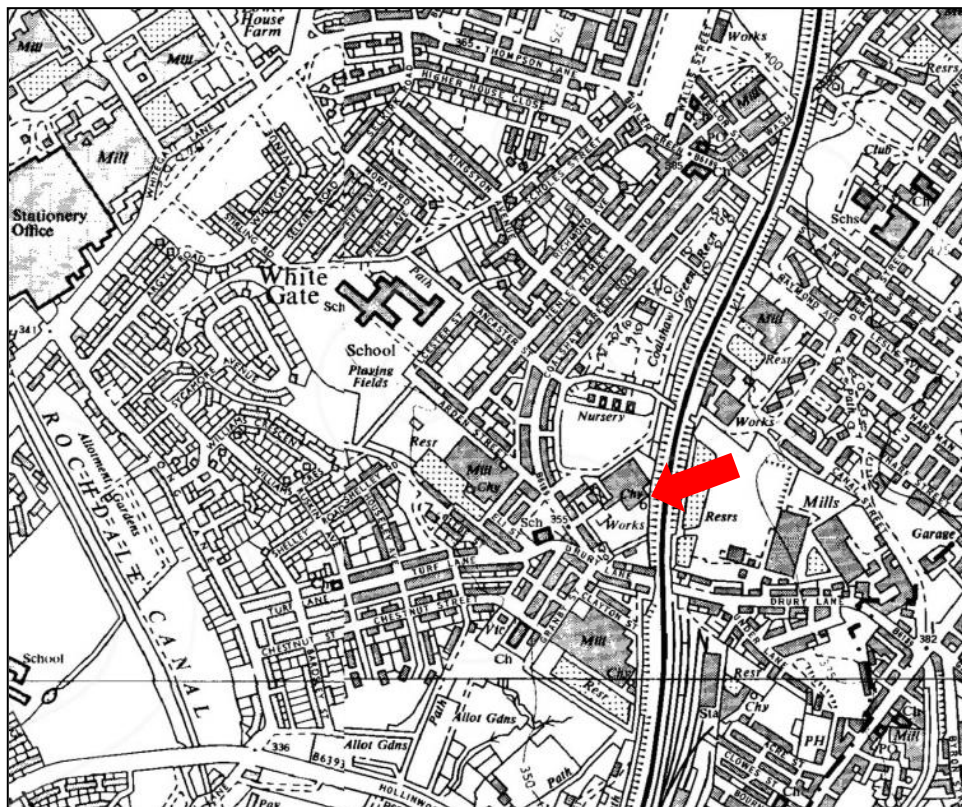
Plate 5: OS map of 1959. Site area marked by red arrow.

During the mid-20th century Chadderton became increasingly urbanised resulting in large areas of rural land to the west of the site being redeveloped for residential and commercial purposes (Plate.5). Within the site there had been some small scale alterations.

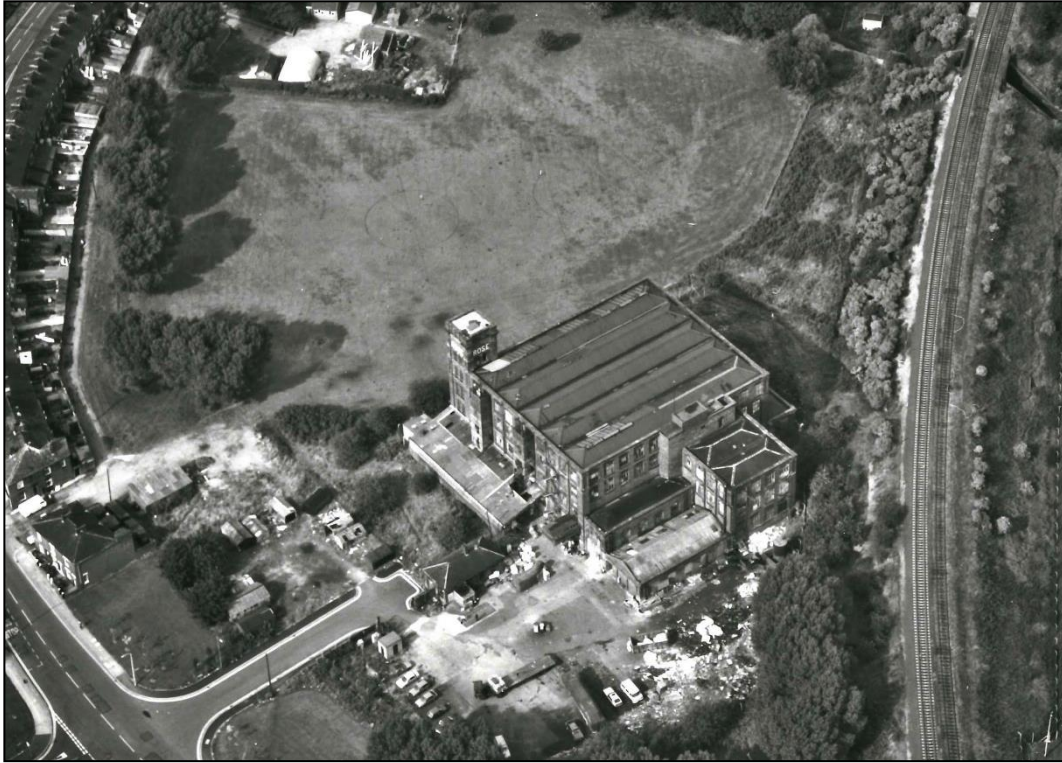
Plate.6: Aerial photograph of the site, dated 1986. Image reproduced with permission from Greater Manchester Archaeological Advisory Service (GMAAS).

The site remained unaltered on all subsequent OS mapping until 1982 when the larger, northern nursery appeared to have been cleared and replaced by a smaller enclosed yard. Within the southern half of the site the early 19th century farm buildings and the late 19th century terraced housing fronting Coalshaw Green had been cleared along with the glasshouses within the southern nursery (Plate.6)

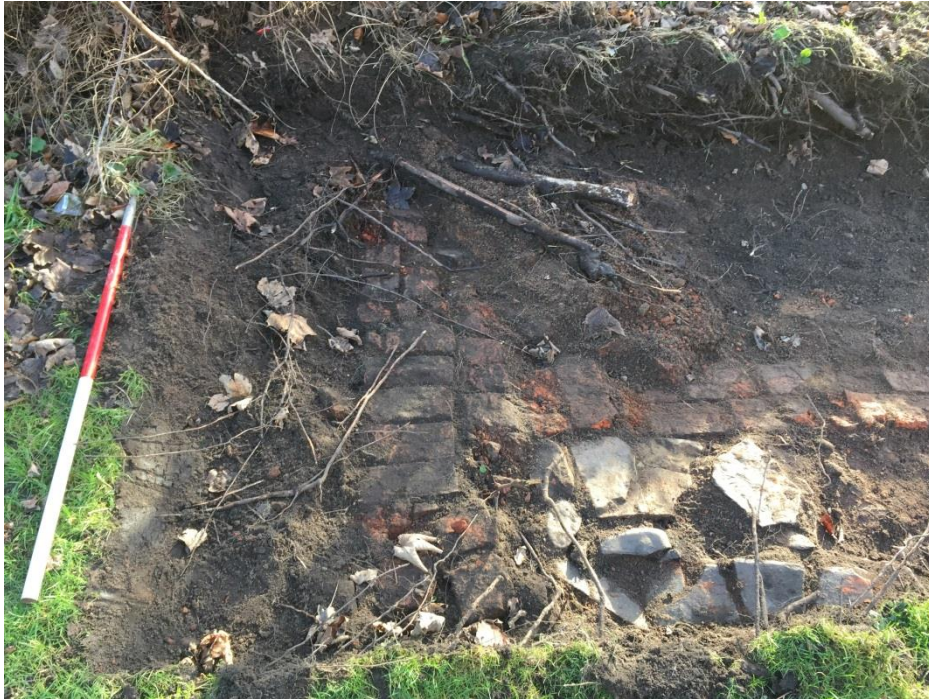
Plate.7: Structural brick walls (102) & (103). Looking south-east.

Progressing along Trench 1 from its north-eastern limit, shallow surviving features were seen at 0.50m along the trench (Plate 7). The remains of a handmade brick wall (102) passed through the trench on a north-west /south-east alignment at a depth of 0.26m. This single course of brick work, with average brick dimensions of 0.23x0.11x0.06m was laid as headers with a grey lime mortar bonding material.

Extending south-west from this, the remains of a further brick wall (103) were seen running for 1.75m before being truncated during demolition (Plate 7). Two courses of this wall were seen at the same depth as the north-west /south-east wall (102). To the north of this the remains of broken stone flags (104) were seen abutting the corner between the two walls.

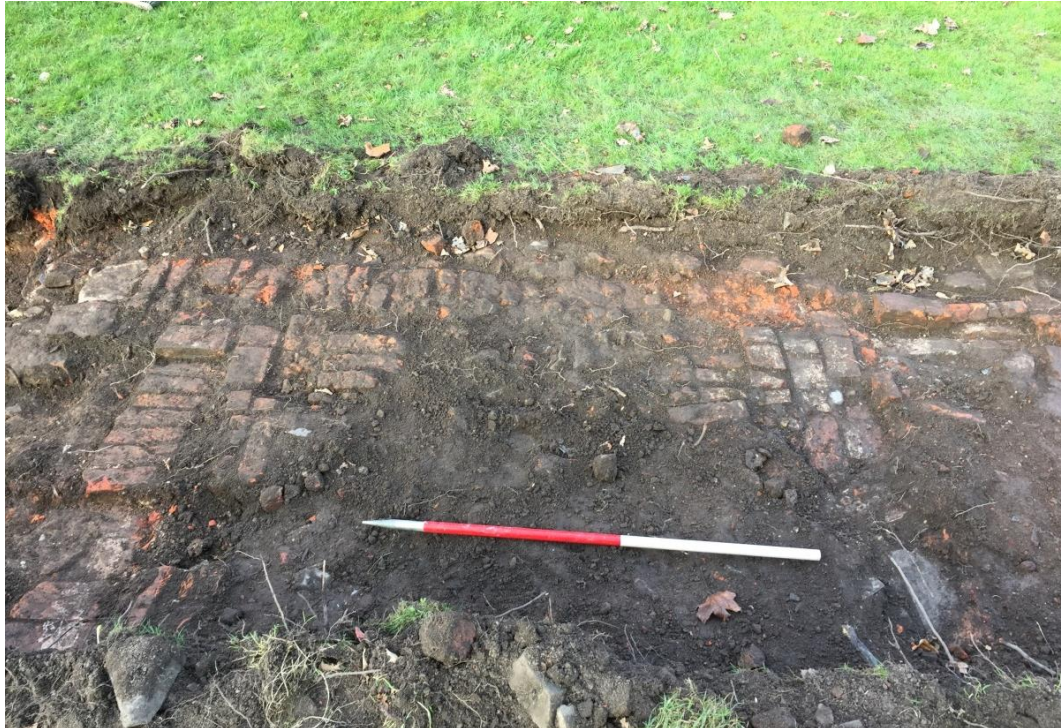
Plate.8: Area of truncated brickwork (109), between walls (107) (NE) & 108 (SE). Looking North-west

brickwork (109) was seen. The brickwork feature had a length of 1.47m and a surviving width of approximately 0.44m. It was laid in rows with 2 width courses of stretcher bricks abutting each wall and between these a mix of stretchers and on edge headers bonded with a pale lime mortar (Plate.8).

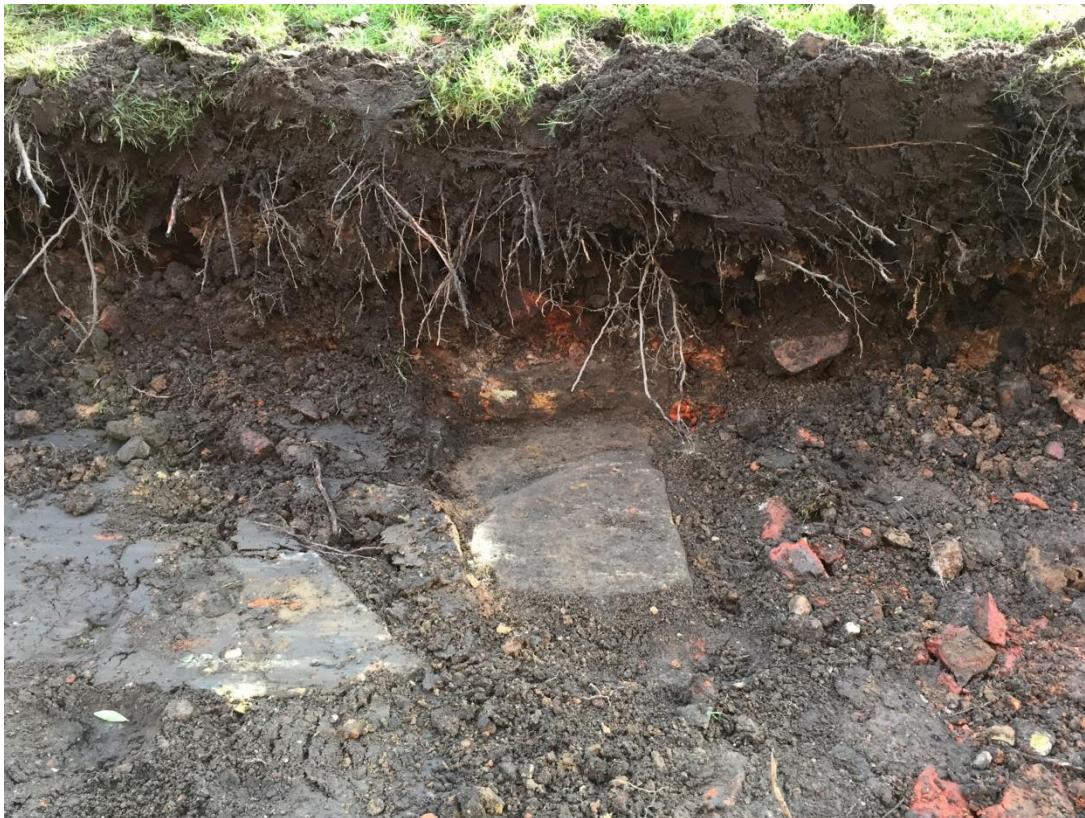
Plate.9: Possible stone and brick wall (111), seen only in section. Looking East

At 8.70m along the trench a large sub angular stone which appeared to have bricks sat upon in (111), was seen in the south-eastern trench section at a depth to the 0.41m. The feature had a width of 0.34m (Plate.9).

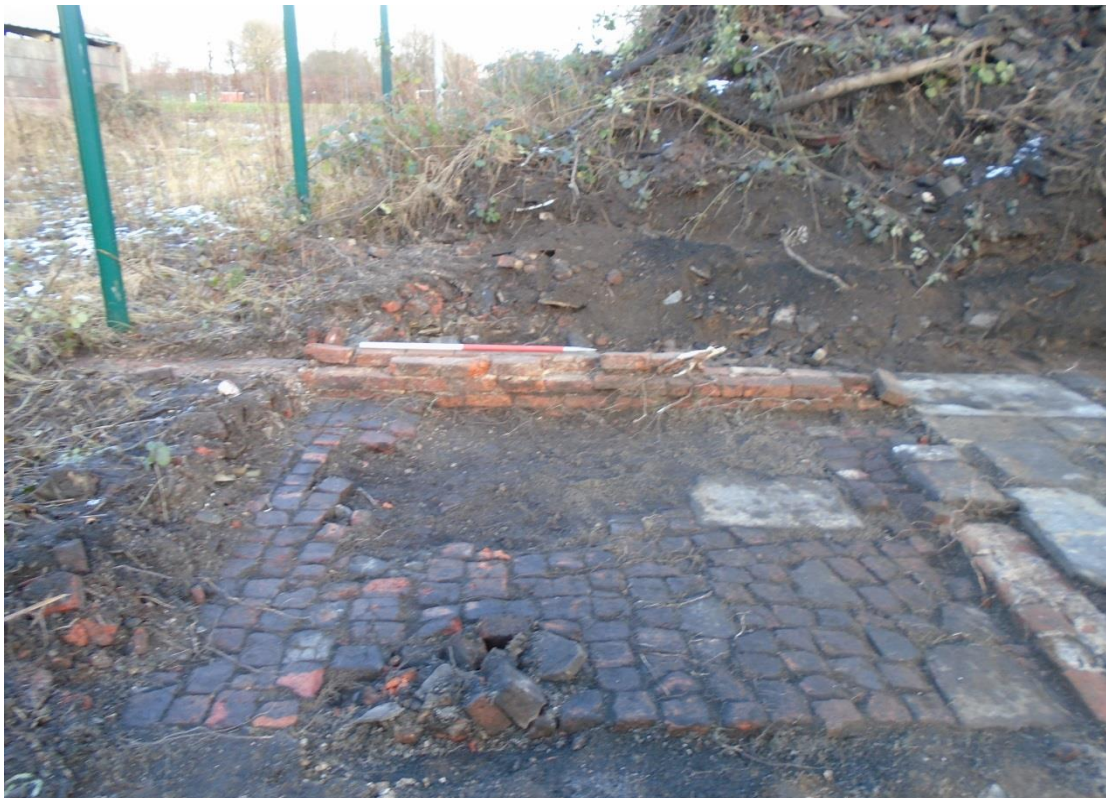
Plate.10: North-west/ South-east aligned brick wall (203), behind brick floor (207). Looking East

A 0.25m wide, 2 course wall (203), constructed of handmade brick abutted wall (202) and was seen to run south-east for 2.90m (Plate10). This wall survived up to 3 courses in height approximately 0.27m and was bonded with a lime mortar. To the north east of this wall a thin concrete screed abutted the wall and extended beyond the limit of excavation. A slot was dug through the concrete which had a depth of 0.05m below this natural ground was seen.

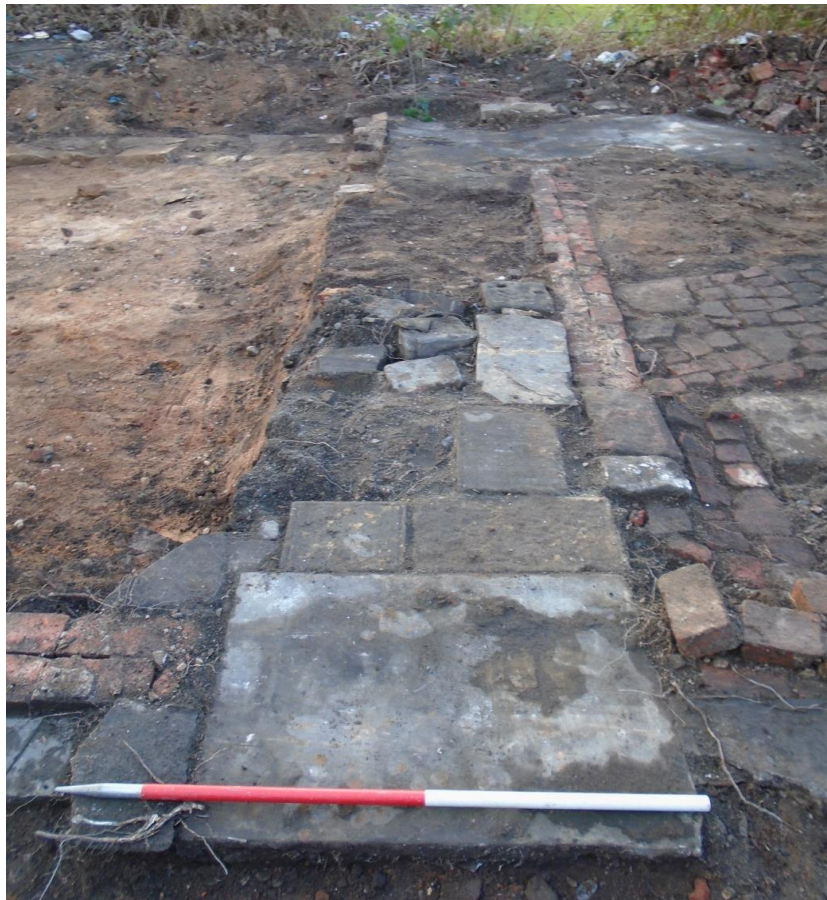
Plate 11: Stone flagged threshold and internal corridor (204). Looking West.

The remains of a flagged passage (204) were seen 3.44m from the north-west limit of the evaluation area. Broken flags were seen aligned north-east /south -west between the remains of two flanking walls. The passage was 0.93m in width and had surviving remains for a length of 2.49m (Plate 11). The north-west end of the passageway seemed to be indicated by a single large stone flag marking a threshold and placed within wall (203).

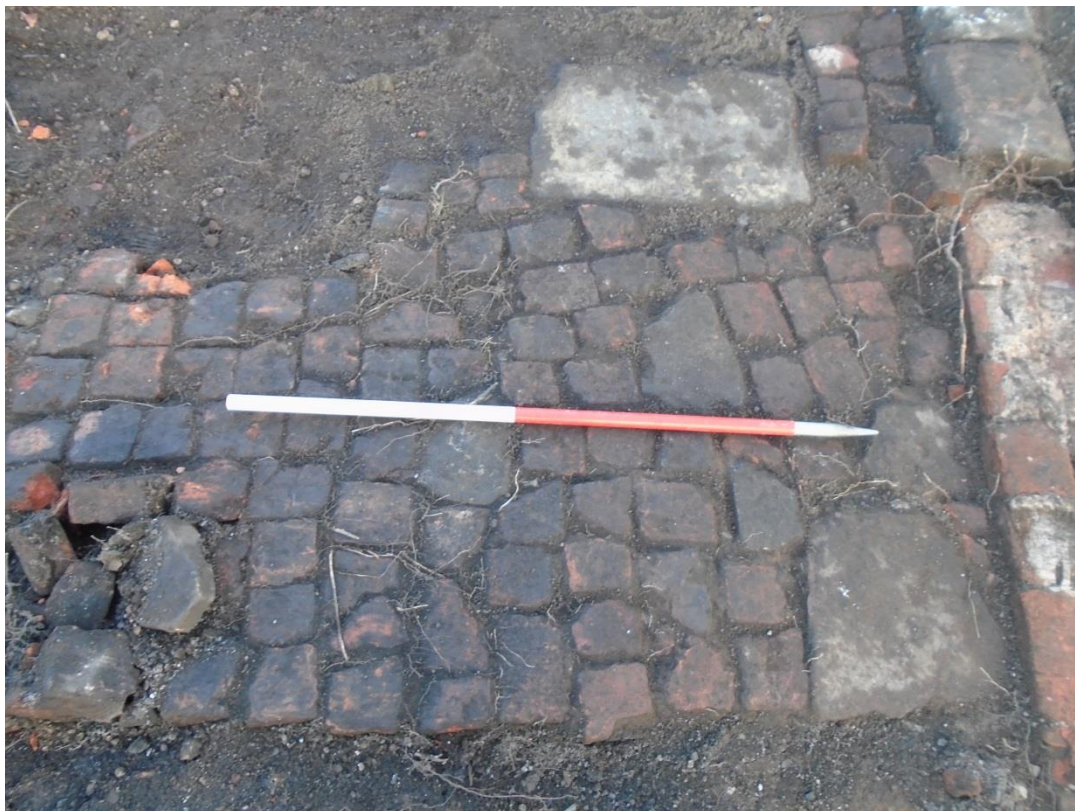
Plate 12: Internal brick floor with stone insets (207). Looking North East

Bounded by walls (202), (203) and (205), was a rectangular floor surface (207). This measured 2.27m in width and had a length of 2.60m. The floor was seen to be constructed of broken brick and stone (Plate.12). The surface had been truncated at its north-east side towards wall (203). This truncation was likely caused during the demolition of the structure. To the west of this floor a thin concrete screed (208) was seen as the floor level. Below this, sandy deposits with pebbles were seen sat just above natural sandy clays (Plate 13).

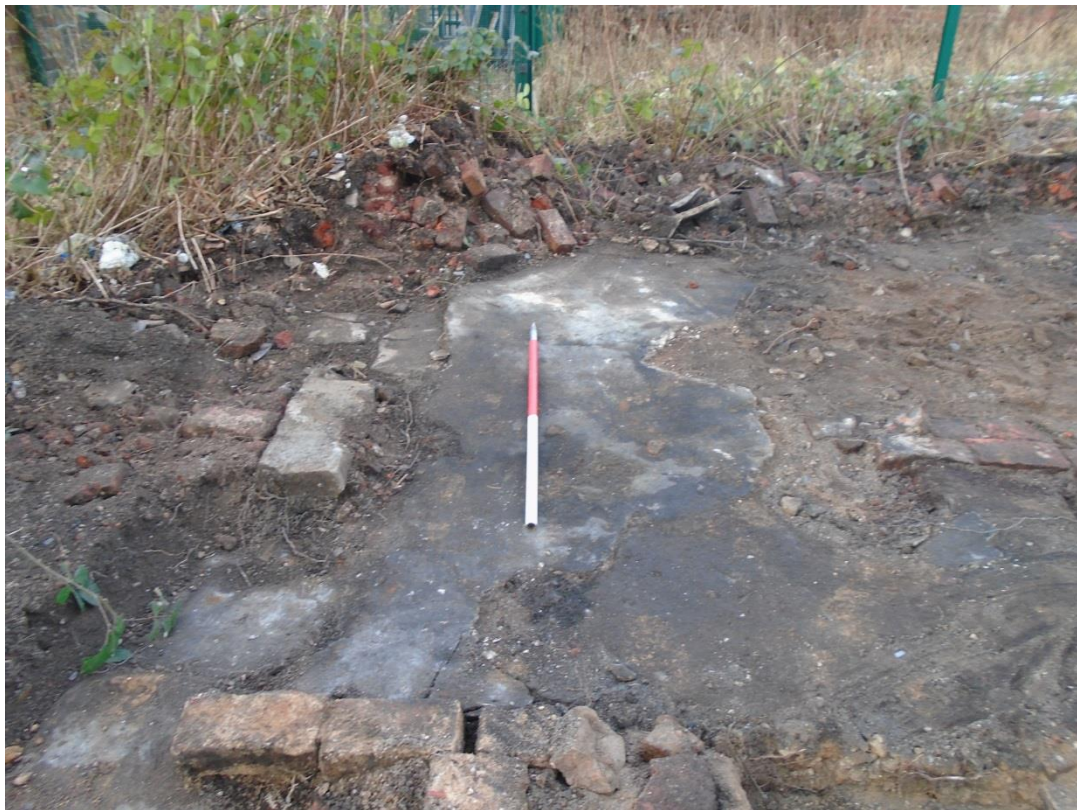
Plate 13: Concrete Screed floor (208) at the north-west corner of trench 2.

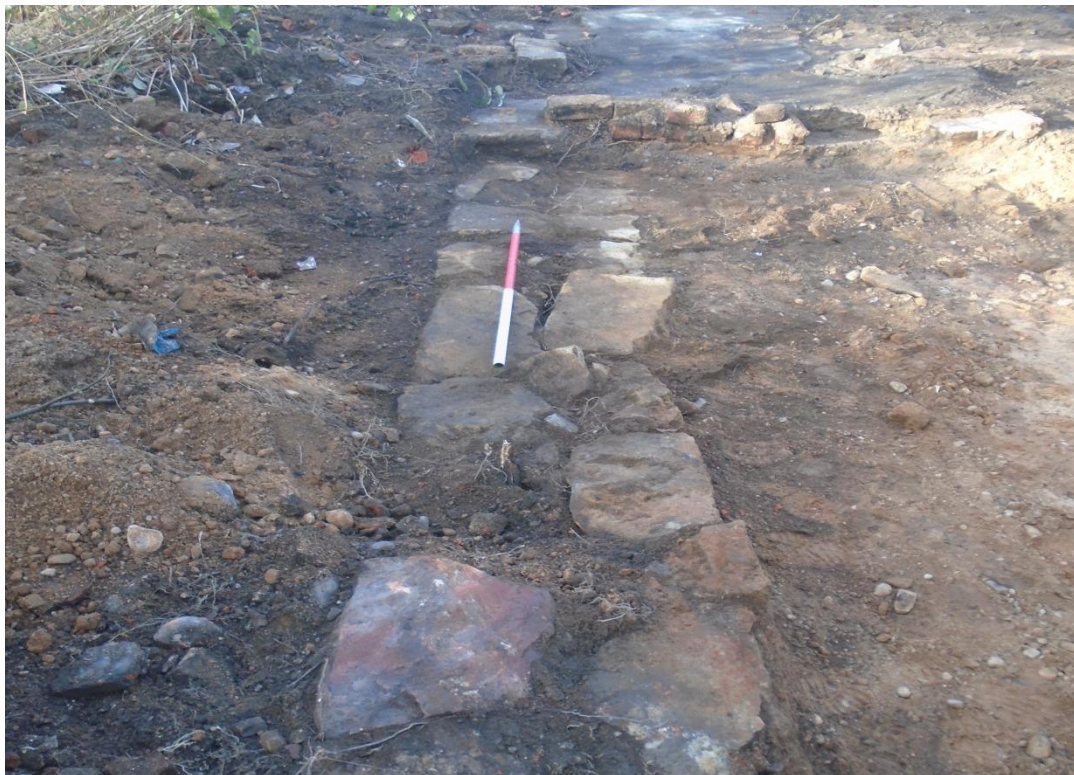
Plate 14: Brought to course farmhouse stone wall (211). Looking north-west
To the south-east of the internal passage, and on the same alignment, wall (203)
abutted a stone wall (211). The stone wall was 4.7m to the north east of stone wall

The concrete extended west to meet the remains of a north-west/south-east aligned wall (209) which formed a right-angle corner with wall (202). The wall had a surviving length of 0.90 m with 4 brick courses in height seen. The brick wall sat on top of a wall (210) made up of brought to course stone and rubble which extended for 7.34m south-east from the truncated limit of the brick wall. The stone wall was 0.60m in width constructed of two courses (Plate 14).

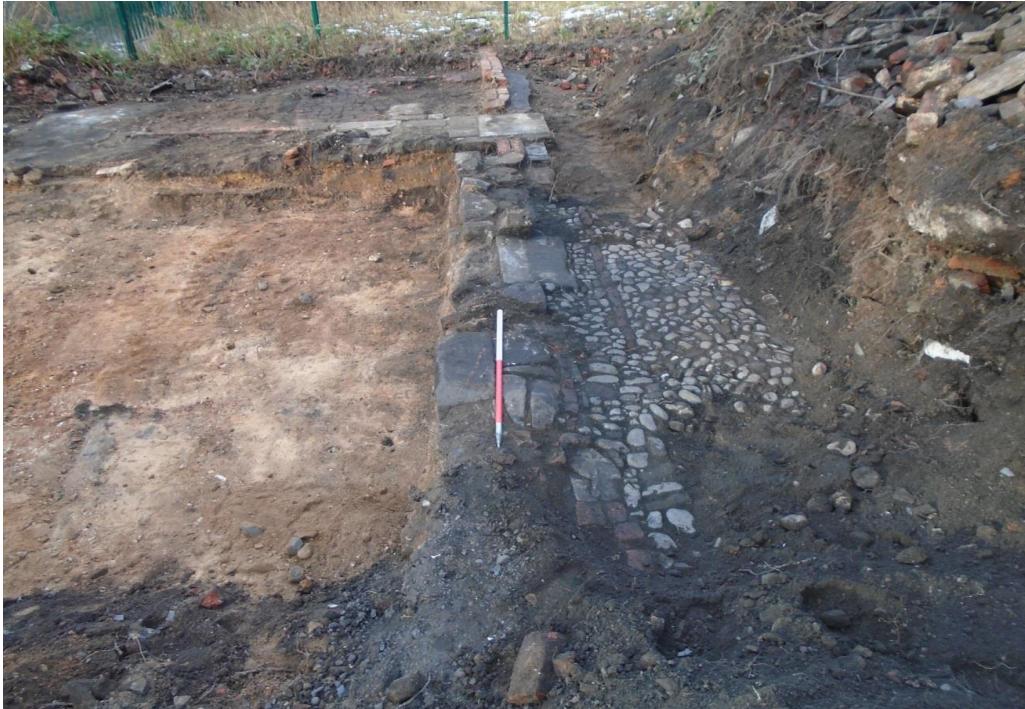
Plate 15: Exterior structural stone wall (211) with cobbled surface to the east

(210). It had the same width of 0.60m as (203) and had a surviving height of 0.42m. The wall extended south-east for 6.0m where it reached the excavation limit (Plate 15).

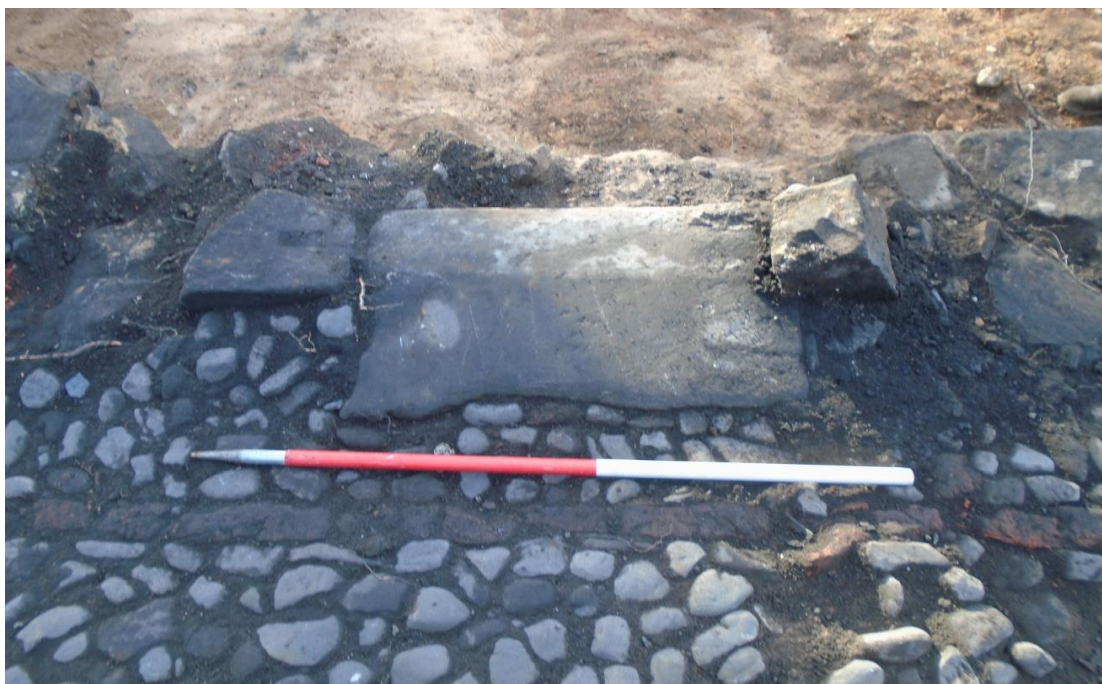
Plate 16. Stone threshold positioned between two stone frame blocks. Looking west

At 1.72m along this wall a stone flag threshold was seen set into the wall (Plate 16). It had a length of 1.0m and width of 0.42m which extended north east beyond the wall. Either side of the flag, stonework with markings from door furniture were seen. To the east of the wall (211) a cobbled surface was seen (212). The exposed cobbled area was up to 1m in width where it met the excavation northeast limit and extended 4.20m to the south-eastern limit of trench 2.

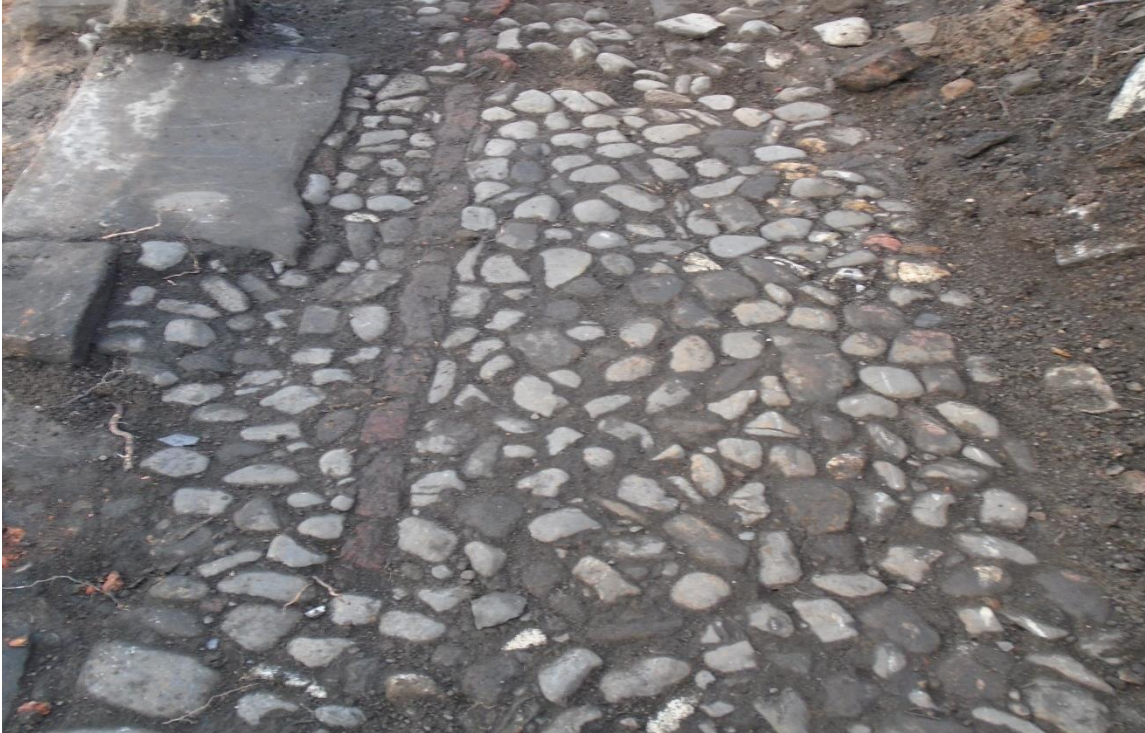
Plate 17: Cobbled yard surface (212). Looking north.

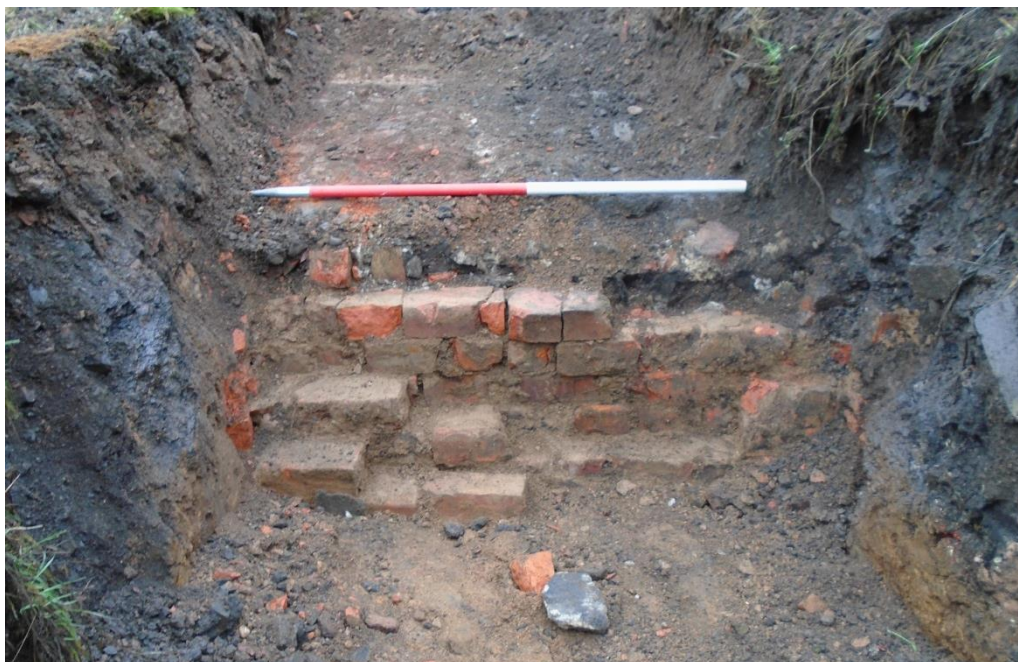
Plate.18: Remains of wall 304 aligned northeast/ south-west across trench 3. Looking north-west.

Beyond this natural sterile sandy clay was seen at a depth of 0.90m. A further wall (304) extended across the trench 1.7m north-west (303). The wall, seen at a depth of 0.43m had a surviving visible height of 0.5m with 5 courses of brickwork seen and a width of 0.35m, 3 courses. The complete brick dimensions were seen as 22 x 11 x 7.5cm. The construct of the wall was stretcher bricks bonded with a sandy mortar (Plate 18).

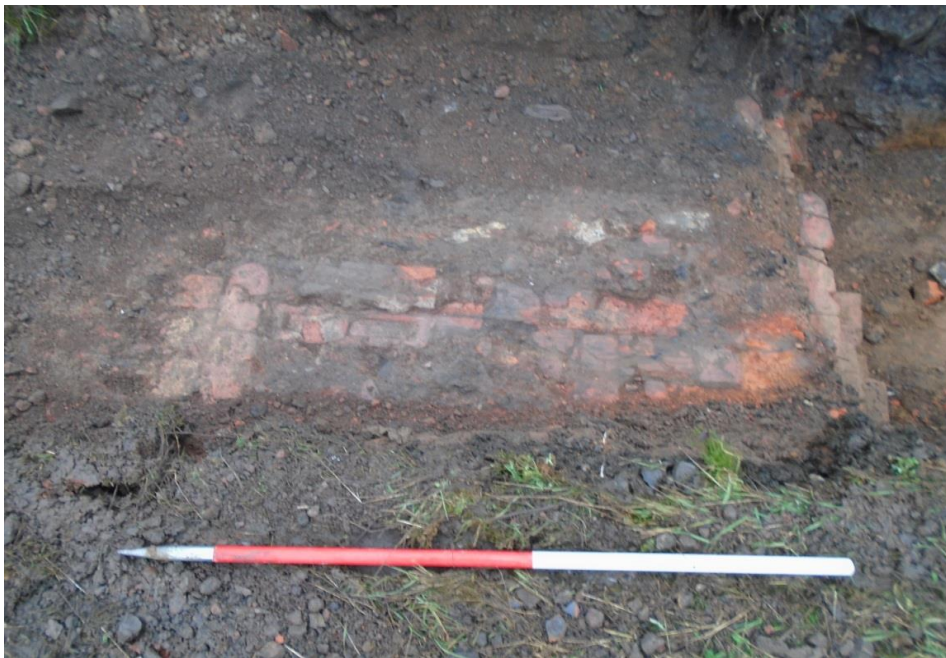
Plate.19: Brickwork feature 305 abutting wall 304. Looking North East

Abutting the south-east face of this wall an area of poorly preserved brickwork (305 & 308) was seen at a depth of 0.36m (Plate 19). The feature appeared to be rectangular or possibly the joint of the remains of two walls. This feature was seen at 4.70m along the trench, with a length of 1.90m and extended northeast into the trench by 0.85m.

Two courses of mixed brick (305), hand-made and frogged, one stamped Wilkinson Elland, extended north-west for 1.8m where it abutted and formed a 90 degree corner with further two courses of brickwork (308) which extended south-west for 0.85m to the trench edge.

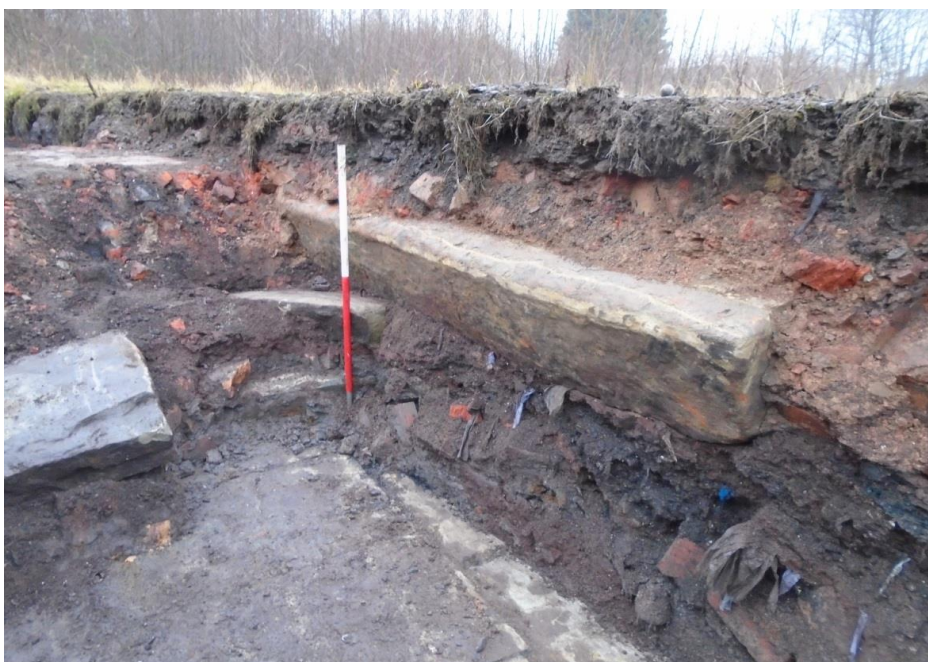
Plate.20: Large rectangular stone bedding block 306 in the south-west section of trench 3. Looking South

At 7.20m along the trench, a large rectangular stone bed (306) was seen protruding from the demolition material in the trench section and extending 0.15m into the trench at its north-west end (Plate. 20). The top of the stone bed was seen at a depth of 0.45 with further demolition crush material underneath.

The sandstone block bedding materials seen within Trench 3 (306) are characteristic of mill engine houses during this period and may suggest the evaluation trench had been placed over the engine house. However, the engine beds were seen within the fill material (302) and not in-situ circumstantial evidence for the destruction caused to the mill by the fire and subsequent demolition works.

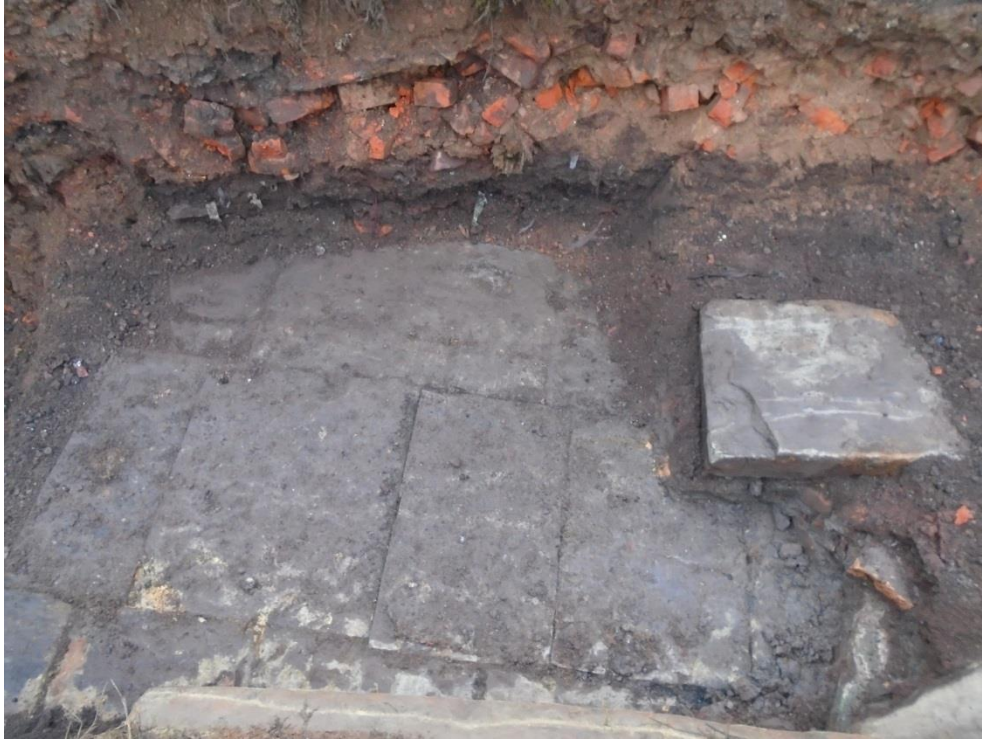
Plate.21: Stone flags (307) seen in trench 3.

At a depth of 1.4m large stone flags (307) of mixed size and shape formed a floor surface which spanned the width of the trench. The floor was seen to extend from 8.20m along the trench on a north /south alignment. The surviving length of the floor was seen to be 2.10m. At this point the surface was truncated, with no further archaeological features being encountered.

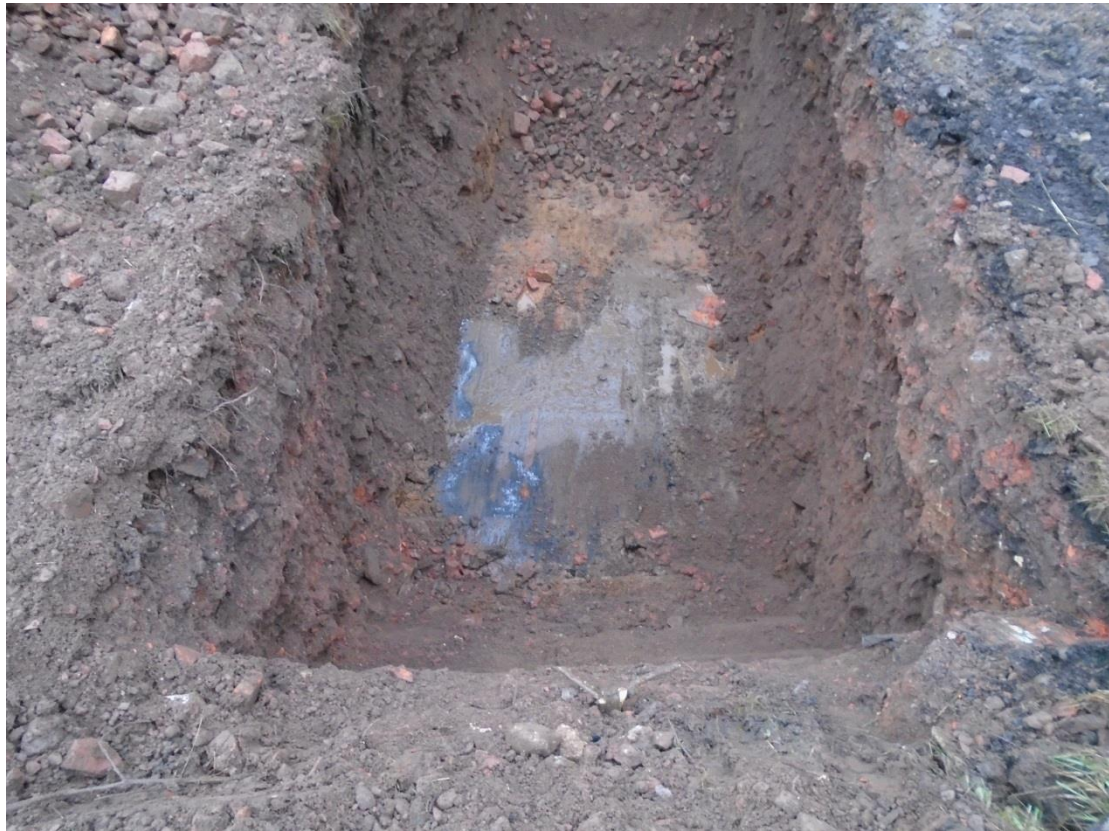
The trench was overlain by a 0.10m layer of made ground topsoil and mosses (401). Beneath this a demolition rubble crush (402) was excavated to a depth of 2m. An area of possible stone flagging (403) measuring 1m in length and extending the width of the trench was seen 1.15m along the trench at a depth of 1.8m. Access to the trench due to the depth and unstable nature of the edges was not possible. The feature was cleaned by machine (Plate 22)

Plate 22: Possible stone flag surface in trench 4. Looking north

Within trenches 3 and 4 the stone flagged floors seen at 1.4m and 1.8m below the current ground level are likely to be a cellared floor.

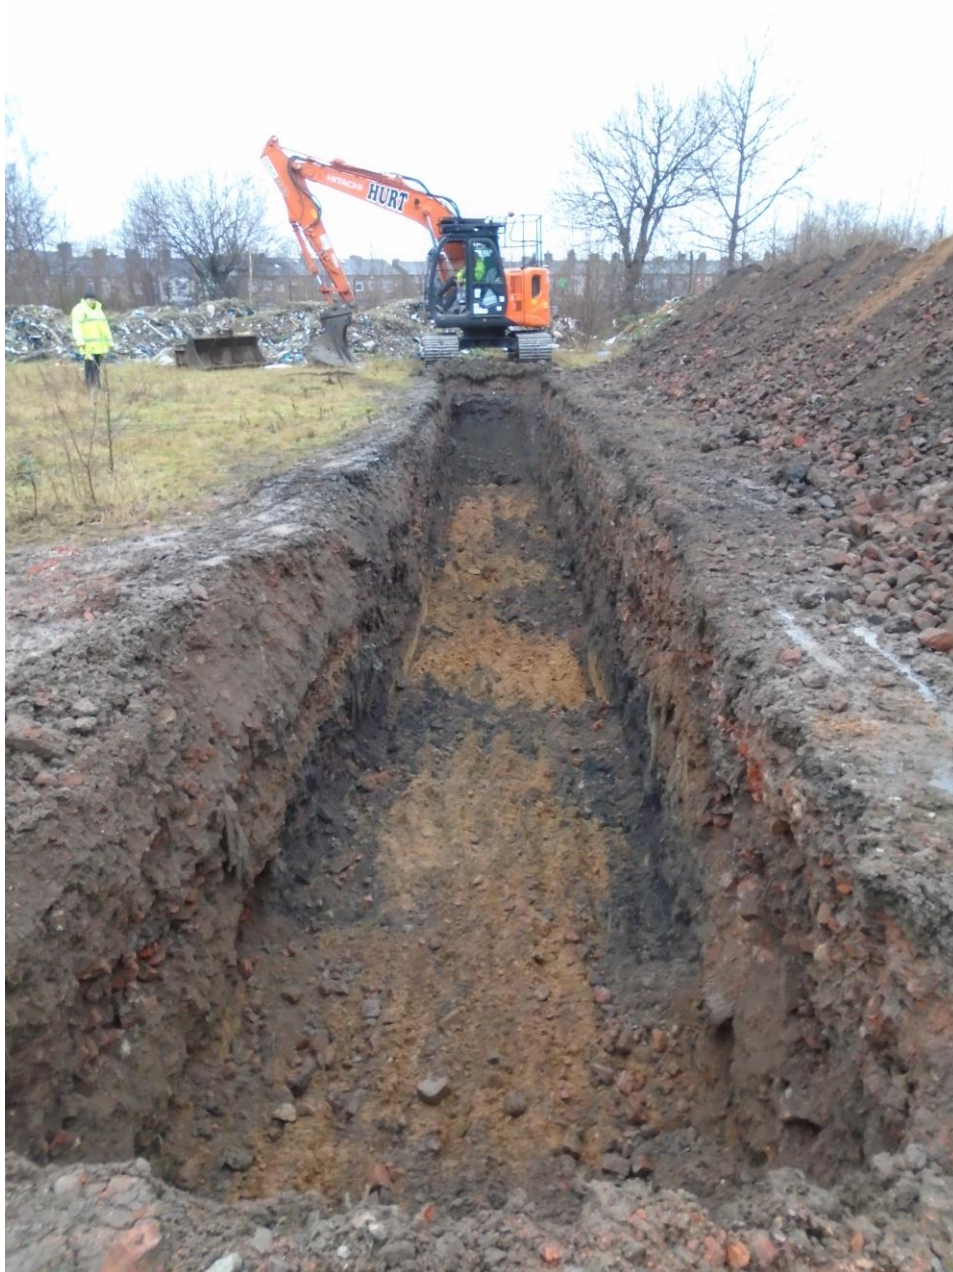
Beyond this area of flag material, no further remains were seen within the trench. Natural sandy clays were seen the length of the trench at depths of 2.2-2.7m.

Plate 23: Natural sandy clay (100) seen the length of Trench 4. Looking North West

Natural sandy clay (100) was seen at a depth of 2.0 - 2.30m within the trench (Plate 23).

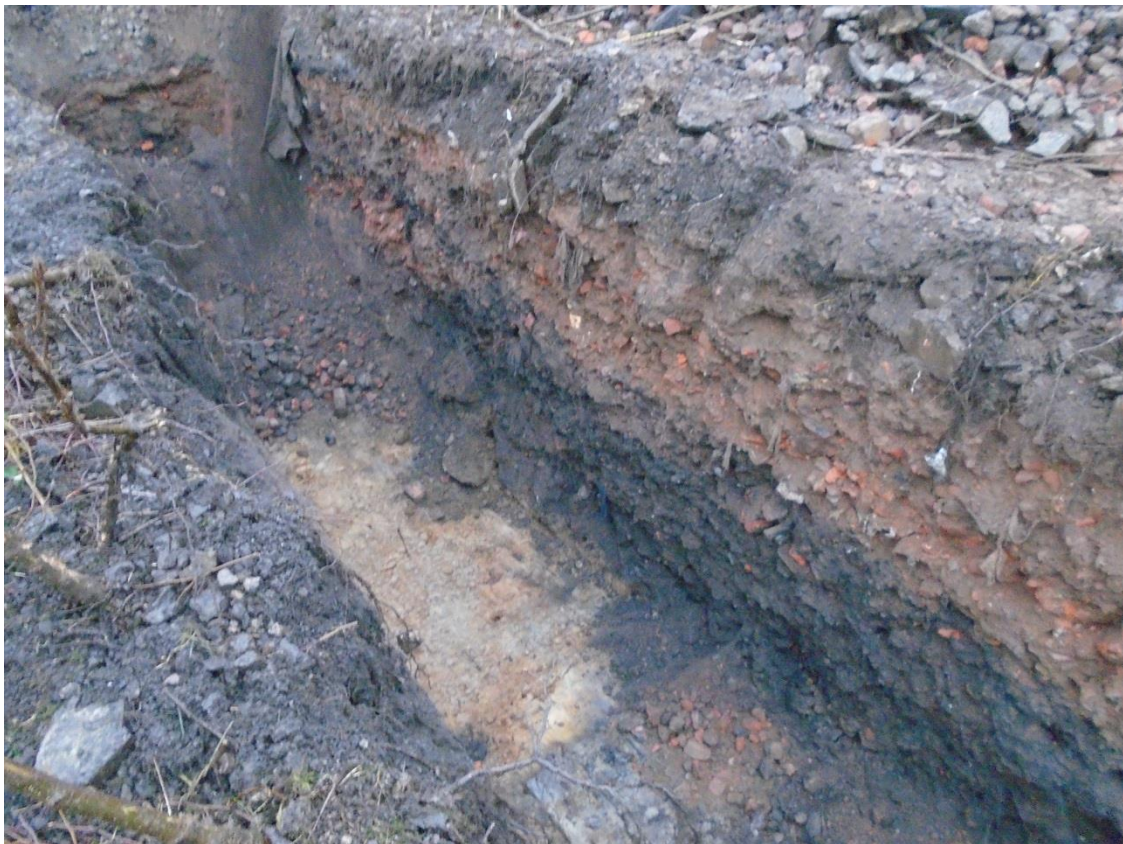
This trench was sited to the north east of trench 4. Measuring 20m in length and 2m in width, the trench was excavated to natural sandy clay at a depth of 2.0m (Plate.24).

No features of archaeological interest were seen within the trench. The trench was overlain by 0.30m of topsoil and made ground. This top deposit (501) is a dark grey ash and sand mix containing gravels and broken brick fragments. Self-seeding young trees cover most of the outer perimeter of the site.

Below the topsoil further made ground of demolition brick and concrete crush (502) have been used as levelling material. These fragments are mixed with site waste materials in a dark brown sandy loose ash.

Sat below the brick crush, a compacted deposit of burnt materials (503) formed a dark grey/black ash and silt mix.

Plate 24: Trench 5 stratigraphy. Looking South
