Archaeological Evaluation

Rose Mill, Coalshaw
Green, Chadderton

Technical Report:
Simon Hinchliffe

Report No: SA/15/2017

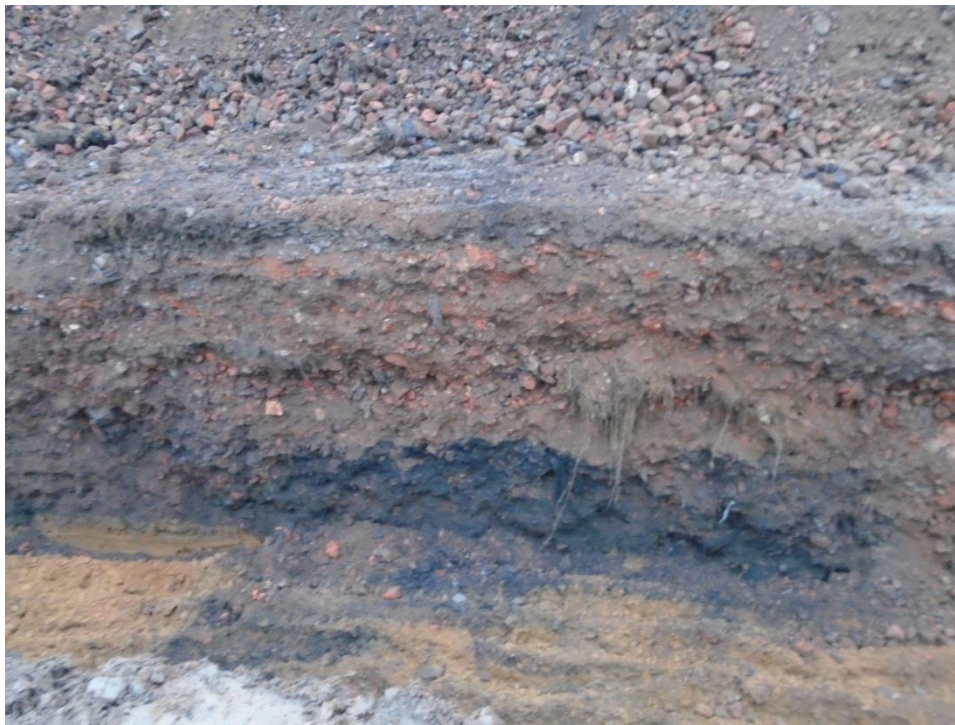
Evaluation trenching confirmed the stratigraphic makeup of the site. The findings align with the results of trial pit and borehole sampling undertaken by e3p in their Geo-Environmental Site Assessment Investigation. The results of the evaluation suggest that after the 2007 fire at the mill subsequent demolition and site clearance removed to natural levels the mill structure. The footprint was filled with burnt site waste and demolition materials and sealed with brick rubble crush forming a loosely compacted levelling material (Plate 25).

Plate 25: Trench 4 stratigraphy. Looking North East.

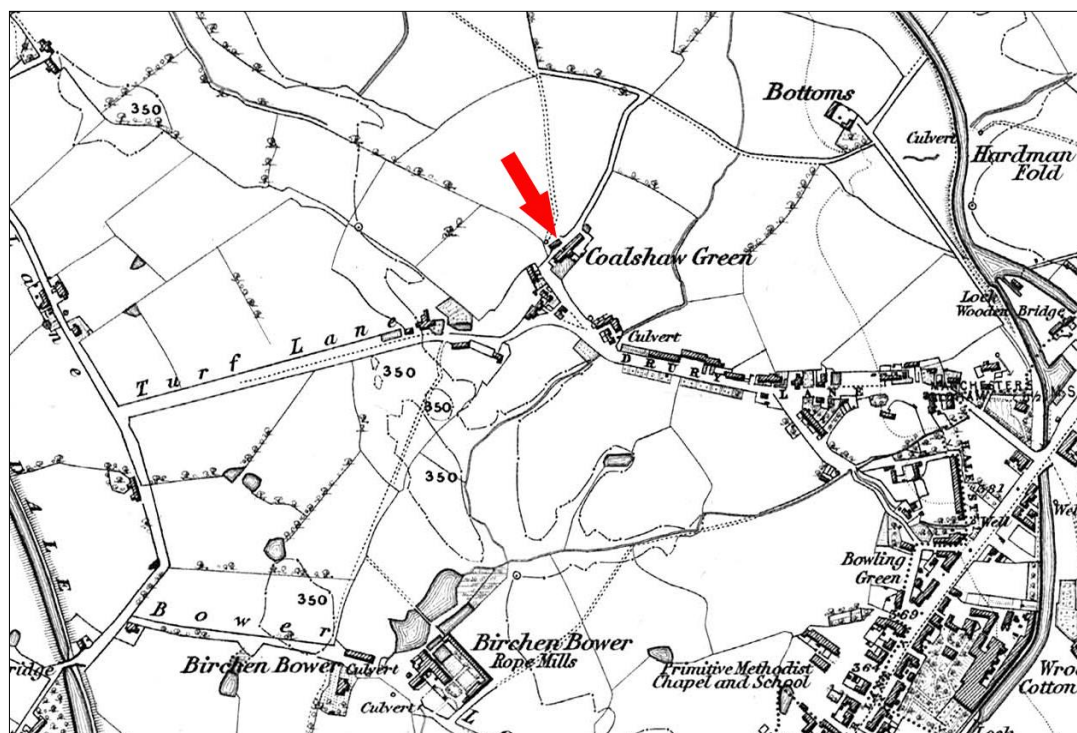
Plate 26: Coalshaw Farm shown on the OS 6 inch First Edition Map of Lancashire surveyed 1841-1853.

When comparing the finds with the maps it has been established that the farm buildings sat within a cobbled yard, seen as (212), which extended south-east to the farms boundary with what would become Rose Street. The farm buildings were seen to have been constructed of both stone and brick. Evidence of phasing was also seen in trench 2, with brick walls being constructed upon earlier stone walls, and concrete screeds being laid over brick floor.

Although the evaluation did not establish the uses of the buildings and what the boundaries of the farmhouse were, it did find recordable features of farm buildings that can be confidently related to the earliest Ordnance Survey map of the area.

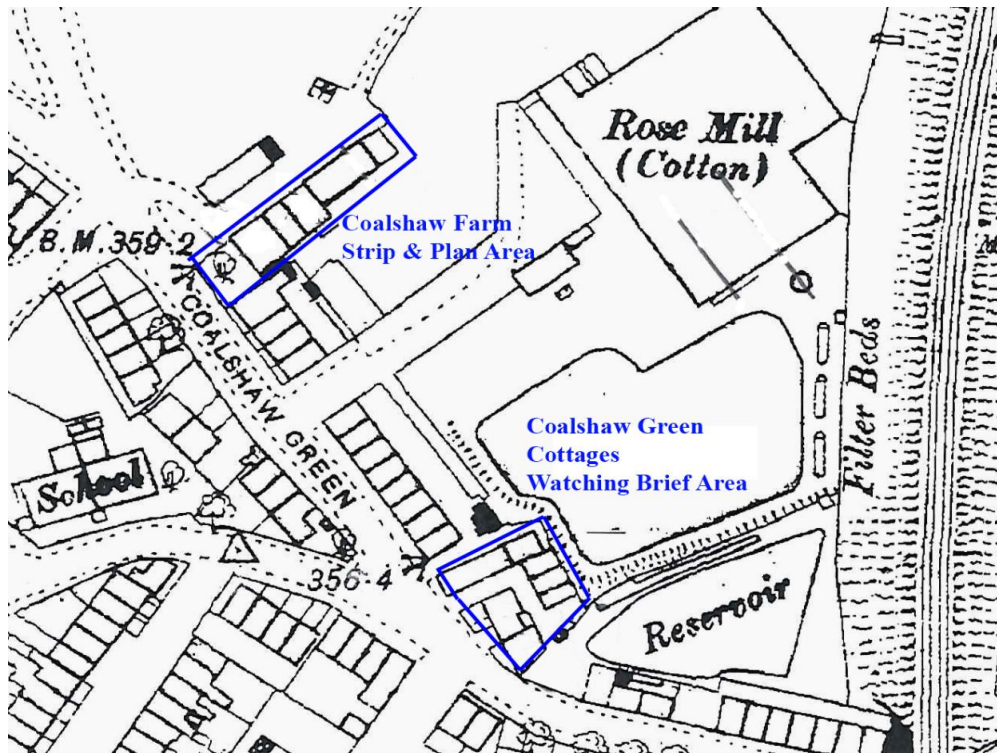
Plate 27: Areas of mitigation marked on the Ordnance Survey 1894 map.

Given the extent of vegetation and dumped material over this part of the site it would seem sensible to carry out any further archaeological work alongside site remediation works.. It should be noted that once the dumped/made ground has been removed the archaeological remains are very close to the surface therefore the removal of the overburden materials should be undertaken with archaeological supervision with the aim of proceeding immediately down to archaeological levels. Care should be taken in the running of vehicles over the area..

It is the opinion of Salford Archaeology that as the process of removing this invasive species involves excavating out the root system an Archaeological Watching Brief is held during this process. This will record any archaeological remains that have to be disturbed or removed during the remediation process and will indicate if any remains of the cottages remain in place after the process which might require further archaeological mitigation.

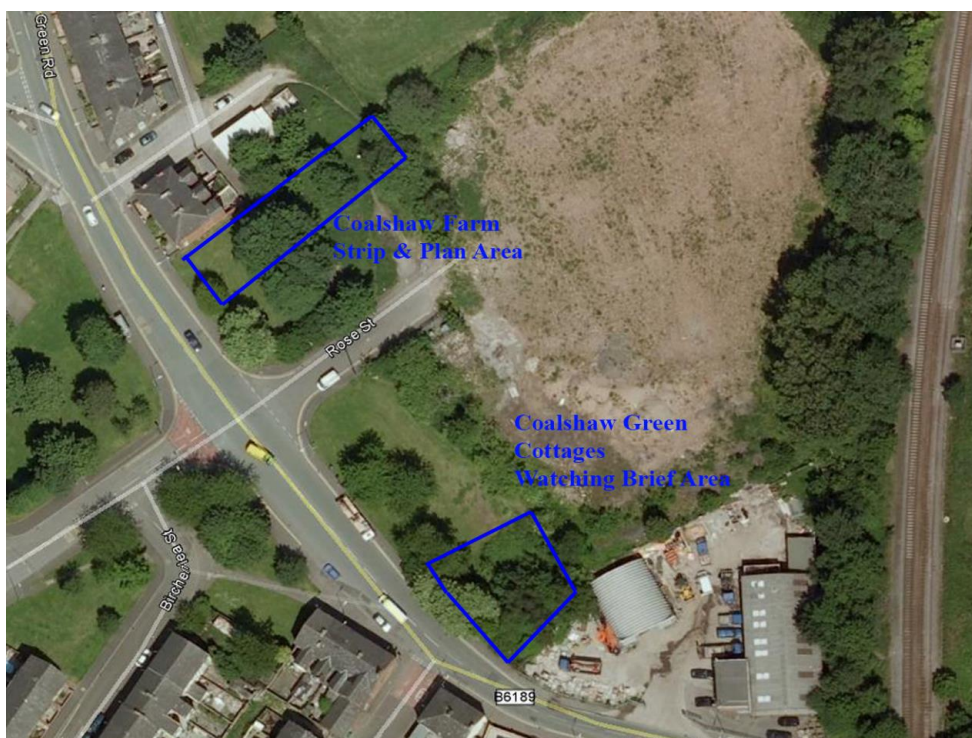
Plate 28: Areas of mitigation marked on a google image.
