An Archaeological Evaluation of Samuel Oldknow's Mellor Mill, The Roman Lakes, Marple Bridge, Stockport

A report by Peter Noble and Brian Grimsditch
University of Manchester Archaeological Unit
University of Manchester Field Archaeology Centre
Oxford Road
Manchester
M13 9PL

UMAU November 2009

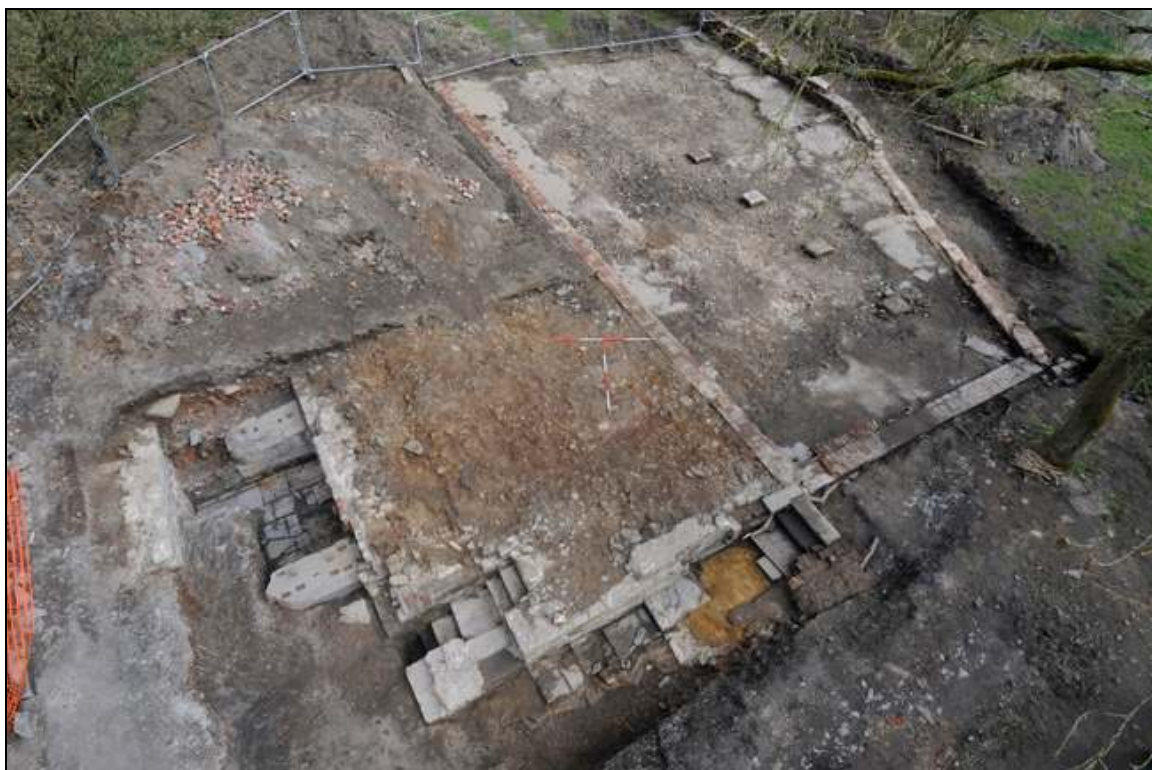
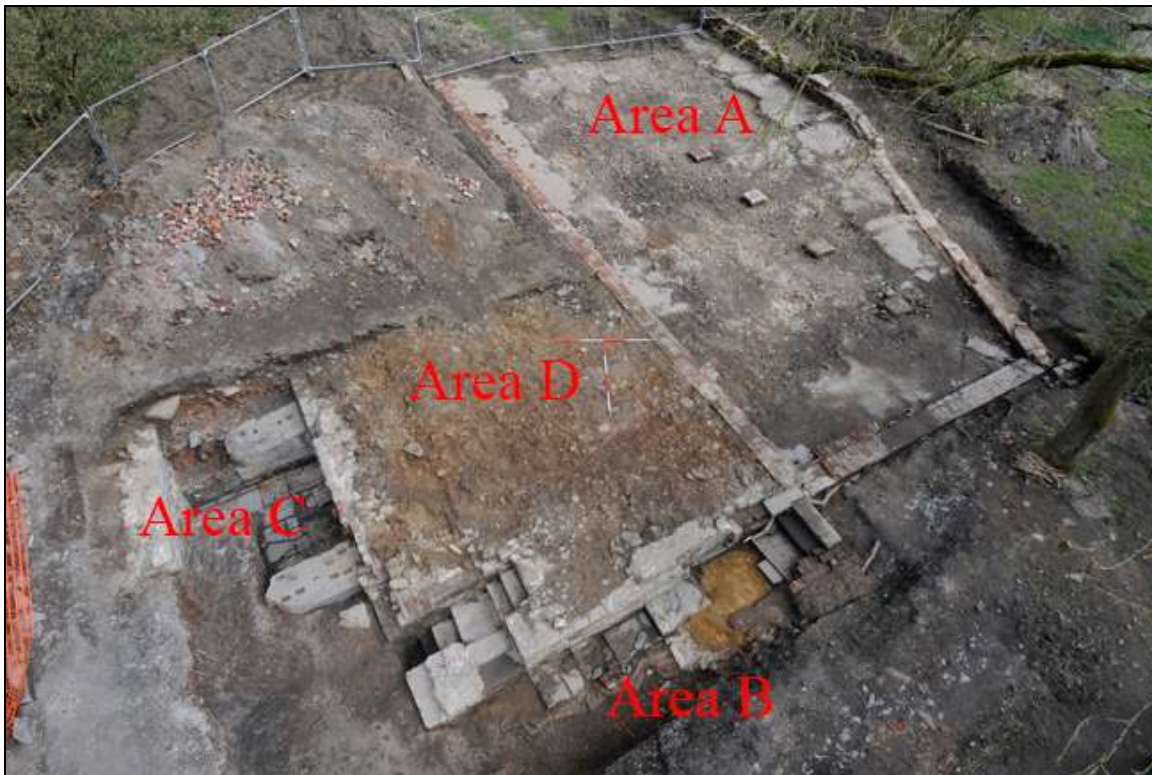
Plates 1 and 2: Aerial view showing Trench 1 (top) with areas highlighted (below). Viewed from the west.
Photo Adam Stanford

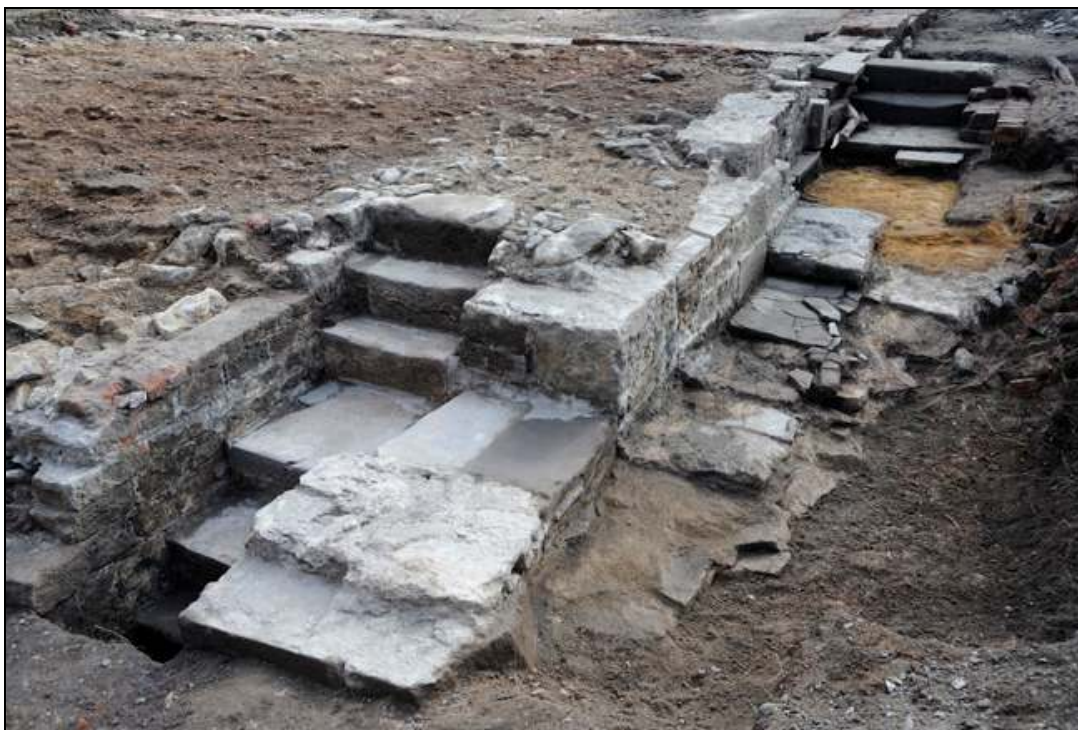
Plate 3 (top): Showing Area B viewed from the northwest, with stone (048) in the foreground. Photo Adam Stanford

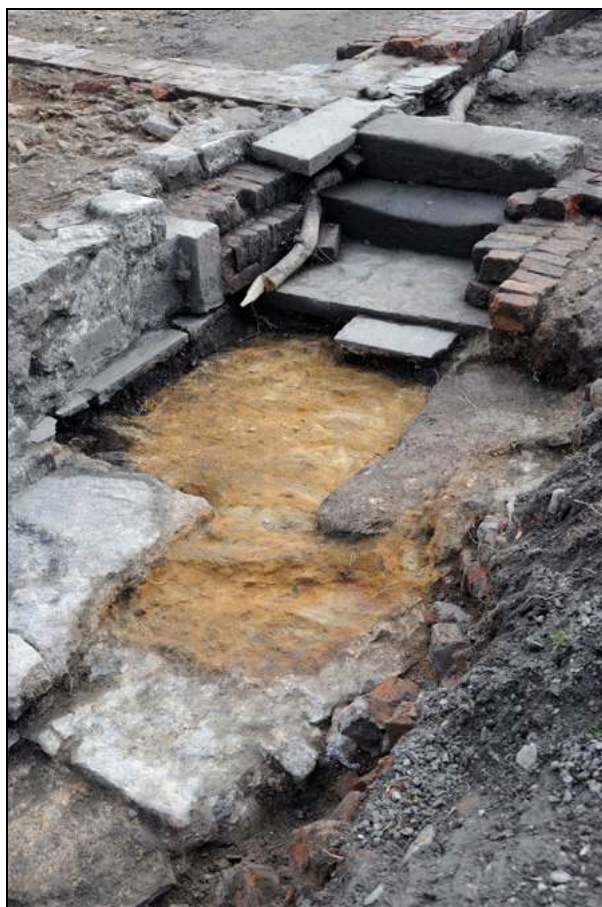
Plate 4 (below): Showing steps (035), flagging (052) and bricks (060) within Area B. Photo Adam Stanford

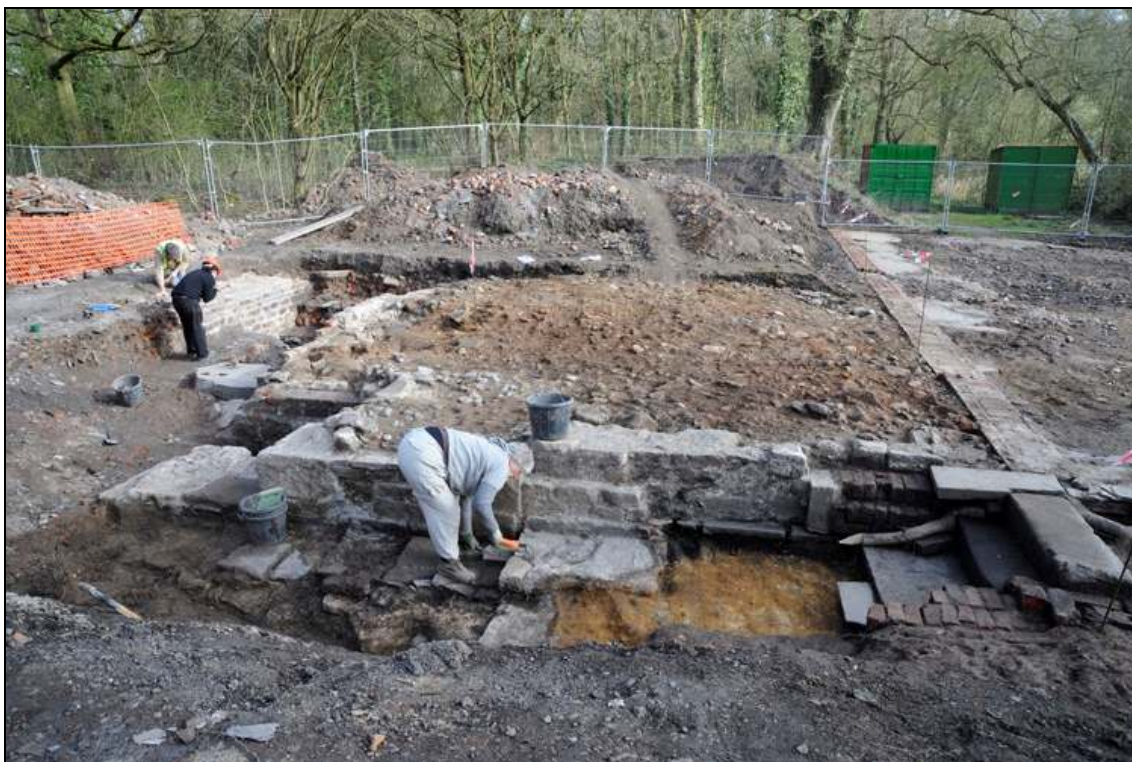
Plate 5 (top): Area B viewed from the west

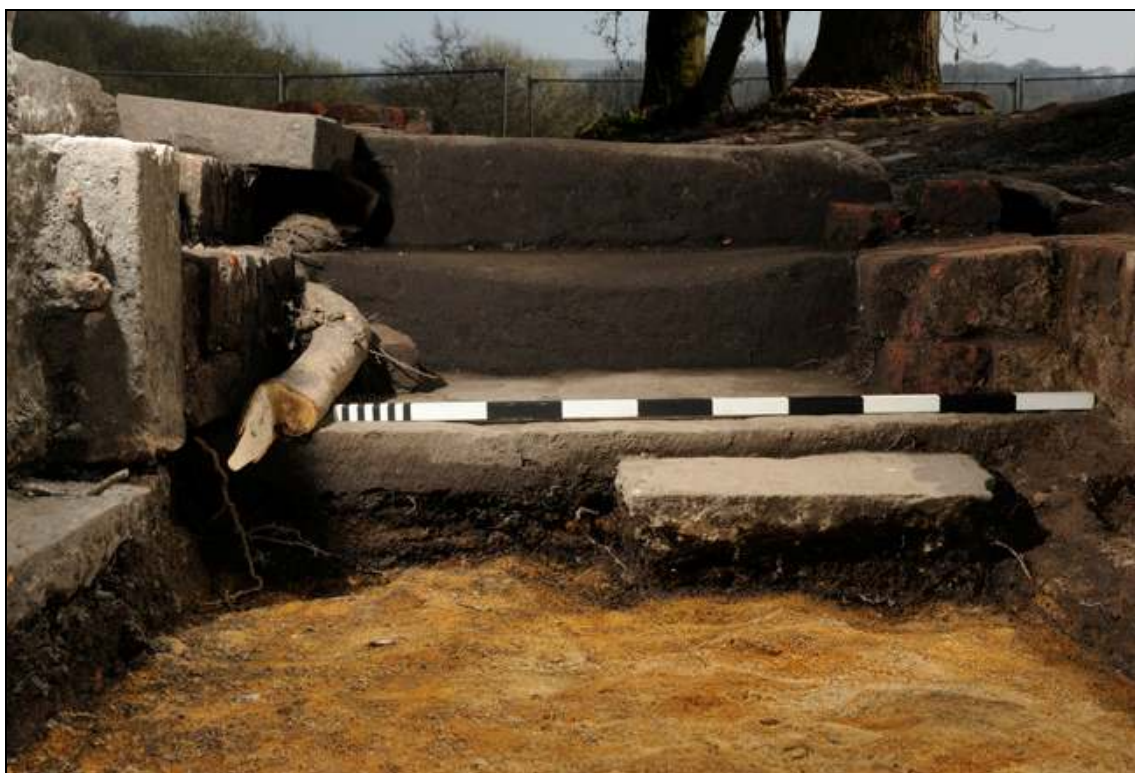
Plate 6 (below): Detail of steps (035) with flag floor levelling layer (057). Viewed from the northwest.
Photo Adam Stanford

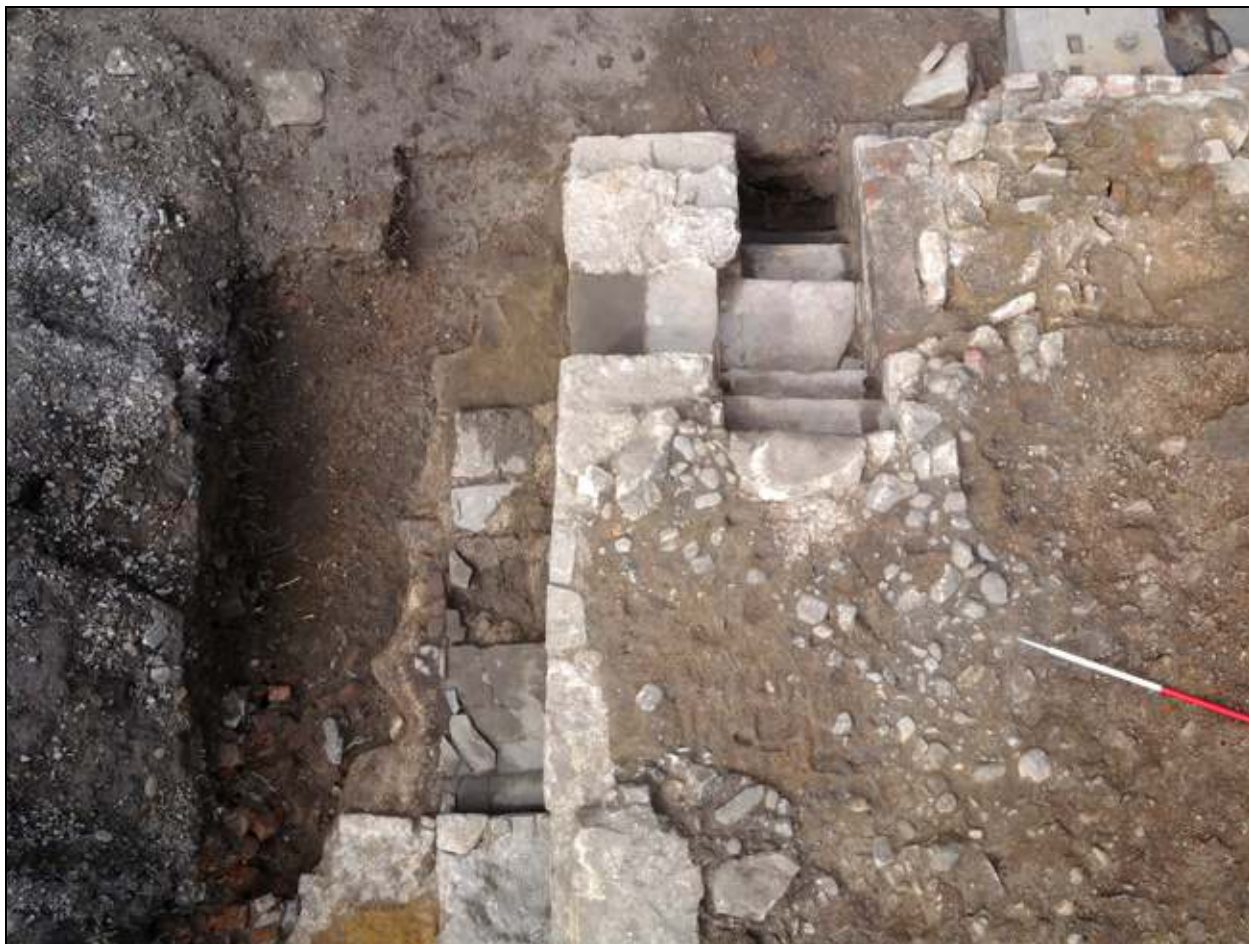
Plate 7: Overhead showing steps (047), steps (055) and cobbled area (033). Note robbed-out/damaged area (30) to the left. Photo Adam Stanford

The destructive fire of 1892 and the subsequent ruin and demolition of the Mellor Mill have left both positive and negative archaeological evidence. As to be expected large-scale stone-robbing has taken place over many years and evidence for this was found in both Trench 1 and 2, as well as in the visible remains of the mill outside of the excavation areas. Trench 1 Area B in particular has suffered major stone loss (**Plate 7**).

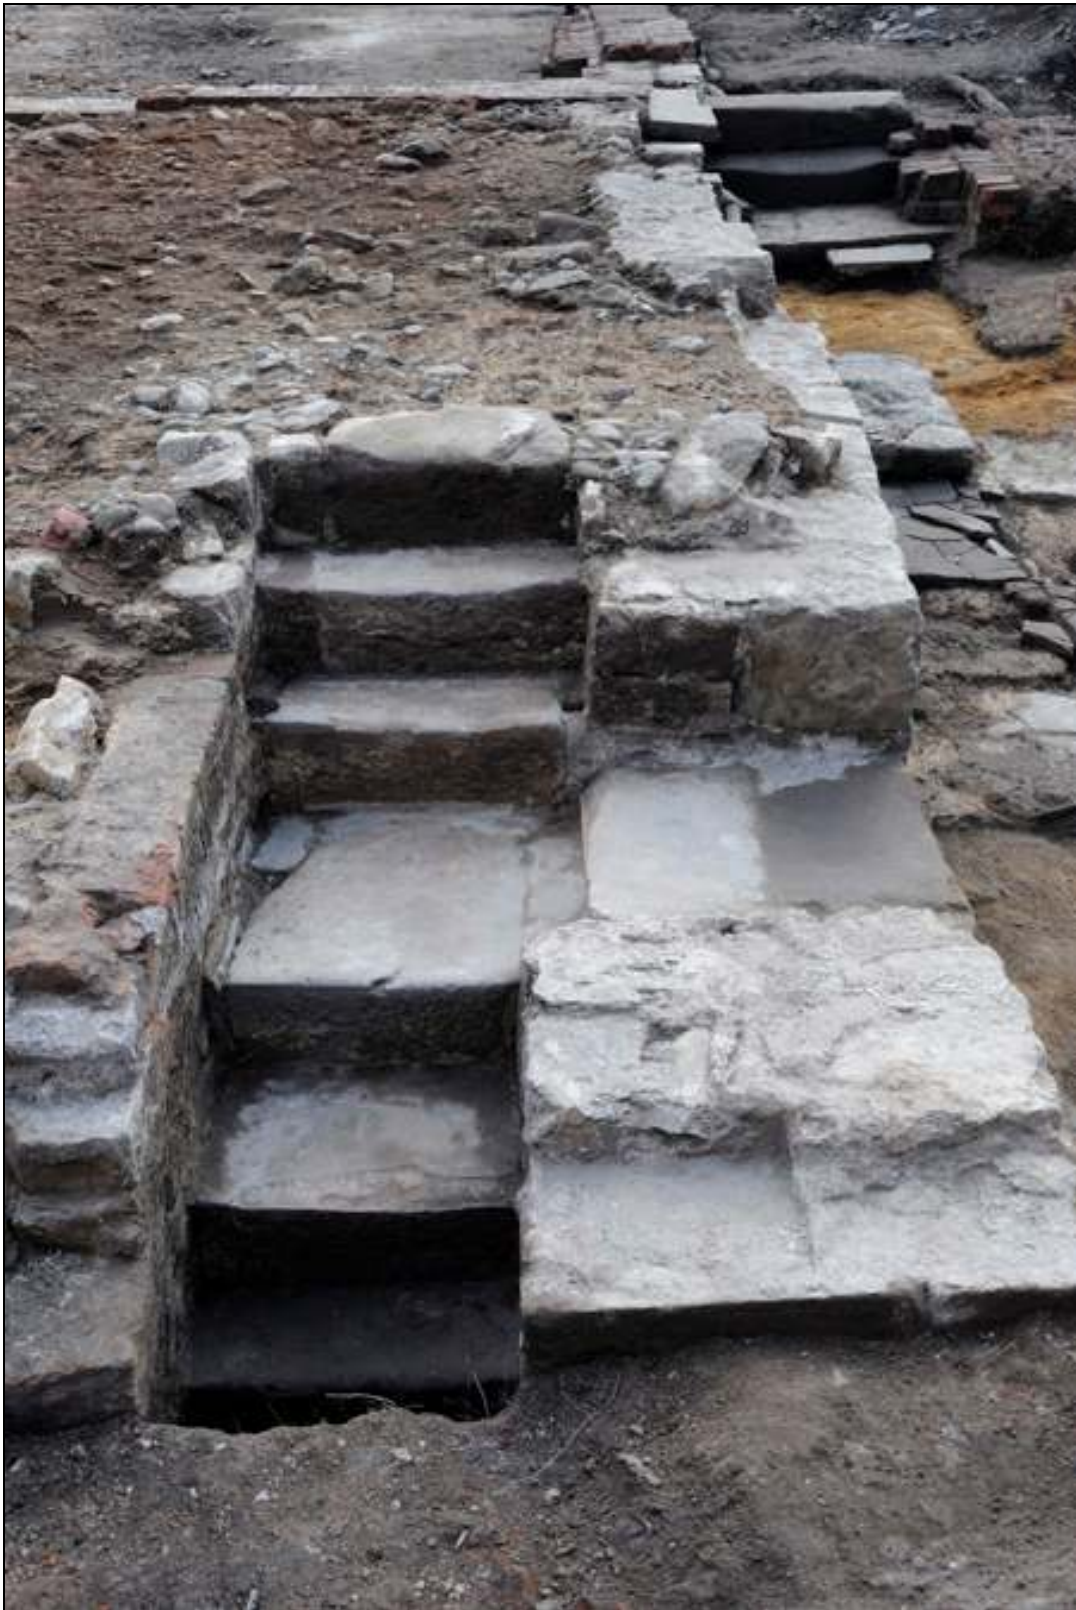
Plate 8: Detail of steps (047) and wall (048), with Phase 2 steps (055), cobbled area (033), and levelling layer (032) in the background. Viewed from the northwest. Photo Adam Stanford

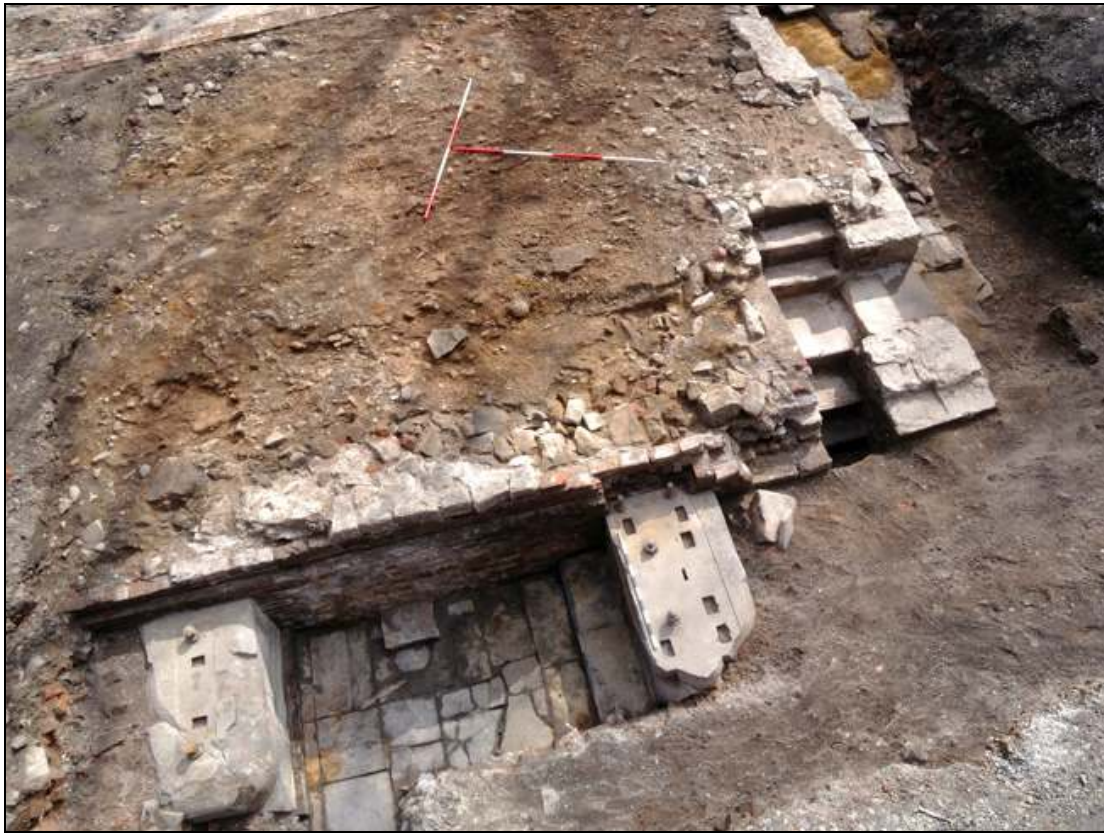
Plate 9: Overhead of Area C with levelling layer (032) to the south. Viewed from the northwest. Photo Adam Stanford

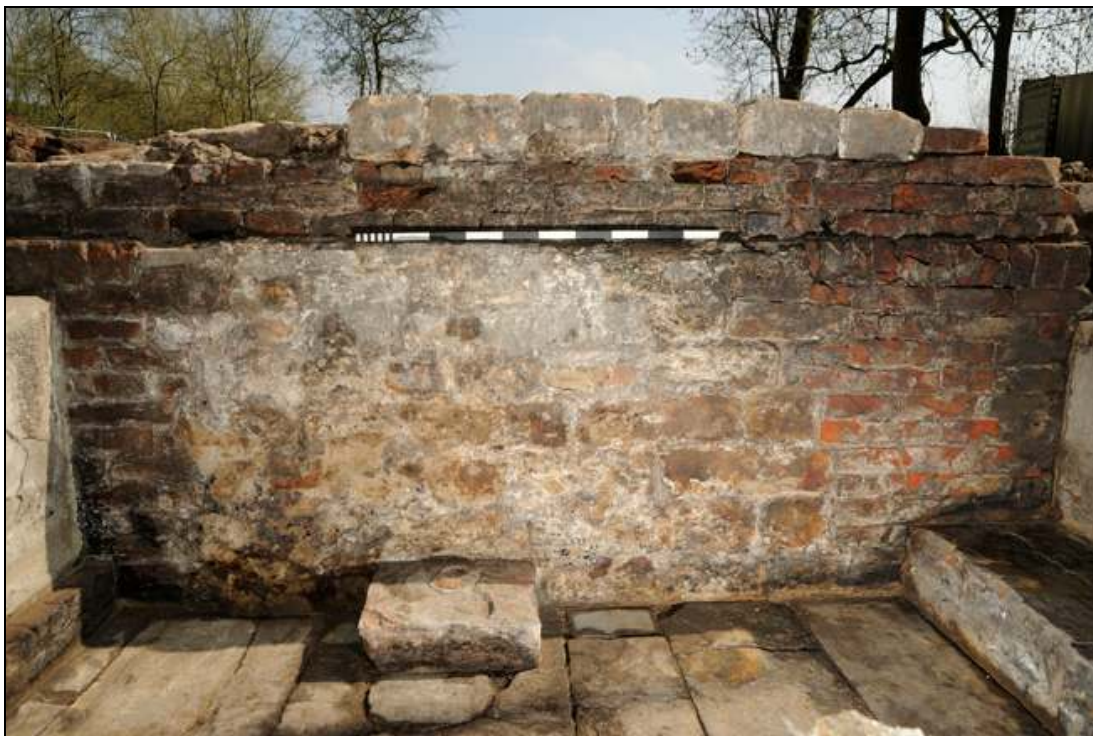
Plate 10: Area C detail of engine room north facing wall (045) and red brick rebuild (072) with (040) in the foreground. Photo Adam Stanford

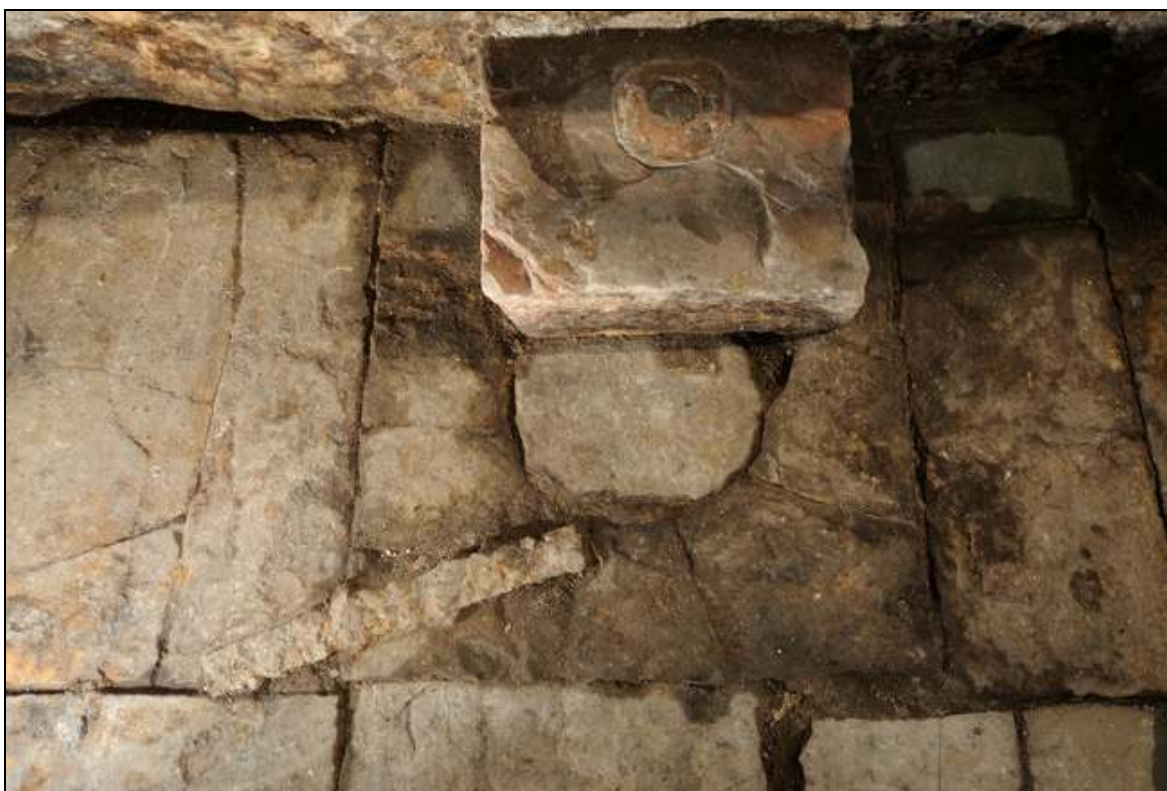
Plate 11: Area C detail of engine room floor (039) showing (040). Photo Adam Stanford

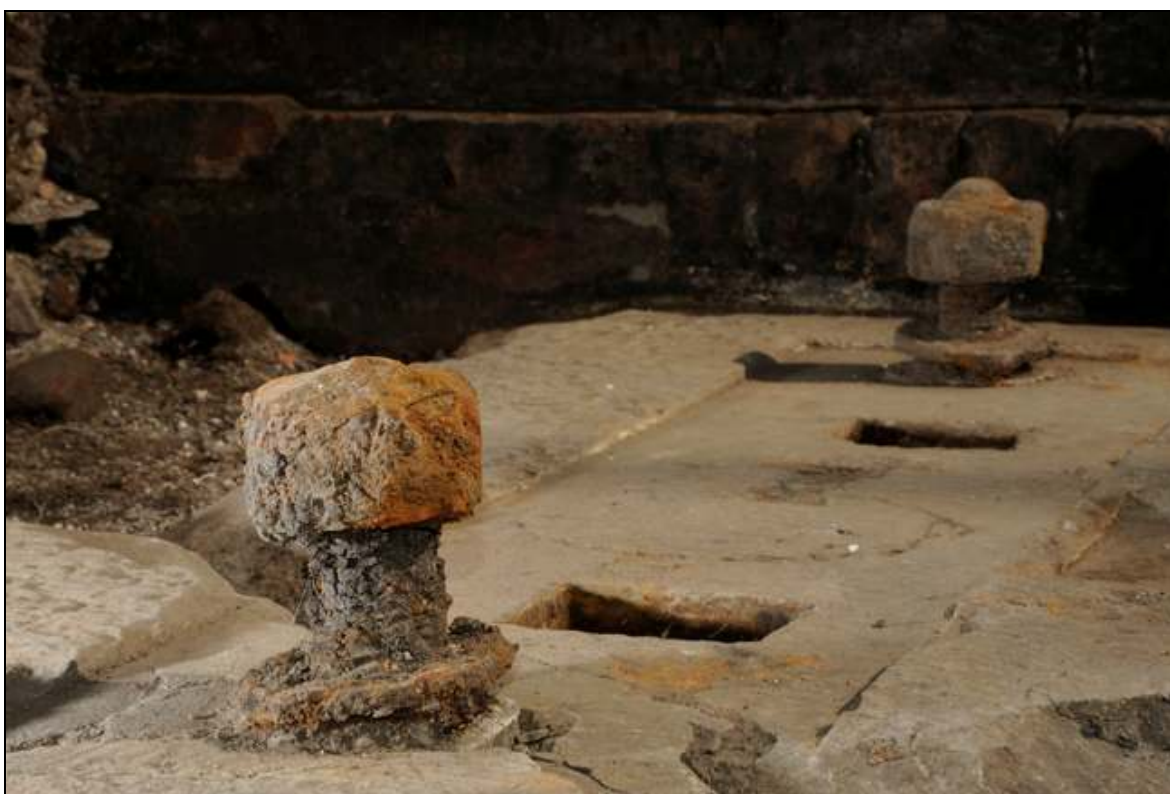
Plate 12: Detail of engine bolts in engine bed (037) Area C. Photo Adam Stanford

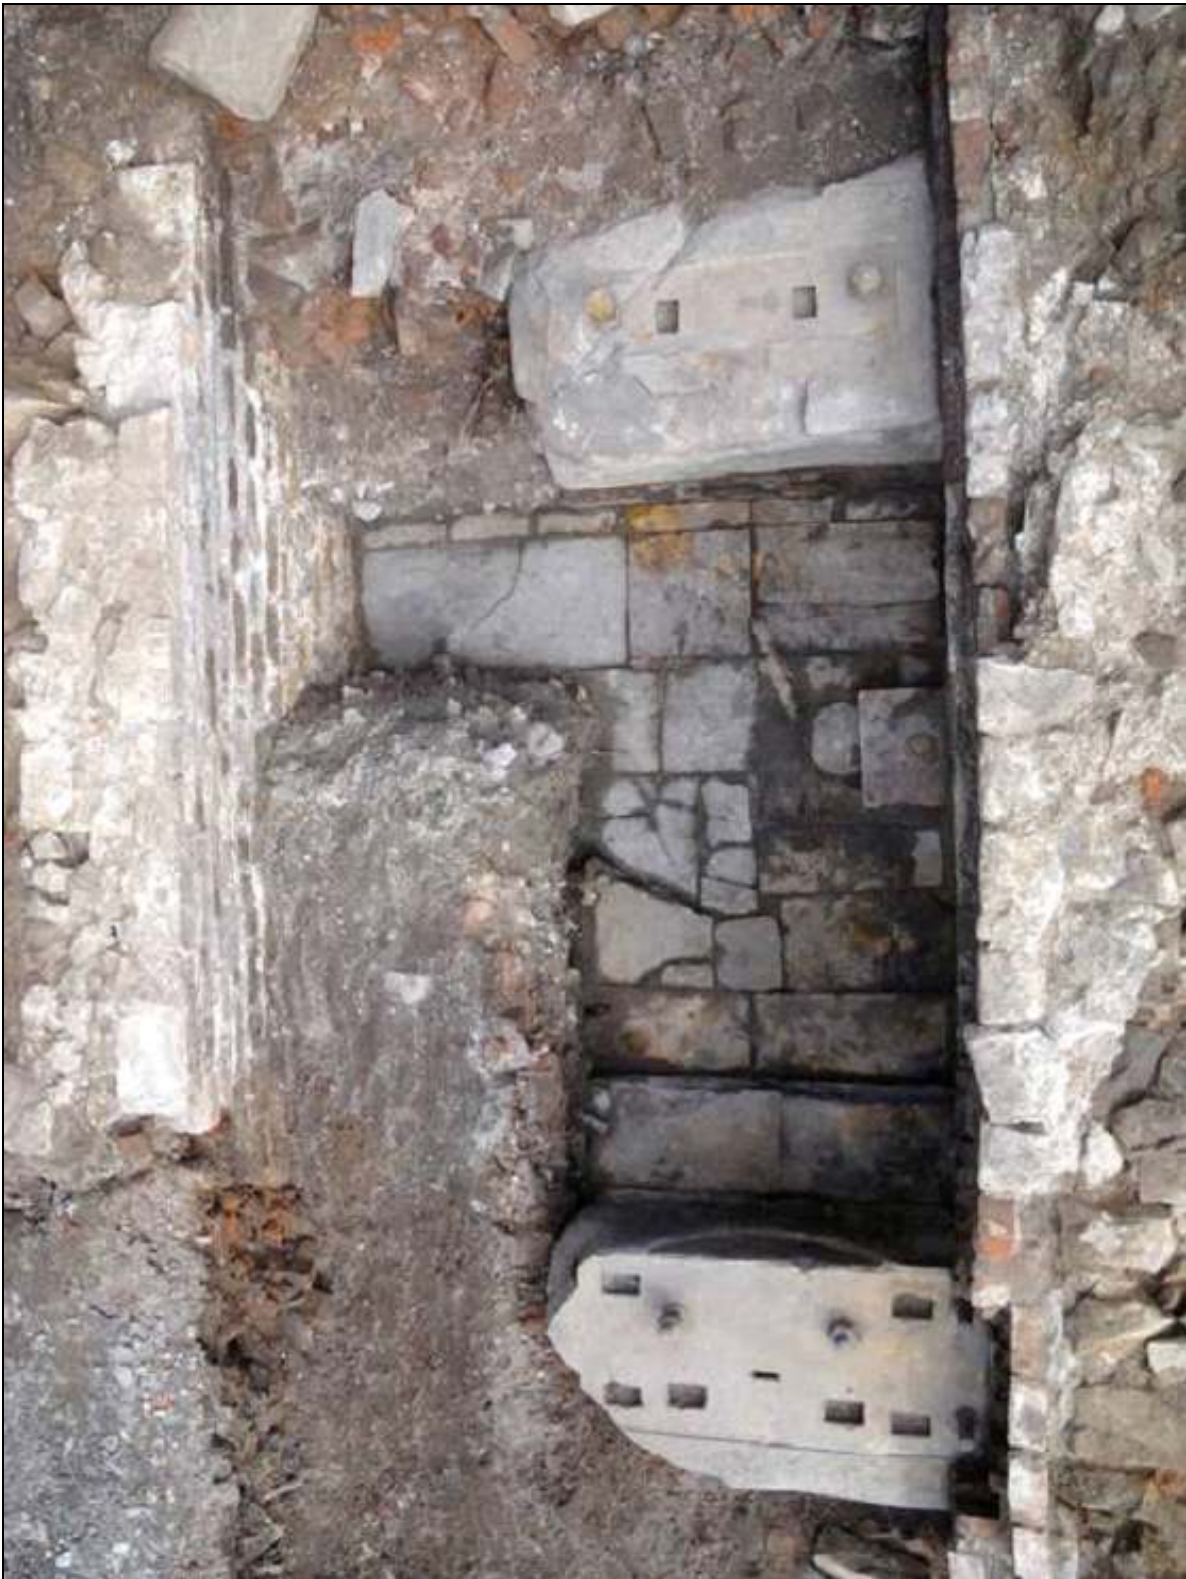
Plate 13: Overhead of Area C showing engine beds (037) and (041), floor (039) and walls (042) and (069).
Photo Adam Stanford

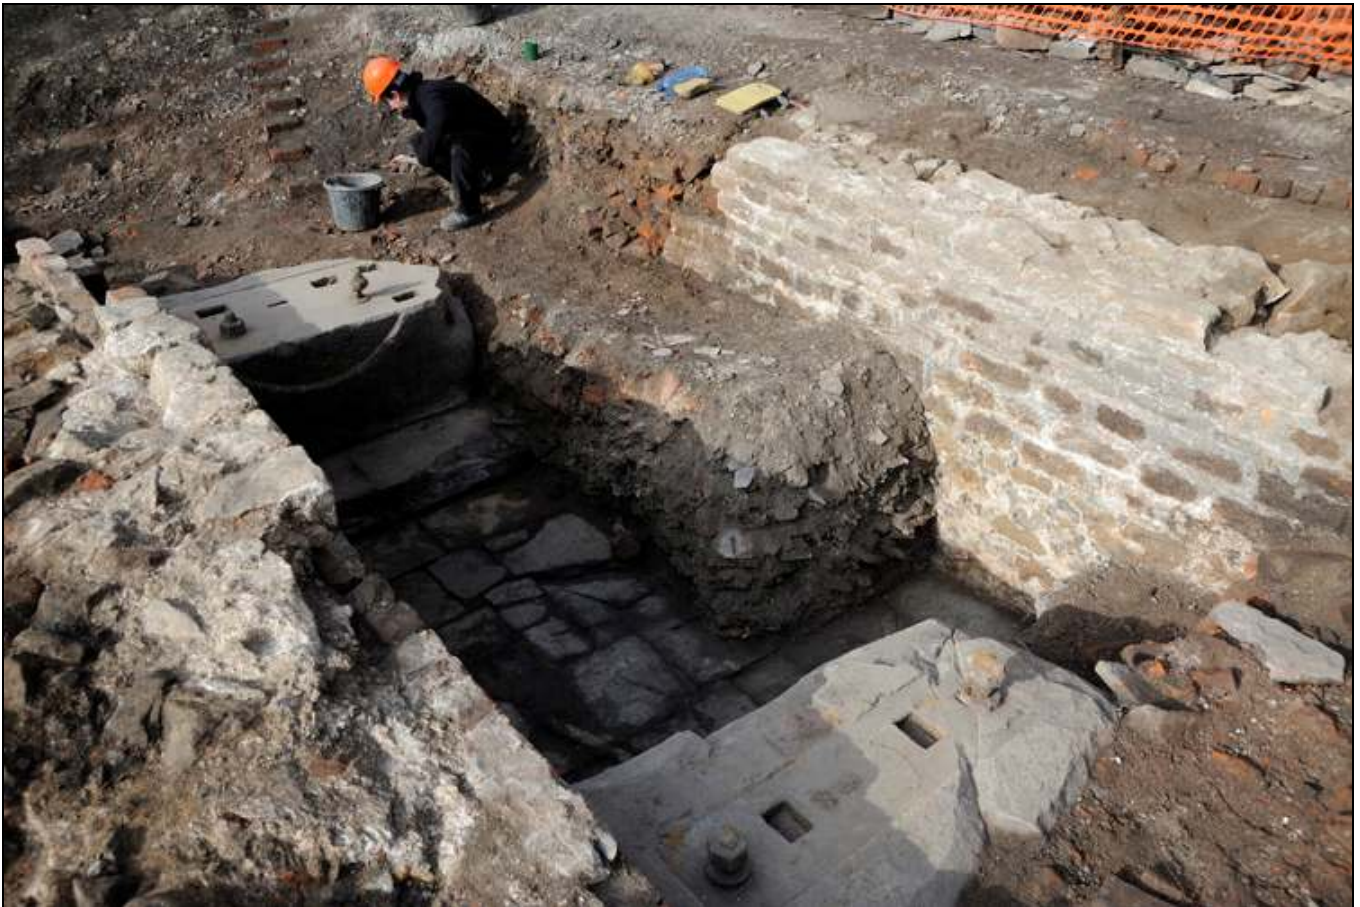
Plate 14: Area C viewed from the southeast. Showing engine beds (037) and (041), floor (039), infill (036) and wall (069). Note break in wall (069) to right of figure

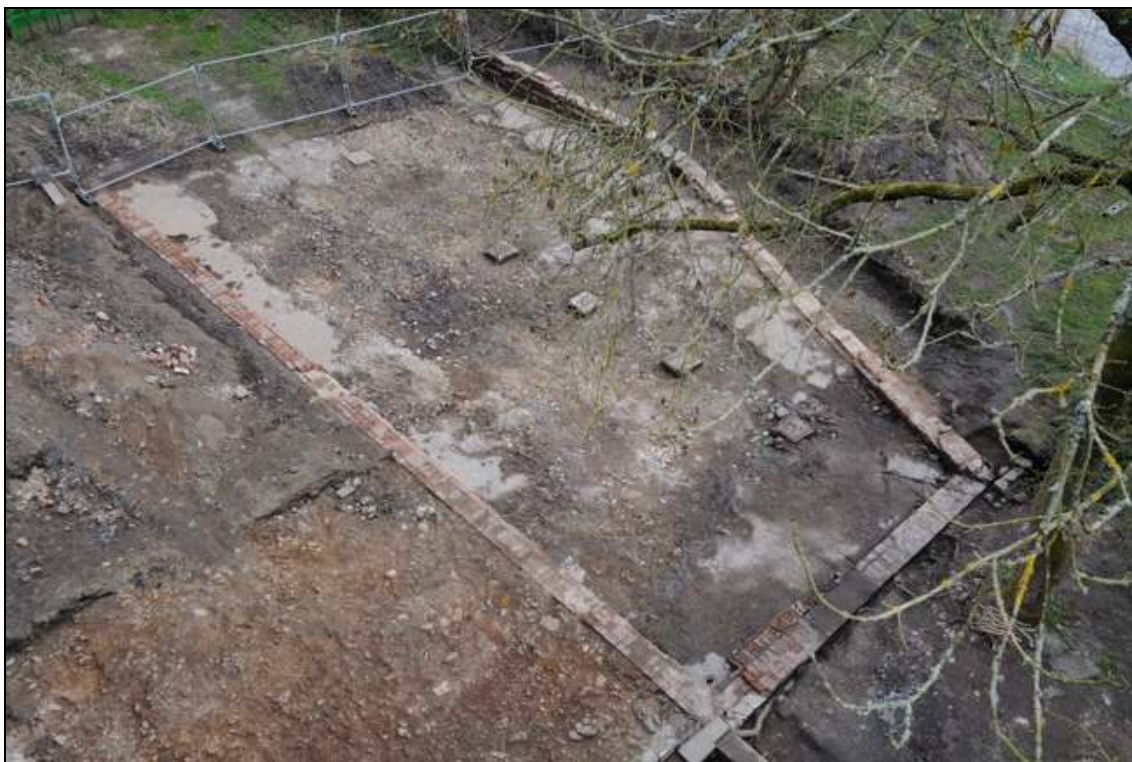
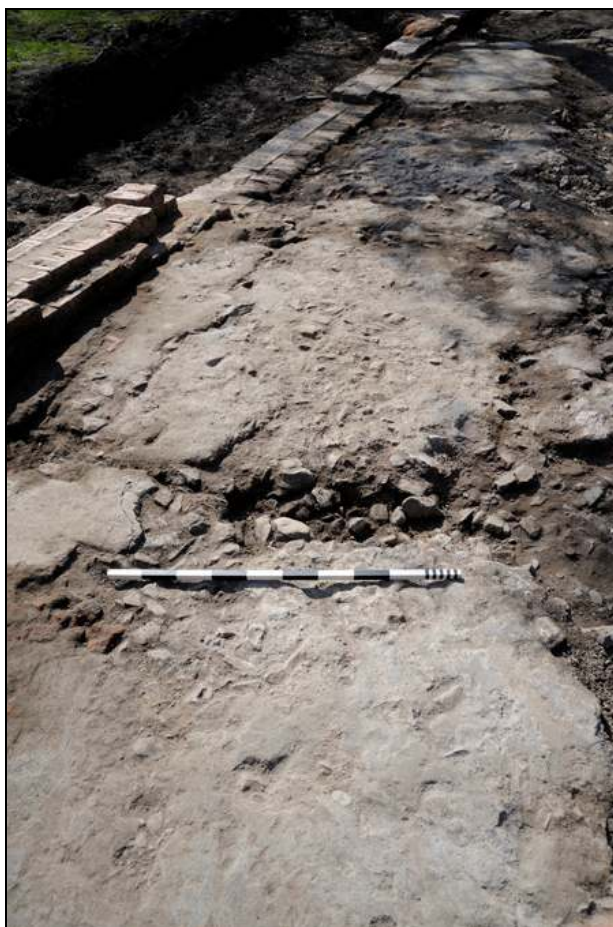
Plates 15 and 16: Area A showing (top) probable warehouse [071] and internal flooring (003) and (004) (below). Photo Adam Stanford

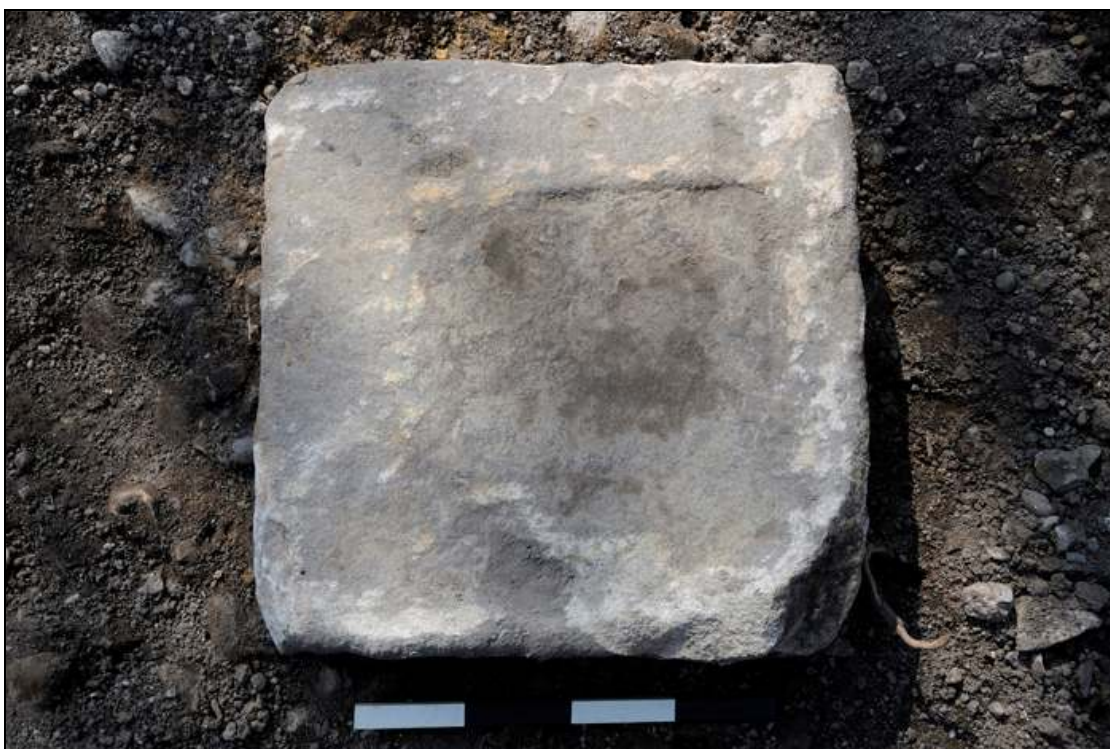
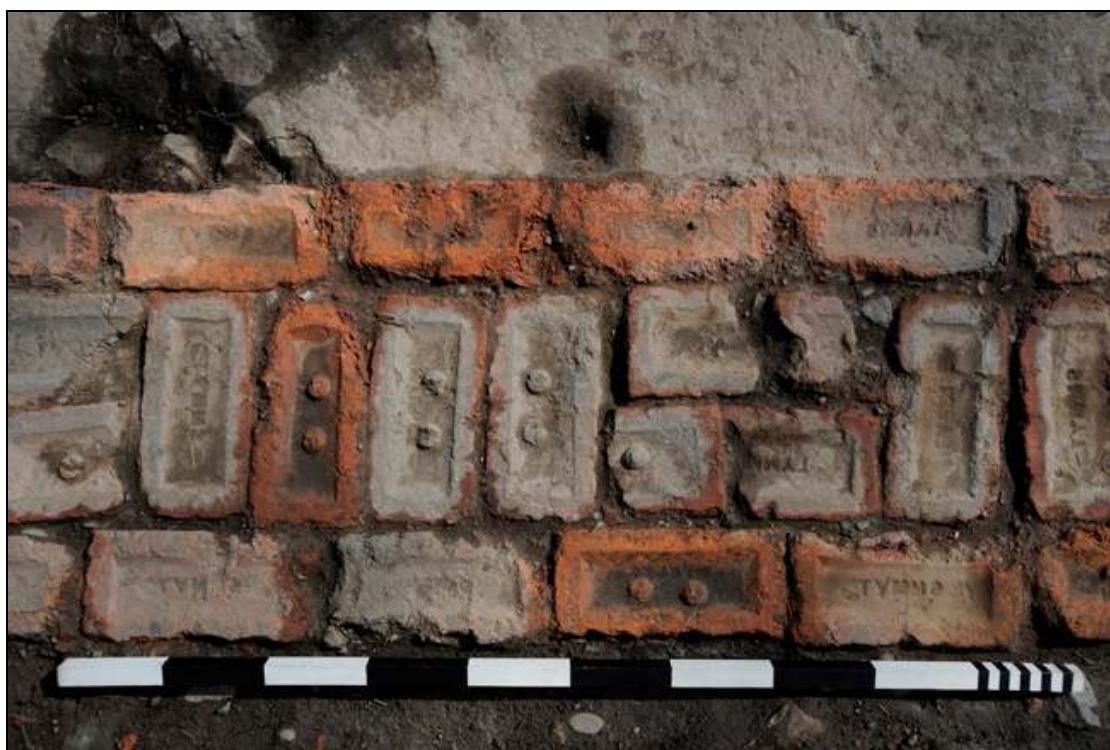
Plates 17 and 18: Area A showing (top) detail of pillar base (009) and (below) detail of brick build in warehouse wall (002) [071]. Photo Adam Stanford

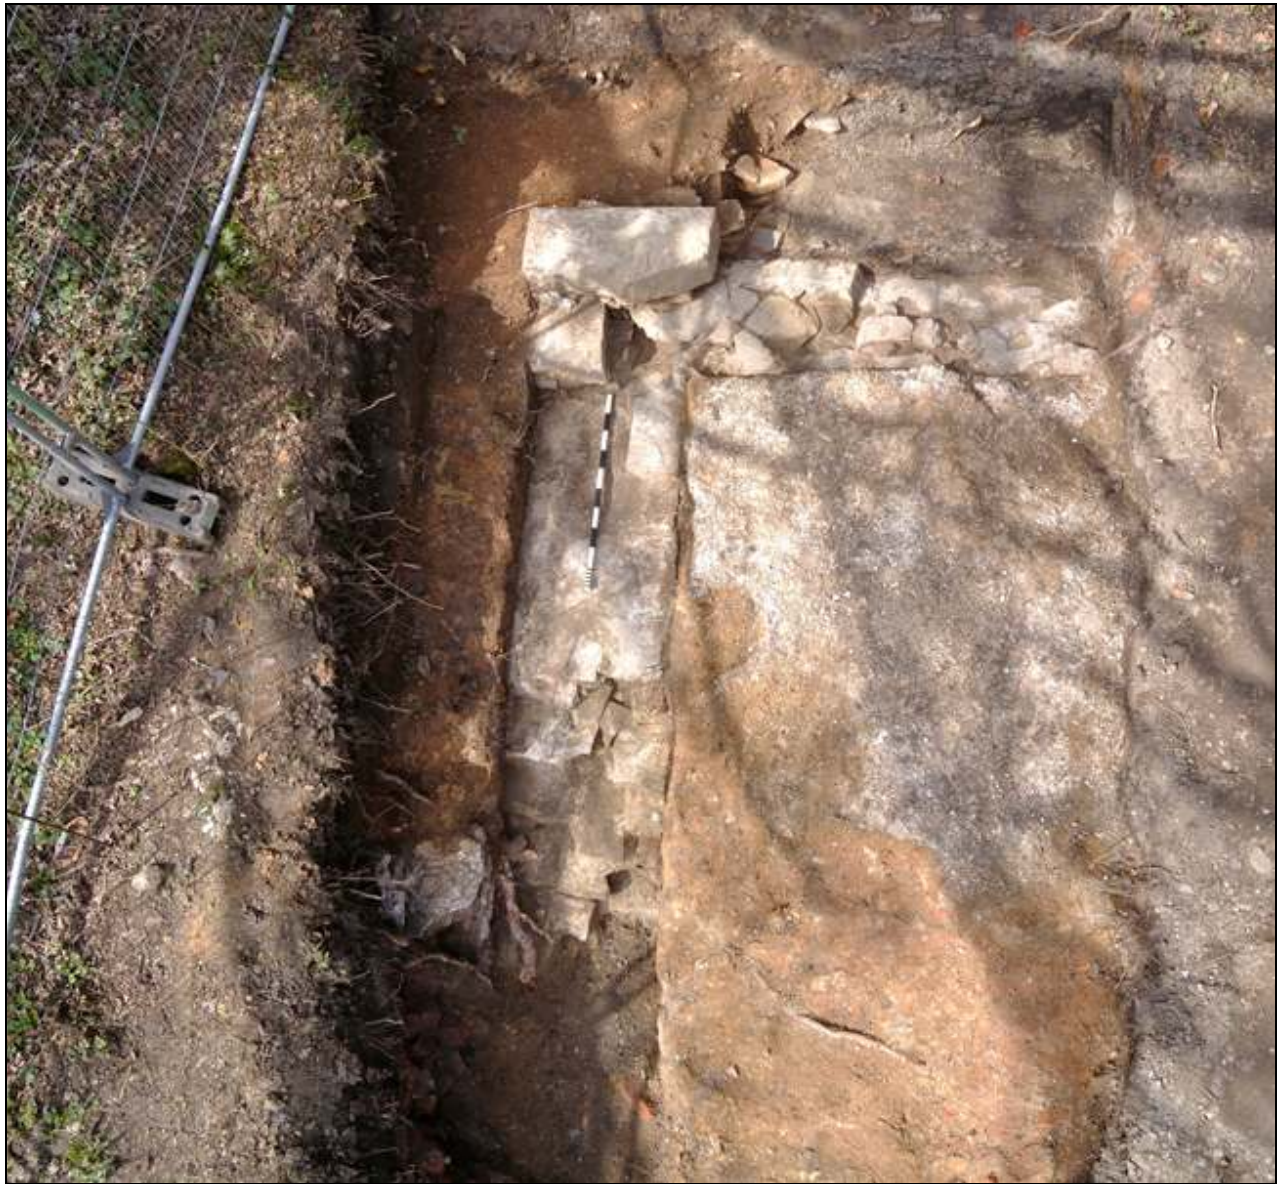
Plate 19: Trench 2 overhead showing western corner of Mellor Mill wall (028), abutting wall (29) (bottom left) and clay layer (026). Photo Adam Stanford

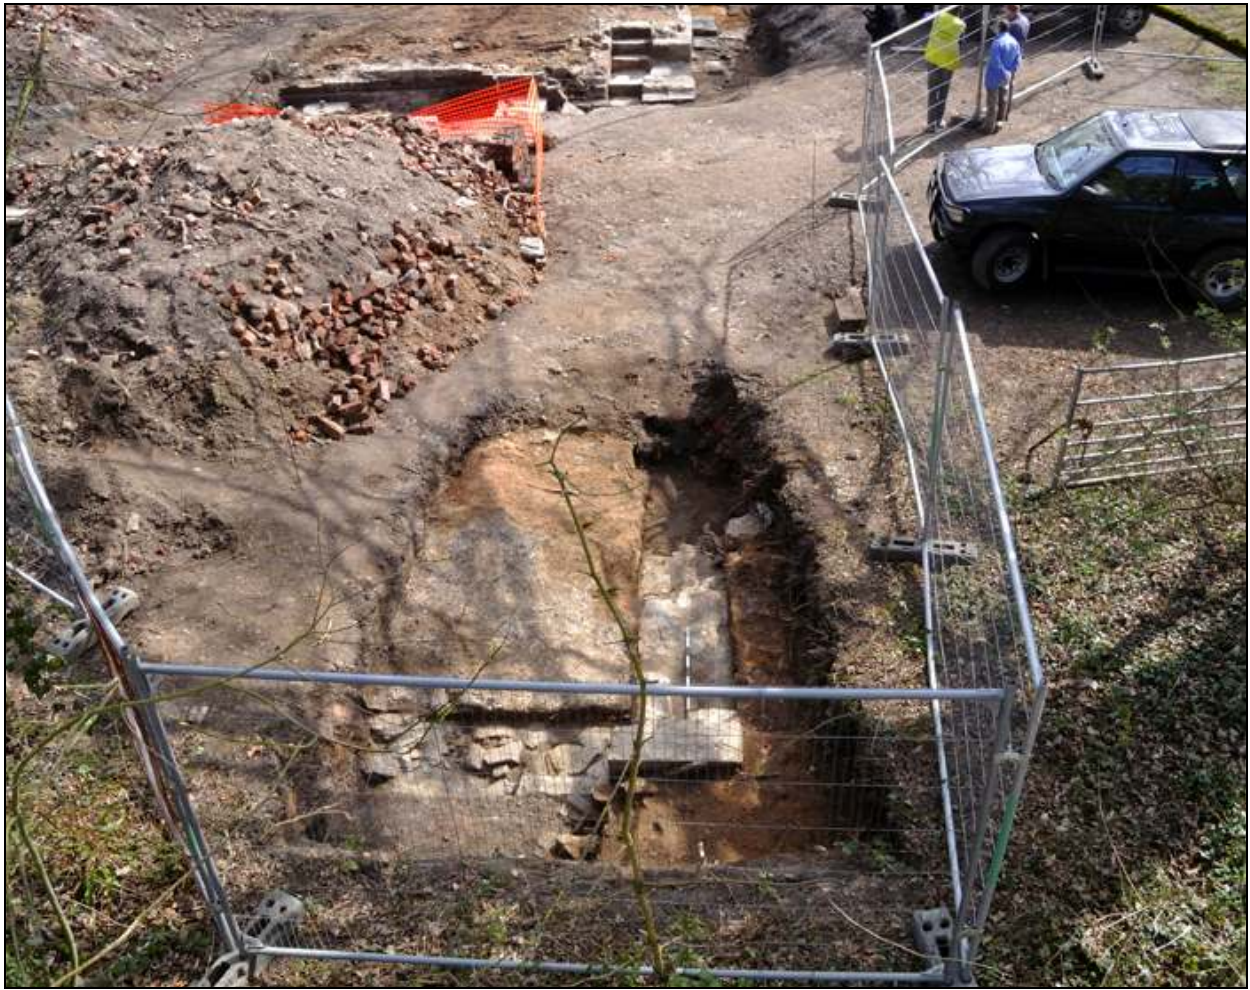
Plate 20: Showing alignment of mill walls in Trenches 1 (background) and 2 (foreground). Viewed from the northwest. Photo Adam Stanford

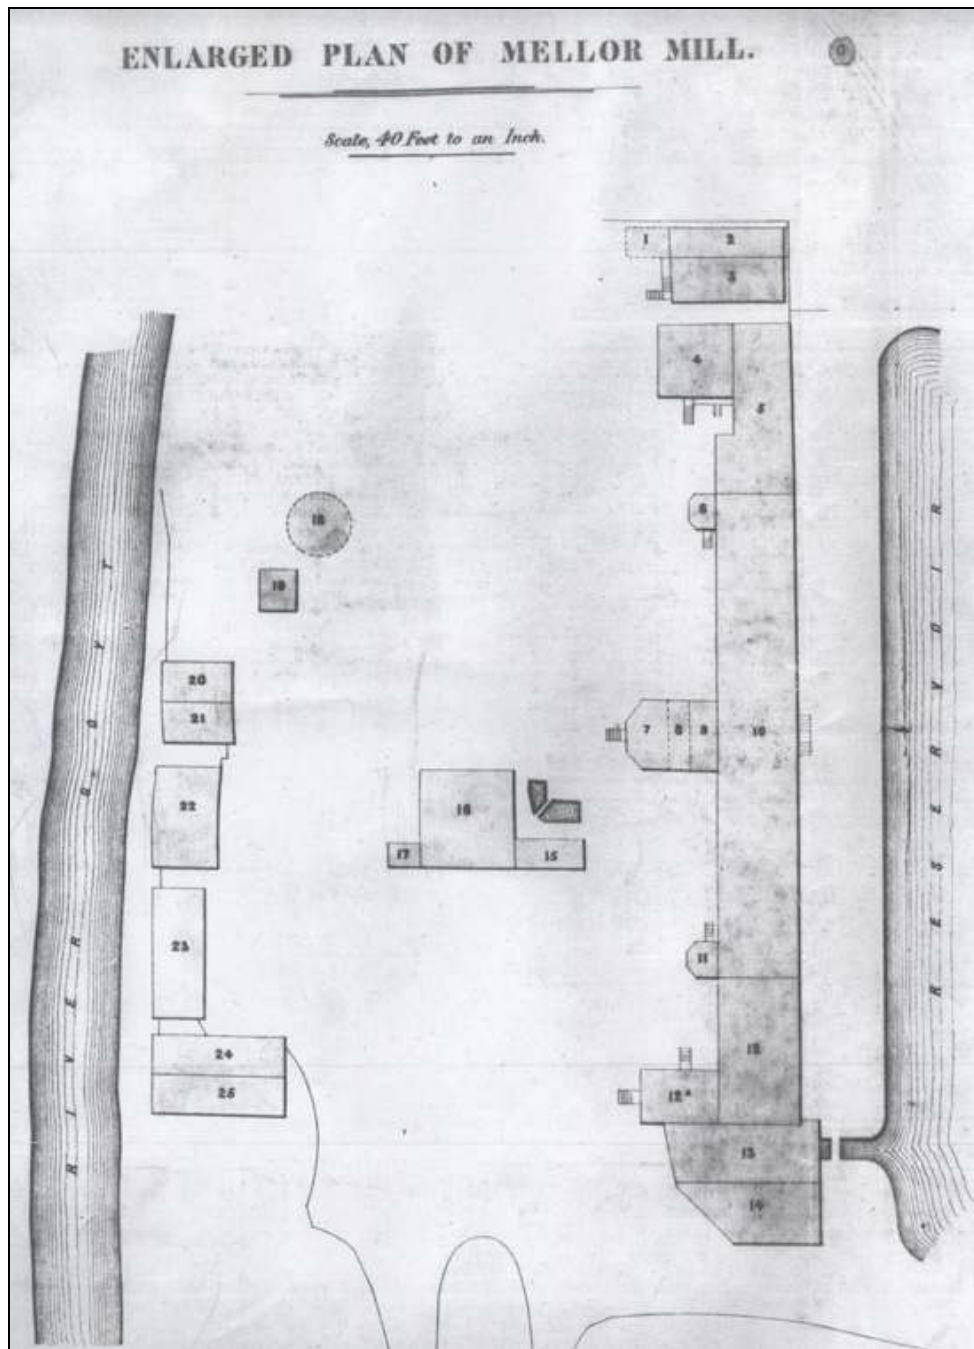
Figure 2: Detail from 1867 plan of Mellor Mill site. Note wall alignment of wheelrace and drying kiln building 13 with buildings 12 and 12 (A) (bottom right). The corn mill is building 14 (extreme bottom right)
