An Archaeological Evaluation of Samuel Oldknow's Mellor Mill, The Roman Lakes, Marple Bridge, Stockport

A report by Peter Noble and Brian Grimsditch
University of Manchester Archaeological Unit
University of Manchester Field Archaeology Centre
Oxford Road
Manchester
M13 9PL

UMAU November 2009

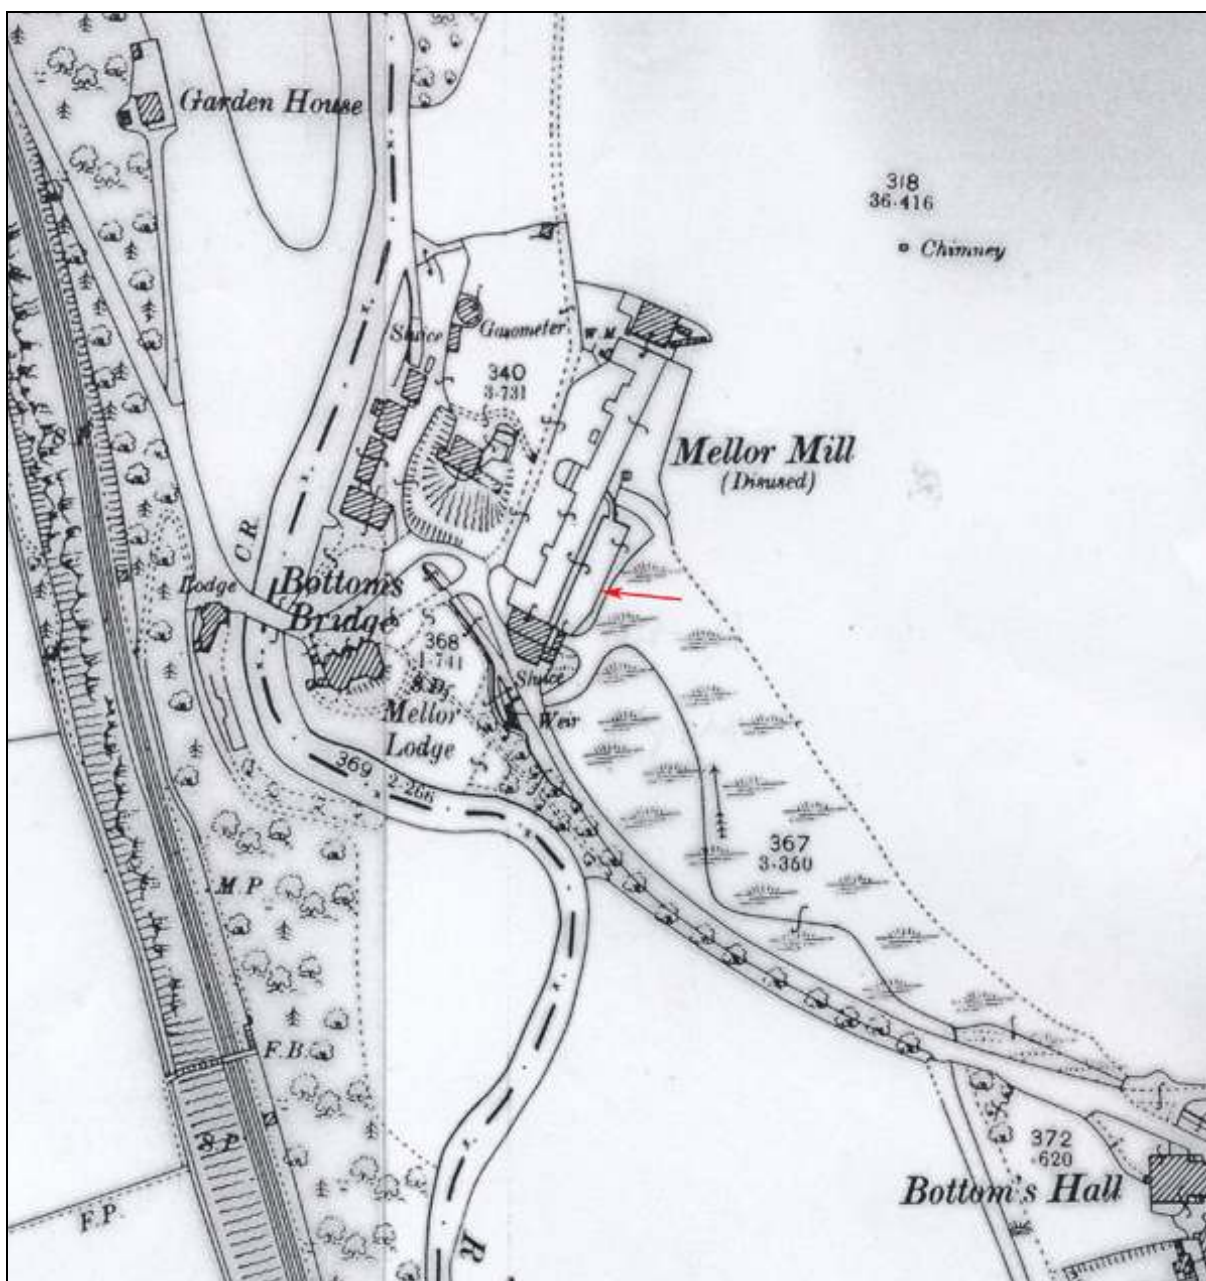
Figure 4: Detail from 1898 OS map of the Mellor Mill. Note arrival of probable warehouse [071] (arrowed)

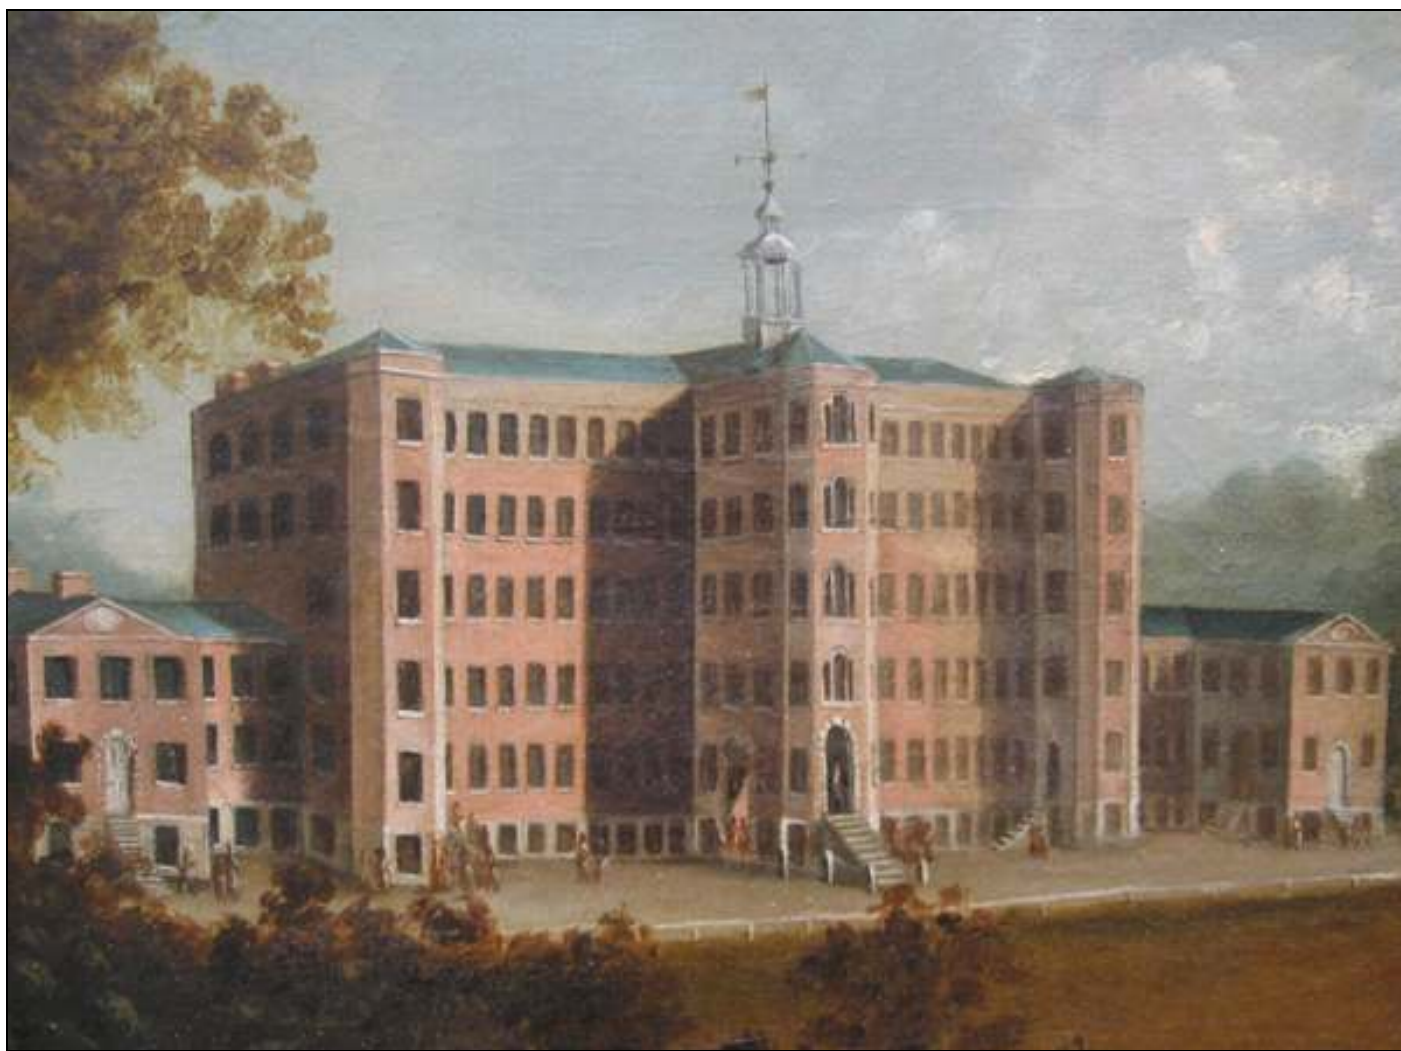
Figure 9: Artist impression (Francis Jukes) of the southeast facing façade of Mellor Mill c.1803, showing stone built ground floor and red brick superstructure

Evidence for the earliest construction of Mellor Mill probably derives from the large-scale excavations of geological/alluvial deposits, potentially from the excavation of the feeder reservoir to the east or other such works. Some of these layers at least (i.e. clay (026)) were used as ground-levelling/foundation layers upon which the mill was built and river gravel (032) would appear to have been used to form the basal layer for a surfaced ‘yard’ area to the southeast of the main mill (see **Figure 9**).

The use of stone for the foundations (walls 028, 045 and 048) and ground-floor build (as shown on **Figure 9**) was a practical matter and would have greatly increased the mills’ load-bearing properties. The depth of these foundations was sufficiently deep to include cellarage [079] which would have further increased these properties with the installation of cellarage cross-walls (069). No documentary evidence exists for the intended use of this cellarage, although its use for storage is a strong possibility (and see Phase 4 below).

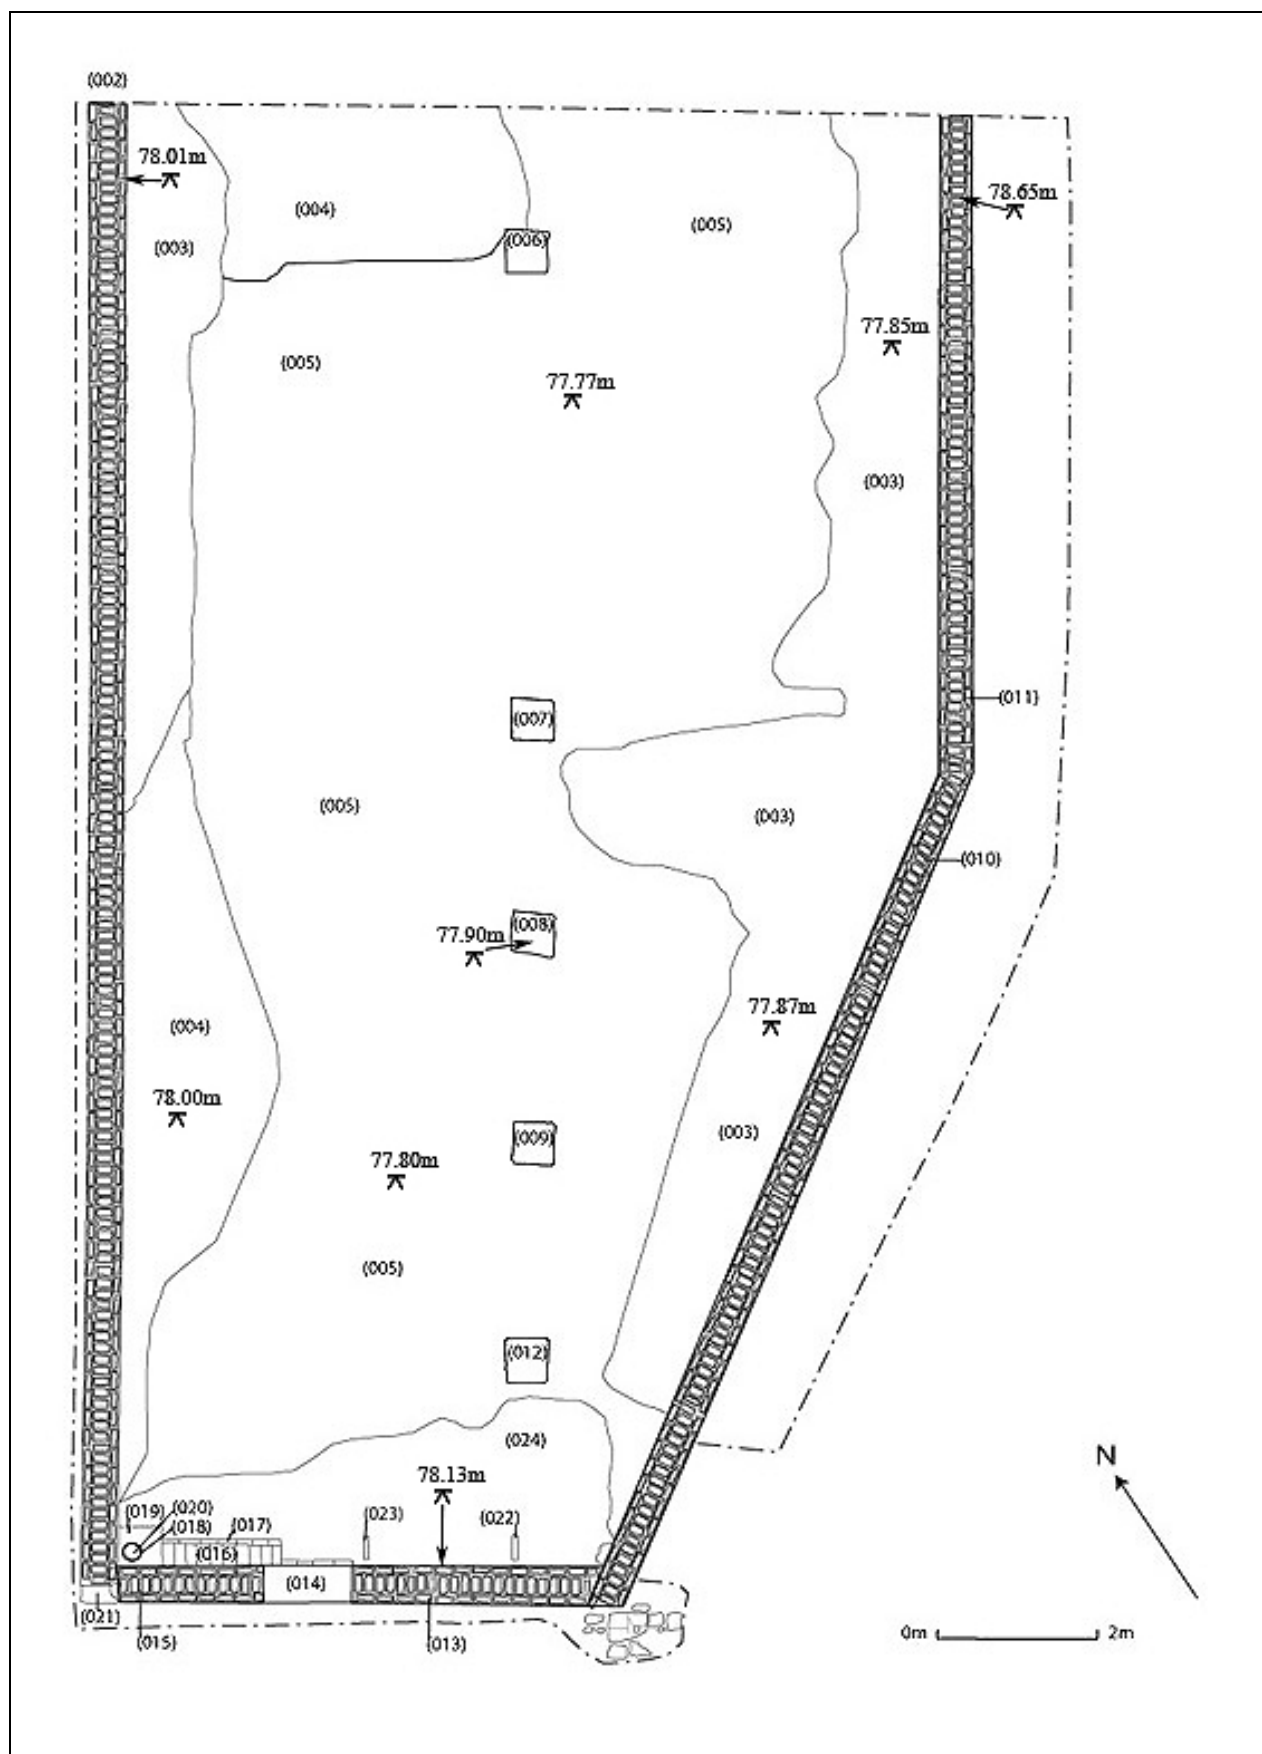
Figure 11: Part plan of Trench 1 showing Area A

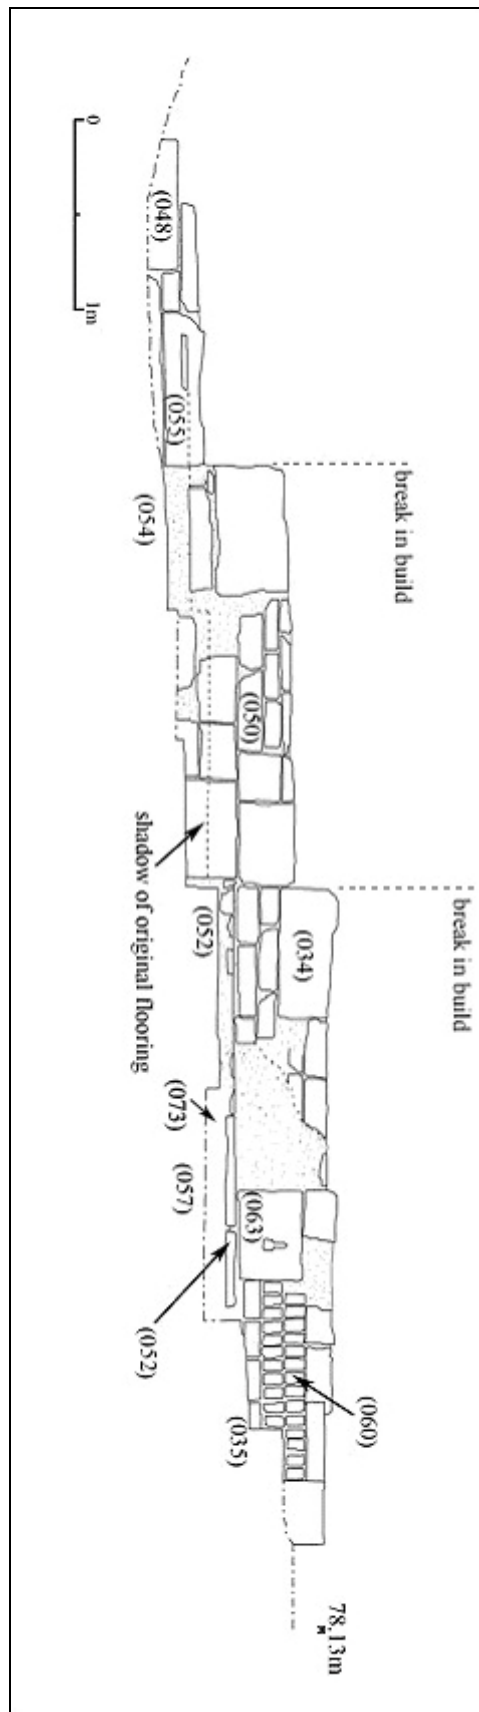
Figure 13: West facing section Area B

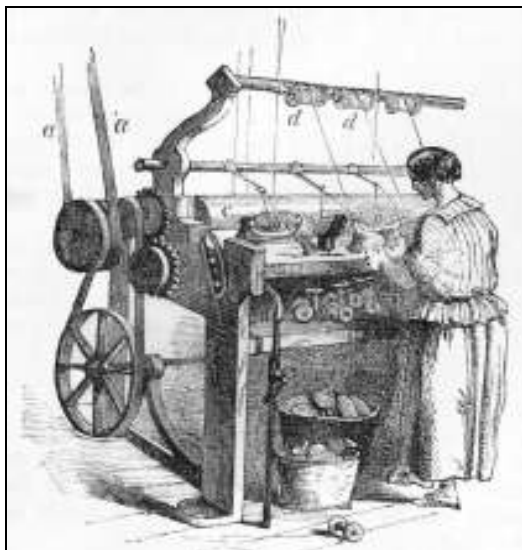
These were machines which transferred cotton yarn from one package to another during which process the yarn was passed through a gas burner. Quite an early and small version of such a machine is shown in the 1866 Cyclopaedia of Useful Arts & Manufactures (Plate 1).

Plate 1 Small Gassing Frame dated 1866 but probably reprinted from 1852

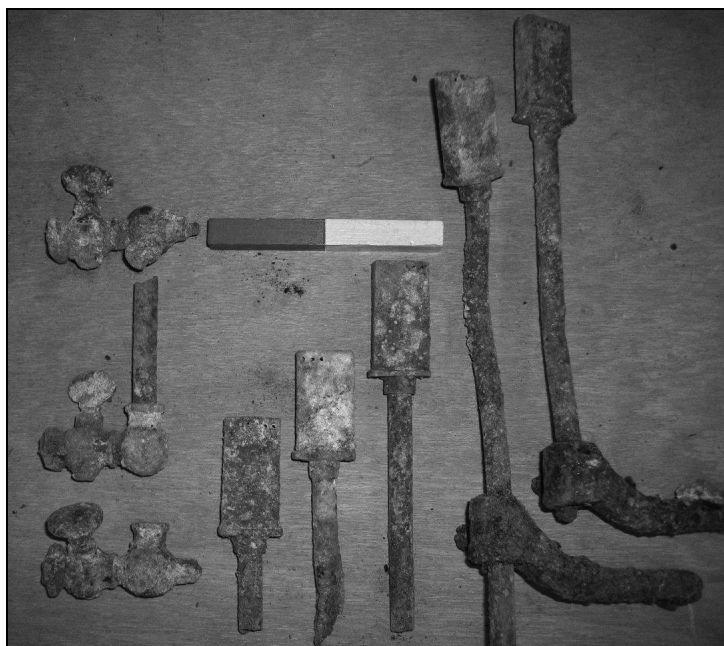
Plate 2 Gas Burners, taps and piping from the excavation

These burners are fed with coal gas and take in air for combustion local to the burner (much like a modern gas cooker). They are very similar to burners shown by Dobson & Barlow in Plate 3.

One of the most important elements of a gassing frame was the need for each strand of yarn to run through the gas flame at the same speed, and for that speed to remain constant. Up until recent times constant yarn speed on such as a Gassing Frame was invariably achieved by using the surface drum driving principle. Thus if the yarn was to be wound onto a wooden bobbin the bobbin would be weighted against an iron pulley running at constant speed from the Mill shafting. Thus the bobbin is driven gradually more slowly as the diameter of the package of yarn on it increases but the linear speed of the yarn as it is wound onto the bobbin stays the same all the time. Unfortunately no pulleys of any description have been found in the excavation. Other components required on Gassing Frames include one gas tap for every burner, and a method of swinging the burner away from the yarn when piecing up a broken end. At least one Gassing Frame of some size must have been in Oldknow's Mill, because one of the most obvious, numerous, and easily identifiable finds is a large number of gas burners, gas taps, and brass/copper pipes. These appear to be the "atmospheric pattern" of burner used on gassing frames (Plate 2).

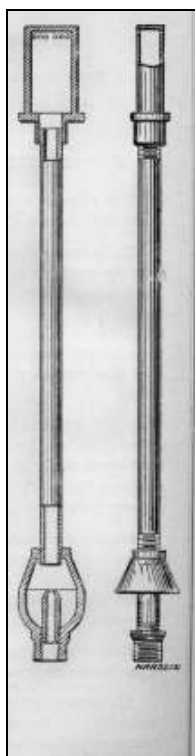
Plate 3 Atmospheric Burners by Dobson & Barlow

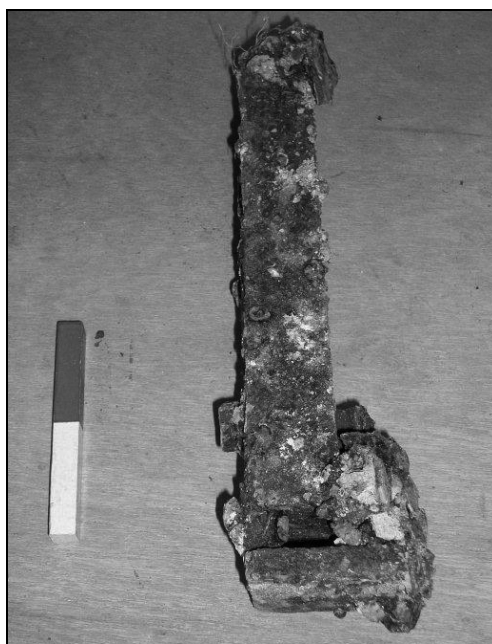
Plate 4 One of three adjustable machine feet found in the excavation

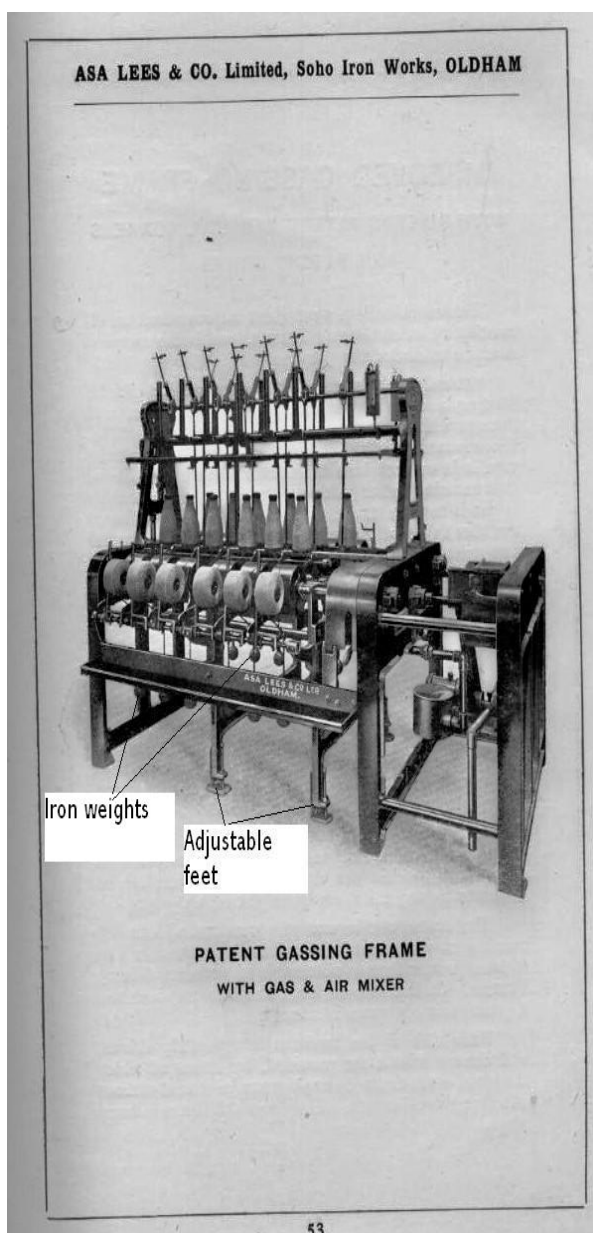
Plate 5 Gassing Frame by Asa Lees

The alternative form of burner involves the gassing frame being equipped with a gas/air mixer which feeds a stoichiometric mixture of coal gas and air to the burners, thus dispensing with the need for any take up of air local to the burners, but their appearance is usually quite different from the ones found. However, such other castings as were found do not seem to be of the pattern used by Dobson & Barlow. Three adjustable feet came out of the excavation (plate 4) and they are very similar to ones used by Asa Lees on their Gassing Frames (Plates 5 & 6) although the machine shown dates from around 1920.

Quite a number of small iron weights (Plate 7) were excavated and compare well with the weights shown in Plates 5 & 6 on the Asa Lees Gassing Frame.

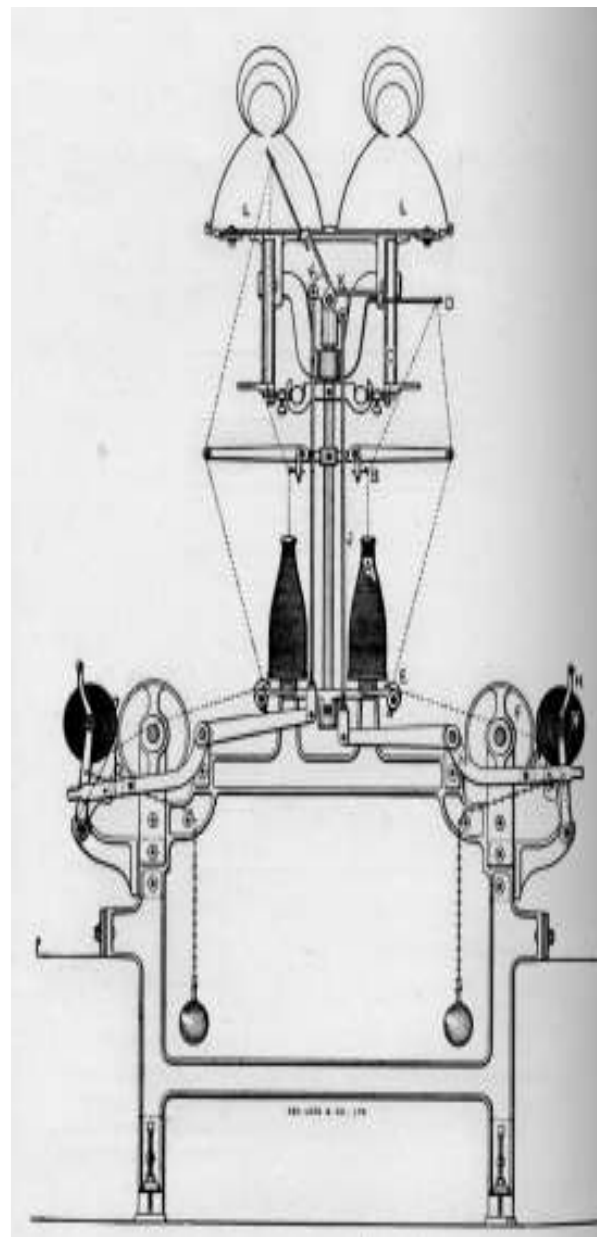
Plate 6 Diagram of Gassing Frame by Asa Lees

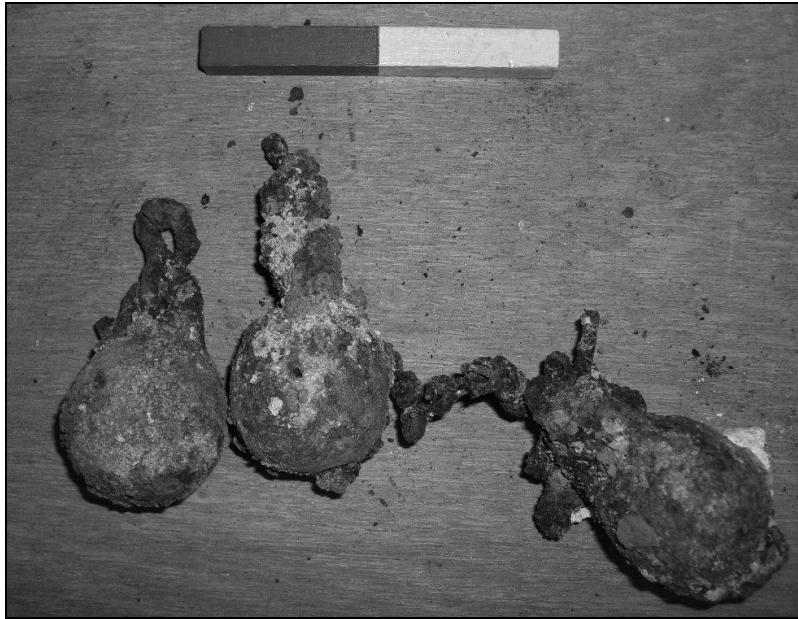
Plate 7 Weights and chains from excavation

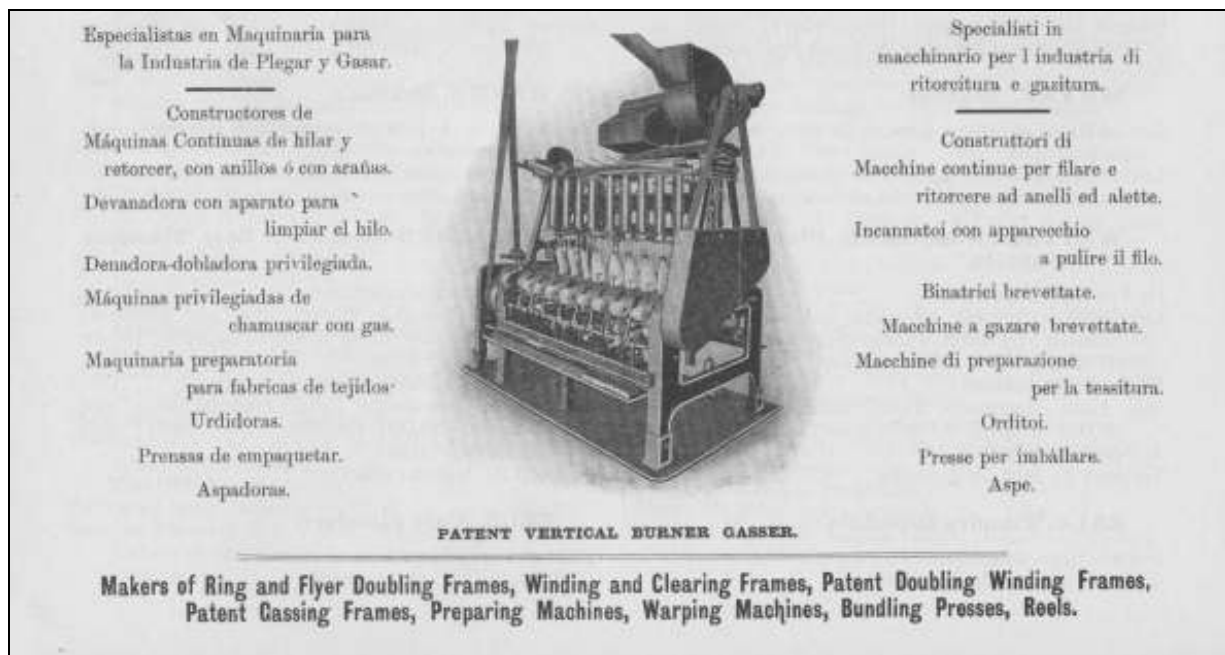
The most local supplier of Gassing Frames to Oldknow Mill was Arundel, Coulthard & Co of Stockport, but so far a catalogue of their products from the 1880's or 1890's has not been found. However, an illustration of their circa 1920 Gassing Frame (Plate 8) reveals an altogether different style of casting to anything found in the excavation.

Plate 8 Arundel, Coulthard & Co (Stockport) Gassing Frame circa 1920

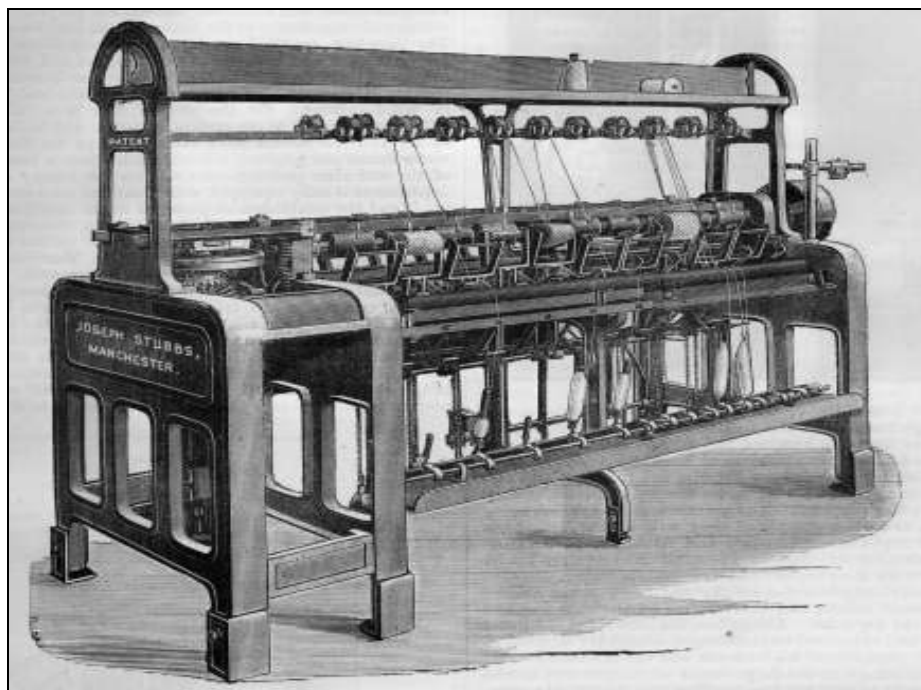
The other big manufacturer of gassing and winding frames in the area was Joseph Stubbs of Ancoats. However, an 1892 illustration of one of their winding frames (Plate 9) reveals frame castings of a different

style to anything found in the excavation (winding, doubling & gassing frames from the same manufacturer and same date would have frame castings of similar style).

Plate 9 1892 Winding Frame by Joseph Stubbs (Ancoats)

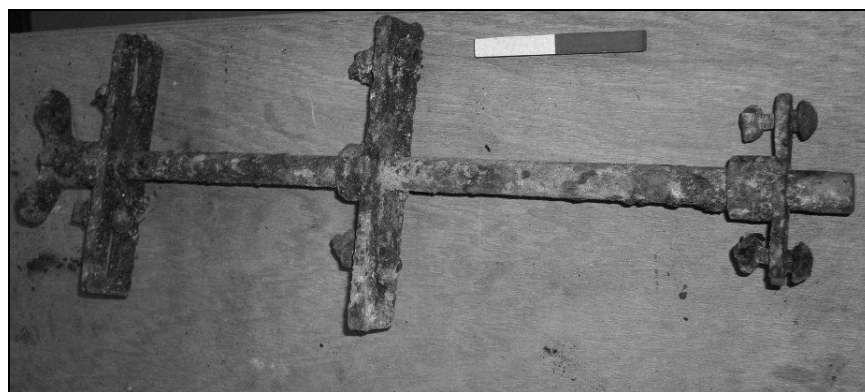
From the excavation there was a total absence of substantial pieces of cast iron machine frame, and very few smaller pieces of such frames. The single largest piece of recovered iron measured about 750mm x 300mm (Plate 10).

Plate 10 The largest single piece of iron found in excavation

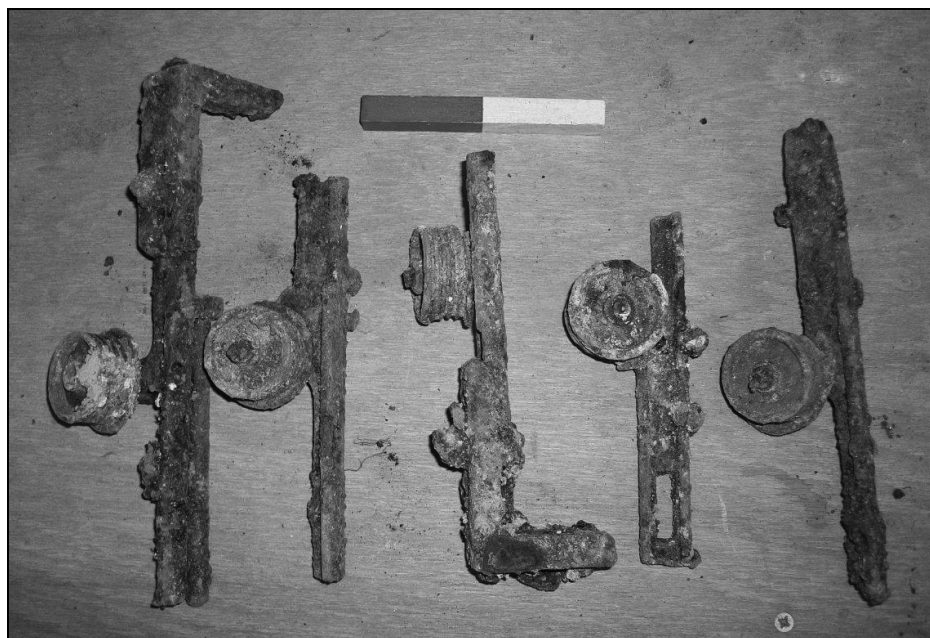
Other surviving components are numbers of grooved brass wheels approximately 30mm (1.25 inches) in diameter, some still attached to broken cast-iron arms (Plate 11).

Plate 11 Brass yarn guides still attached to brackets

Also shown in plate 11 are the only two pieces of shafting found in the excavation. These are not very illuminating as they are quite short and appear to have had wooden arms bolted to the cast iron flanges still attached to the shafts.

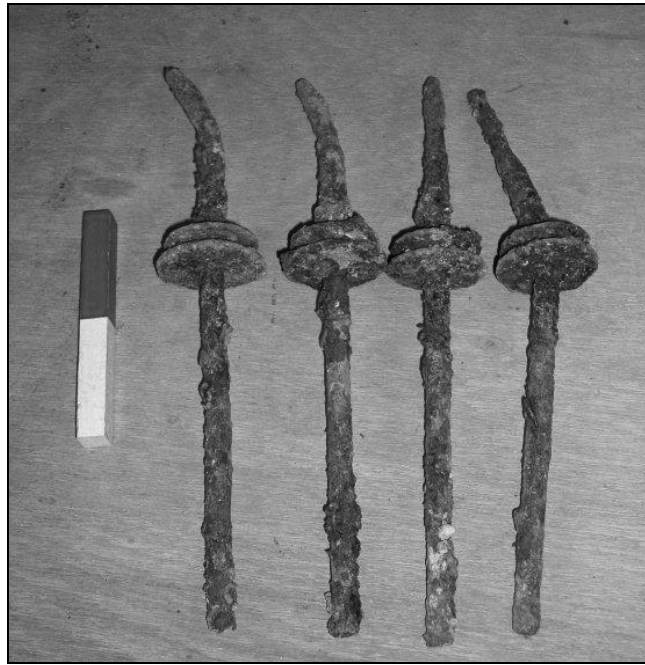
Finally, there were a very few spindles with whorls still attached (Plate 12).

Plate 12 Spindles with whorls to drive them.

These are somewhat reminiscent of mule spindles but they are shorter and thicker than would be expected. Also there were very few of them found, whereas a single medium count cotton mule of this period might have anywhere between 700 and 1000 spindles. In addition this south west section of the Mill would not be likely to contain mule spinning, for which the much larger areas of the centre part of the Mill would be appropriate.

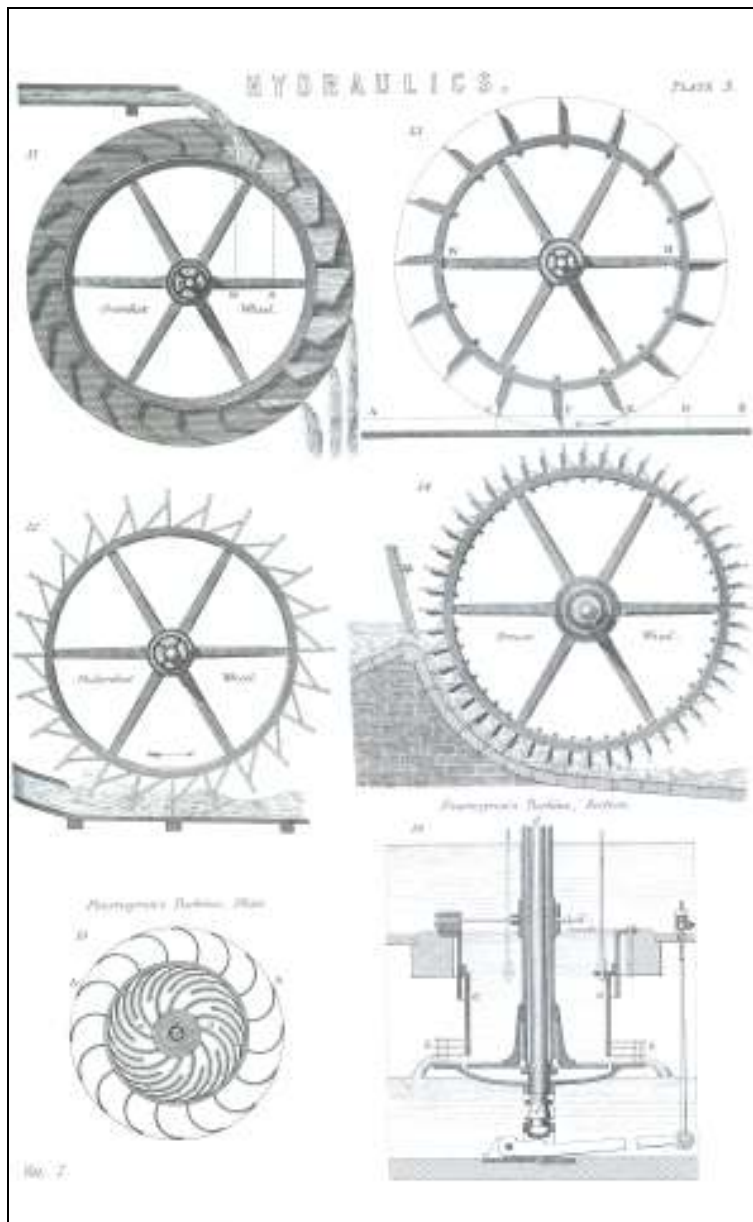
Figure 3: Waterwheel designs (from MacKenzie (publ.) c 1876)

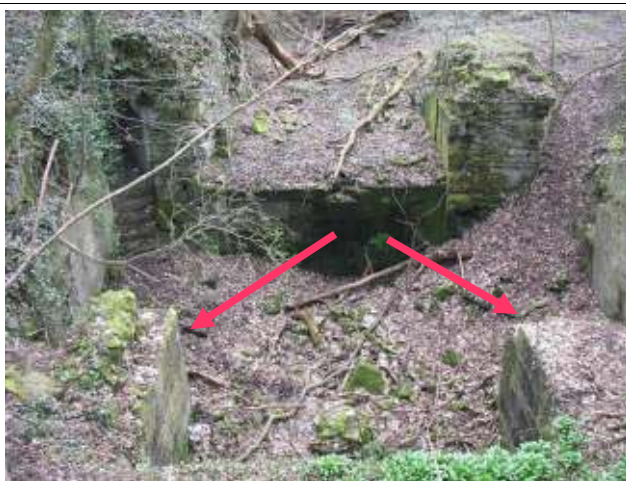
1.1 Wellington wheelpit viewed from above the tailrace. The picture is looking east. The narrower walls of the axle supports are visible in the foreground. The water would have been fed over the lip in the middle of the picture. Tunnel 11 is visible in the top left of the picture.

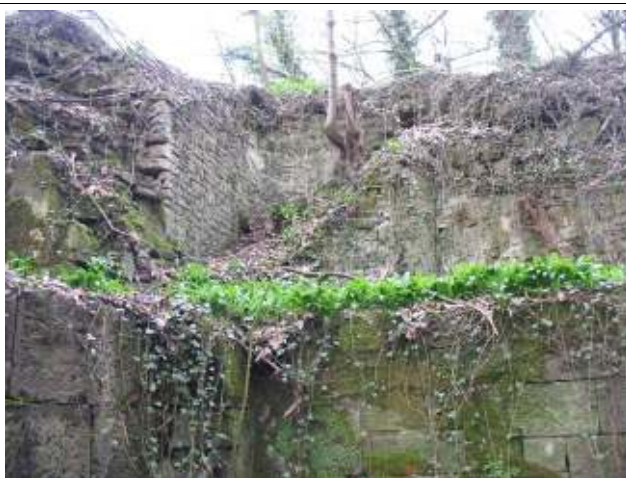
1.2 Looking out of Wellington wheelpit towards the west. The nearer wall is the wall over the tailrace arch. The further wall is probably the limit of the mill building above. There appears to be a staircase curving down into the wheelpit in the corner

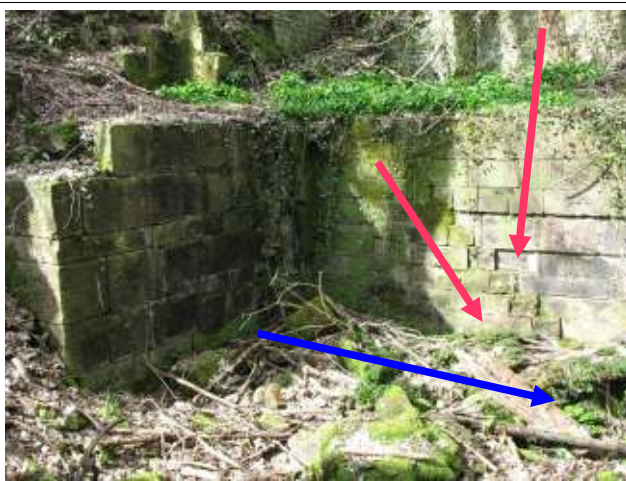
1.3 Looking west in Wellington wheelpit from the same point as the picture above. The line of a possible line of steps is visible in the facing wall (red arrow). The tailrace arch is out of sight below the debris in the foreground (blue arrow).

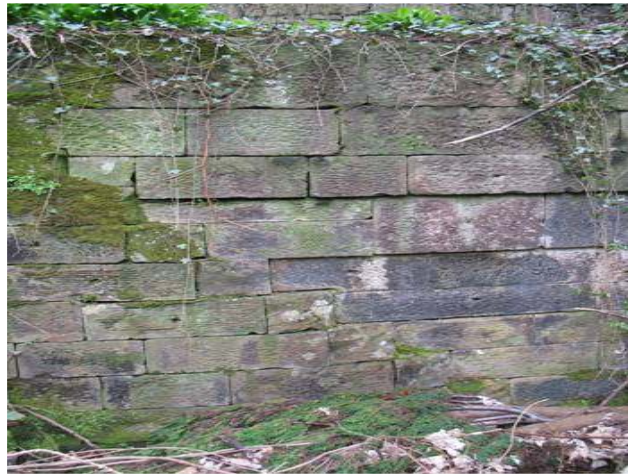
1.4 Close-up of wall above tailrace showing the apparent line of steps. At first sight, this appears to be a later addition although close examination shows the same masons' marks on both the left (apparently original wall) and right (apparently infill) of the steps.

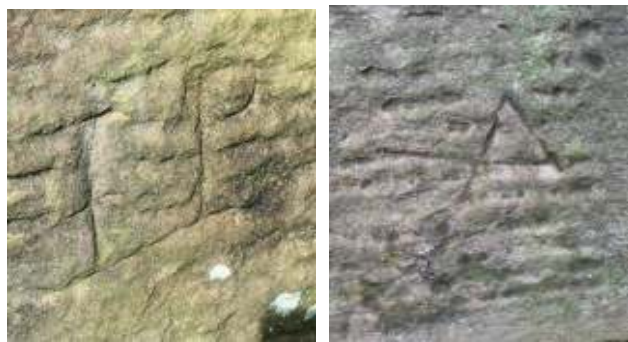
1.5 Two of the masons' marks on the wall above the tailrace: a cross with a line joining two of the legs and the letters JP in 18th century script (appearing as: ÷P)

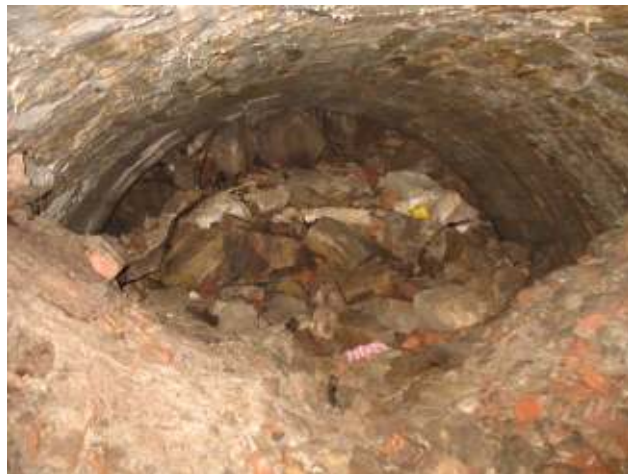
1.6 The inner side of the infilled wheelpit viewed from below. The debris infill from the inlet shafts is visible on both sides of the picture. The picture is taken looking east and represents the eastern end of feature 1.

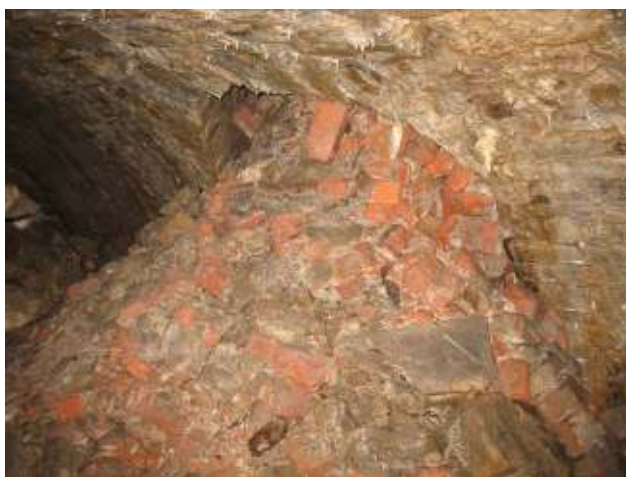
1.7 The southern inlet shaft with rubble infill. The northern inlet shaft is essentially the same.

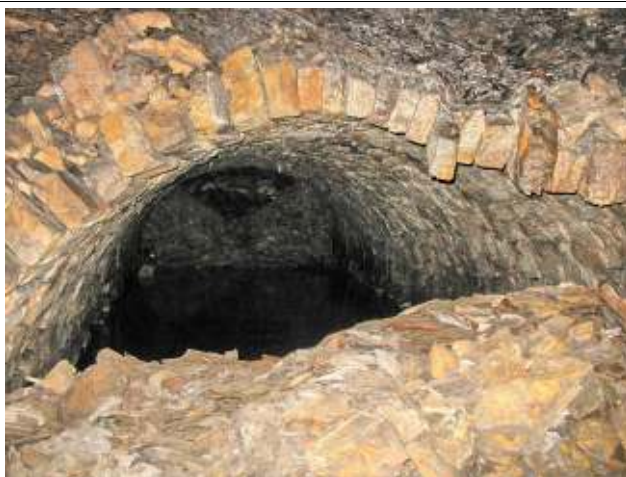
1.8 The roof fall in the Wellington tailrace viewed from the west. The inlet shafts on each side of the tunnel are just visible in this picture which has been artificially lightened.

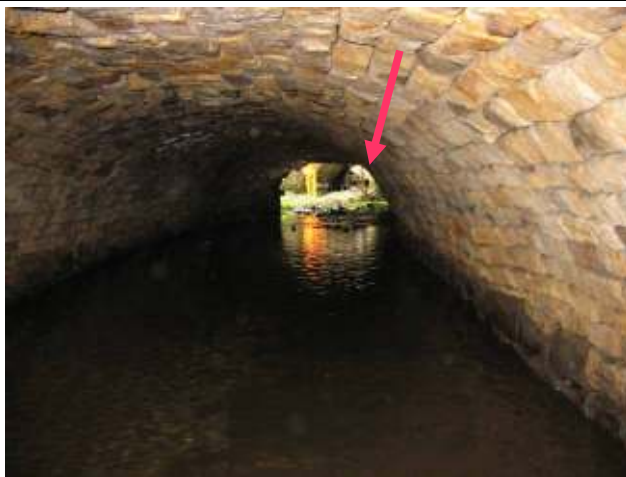
1.9 Looking west down the Wellington tailrace with the roof fall behind the camera. The passage is a good walking height in the centre but the floor is covered in mud and water. A figure is visible outside the entrance and the light from the arch of the extension (feature 3) is just visible (red arrow).

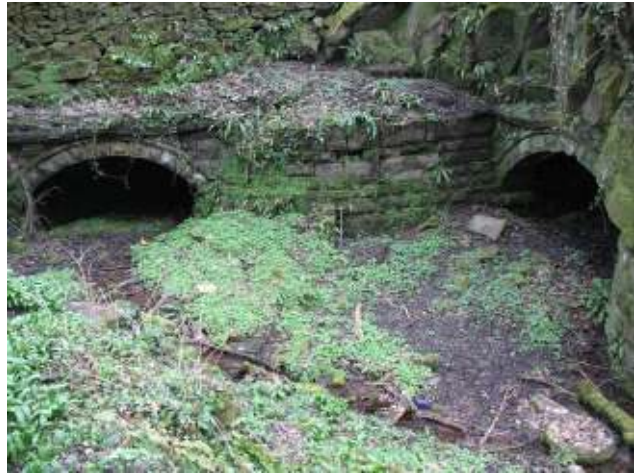
1.10 / 2.1 The entrance to the Wellington tailrace (feature 1) is on the left and the Southern tailrace (feature 2) is on the right. “Waterloo” is carved above the right hand entrance.

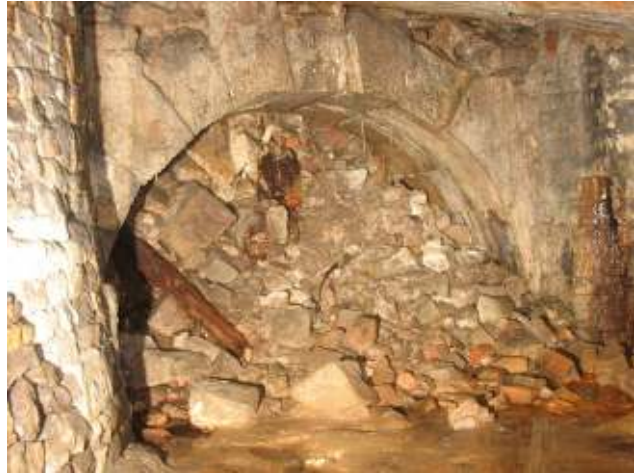
2.2 The archway at the inner end of the Southern tailrace. Note the splendid stone arching and the flat roof (just visible at top right hand corner). The curvature of the left hand wall is believed to have been formed when the tailrace was diverted north to join the Wellington tunnel.

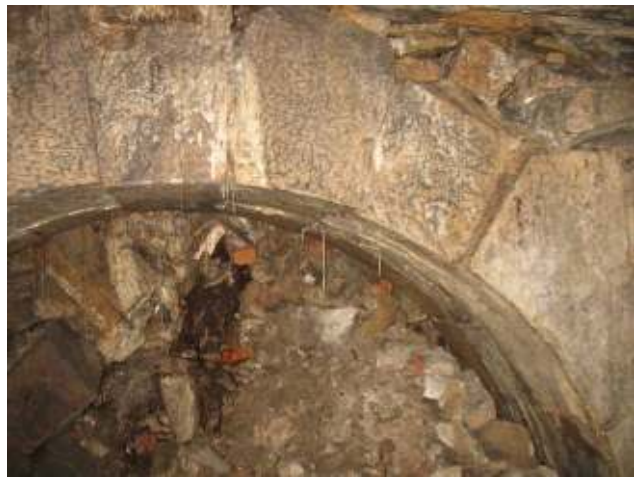
2.3 Detail of the stone arching. Alternate blocks are recessed suggesting a decorative function, even at this location.

The tunnel from the outer Waterloo end runs along the strike of the bedding with a good roof of sandstone on a slope and walls of dry stone walling holding back a shale band. This structure can clearly be seen in the photographs 2.8 and 2.9. Shale has pushed down the higher (eastern) wall in places but there are no serious problems of collapse or infilling. At the inner end, the tunnel curves to the left (to the east) before coming to a substantial stone-built arch with large blocks alternately recessed to give an attractive decorative effect on inner side (not presumably visible from either side when the wheel was operating). The last curved section of the tunnel is walled on both east and west sides and roofed with stone (see photograph 2.3), supporting the theory that the tunnel originally ran straight on to the river.

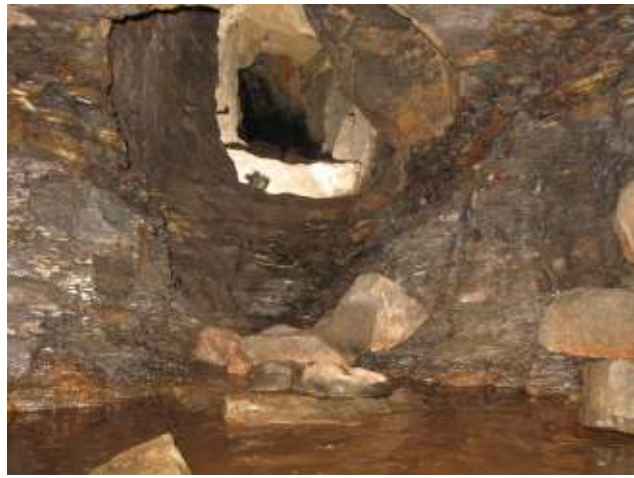
2.4 The start of the side tunnel in solid rock leading off west just after the inner end of the tailrace.

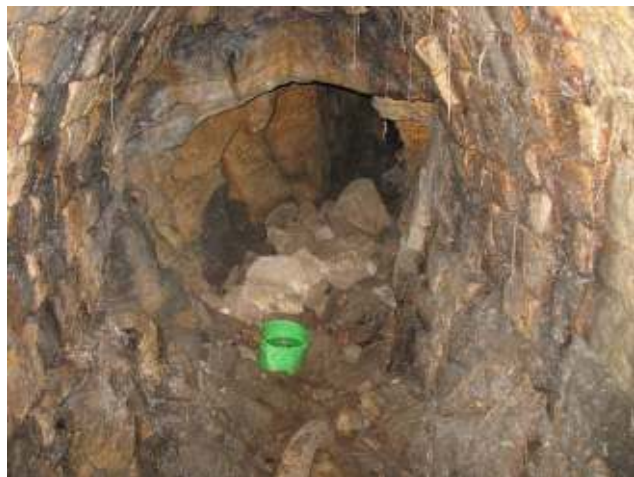
2.5 Join between the side tunnel in solid rock (background) and walled tunnel (foreground). The arched tunnel may represent the area where the original tailrace was backfilled.

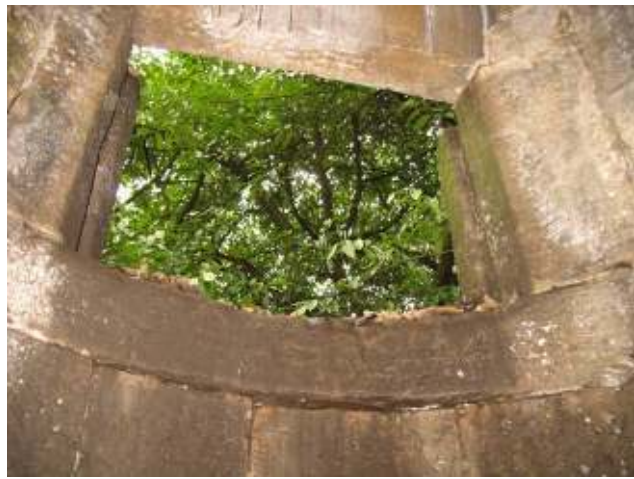
2.6 Inside the entrance shaft to the side tunnel. The walls are superbly shaped both inside and out.

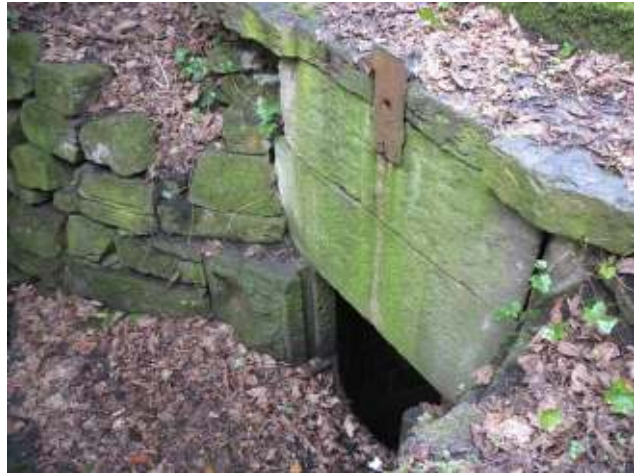
2.7 Outside the entrance shaft showing signs of there having been a sluice and the metalwork required to lift it. The shaft would have allowed water from the spill way to enter the tailrace, possibly to supplement the feed to Waterloo if the Southern wheel was out of service.

Just before the inner end is a side passage on the north west side. This starts as an excavation in solid rock and then becomes arched in stone. The purpose of this tunnel is not clear but it could have served as a point from which water could be let in to by-pass the wheel so as to keep the Waterloo wheel fed with water when the southern wheel was out of service. Where the tunnel is rock arched may correspond with the back-filled section of the original, straight tailrace. The side tunnel starts at the foot of a very neatly built circular stone lined shaft to surface which had a sluice from the bypass spillway. The groove and a small part of the mechanism of the sluice can still be seen on the surface (photograph 2.7).

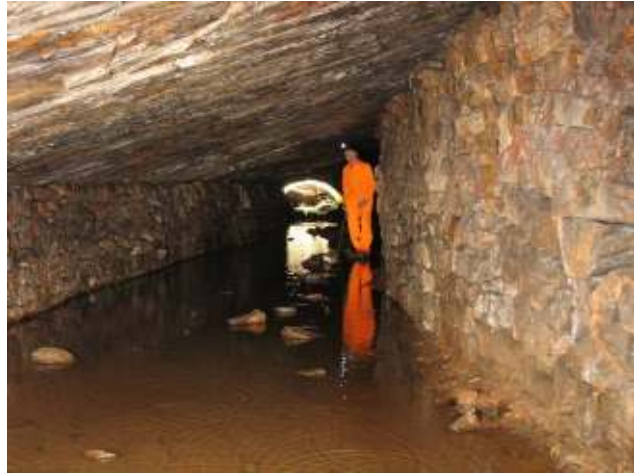
2.8 Looking northwards out of the Southern tailrace. The solid sloping roof can clearly be seen. The walls hold back shales. Note the right hand wall which is curved by the realignment of the tunnel towards Waterloo.

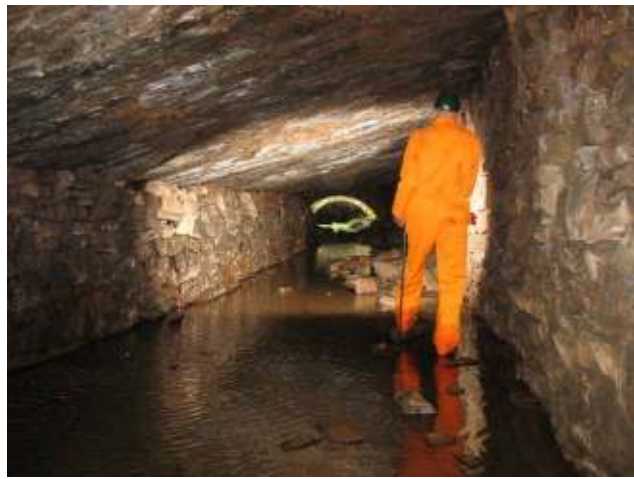
2.9 Another view in the Southern tailrace. The curved section in the distance is the arched entrance.

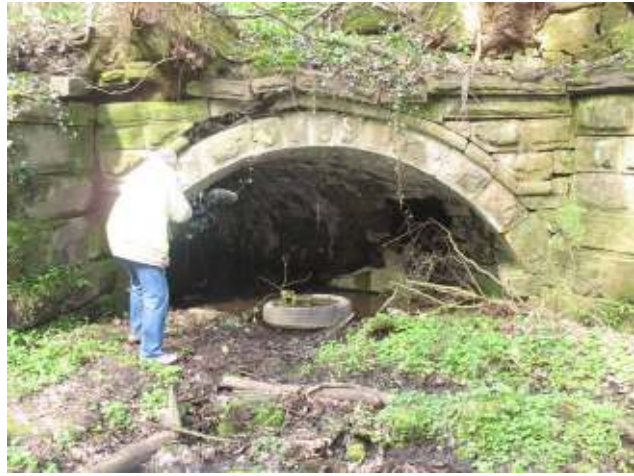
3.1 Wellington wheelpit tailrace extension (feature 3), eastern entrance. The arching matches the entrances to the other two tailraces.

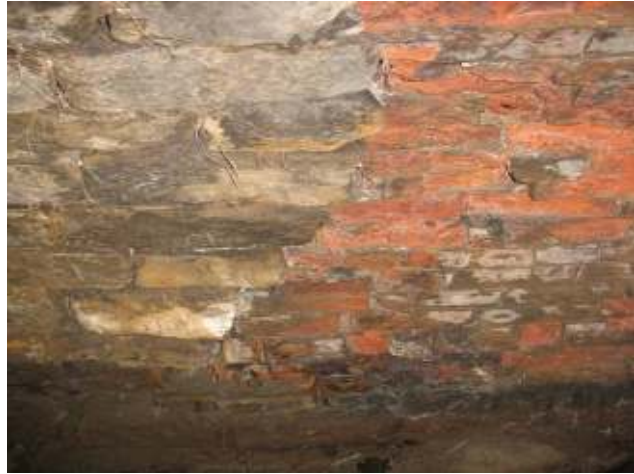
3.2 The point in the tailrace tunnel where stone (upstream) joins brick (downstream). It is possible that the brick section was covered over to make more room for the riverside buildings.

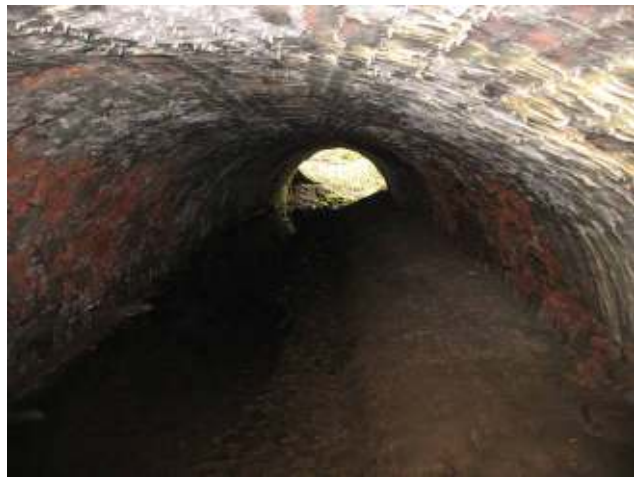
3.3 Looking west, towards the Goyt

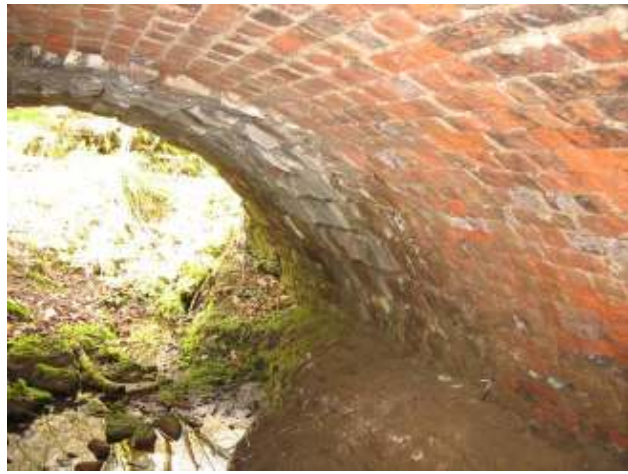
3.4 The final section approaching the Goyt where brick ends and stone restarts.
