An Archaeological Evaluation of Samuel Oldknow's Mellor Mill, The Roman Lakes, Marple Bridge, Stockport

A report by Peter Noble and Brian Grimsditch
University of Manchester Archaeological Unit
University of Manchester Field Archaeology Centre
Oxford Road
Manchester
M13 9PL

UMAU November 2009

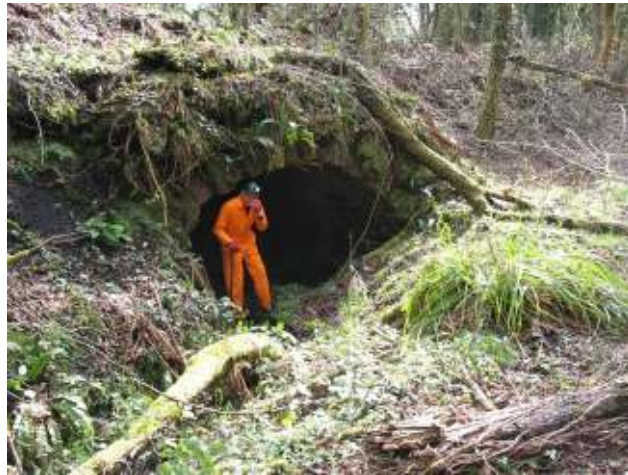
3.5 The downstream exit of feature 3. The tunnel approaches the photographer but the channel turns away to the left of the picture taking the water parallel to the river Goyt for a short distance, through a sluice (abutments remain) to where it joins the river.

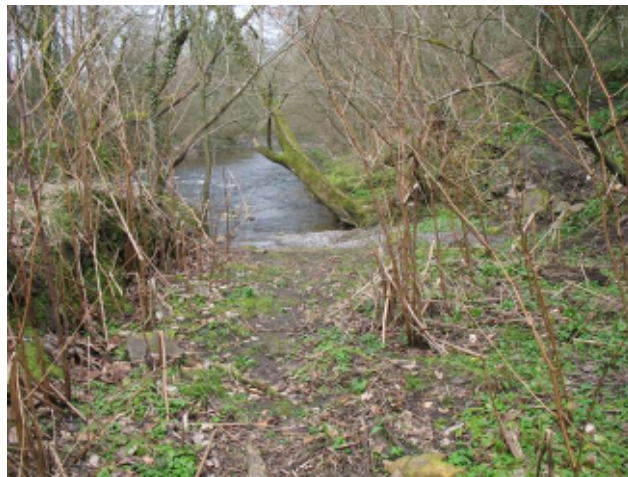
3.6 Outfall from the channel to the river Goyt.

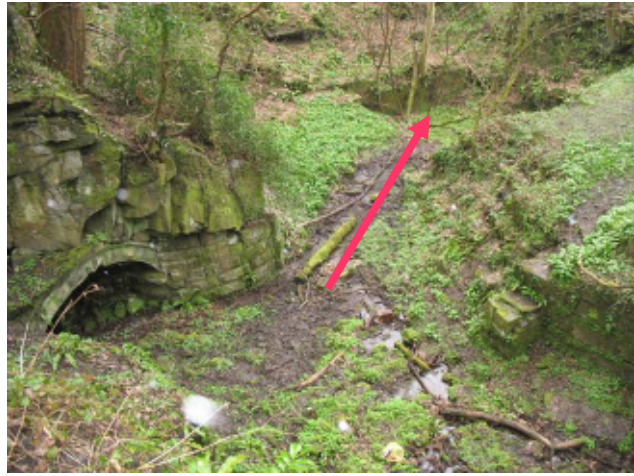
4.1 Waterloo wheelpit seen from above. The Southern tailrace is on the left and the Wellington tailrace is below the photographer. The waters went through the gap in the centre to feed Waterloo (red arrow).

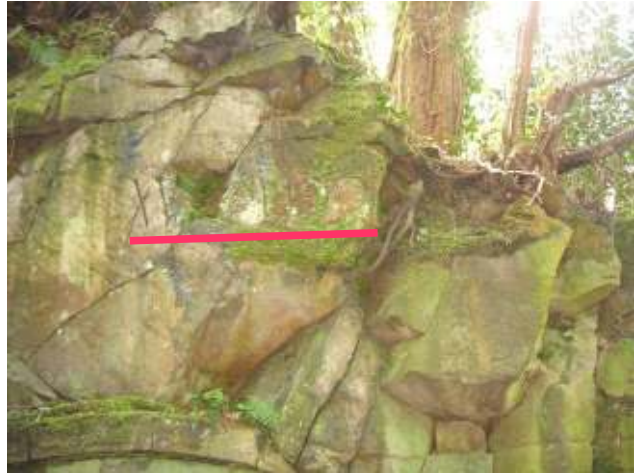
4.2 Waterloo inscribed above the entrance to the Southern tailrace. The typescript is typical of the period.

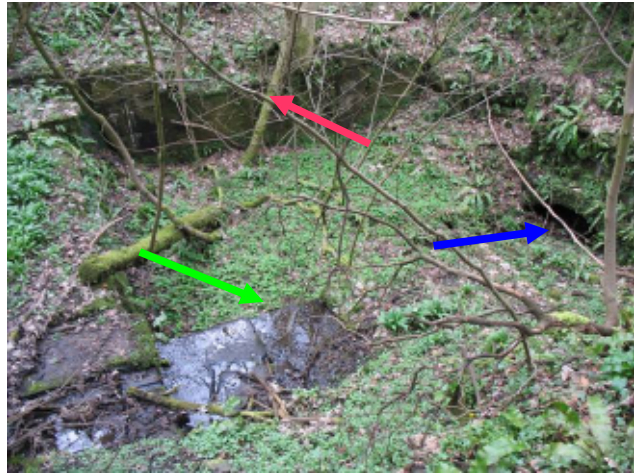
4.5 The southern side of the wheelpit. The bearing block is indicated by the arrow. The curved line around it has been carved out of the stone wall and might indicate a need to widen the pit at some time, possibly to extend the gear ring on the wheel

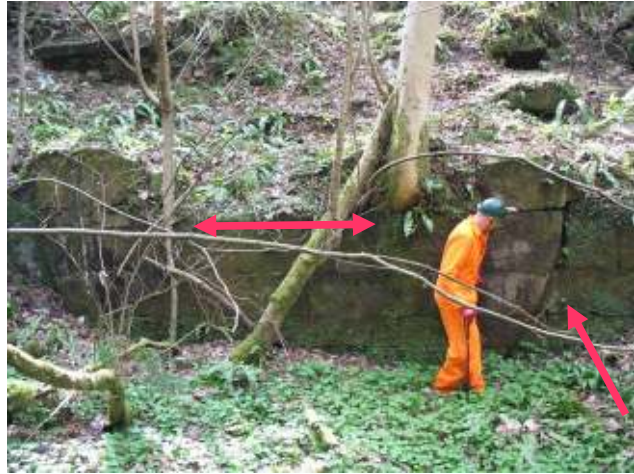
4.6 Cut out on the northern wall, possibly to accommodate the hub of a wheel.

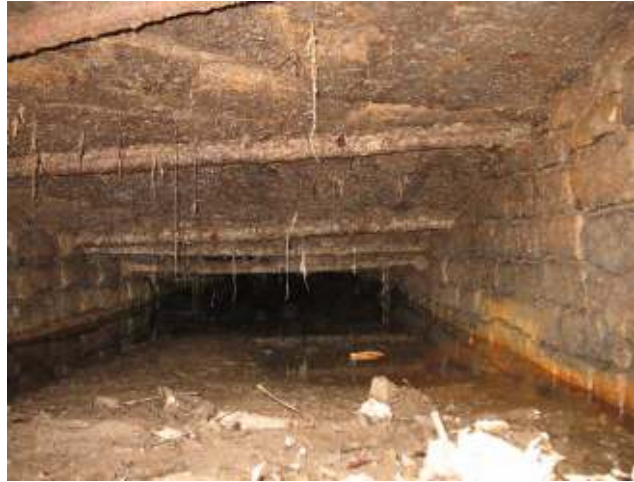
5.1 The spillway culvert, feature 5, upstream eastern end, where it passes under the road. Note the well-dressed stonework similar to that on the shaft entering the Southern tailrace (compare pictures 2.5 and 2.6). Daylight can be seen at the river end of the culvert.

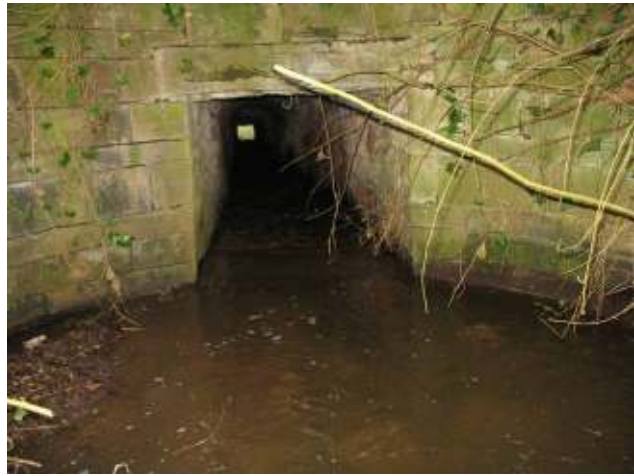
5.2 Looking eastward up the culvert from the river end, the roof can be seen to be slabbed, arched and then slabbed again. The arching may represent an old track parallel to the river before the stream was fully culverted.

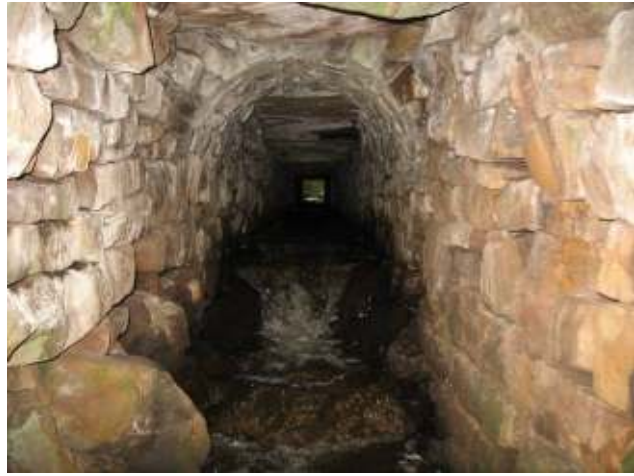
5.3 River end of the culvert looking westward with the river Goyt visible beyond. The Goyt is flowing from left to right across the picture.

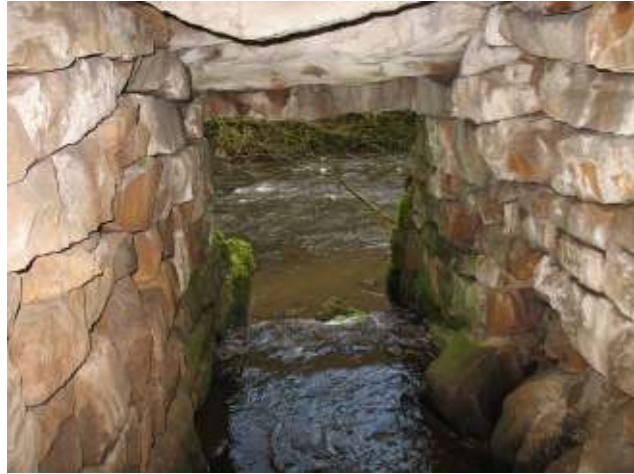
6.1 Drive shaft tunnel, feature 6, through which power was supplied to the mill. The picture shows the first section leaving Waterloo wheelpit. The large slab was part of the roof.

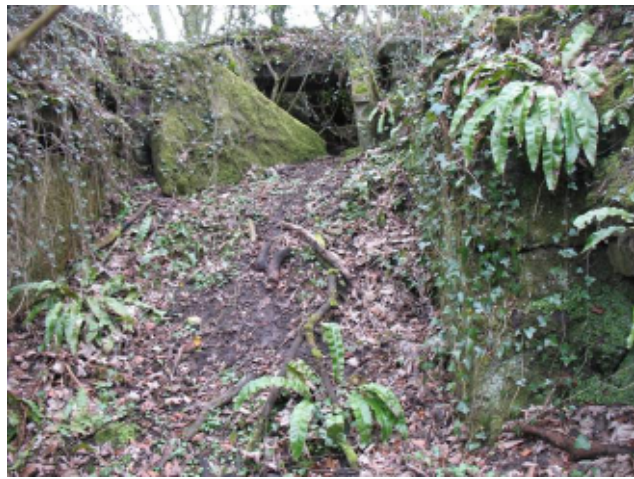
6.2 Inner (eastern) end of the drive shaft tunnel infilled with demolition rubble from the mill. The clean stone arch at the end of the tunnel can clearly be seen.

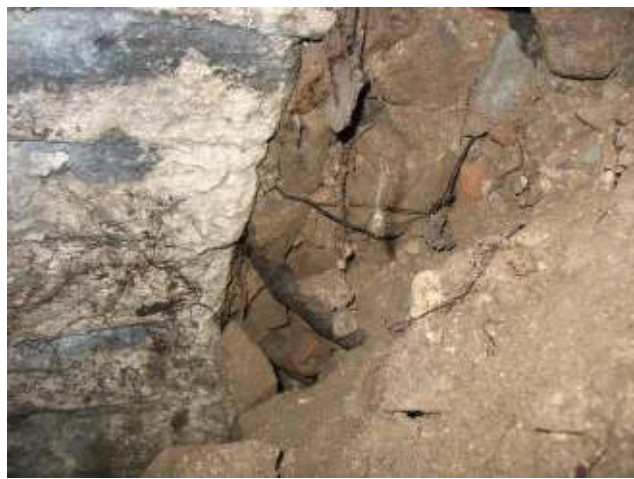
6.3 Looking out from the end. The soil on the floor has come down the manhole on the left (see picture 6.4).

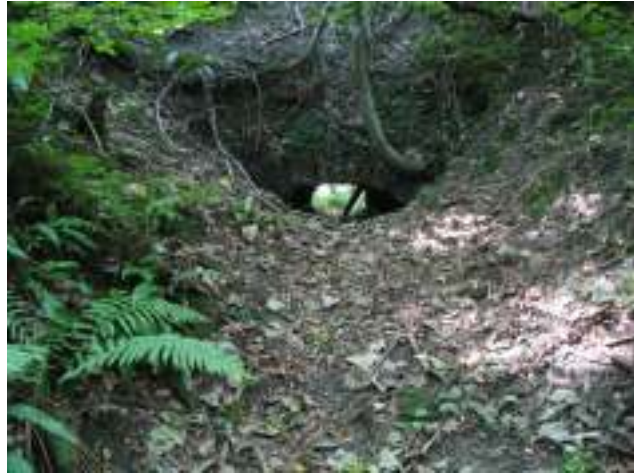
8.2 View from west to east through drive tunnel.

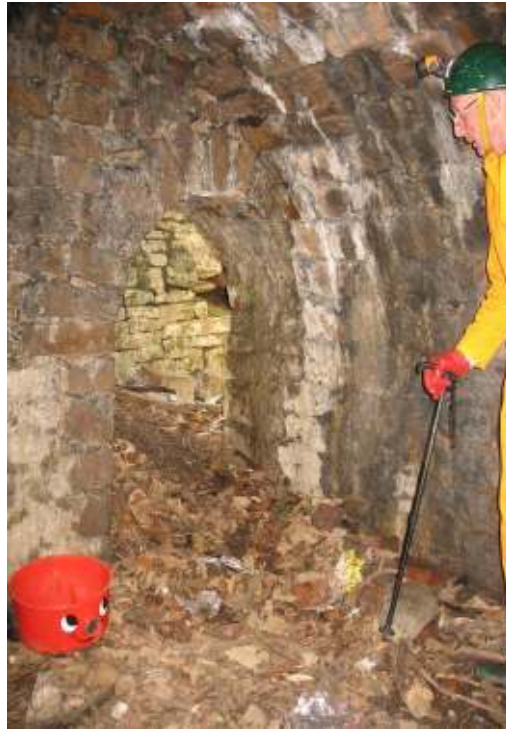
9.4 Coal chute. This would be between the front wall of the mill and the road.

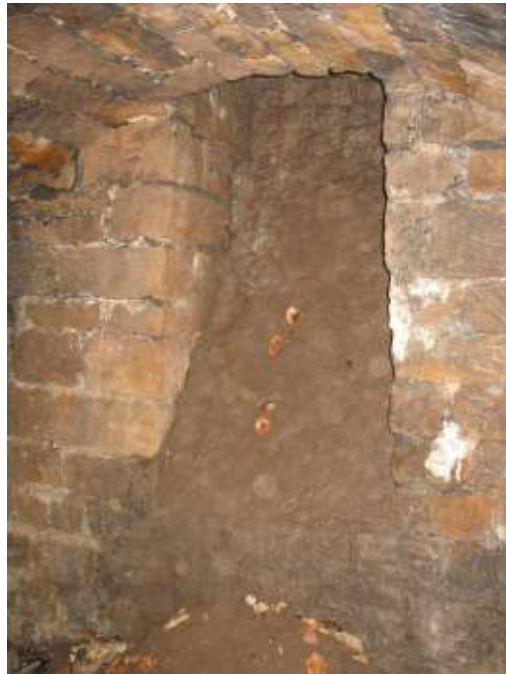
10.1 Entrance to the bridge abutment cellars, feature 10. The crown of the arch is probably less than one metre below the road surface. The stonework has some reasonable architectural features about it such as rustication on the door jambs.

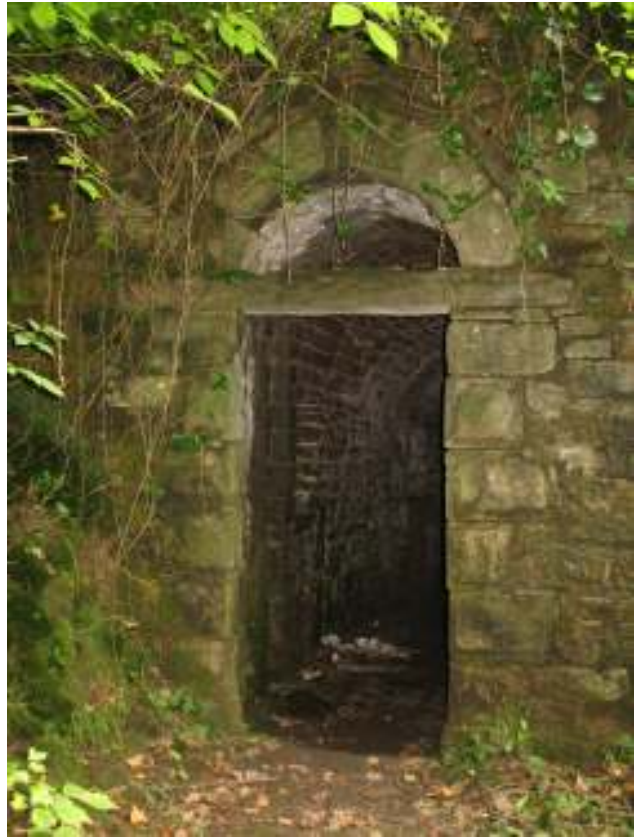
10.2 Main cellar passage looking out (northwards). There are shallow steps on the floor about 3 m apart. This would make it accessible by horse if required. Note the blind arch on the right and beyond it a blind rectangular recess in the wall of which there are at least two on each side.

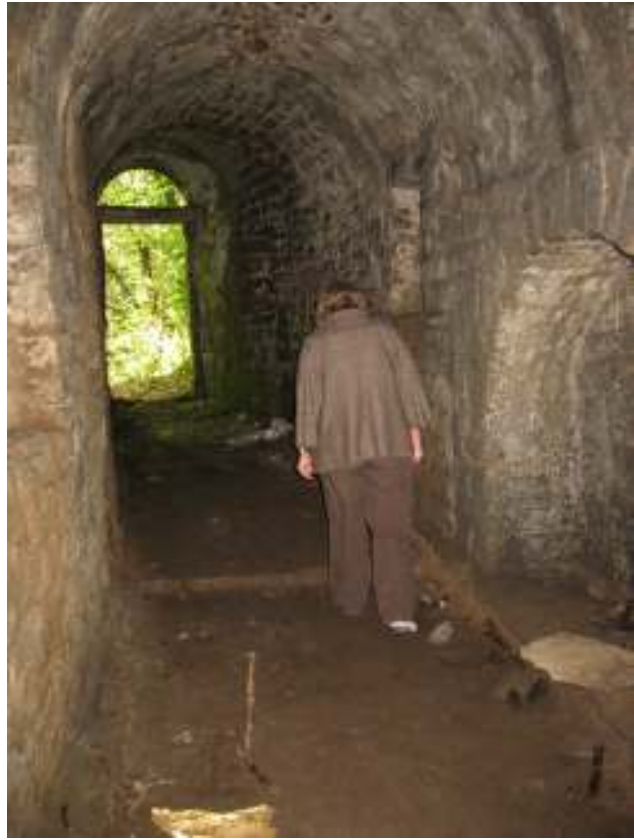
10.3 The way into the end rooms of the cellar which have been filled with soil. Another room is accessible on the right hand side at this point.

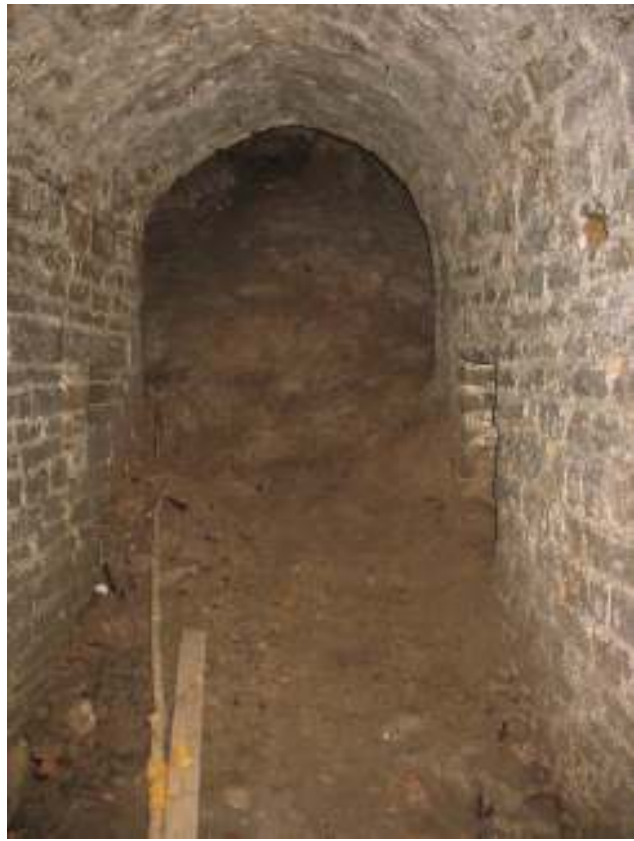
10.4 The east side passage. It appears to open into a chamber filled with a circular stone built feature. Could this have been a circular stairway from the house above? A more detailed map of the tunnel is required to establish whether this is possible. The floor of the passage at this point is covered with broken nineteenth and early twentieth century pottery.

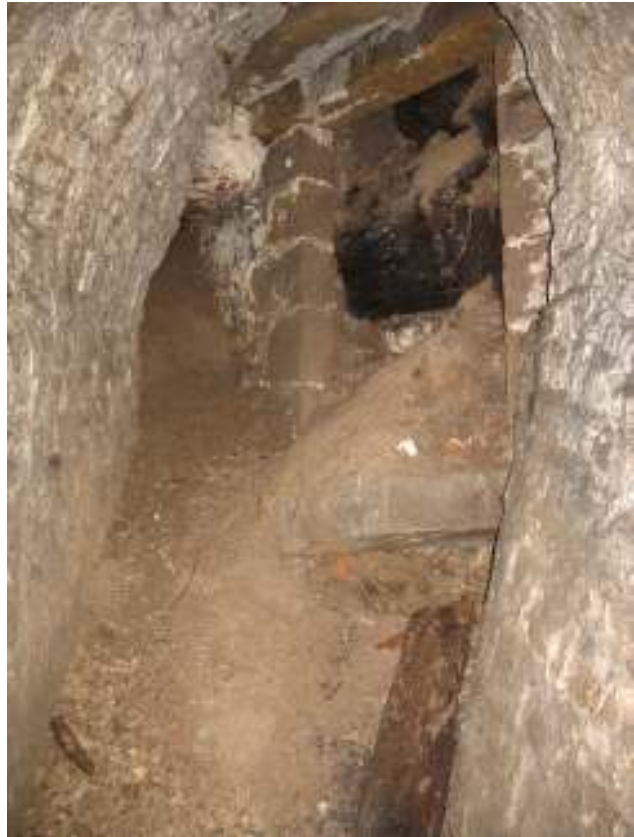
11 The Wellington wheelpit access tunnel, feature 11, is a short tunnel with steps into the wheelpit. It may have served to provide access from the wheelpit under the building to the controls of the water feed sluices by the mill lodge.

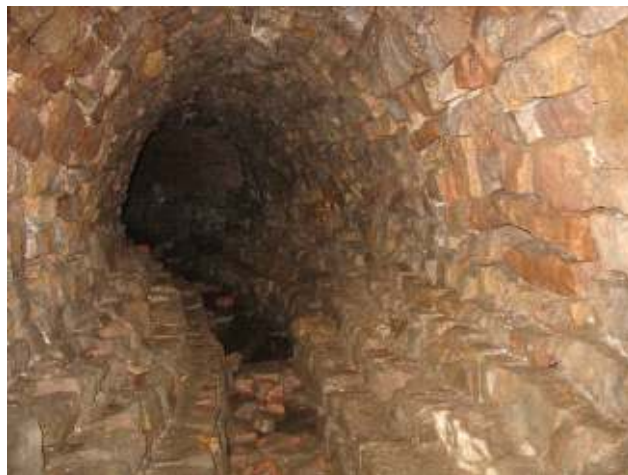
12.2 Near the end is a branch on the right leading to a partly closed entrance with daylight entering. This is presumably one of the inlets to the drain.

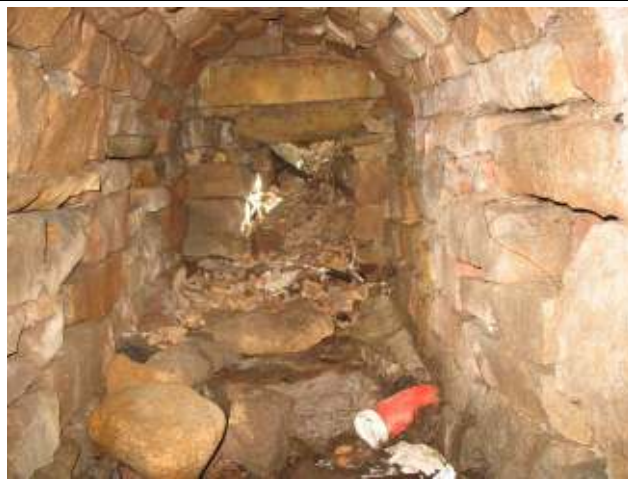
12.3 The section before the end is brick arched, possibly where it runs close to the building or the road. The picture is taken looking downstream.

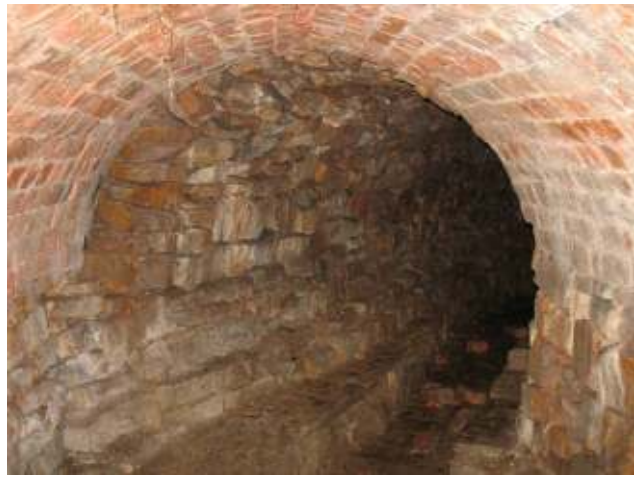
12.4 The end of the drain is in debris, probably from the mill.

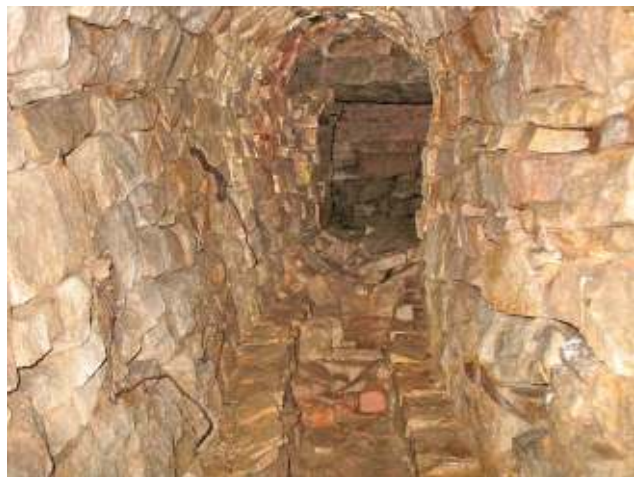
13.1 The northern drain, feature 13, runs downstream from the point where it is intersected by the drive shaft tunnel, feature 6, just west of the road. The tunnel is oval shaped and dry stone walled. It bends left, then right and then left again. Shortly before the end, there is a right hand branch that heads back towards the mill,

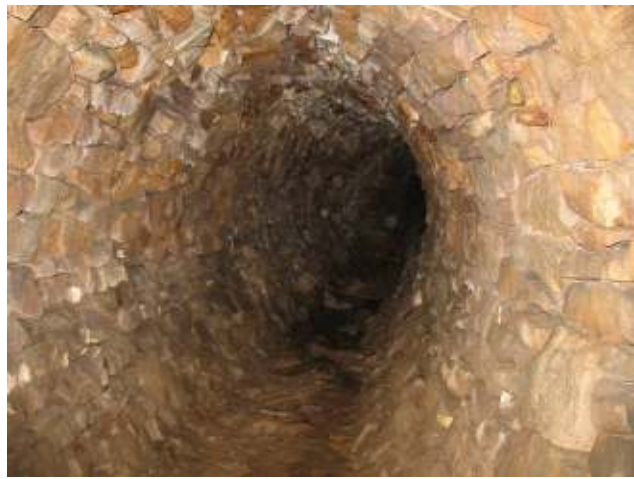
13.2 The downstream end of the drain breaks surface. It may have continued as a surface channel from this point which was probably chosen to ensure that water did not invade the workshop area.

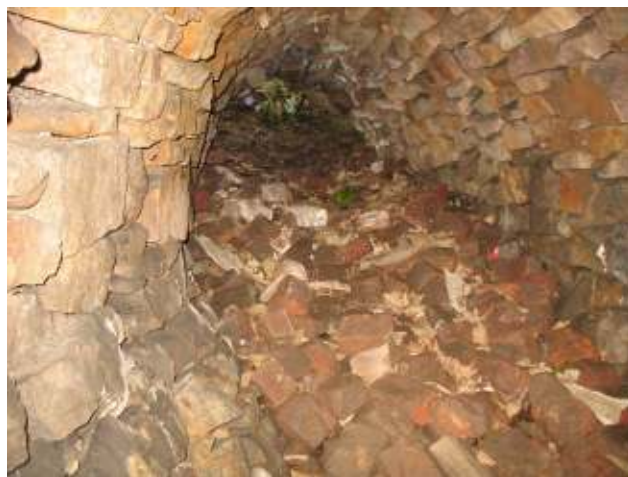
13.3 The right hand branch tends to have a flat floor. At the point illustrated, a manhole in the right hand wall has allowed soil to run into the drain.

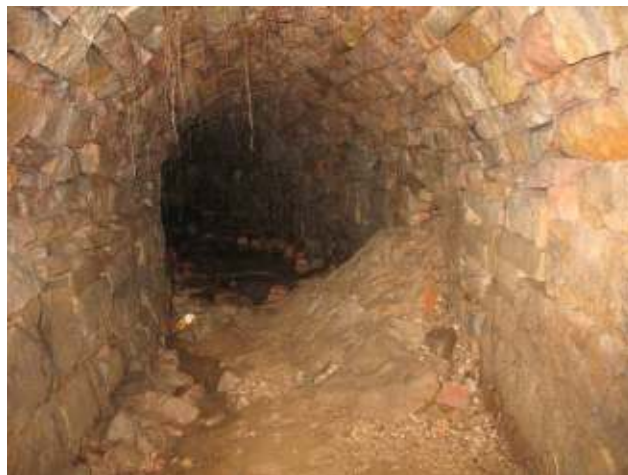
13.4 The floor of the northern drain is not stepped but is covered with large flat stone slabs as seen in this photograph.

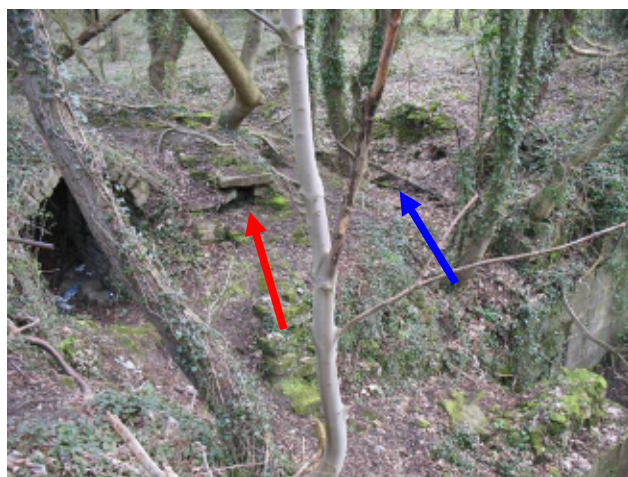
15 Southern culvert - unknown purpose. The torch is for scale. This tunnel may have been intersected by the power tunnel, feature 6.
