**Site location:** Land adjacent to Roman Lakes Leisure Park, Lakes Road, Marple,

**Proposal:** Community Archaeological Excavation

**Document title:** Archaeological Excavation: Mellor Lodge, Coach House and Stables

**Document type:** Archaeological Excavation Report.

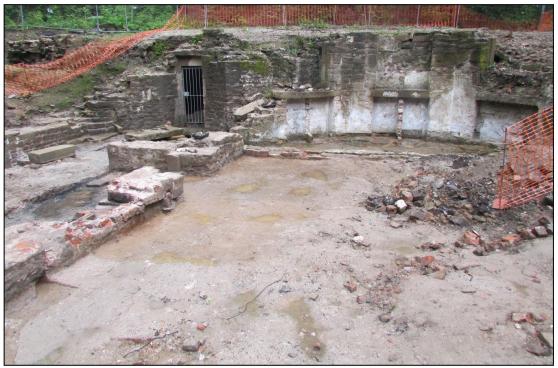
**Figure 4.** General view of Mellor Lodge Area showing the standing remains of the front wall of the house and internal dividing walls. Looking northwest.

The excavation area was located over the site of the eastern end of the house where remains had previously been identified at basement level. The area measured 14.00m x 14.00m, orientated northeast-southwest. The removal of the vegetation and topsoil revealed a demolition layer comprising a dark brown silty loam (003) with frequent inclusions of broken brick and stone, mortar, coal, clinker and  $19^{th}$  and  $20^{th}$  century pottery, metal and glass which covered all the features in this area and existed to a depth of c.2.50m.

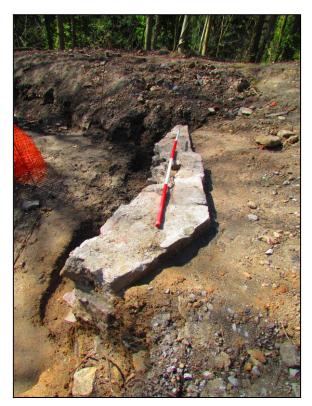
**Figure 5** Wall (006) showing the absence of the internal facing stones. Looking southwest.

Four sections of stone wall were revealed to stand at the front of the building (northern side) which stood to a height of between 2.50m-3.00m. All four were constructed from dressed stone blocks laid with white mortar and a mortared rubble core. The easternmost of these walls was (002), a short section of the eastern wall of the house measuring 0.50m wide x 3.00m long which contained a recess in the upper part, and a fireplace, although this was not fully excavated. This abutted (004) measuring 0.50m x 7.00m which formed the hexagonal eastern bay of the house and possessed three full-length recesses c.1.20m wide, each of which were split by a central horizontal stone sill with a vertical single course brick wall below and were whitewashed. Wall (005), measuring 0.50m x 4.50m was semi-circular and lay between the eastern bay (004) and the western bay (006) and possessed a single doorway to a tunnel leading to the mill outbuildings to the north of

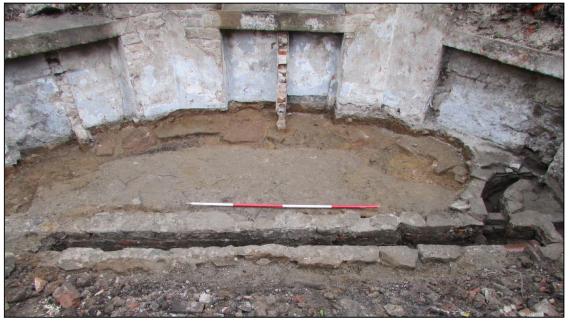
Figure 6. Area enclosed by wall (004) showing drain (009) and wall recesses. Looking north.

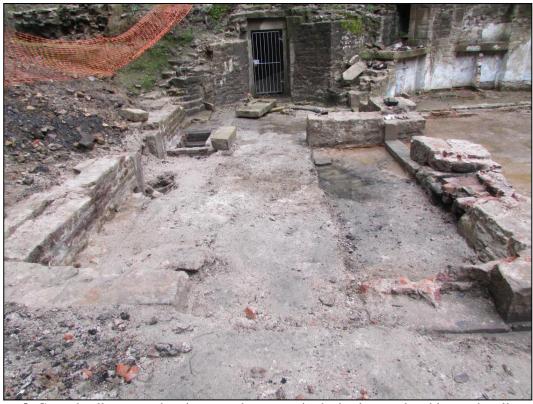
**Figure 9.** Central cellar room showing tunnel entrance in the background and internal walls (014), (024) and (027). Looking north.

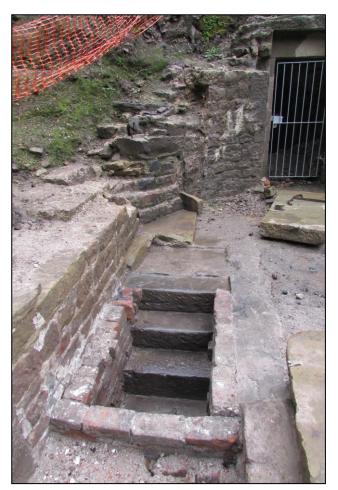
**Figure 10.**Staircase (032) showing inserted brick walls (030), (033) and (034) with (016) and (017) visible in the background. Looking north.

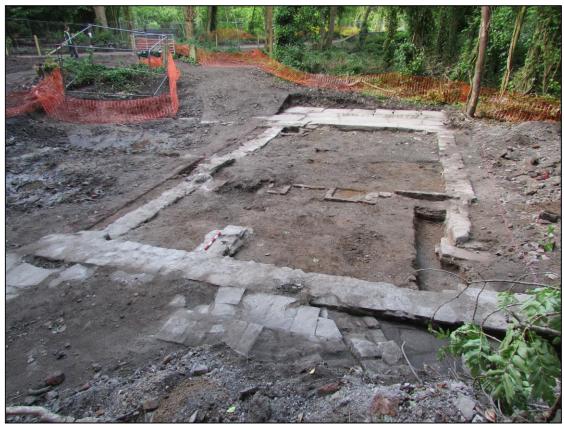
Figure 13. General view of the Coach House/Stables trench. Looking south.

The excavation area was located over the site of the coach house/stables structure at the southern end of the line of ancillary building which lay between the mill and the river. The area measured 16.00m x 8.20m, orientated northeast-southwest. Following the removal of the overlying vegetation, a demolition layer comprising a mid-grey-brown silt (002) with frequent inclusions of broken brick and stone, mortar, slate and 19<sup>th</sup> century pottery and metal was identified which covered all the features in this area and existed to a depth of between 0.15m-0.30m.

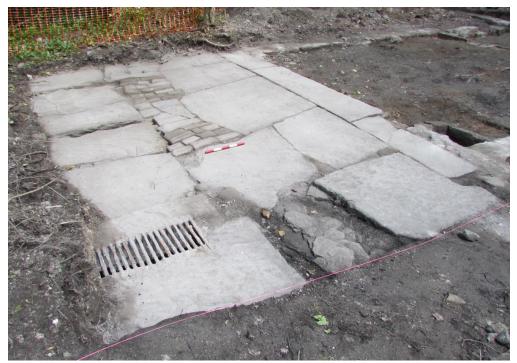
**Figure 14.** Flagged yard showing stone flags (004) and (007) with grid (008) and cobbled infill (005) and (006). Looking north.

At the southwestern end of the trench a stone surface was uncovered which was composed of stone flags and cobbles of varying sizes, contexts (004)-(007). At the far southern corner of the trench an iron grate (008) was revealed set within the flagged surface (007), through which could be seen running water. The flow of the water indicated it ran in a northwest-southeast course towards the river.

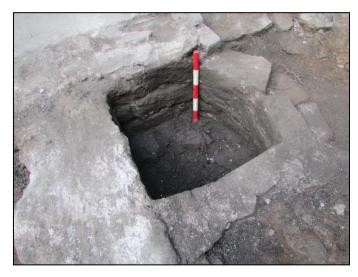
**Figure 15**. Possible sump/ soak away in the southern corner of the building. Looking west.

was identified in the far southern corner of the building which comprised a single course of sandstone blocks laid with white mortar and abutting the main and return sections of wall (010). The feature was filled by a black-brown silty deposit and contained a large number of 19<sup>th</sup> century objects including pottery, glass and metal fittings such as pulley wheels and hooks. The north-eastern part of the building was crossed by a single course, handmade brick wall (015), which was irregularly stepped in plan and bonded with white mortar.

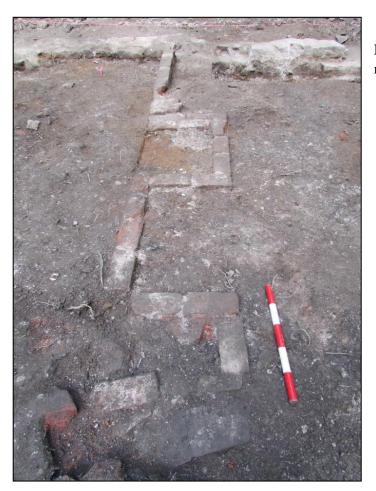
**Figure 16**. Wall (015), looking northwest.

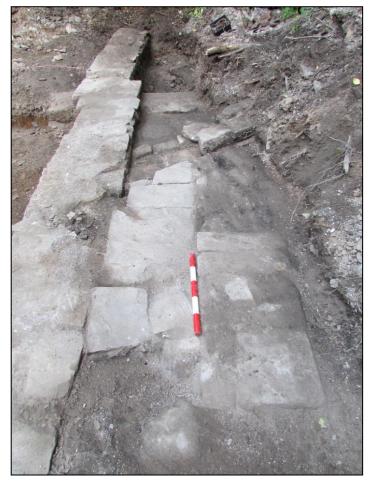
**Figure 17**. Area to the northeast of (011), showing walls (011), (012) and (020) and flags (013). Looking northwest.

Several features were identified to the northwest of wall (011) that appeared to be associated with structures linking the coach house building with the next outbuilding to the north, as viewed on the historic mapping. These features comprised a flagged stone surface, (013) which was crossed by a two course sandstone wall (012) which continued from wall (011) beyond the trench edge in a northerly direction. The flagged surface (013) measured 1.73m x 0.95m and was moderately damaged comprising flags measuring up to 0.86m x 0.48m. Wall (012) was aligned north-south, continuing north from (011) beyond the trench edge and was 0.42m wide. A second section of stone walling (020) which lay 0.60m northwest of wall (012) extended from (011) at a right angle and also continued beyond the trench edge. This wall abutted the end of the flagged surface (013) and was excavated to a height of 0.36m.

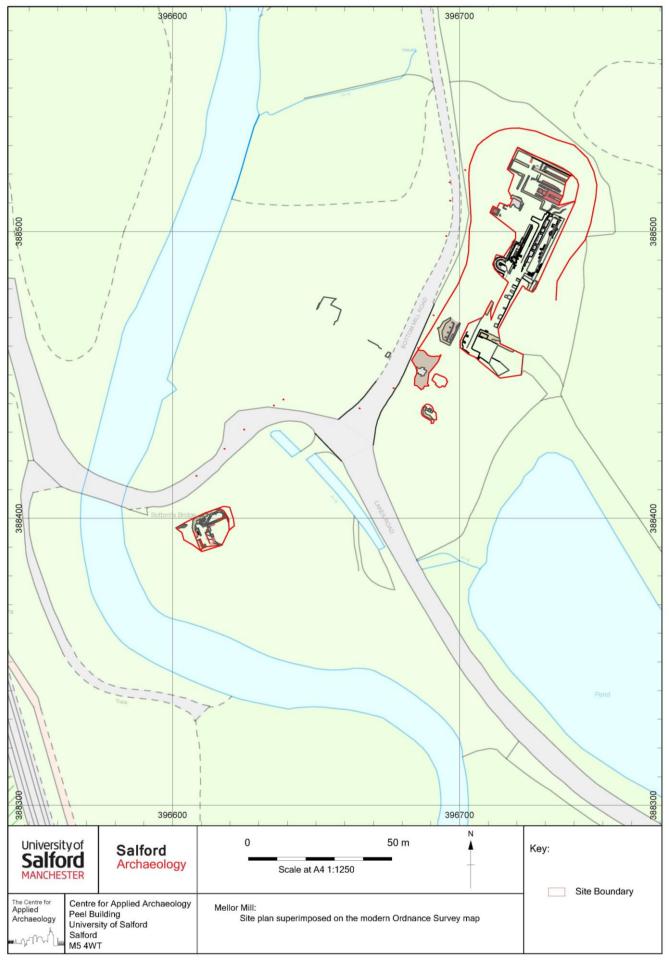
**Figure. 25.** Site plan showing both the Lodge and Mellor Mill superimposed on modern OS mapping.

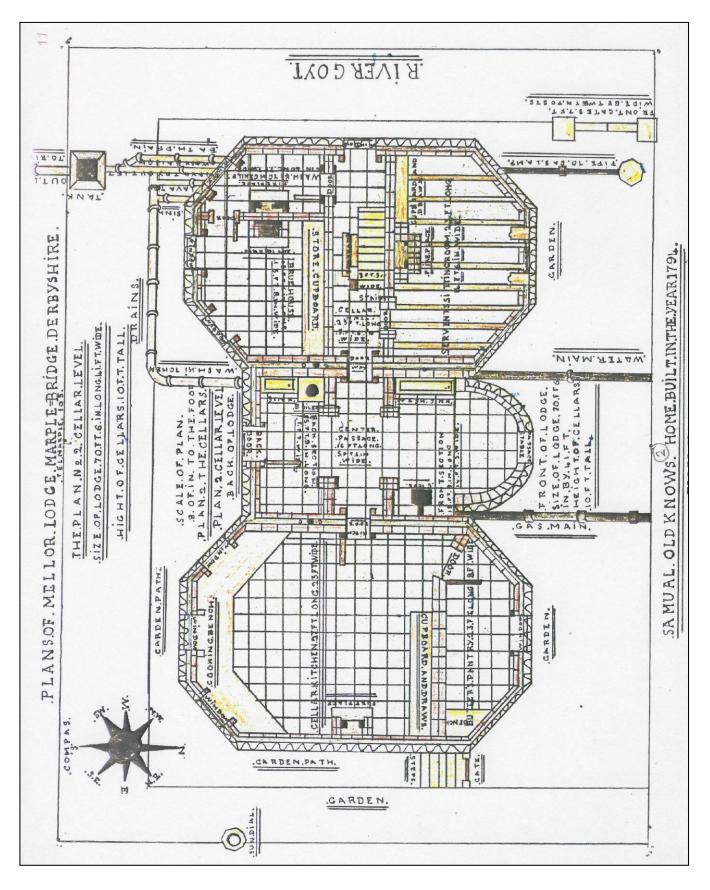
**Figure 27.** Plan of the Lodge basement level, drawn c.1920s by 'Squeaky' Dixon.

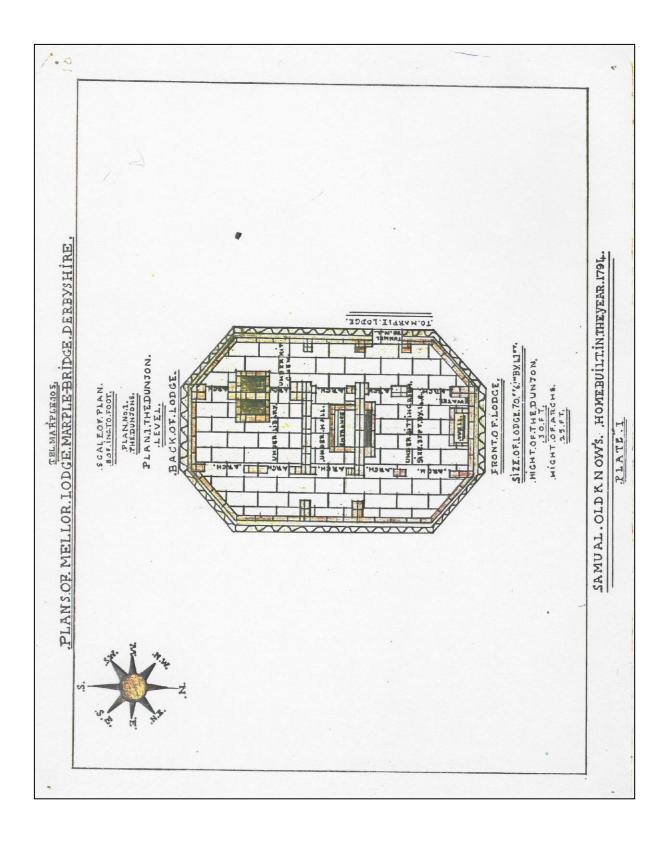
**Figure 28.** Plan of the Lodge sub-basement level, drawn c.1920s by 'Squeaky' Dixon.

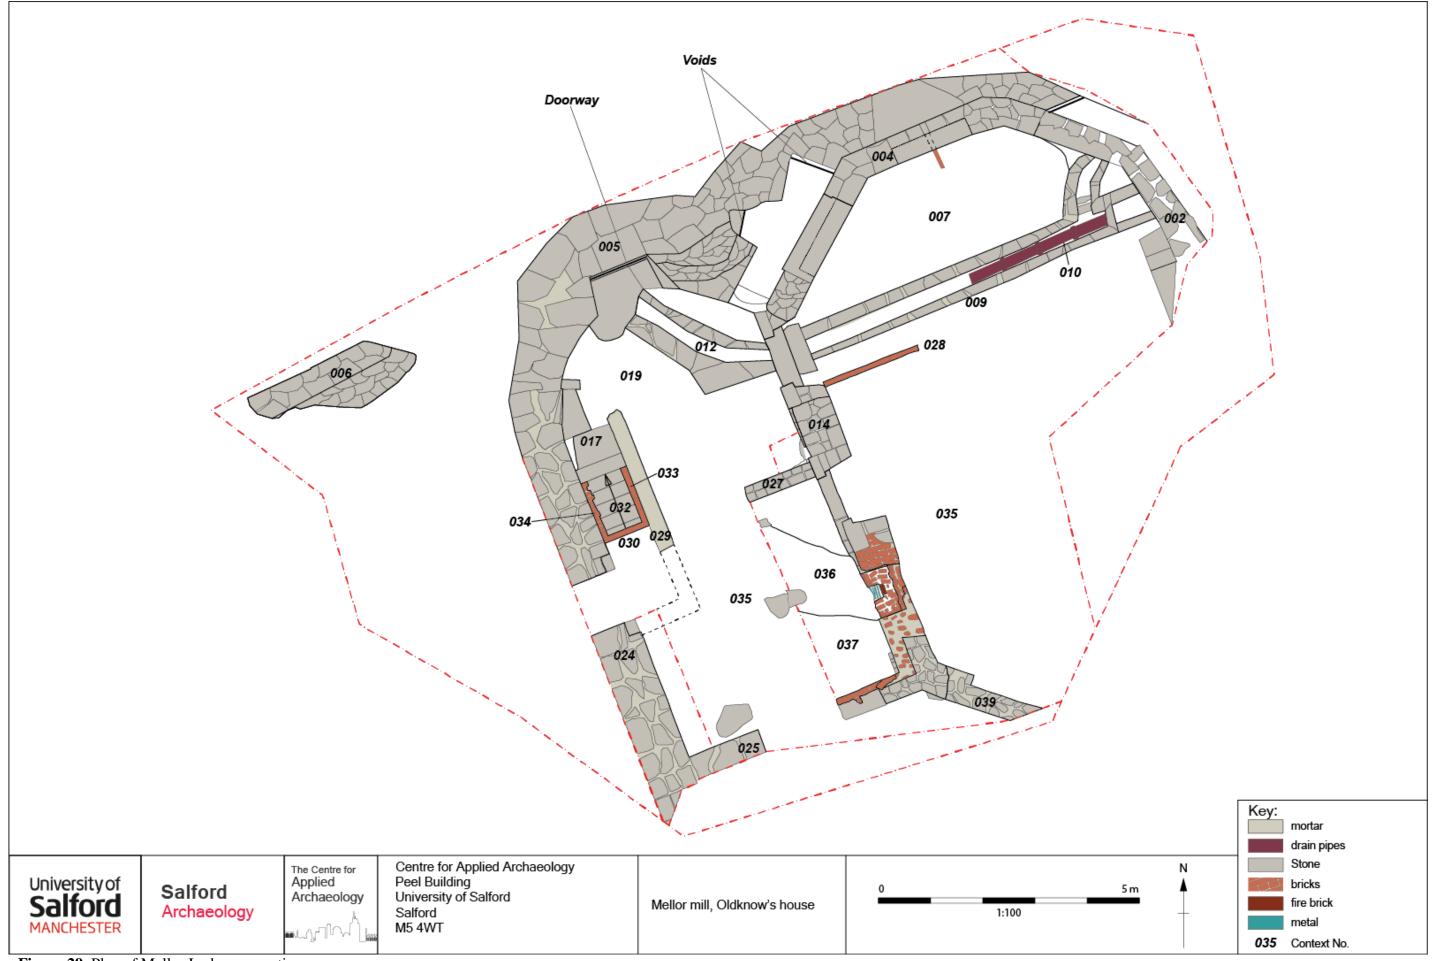
Figure 29. Plan of Mellor Lodge excavation area.

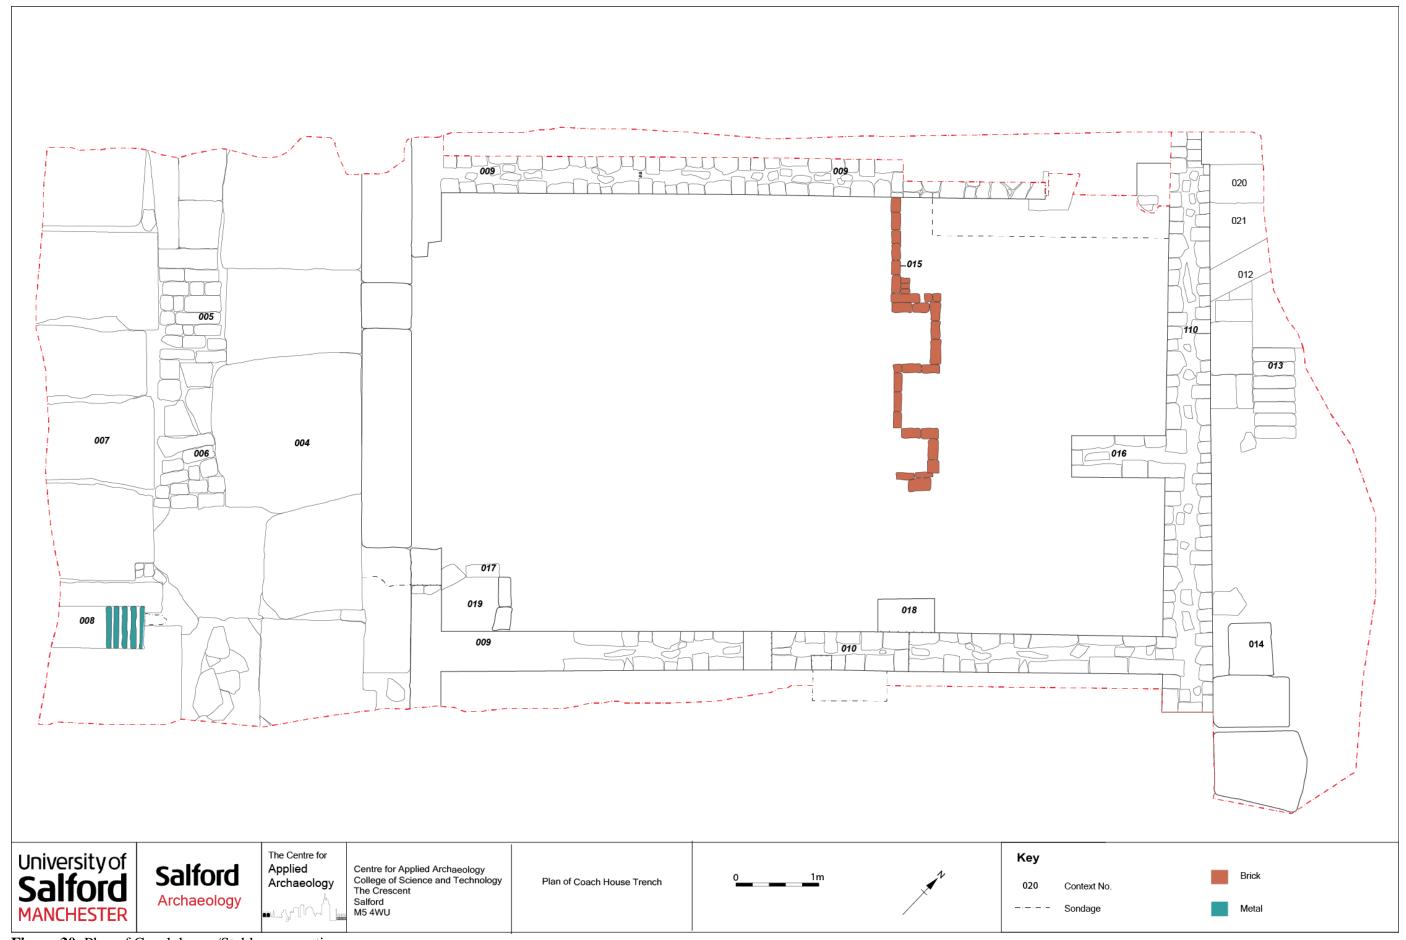
**Figure 30**. Plan of Coach house/Stables excavation area.

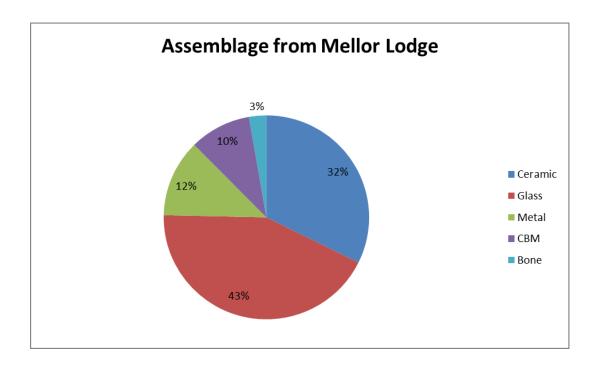
The ceramic element of the assemblage was relatively low for a residential building with a count of 190 items producing 32% of the assemblage, whereas glass was the dominant material at 253 accounting for 43% of the total assemblage. Unusually there was a high count of ceramic building materials, such as tiles, accounting for 10% of the assemblage (57).

The pie chart below outlines the percentages of materials within the assemblage.
