## **Archaeological Desk- based Assessment Report**

Cuerden Employment  
Site, South Ribble,  
Lancashire

**Technical Report:**  
Rachael Reader

**Report No:**  
2016/37

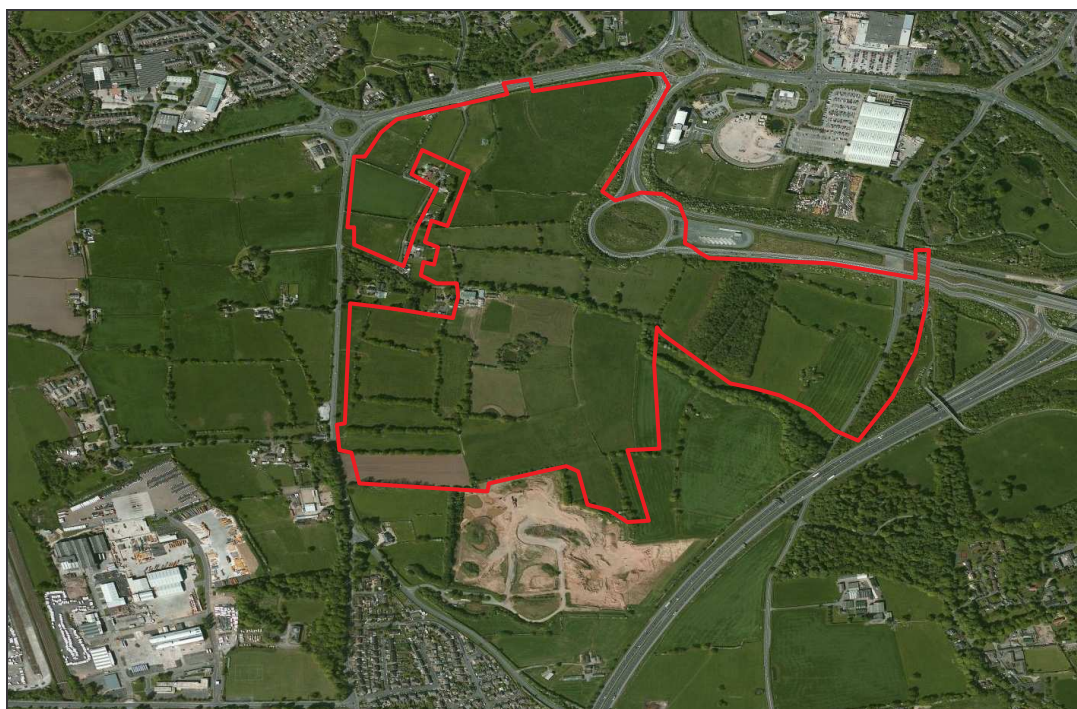
*Plate 1: Aerial view across Cuerden, showing the Site Area boundary*

Topographically, the area is relatively flat, gently slopes from the south-east to the north-west, and lies at *c* 45m above Ordnance Datum. The River Lostock takes a course through Cuerden Valley to the east of the site before turning to run north of the site, beyond the A582 westwards (Plate 1).

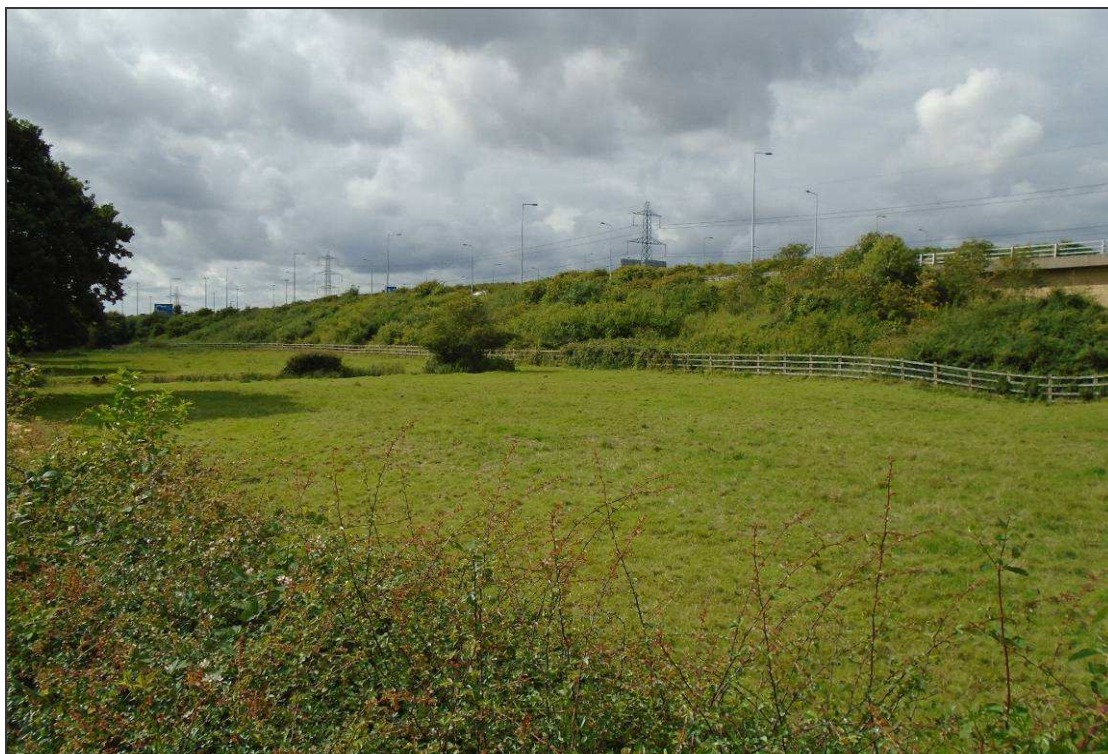
*3: View looking north-west towards the M65 in the eastern part of the Site Area, showing relic field boundary*

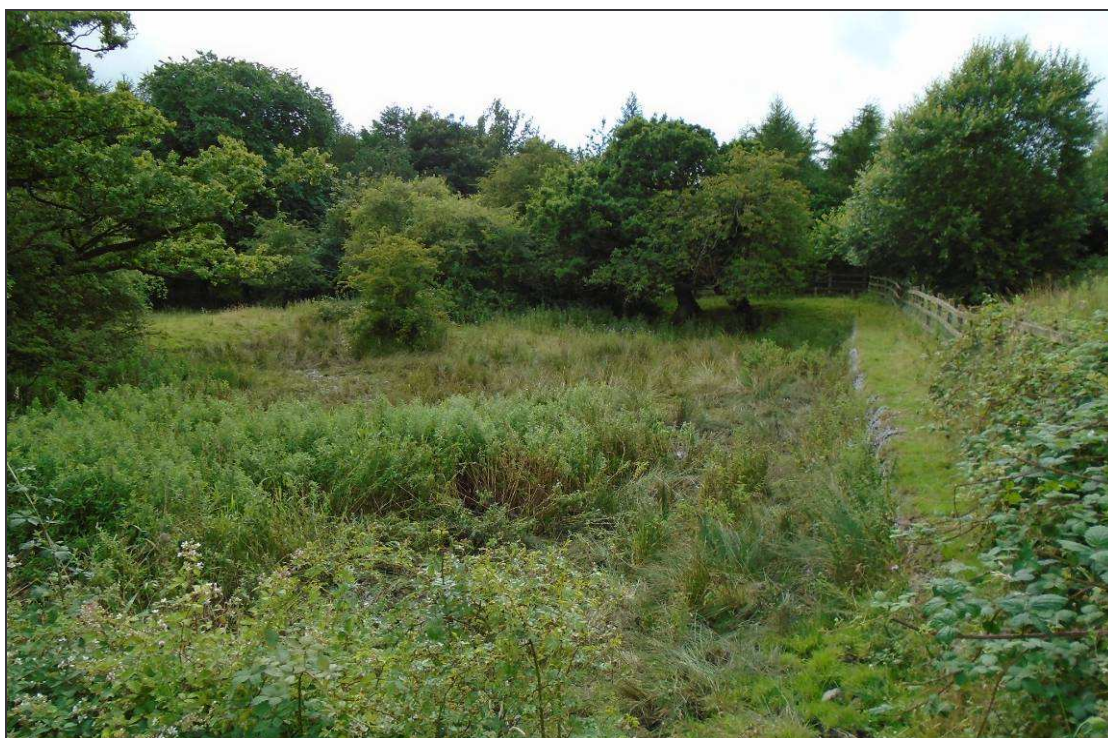
*4: View along north-eastern edge of the Site Area, showing former pond and gabion baskets forming revetment for M65 embankment*

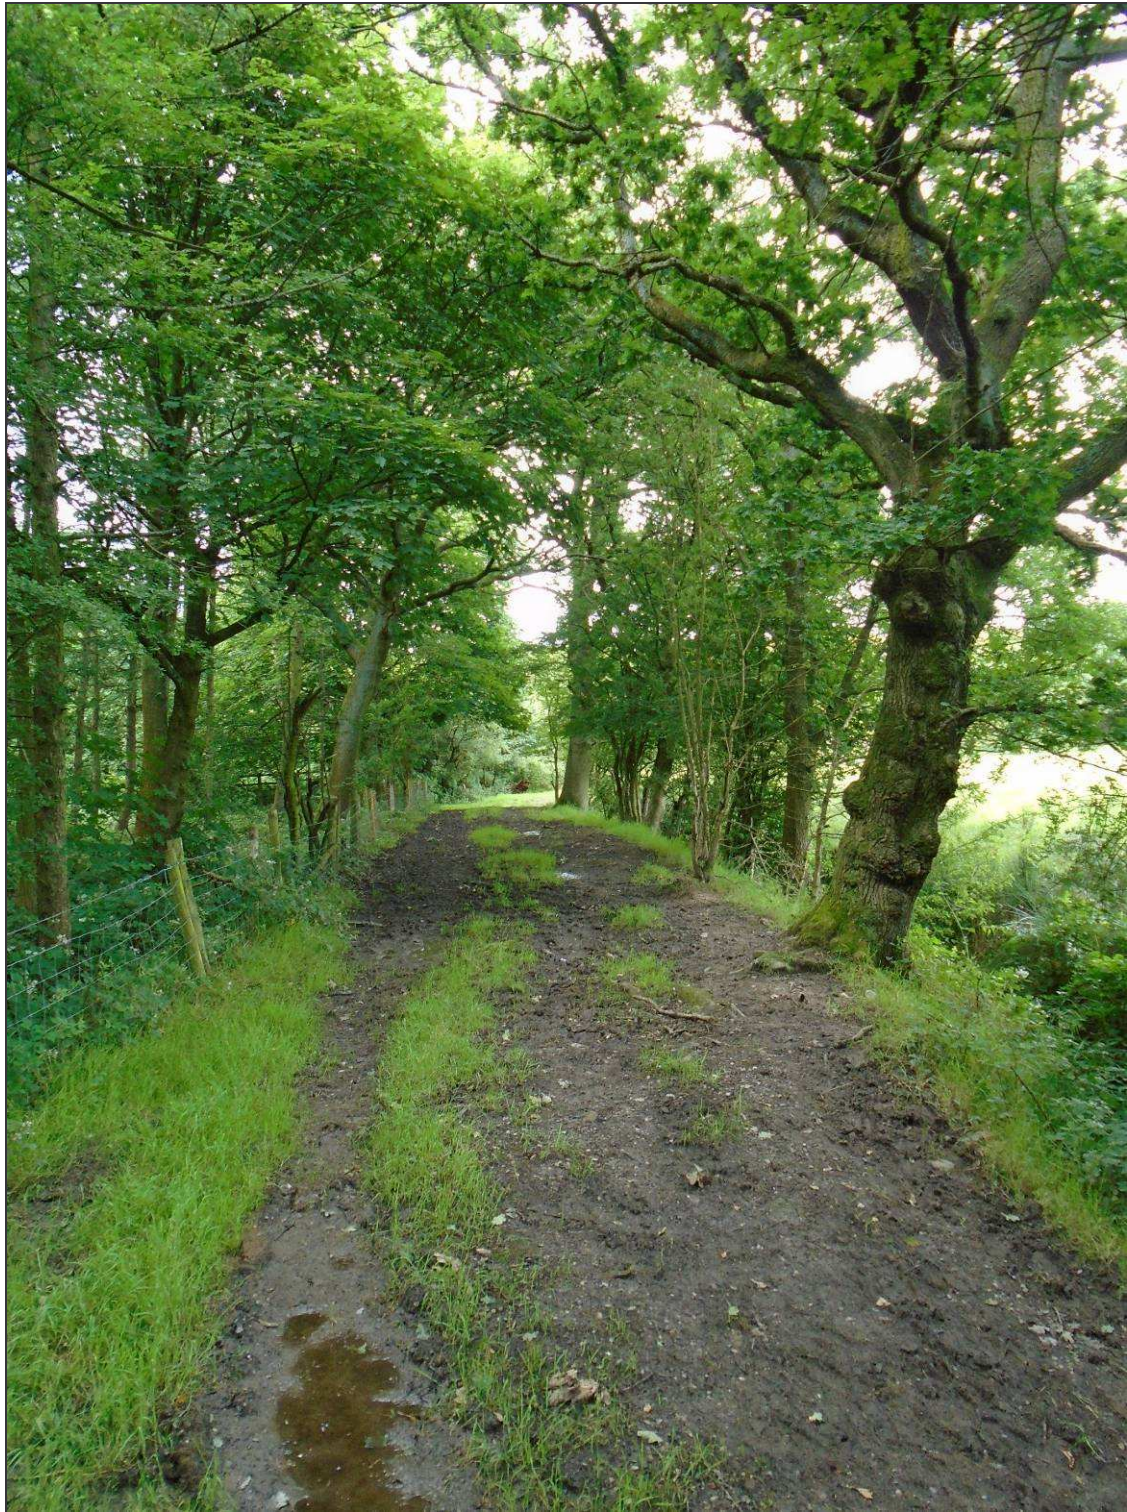
*5: View looking north along a tree-lined track, truncated by the construction of the M65, in the north-eastern part of the Site Area*

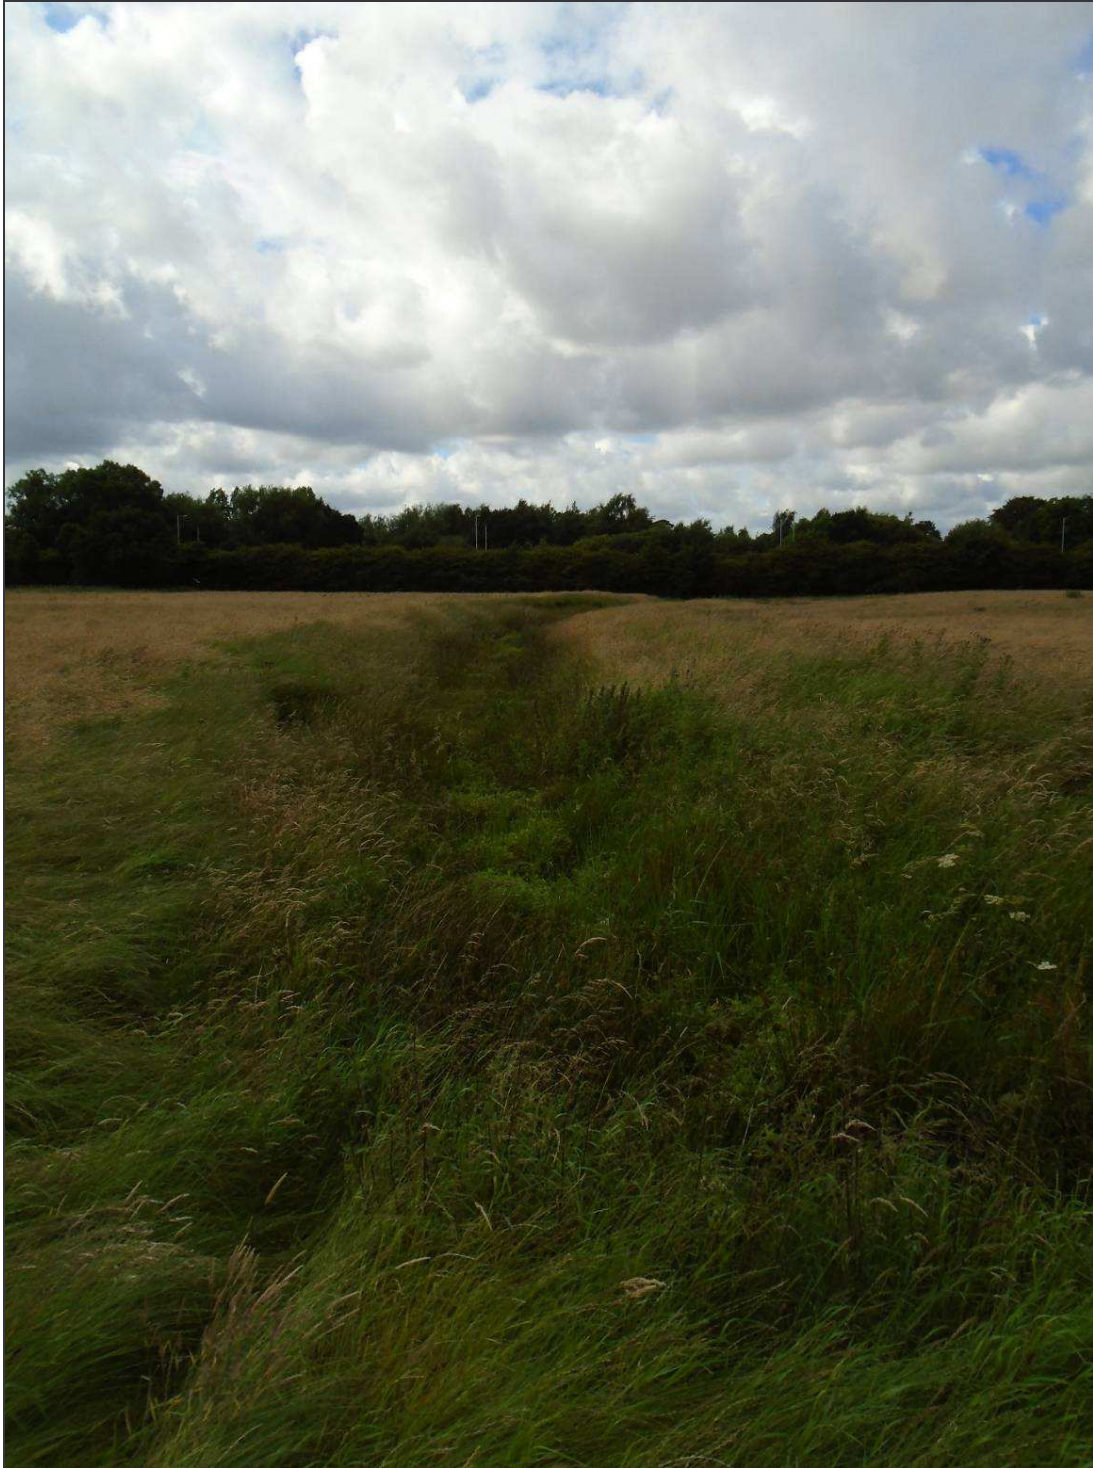
*10: View looking north along a curvi-linear ditch feature in the northern part of the Site Area*
