2-3 CHESTER ROAD: MON. 7:20

- STRIP + RECORD LOWER TERRACE
- TAKE DOWN TO ARCHAEOLOGICAL LAYER
- CORELES/SETS +/- OR NATURAL
- RENAKER
- 8m WIDE BUFFER ZONE IN PART OF SITE
- RESULTS RECORDED PRO-FORMA CS
- HML
- QUAY BAR E. PART OF CPE, NO ARCH. POTENTIAL TO BE EXPECTED, DEEP FORD MODERN BUILDING
- LOWER TERRACE, STRIP + PLAN BETWEEN QUAY BAR (SITE OF), CANAL TOW PATH, LUND + TREE PROTECTION ZONE

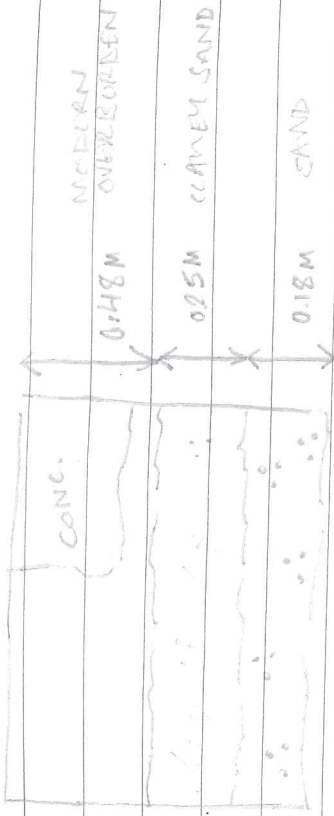
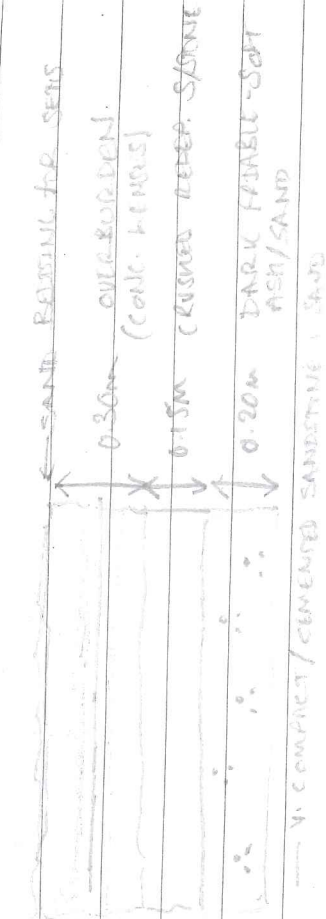
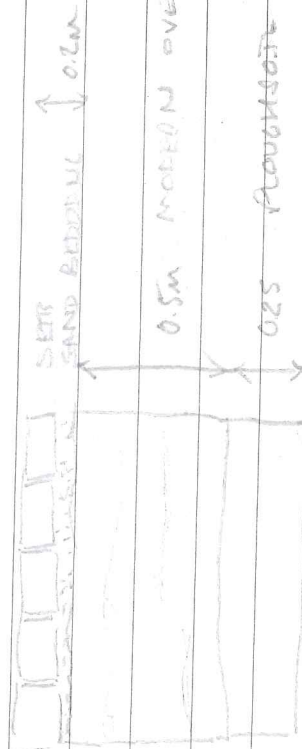
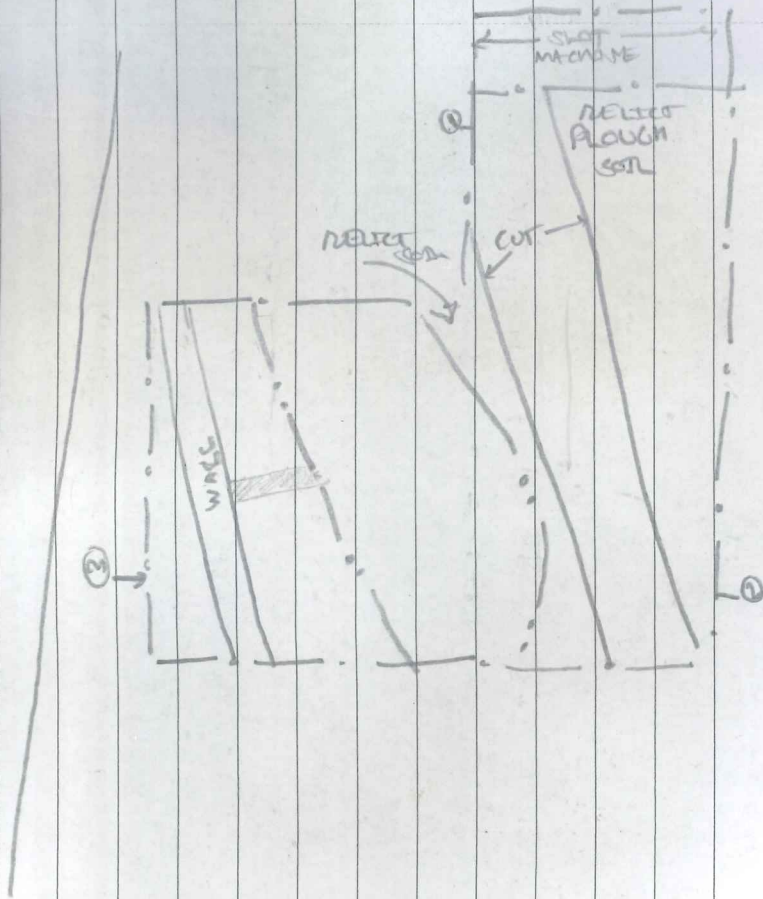
# ① DIFFERENTIAL SECTIONS

← RETAINING WALL →

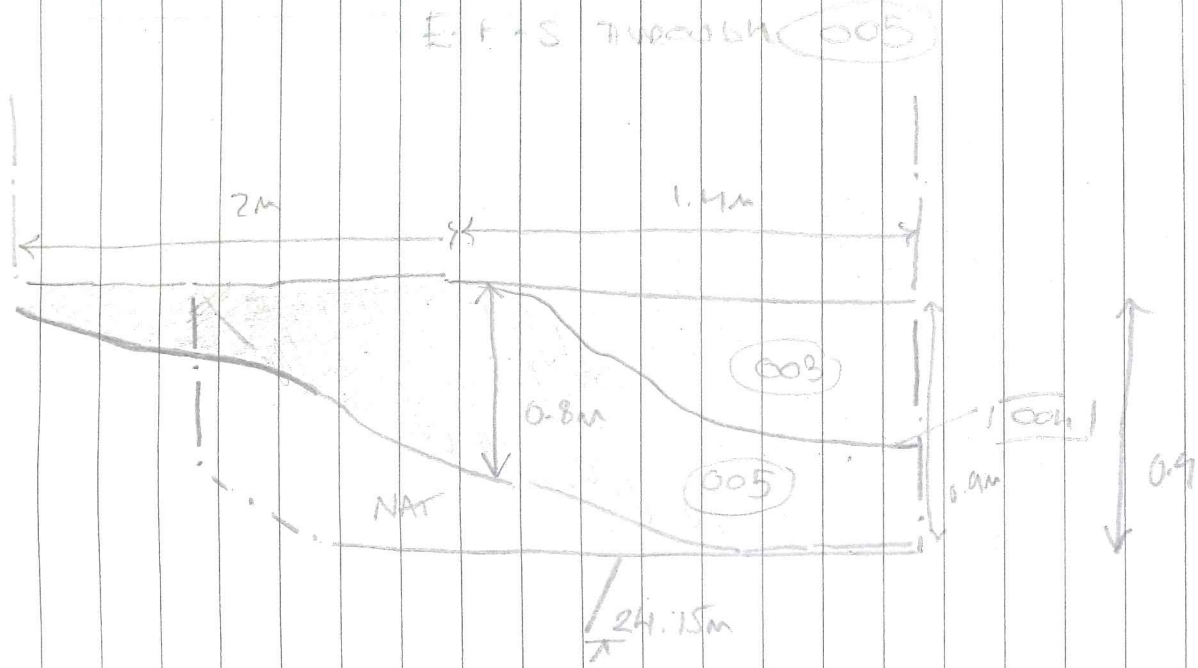
WALL AND REMAINING GROUND  
EITHER SIDE CLEARED, SHOWED WALL  
ON TOP OF FIRM CHY. <sup>SANDY/SILT</sup> LAYER (POSS.  
RIVER DEPOSITED) THIS CONTAINED A  
MIXTURE OF POST MED + RB POTTERY.  
THE LAYER ABOVE THE WALL SIMILARLY  
CONTAINED POST-MED-INDUSTRIAL DEBRIS POT  
AND FRAGMENTED BRICK (MOTTLED SANDY LAYER)

WALL LARGE, NO CONSTRUCTION TRENCH  
VISIBLE, FREESTANDING??

CONTEMPORARY GROUND LEVEL = (012)

NO RELATIONSHIP TO FLOOR SURFACE

PROBABLY IT WAS A STRUCTURE IN OWN RIGHT  
RIVER WALL PRE-DATING CANAL

SURVIVING AS FOUNDATION COURSE

1 COURSE HIGH

MASONS' MARKS - NO TOOL MARKS (NO)

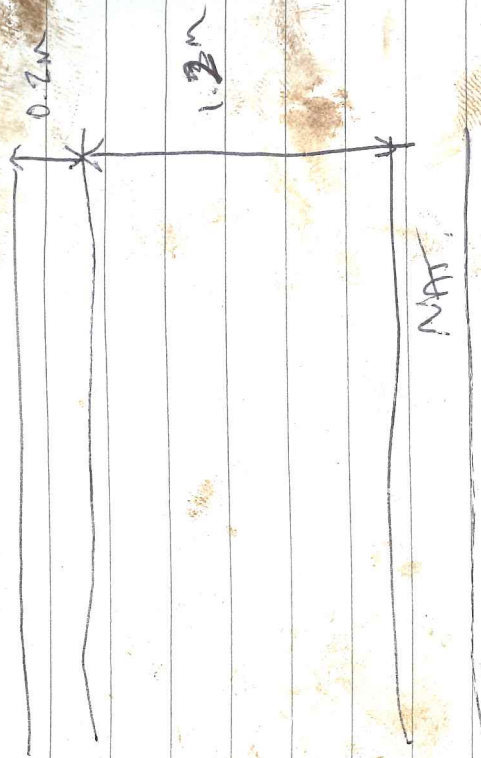
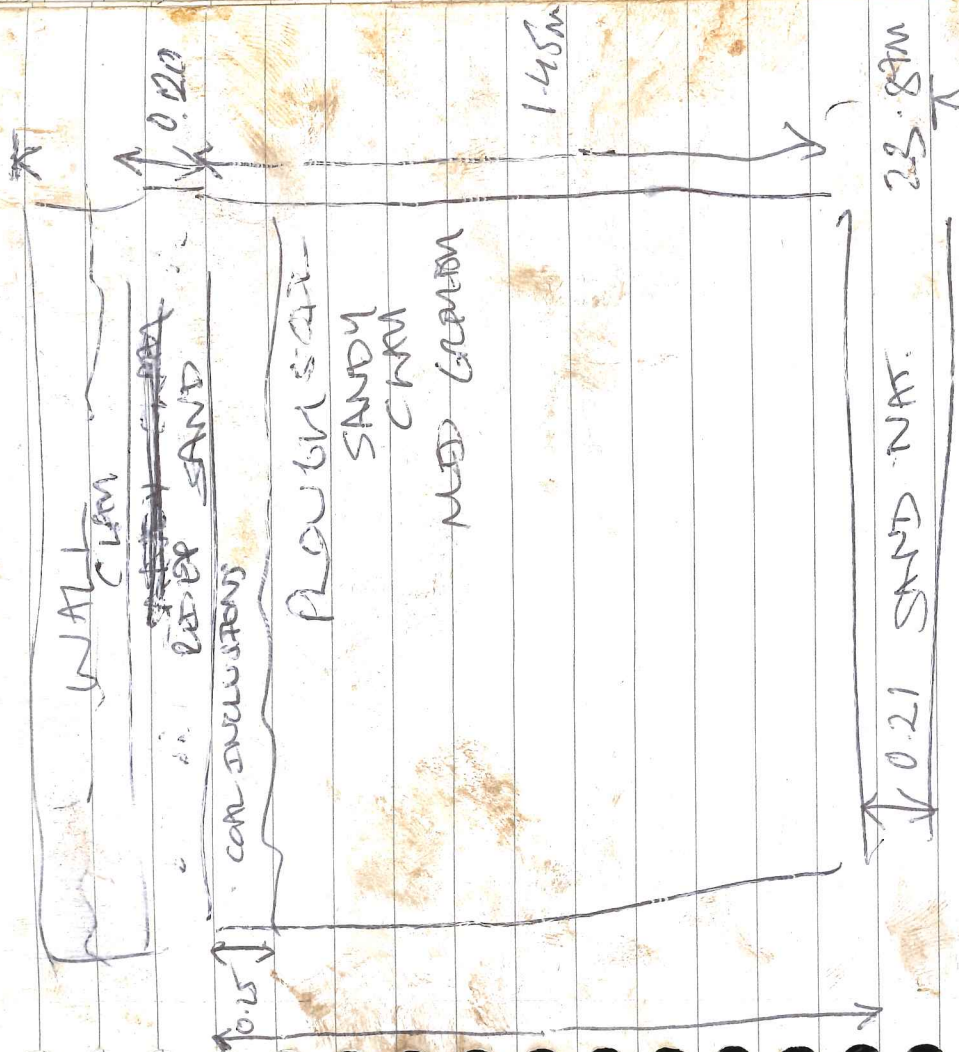
TRIAL PIT RESECTION  
CONTAINING WALL FACING

ESTIMATED TO A MAXIMUM  
DEPTH OF

1.7m below ground level on  
canal side of trench NRM (adj to  
retaining wall)

2.6m from conc. foundation  
unknown German tower ends of  
trench

↓  
Sub circular found started 751  
negative feature

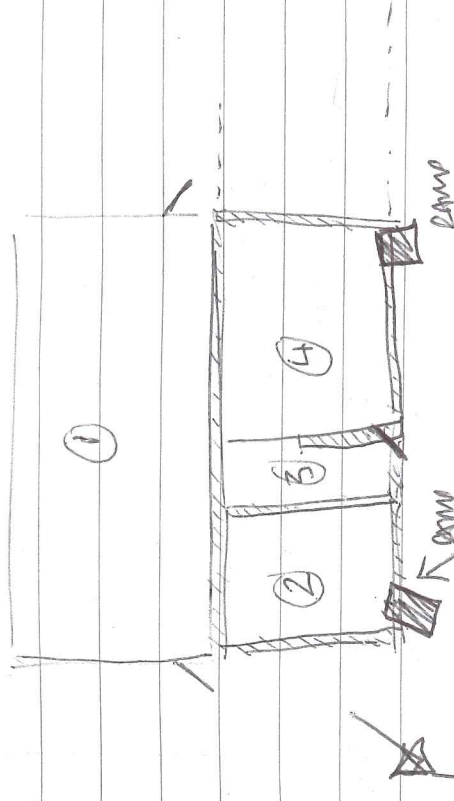
ROOM I

FLATU STONE FLOOR. CONSTRUCTED OVER 0.3 M OF  
SAND OVER KOROKU, FIRECLAY + SAND SETTING  
DOORS AT SE + NW ENDS OF ROOM  
SE DOOR - BLOCKED UP.

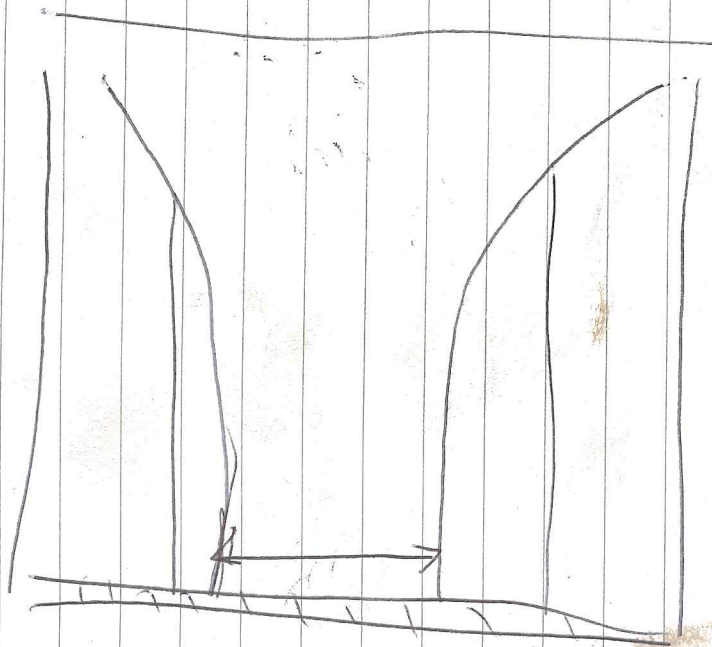
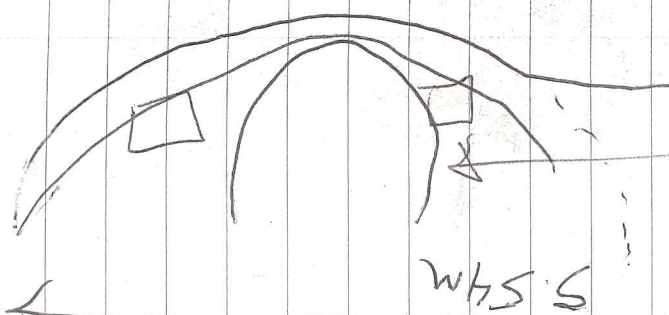
CELL 3.

SUPPORT  
WALL  
ADDED LATER  
POST FOR

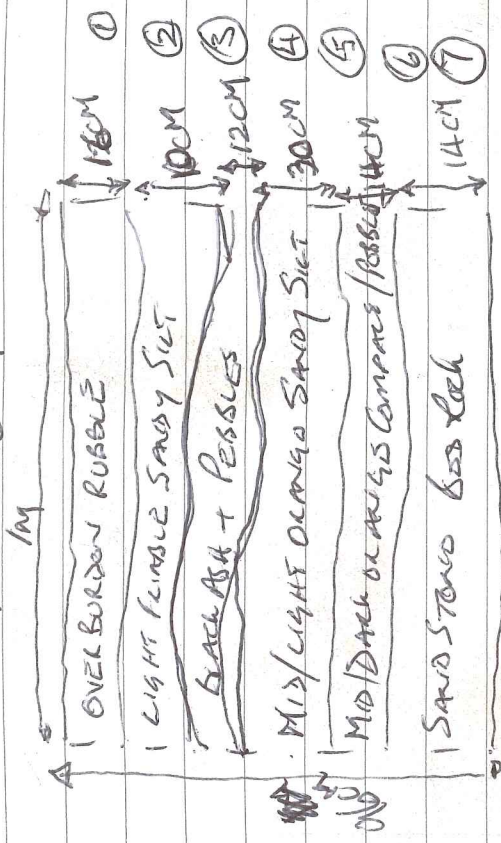
REP SEC A

- ① OVERBORDEN RUBBLE BUILDING MATS STONE
- ② LIGHT FINE SANDY SILT PESSIES IN CURSIONS SMALL
- ③ BLACK ASH/SAND LAYER PESSIES SMALL FINE
- ④ MID/LIGHT ORANGE SANDY SILT FINE
- ⑤ MID/DARK ORANGE COMPACT PESSIES
- ⑥ SANDSTONE BED ROCK SANDSTONE

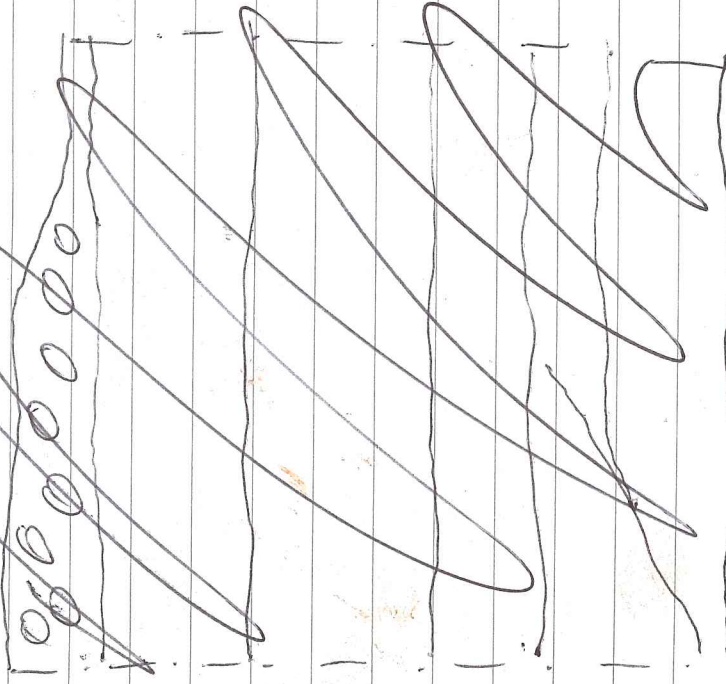
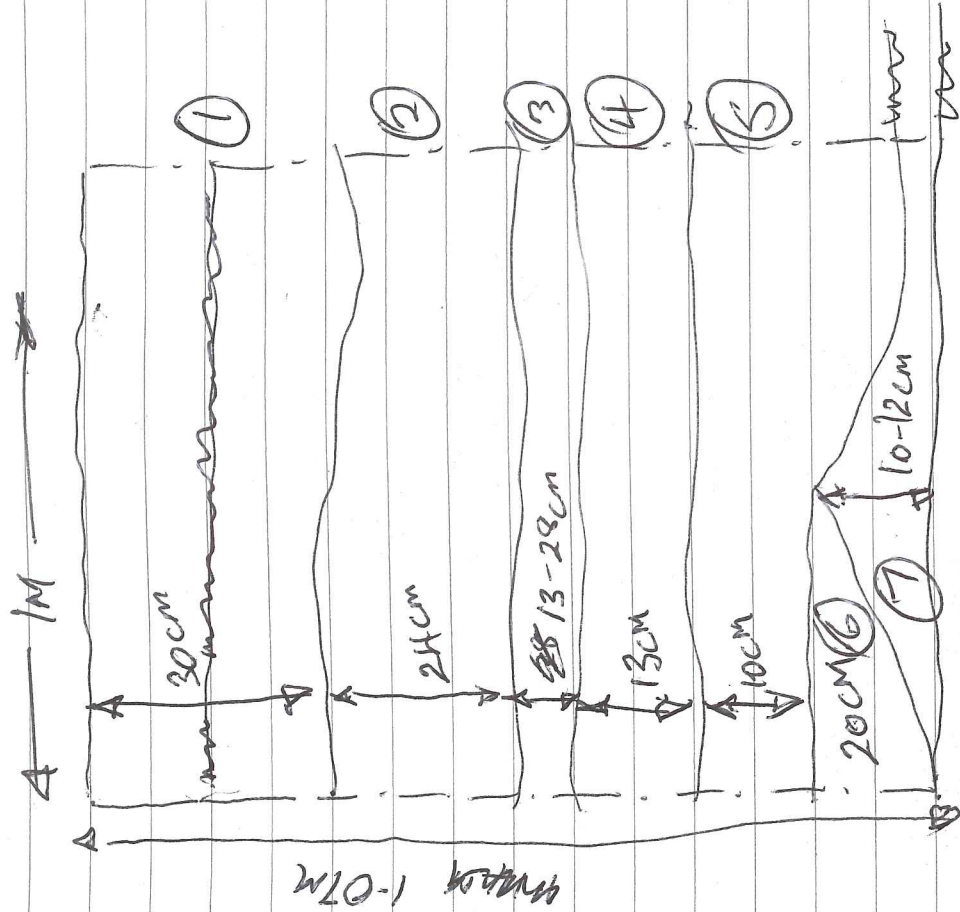
# Ref Sec C

1. Brown clay fissures S. of Sand Clay  
with Charcoal incursions

2. Light brown sandy S. clay

with brown charcoal back

3. mid light orange & brown S. clay

occasional charcoal

4. Light sandy laminations white

voids of incursions

5. Sandy S. with random pebbles

glacial deposits. pebbles 20-50mm

6. Loess clay white sand

7. Natural sandstone & rock

lens 40cm

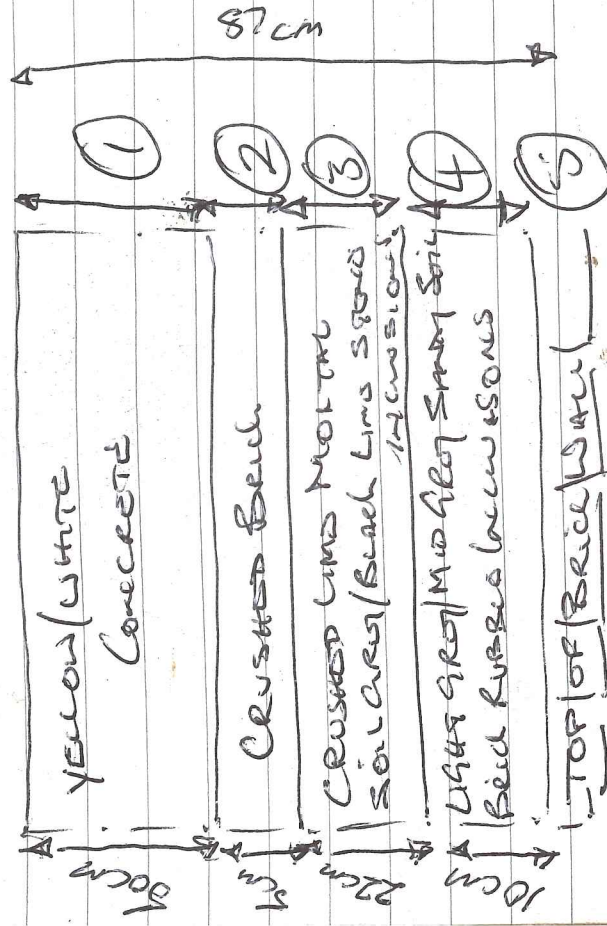
RSP Sec D.

- ① yellow/white concrete hard core surface
- ② crushed brick layer no inclusions
- ③ crushed lime/mortar - concrete with grey soil / rubble with lime stone inclusions
- ④ light grey / mid grey sandy soil bed rubble inclusions

⑤ Brick Wall of Moss Building found but plans unidentified overall purpose. Located adjacent to party wall & adjoining fence

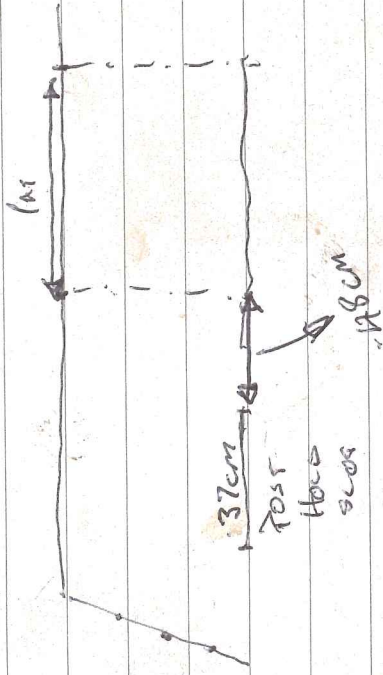
For  
Hoc  
Soc

- ① MID/DARK BROWN FINESS SANDY SILT WITH  
RED ROUND PEBBLES 3cm IN DIAMETERS
- ② MID BROWN/ORANGE FINESS SANDY SILT WITH  
+ CHANCOAL  
RED PEBBLES IN CLUSTERS 50-15cm ROUNDED PEELS  
PEBBLES <sup>4-5</sup> SLOPES UPWARDS FROM E-W
- ③ MID/DARK BROWN SILTY SAND CLAY LOAM  
INTERMEDIATE ROUNDED PEBBLES IN CLUSTERS  
SLOPES UP FROM E-W WIDENING FROM 9-18cm
- ④ LIGHT SILTY CLAY SAND LAYER IN THE SOUTH  
ROUND PEBBLES IN CLUSTERS 0.5-1cm SLOPES  
UP FROM E-W 4-7cm IN DEPTH

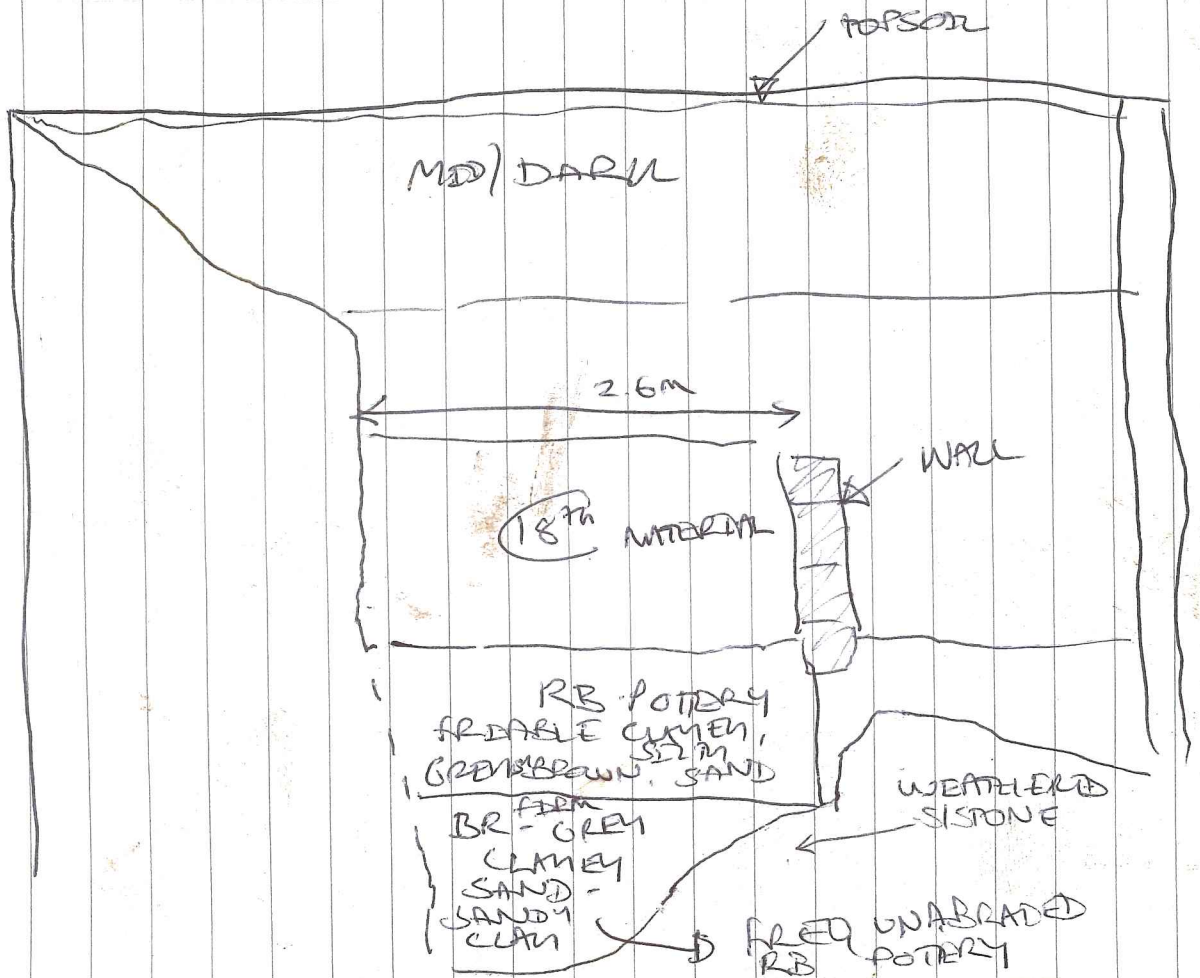
REP SEC LOCATED E

SIDE OF MOUNT WITHIN RETAINING  
WALL, S. OF DEEP STONE WALL
